1st International Workshop on Plasticity, Damage and Fracture of Engineering Materials

Investigation of fretting fatigue failure mechanism of lug-bush connection members

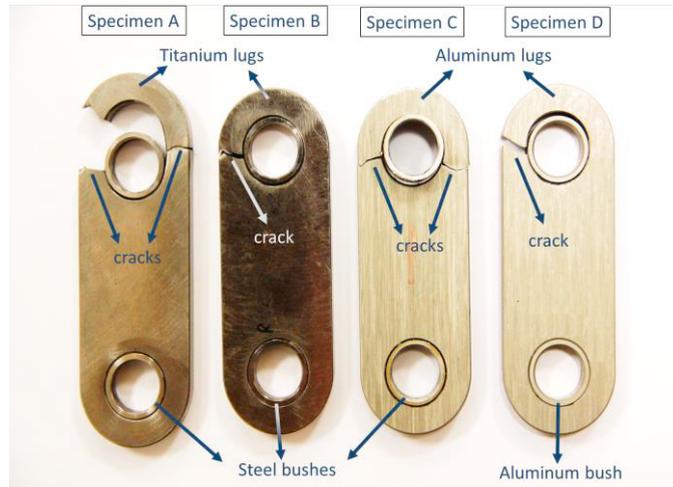
Fig. 3. Investigated lug-bush connection members, made of Ti and Al lugs with Al and steel bushes.

Under tensile fatigue loading of investigated lug-bush connection members, failure occurred at high number of cyclic tensile loads. The observed lug-bush members are made of Ti lugs with steel bushes (specimens A and B) as shown in Fig. 3. A crack initiated at the contacting surface of the lug and bush, leading to fracture of the lug. Investigations of the contact surfaces revealed black residues both on the lug and bush surfaces, as shown in Fig. 4-a.

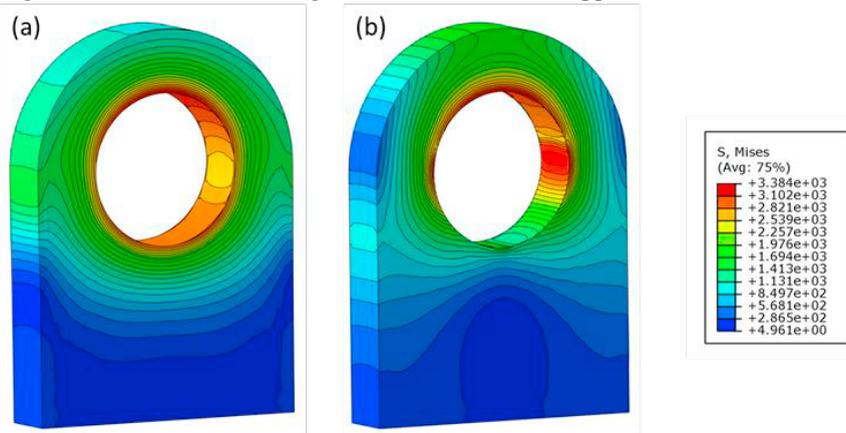
Fig. 11 shows the von Mises stress contours in the Ti lug at the end of the first and second steps. The compressive residual stresses at the lug opening after the interference of the bush is shown in Fig. 11-a. The stress level at the bottom half of the lug increases, as shown in Fig. 11-b, after the load is applied.

Fig. 11. Von Mises stress contours in the Ti lug at the end of (a) first step and (b) second step of the analysis.
