29 October 2007, Çameli earthquake and structural damages at unreinforced masonry buildings

Abstract. A recent earthquake of $M=4.9$ occurred on 29 October 2007 in Çameli, Denizli, which is located in a seismically active region at southwest Anatolia, Turkey. It has caused extensive damages at unreinforced masonry buildings like many other cases observed in Turkey during other previous earthquakes. Most of the damaged structures were non-engineered, seismically deficient, unreinforced masonry buildings. This paper presents a site survey of these damaged buildings. In addition to typical masonry damages, some infrequent, event-specific damages were also observed. Reasons for the relatively wide spread damages considering the magnitude of the event are discussed in the paper.

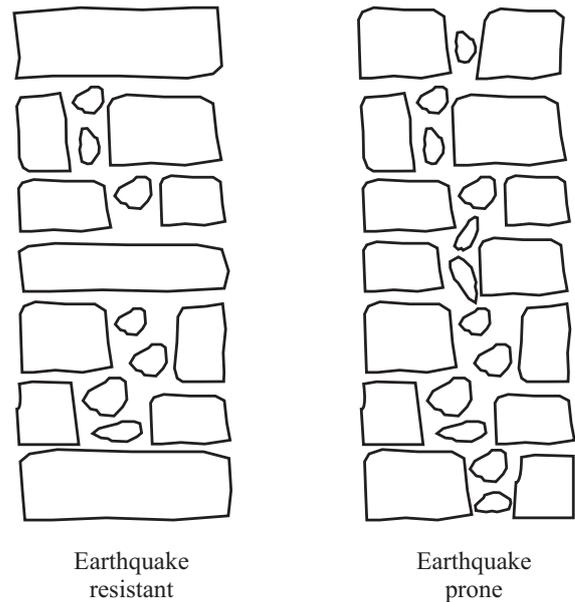
Fig. 10. Typical cross sections of earthquake resistant and fragile stone masonry walls.

Marl blocks have low strength and ductility values. When the natural stone blocks are used as a wall material, selected stones usually do not have a proper shape to be used in the masonry walls; instead they have smooth and oval surfaces. Walls were formed by varying sizes of stone blocks, from 4–5 cm to 30 cm. These variations made it impossible to form an overlapping wall section. In addition to non-overlapping wall sections, walls were composed of an inner and an outer wythes, which were not connected to each other by interlocking elements. This bad wall configuration also made the walls more prone to out-of-plane failure, as the net length of the outer wythes of walls increased considerably. Some examples of these types of damages are shown in Figs. 7–9. Typical wall section observed at the site is compared with an earthquake resistant section in Fig. 10, where lack of connection between outer and inner wythes can be seen easily.
