THE RESTORATION PROJECT OF A XIIIth CENTURY ANATOLIAN
SELJUK "MESCİD" IN KONYA WITH THE EMPHASIS ON THE MATERIALS
AND RELATED PROBLEMS

A Master's Thesis

Selim Sarp TUNÇOKU

February, 1993

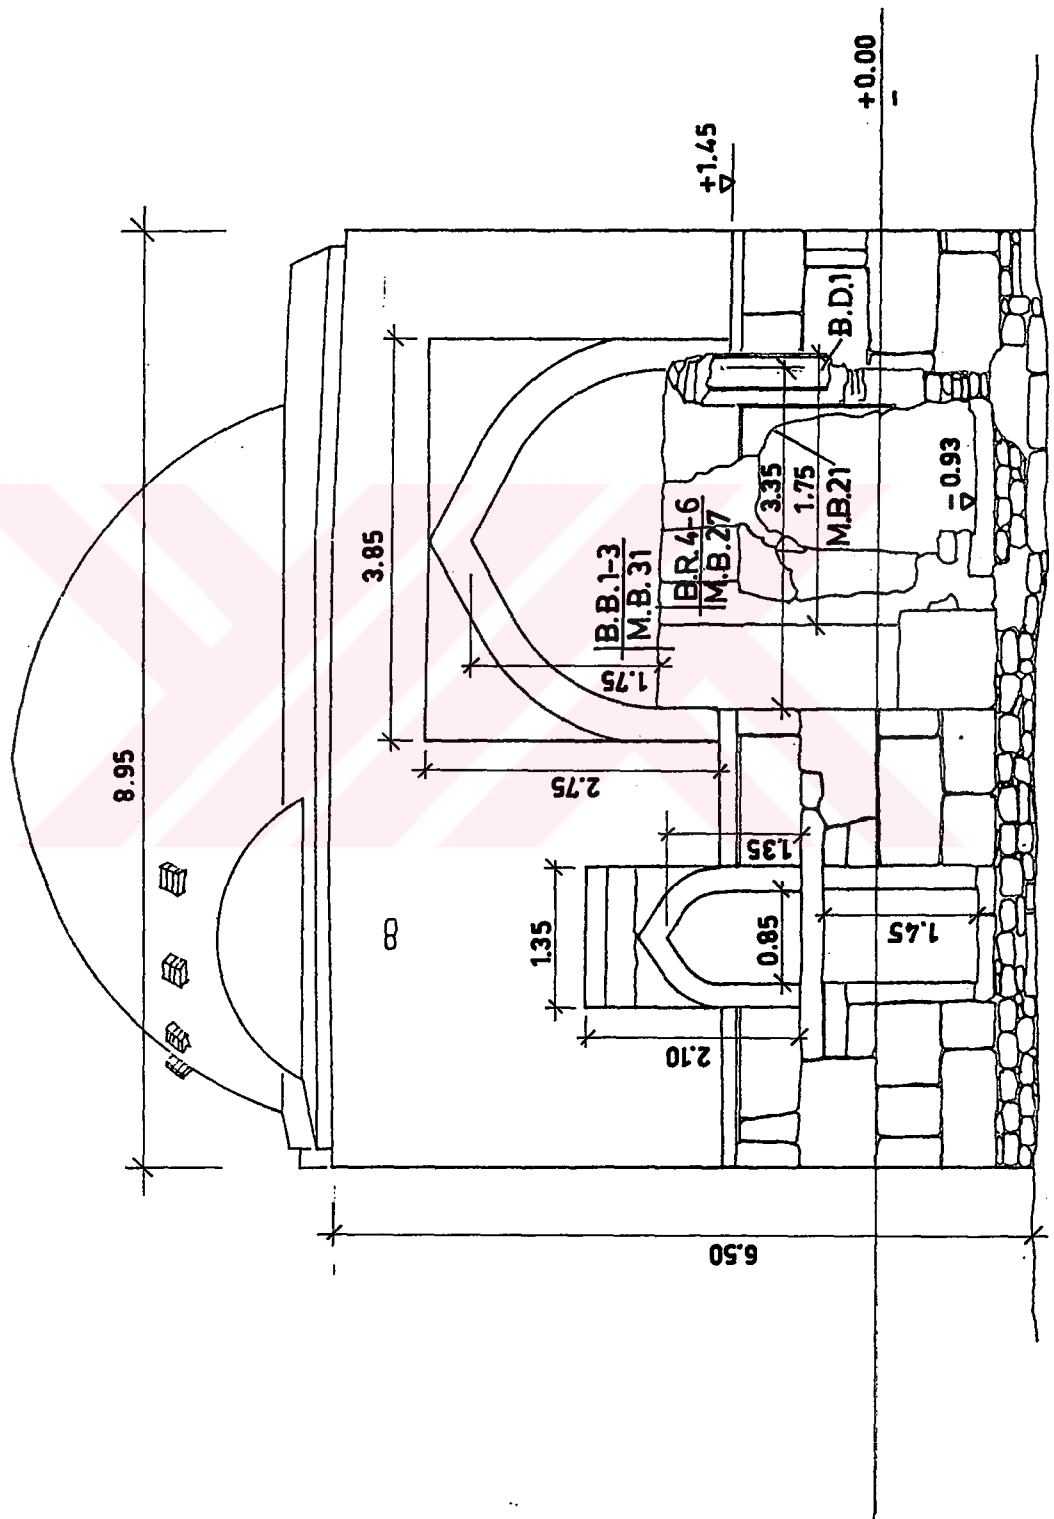
Figure 4. East Facade

a. The east facade forms a rectangle with the dimensions of 8.95m long and 6.50m high from the existing ground. Within this frame it has two openings; the one to the North placed in a rectangular frame 3.85m long, 2.75m high and recessed by 0.06m is a one centered-tangent arch providing the entrance to the "mescid" through the portal. The span of this arch is 3.15m and 1.75m is the height. The second opening to the south belonging to the "türbe" framed by a two centered tangent arch is also placed in a rectangular frame 1.35m long, 2.10m high and recessed by 0.06m same as the first opening. The span of this arch is 0.85m and it is 1.35m high. Some remains of ceramic tiles are perceived at the spandrils of this arch. The third one is the downwards continuation of the same opening with the dimensions of 0.85m wide and 1.45m high. It is filled with brick at the present (Figure 4).

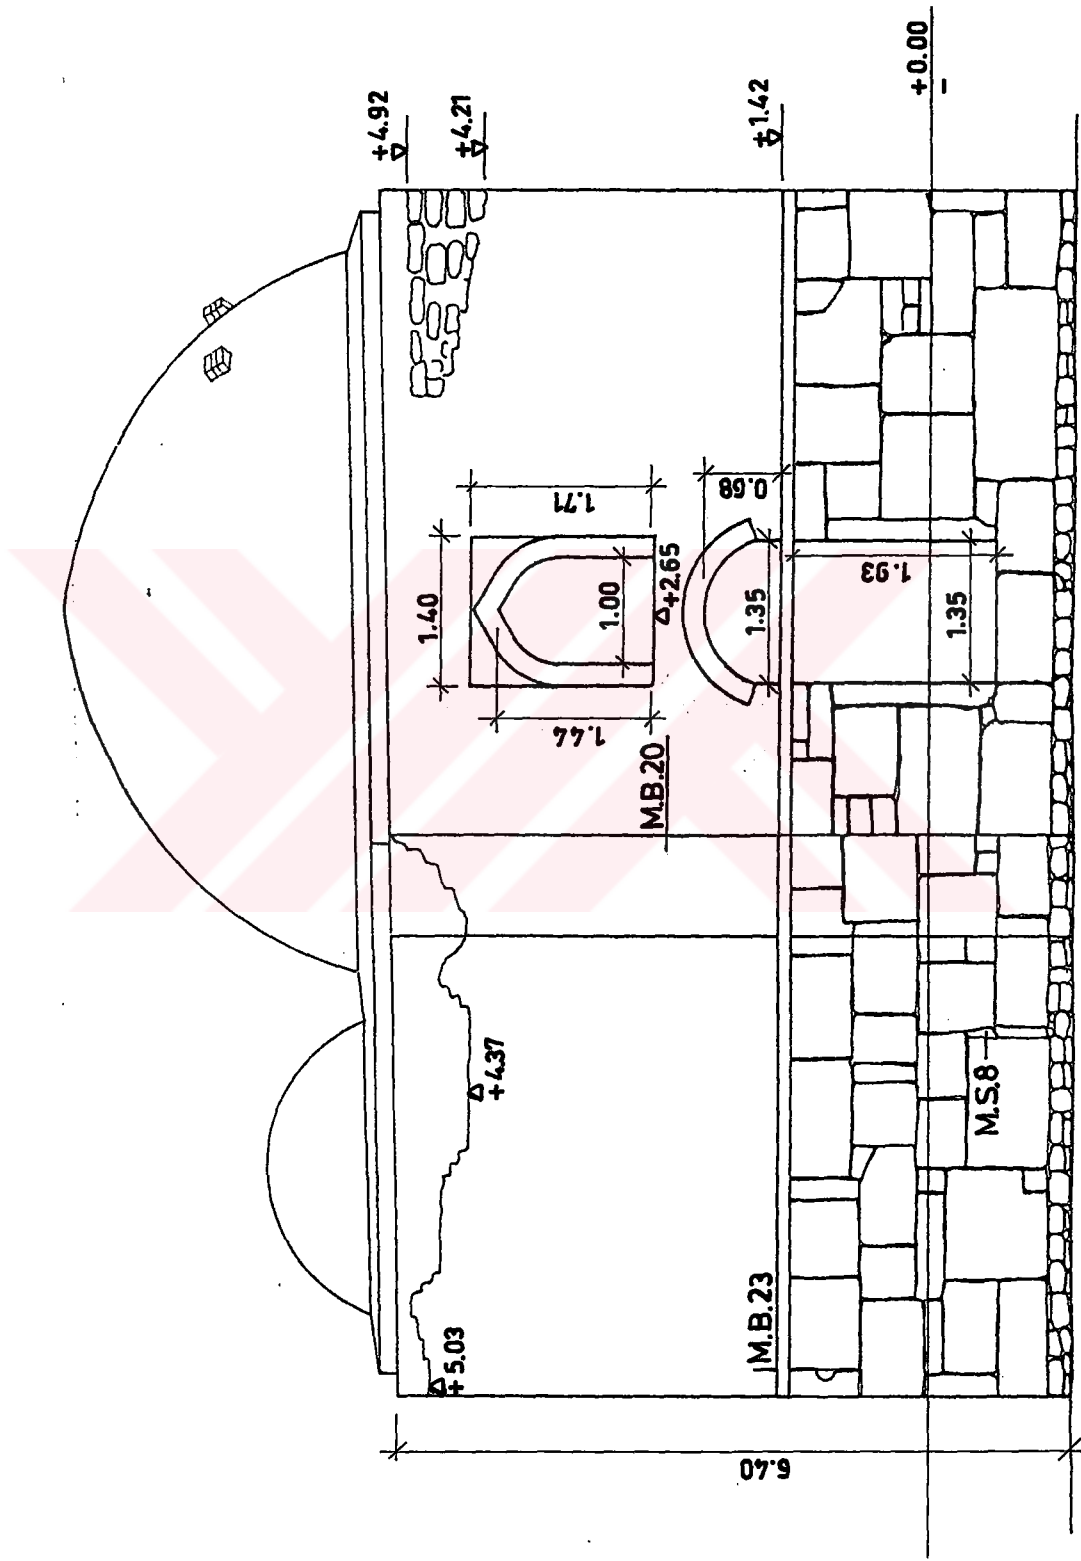
Figure 5. North Facade

b. The north facade forms a rectangular frame with the dimensions of 11.35m long, including the diagonal protrusion at the East (0.90m from the surface of the western part) and 6.40m high (Figure 5). It has two openings that are placed at the West on the same vertical axis but with different dimensions and profiles. The first one above placed in a rectangular frame which is recessed by 0.06m is 1.40m long and 1.71m high (placed at the level of +2.65) and it is framed by a two centered-tangent arch 1.00m wide and 1.44m high. The second arch below the first one is spanned by a 1.35m wide segmental arch with a 0.68m height rests upon a timber tie beam placed at the level of +1.42. The rectangular downwards continuation of this arch has the measures of 1.35m wide and 1.93m high and placed between the levels of -0.62 and +1.30. The lower part below the timber tie beam is of finely cut rectangular blocks of travertine and the upper part is brick same as the east facade. Some courses of brick remain between the levels of +437 and +5.03 of the protrusion at the East are missing. There are a few courses of rubble stone

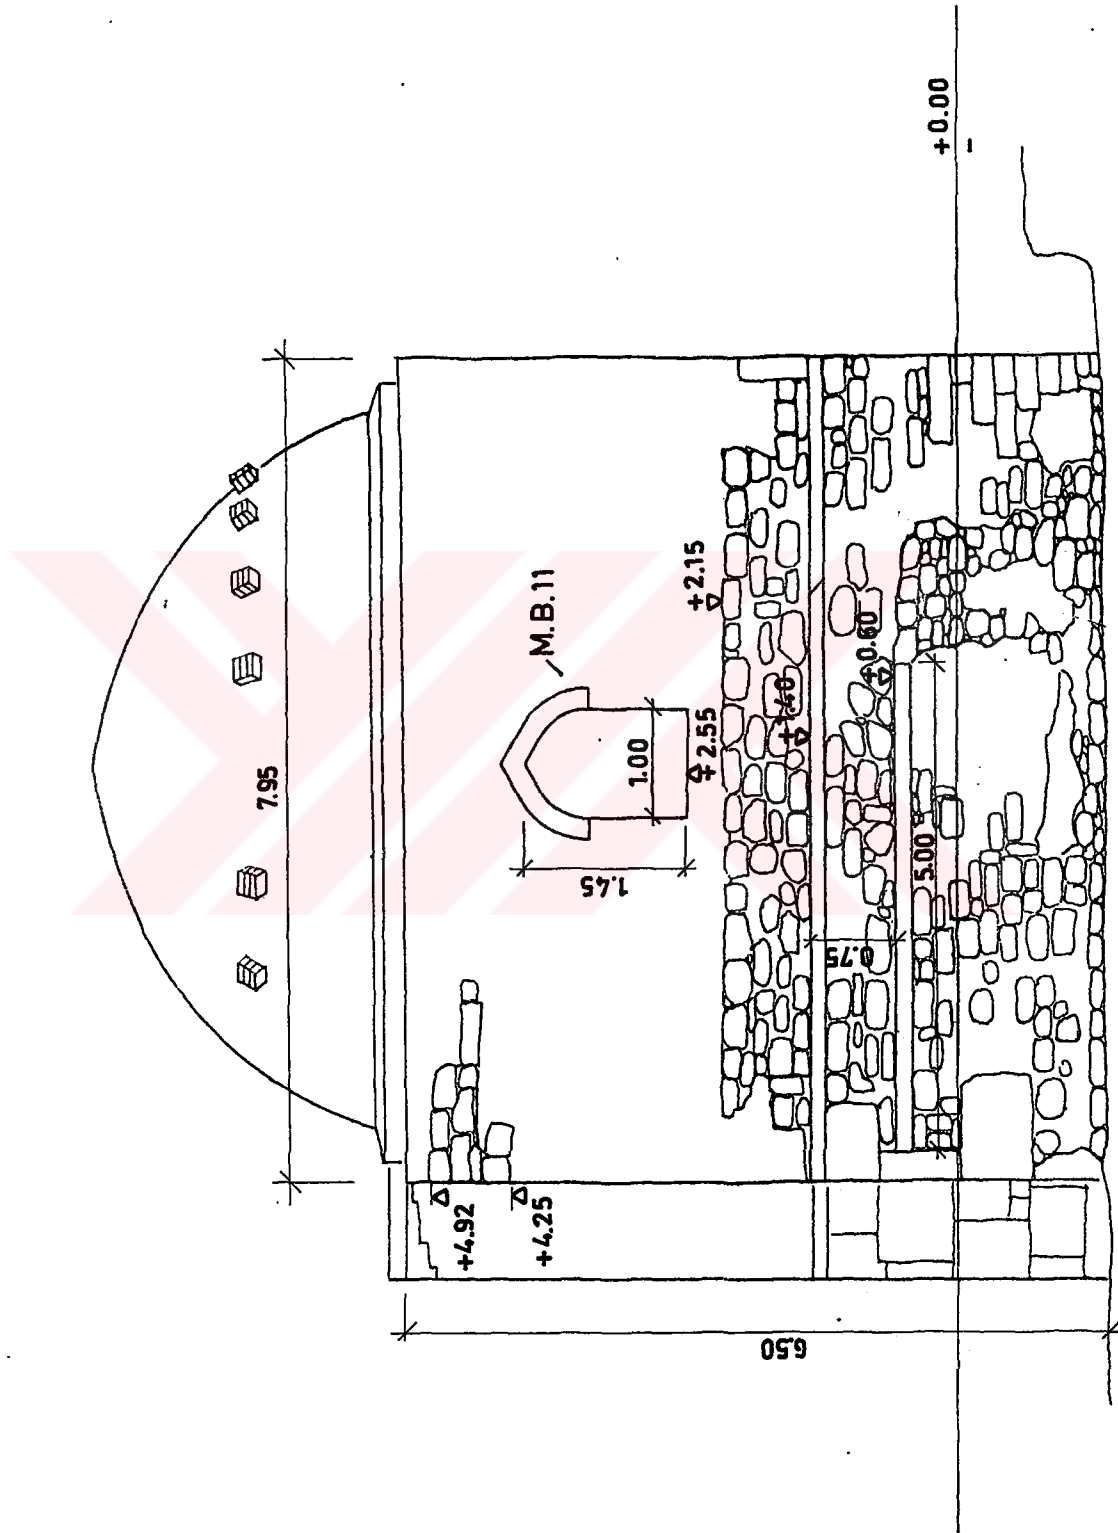
Figure 6. West Facade

c. The west facade is also a rectangle measuring 7.95m long and 6.50m high. It has only one opening placed at the level of +2.55 with the same profile and dimensions of the one above the north facade but it has no a rectangular frame (Figure 6). On the contrary of the east and north facades the stone masonry of random rubble of andesites on this facade extend over the timber tie beam to the approximate level of +2.15. In addition to this, there is a second tie beam 0.75m below the first one. The length of this tie beam which is not running throughout the facade is 5.00m. A certain part of the facade, which is approximately 2.20 square meter and placed to the South where the second tie beam ends is damaged as the discharges of mortar in the joints indicate. A few layers of rubble, in fact, the continuation of the ones at the west of the north facade, is seen between the levels of +4.25 and +4.92 to the north side of this facade.

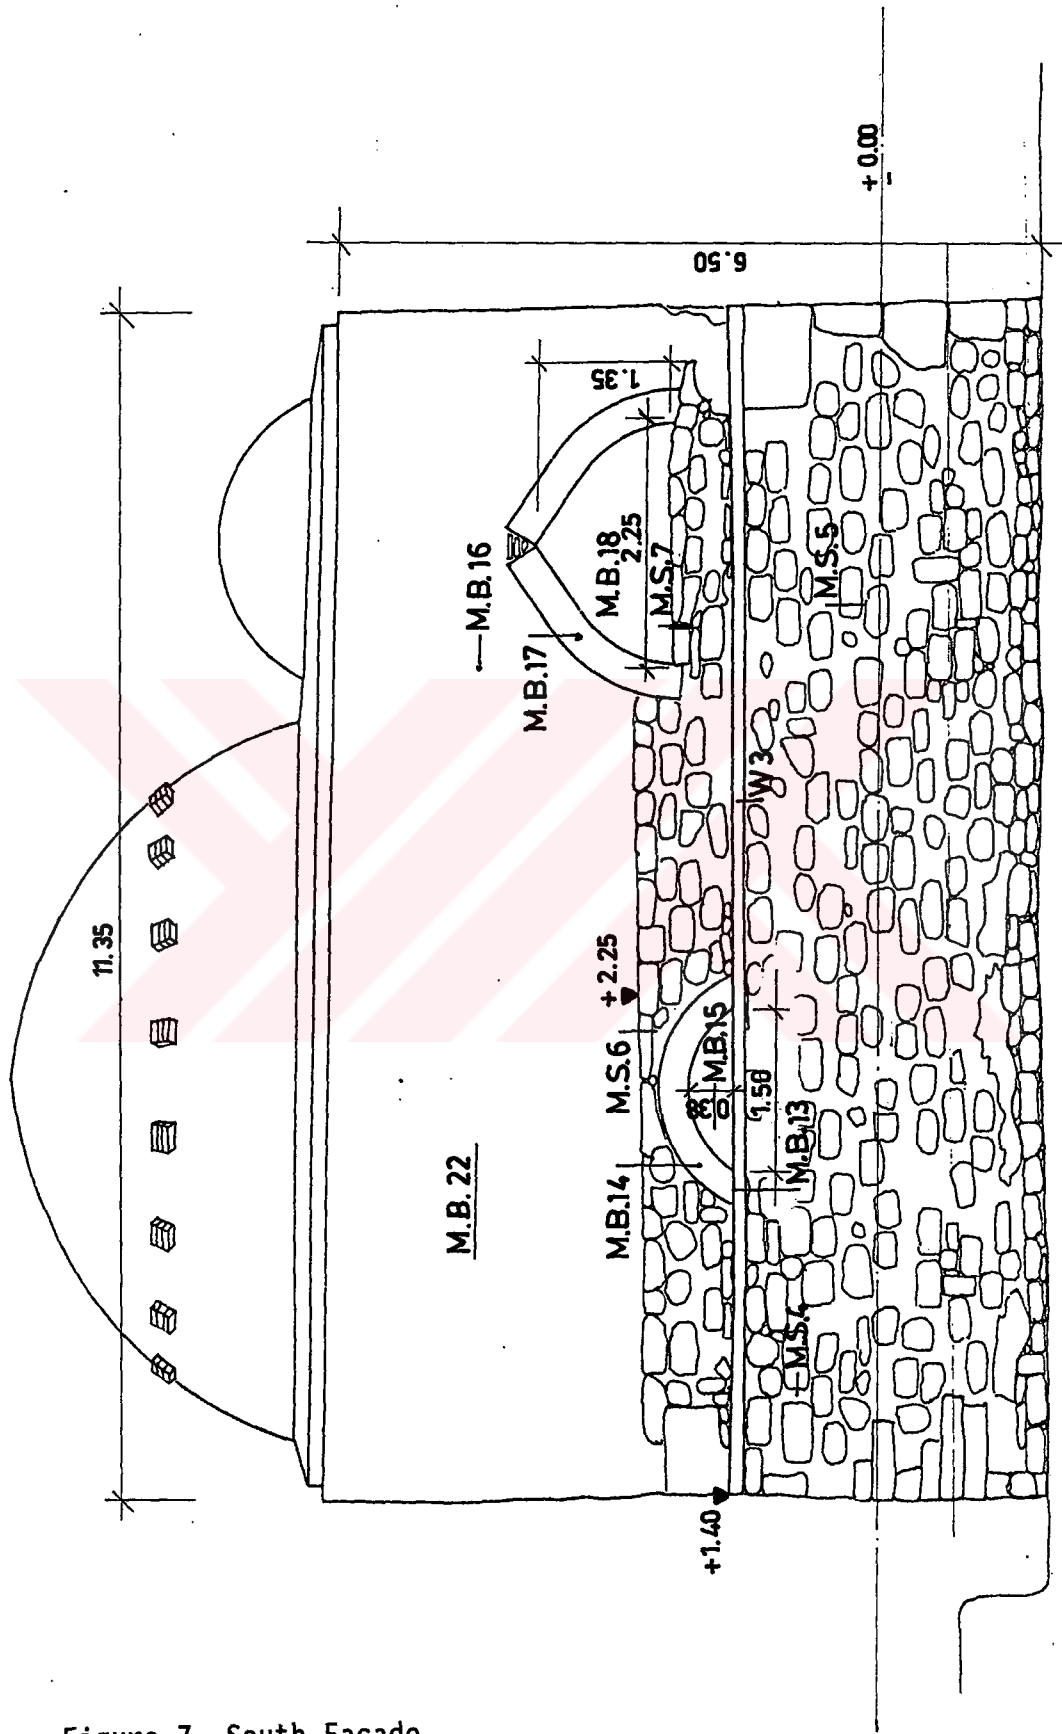
Figure 7. South Facade

d. The south facade has a rectangular frame of 11.35m long and 6.50m high. It has no opening but two different types of relieving arches are the prominent elements in the overall facade (Figure 7). The first one to the West is a segmental arch with a span of 1.50m and 0.38m high from the timber tie beam placed at the level of +1.40. The second arch to the East is a one centered tangent arch. The span of this arch is 2.25m and 1.35m is the height measured from the tie beam. The extension of the rubble layers, till the level of +2.25 above the tie beam is also seen at this facade. The brick arch at the West remains within this zone.

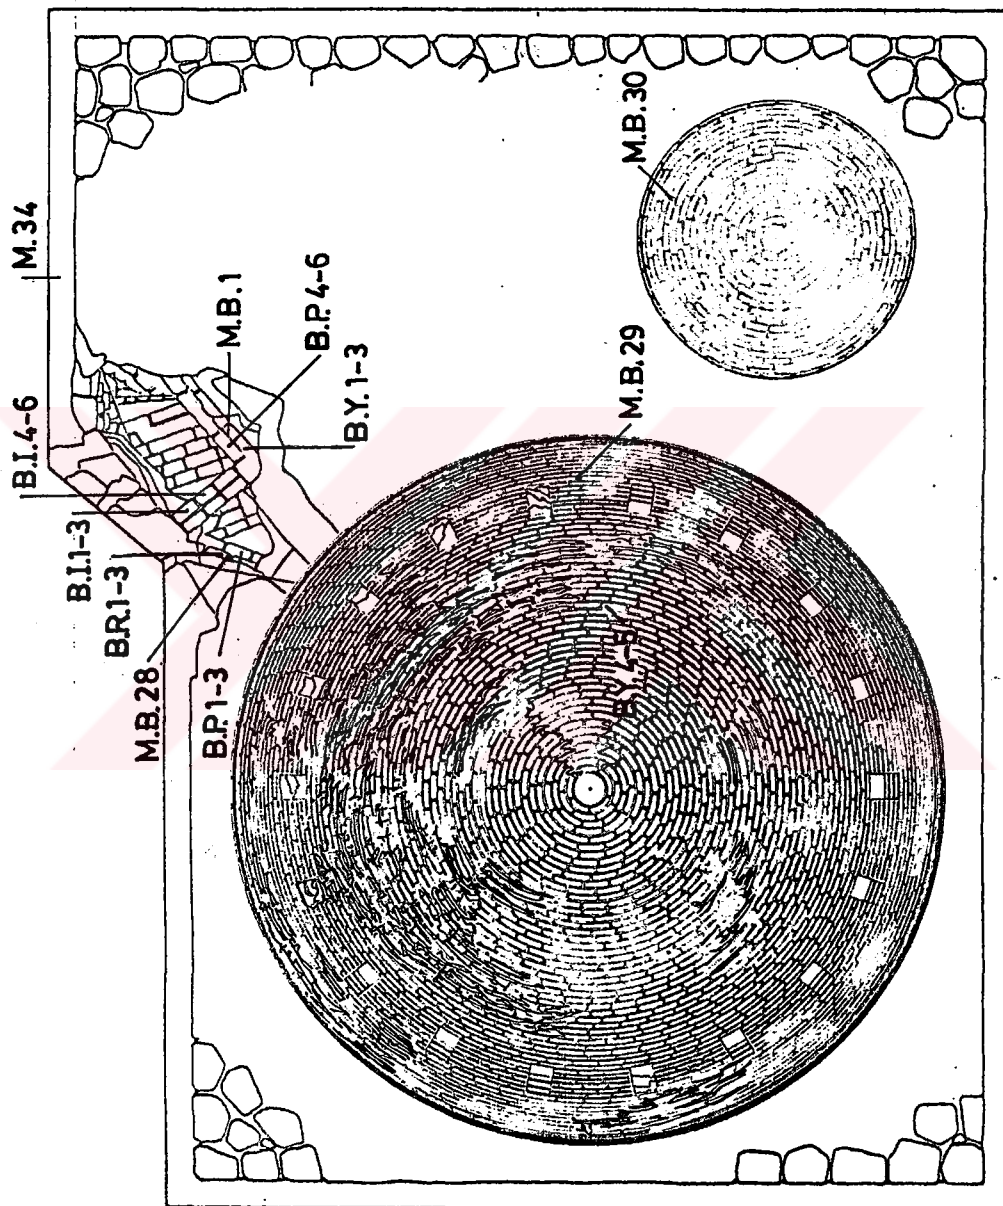
Figure 8. Roof Plan

e. The roof consists of two domes and a flat part inclining towards the north-east corner. It is reached by a horizontal opening through the stairs which are accessed by the north wall of the entrance hall (Figure 8). The edges of this opening are damaged. Exterior face of the larger dome with the approximate external diameter of 6.75m has eighteen spurs nine of which are missing. They are placed around the dome with the almost equal intervals of 0.75m at the approximate level of 1.05m from the roof surface. The smaller dome has 2.5m external diameter and 0.75m high from the roof surface. It is plastered. The flat part at the north-east corner and the other flat surfaces where the domes rest are covered with cement, applied in later years probably in 1958, for the purpose of insulation.

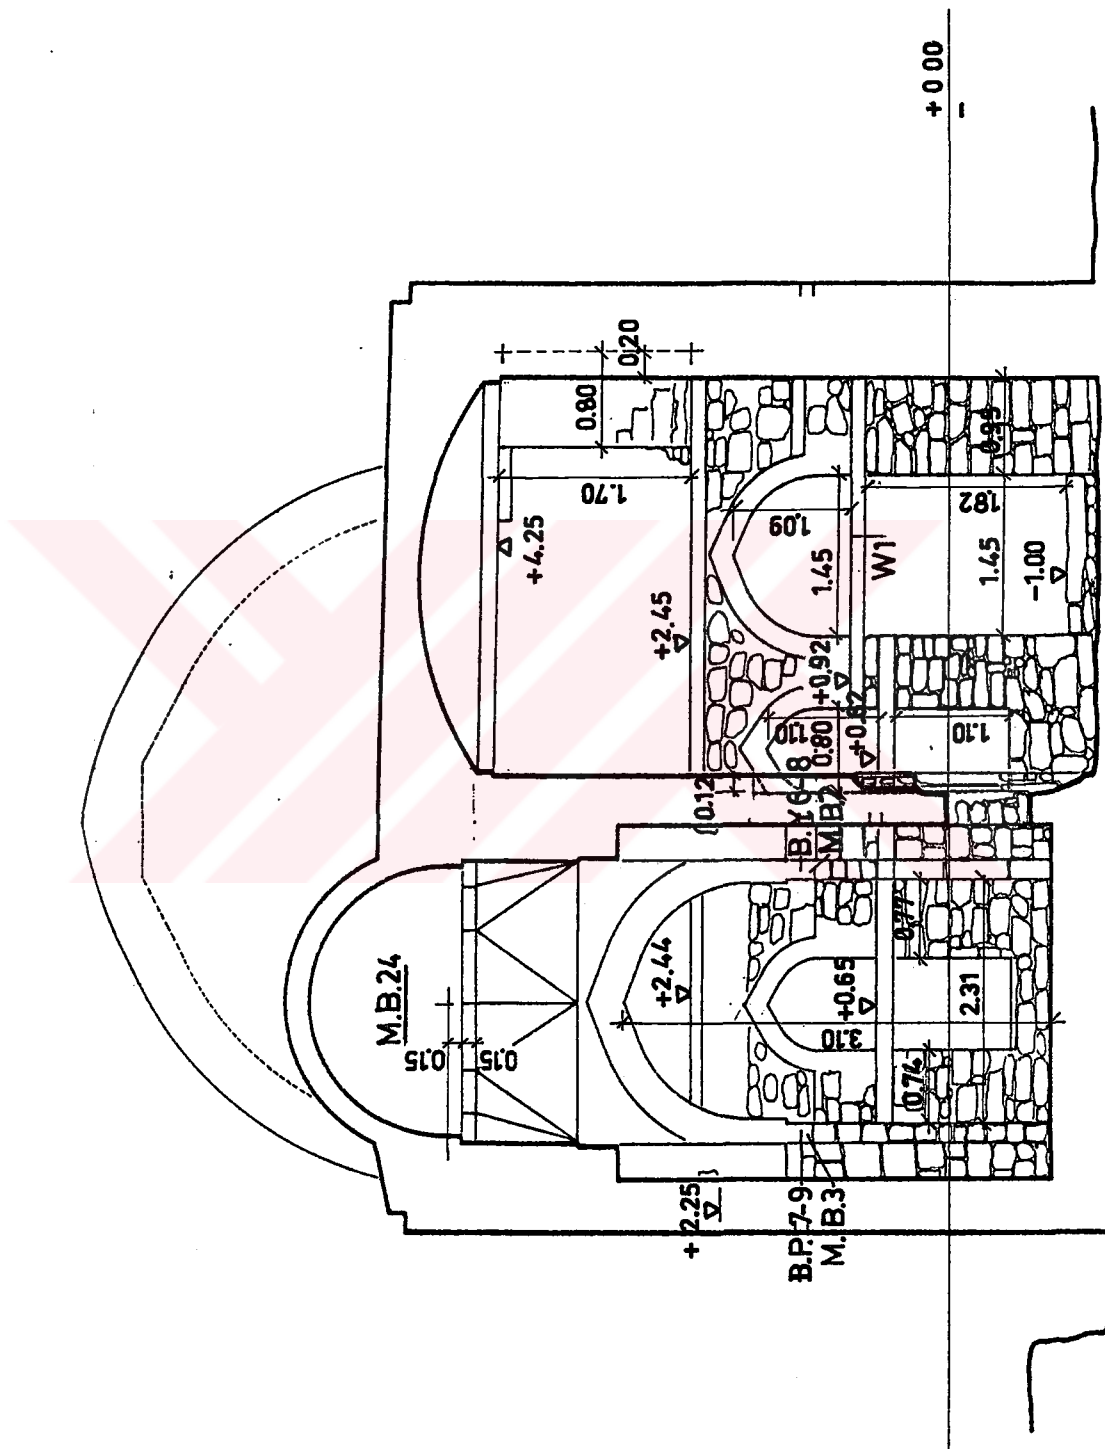
Figure 11. Section 3-3

The first opening is placed on the west wall at the distance of 0.95m from the north corner (Figure 11). The above part of this opening is spanned by a one centered-tangent arch 1.45m wide and 1.09m high resting upon the timber tie beam at the level of
