Assessment of kinematic rock slope failures in Mudurnu Valley, Turkey

A Arslan Kelam¹, H Akgun¹, A Bobet² and MK Kockar³

¹ Geotechnology Unit, Department of Geological Engineering, Middle East Technical University (METU), Ankara, Turkey

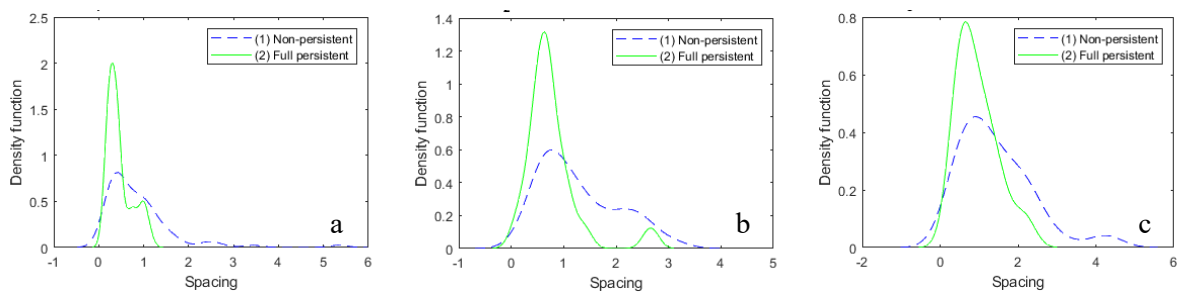
Figure 6. Density function of spacing of a) BP, b) J1 and c) J2 for Sector 8.

The discontinuity spacing and persistence distributions were also obtained with the DSE method. The spacing was found to be log-normally distributed. The probability density functions of each set are given in figure 6. The BP spacing has a maximum value of 1.13 m, with a mean value of 0.46 m and standard deviation of 0.28 m. The maximum spacing of J1 was 2.66 m, the distribution had a mean value of 0.77 m and standard deviation of 0.52 m. J2 had a mean value of 0.95 m and standard deviation of 0.51 m where the maximum spacing is 2.22 m. The persistence measurements of Sector 8 are given in figure 7. Table 1 summarizes the values obtained by scan-line survey and DSE method. The results show that the discontinuity sets are persistent and the persistence is limited by the length of the studied sectors.
