# Preliminary Report on Engineering and Geological Effects of the January 24, 2020 Magnitude 6.7 Earthquake in Elaziğ, Turkey

A report of the NSF-Sponsored Geotechnical Extreme Event Reconnaissance Association

Report GEER-065

**January 24, 2020 Elazığ-Sivrice Earthquake ( $M_w=6.8$ )  
Reconnaissance Study Report**

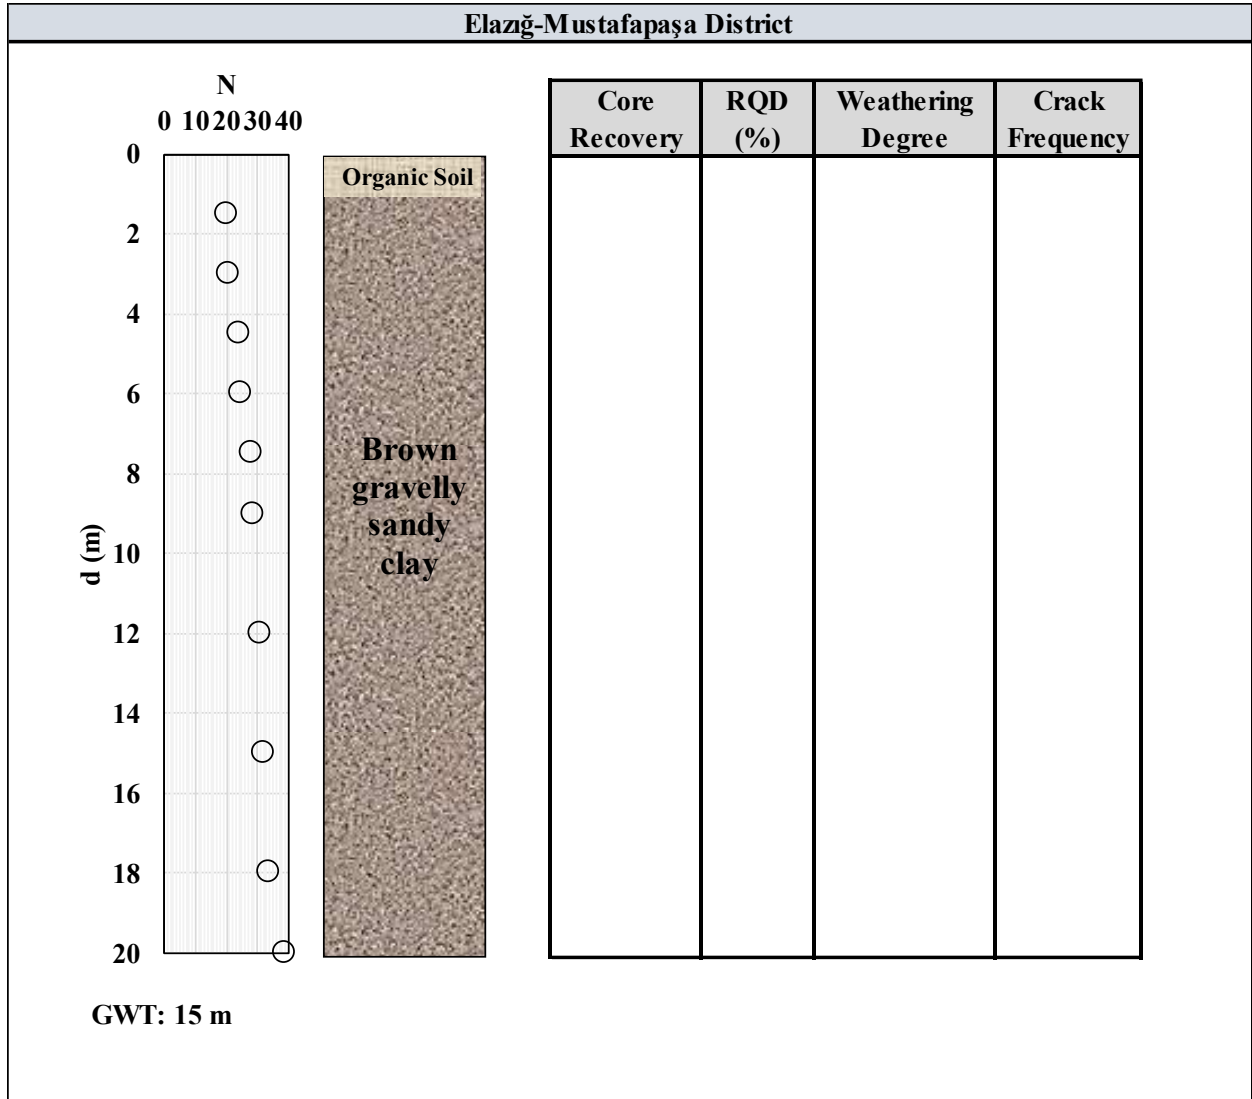
Figure 4.1. Typical Borelog for Elazığ-Mustafapaşa District

Several structurally damaged residential buildings were mapped in Elazığ-Mustafapaşa district, which is located in the city center of Elazığ city. Mustafapaşa district consists of Plio-Quaternary aged young sediments. Typical soil type observed in the district is classified as brown gravelly sandy clay. Groundwater table is typically observed at 15 meters. A representative lithology is presented in Figure 4.1. Shear wave velocity of the upper 30 m ( $V_{s,30}$ ) for the region is estimated as 300-350 m/s by Multi-Channel Surface Wave Analysis Method (MASW). Note that the borelog given in Figure 4.1 reflects idealized soil conditions, which may not representative for the whole district.

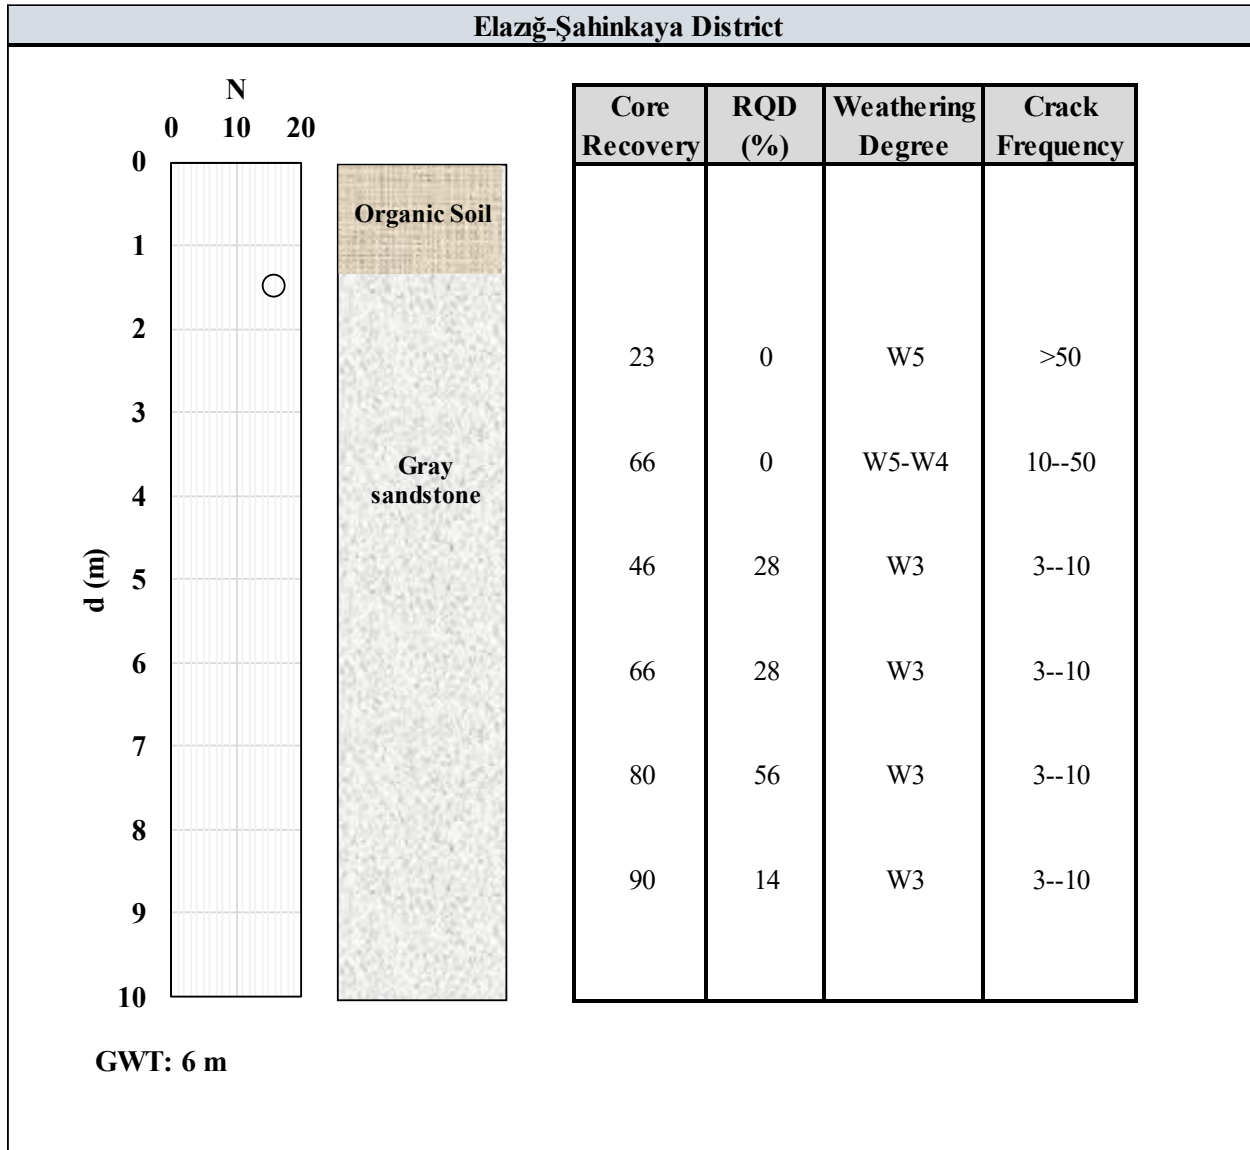
Figure 4.2. Typical Borelog for Elazığ-Şahinkaya District

In Şahinkaya district, again a concentration of structural damage has been observed. The district foundation soil/rock profile is composed of mostly weathered sandstone. The weathering and fracturing decreases with depth. Groundwater table is located at 6 meters. A representative soil/rock profile is presented in Figure 4.2. Shear wave velocity of the upper 30 m ( $V_{s,30}$ ) for the district is estimated as 400-500 m/s by Multi-Channel Surface Wave Analysis Method (MASW).

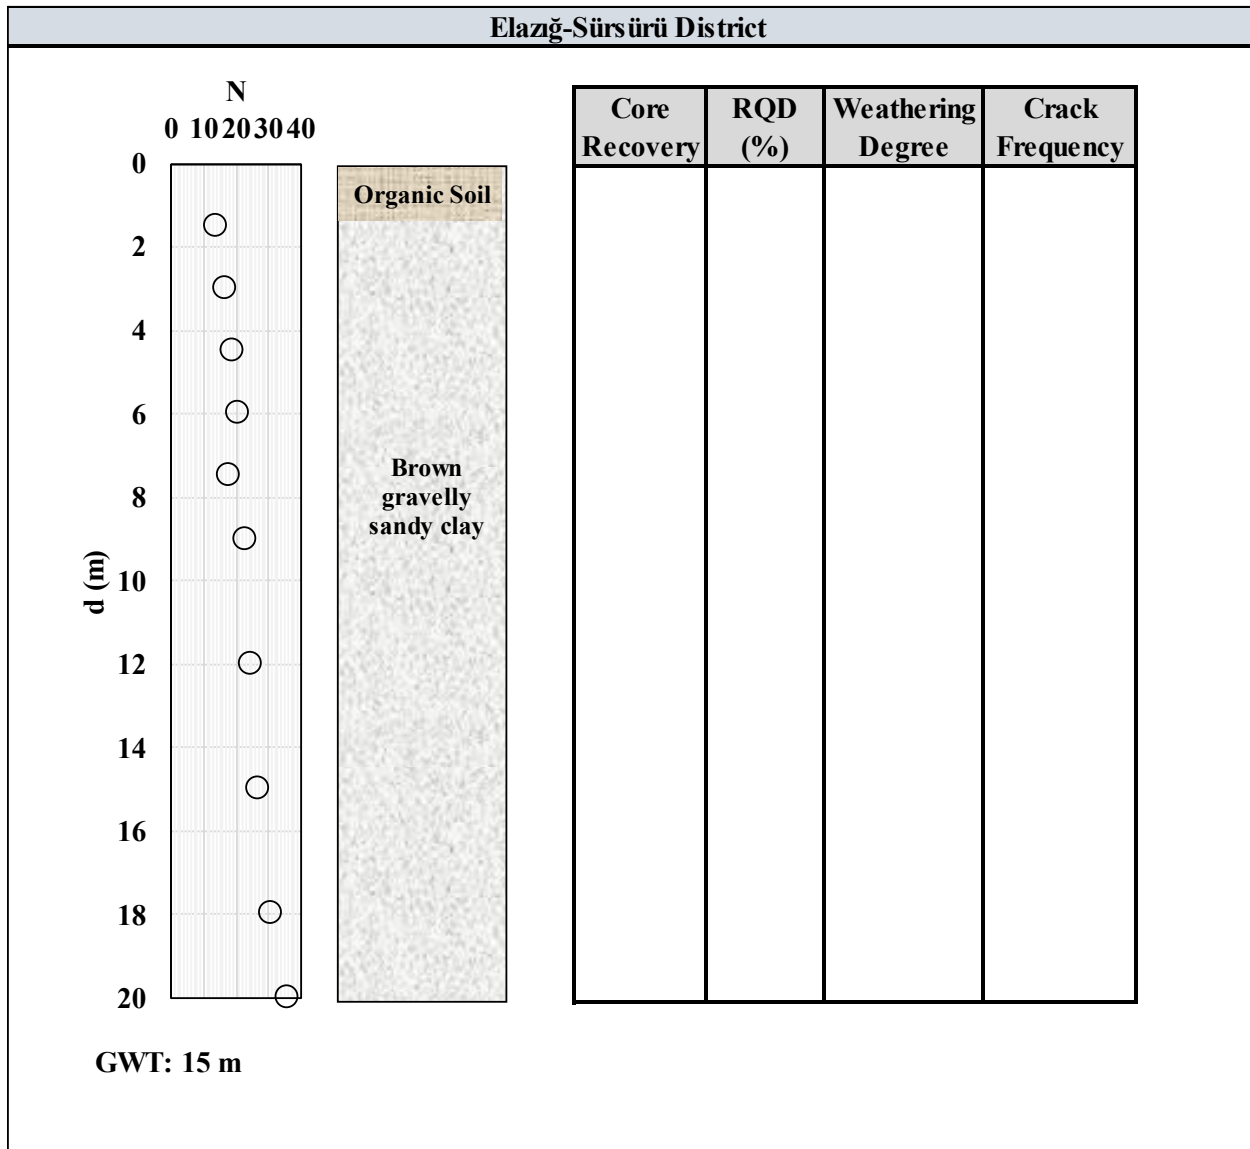
Figure 4.3. Typical Borelog for Elazığ-Sürsürü

The most of the structural damage had been concentrated in Elazığ-Sürsürü district, where Plio-Quaternary aged young sediments dominate foundation profiles. The upper surficial layers are classified as brown gravelly sandy clay. Groundwater table is located below 15 m depth. Two representative lithology are presented in Figure 4.3. Shear wave velocity of the upper 30 m ( $V_{s,30}$ ) for the region is estimated as 350-400 m/s by Multi-Channel Surface Wave Analysis Method (MASW).

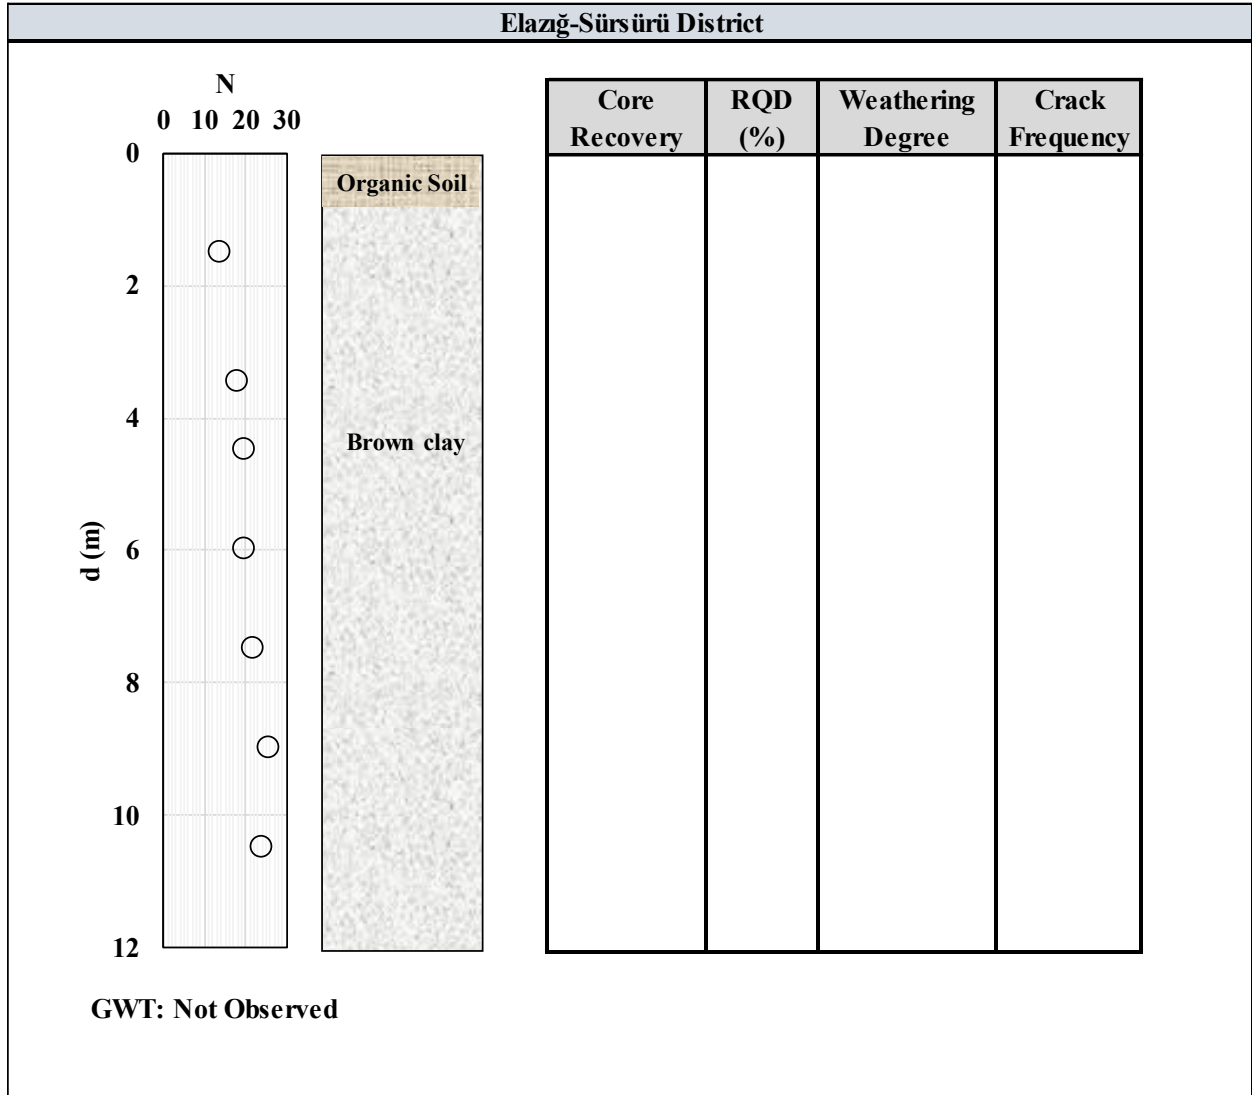
Figure 4.4. Typical Borelog for Elazığ-Sürsürü District

During the site visit, a field investigations study including borehole drilling, undisturbed and disturbed soil sampling with SPT measurements, was witnessed. The borelog of this study is retrieved by personal communication and is presented in Figure 4.4.

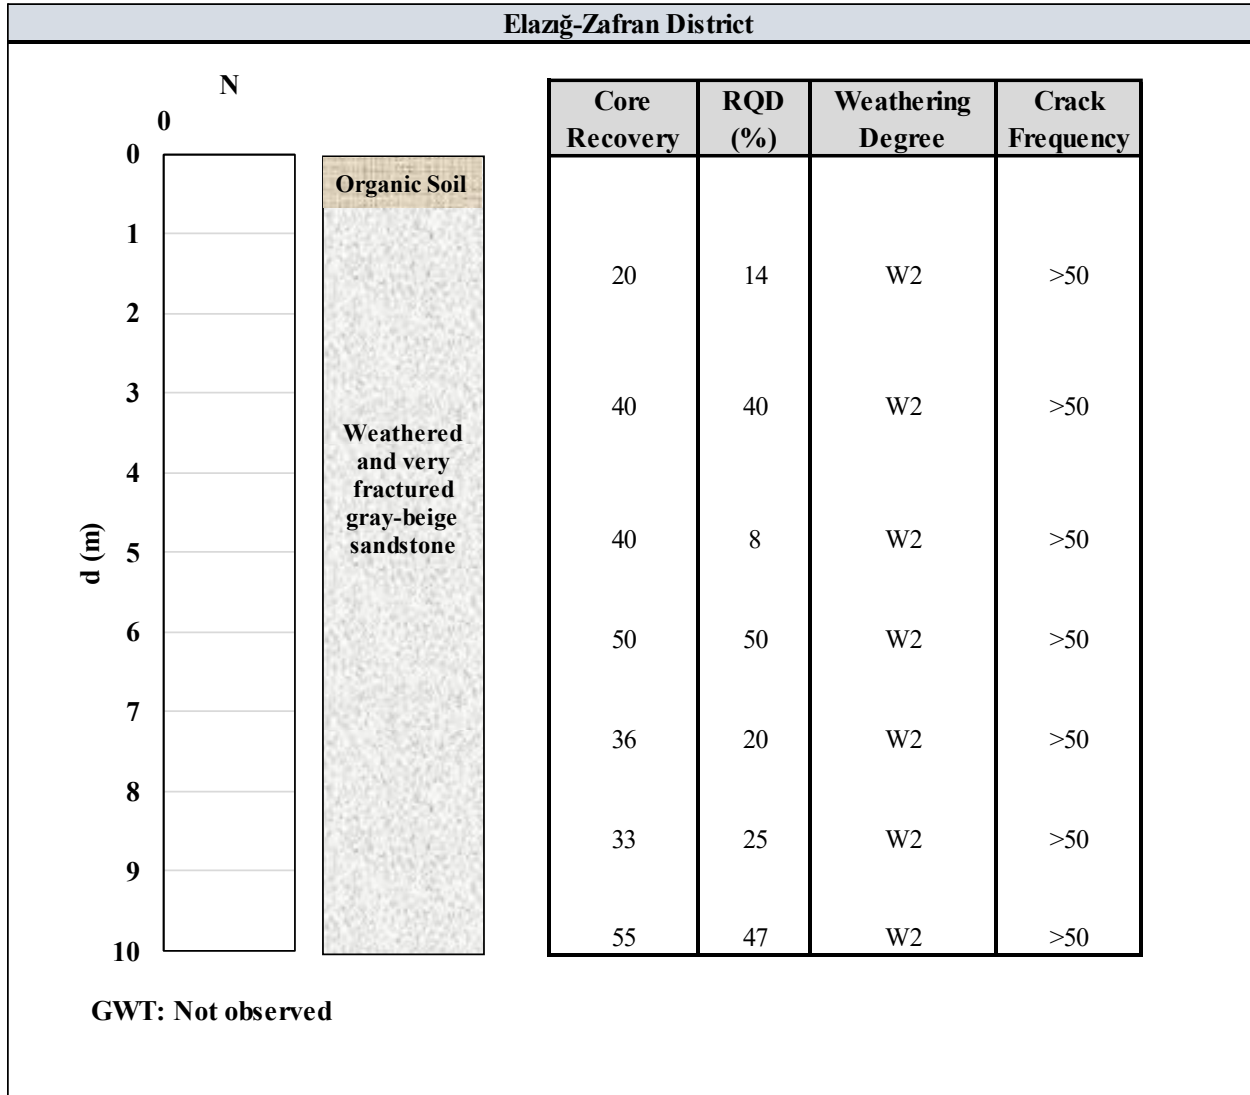
Figure 4.5. Typical Borelog for Elazığ-Zafran District

Mainly weathered and fractured gray-beige sandstone is observed in Elazığ-Zafran District. The rock becomes relatively intact with depth. Groundwater table is observed to be deeper than 10 meters. A representative soil/rock profile is presented in Figure 4.5. Shear wave velocity for the upper 30 m ( $V_{s,30}$ ) is estimated as 650-700 m/s by Multi-Channel Surface Wave Analysis Method (MASW). The structural damage patterns specific for the district are not available yet, and will be the scope of future studies.

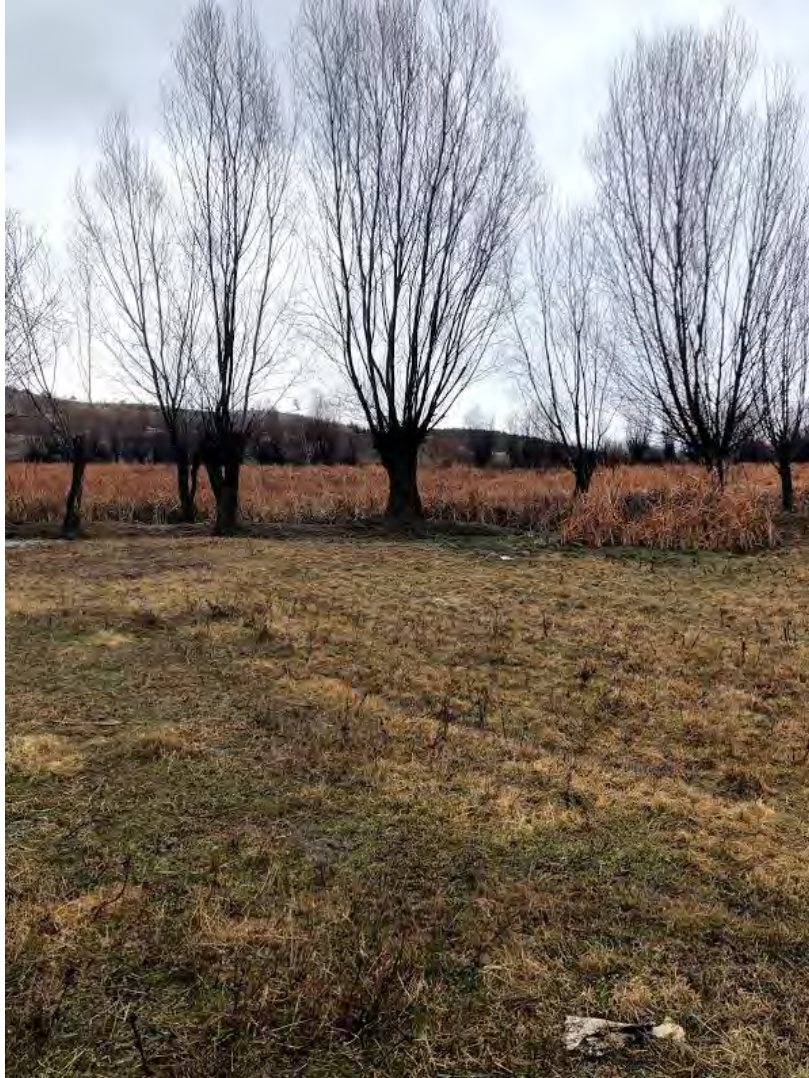
The surficial soils and the alluvial geological setting are concluded to be suitable for liquefaction triggering. However, no signs of liquefaction in the form of sand boils, lateral spread, excessive settlements, etc. were observed at the first stop, as shown in Figure 4.8.

Figure 4.8. A view of the site taken by Sivrice road  
(38°28'08.6"N 39°16'40.2"E / 31.01.2020 / 11:47)

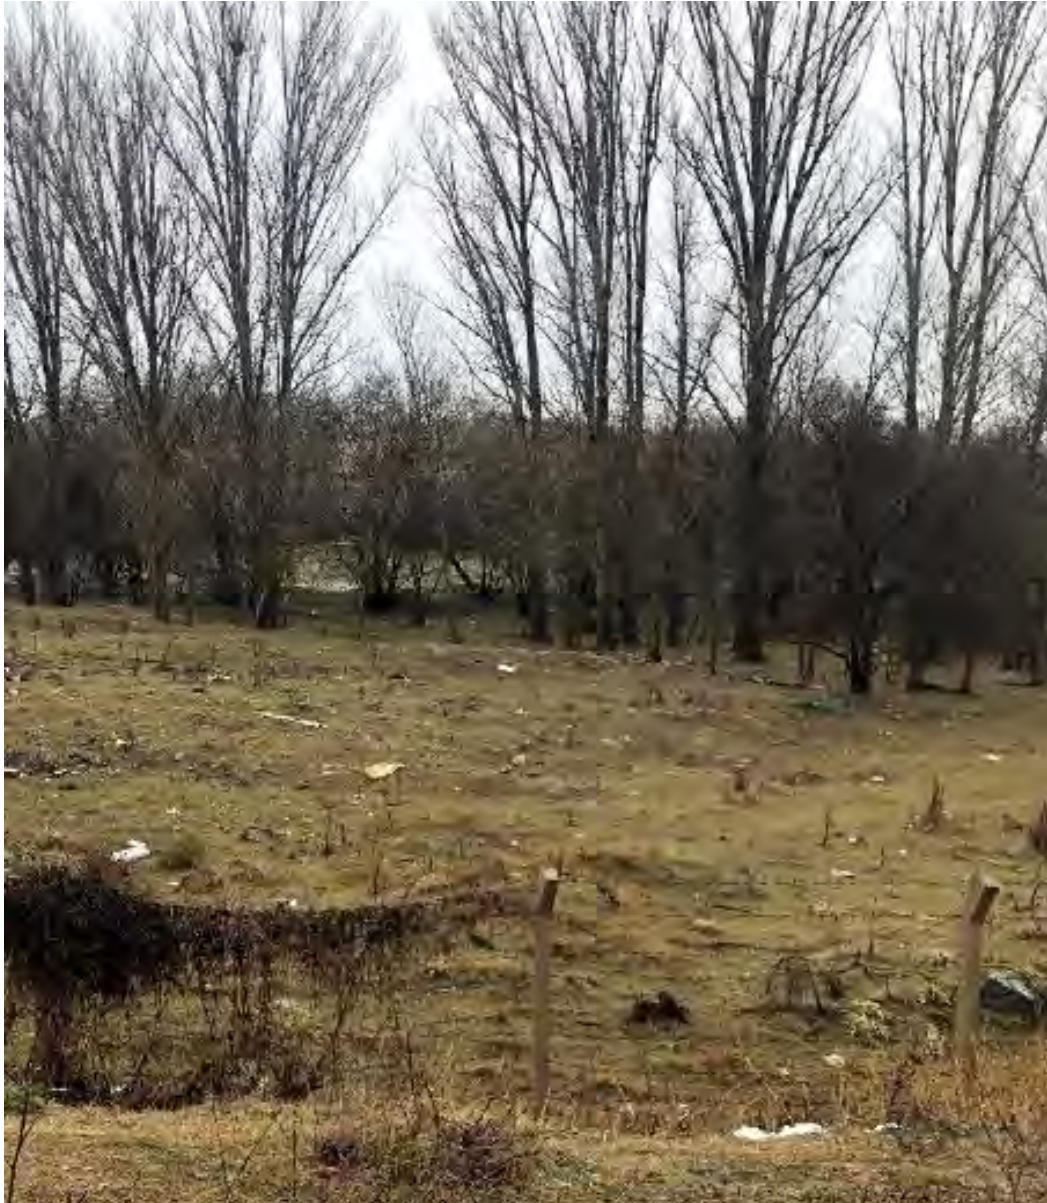
On the first stop just down the road embankment, a neighboring site was also visited, as shown in Figure 4.10. The site is composed of surficial clayey soils based on field observations. No damage and surface manifestation of ground deformations were observed.

Figure 4.10. Clayey site and no signs of ground failure  
(38°28'09.0"N 39°16'46.8"E / 31.01.2020 / 11:51)

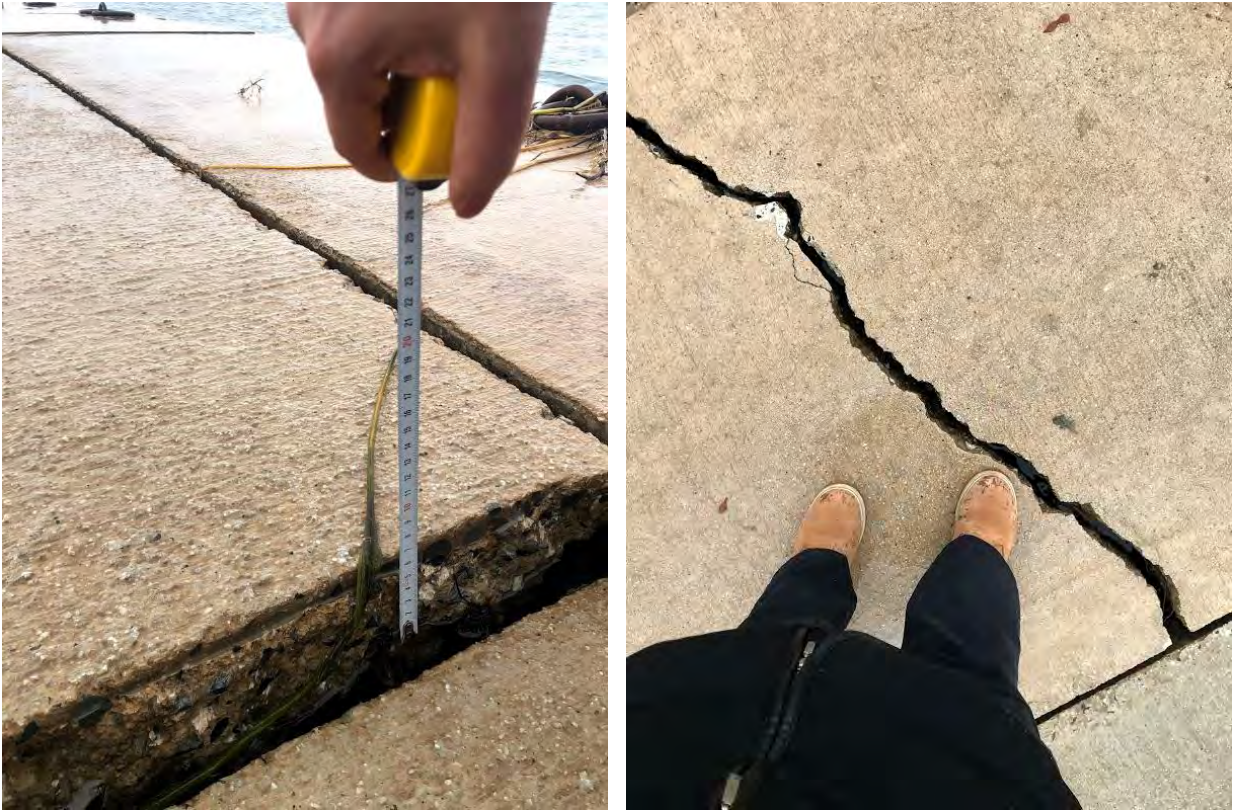
Seismically-induced lateral spreading and volumetric settlements were observed on the natural beach of Hazar Lake shoreline and Sivrice dock. Observed ground failure was mapped and discussed in a detailed manner in Section 4.7. Distribution of volumetric settlement and lateral displacements are mapped as shown in Figures 4.12 to 4.19, respectively. Next to the lake beach, where liquefaction manifestation is observed, a neighboring beach has exhibited no signs of ground failure, as given in Figure 4.20 and 4.21.

Figure 4.13. Measurements of seismically-induced volumetric settlement in the dock of Hazar Lake  
( $38^{\circ}26'53.1''N$   $39^{\circ}18'53.6''E$  / 31.01.2020 / 12:16 &  $38^{\circ}26'53.2''N$   $39^{\circ}18'52.9''E$  / 31.01.2020 / 12:13)

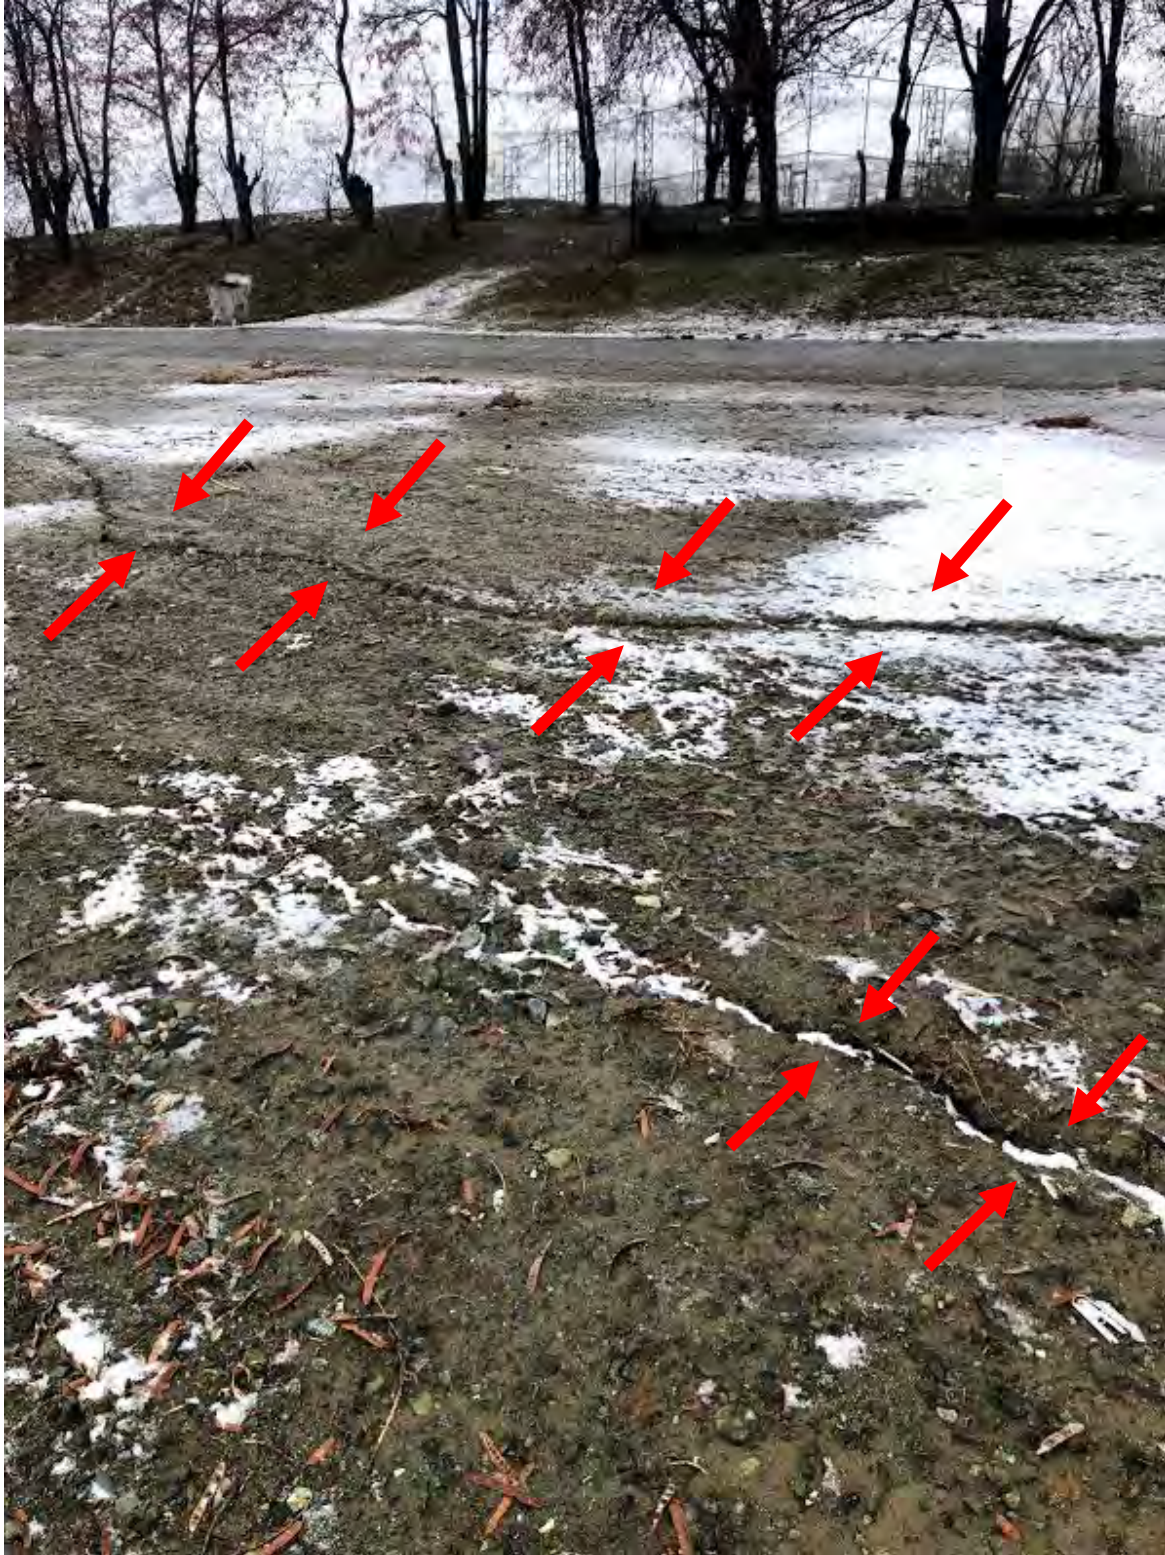
Figure 4.16. Seismically-induced lateral spreading ground deformations mapped on the beach of Hazar Lake  
( $38^{\circ}26'50.7''N$   $39^{\circ}18'56.7''E$  / 31.01.2020 / 12:28)

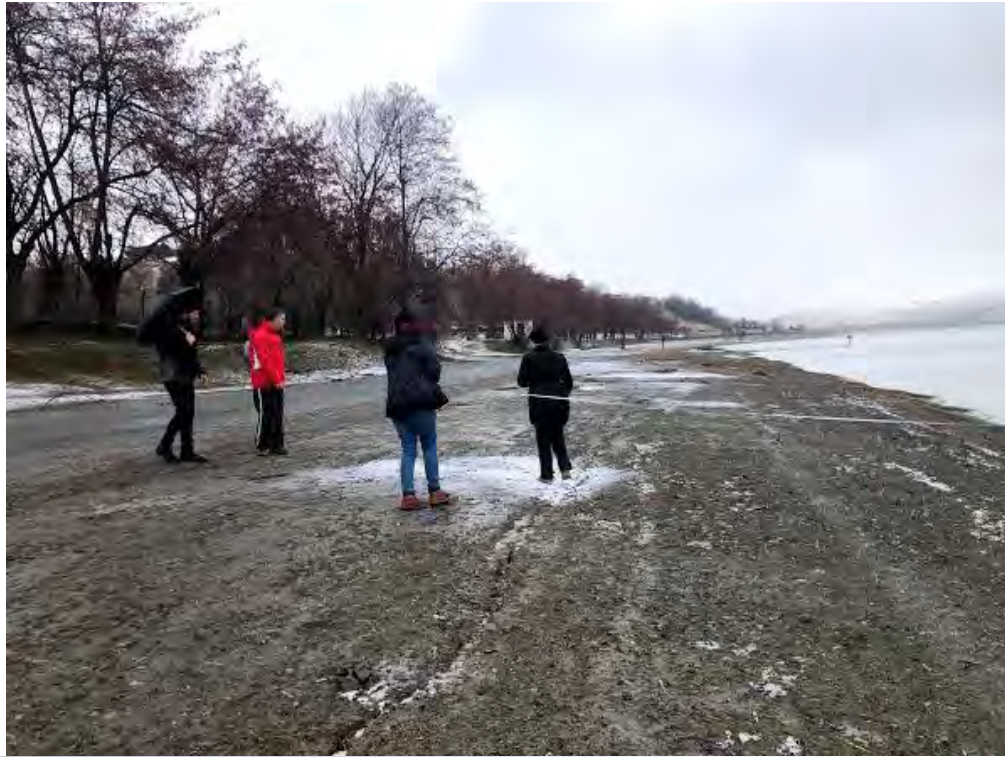
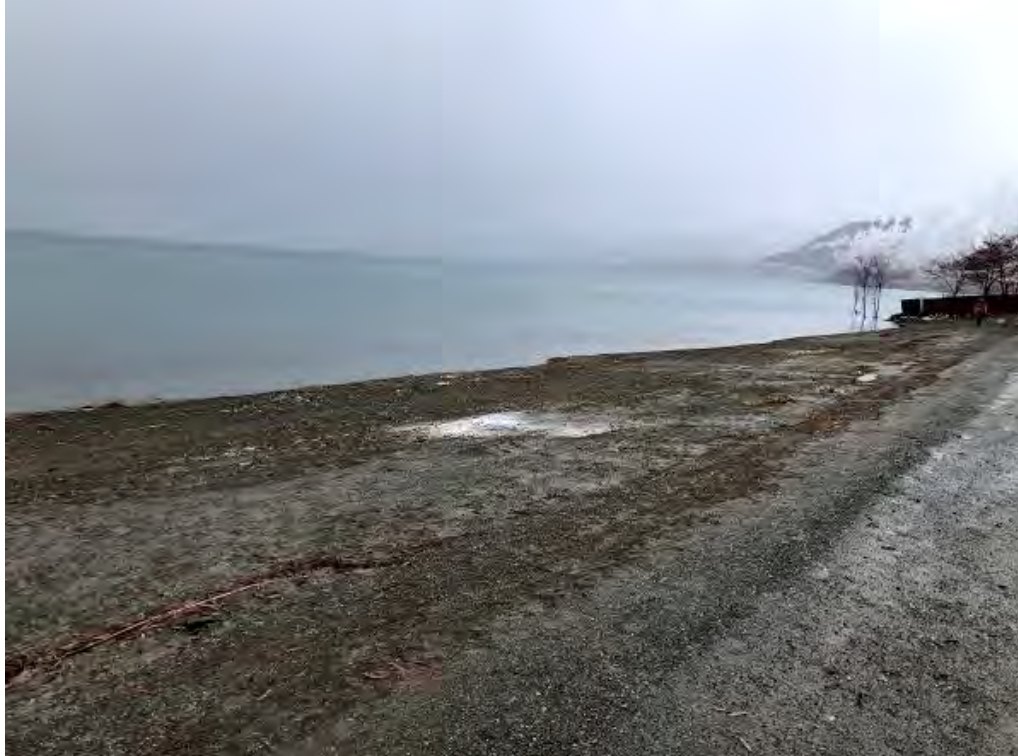
Figure 4.17. Seismically-induced lateral spreading on the beach of Hazar Lake  
( $38^{\circ}26'48.4''N$   $39^{\circ}18'57.4''E$  / 31.01.2020 / 12:31 &  $38^{\circ}26'50.1''N$   $39^{\circ}18'57.2''E$  / 31.01.2020 / 12:54)

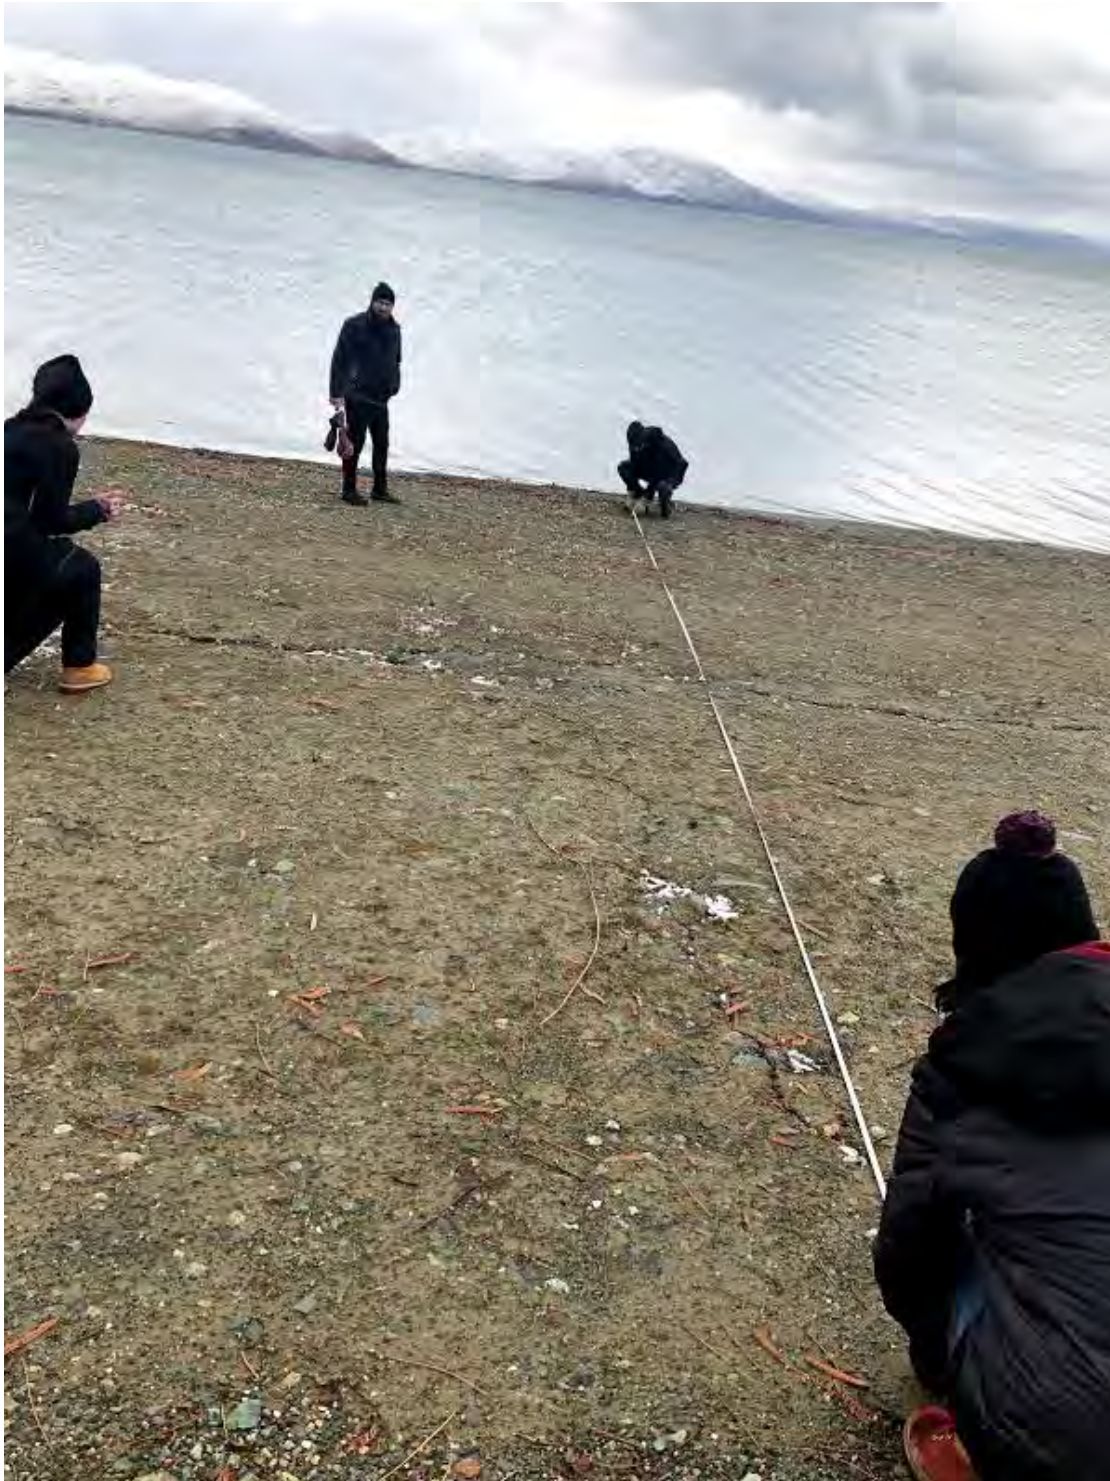
Figure 4.19. Mapping efforts of seismically-induced lateral spreading on the beach of Hazar Lake  
( $38^{\circ}26'50.0''N$   $39^{\circ}18'57.2''E$  / 31.01.2020 / 13:14)

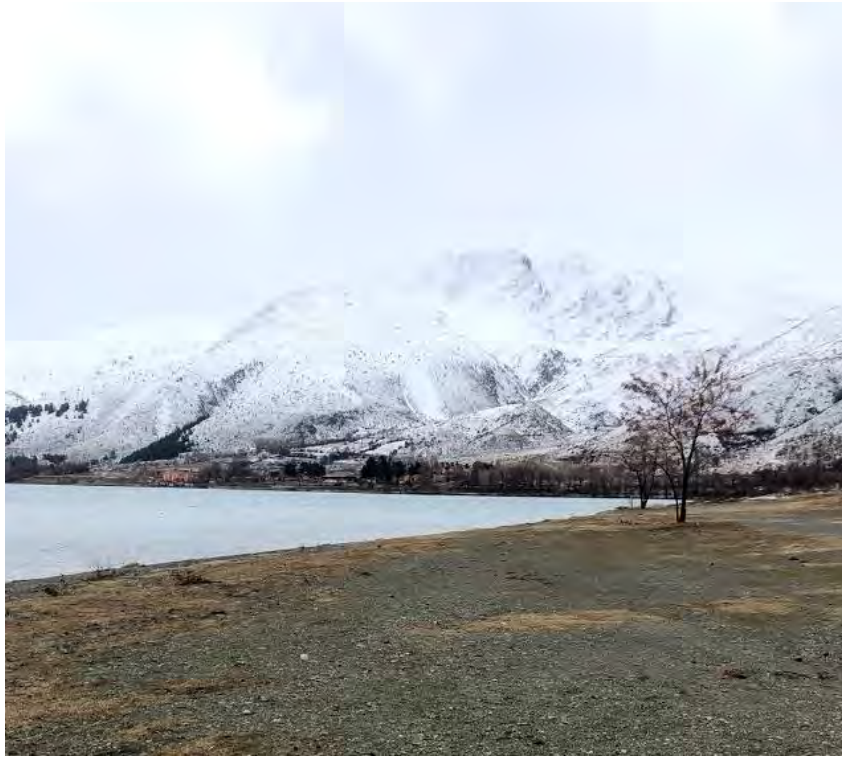
Figure 4.20. No ground failure on a neighboring beach of Hazar Lake  
( $38^{\circ}26'48.9''N$   $39^{\circ}18'59.4''E$  / 31.01.2020 / 13:08)

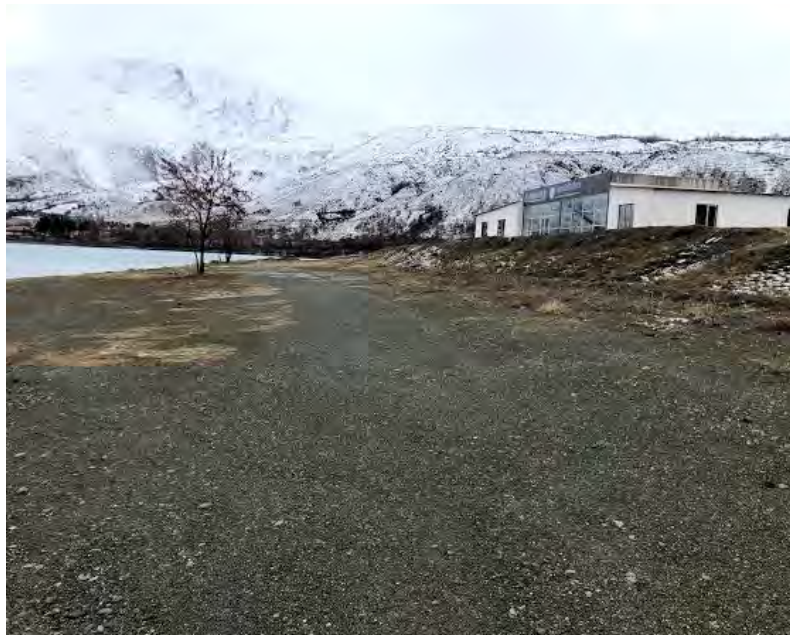
Figure 4.21. No ground failure on a neighboring beach of Hazar Lake  
( $38^{\circ}26'48.9''N$   $39^{\circ}18'59.4''E$  / 31.01.2020 / 13:08)

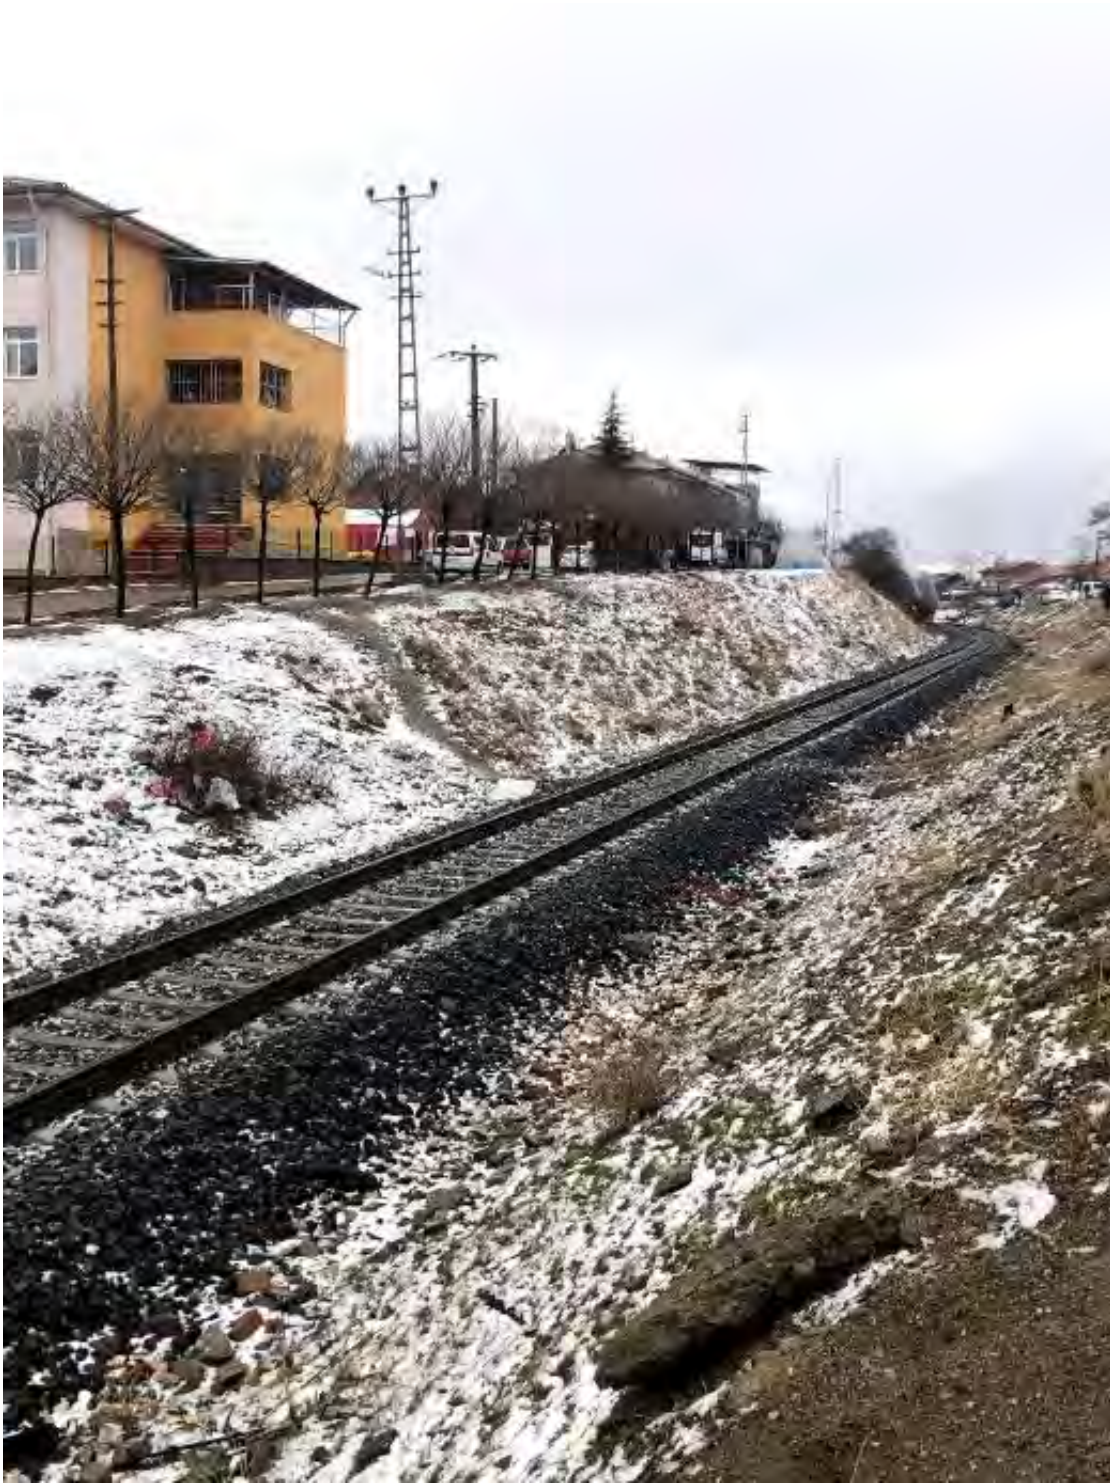
Moreover, the railway tracks were observed to experience no damage, as shown in Figure 4.23.

Figure 4.23. A view of railway tracks without any damage at Sivrice  
( $38^{\circ}26'49.5''N$   $39^{\circ}18'33.4''E$  / 31.01.2020 / 13:29)

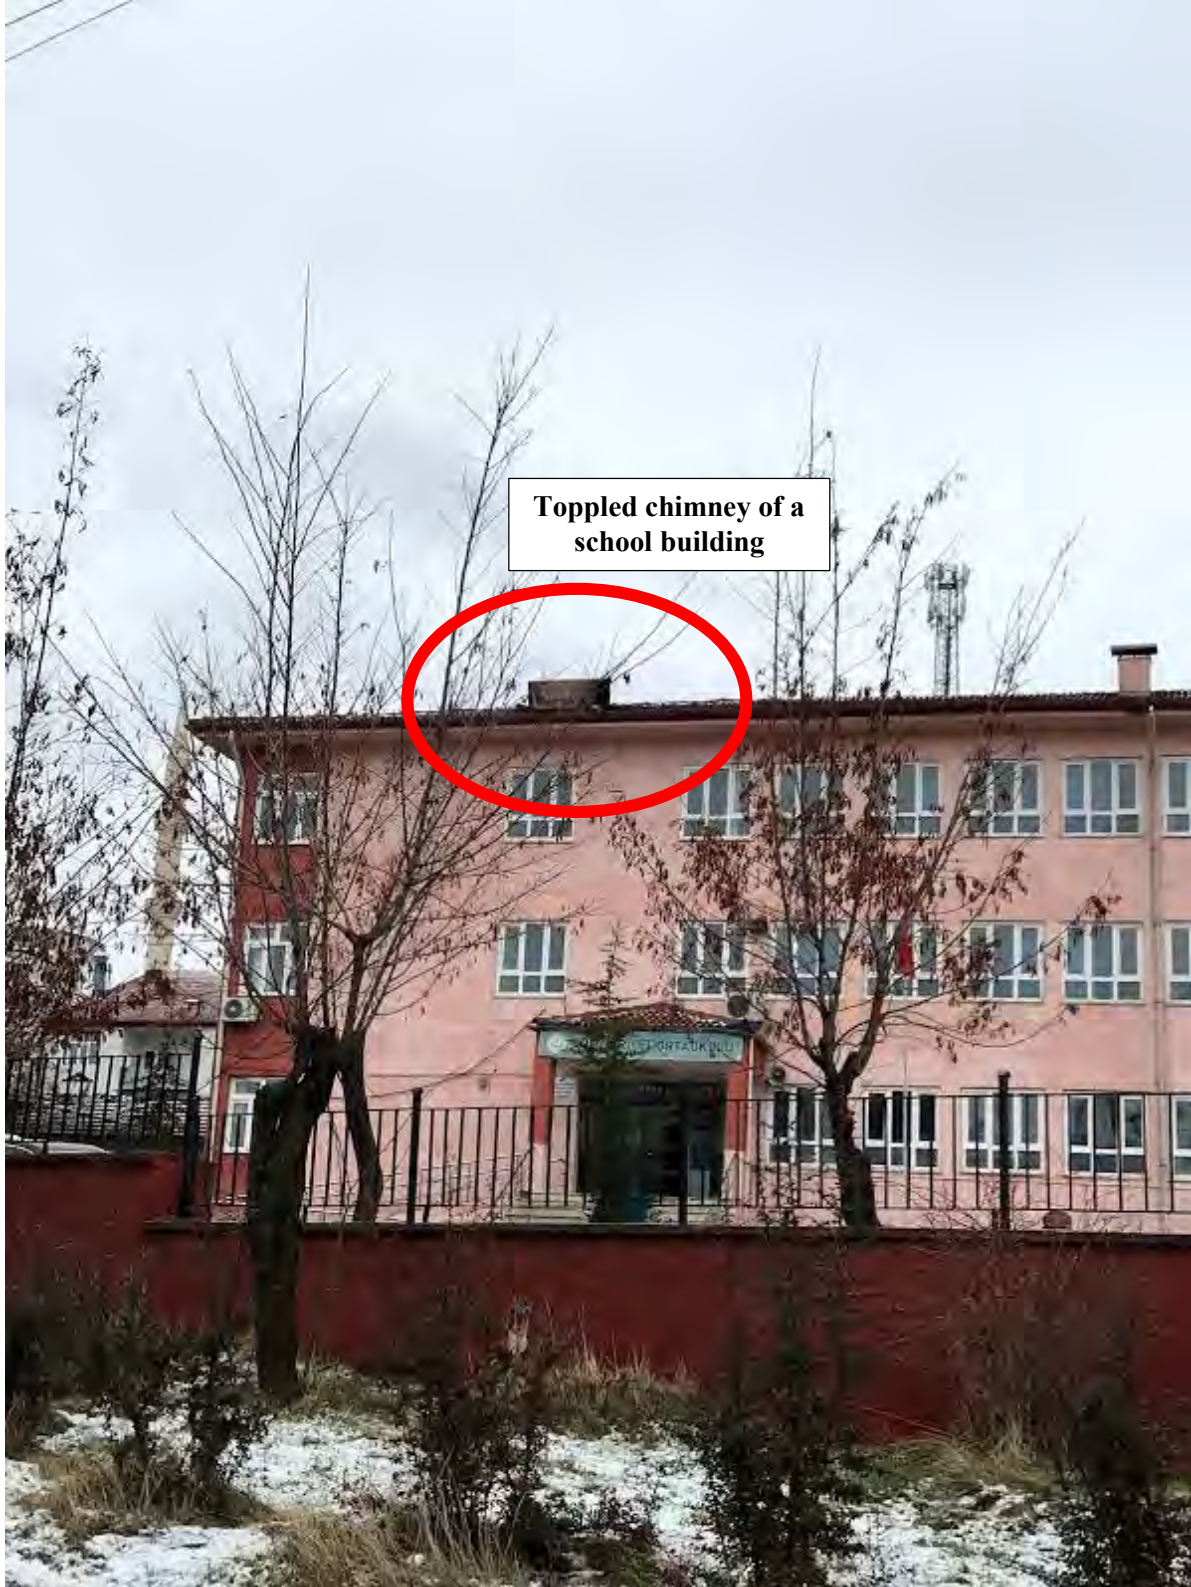
Toppled chimneys were observed as presented in Figure 4.24 and Figure 4.25. These failures show the intensity of shaking observed at the site, indicating a Mercalli intensity scale of VIII.

Figure 4.25. Topped chimney in Sivrice  
( $38^{\circ}26'49.7''N$   $39^{\circ}18'33.0''E$  / 31.01.2020 / 13:30)

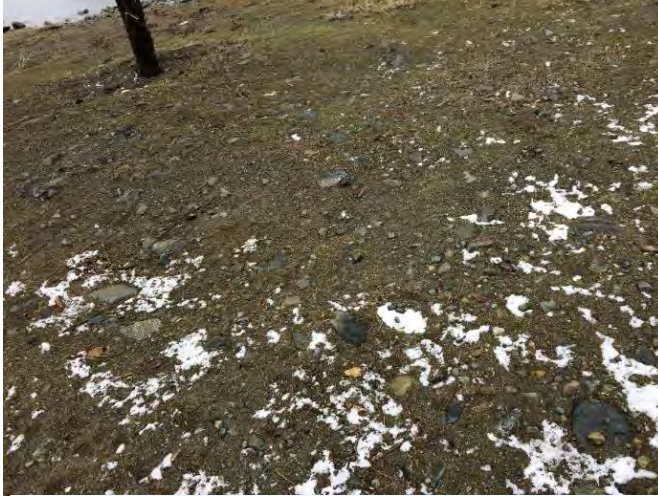
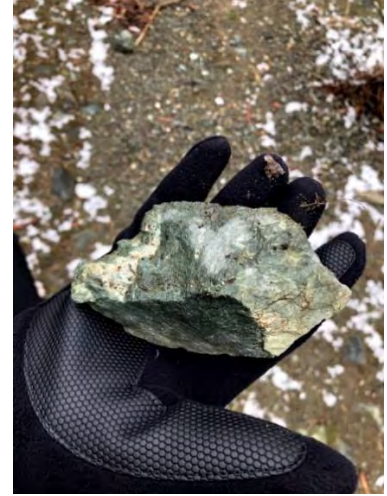
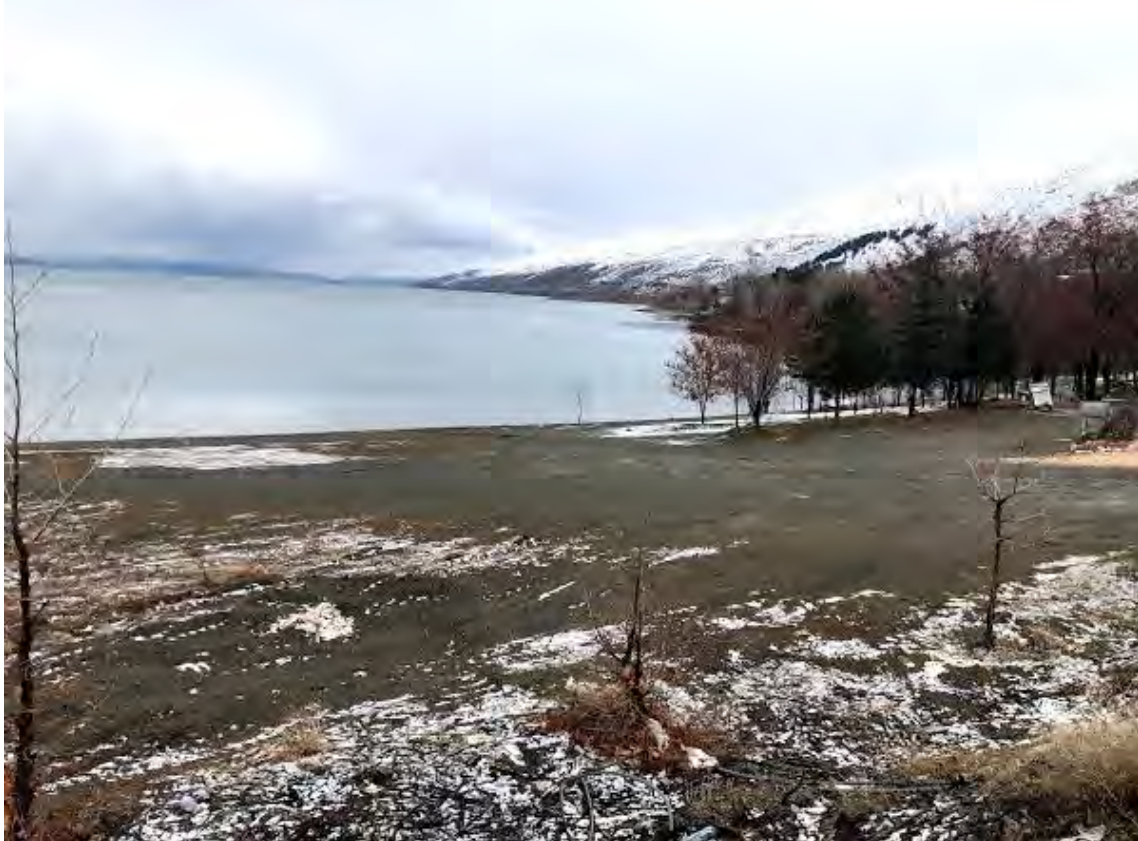
In the fourth stop, surface geology has changed to volcanic rocks, as shown in Figure 4.26. No ground failure was observed due to earthquake.

Figure 4.26. No signs of ground failure  
( $38^{\circ}26'32.0''N$   $39^{\circ}19'11.4''E$  / 31.01.2020 / 13:42 &  $38^{\circ}26'33.2''N$   $39^{\circ}19'10.0''E$  / 31.01.2020 / 13:42 &  
 $38^{\circ}26'31.9''N$   $39^{\circ}19'04.4''E$  / 31.01.2020 / 13:34)
