# Preliminary Report on Engineering and Geological Effects of the January 24, 2020 Magnitude 6.7 Earthquake in Elaziğ, Turkey

A report of the NSF-Sponsored Geotechnical Extreme Event Reconnaissance Association

Report GEER-065

**January 24, 2020 Elazığ-Sivrice Earthquake ( $M_w=6.8$ )  
Reconnaissance Study Report**

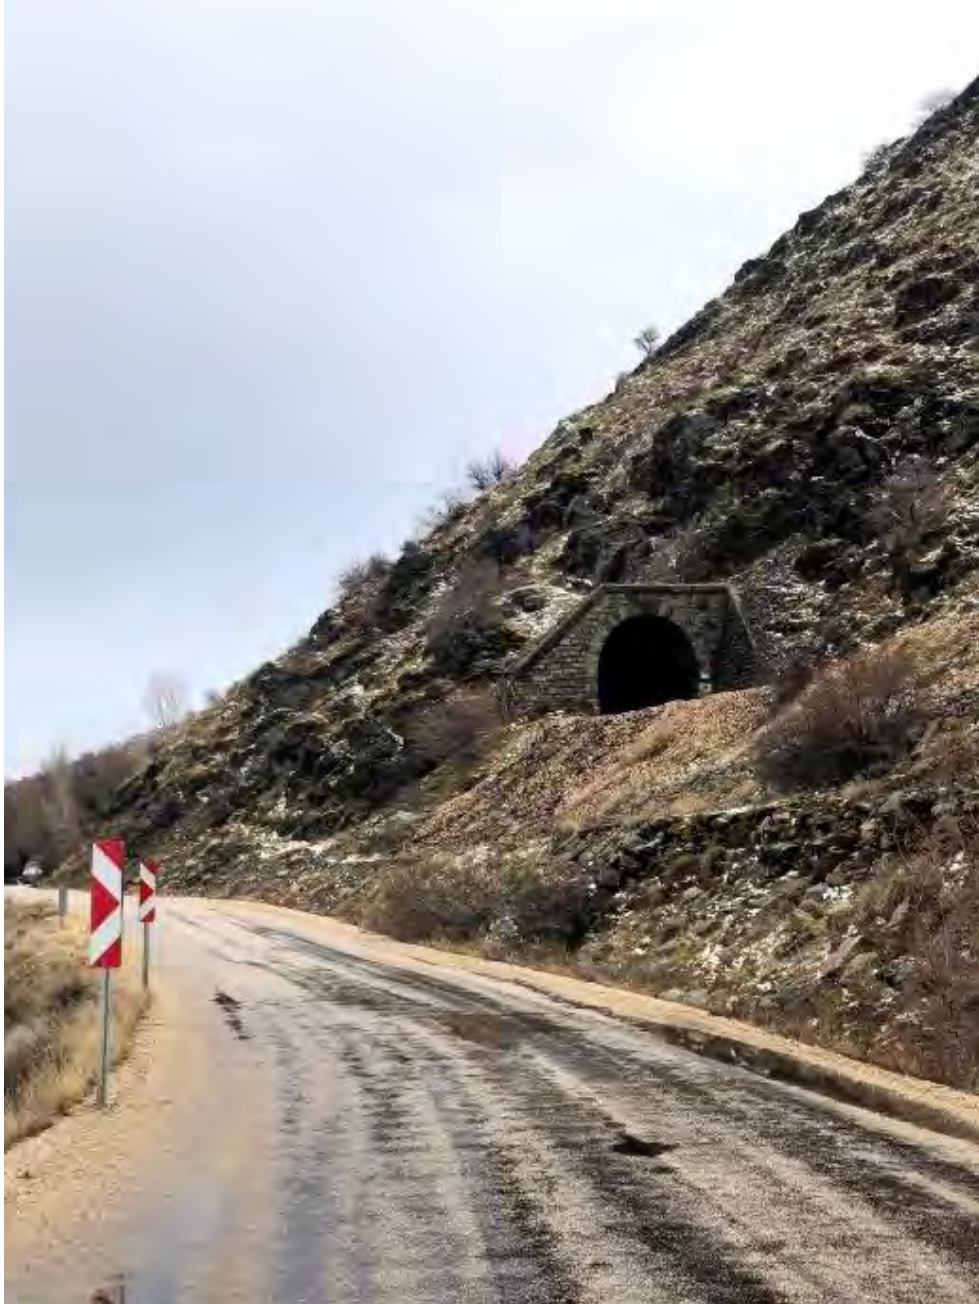
No damage was observed on the railway tunnel. Railway tunnel is open to service and Güney Kurtalan Express Train was serving, as documented in Figures 4.27 and 4.28 along with the coordinates of the pictures taken.

Figure 4.27. A view of the tunnel in Stop 5  
(38°26'43.7"N 39°20'40.8"E / 31.01.2020 / 13:54)

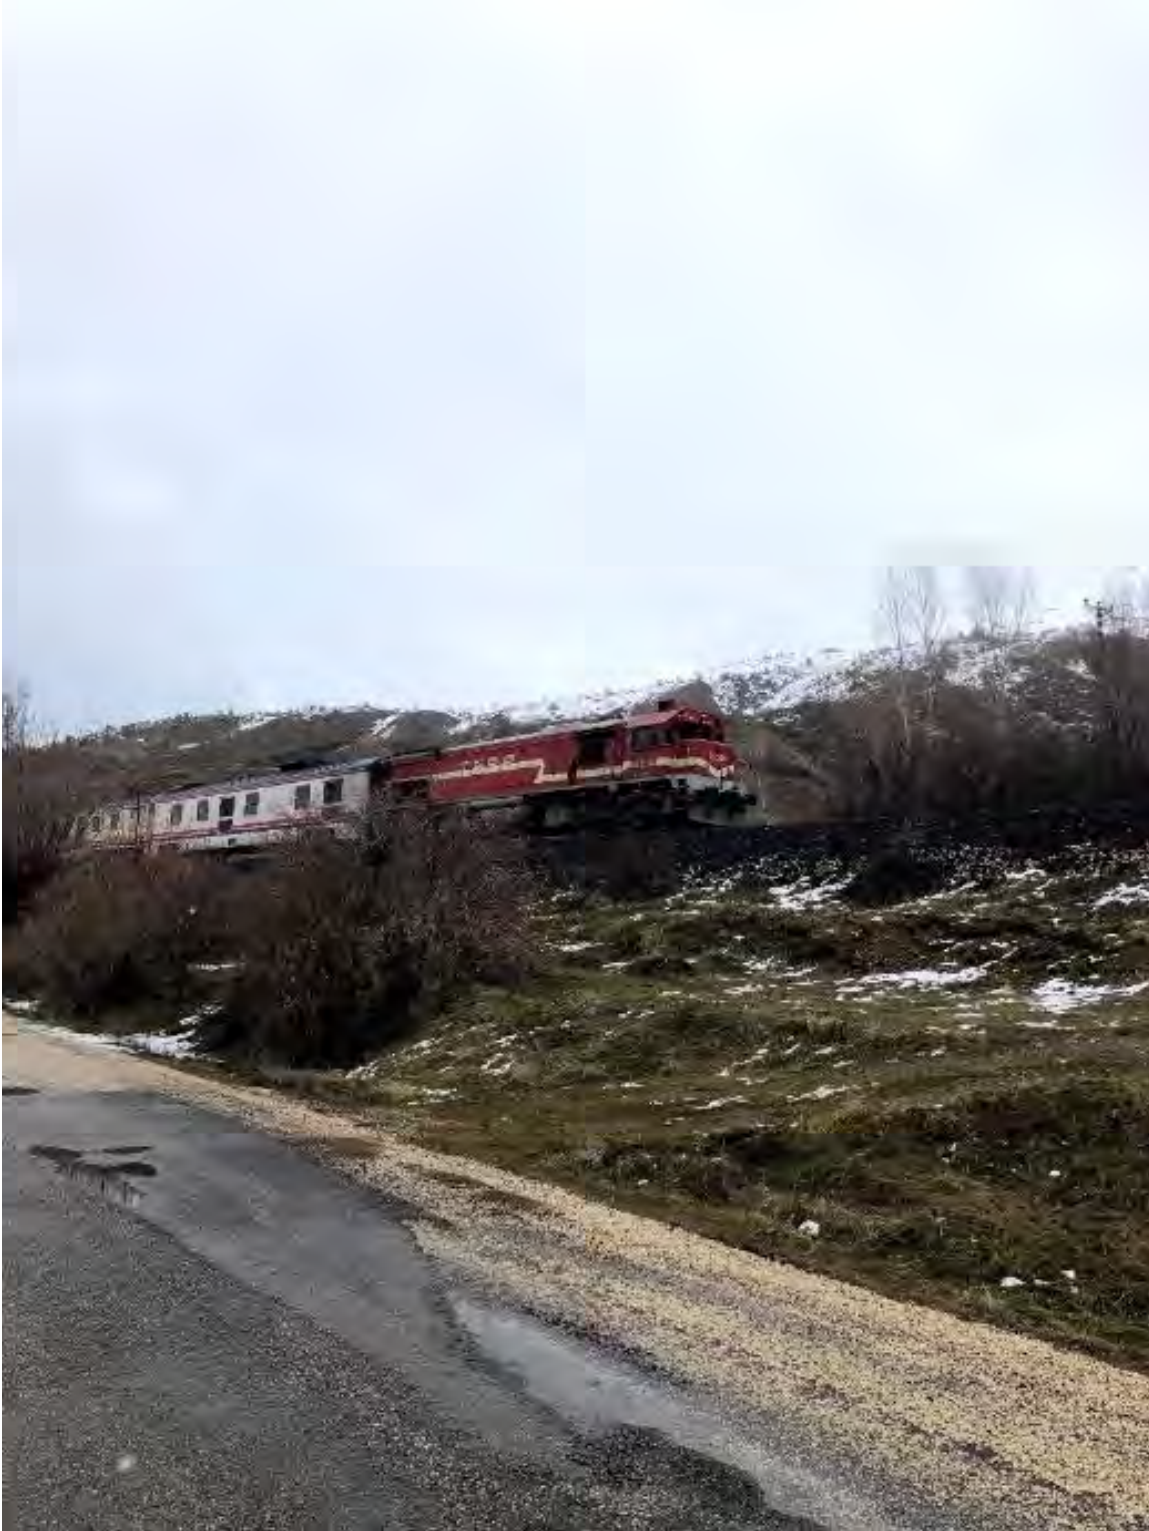
Figure 4.28. Güney Kurtalan Express Train passing by  
( $38^{\circ}26'56.9''N$   $39^{\circ}21'16.7''E$  / 31.01.2020 / 13:59)

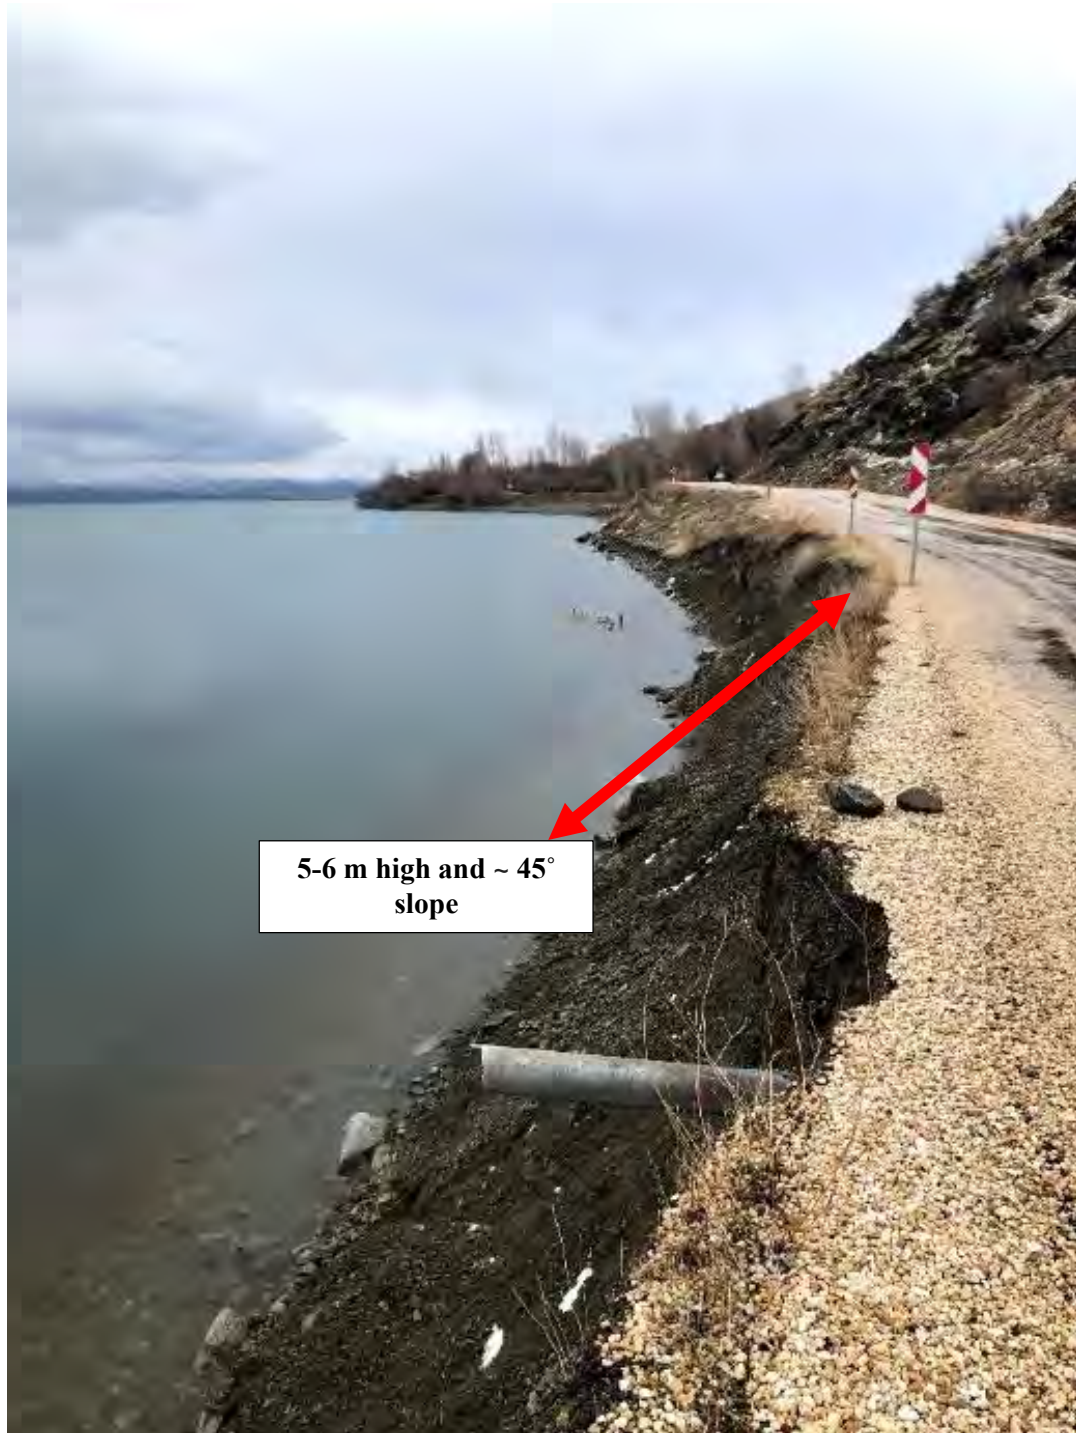
The shoreline by the railway tunnel was also visited. The road embankment has relatively steep slopes (nearly  $45^\circ$ ); however, no ground failure was observed along this shoreline (Figure 4.29).

Figure 4.29. No failure on the road embankment  
( $38^\circ 26' 43.7'' N$   $39^\circ 20' 40.7'' E$  / 31.01.2020 / 13:54)

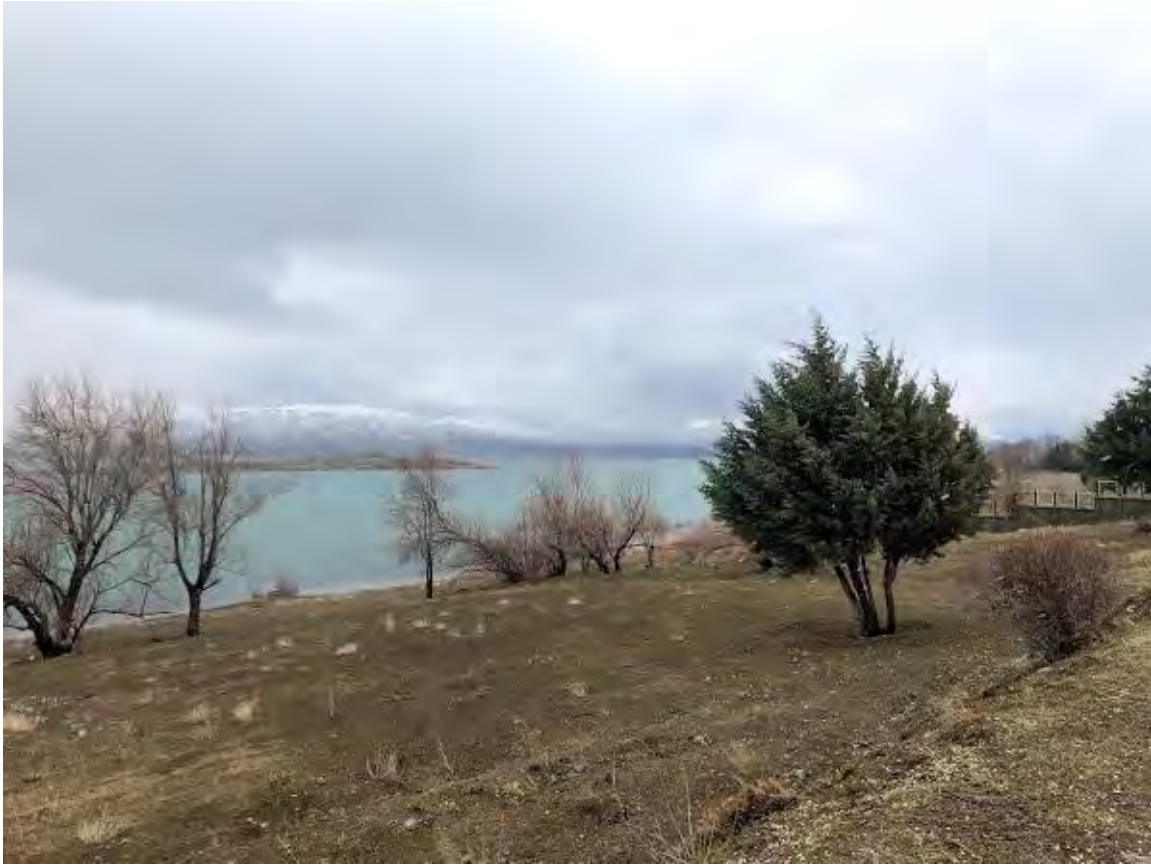
The surficial soil layers are composed of low plasticity clays as shown in Figure 4.30. No signs of ground failure were observed.

Figure 4.30. No ground failure at the 6<sup>th</sup> stop  
(38°27'17.1"N 39°21'49.3"E / 31.01.2020 / 14:03)

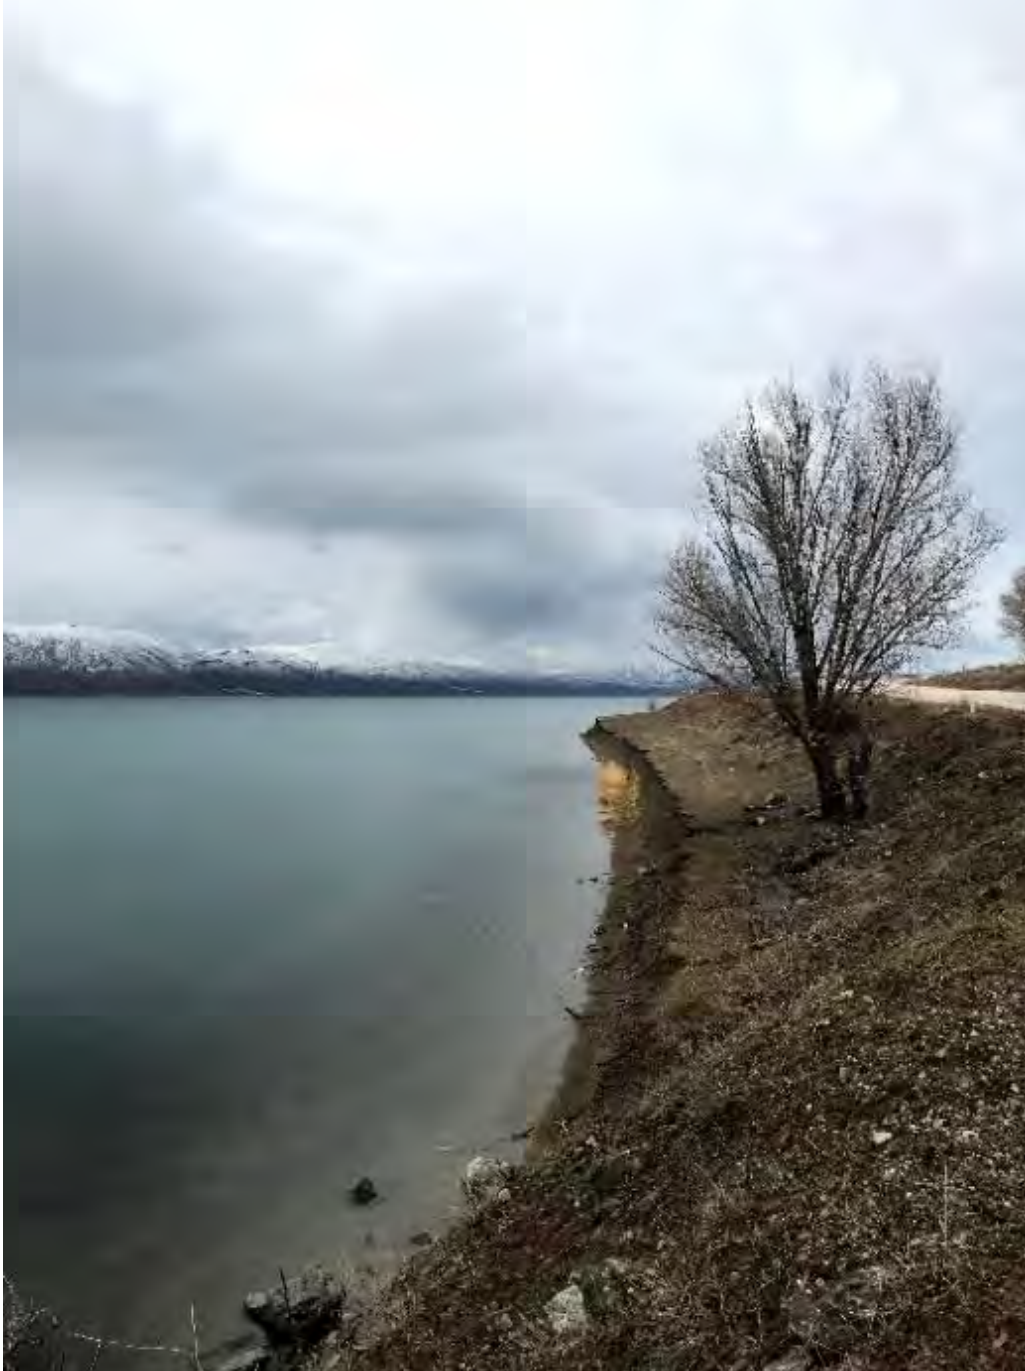
No ground failure was observed at steep slopes of the 7<sup>th</sup> stop, as shown in Figure 4.31.

Figure 4.31. No ground failure was observed at the shores of 7<sup>th</sup> stop  
(38°27'31.0"N 39°22'55.9"E / 31.01.2020 / 14:08)

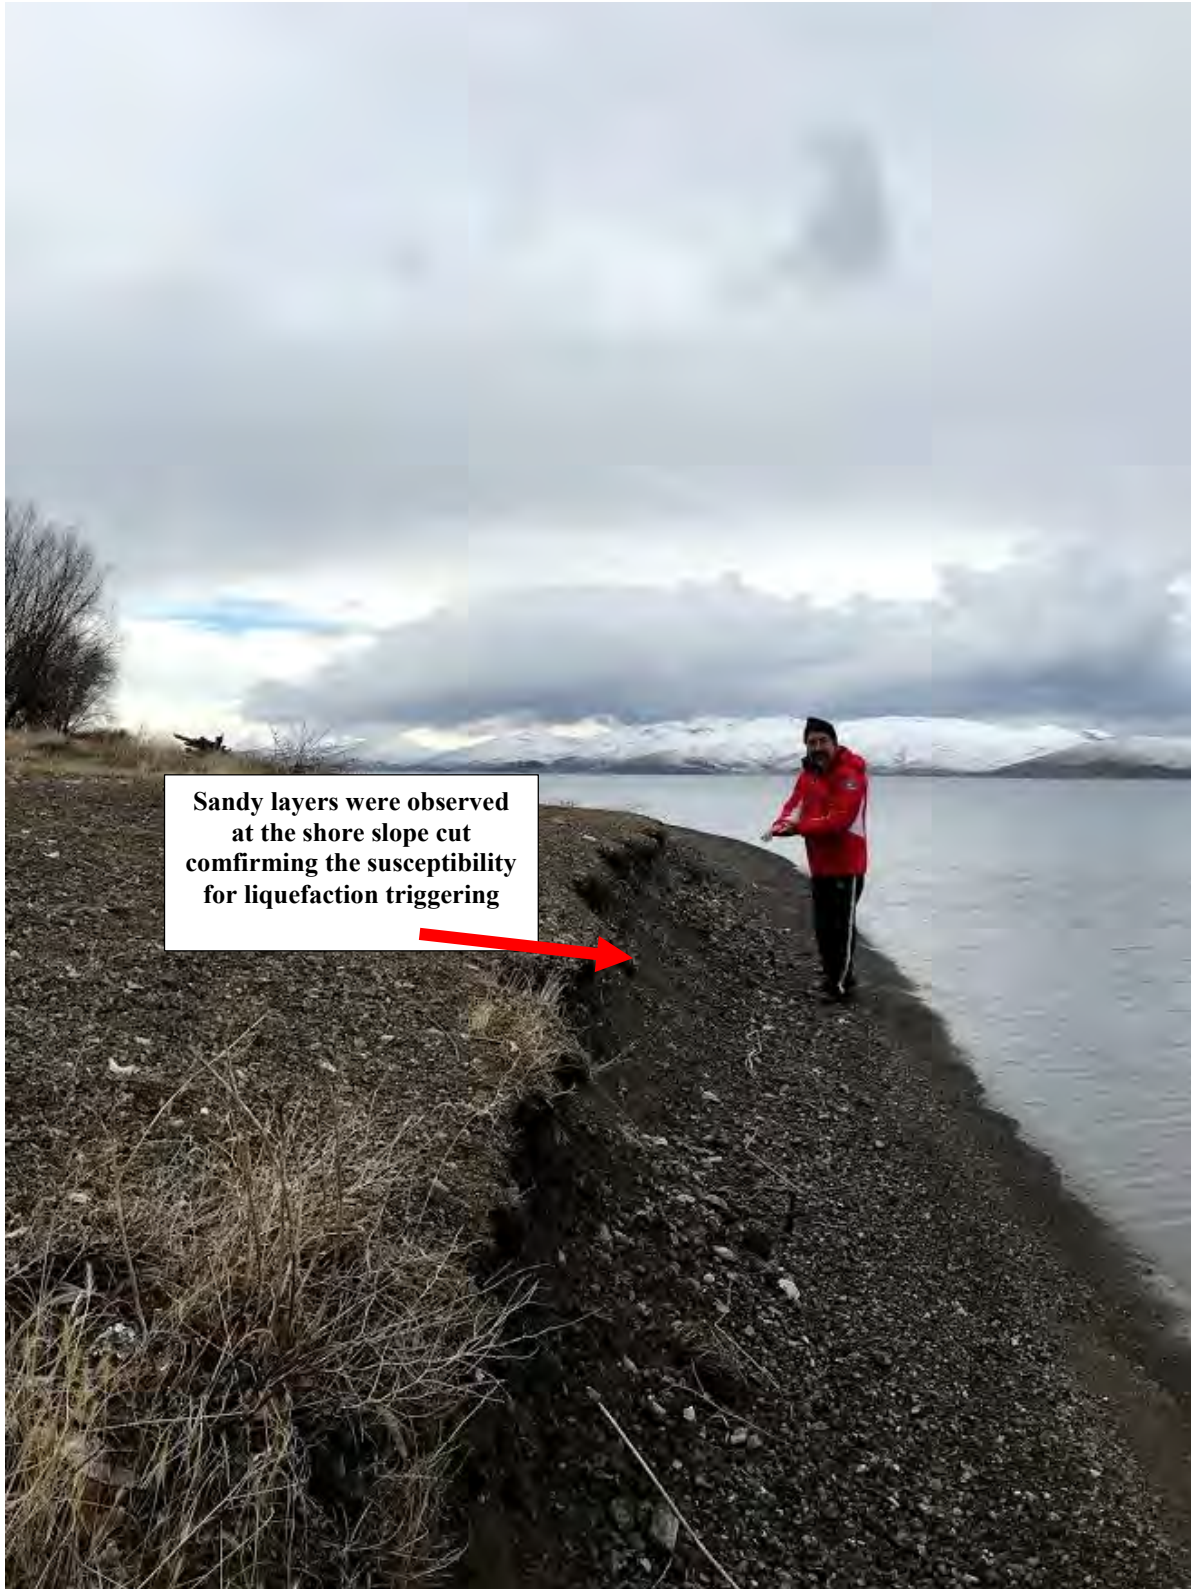
Figure 4.35. Sandy soil layers observed in Stop 8  
( $38^{\circ}27'50.3''N$   $39^{\circ}24'02.1''E$  / 31.01.2020 / 14:21)

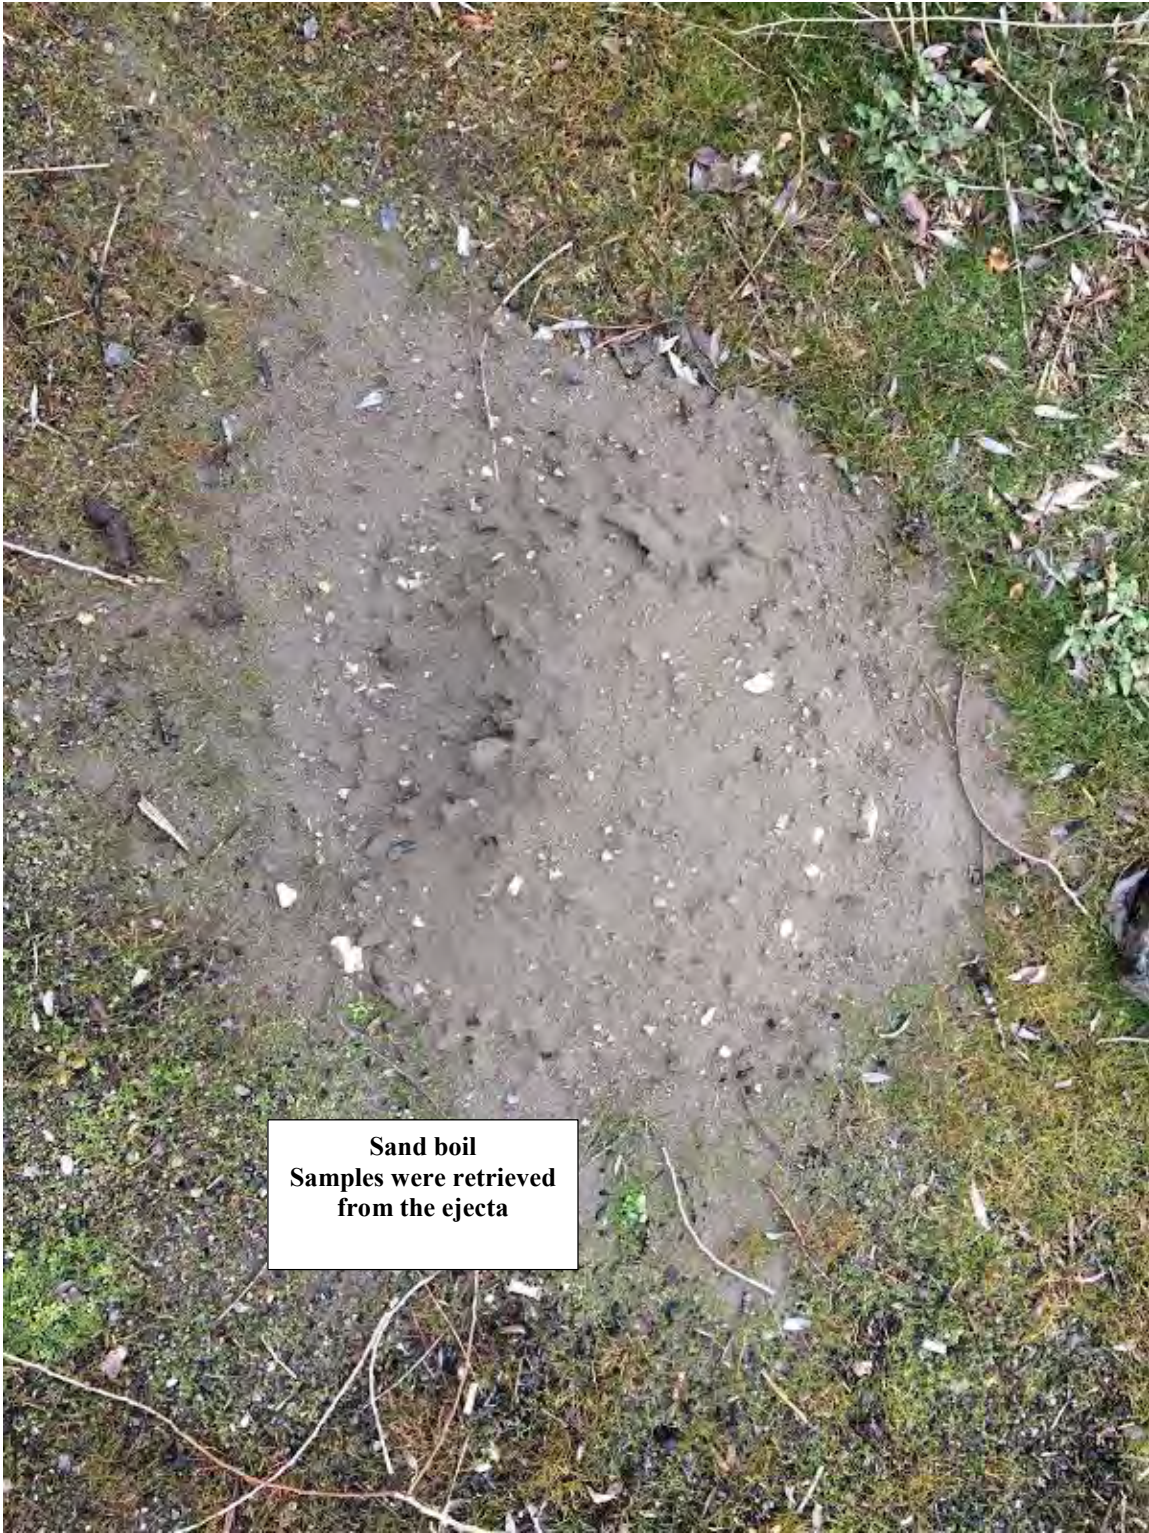
**Sand boil**  
Samples were retrieved  
from the ejecta

Figure 4.38. Sand boil observed in Stop 8  
( $38^{\circ}27'50.1''N$   $39^{\circ}24'01.3''E$  / 31.01.2020 / 14:43)

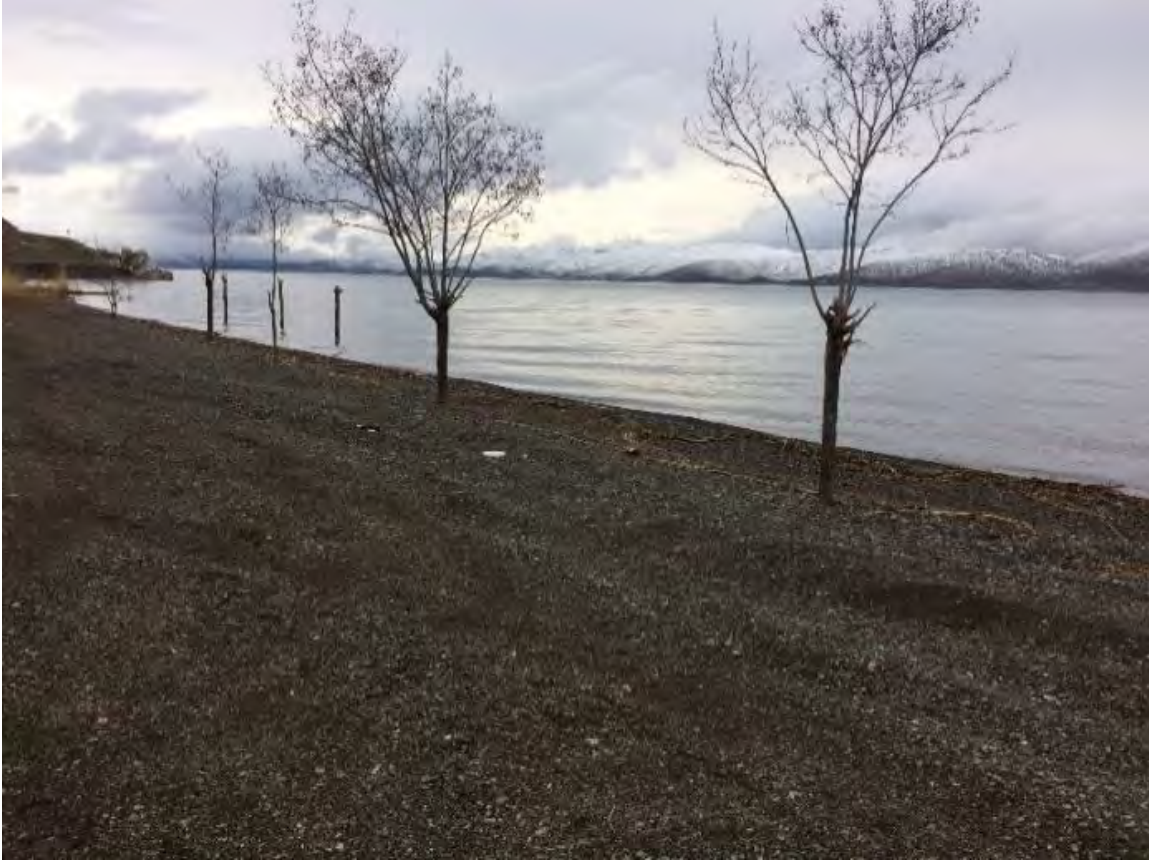
No ground failure was observed at this site, as presented in Figure 4.39.

Figure 4.39. No ground failure was observed at shore of 9<sup>th</sup> stop  
(38°28'22.2"N 39°25'24.9"E / 31.01.2020 / 14:53)

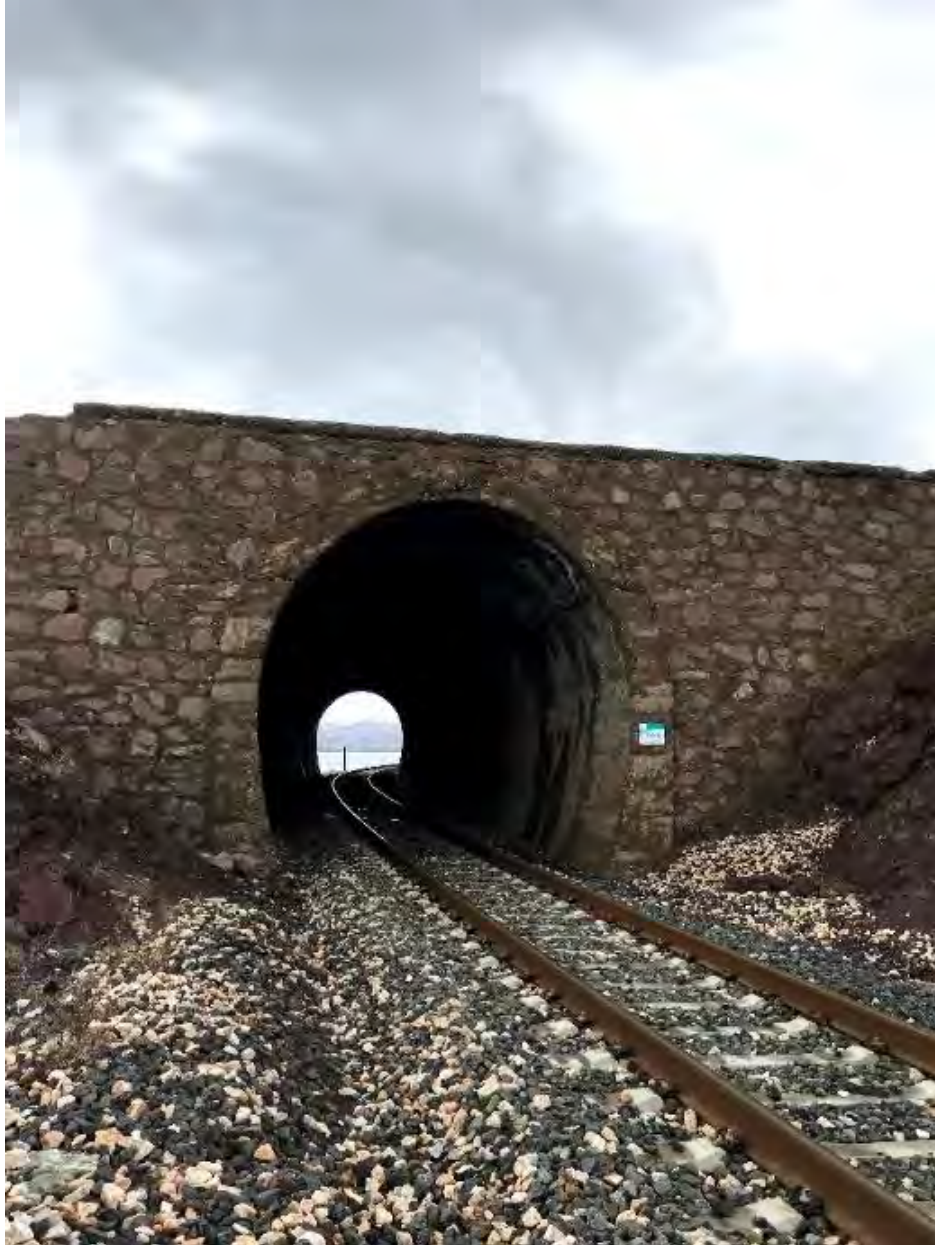
A relatively very short (~15 m long) railway tunnel was constructed at the toe of a highly weathered rock steep slope. Tunnel has been possibly designed to eliminate toe excavations, which may trigger slope instability problems. No damage was observed, as also presented in Figures 4.40 to 4.43. Additionally, no slope failure was observed near Hazar Lake, as presented in Figure 4.44.

Figure 4.40. A railway tunnel and rails exhibiting no damage  
(38°28'52.8"N 39°27'18.2"E / 31.01.2020 / 15:08)

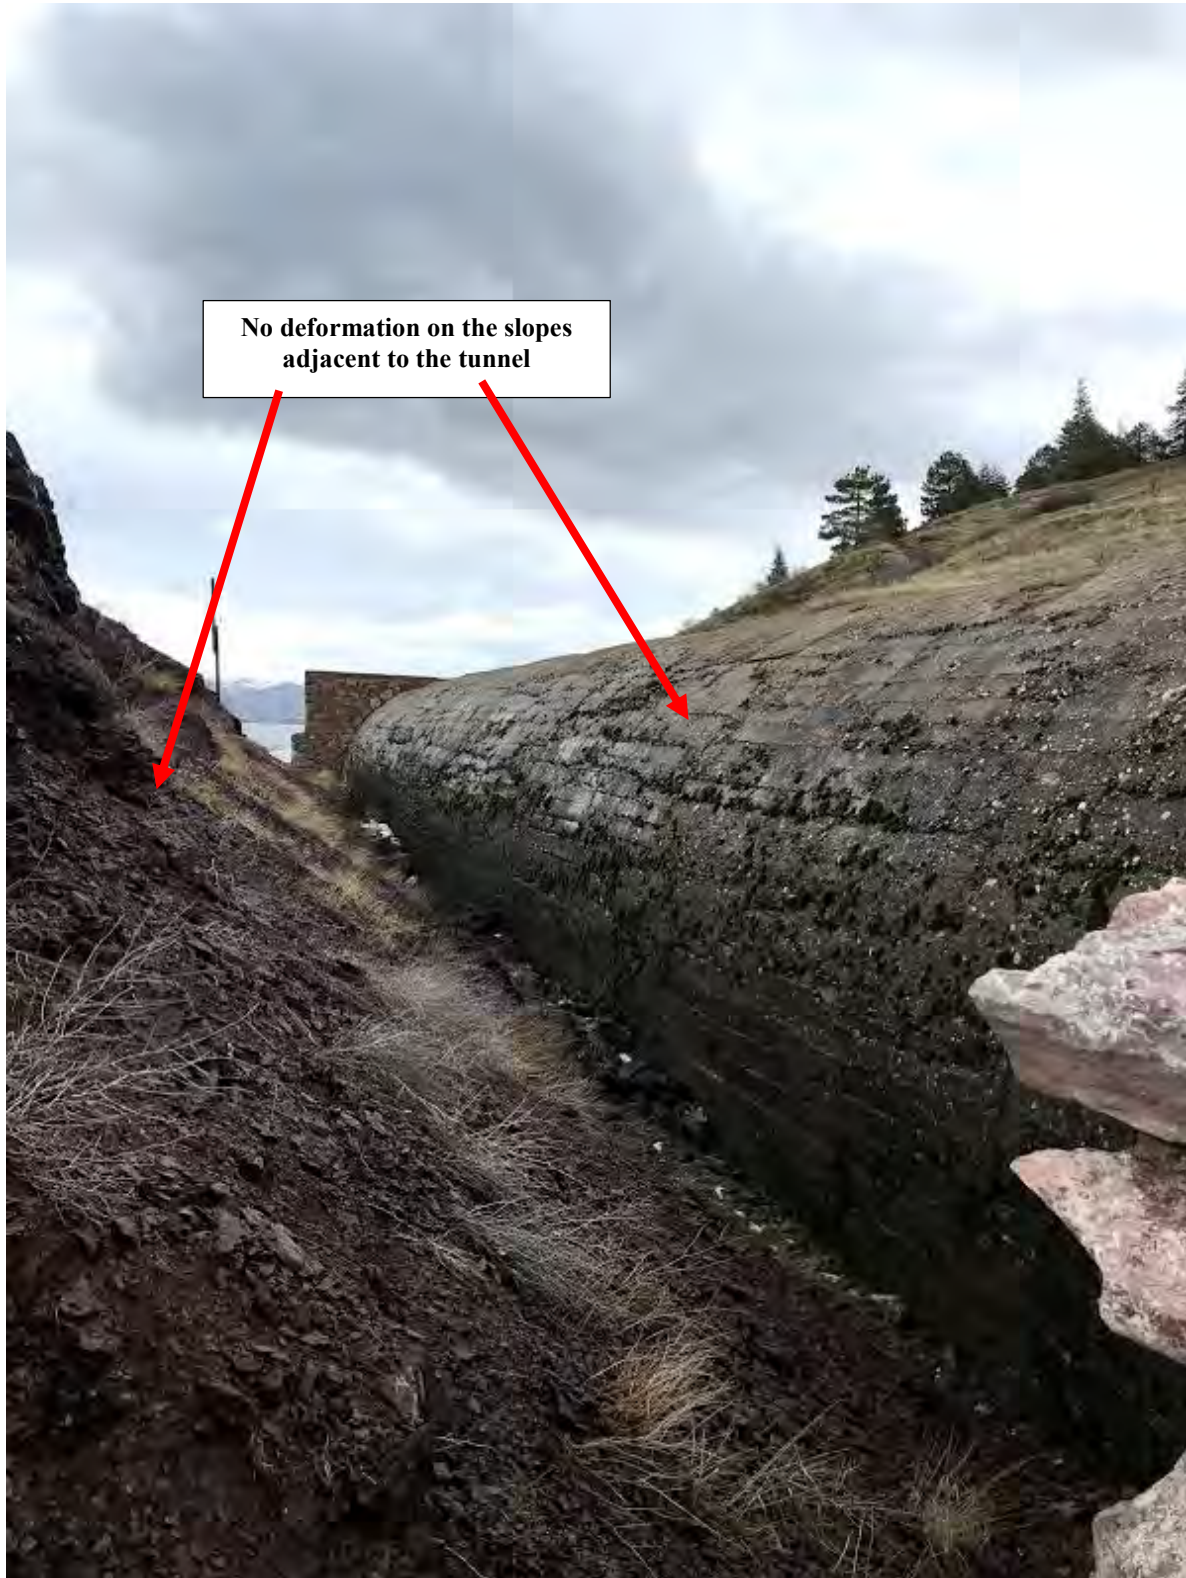
Figure 4.41. A view of tunnel body at Stop 10  
( $38^{\circ}28'53.2''N$   $39^{\circ}27'18.4''E$  / 31.01.2020 / 15:09)

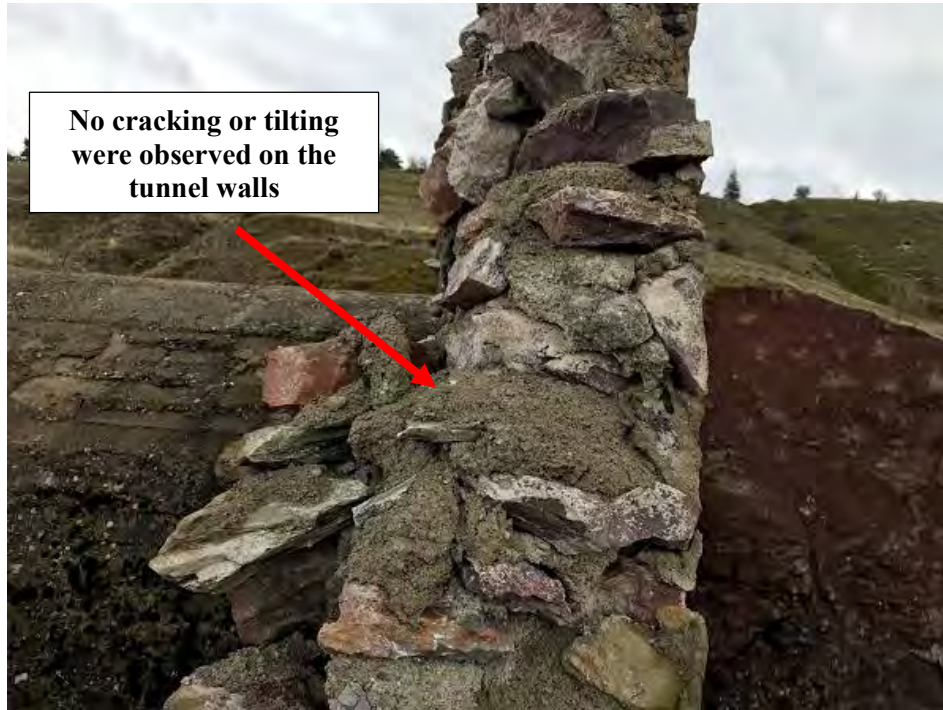
Figure 4.42. Side view of tunnel wall at Stop 10  
( $38^{\circ}28'53.2''N$   $39^{\circ}27'18.4''E$  / 31.01.2020 / 15:09)

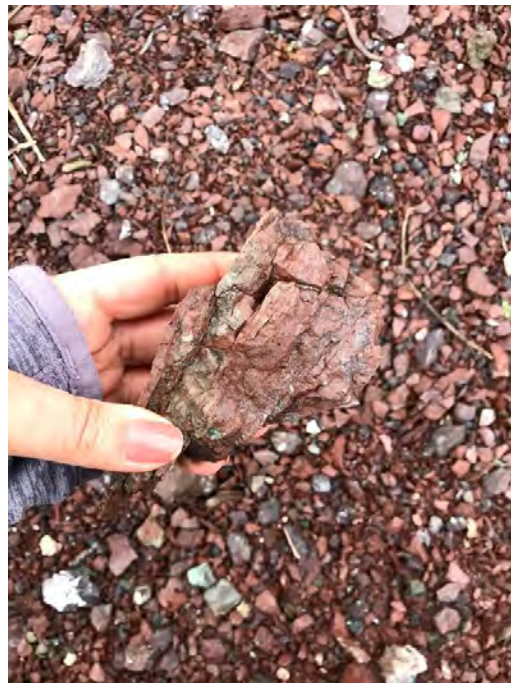
Figure 4.43. Interbeddings observed in volcanic rocks  
( $38^{\circ}28'53.2''N$   $39^{\circ}27'17.9''E$  / 31.01.2020 / 15:08)

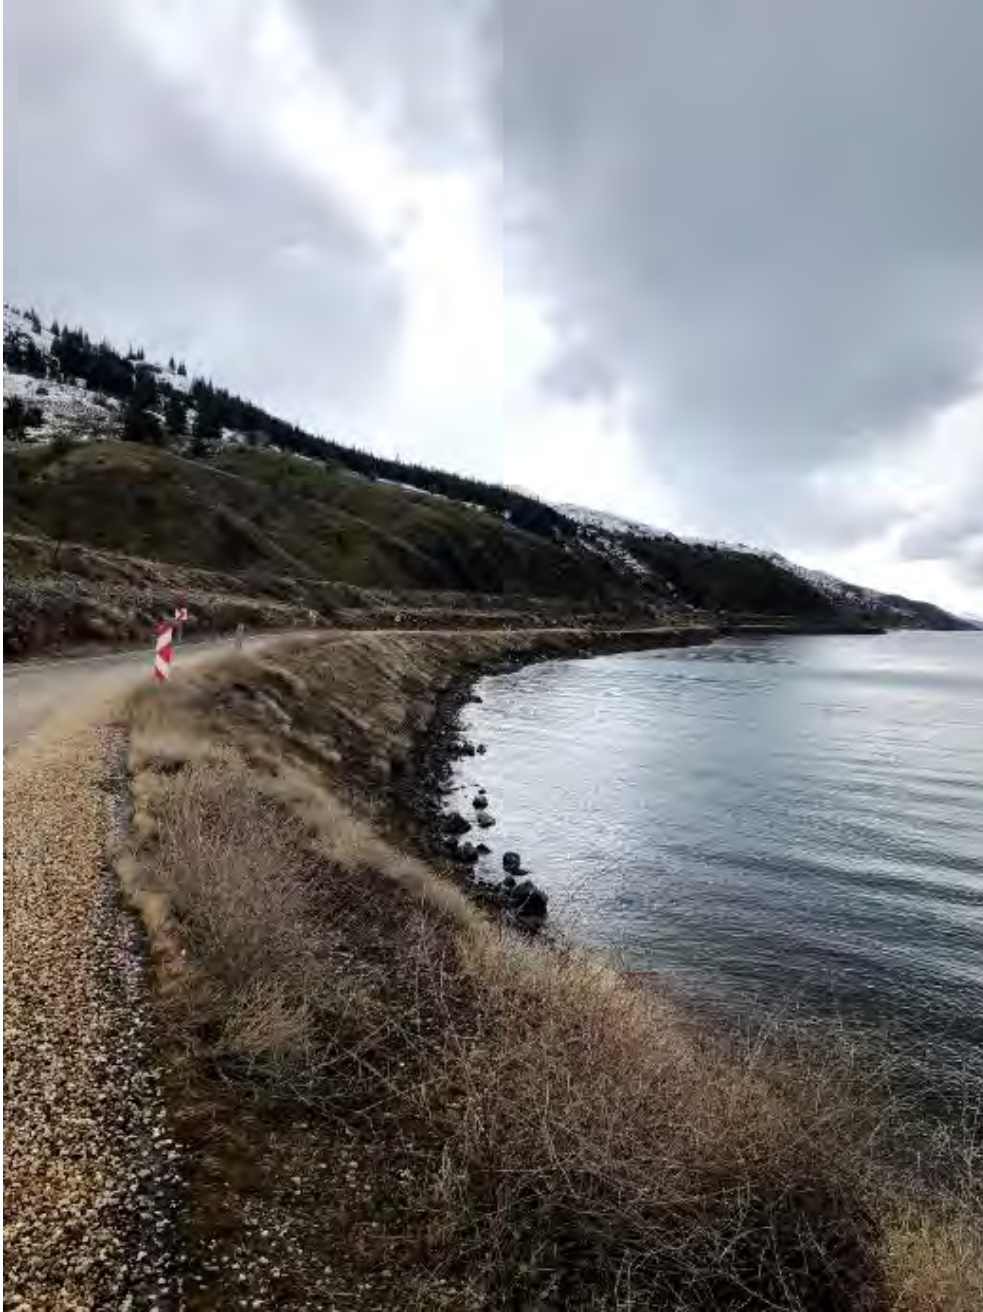
Figure 4.44. No ground failure was observed at shore of 10<sup>th</sup> stop  
(38°28'52.6"N 39°27'16.9"E / 31.01.2020 / 15:04)

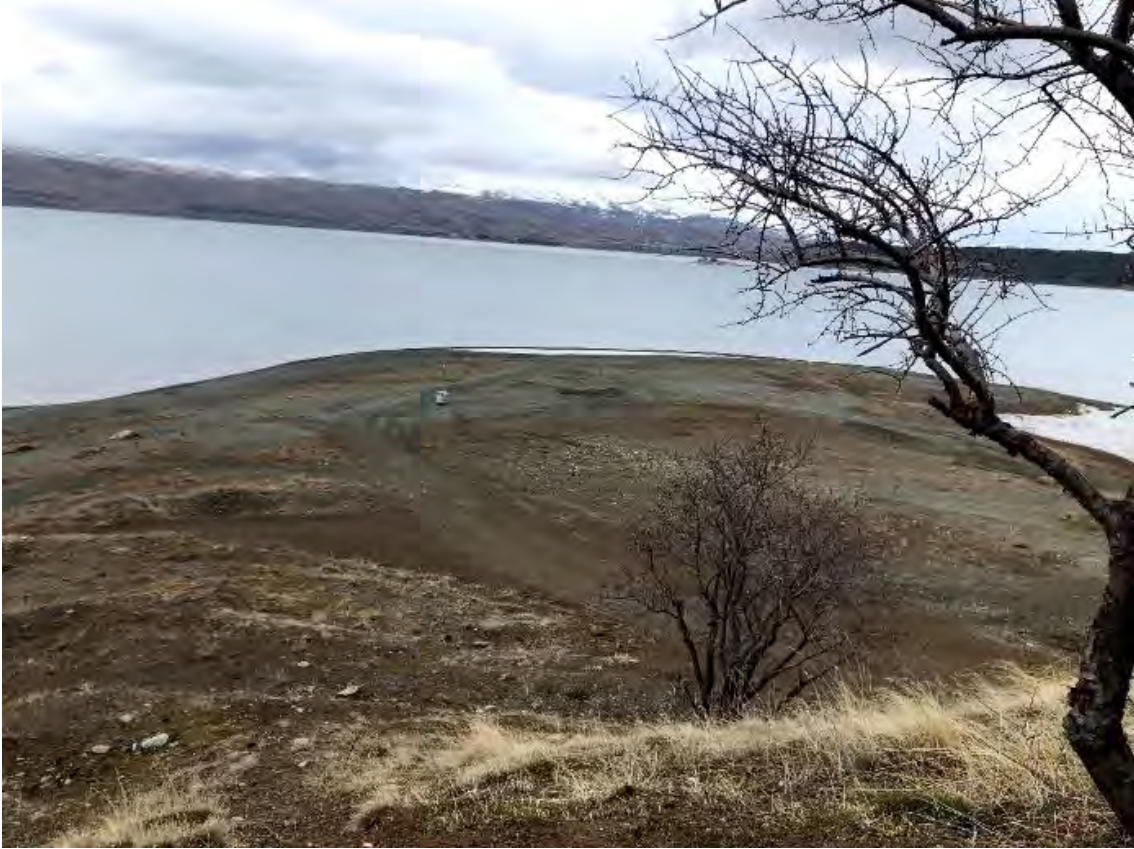
At 11<sup>th</sup> stop, no ground failure was observed as shown in Figure 4.45.

Figure 4.45. No ground failure was observed at shore of 11<sup>th</sup> stop  
(38°29'37.1"N 39°29'02.3"E / 31.01.2020 / 15:18)

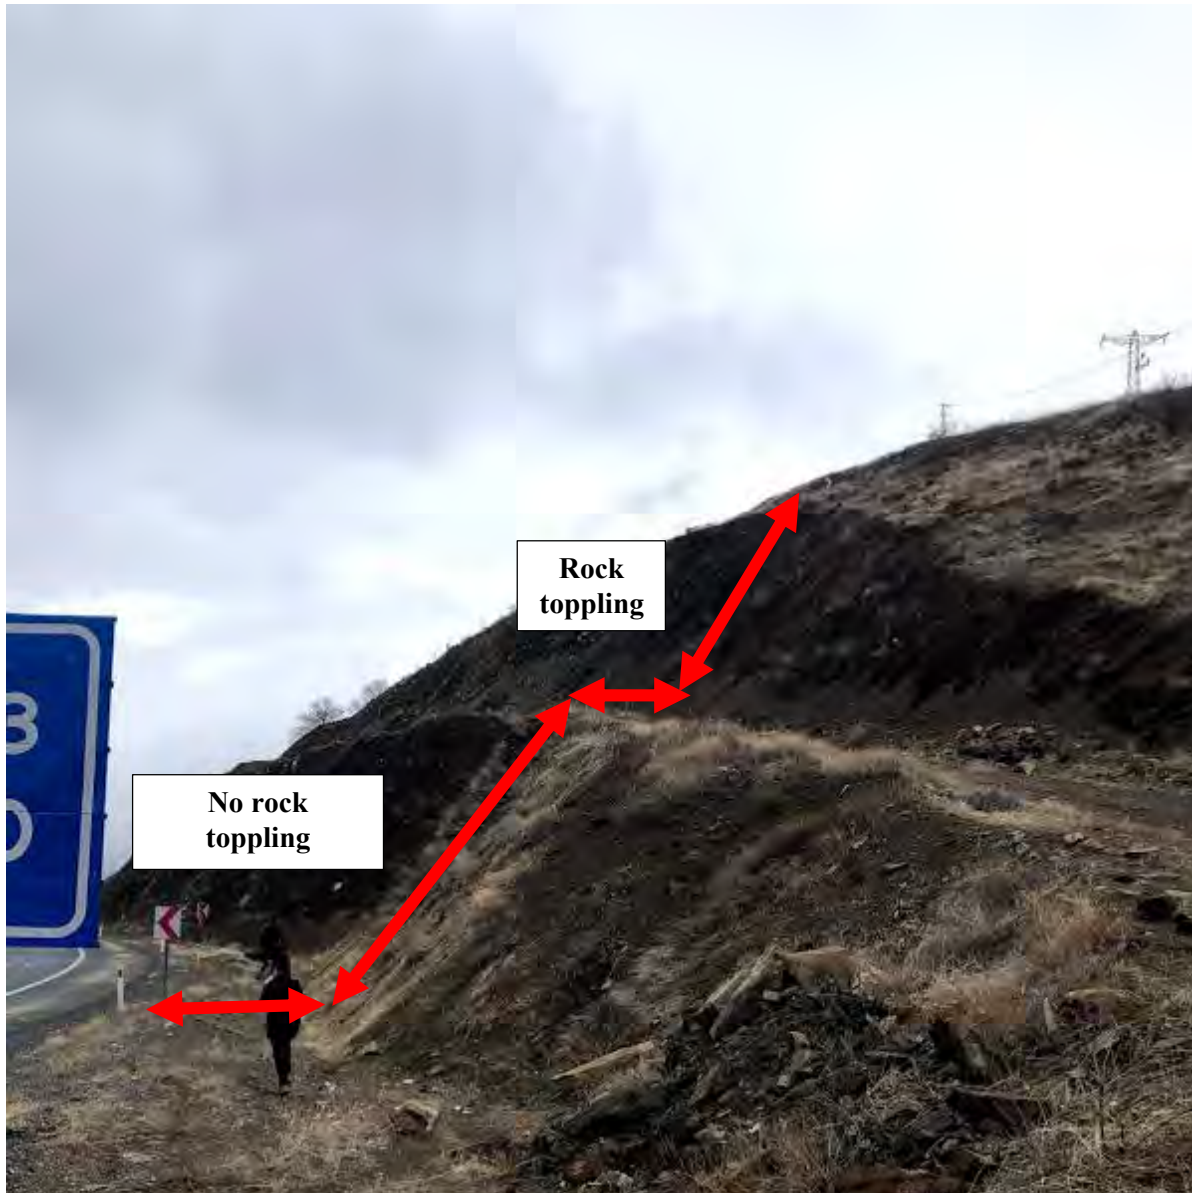
Rock falls were mapped at 13<sup>th</sup> stop as shown in Figures 4.47 to 4.51. Approximate dimensions (length, width, height) of the rocks are measured in the field. A simulation of the rock fall mechanism suggested a peak ground velocity of 4-6 m/s at the region as will be discussed later in the report. Fallen rock blocks horizontal distances from the toe of the first bench were measured as 3-5 m. The details of rockfall assessments will be presented later in the report.

Figure 4.47. Rockfall at 13<sup>th</sup> stop (general view)  
(38°31'40.3"N 39°28'02.9"E / 31.01.2020 / 16:20)

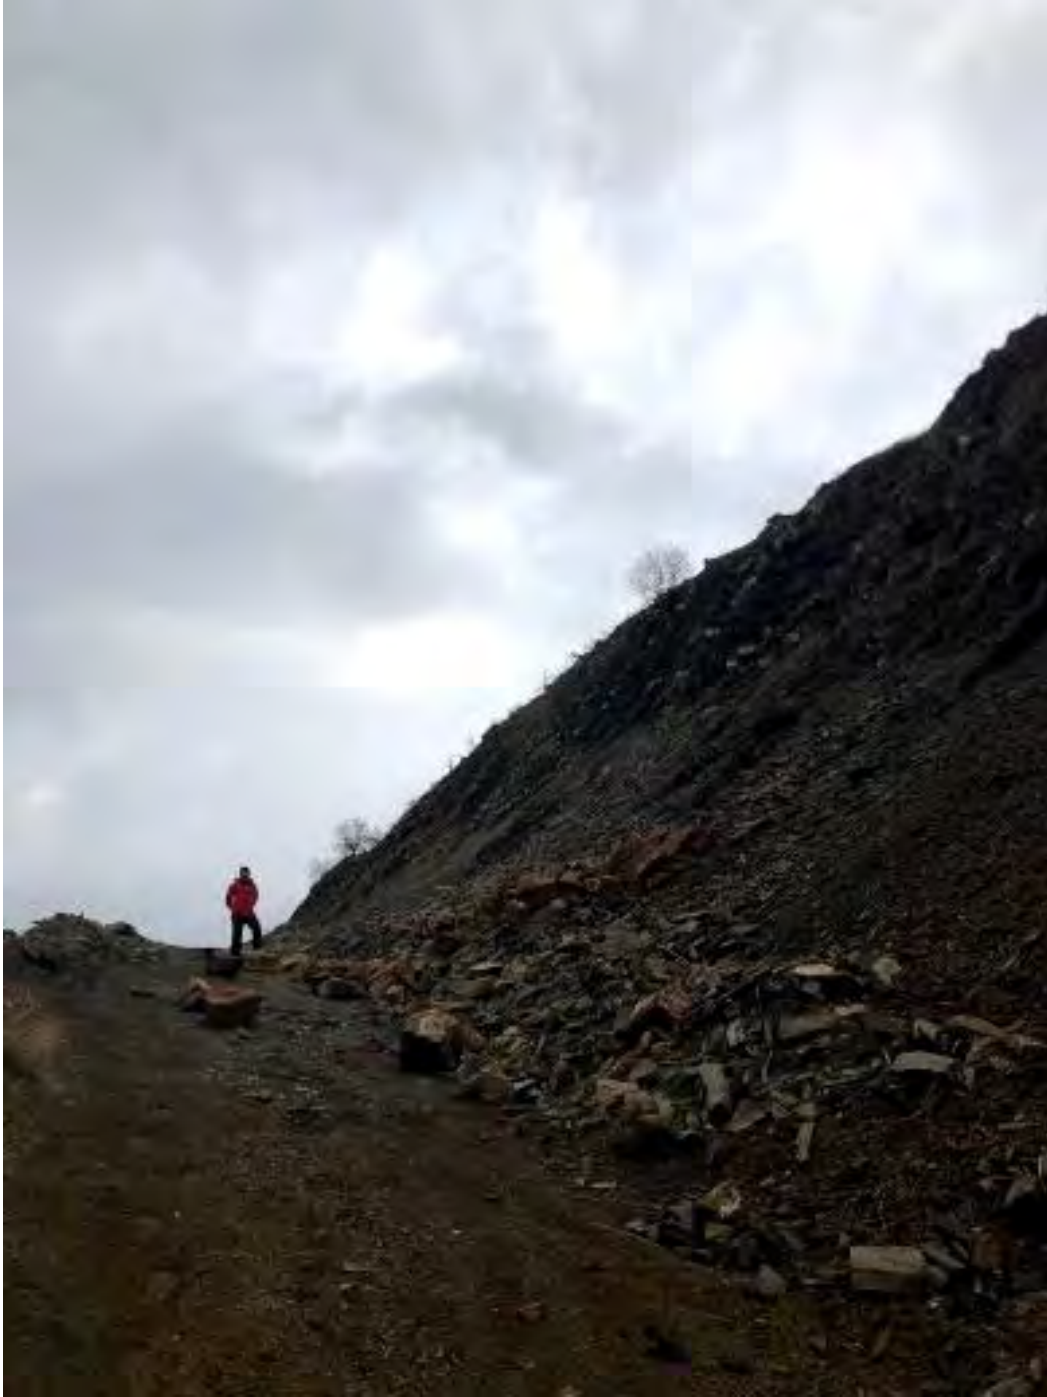
Figure 4.48. Rockfall at 13<sup>th</sup> stop (upper bench)  
(38°31'41.5"N 39°27'60.0"E / 31.01.2020 / 16:10)
