# Preliminary Report on Engineering and Geological Effects of the January 24, 2020 Magnitude 6.7 Earthquake in Elaziğ, Turkey

A report of the NSF-Sponsored Geotechnical Extreme Event Reconnaissance Association

Report GEER-065

**January 24, 2020 Elazığ-Sivrice Earthquake ( $M_w=6.8$ )  
Reconnaissance Study Report**

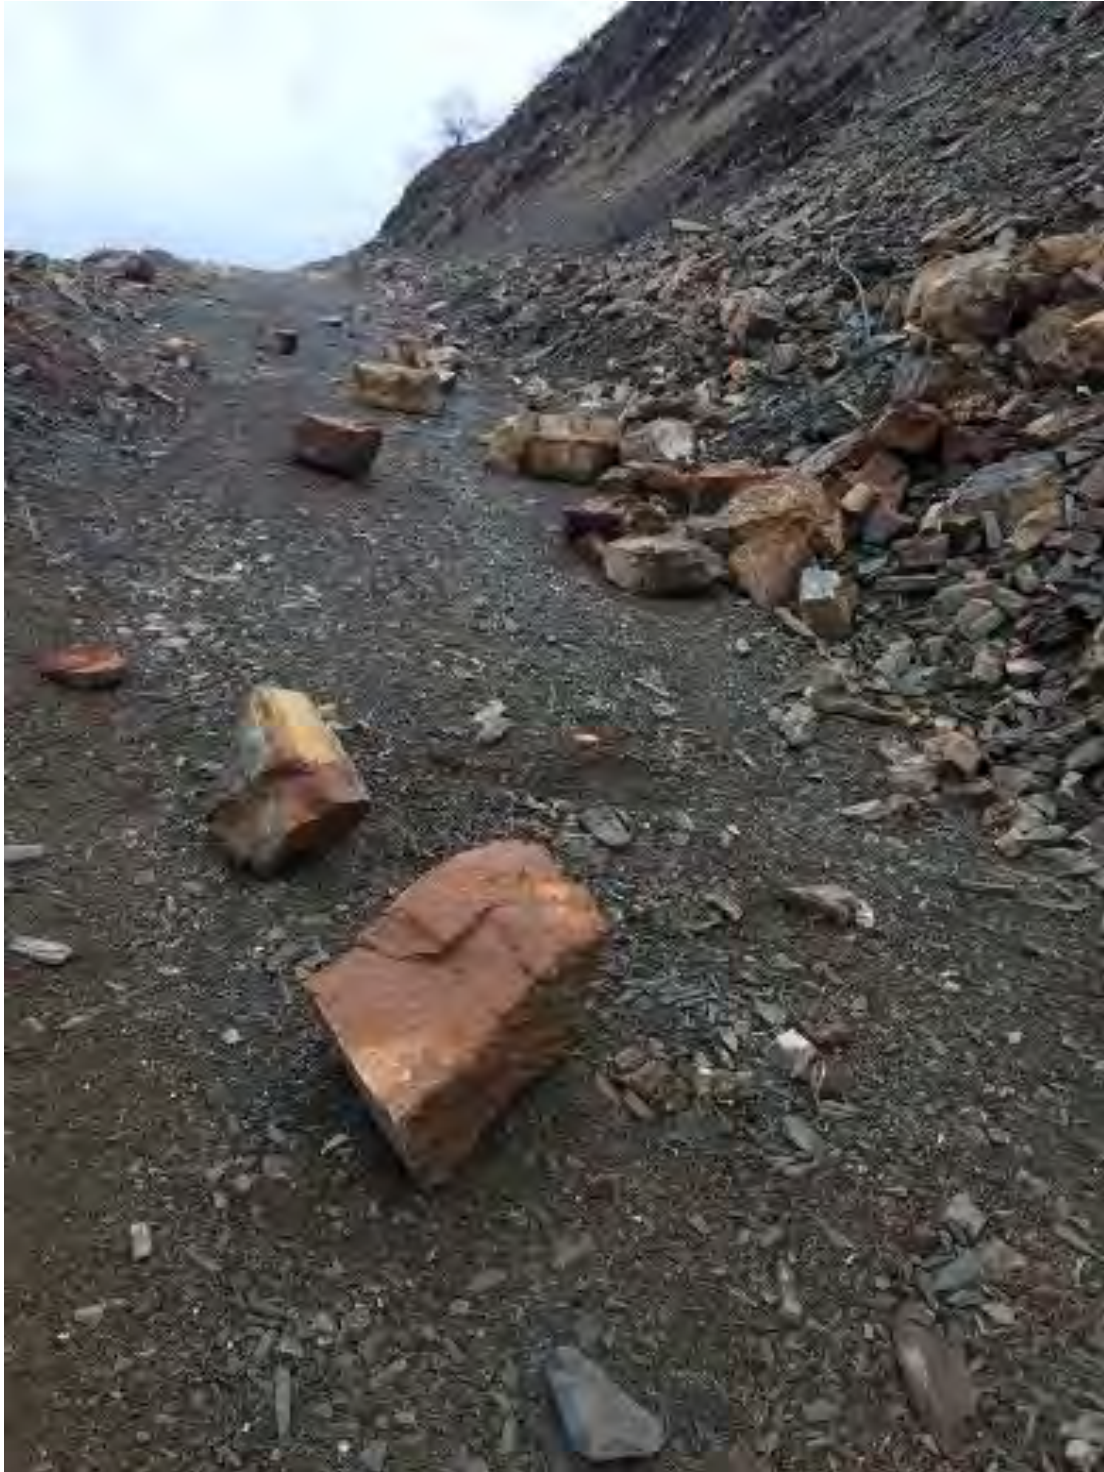
Figure 4.49. Rockfalls at 13<sup>th</sup> stop  
(38°31'41.0"N 39°27'59.6"E / 31.01.2020 / 16:13)

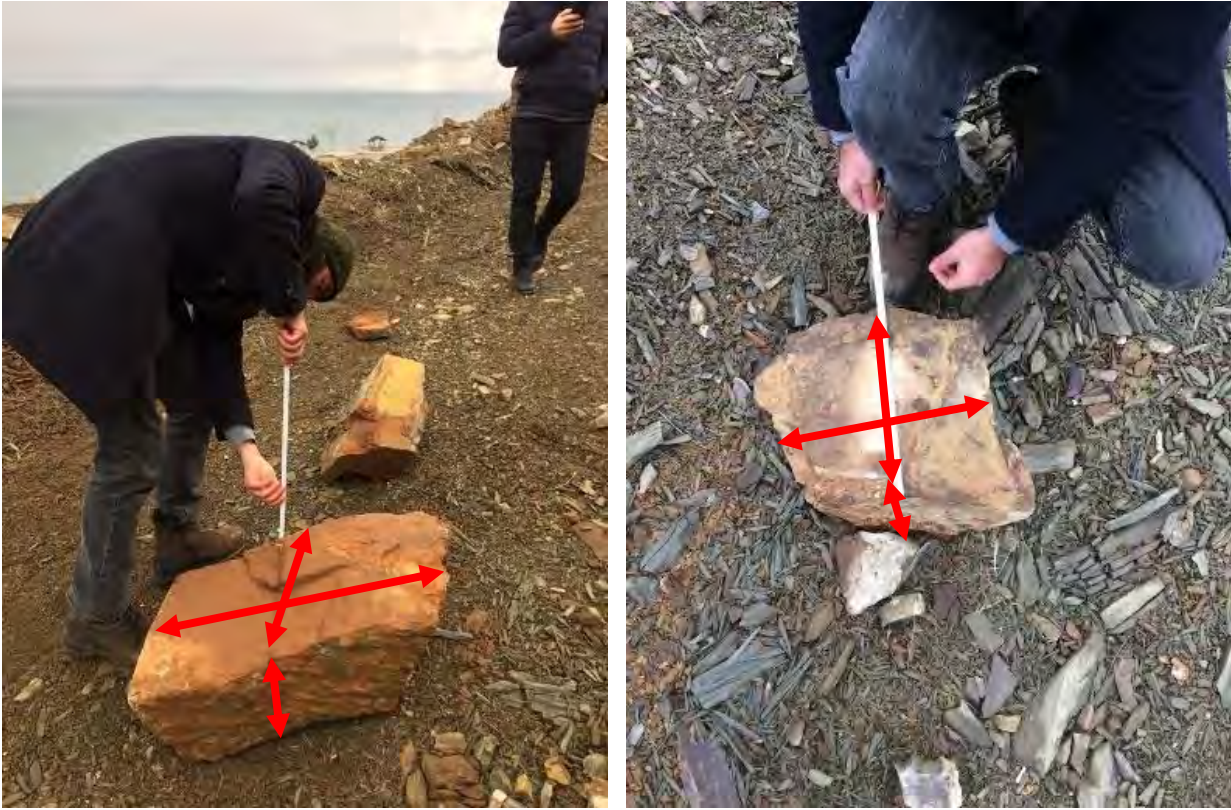
Figure 4.50. Measurement of rockfalls' dimensions at 13<sup>th</sup> stop.  
(38°31'41.3"N 39°27'59.5"E / 31.01.2020 / 16:15 & 38°31'41.5"N 39°27'59.0"E / 31.01.2020 / 16:16)

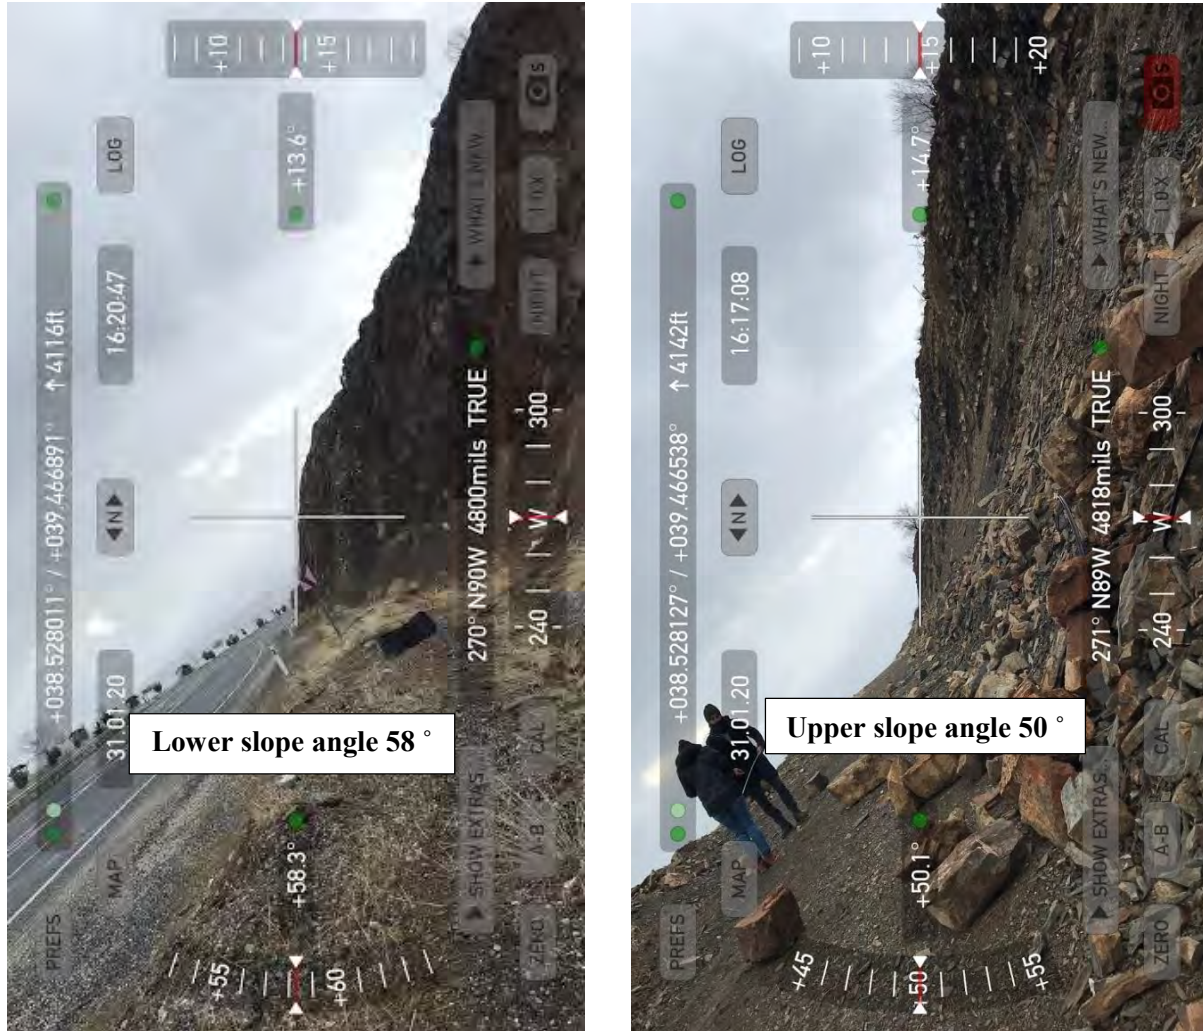
Figure 4.51. Rockfalls at 13<sup>th</sup> stop (Slope angle determination)  
(38°31'40.8"N 39°28'00.8"E / 31.01.2020 / 16:20 & 38°31'41.3"N 39°27'59.5"E / 31.01.2020 / 16:17)

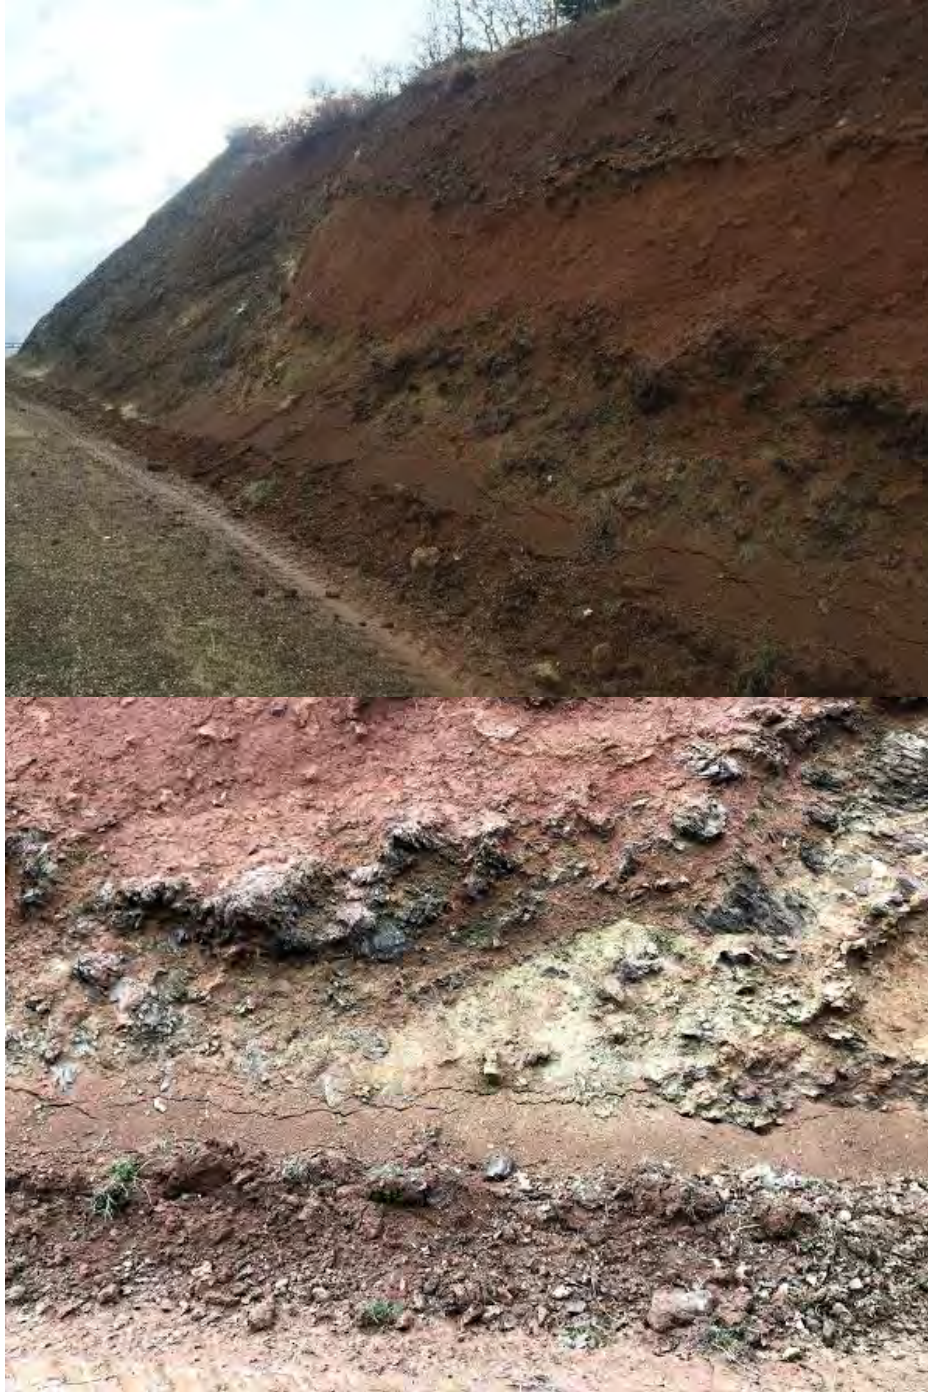
A 65° slope was documented to be stable as shown in Figures 4.52 and 4.53.

Figure 4.52. Side view of the slope  
(38°30'11.7"N 39°23'33.4"E / 31.01.2020 / 16:34 & 38°30'11.8"N 39°23'33.3"E / 31.01.2020 / 16:34)

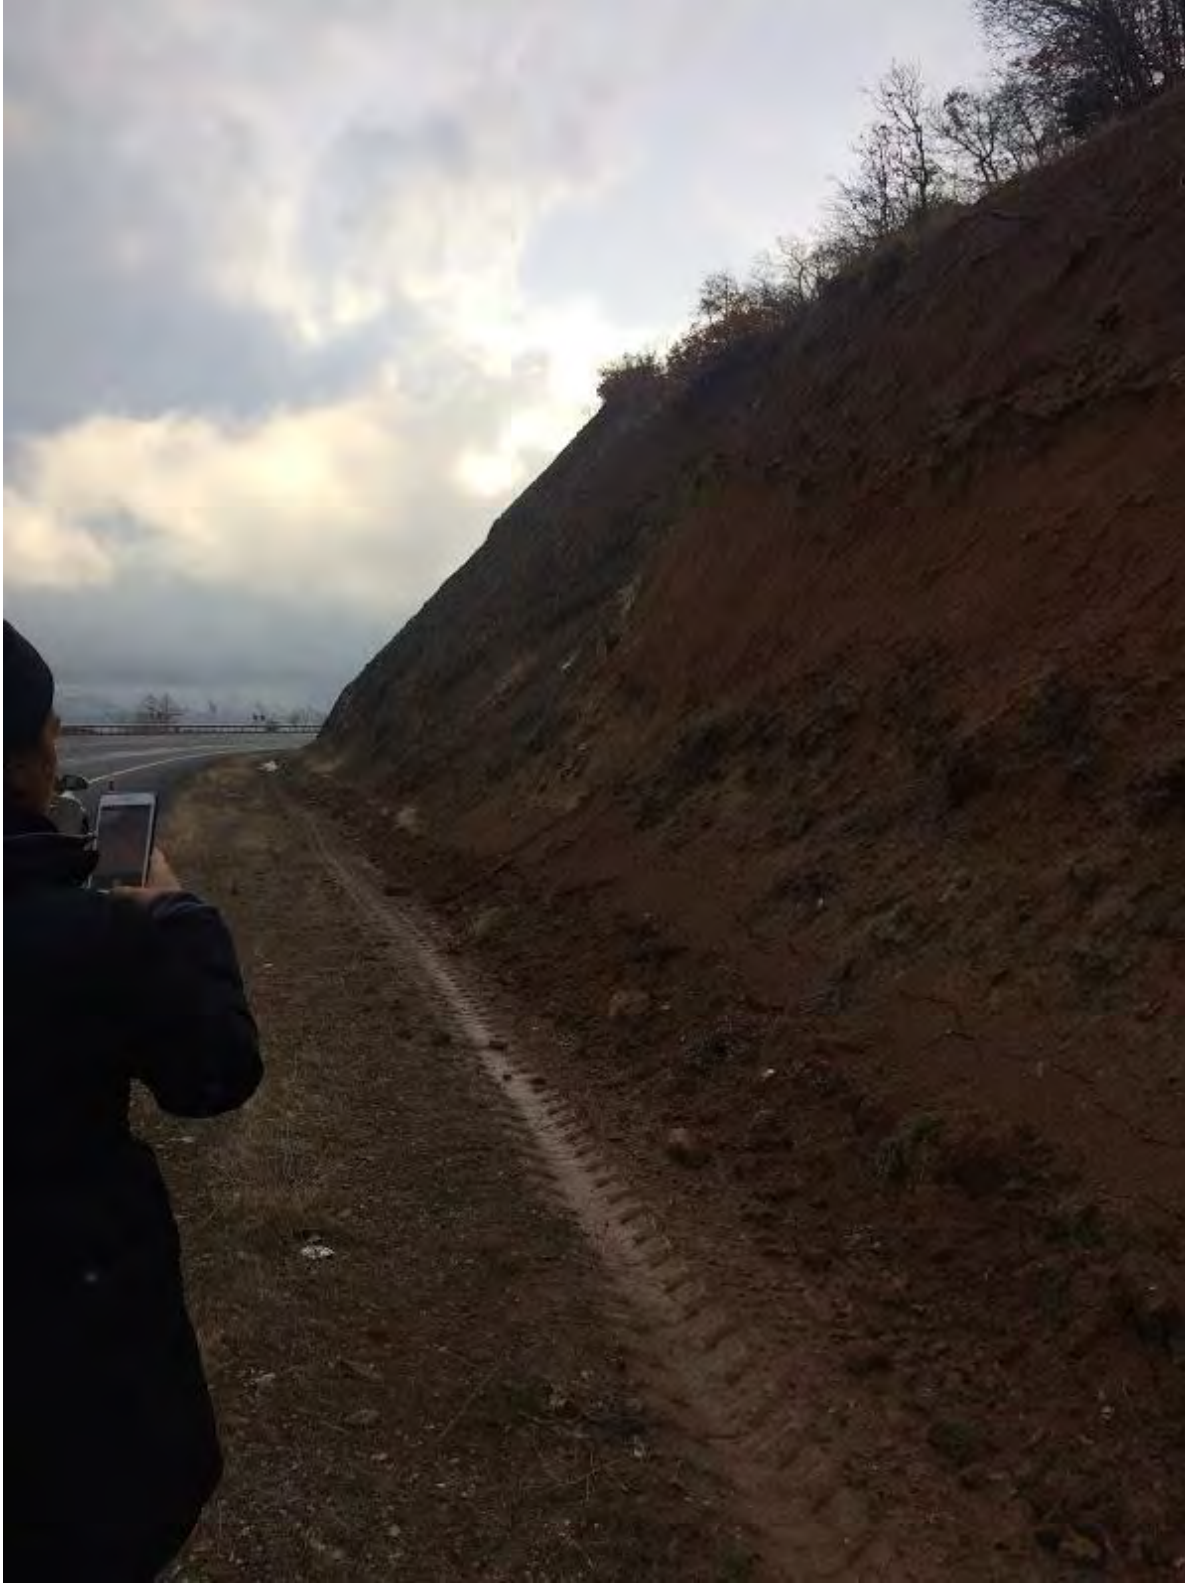
Figure 4.53. Side view of the slope  
( $38^{\circ}30'11.6''N$   $39^{\circ}23'33.7''E$  / 31.01.2020 / 16:34)

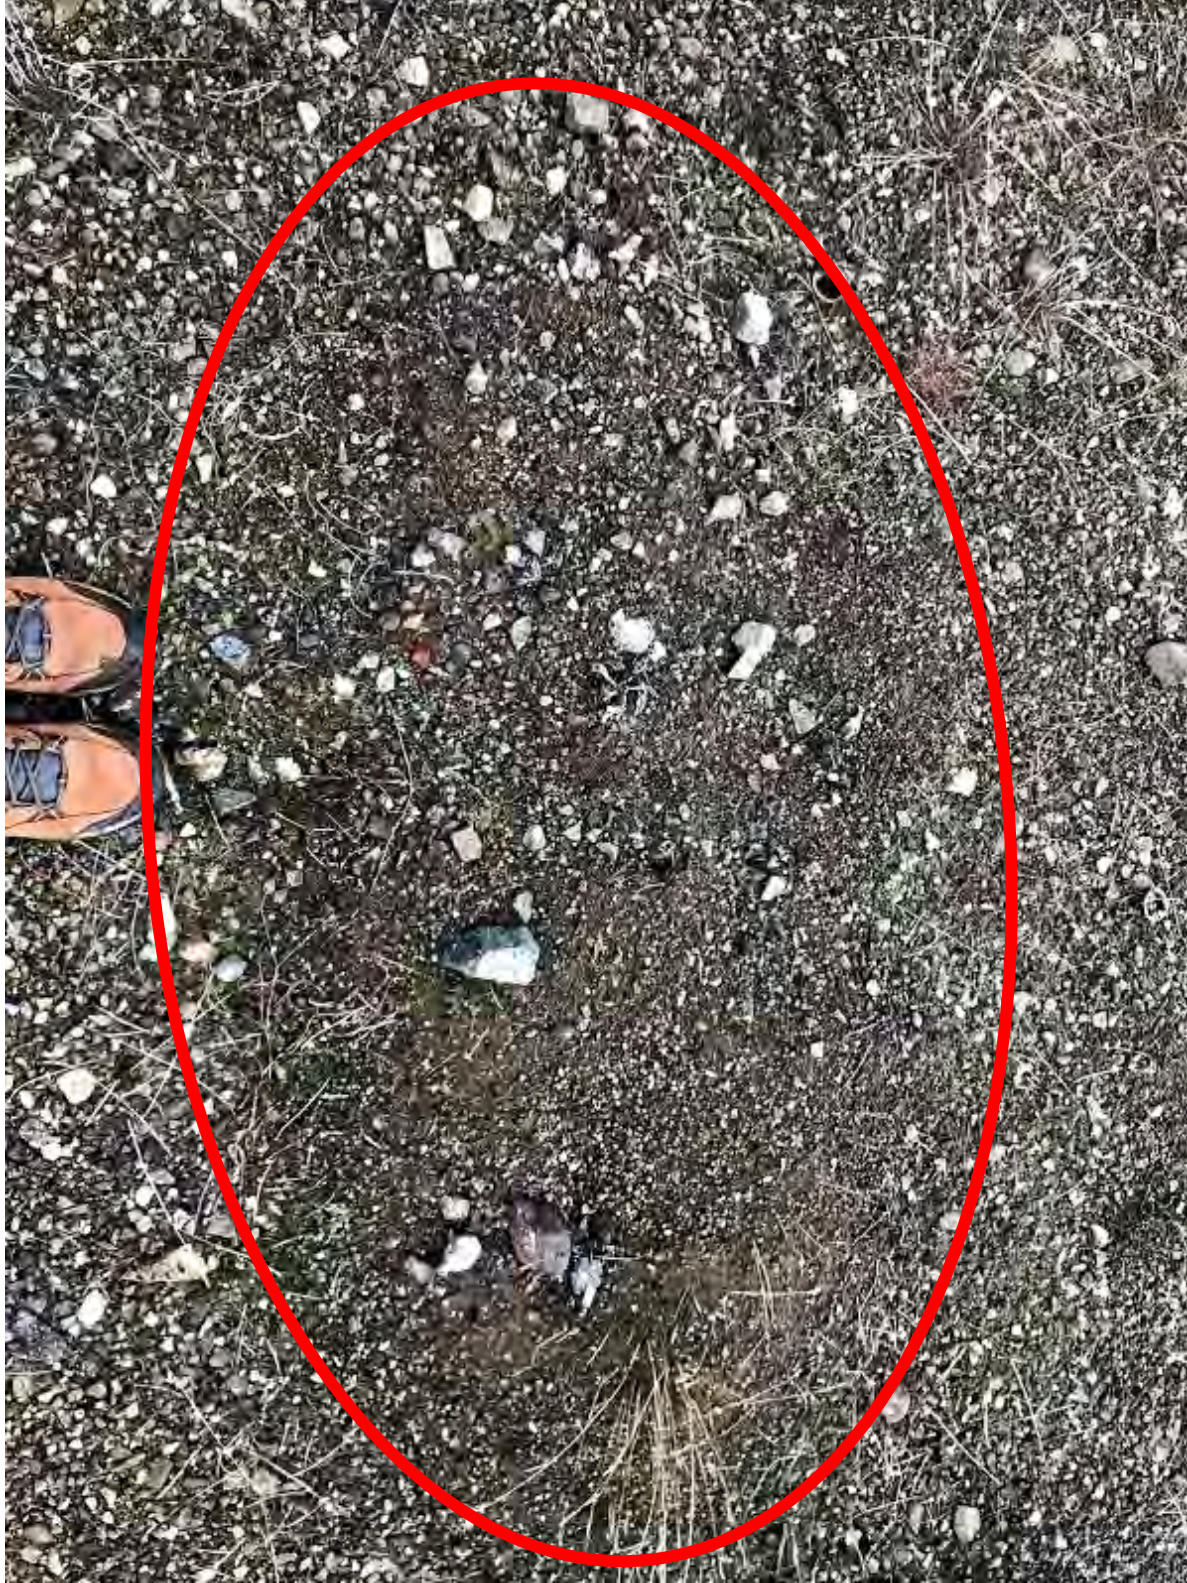
Seismically-induced liquefaction failure was observed in the form of sand boils at the 15<sup>th</sup> stop. Examples of sand boils in different forms are presented in Figures 4.55 to 4.57. Note that the plane tree leaves were covered by the sand boils in Figure 4.55.

Figure 4.56. Seismic soil liquefaction-induced sand boils  
( $38^{\circ}29'32.1''N$   $39^{\circ}21'02.0''E$  / 31.01.2020 / 16:58)

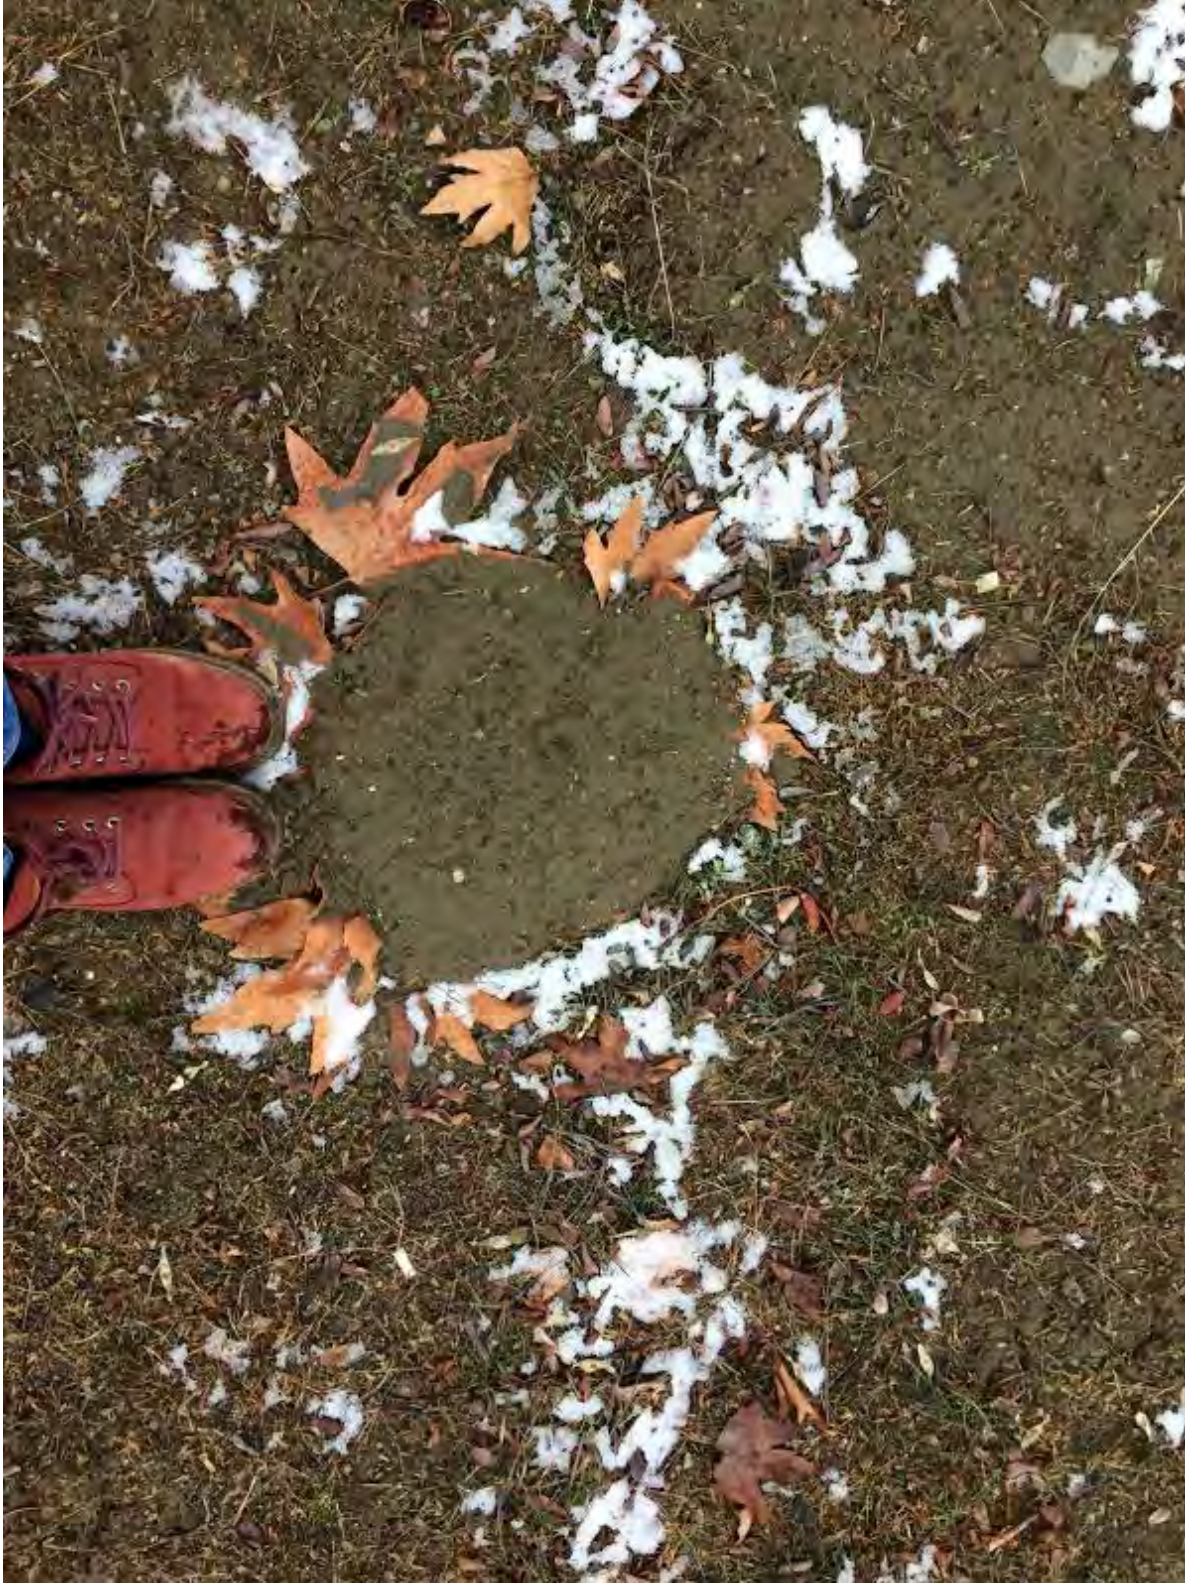
Figure 4.57. Seismic soil liquefaction-induced sand boils  
( $38^{\circ}29'34.5''N$   $39^{\circ}21'03.7''E$  / 31.01.2020 / 17:12)

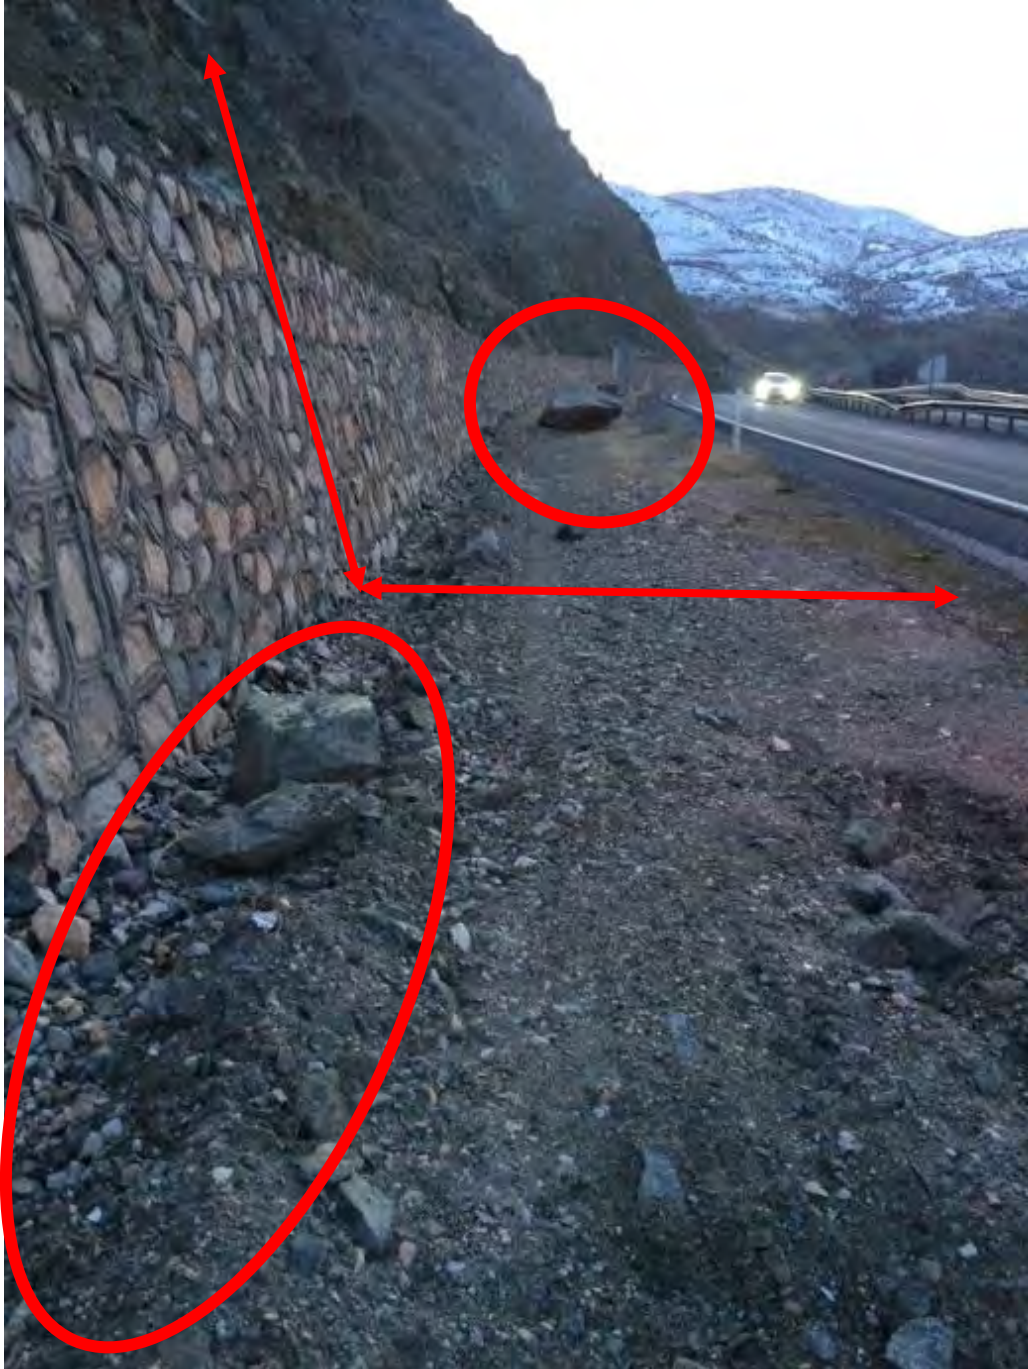
2-3 m diameter rocks were fallen freshly on the shoulders of the highway, as shown in Figure 4.59.

Figure 4.59. Fallen rocks on the highway  
(38°26'19.8"N 38°49'38.8"E / 01.02.2020 / 7:23)

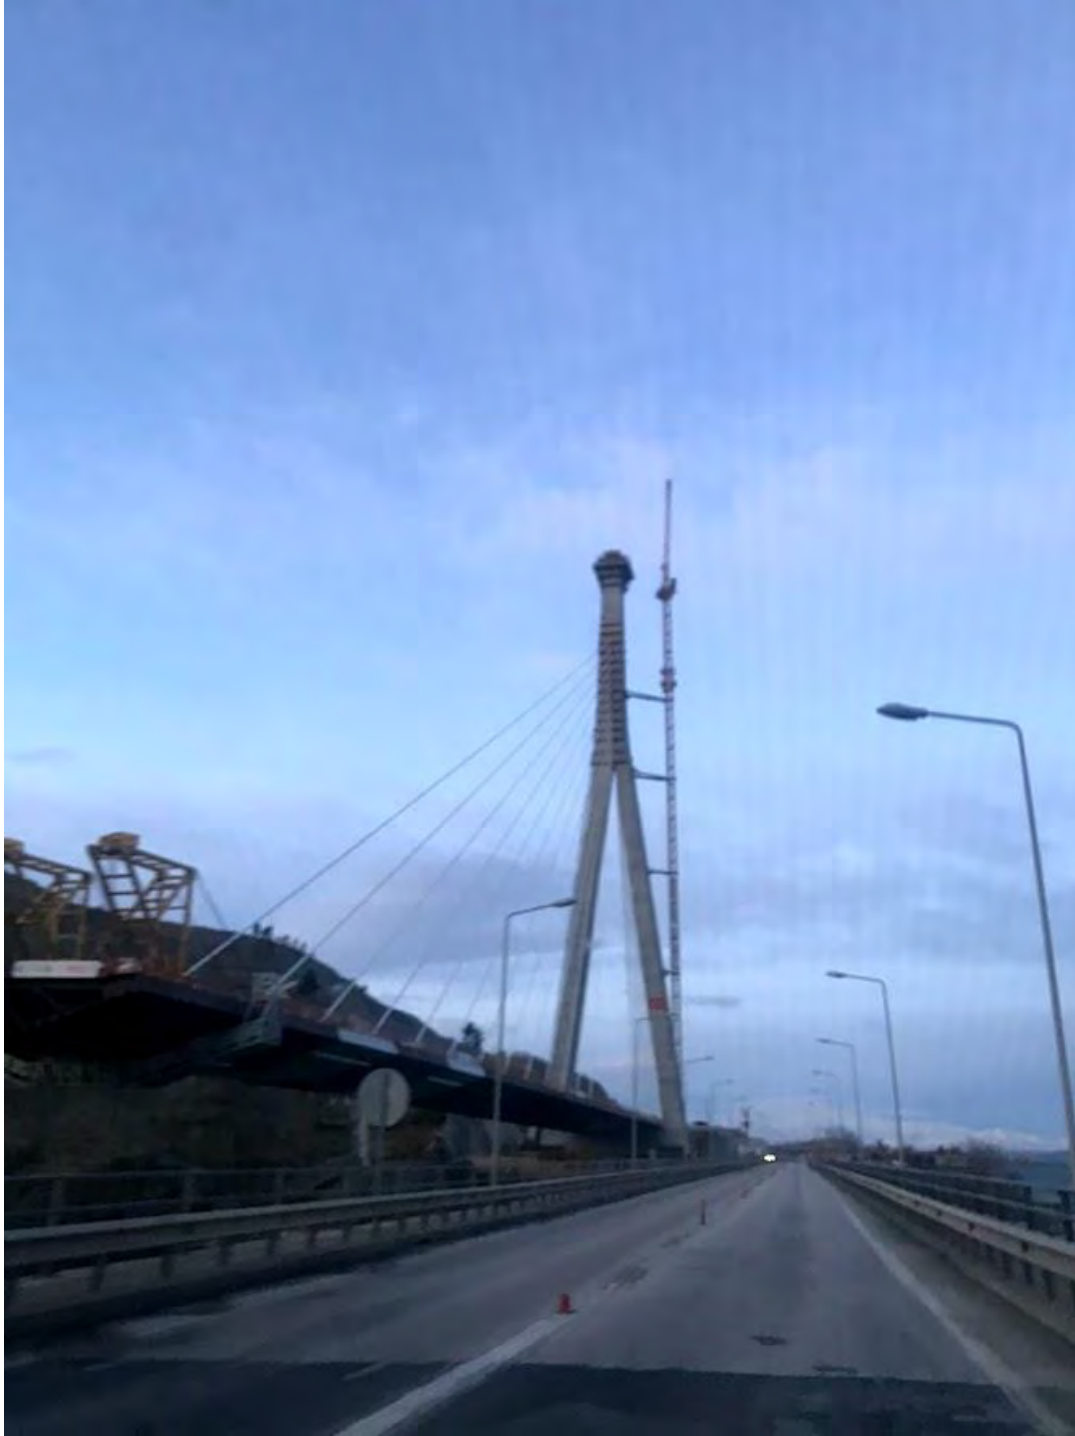
New K m rhan Bridge under construction on Fırat River was visited, which experienced no damage as shown in Figure 4.60.

Figure 4.60. New K m rhan Bridge under construction on Fırat River  
(38°26'29.6"N 38°49'10.3"E / 01.02.2020 / 7:25)

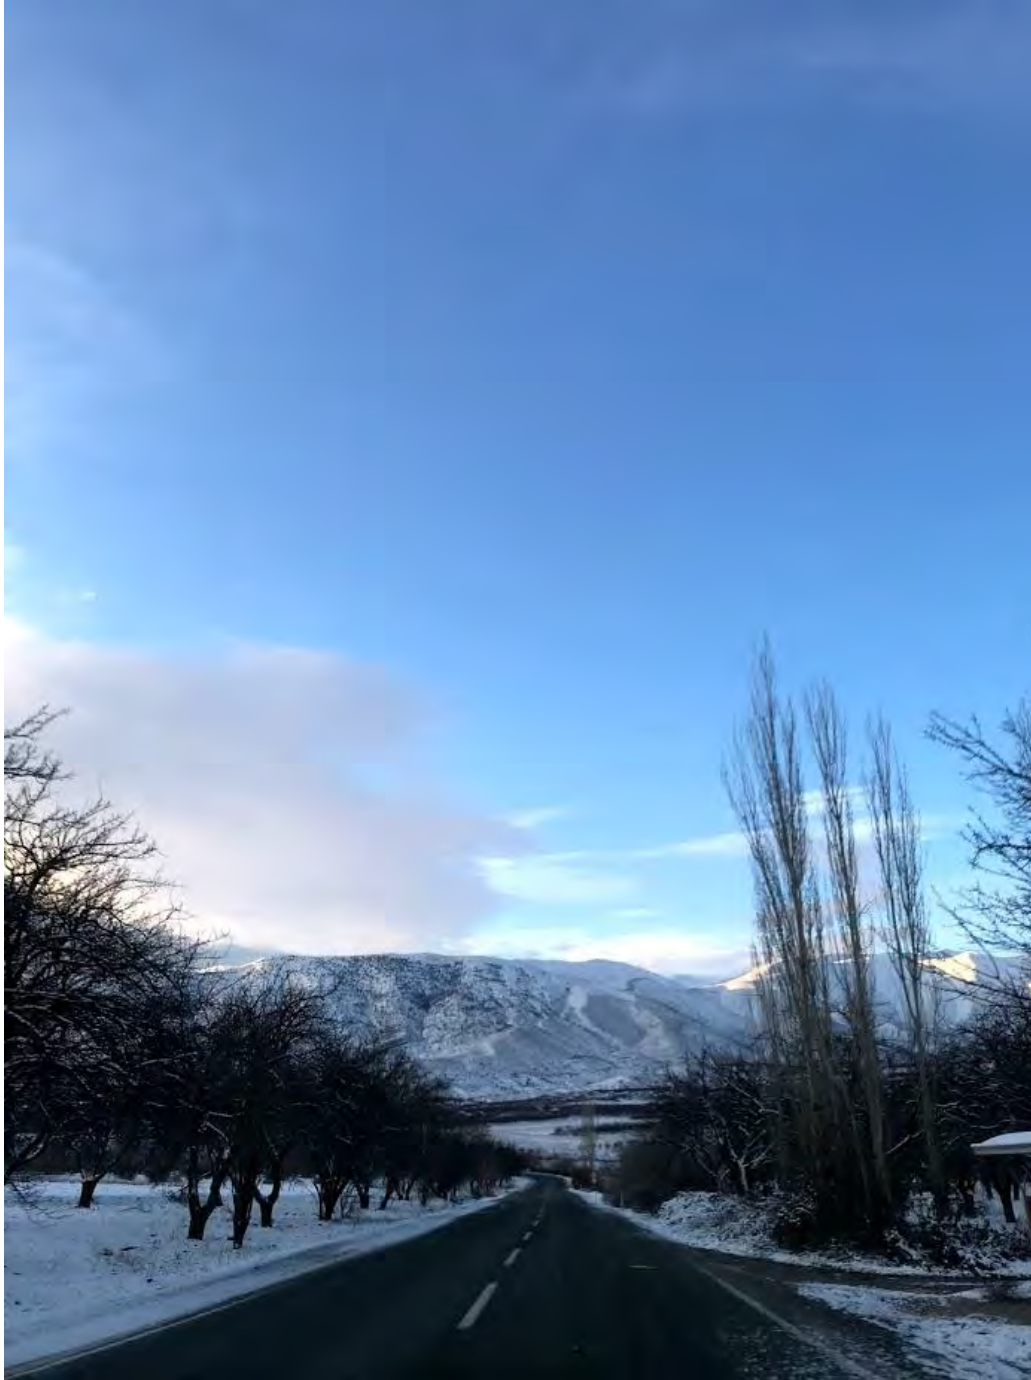
As stated earlier, in the second day's morning the plan was to go to the Doğanyol village; however, the road accessing to Doğanyol was closed at the hills due to heavy snow storm, as shown in Figure 4.61. The Gendarme prohibited cars traveling beyond this point.

Figure 4.61. Road to Doğanyol  
(38°18'39.9"N 38°29'41.7"E / 01.02.2020 / 7:52)

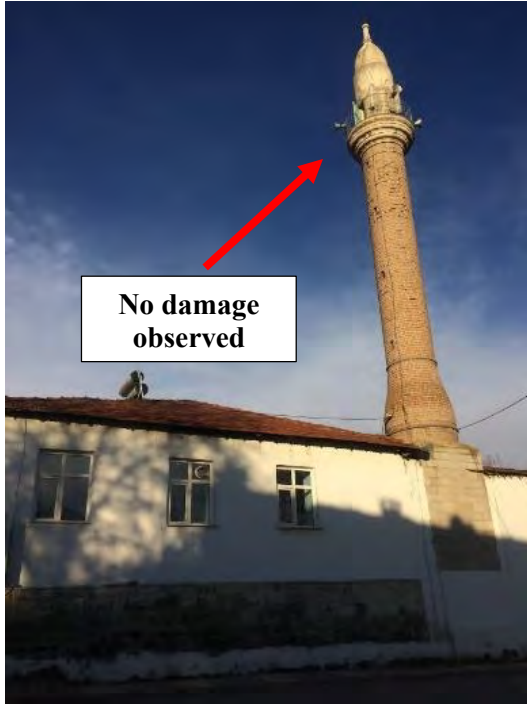
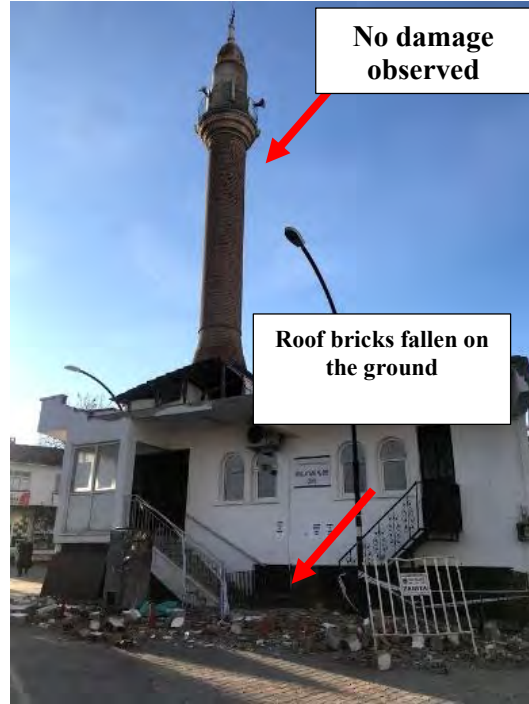
Damages on a number of non-engineered masonry, and reinforced concrete structures were observed in the Battalgazi village, as shown in Figures 4.62- 4.66. Some of these structures suffered from intensive cracking, partial collapse, whereas some others experienced no evident damage. The minarets of village Mosques were not damaged. Historical monument (Ulu Cami) was also documented to be not damaged. No signs of ground deformation-induced structural failures.

Figure 4.63. Minaret's of village Mosque  
( $38^{\circ}25'28.6''N$   $38^{\circ}21'55.5''E$  / 01.02.2020 / 8:41)

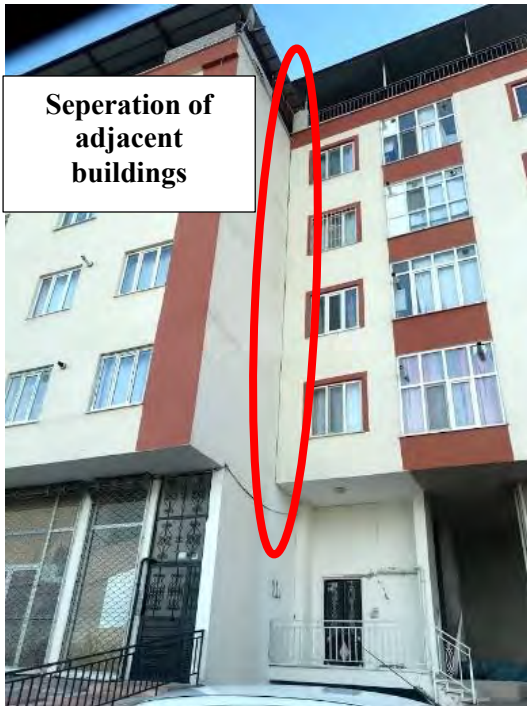
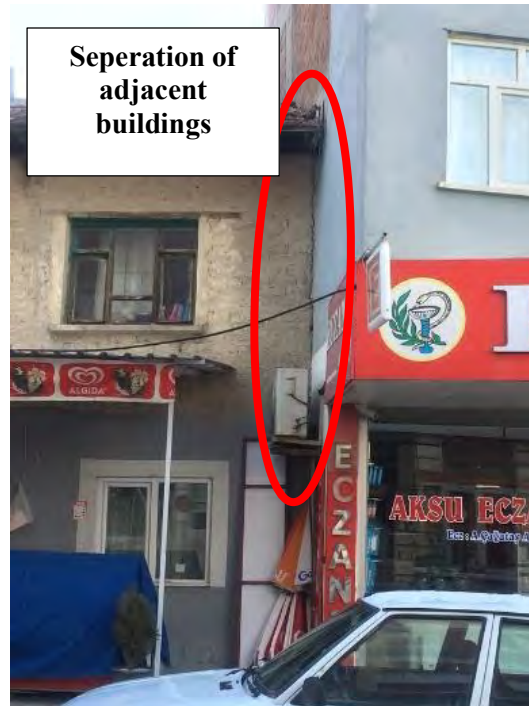
Figure 4.64. Separation of two adjacent buildings in Battalgazi Village  
( $38^{\circ}25'40.4''N$   $38^{\circ}22'02.8''E$  / 01.02.2020 / 8:44 &  $38^{\circ}25'35.4''N$   $38^{\circ}22'00.4''E$  / 01.02.2020 / 8:43)

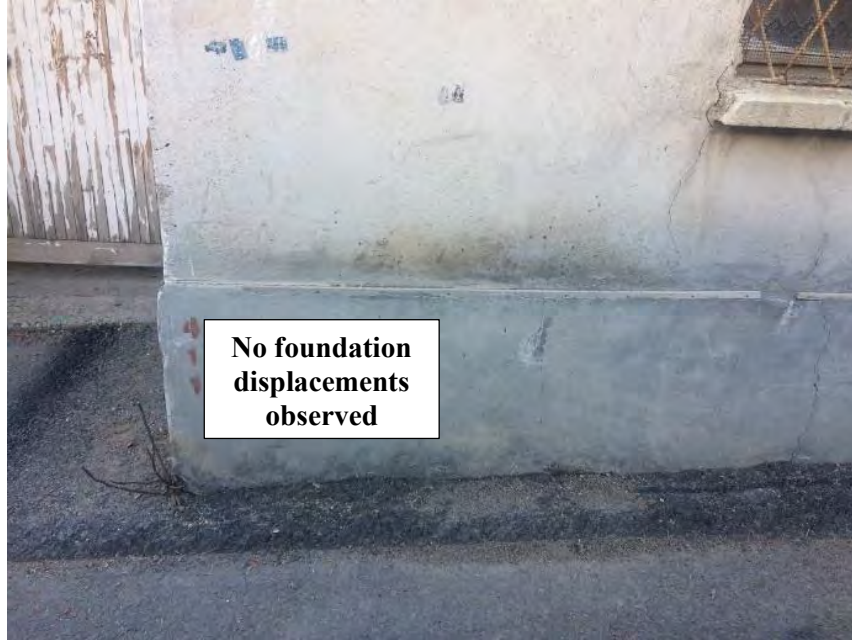
Figure 4.65. No foundation displacements observed at a residential building in Battalgazi Village  
( $38^{\circ}25'20.7''N$   $38^{\circ}21'59.3''E$  / 01.02.2020 / 8:31)

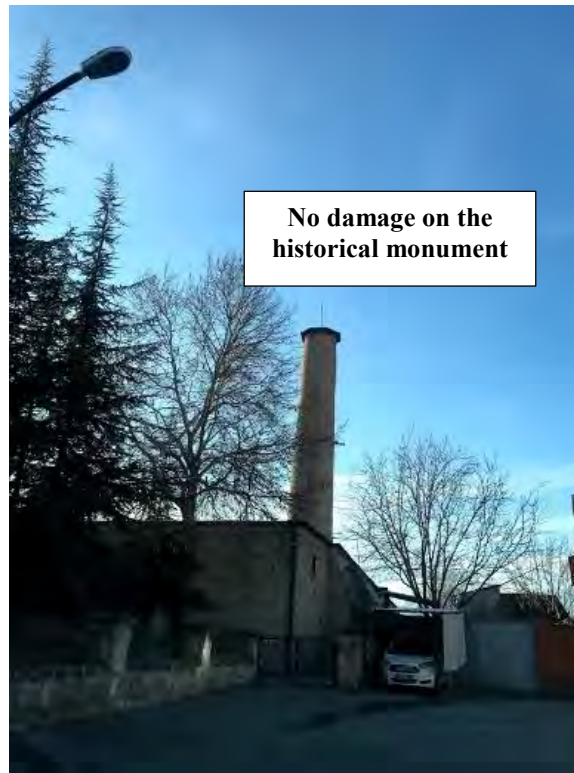
Figure 4.66. Historical monument in the Battalgazi Village  
( $38^{\circ}25'15.5''N$   $38^{\circ}21'59.7''E$  / 01.02.2020 / 8:32)

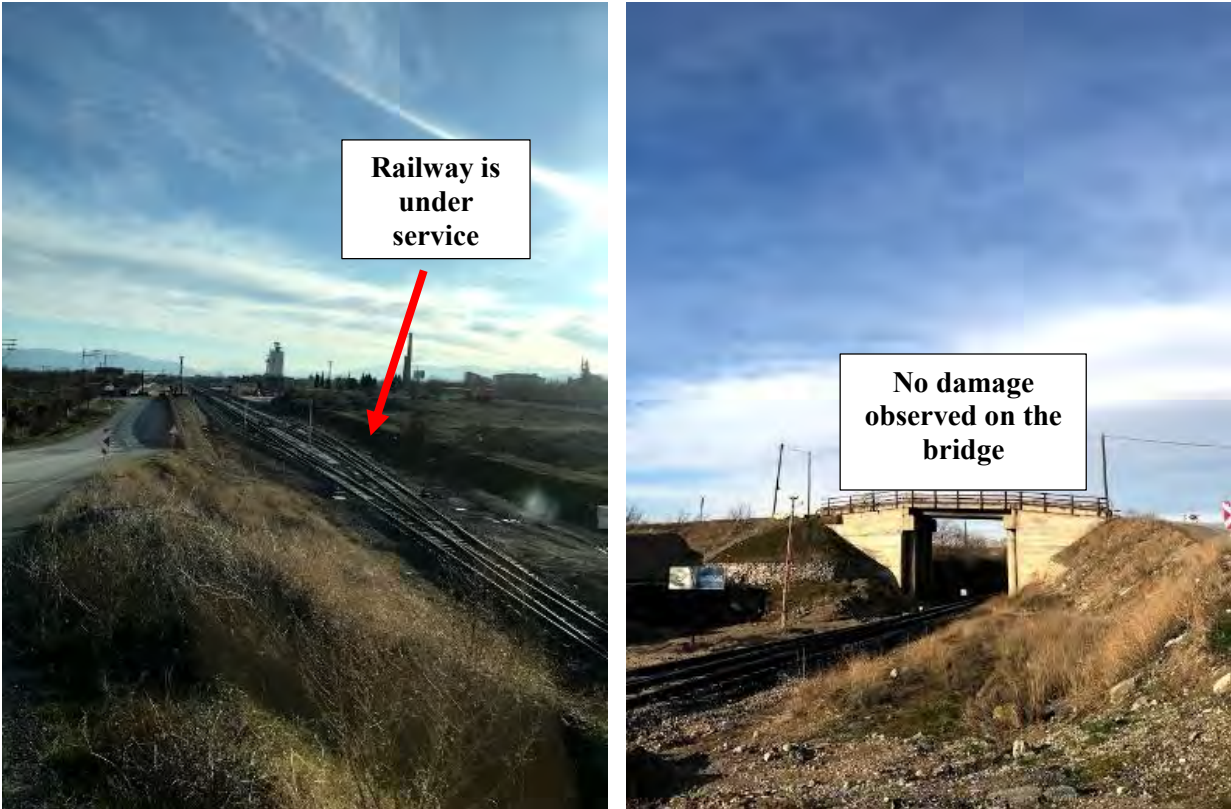
Railway tracks were observed to be not damaged at the 29<sup>th</sup> stop. The railway was under service as presented in Figure 4.67. In the same figure a small bridge is shown again with no signs of damage.

Figure 4.67. Railway and bridge at 20<sup>th</sup> stop  
(38°26'00.1"N 38°21'59.1"E / 01.02.2020 / 8:49 & 38°26'00.2"N 38°22'01.3"E / 01.02.2020 / 8:50)

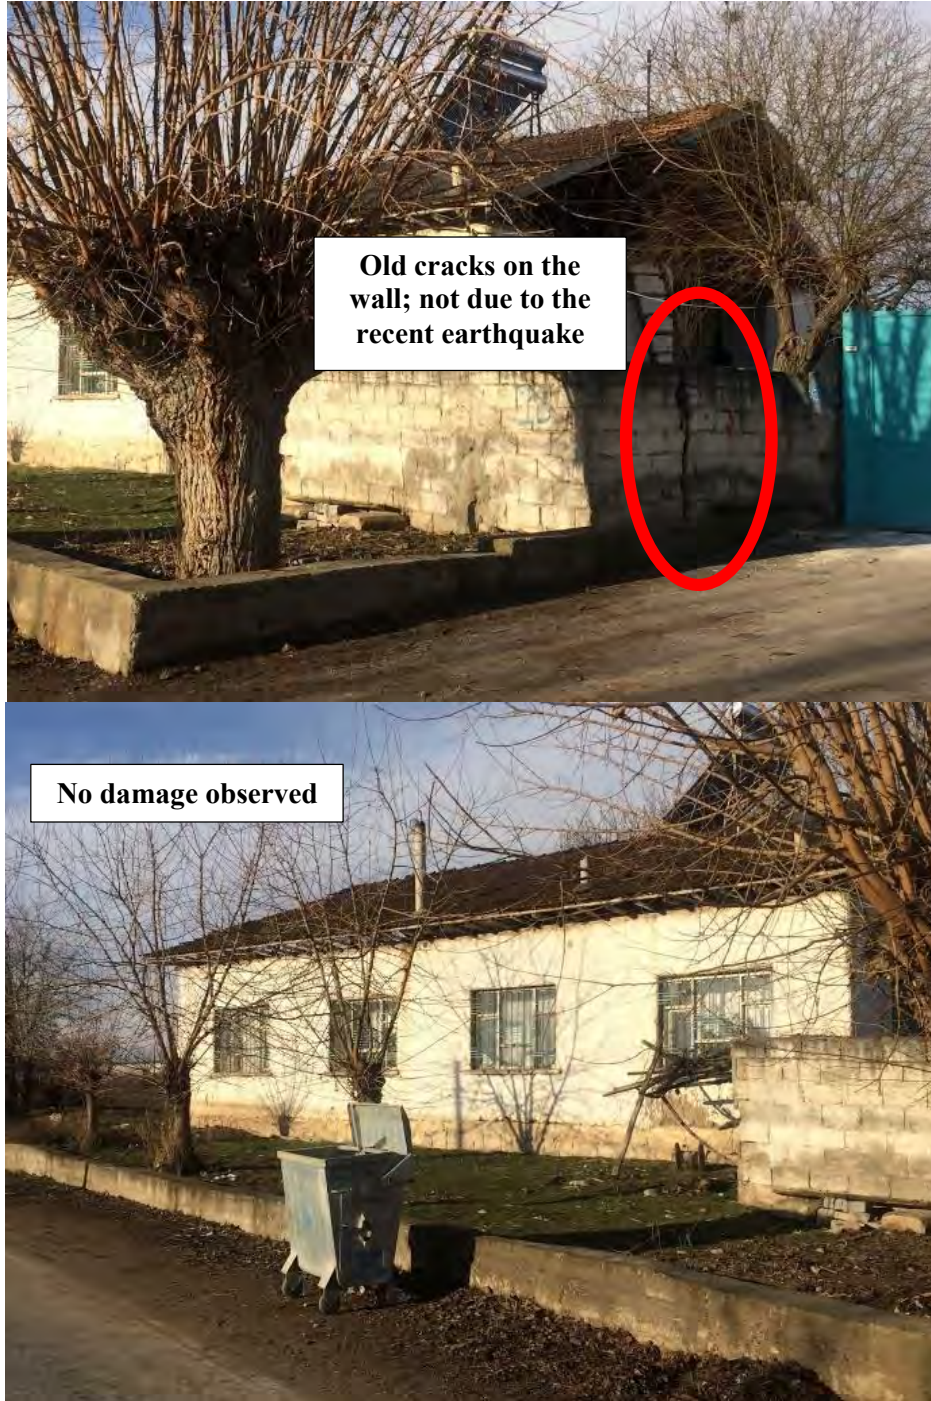
A number of structural damages were observed, mostly concentrating on masonry buildings in Bahçelievler district of Battalgazi village, as shown in Figure 4.68 and 4.69.

Figure 4.68. Residential buildings in the Bahçelievler district of Battalgazi Village  
(38°26'51.2"N 38°22'19.2"E / 01.02.2020 / 8:52 & 38°26'51.1"N 38°22'19.2"E / 01.02.2020 / 8:53)

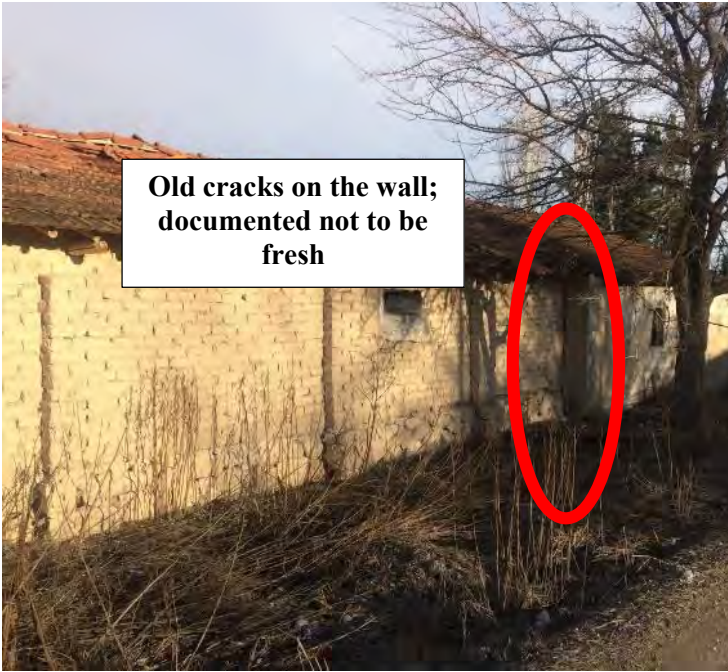
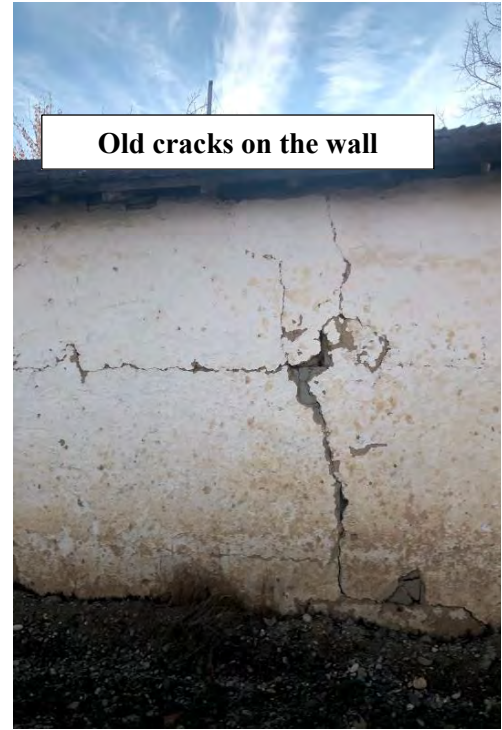
Figure 4.69. Cracks on the wall of a residential building in the Bahçelievler district of Battalgazi Village  
( $38^{\circ}27'48.5''N$   $38^{\circ}22'50.6''E$  / 01.02.2020 / 8:56 &  $38^{\circ}27'49.0''N$   $38^{\circ}22'51.7''E$  / 01.02.2020 / 8:56)
