# Preliminary Report on Engineering and Geological Effects of the January 24, 2020 Magnitude 6.7 Earthquake in Elaziğ, Turkey

A report of the NSF-Sponsored Geotechnical Extreme Event Reconnaissance Association

Report GEER-065

**January 24, 2020 Elazığ-Sivrice Earthquake ( $M_w=6.8$ )  
Reconnaissance Study Report**

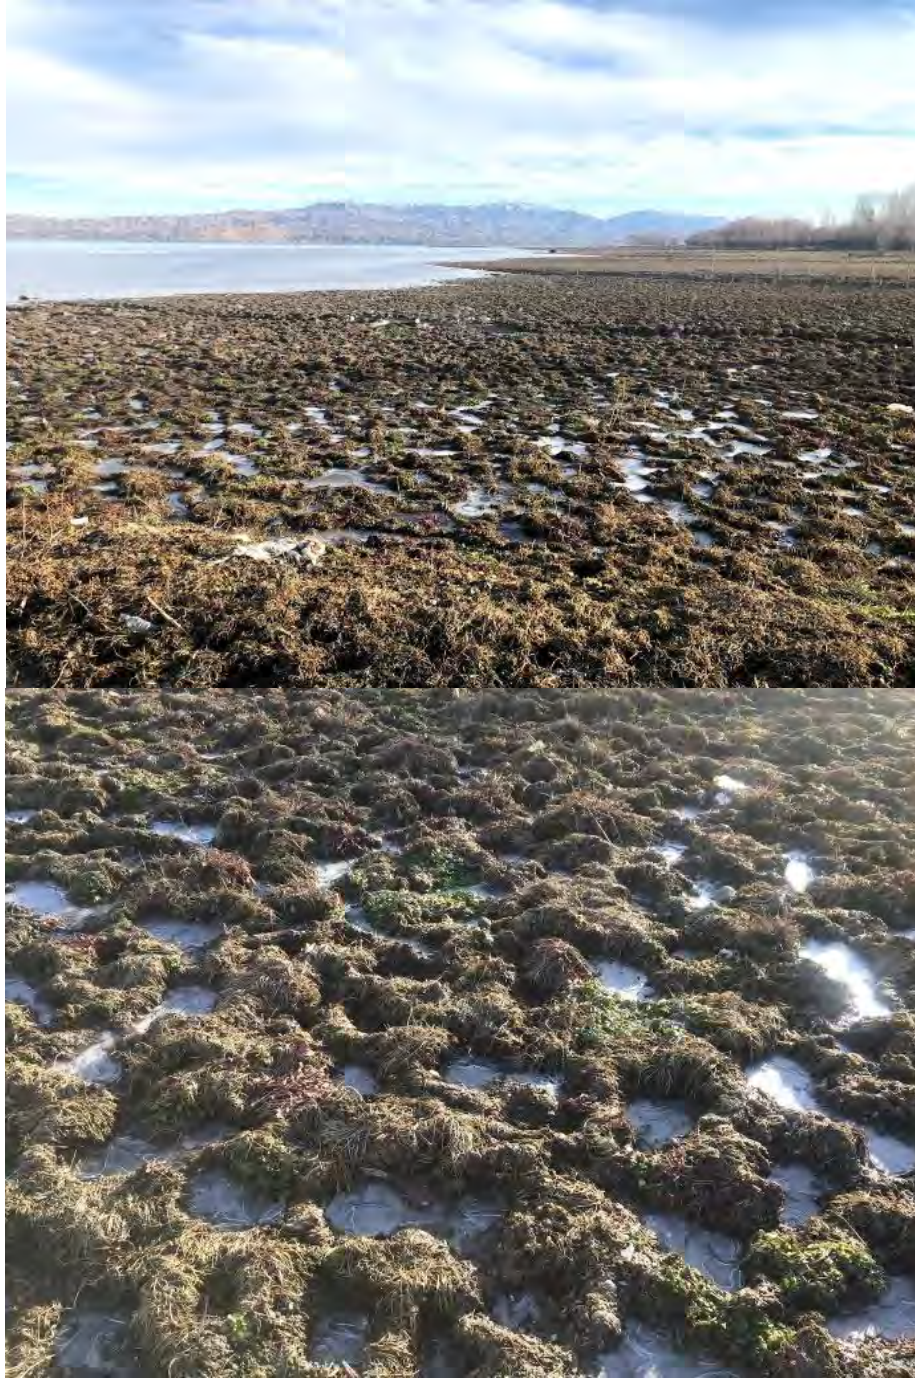
Although it is composed of alluvial deposits with potential for ground failure, no signs of it were observed. Surficial soils, observed to be of high plasticity clays, and frozen ground were listed as two factors, which might have impeded possible ground failure, as shown in Figures 4.70 and 4.71.

Figure 4.70. Views of frozen soil in Toygar district of Battalgazi Village  
(38°28'38.6"N 38°23'26.4"E / 01.02.2020 / 9:02 & 38°28'38.6"N 38°23'27.1"E / 01.02.2020 / 9:03)

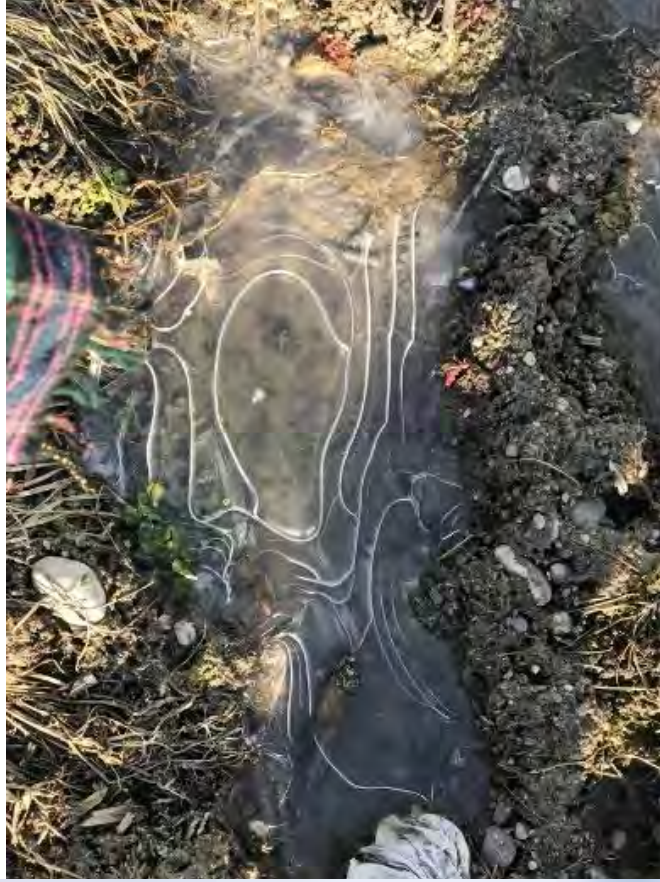
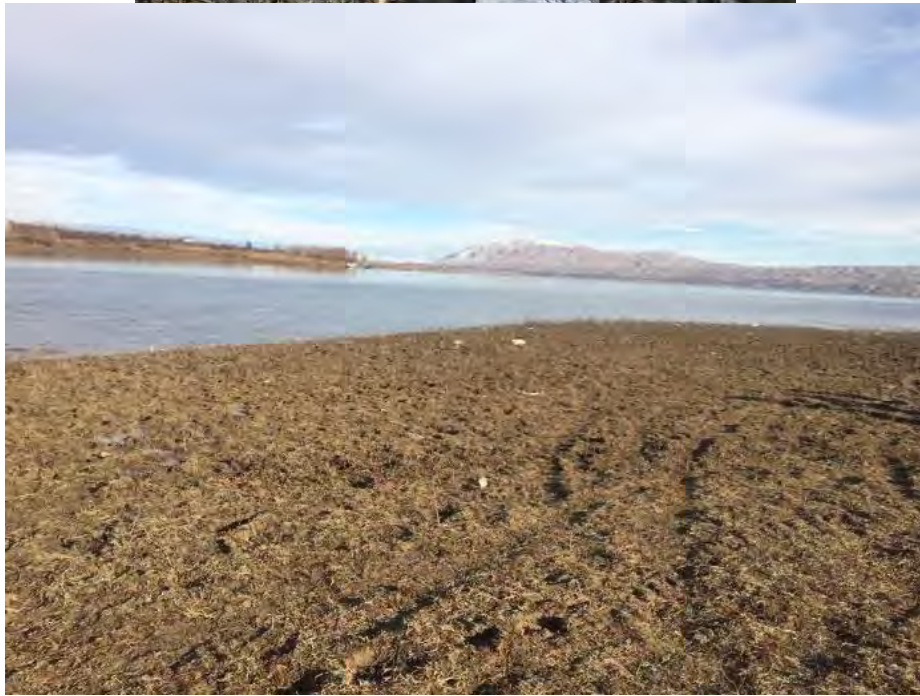
Figure 4.71. Views of frozen clayey soils in Toygar district of Battalgazi Village  
( $38^{\circ}28'38.9''N$   $38^{\circ}23'27.3''E$  / 01.02.2020 / 9:03 &  $38^{\circ}28'39.8''N$   $38^{\circ}23'29.3''E$  / 01.02.2020 / 9:05)

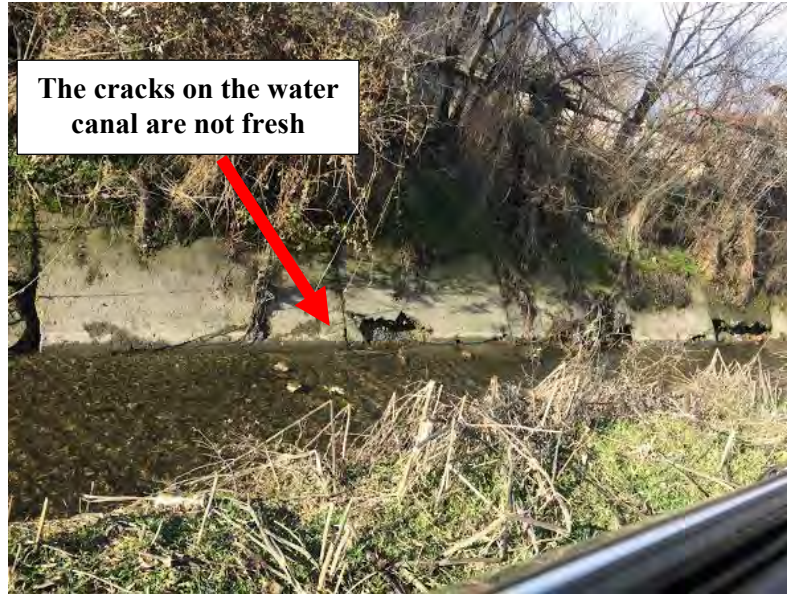
A water canal and the highway bridge were documented with no signs of damage, as shown in Figure 4.72 and Figure 4.73. Note that the observed cracks were dated older, and are not associated with the recent earthquake event.

Figure 4.72. Water trench in Dolamantepe district of Battalgazi Village  
( $38^{\circ}26'00.4''N$   $38^{\circ}21'44.1''E$  / 01.02.2020 / 9:25)

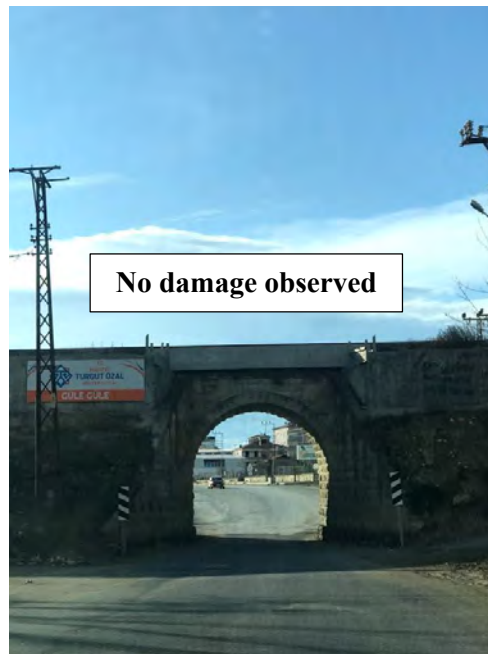
Figure 4.73. Dolamantepe district of Battalgazi Village  
( $38^{\circ}25'59.9''N$   $38^{\circ}21'41.5''E$  / 01.02.2020 / 9:26)

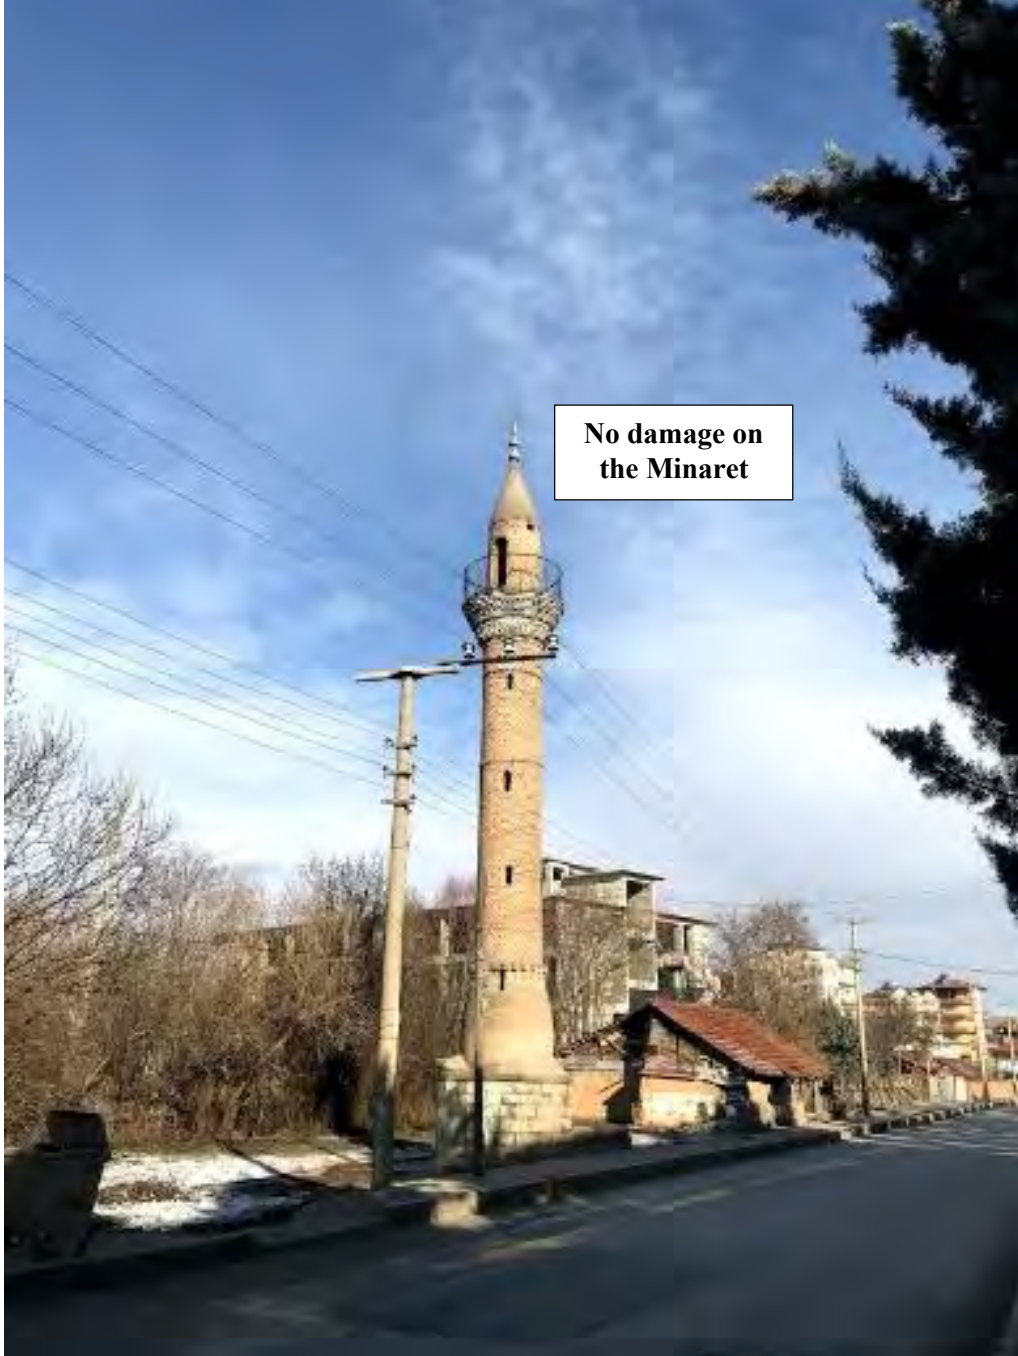
The minaret of village Mosque was not damaged, as shown in Figure 4.74.

Figure 4.74. Minaret's of a Mosque in the Hanımınçiftliği district of Battalgazi Village  
(38°22'39.4"N 38°20'08.7"E / 01.02.2020 / 9:44)

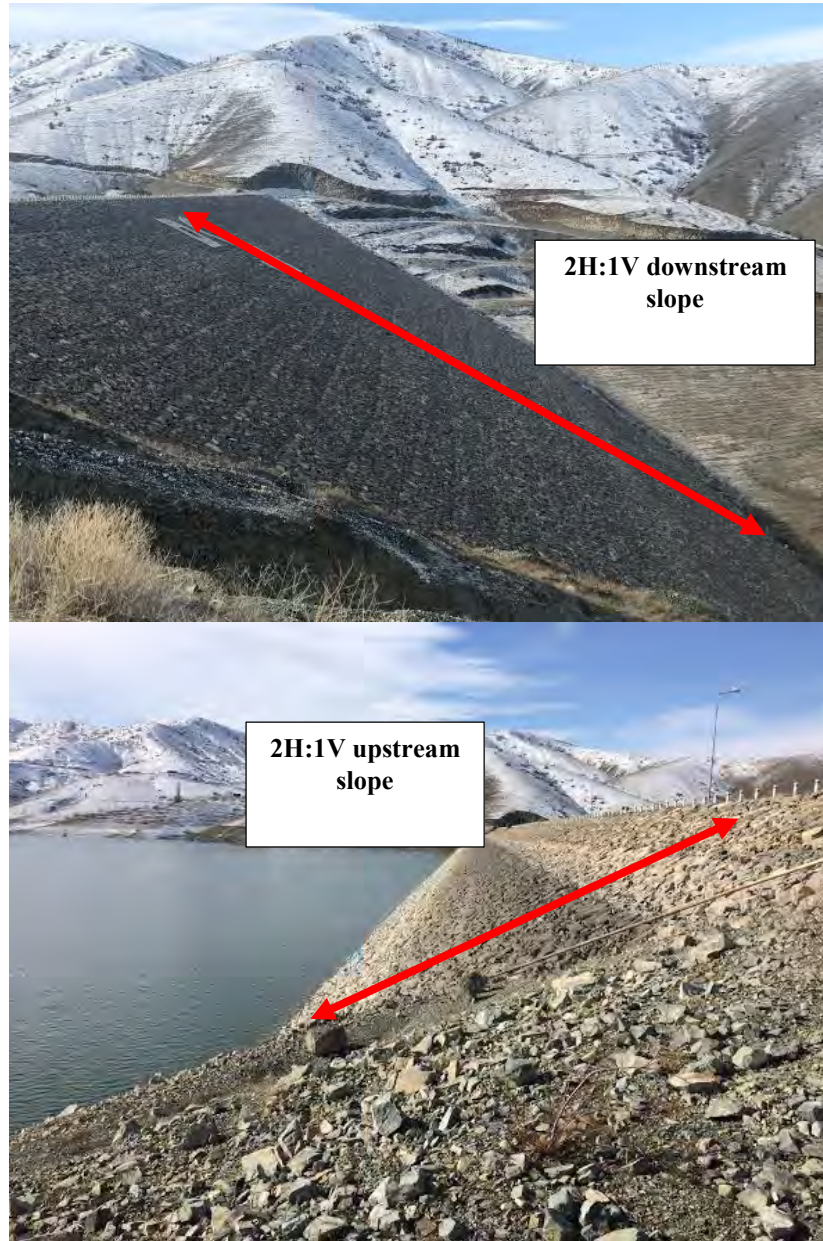
The dam was built on Memikhan River for irrigation purposes. It is an 89.5 m high clay core rockfill dam. The crest and normal water elevations were 868 m and 864.9, respectively. During our visit the water level was measured as 854.70 m. The right and left abutments along with the dam body itself were documented to be not affected from the shaking. Also, no damage to water in-take and spillways were observed. Pictures taken at the dam site can be seen in Figures 4.75 to 4.83.

Figure 4.75. Side views of Kapıkaya Dam  
(38°21'19.1"N 38°36'33.9"E / 01.02.2020 / 10:21 & 38°21'16.3"N 38°36'35.0"E / 01.02.2020 / 10:38)

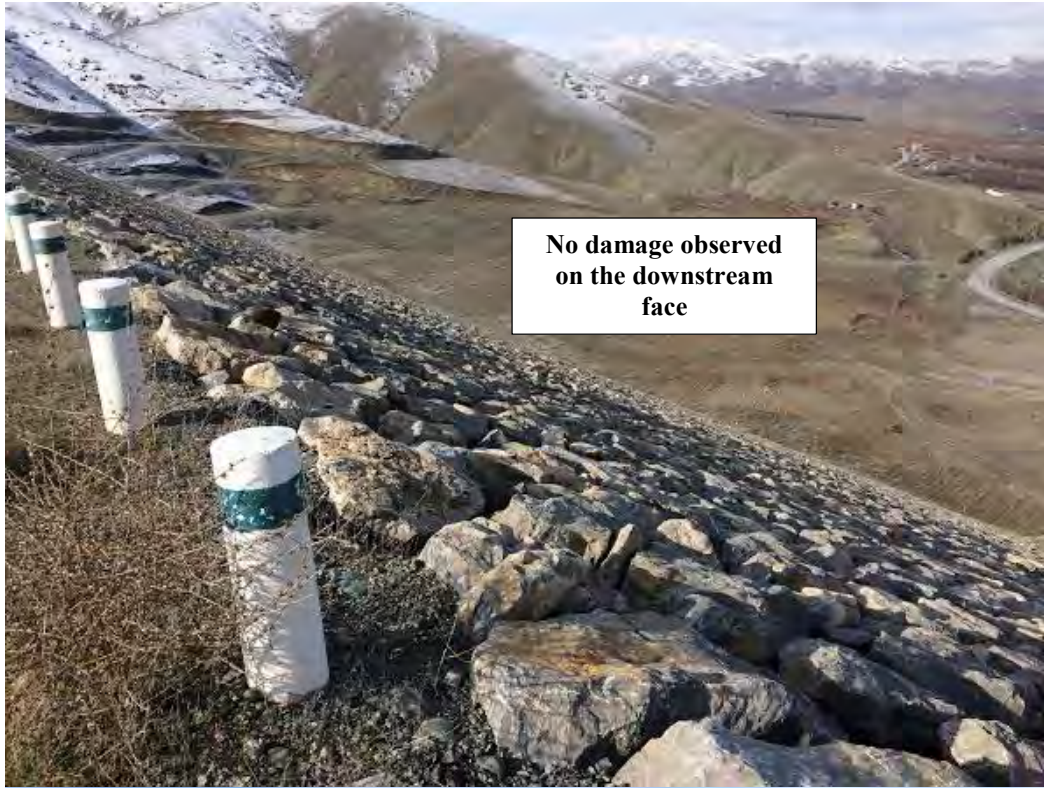
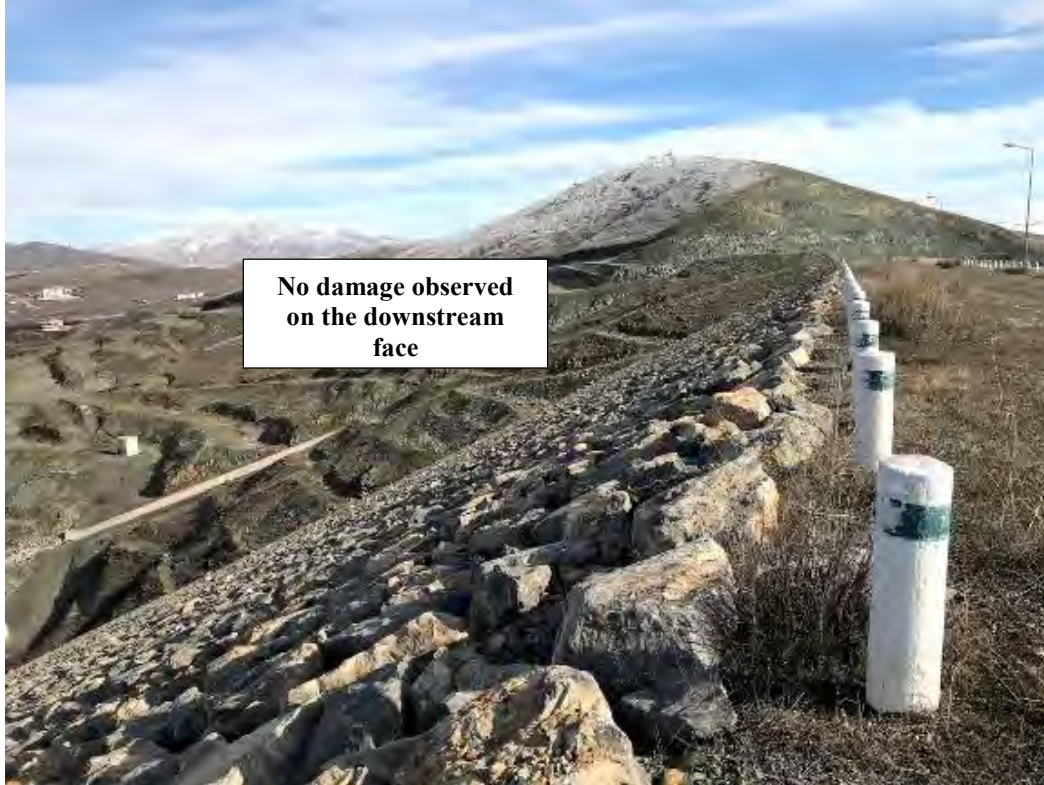
Figure 4.76. Side view of Kapıkaya Dam downstream face  
( $38^{\circ}21'16.3''N$   $38^{\circ}36'33.2''E$  / 01.02.2020 / 10:40 &  $38^{\circ}21'13.1''N$   $38^{\circ}36'26.7''E$  / 01.02.2020 / 10:46)

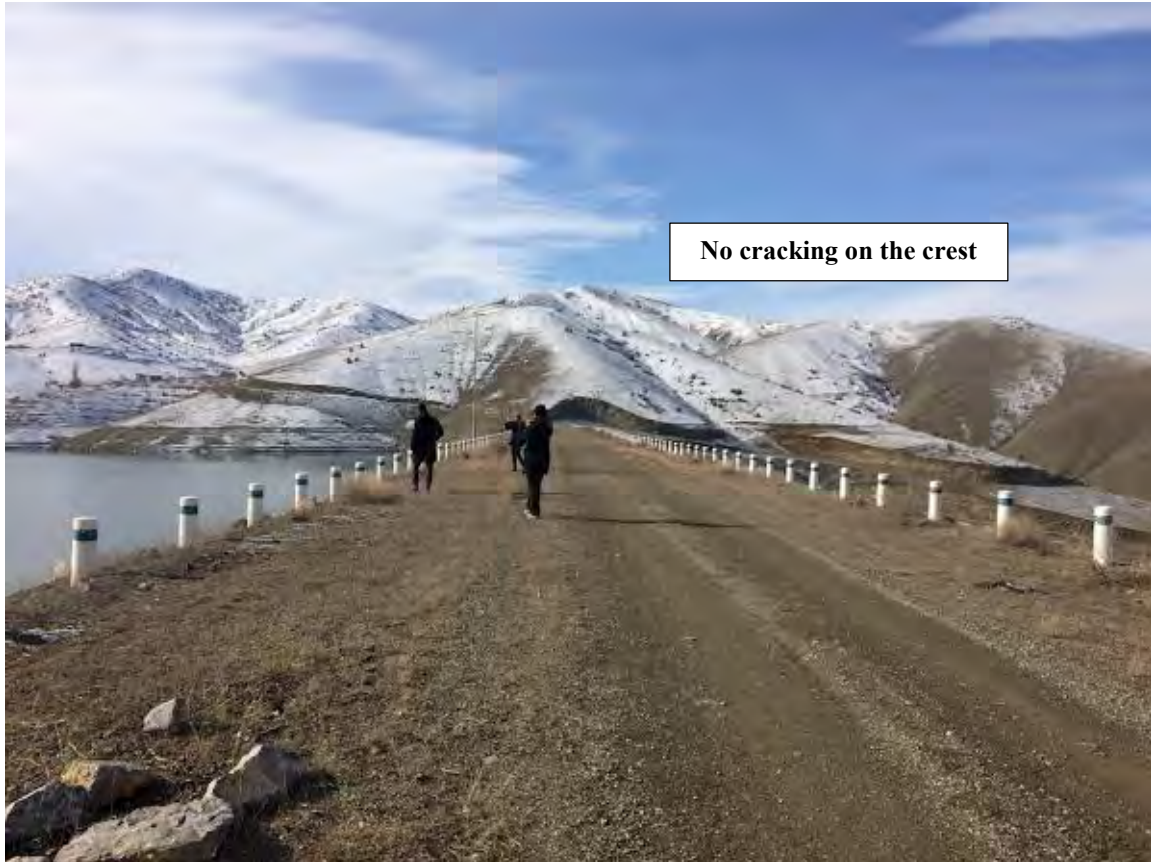
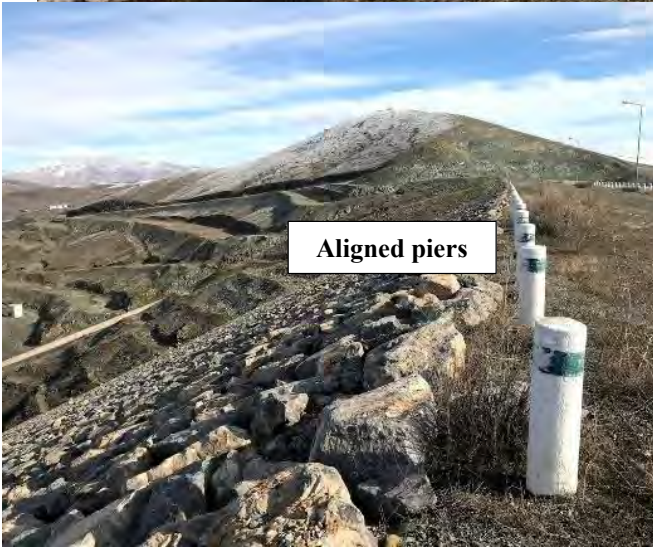
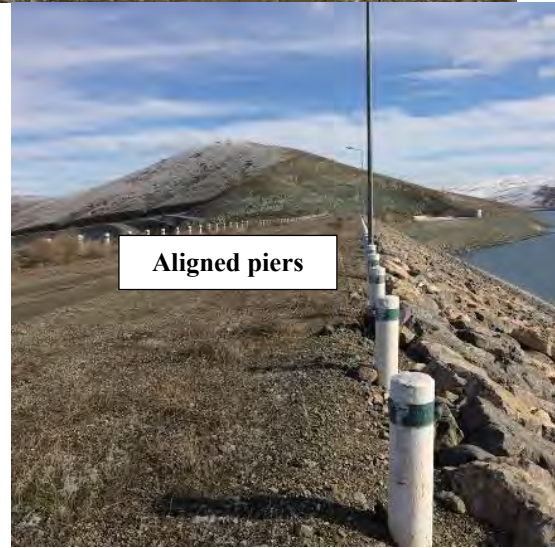
Figure 4.77. Crest view of Kapıkaya Dam  
( $38^{\circ}21'15.9''N$   $38^{\circ}36'32.8''E$  / 01.02.2020 / 10:40 &  $38^{\circ}21'12.6''N$   $38^{\circ}36'26.9''E$  / 01.02.2020 / 10:46 &  $38^{\circ}21'16.9''N$   $38^{\circ}36'36.0''E$  / 01.02.2020 / 11:13)

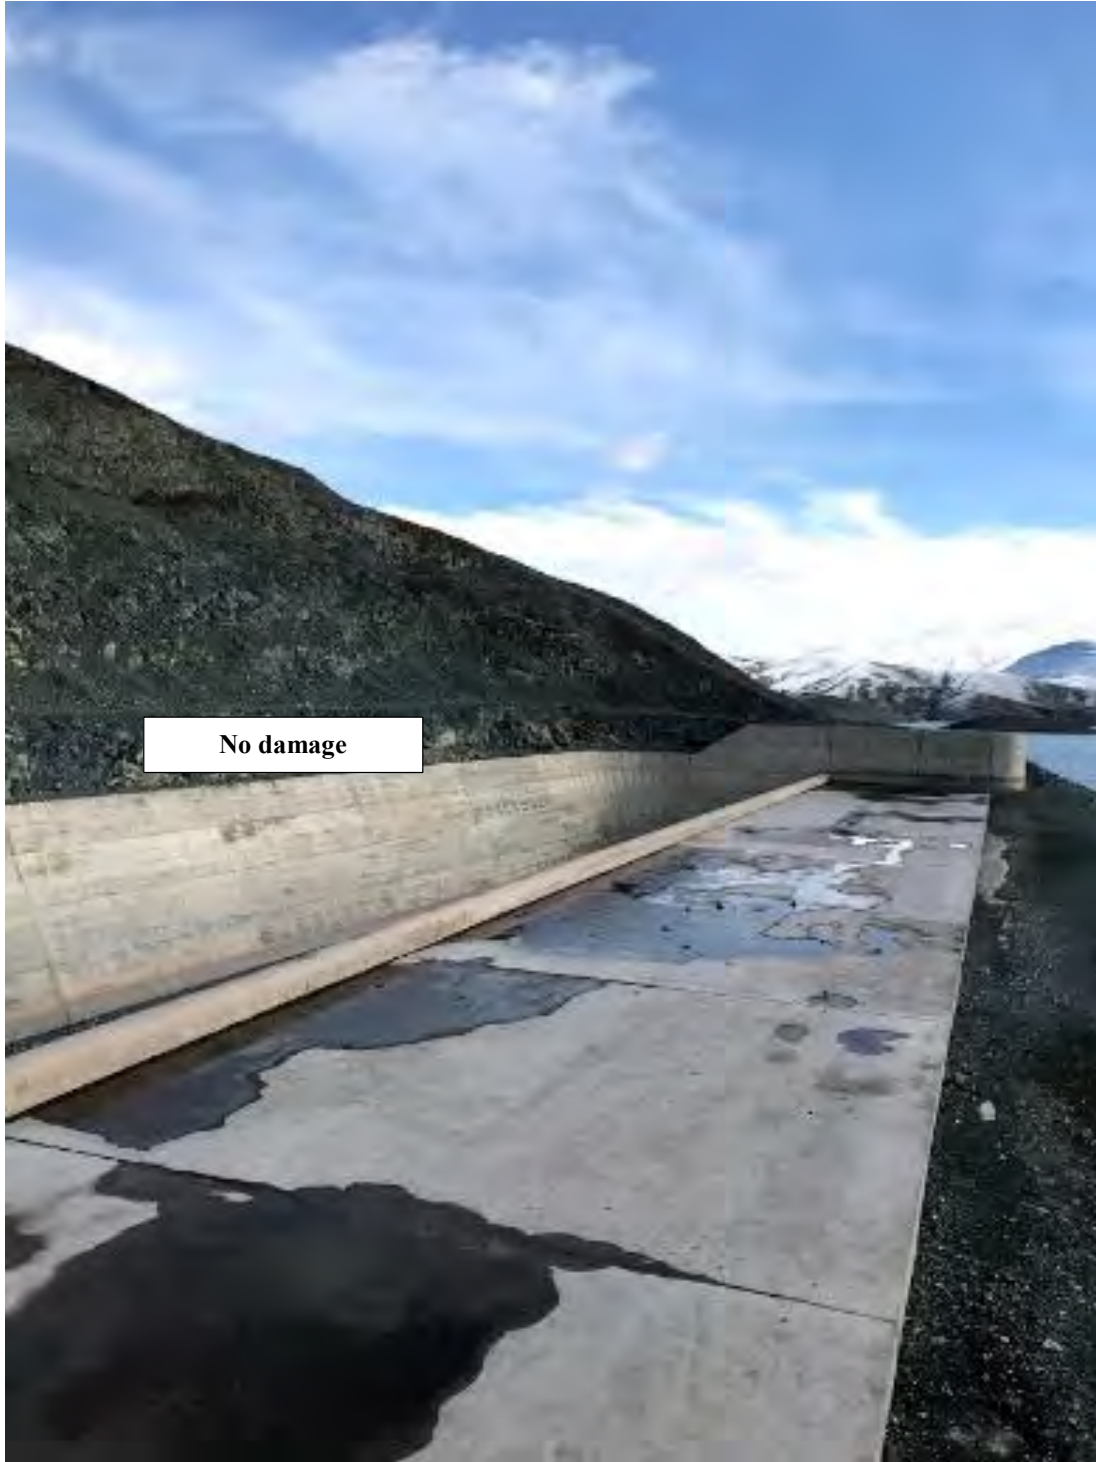
Figure 4.78. Water in-take structure of Kapıkaya Dam  
( $38^{\circ}21'16.9''N$   $38^{\circ}36'36.0''E$  / 01.02.2020 / 11:13)

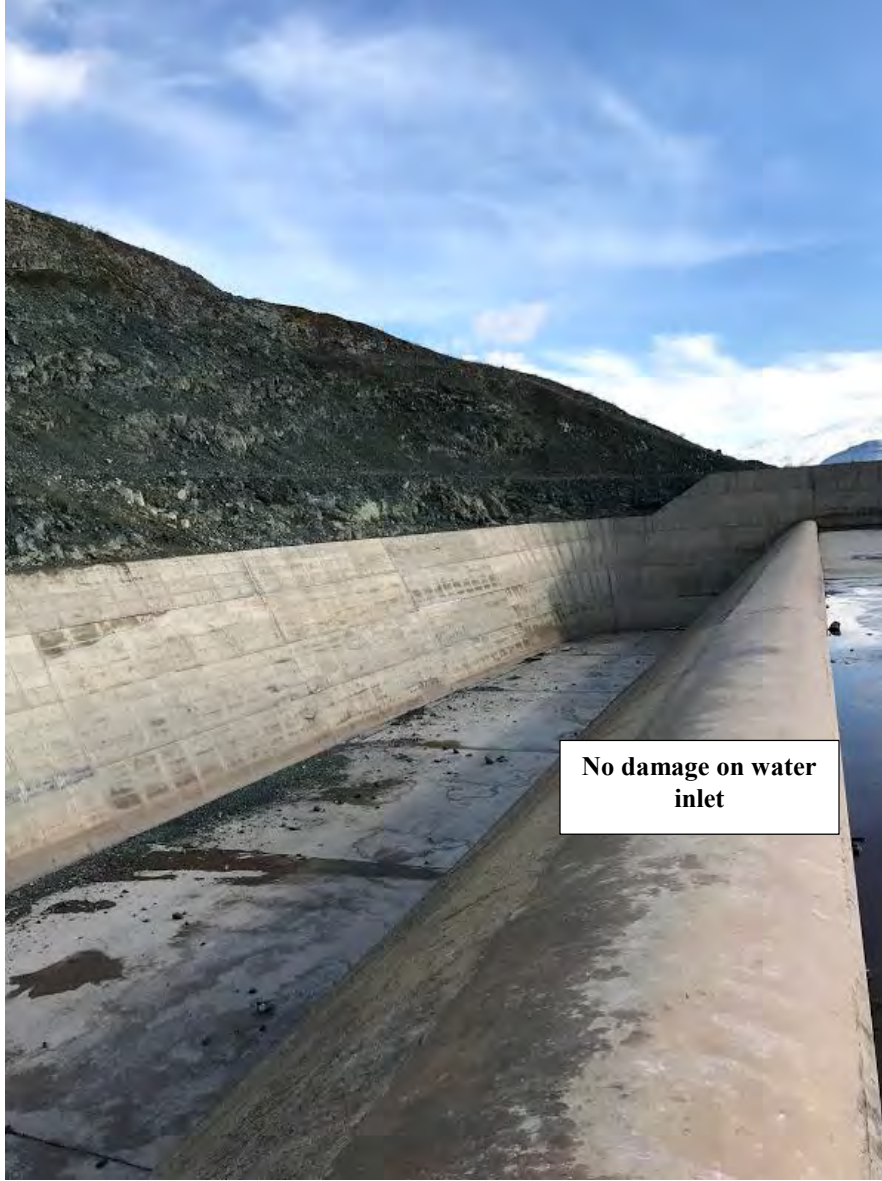
Figure 4.79. Spillway of Kapıkaya Dam  
( $38^{\circ}21'17.2''N$   $38^{\circ}36'36.7''E$  / 01.02.2020 / 11:14)

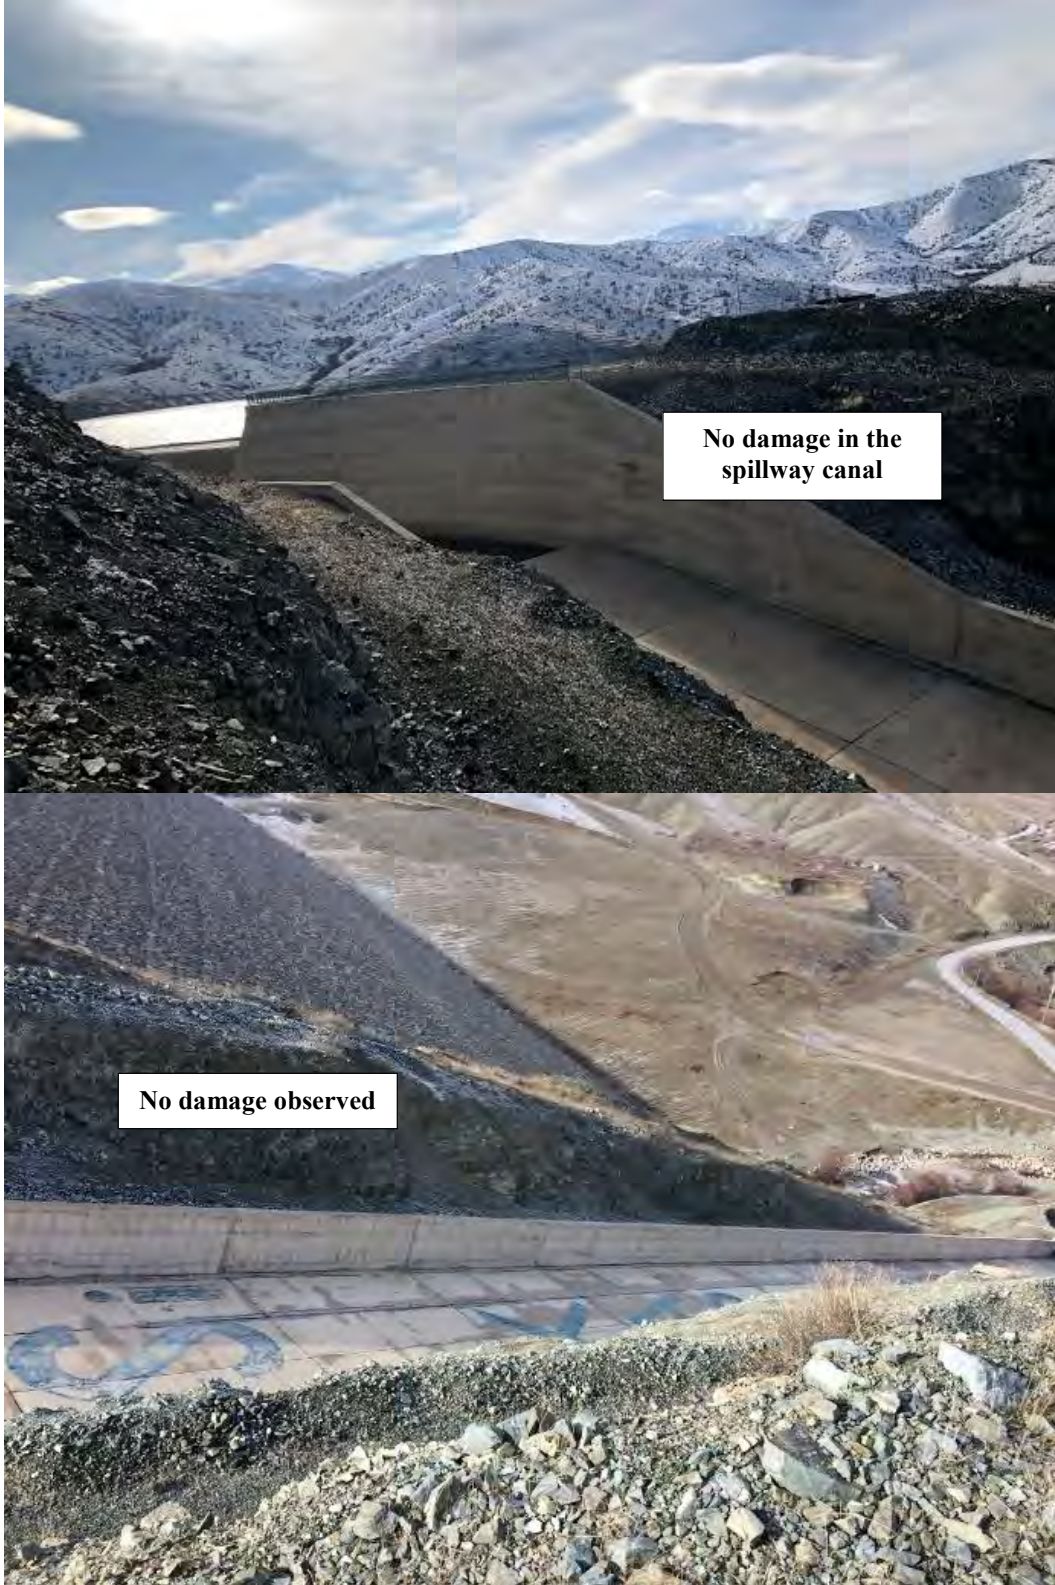
Figure 4.80. Spillway of Kapıkaya Dam  
( $38^{\circ}21'19.1''N$   $38^{\circ}36'33.9''E$  / 01.02.2020 / 10:22 &  $38^{\circ}21'19.2''N$   $38^{\circ}36'34.1''E$  / 01.02.2020 / 10:22)

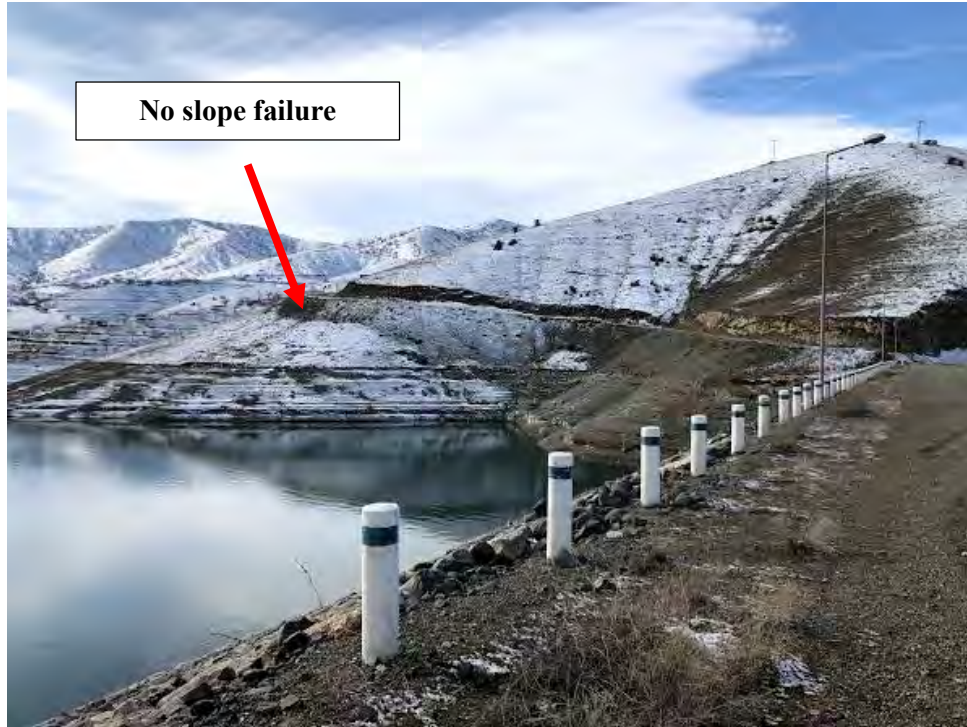
Figure 4.81. Abutment slopes of Kapıkaya Dam  
( $38^{\circ}21'07.1''N$   $38^{\circ}36'22.0''E$  / 01.02.2020 / 10:51)

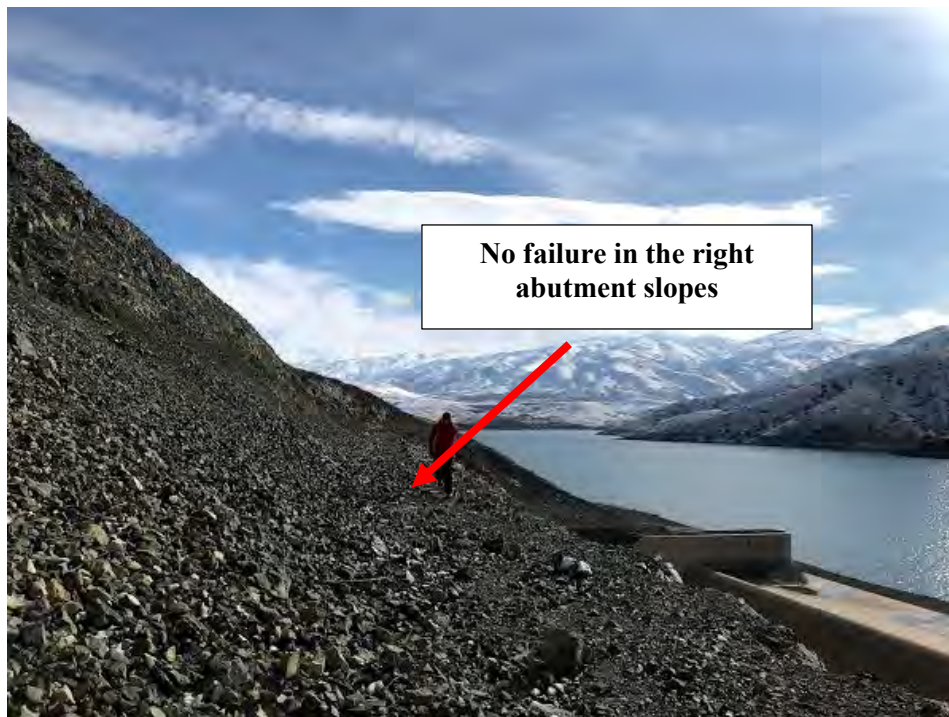
Figure 4.82. Right abutment natural slopes  
( $38^{\circ}21'18.7''N$   $38^{\circ}36'36.0''E$  / 01.02.2020 / 10:25)

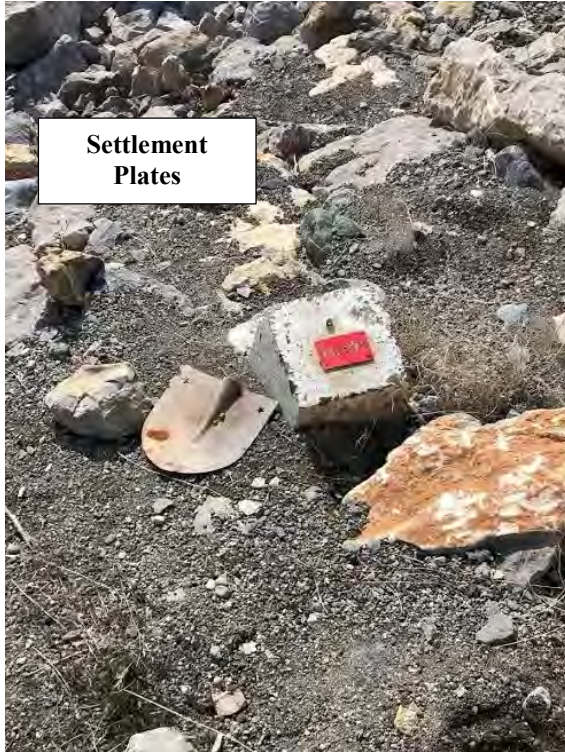
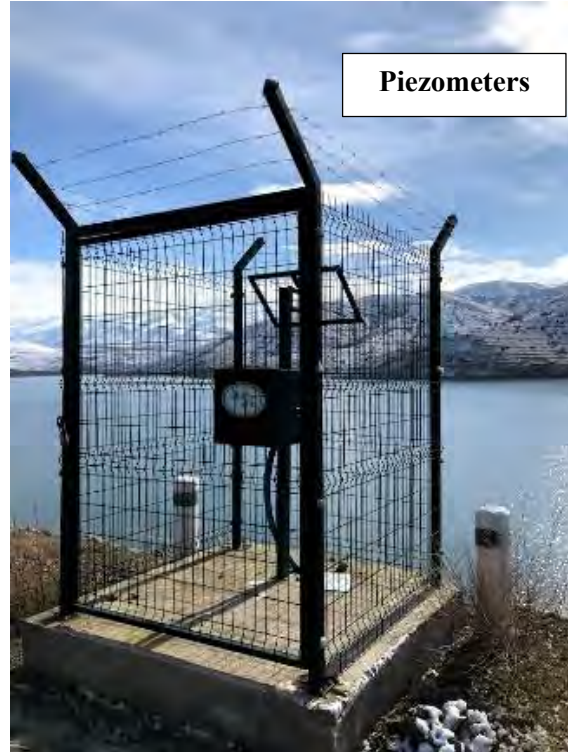
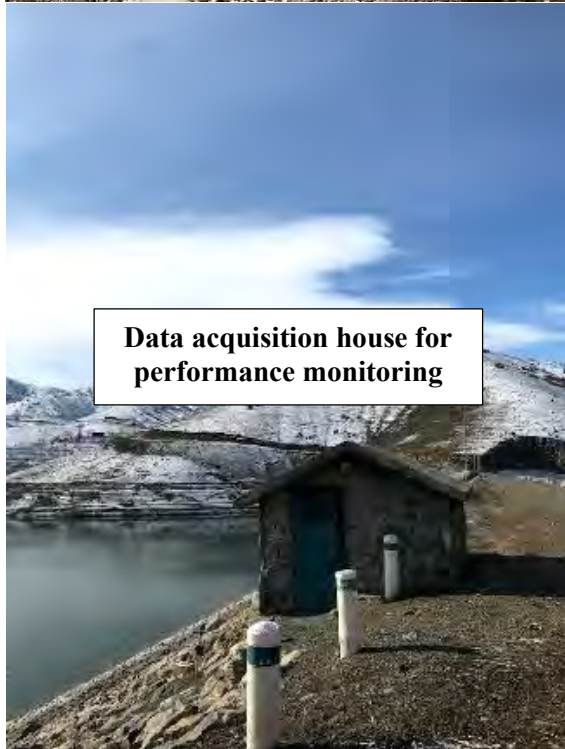
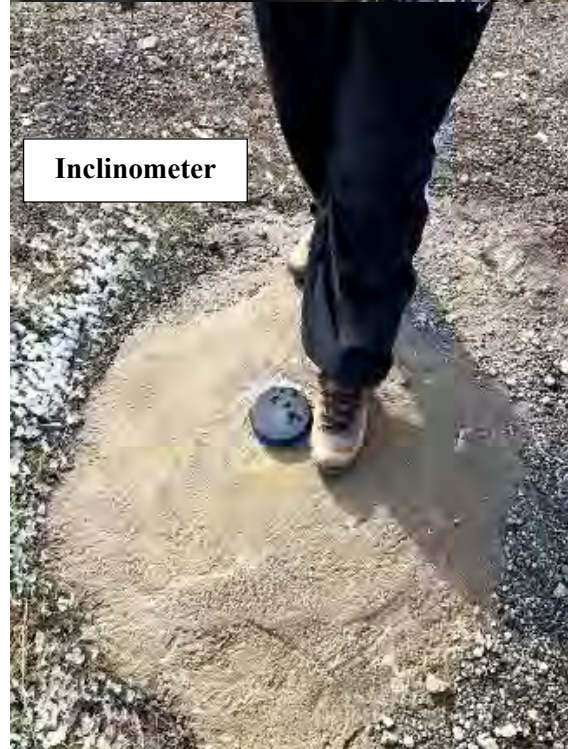
Figure 4.83. Settlement Plate, piezometer, data acquisition house and inclinometer borehole located at Kapıkaya Dam  
(not available / 01.02.2020 / 10:50 & 38°21'11.7"N 38°36'23.5"E / 01.02.2020 / 10:48  
38°21'11.1"N 38°36'23.7"E / 01.02.2020 / 10:48 & 38°21'10.2"N 38°36'23.0"E / 01.02.2020 / 11:06)

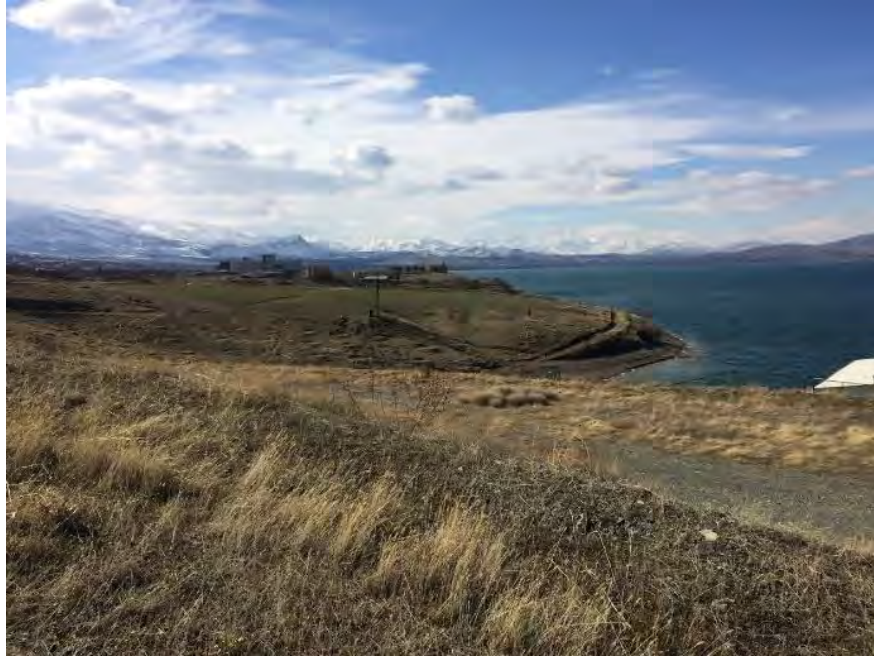
Seismically-induced liquefaction failure was observed in the Kale shores (Figure 4.84 and 4.85) in the form of sand boiling at 15<sup>th</sup> stop. A site view is shown in Figure 4.86. Pictures documenting sand boils are presented in Figures 4.87 to 4.91.

Figure 4.84. View of Kale shore  
( $38^{\circ}25'25.1''N$   $38^{\circ}45'46.1''E$  / 01.02.2020 / 12:12)

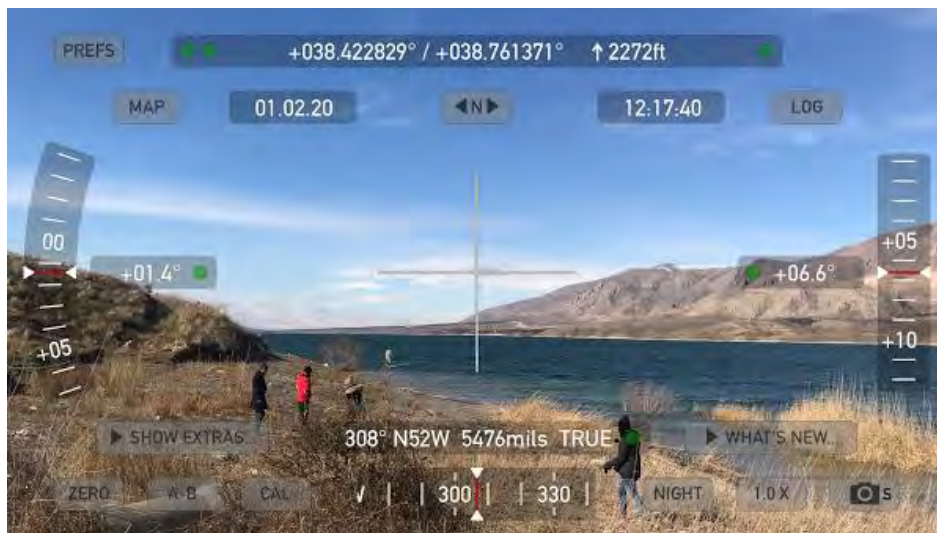
Figure 4.85. Another view of Kale shore  
( $38^{\circ}25'22.2''N$   $38^{\circ}45'40.9''E$  / 01.02.2020 / 12:17)

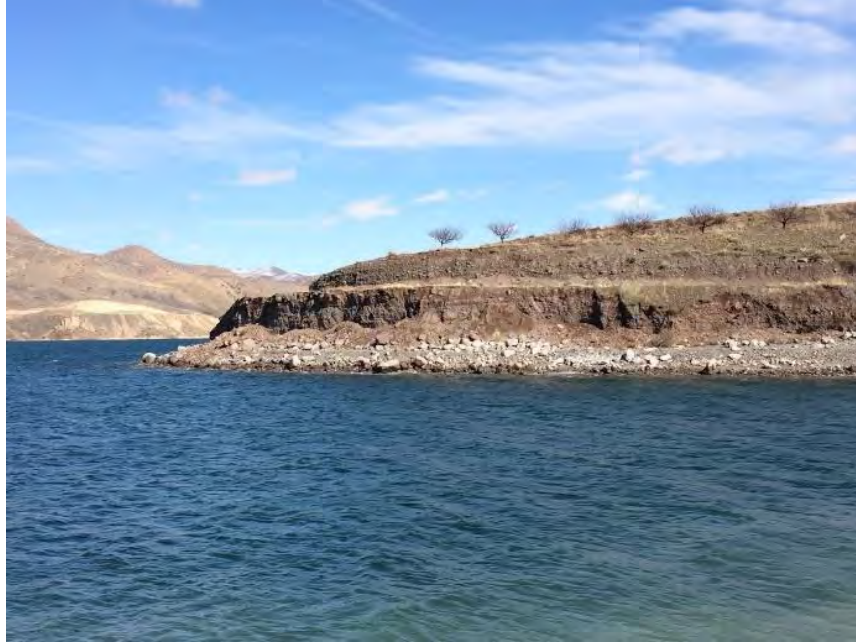
Figure 4.86. Kale shore  
( $38^{\circ}25'15.9''N$   $38^{\circ}45'28.8''E$  / 01.02.2020 / 12:39)

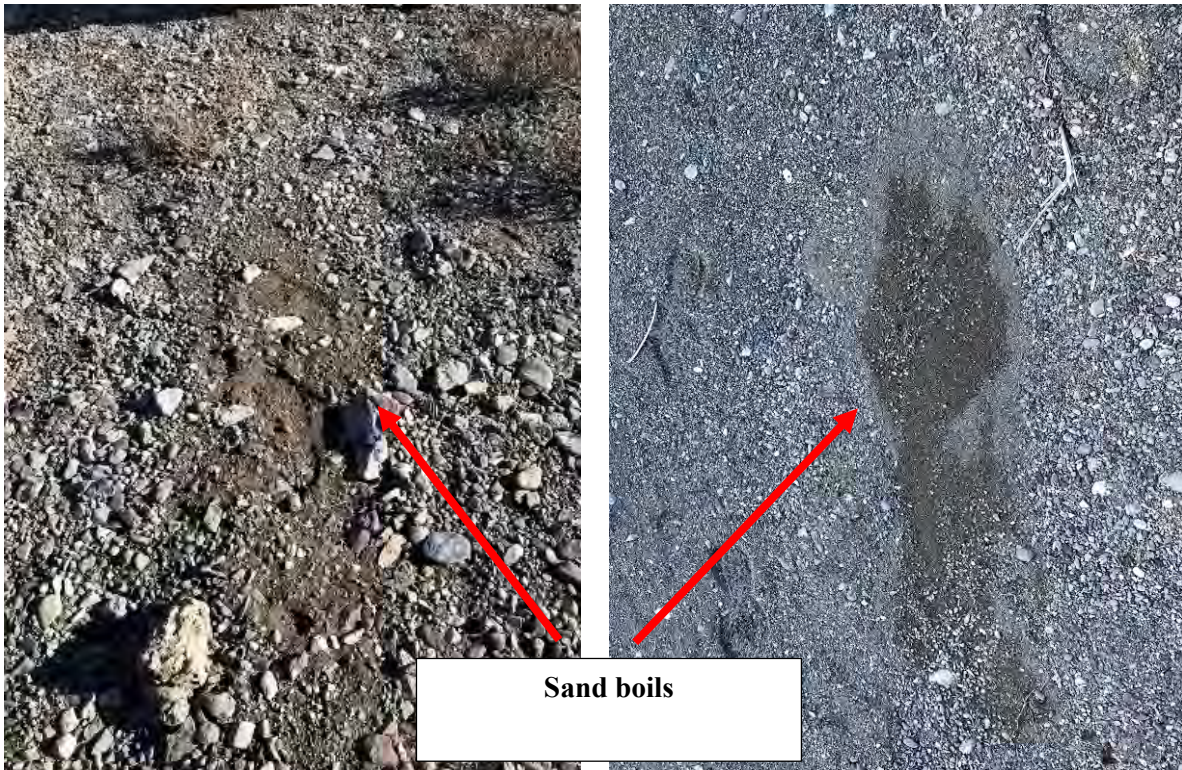
Figure 4.87. Seismic soil liquefaction-induced sand boils at Kale shore  
( $38^{\circ}25'19.9''N$   $38^{\circ}45'33.2''E$  / 01.02.2020 / 12:25 &  $38^{\circ}25'14.6''N$   $38^{\circ}45'24.7''E$  / 01.02.2020 / 12:45)

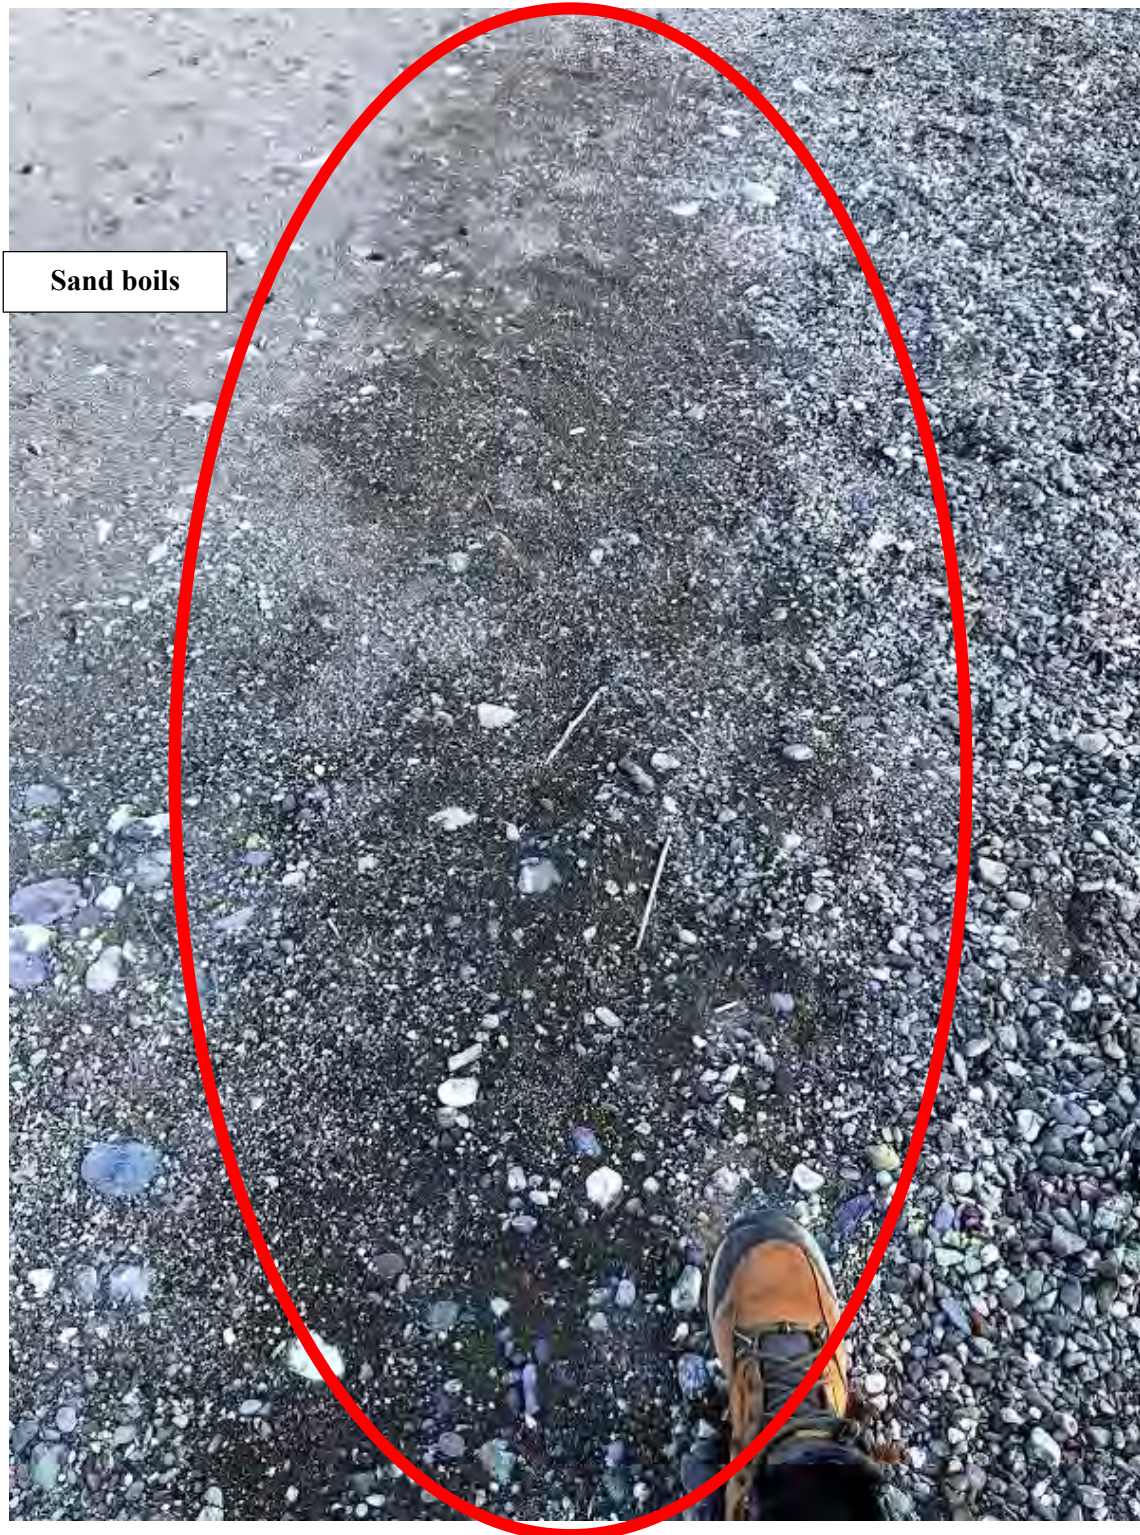
Figure 4.88. Seismic soil liquefaction-induced sand boils at Kale shore  
( $38^{\circ}25'15.2''N$   $38^{\circ}45'24.1''E$  / 01.02.2020 / 12:45)

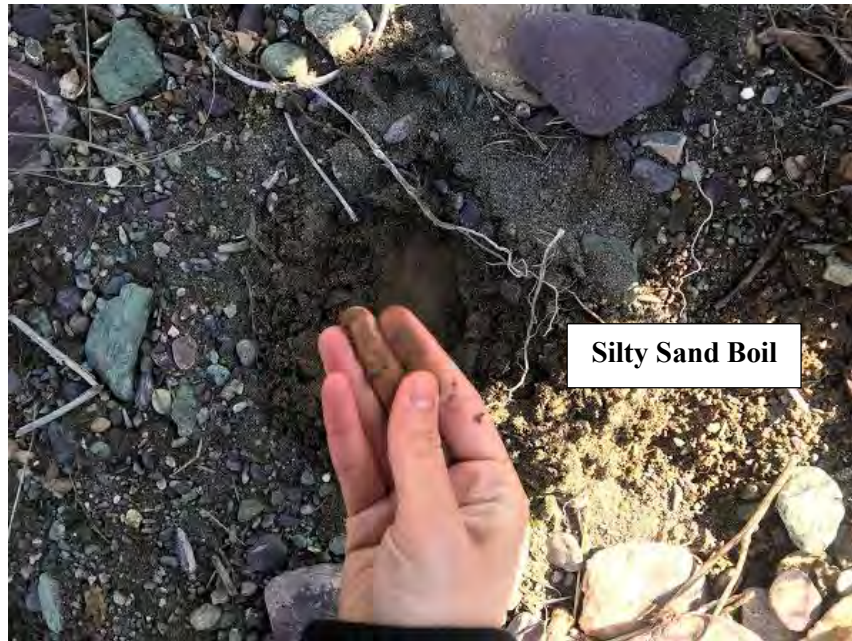
Figure 4.89. Seismic soil liquefaction-induced sand boils at Kale shore  
( $38^{\circ}25'22.8''N$   $38^{\circ}45'38.4''E$  / 01.02.2020 / 12:21)

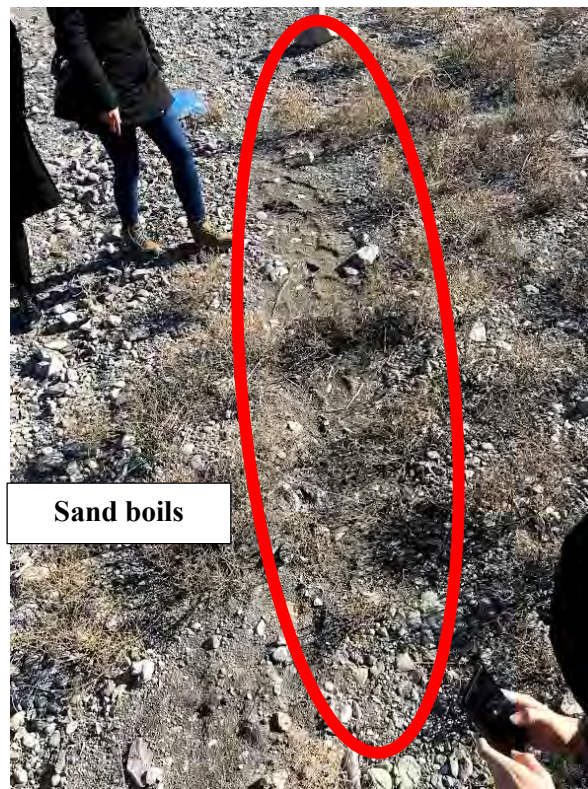
Figure 4.90. Seismic soil liquefaction-induced sand boils at Kale shore  
( $38^{\circ}25'19.9''N$   $38^{\circ}45'32.1''E$  / 01.02.2020 / 12:27)
