# Preliminary Report on Engineering and Geological Effects of the January 24, 2020 Magnitude 6.7 Earthquake in Elaziğ, Turkey

A report of the NSF-Sponsored Geotechnical Extreme Event Reconnaissance Association

Report GEER-065

**January 24, 2020 Elazığ-Sivrice Earthquake ( $M_w=6.8$ )  
Reconnaissance Study Report**

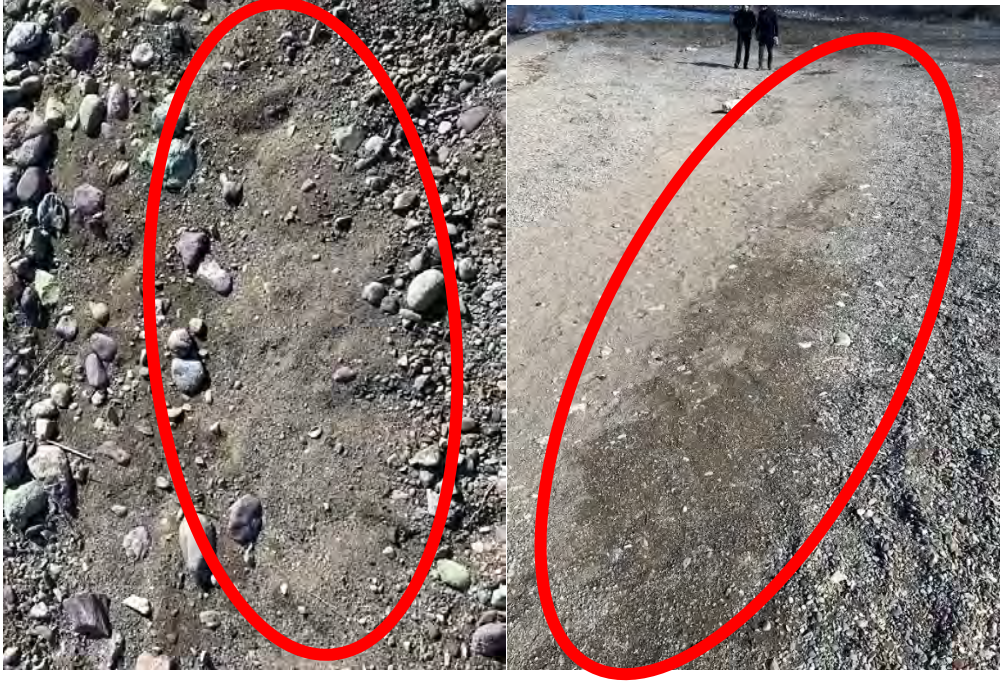
Seismically-induced liquefaction failure was observed in the Kale shores (Figure 4.84 and 4.85) in the form of sand boiling at 15<sup>th</sup> stop. A site view is shown in Figure 4.86. Pictures documenting sand boils are presented in Figures 4.87 to 4.91.

Figure 4.91. Seismic soil liquefaction-induced sand boils at Kale shore  
( $38^{\circ}25'15.2''N$   $38^{\circ}45'32.2''E$  / 01.02.2020 / 12:32 &  $38^{\circ}25'15.2''N$   $38^{\circ}45'23.9''E$  / 01.02.2020 / 12:45)

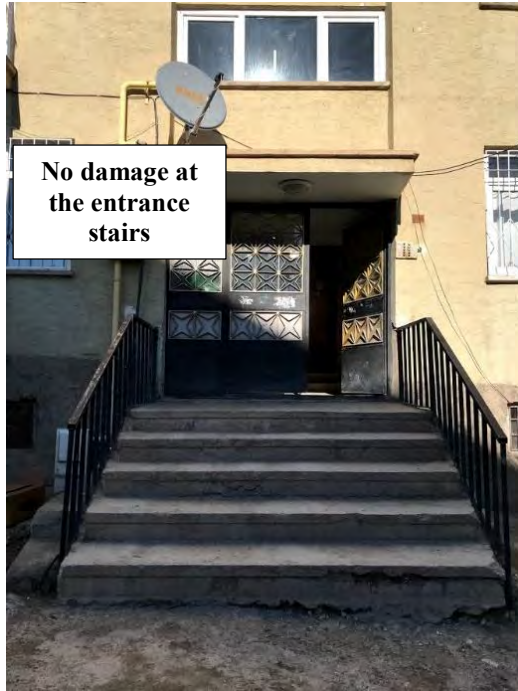
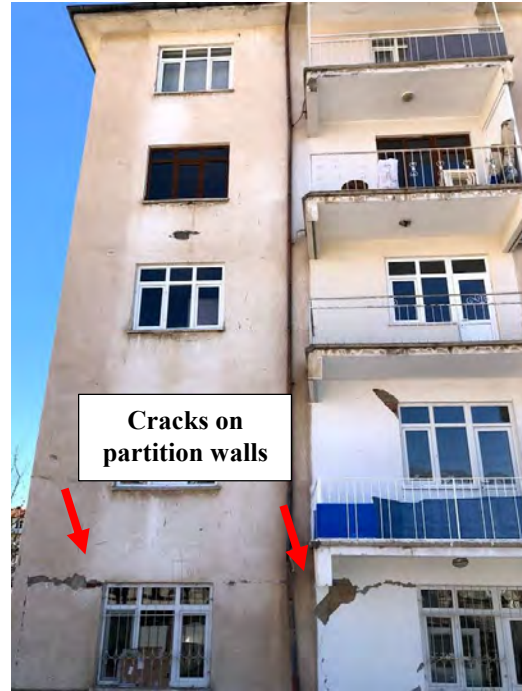
Figure 4.95. Residential buildings located at the Abdullah Paşa district of Elazığ city center ( $38^{\circ}39'29.3''N$   $39^{\circ}09'02.6''E$  / 01.02.2020 / 14:32 &  $38^{\circ}39'29.6''N$   $39^{\circ}08'59.0''E$  / 01.02.2020 / 14:28)

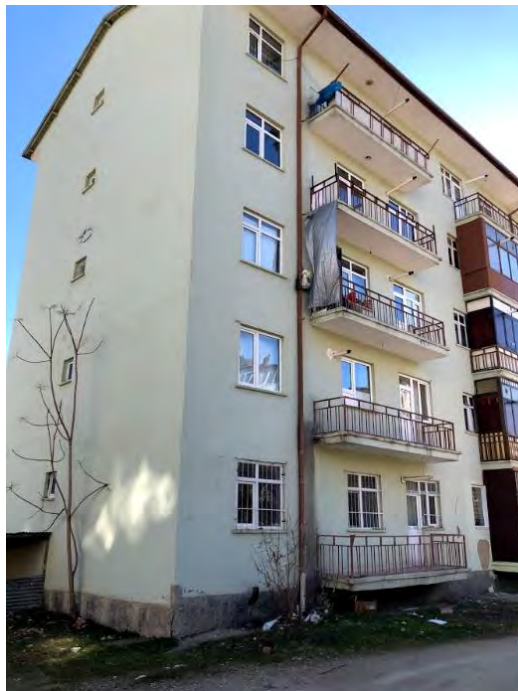
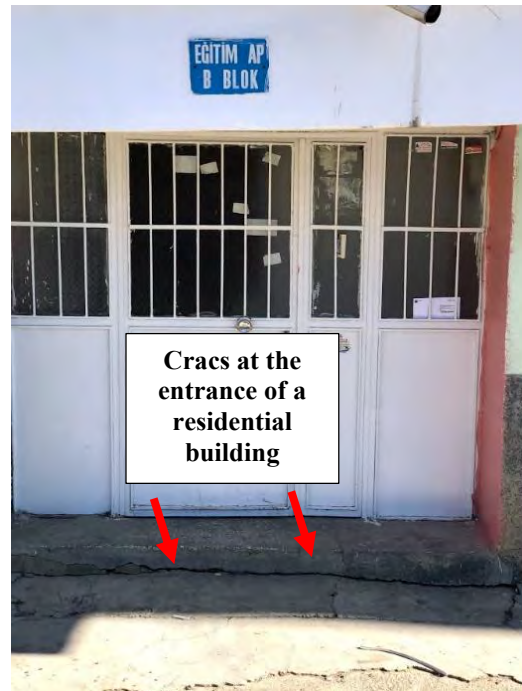
Figure 4.96. Cracks observed at the entrance of Eğitim Apartment. ( $38^{\circ}39'29.2''N$   $39^{\circ}09'01.6''E$  / 01.02.2020 / 14:31 &  $38^{\circ}39'32.0''N$   $39^{\circ}09'00.8''E$  / 01.02.2020 / 14:36)

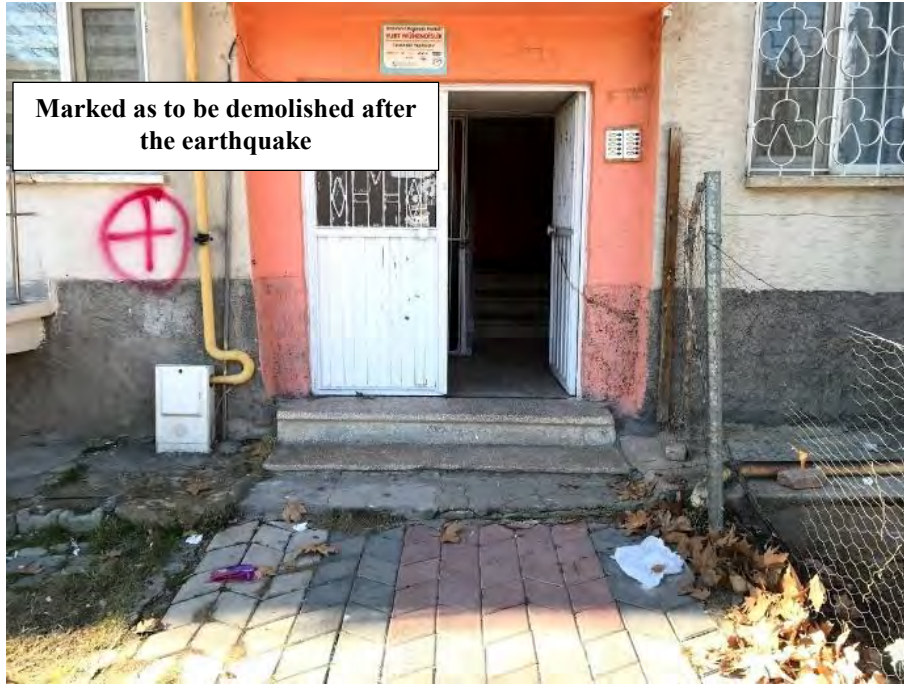
A number of structurally damaged residential buildings were documented in Abdullah Paşa district of Elazığ city center, as shown in Figures 4.93 to 4.100. The level of damage varies in a large scale, from no damage to heavy damage. No signs of foundation failures were observed except a few rare cases of volumetric settlements of foundation backfill soils.

Figure 4.97. A residential building located in the Abdullah Paşa district of Elazığ city center ( $38^{\circ}39'25.2''N$   $39^{\circ}09'10.3''E$  / 01.02.2020 / 14:45)

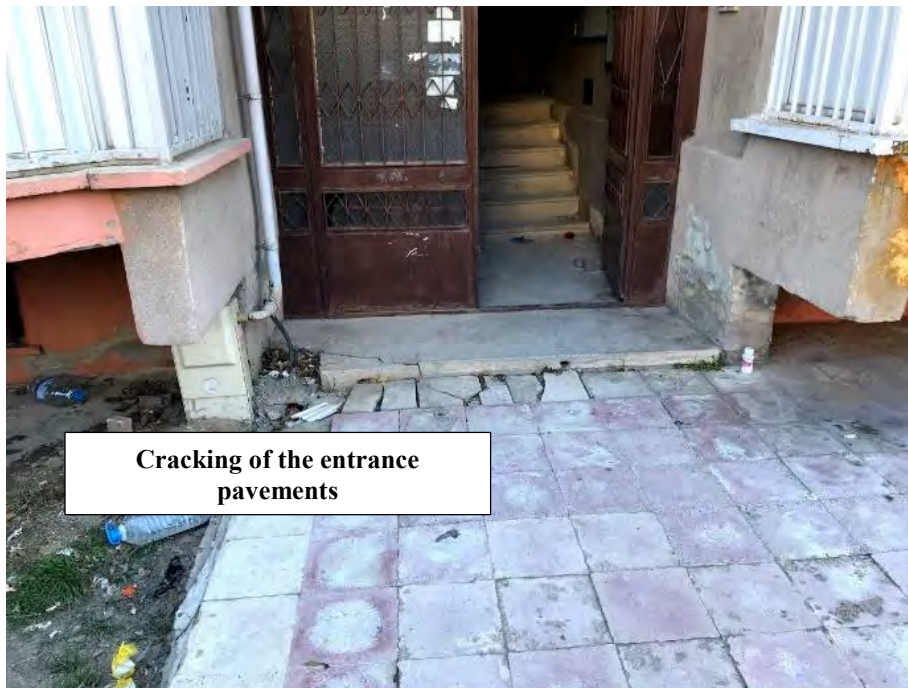
Figure 4.98. Cracking observed at the entrance of the of a residential building ( $38^{\circ}39'21.9''N$   $39^{\circ}09'10.4''E$  / 01.02.2020 / 14:50)

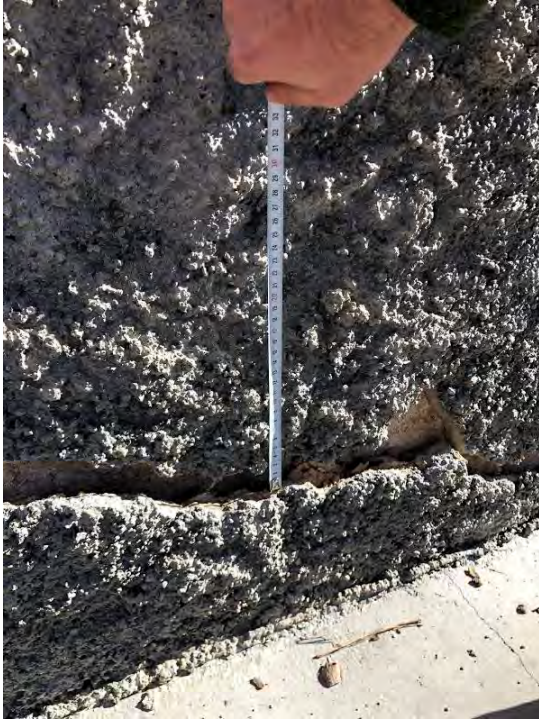
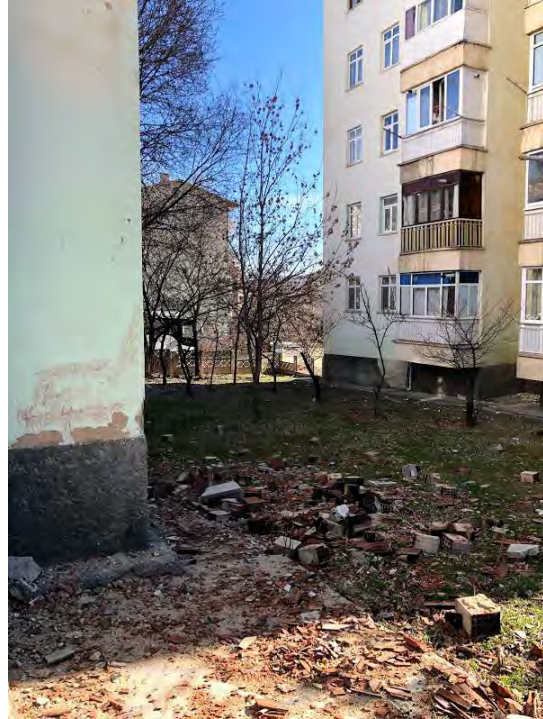
Figure 4.99. Cracks at the first floor, and fallen bricks  
( $38^{\circ}39'31.9''N$   $39^{\circ}08'57.9''E$  / 01.02.2020 / 14:38 &  $38^{\circ}39'32.0''N$   $39^{\circ}09'01.3''E$  / 01.02.2020 / 14:39)

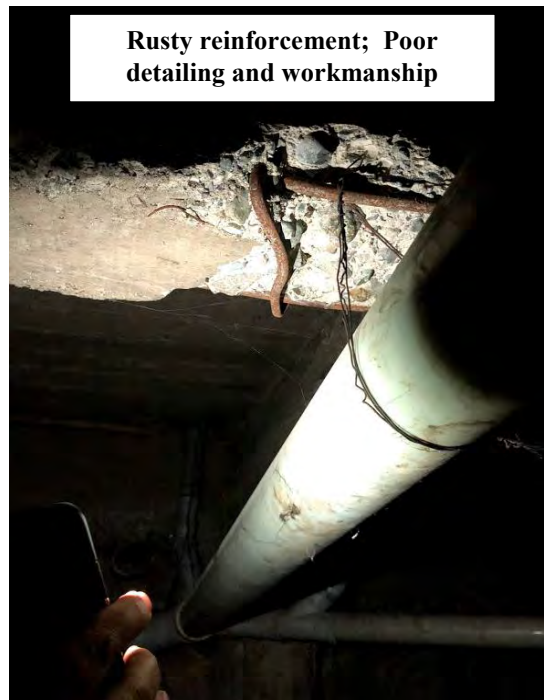
Figure 4.100. View of the basement of a residential building, rusty reinforcement bars, poor detailing and construction  
( $38^{\circ}39'24.8''N$   $39^{\circ}09'10.7''E$  / 01.02.2020 / 14:48)

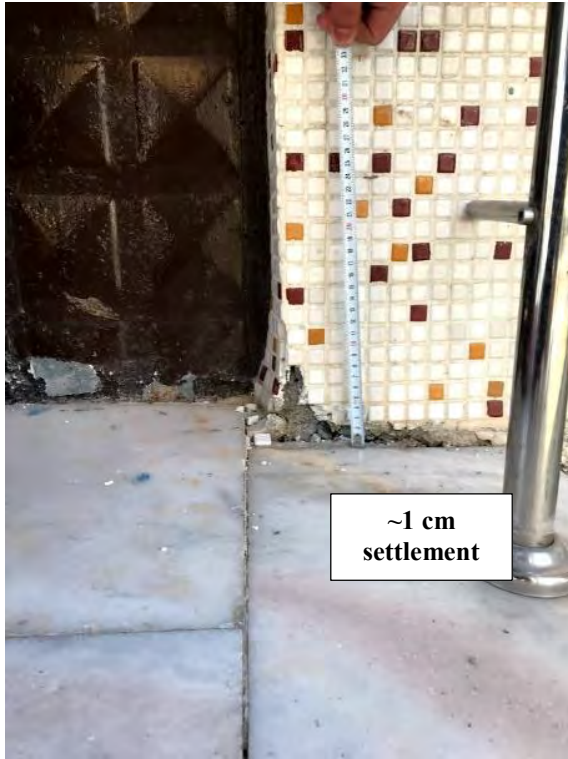
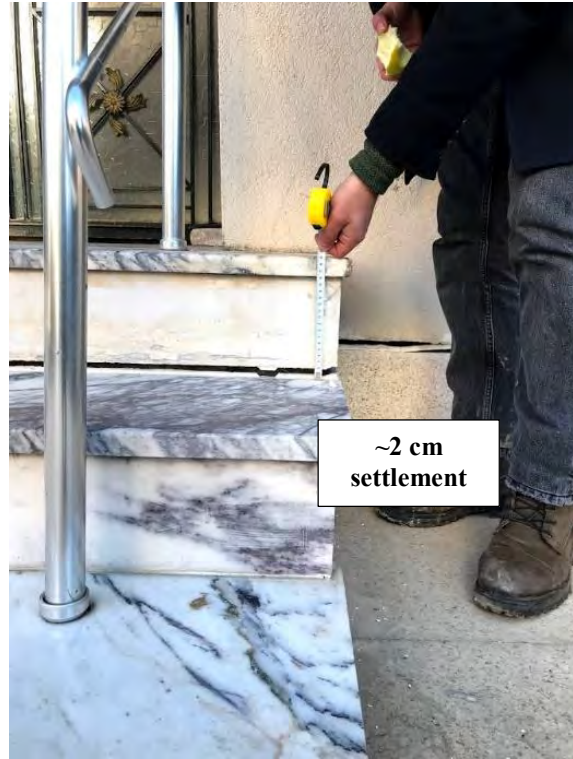
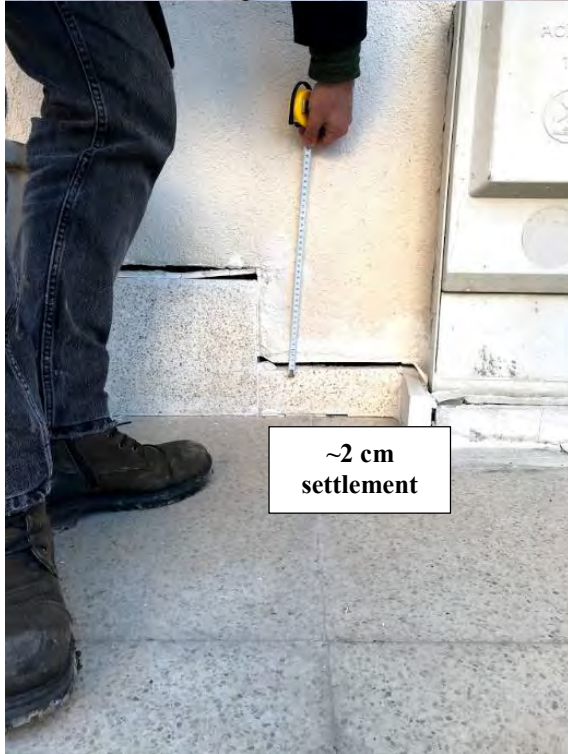
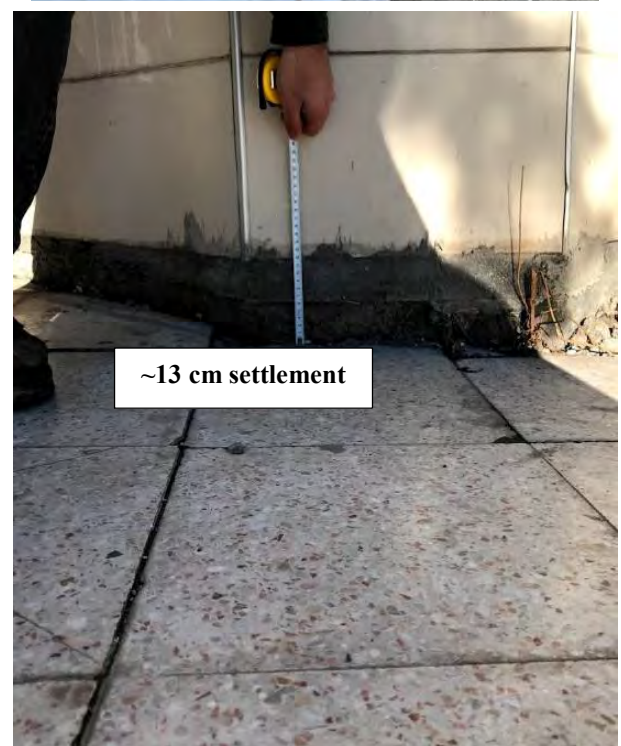
The most of the structural damage was concentrated in Elazığ-Sürsürü district. Several structurally damaged residential buildings were documented, as shown in Figures 4.102 to 4.106. The level of damage varies in a large scale, from no damage to heavy damage. Cracks at the pavements, walls and foundations, due to cyclic and residual lateral and volumetric deformations were observed.

Figure 4.103. Settlement mapped at the entrance of some buildings  
( $38^{\circ}40'04.7''N$   $39^{\circ}11'12.4''E$  / 01.02.2020 / 15:31 &  $38^{\circ}40'05.9''N$   $39^{\circ}11'08.2''E$  / 01.02.2020 / 15:41  
 $38^{\circ}40'05.9''N$   $39^{\circ}11'08.1''E$  / 01.02.2020 / 15:41 &  $38^{\circ}40'04.7''N$   $39^{\circ}11'09.7''E$  / 01.02.2020 / 15:40)

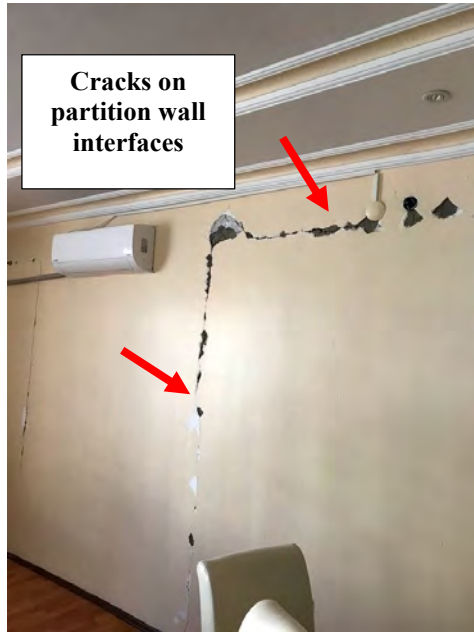
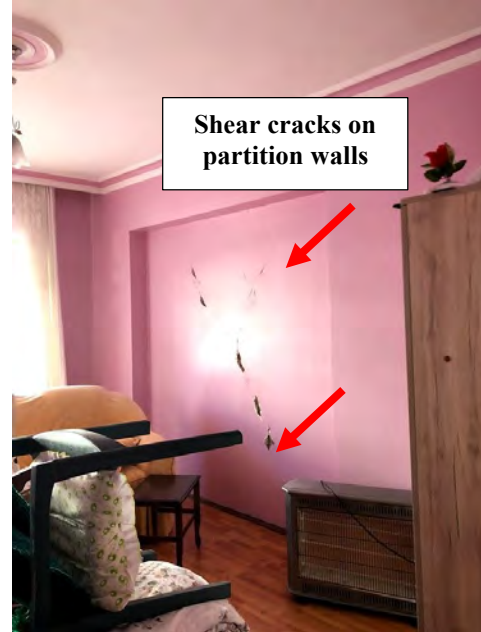
Figure 4.106. Cracks on partition walls  
( $38^{\circ}40'03.9''N$   $39^{\circ}11'13.5''E$  / 01.02.2020 / 15:35 &  $38^{\circ}40'04.2''N$   $39^{\circ}11'14.2''E$  / 01.02.2020 / 15:36)

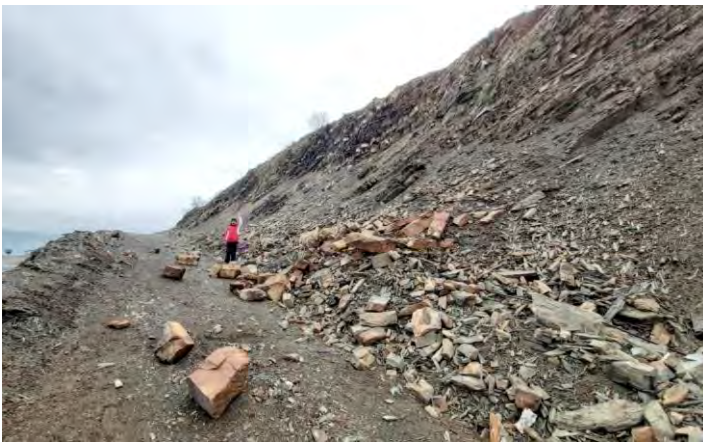
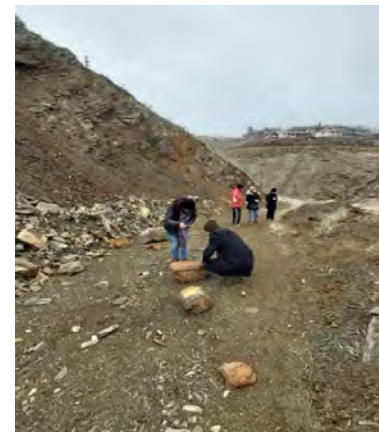
Field reconnaissance team observed rockfalls during their visit to the coast of Hazar Lake as shown in Figure 4.111 and 4.112. In this section, a more detailed discussion of these rockfalls will be presented.

At the first rockfall site, the surface geology reveals phyllyites with schistosity texture. The cross section is 15 m high with a slope of  $50^\circ$ . The dimensions of the fallen rocks and the distance from the edge of the benches are mapped in the field. No fallen rocks were observed on the lower, second bench of the highway cut. Slope angle, length and height of different sections of the upper and lower benches, and possible height that rock falls were initiated were also mapped in the field. RocFall 2019 software program is used to gueestimate the initial velocity of the rock.

Figure 4.111. Rock falls observed at the shores of Hazar Lake at 13<sup>th</sup> stop  
( $38^\circ31'40.0''N$   $39^\circ28'01.5''E$  / 31.01. 2020 / 16:08 )

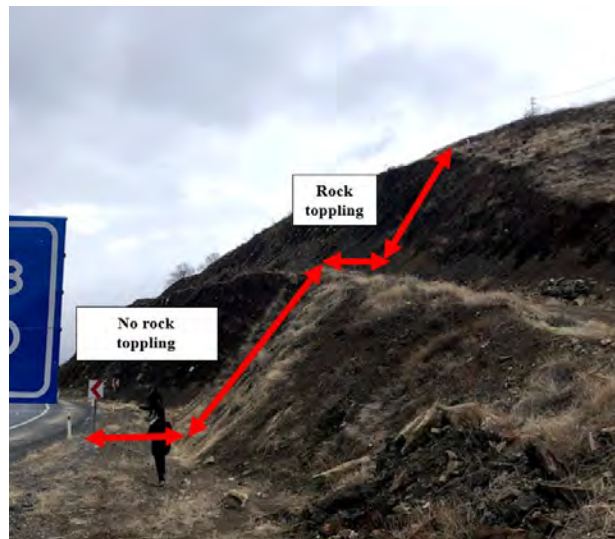
Figure 4.112. Cross section of the rockfall at 13<sup>th</sup> stop  
( $38^\circ31'40.3''N$   $39^\circ28'02.9''E$  / 31.01.2020 / 16:20)

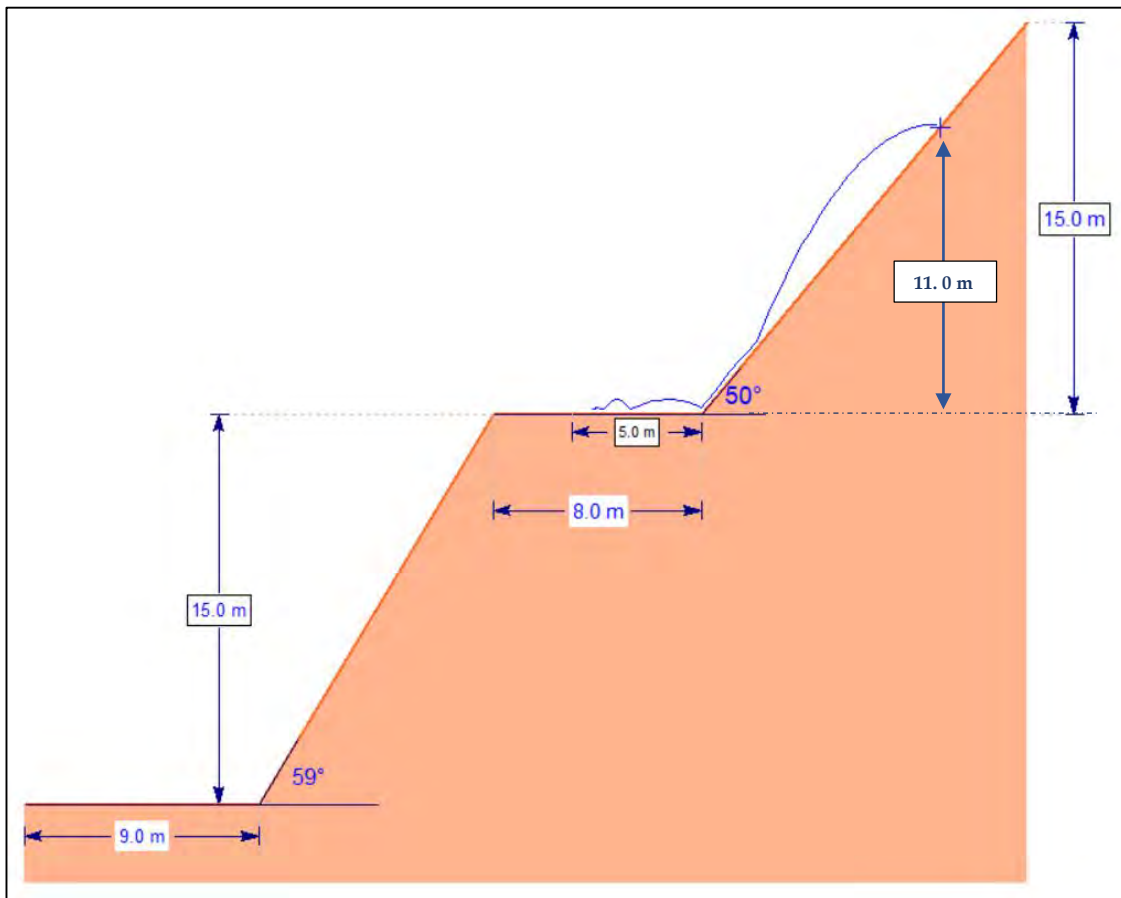
As seen in Figure 4.113, back analysis is performed to guess the initial velocity of the rock blocks to reach their final positions observed in the field. RocFall 2019 by RocScience is used for the purpose. Based on these very preliminary assessments, velocity range to trigger the fall and match with observed travel distances is calculated as 4 to 6 m/s.

Figure 4.113. Back analysis of rockfall with RocFall 2019

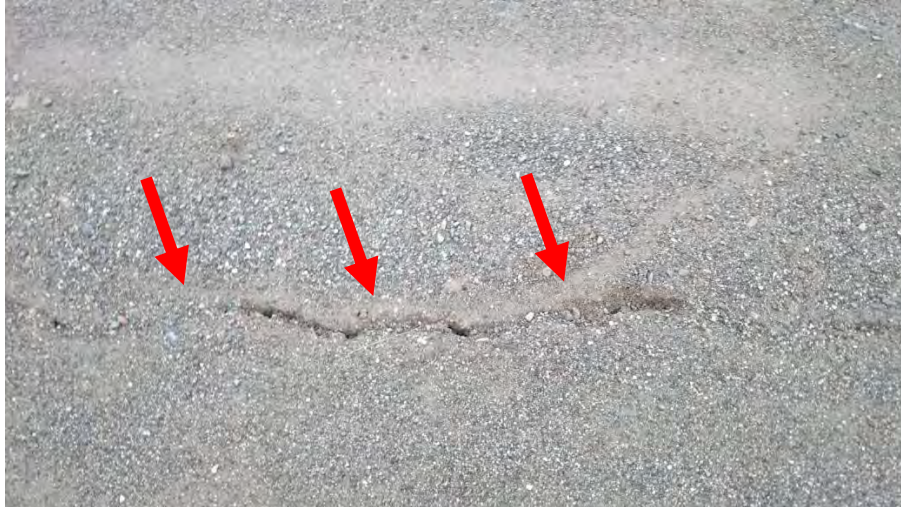
On the basis of reconnaissance studies performed by Dam Agency, no significant damage was reported to be observed at these dams after Sivrice Earthquake, except a limited extent longitudinal  $< 8$  mm crack, as shown in Figure 4.119, observed on the crest of Dedeyolu Dam.

Figure 4.119. Longitudinal cracks on Dedeyolu Dam crest (DSI)

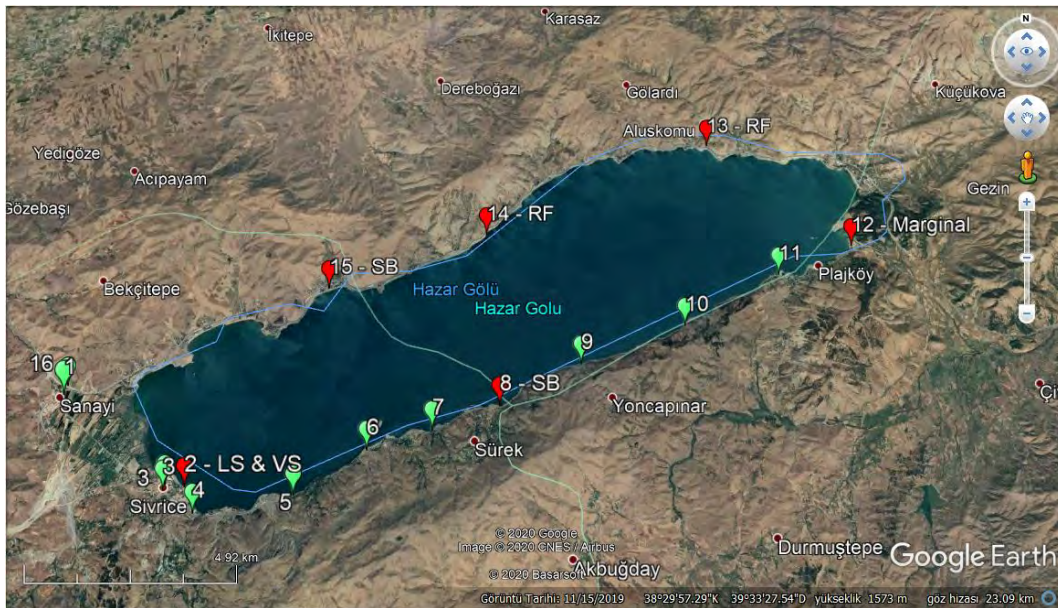
By the natural shores of Hazar Lake, seismically-induced lateral spreading, sand boils and excessive volumetric settlements were observed. A map, summarizing consolidated field observations along the shores of Hazar Lake is shown in Figure 4.121. In Figure 4.121, green pins indicate non-liquefied sites, red pins indicate sites with surface deformations along with abbreviations of type of ground failure; RF: Rock fall, LS: Lateral spread, VS: Volumetric settlement, SB: Sand Boil.

Figure 4.121. A summary of ground failure observations along the shores of Hazar Lake (Green pins indicate Non-Liquefied sites, Red pins indicate sites with surface deformations, RF: Rock fall, LS: Lateral spread, VS: Volumetric settlement, SB: Sand Boil)

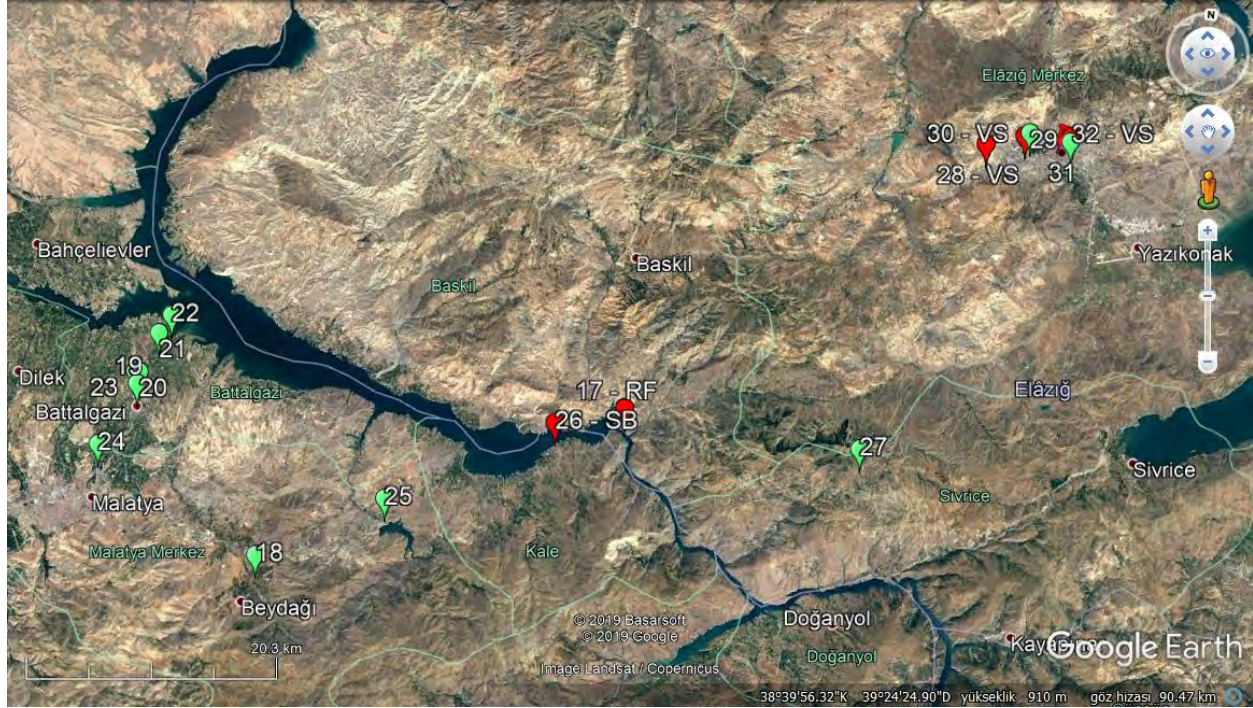
By Kale Village, at the shores of Fırat River, surface manifestations of seismic soil liquefaction in the form of sand boils were observed. A map, summarizing consolidated field observations along the shores of Fırat River is shown in Figure 4.122.

Figure 4.122. A summary of ground failure observations along the shores of Fırat River and Malatya-Elazığ Route

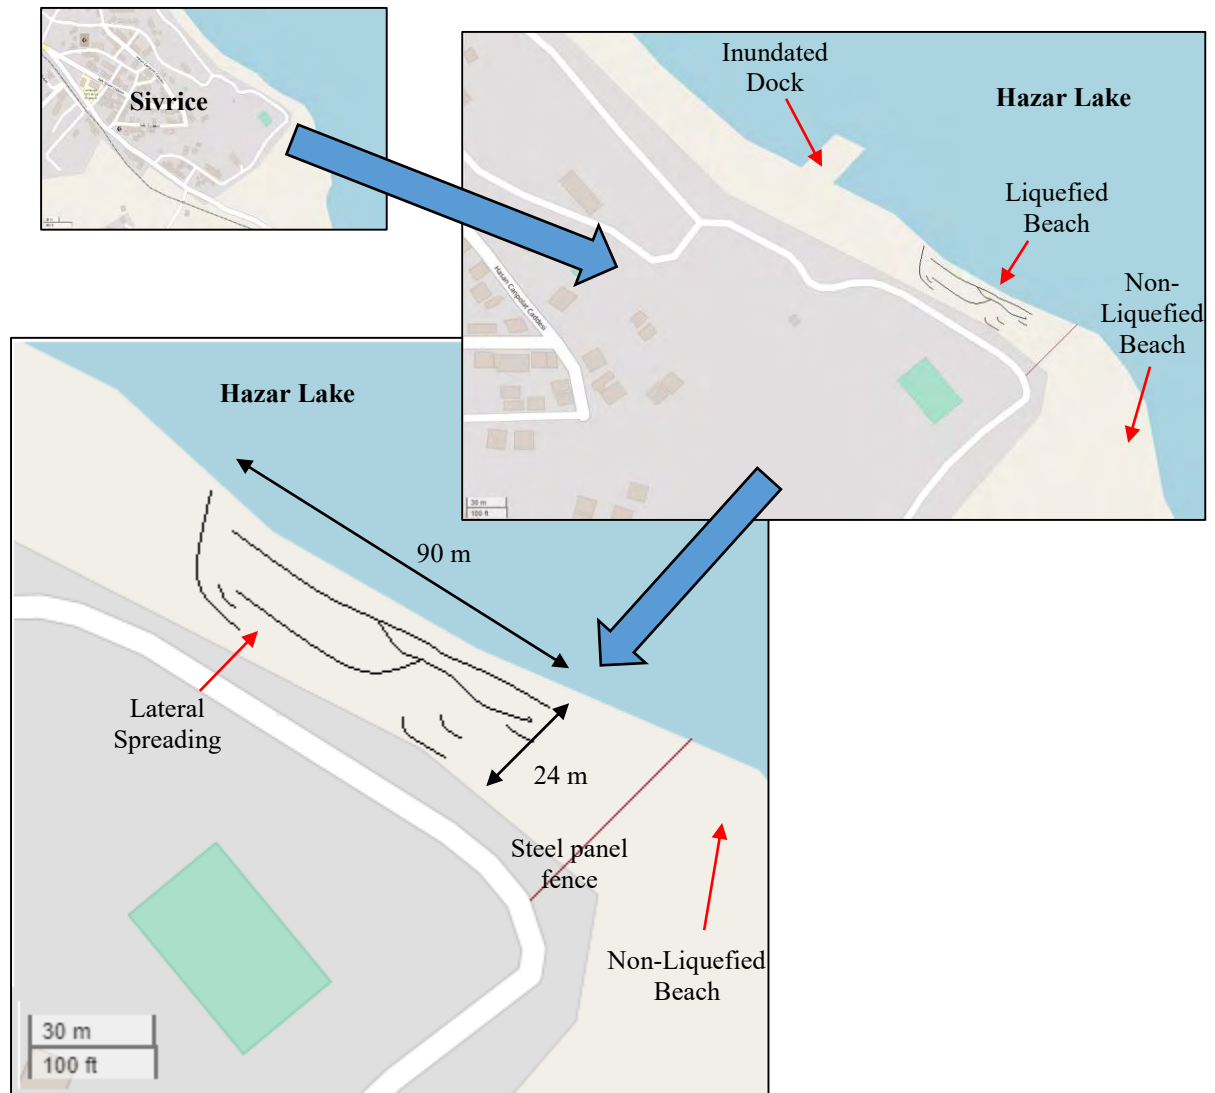
In day 1, surface manifestation of soil liquefaction in the form of sand boils and lateral spreading were mapped. The extent of lateral deformations was mapped as 3-5 cm along a 90 m long and 23 m wide zone at the second stop in the vicinity of Sivrice Dock, as shown in Figure 4.123. Figures 4.124 and 4.125 present the photos of lateral spreading site taken during field investigations.

Figure 4.123. A sketch of lateral spread deformations at 2<sup>nd</sup> stop  
(Sivrice Dock-38°28'10.0"N 39°17'03.6"E / 31.01.2020 / 12:11)

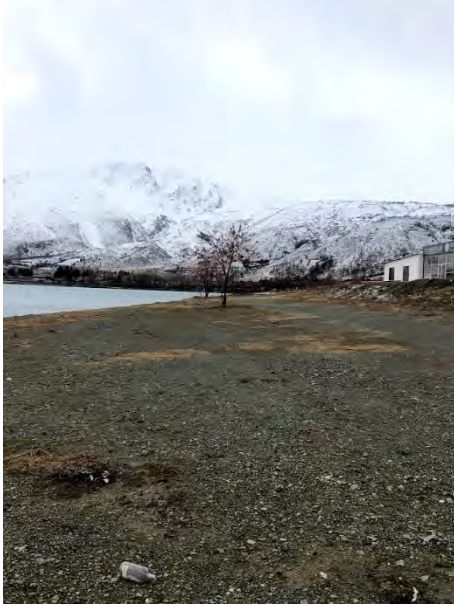
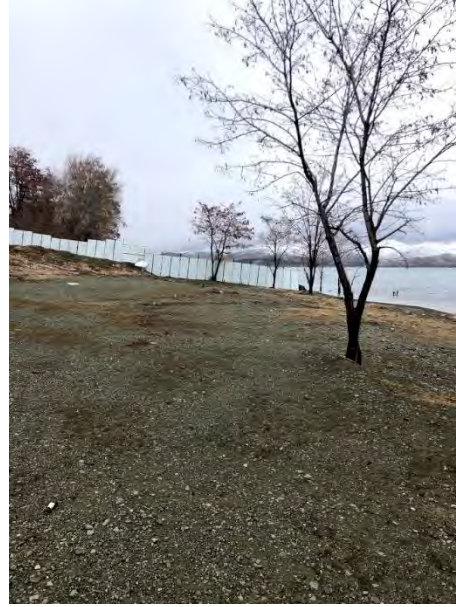
No signs of liquefaction were observed at a natural beach neighboring the lateral spreading site as shown in Figure 4.126. This beach was observed to have a milder slope when compared to the lateral spreading site shown in Figures 4.123-4.125.

Figure 4.126. No ground failure at the natural beach neighboring the lateral spreading  
(2<sup>nd</sup> stop)

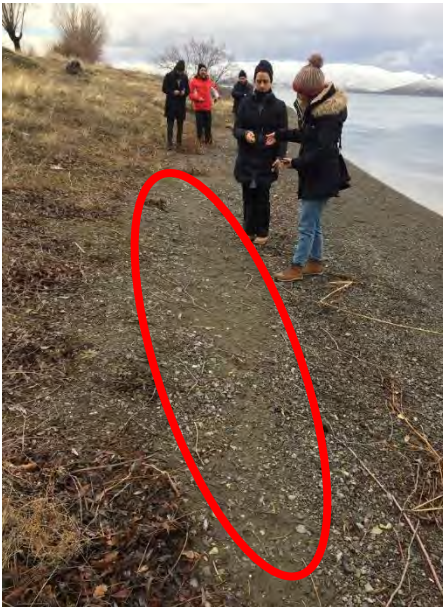
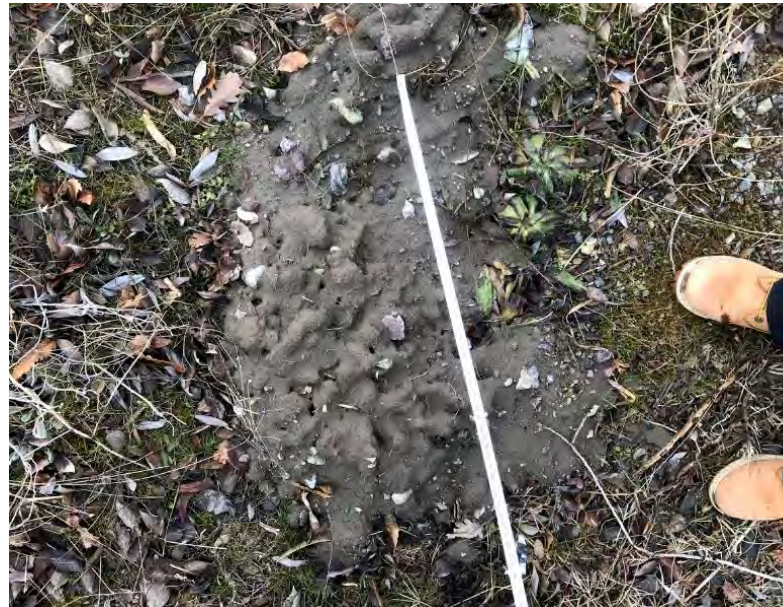
Ground deformations were observed due to liquefaction at 8<sup>th</sup> and 15<sup>th</sup> stops along Hazar Lake as shown in Figures 4.127 and 4.128. Sand boils were mapped and soil samples were retrieved from these locations. A series of sieve analysis tests has been performed at METU Soil Mechanics Laboratory. Based on the results of these tests, samples were reported to be potentially liquefiable as also will be discussed in the next section.

Figure 4.127. Surface manifestations of soil liquefaction in Hazar Lake (8<sup>th</sup> stop)

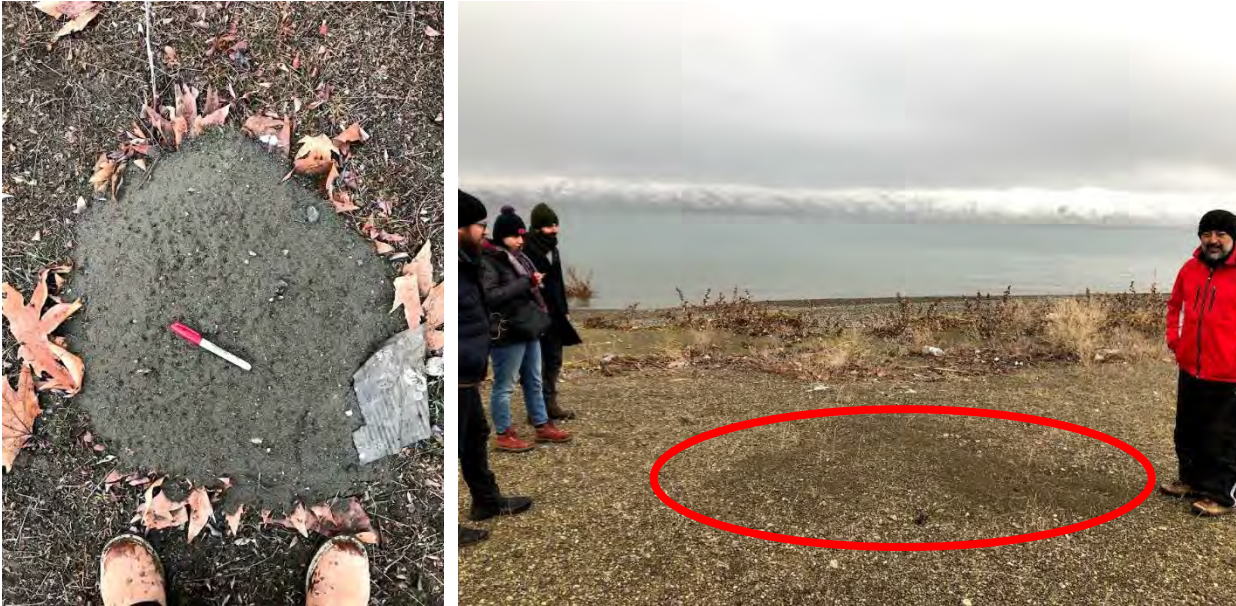
Figure 4.128. Surface manifestations of soil liquefaction in Hazar Lake (15<sup>th</sup> stop)  
(38°29'34.6"N 39°21'03.7"E / 31.01.2020 / 17:11 & 38°29'30.6"N 39°20'57.7"E / 31.01.2020 / 17:01)

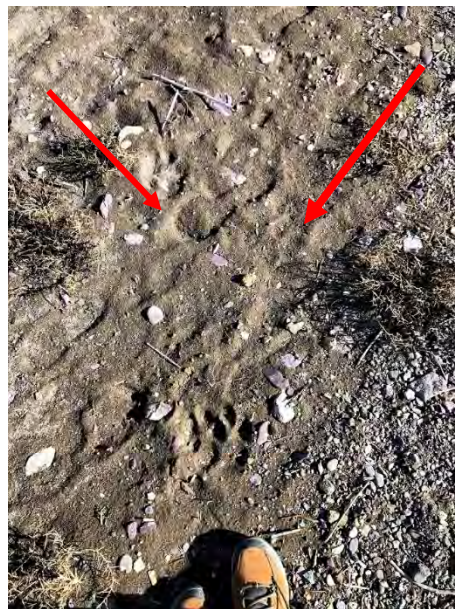
In day 2, surface manifestation of soil liquefaction in the form of sand boils were mapped along Kale shores. Figures 4.129 and 4.130 present the photos of the sand boils taken at the shores of Kale Village.

Figure 4.129. Surface manifestation of soil liquefaction at Kale Village shores (26<sup>th</sup> stop)  
(38°25'23.6"N 38°45'39.0"E / 01.02.2020 / 12:18)

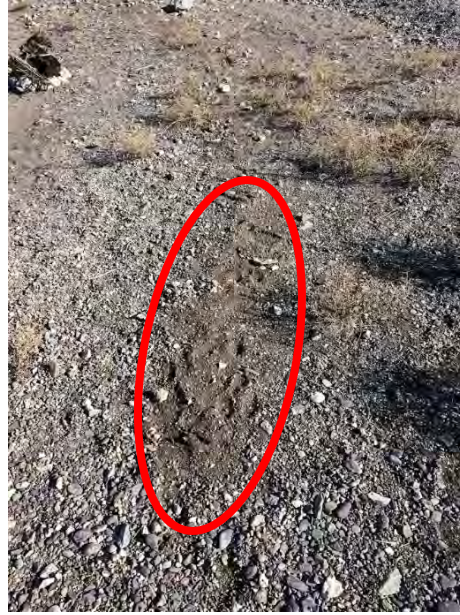
Figure 4.130. Surface manifestation of soil liquefaction at Kale Village shores  
(26<sup>th</sup> stop)  
(38°25'20.2"N 38°45'33.2"E / 01.02.2020 / 12:25)

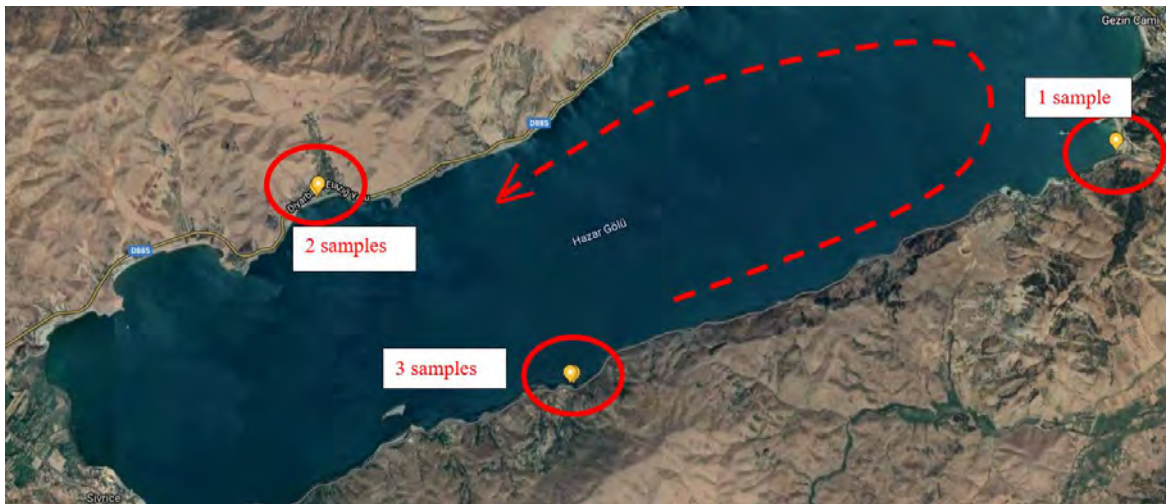
Disturbed samples were taken from the surface of the liquefied areas. The locations of sites from where 6 samples (Hazar Lake) and 4 samples (Kale Village) were taken, are shown in Figure 4.131 and 4.132. A map showing these locations are also presented in Figure 4.133. These samples were tested at METU Soil Mechanics Laboratory to determine the soil-type, grain size and consistency characteristics. The results are comparatively presented with the particle size distribution ranges common for potentially liquefiable soils (Tsuchida, 1970), as given in Figure 4.134. Sieve analysis test results are summarized in Table 4-3. Based on USCS, most of the samples retrieved from sand boils were classified as SP (poorly graded sand) and SM (silty sand).

Figure 4.131. Location of sand boil samples taken from Hazar Lake shores

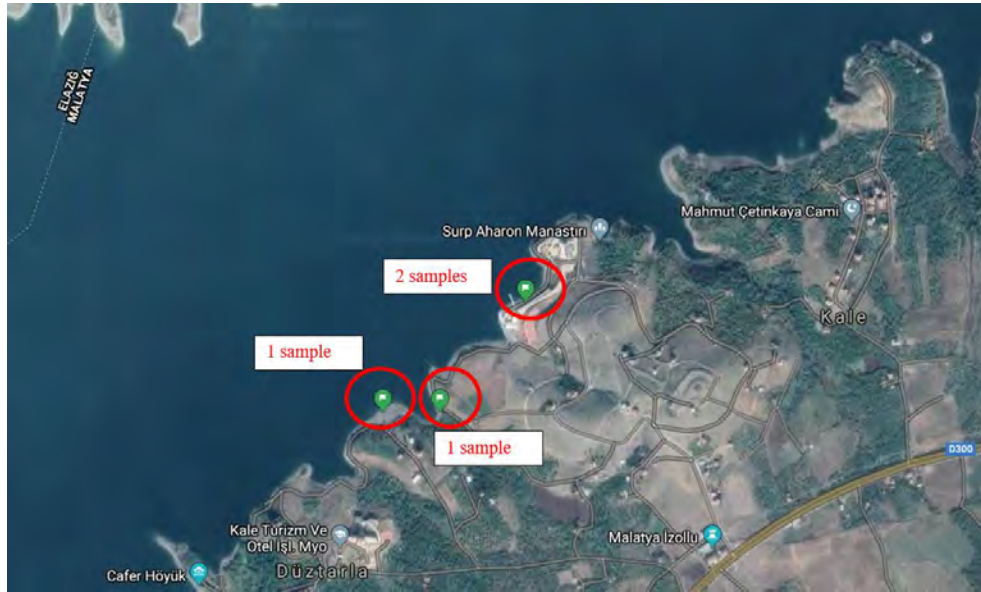
Figure 4.132. Location of sand boil samples taken from Kale Village shores

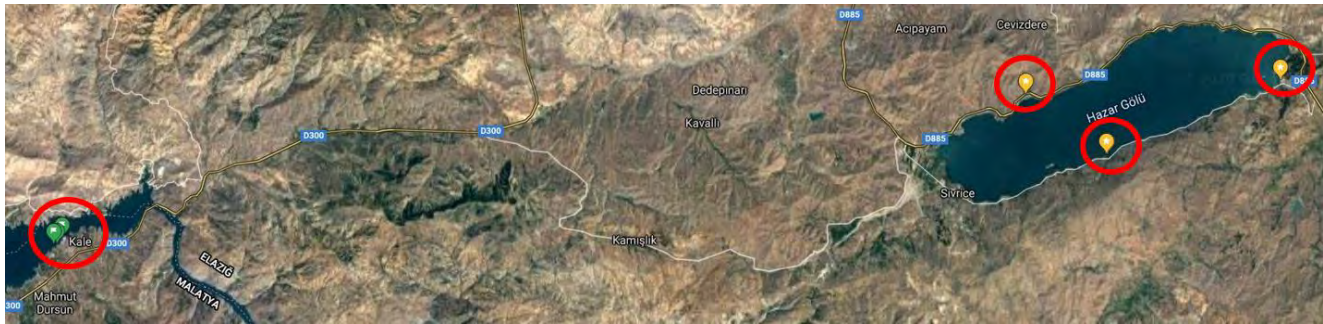
Figure 4.133. Location of the samples taken during site investigation (general view)

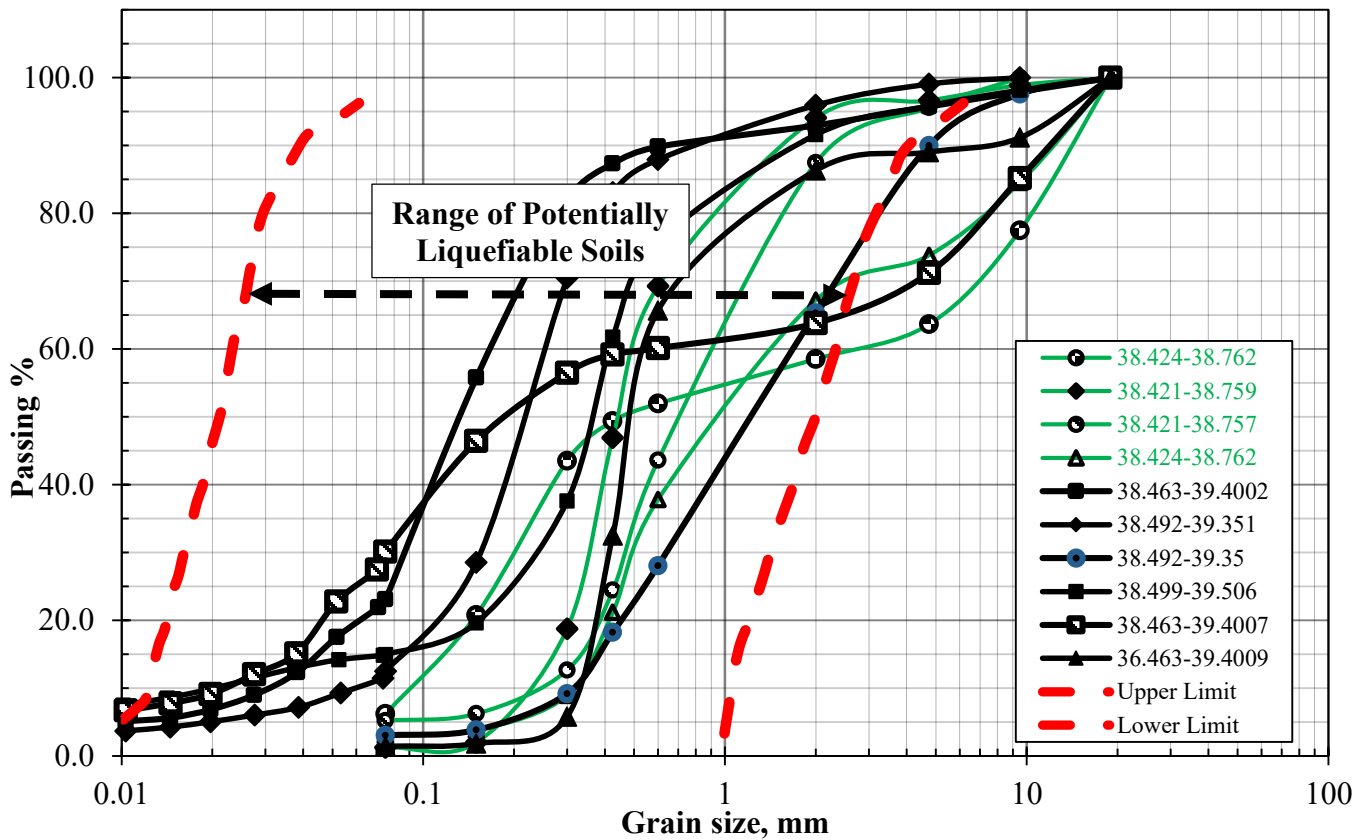
Figure 4.134. Particles size distribution curves of the sand ejecta taken from liquefied sites. (Black lines are obtained from Hazar Lake region and green lines from Kale Village side, respectively)
