A STUDY ON CONSERVATION AND REHABILITATION PROBLEMS OF  
HISTORIC TIMBER HOUSES IN ANKARA

A THESIS SUBMITTED TO  
THE GRADUATE SCHOOL OF NATURAL AND APPLIED SCIENCES  
OF  
THE MIDDLE EAST TECHNICAL UNIVERSITY

NERİMAN ŞAHİN

JUNE, 1995

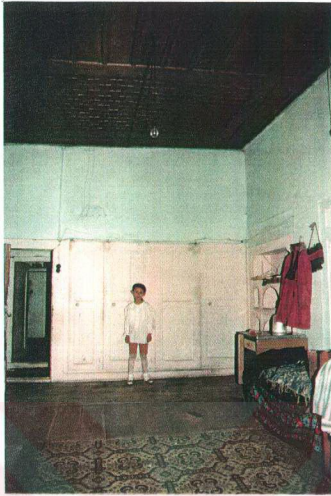
1

The removal of original ornamented ceilings or timber panels from the walls, probably for sale, are also documented in the house at Cingöz street, no: 20. The ceilings and floor pavements of the first floor of the house at Gelin St., no: 12 are all removed and renewed with timber and some original ceiling timbers are also used on the later added partition wall.

- 1) Partly altered ceiling boards in the main room
- 2) The former ceiling boards of the main room are used in partition wall in the kitchen
- 3) Partition wall in the kitchen

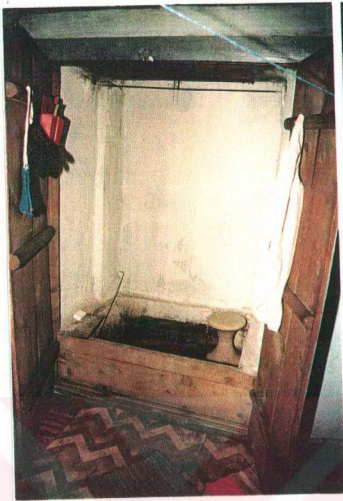
1

- 1) Original fireplace -ocak- transformed to a door
- 2) Original window transformed to gusulhane

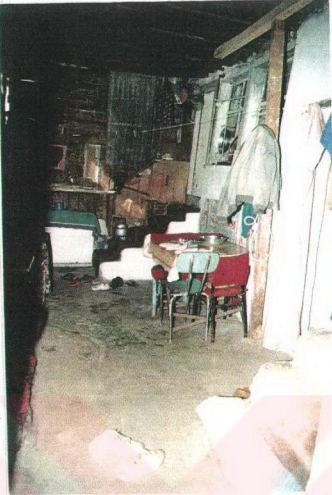
1

- 1) Ökstüzler St., 17, Ulucanlar Qu., covering timber staircase with cement based screed
- 2) Eskiçi St., 2, Yahudi Qu., alteration of original staircase by changing its dimensions
- 3) Gelin St., 12, Ulucanlar Qu., renewal of timber staircase with concrete

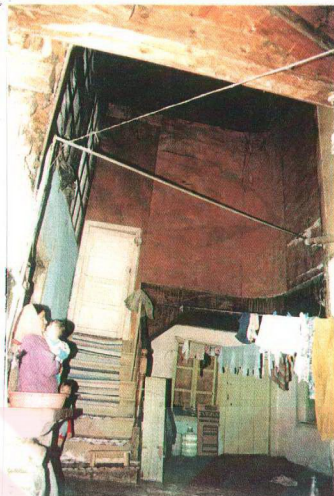
1

- 1) Eylül St., 1, Utucanlar Qu., closing of former *sofa* with plywood
- 2) Eskiçi St., 2, Yahudi Qu., alteration of a window to a door and closing of a window
- 3) Cingöz St., 20, removal of an original fireplace -*ocak*-

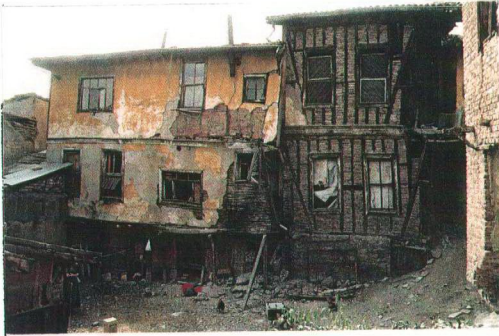
1) Sarıkadın St., 69,  
Erzurum Qu., mass edition  
to back facade

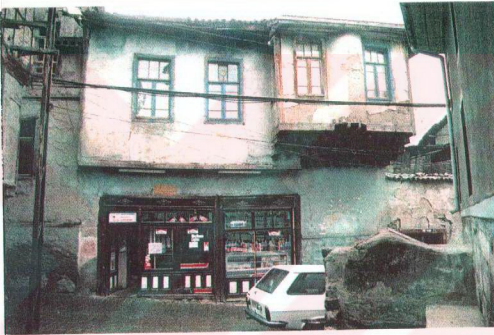
2) Kalekapısı St., 10,  
Kaleiçi, new window  
opening in ground floor for  
new function

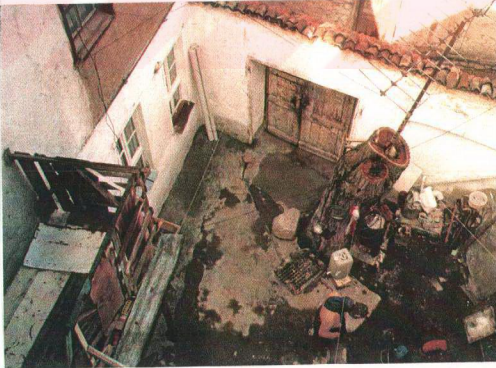
3) Yağcılar St., 1, Yahudi  
Qu., covering of original  
stone paved courtyard with  
screed

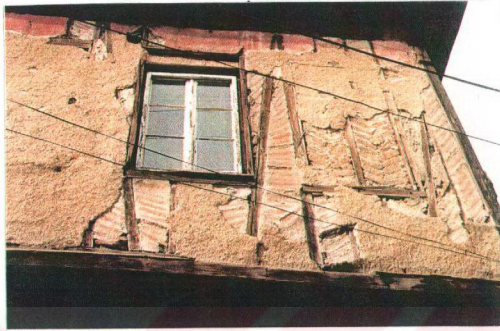
The timber framed section, consisting mainly of vertical, horizontal and bracing elements has a great elasticity and it is tolerable to deflection, cracking and distortion. Boarded floors and ceilings, timber partition walls and pitched roof provide a stiffness and buttressing to the walls. This ability of timber structures should always be considered and architects should not over-react to the signs of failure when there is not any evidence of continuous movement. Separation of vertical timber frames from the main structure may be due to foundation problems, deflection or shrinkage. As the junction points are not strong enough (only connected with nails, see sections: 3.5.2.1, 3.5.3.5) the disintegration of some walls from the timber sections is seen when there is settlement in one section of the foundations (see the catalogue in App. C, Kalas st., no: 11; Öksüzler st., no: 13, back walls separated from the roof structure).

- 1) Shrinkage cracks on timber framed section
- 2) Disintegration of brick infill, Kalem St., 2, Erzurum Qu.

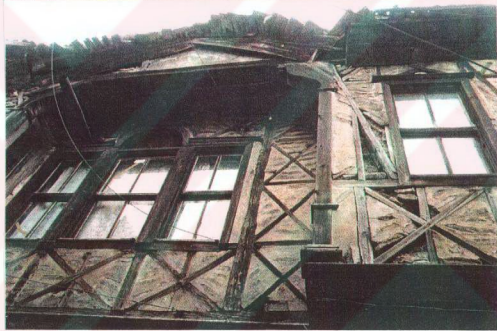
Disintegration of infill panels is another common problem observed in vertical elements although it does not directly effect the structural stability. In case of use of unplastered brick and lime mortar as infill material between the timber framed sections, as these three materials have different shrinkage capability, cracks first occur between the infill panels and the timber elements. The disintegration of infill panels as a whole or the loss of brick elements may happen later when the lime mortar loses its binding character (Figure 4.13). If plastered mud brick is used as infill material with mud mortar, a similar type of degradation occurs after the erosion of plaster. In such a case, the mud mortar erodes firstly before the mud bricks. In this combination, instead of the loss of infill material surface erosion is more common (see the facade photographs of the houses in the catalogue in App. C: Gelin, 8, 12; Yağcılar st., 1; Zülüflü, 18;). If the building facades are exposed to direct rain flow, which could not be protected by the eaves, gutters and projections, first the plaster disappears, then surface erosion starts on the infill materials. The lack of plaster creates problems for the

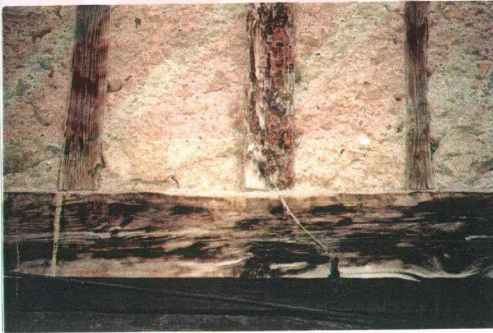
2) Sarıca St., 7,  
Ulucanlar Qu.

Some infected timbers are detected in the selected examples in Ankara (Figure 4.14). But, whether they are active or not and their type could not be determined. However, it is generally observed that wood rotting fungi and wood boring insects are not so common in the timber houses in Ankara (for a statistics on UK see Carey, J., et al.; 1986:65). Local climate characteristics, timber types, pretreatments might be the reason for that and this subject needs further examination.

Figure 4.14 Insect Attack Detected in the Examples Studied, Cingöz st., 20 and Sarıca st., 7.

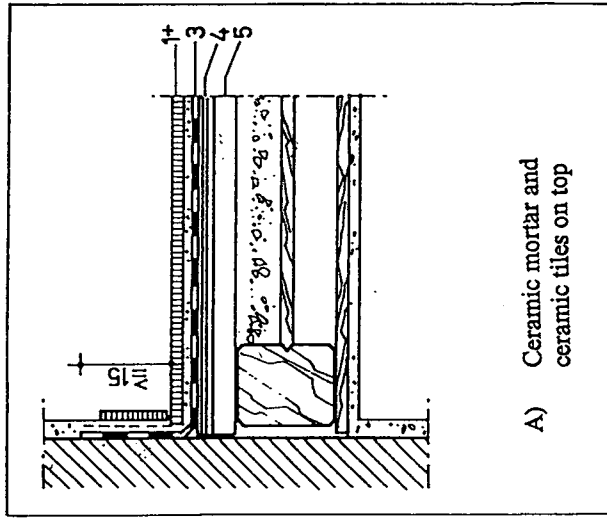
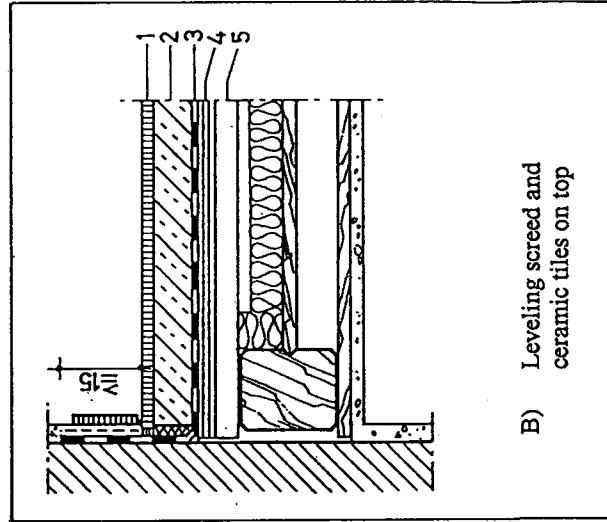
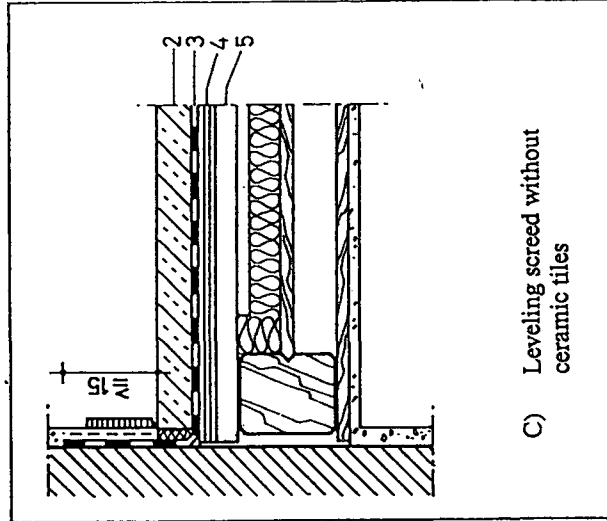
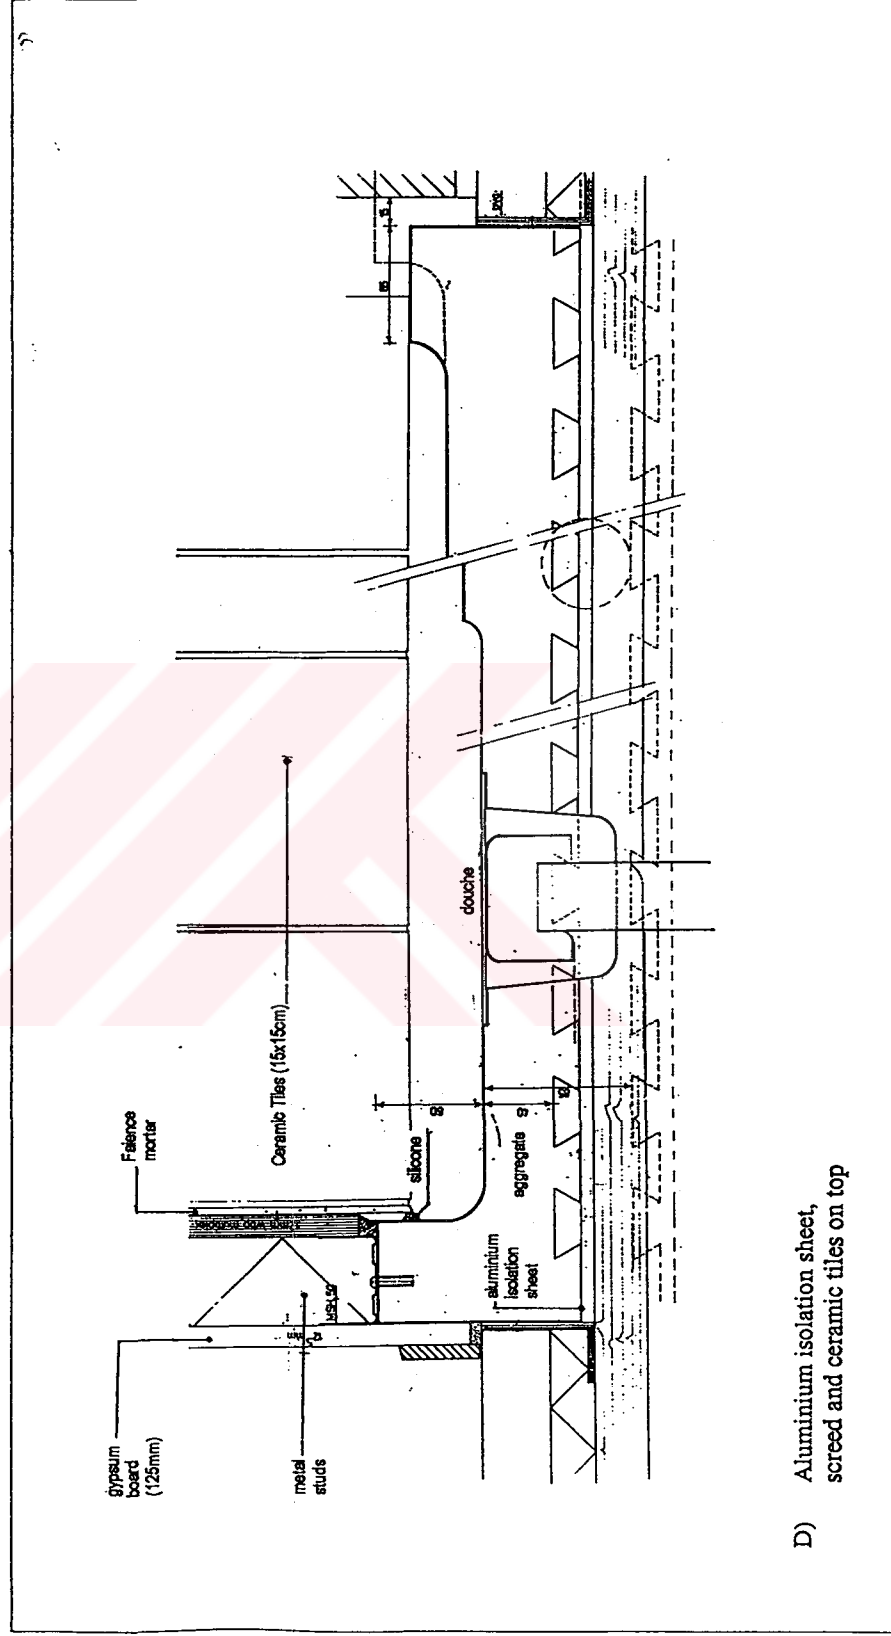
Figure 5.18 Some Alternatives for Installation of a Service Space on Timber Floor Girders (Ref. A, B, C: Bausteine Zur Selbsthilfe, Badeinbau, IBB, Erns & John, 1985: 70-71; D: J. Van Stught's Architect Office, Stichting Begijnhof-Andrieshof Amsterdam, 1985).

In the first alternative (fig. 5.18., A) the pavement mortar placed with a thickness about 6 mm (i.e. Lazemotlex<sup>TM</sup>) when it is wet and reaches to an elastic consistency. The ceramic tiles are set into the mortar when it is still wet. If the ceramic floor tiles are too thin, the entry of mortar to the joints should be avoided by good workmanship. They should be left to dry out for 1 or 2 days, afterwards the pointing of the tile joints can be filled with the proper ceramic mortar. This alternative will provide a thinner covering which can be completed below the original threshold of the door. It is light and does not bring too much load to the structure carrying it. This application does not require a long time. However, it has disadvantages like, it necessitates a perfect workmanship and if the timber girders underneath move cracks may occur in the pavement mortar.

In the second alternative (Figure 5.18, B) which is a modest technique, the cement based screed pavement is leveled on top of the isolation sheet. The screed pavement provides a strong base for the ceramic floor tiles. However, it brings extra loads and the threshold height increases. The thickness of the screed layer should be a minimum of 40 mm and the floor tiles should be paved with 2% slope.

In the third alternative (Figure 5.18, C) which follows the same procedure of the latter application, in place of ceramic tiles a fine finishing (like a chlorine based polish, mineral pigments or fine mosaic) can be applied. It has a lower cost, but the fine polish creates a slippery surface which may be dangerous for the users (Bausteine Zur Selbsthilfe, Badeinbau, IBB, Erns & John, 1985: 70-71).

In the fourth alternative (Figure 5.18, D) which was used in the restoration of timber houses in Amsterdam, corrugated stainless steel sheets are used on top of the floor girders which have grooves laid perpendicular to the timber girders. Screed is placed on top and ceramic floor tiles and the washbasin can be placed on these. The grooved steel sheets provide air flow between the girders and the sheet itself, and they also work as isolator. In this detail the upper facades of the girders are not completely covered and if they get wet they have the possibly to dry out more easily.

For this reason, in the installation of service spaces which are located on top of the timber floors isolation is extremely important. If a service space should be placed on a timber floor, complete isolation of the whole service space will be necessary to prohibit water penetration to the structure. Correspondingly, if the design of the floor pavement can also provide the evaporation of water inside the neighboring original timbers, this will prevent the decay of the timber elements even though they may get accidentally wet by water.

The first three alternatives can be applicable in Turkey, as the materials used in them are available. However, the fourth one necessitates special production, as grooved corrugated stainless steel sheets are not commercially available in Turkey yet.

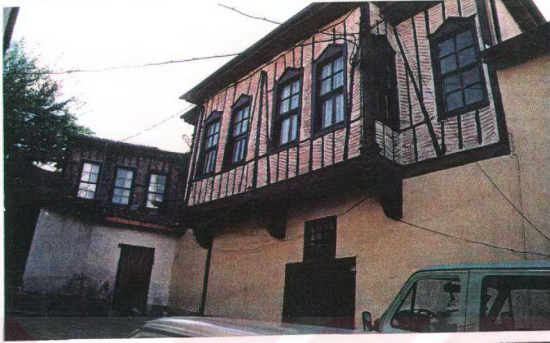
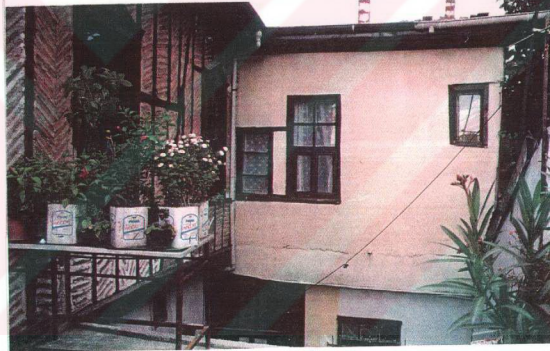
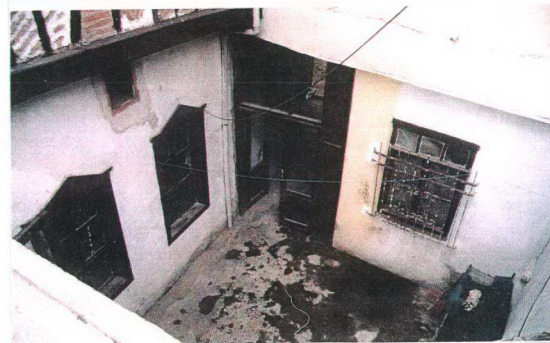
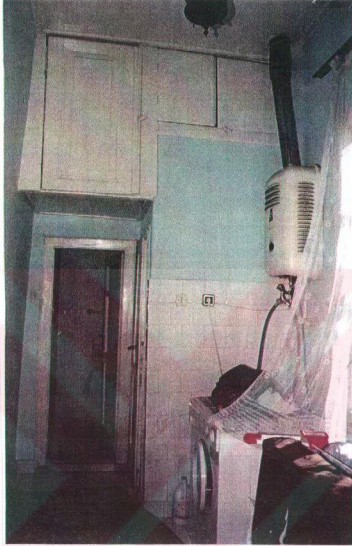
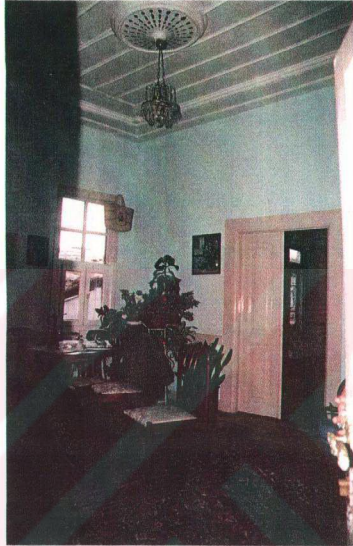
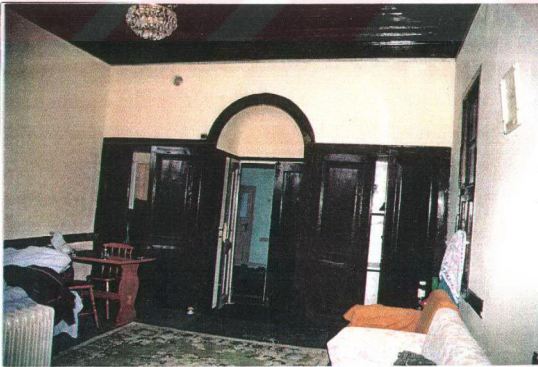
SHEET  
**6d**  
NO

**STRUCTURE:** There is no major structural problem, deformation and/or crack in the building and condition of the roof is good. It only needs some repairs like: replacement of decayed tiles, repair of degraded or missing timber pieces in the roof structure, eaves and the repair and installation of gutters. There is no visible damage done by rising damp because the stone masonry ground floor level is in good condition. But there is problem of dampness in service spaces.

**MATERIAL:** The condition of the exterior plaster at the back facade is poor as a result of rainwash through the facades, but it needs partial repair and paint. The plaster of the interiors are in better condition because they are renewed by the users periodically. There are no color changes especially in the ceilings and the floor pavements of the first floor, but there are some in the original ceilings of the ground floor (possibly because of combined action of pollution and dampness). There is discoloration (the color turned to dark brown) on timber elements of the roof eaves. The stone base of the ground floor is in good condition and it partly stops the rising damp. Condition of timber elements in general is quite good, they need some cleaning and maintenance. There is not any timber element which lost its structural strength and there is no biodeterioration or insect attack.

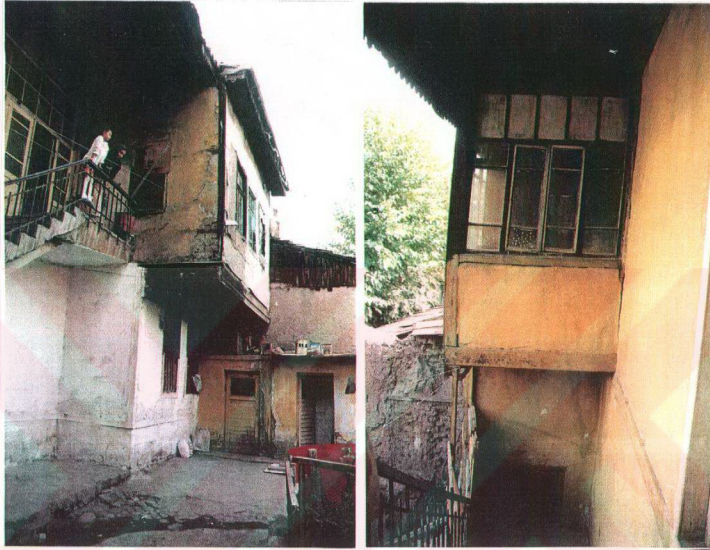
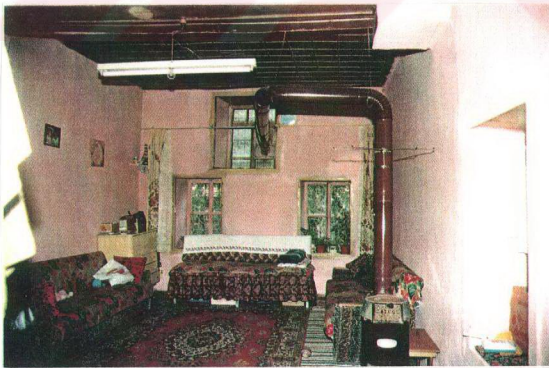
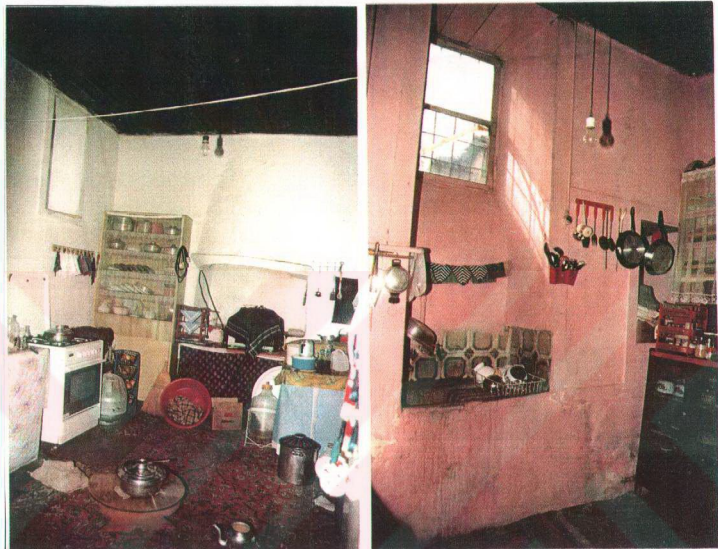
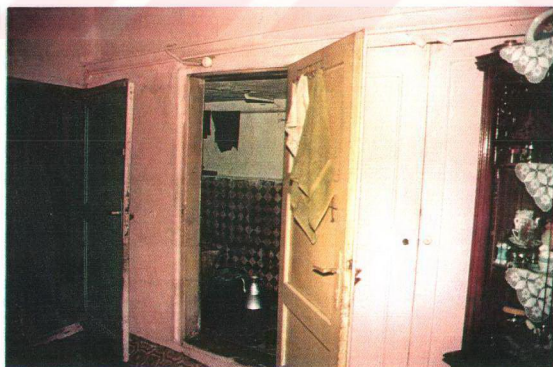
SHEET  
**7d**  
NO

**STRUCTURE:** There is a serious settlement problem on the floor pavements of the east and south facades. The deformation of the projection on Öksüzler street was done by a truck which hit this facade of the building. The level of the projection on Öksüzler street became very low by the rise of the street level in each asphalt repair and cover. This danger is always valid because the street is not closed to the entrance of high vehicles. There are different settlements on the outer masonry east wall that caused collapse of the floor boards especially in the room F6. This structural deformation creates many problems inside the house.

The condition of the roof is not good but its repair is still continuing like alteration of broken tiles and defected timbers, etc. There is a rising damp problem on the street facade even though it can be seen that the plaster is just renewed. But the biggest dampness problem is in the taşlık and the mezzanine floor resulting from both rising damp and poor isolation.

**MATERIAL:** The condition of the plaster is not good because the workmanship quality of the repairs is very poor. The condition of the building is also very bad which needs special care and solutions for problems. Some of the timber elements (like doors and windows) are oil painted, but they need repair. The other timber elements like ceiling and floor pavements, eave timbers are in bad condition because of combined action of pollution and dampness. The original structural materials are all plastered today and it is not possible to identify if there is any damage. But the cement based mixtures used in repairs (plaster or screed) might be harmful for the original materials.

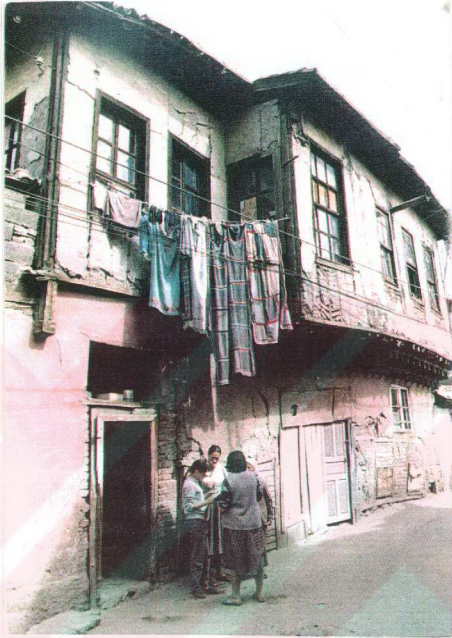
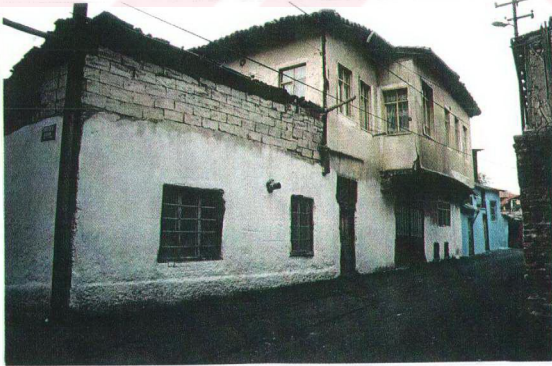
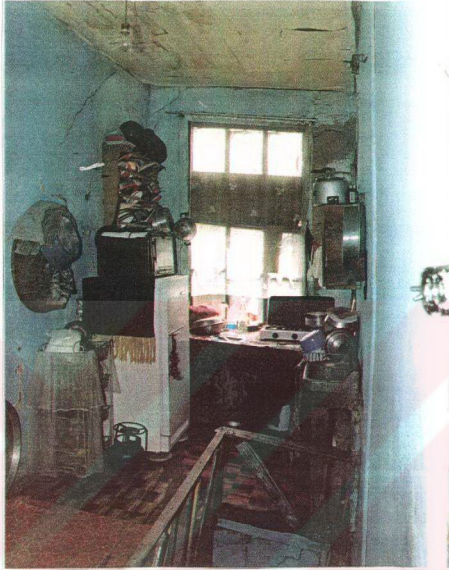
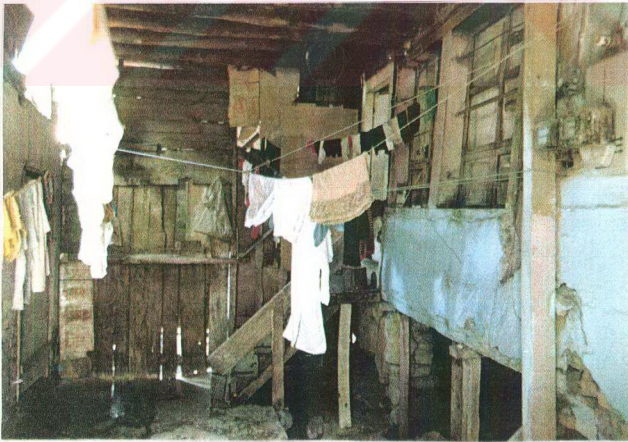
SHEET  
**8d**  
NO

**STRUCTURE:** There is no major structural problems, deformations and/or cracks in the building and the condition of the roof is good. There is some rising damp problem on the courtyard facade and especially in the basement floor where the floor is covered with earth.

**MATERIAL:** The condition of the plaster and timber elements was good because the building is repaired by the owner periodically until this year. But there is still a dampness problem in the service spaces and in the basement floor.

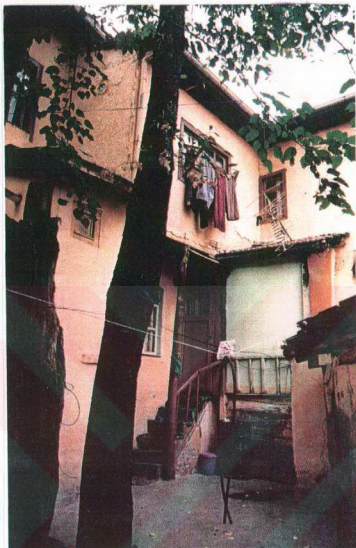
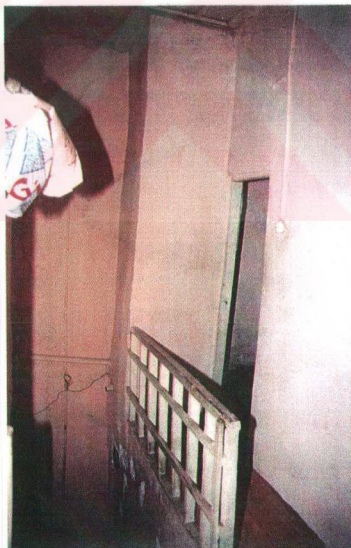
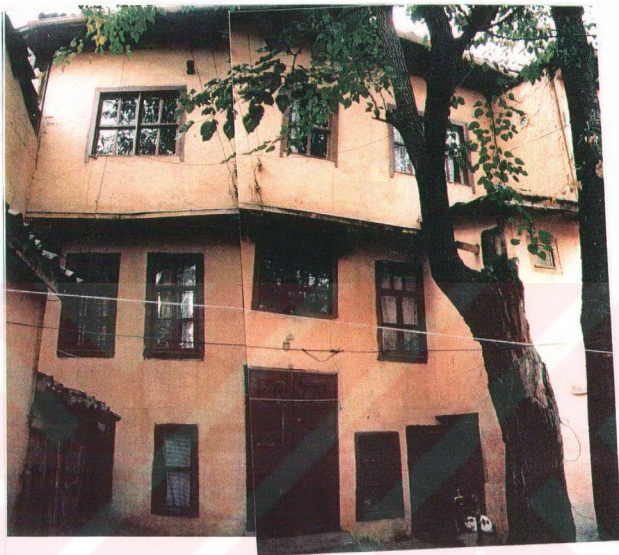
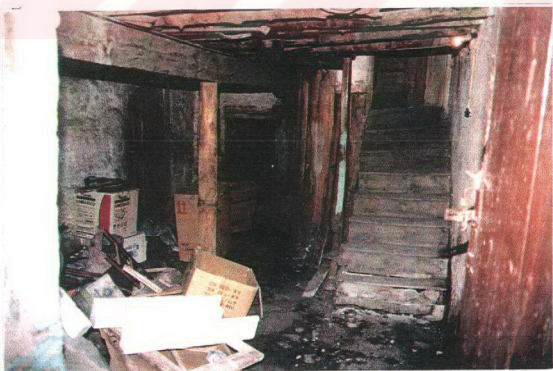
SHEET  
**9d**  
NO

**STRUCTURE:** There is neither a major structural problem, nor any deformation and/or crack in the building. The roof is not in good condition and has no gutter, it needs extensive repair.

**MATERIAL:** The condition of the exterior plaster is fairly poor as a result of rainwash through the facades. The plaster is almost lost and the infill material (mud brick) is washing away and falling down from the parts where there is no plaster. The exterior facades need complete renewal and paint. Left part of the Sarica street facade is recently renewed with cement plaster. There is no a visible decay yet, but compatibility of this material with the infill material is a question. The mortar in the joints of the stone used in the ground floor level is missing as a result of rising damp from the ground. There is discoloration in the timber elements of the facade, some small cracks parallel to fiber orientation and fiberisation ? fibrillation in small scale. A danger resulting from the organisms was not observed on the timber elements of the facades in general. But in only one of the timber beams on the first floor facade in Sarica street some insect holes were identified, but naturally whether they are active or not could not be determined. The insect holes were not observed in one element not in the neighboring timber elements. So, it is strongly possible that this element was decayed before it was placed in the structure. The roof timbers could not be observed, therefore it is not possible to comment if there are timber rots in the roof. But careful observation done only on the visible sections of the timber elements has shown that their condition is quite good. There is a dampness problem in service and entrance spaces in the ground floor, especially in the spaces covered with screed.

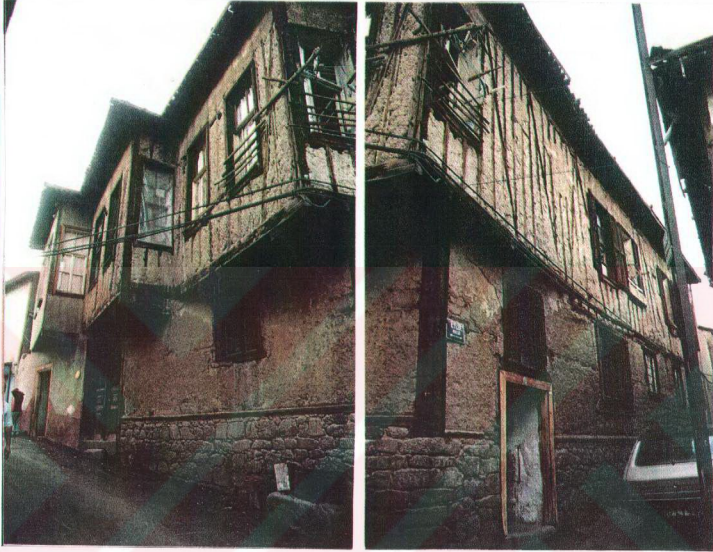
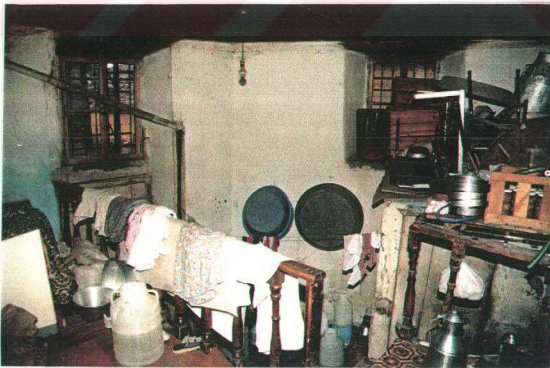
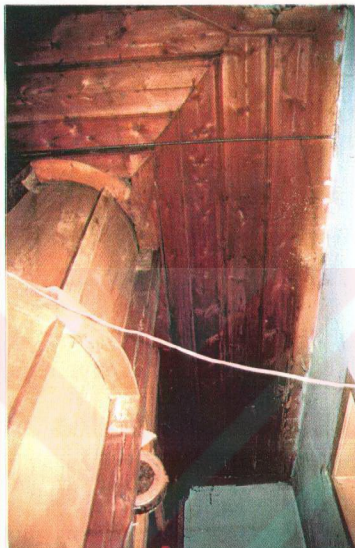
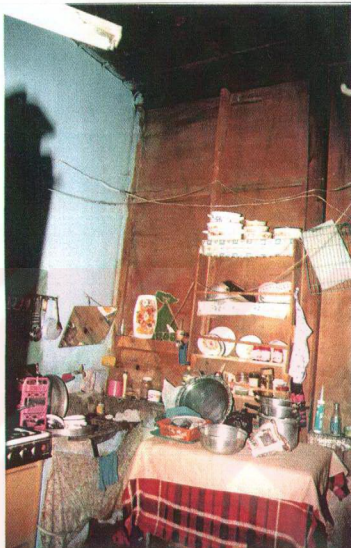
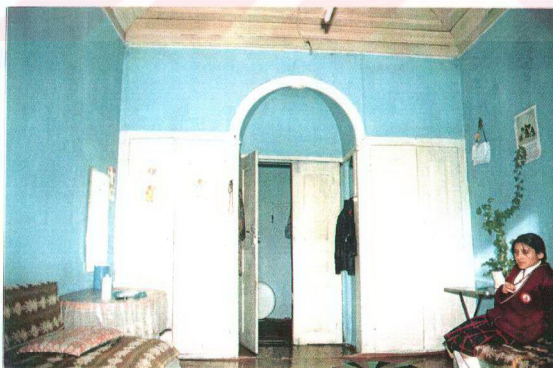
SHEET  
**10d**  
NO

**STRUCTURE:** There are no major structural problems. The condition of the roof is good but it needs gutters. There is the problem of rising damp problem on the street facade up to 80-100 cm.

**MATERIAL:** The condition of the plaster and timber elements are good, because the finishing of the building is maintained by the owner. However, there is dampness problem in the ground floor which results from rising damp.

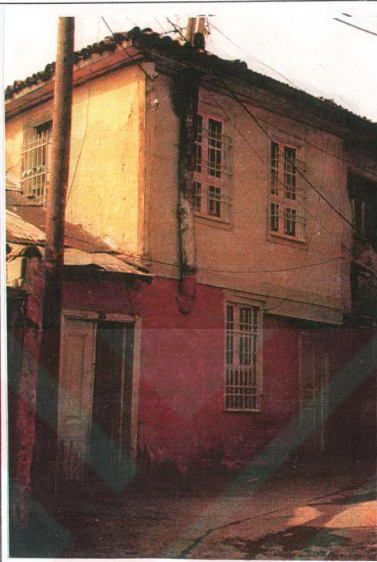
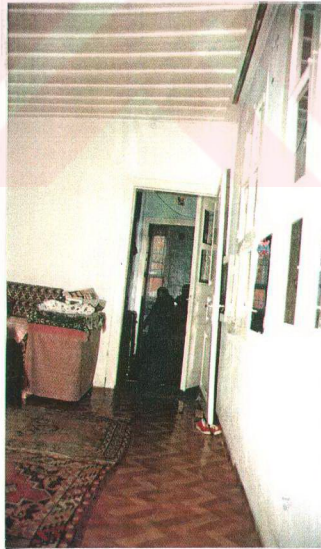
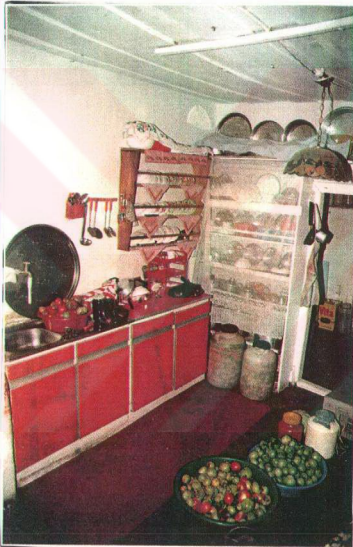
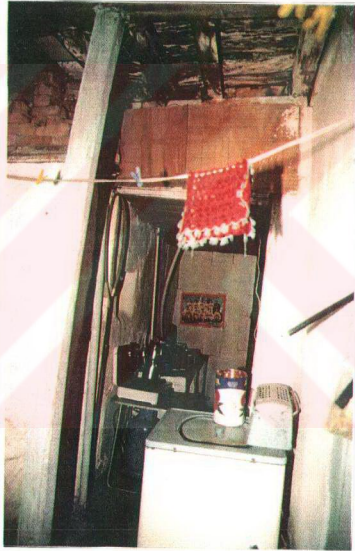
SHEET  
**11d**  
NO

**STRUCTURE:** The biggest structural problem is the deformation of the floors and the deformation of the rear wall in the first floor. The building is affected from all types of dampness, especially rain penetration, rain wash and rising damp. The condition of the roof could not be observed in detail but dampness problem is visible on the ceilings of the first floor. The eaves of the roof are not adequate to prevent the facades from rain wash. The gutters are not effective also, they need extensive repair.

**MATERIAL:** The condition of the exterior and interior plaster is extremely bad. There are color changes in all timber elements but especially in the ceilings and floor pavements of the first floor (possibly because of combined action of pollution and dampness). There is discoloration (the color of timber elements is usually dark brown and in the sections where water penetrates, the color turns to gray) on timber elements of the roof eaves. The level of the stone base of the building is very low and does not prevent the increase of rising damp. Condition of mud brick is bad, a certain thickness from the surface is regularly washed by rain.

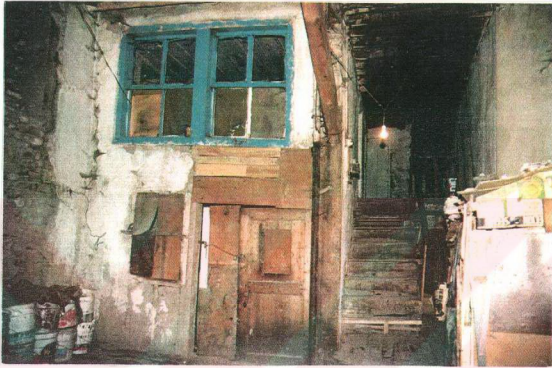
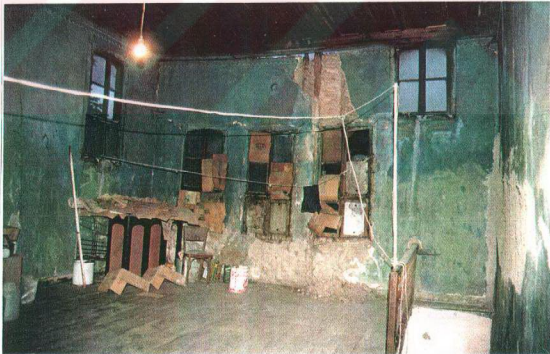
SHEET  
**12d'**  
NO

**STRUCTURE:** There is no major structural problem, deformation and/or cracks in the building and condition of the roof is good. Rising damp has not caused any visible damage because the exterior plaster is in a good condition. But there is a dampness problem in the taşlık in the ground floor and the service spaces.

**MATERIAL:** The condition of the exterior plaster is good, even though there are some color changes on the facades. The plaster of the interiors are in better condition because they are periodically renewed by the users. There is no color change especially in the ceilings and floor pavements of the first floor, but there are some in the original timber elements in the ground floor (possibly because of combined action of pollution and dampness). Condition of the timber elements in general, are quite good, they need some cleaning and maintenance. There is no timber element which has lost its structural strength and there is no biodeterioration or insect attack.

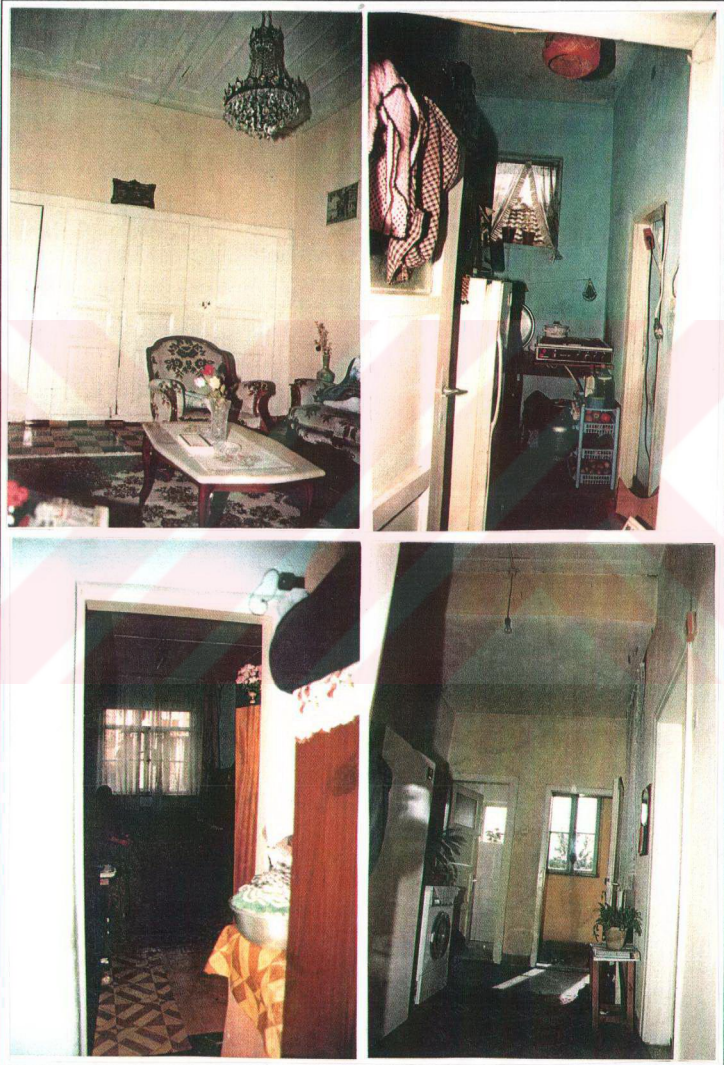
SHEET  
**13d'**  
NO

**STRUCTURE:** There is no major structural problem, deformation and/or crack in the building and condition of the roof is good. It only needs some repairs like: replacement of broken tiles, repair of degraded or missing timber pieces in the roof structure and eaves, repair and installation of gutters. There is no visible damage done by rising damp because the stone masonry ground floor is in good condition but there is a bad smell in inhabited sections in the ground floor resulting from dampness. Taşlık space has also similar problems increasing in winter time when there is too much rain or snow.

**MATERIAL:** The condition of the exterior plaster and mud brick masonry is fairly bad as a result of rainwash through the facades, especially on the south and west facades, the plaster is almost lost. The exterior facades need complete renewal of plaster and paint. The plaster of interiors are in better condition because they are periodically renewed by the users. There is color changes especially in the ceilings of the ground floor, (possibly because of combined action of pollution and water). There is discoloration (the color turned to dark brown) on timber elements of the roof eaves where is no gutter. The stone masonry ground floor of the building is in good condition and it therefore preserves the upper floors from rising damp. Condition of timber elements in general is quite good, they need some cleaning and maintenance. There is no any timber element which loses its structural strength and there is not biodeterioration or insect attack.

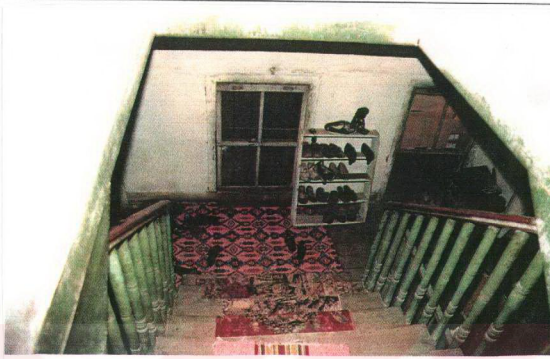
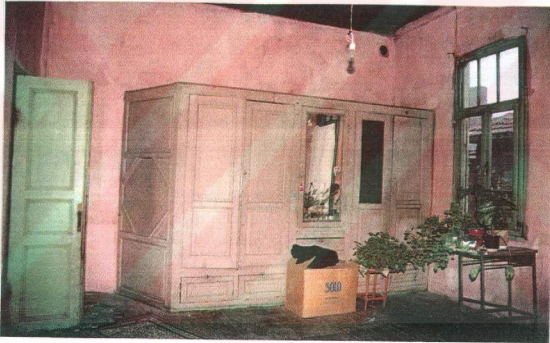
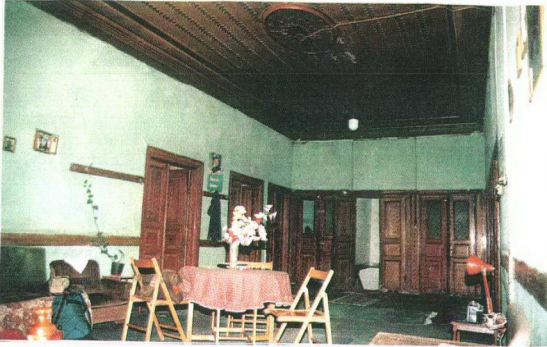
SHEET  
**14d'**  
NO

**STRUCTURE:** There are no major structural problems in the original section of the house. But there is deformation on the floor of the spaces directed to the courtyard. There is different settlement in the foundations of the spaces G2, F2 and G9, F1. As a result of this the staircase is also moved. There is a big problem also on the roof especially at the section closing the entrance space. The eaves need repair and renewal in some sections and gutters should be installed to the eaves. There is a great damage done by rising damp especially on Yan Street and the courtyard facade and the spaces facing the court in ground level. Today, the level of stone masonry is below street level. So, mud brick masonry walls are in direct contact with the street are damp.

**MATERIAL:** The condition of the exterior plaster at the back facade is very poor, as a result of rainwash through the facades and leakage from the roof. The use of cement plaster could not solve the problem on Yan street facade. The plaster of the interiors are in better condition because they are renewed periodically but there are many cracks on the walls of the lately added spaces. There is darkening problem almost in all timber elements be it the ornamented ceilings or exterior timber works. There is salt accumulation in the timber pavement below the screed in the kitchen. The color turns to gray. We could observe directly in the ground floor which are dark, cold, humid and empty spaces are suitable for fungal growth. The eaves of the roof are also deteriorated a lot and there is whitening and graying on the timber elements possibly because of combined action of pollution and rain water. Condition of timber elements in general is not good, there is a serious problem in the building resulting from rain penetration and rising damp.

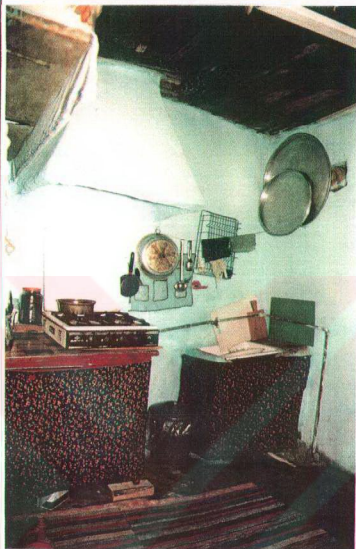
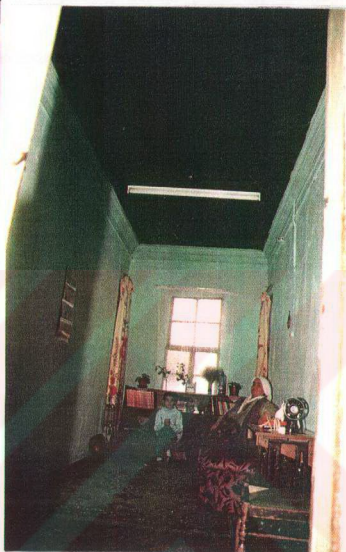
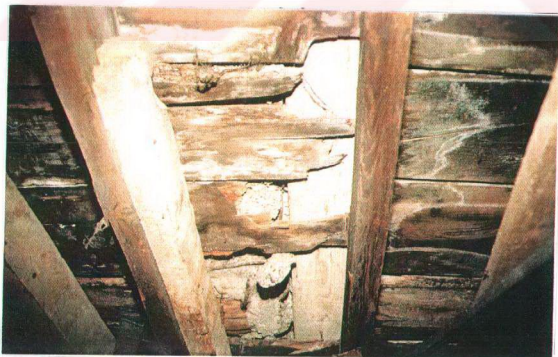
SHEET  
**15d'**  
NO

**STRUCTURE:** There is a great structural problem in the later added section. The building is sliding towards the garden caused by different settlements of the foundations. The fire that took place in the first floor affected the structural capacity of the materials. So, the addition is separated from the house. Despite that there are no structural problems in the original sections except the WC and the rooms F4, F5; M5, M6, G5, G6. There is also the problem of rising damp on the street facade and entrance spaces of the ground floor.

**MATERIAL:** The condition of the plaster and timber elements in the original sections are comparatively better than the added section. The exterior plaster needs some repair and there is darkening on the timber elements of the facade.

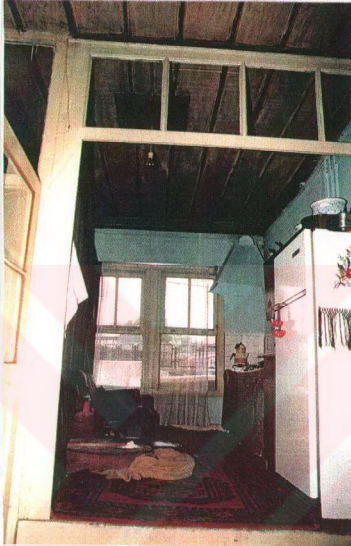
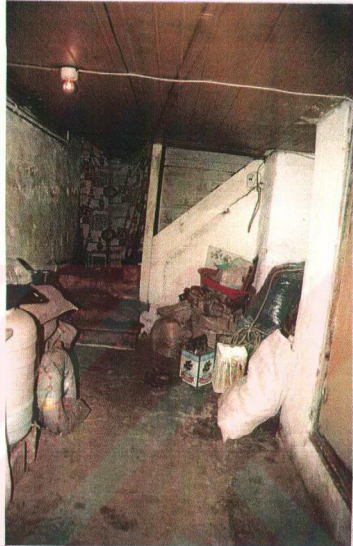
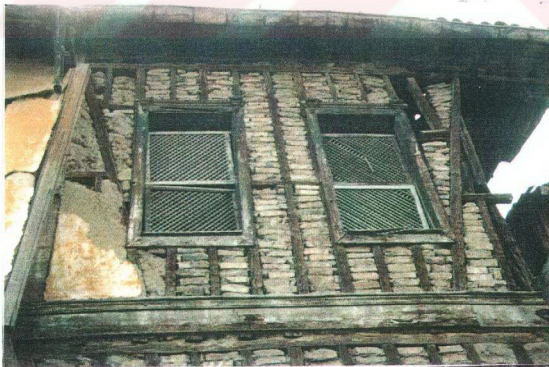
SHEET  
**16d'**  
NO

**STRUCTURE:** There are no major structural problems, deformations and/or cracks in the building and the condition of the roof is good. There is some rising damp problem on the street facade and entrance spaces in the ground floor.

**MATERIAL:** The condition of the plaster and timber elements is very good because the building is periodically repaired. The plaster needs some repair and there is darkening on the timber elements of facade.

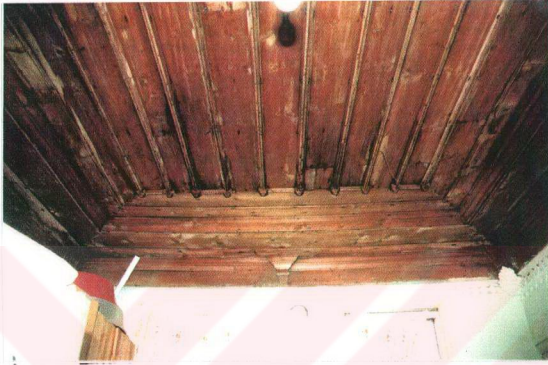
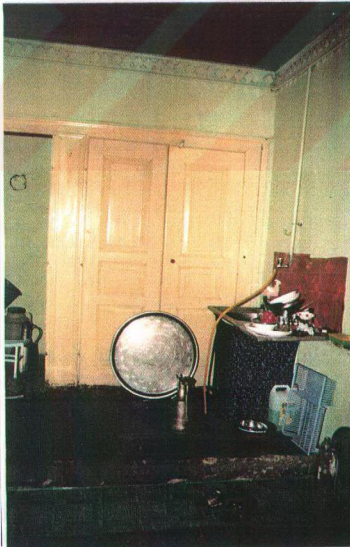
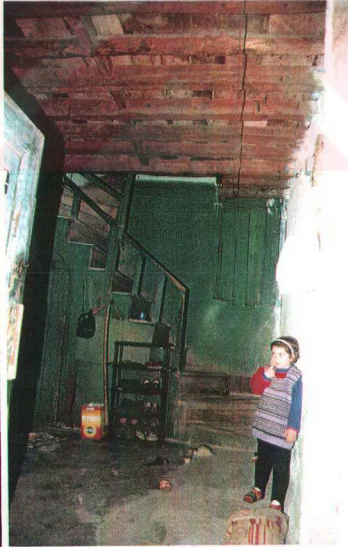
SHEET  
**17d'**  
NO

**STRUCTURE:** There is no major structural problem, deformation and/or crack in the building and condition of the roof is very good. There are some problems of rising damp on the street facade especially in the stone sections but the biggest dampness problem is in the taşlık, resulting from both rising damp and poor isolation of the WC.

**MATERIAL:** The condition of the plaster and timber elements is good because the building is completely repaired. But still there is a dampness problem in the taşlık. The paint of common the WC needs renewal. There is some problem on the ceiling of the taşlık and WC in the ground floor possibly because of combined action of pollution and dampness.

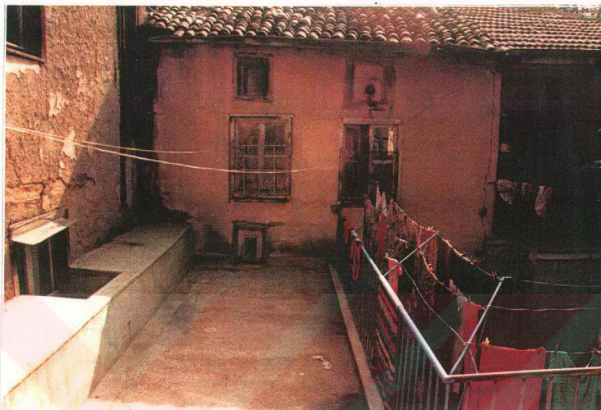
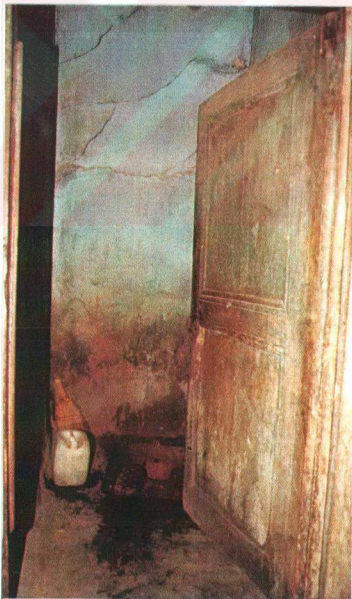
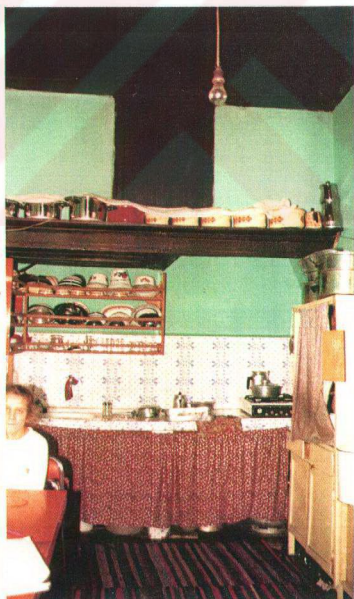
SHEET  
**18d'**  
NO

**STRUCTURE:** There is a deformation in the Cihannüma floor. This space is sloping down towards east and the rear wall is detached from the roof structure where rain penetrates. There are small deformations in the floor pavements of the building. The ground floor and the upper floors are all made with timber. The level of stone masonry base is about 50-70 cm. on Esen street and 40-50 cm. on Kalas street. The plaster and even the mortar of the stone masonry is lacking in some parts. The plaster is washed by the rain and fallen down. The infill material is exposed to weathering conditions, as a result of this the infill material is emptied in some section by falling down from its original place.

**MATERIAL:** The condition of the exterior plaster is fairly bad, it needs complete repair and whitewash. The plaster of the interiors is relatively in better condition because they are renewed by the users. The color of the exterior timber elements have turned to dark brown but the condition of timber used in interiors is better which are oil painted. It is observed that in general, the condition of timber elements are good, they need some cleaning and maintenance. Timber elements did not loose their structural strength and there is no major problem of biodeterioration or insect attract.

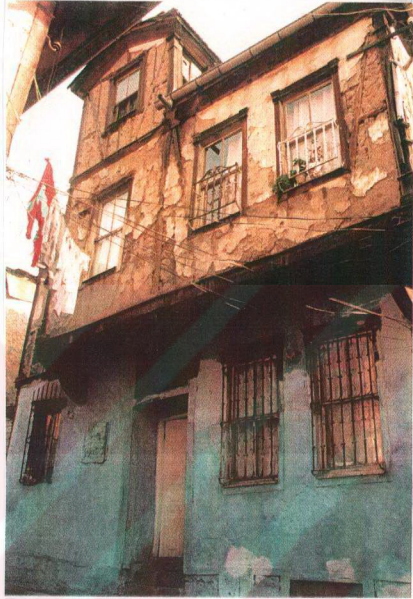
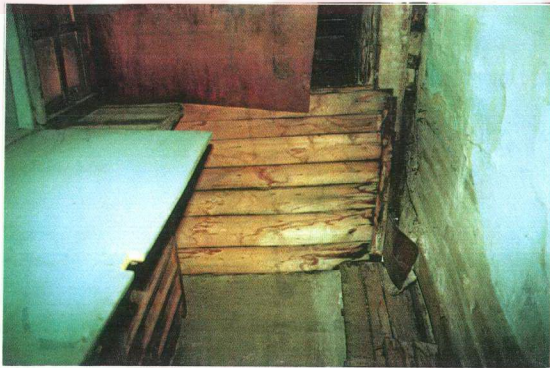
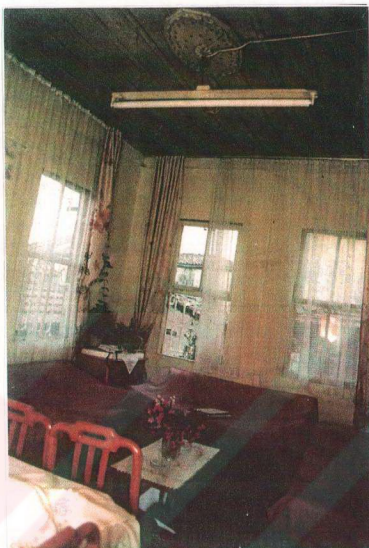
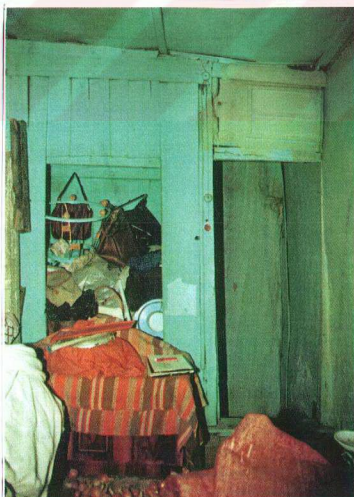
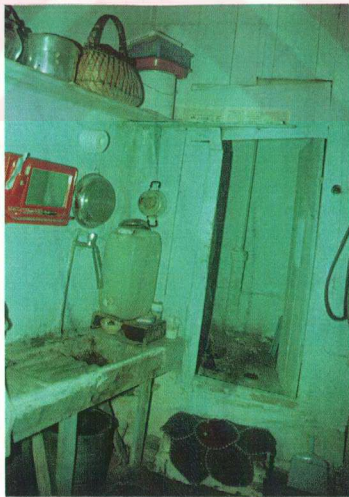
SHEET  
**19d**  
NO

**STRUCTURE:** There is no major structural problem, deformation and/or cracks in the building and the condition of the roof is good. It only needs some repairs like: replacement of decayed tiles, repair of degraded or missing timber pieces in the roof structure and eaves and repair and installation of the gutters. There is no visible damage done by rising damp because the stone masonry ground floor level is in good condition. But there is dampness problem in the service spaces.

**MATERIAL:** The condition of the exterior plaster at the back facade is poor as a result of rainwash through the facades, but it needs partial repair and paint. The plaster of the interiors are in better condition because they are renewed by the users periodically. There are no color changes especially in the ceilings and the floor pavements of the first floor, but there are some in the original ceilings of the ground floor (possibly because of combined action of pollution and dampness). There is discoloration (the color turned to dark brown) on the timber elements of the roof eaves. The stone base of the ground floor is in good condition and it partly stops rising damp. Condition of the timber elements in general, is quite good, they need some cleaning and maintenance. There is no timber element which has lost its structural strength and there is no biodeterioration or insect attack.
