EVALUATING THE IMPACTS OF REFUNCTIONING ON OTTOMAN  
MEDRESES IN ISTANBUL

A THESIS SUBMITTED TO  
THE GRADUATE SCHOOL OF NATURAL AND APPLIED SCIENCES  
OF  
MIDDLE EAST TECHNICAL UNIVERSITY

IN PARTIAL FULFILLMENT OF THE REQUIREMENTS  
FOR  
THE DEGREE OF MASTER OF SCIENCE  
IN  
CONSERVATION OF CULTURAL HERITAGE IN ARCHITECTURE

SEPTEMBER 2023

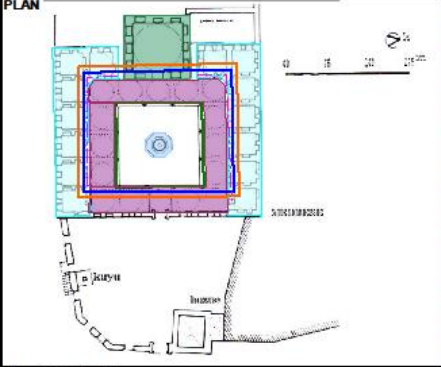
<b>NAME OF THE MEDRESE: BAYRAMPASHA MEDRESE</b>		<b>BUILDING DATE: 1635</b>	<b>OWNER: DIRECTORATE GENERAL OF FOUNDATION</b>								
<b>PLAN</b>		<b>CURRENT ALTERATIONS</b>		<b>PHYSICAL ENVIRONMENT( building lot and close surroundings - r:200m):</b>

ROOFING		General uses of close environment							
		WOODWORKING	X	resident	X	comm.	X	tourism	X		
		ELECTRIC INST.	X	health	X	educa.	X				
		HEATING INST.	X	Number of historical monumental build.	indus	3	single build.		other		
		SECURITY INST.		Number of historical civil buildings	one story		two story		three story		
		WALLING		Number of historical trees in the lot	apartment	2	needle		other	3	
		WALL REMOVAL		Number of empty lots	small		medium		large		
		OPENING ADDITION		New buildings	one story		two story	R	M	three story	D
		OPENING REMOVAL		Physical quality of environment	L		M	X	H		
		SANITARY INST.	X	<b>CURRENT USER: HANIMLAR İLİM VE KÜLTÜR DERNEĞİ</b>

FLOORING		<b>FUNCTION</b>	<b>START DATE</b>	<b>AND DATE</b>							
PAVEMENT ADD.	X	THE LAST	Cultural center	—	—						
SERVICE SPACE ADD.	X	PREVIOUS	1962	1962	2010						
FIXED FURNITURE	L M D		Not used	—	1962						
			Housing	_1918_	—						
<b>Plan: Kütükoğlu, M.</b>		<b>SPATIAL CAPACITY and CHARACTERISTICS</b>

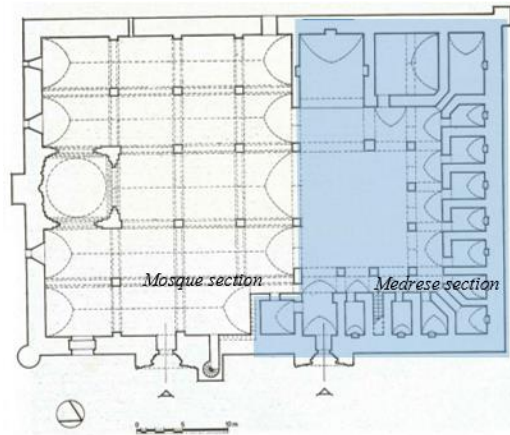
Figure 2.5. Hacı Kılıç Mosque and Medrese in Kayseri, 1249-1250 (Sözen 1984)

General plan layout of Seljuk Medreses in Anatolia affected the Anatolian Principalities and Ottoman medrese typology (Aşkun 1980, Orman 2003). Anatolian principalities also developed a new layout in Mardin, Kayseri and Balat. In this type, medrese and the mosque shared the same courtyard (Orman 2003). The existing examples of this type in 2000's are; Hacı Kılıç Medrese (1249-1250) in Kayseri from Danişmends, (Figure 2.5) İlyas Bey Medrese in Balat from Menteşeoğulları, built in 1404, and Şah Sultan Medrese in Mardin from Artukids, built around at the end of 15th and at the beginning of 16th centuries (Sözen 1984).

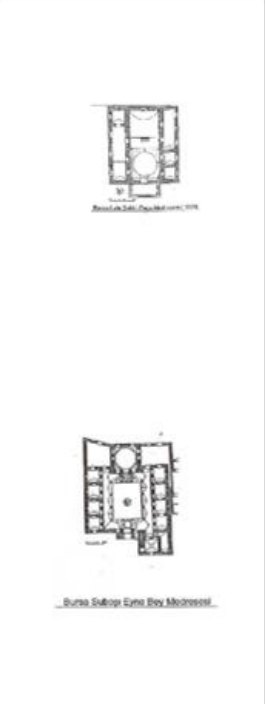
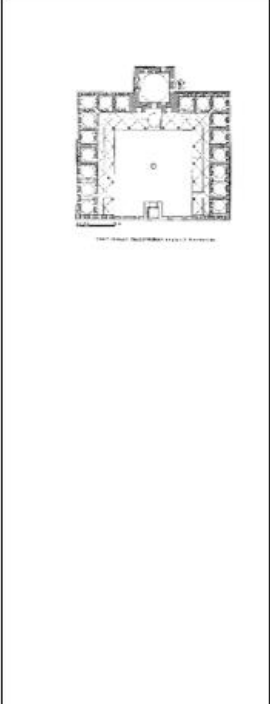
TYPOLOGY OF 14th and 15th CENTURY OTTOMAN MEDRESES			
PARALLEL PLAN TYPE	U PLAN TYPE

Figure 2.7. 14th and 15th centuries Ottoman medrese typology (Ildız 2006)

Ottoman medrese typology is generally shaped considering the order of rooms. According to Ildız, two medrese plan types were used in 14th and 15th centuries in Ottoman; U type and parallel type (Ildız 2006) (Figure 2.7.).

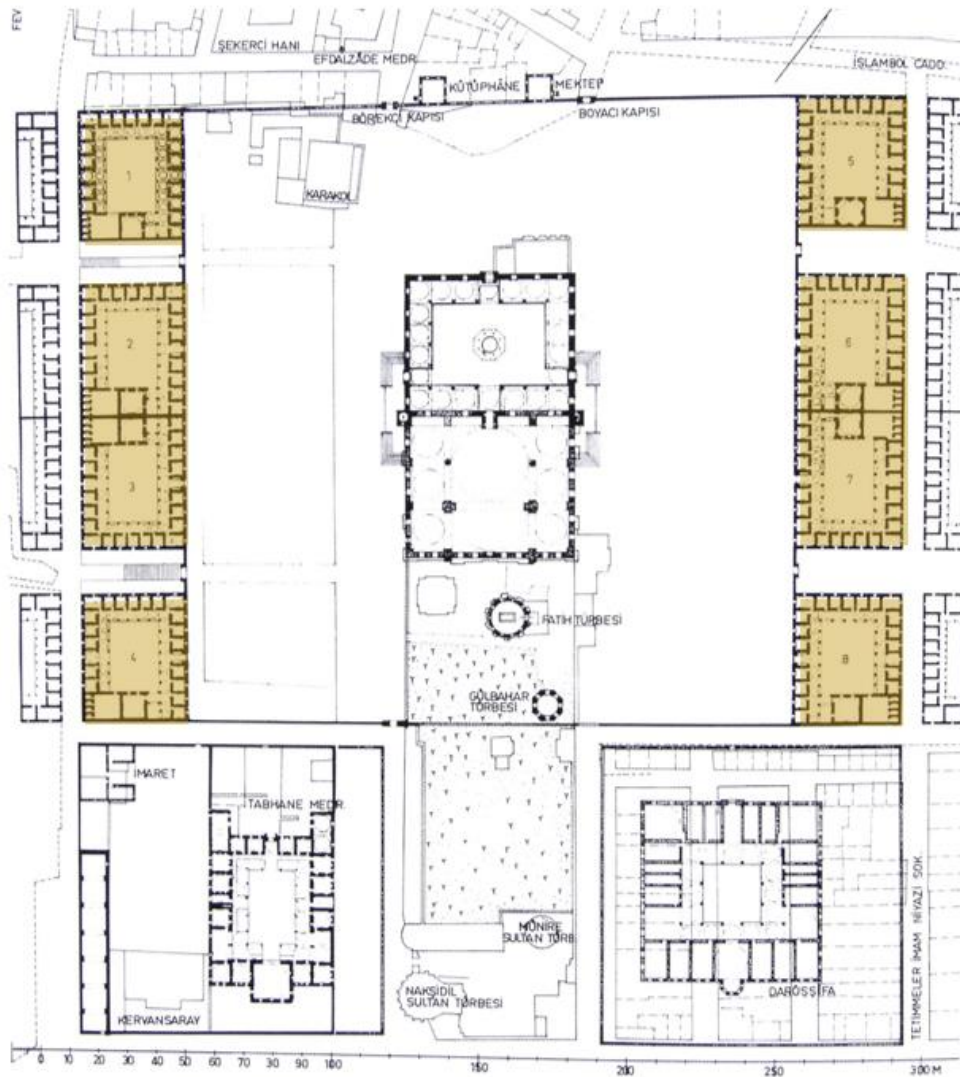
Figure 2.8. Semaniye (or Sahn-ı Seman) Medreses in Fatih Complex (Müller-Wiener 1977)

In the second half of 15<sup>th</sup> century, U type self-standing medreses were widely used in Istanbul. Following the conquest of Istanbul in 1453, Sahn-ı Seman Medreses in Fatih Complex (1474) had been a model for further Sultan and Vizier complexes with U plan type (Orman 2003) (Figure 2.8).

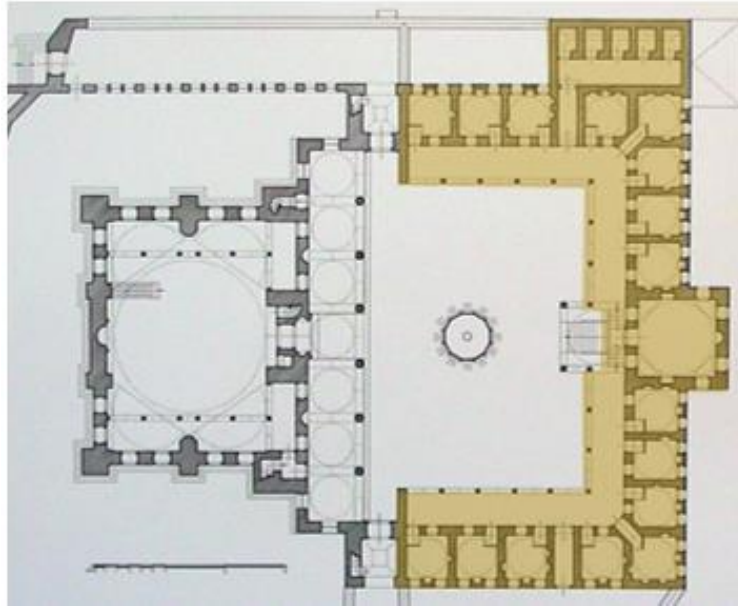
Figure 2.9. Sokullu Mosque and Medrese in Kadırga built by Mimar Sinan in 1571/72 (Ali Saim Ülgen)

former typologies. He also developed a new plan layout interpreting the Anatolian Principalities' common courtyarded mosque-medrese plan type (Nayır 1975, Orman 2003). Some of these medreses have an individual classroom, while some of used the mosque as classroom. Sinan Paşa Medrese in Beşiktaş<sup>36</sup>, Mihrimah Sultan Medrese in Edirnekapı, Kara Ahmet Paşa Medrese in Topkapı, Zal Mahmut Paşa Medrese in Eyup, Sokullu Medrese in Kadırga and Şemsi Paşa Medrese in Üsküdar are the examples of this type in Istanbul (Figure 2.9).

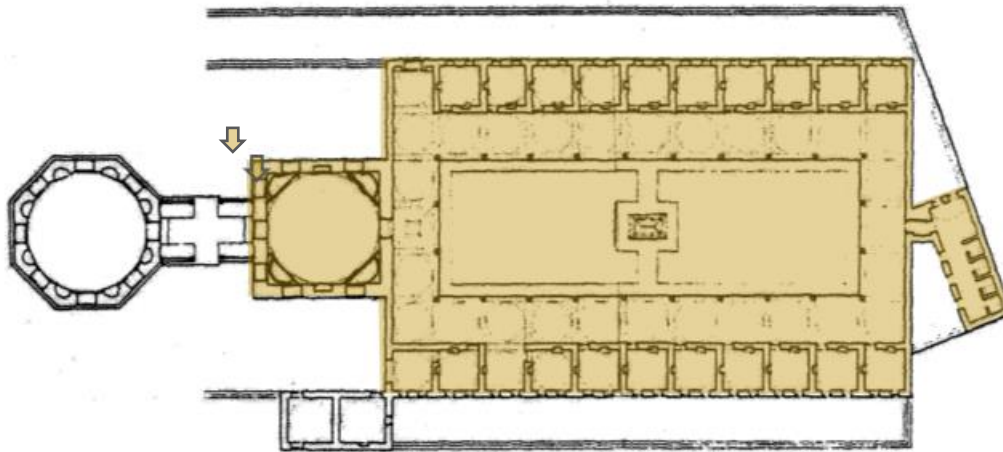
Figure 2.10. Sokullu Medrese in Eyup, built by Mimar Sinan in 1569 (Öklü 2005).

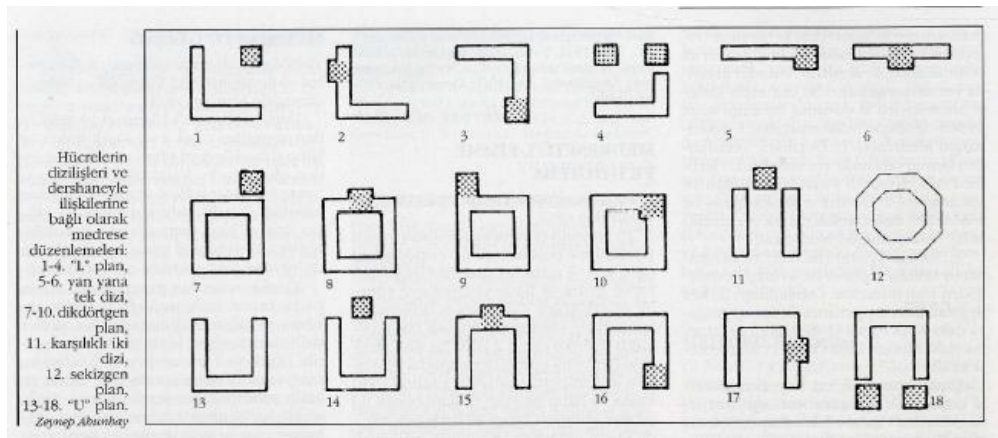
Figure 2.11. Typology of Ottoman Medreses developed in 16th century (Ahunbay 1994)

According to Zeynep Ahunbay, there are 6 types of medreses in Ottoman architecture; (Ahunbay 1994) (Figure 2.11).

- a) I type,
  - a. Classroom is in between rooms. (Scheme 6 in Figure 2.11)
  - b. Classroom is at the end of room line. (Scheme 5 in Figure 2.11)
- b) Parallel type, (scheme 11 in Figure 2.11)

- c) L type,
  - a. Individual classroom. (Scheme 1 in Figure 2.11)
  - b. Classroom is at the end of room line. (Scheme 2-3 in Figure 2.11)
  - c. Individual classroom with another individual space (scheme 4 in Figure 2.11)

- d) U type,
  - a. Simple U / without classroom (Scheme 13 in Figure 2.11)
  - b. Classroom on symmetry axis opposite to rooms (Scheme 14 in Figure 2.11)

- c. Classroom on symmetry axis between rooms (Scheme 15 in Figure 2.11)
  - d. Classroom is at the end of room line (Scheme 16 in Figure 2.11)
  - e. Classroom is one of the wings of room line (Scheme 17 in Figure 2.11)

- f. Individual classroom with another individual space (Scheme 18 in Figure 2.11)
- e) Rectangular type

- a. Individual classroom (Scheme 7 in Figure 2.11)
- b. Classroom is in between rooms (Scheme 8 in Figure 2.11)
- c. Classroom is in the corner (scheme 9-10 in Figure 2.11)
- f) Octagonal type. (Scheme 12 in Figure 2.11)

Her classification considers order of rooms and position of classroom within rooms. There are also some out of typology medreses, because of restrictions of lots. These out of typology medreses are distorted forms of “L” or “U” types (Ahunbay 1994). This classification does not take into account either position of courtyard, or being part of a group.

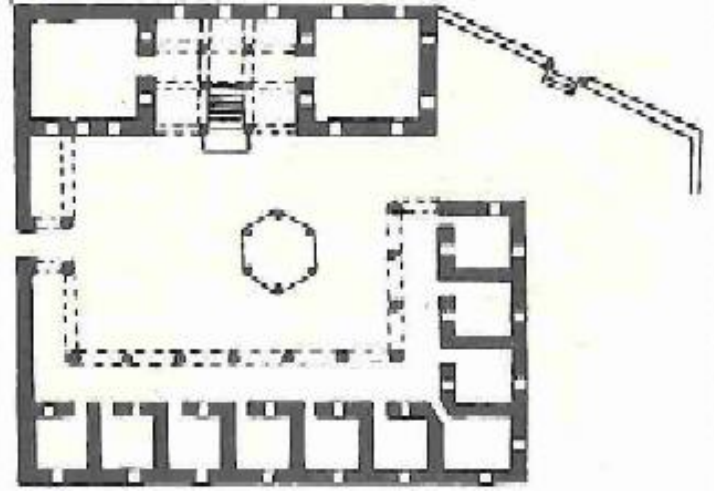
Figure 2.27. Plan of Şeyhülislam Feyzullah Efendi Medrese (Uluçam 1995)

The longest-running new facility in medreses was the function "library", as long as 99 years, in Şeyhülislam Feyzullah Efendi Medrese (Figures 2.27 and 2.28). The medrese was composed of a classroom, a library and 10 rooms. It is constructed by Şeyhülislam Feyzullah Efendi and kept his manuscript collection in library section. At the beginning of 20th century, 200 years after it was built, it was derelict and almost in ruins. Then, the municipality had planned to demolish the medrese in order to design a park. However, it was restored by Istanbul Muhibleri Association in 1916 with the encouragement of the Minister of Foundations Şeyhülislam Mustafa Hayri Efendi. Between 1916 and 2015, the medrese was using as a public library, known as Millet Library (Uluçam 1995, Tayşi and Ülker 2005). In 1999 Marmara Earthquake the

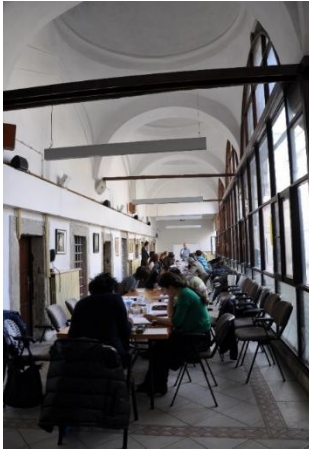
Figure 2.29. Revak section of Köprülü Mehmet Paşa Medrese. 2011

According to Table 2.1, cultural center facility was another long-running new use for medreses. In some examples, the name of the function became more popular the name of the medrese. For instance; the name “Kubbealtı Academy”, as a 31 year cultural and traditional art center, was more famous than the name of Köprülü Mehmet Paşa Medrese in 2015. Some of important illumination artists had educated in this medrese. Revak section was intervened for illumination lectures and rooms were used for administrative and service necessities (Figures 2.29 and 2.30). Köprülü Mehmet Paşa Medrese was located on Divanyolu Street. Seyit Hasan Paşa Medrese had been using for 25 years for cultural activities by Istanbul University, Euresia Institute. The medrese was located at Vezneciler, which was a district very close to Istanbul University. The courtyard was the main space using for the main activities, like seminars and international meetings, while the rooms were using as offices, administrative facilities and service spaces (Figure 2.31).

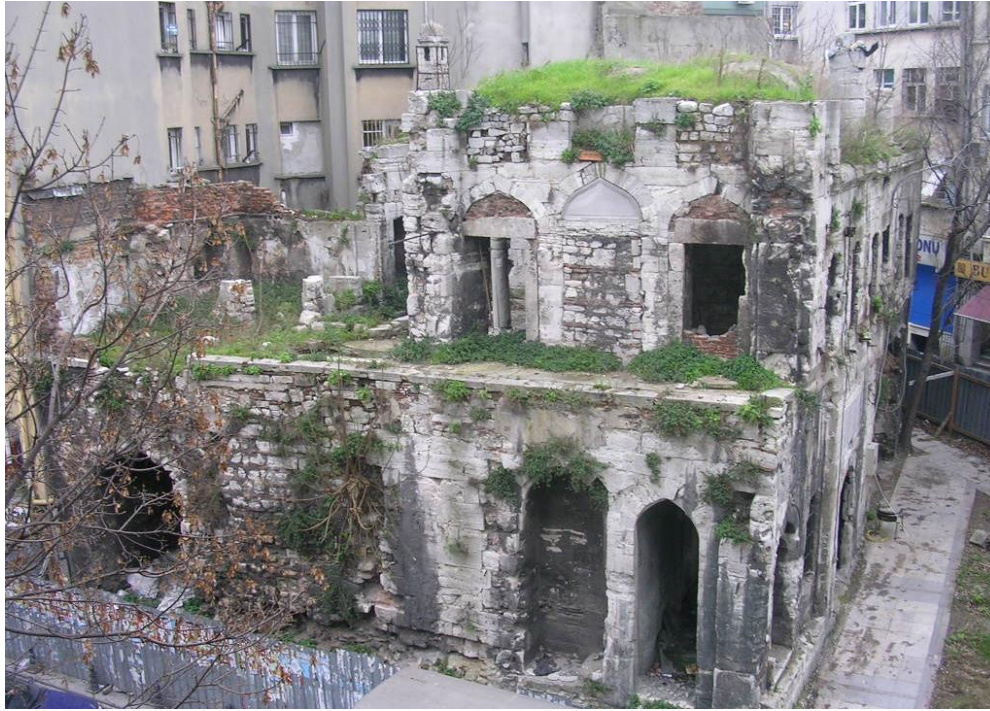
Figure 2.32. Hadım Hasan Paşa Medrese before refunctioning. 2005 (archive of DGF)

Since the beginning of 2000's, a considerable refunctioning and rehabilitation works on medreses had been continued by 2015. Some of those rehabilitations also included reintegration works; such as Hadım Hasan Paşa and Hadım İbrahim Paşa medreses. Furthermore, there was a tendence to reconstruction of not existed medreses in conservation plan decisions taken by Istanbul Metropolitan Municipality. These medreses were mostly owned by municipalities or private sector. This demonstrated that ownership by a decision maker body had a strong effect on refunctioning, or reconstruction or revitalization of medreses in 2000's.

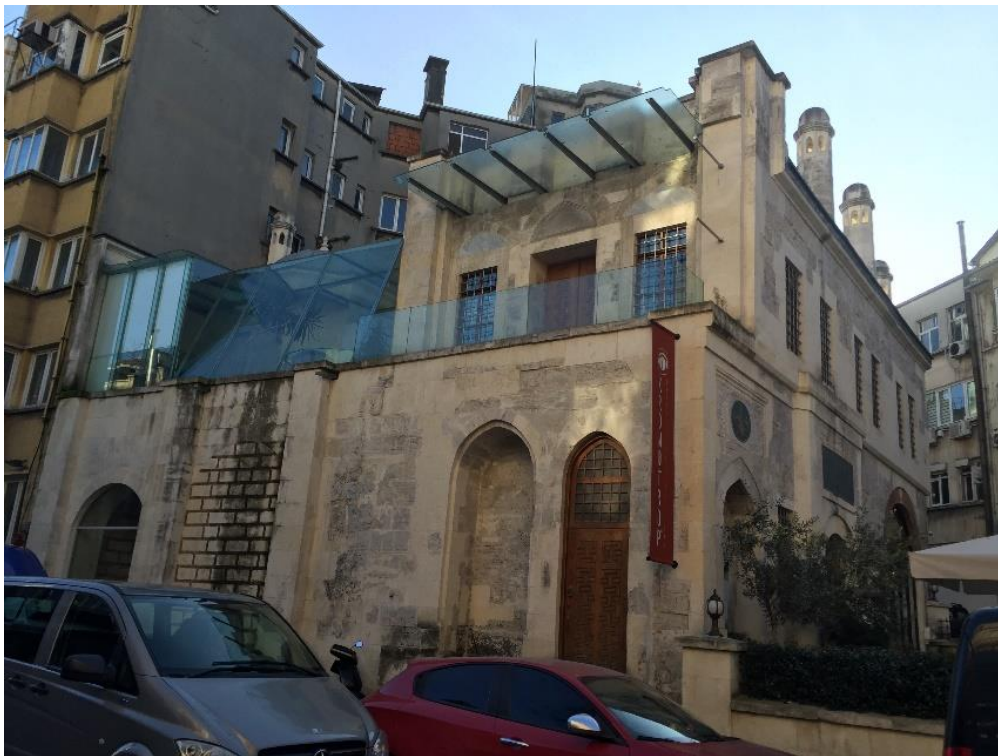
Figure 2.33. Hadım Hasan Paşa Medrese after refunctioning. 2015

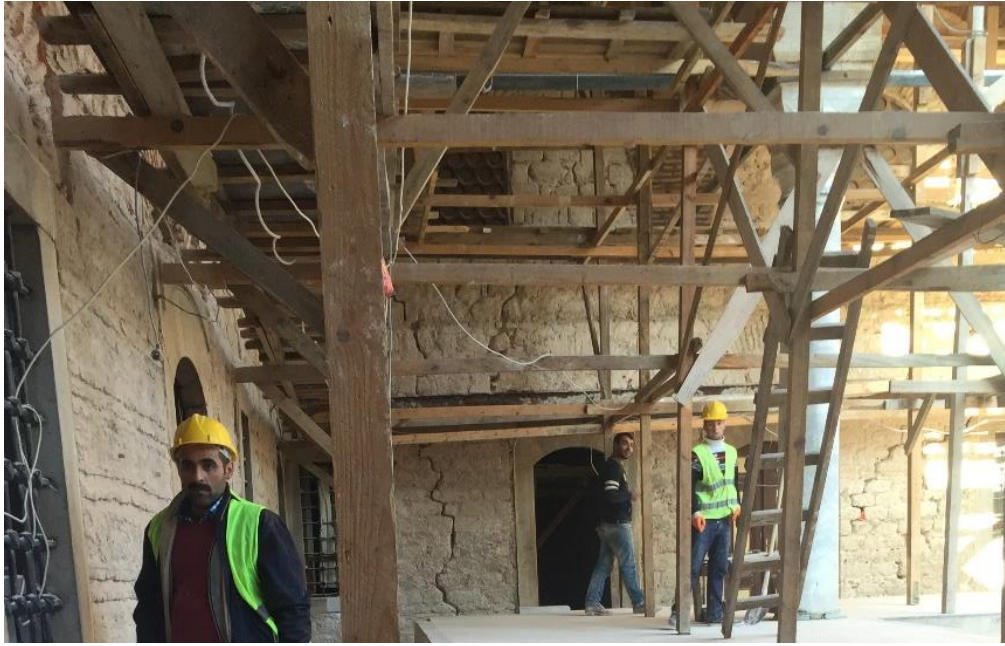
Figure 2.34. Structural cracks on Tabhane Medrese in Fatih Complex. 2016

Site survey on the medreses in Istanbul between 2010-2015 showed that, refunctioned medreses either had needed considerable structural repair for renewing process or they had been considerably deteriorated due to long lasting occupations, changing functional needs and lack of maintenance (for example Beyazıt Medrese and Atik Ali Paşa Medrese). Structural needs were seen in the form of partially demolishing (for example Siyavuş Paşa Medrese and Hadım Hasan Paşa Medrese) (Figures 2.32 and 2.33) and advanced structural problems (for example; Akdeniz Medreses and Tabhane Medrese of Fatih Complex and Davut Paşa Medrese) (Figure 2.34). In some medreses, it was observed some exceptional remains of past interventions referring to historical interventions that were understood from some written and visual archive documents (for example Hacı Beşir Ağa Medrese) (Figure 2.35).

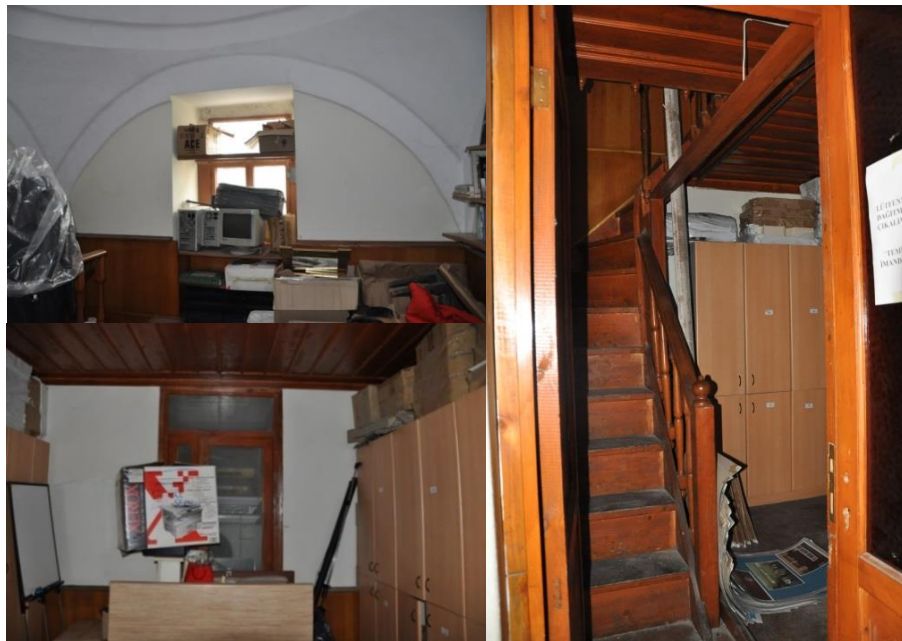
Figure 2.35. Ground and upper floor divisions and staircase of a room in Hacı Beşir Ağa Medrese, 2011

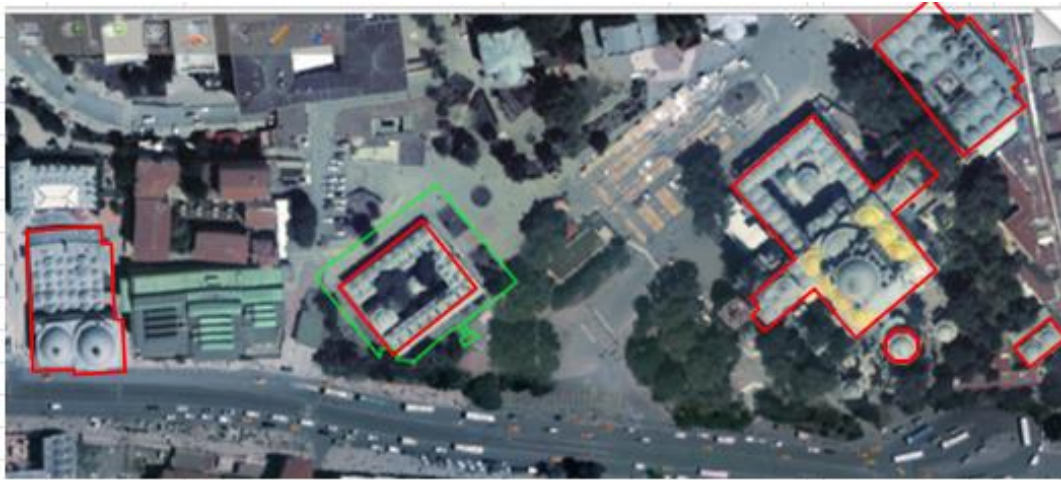
Figure 3.5. Beyazıt Medrese superposed with its lot in aerial photo 2013 (IMM)

Except for sebil, all the buildings of the complex still existed in 2015 (Figure 3.5.). The mosque and the tomb had kept their original functions. However, the medrese, hamam, caravanserai, tabhane and primary school were refunctioned by different users. Hamam was used as a museum, namely Bayezid II Hamam Culture Museum, by Istanbul University. Caravanserai and tabhane had being used together as city library since the late Ottoman period. 1800s, primary school had also being used as a library, namely Hakkı Tarık Us Library, since 1960s.

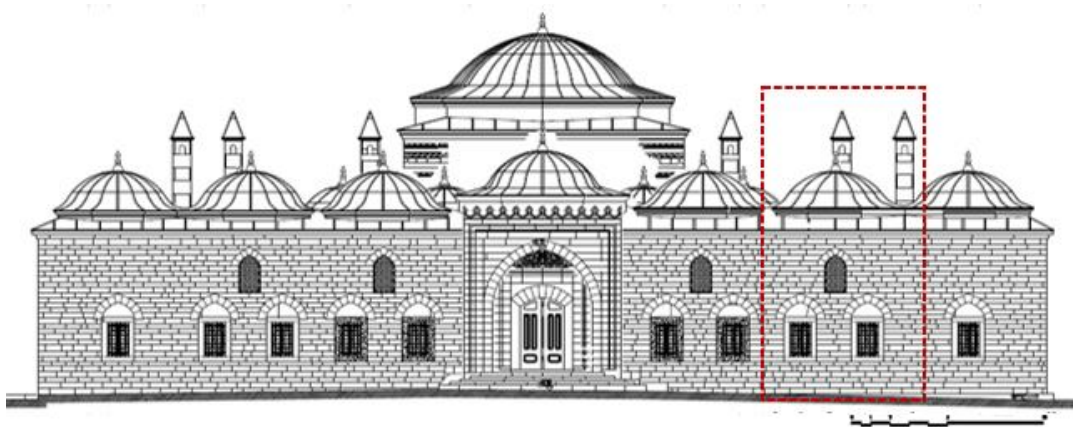
Figure 3.8. Original entrance facade of Beyazıt Medrese, Restitution by Halil Onur, 2007 (Archive of Istanbul Ist. RDF)

**Layout:** The medrese was a rectangular building with U type layout (Figure 3.1. and 3.7.). It was 36.63 x 43.90 m from outside. It had a monumental main entrance opening through Beyazıt Square on north-east façade (Figure 3.8.). The medrese was

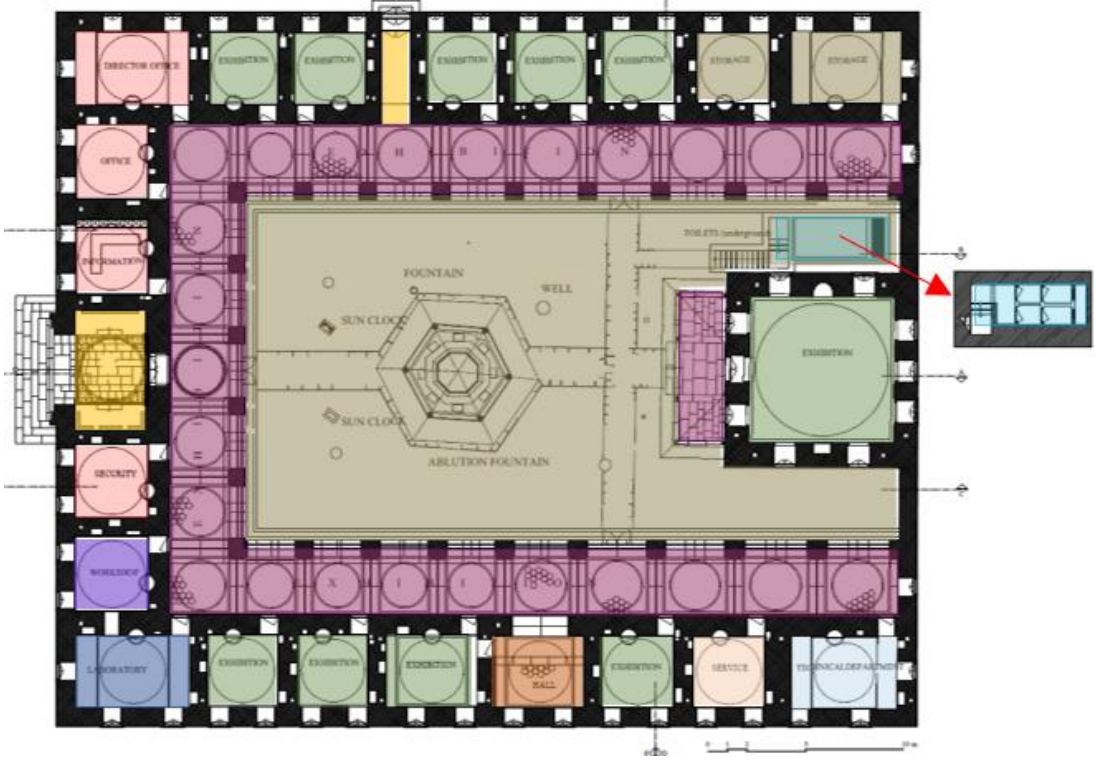
Figure 3.10. New uses of spaces in approved restoration plan and original architectural elements in the courtyard, by Halil Onur (Archive of Istanbul Ist. RDF)

ablution fountain, a well and two historical sun clocks were in the courtyard. (Figures 3.10. and 3.11.).

The decisions of the Istanbul I. Regional Conservation Council played important role on the reuse implementations history of the medrese. In 1986-1989, DGF demanded to install a hot-water heating system to protect the sensitive objects in museum and wanted to build a heating center in the courtyard, in a symmetrical position to the existing toilets (Council IV archive document 1, 2). Council I Decision 1989/1367 had rejected the proposed heating system and decided an air conditioning project to be prepared compatible with the museum function. The council also decided to return back to the original revak features, however there were no project or proposal about it. 18 years later, with the Council IV Decision 2007/1630, except for interior design projet, all the measured drawings, restitution and restoration projects with details renewing the frameworks were approved. Museum Exhibition Plan (Figure 3.10.) had been approved with the Council IV Decision 2009/3005.

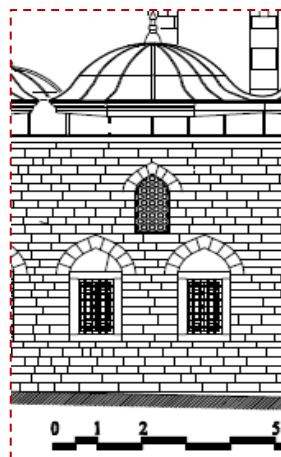
Figure 3.12. Typical room window order of the Beyazıt Medrese (detail from Figure 3.8.)

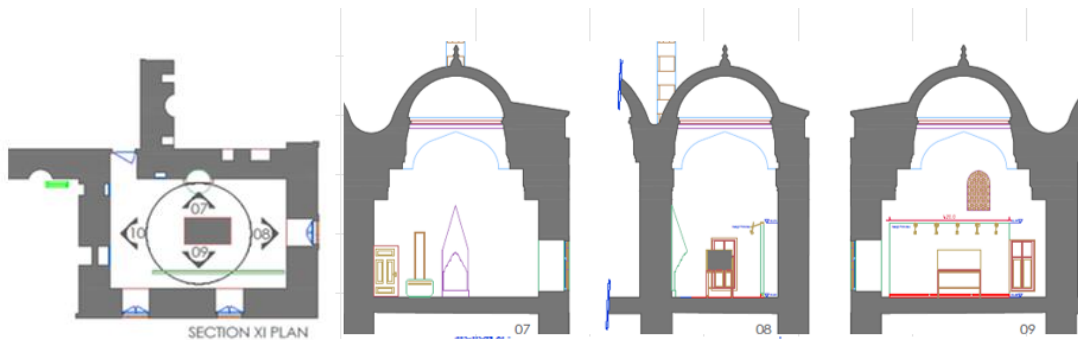
Figure 3.17. Plan and sections according to the Interior Design Project by Paralel 41 Architecture (Archive of Istanbul Ist. RDF)

During restoration implementation phase, some revisions were requested on museum interior design project in the Council IV Decision 2011/4312. According to the decision 2011/4312, exhibition panel proposals were revised as movable units made of transparent glass with wooden base, with respect to the character of the building. The decision 2011/4312 had also asked for some revisions on reuse of spaces. It was advised to place security office and entrance control inside the building and to use the eivan as a cold drink buffet instead of cafeteria. Finally, applied interior design project was approved with the Council IV Decision 2011/4396 (Figures 3.16 -3.19).

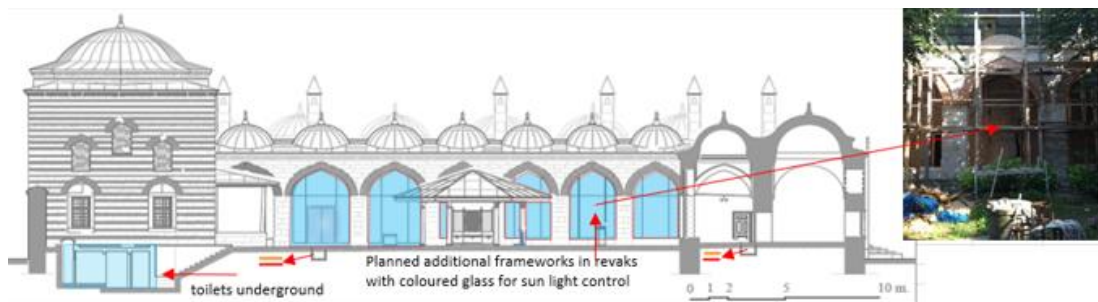
Figure 3.19. Section B-B of the Restoration Project by Halil Onur, (Archive of DGF)

The classroom was used for relics works exhibition, rooms and revaks for calligraphic art crafts. 2 rooms were used as seminar rooms for visitors. 3 rooms at the south end of the building and the revaks in front of them, as well as the 2 rooms at the left and right sides of the entrance eivan were reserved for administrative and office uses. 3 rooms at the west corner and the revaks in front of them were used as secondary services and workshops. Eivan was used as cold drink buffet. All the revaks were used for both circulation and exhibition of the stone works. The frameworks closing the revaks were kept by renewal to get a comfortable circulation between the museum sections (Figures 3.16., 3.17. and 3.18.). Fritt texture was applied on the glass on the renewed framework for better sunlight control. The window shutters of all sections were also kept closed for sun light control and 2.30m height exhibition panels placed in front of the windows (Figure 3.18.). Revak parts used for different purposes such as –administrative meetings and workshop- were also separated with frameworks from the circulation area. Despite all these, to reach the relics works section located at the classroom, it was necessary to go outside. The circulation scheme forced to enter inside to reach the other exhibition section (Figure 3.16). Existing wc unit for staff, which was located underground at the south end of the courtyard, was rehabilitated (Figures 3.16. and 3.19.).

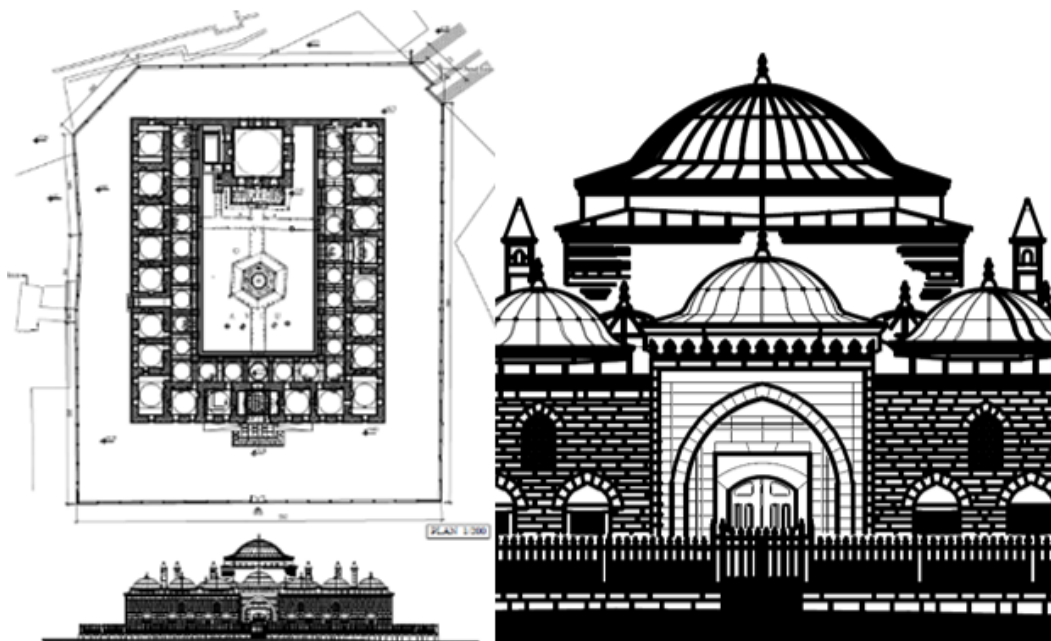
Figure 3.22. Reconstruction Project for the garden walls of Beyazıt Medrese by Halil Onur (archive of Yılmaz Yapı)

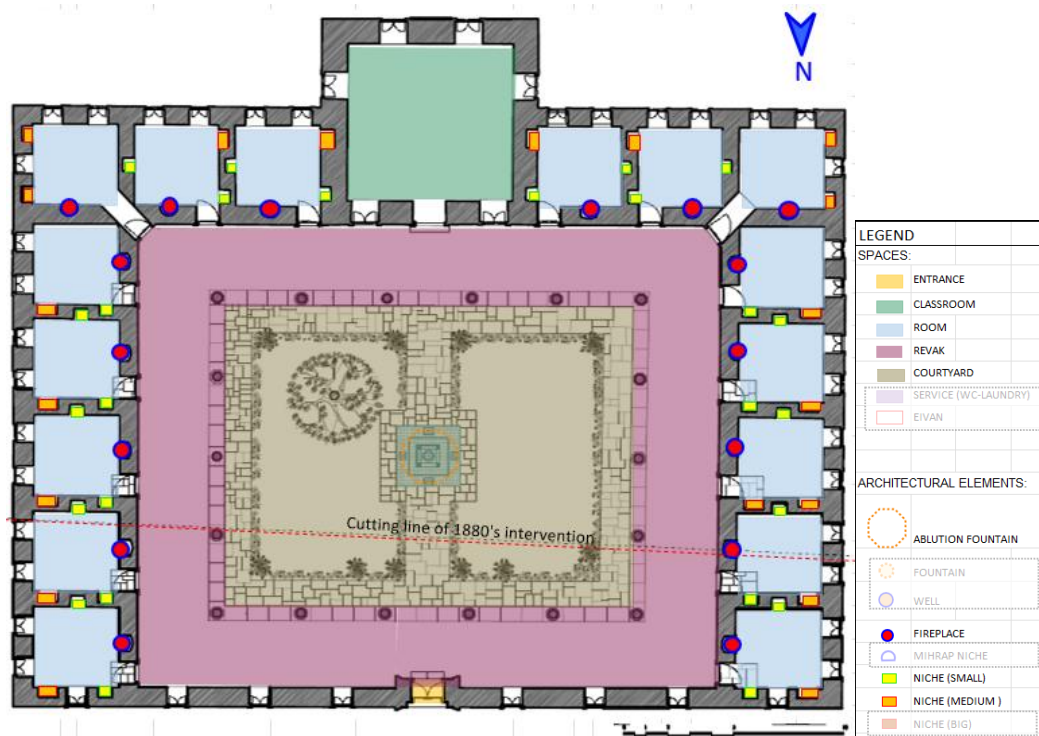
Figure 3.26. Original plan of Atik Ali Paşa Medrese, between 16th-19 th century. (1st period restitution plan by ArtLite Architecture, 2012)

**Layout:** Atik Ali Paşa Medrese was a rectangular one-storey building with a courtyard in original. The revaks surrounded the courtyard from four sides and behind revaks 16 rooms in U plan scheme and a classroom in the middle of U in original (Figure 3.26.). Entrance and classroom were in the middle of the facades and on the same axis. According to restitution report prepared by Artlite Mimarlık in 2012, the original wc and laundry place were in the backyard of the medrese. In the layout, the medrese kept its original dimension only on the north façade. This façade was 37.20m in width from outside.

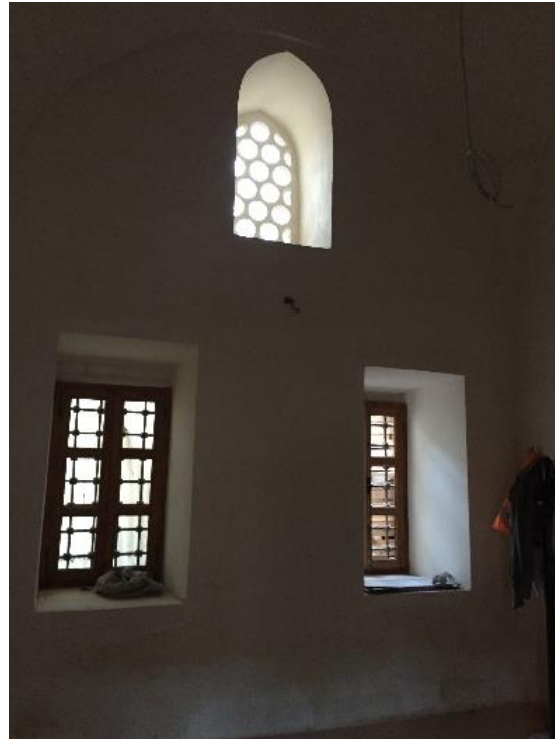
Figure 3.30. Ground floor rooms window order, 2015

**The Rooms:** All the rooms were about 3.70x3.70m. (Approved Restitution Project of Artlite Architecture, 2012) Each of them had three windows facing through outside, two were lower, one was upper. Corner rooms had extra two windows, one was at

lower and one was at upper (Figure 3.30.). Each room had a fireplace and niches in different sizes (Figure 3.31.). The rooms covered with domes.

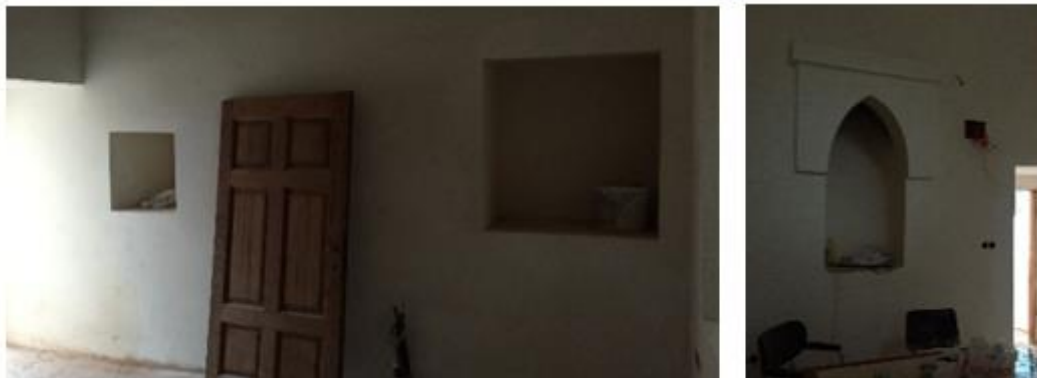
Figure 3.31. Original ground floor rooms' niches, and original fireplace, 2015

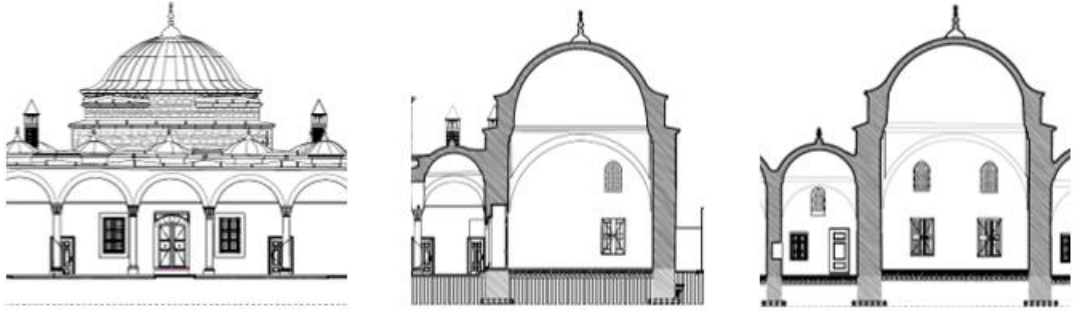
Figure 3.32. Original classroom – revaks relation (from Restitution Project drawn by ArtLite Architecture in 2012)

**The Classroom:** According to approved restitution project drawn by Artlite Architecture in 2012, the classroom was 7.33x7.36m. It is 30 cm higher than the revaks, so there is two steps in front. It has six lower windows, two of them open through revaks and four upper windows on backyard (Figure 3.32.).

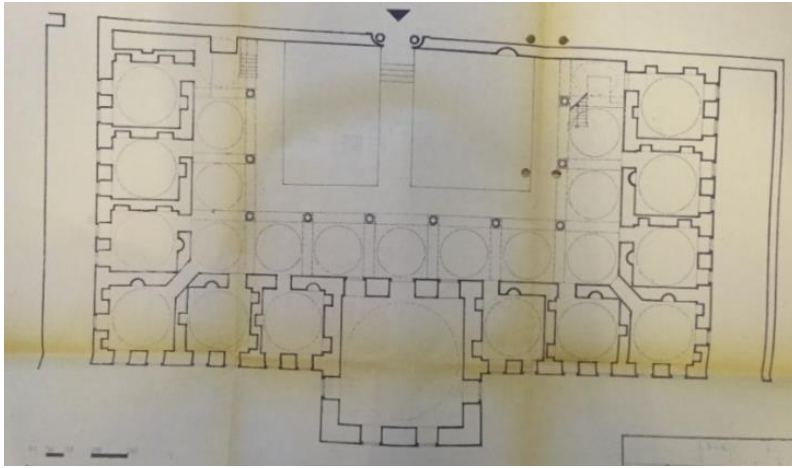
Figure 3.33. Measured Drawing of Atik Ali Paşa Medrese, 1975 (archive of DGF)

The medrese had some repairs, rehabilitations and changes between 1918-2013 by the owner institution. Between 1951-1953, lead covers of domes and plasters were repaired. (DGF document-1) In the photo showing the situation in 1975 and according to archive documents, the medrese was unused, there was no decoration inside, it was needed to get its measured drawings and the drawings were done in 1975 (DGF document-2, 3) (Figure 3.33.) but the electric installations had been done formerly (Figure 3.34.). Moreover, a window had been altered to a door to reach backyard in an unknown date (Figure 3.38.).

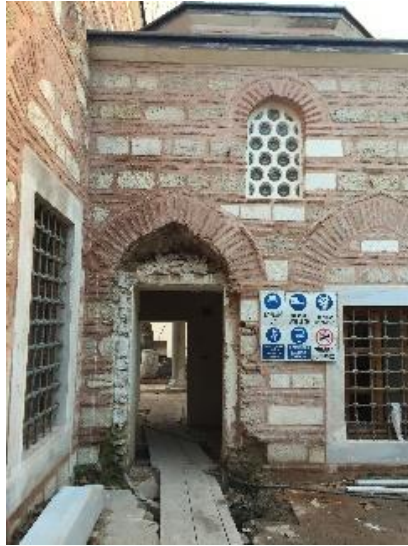
Figure 3.38. Window alteration in the room next to the classroom after 1975 interventions in unknown date, 2015

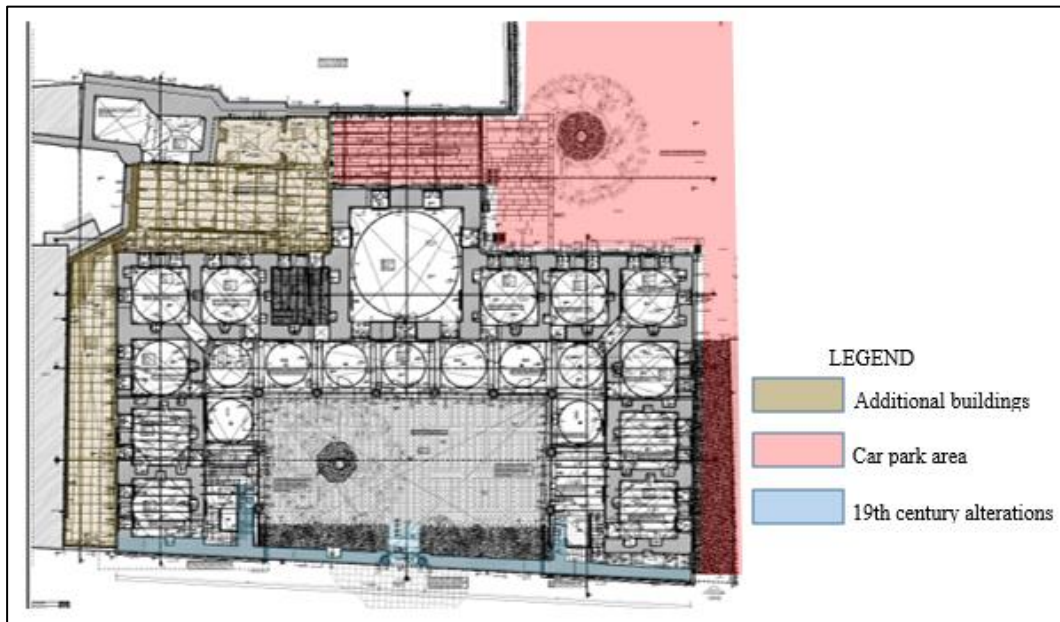
Figure 3.41. Ottoman alterations and unqualified additional spaces applied on measured drawing of Atik Ali Paşa Medrese by ArtLite Architecture, 2013.

After 1975 ground floor revaks were closed with framework to get extra space (Figure 3.27. and 3.40.), kitchen and users/staff restaurant had been added to the backyard. Backyard is also begun to be used as car park area (Figure 3.41.).

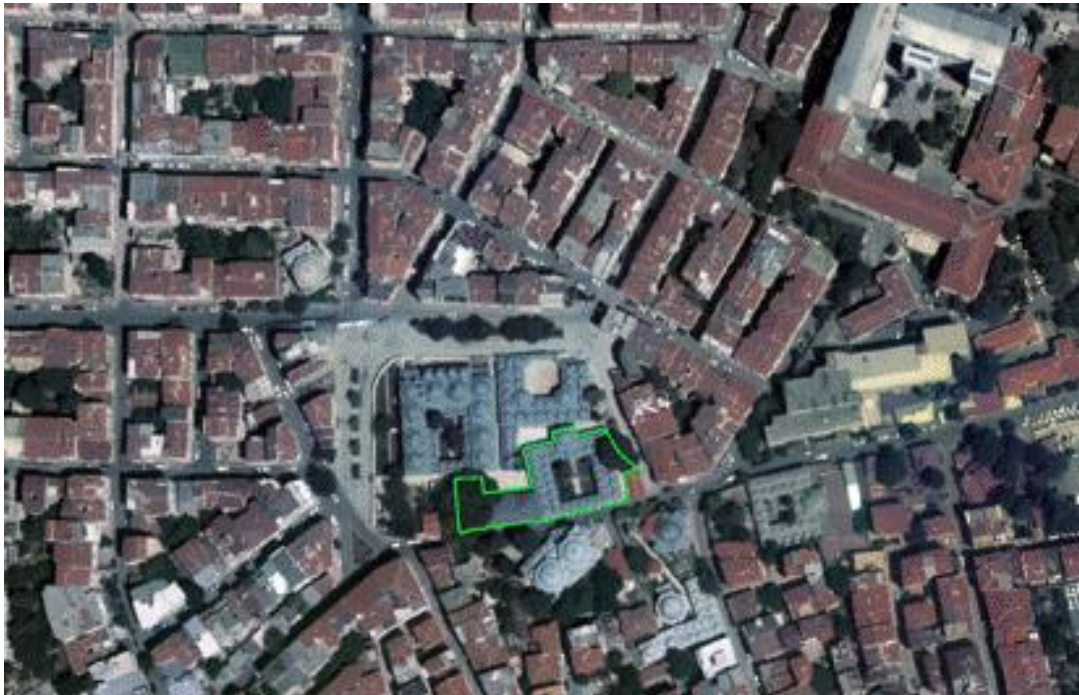
Figure 3.57. Haseki Medrese with its lot in aerial photo 2013 (IMM)

The medrese was a self-standing building opening through Haseki Street. It was in connection with other buildings of the complex, except the mosque, connecting by a secondary entrance (Figures 3.49-3.52.). It shared the lot with the primary school (Figure 3.57.). Opposite the medrese, on the other side of the Haseki Street, was the Haseki Sultan Mosque (Figures 3.57. and 3.58.).

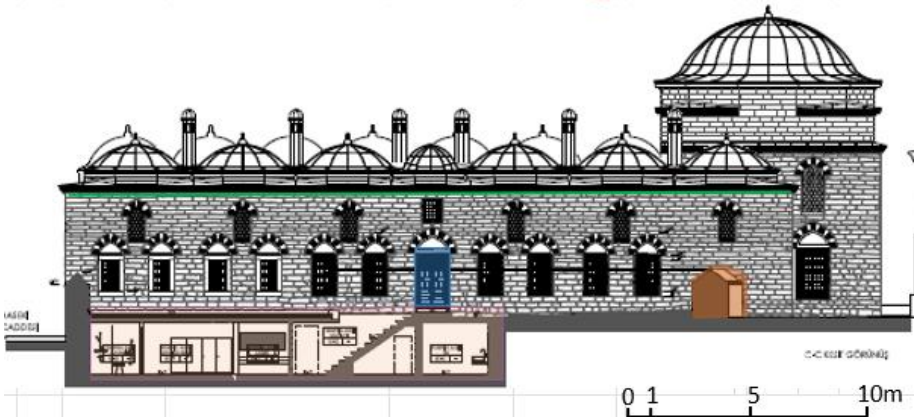
Figure 3.60. Section C-C showing the staffroom underground of the backyard and the additional garden wall, 2012 (archive of DGF)

the existing timber house which is next to the primary school was the administration unit. Staff rooms and service spaces were designed at the place of previous additional service space in East backyard of the medrese (Figures 3.58.-3.60.). The Haseki Street between the mosque and the rest of the complex was pedestrianized (Figure 3.58.).

The rooms were squared and approximately 10m<sup>2</sup>. Each had a small wooden künde-kari door, opening through revak. Rooms had two bottom windows and a top window on outer façade (Figures 3.60. and 3.47.). Each room had a fireplace and rectangular niches in different sizes (Figures 3.67. and 3.68.). Corner rooms, except for northeast one, had extra windows looking through two facades. The window orders of the two rooms that facing through the primary school were different (Figure 3.69.). There were also two small spaces above the west and east corridors with small rectangular windows (Figures 3.60. and 3.70.). It was reached these rooms through small rectangular openings in ceilings of the corridors with a portable ladder.

**The Classroom:** The classroom was 45,5 m<sup>2</sup>. It is 33 cm high from the revaks level (Figures 3.59., 3.70. and 3.71.). The classroom had six rectangular bottom windows, two of which look through revaks, and four arched top windows (Figures 3.59., 3.60., 3.70. and 3.72.). There were also two niches with künde-kari covers as big as the bottom windows but no mihrap niche inside.

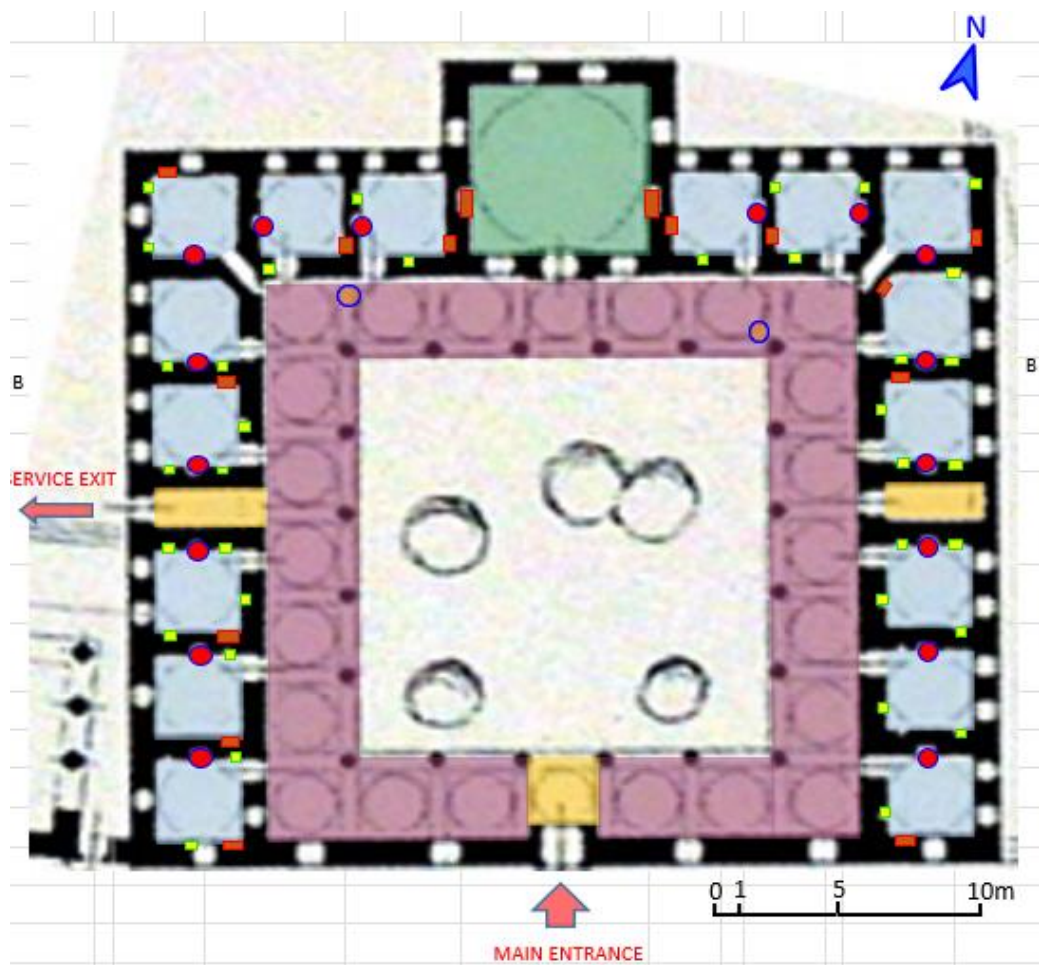
Figure 3.63. Original Plan of Medrese (Ülgen 1962)

Haseki medrese had a self-standing squared and symmetrical layout. It is a U plan type medrese. There was a courtyard in the center and a revak surrounding the courtyard from four sides. 16 rooms surround the revaks from three sides and a classroom in the middle of the symmetry axis (Figure 3.63.). This layout seemed like original Atik Ali Paşa Medrese. Main entrance was in the middle of South revaks and opened through

**Courtyard and Revaks:** The landscaped courtyard was 16x16m. There was no şadırvan, that is ablution fountain, in the courtyard but two wells in revaks (Figures 3.63., 3.65. and 3.66.). Width of the revak was 3.35m in average (in range of 3.31 and 3.41 m).

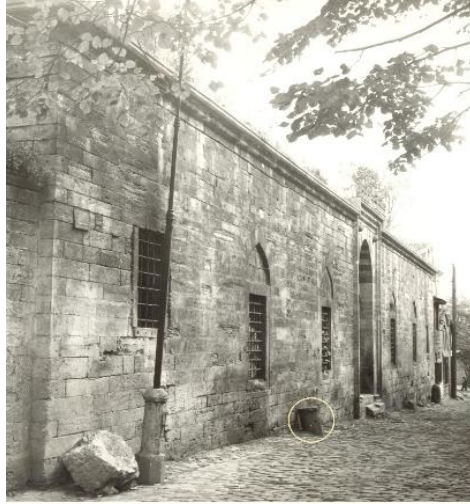
Figure 3.64. Entrance facade on Haseki Street, 1960's (archive of DGF)

the Haseki Street (Figures 3.49., 3.53. and 3.64.). The entrance was on the symmetry axis and opposite the classroom. Different from Atik Ali Paşa Medrese, there were two symmetrically located small corridors on East and West wings (Measured Drawing, DF Mimarlık, 2006). The small corridor on West side connected the medrese to imaret, hospital and primary school, and the east corridor was a narrow niche. (Doğan, S. 1997) (Figure 3.63.). In 1960's, the East corridor was opened through the east garden for additional underground service spaces (Figure 3.73.). Original toilets and laundry were at out of medrese in backyard where imaret side (Kütükoğlu 2000, p.290).

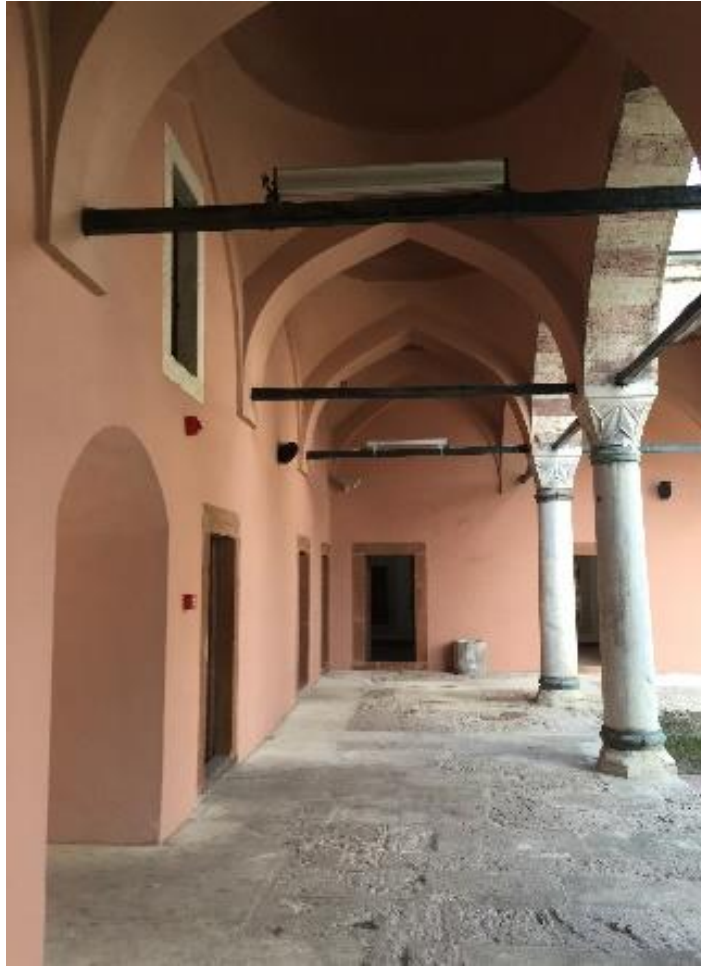
Figure 3.65. Revaks; secondary entrance and room entrances, 2015

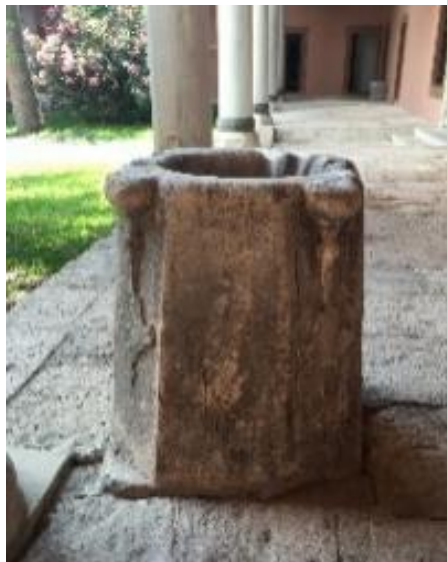
Figure 3.66. Stone made well ring, 2015

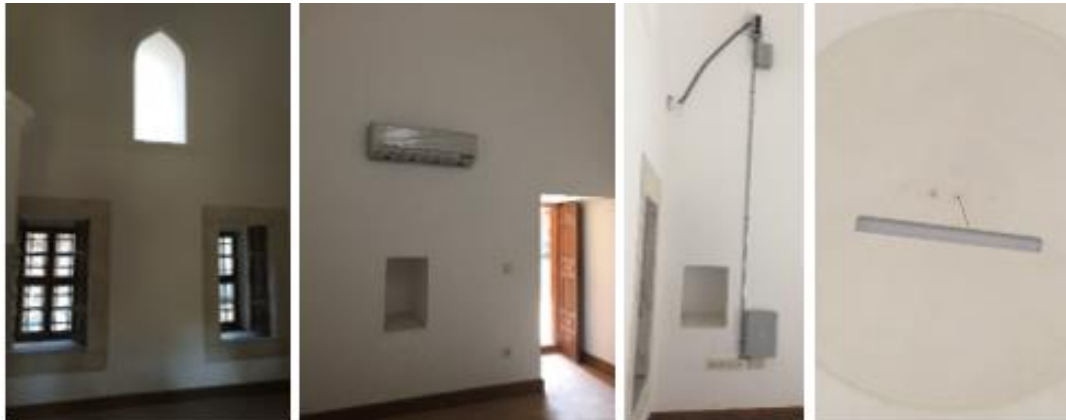
Figure 3.67. Typical room; its architectural elements and installations, 2015.
