EVALUATING THE IMPACTS OF REFUNCTIONING ON OTTOMAN  
MEDRESES IN ISTANBUL

A THESIS SUBMITTED TO  
THE GRADUATE SCHOOL OF NATURAL AND APPLIED SCIENCES  
OF  
MIDDLE EAST TECHNICAL UNIVERSITY

IN PARTIAL FULFILLMENT OF THE REQUIREMENTS  
FOR  
THE DEGREE OF MASTER OF SCIENCE  
IN  
CONSERVATION OF CULTURAL HERITAGE IN ARCHITECTURE

SEPTEMBER 2023

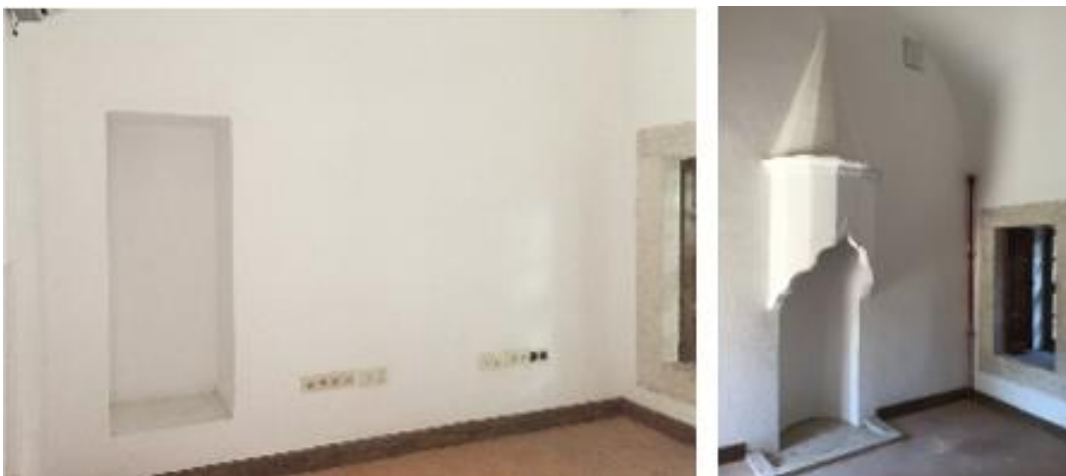
Figure 3.68. Typical room; its architectural elements and installations, 2015.

The rooms were squared and approximately 10m<sup>2</sup>. Each had a small wooden künde-kari door, opening through revak. Rooms had two bottom windows and a top window on outer façade (Figures 3.60. and 3.47.). Each room had a fireplace and rectangular niches in different sizes (Figures 3.67. and 3.68.). Corner rooms, except for northeast one, had extra windows looking through two facades. The window orders of the two rooms that facing through the primary school were different (Figure 3.69.). There were also two small spaces above the west and east corridors with small rectangular windows (Figures 3.60. and 3.70.). It was reached these rooms through small rectangular openings in ceilings of the corridors with a portable ladder.

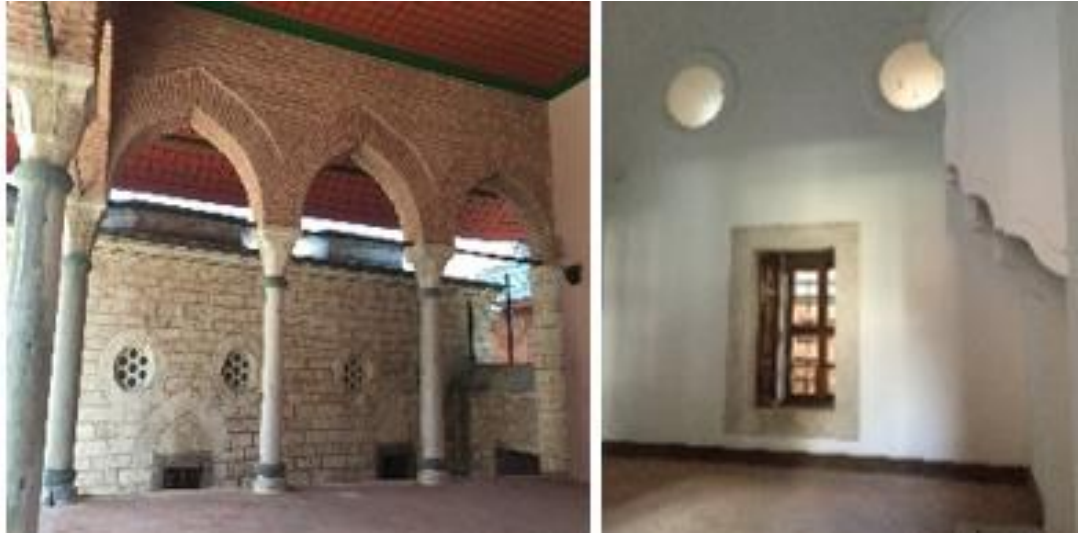
Figure 3.69. South-west room's windows from west (from outside) and inside, 2015

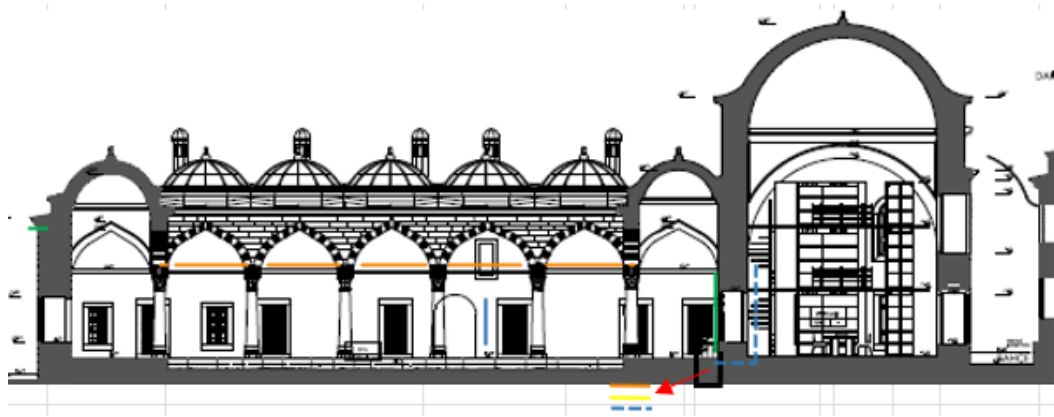
Figure 3.70. Section D-D (archive of DGF)

**The Classroom:** The classroom was 45,5 m<sup>2</sup>. It is 33 cm high from the revaks level (Figures 3.59., 3.70. and 3.71.). The classroom had six rectangular bottom windows, two of which look through revaks, and four arched top windows (Figures 3.59., 3.60., 3.70. and 3.72.). There were also two niches with künde-kari covers as big as the bottom windows but no mihrap niche inside.

corridor was altered for a new service door needed by the hotel function (Figures 3.73. and 3.70.).

Electric and fire alarm systems in all spaces, and air conditioning system cables in rooms were hidden under plaster. Heating system (wrf) in classroom and fire suppression system (argon gas) in all spaces were underground. Heating center for the whole complex was located in the hospital building, Argon gas tank was in the backyard at North side of the classroom (Figure 3.59.). The installation channel was dug surrounding the revaks for lying down the cables and the garden walls on East boundary was constructed (Figures 3.59. and 3.70.).

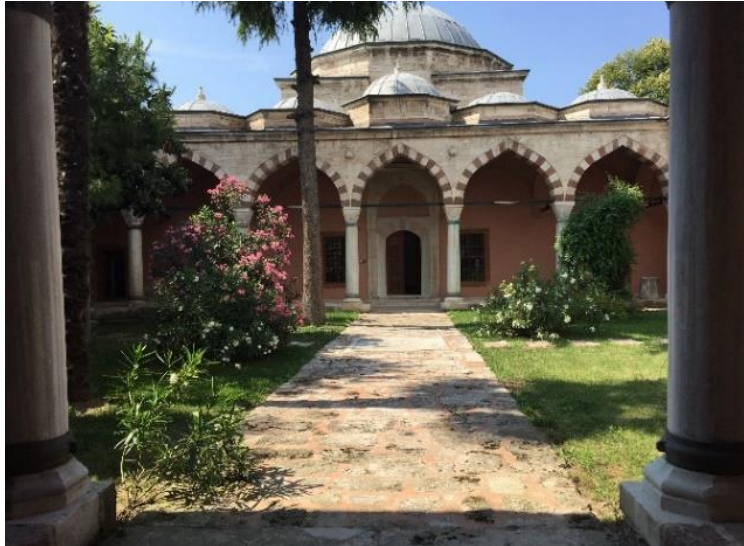
Figure 3.71. Courtyard, revaks and the classroom, 2015

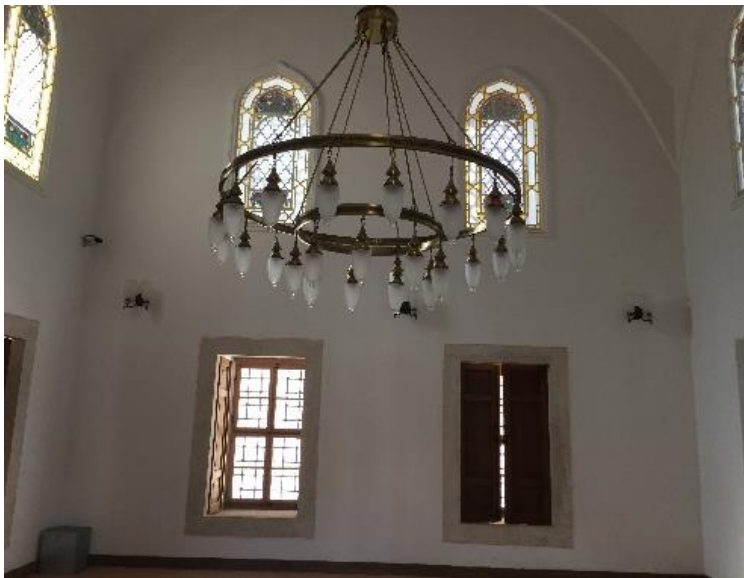
Figure 3.72. Classroom (library); architectural elements and installations. 2015

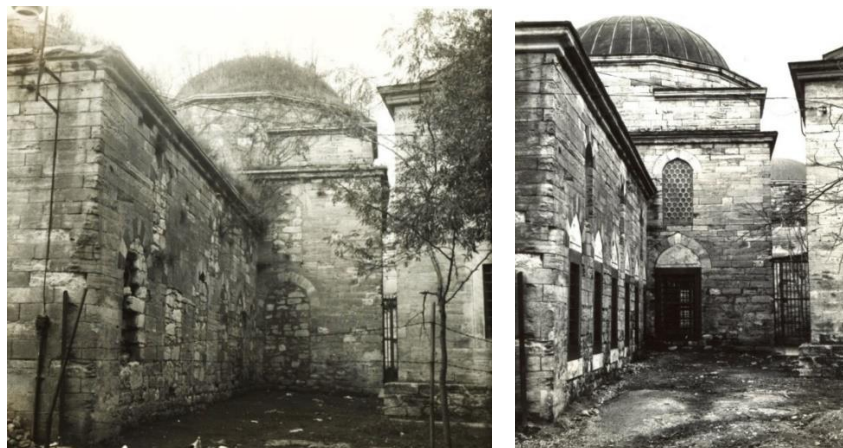
Figure 3.74. North facade before and after 1960's restoration (archive of DGF)

All the plasters were renewed with cement-based plasters, all the frameworks were reproduced as in original and all the lead covers of domes were recovered (DGF document-4) (Figure 3.74.). Electric installations according to project where in the archive of DGF prepared in 1961, mechanical projects for radiator system with hot water in 1967 and sanitary installation project drawn in 1969 were loaded all the rooms and the classroom for new hotel use. However, as the residents complained and rejected the new use in the district, the building could not be used as hotel.

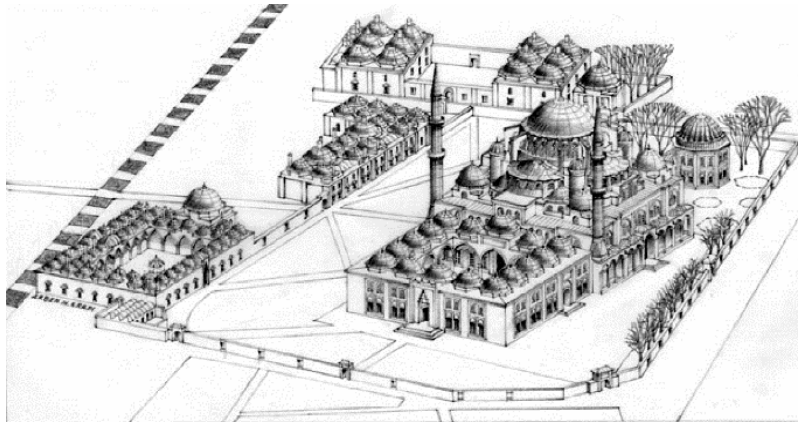
Figure 3.76. Axonometric drawing of the complex from restitution report by Anit Architecture (archive of DGF)

The most important building of the complex was the Şehzade Mehmet Mosque. It was in a great garden at the hub of the complex. Plan type and scale of the mosque, decorations of both the mosque and tomb with coloured stones and tiles were the most expressive features of the complex (Figure 3.76.).

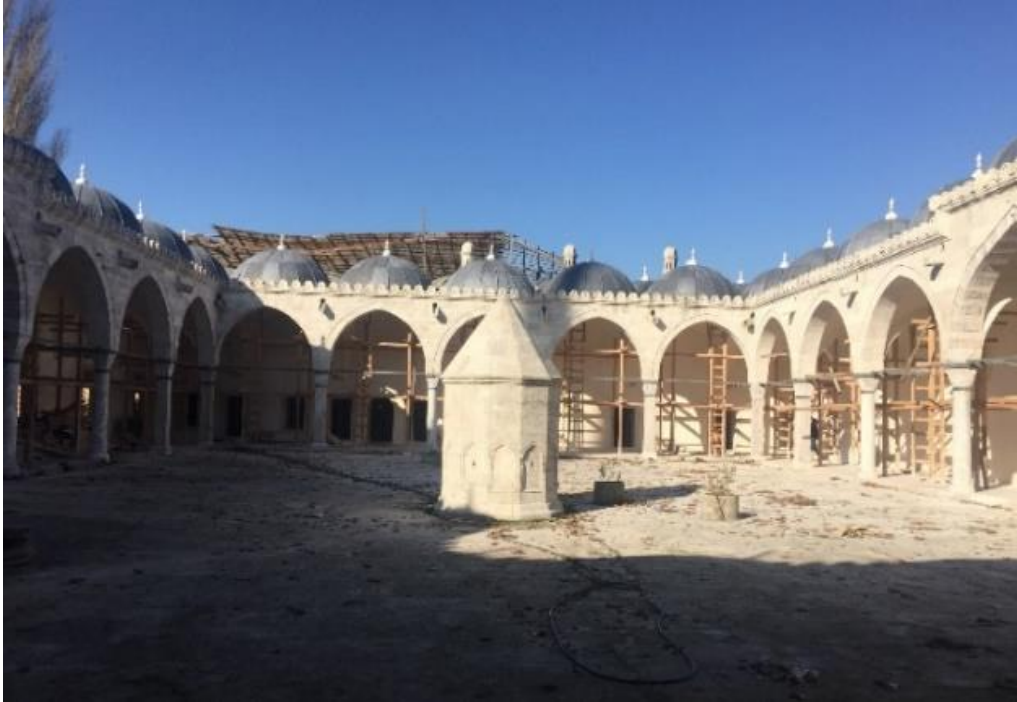
Figure 3.84. Courtyard through South and the ablution fountain, 2015

**The Courtyard, Revaks and The Entrance Portal:** The courtyard was 31.13x19.95m. and surrounded with revaks from four side. In the courtyard, there was an ablution fountain in the middle and a well in south east part, in front of the entrance (Figures 3.84.-3.87. and 3.102.). Width of the revaks in short wings; north west and south east, was 4.10m, and in long wings; north east and south west, was 3.40m.

The medrese was made from fine cut stone. Revaks located in main entrance, revaks in front of eivan and the classroom were exposed with their height. They had also porphire columns (Figures 3.84., 3.86., 3.94 and 3.95.). Revak arches were made from alternate-coloured stones and the façade finish was decorated with engraved stone. Rooms' facades behind revak side, inner spaces and toilets were plastered. Courtyard floor was paved with cut stone, revaks and other spaces were paved with hexagonal brick. All the roofs were covered with lead sheeted domes.

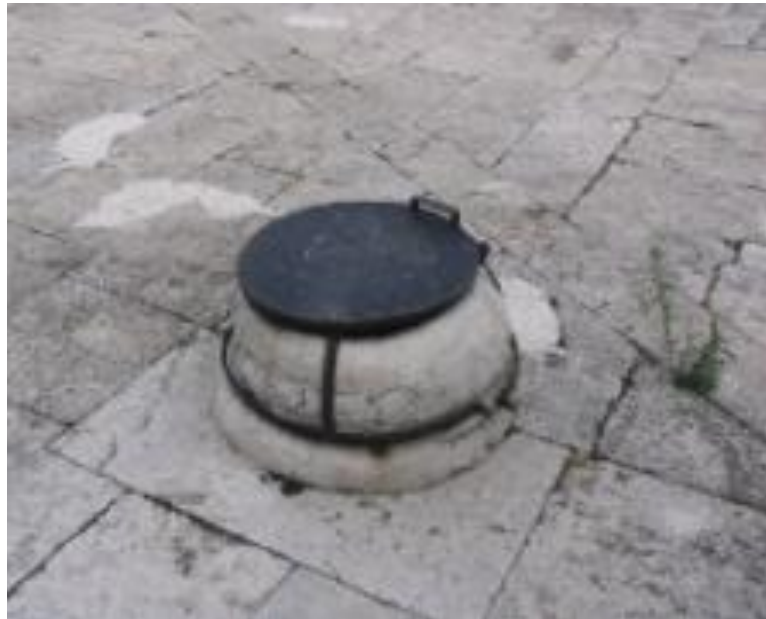
Figure 3.85. Well, 2015

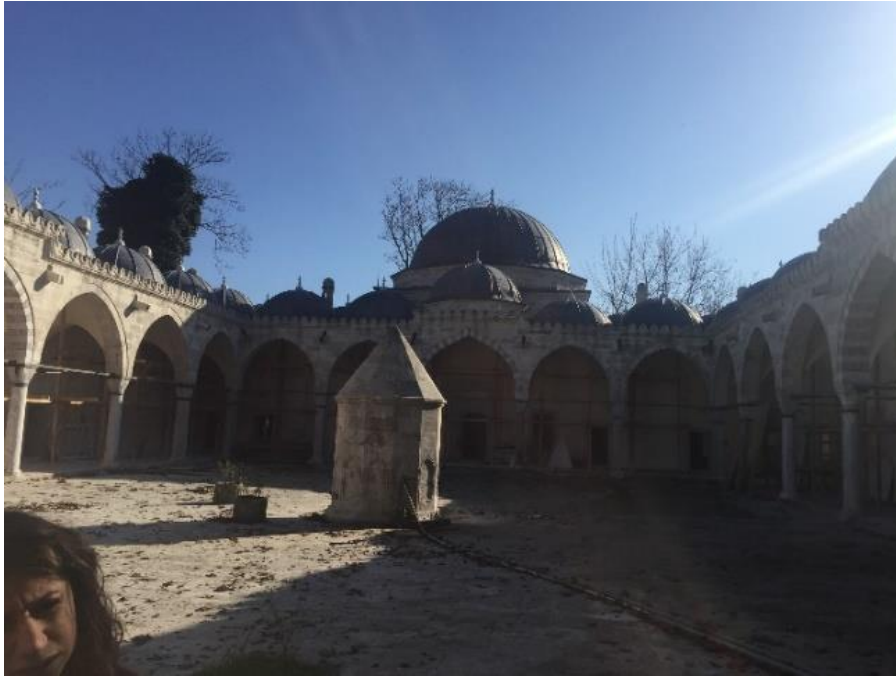
Figure 3.86. Courtyard through North side, 2015

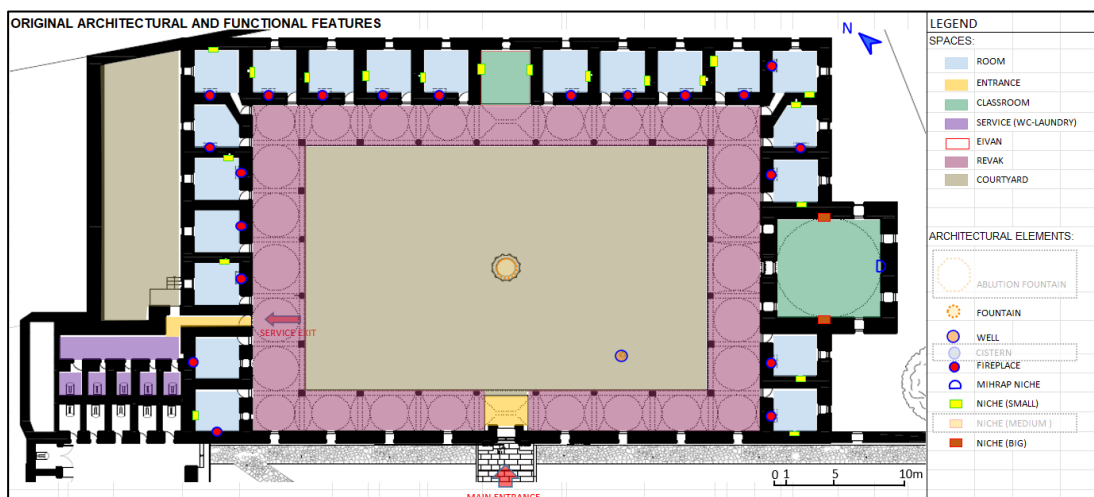
Figure 3.87. Restitution Plan of Shehzade Medrese. (Ant Architecture 2012)

Main entrance was a high and decorated portal located in the middle of south west façade, facing through the mosque side. On this façade there were no rooms, but windows in revaks looking through the outer garden of the mosque (Figure 3.87.).

sqm of each. However, the corner rooms and the rooms next to them with diagonal entrances were smaller, about 13.4sqm. Rooms had two windows facing through backyard, one at bottom, one at upper with stucco frame and (Figure 3.88.). Only the room where in east corner has four windows on two facades. Each room had only one small niche (Figures 3.87. and 3.89.). Each room also had a fireplace (Figure 3.89.).

**The Classroom and the Eivan:** Opposite the main entrance of the Şehzade Medrese, there was an eivan in the middle of north east façade. The eivan was 4.12x4.46m in layout. It was 18sqm and 0.5m high from revak level and had the same window order with rooms. Differently, it had two small niches (Figures 3.87. and 3.90.).

The classroom was in in the middle of south east façade, between the rooms (Figure 3.87.). The dimensions of the classroom were 8.22x8.22m. It was approximately 66.25sqm and 0.39m high from the revak level. Revak level continued inside the classroom 1.5m as shoe place (pabuçluk) and then there was a seki on two steps height. Entrance of the classroom was decorated with coloured stones on revak façade and decorated with cut stone stalactites inside. The classroom had six bottom windows, two of them facing through courtyard and four upper windows decorated with stucco frame and vitray (Figure 3.87.). The classroom had a mihrap niche decorated with stalactites.

**Toilets:** On the north west façade there was a narrow and vaulted corridor connecting the toilets and backyard to the medrese. Toilets were in original position and original layout at the west corner of the medrese with five cabins (Figures 3.87. and 3.91.). It was designed together with the mosque's toilets and shared a common water depot

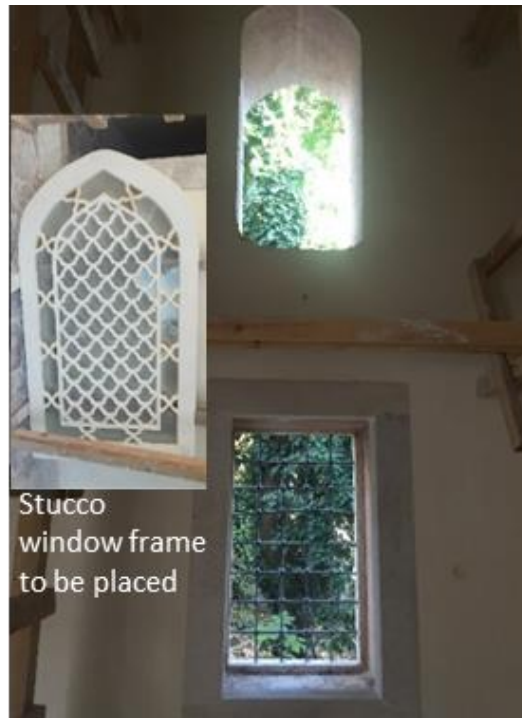
Figure 3.88. Original room window order, 2015

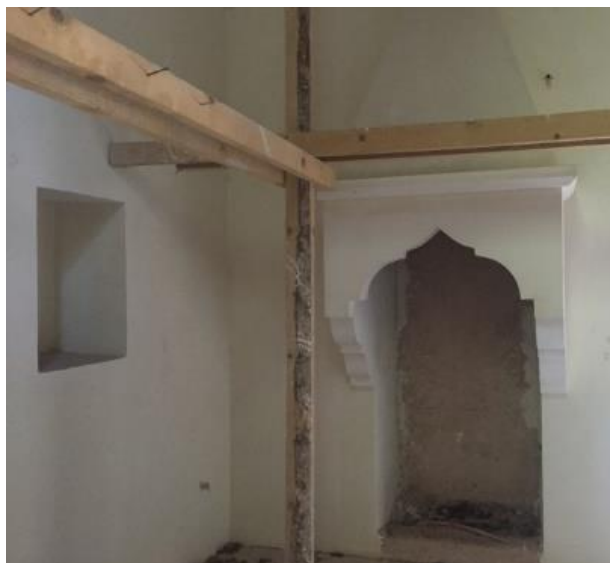
Figure 3.89. Fireplace in rooms, 2015

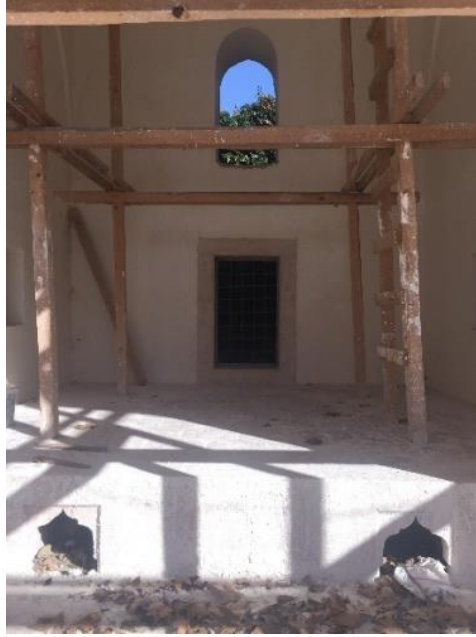
Figure 3.90. Eivan in Şehzade Medrese, 2015

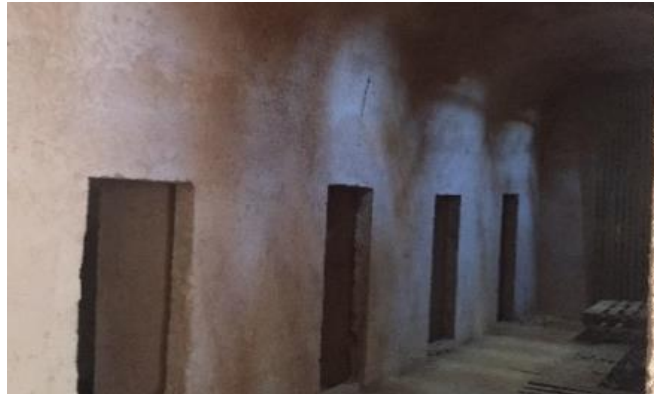
Figure 3.91. Original toilets, 2015

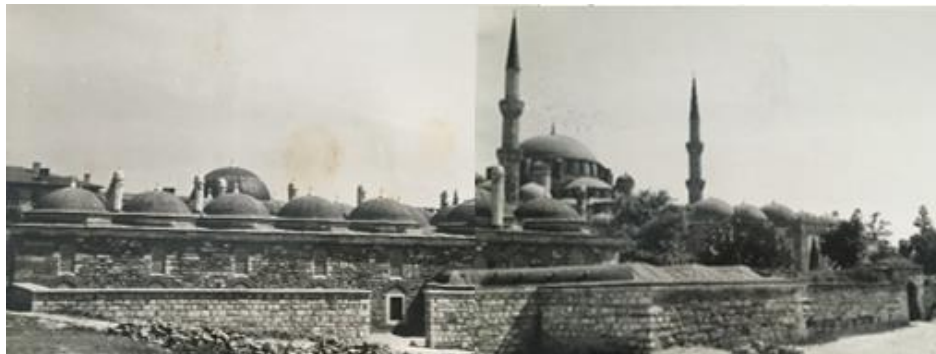
Figure 3.92. Şehzade Medrese and the Mosque from North-West, 1959 ( archive of DGF)

(Figures 3.87., 3.92. and 3.93.). In front of the toilets was a backyard (Figures 3.87. and 3.102.).

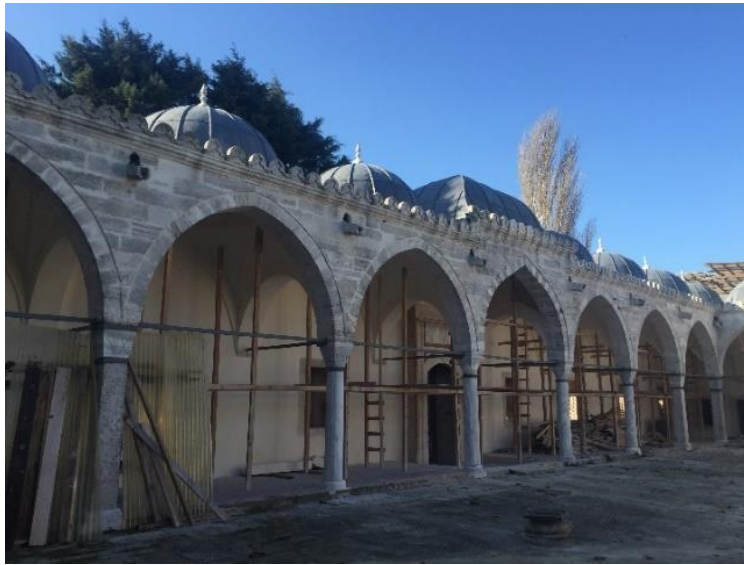
Figure 3.94. East revaks and main entrance, 2015

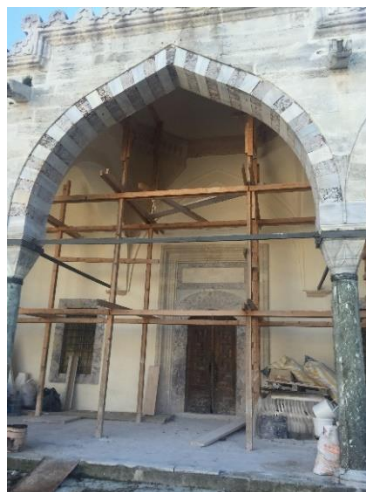
Figure 3.95. Classroom entrance, 2015

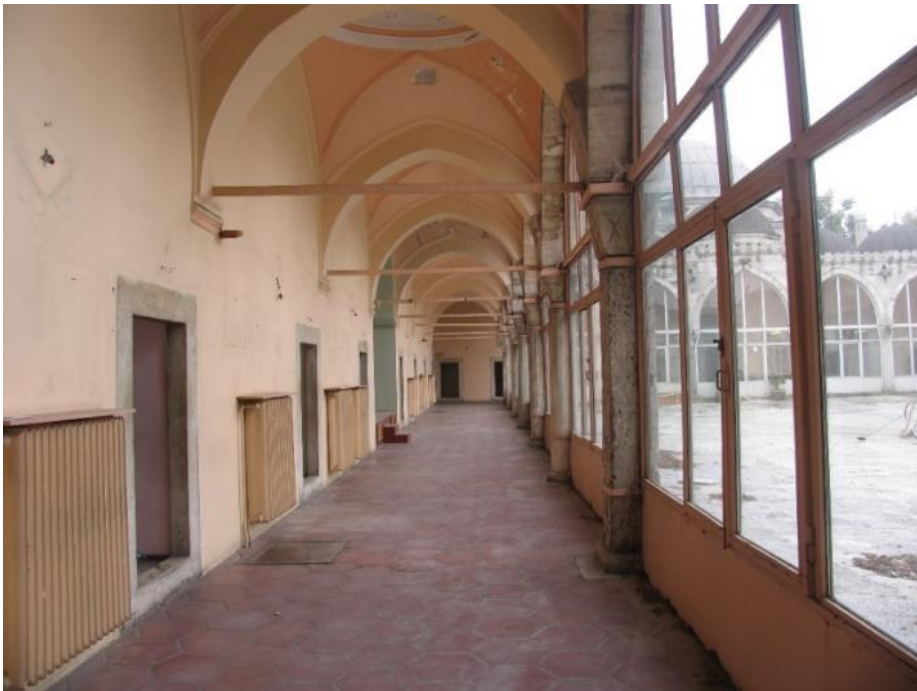
Figure 3.97. Metal framework addition and heating system intallation in 1960 closure of revaks of Şehzade Medrese (archive of DGF)

**Past Refunctioning Works and Interventions:** Şehzade Medrese had been repaired and rehabilitated numbers of times along its history. During the 16th and 17th centuries, the complex had been affected numbers of fires and has been repaired (Müller-Wiener 1977). In 19th century the medrese had also been repaired several times rather for sanitary systems and rehabilitating of lead covers (Kütükoğlu 2000). After a long-abandoned period, with the decision of High Council of Immovable Heritage and Monuments, Şehzade Medrese was decided to be rescued by DGF (decision date/number; 24 VII 1954/292 –archive of Cultural Heritage Council of Rehabilitation Zone I). As a result of this decision, in 1956 the domes were covered with cement finish (DGF document-7) and in 1960-1961 the revaks were closed with a reversible metal framework which made from iron (Figures 3.96. and 3.97.).

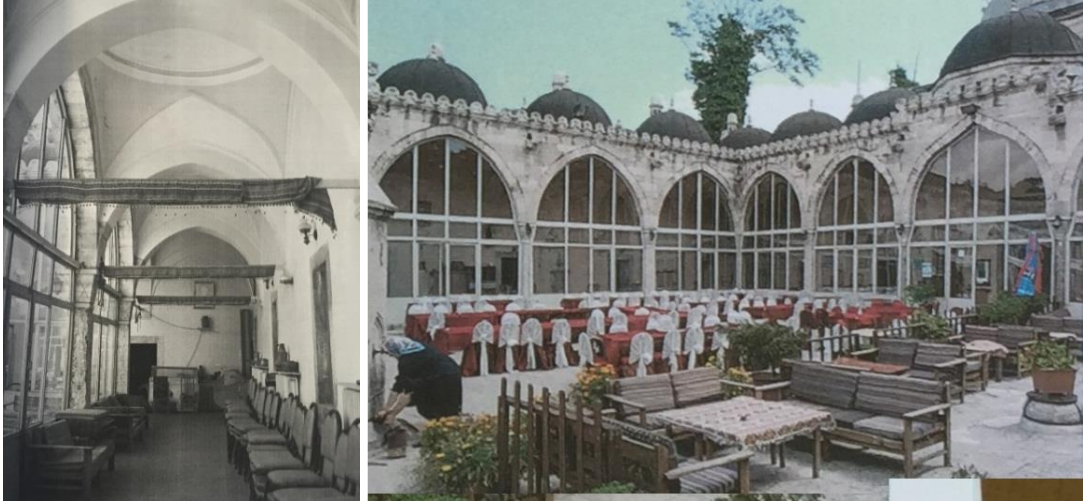
Figure 3.98. Revaks of Şehzade Medrese in 2009 (archive of DGF)

Figure 3.99. Courtyard of Şehzade Medrese in 2009 (archive of DGF)

In 1999, while the medrese was allocated to be used as dormitory (DGF document-6) the user made some unauthorized interventions while changing it into a restaurant (Figures 3.98. and 3.101.).

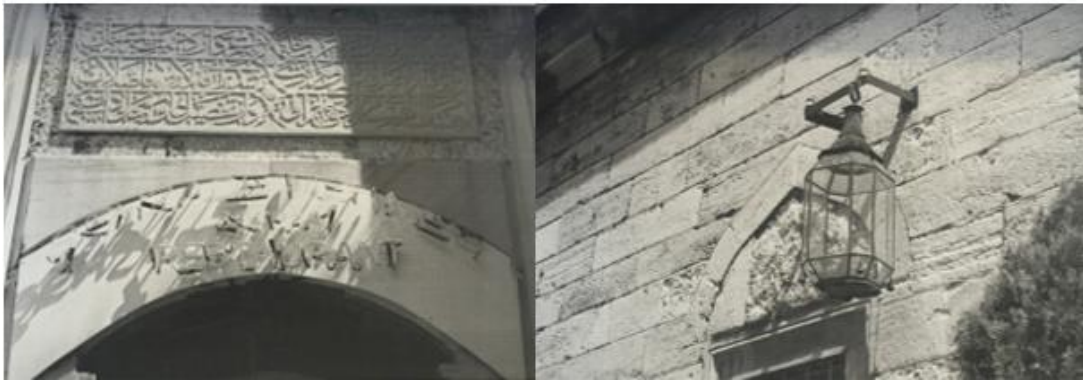
Figure 3.100. Interventions nailed to original masonry of Şehzade Medrese in 1990's (archive of DGF)

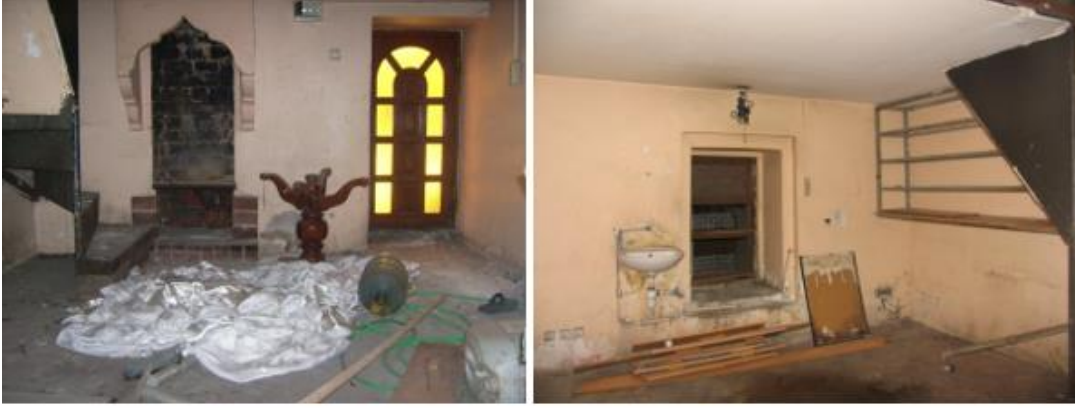
Figure 3.101. Floor addition in two rooms in the south corner of Şehzade Medrese in 1990's (archive of DGF)

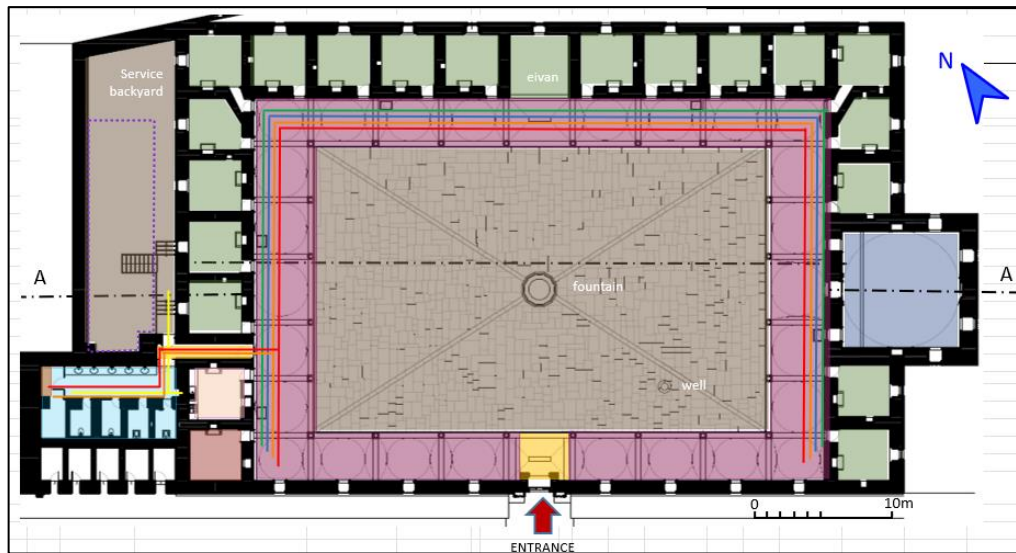
Figure 3.102. Plan of restoration Project (adapted from the approved restoration Project prepared by Anit Architecture), 2012

The last refunctioning interventions were made according to decision number 2012/468 of Ministry of Culture, Cultural Heritage Council of Rehabilitation Zone I. With the decision of the council, measured drawing and restoration projects were approved. In restoration project, reuse decisions of all spaces were also approved. According to the approved project, classroom would be used as seminar room, two rooms at west corner would be used as administrative office and kitchen. Rest of the rooms and eivan would be used as gallery (Figure 3.102.). The revaks and the courtyard would be used for circulation and temporary common activities.

An additional building including toilets for female users, heating center and water depot was built underground the service backyard at north side of the medrese (Figures 3.102. and 3.103.).

installed into existing channel of past interventions surrounding the revaks (Figure 3.102. and 3.104.).

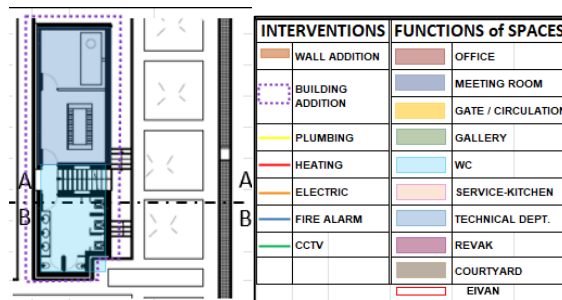
Figure 3.103. 3.90 Level Partial Plan of service backyard, restoration project, 2012 (Anit Architecture)

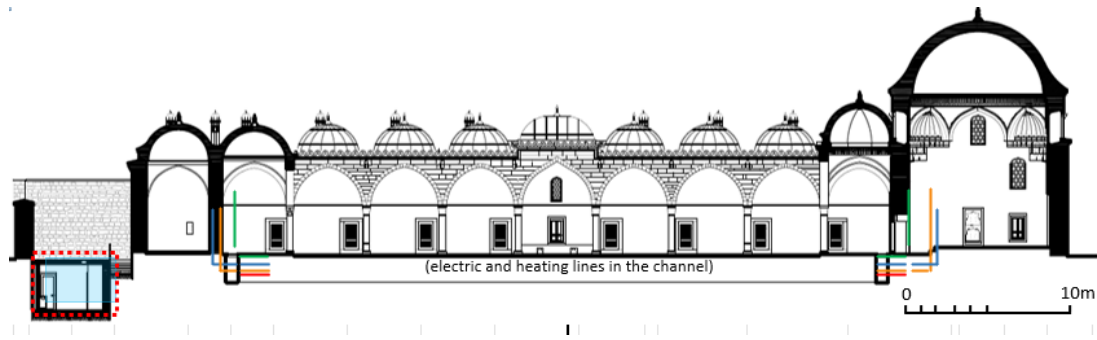
Figure 3.104. A-A Section of restoration project, 2012 (archive of Anıt Architecture)

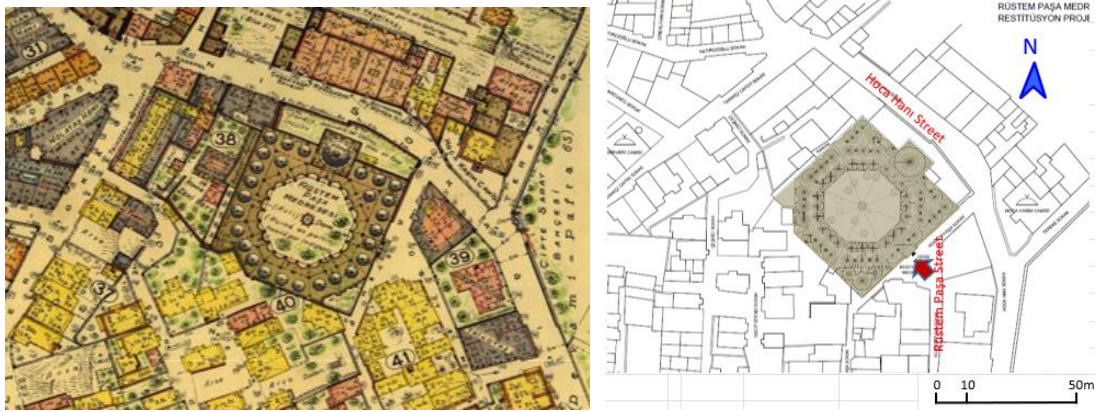
Figure 3.108. (left) Rüstem Paşa Medrese with its complex in Pervititch Maps, 1934

Figure 3.109. (right) Site Plan restitution, referring to 16th century situation, by UB Construction Limited Company, 2009 (Archive of DGF)

front of the entrance façade, there was small square used as a car park and a service area by the merchants around it (Figures 3.108. and 3.109.). Around the medrese was full of historic and contemporary khans used by merchants of drapery, textile, clothing and accessory dealers. Historic Istanbul High School, Istanbul Governorate, Iran Consulate, historic Grand Bazaar, Nur-u Osmaniye Complex, famous and historic shopping axis Mahmut Paşa Street and Mahmut Paşa Complex were important points that were close to the medrese. Major function of the region was commerce. General architectural and structural quality of surrounding was rather poor.

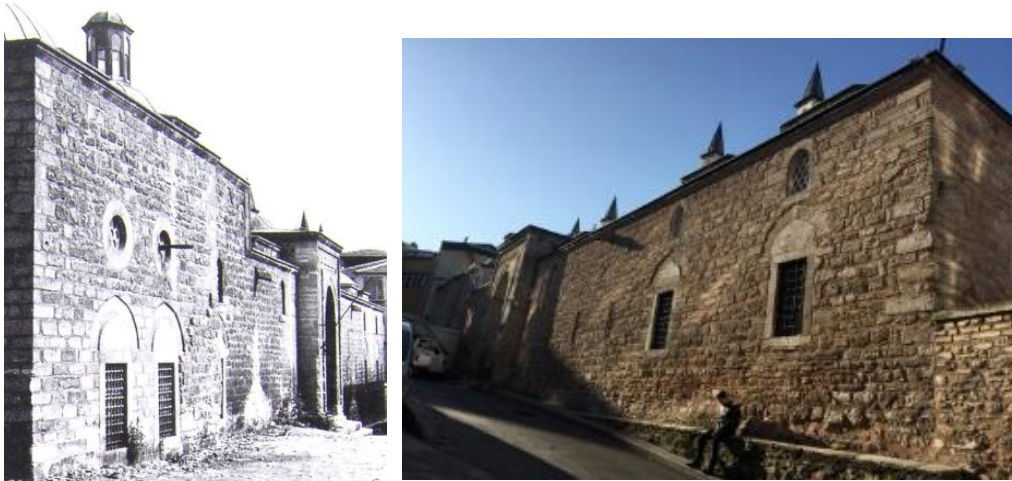
Figure 3.111. (left) Entrance facade (Wiener 1978)

Figure 3.112. (right) Entrance Facade from Rüstem Paşa Street, 2015

According to the approved restoration project by UB company in 2009, Rüstem Paşa Medrese was 42.86x42.76m from outside. The medrese and outer garden walls were made from cut stone with thick khorasan mortar (Figures 3.111. and 3.112.) and the spaces were covered with lead covered domes. Courtyard was paved with rubble stone, revaks and the entrance eivan were paved with cut stone (Figures 3.113.- 3.115.), the other eivans and the spaces were paved with hexagonal brick (Figures 3.116.- 3.118.). There was no information about the original pavement of the toilets.

**The Triangular Space:** According to Mübahat Kütükoğlu, the triangular space in south corner was probably a kitchen in original (Kütükoğlu 2000). It was covered with three domes; in the middle the bigger dome and on symmetric corners smaller ones were located. Smaller domes had barrel lights at the top as typical in imaret buildings or similar to tabhane buildings (Figure 3.111.). However, this space had no fireplace or niches. It had six bottom windows like other rooms and six top windows, four of those closer to the corner were round shaped (Figures 3.111., 3.123. and 3.129.).

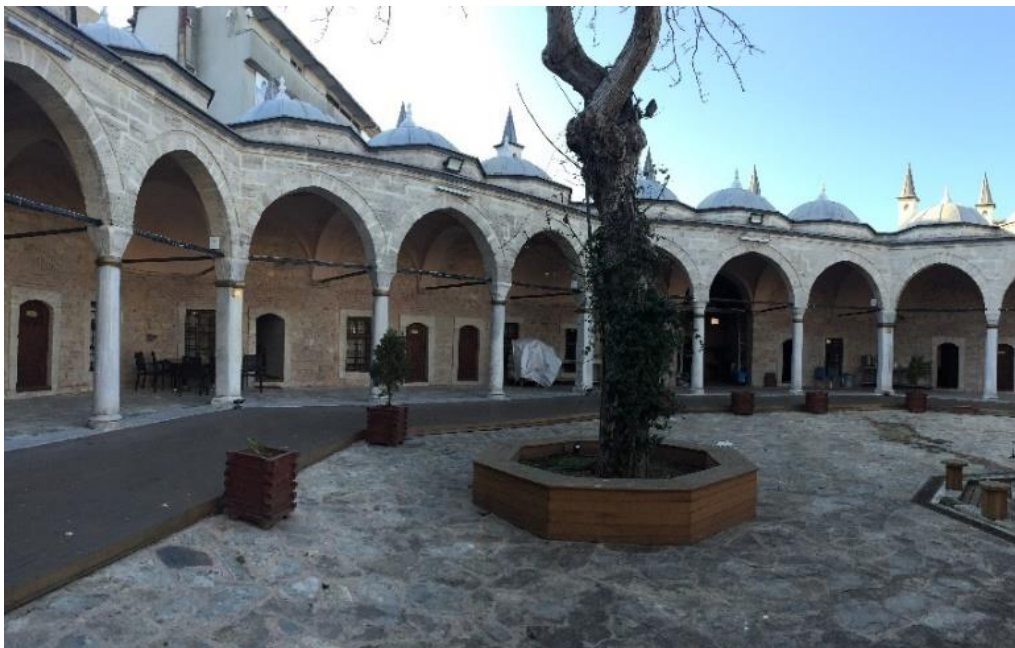
Figure 3.113. Courtyard pavement, 2015

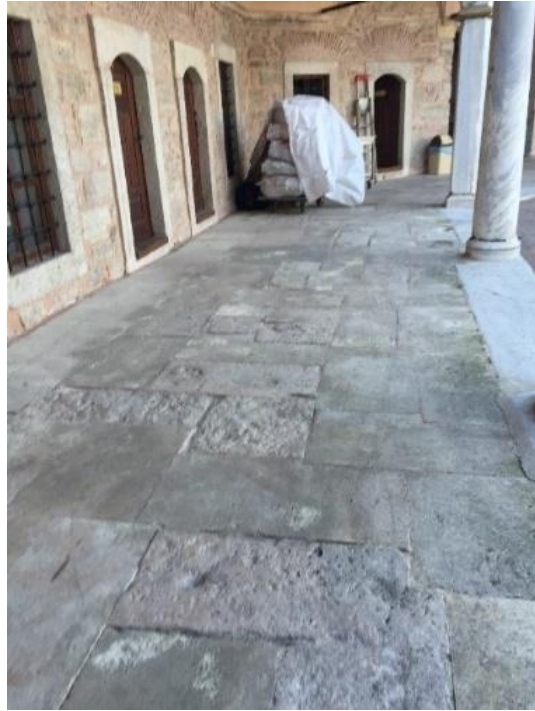
Figure 3.114. Revak pavement, 2015

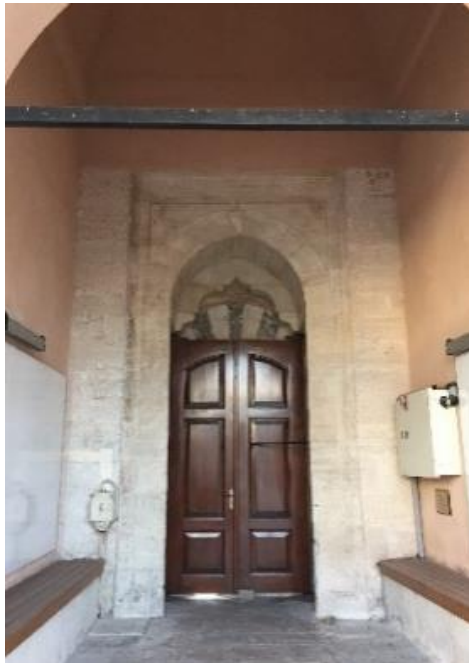
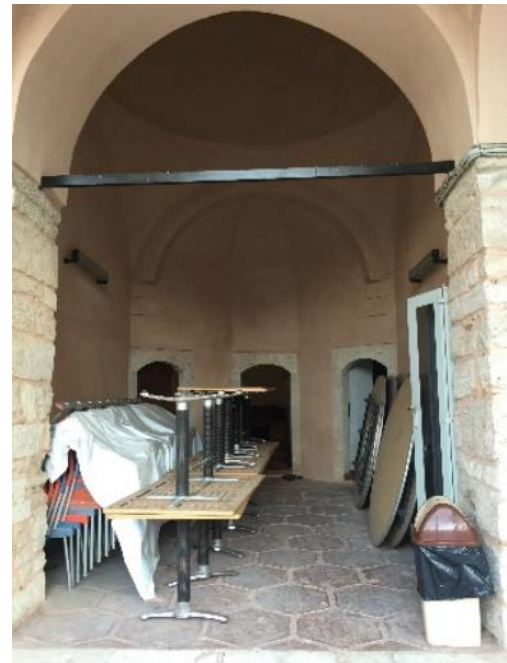
Figure 3.115. (left) Entrance eivan  
Figure 3.116. Eivan in the North corner, 2015

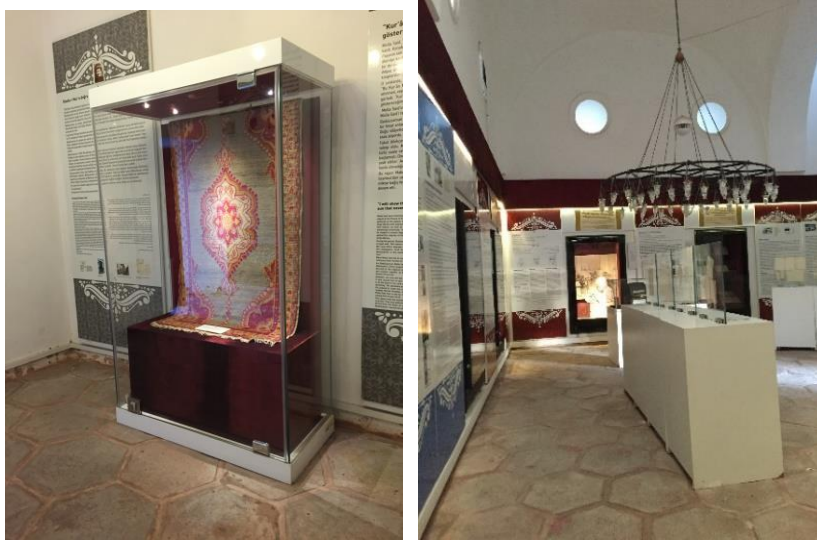
Figure 3.117. (left) Pavement of the room located at the east side of the south eivan, 2015

Figure 3.118. (right) Triangular space pavement, 2015

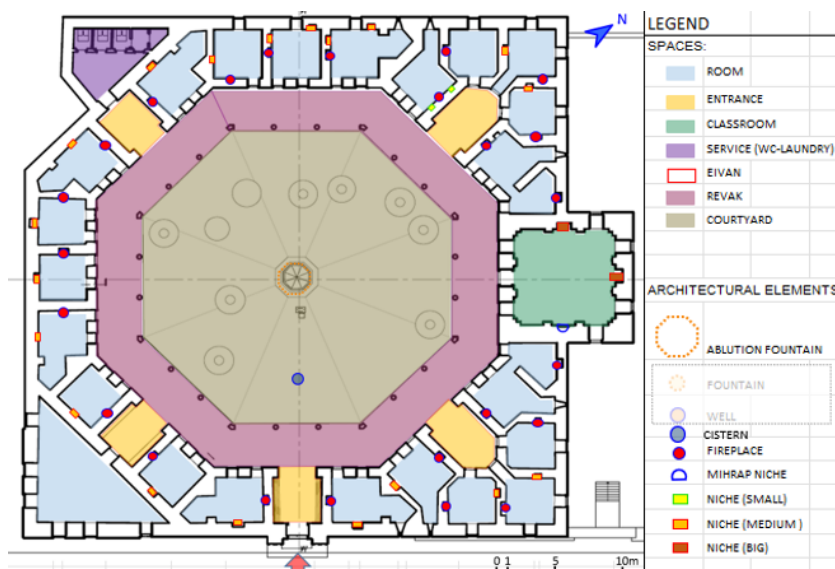
Figure 3.119. Approved restitution plan, referring to 16th century situation, by UB Construction Limited Company 2009 (Archive of DGF)

**Courtyard, Revaks and the Entrance Portal:** The octagonal courtyard was 24.11x24.17m. There was an ablution fountain in the middle of the courtyard (Figures 3.120. and 3.121.). Under the courtyard there was a cistern in between the fountain and the entrance eivan. In the courtyard, there were also a few trees (Figures 3.119. and 3.120.).

Entrance of the medrese was a big portal with the original inscription panel and opened through the entrance eivan from south east (Figures 3.119. and 3.122.). The main entrance portal's height is 7.42m, that was higher than eave profiles' level.

As the result of unique layout, some of rooms had only one window at revaks side, some of rooms had a window facing towards outside –where the street level was higher than the rooms level-, some of rooms had windows on both sides, towards revaks and outside. The corner rooms had windows on both outer walls, so they were well illuminated. There were small top windows on outside facades above the bottom windows (Figures 3.112. and 3.123.). The rooms had künde-kari woodwork doors, however, some of the doors had been changed in the past repairs. Each room had a fireplace and one or two small niches (Figure 3.119.). The rooms located on both side of the classroom had two fireplaces.

**The toilets:** The original toilets were at the west corner in a small backyard (Figures 3.119. and 3.130.).

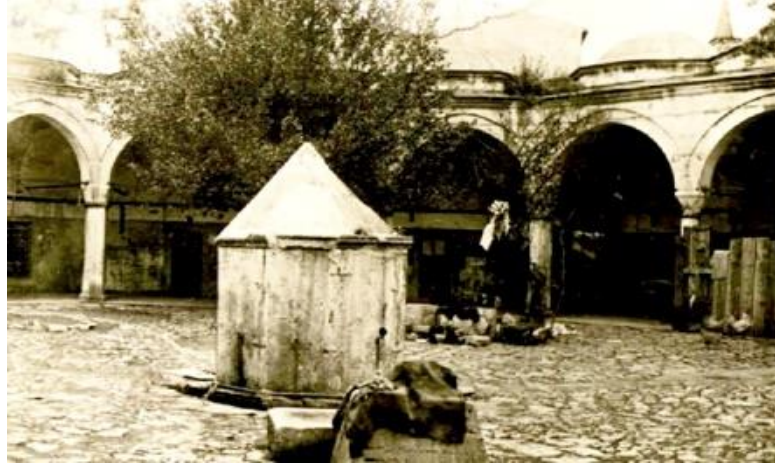
Figure 3.120. Rüstem Paşa Medrese Courtyard in 1937 (Eski İstanbul Resimleri)

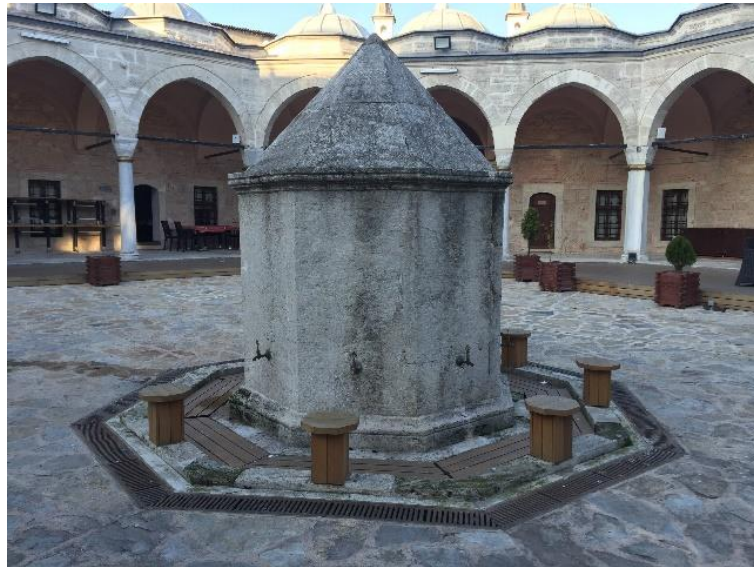
Figure 3.121. Ablution fountain, courtyard and revaks of Rüstem Paşa Medrese, 2015

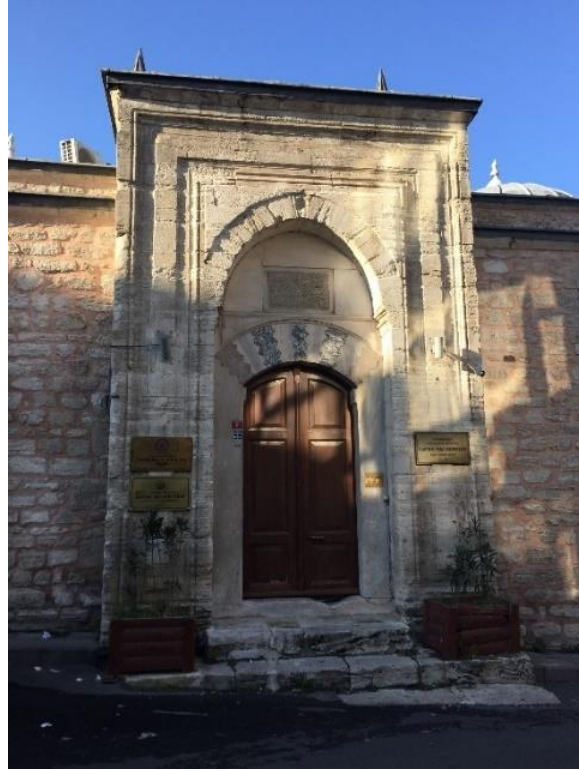
Figure 3.122. Portal of Rüstem Paşa Medrese, 2015

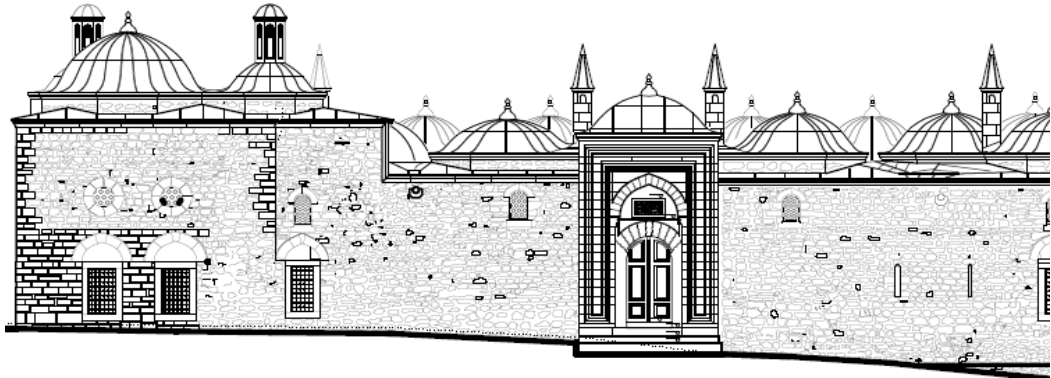
Figure 3.123. South-East Facade, restoration project by UB Construction Limited Corporation, 2009 (Archive of DGF)

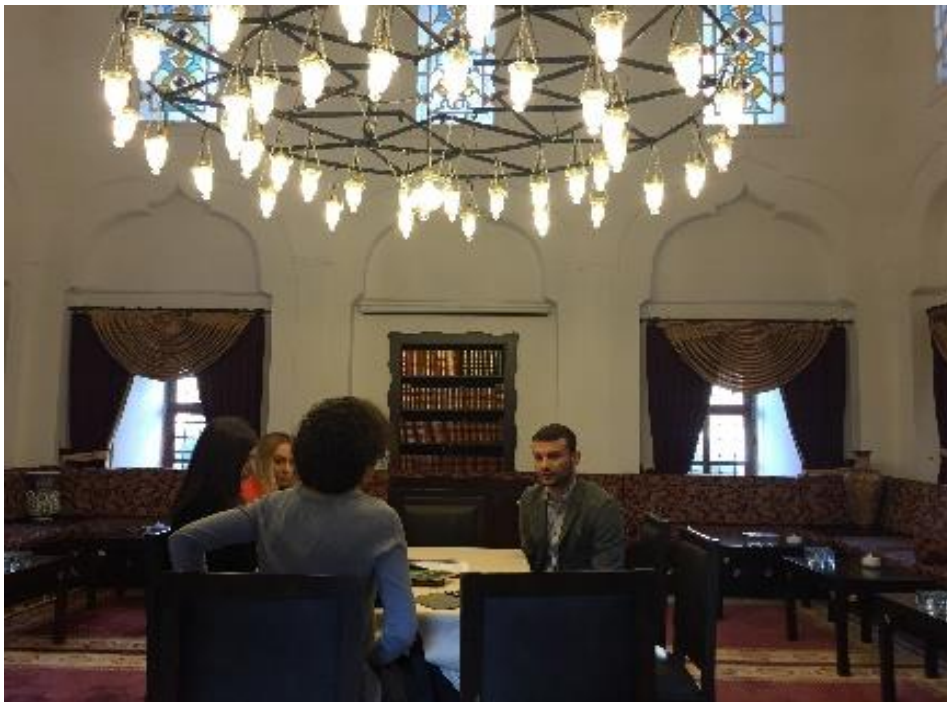
Figure 3.126. Classroom interior, 2015

**The Classroom and Eivans:** The classroom was squared and 7.50x7.43m in size, 59sqm. It was 0,37m higher than the revaks floor and the revaks floor was 0,09m higher than the courtyard level. The entrance door was made from the original künde-kari woodwork and the arch at the top of the entrance was decorated with alternate coloured cut stone having a rectangular cartouche made from marble. The classroom had six windows, two of them were located both sides of entrance in a symmetry (Figures 3.119., 3.124. and 3.125.). Other four windows faced towards backyard and they had top windows decorated with colourful vitrays (Figure 3.126.). It had a mihrap niche and two bookcase niches inside (Figures 3.127. and 3.128.).

In addition, despite the council decision 2009-2617, the chandelier places on the walls were backed out and electric lines were extended to the domes in order to put big chandeliers (Figures 3.126., 3.129. and 3.141.). Some of the architectural elements

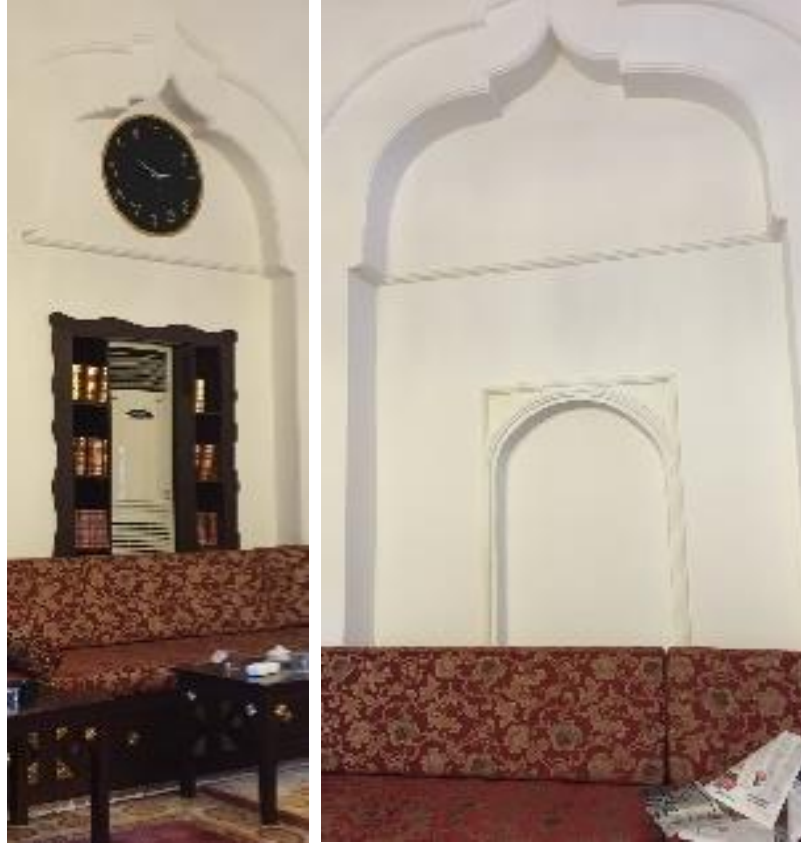
Figure 3.127. (left). Classroom, bookcase, 2015  
 Figure 3.128. (right). Classroom, mihrab niche, 2015

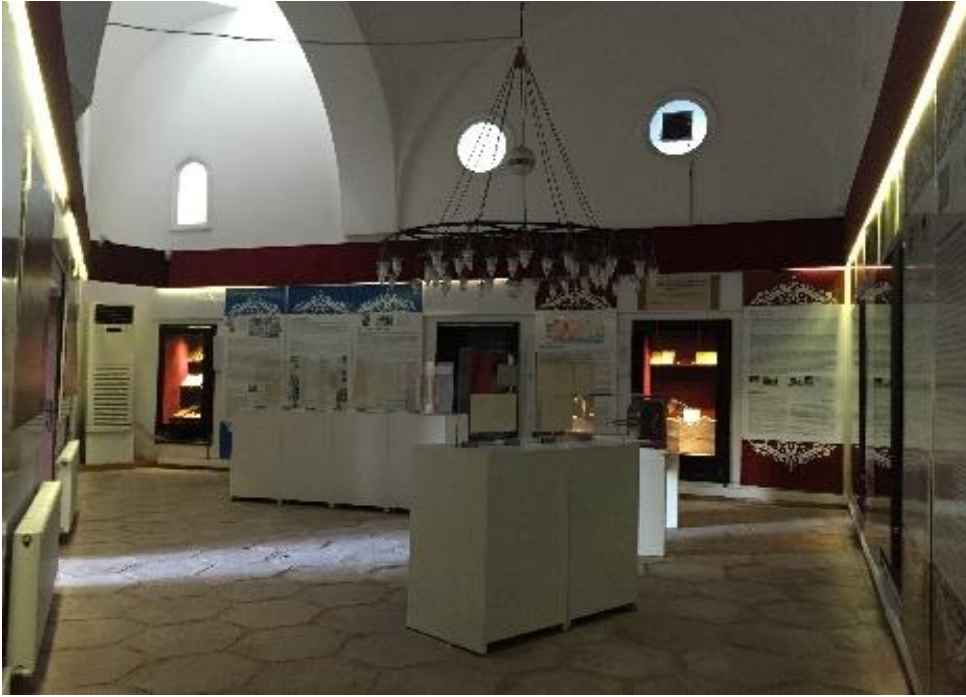
Figure 3.129. The triangular space in Rüstem Paşa Medrese, 2015

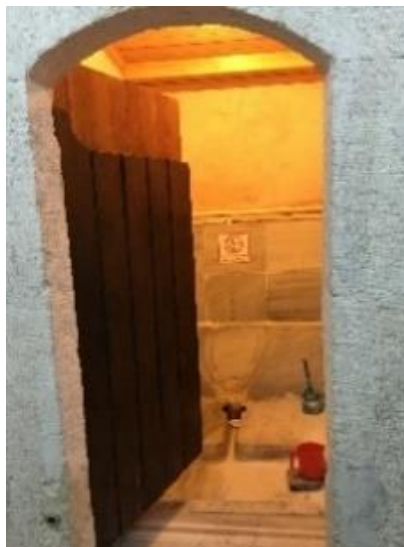
Figure 3.130. An original toilet cabin in Rüstem Paşa Medrese, 2015
