EVALUATING THE IMPACTS OF REFUNCTIONING ON OTTOMAN  
MEDRESES IN ISTANBUL

A THESIS SUBMITTED TO  
THE GRADUATE SCHOOL OF NATURAL AND APPLIED SCIENCES  
OF  
MIDDLE EAST TECHNICAL UNIVERSITY

IN PARTIAL FULFILLMENT OF THE REQUIREMENTS  
FOR  
THE DEGREE OF MASTER OF SCIENCE  
IN  
CONSERVATION OF CULTURAL HERITAGE IN ARCHITECTURE

SEPTEMBER 2023

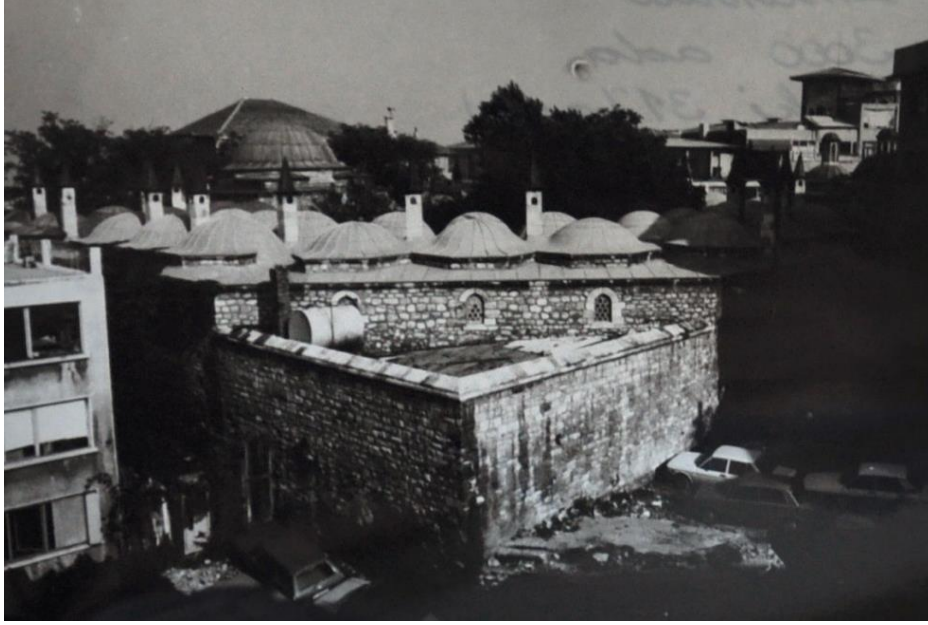
Figure 3.131. Additional service space as heating center in service backyard in 1979

In 1979, electric, heating systems were installed and 4 fire cabinets were added to the medrese by DGF in accordance with the decision no 1979/11034 of Supreme Council of Cultural Heritage. A heating center was also constructed in the service courtyard located in the west corner (Figure 3.131.). Within the time, some additions had been built in the medrese by the user; such as wall additions in triangular space, tile coverings on masonry walls and the user also added a tent in the courtyard. The user also attempted to build a restaurant in backyard of the medrese facing towards east street, demolishing the garden door and wall. Istanbul Metropolitan Municipality had reported the attemption to the Istanbul Cultural and Natural Assets Protection Council

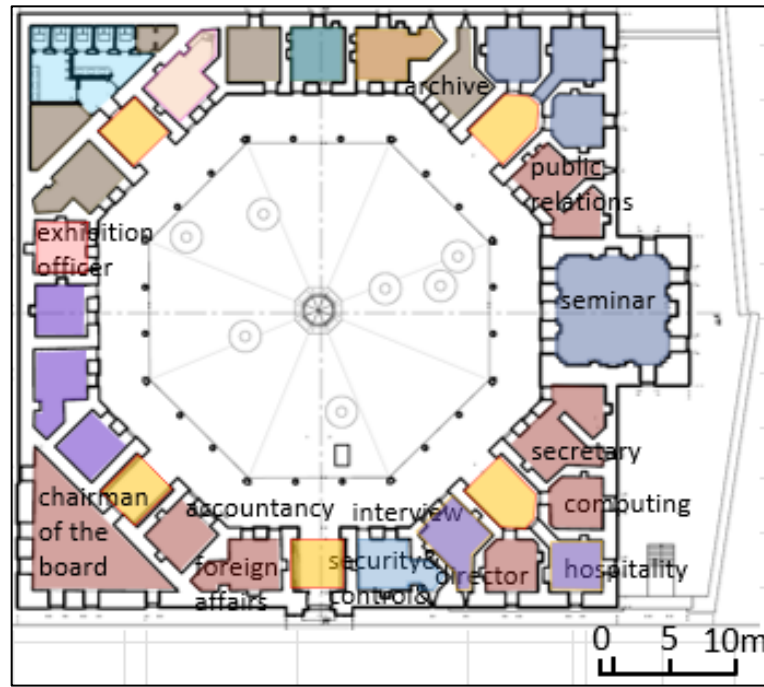
Figure 3.132. Plan, approved restoration project by UB Construction Limited Corporation, 2009 (Archive of DGF)

The last reuse interventions were made in accordance with the restoration project approved by the decision number 2009-2617 of Ministry of Culture, Cultural Heritage Protection Council IV. The functions of spaces were also decided in this approved project (Figure 3.132.). Within the last intervention works; reinforcement of the building<sup>56</sup>, architectural restoration on deteriorated and changed elements –plasters, floor pavements, windows, doors, lead covers and metal elements-, electric and mechanical interventions were done as a requirement of article 4i of the repair

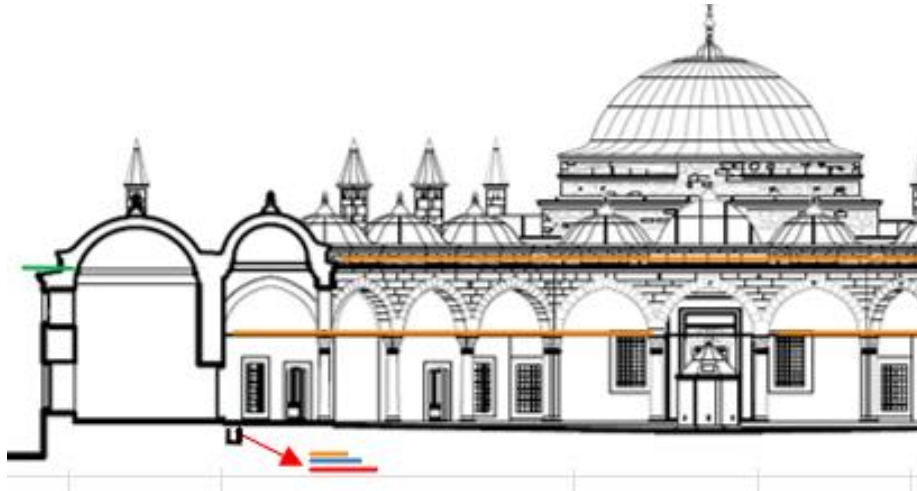
Figure 3.134. Interventions in A-A Partial Section of restoration project by UB Construction Limited Corporation, 2009 (Archive of DGF)

protocol<sup>57</sup> and article 3i of the allocation protocol.<sup>58</sup> Toilet space was reorganized according to the approved project (Figure 3.133.); the small backyard was covered with a roof and toilets' floor was paved with marble (Figures 3.133., 3.138. and 3.139.). In the last restoration, fire precaution and security installations were also applied (Figures 3.134. and 3.135.).

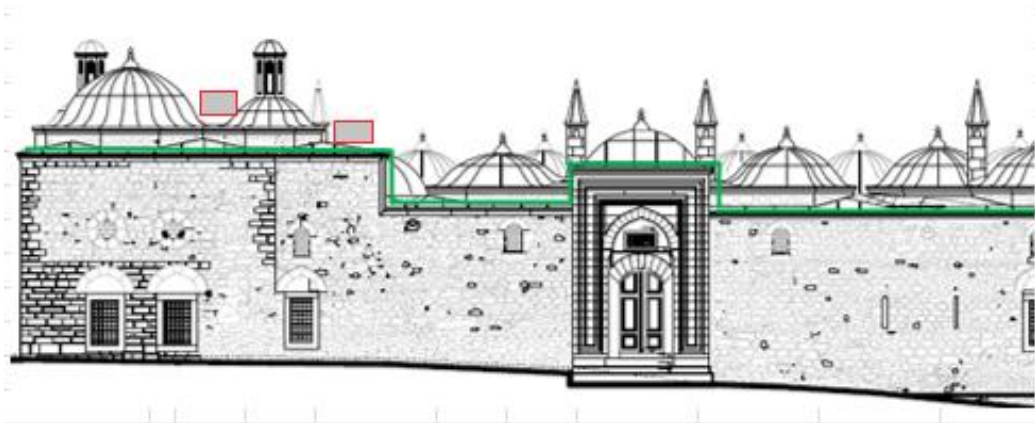
Figure 3.135. Interventions on South-East Facade, restoration project by UB Construction Limited Corporation, 2009 (Archive of DGF)

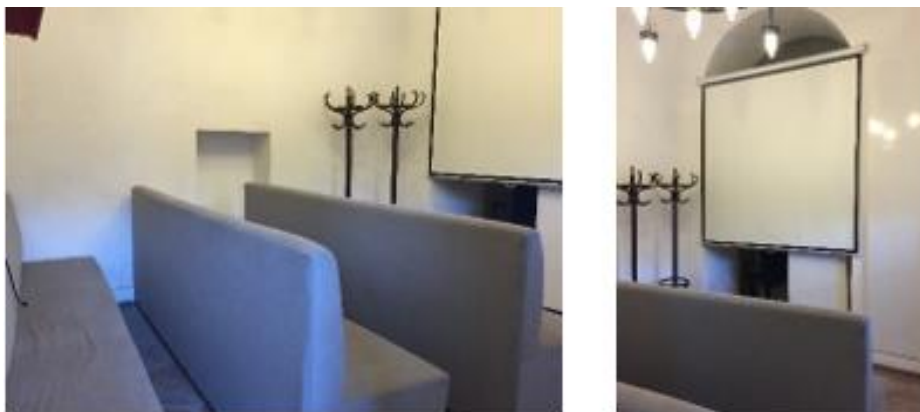
Figure 3.136. The room next to the entrance eivan refurbished as projection room, 2015

After had being completed the restoration works, the use of some spaces was changed; workshop use was completely cancelled, accommodation, restaurant and museum functions were added (Figure 3.133.), one room refurnished as projection room (Figure 3.136.), interior design of the room which was used as a kitchen was changed and was extended for broad participated dinner organizations in the courtyard (Figures 3.137. and 3.140.).

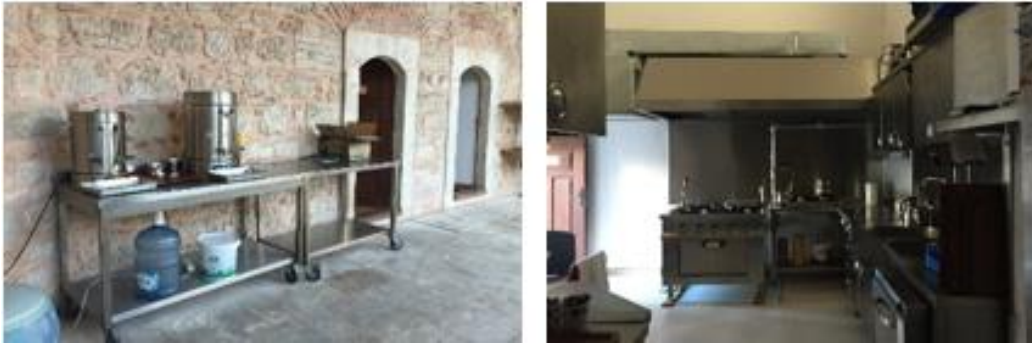
Figure 3.137. Service banch in revaks, in front of the kitchen, 2015

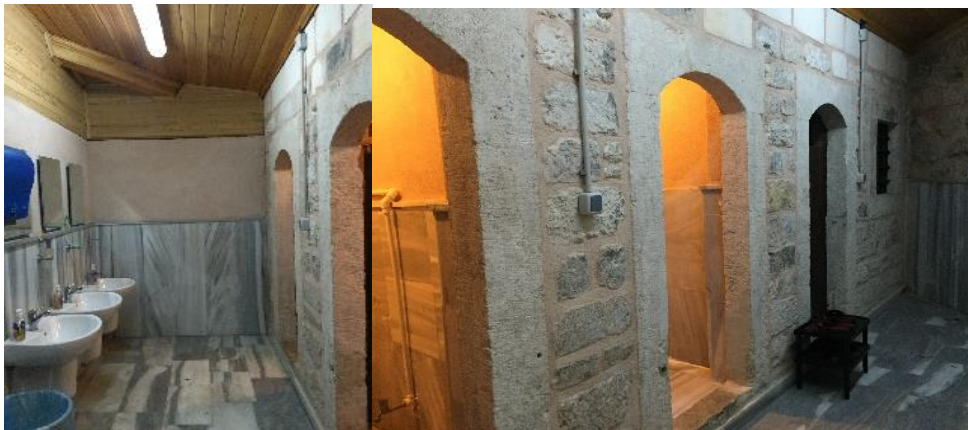
Figure 3.138. left. Roofing and marble pavement in women's toilets, 2015

Figure 3.139. Electric and sanitary installations in women's toilets, 2015

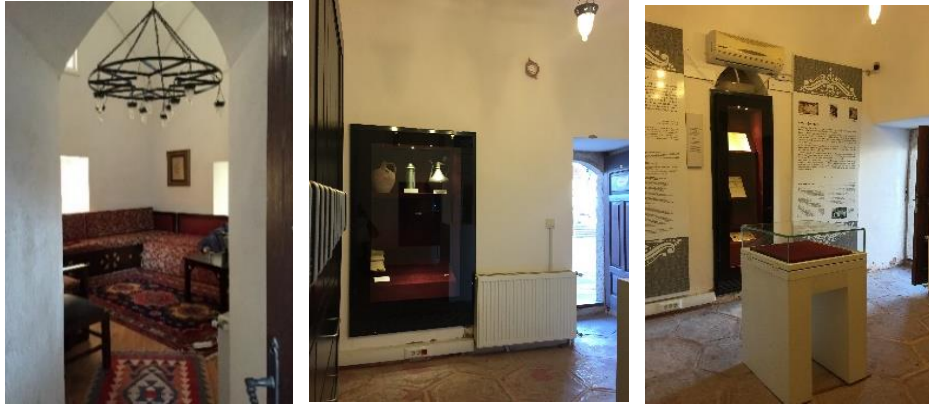
Figure 3.141. (left) Chandelier and refurnishing in welcoming room, 2015  
 Figure 3.142. (middle) Window alteration in the east room, gallery, 2015  
 Figure 3.143. (right) Fireplace alteration in the west room, gallery, 2015

were changed; a window was turned into a showcase in a room which was refunctioned as gallery (Figures 3.142. and 3.143.). Fireplaces and niches in the rooms were either stayed unfunctioned or using uneffectively for the purpose of storage, and some of were furnished as bookcases, while some of were left just plastered (Figures 3.144.-3.150.). Together with these post refunctioning interventions, the area in front of the medrese was had still been using as car park in 2015 (Figures 3.133. and 3.151.).

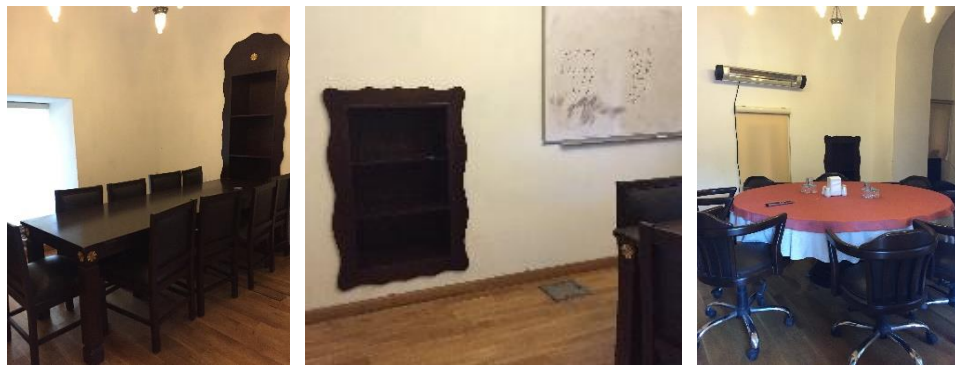
Figure 3.144. (left) Refurnishing and fireplace use in meeting room, 2015  
 Figure 3.145. (middle) Niche in the meeting room, 2015  
 Figure 3.146. (right) Reuse of meeting room, heater and lighting, 2015

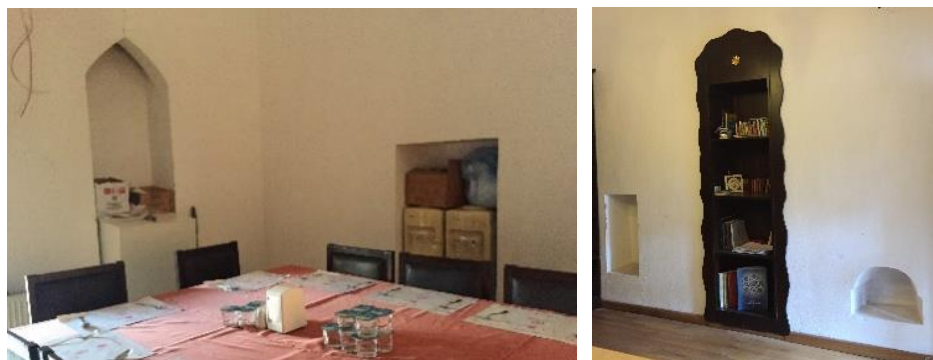
Figure 3.147. (left) Reuse of a room as restaurant, reuse of its fireplace and a niche, 2015  
 Figure 3.148. (right) Fireplace and niches in the room used as a library, 2015

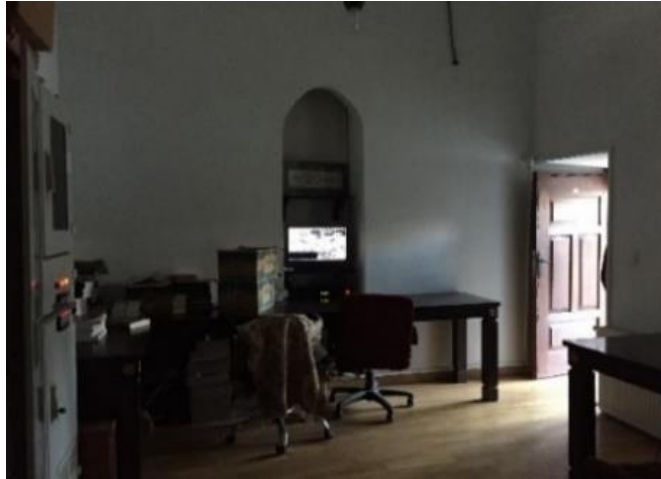
Figure 3.149. Fireplace in the room used for security and control, 2015

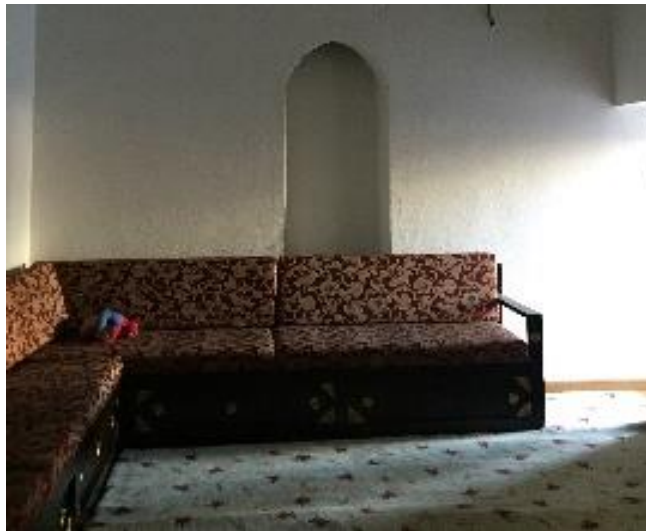
Figure 3.150. Fireplace in the room used as seminar hall for women, 2015

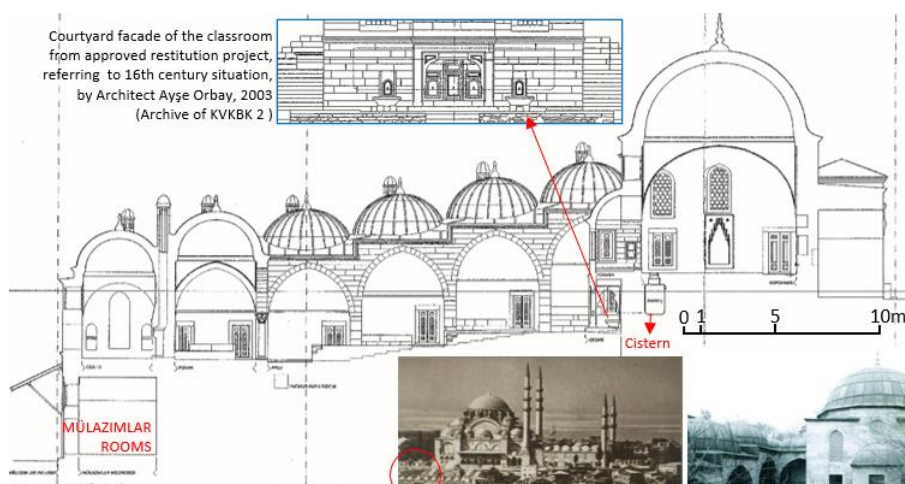
Figure 3.160. A-A Section from approved restitution project, referring to 16th century situation, by Architect Ayşe Orbay, 2003 (Archive of KVKBK 2)

**Layout:** Rabi Medrese was originally designed in connection with Salis Medrese and Mulazimlar Rooms<sup>60</sup>. In 2016, they shared the same lot (Figure 3.157.). Rabi and Salis medreses had the same layout but in symmetry. The layout was stepped following the inclined topography (Figures 3.159. and 3.160.). This stepped layout had been used before in Yıldırım Darüşşifa in Bursa in 14th century. (Eyüpgiller and Özaltın 2007, p.203)

Rabi Medrese was a rectangular building including 20 rooms and a classroom. It was 37.60 x 36.82m except for entrance and wc wings. Inside the medrese there was an inclined and stepped courtyard towards north east surrounded with revaks from three sides. The rooms were located in different levels behind the revaks. The classroom was in the middle of south west façade where the highest point of the building. This layout formed the U plan type of the medrese. Rabi Medrese was connected with Mulazimlar Rooms and Salis Medrese via the north corner room. A sheltered terrace in front of two upper rooms of Mulazimlar Rooms located in between Rabi and Salis medreses was a connection point of the three of the buildings (Figures 3.159. and 3.160.). Second doors of the symmetric end rooms of Rabi and Salis medreses opened to these two symmetric upper rooms of Mulazimlar Rooms (Figures 3.173. and 3.174.). Two symmetric stairs in the terrace went down the Mulazimlar Rooms and its courtyard (Figures 3.159. and 3.160.).

**The Courtyard and Revaks:** As it was explained above, the courtyard was inclined and stepped due to topographic features. In the courtyard, ablution fountains were designed on the subbasement wall of the classroom, on the upper step of the courtyard (Figure 3.160.). Next to the south entrance of the classroom, there was a well (Figures 3.159., 3.160. and 3.163.).

**The Classroom:** The classroom was 7.78x7.78m and stilted from revak level as high as 6 step (1.37m up to wet section level). It had two entrances on south east and on north west facades, close to south west façade. Inside the classroom, there was also another wet space area in between the two entrances and there was a seki one step (0.11m) higher than the wet part. Inside, a tap was located on south east wall probably for ablution (Figures 3.159. and 3.160.). In the middle of the north east façade, was a projection (Figures 3.160. and 3.171.). On the south east wall, there was also a mihrap. The classroom had 12 windows, 6 of them at the bottom and 6 at the top. There were 6 small niches and a bookcase in the walls. Under the classroom was a cistern and the cover was on the floor of the classroom (Figures 3.159. and 3.160.).

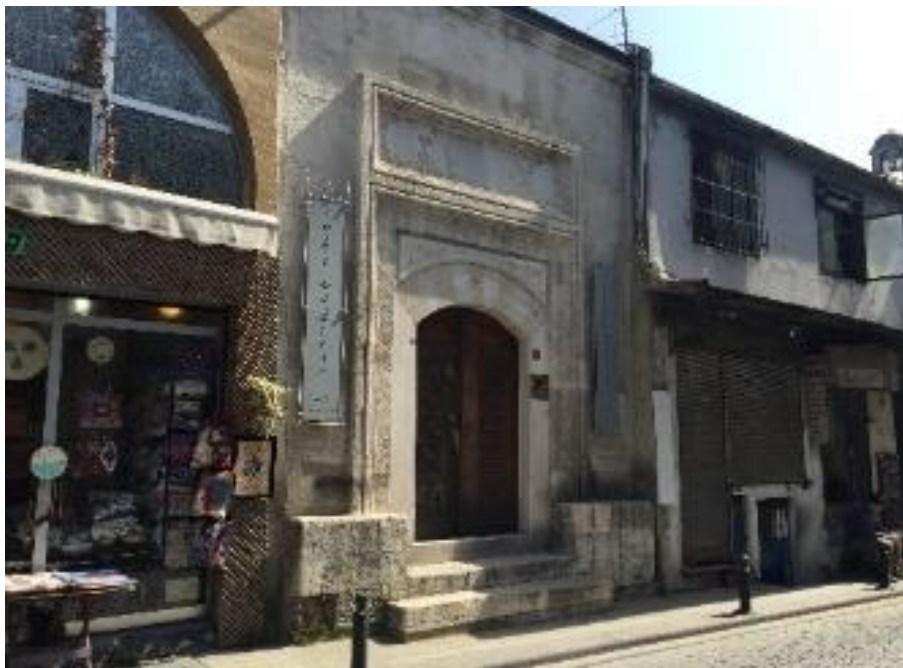
Figure 3.161. The main entrance, 2016

**The Entrance Portal:** Entrance of the Rabi Medrese was a big and decorated portal, and the portal of Salis Medrese was the same (Figure 3.161.). It was higher than the façade line and decorated with profiled cut stones. The entrance was located at the south east corner of the backyard and opened through a sheltered terrace (Figure 3.162.). Entrance terrace was a kind of view point looking towards Galata part of the city. On the south east corner of the terrace was the second entrance door opening through revaks surrounding the courtyard (Figure 3.162.).

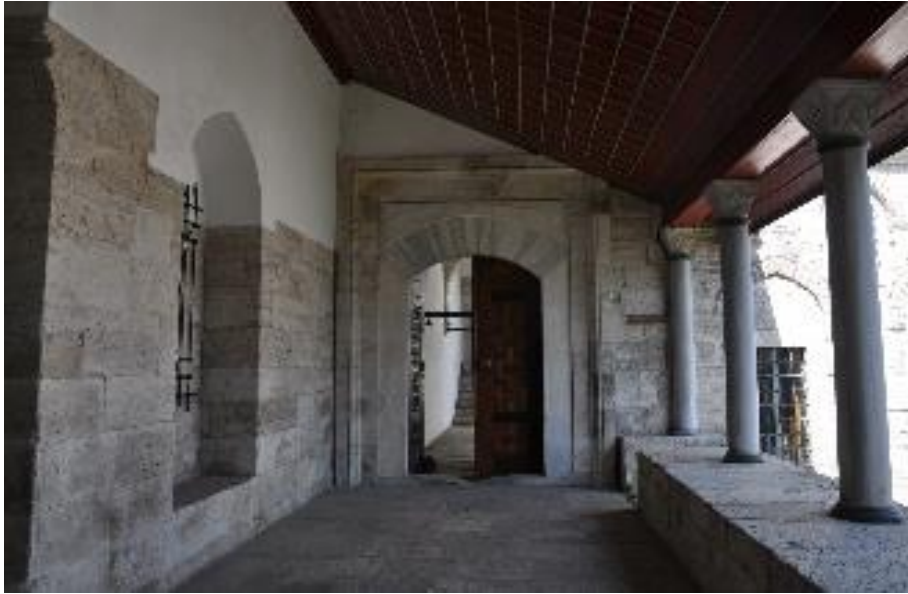
Figure 3.162. Entrance revaks, 2016

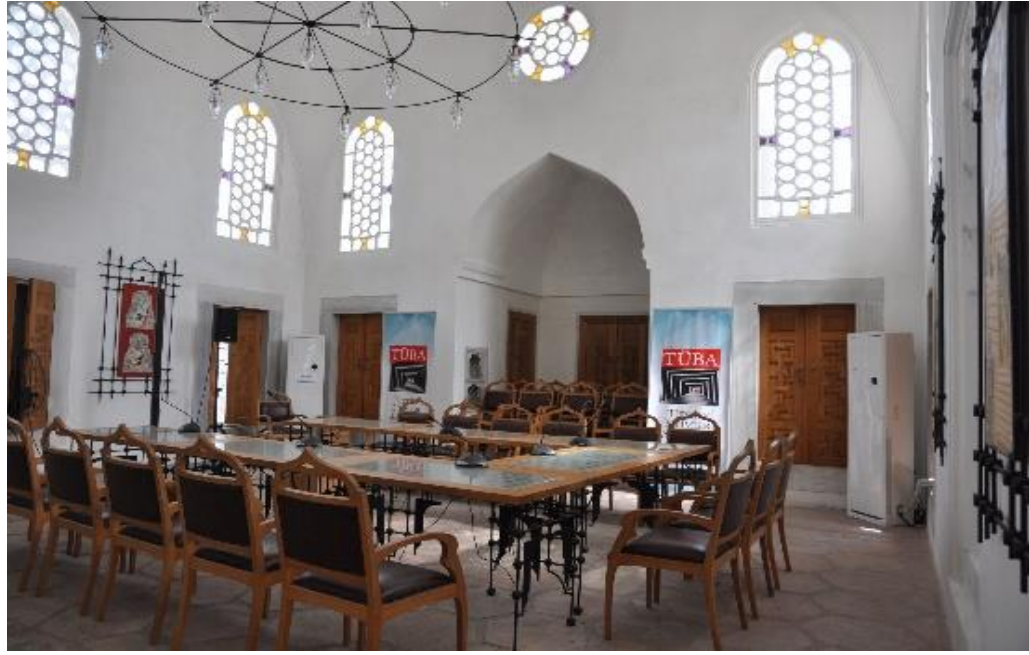
Figure 3.163. Seminar hall (classroom,) of Rabi Medrese 2016

However, some interventions were made after restoration by the user. Audio system, other essential systems for broadcasting and air conditioning system was also installed to the classroom (Figures 3.163. and 3.184.) As the walls were too thick for wireless system to work effectively, extra wireless boxes and cables were loaded onto revak façade. As the heating system was not enough for getting effective temperature, additional portable heaters were put inside the rooms. All these installations negatively effected the architectural perception of the medrese.

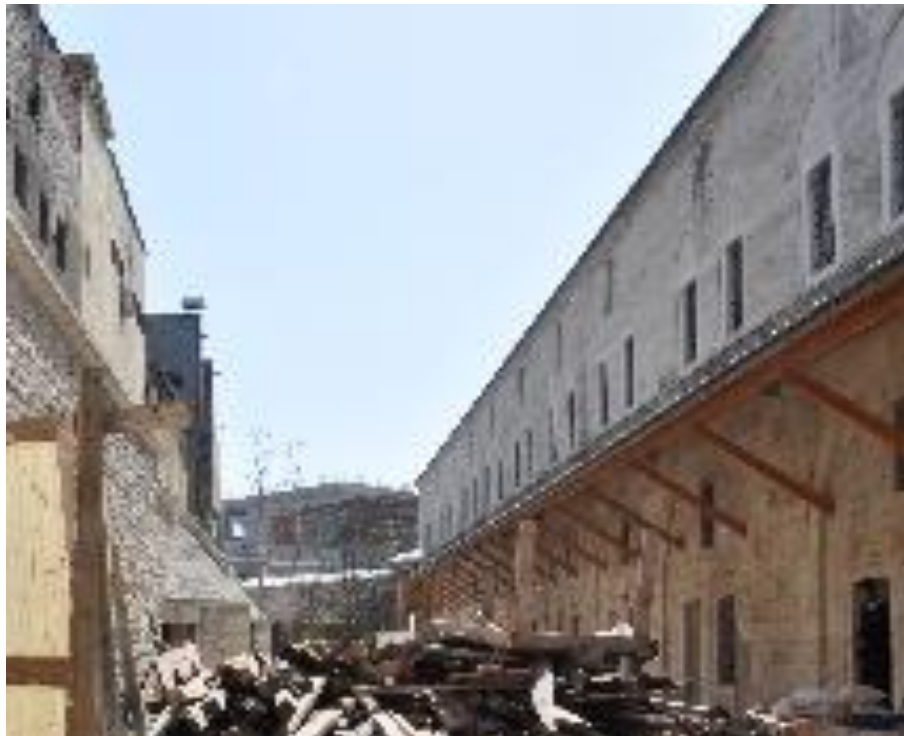
Figure 3.164. North East facade of Rabi Medrese from the courtyard of the Mulazımlar Rooms, 2016

North-West and South-East wings of the revaks were stepped following the slope. Each step had been designed as if it was a private terrace in front of each room (Figure 3.164.). Northeast revaks were the lowest and not a stepped wing. There were two individual sekis made from cut stone in that section.

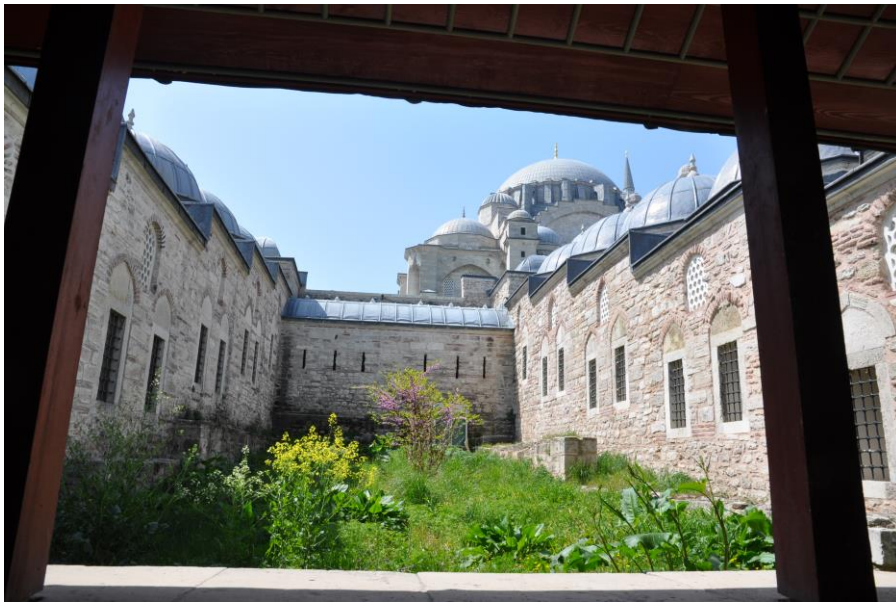
Figure 3.165. Outer façade and window order of the rooms in Rabi and Salis medreses, 2016

**The Rooms:** The rooms were squared in shape and had approximate sizes; 3.70x3.70m. Each had 3 windows on outer façade, two at the bottom and one at the top (Figure 3.165.). Each room had three niches in the same sizes (Figures 3.166. and

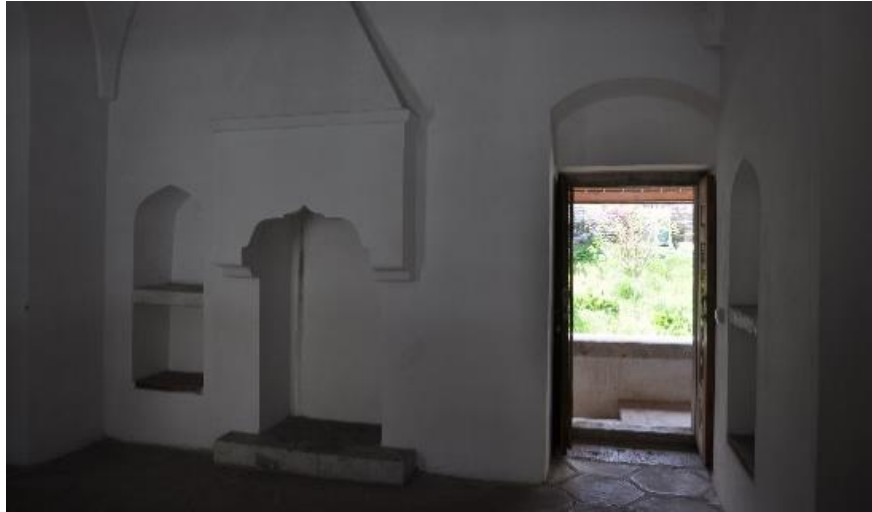
Figure 3.167. Interior of a typical room

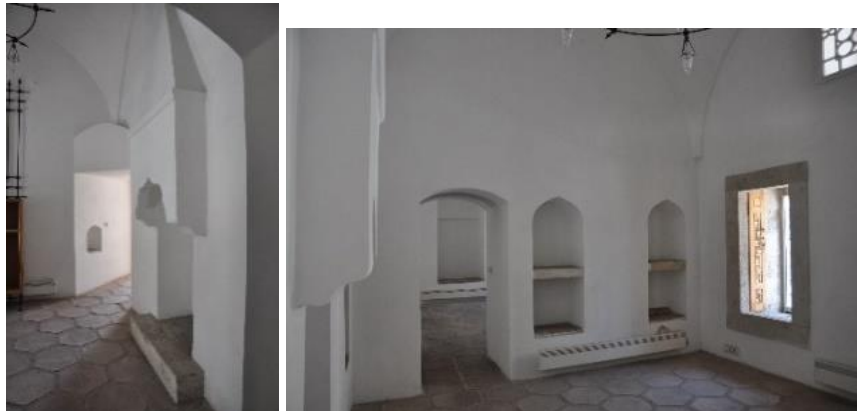
Figure 3.168. (left) The first part of the north corner room, 2016  
Figure 3.169. (right) The first part of the north corner room, 2016

3.167.). The north corner room was a connection space, as well. It had a fireplace and a second door opening into the next room (Figures 3.168. and 3.169.). The next room was one of two upper rooms of Mulazimlar Rooms (Figure 3.170.). These upper rooms and the common terrace in front of those were the connection point of Rabi and Salis Medreses and Mulazimlar Rooms as it was explained above (Figure 3.159. and 3.165.). As the windows of the rooms were on the outer walls, and had a deep backyard in front, as well as the classroom was on the highest point of the courtyard, all the spaces were good ventilated and well illuminated.

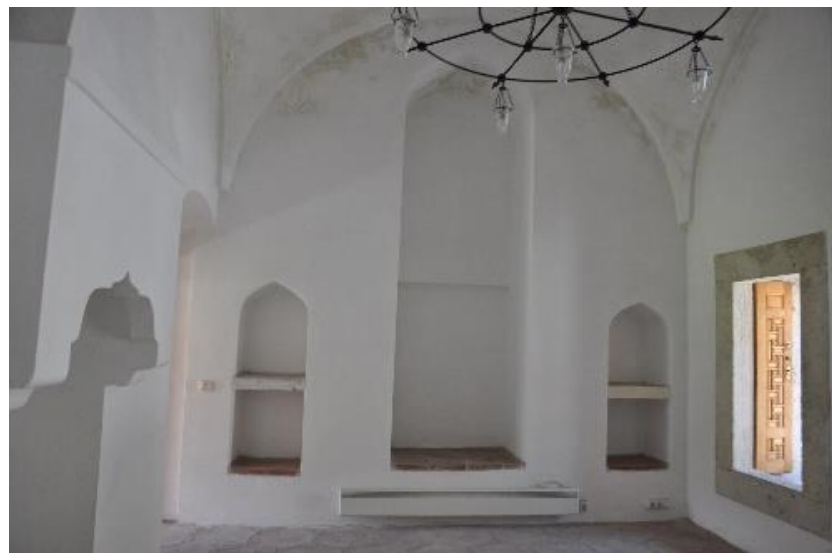
Figure 3.170. The second part of the north corner room (upper Mülazımlar room),  
2016

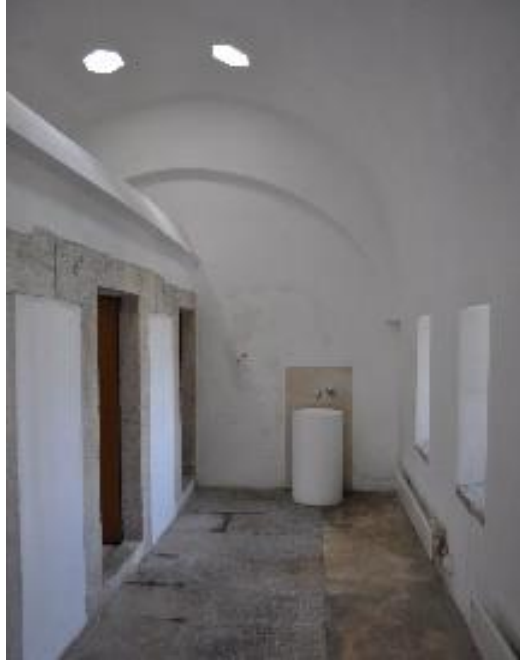
Figure 3.172. Original wc hall of Rabi Medrese, 2016

**The service space:** The service space was original and located in a symmetric position with the entrance, at the top level of the medrese. There was a small space before toilets and 3 toilet cabins in the service space (Figure 3.159.). The space was good ventilated by embrasures and enlightened by light holes in the vault (Figure 3.172.).

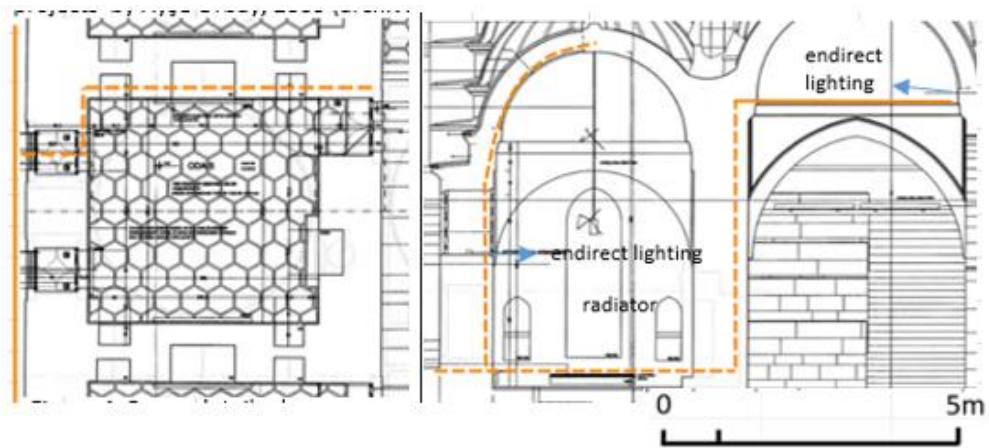
Figure 3.175. Electric lines installation in rooms and revaks; plan and section from restoration detail projects by Ayşe Orbay, 2003 (archive of KVKBK 1)

Electric lines including lighting, heating, security, data, cable TV and telephone were installed in the channel under the floor and joints on the cut stone walls (Figures 3.173.-3.178.). For space heating, the radiator system was preferred in the rooms and air conditioners in the classroom. As the choice of use of the rooms requires different spaces to be heated in different periods of times, choice of radiator system as a central heating system becomes a false technical installation in the medrese. This led to an alternative choice for heating the permanently used rooms by means of an electrical heating sheet (Figure 3.179.).

Endirect lighting system was installed to the revaks to emphasize and reveal the architectural perception (Figure 3.175.). Additional lighting armatures were placed in the courtyard and under the trees to get extra lighting and to emphasize ablution

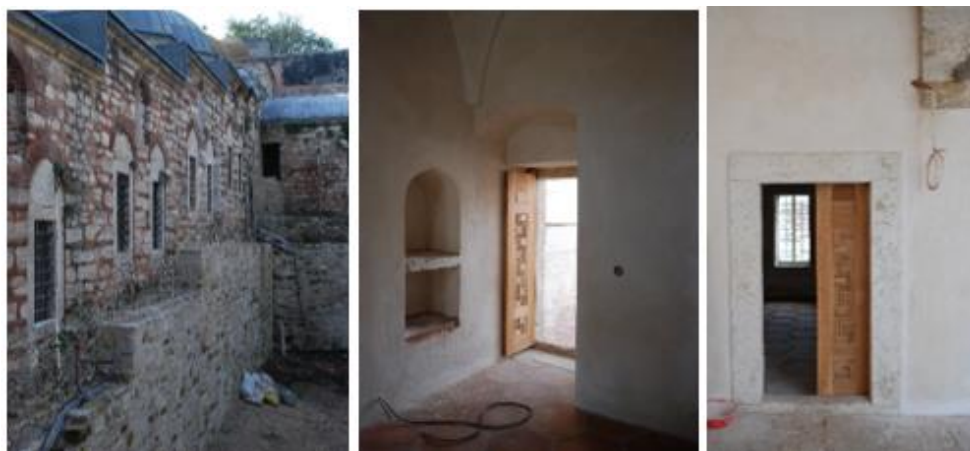
Figure 3.176. Installations in North garden, rooms and revaks, 2009 (archive of DGF)

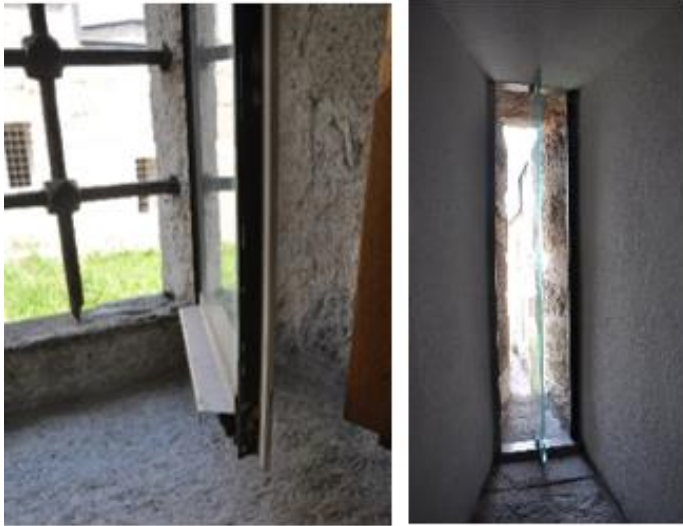
Figure 3.177. Window framework detail applied in rooms and classroom (left) and in toilets (right), 2016

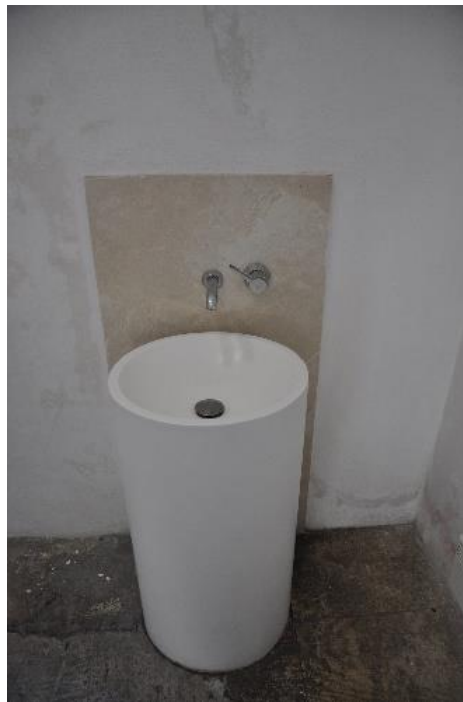
Figure 3.178. A sink detail from wc, 2016

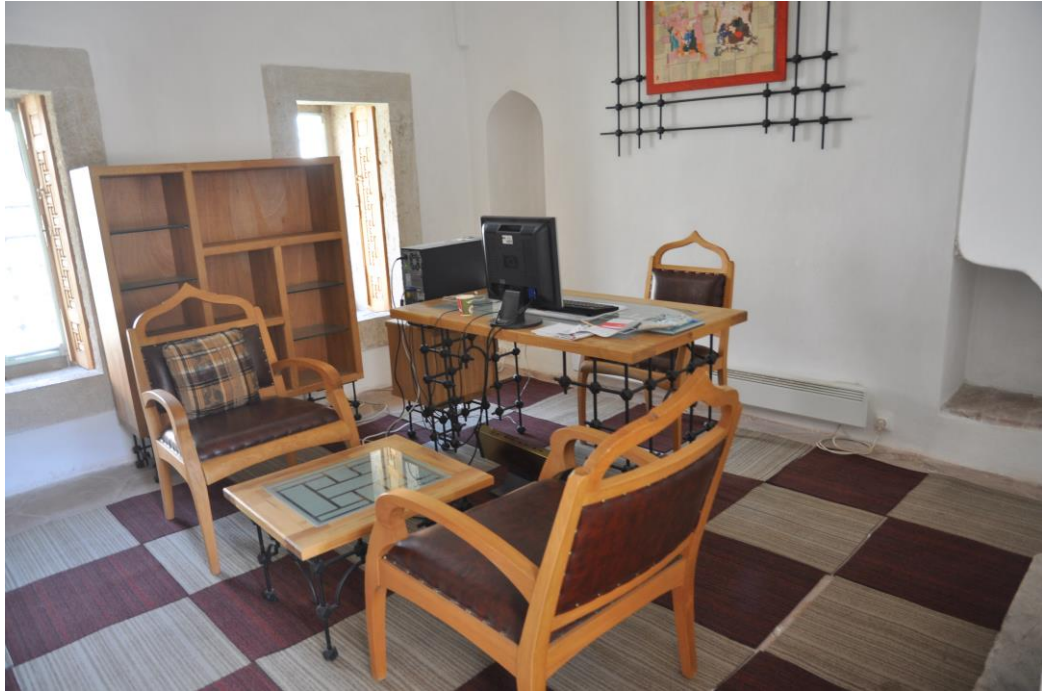
Figure 3.179. Electrical heating sheet in and radiator in administration office, 2016

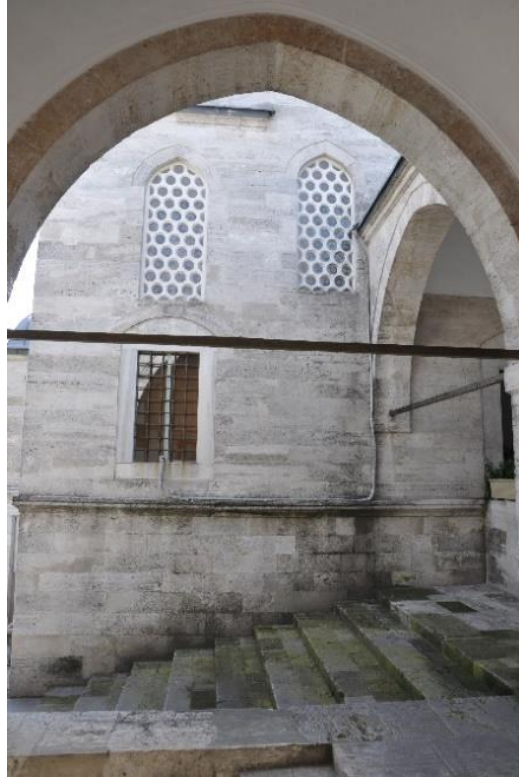
Figure 3.184. Improper installations after restoration on the façade of the classroom, 2016

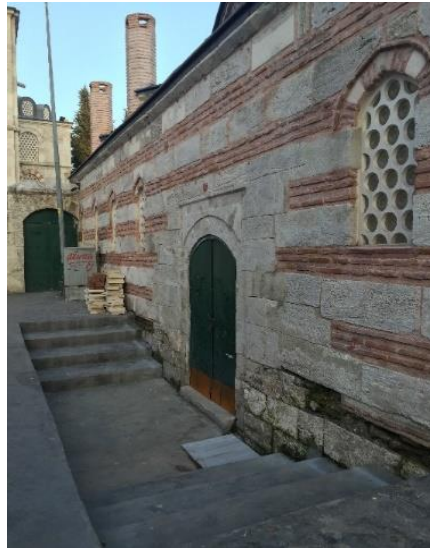
Figure 3.199. Entrance facade and entrance door of Kılıç Ali Paşa Medrese, 2015

The medrese was at south of the mosque and very close to shore of the Bosphorus. Entrance of the medrese was on the north façade of the medrese facing to Kılıç Ali Paşa Medresesi Street (in Ottoman Period it called Medrese Street). As the street level had risen up within centuries, the medrese was lower than neighbor buildings in 2016. The revaks were 95cm lower than the street level (Figure 3.199.).

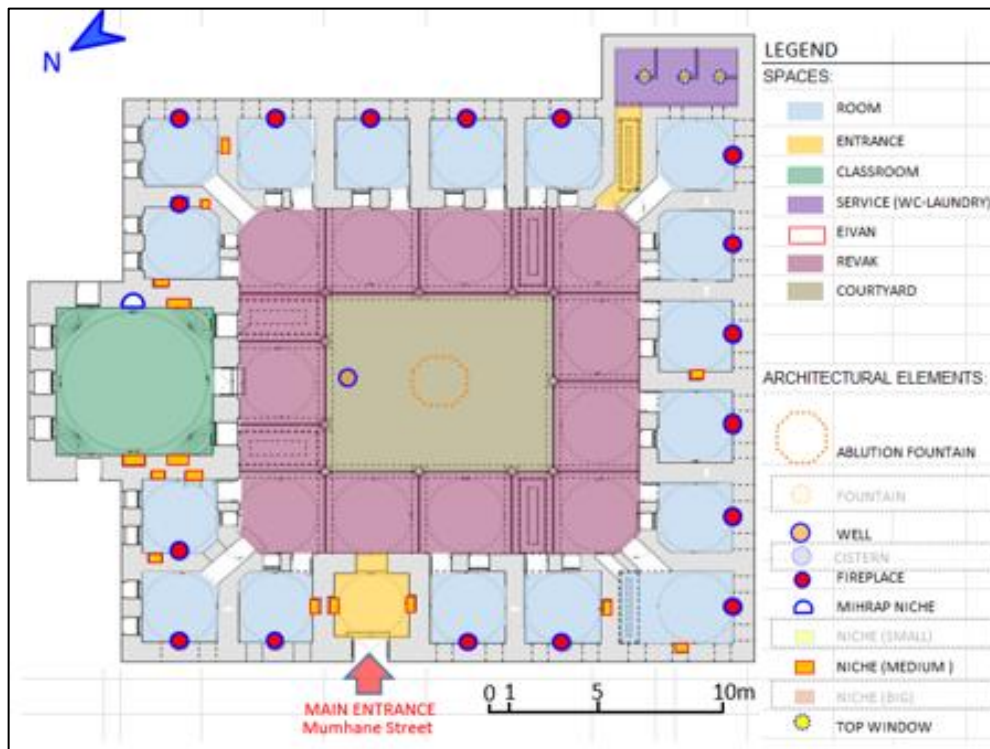
Figure 3.202. Original situation adapted from Restitution Plan by DK Architecture, 2009 (archive of DGF)

**Layout:** Kılıç Ali Paşa Medrese was a rectangular planned self standing building (Figure 3.202.). It was not as high as other studied medreses. According to the last approved restoration project, the medrese was 27.36x28.66m from outside. It was 4.73m up to lead cover line on east -graveyard- façade. The medrese had 17 rooms, a classroom, courtyard, revaks, entrance eivan and toilets.

**The Rooms:** The rooms were squared and approximately 3.30x3.30m. The corner room on north west was different in size, it was rectangular as a result of symmetric plan layout and 3.29x4.87m. All the rooms had three bottom windows, one was on revak façade, two were on outer façade (Figure 3.202., 3.205.-3.207.). The rooms facing towards east and south backyard facades were also had three top windows in the same vertical axis with the bottom windows. The rooms on north and west wings had only top windows on outer facades. The three corner rooms on north west, north east and south east had double window order on outer facades.

**The Toilets:** The toilets were re-designed within the medrese, out of the south west corner in a small courtyard of 5.28x2.53m. The courtyard connected to the narrow backyard at alongside the south facade (Figure 3.202.).

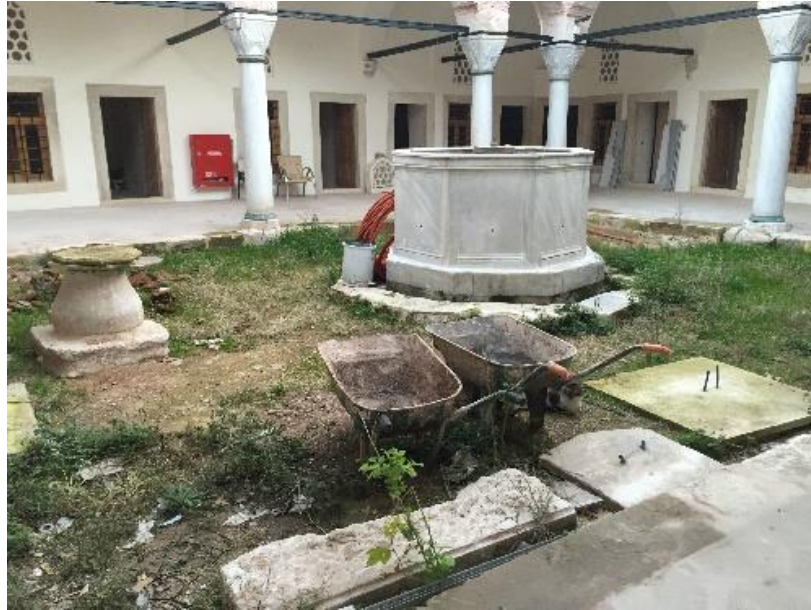
Figure 3.204. Ablution fountain and well in the courtyard, 2015

**Courtyard and Revaks:** The courtyard was rectangular, 9.35x7.68m and surrounded with revaks from four sides. In the middle of the courtyard, there was an octagonal ablution fountain without a shelter (Figure 3.203.) and a well between the ablution fountain and the classroom (Figure 3.204.).

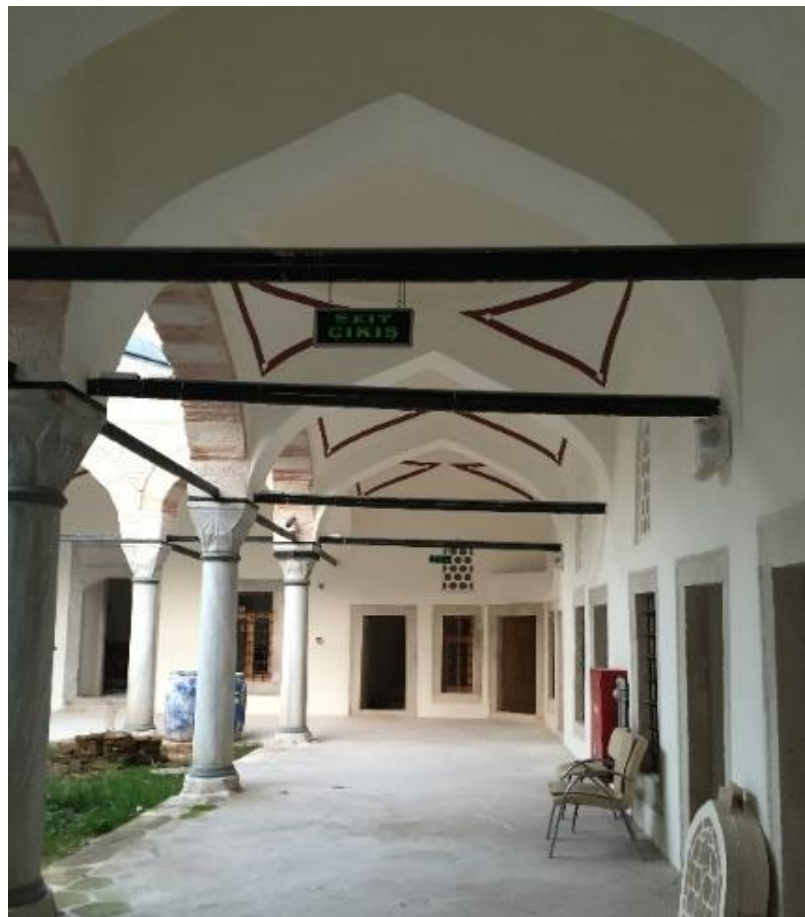
Figure 3.205. North east revaks, 2015

The revaks were 4m in width. The revaks carried by marble columns with marble capitals (Figure 3.205.) Capitals had baklava shaped decorations. Domes of revaks were plastered from inside and had dark red fillet decorations.

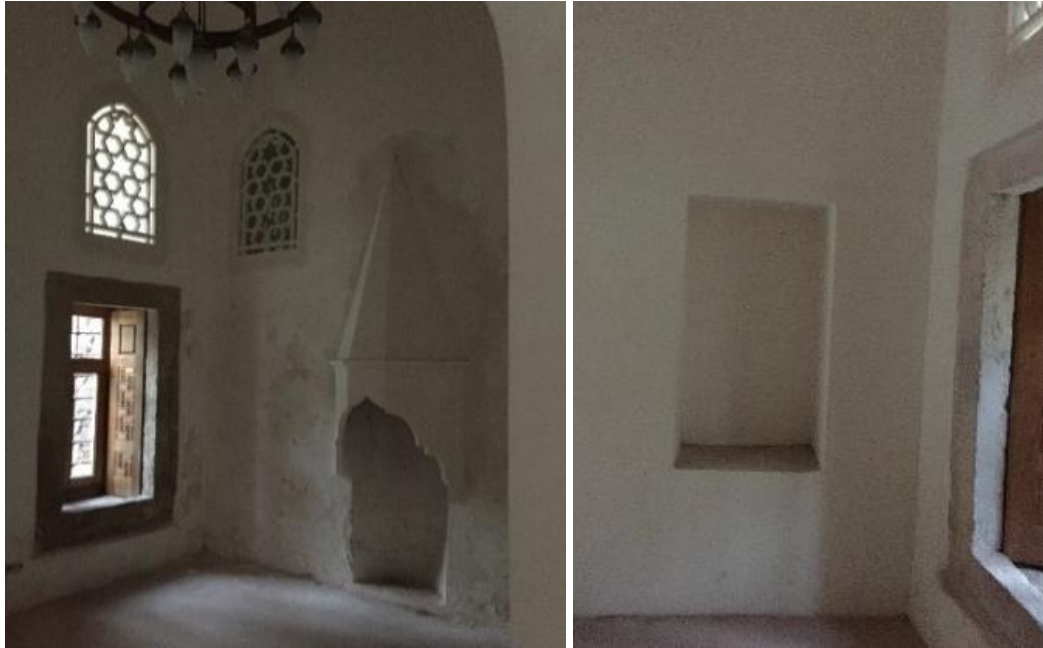
Figure 3.208. (left). East corner room 2015

Figure 3.209. (right) Niche in rooms 2015

Rooms had a fireplace and had small niches in different sizes and different numbers in range of 1 to 3 (Figures 3.208. and 3.209.). The rooms were well ventilated in general, however, the ones on south wing were comparatively dark and humid due to lack of direct sunlight both for narrow backyard and high neighbor buildings.

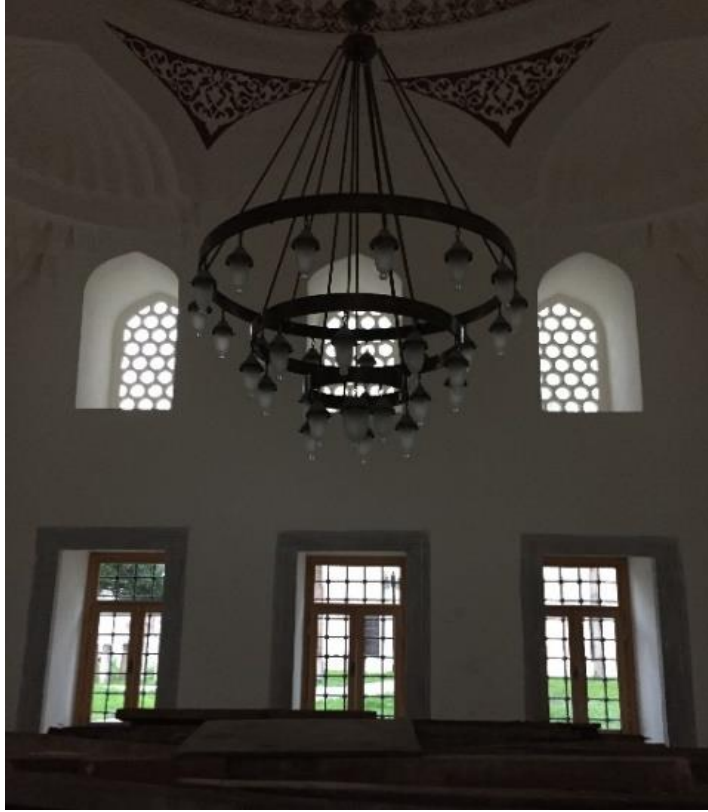
Figure 3.210. Classroom of Kılıç Ali Paşa Medrese in 2015

**The Classroom and the Entrance Eivan:** The classroom was in the middle of the east façade and projected through graveyard of the mosque. It was covered with a dome. The classroom was two steps, 0.27m, higher than the revak level. It had 10 windows, 6 were at bottom, 4 at top. There was also a mihrap niche and bookcase niches in the classroom. The classroom was the only decorated space of the medrese; shell shaped transition semidomes and stalactites below the semidomes, malakari decorations both in triangular surfaces between the semidomes and surrounding the main dome at drum level and stalactite decoration in mihrap were the characteristics of the classroom (Figures 3.210. and 3.211.).

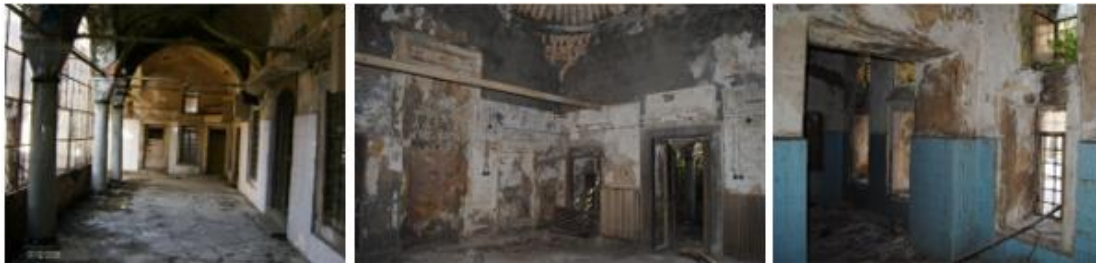
Figure 3.212. Unpermitted harmful interventions in revaks (left), in the classroom (middle) and in a room (right) of Kılıç Ali Paşa Medrese during the nursery function. (archive of DGF)

In Republic Period, during the nursery use, the user made some unpermitted and very dangerous interventions for new function (Appendix B., Chart 7.1.1.) (Figure 3.212.). Within these interventions, almost all the original plasters, floor coverings, windows, doors and metal fancings were changed. Original fireplaces, chimneys and lead dome coverings were removed. Door openings were added destroying the masonry walls between rooms. Some of the doors were closed with brick bonds. Additional top windows were opened on some of the domes. Original octagonal brick pavements were covered with cement splash. Original masonry walls were covered with tiles. Radiator heating system was installed. The revaks were covered with metal framework.

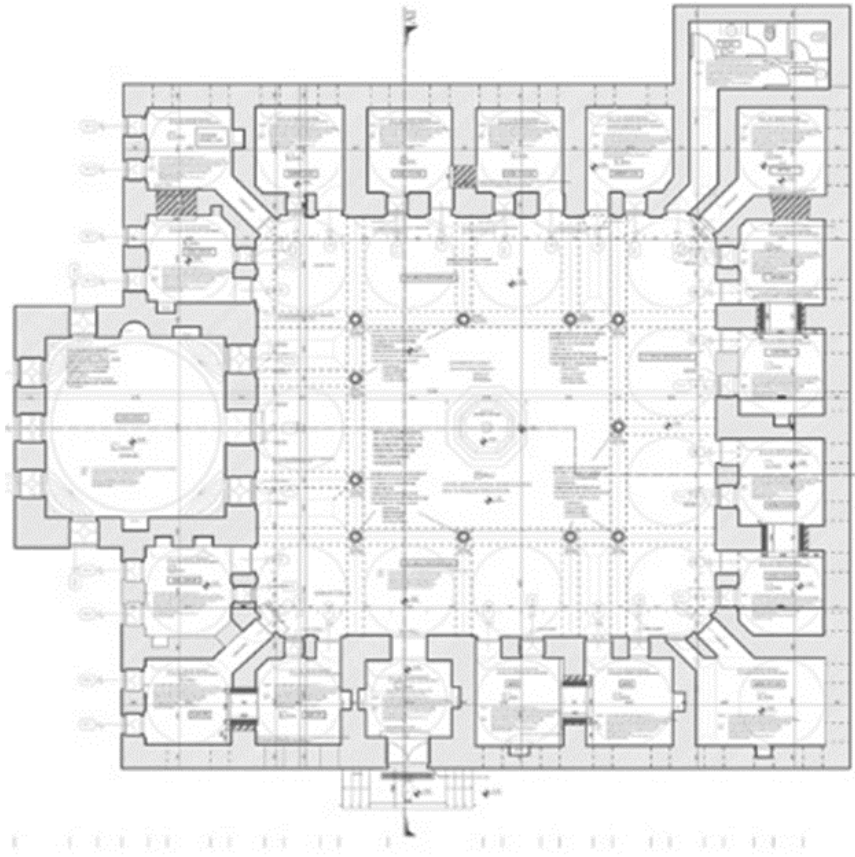
Figure 3.213. Rejected restoration plan proposal (DK Architect)

The last reuse process started with project works in 2002. The first measured drawings, restitution and restoration projects prepared by the new user were rejected in 2003 with the decision number 2003/15438 of the Conservation Council II, for technical reasons and with the condition of proposing a restoration project considering the original features of the building. According to archive documents (Council II documents-1, 2 and 3), as the prepared restoration projects included alternative designs for closure of the revaks and closure of the courtyard systems for new function, (Figures 3.213.-3.215.) the project proposals had never been approved by the council and the allocation was ended. Meanwhile, Kılıç Ali Paşa Medrese was registered in 2003 by the Council II (Council II document 1)

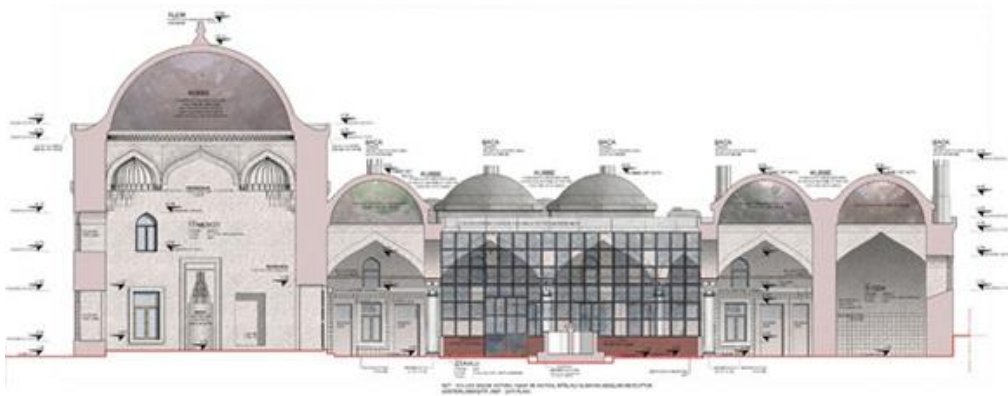
Figure 3.214. Closure of the revaks proposal for Kılıç Ali Paşa Medrese, prepared by DK Architecture in 2005 (DK Architect)
