EVALUATING THE IMPACTS OF REFUNCTIONING ON OTTOMAN  
MEDRESES IN ISTANBUL

A THESIS SUBMITTED TO  
THE GRADUATE SCHOOL OF NATURAL AND APPLIED SCIENCES  
OF  
MIDDLE EAST TECHNICAL UNIVERSITY

IN PARTIAL FULFILLMENT OF THE REQUIREMENTS  
FOR  
THE DEGREE OF MASTER OF SCIENCE  
IN  
CONSERVATION OF CULTURAL HERITAGE IN ARCHITECTURE

SEPTEMBER 2023

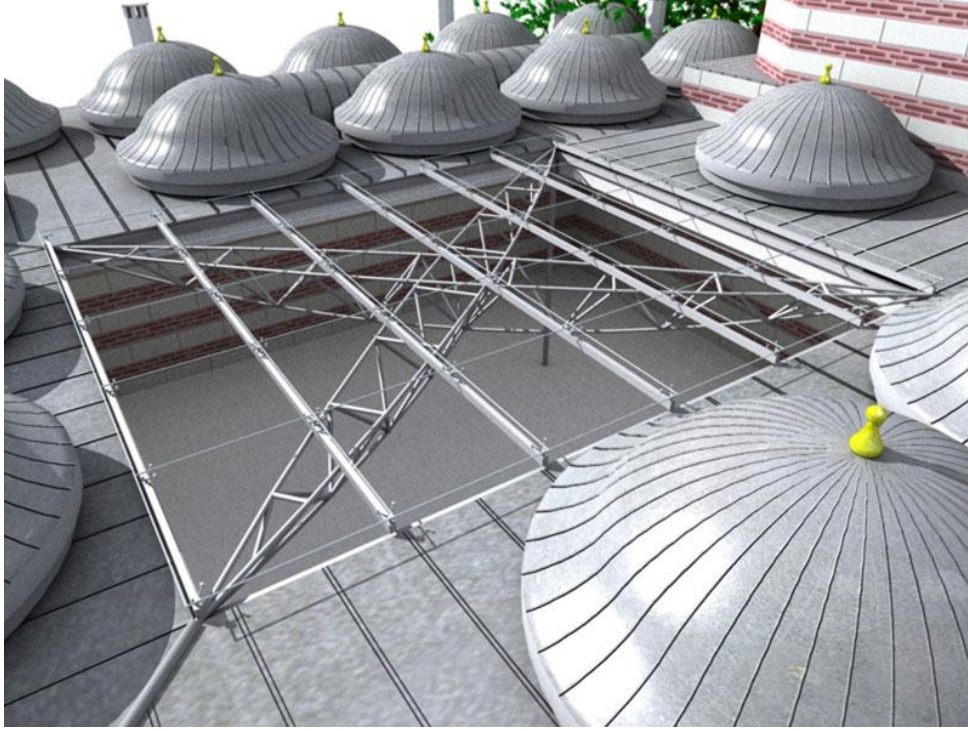
Figure 3.215. Courtyard covering system proposal for Kilic Ali Paşa Medrese prepared by DK Architecture in 2005 (DK Architect)

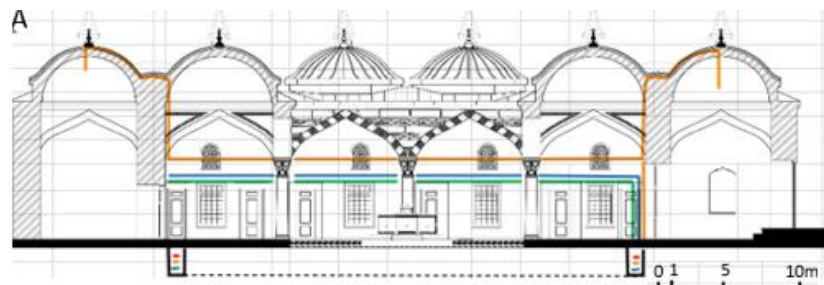
Figure 3.217. Interventions in A-A Section, restoration project by DK Architecture, 2009 (archive of DGF)

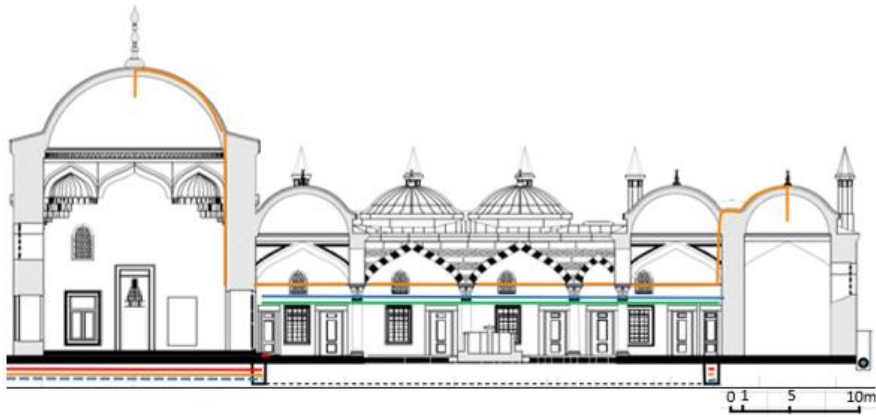
Figure 3.218. Interventions in B-B Section, restoration Project by DK Architecture, 2009 (archive of DGF)

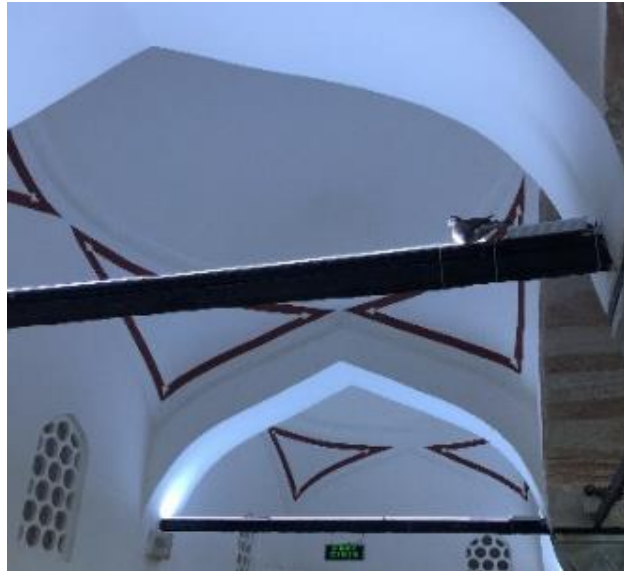
Figure 3.220. (right) Lighting on the tension rods in revaks 2015

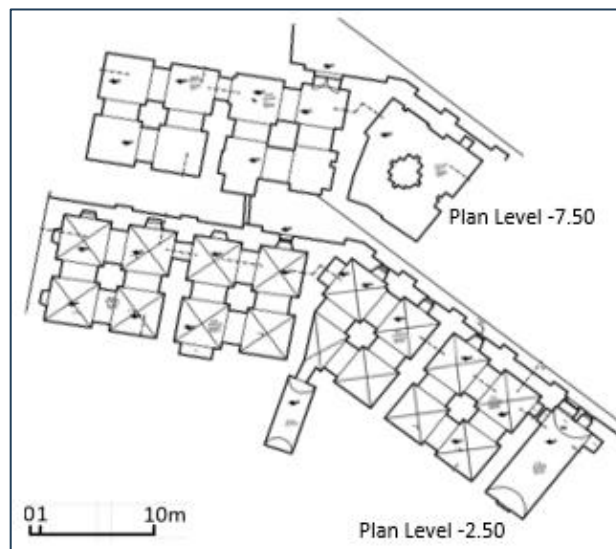
Figure 3.226. Basement Floor Plans restitution Architecture Foundation, 2010 (archive of DGF)

Although the Siyavuş Paşa Medrese has an extraordinary triangular plan scheme, it was typologically considered within distorted U type medreses of Ahunbay's classification. The entrance door from the street directly opens through a small courtyard, at west side of the classroom. The second and triangular courtyard was surrounded with a lead covered wooden shelter as revaks. Behind revaks there were 14 rooms, a classroom and a rectangular space which was supposed to be a laundry in original (Ahunbay 1994-2). 5 of rooms were placed on south wing of the triangle, 1 room and laundry on west wing, 8 of rooms were on north wing (Figure 3.225. and 3.227.). Due to the topography, two partial basement floor was designed as storages and shops (Figure 3.226).

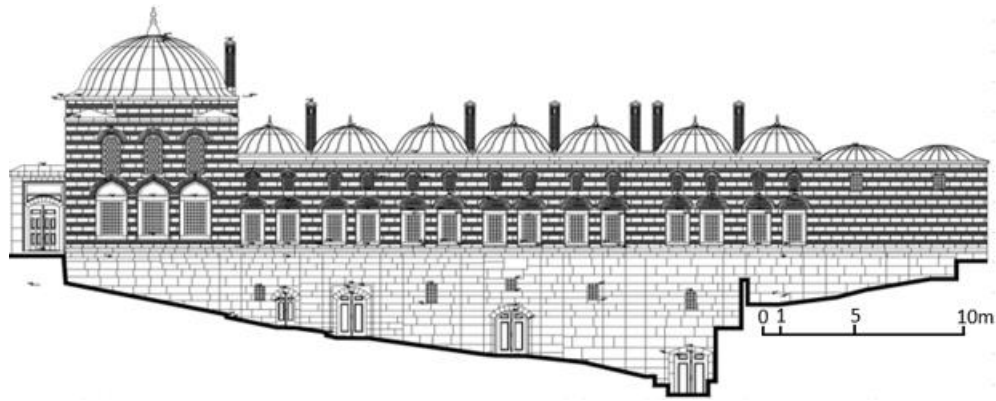
Figure 3.227. North Facade Restitution by Architecture Foundation, 2010 (archive of DGF)

**The Rooms:** The rooms were squared and approximately 3.50x3.50m in size. Each room has a fireplace and 4 niches in the same wall symmetrically designed at both sides of the fireplace (Figures 3.225. and 3.229.). South, west and north rooms had one window facing through courtyard. North rooms had extra 4 windows on north wall, two of them at bottom, two at top (Figure 3.227.).

**The Classroom:** The classroom was also squared, 6.82x6.90m in size. It had a mihrap niche, two medium niches on both sides the mihrap, 5 windows at bottom line and 7 top windows (Figures 3.225., 3.227. and 3.230.).

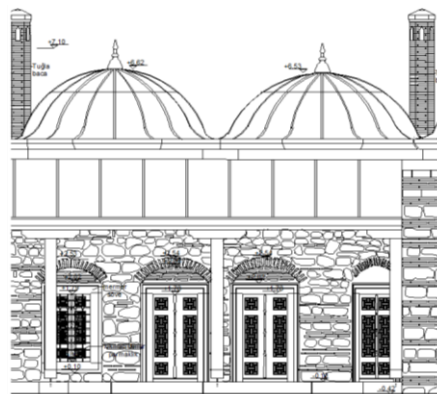
Figure 3.228. South rooms elevation from courtyard in restitution project by Architecture Foundation, 2010 (archive of DGF)

Original revaks surrounding the triangular courtyard were covered with inclined and wood made shelter probably supported by wooden posts in original (Restitution Report of Siyavuş Paşa Medrese 2010) (Figures 3.225. and 3.228.).

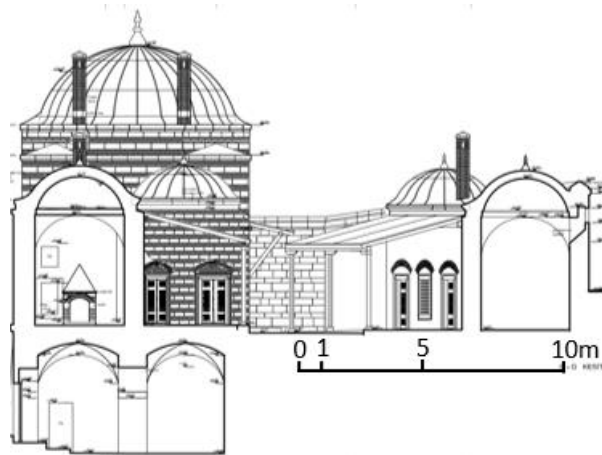
Figure 3.229. G-G Section restitution by Architecture Foundation, 2010 (archive of DGF)

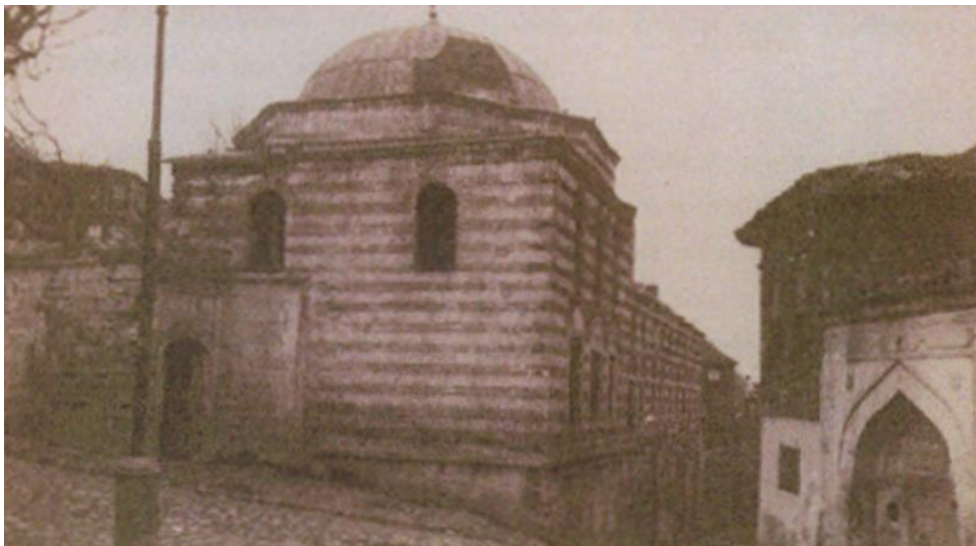
Figure 3.230. East facade, entrance and classroom in 1941 (Town Council Archive)

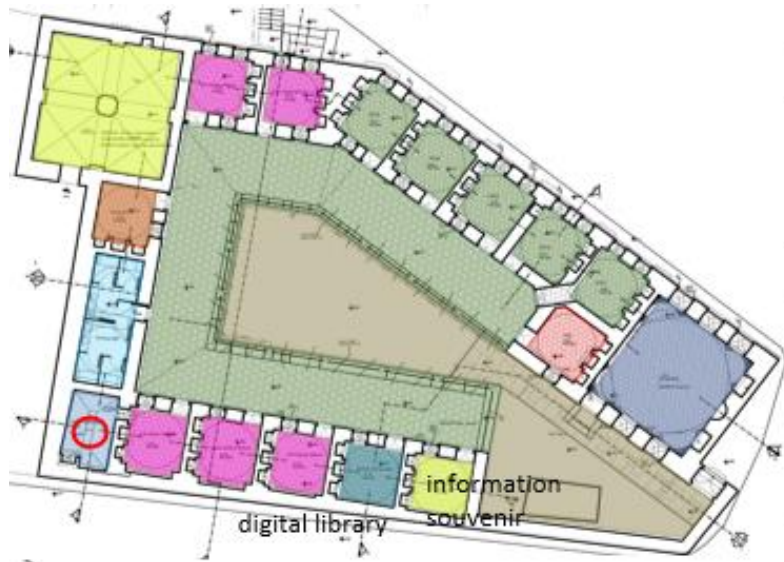
Figure 3.232. Plan of approved restoration project, prepared by Architecture Foundation, 2010 (Archive of DGF)

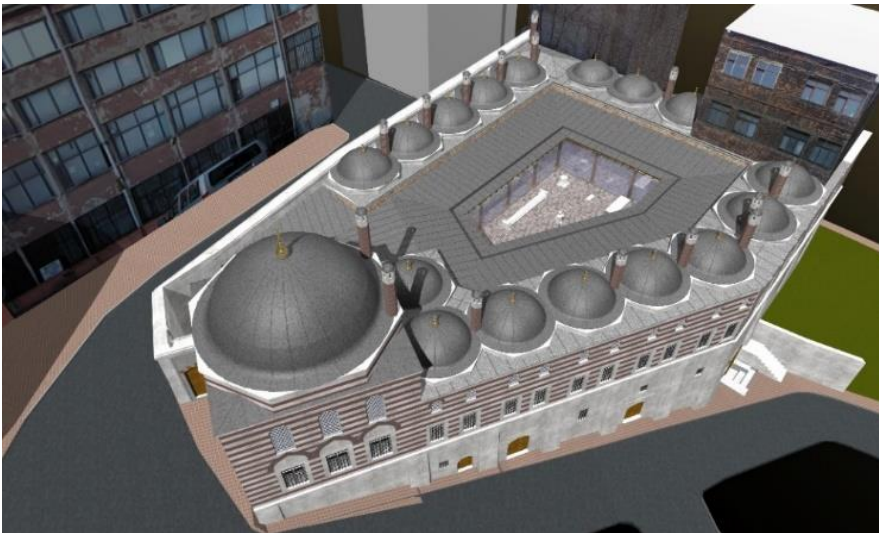
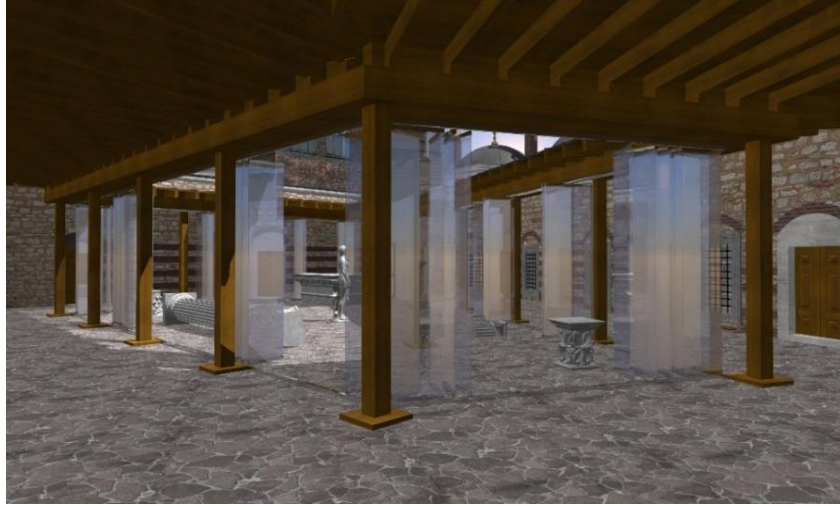
Figure 3.233. Model of restoration plan of Siyavuş Paşa Medrese by Architecture Foundation (archive of DGF)

Figure 3.234. Model of restoration plan of Siyavuş Paşa Medrese by Architecture Foundation (archive of DGF)

According to new use decision as architecture center; the shops would be used for workshop and exhibition activities, the rooms would be used as small workshops, digital library and buffet, the classroom would be used as seminar hall, and the courtyard would be used for broad participated meetings and events (Restoration Report of Siyavuş Paşa Medrese 2010) (Figure 3.232.). The revaks were designed as closable space with non-framed glass seperators so that it could be opened for broad participated meetings to be held in the courtyard (Figures 3.233. and 3.234.).

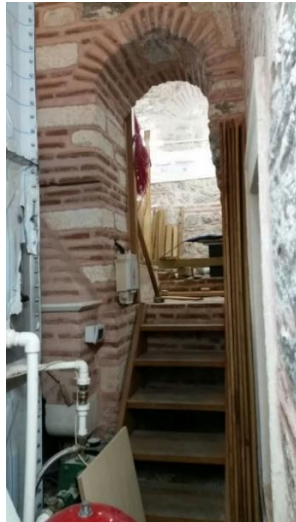
Figure 3.238. Existing door opening connecting two spaces in southwest corner of Siyavuş Paşa Medrese in 2016.

During the restoration, severely deteriorated parts was restored as original (Figures 3.235., 3.236. and 3.237.). The lost architectural and structural elements were completed with suitable materials and details. As all the plasters and hand paint decorations were either original or Ottoman repairs, they had just been consolidated and protected without any complementary plaster or painting. Wooden revaks were reconstructed within this last restoration. Existing door opening between the two spaces in southwest corner was kept for the new use (Restoration Report of Siyavuş Paşa Medrese 2010) (Figure 3.238.).

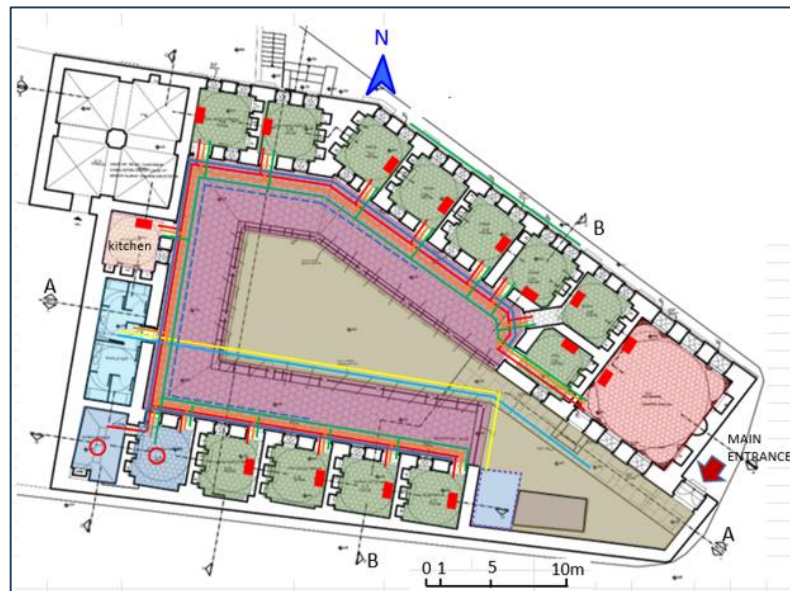
Figure 3.239. Plan (Applied situation), restoration project by Architecture Foundation, 2010 (Archive of DGF)

During the abandoned years between 1914-2007, the medrese had been subjected to natural deteriorations as well as illegal interventions and demolitions by occupants. Within this period, original lead covers had been dismantled, plasters, doors, windows, fireplaces and book cases had been demolished, revaks and ablution fountain in the center of the triangular courtyard had completely been collapsed or destroyed (Figure 3.231.). Two spaces in the southwest corner had been connected with a door demolishing the masonry wall in between (Figure 3.239.).

Before restoration works were about being completed, the medrese had been allocated to Istanbul Art and Civilization Foundation in 2015 as it was expressed above and the medrese refurbished as Hilye and Prayer-Beads Museum. Restoration was completed, however revaks were not covered with the framework. Uses of the spaces were changed (Figure 3.239.). The rooms and the revaks were used for exhibition, the classroom was designed for welcoming and administration (Figure 3.251.). South west corner room used for technical equipment. The bottom niches in rooms were furnished for exhibition and one or two additional small show cases were placed inside of each room (Figures 3.239.-3.241.). In the classroom, niches were refurbished with wooden

bookcases (Figure 3.243.). Installation lines were lyed down in installation channel surrounding the revaks (Figures 3.239. and 3.244.). Heating system was designed and applied as floor heating; however, radiator system was also applied after the restoration had been completed (Figures 3.246. and 3.247.). Electric and CCTV lines inside rooms and the classroom were lyed under plaster (Figures 3.245. and 3.246.). Specially designed chandeliers were used both in the rooms and the classroom (Figure 3.242.). A prefabric additional building was built in the entrance courtyard to protect technical equipment (Figure 3.248.). Triangular courtyard was designed for recreation (Figures 3.249.-3.251.). Revak façade walls and entrance courtyard walls were used for information boards (Figure 3.242.).

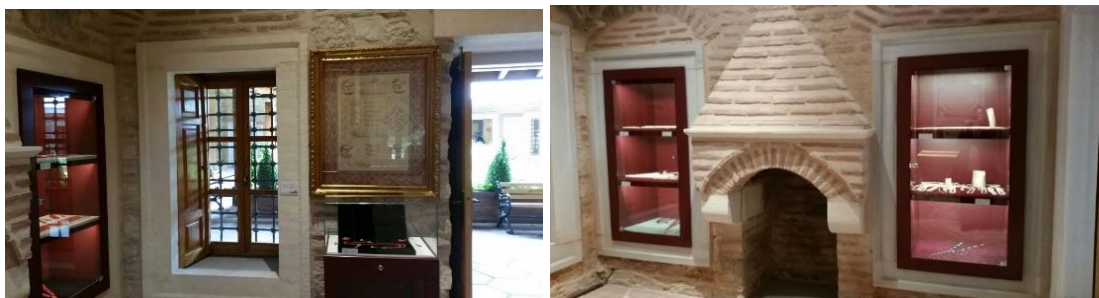
Figure 3.240. (left) South east corner room, refunctioned as a gallery, 2016.

Figure 3.241. (right) Fireplace and niches in rooms, 2016.

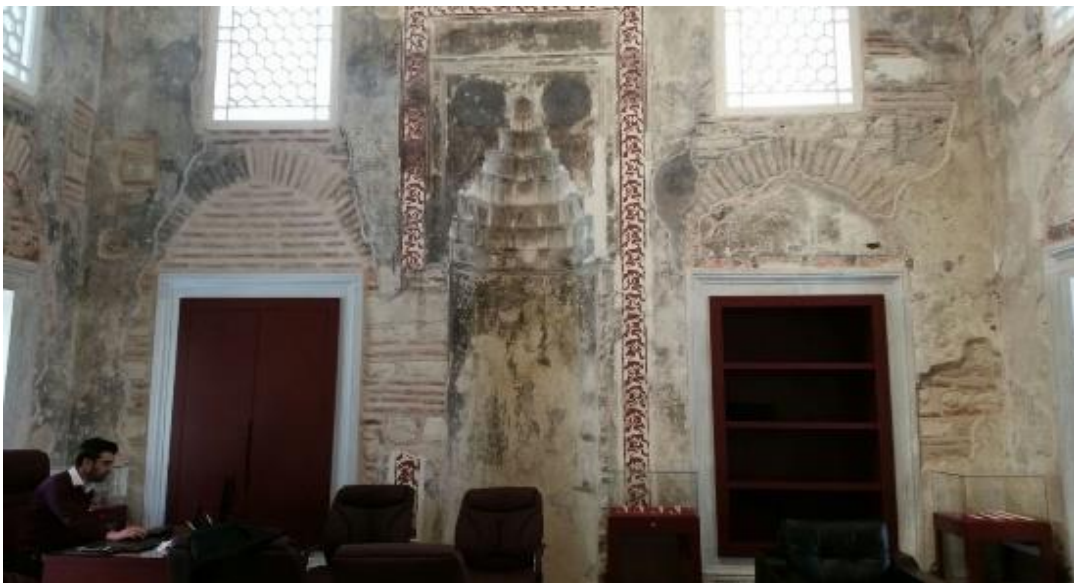
Figure 3.243. Classroom, refunckioned as the administration office, 2016.

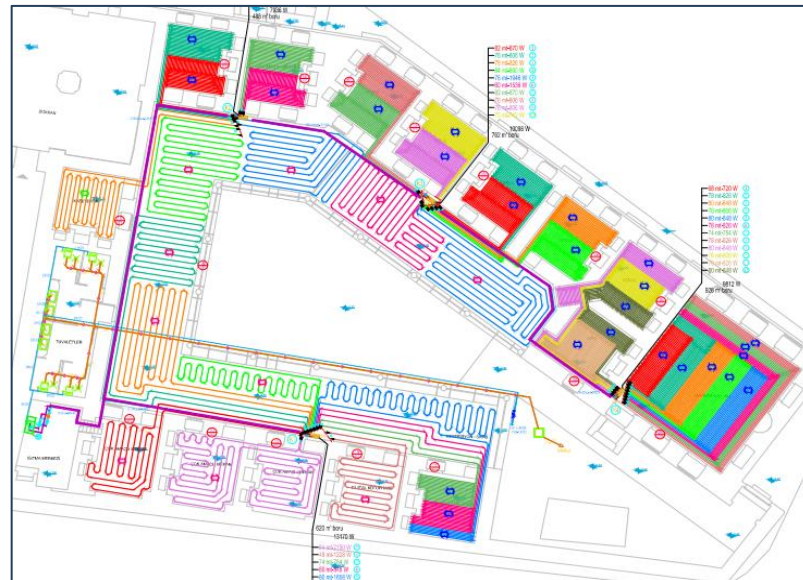
Figure 3.246. Plan, approved mechanical project by Detay Engineering, 2010 (archive of DGF)

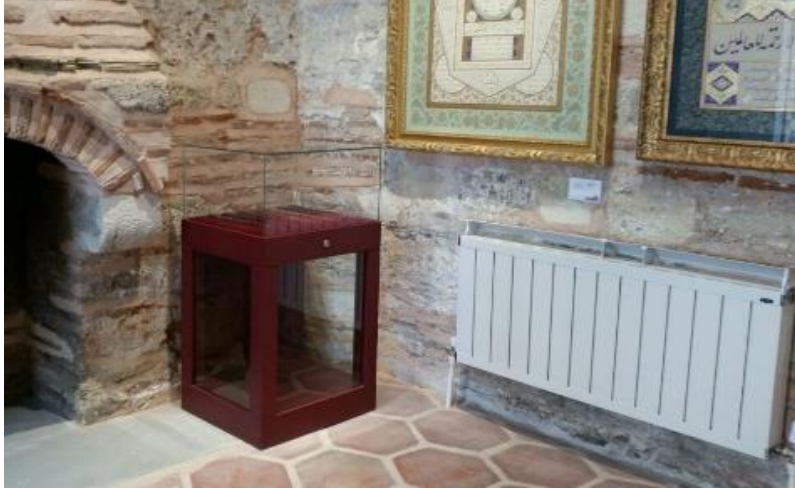
Figure 3.247. Radiator in a room in Siyavuş Paşa Medrese, 2016

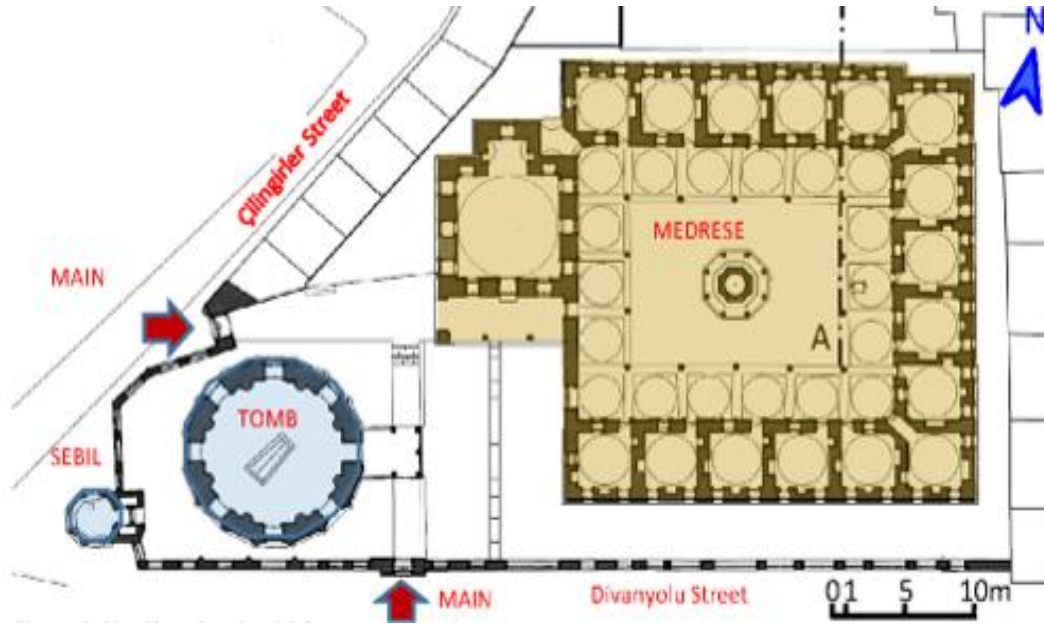
Figure 3.254. Site plan showing 16<sup>th</sup> century situation of Koca Sinan Paşa Complex from restitution project prepared by Anfora Architecture in 2011 (archive of Anfora Architecture)

Koca Sinan Paşa Medrese was part of Koca Sinan Paşa Complex. Koca Sinan Paşa Complex was built by the Grand Vizier, the Conqueror of Yemen, Sinan Paşa between 1592-1593 (Kurşun 2008). The architect of the complex was Mimar Davut Ağa. (Karakaya 2002). The complex consisted of a medrese, a tomb and a sebil (Figure 3.254.). The complex was on the Divanyolu Street (Figure 3.255.) which was the protocol axis of Ottoman Period. However, the entrance of the medrese was on a small garden wall on Çilingirler Street, which opened to Divanyolu.

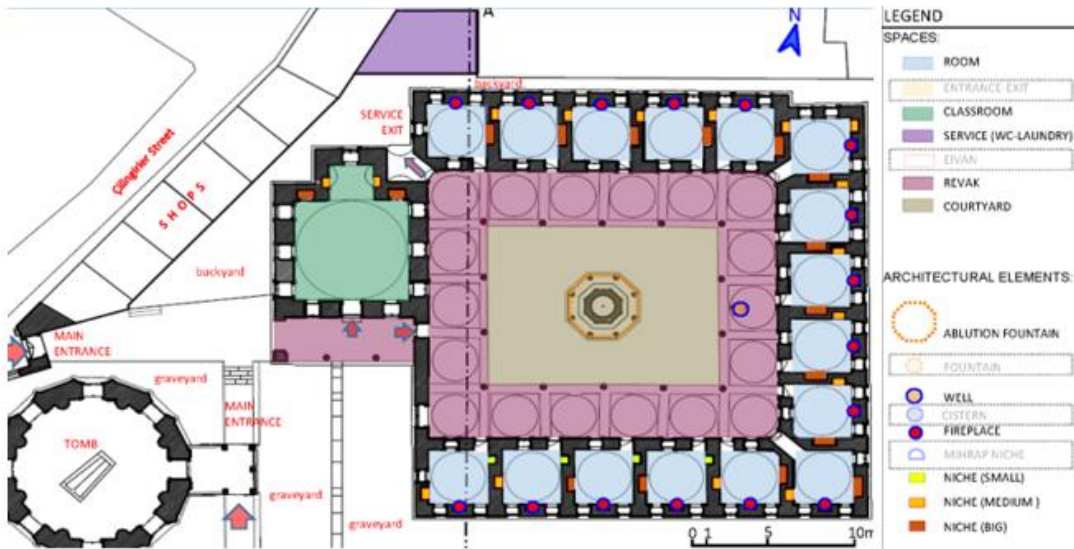
**The Layout:** Koca Sinan Paşa Medrese was a squared building with U plan type (Figure 3.262.). It has 16 rooms around a courtyard with revaks. Revaks surround the courtyard from four sides. On the open end of U layout, the classroom was placed in asymmetric position. The entrance of the classroom was on north side looking through the garden-graveyard- between the medrese and the tomb, not on courtyard side as other usual examples. In front of the classroom, was a revak. The courtyard had a separate entrance from this revak. Behind the classroom was a service backyard. The service backyard was connected with another courtyard on west side of the classroom. As the medrese was surrounded with very close neighbor buildings from north, east and partially from west, the rooms face through north west and especially north east directions were dark and humid.

Figure 3.262. Original layout (produced by using restitution plan) (restitution from archive of Anfora Architecture, 2011)

According to the approved restitution project, the medrese was 28.36x29.19m from outside. It was made from cut stone on Yeniceriler Street, entrance and courtyard facades. Backside facades –north and east facades- were made from alternate brick and lime stone. Revak facades of the rooms and both inside the rooms and the classroom were plastered. The floors of the courtyard, revaks and service backyard were paved with fine-cut lime stone, rooms were paved with brick. All the rooms, classroom and revaks were covered with domes. Domes were covered with lead sheet. Revaks were carried by white-grey, round shaped Marmara marbles with marble capitals. All the capitals have classical baklava decoration. Domes of revaks were not plastered, they were made from exposed fine brick bond. All the window and door frames were made from marble. Windows have classical iron grill called “lokmalı parmaklık”.

The rooms were almost squared and have approximate sizes, 3.74x3.70m. Each room was about 14sqm. Rooms have three windows at bottom level; two of those face through outside, one through revak side. All the outer windows also had one top window above itself (Figures 3.262. and 3.264.). Corner rooms at north east and south east had similar window order; two windows at north and south, one window at east façade and three top windows on the same axis of the bottom windows. Exceptionally, the southwest and north west corner rooms have four bottom and three top windows on three different facades. Each room has a fireplace niche with a chimney in outer wall (Figure 3.262.). The rooms had also two bookcase niches; one was larger –in range of 82x143 and 144x220cm- and the other one was smaller –in range of 92x125 and 53x112cm- (Figures 3.262., 3.265. and 3.266.). The north west corner room had only a larger niche and the north east corner room had three niches.

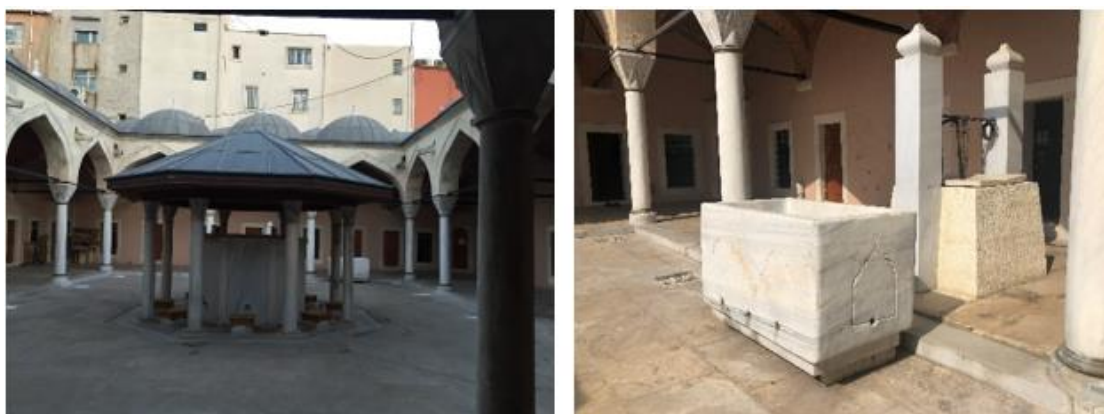
**The Courtyard and Revaks:** The courtyard was 14.3x10.76m. In the middle, there was an octagonal abluion fountain 4.7x4.7m (Figure 3.262.). The fountain was sheltered with a lead covered roof carried by 8 round marble columns (Figure 3.263.).

Figure 3.263. Courtyard and revaks; ablution fountain, well and stone water tank, 2015

The revaks surrounding the courtyard were 30cm higher than the courtyard level. The width of the revaks was 3.7m, height was 5m until the top of the profiled profile. In eastern wing of the revaks, there was a well with stone ring and a pump and a stone water tank next to the well probably for drinking water and ablution.

Some of architectural elements of Koca Sinan Paşa Medrese were also used. The ablution fountain in the middle of courtyard was used with its original function, however the well under the revaks and the stone water tank next to it was unused in 2015 (Figure 3.263.). Niches in the office rooms were redesigned as bookcases with wooden furnitures (Figure 3.278.). Big niches inside the corner rooms were designed as cupboards with wooden covers (Figure 3.265.).

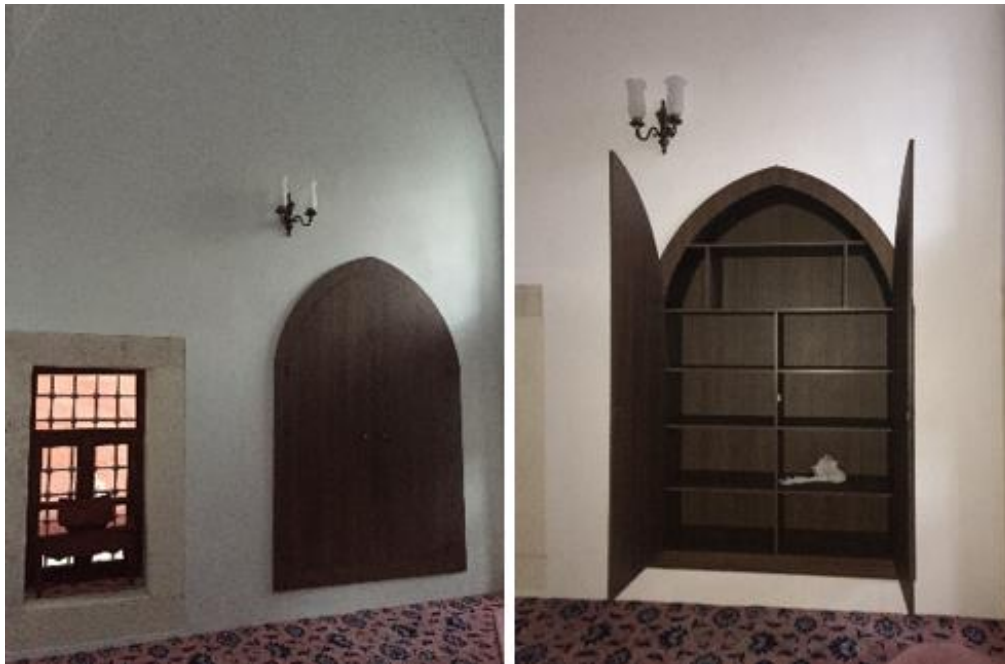
Figure 3.265. Big niche in the room where was used as masjid, 2015

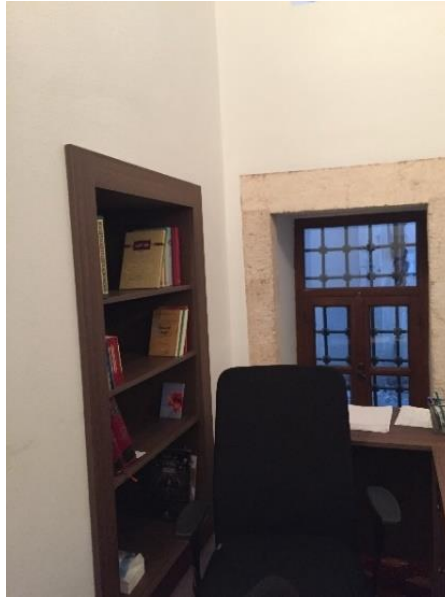
Figure 3.266. Small niche in rooms, 2015

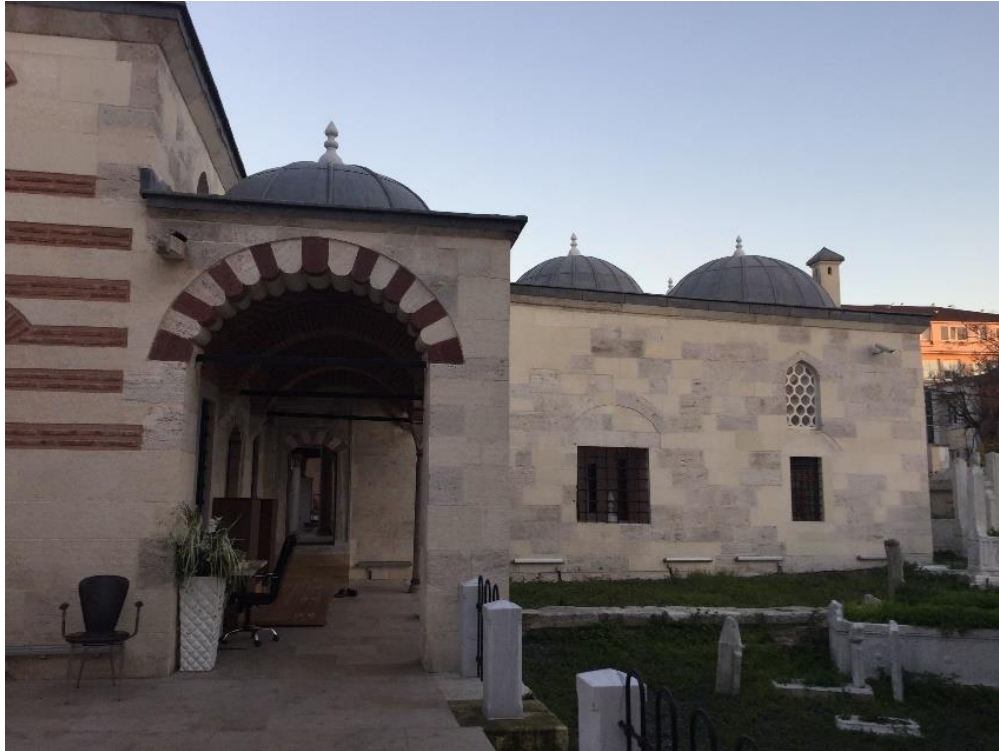
**The Classroom:** The classroom was squared and has a projected sofa on north side.<sup>74</sup> It was 54 cm higher than the revaks in front of it (Figures 3.267. and 3.268.). Those revaks were 54 cm lower than the courtyard revaks. Thus, the classroom stood on the same level with the courtyard revaks. The classroom was 6.59x6.96m in width, and the sofa was 2.42x2.41m. The sofa was a kind of seki which was stilted 21 cm from the main space. The classroom had 8 bottom and 9 top windows. Three bottom and three top windows on west façade and the same order on opposite west façade, but two of those were round shaped. Two windows with the same order existed on both sides of the entrance (Figures 3.262. and 3.269.-3.271.). At the top of the entrance door was also a top window. The classroom has two bookcases on both sides of the sofa (Figure 3.269.). The entrance of the classroom was decorated with red and white entrance arch. The most extraordinary structural elements of the classroom were transition elements on four corners (Figure 3.269.). These were vault ceiled tromps connecting the squared plan to octagonal drum of the dome. On both outer walls of each tromp, two top windows were located. Inside, there were hand drawn decorations on transition zone and at the top of the dome.

Figure 3.267. Revaks of the classroom from west and the entrance of the medrese at the end, 2015

Within restoration and rehabilitation works of Koca Sinan Paşa Medrese, structural reinforcements on domes, masonry consolidations, renewals of plasters and pavements were made as original, renewals of lead covers on domes were done. A new toilet was built in backyard in its probable original place (Figure 3.273.). Electrical, mechanical communicational and security installations were applied including façade lighting. As the original pavement and plaster of interiors had already been changed in past restorations, floor heating, underplaster cable installation and aplics for interior space lighting was preferred and applied. For mechanical and electrical installations, a small installation channel was created surrounding the revaks (Figures 3.273.-3.275.). However, façade lighting and CCTV installations fixed to the façade give damaged to the fine cut stone outer walls (Figure 3.267.).

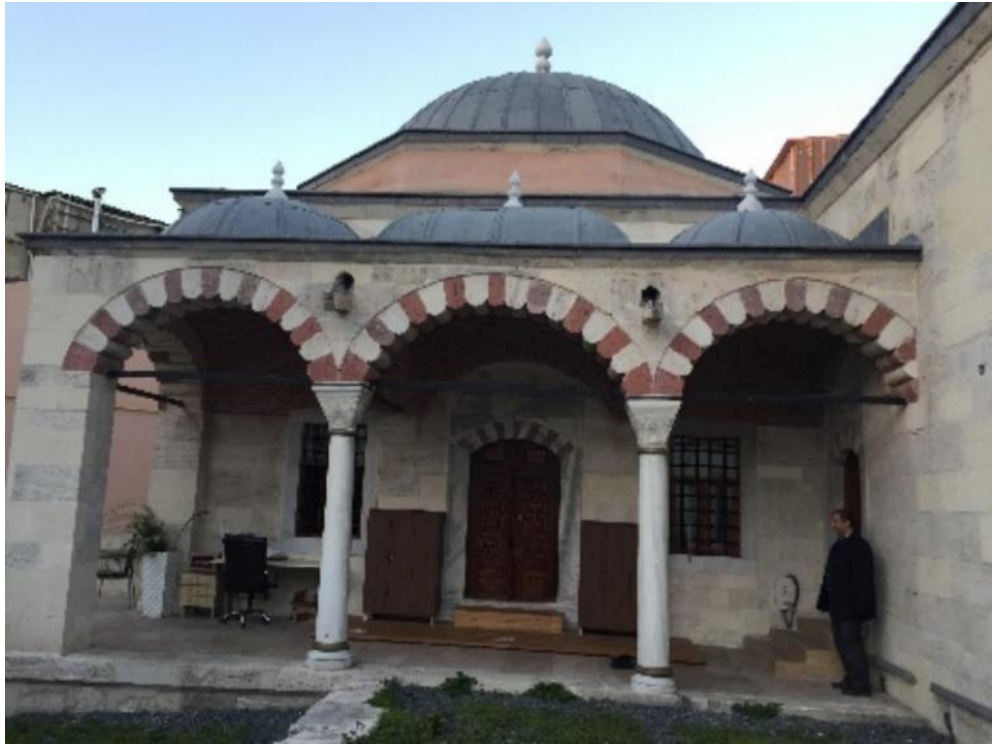
Figure 3.268. Revaks of the classroom from south, 2015

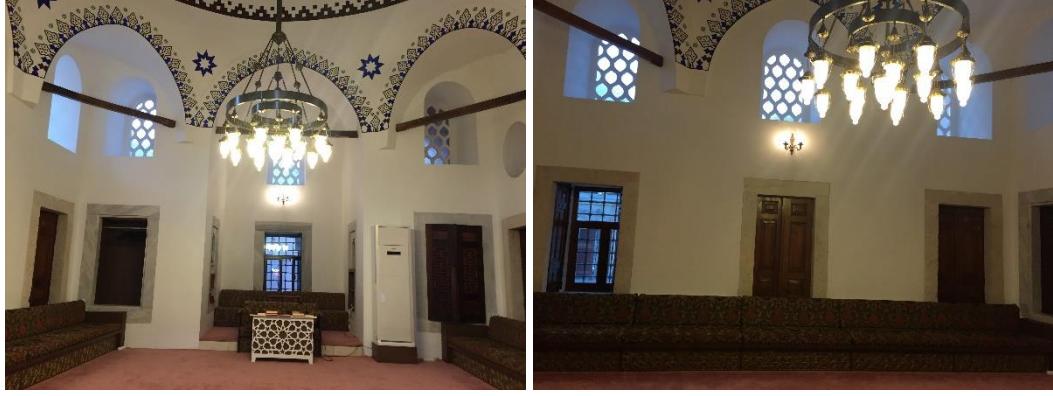
Figure 3.269. (left), Classroom north wall and transition elements, 2015

Figure 3.270. (right), Classroom east wall window order, 2015

Medrese rooms were reused for cultural- educational and administrative facilities for the user foundation (Figure 3.273.). Closer rooms to the entrance were reused for security and administration. Service spaces were designed in the rooms looking toward backyard. Corner rooms opening through two sides and well sunlighted ones were reused for secondary facilities like accommodation, storage, masjid and security. Other rooms were reused as book translation offices designed for two users. Exceptionally, one of more illuminated room look through front façade was assigned to a calligrapher for giving a course (Figure 3.276.). Accomodation service was for foreign students who need temporarily to accommodate. Classroom was used for cultural seminars open to all interested people, as well as tourists. Interior design was made in sedir order referring to sofa order of a traditional Turkish house (Figures 3.269. and 3.270.). As the classroom needed to be air conditioned during large scaled seminars, a portable air conditioner was placed inside after the restoration (Figures 3.269. and 3.277.).

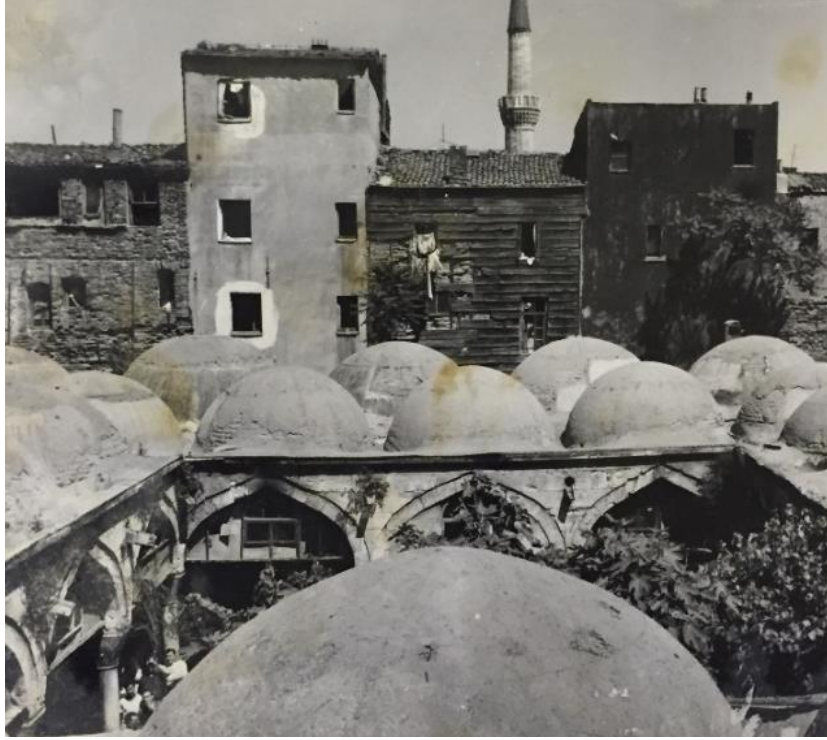
During 1926-1957 allocation, the medrese was damaged with improper interventions (Figure 3.272.).

Figure 3.272. Koca Sinan Paşa Medrese in 1964 (archive of IRDF)

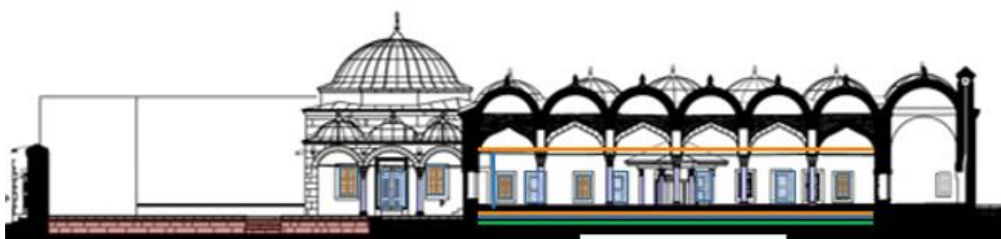
Figure 3.274. Reuse interventions applied on A-A section of restoration project by Anfora Architecture in 2011 (restoration project from archive of Anfora Architecture)

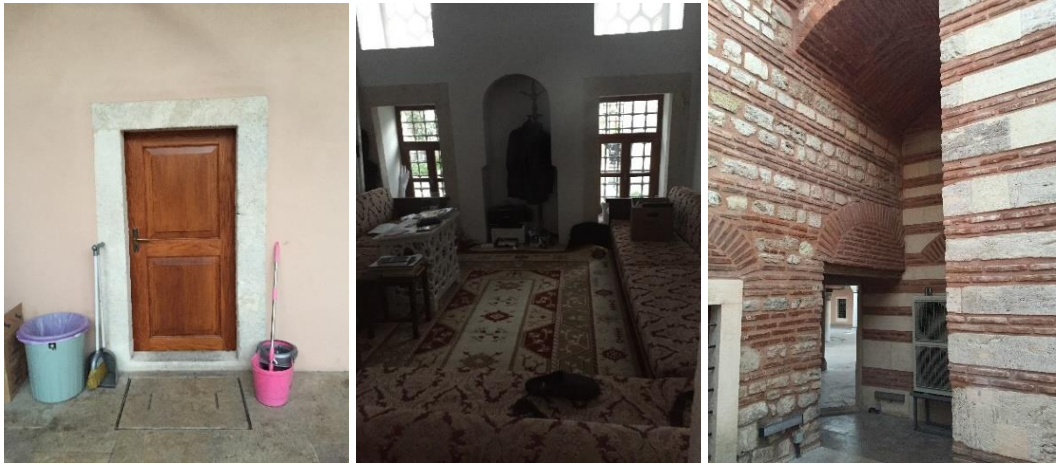
Figure 3.275. (left) Control cap on the installation channel surrounding revaks, 2015  
Figure 3.276. (middle) The room refurnished for calligraphy workshop, 2015  
Figure 3.277. (right) External airconditioning unit of the classroom, 2015

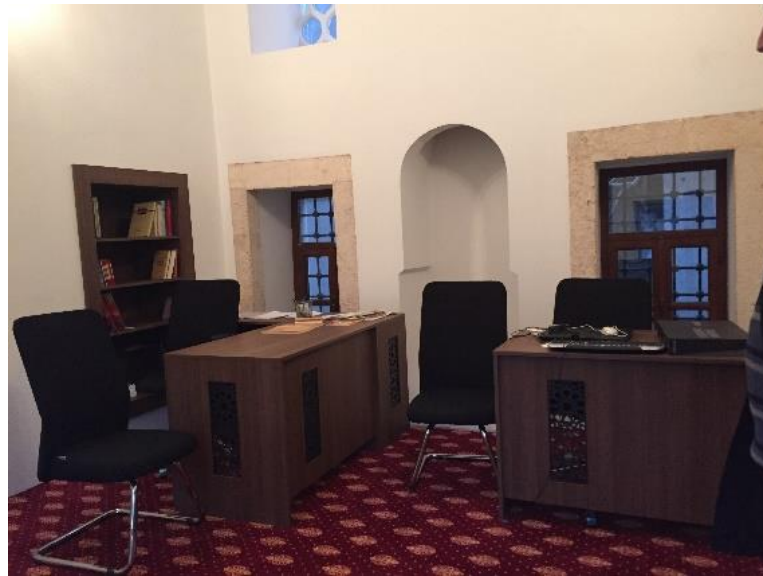
Figure 3.278. The room refurnished as translation office for two users, 2015

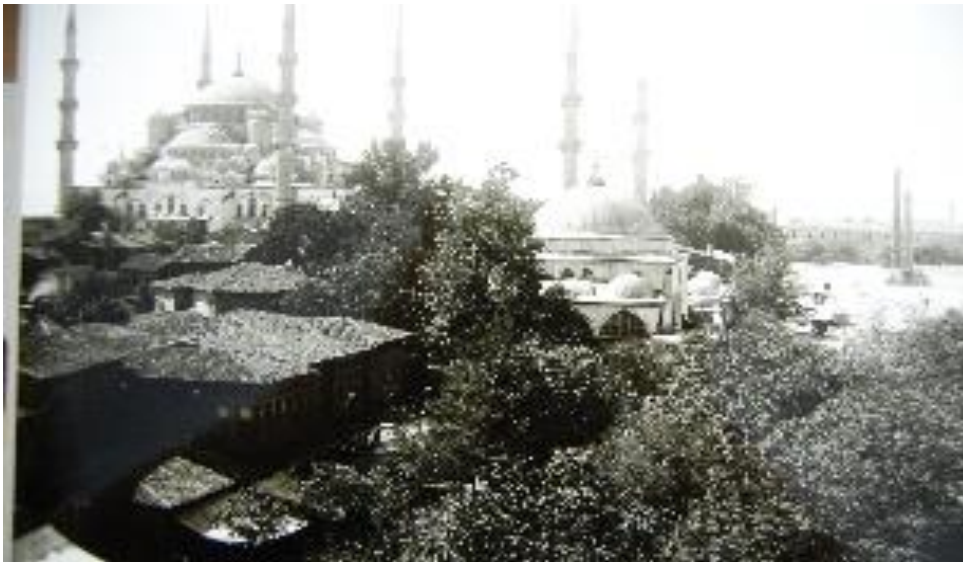
Figure 3.288. Mosque from Haqia Sophia and district 1910's (archive of DGF)

In 19<sup>th</sup> century the area was full of houses (Figures 3.288. and 3.289.). In this century, on some of the buildings of the complex located at the end of Hippodrome that had been demolished or collapsed before, Hamidiye Commercial School was built. Darülfünun and Tapu Kadastro Headquarter were also constructed in the Sultanahmet area.

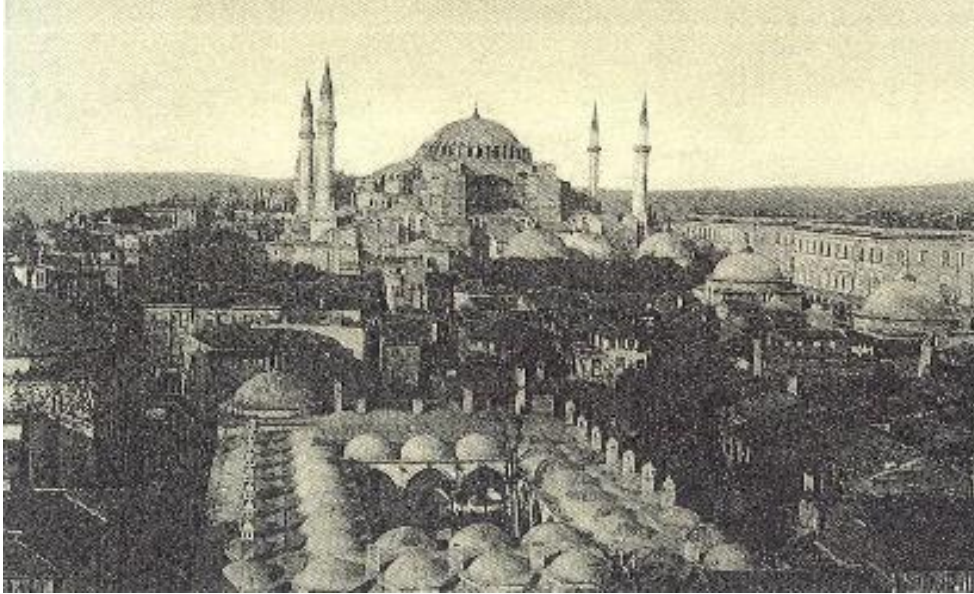
Figure 3.289. Medrese and district surrounding it in 1900's (Eski İstanbul Resimleri)

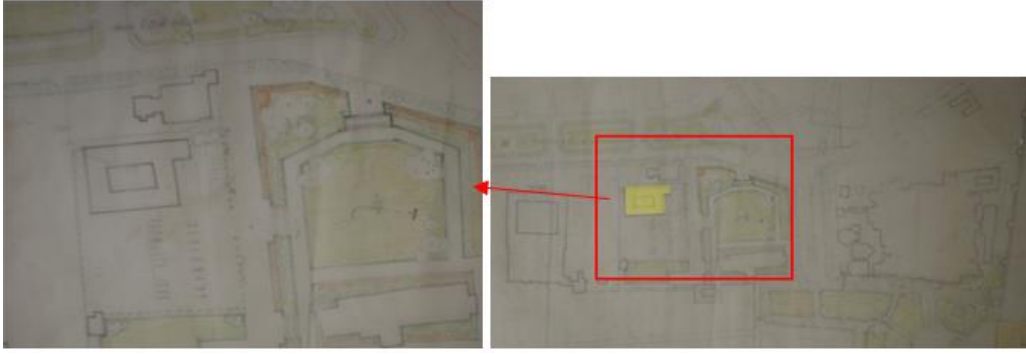
Figure 3.290. Sultan Ahmet Medrese (in detail) in Sultanahmet Archaeologic Park in Prost Plan, 1940

In 2016, Sultanahmet Area was the most important historic, archaeological and architectural touristic center of Istanbul. The area, which is known as “Sultan Ahmet Archaeological Park” since 1953 was also one of the four World Heritage Sites of Istanbul since 1995 (Figure 3.290). Within the site, there were 990 listed heritage assets 207 of which -that was 21%- were foundation heritage (IHMR 2011, pg.45) (Figure 3.291). Sultan Ahmet Medrese was within and part of this universally important site. On the other hand, Sultan Ahmet Complex was declared within the “Sultanahmet Square Tourism Center” by Ministry of Tourism and Culture in accordance with “Tourism Encouragement Law”, law no 2634. The complex was also the source the name of the district Sultanahmet.

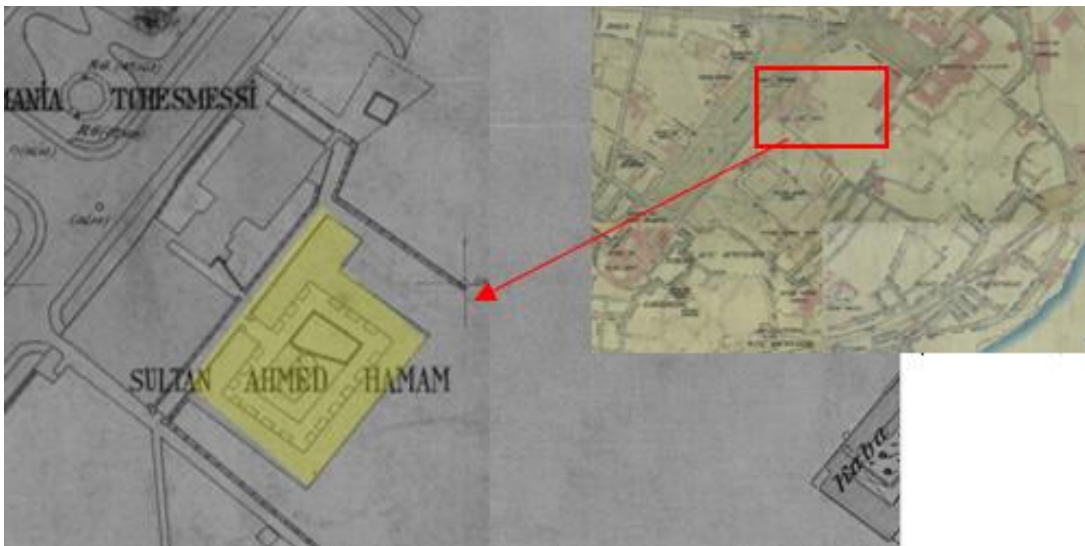
Figure 3.292. Sultan Ahmet Medrese in German Blues, 1909-1913

**Layout:** The Sultan Ahmet Medrese was a self standing building and it was located at northeast of the Sultan Ahmet Mosque (Figure 3.280). It was reached by a narrow dead-end street between the medrese and the garden wall of the tomb and darulkurra (Figure 3.292). End of the street there was a small gate in the garden wall of the mosque connecting the medrese to the mosque. In the middle of this small street, entrance of the medrese was on the south. On the northern side, there was a small garden gate of the darulkurra.

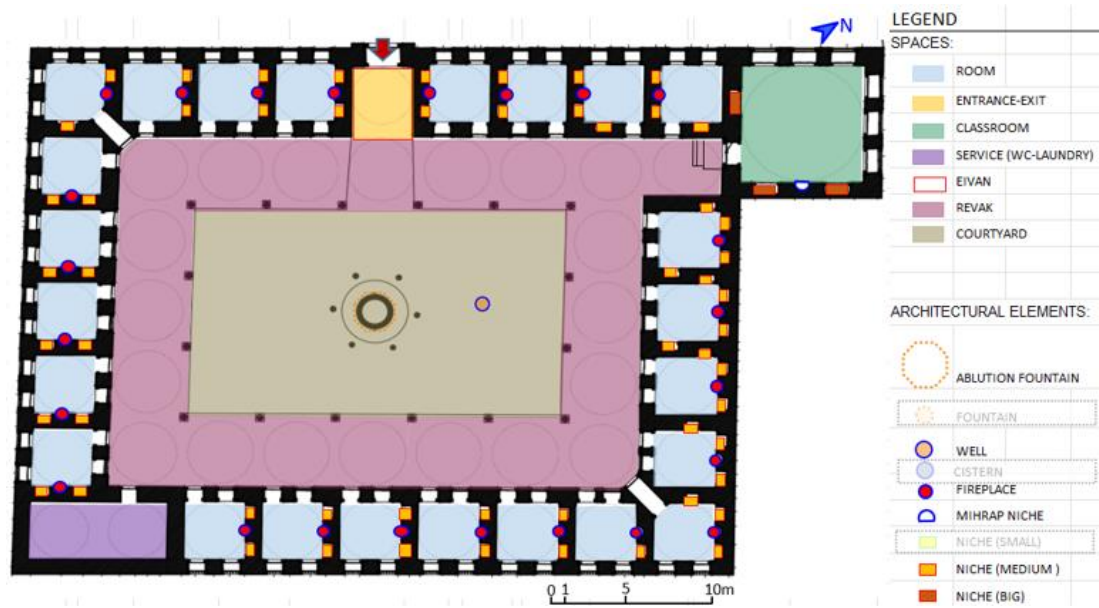
Figure 3.293. Plan showing the original architectural and functional features of Sultan Ahmet Medrese applied on Restitution Plan of Sultan Ahmet Medrese. (restitution Project from archive of Anfora Architecture, 2011)

Sultan Ahmet Medrese was a rectangular building with rectangular type layout (Figure 3.293). It was 42.39x33.57m from outside. The height was 5.84 m. The entrance was a gradually simple and located in the middle of the façade facing through the dead-end street.

There was also a well in the courtyard as an architectural element (Figure 3.293). Except for these, there were two, marble caved, decorated, stand alone, movable

**The Service Space (Toilets and Laundry):** Service space was at the south corner (Figure 3.293). It was 8.44x3.62 m in size and covered with two domes. There were six rectangular crenels 3.8 m up to ground level and six small light holes in the domes for lighting and ventilation. Original toilet cabins were not surviving in 2016.

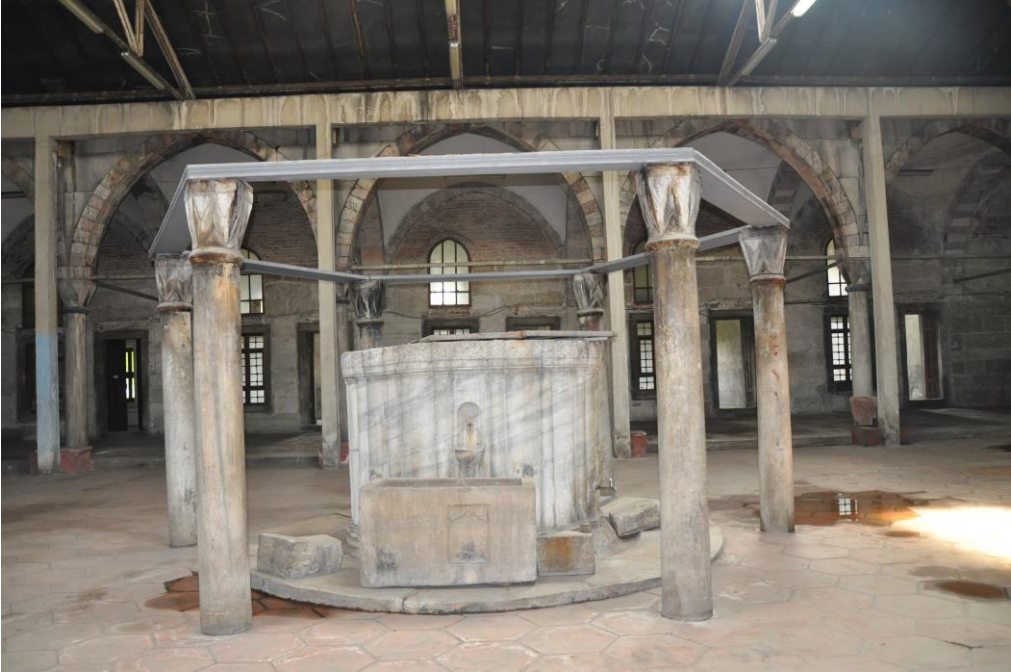
Figure 3.294. Carved marble water tank in front of the ablution fountain, 2011

architectural elements related with drinking water facility in the medrese; a sebil pool and a small size marble water tank (Figures 3.294.-3.296.).
