EVALUATING THE IMPACTS OF REFUNCTIONING ON OTTOMAN  
MEDRESES IN ISTANBUL

A THESIS SUBMITTED TO  
THE GRADUATE SCHOOL OF NATURAL AND APPLIED SCIENCES  
OF  
MIDDLE EAST TECHNICAL UNIVERSITY

IN PARTIAL FULFILLMENT OF THE REQUIREMENTS  
FOR  
THE DEGREE OF MASTER OF SCIENCE  
IN  
CONSERVATION OF CULTURAL HERITAGE IN ARCHITECTURE

SEPTEMBER 2023

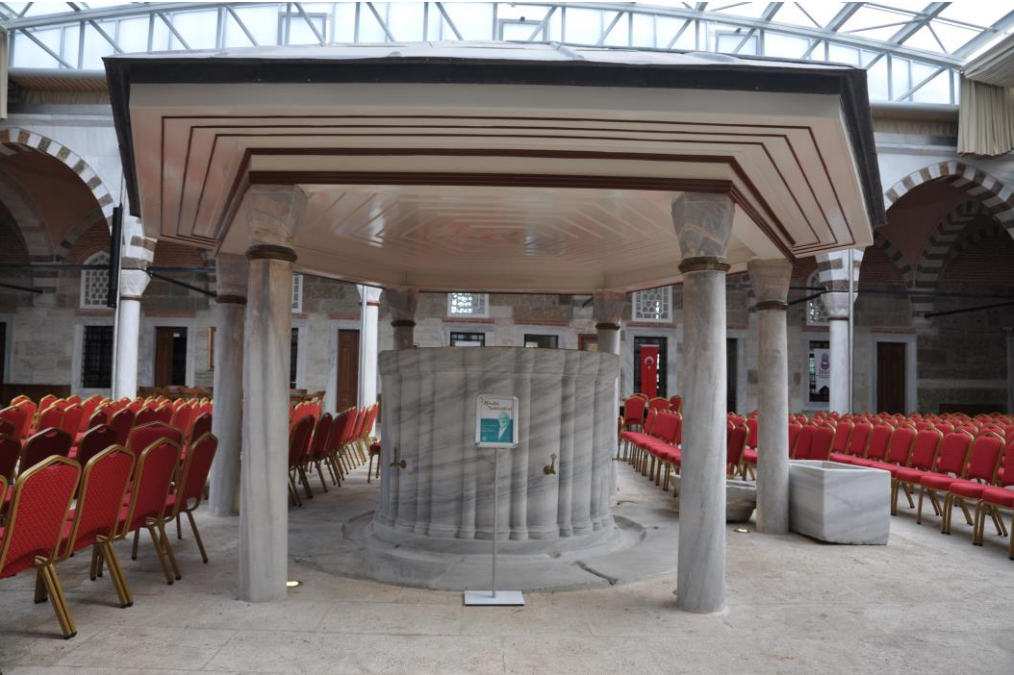
Figure 3.295. Carved marble water tank in front of the ablution fountain, 2016

architectural elements related with drinking water facility in the medrese; a sebil pool and a small size marble water tank (Figures 3.294.-3.296.).

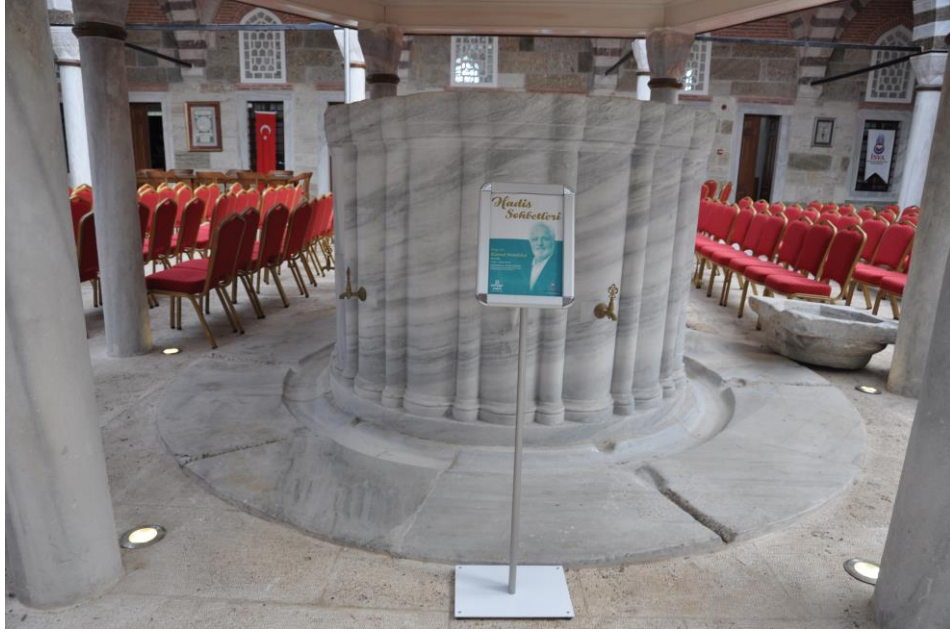
Figure 3.296. Drinking water pool in front of the ablution fountain, 2016

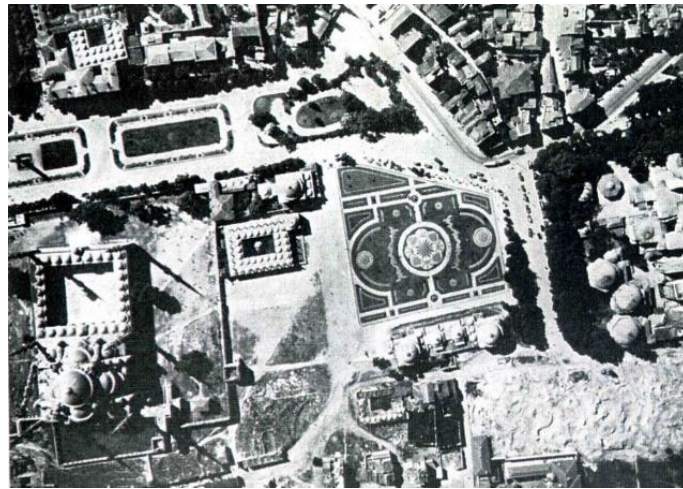
Figure 3.297. Sultan Ahmet Medrese in aerial photo around 1933-1935<sup>80</sup> (archive of Halil Onur)

<sup>80</sup> The demolished building in the right bottom corner was the Ministry of Justice, old Darulfunun. The photo shows the situation after it has burnt in a fire at 3-4 December 1933 night. (Öğretmenler Vakfı)

At the beginning of 20<sup>th</sup> century, Sultan Ahmet Medrese was affected from İshak Paşa Fire in 1912 and immediately repaired once again. The medrese was one of the very few medreses that was in very good condition in 1914 inspection (Figure 3.297). The last repair of Ottoman period was in 1916-1917 (Kütükoğlu 2000, p.39)

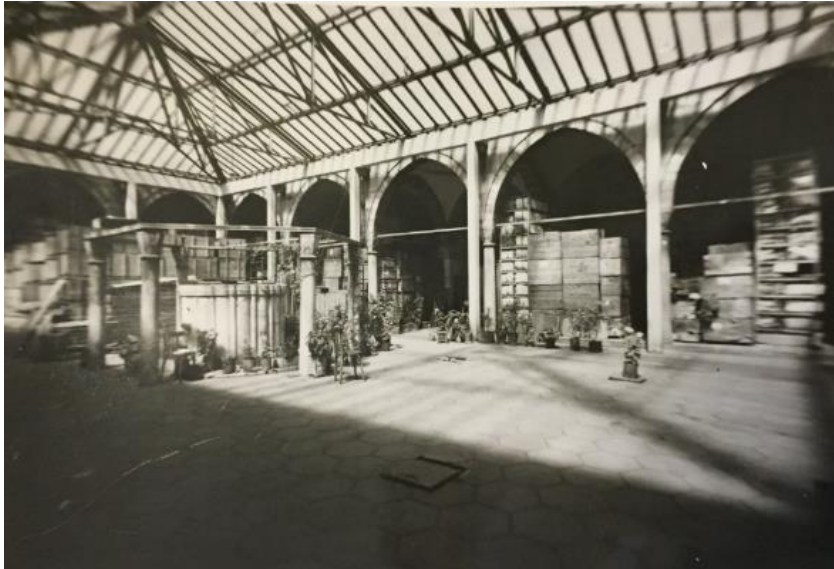
Figure 3.298. Sultan Ahmet Medrese as archive store, after 1935 (archive of DGF)

In 1935, the medrese had a comprehensive repair to be refunctioned as storage (Kütükoğlu 2000, p.39) by General Directorate of Archives of Prime Ministry. Within this repair, courtyard was covered with a metal roof supported by 16 reinforced concrete columns. Probably, courtyard was also covered within the same repair due to the function (Figures 3.298. and 3.299.). Later, the octagonal roof of ablution fountain was dismantled probably before 1962 and some interventions were made to the roof for sun light control in time (Figure 3.300), and some remains from wooden ceiling and pavement from recent unpermitted repairs for officers in the room located at the south west of the entrance eivan (Figure 3.301.). Because, General Directorate of Archives of Prime Ministry had committed in 1962 dated allocation protocol with the condition of “not to make any change in the medrese without permission of DGF” during the 1962-2012 allocation (DGF document-12). In 1966, General Directorate of Archives of Prime Ministry applied to DGF to repair the medrese, however, except for an inspection report for the current situation and a measured drawing plan prepared by DGF technicians, there was no document about any repair after that application. The situation was still protected in 1966 (DGF document-13).

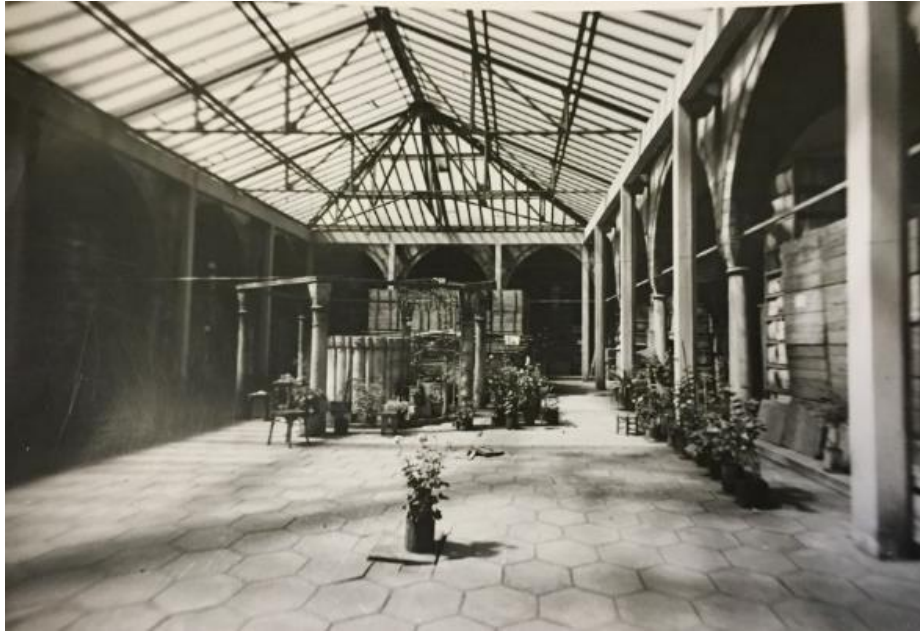
Figure 3.299. Sultan Ahmet Medrese as archive store, after 1935 (archive of DGF)

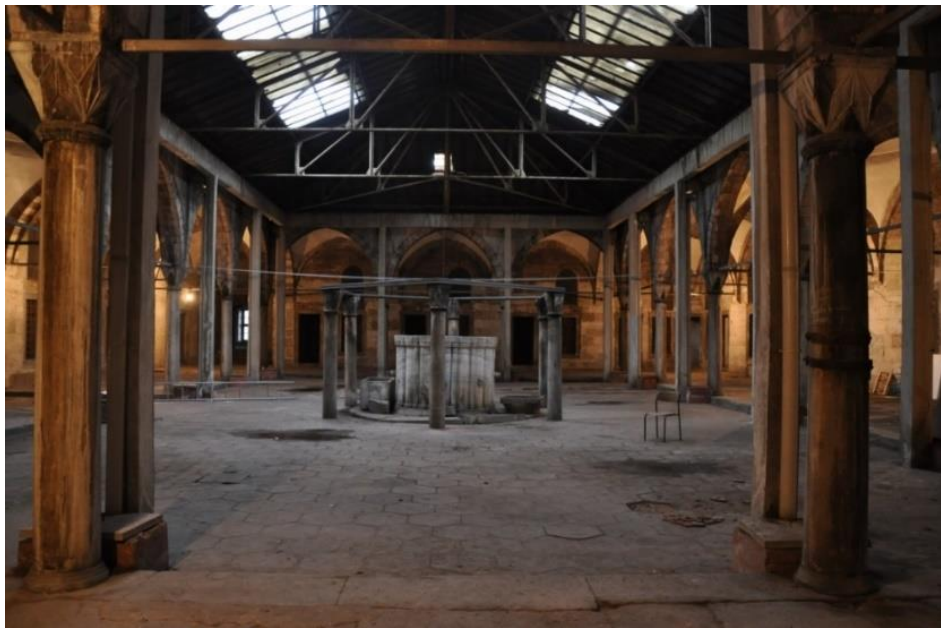
Figure 3.300. Courtyard of Sultan Ahmet Medrese in 2011, before restoration

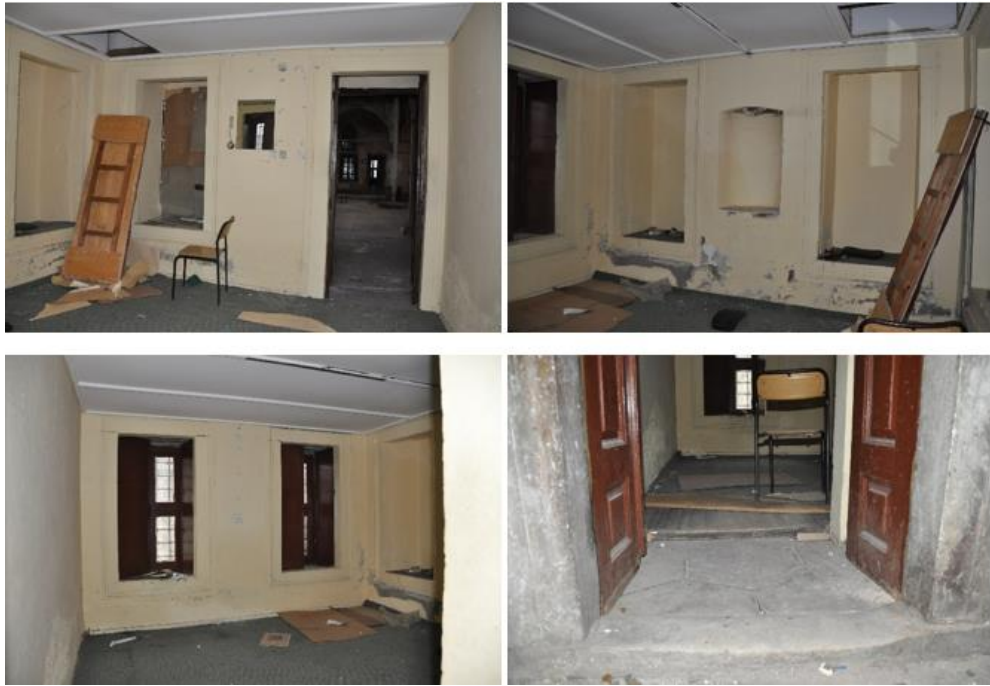
Figure 3.301. The situation of unpermitted past interventions in the room on south west side of the entrance eivan of Sultan Ahmet Medrese in 2011, before restoration

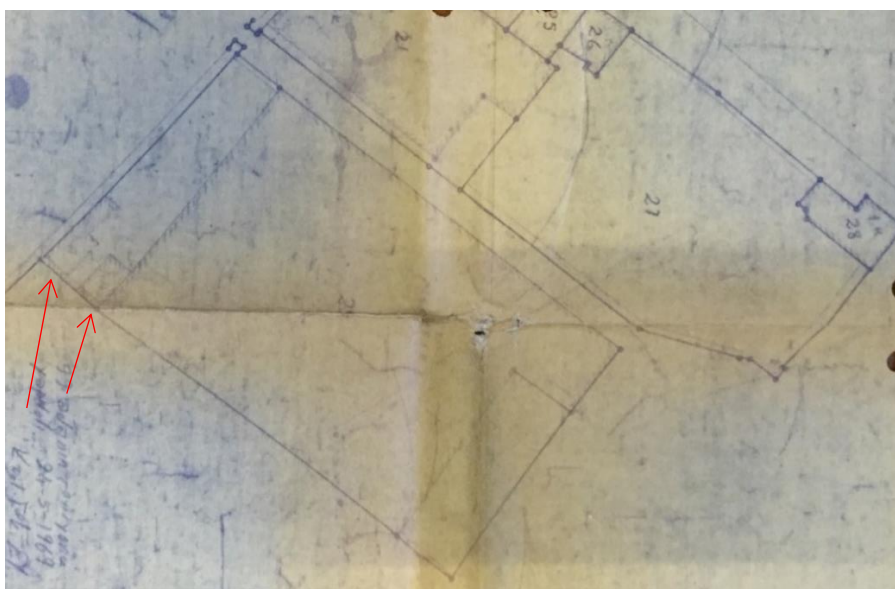
Figure 3.302. Cadastral map showing unpermitted occupations in backyard of Sultan Ahmet Medrese in 1969. (archive of DGF)

According to archive documents, backyard of the medrese was occupied by an unpermitted barracks around 1960's and used by a family (Figure 3.302.). Afterwards, the barracks were removed.

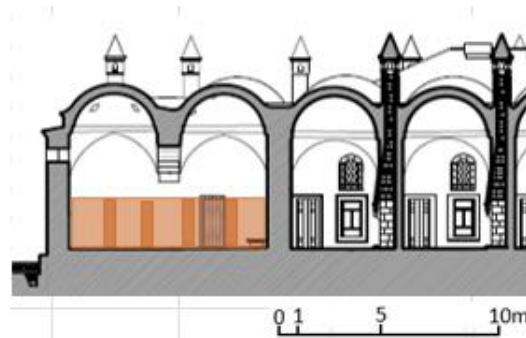
Figure 3.304. Reuse interventions for toilets applied on C-C Section of restoration Project made in 2011 (restoration Project from archive of Anfora Architecture)

Projects and reports were approved with the council IV decision no 2011/4747 in 15.08.2011 without any change or suggestion. According to approved restoration project, except for conservative interventions, the medrese was restored in accordance with the restitution project. In addition, existing courtyard roofing was decided to be kept as a significant addition, ablution fountain roofing was reconstructed and toilets were reorganized with wall additions (Figures 3.303.-3.306.).

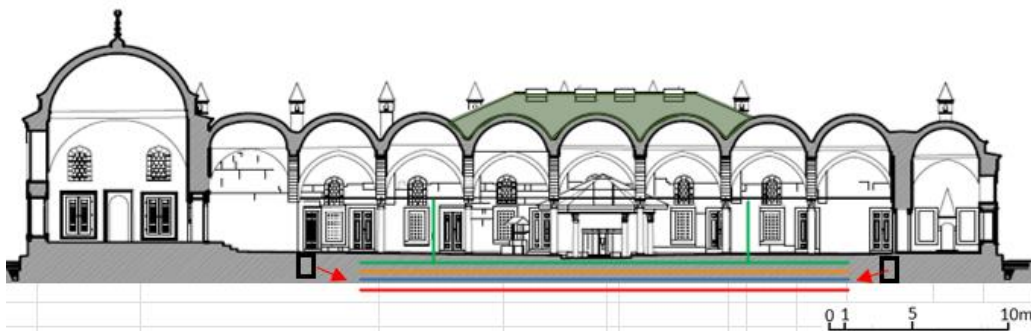
Figure 3.305. Reuse interventions applied on A-A Section of restoration Project made in 2011 (restoration Project from archive of Anfora Architecture)

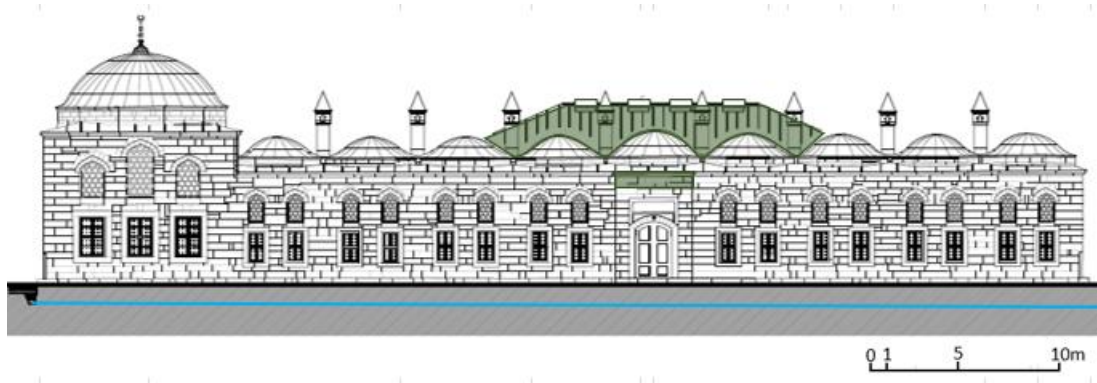
Figure 3.306. Reuse interventions applied on North-West Facade of restoration Project made in 2011 (restoration Project from archive of Anfora Architecture)

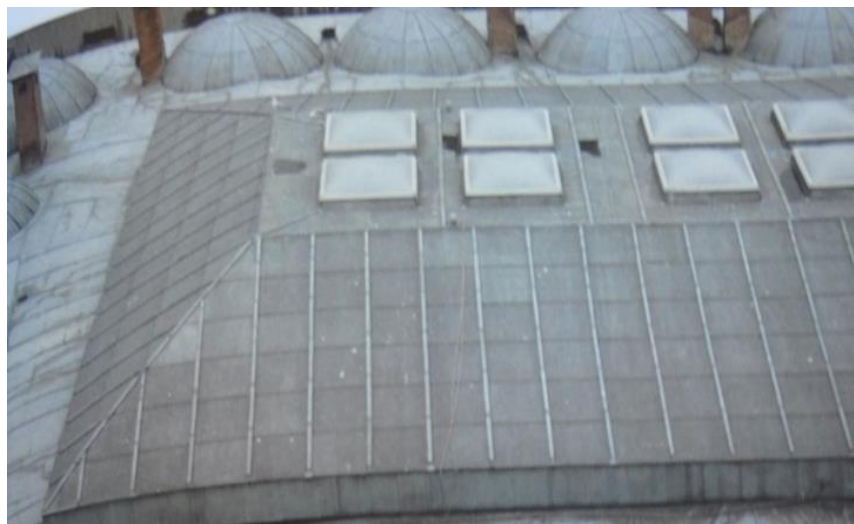
Figure 3.307. 1920's Courtyard Roofing of Hamidiye Medrese in Eminönü, (Restoration Report of Sultan Ahmet Medrese 2011)

According to the restoration report, the reason of keeping the courtyard roof was that *“the roof addition of 1935 was one of the rare examples of bolted roof covering construction additions of the period”* and it has no structural problems. Thus, the roof would be kept but covered with aluminum panels instead of existing curved sheets, as aluminum was a compatible material with lead covers of the domes. The polycarbon made roof windows will be made at alongside the roof ridge for both ventilation and prevention of the greenhouse effect just like the roof windows of Istanbul Commerce Stock Market, Hamidiye Medrese (Figure 3.307.) (Restoration Report of Sultan Ahmet Medrese 2011).

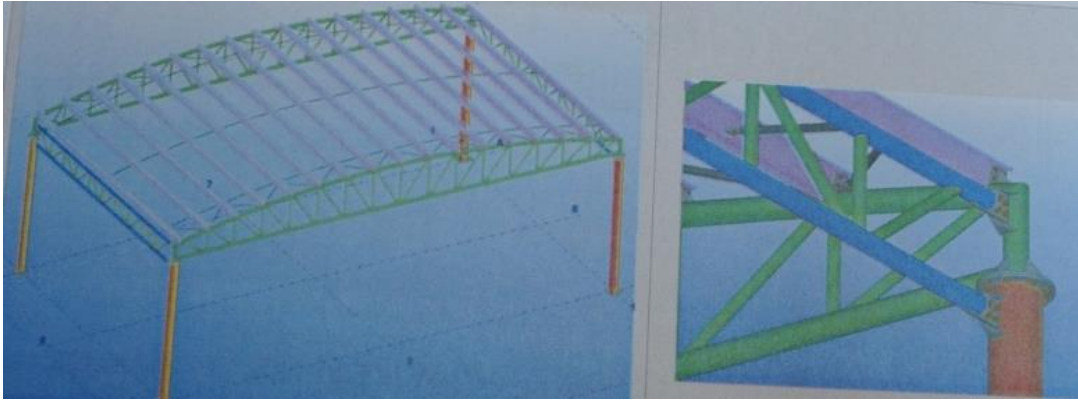
Figure 3.308. 3D model of proposed stainless steel roof covering in structural report , 2012 (Archive of Conservation Council IV of Istanbul)

After that the application of the projects had been started, a structural report was ordered to Istanbul Technical University by the contractor. According to the structural report keeping the unqualified existing roof cover was considered as dangerous and, it was suggested to be removed completely together with its reinforced concrete columns.<sup>81</sup> In the same report, it was also expressed that “ *if a roof cover is essential for new use, it is suggested to make a new roof made of laminated timber/stainless steel prestressed beams and preferably a transparent cover..... It will be suitable to fixed the roof beams either to revaks or to columns to be constructed at a distance from the revaks enough not to interfere with them visually.*” (Figure 3.308.). New use had already been decided in allocation protocol, however, a revised restoration project was prepared without any explanation about vitality of courtyard roofing for the new use.

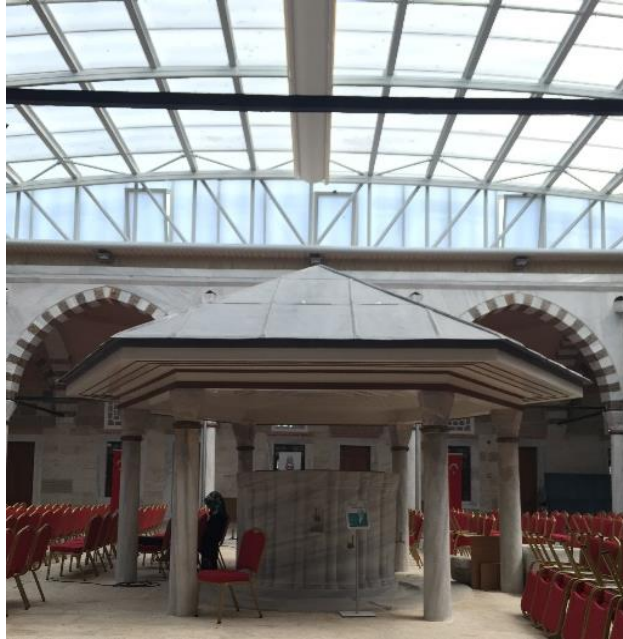
Figure 3.309. Courtyard roofing and reconstructed fountain roof, 2015

With the council IV decision no 2012-631, revised restoration project was approved. According to this revision, courtyard covering system was changed and a glass door was added to the entrance eivan (Figures 3.309.- 3.311.). Cables for installations were lyeed down a channel surrounding the revaks (Figures 3.303 and 3.305.). Radiators were placed for heating in both rooms and the revaks (Figures 3.303 and 3.312.). Lightining system was installed on the walls of rooms by renewing the plasters, classroom and revaks in front of the classroom as well as on new roof structure in the courtyard (Figures 3.309., 3.310. and 3.313.). Classroom was also illuminated with a

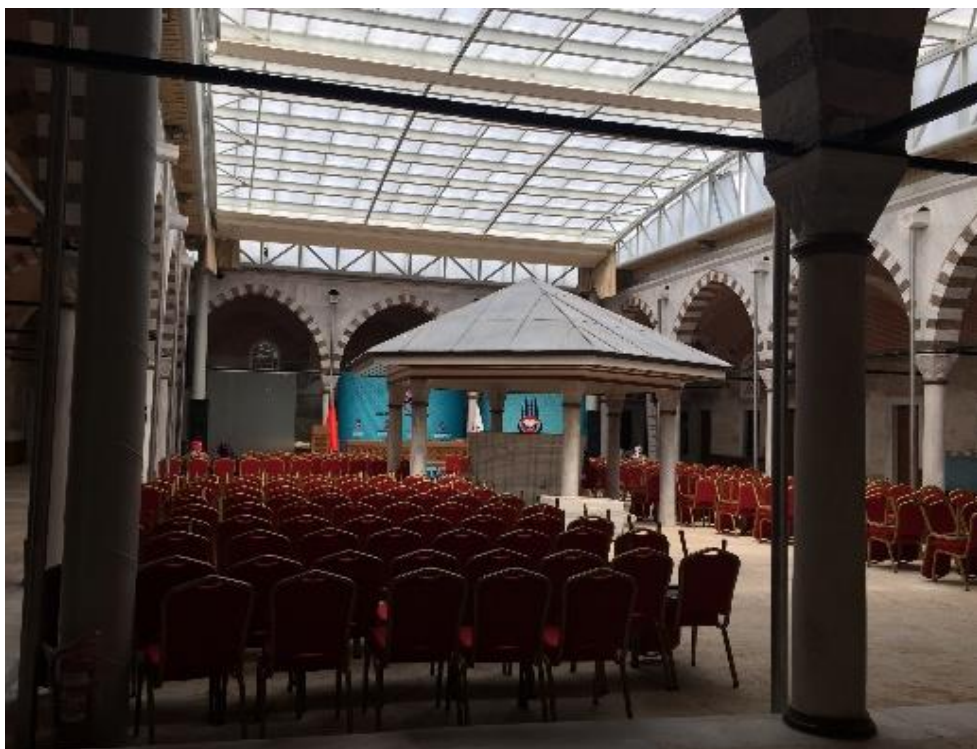
Figure 3.310. Seminar hall (courtyard), 2015

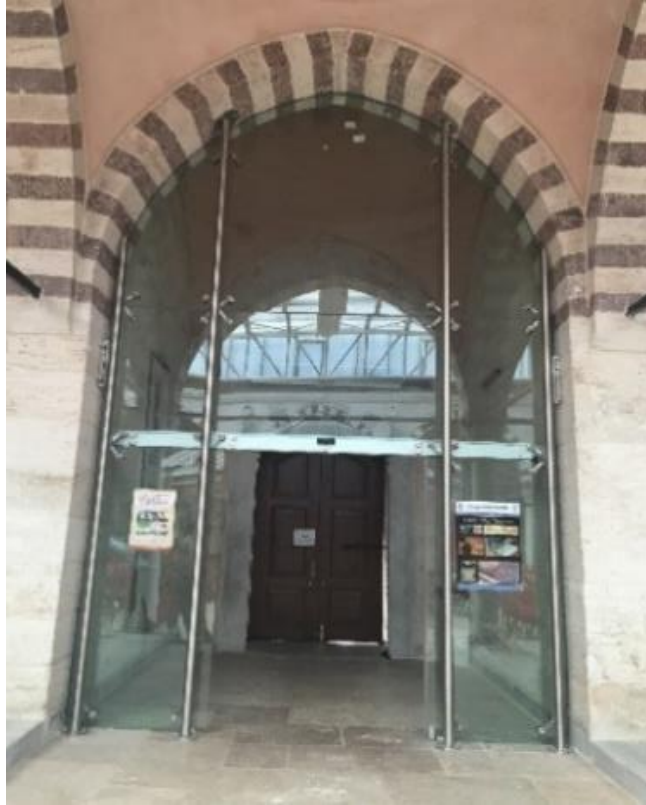
Figure 3.311. Glass separation of entrance eivan on revaks side, 2015

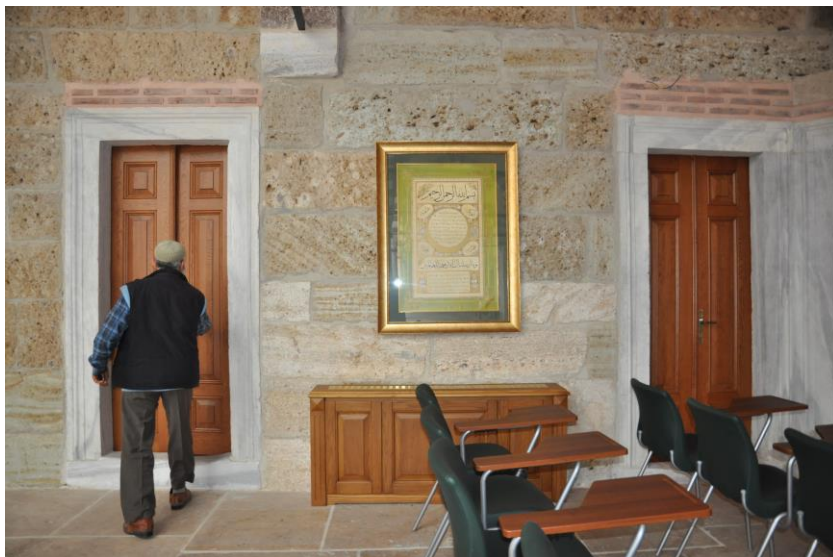
Figure 3.312. Radiator covered with a wooden furniture in revaks, 2015

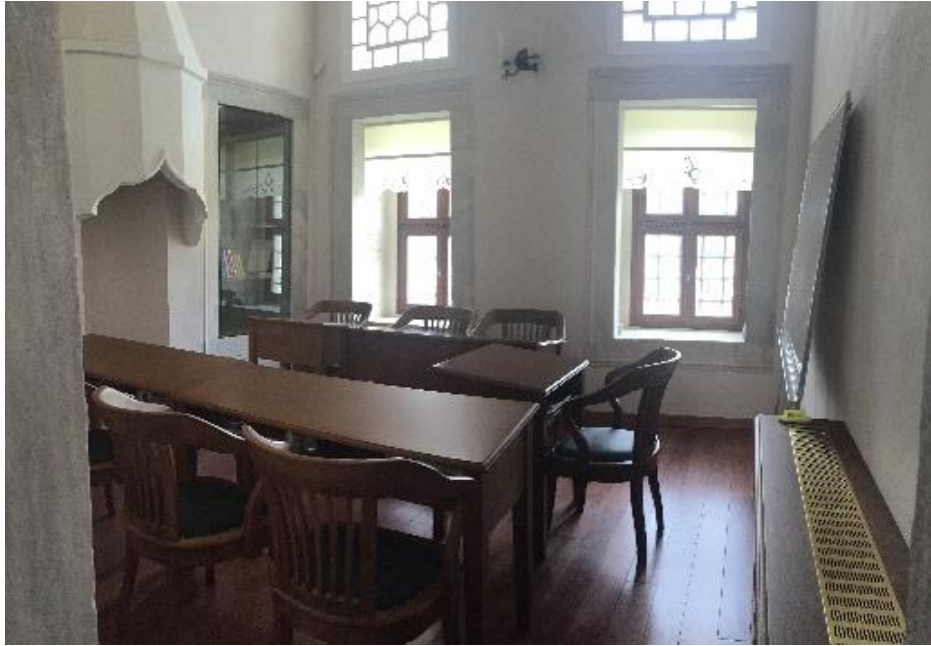
Figure 3.313. Room used for traditional illumination art workshops, 2015

obstacle for participants to see the scene. Revaks on north east side of the courtyard were rearranged as a scene for projections with a separator membrane. Behind it, the kitchen got larger gradually through revaks for need of extra space; because the user foundation was managing dormitories in different buildings and in different districts. Thus, the medrese was using as the common kitchen of those dormitories in 2015. Having been completed the structural restoration works, user refurnished and reorganized the spaces without any interior design project (Figures 3.313., 3.314., 3.320.-3.325. and 3.328.).

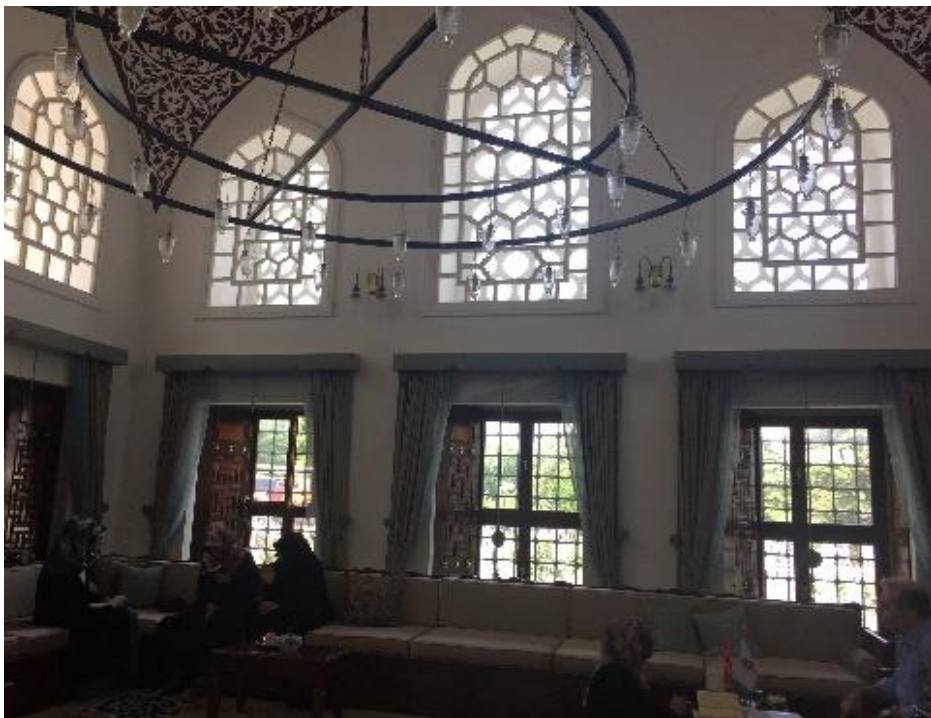
Figure 3.314. Meeting room (classroom), 2015

chandelier. (Figure 3.314.) Electric cables for CCTV and speakers were embedded into joints of stone masonry revak walls as it was in Rabi Medrese revaks facade. (Figure 3.315.).

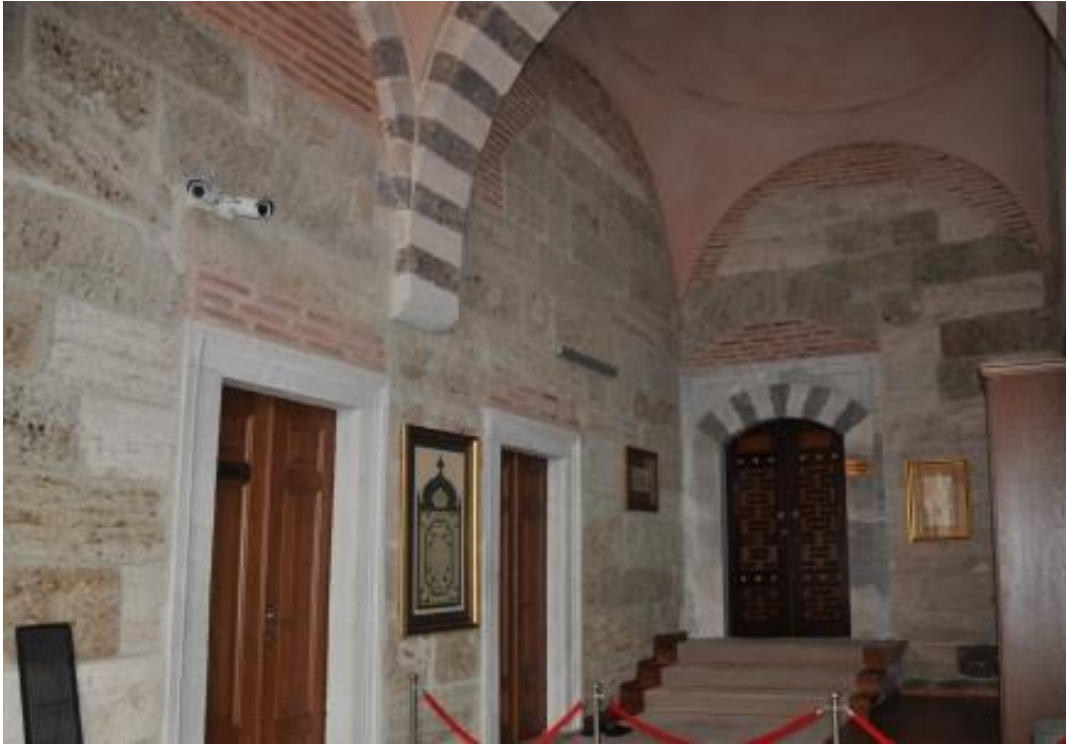
Figure 3.315. Electric installations on revak walls, 2015

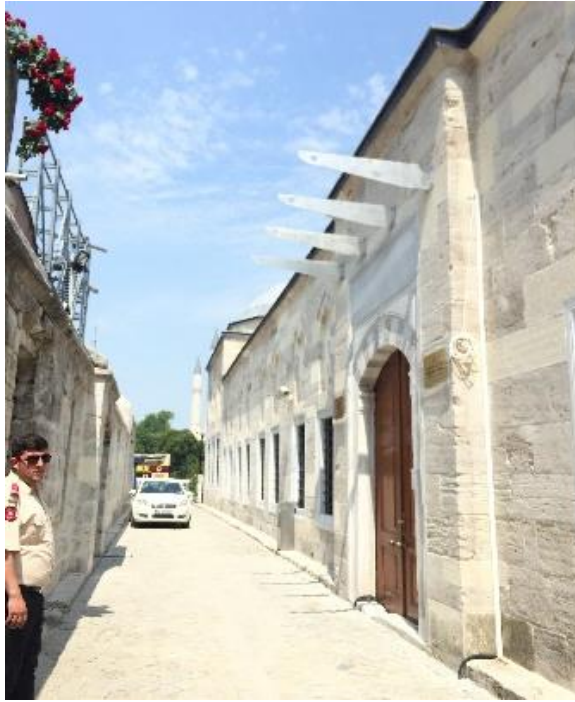
Figure 3.316. Main entrance and a steel made construction fixed to the facade for a shelter, 2015

During the application, some changes and additions were also made out of approved project; a glass eave with stainless steel supporters was added to the entrance door, bookcase niches were furnished with glass shelf system with glass covers and the name of the user foundation has been nailed onto the important northeast façade of the medrese, looking to Sultanahmet Park and the Hagia Sophia Mosque. (Figures 3.316. and 3.317.) The entrance of the medrese was strictly controlled from a security cabin in the entrance garden and only participants or related people were allowed to enter (Figure 3.318.). A generator was placed at the backyard (Figures 3.303. and 3.319.).

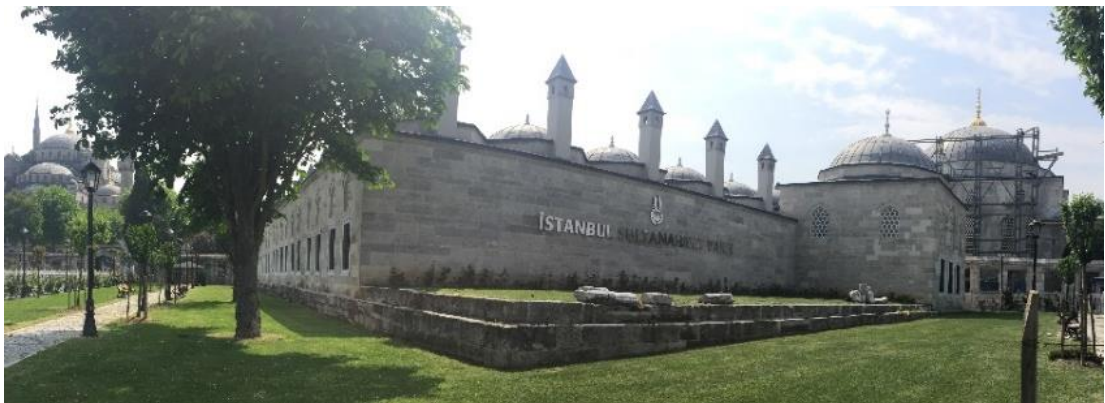
Figure 3.317. Garden (backyard) from East and name plate nailed to the cut stone facade, 2015

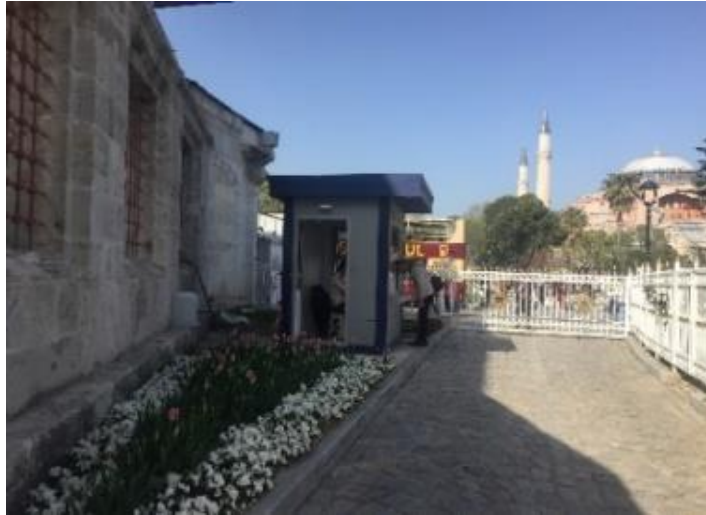
Figure 3.318. Security cabin in front of the medrese next to the tomb wall, 2016

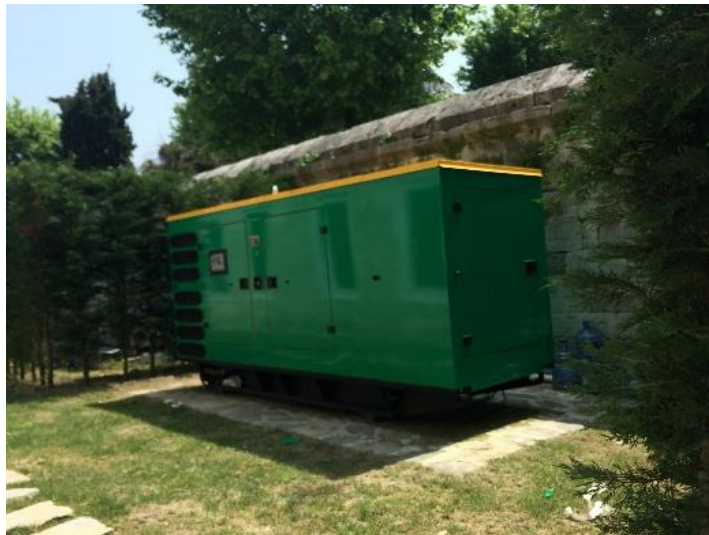
Figure 3.319. Generator at the back garden, 2015

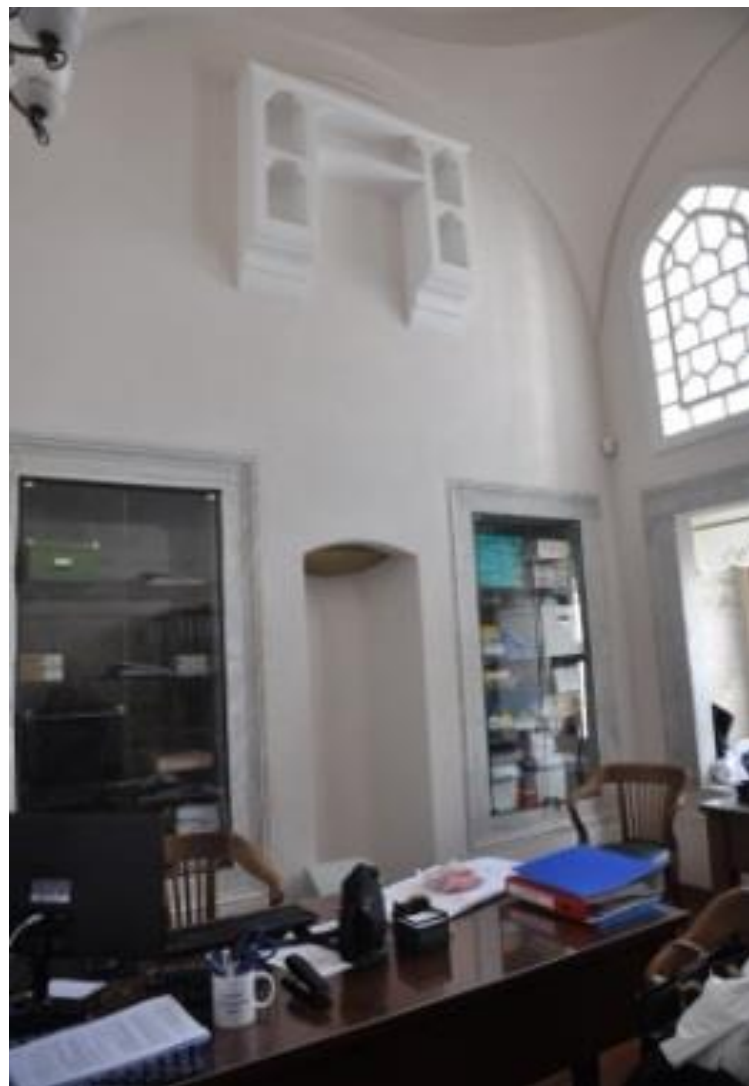
Figure 3.320. Room used as office, 2015

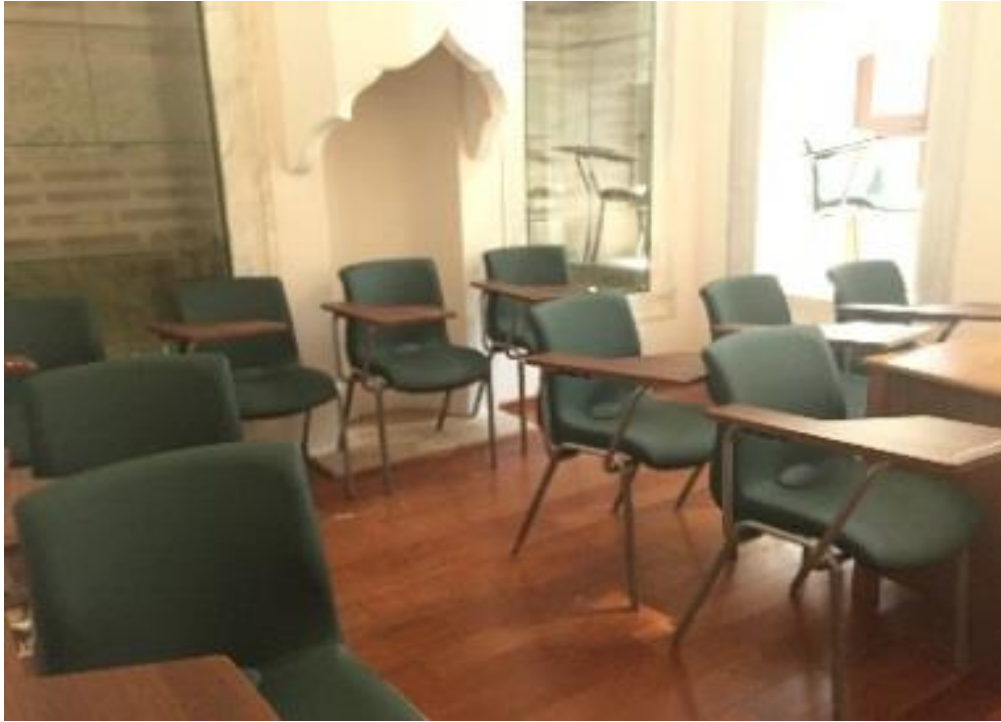
Figure 3.321. Room used as lecture room, 2015

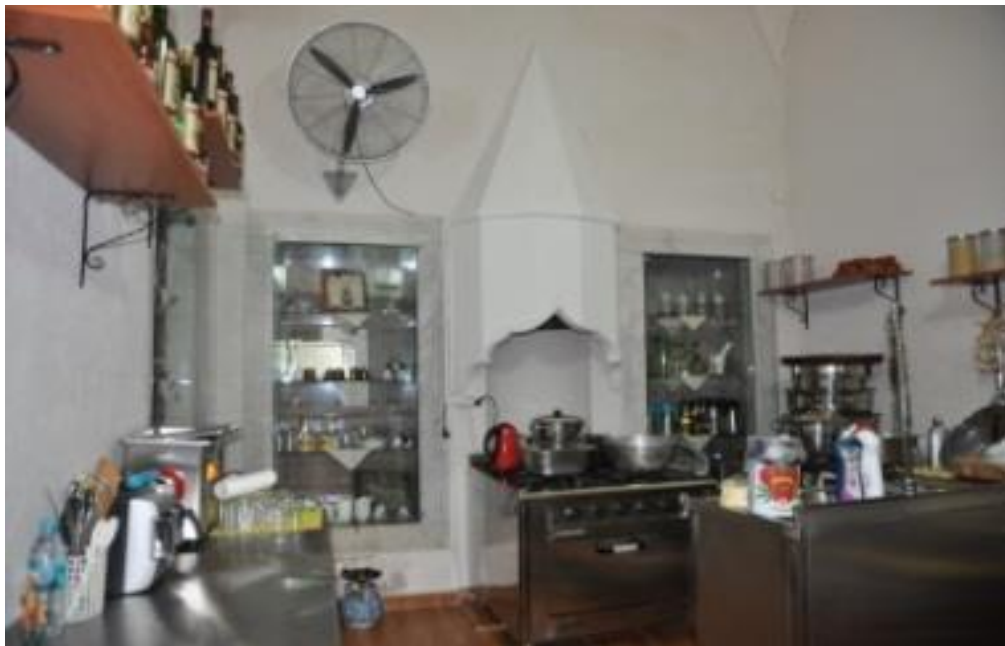
Figure 3.322. Room used as kitchen, 2015

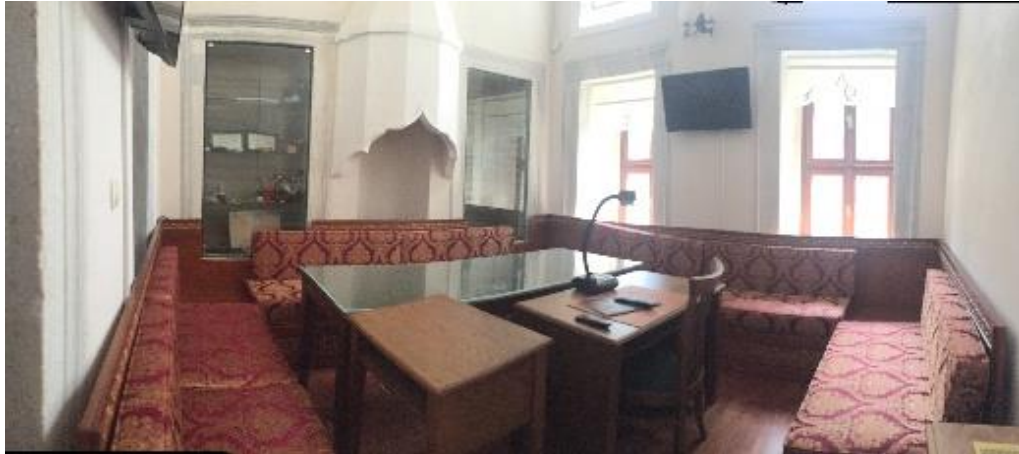
Figure 3.323. Room used for traditional calligraphy art workshop, 2015

In 2016, the user rechanged the decoration of classroom and kitchen, turned a lecture room into a library and reorganized revaks for lectures and meetings for changing needs (Figures 3.303. and 3.326.-3.329.). It was seen that some of the furnitures were forced to placed into rooms and some of them had to be cutted in order to be placed in front of the glass covered bookcase niches (Figure 3.323.).

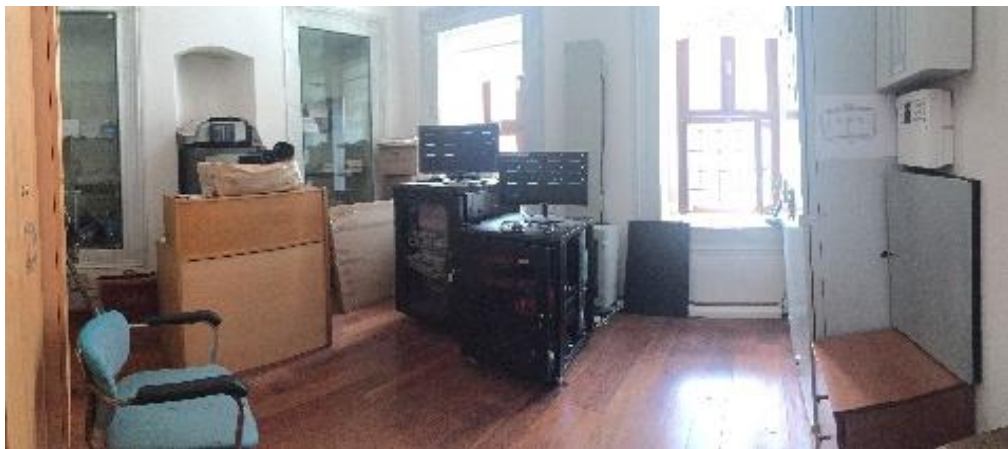
Figure 3.324. Room used for security system control, 2015

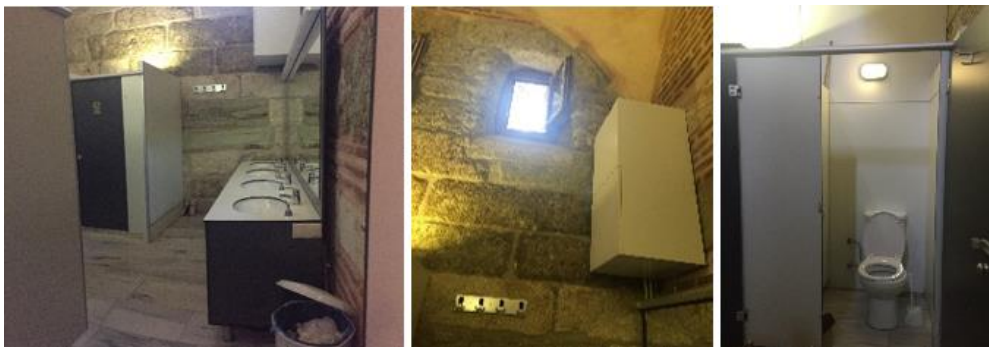
Figure 3.325. Reorganisation of toilets, 2015

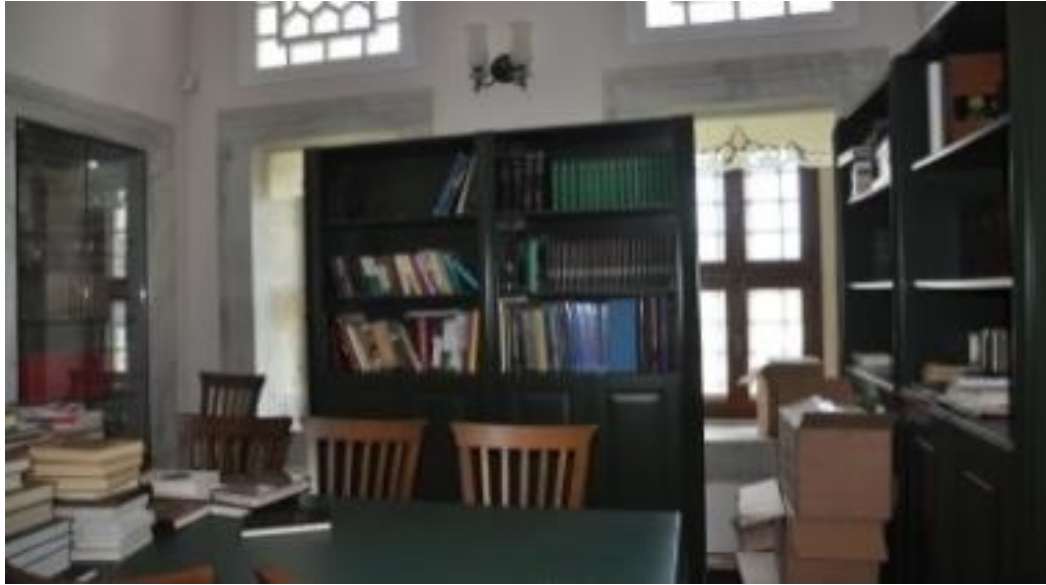
Figure 3.326. Library, 2016

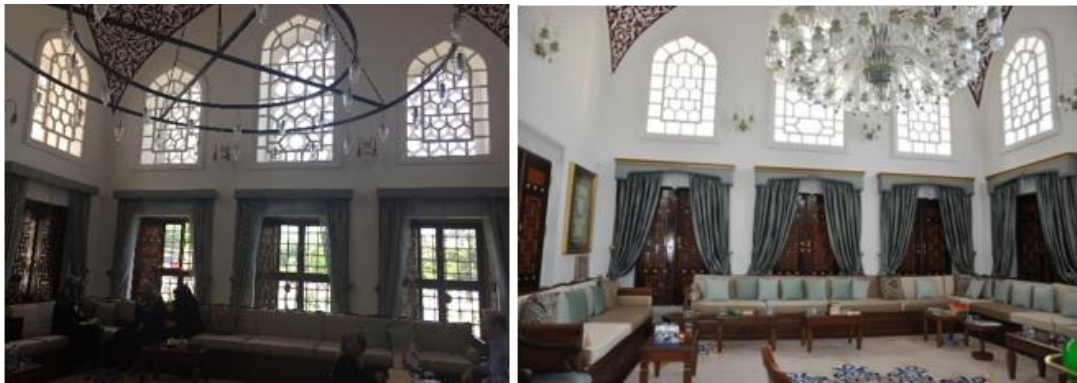
Figure 3.327. Classroom decoration of Sultan Ahmet Medrese in 2015 (left) and 2016 (right)

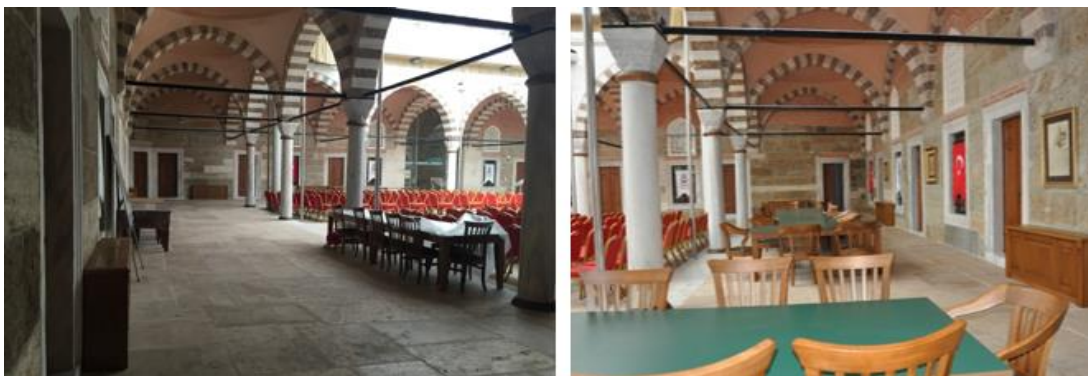
Figure 3.328. Reorganisation of south west revaks in 2015 (left) and 2016 (right)

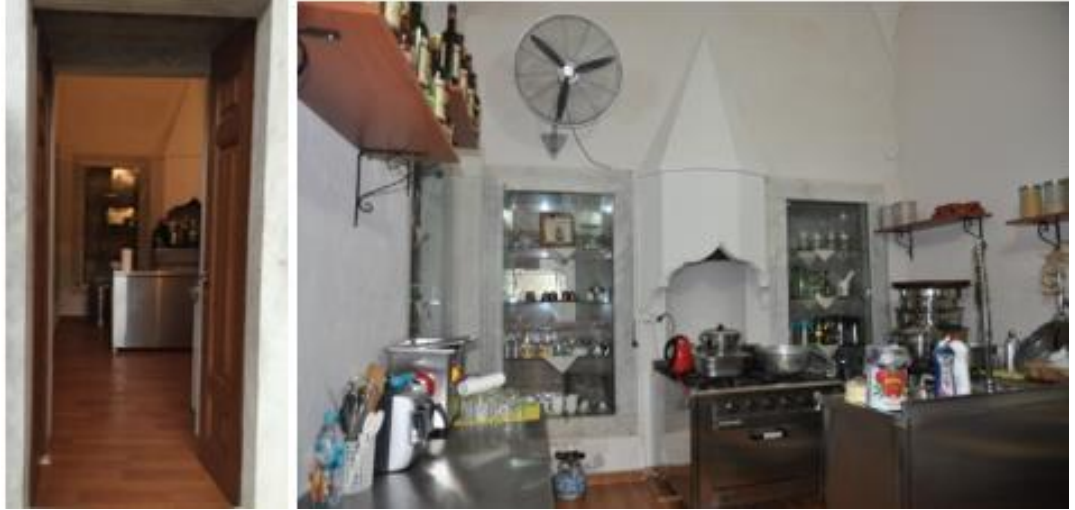
Figure 3.329. One of rooms of Sultan Ahmet Medrese refunctioned as kitchen, the situation in 2015 (left) and in 2016 (right)

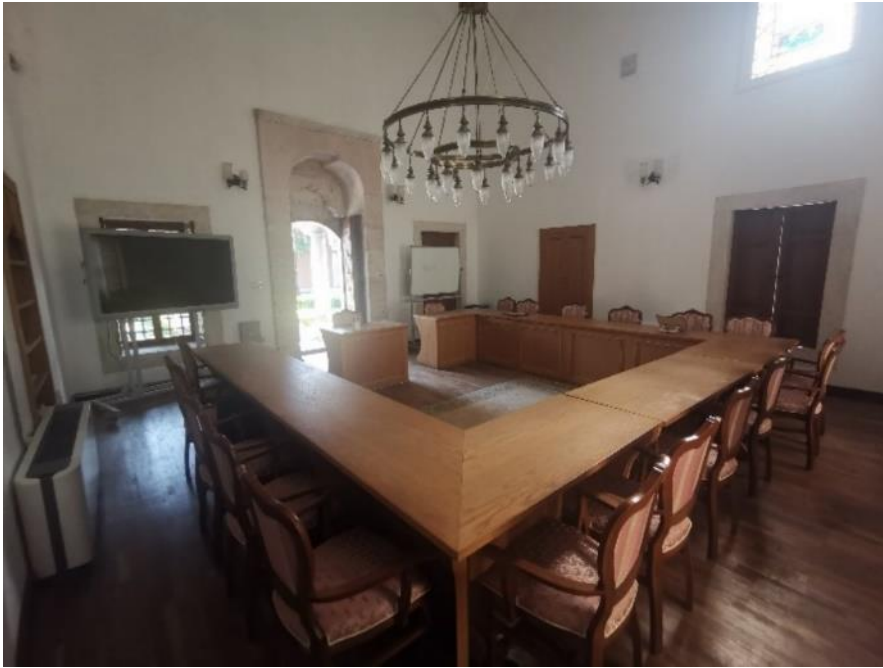
Figure 4.5. Post refunctioning use of the classroom of Haseki Medrese for group lectures in 2023 (Private Archive of Muammer Saraç)

**The situation in 2023:** The classroom of Haseki Medrese was using for daily group lectures by approximately 15-16 students and a teacher. The tables were organized in U shape (Figure 4.5.). In total, the center has approximately 90 attendees as students.

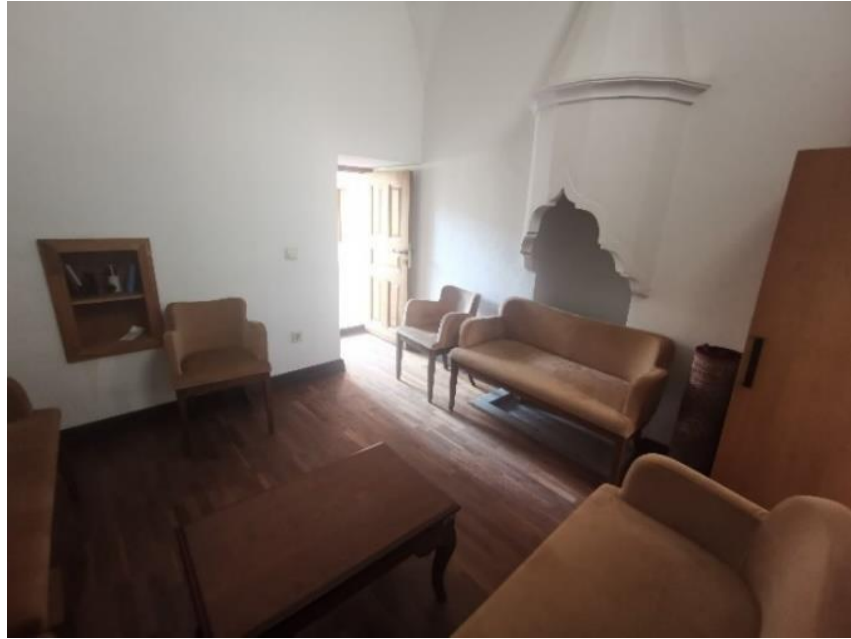
Figure 4.6. Post refunctioning use of the room on the west side of the classroom as a teacher's office in Haseki Medrese in 2023 (Private Archive of Muammer Saraç)

Rooms were using for variety of purposes. 9 of rooms were using for service facilities; 1 room for mechanical, 1 room for security, 1 room for women staff, 1 room for men staff, 1 room for store, 4 rooms for other departments' teachers' offices. Rest of the rooms were allocated to the teachers as offices (Figure 4.6.). The revaks were using for circulation and the courtyard was kept for a recreation area in 2023 (Figure 4.7.).

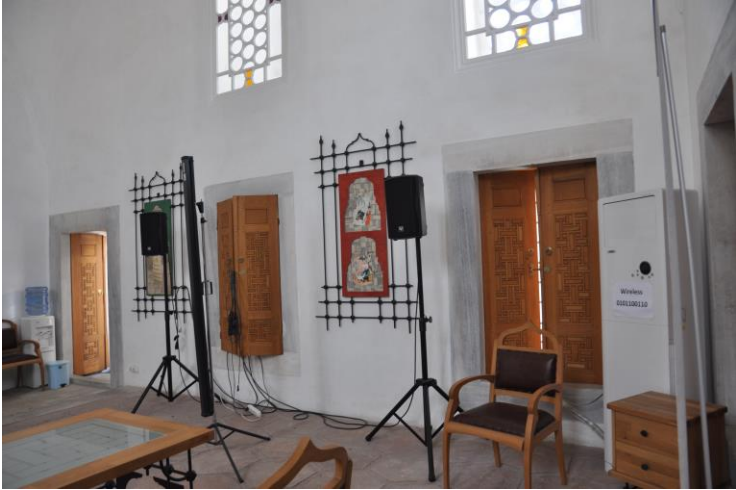
Figure 4.8. Broadcasting and air-conditioning installations in the classroom of Rabi Medrese in 2015

character defining features including the architectural elements were the most essential factors for sustainable conservation that was observed in Rabi Medrese. However, the classroom which was used for broad participated events was loaded with a broadcasting system and air-conditioning units resulting in visual pollution inside and outside (Figures 4.8. and 4.9.).

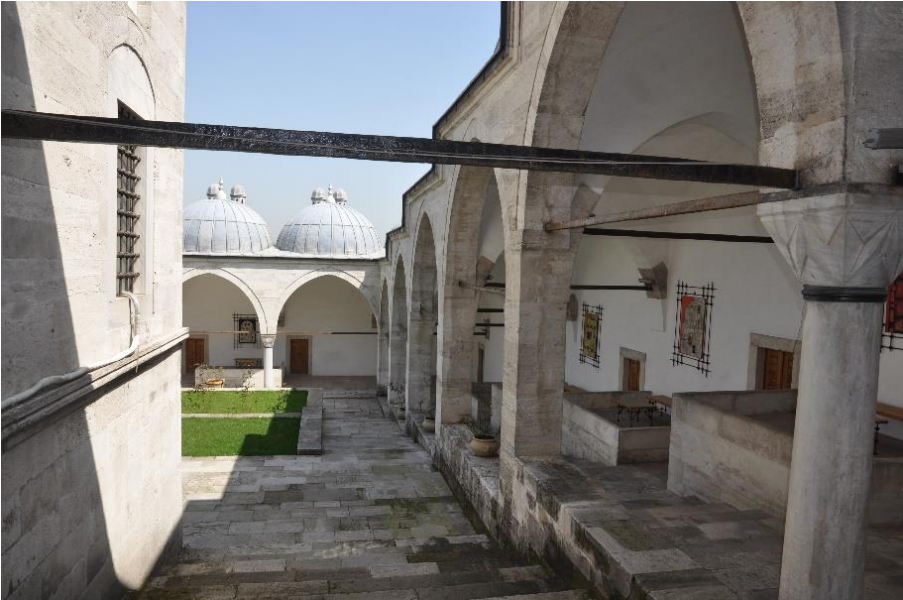
Figure 4.9. Air-conditioning installation on the classroom façade of Rabi Medrese in 2015
