EVALUATING THE IMPACTS OF REFUNCTIONING ON OTTOMAN  
MEDRESES IN ISTANBUL

A THESIS SUBMITTED TO  
THE GRADUATE SCHOOL OF NATURAL AND APPLIED SCIENCES  
OF  
MIDDLE EAST TECHNICAL UNIVERSITY

IN PARTIAL FULFILLMENT OF THE REQUIREMENTS  
FOR  
THE DEGREE OF MASTER OF SCIENCE  
IN  
CONSERVATION OF CULTURAL HERITAGE IN ARCHITECTURE

SEPTEMBER 2023

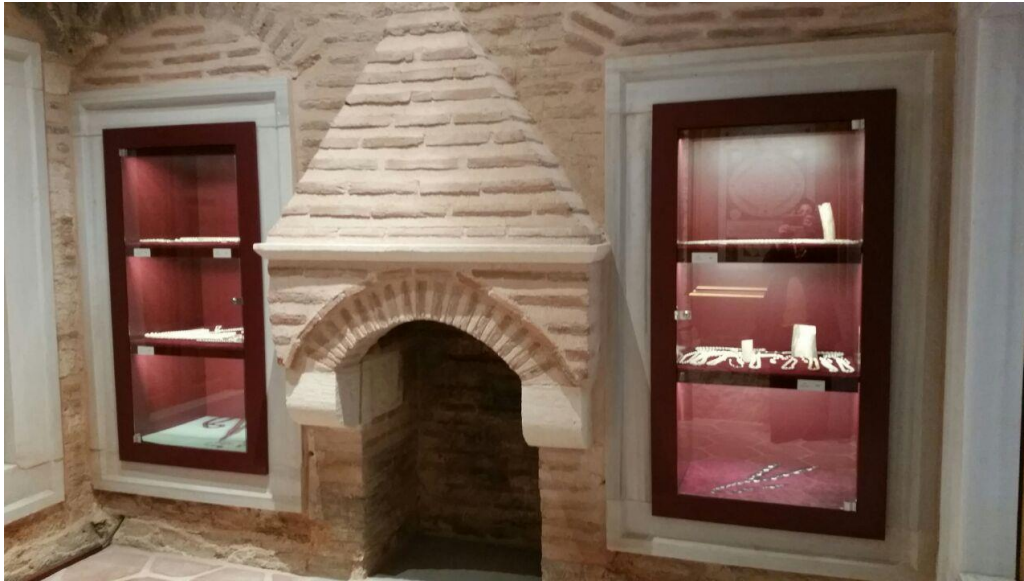
Figure 4.14. Use of architectural elements in the rooms of Siyavuş Paşa Medrese in 2015

The rooms support the function of exhibition of prayer beans, as the materials were very small and they need to be visited from close distance. In addition, the reorganization of open niches in the rooms of Siyavuş Paşa Medrese seems an example of effectively used architectural elements supporting the small size organic artwork exhibition in terms of their sizes, features, positions and numbers within the cases (Figure 4.14.). The use of classroom for an administrative purpose caused the ignorance of its potential to exhibit itself with its rich wall decoration, as well as the example of a sensitive and careful restoration (Figure 4.15.).

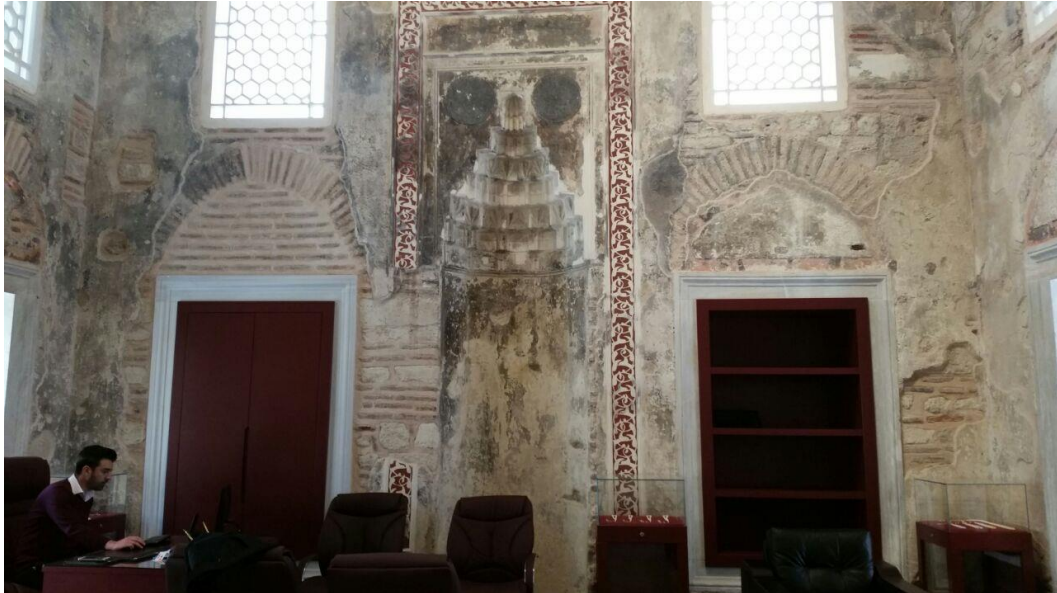
Figure 4.15. Use of the classroom of Siyavuş Paşa Medrese as administration office in 2015

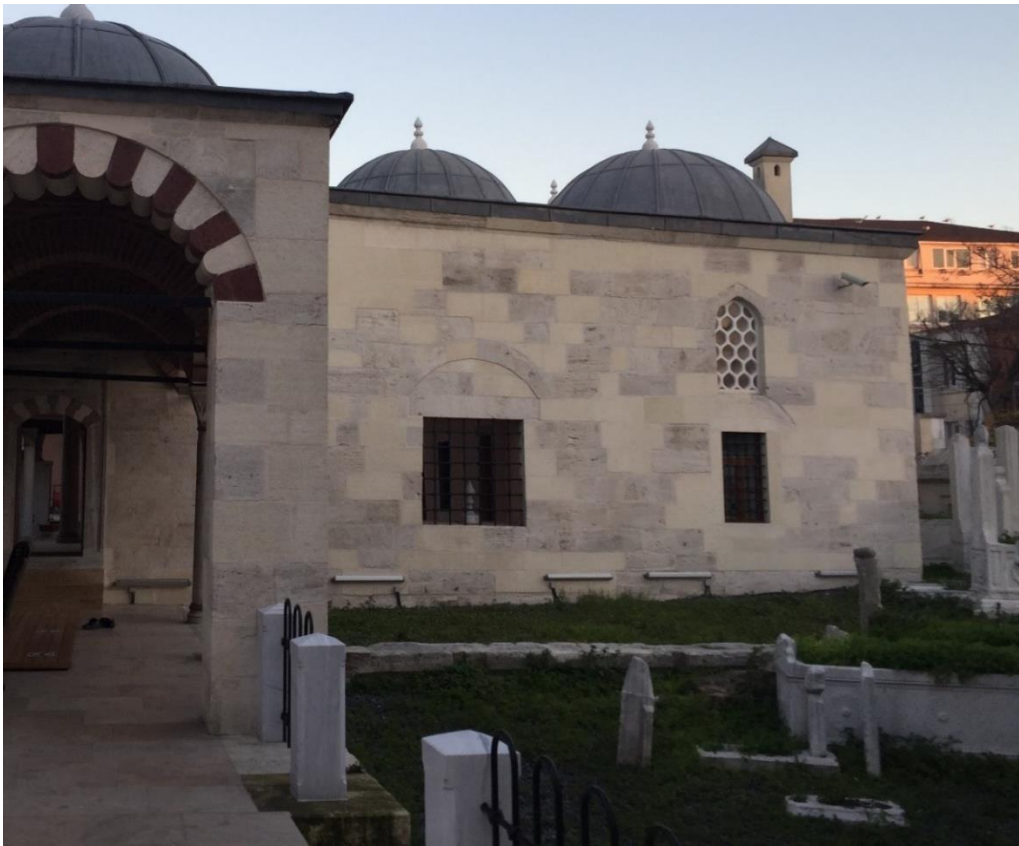
Figure 4.16. The façade lighting in Koca Sinan Paşa Medrese in 2015

Electrical, CCTV and fire supression installations were lined in the channel surrounding the revaks. Besides, under plaster electrical lines were also used for interior lighting, using with the advantage of pasr plaster renewals. However, the outer façade lighting projectors which were fixed on the cut stone wall gave a damage to the masonry (Figure 4.16.). Floor projectors would be the more suitable solution for façade lighting.

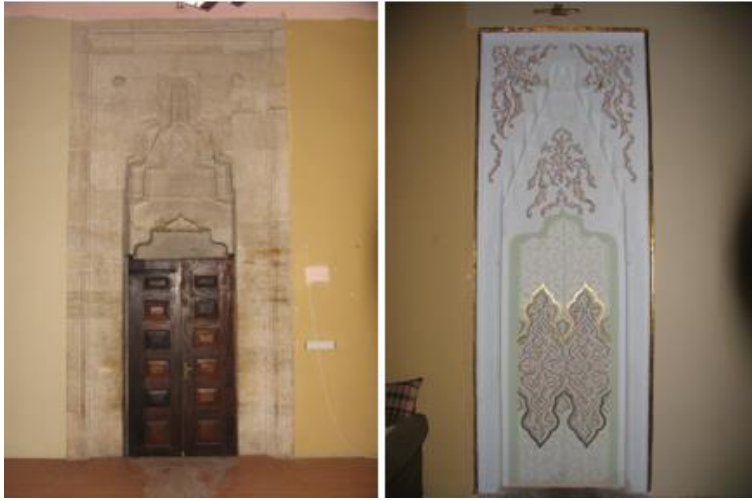
Figure 4.18. Ornamented architectural elements in the classroom of Şehzade Medrese in 2013 (Private Archive of Kübra Construction Co.)

The classrooms of medreses were the most distinguished and special spaces of the medreses with their special and unique ornamental features and architectural elements. (Figures 4.18.-4.25.), Exhibiting the original decorated architectural elements in suitable conditions, considering their original uses and cultural values, was essential to increase the cultural awareness of the historical character and originality of the building. It was observed that, the exceptional architectural elements in the courtyard were ignored as parts of the recreation.

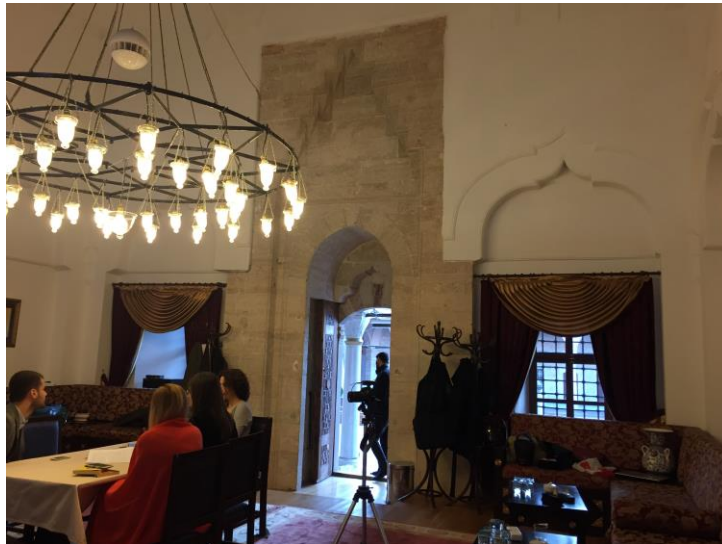
Figure 4.19. Ornamented architectural elements in the classroom of Rüstem Paşa Medrese in 2015

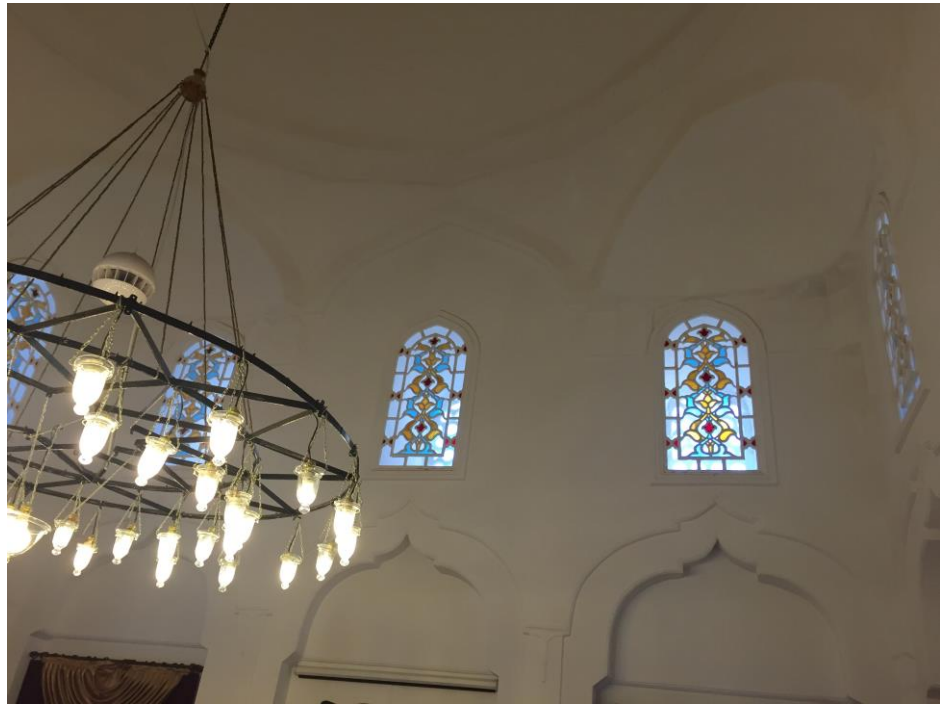
Figure 4.20. Ornamented architectural elements in the transition zone of the classroom of Rüstem Paşa Medrese in 2015

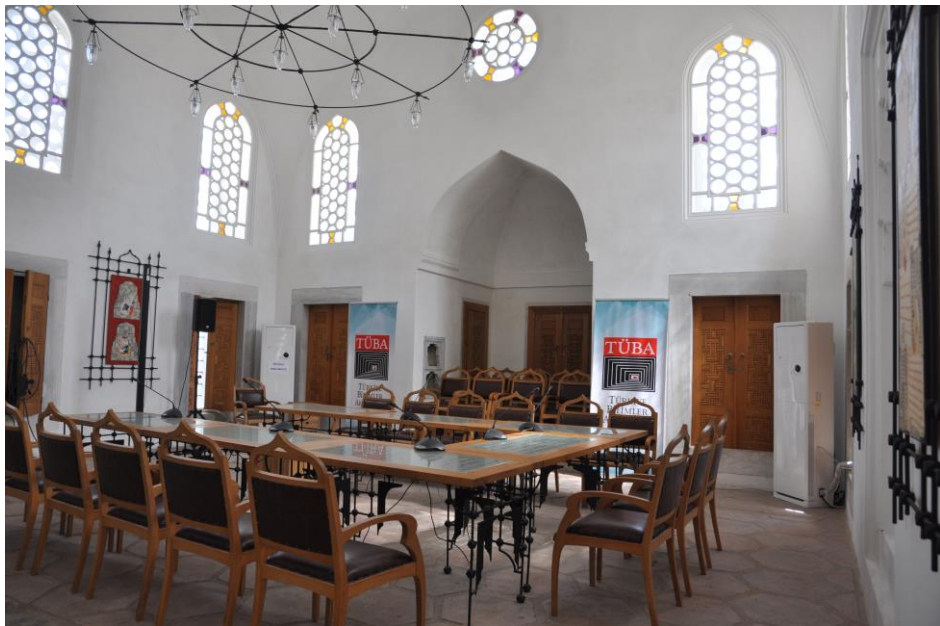
Figure 4.21. Ornamented architectural elements in the classroom of Rabi Medrese in 2015

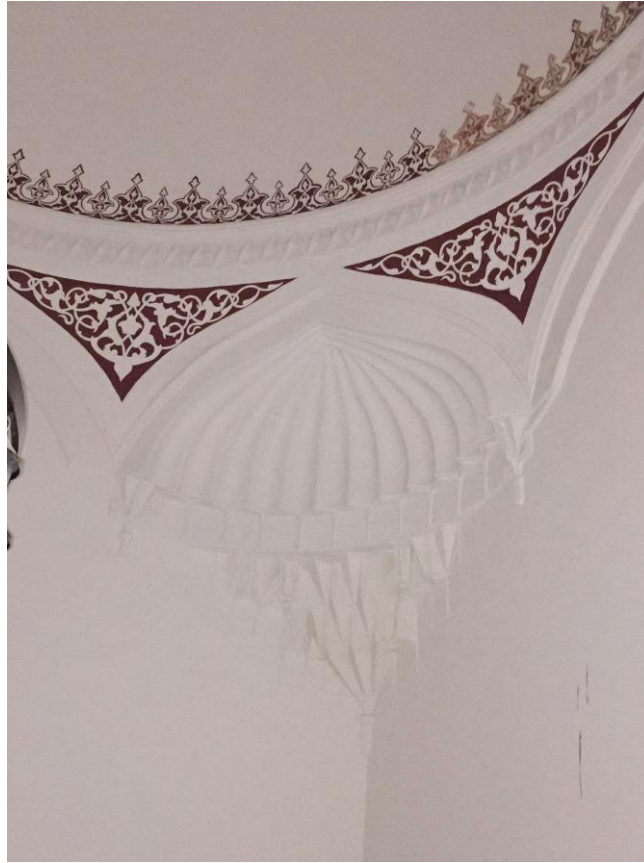
Figure 4.22. Ornamented architectural elements in the classroom of Kılıç Ali Paşa Medrese in 2015

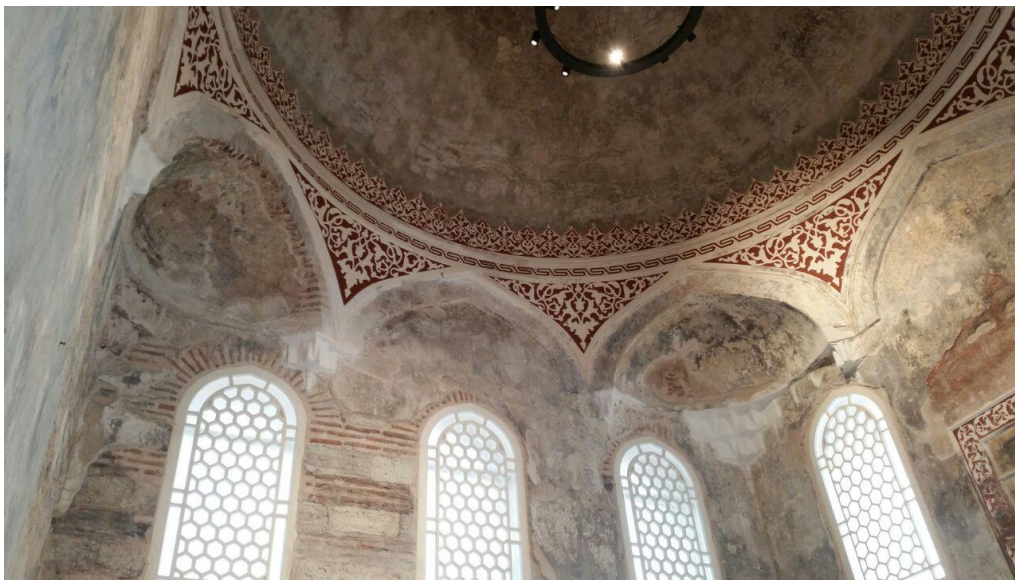
Figure 4.23. Ornamented architectural elements in the classroom of Siyavuş Paşa Medrese in 2016

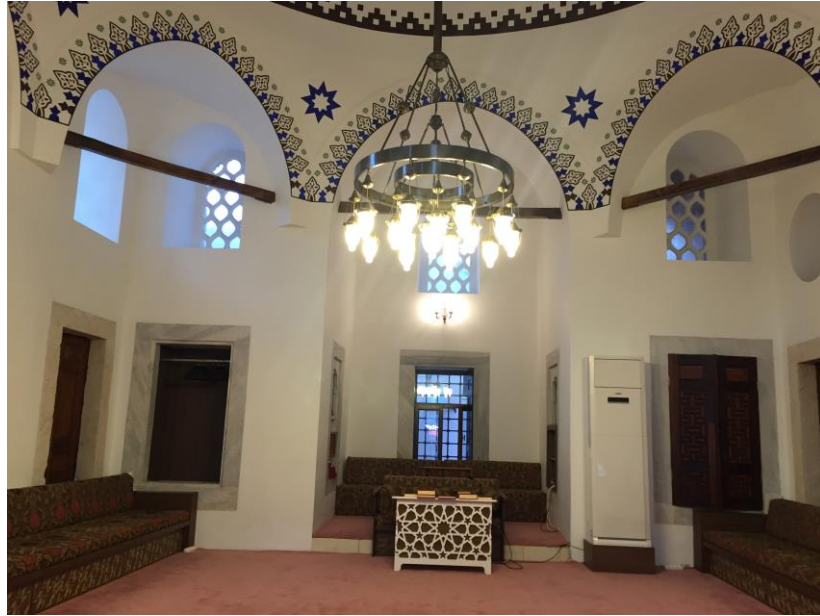
Figure 4.24. Ornamented architectural elements in the classroom of Koca Sinan Paşa Medrese in 2015

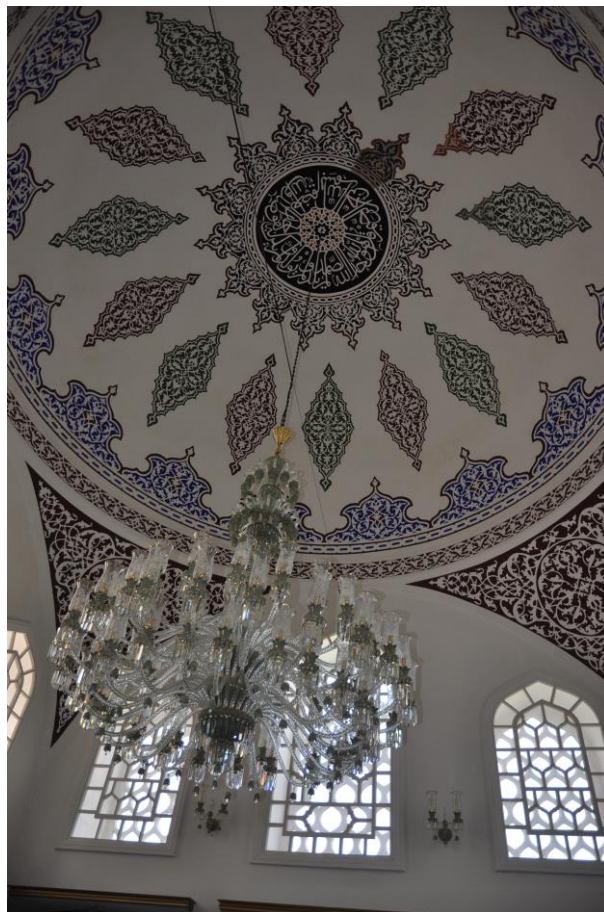
Figure 4.25. Ornamented architectural elements in the classroom of Sultan Ahmet Medrese in 2016

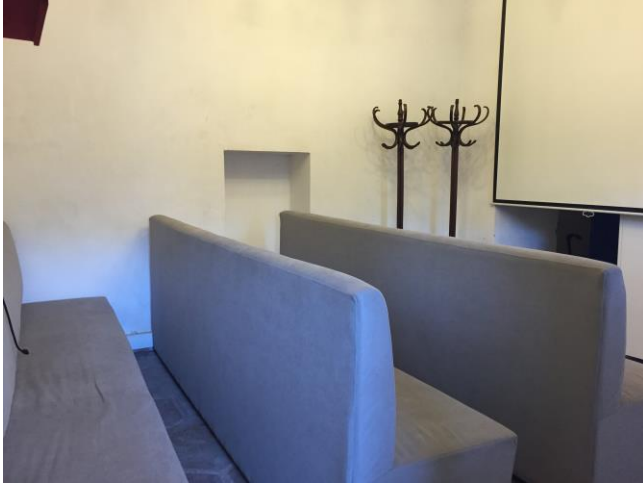
Figure 4.26. The use of a room for projection in cinematic order in Rüstem Paşa Medrese in 2015

**Rüstem Paşa Medrese:** Overdesign in spaces reducing the quality of use was strongly felt in the rooms, especially those used as the projection room and the restaurant (Figure 4.26.). Using the eivans as a storage for the garden furniture, for kitchen equipments and for other service tools caused an interior visual pollution in the building (Figure 4.27.).

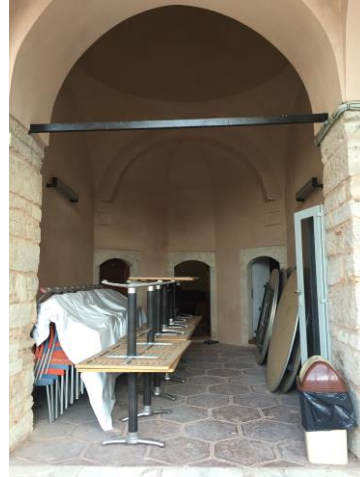
Figure 4.27. The use of an eivan as a storage for garden events in Rüstem Paşa Medrese in 2015

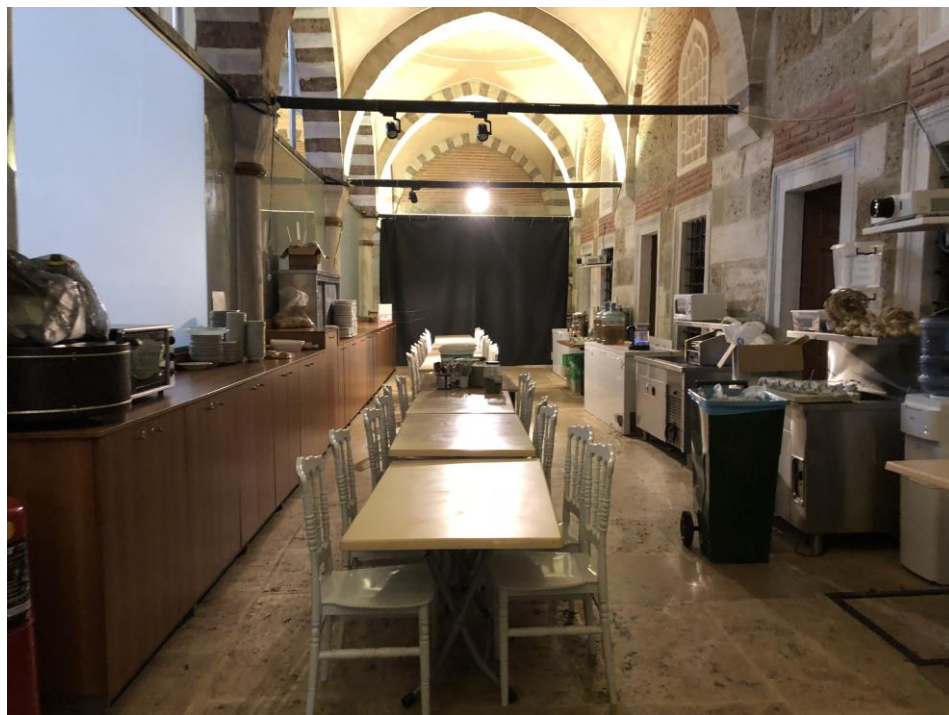
Figure 4.28. Post refunctioning extention of kitchen use in the north revaks in Sultan Ahmet Medrese in 2018

The rooms located on the north wing have only one window facing towards the revaks, originally. These rooms were not good lighted and good ventilated naturally. This resulted in those rooms to be assigned for subsidiary uses; like kitchen and storage. Besides, this also caused the north wing being ignored for the preference of the

courtyard use (Figure 4.28.). The smell diffusing from the kitchen due to intensive use and insufficient ventilation was felt from the moment you enter the building. This adversely affects the quality of use, especially in the courtyard.

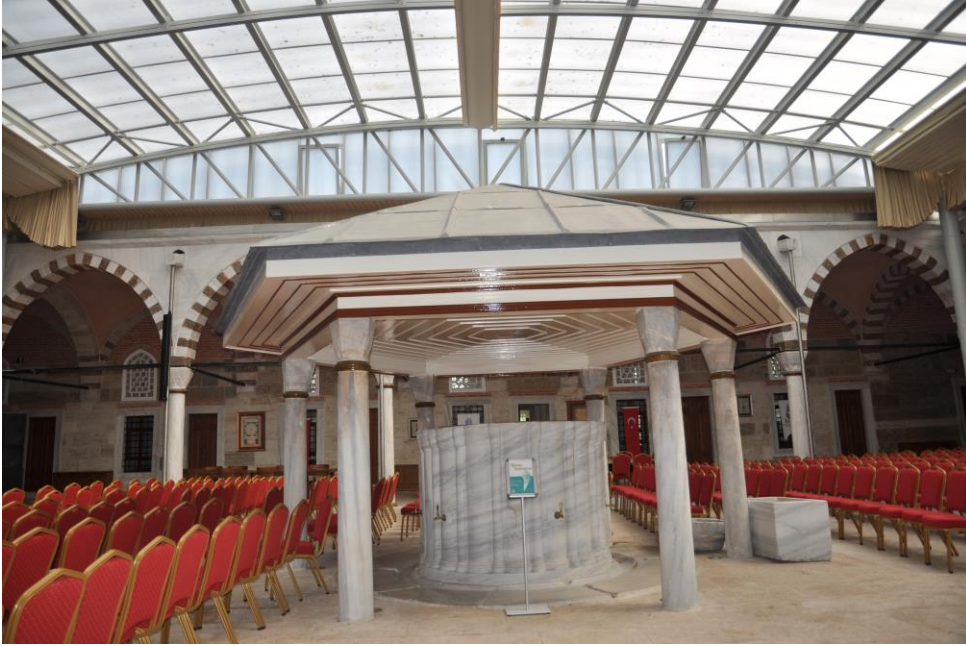
Figure 4.29. The ablution fountain and some other movable architectural elements in the courtyard of Sultan Ahmet Medrese in 2016

Architectural character defining elements in the courtyard were also ignored while using the space in seminar order. For instance, restored ablution fountain with a roof in the middle of the courtyard was a visual obstacle for some audiences. Thus, there was a contradiction between the seminar order oriented to a scene with linear seats and the original central character of the courtyard. This order preference poses both functional and visual barrier to the new use, while damaging the original interior character (Figure 4.29.).

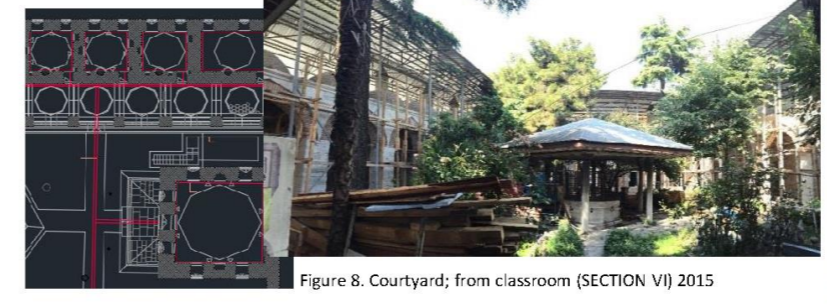
Figure 7. Partial electrical plan (Archive of Istanbul Ist. RDF)

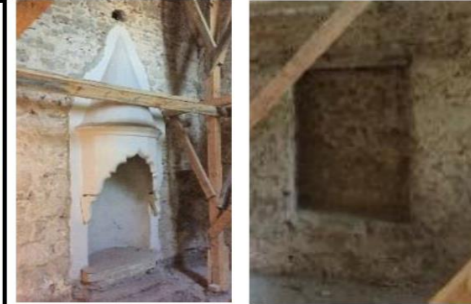
Figure 11,12. Fireplace and medium niche in room, 2015

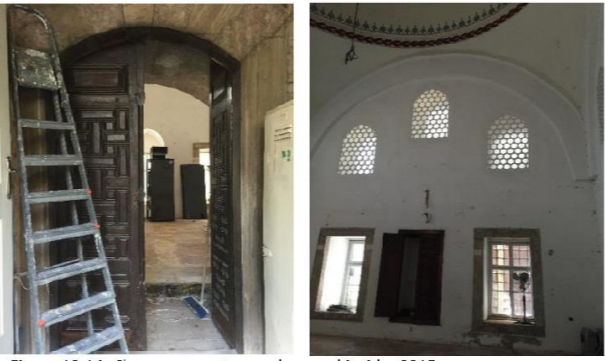
Figure 13,14. Classroom; entrance door and inside, 2015

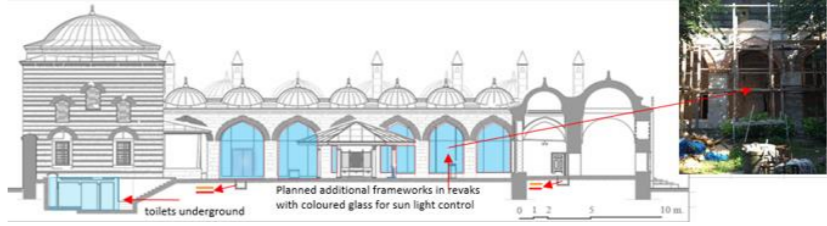
New use: **Foundation Calligraphy Arts Museum**  
 Building size (m): 36.63 x 43.90  
 Number of rooms: 19  
 Room sizes: 3.60x3.70-3.90  
 3.75x5.40-5.60-5.75-5.80  
 Classroom size (m): 7.34x7.40  
 Number of eivans: 1  
 Eivan size (m): 3.74x4.50m  
 Width of the revaks (m): 3  
 Courtyard size (m): 33.35x17,62  
 Total backyard area (sqm): 0

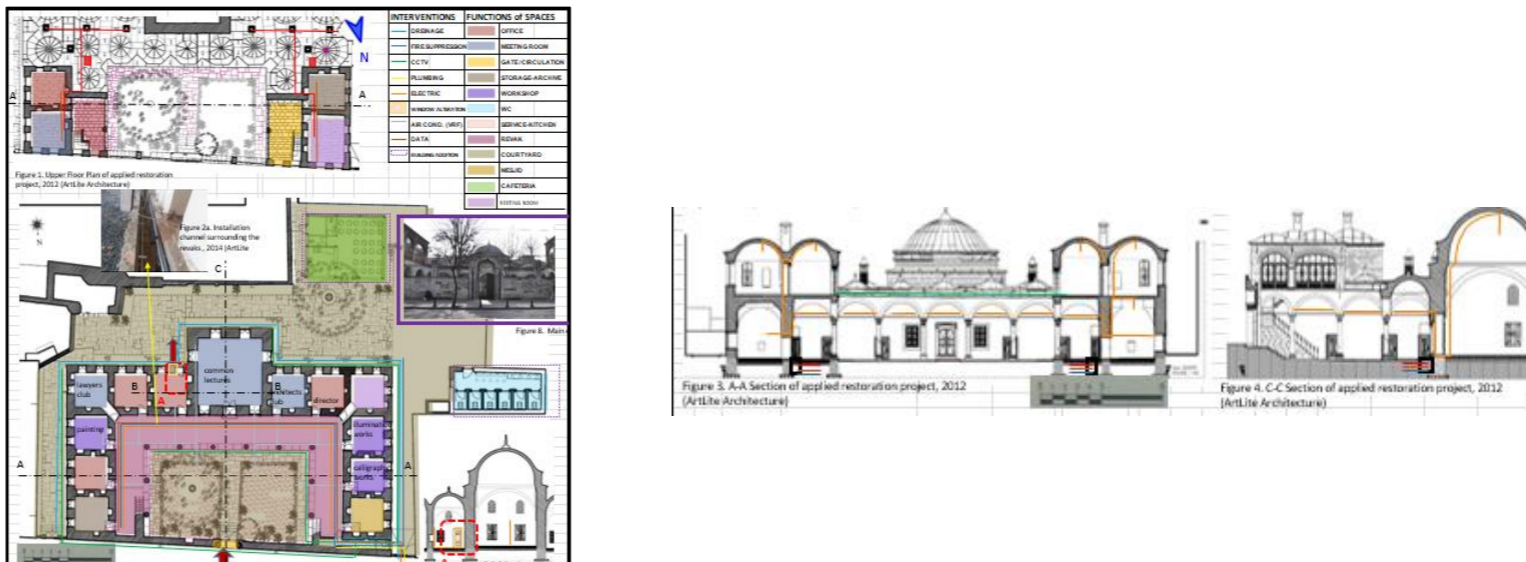
C.2. Table 4.2. Analysis of reuse decisions of Atik Ali Paşa Medrese on aspects of design decisions, spatial-structural and system alterations and contemporary sustainability approaches

Atik Ali Paşa Medrese	New use: <b>Headquarter of Birlik Foundation</b>		Building size (m): 37,20 x 20		Number of rooms: 16		Room sizes: 3.70x3.70		Classroom size (m): 7.33x7.36		Number of eivans: 0		Eivan size (m):		Width of the revaks (m): 3,80		Courtyard size (m): 18,20x12		Total backyard area (sqm):

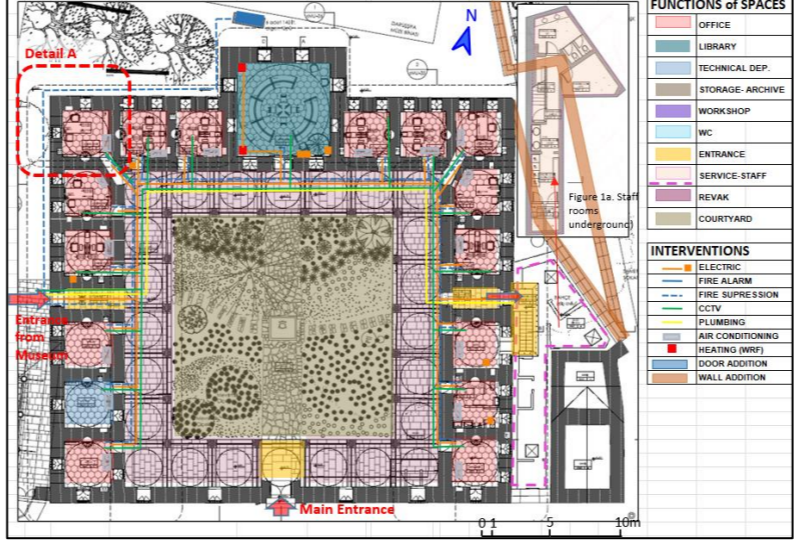
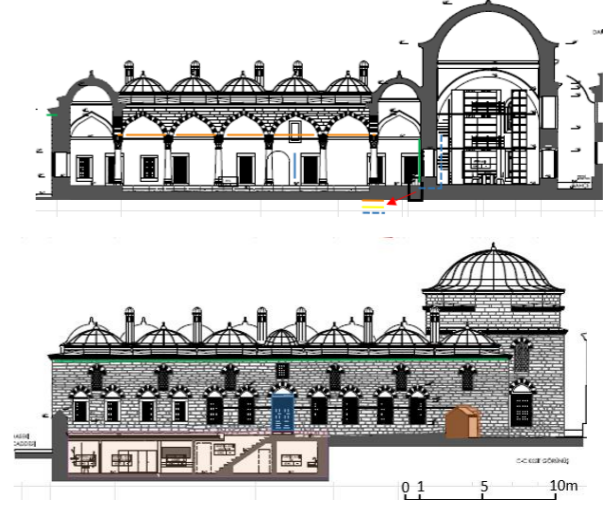
C.3. Table 4.3. Analysis of reuse decisions of Haseki Medrese on aspects of design decisions, spatial-structural and system alterations and contemporary sustainability approaches

Haseki Medrese	New use: <b>Haseki ReisulKurra Abdurrahman Gürses Religious Specialization Center</b>

Building size (m):																																		
	Number of rooms:	16																																	
	Room sizes:	3.3x3.3																																	
	Classroom size (m):	6.75x6.75																																	
	Number of eivans:	0																																	
	Eivan size (m):																																		
	Width of the revaks (m):	3.35																																	
	Courtyard size (m):	16x16																																	
	Total backyard area (sqm):																																		
	Reuse Preparations			Appropriateness of Design Decisions										Appropriateness of Construction of Additions				Appropriateness of installed systems						Sustainability											
+ (appropriate) - (not appropriate) space, refers to absence	Significance assessment	Alternative Uses Analysis	Need Program	Drawings	Subdivision of the spaces	Architectural elements' refurbishment (niches)	Architectural elements' refurbishment (fireplaces)	Closure of windows	Closure of the revaks	Roofing the courtyard	Space alteration to wet space	Refurbishment of spaces	Refurnishing of spaces	Original space reorganisation	Roof addition	Window alteration	Door alteration	Closure of the space	Roofing the courtyard	Subdivision of the space	Service building addition	Wall addition and alteration (in backyard)	Roof addition in backyard	Air-conditioning or ventilation	Heating (radiator /wrf/underfloor)	Plumbing	Electric	CCTV	Fire alarm and/or fire supression	Drainage	Data	Accessibility (for public)	Energy efficiency	Management / maintenance plan

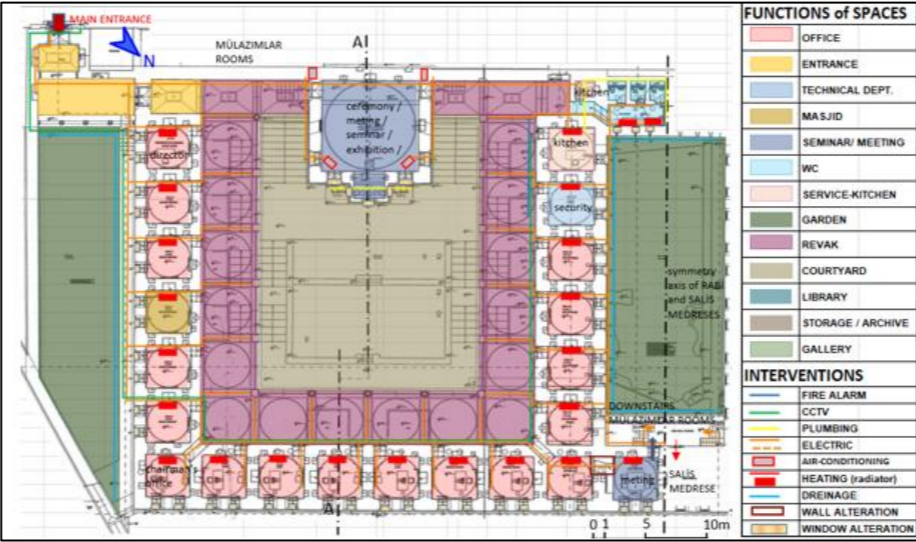
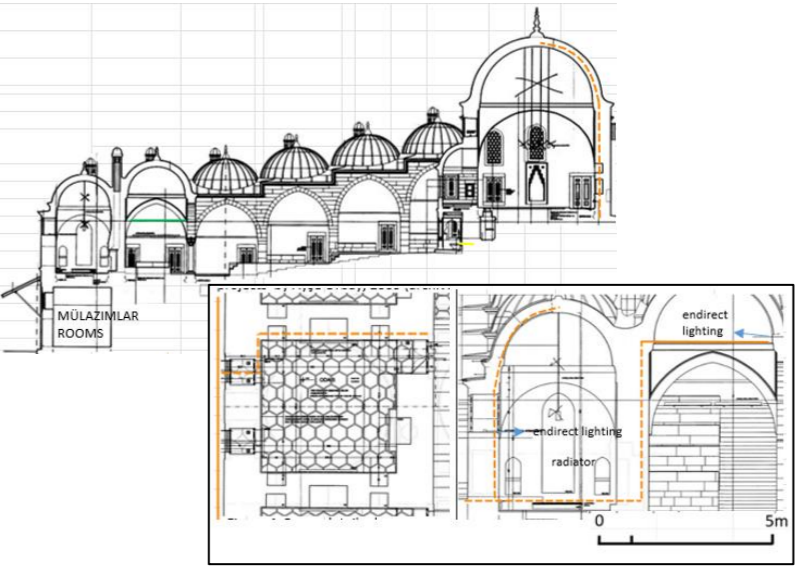
C.6. Table 4.6. Analysis of reuse decisions of Rabi Medrese on aspects of design decisions, spatial-structural and system alterations and contemporary sustainability approaches

<b>Rabi Medrese</b>	New use: <b>TUBA-Rabi Medrese</b>	
	Building size (m):	37.60 x 36.82
	Number of rooms:	20
	Room sizes:	3.70x3.70
	Classroom size (m):	7.78x7.78
	Number of eivans:	1 (entrance and terrace)
	Eivan size (m):	
	Width of the revaks (m):	4.48 and 3,56 (south west)
	Courtyard size (m):	24.11x24.17 (octagonal)
	Total backyard area (sqm):

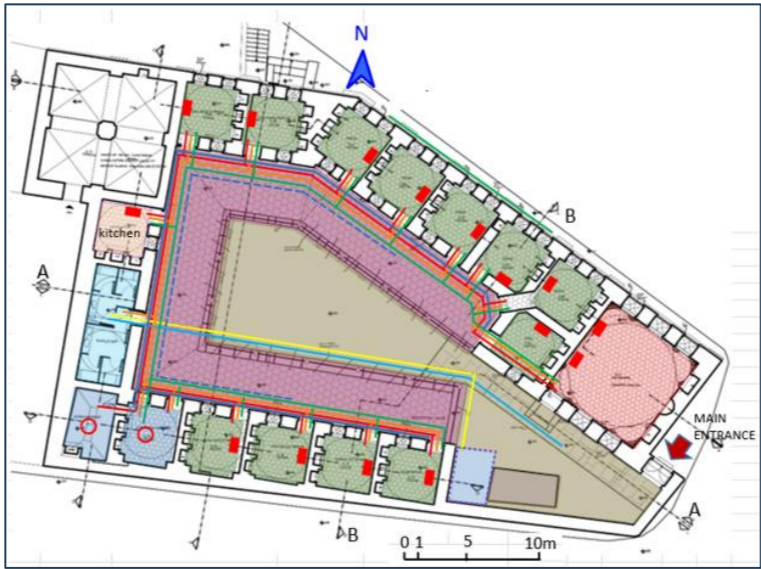
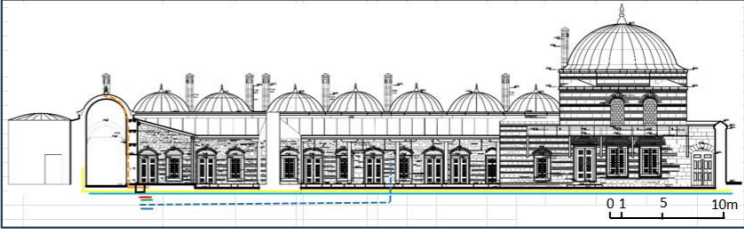
C.8. Table 4.8. Analysis of reuse decisions of Siyavuş Paşa Medrese on aspects of design decisions, spatial-structural and system alterations and contemporary sustainability approaches

<b>Siyavuş Paşa Medrese</b>	New use: <b>Siyavuş Paşa Medrese Hilye and Prayer-Beads Museum</b>

Building size (m): Number of rooms: 14 Room sizes: 3.50x3.50 Classroom size (m): 6.82x6.90 Number of eivans: 0 Eivan size (m): Width of the revaks (m): Courtyard size (m): Total backyard area (sqm):																																		
	Reuse Preparations			Appropriateness of Design Decisions													Appropriateness of Construction of Additions					Appropriateness of installed systems					Sustainability								
+ (appropriate) - (not appropriate) space, refers to absence	Significance assessment	Alternative Uses Analysis	Need Program	Drawings	Subdivision of the spaces	Architectural elements' refurbishment (niches)	Architectural elements' refurbishment (fireplaces)	Closure of windows	Closure of the revaks	Roofing the courtyard	Space alteration to wet space	Refurbishment of spaces	Refurnishing of spaces	Original space reorganisation	Roof addition	Window alteration	Door alteration	Closure of the space	Roofing the courtyard	Subdivision of the space	Service building addition	Wall addition and alteration (in backyard)	Roof addition in backyard	Air-conditioning or ventilation	Heating (radiator /wrf/underfloor)	Plumbing	Electric	CCTV	Fire alarm and/or fire supression	Drainage	Data	Accessibility (for public)	Energy efficiency	Management / maintenance plan
