High-speed observation of dynamic delamination failure in tapered composite laminates under tensile loading

Mirac Onur Bozkurt^{1,2} | Emine Burcin Ozen¹ | Burak Ogun Yavuz¹ |
Levend Parnas³ | Demirkan Coker^{1,2}

¹Department of Aerospace Engineering,
Middle East Technical University,
Ankara, Turkey

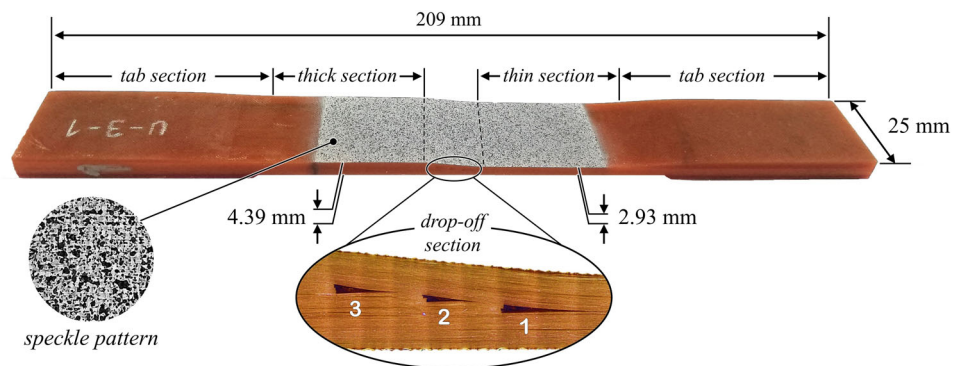
FIGURE 1 Dimensions and close-up views of the asymmetrically tapered test specimen with numbering of resin pockets.

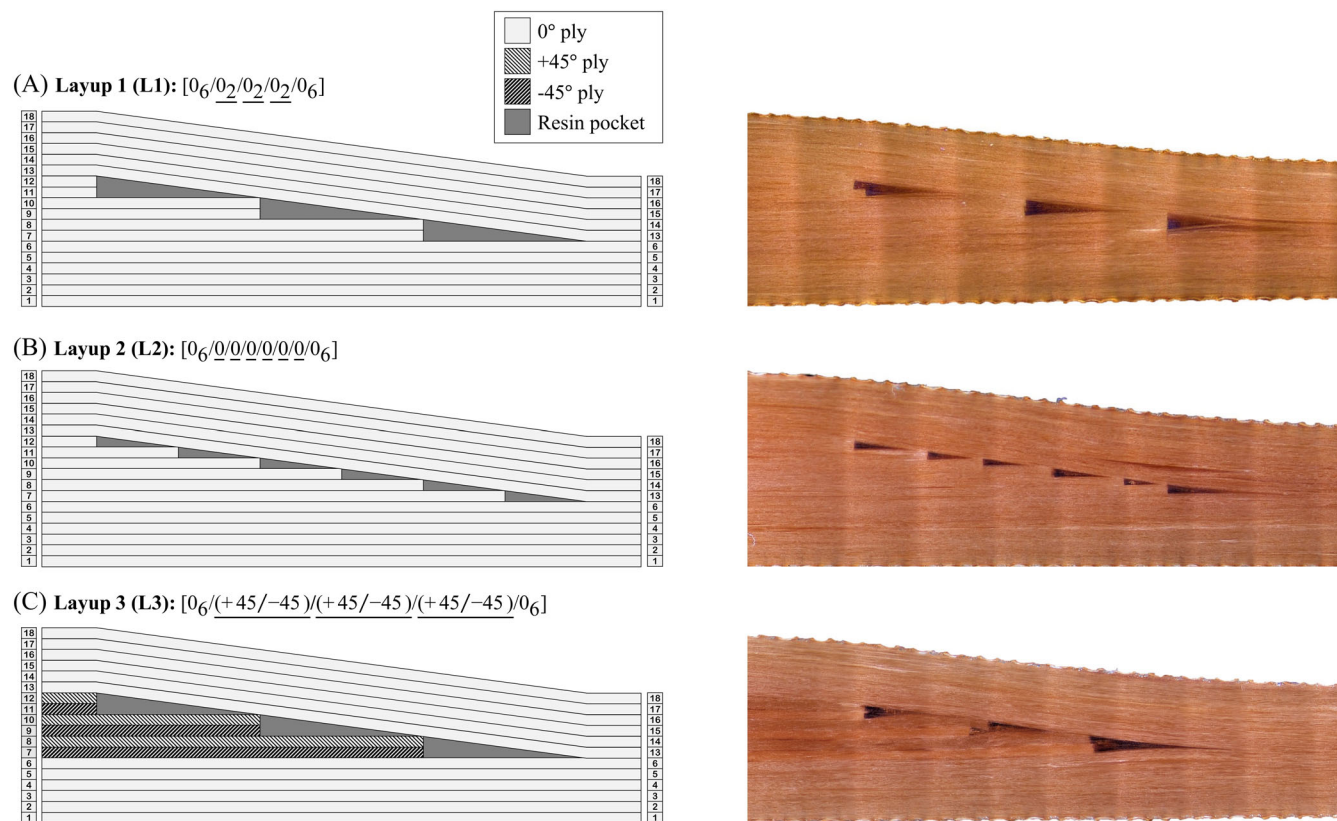
FIGURE 2 Laminate configurations (left) and side views of manufactured specimens (right). Underlined angles indicate drop-off plies.

In this study, dynamic delamination in tapered beams was investigated through laminates with grouped drop-off plies, as dispersed configurations are likely to have the characteristic of slow delamination growth.⁵ Staircased-grouped tapered specimens with three different configurations were manufactured with different stacking combinations of 0°, +45°, and -45° layers, as illustrated in Figure 2. Two unidirectional configurations (A) and (B) have discontinuous 0° plies which were cut at three and six consecutive steps, respectively, while the configuration (C) have discontinuous +45°/-45° plies which were cut at three consecutive steps.

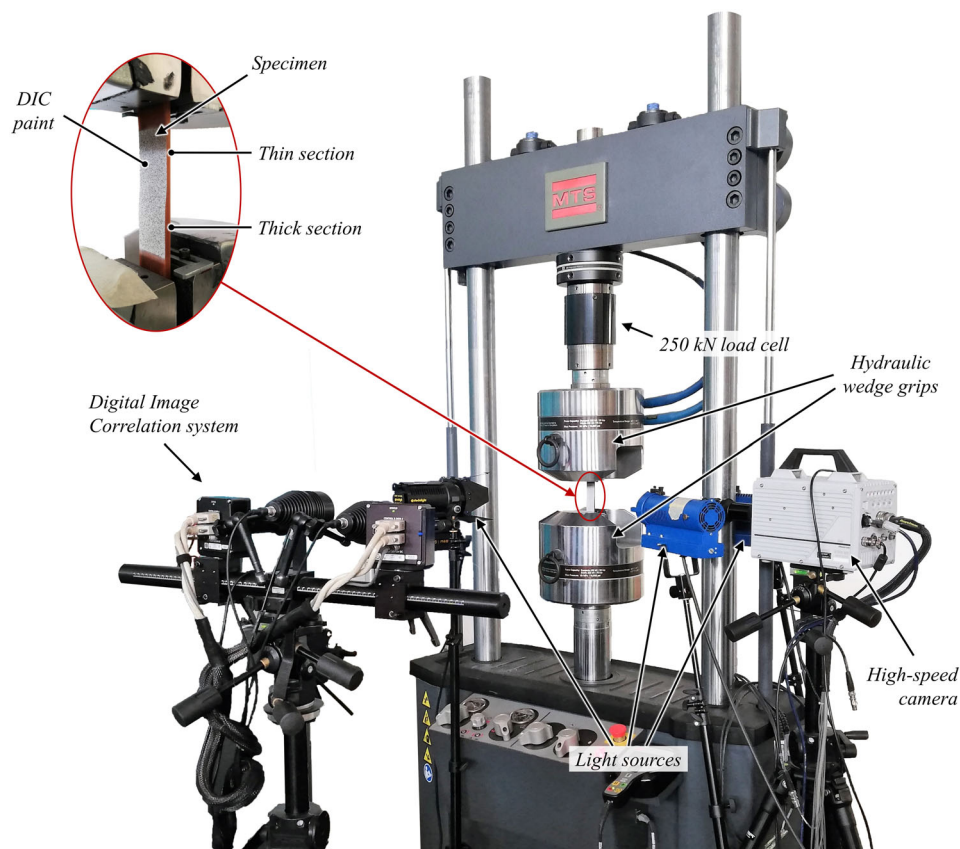
FIGURE 3 Experimental setup for the observation of a dynamic failure sequence in tapered laminates under tensile loading.

hydraulic testing machine seen in Figure 3. Thin and thick sections of the specimens were positioned inside the upper and lower hydraulic wedge grips, respectively, such that the free span length is 109 mm and equal portions of 50 mm remained inside each grip. Throughout the experimental program, grip pressures between 20 and 25 MPa were applied to squeeze specimens to prevent sliding inside the grips. All tensile tests were carried out in displacement control mode with a stroke rate of 0.5 mm/min, and the displacement was applied through the vertical motion of the lower grip while the upper grip was fixed.

In order to capture the damage sequence in a possible dynamic failure scenario, the high-speed photography technique was used. During each test, the specimen was lit by two Dedocool COOLH lights with 250 W Osram HLX Tungsten lamps. Failure events were recorded from the edge by a Photron SA5 ultra-high-speed camera at 124,000 fps providing images of 128 × 288 pixels resolution. To acquire the above-mentioned settings, the ultra-high-speed camera was equipped with a Titanar lens having 5.6-to-100 mm focal length and a 150 mm distance ring. The recording was triggered manually following a loud sound indicating failure or a sudden load drop in the real-time load–displacement curve. In some tests, snapshots were also taken at every 10 s during the loading not to miss any stable damage formation and

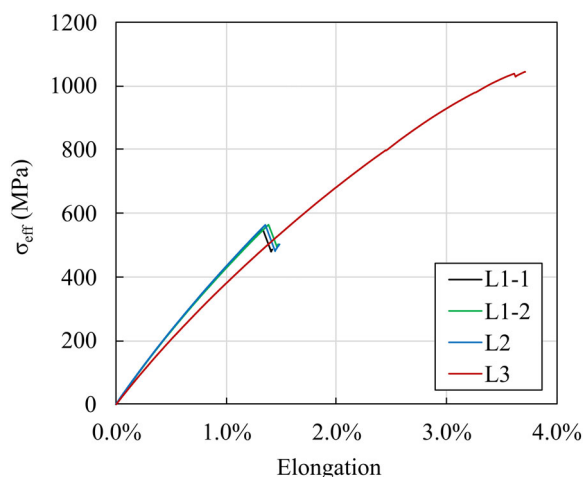
FIGURE 4 Effective stress versus elongation curves for specimens with L1, L2, and L3 layups.

Effective stress, σ_{eff} , vs elongation curves obtained from tensile tests of four asymmetrically tapered specimens are presented in Figure 4, where $\sigma_{\text{eff}} = \text{load}/(\text{width} \times t_{\text{eff}})$ and $t_{\text{eff}} = 2(t_{\text{thick}}t_{\text{thin}})/(t_{\text{thick}} + t_{\text{thin}})$. Unidirectional configurations L1 and L2 show very similar mechanical responses in terms of their stiffnesses and the effective stresses at failure. The stiffness of L3 configuration, however, is slightly lower but its failure stress is significantly higher compared to that of the other two configurations. Load, effective stress, and elongation measurements recorded just before the failure and percentage load drops in all specimens are reported in Table 2. In addition to its greater failure load and elongation values, L3

configuration loses only 0.7% of its tensile load carrying capacity upon failure. In the case of unidirectional laminates, that is, L1 and L2 configurations, percentage load drops are relatively higher, being around 12%–15%.

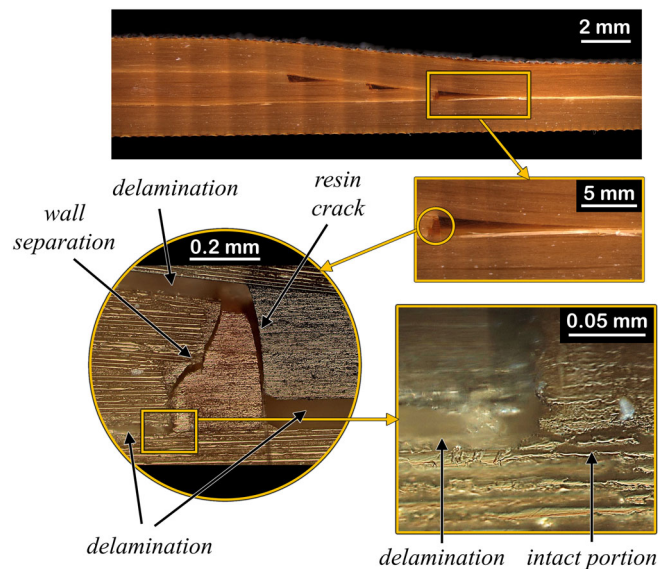
FIGURE 6 Micrographic inspection of the post-mortem damage pattern in specimen L1-1.

Micrographs presented in Figure 6 show the post-mortem damage pattern in specimen L1-1. In the upper micrograph showing the whole tapered region, it is seen that major delaminations exist between any two of the core, belt, and drop-off sublaminates within and beyond the transition region. Besides these major delaminations, which were also observed clearly in in situ images, one can also distinguish that short delaminations facing towards the thick side exist at bottom-left corners of the second and third resin pockets. Additionally, it is notable that there are straight transverse cracks within the resin pockets rather than or in addition to separations at resin pocket walls. These might have occurred due to a manufacturing impurity; that is, slightly sliding of the

Detailed investigation of the post-mortem damage can be conducted through micrographs of greater magnification levels. As mentioned earlier for Figure 5, two distinct transverse cracks are seen in the first resin pocket. The right-handed one is a straight transverse crack within the resin pocket, and it is connected to the thin-side delamination. The left-hand side crack, on the other hand, is the separation of cut-ends of dropped-off plies from the resin pocket, hence the junction between the two thick side delaminations. Between these two transverse cracks, there is a residue connected to the core sublaminates, which separates left and right-handed delaminations.

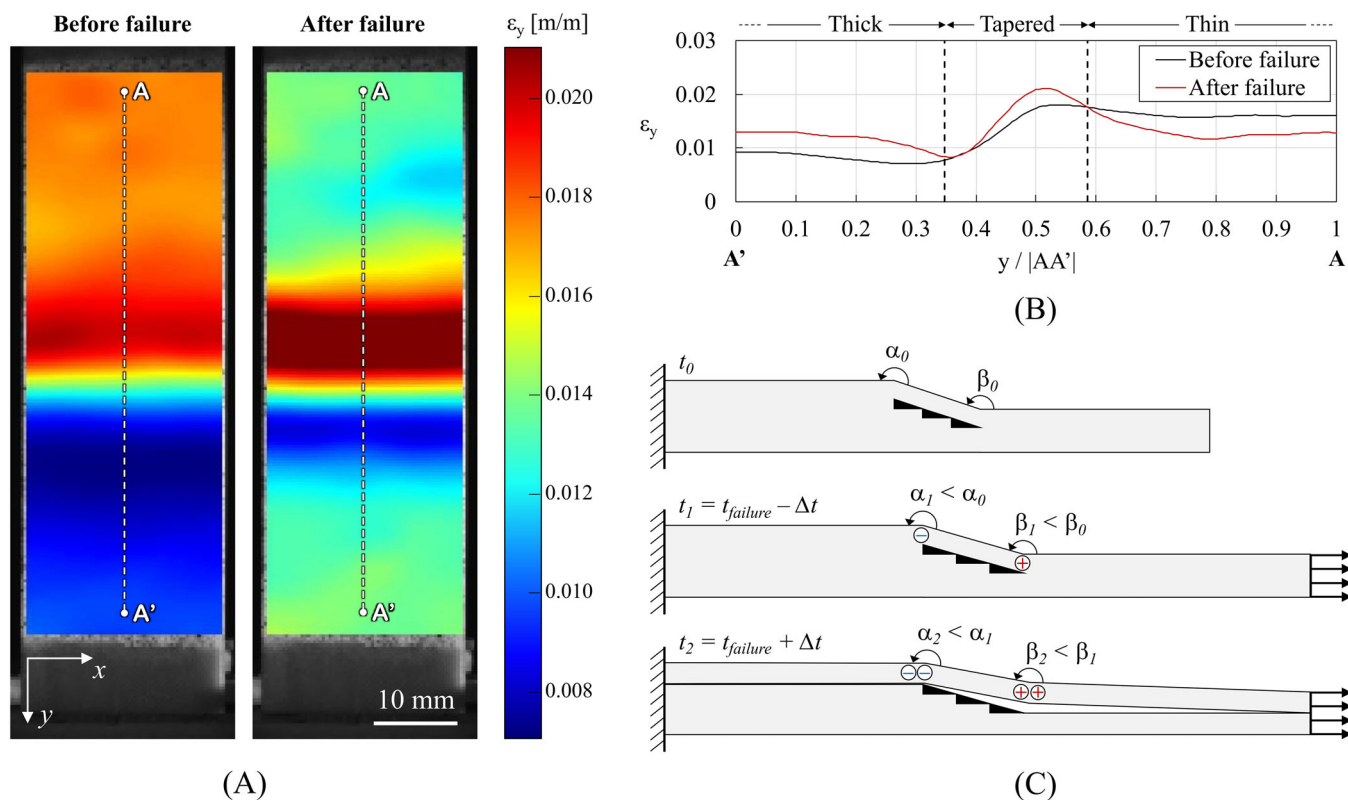
FIGURE 7 (A) DIC contours of ϵ_y just before and after the failure, (B) variation of ϵ_y along the path AA', and (C) schematical illustration of the tapered geometry under tension before and after the failure.

DIC contours of the longitudinal strain ϵ_y over the tapered face of the beam just before and after the failure are presented in Figure 7A. Before the failure, ϵ_y distribution is nearly uniform within the thin and thick portions of the beam, and the thin portion is strained more in the axial y -direction as expected. After the failure, on the other hand, ϵ_y is uniform and at the same level at two ends of the tapered beam. In both cases, ϵ_y is observed to be nearly uniform in transverse x -direction.

In Figure 7B, variation of ϵ_y along the path AA' before and after the failure is presented. Before the failure, ϵ_y is almost constant at far thick and thin ends of the beam

with approximate measured strain values of 0.016 and 0.009, respectively. As it approaches to the tapered region from the thick end, ϵ_y slightly decreases. Conversely, as it approaches to the tapered region from the thin end, ϵ_y slightly increases. A smooth transition of ϵ_y is observed along the tapered region of the beam. After the failure, farfield ϵ_y values come to a similar level which is about 0.013 strain. Additionally, a plunge and rise in ϵ_y is observed near the thick and thin boundaries of the tapered region, respectively, which are interconnected by means of a steeper strain transition compared to the no failure case.

The plunges and rises observed in the axial strain beyond the transition region are mainly due to the bending of the belt sublaminates.¹⁸ To understand the physical basis of such a strain variation, it is useful to examine a hypothetical case illustrated in Figure 7C. Consider an asymmetrically tapered beam fixed in the axial direction at its thick end. At time t_0 , the beam is load-free, and the angles made by the tapered edge to the flat edges of the thick and thin portions are α_0 and β_0 , respectively. When this beam is pulled axially until a time t_1 which corresponds to an instant just before the failure, whole length of the belt sublaminates elongates. Such an elongation results in a change in the angles α and β , such that

$\alpha_1 < \alpha_0$ and $\beta_1 > \beta_0$. Accordingly, compressive and tensile strains are induced by the bending of the corners at the thick and thin transition boundaries, respectively. Assume that further elongation causes the beam to fail only in the form of a full-length delamination underneath the belt sublaminates at a time t_2 . Since the belt under tension tends to split up from the core on the thin side, such delamination failure leads to further decrease in α and increase in β . Therefore, splitting of the belt induces higher bending strains at the transition boundaries, which appear as a plunge and a rise in the red curve shown in Figure 7B.

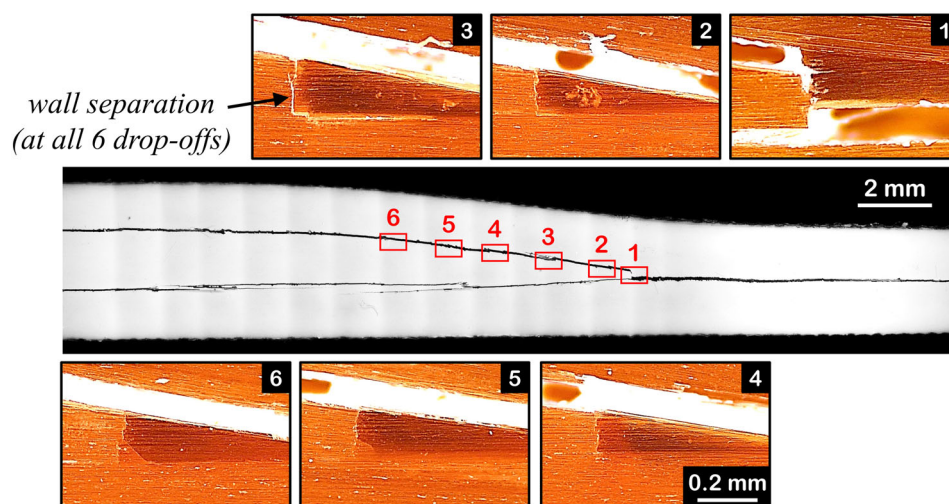
FIGURE 10 Micrograph showing the post-mortem damage pattern in specimen L2.

Figure 10 depicts the post-mortem failure pattern in specimen L2 via a tiled micrograph of the tapered region in conjunction with close-up micrographs of all six resin pockets (after white paint has been removed). In these micrographs, the residual opening of the delaminated surfaces can be clearly observed. Besides, the microscopic inspection of the resin pockets reveals that transverse cracks exist also at the 5th and 6th drop-off sites which were not visible in the HSC images. It is clearly seen that all these transverse cracks are separations at resin pocket walls rather than independent cracks within resin pockets such as ones observed in the staircased/grouped unidirectional configuration L1. This observation supports our claim which was the manufacturing impurity in grouped drop-offs causing transverse cracks within resin pockets (see the discussion of Figure 6).
