ASSESSING THE IMPACT OF CHANGES ON VALUES DURING THE  
TRANSFORMATION OF TRADITIONAL HOUSES INTO HOTELS: THE  
CASE OF TARAKLI

A THESIS SUBMITTED TO  
THE GRADUATE SCHOOL OF NATURAL AND APPLIED SCIENCES  
OF  
MIDDLE EAST TECHNICAL UNIVERSITY

IN PARTIAL FULFILLMENT OF THE REQUIREMENTS  
FOR  
THE DEGREE OF MASTER OF SCIENCE  
IN  
CONSERVATION OF CULTURAL HERITAGE IN ARCHITECTURE

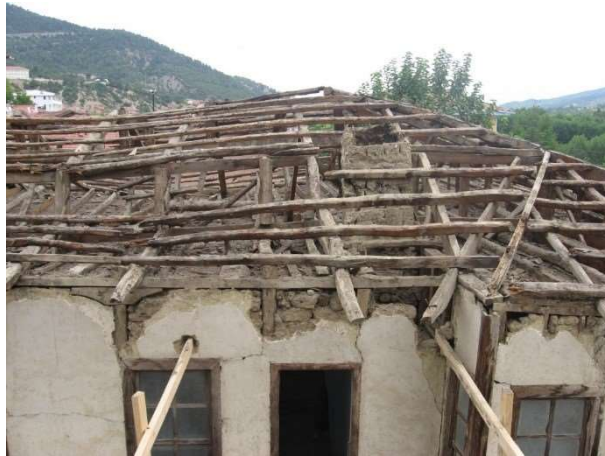
**Wood:** The climate and geographical conditions of the Taraklı region make wood the most common construction material. During the construction of timber-framed houses, wood was used for post and lintel systems, wooden frames of windows, and doors, and covering of ceiling, floor, cupboard and roof (Figure 2.11). The dimension of timber was 10-12 cm for structural purposes. To provide a better base for plastering, the thickness of timber might be varied. Three types of wood were used such as oak, pine and fir and their main characteristics are being hard and long life, resisting moisture and heat changes. Oak was chosen for constructing load-bearing columns, for load-bearing beams and pine for braces and secondary posts (Özyer, 2008).

Figure 2.11. Wooden structure of the roof of Abdi İbrahim house before hotel transformation (taken from the Taraklı Municipality, 2013)

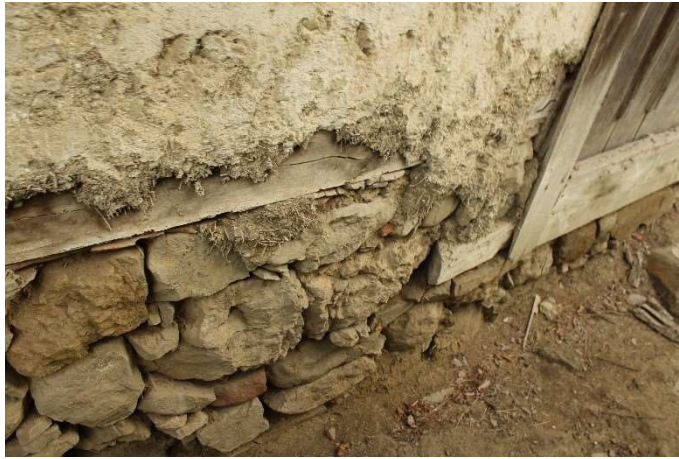
**Stone:** Stone was used as a second material for Taraklı houses. It was generally chosen for constructing the foundation and ground floors because stone prevents dampness on the ground of the building (Figure 2.12). In addition, it is an appropriate material for transition through timber and mudbrick but stone was not a popular construction material as timber in this region because it was hard to find stone in nearby areas. Furthermore, quarrying and transporting stone expenses were hard to overcome (Özyer, 2008). Rubblestone for the foundation, and Kayran for garden walls and pavements were chosen as construction material. Ground floor walls were raised through 80-120 cm height. On the other hand, if the house is located on a sloped topography, a stone wall can be constructed at one-floor height to provide resistance against dampness and other issues of ground. (Özyer, 2008).

Figure 2.12. Stone foundation of Ezancılar house (Author, 2016)

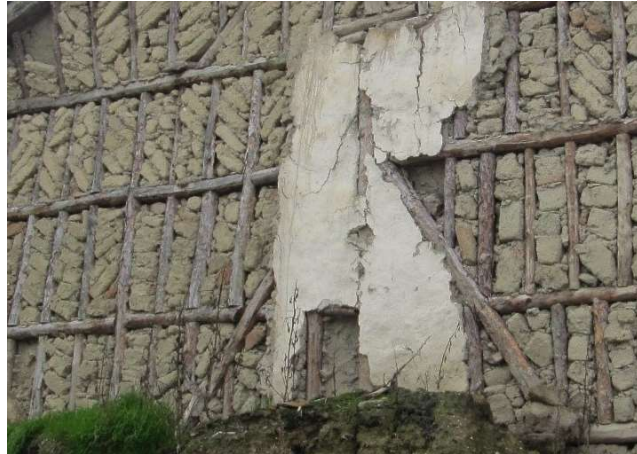
**Mudbrick:** It had significance in the Taraklı region as a construction material. Especially for the houses that were constructed on plain topography. Lots of houses were designed as timber-framed structures and their structures were infilled with mudbrick (Figure 2.13). Ingredients of mudbrick were water, clayey earth, and straw. Although the dimension of mudbrick change, the most common sizes was 10x12x20 cm, and 10x15x20 cm but for masonry walls, it changed to 10x15x30 cm or 10x20x30 cm according to a cross section of timber posts (Özyer, 2008).

Figure 2.13. Mudbrick detail as a construction material from unnamed house in Taraklı (Author, 2016)

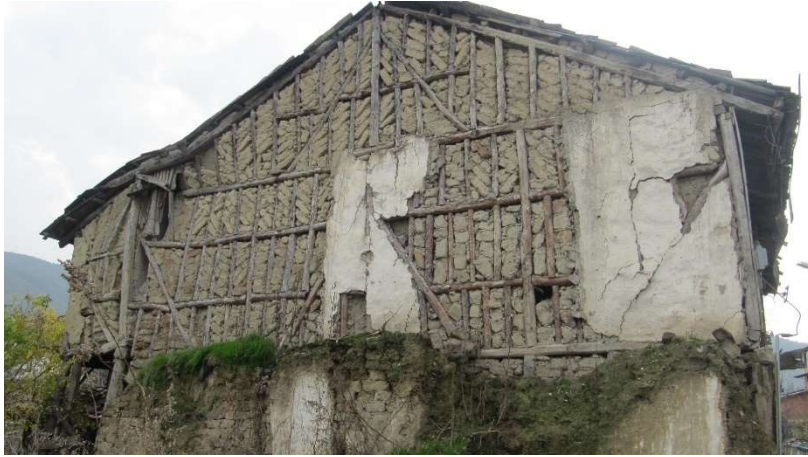
**Timber skeleton system with mudbrick infill:** The most popular technique for Taraklı houses because it was easy to produce mudbrick. After constructing a stone wall that achieved 80-90 cm height from the ground level, main and secondary timber elements were placed (Figure 2.14). Finally, gaps between timber elements are filled with mudbrick. (Özyer, 2008).

Figure 2.14. Timber skeleton system with mudbrick infill from unnamed house in Taraklı (Author, 2016)

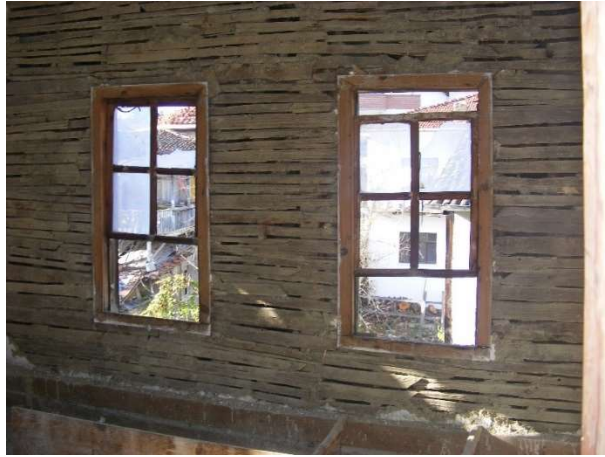
**Bağdadi system (timber skeleton without infill material):** Laths were applied both inside and outside of wall surfaces horizontally (Figure 2.15). Empty spaces filled with little brick and stone pieces or left empty. After filling application, finishing plaster was implemented. Exterior side of walls were filled but interior walls were left empty (Özyer, 2008).

Figure 2.15. Bağdadi system in unnamed house in taraklı (taken from the Taraklı Municipality, 2013)

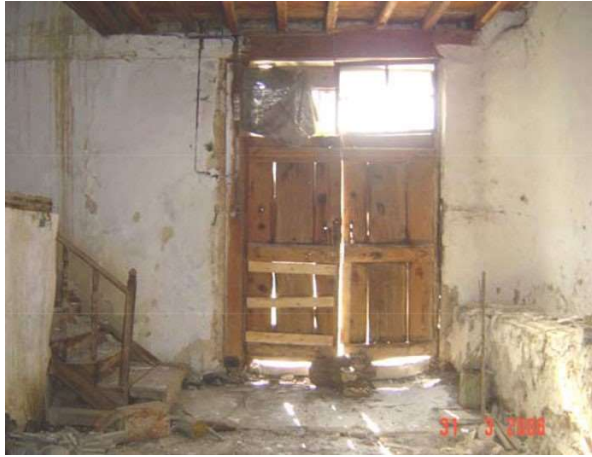
**Hayat & Taşlık:** It provides circulation on the ground floor (Davulcu, 2009). When the flooring is covered with stone, it is called taşlık (Figure 2.17) Hayat or taşlık can be divided into different spaces like storage, dam, barn, and garage and it can also called işlik to provide production area (Çetin, 2006). Hayat includes a big fireplace for the preparation of food for the winter seasons. It is also lightened by small, loopholed openings (Çetin, 2006).

Figure 2.17. Taşlık of Hacı Rıfatlar konağı before its transformation (Özkan, 2008, p.103)

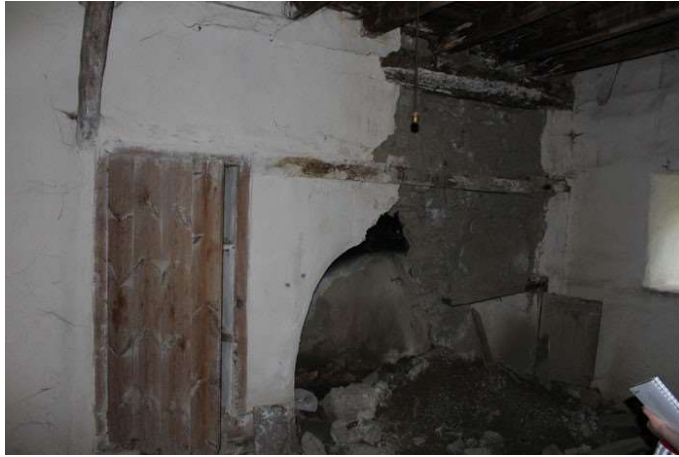
**Kitchen:** On the ground floors, If there is no barn or hayloft then it is possible to say that there are spaces like a kitchen (Figure 2.18) and bathroom (Özkan, 2008). The kitchen might be located on the first floor (Özkan, 2008).

Figure 2.18. Kitchen of Ezancılar konağı (Author, 2016)

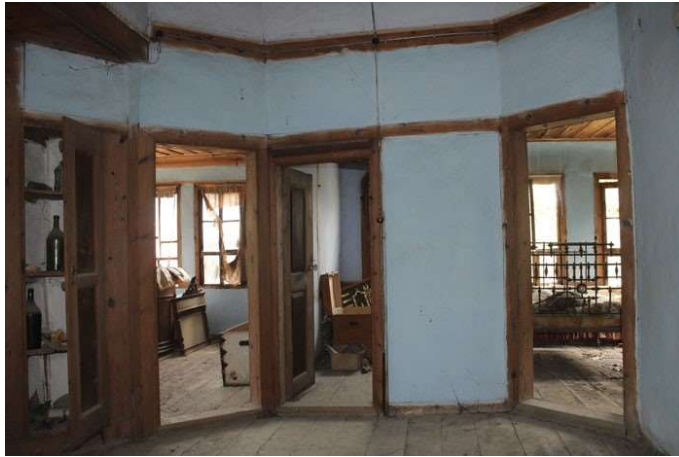
**Sofa:** In addition to being everyday places, sofas (Figure 2.19), which are common areas when they are opened, serve as circulation zones. It's an important location for daily life routines. The sofa has to be considered in the plan typology while developing the layout (Özkan, 2008).

Figure 2.19. Partial view of sofa which belongs to Ezancılar house (Author, 2016)

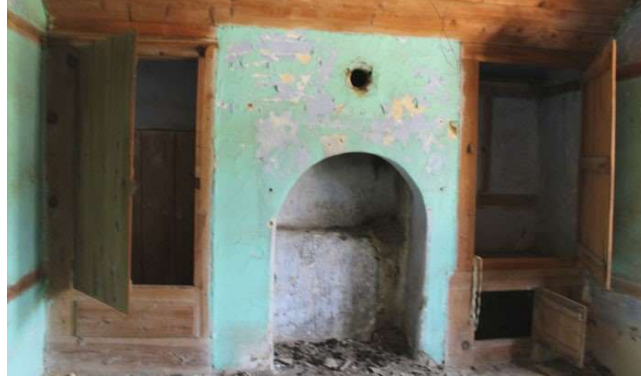
**Room:** Room entrances can be divided into two one of them is 45 degrees sloped or plain. It can be said that rooms have 4m. width and 4m. depth and they own also a fireplace, cupboards, and sedir, too (Figure 2.20). The walls are covered with bağdadi plaster in pastel colors. A few examples of wall decoration can be found. Room doors have a single wing (Özkan, 2008).

Figure 2.20. Gusülhane (at left side of fireplace) , fireplace and closet (at right side of fireplace) view of the room, Haşmet Doğru house (Author, 2016)

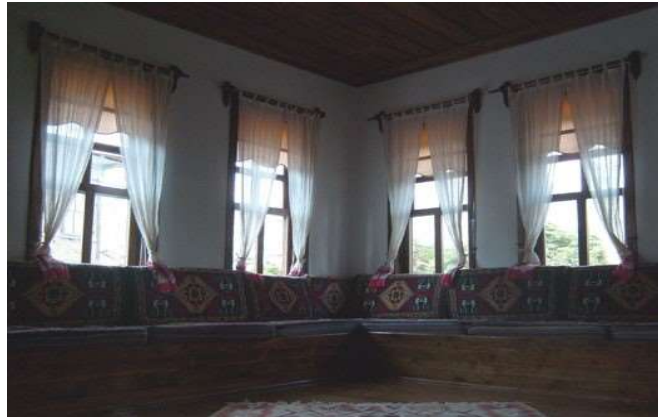
**Başoda:** It is designed for guests so it is the room with the most decoration elements and most beautiful view (Figure 2.21). If the house has a cantilever, başoda owns the cantilever and it opens outside with windows on two sides becoming a corner room. Another important advantage is staying close to the basement (Kan, 2009).

Figure 2.21. Başoda of Çakırlar konağı after its transformation (Author, 2013)

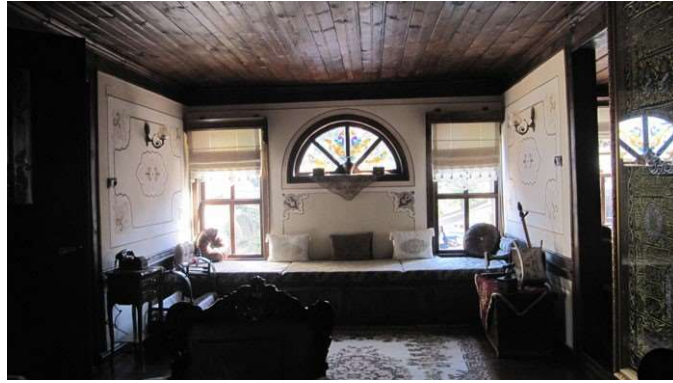
**Window:** To provide better lighting conditions, lots of windows were opened during construction. Windows are divided into different groups such as flat and vaulted lintels. The most known flat lintel has two stable partitions at the top and middle and is openable below. Newer dwellings have flat lintel with two partitions and it is formed by two guillotine covers. Windows with arched lintels are used to emphasize significant places such as the *eyvan* and *sofa*. The design of the arched lintel is close to a window with three partitions but it has both two and three partitions (Özkan, 2008).

Figure 2.22. Eyvan window of Kadirler konağı after its transformation (Author, 2013)

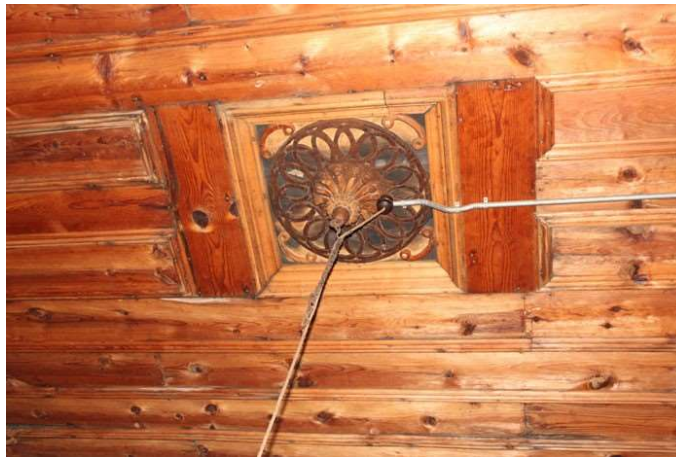
**Ceiling:** Although wooden ornament was not used on interior door wings, yüklük and closet doors, it was used for ceiling of traditional houses with ‘çıtakari technique’ by closing holes between woods on ceiling with laths. Besides, ceiling woods can be nailed to ceiling as parallel or cross to wall and different geometric forms were applied (Çetin, 2006). Ceiling panels were not applied on corridors and service areas but ceiling panels with ornamentation and paint can be seen in living units generally (Özyer, 2008).

Figure 2.23. Ceiling ornament of 2.nd floor sofa, Ezancılar house (Author, 2016)

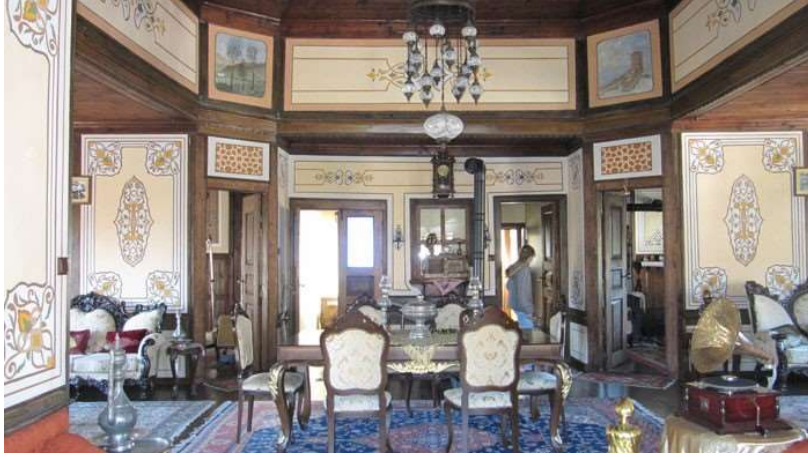
**Walls:** Walls are usually ordinary and colored. Kalemîşi ornament (Figure 2.24) can be rarely seen in Sakarya houses but in two different forms on plaster and wood material (Çetin, 2006).

Figure 2.24. Kalemîşi ornamentation on wall of 2.nd floor sofa of Kadirler house after its transformation (Author, 2013)

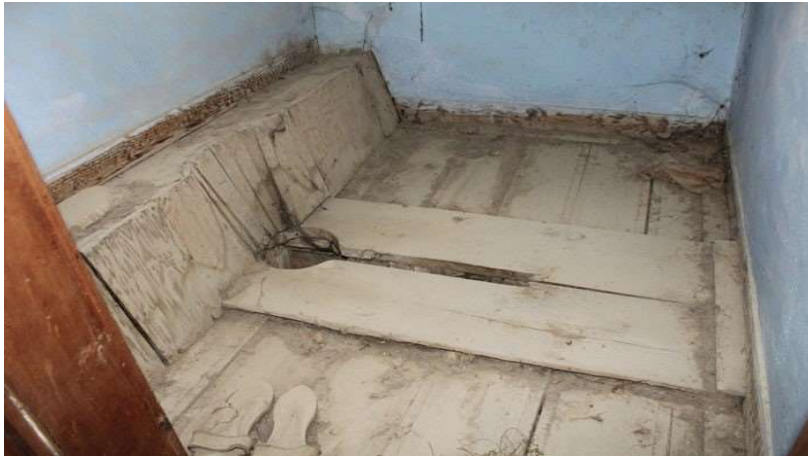
**Hela:** On one side of the Sofa, there is an ablution space for washing hands or dishes. Hela locates at back of it (Davulcu, 2009).

Figure 2.25. Hela of Ezancılar house in Taraklı (Author, 2016)

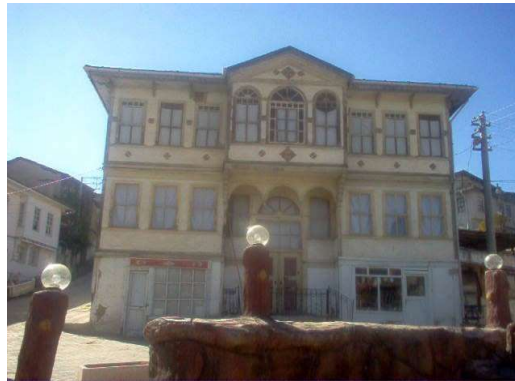
Figure 3.4. Pre-intervention view of Kadirler house, east facade (taken from the Taraklı Municipality, 2013)

The east facade of the Kadirler house (Figure 3.4) has a staircase that is reached by a one-way concrete staircase with iron railings. There are shop entrances with wooden glass windows and single-winged doors at the right and left sides of the staircase. Door and window frames are painted with oil paint. Swelling and cracks are visible on the paint. The ground floor was plastered and painted. Cracking, swelling, and flaking have been detected on plaster. The first floor has eight rectangular, wooden framed, and painted windows and one arched window on top of the entrance. Arched, timber decorations emphasized the main entrance.

Deteriorations were inspected on doors and windows. The first floor was plastered and painted. Cracking, swelling, and flaking have been detected on plaster. On the first floor, there are a total of 9 original, 6 rectangular, and 3 arched wooden windows. It is emphasized by a cantilever. The second floor was plastered and painted. Cracking, swelling, and flaking have been detected on plaster.

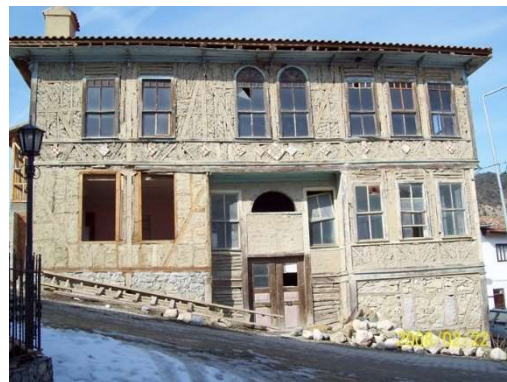
Figure 3.5. Pre-intervention view of Kadirler house, south facade (taken from the Taraklı Municipality, 2013)

The south facade of the Kadirler house (Figure 3.5) has an original double-winged wooden door that provides the entrance on this floor. On the second floor, It has two rectangular, wooden framed windows and an arched window on top of it. It also has five, rectangular, wooden framed windows. On the first floor, it has five rectangular windows and two arched windows. Floors were plastered and painted. Cracking, swelling, and flaking have been detected in plaster.

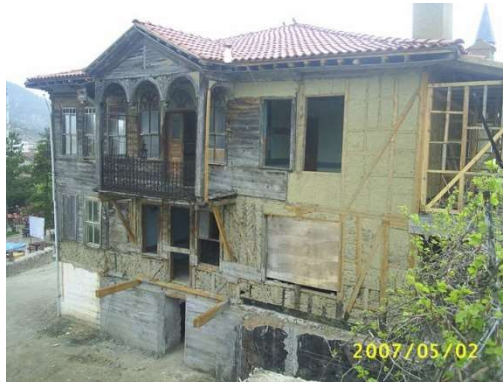
Figure 3.6. Pre-intervention view of Kadirler house, north facade (taken from the Taraklı Municipality, 2013)

The north facade of the Kadirler house (Figure 3.6) had an additional structure on the ground floor which covered a large part of the ground floor. On this floor, one wooden door was detected. The walls of the additional building were plaster and painted. Cracking, insect infestation, discoloration, etc. on windows, door frames, and distortions have been detected. On the first floor, there were four original wooden windows, two wooden toilet windows, and one original single-winged wooden door. Two of the windows are half covered with bricks. The walls were covered with plaster and painted. Cracking, insect infestation, discoloration, etc. on windows, door frames, and distortions have been detected. On the second floor, there are a total of five original wooden windows, three rectangular and two arched, one wooden toilet window, and one original double-winged wooden balcony door. The walls were covered with plaster and painted. Cracking, insect infestation, discoloration, etc. on windows, door frames, and distortions have been detected on this floor, too.

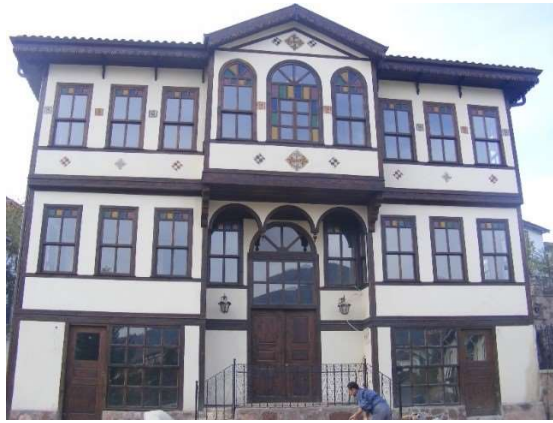
Figure 3.11. Post-intervention view of Kadirler house, east facade (Author, 2013)

The east facade (Figure 3.11) was emphasized by the cantilever. The main entrance door was also emphasized by a cantilever and raised by a staircase which has two directions. The main entrance has an arched window on top of it. The cantilever also has an arched windows. Other windows of the front facade are rectangular. The east facade has a main entrance and it has also two other entrances that open through the shop areas. The second floor was ornamented by ceramic tiles that were located below the windows and on top of the triangular face of the cantilever. The ending points of floors were defined with horizontal and wooden lines on the front facade.

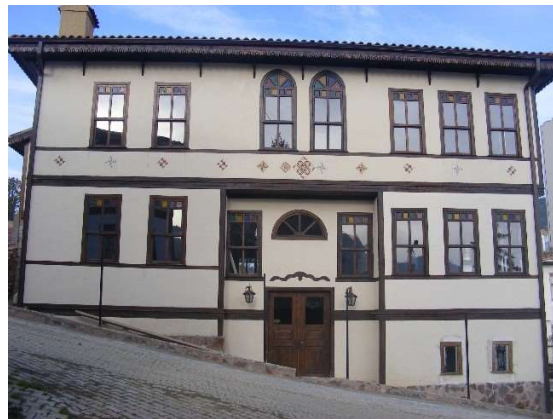
Figure 3.12. Post-intervention view of Kadirler house, south facade (Author, 2013)

The south facade (Figure 3.12) opens to the street by a door with a double wing. It was defined with an arched window on its top and two rectangular windows with colored glasses on its right and left sides. The entrance was pulled away to the interior. The ground floor has two, little windows on the left side of the entrance. The first floor includes five windows that are positioned on the right and left sides of the entrance. The second floor contains five rectangular and two arched windows with colored glasses on their top. Two arched windows were positioned on top of the entrance. The second floor was ornamented by ceramic tiles that were located below the windows. The ending points of floors were defined with horizontal and wooden lines on the front facade. The finishing of the north facade is plaster. The door and windows were made out of timber. On the left side of the mentioned facade, it has a volume addition. The added space has a small window on its first floor. The ending points of floors were defined with horizontal and wooden lines.

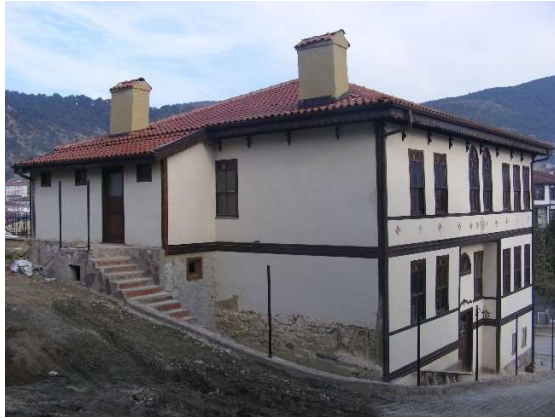
Figure 3.13. Post-intervention view of Kadirler house, west facade (Author, 2013)

The west facade (Figure 3.13) has an addition with a door that opens to the street by a stone staircase at the back side and three little windows on top of it. The first floor also has a single, rectangular window with colored glass on its top. The finishing of the second floor is plaster but the first floor was made out of plaster. The ending point of the floor was defined with horizontal and wooden lines.

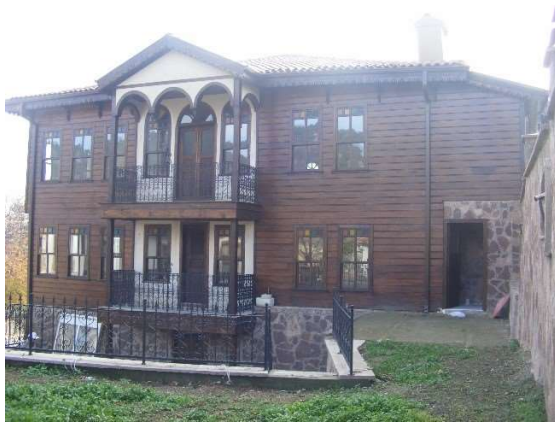
Figure 3.14. Post-intervention view of Kadirler house, north facade (Author, 2013)

The north facade (Figure 3.14) has a vertical axis at the middle of the facade which contains door openings on each floor. The ground floor opens to a garden with a wooden door. The door is the only opening on the ground floor on the right side of the house. The surface of the ground floor is stone. The first floor has a balcony entrance and one window on each side of the balcony entrance. The floor has five windows with colored glass on their tops. Three of them are located on the left side of the balcony, and two of them are located right side of the balcony. The second floor has a balcony with a door and two windows on each side of the door. The balcony of the second floor was emphasized by arched windows and doors with colored glasses on their tops. It also has an arched and triangular roof on it. The

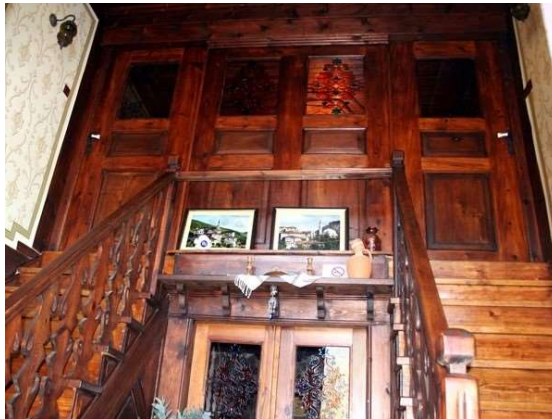
The room GPOI05 is an entrance area (Figure 3.16) and it has two wooden staircases both at the right and left sides. In between the staircases, there is a double-sided door that opens through room GPOI01. In space GPOI05, the floor is covered with ceramic tiles. Its ceiling material is wood. The walls are covered with kalemışı works

Figure 3.16. Entrance space of Kadirler house, GPOI05 (Author, 2013)

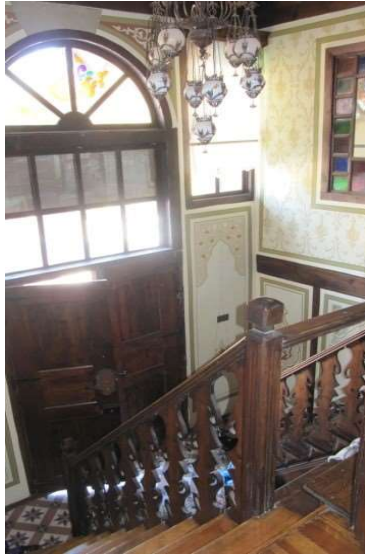
of art (Figure 3.17). The entrance area is illuminated by two colored windows on the upper right and left side and windows which were decorated and colored with figures on the upper side of the entrance door.

Figure 3.17. Interior entrance of Kadirler house, GPOI05 (Author, 2013)

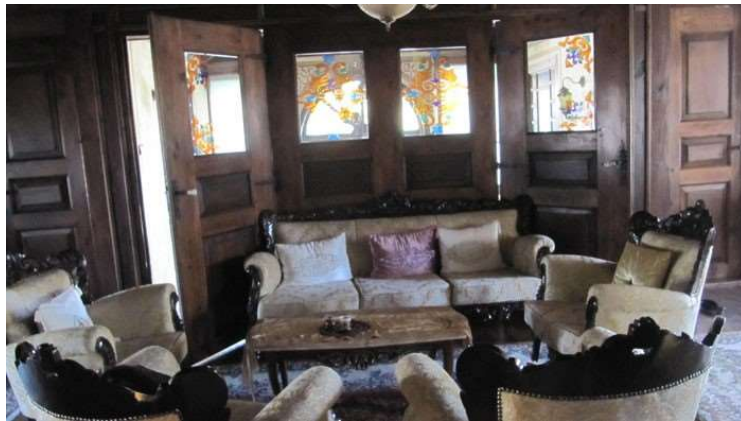
Figure 3.19. Sofa of Kadirler house at first floor, FPOI07 (Author, 2013)

The first floor (Figure 3.18) has a main space, called FPOI07. It is a sofa (Figure 3.19). The sofa space opens to FPOI01, FPOI04, FPOI05 and FPOI06 rooms. It also opens to wet spaces which are numbered as FPOI02 and FPOI03. Rooms have eyvan (Figure 3.20) spaces in between them. The sofa has a balcony on the south facade. Two staircases that come from the ground floor open to the sofa on the first floor on the eastern side. A staircase that rises from the first floor to the ground floor is located on the western side of the sofa. The sofa was pulled in and emphasized on the northern and eastern sides. It also has built-in seating units that are called sedir. The floor and the ceiling are wooden. The walls are covered with kalemîşi.

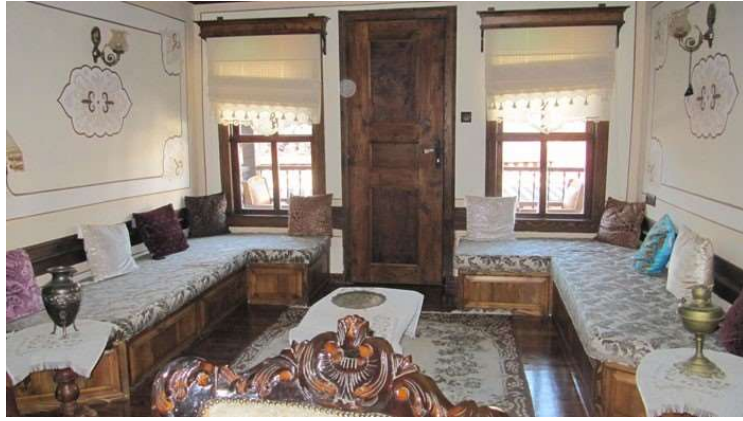
Figure 3.20. Eyvan of Kadirler house at first floor (Author, 2013)

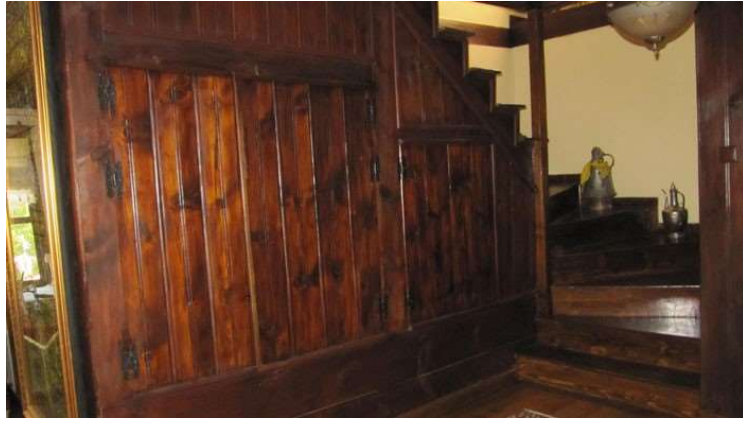
Figure 3.21. Built-in closet under staircase at first floor (Author, 2013)

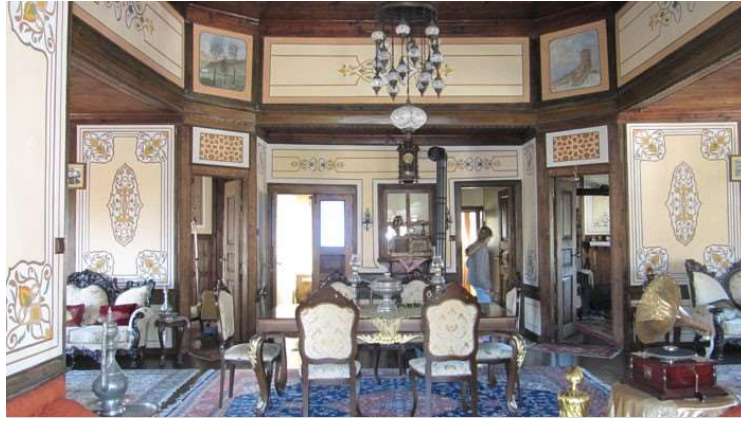
Figure 3.23. Second floor sofa of Kadirler house (Author, 2013)

The second floor (Figure 3.22) has a space that is numbered as SPOI07. The SPOI07 opens to rooms SPOI01, SPOI04, SPOI05 and SPOI06. The sofa (Figure 3.23) was emphasized by the cantilever on the eastern facade. The sofa has a staircase and wet spaces on the western facade. The floor and ceiling are wooden. The walls are painted white color.

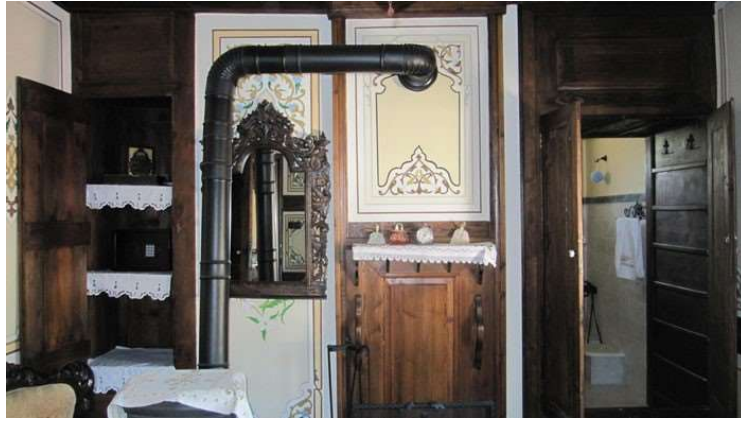
Figure 3.24. Closet, fireplace and gusülhanes' current condition (Author, 2013)

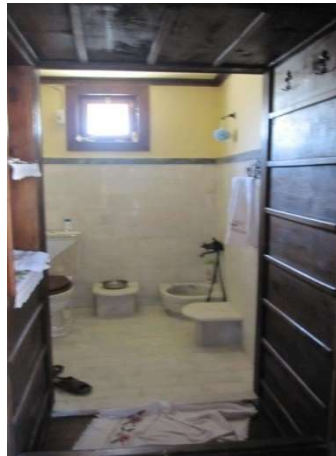
Figure 3.25. Current view of gusülhane and wet space addition (Author, 2013)

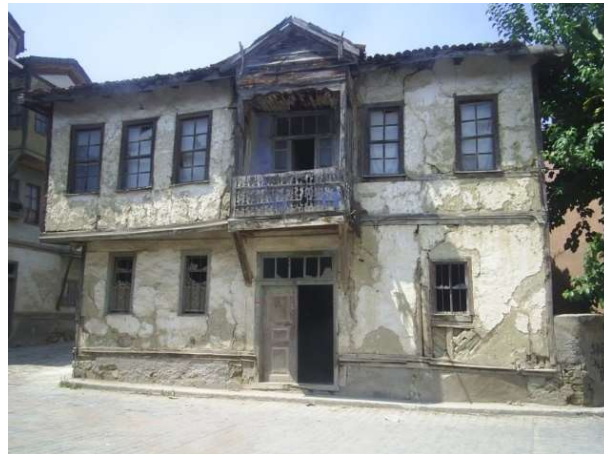
Figure 3.28. Pre intervention south facade view of Abdi İbrahim house (taken from the Taraklı Municipality, 2013)

The south facade of the Abdi İbrahim house (Figure 3.28), has a double-winged, rectangular-shaped, wooden entrance door with a little, five rectangular glasses on top of it. The main door has two rectangular windows on its left side and one rectangular window on the right side on the ground floor. The first floor has a cantilever and a balcony. The balcony has a door with little glass frames. There are also five rectangular windows. On this facade, all of the window and door frames are wooden. The balcony has a wooden covering, too. Its balustrade is also wooden. The construction style of this facade is timber-framed mudbrick. The wall is plastered and painted. Cracking, swelling, and flaking have been detected in plaster. There are cracks and lots of materials on the wall. Most of the windows on the ground floor were broken. Wooden parts were also damaged.

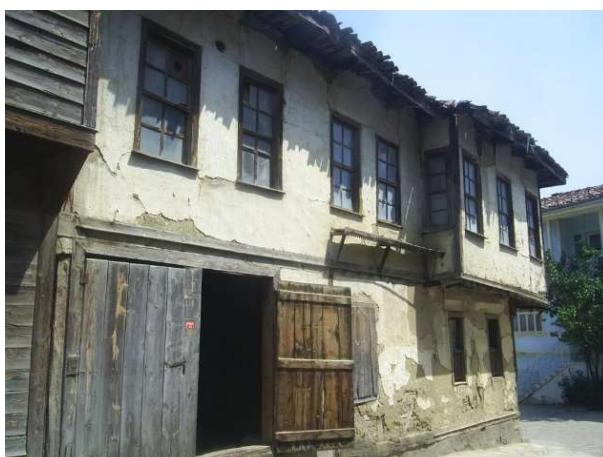
Figure 3.29. Pre intervention east facade view of Abdi İbrahim house (taken from the Taraklı Municipality, 2013)

The east facade (Figure 3.29) of the Abdi İbrahim house has a large double-winged, wooden door. It has a rectangular, window with a wooden covering and two rectangular windows on its right side on the ground floor. There are five rectangular windows on the first floor. The construction style of this facade is timber-framed mudbrick. The wall is plastered and painted. Cracking, swelling, and flaking have been detected in plaster. There are cracks and loss of materials on the wall. Most of the windows on the ground floor were broken. Wooden parts were also damaged.

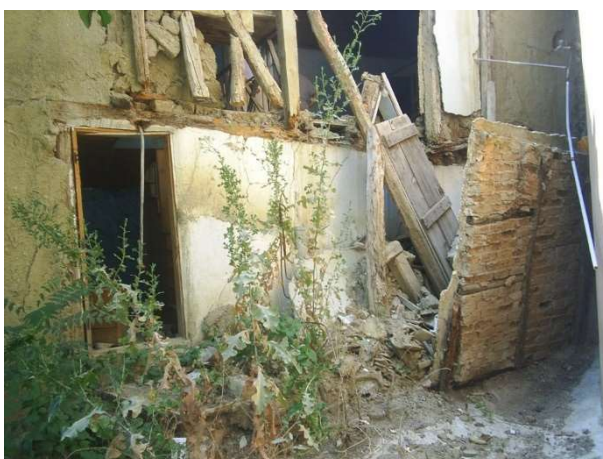
Figure 3.30. Pre intervention west facade view of Abdi İbrahim house (taken from the Taraklı Municipality, 2013)

The west facade (Figure 3.30) of the Abdi İbrahim house has a small window on the ground floor which serves to the taşlık. It has four windows. Two of them serve to the wet spaces. One of them serves to the Sofa. The other one serves to the room FPRI04 on the first floor. Cracking, swelling, and flaking have been detected in plaster. Most part of this facade was harmed. GPRI03 and FPRI03 were demolished. Some part of the FPRI02 was also demolished.

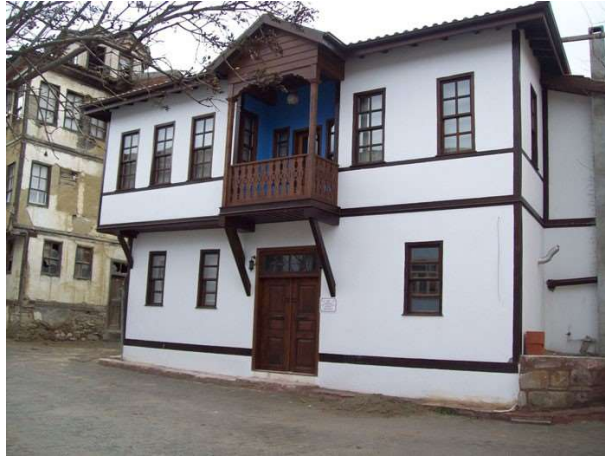
Figure 3.33. South facade of Abdi İbrahim house (taken from the Taraklı Municipality, 2016)

The south facade of the Abdi İbrahim house (Figure 3.33) includes the main entrance door. The door is wooden and has small glasses on top of it. The entrance door has three, rectangular windows with a wooden frame on the ground floor. The main entrance was emphasized by a balcony with a gable roof on the first floor. The balcony was covered with wooden material. The balcony has a door and four windows on the right and left sides of it. There are also five rectangular windows on the first floor. The South west part of the first floor was cantilevered towards the street with three windows. The walls are plastered and painted to the white color. Floor and opening finishings were defined by vertical, timber lines.

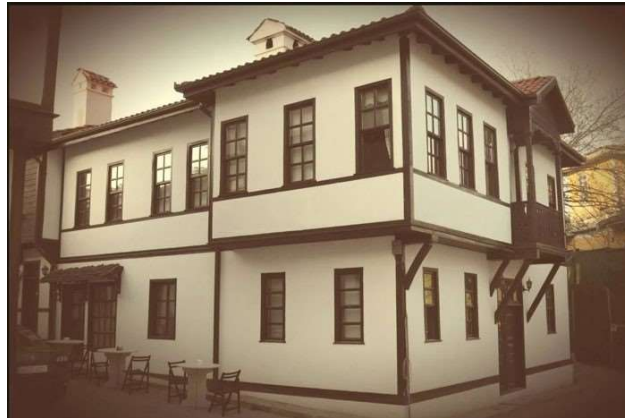
Figure 3.34. West facade of Abdi İbrahim house (taken from the Taraklı Municipality, 2016)

The west facade of the Abdi İbrahim house (Figure 3.34) includes a secondary entrance and a large window on its right side. The facade has three rectangular, windows on the ground floor. There are seven rectangular windows on the first floor. The construction material of window frames is wood. The Southwest part of the first floor was cantilevered towards the street with three windows. The walls are plastered and painted to the white color. Floor and opening finishings were defined by vertical, timber lines.

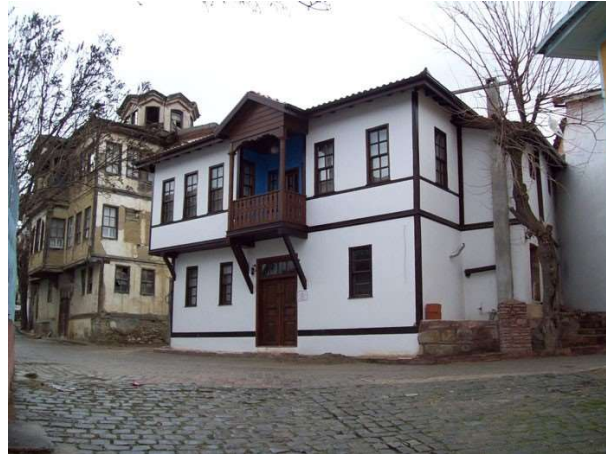
Figure 3.35. : South and east facades of Abdi İbrahim house (taken from the Taraklı Municipality, 2016)

East facade of the Abdi Ibrahim house (Figure 3.35) has rectangular, guillotine window for corner room at first floor. It also includes small openings for the purpose of ventilating wet spaces. Wet spaces were cantilevered towards small garden as mass addition.

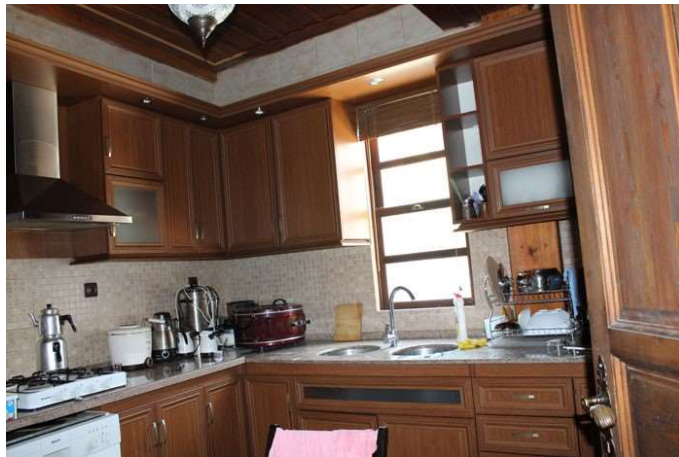
Figure 3.37. Post-intervention view of the kitchen, GPOI05 (Author, 2016)

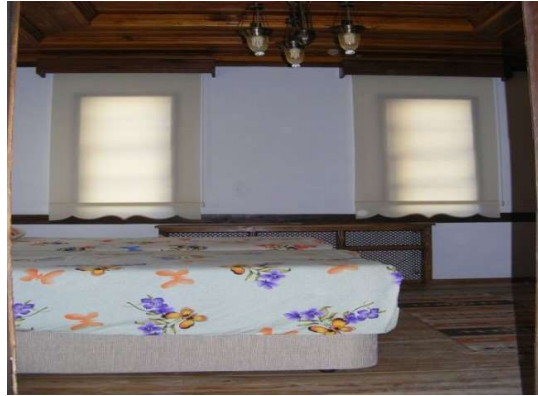
Figure 3.38. Post-intervention view of bedroom at ground floor, GPOI07 (Author, 2016)

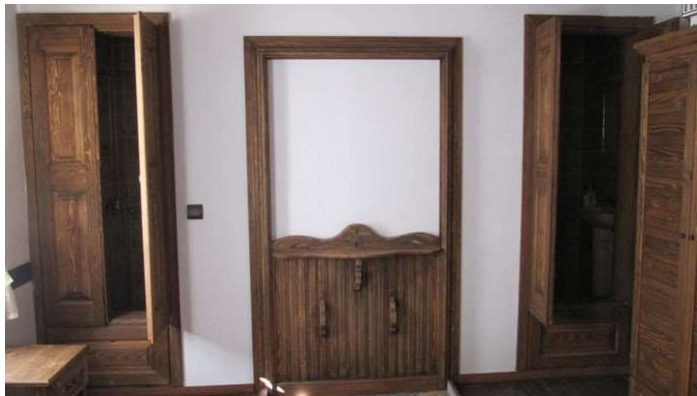
Figure 3.39. Closets of bathroom and wc in a bedroom of ground floor, GPOI07 (Author, 2016)

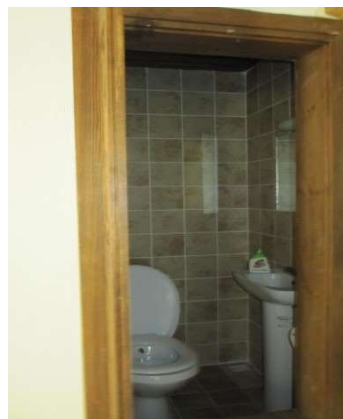
Figure 3.40. WC solution in a bedroom of ground floor, GPOI07 (Author, 2016)

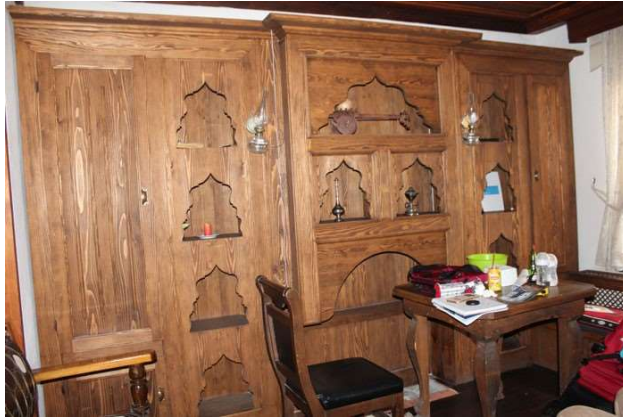
Figure 3.41. Fireplace and closets on lobby, GPOI08 (Author, 2016)

The post intervention ground floor plan of Abdi Ibrahim house (Figure 3.36) has main entrances from the south and east facades. The room GPOI01 is an entrance space with a door and a window on the right side of it. GPOI08 is a lobby area (Figure 3.41). It has a fireplace and storage on the right and left sides of the fireplace. It has a window and a wooden staircase with two steps. The GPOI07 is a bedroom (Figure 3.38), (Figure 3.39) and (Figure 3.40) that has a door, four windows, wooden staircase with two steps. It also has a fireplace and bath on the left side of the fireplace and wc on the right side of the same fireplace. GPOI06 is an entrance space that opens through the GPOI02. It is used as a dining room (Figure 3.42). GPOI02 has a wooden staircase and two WC areas behind the staircase. GPOI04 has an exit door which opens to the street. GPOI05 is a kitchen. The rooms GPOI01, GPOI02, GPOI06, GPOI07, and GPOI08 have wooden flooring and ceiling. The room GPOI02 has a stone flooring and wood ceiling. Their walls are covered with plaster and painted to the white color. Floor and wall covering materials of the GPOI03, GPOI04, and GPOI05 spaces were changed with new materials (ceramic tiles). New types of fixtures were added to these spaces. GPOI03 has a door and a small window. GPOI04 has two doors. GPOI05 has a door and a window.

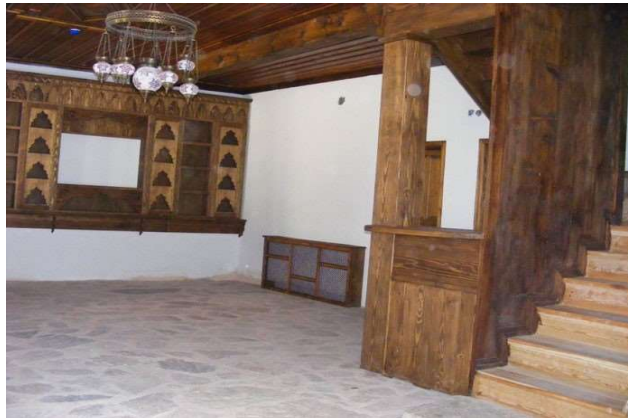
Figure 3.42. Dining room and information desk under staircase, GPOI08 (taken from the Taraklı Municipality, 2016)

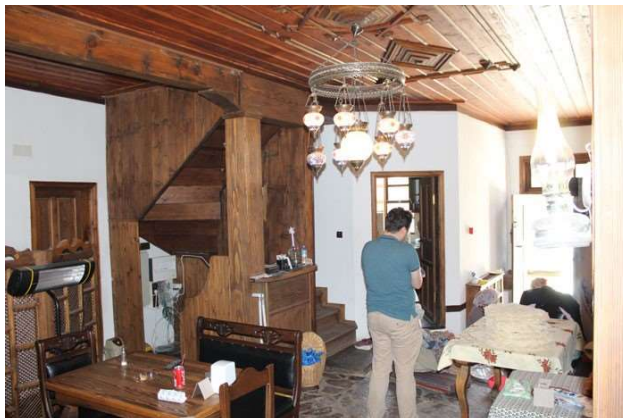
Figure 3.43. View of dining area and entrance of kitchen, GPOI08 (Author, 2016)

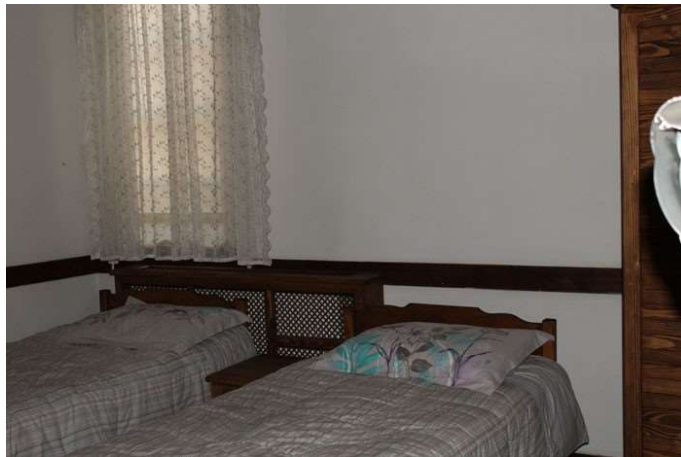
Figure 3.45. Post intervention view of the room in first floor, FPOI04 (Author, 2016)

The post intervention first floor plan of Abdi İbrahim House (Figure 3.44) has a hall named FPOI08 (Figure 3.47). It has a wooden staircase. The ceiling and flooring were covered with wood material. FPOI08 opens to the FPOI01, FPOI04 (Figure 3.45), FPOI07, FPOI09 and FPOI10. They are used as a bedroom for the guests. FPOI01 has a door, two windows, and a niche. It also has a bathroom. Its door, window frames, ceiling, and flooring are wooden. FPOI02 is covered with ceramic tile. Brand new materials were used as a fixture (Figure 3.46). FPOI04 has a door, window, and a niche. It also has a bathroom. Its door, window frames, ceiling, and flooring are wooden. FPOI03 is covered with ceramic tile. Brand new materials were used as a fixture. FPOI07 has a door, three windows, and a niche. It also has a bathroom. Its door, window frames, ceiling, and flooring are wooden. FPOI06 is covered with ceramic tile. FPOI09 has a door and eight windows. During the study, it cannot be entered into FPOI09 because it was locked. It was drawn according to the description of the owners. It cannot be entered into FPOI10, too. FPOI05 is a bathroom. It is covered with ceramic tile. Brand new materials were used as a fixture.

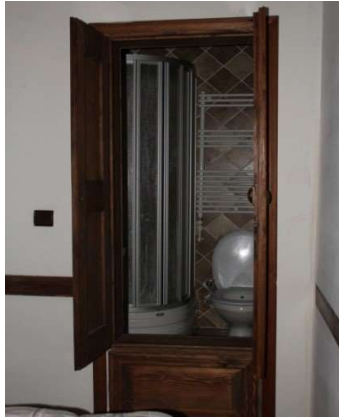
Figure 3.46. Post-intervention view of FPOI03 (bathroom) (Author, 2016)

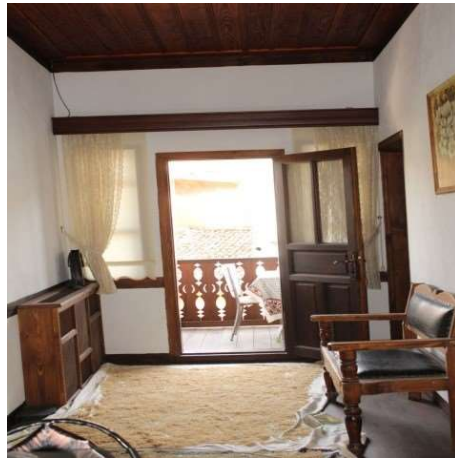
Figure 3.47. Post-intervention view of hall, FPOI08 (Author, 2016)

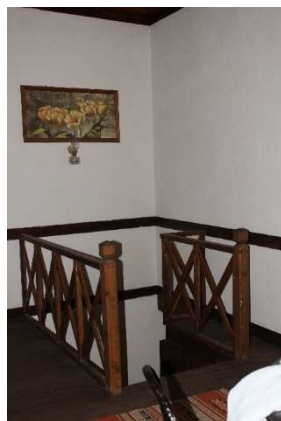
Figure 3.48. Post-intervention view of staircase, FPOI08 (Author, 2016)

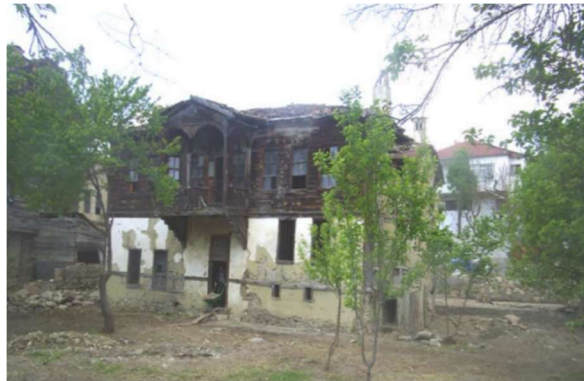
Figure 3.52. Pre intervention view of Hacı Rıfatlar house, south facade (Özkan, 2008, p.121)

The south facade of the Hacı Rıfatlar house (Figure 3.52), has a wooden door which opens to the garden and four wooden framed rectangular windows on the ground floor. It has also two wooden framed, small windows which belong to the basement floor. The construction style of this part is timber-framed mudbrick. This part is plastered and painted. The first floor has a balcony which emphasizes the entrance of the facade. The balcony has a double winged wooden door and a two wooden windows. It has a triangular roof with an arched decorations and wooden balustrade. The floor also has six wooden framed rectangular windows. At the right side of the facade, there is a wet space mass. It has wet space windows for ventilation. The walls of the first floor is covered with timber. There are cracks and lots of materials on the walls. Wooden parts were also damaged.

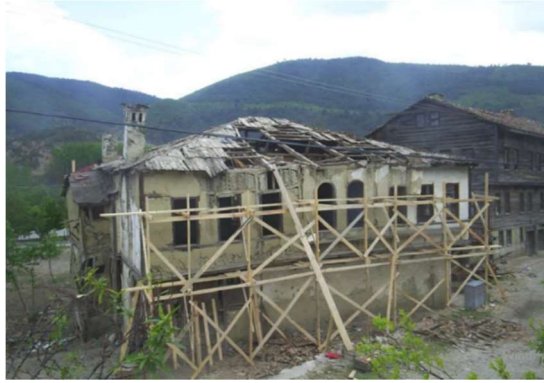
Figure 3.53. Pre-intervention view of Hacı Rıfatlar house, north facade (Özkan, 2008, p.187)

The north facade of the Hacı Rıfatlar house (Figure 3.53), has a window with wooden frame on ground floor. There is no any other openings on this floor. The first floor has two arched and wooden framed windows in the middle and six rectangular-wooden framed windows. This floor is cantilevered. The construction style of this facade is timber-framed mudbrick. The wall is plastered and painted. Cracking, swelling, and flaking have been detected in plaster. There are cracks on the walls and loss of materials. The roofing tile is alaturca and damaged.

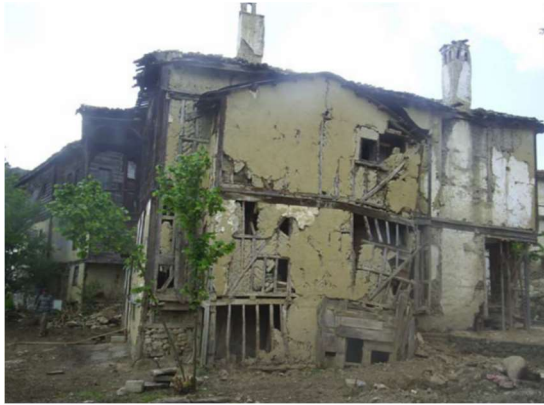
Figure 3.54. Pre-intervention view of Hacı Rıfatlar house, east facade (Özkan, 2008, p.123)

The east facade of the Hacı Rıfatlar house (Figure 3.54), has a wet space mass. There are small wooden windows but this facade was damaged. The construction style of this facade is timber-framed mudbrick. The wall is plastered and painted. Cracking, swelling, and flaking have been detected in plaster. There are cracks and loss of materials on the walls. Wooden parts are also damaged. Some part of the wet space mass is about to collapse.

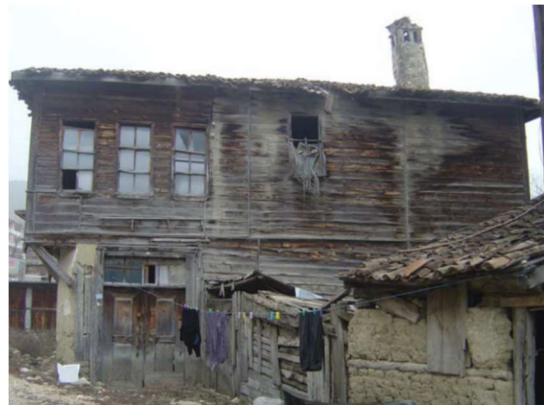
Figure 3.55. Pre-intervention view of Hacı Rıfatlar house, west facade (Özkan, 2008, p.125)

The west facade of the Hacı Rıfatlar House (Figure 3.55), has a wooden framed entrance door with a two wings. The door has a glass window on top of it. The first floor has four rectangular wooden framed windows. This facade has a timber

covering on ground and first floors. Timber coverings and frames are damaged. Window glasses are broken. On this facade, there is a mass addition.

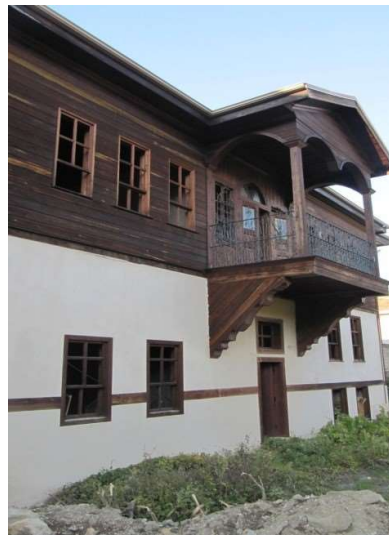
Figure 3.60. Post-intervention view of Hacı Rıfatlar house, south facade (Author, 2013)

The south facade (Figure 3.60) has a door which opens to the garden. It has two windows with a wooden frame on first floor and four wooden framed windows on ground floor. The basement, ground and first floor were covered with plastered and painted. The entrance door was emphasized by the balcony on second floor. The balcony has an arched door and eight wooden framed windows. Main construction material of the balcony is timber. The covering material of the second floor is timber.

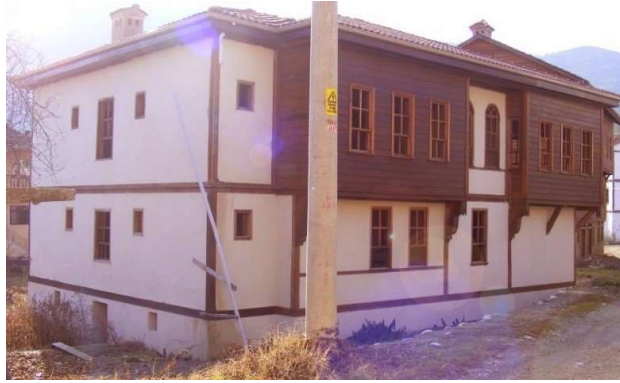
Figure 3.61. Post-intervention view of Hac1 Rıfatlar house, north facade (Author, 2013)

The north facade (Figure 3.61) has no door. It has three wooden framed, rectangular windows and a wooden framed, small window for the wet spaces on first floor. The facade has two cantilevers with six wooden framed, rectangular windows. At the middle of the cantilevers, there are two arched, wooden framed windows on second floor. It also has a small, wooden framed window for the ventilation of wet space. The ground, first and second floor of the facade is plastered and painted. Cantilevers are covered with timber.

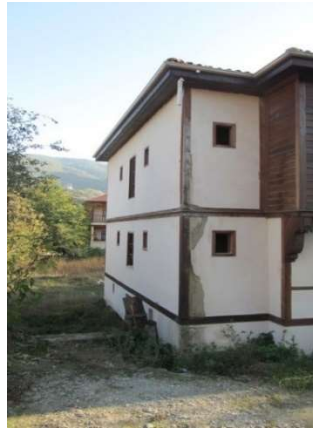
Figure 3.62. Post-intervention view of Hac1 Rıfatlar house, east facade (Author, 2013)

The east facade (Figure 3.62) has wet space mass. There are four small, wooden framed windows and two rectangular, wooden framed windows on first and second floors and two small, wooden framed windows on ground floor. The ground, first and second floor of the facade is plastered and painted.

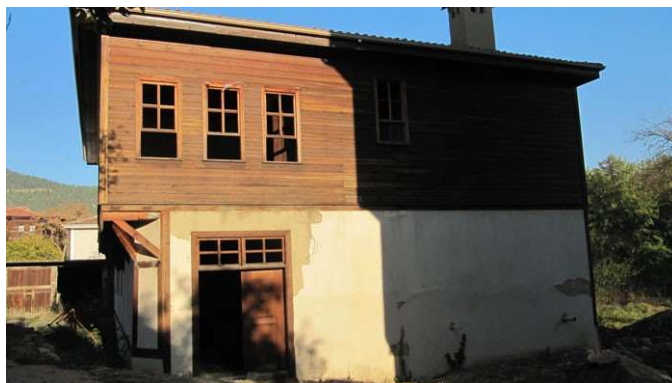
Figure 3.63. Post-intervention view of Hac1 Rıfatlar house, west facade (Author, 2013)

The west facade (Figure 3.63) has a main entrance door on ground floor. It has a double wing and wooden frame. The main entrance door has a glass window on top of it. The first and second floor has a three, wooden framed windows. The ground floor is covered with plaster and painted. The second floor was covered with timber.

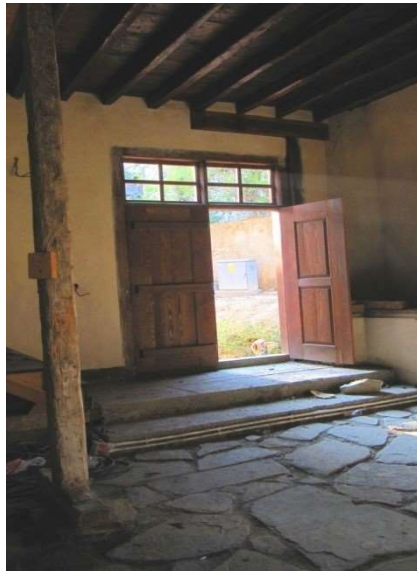
Figure 3.66. Current interior view of circulation Area (Author, 2013)

Ground floor has large circulation area (GPOI01) (Figure 3.66), reception area (GPOI03) under the staircase and a kitchen (GPOI02) Circulation area spreads the floor as *L shape*. Circulation area has two wooden staircases. One of them provides access to first (mezzanine) floor. The other one rises towards second floor. GPOI01 has another two staircases which provide an access to basement floor. The GPOI01 has two doors. One of them is on front facade and opens to street, secondary entrance is on right side and opens to garden. The floor material of GPOI01 is cut stone and its ceiling material is timber. Its walls are covered with plaster and painted. GPOI02 (Figure 3.67) keeps its fireplace and counter. Flooring was made out of stone and its ceiling material is timber. Its walls are covered with plaster and painted. Ground floor has high volume because of owning a mezzanine (first) floor. The floor has no ornamentation.

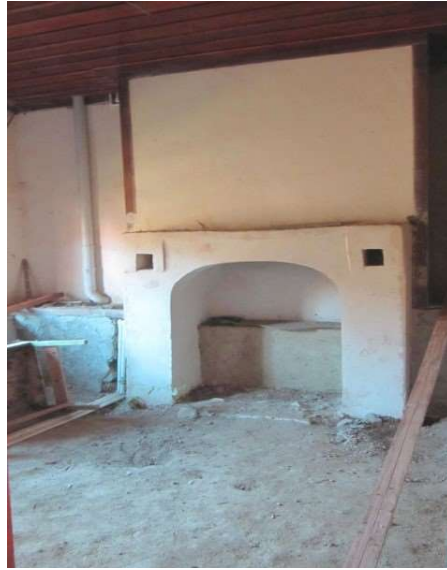
Figure 3.67. Current view of Kitchen and fireplace (Author, 2013)
