ASSESSING THE IMPACT OF CHANGES ON VALUES DURING THE  
TRANSFORMATION OF TRADITIONAL HOUSES INTO HOTELS: THE  
CASE OF TARAKLI

A THESIS SUBMITTED TO  
THE GRADUATE SCHOOL OF NATURAL AND APPLIED SCIENCES  
OF  
MIDDLE EAST TECHNICAL UNIVERSITY

IN PARTIAL FULFILLMENT OF THE REQUIREMENTS  
FOR  
THE DEGREE OF MASTER OF SCIENCE  
IN  
CONSERVATION OF CULTURAL HERITAGE IN ARCHITECTURE

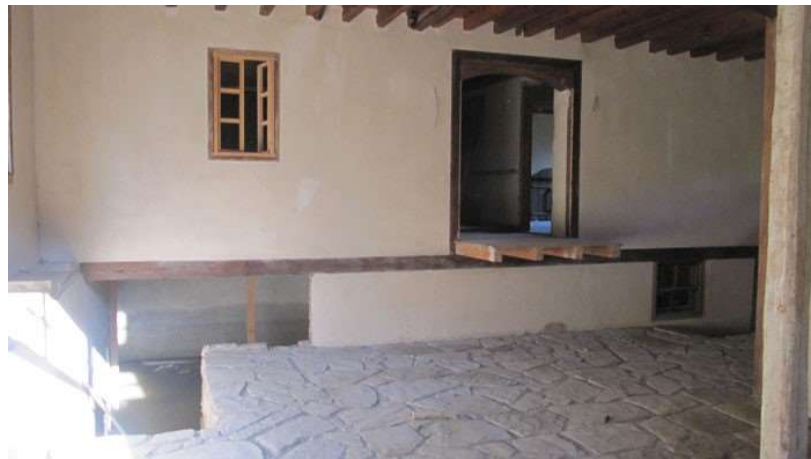
Figure 3.68. View of basement floor and mezzanine (first) floor from the main entrance (Author, 2013)

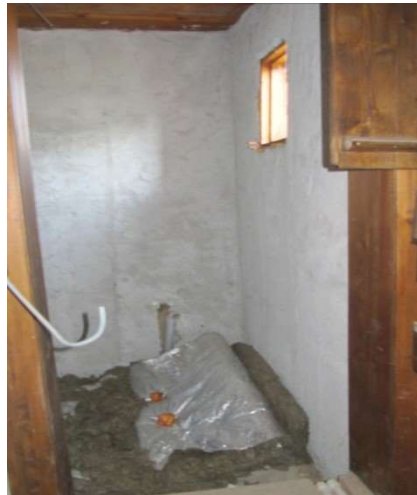
Figure 3.70. Wet space addition inside the closets at rooms of mezzanine floor (Author, 2013)

The mezzanine (first) floor (Figure 3.69) has a connection with the ground floor with the help of a wooden staircase. The floor was designed with a rectangular hall that opens towards rooms on both left (FPOI01) and right side (FPOI05) and two technical rooms (FPOI03) at the end of it. There is a connection towards to bathroom from the inside of closets (FPOI02 and FPOI04) Windows provide lighting and ventilation for rooms.

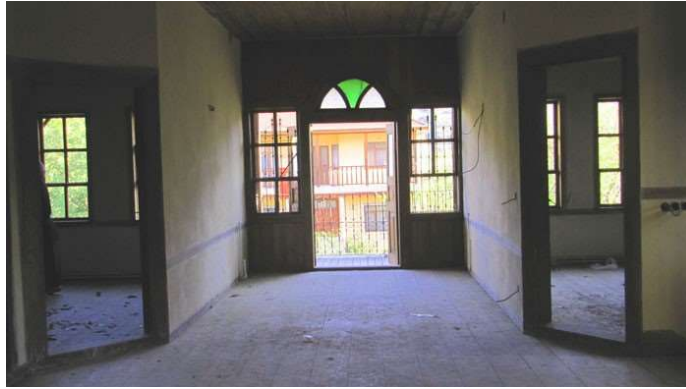
Figure 3.72. Post-intervention of sofa on second floor after its transformation (Author, 2013)

The second floor plan (Figure 3.71) has a large circulation area (SPOI06). It has two rectangular-shaped, wooden-framed windows on the north facade and a balcony on the south facade. The balcony has a door and two windows. The material of the balcony is timber. SPOI06 (Figure 3.72) has a wooden staircase and four doors that open to the rooms and two other doors that open through the staircase and wet areas. Its flooring and ceiling material is timber. The walls are plastered and painted.

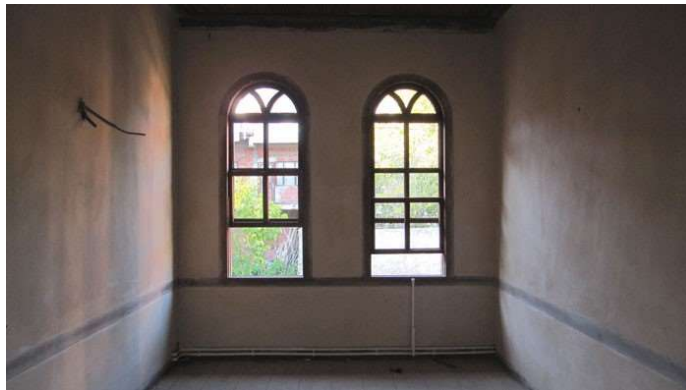
Figure 3.73. Post intervention of eyvan on second floor after its transformation (Author, 2013)

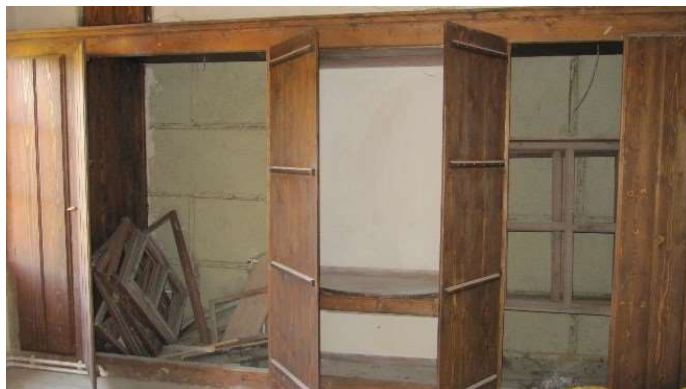
Figure 3.74. Post intervention of rooms on second floor after its taransformation (Author, 2013)

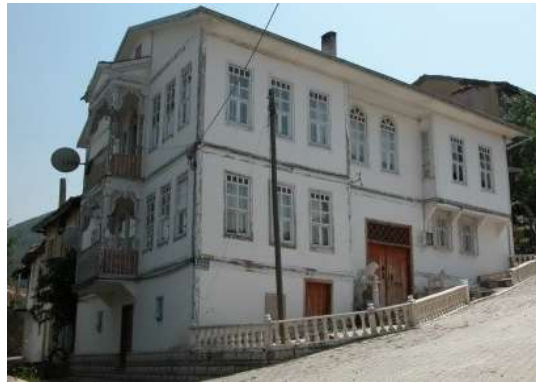
Figure 3.77. Pre-intervention view of Çakırlar house, north-east facade (Çetin, 2006, p.546)

The north facade (Figure 3.77) has a main entrance door on the first floor. The door has a wooden, rectangular frame. It has a glass window on top of it. The ground floor also has a small, wooden door. The ground floor has three, rectangular framed windows. There are small, colored glasses on top of these windows. It also has two small windows. The second floor has eight windows with rectangular, wooden frames. The floor also has two arched windows. All of the windows have small, colored glasses on top of them. This facade is plastered and painted. The north facade includes stairs for adapting it to the sloped ground.

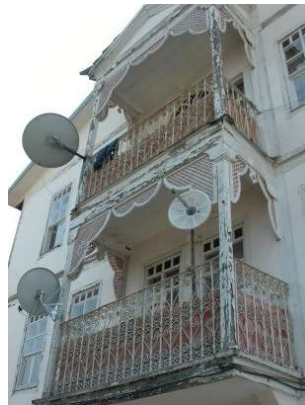
Figure 3.78. Pre-intervention views of Çakırlar house, east facade (Çetin,Y, 2006, p.550)

The east facade (Figure 3.78) includes a secondary entrance and small, rectangular windows on its right and left sides on the ground floor. The facade has balconies on the first and second floors. Each balcony has a door and two windows. Balconies were made out of timber. They have timber ornamentations. Their ballustrates are cast iron and decorated. The balcony of the first floor has a triangular forehead on top of it. The door opening of the balcony is also arched. Other windows of the east facade are rectangular. This facade is plastered and painted.

Its ground floor was made out of stone masonry and upper floors were made out of timber structure with mudbrick infill.

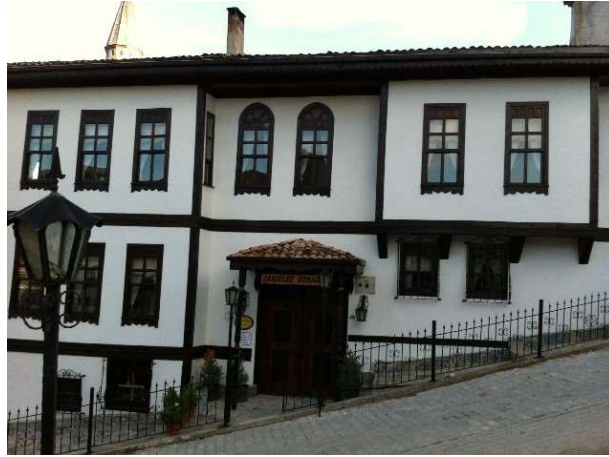
Figure 3.82. Post-intervention view of Çakırlar house, north facade (Author, 2013)

The north facade (Figure 3.82) has a main entrance door. The material of a door is timber. It has its roof on top of it. The main entrance is provided on the first floor. The first floor has three rectangular windows with a wooden frame and two small windows. The ground floor has two windows. The first floor has two windows with an arched frame in the middle of the floor and eight windows with rectangular, wooden frames. This floor has a cantilever on its right side. This facade sits on sloped topography. The facade is plastered and painted.

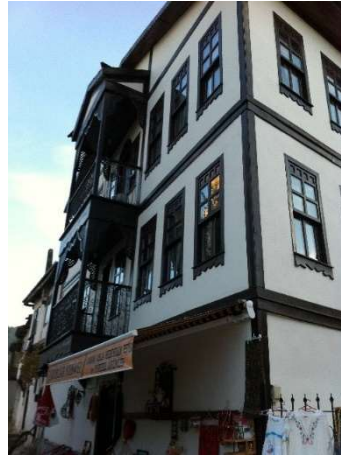
Figure 3.83. Post-intervention view of Çakırlar house, west facade (Author, 2013)

The west facade (Figure 3.83) has an entrance door on the ground floor. The ground floor has a room and it is used as a shop. The ground floor is a completely independent floor in the house with its entrance and usage area. It has a door and two small windows with a wooden frame. The first floor has a balcony with a door and one window. The material of the balcony is timber. It also has five rectangular windows with a wooden frame. The second floor also has a balcony. It has a door and one small window with a wooden frame. The first floor has a balcony with a door and two windows. The material of the balcony is timber. The second floor also has five windows. The facade is plastered and painted.

Its ground floor was made out of stone masonry and upper floors were made out of timber structure with mudbrick infill.

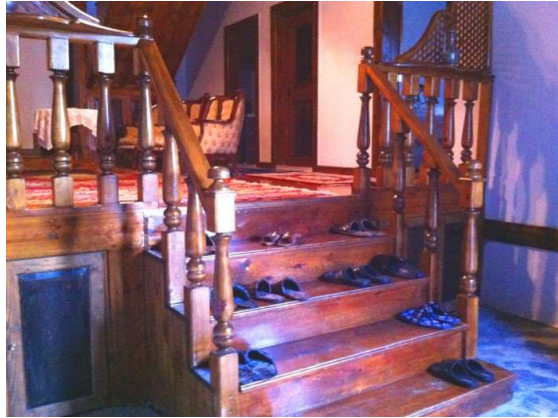
Figure 3.86. Post-intervention view of GPOI05 (Author, 2013)

The first floor (Figure 3.85) has a main entrance on the north facade. In front of the door, there is an entrance area (GPOI05) (Figure 3.86) with a staircase and two closets on the right and left sides of the staircase. The material of the staircase and closets is timber. The staircase has three steps (Figure 3.87).

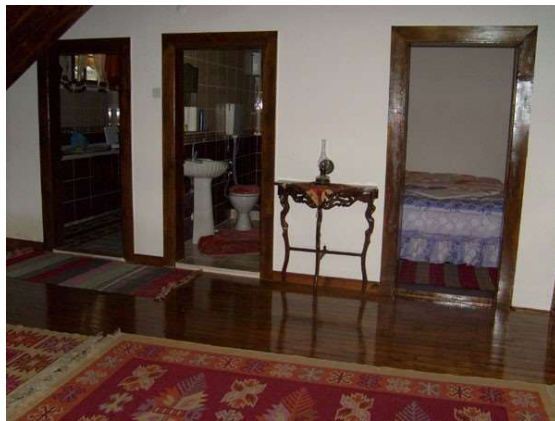
Figure 3.88. Post-intervention view of GPOI07 (taken from the Taraklı Municipality, 2013)

On the upper part of the GPOI05, there is an area which is called a main hall (GPOI07). GPOI07 (Figure 3.88) has a main staircase. The material of the staircase

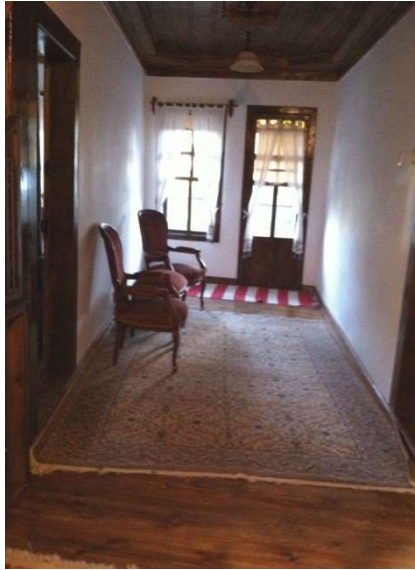
Figure 3.89. Post-intervention view of balcony entrance on GPOI07 (Author, 2013)

is timber. GPOI07 has an entrance to the balcony (Figure 3.89) The balcony has a window and a door. GPOI07 also has another door that opens to the outside on the south facade of the house. It is used as a service door. GPOI07 is surrounded by three rooms, a bathroom and a kitchen.

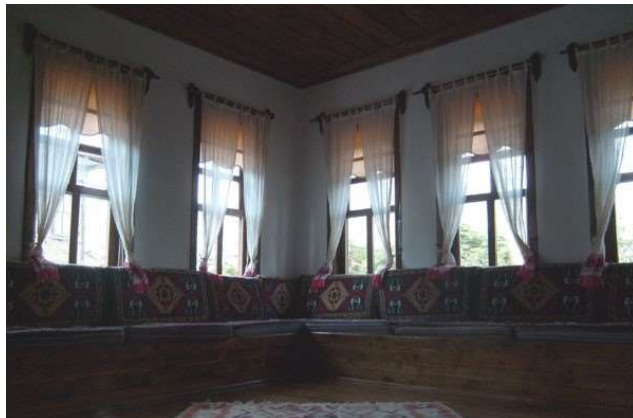
Figure 3.90. Post-intervention view of GPOI06 (Author, 2013)

The room GPOI06 (Figure 3.90) is used as a living room. It has a door, six windows, a niche and a sedir. The material of the floors, walls and ceiling is timber.

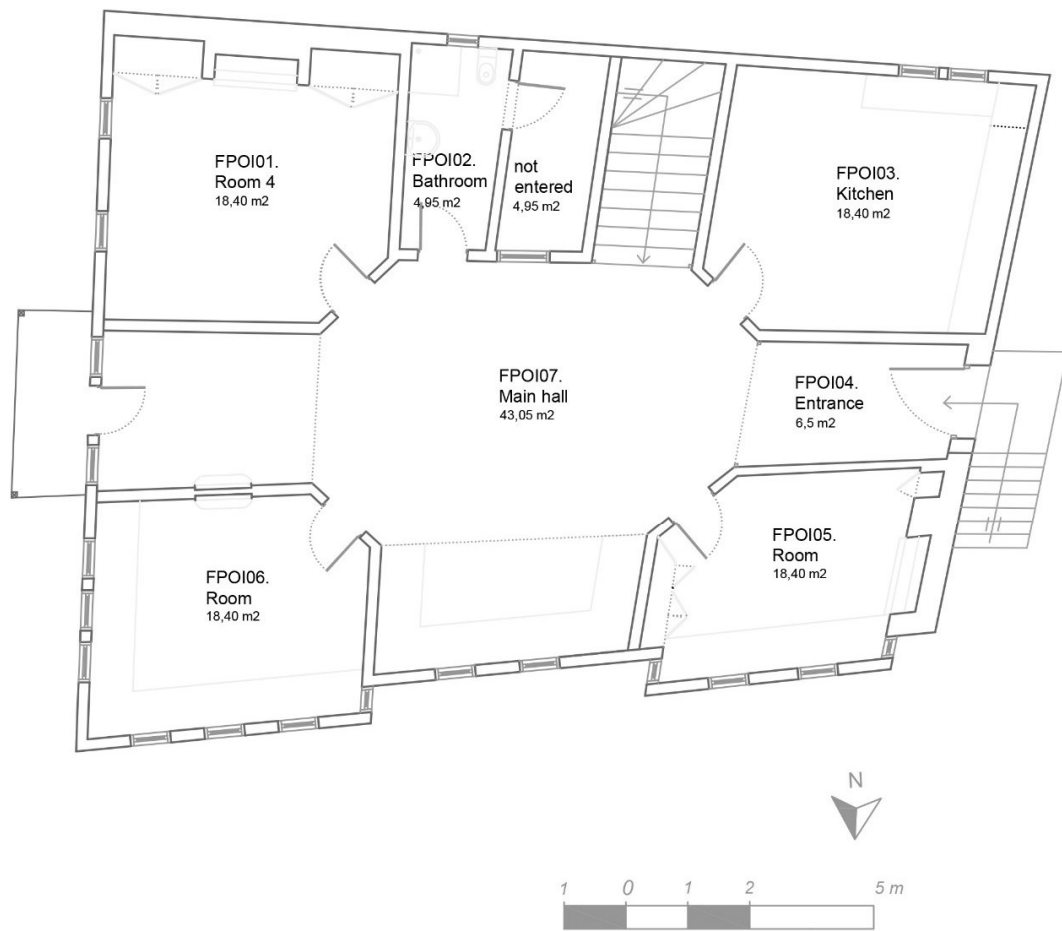
## SECOND FLOOR PLAN

Figure 3.91. Post-intervention second floor plan of Çakırlar house (Author, 2023)

The second floor has access to it by the staircase from the first floor. It also has an independent entrance on the east facade. FPOI07 (Figure 3.92) is surrounded by rooms, a staircase on the south facade, and a balcony on the west facade. The balcony has a door and two windows. The floor and ceiling material of FPOI07 is timber.

FPOI06 is used as a living room. It has a door, seven wooden windows with a rectangular frame, a niche and sedir. The material of the ceiling and floor is timber. The walls are covered with plaster and painted.

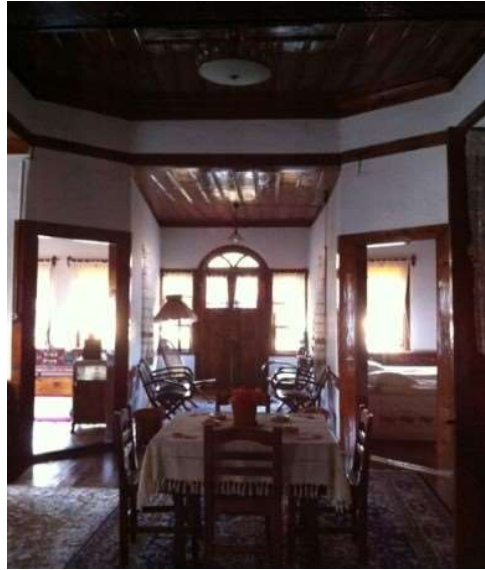
Figure 3.92. Post-intervention view of FPOI07 that looks towards balcony entrance (Author, 2013)

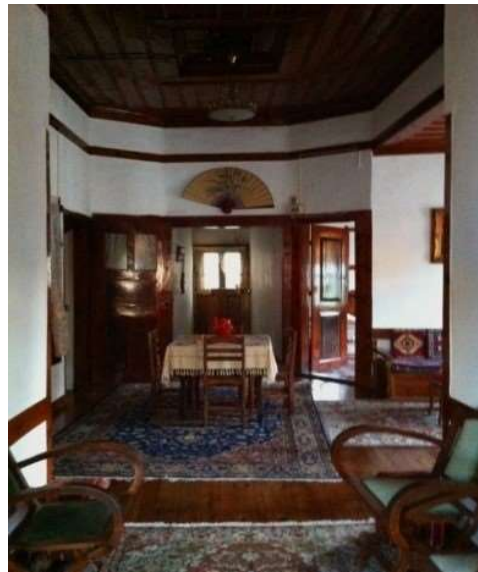
Figure 3.93. Post-intervention view of FPOI07 that looks towards secondary entrance of the house (Author, 2013)

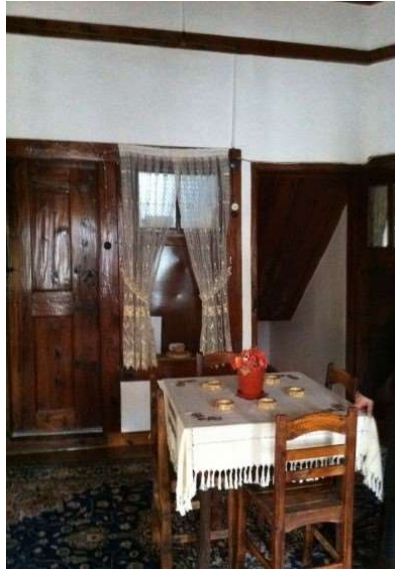
Figure 3.94. Post-intervention view of FPOI07 that looks towards bathroom and staircase of the house (Author, 2013)

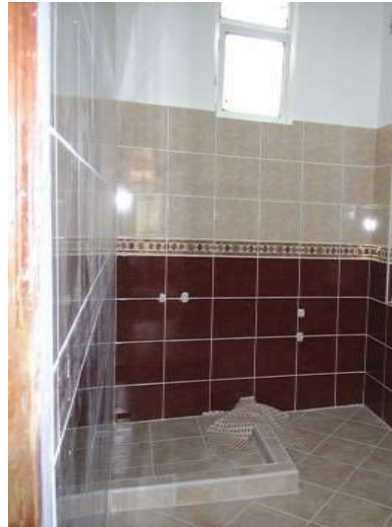
Figure 3.95. Post-intervention view of FPOI02 (taken from the Taraklı Municipality, 2013)

FPOI02 is used as a bathroom (Figure 3.95). The material of the floors, walls and ceiling is ceramic tile. The bathroom has a connection with a closed room that serves as a service room for the staircase. The service room was locked during the site survey so it remains unstudied.

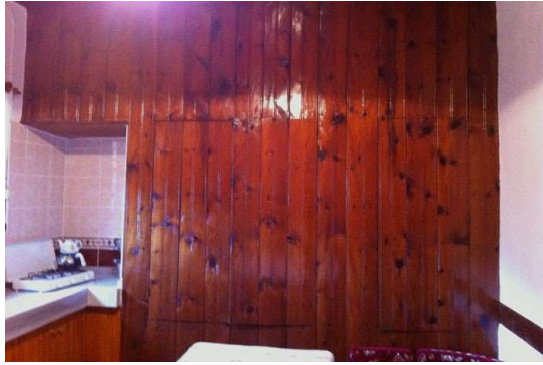
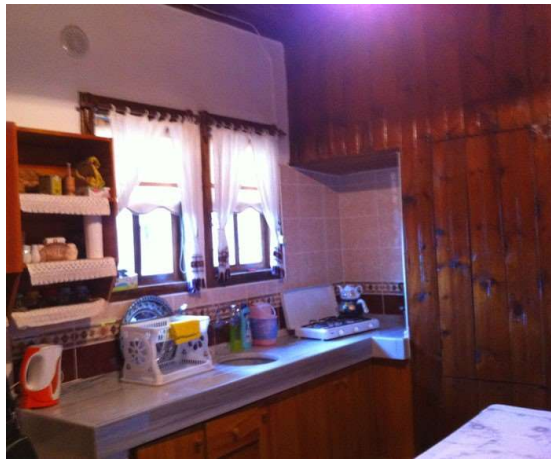
Figure 3.96. Post-intervention view of FPOI03 at second floor (Author, 2013)

Figure 3.97. Counter and cabinet addition of FPOI03 (Author, 2013)

FPOI03 is used as a kitchen (Figure 3.96 and Figure 3.97) It has a door, two windows, a kitchen counter and cabinets. The material of the floors and walls is ceramic tile. The material of the ceiling is timber.

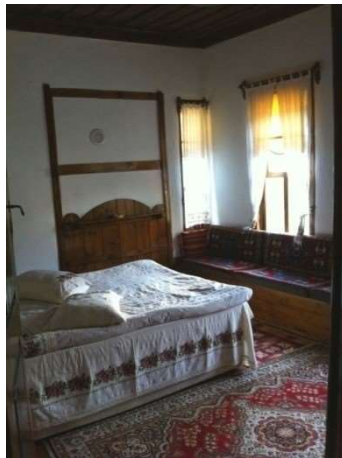
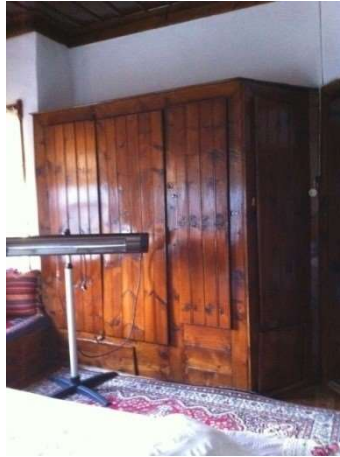
Figure 3.98. Post-intervention view of FPOI05 (Author, 2013)

Figure 3.99. Post-intervention view of FPOI05 (Author, 2013)

FPOI05 is used as a bedroom (Figure 3.98 and Figure 3.99). It includes a door, four rectangular framed windows, a niche, fireplace, closets and sedir. The material of the ceiling and floor is timber. The walls are covered with plaster and painted.

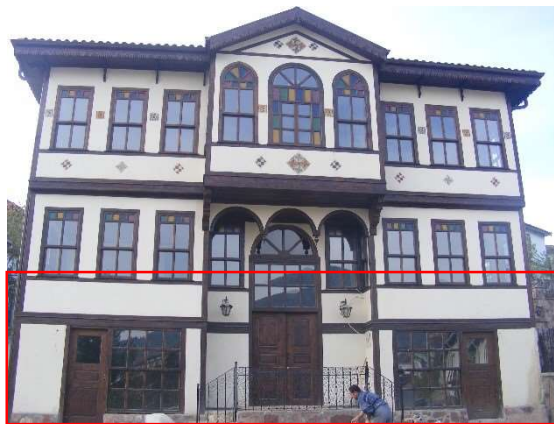
Figure 4.2. Post-intervention view of east side facade that show the alterations of entrance staircase and alterations of shop windows and doors at ground floor (Author, 2013)

For the ground floor (Figure 4.1) G.A1 and G.A4 (Figure 4.2 and Figure 4.3) indicate the alterations on the doors and windows of GPOI06 and GPOI04. Windows and doors were changed with a new type of ones. Their color was also changed. G.A2 and G.A3 show the material change on the floors of GPOI06 and GPOI04. The wooden floor material was changed with ceramic tile. The original material of the north side wall of the main building was stone masonry but it was altered with concrete material (G.A5). G.A6 shows the alteration of the floor material of the garden. The floor material was concrete. It was altered as stone.

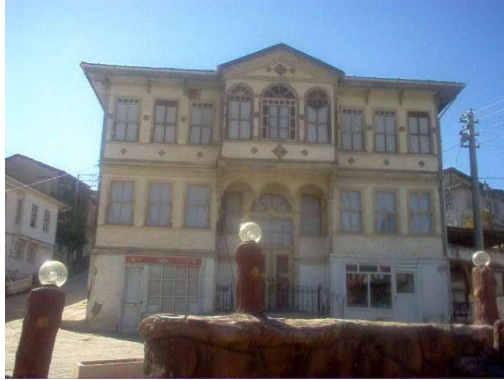
Figure 4.3. Pre-intervention view of east side facade that show the alterations of entrance staircase and alterations of shop windows and doors at ground floor (taken from the Taraklı Municipality, 2013)

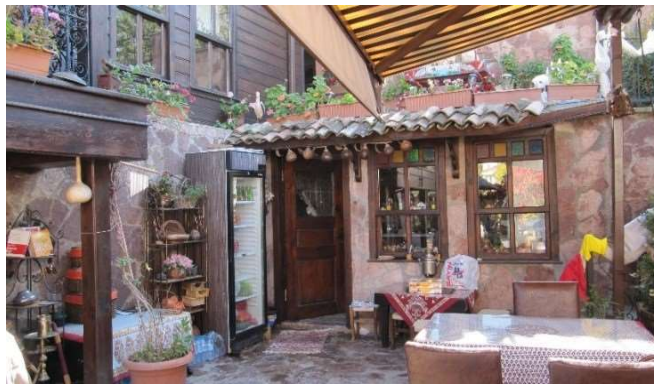
Figure 4.4. G.AD2, Post-intervention view of north side facade that show the addition of the kitchen (Author, 2013)

The addition indicated as G.AD1 is a staircase addition to the left side of the existing staircase. GPOI02 was added mass (G.AD2). It is used as a kitchen (Figure 4.4). G.AD3 is a staircase addition to the garden. G.AD4 is a new lot addition to enlarge the garden. G.AD5 is a new wall addition with a wooden door (Figure 4.5). G.R1 and G.R2 are the removal of walls. They were used as a wall of old mass additions.

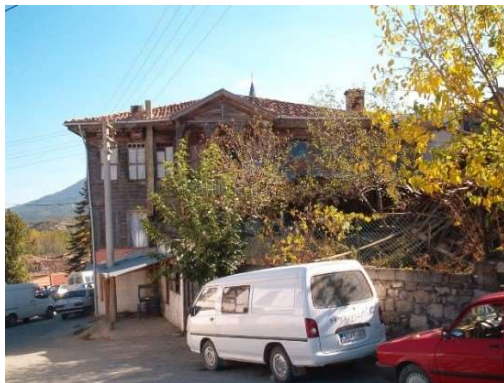
Figure 4.5. Pre-intervention view of north side facade (taken from the Taraklı Municipality, 2013)

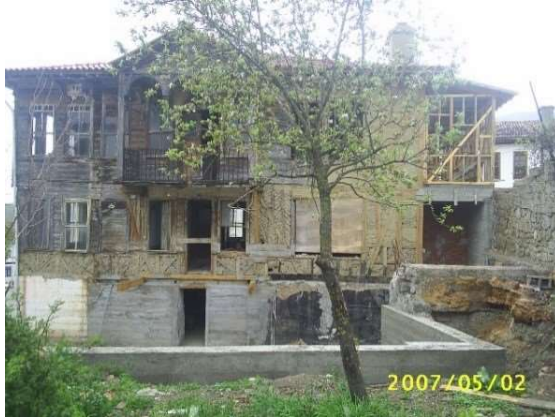
Figure 4.6. North side view that indicates the changes in the garden during the hotel transformation (taken from the Taraklı Municipality, 2013)

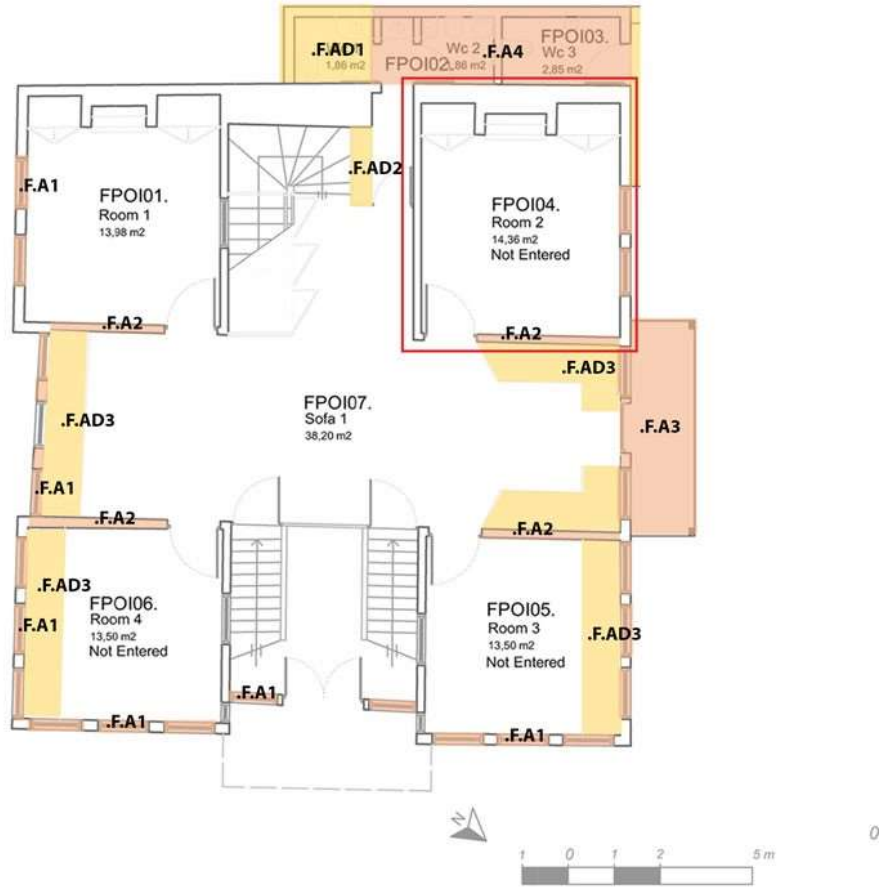
FIRST FLOOR PLAN

Figure 4.7. First floor plan of Kadirler house that indicates the changes during the hotel transformation (Author, 2023)

For the first floor (Figure 4.7), F.A1 indicates the alteration of window and door frames (Figure 4.8 and Figure 4.9). New types of window frames were used instead of old ones. New types of window frames include colored rectangular glasses on top of them. F.A2 shows the alteration of kalemîşi works on the walls (Figure 4.10 and Figure 4.11). There are some changes in the patterns and colors of kalemîşi works. F. A3 is an alteration of the balcony. The balcony was re-constructed according to the original balcony with the same material and same size. Wet spaces were altered. Their wooden floor and wall covering materials were changed with marble. New marble fixtures were added. New openings were created and old openings were closed. The related alteration is indicated with the F.A4 number (Figure 4.12 and Figure 4.13).

F.AD1 is a mass addition of wet spaces. F.AD2 is a wooden closet addition to hide and define the entrance of bathrooms. F.AD3 is new seating unit (sedir) addition to the old sofa (Figure 4.14). F.AD4 is an addition of a new parcel with cut stone flooring which opens through FPOI03. F.AD5 is an addition of a cut stone-covered staircase. F.AD6 is a garden addition to the Kadirler house.

The use of the room FPOI04 is changed. It was used as a kitchen before the hotel transformation. After the transformation, it has been used as a room. During the site survey, this room was not studied because it was locked but its information was gathered by the old photographs and the owner.

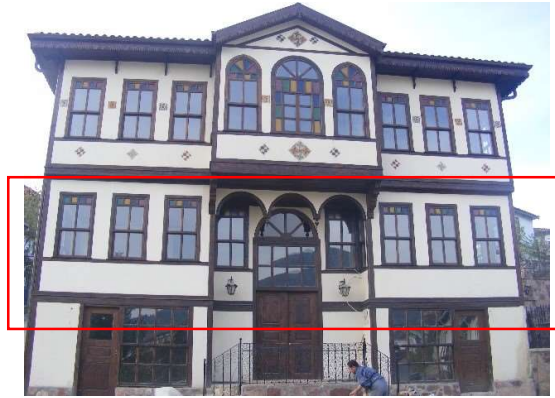
Figure 4.8. A1. Post-intervention view of east side facade that show the alterations of windows at first floor (Author, 2013)

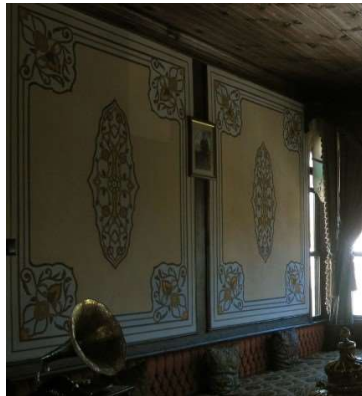
Figure 4.10. A.2, post-intervention view of kalemîşi works on the walls of ground floor (Author, 2013)

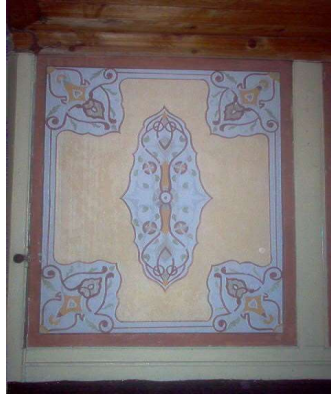
Figure 4.11. A2, pre-intervention view of alteration of kalemışı works on the walls. (taken from the Taraklı Municipality, 2013)

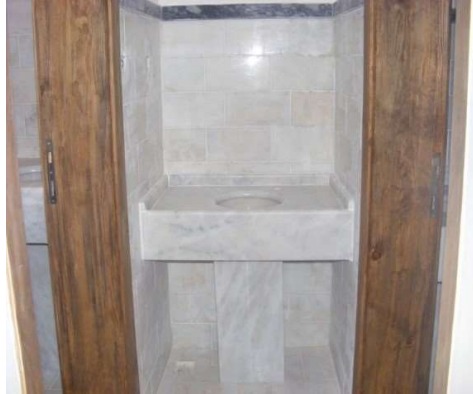
Figure 4.12. A4, alteration of bathrooms I (taken from the Taraklı Municipality, 2013)

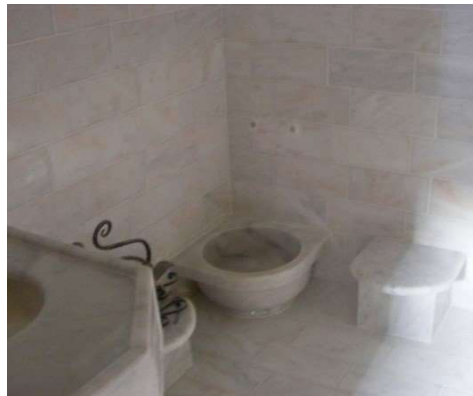
Figure 4.13. A4, alteration of bathrooms II (taken from the Taraklı Municipality, 2013)

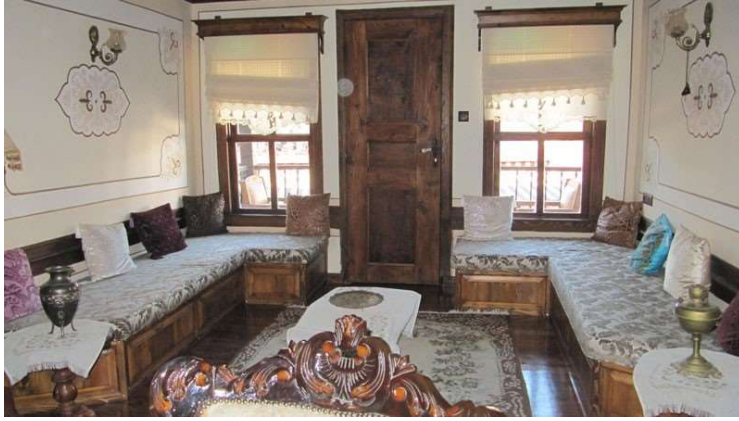
Figure 4.14. F.AD3, addition of seating unit (sedir) to old sofa (Author, 2013)

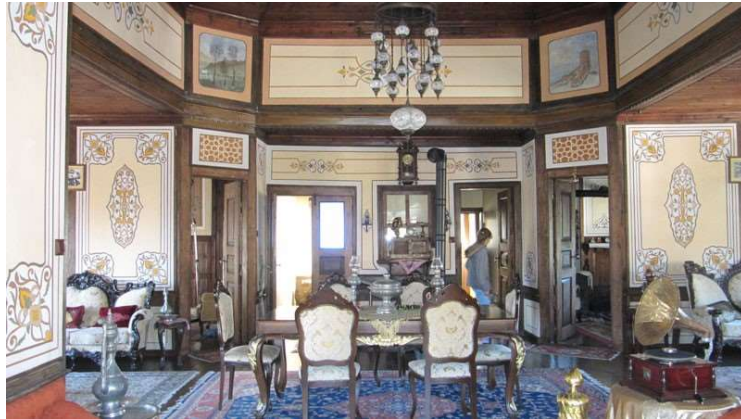
Figure 4.16. S.A1, post-intervention view of kalemîşi works on the walls of first floor (Author, 2013)

For the second floor (Figure 4.15), S.A1 is an alteration of kalemîşi on walls (Figure 4.16 and Figure 4.17). S.A2 is an alteration of a wet area (Figure 4.18). The opening which opens to the street was opened after the hotel transformation. S.A3 indicates the alterations of bathrooms. Wall and floor coverings were changed to ceramic tile. Also, new fixtures were added. S.A4 (Figure 4.19 and Figure 4.20) shows the alteration of the bathroom and closet of room SPOI04. Wall and floor coverings were changed to ceramic tile. Also, new fixtures were added and the closet of room SPOI04 was altered. It was opened to the bathroom. It is used as a door not as a closet. New openings were created and old openings were closed.

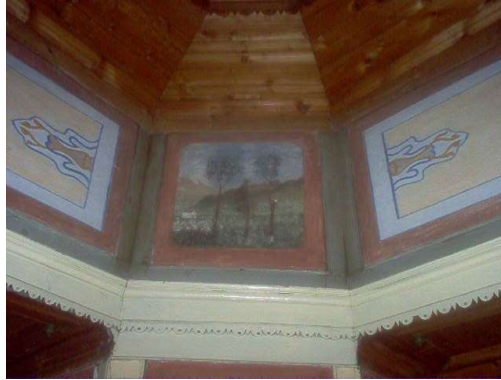
Figure 4.17. S.A1, pre-intervention view of kalemışı works on the walls of first floor (Author, 2013)

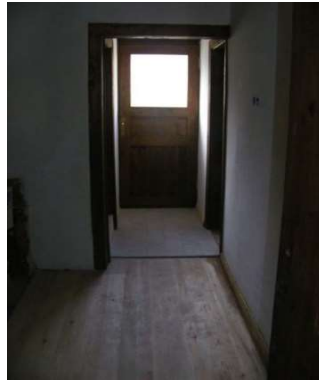
Figure 4.18. S.A2, Alteration of a wall. The new door was opened on the indicated wall (taken from the Taraklı Municipality, 2013)

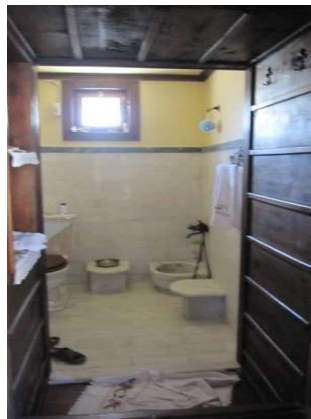
Figure 4.19. S.A4, Alteration of a closet. It is transformed to the door which opens through the altered bathroom (Author, 2013)

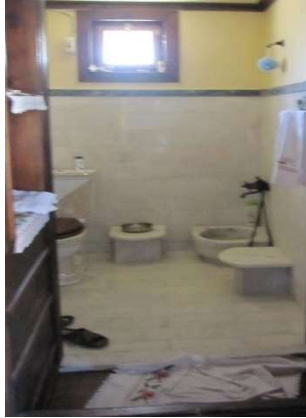
Figure 4.20. S.A4, Alteration of a bathroom (Author, 2013)

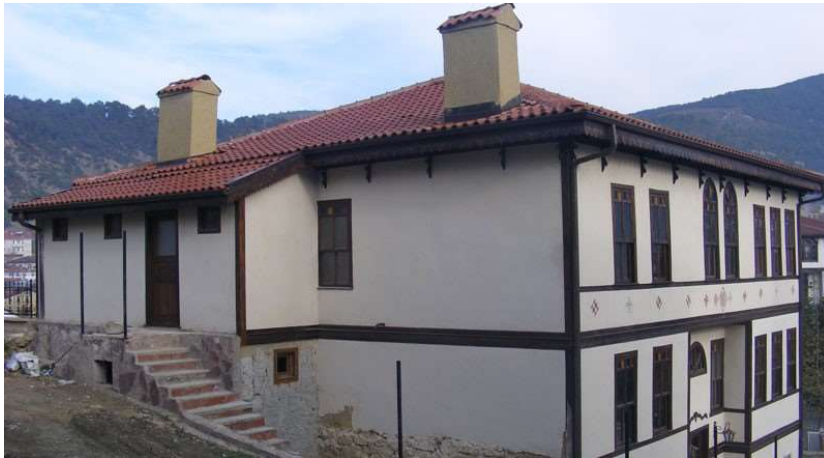
Figure 4.21. S.AD1, Mass addition of wet space and AD2. Addition of outdoor staircase to the existing building (Author, 2013)

S.AD1 is an addition of an outdoor staircase to the Kadirler house and S.AD2 is a new mass addition (wc) to the existing building (Figure 4.21). S.AD3 is an addition of a seating unit (sedir) to the sofa and rooms.

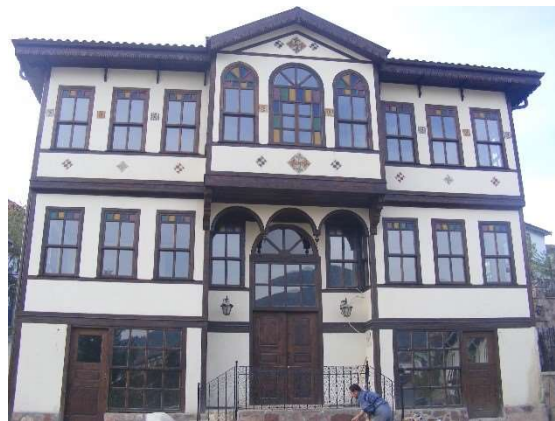
Figure 4.23. Post-intervention view of east side facade (Author, 2013)

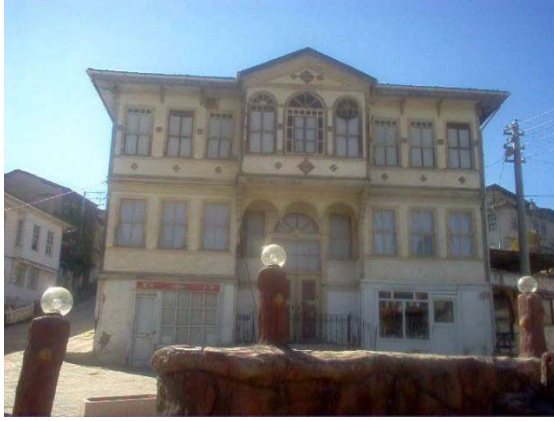
Figure 4.24. Pre-intervention view of west side facade (taken from Taraklı Municipality archives, 2013)

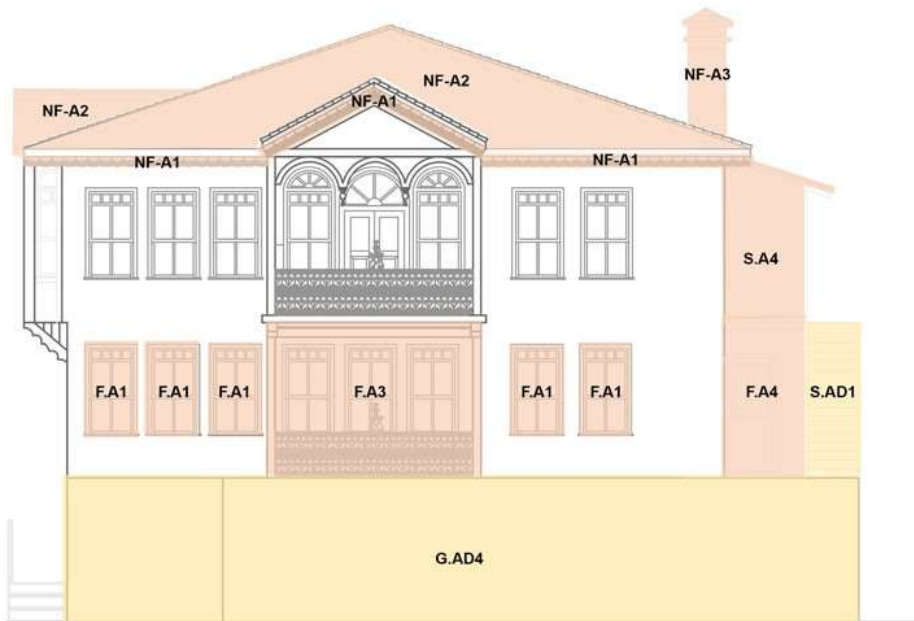
**NORTH FACADE**

Figure 4.25. North facade view indicates the changes during the hotel transformation (Author, 2023)

For the north facade (Figure 4.25), G.AD4 is an additional wall on the ground floor. F.A1 indicates the alteration of window frames. F. A3 is an alteration of the balcony. These are the changes on the first floor and affect the east side facade. F.A4 is an addition of wet space (bathroom and WC). S.A4 is an addition of wet space (bathroom and WC) S.AD1 is an addition of an outdoor staircase. These are the changes on floor plan layouts and affect the east side facade.

NF.A1 is an alteration of roof eaves. A new type of eaves was changed from the old type of eaves. Its decoration was changed. NF.A2 is an alteration of roof tiles. Alaturca roof tile was changed with Marseille roof tile. NF.A3 is an alteration of chimneys and chimney tops. Old chimneys were fixed and altered. These are the changes that can be seen on only east side facade (Figure 4.26 and Figure 4.27).

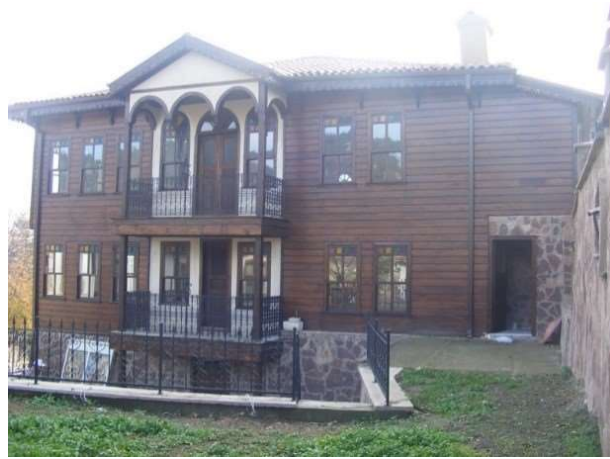
Figure 4.26. Post-intervention view of north side facade (Author, 2013)

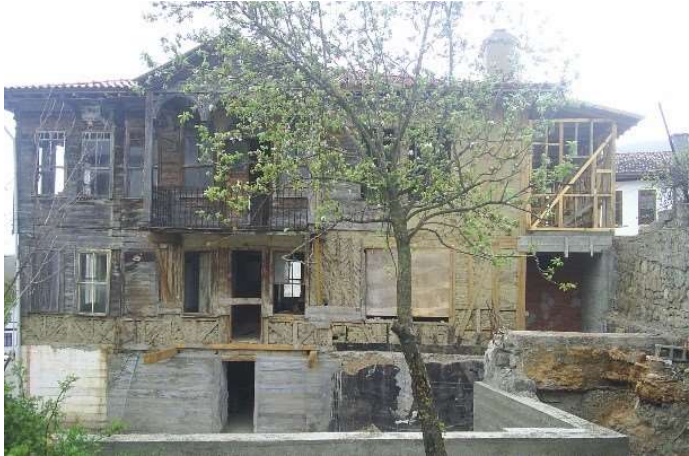
Figure 4.27. Pre-intervention view of north side facade (taken from the Taraklı Municipality, 2013)

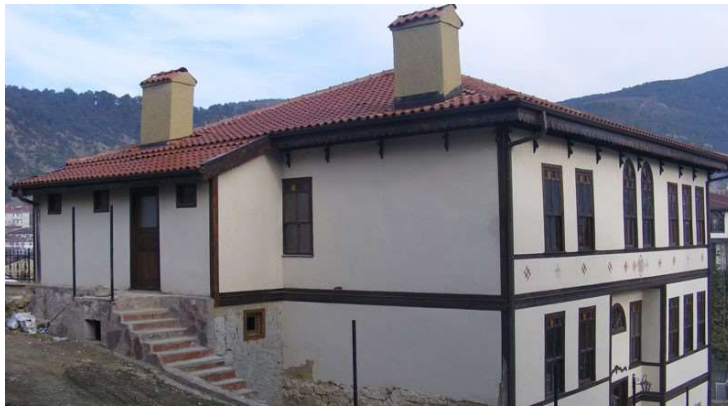
Figure 4.29. Post-intervention view of west facade (Author, 2013)

For the west facade (Figure 4.28), G.AD2 is an addition to the kitchen area on the ground floor. F.AD2 is an addition to the outdoor staircase. F.A4 is an alteration of wet spaces (bathroom and WC). S.AD2 is a mass addition to bathroom and WC spaces. S.A2, S.A3, and S.A4 are alterations of wet spaces. These are the changes on floor plan layouts and affect the west side facade (Figure 4.29 and Figure 4.30).

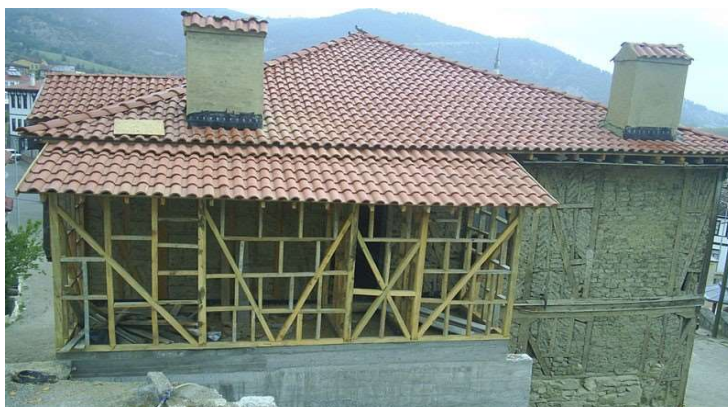
Figure 4.30. Pre-intervention view of west facade (Author, 2013)

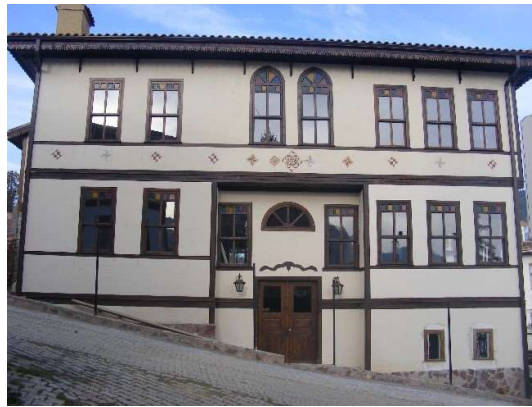
Figure 4.32. Post-intervention view of south facade (Author, 2013)

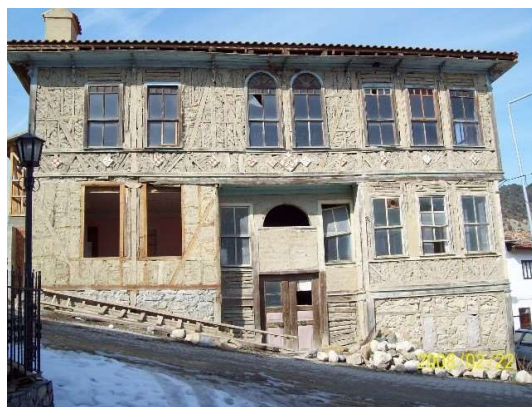
Figure 4.33. Pre-intervention view of south facade (Author, 2013)

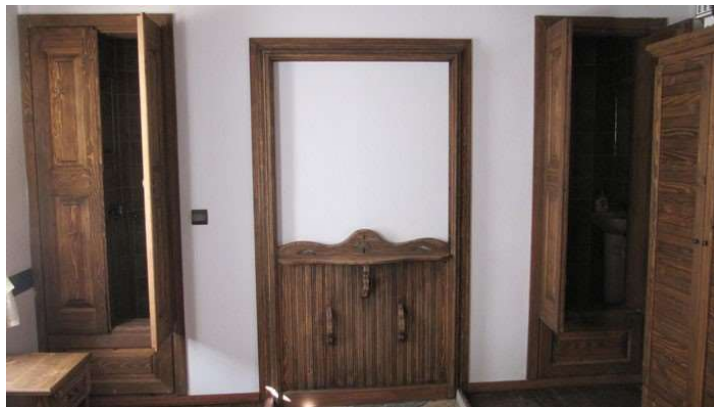
Figure 4.35. G.A1, closets that were altered and transformed into bathroom and wc in GPOI07 (Author, 2013)

For the ground floor (Figure 4.34), G.A1 (Figure 4.35 and Figure 4.36) indicates the alteration of the fireplace and closets on this wall. The fireplace was closed and lost its original function. Closets also lost their function and had been used as a bathroom. Floors and walls of old closets were covered with ceramic tile. New bathroom fixtures were added there. G.A2 (Figure 4.37 and Figure 4.38) is an alteration of the fireplace and closet on this wall. G.A3 is an alteration of window and door frames. Their frames were changed with new ones. A new, small window was opened on this wall. G.A4 is an alteration of the related wall. A new window was opened on this wall. G.A5 is an alteration of WC. The wall and floor covering were changed with ceramic tile. New bathroom fixtures were added to the WC. G.A6 is an alteration of wc. The wall and floor covering were changed with ceramic tile. New bathroom fixtures were added to the WC. The outer walls of the WC areas were demolished before the transformation so that new walls were constructed. G.A7 is an alteration of a wall. The new door was opened on this wall. G.A8 is an alteration of the kitchen (Figure 4.44). The wall and floor covering were changed with ceramic tile. New bathroom fixtures were added to the kitchen. G.A9 is an alteration of the kitchen counter. The old kitchen counter was changed with a new type of kitchen counter.

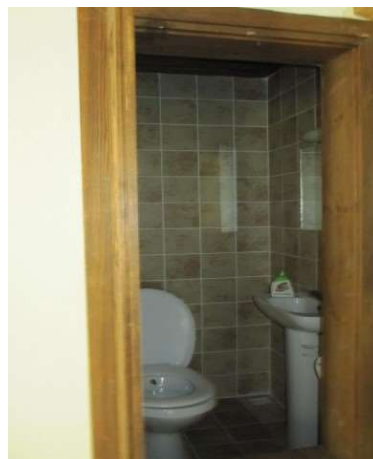
Figure 4.36. G.A1, interior of the closets that were altered and transformed into bathroom and wc in GPOI07 (Author, 2013)

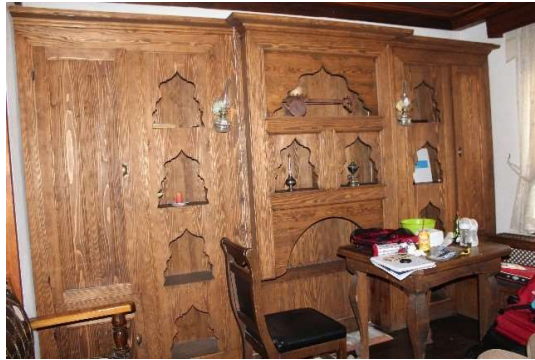
Figure 4.37. G.A2, Alteration of closet during the hotel transformation (Author, 2013)

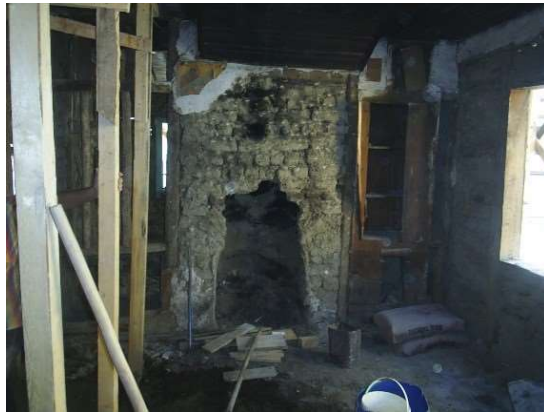
Figure 4.38. G.R1 is a removal of original fireplace in GPOI08 (taken from the Taraklı Municipality, 2013)

G.R1 is a removal of the original fireplace. G.R2 is a removal of the wall in between wc.

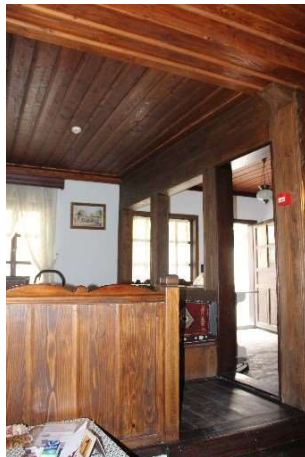
Figure 4.39. Post-intervention views of GPOI08 (Author, 2013)

G.AD1 (Figure 4.39) is an addition of a wooden balustrade to the lobby area. G.AD2 is also a wooden balustrade addition to the lobby area. G.AD3 is a wooden shelf addition to the entrance area. G.AD4 is an addition of a new shelf to the dining area. G.AD5 is an addition of a partition wall to the entrance of wc area. It was added to hide the entrance of the wet spaces. G.AD6 is a new addition of a wall to divide the wet spaces into two. G.AD7 (Figure 4.40 and Figure 4.43) is a wooden reception counter addition. G.AD8 is an addition of a new kitchen counter.

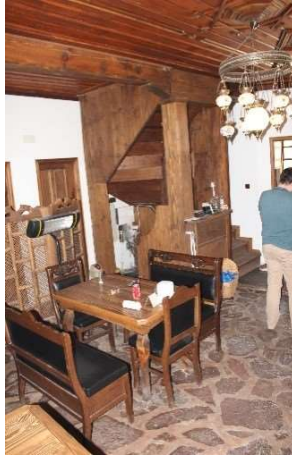
Figure 4.40. Post-intervention views of GPOI02 (Author, 2013)

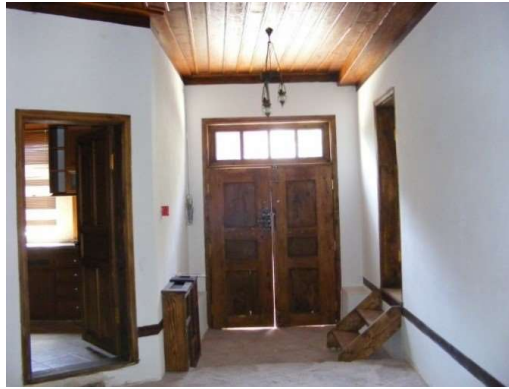
Figure 4.41. Post-intervention views of GPOI06 (Author, 2013)

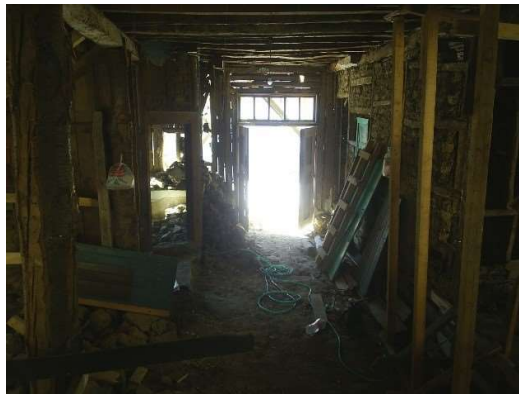
Figure 4.42. Pre-intervention views of GPOI06 (taken from the Taraklı Municipality, 2013)

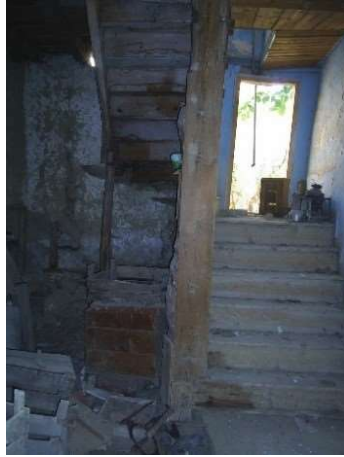
Figure 4.43. Pre-intervention views of GPOI02 (taken from the Taraklı Municipality, 2013)

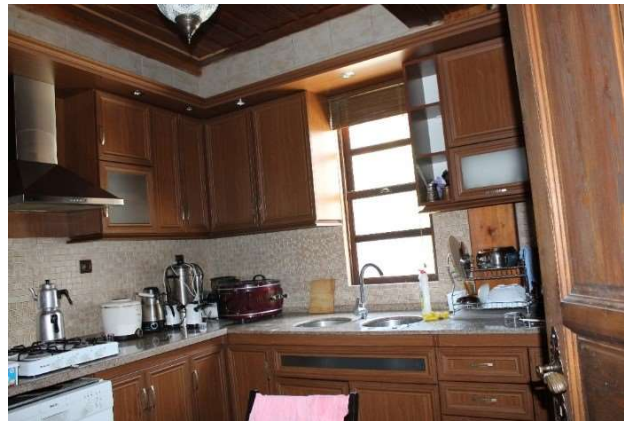
Figure 4.44. G.A8 and G.A9. Alteration of the kitchen (Author, 2013)

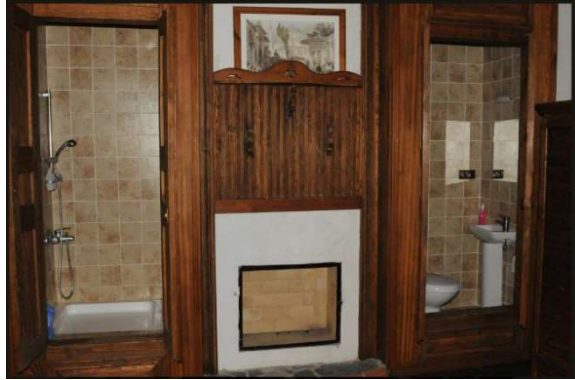
Figure 4.46. F.A1, alteration of fireplace and closets in room FPOI09 (taken from the Taraklı Municipality, 2013)

F.A1 indicates the alteration of the fireplace and closets on this wall (Figure 4.46). The fireplace was closed and lost its original function. Closets also lost their function and had been used as a bathroom. Floors and walls of old closets were covered with ceramic tile. New bathroom fixtures were added there. F.A2 is an alteration of the wall. This part of the wall was opened to create an entrance to the bathroom. Its doors were designed as wooden closet doors. F.A3 is an alteration of WC. The wall and floor covering were changed with ceramic tile. New bathroom fixtures were added to the WC. F.A4 is an alteration of wc. The wall and floor covering were changed with ceramic tile. New bathroom fixtures were added to the WC. The outer walls of the WC areas were demolished before the transformation so that new walls were constructed. F.A5 is an alteration of the wall. A new door opened on this wall to create an entrance to the bathroom.

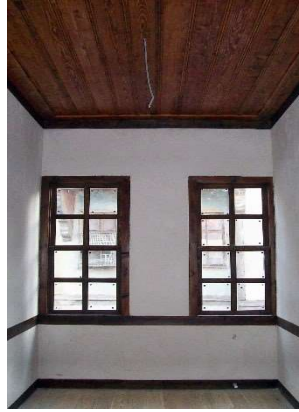
Figure 4.47. F.R1 is a removal of the sedir (taken from the Taraklı Municipality, 2013)

F.R1 (Figure 4.47 and Figure 4.48) is a removal of the sedir (seating unit) from FPOI10.

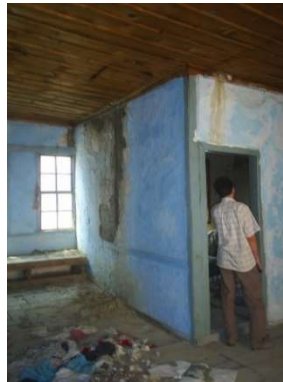
Figure 4.48. F.R1 is a removal of the sedir and F.AD1 is addition of new room (taken from the Taraklı Municipality, 2013)

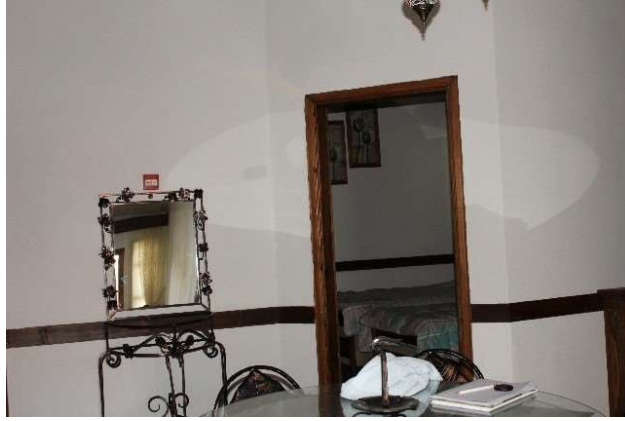
Figure 4.49. F.AD2 is an addition of room to the old sofa after the hotel transformation (Author, 2013)

F.AD1 is an addition to a new room. A new door and a window were added to this part to create a new room. F.AD2 (Figure 4.49 and Figure 4.50) indicates a new bedroom and two bathroom additions. To create related spaces, new walls, and doors were added to this part. F.AD3 is an addition of a new wall to divide the two wc areas into two.

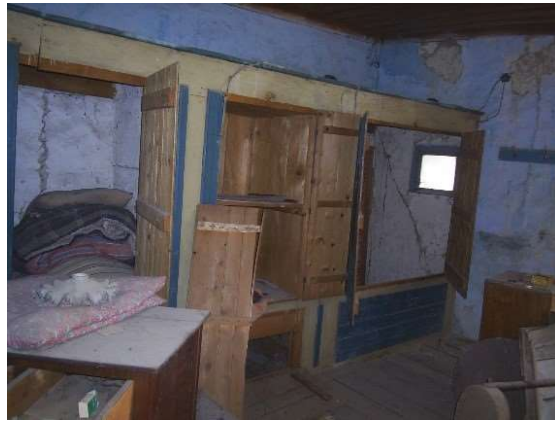
Figure 4.50. Pre-intervention view of the sofa (taken from the Taraklı Municipality, 2013)

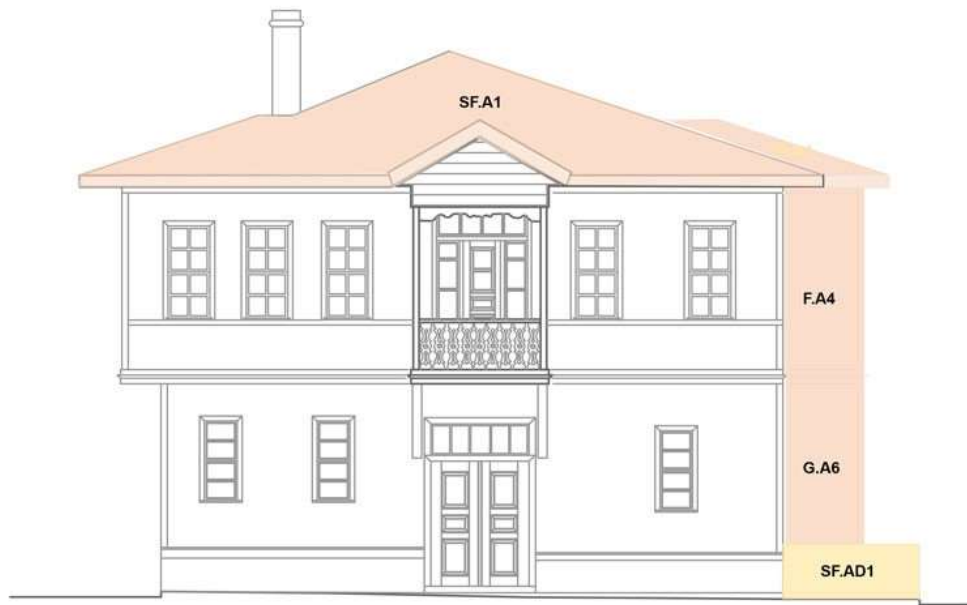
**SOUTH FACADE**

Figure 4.51. South facade view indicates the changes during the hotel transformation (Author, 2023)

For the south facade (Figure 4.51), G.A6 and FA.4 indicate the alterations of wet spaces. Old wet spaces were demolished in pre-intervention plans so they were constructed again with similar materials and their interiors were altered. The walls and floors were covered with ceramic tiles. Brand-new fixtures were used. The plan layout was changed, too. SF.A1 is an alteration of the roof and its tiles. The roof was demolished and a new roof was constructed with similar material. Alaturca roof tile was changed with Marseille roof tile. SF.AD1 is an addition of a stone garden wall.

For the facade views, codes that start with G-F and S letters were taken from the intervention plan layouts of Abdi İbrahim House. Codes started with ...F only belong to changes on ... (related) facades.
