ASSESSING THE IMPACT OF CHANGES ON VALUES DURING THE  
TRANSFORMATION OF TRADITIONAL HOUSES INTO HOTELS: THE  
CASE OF TARAKLI

A THESIS SUBMITTED TO  
THE GRADUATE SCHOOL OF NATURAL AND APPLIED SCIENCES  
OF  
MIDDLE EAST TECHNICAL UNIVERSITY

IN PARTIAL FULFILLMENT OF THE REQUIREMENTS  
FOR  
THE DEGREE OF MASTER OF SCIENCE  
IN  
CONSERVATION OF CULTURAL HERITAGE IN ARCHITECTURE

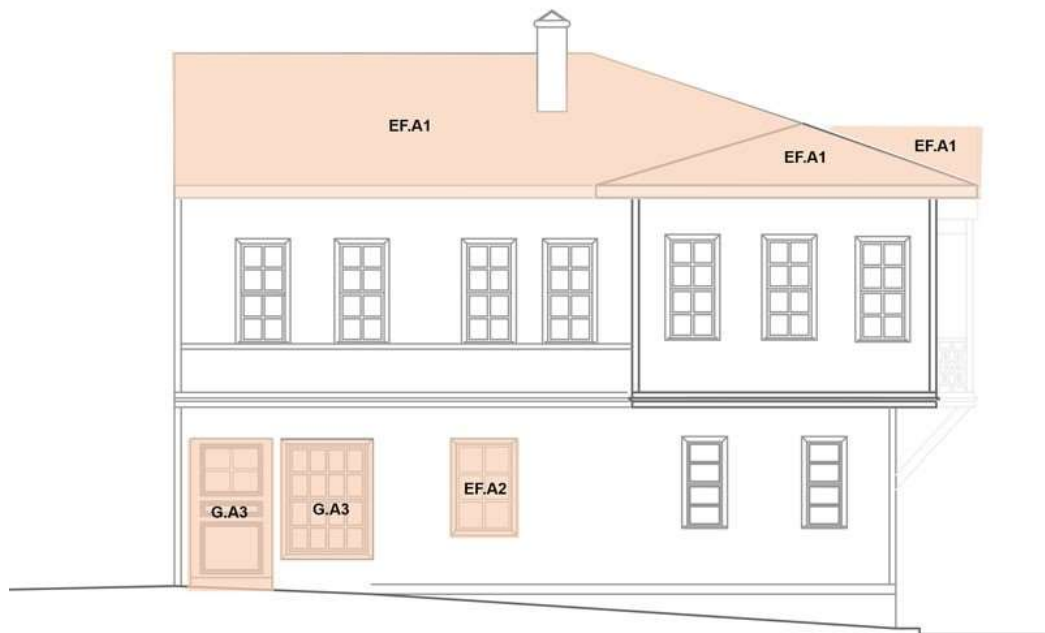
Figure 4.52. East facade view that indicates the changes during the hotel transformation (Author, 2023)

For the east facade (Figure 4.52), G.A3 indicates the alteration of window and door frames. They were changed with new types of frames. EF.A2 was a closed window. It was opened. SF.A1 is an alteration of roof tiles. Alaturca roof tile was changed with Marseille roof tile.

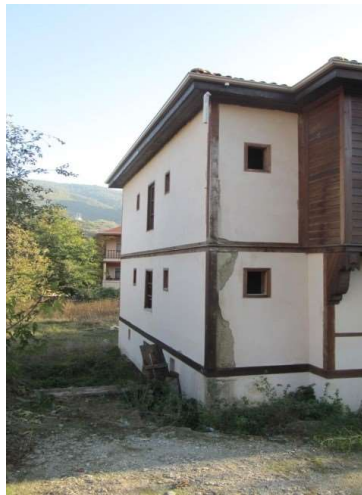
Figure 4.55. Current view of east side facade that indicate the G.AD1 and G.A1 (Author, 2013)

G.AD1 (Figure 4.55 and Figure 4.56) is an addition of a mass. G.AD2 is an addition of a reception desk.

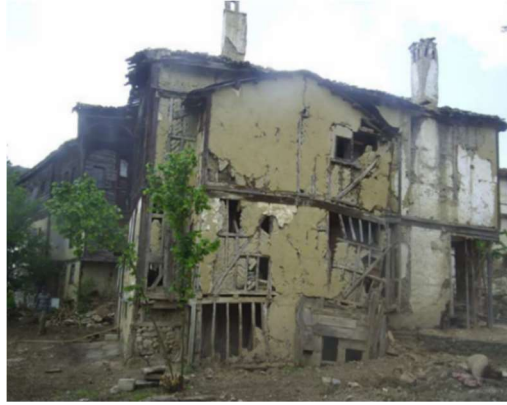
Figure 4.56. Old view of east side facade that indicate the G.AD1 and G.A1 (cited in Selçuk, 2008, p.123)

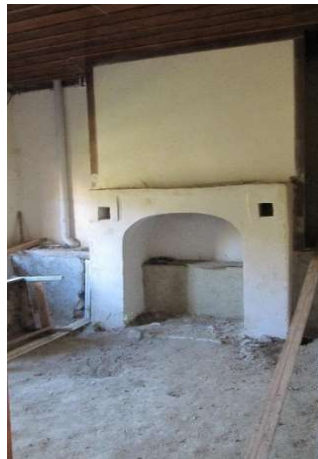
Figure 4.57. Current pictures of the kitchen that indicate the G.R3 (Author, 2013)

G.R1 (Figure 4.59 and Figure 4.60) is a removal of a storage area. It had a connection between the kitchen but after the hotel transformation, this part removed from the ground floor. Instead of storage space, the reception desk was placed to there. G.R2 is a removal of the staircase. G.R3 (Figure 4.57 and Figure 4.58) is a removal of old kitchen cabinets.

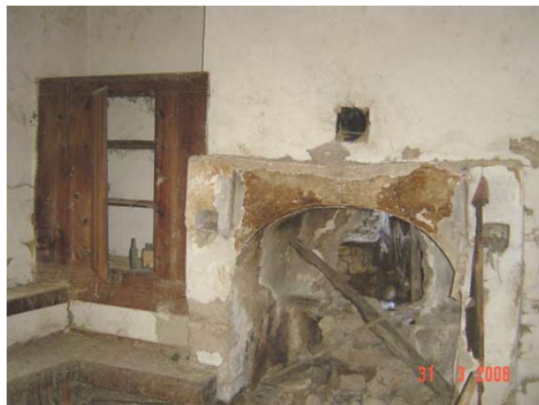
Figure 4.58. Old pictures of the kitchen that indicate the G.R3 (Selçuk, 2008, p.107)

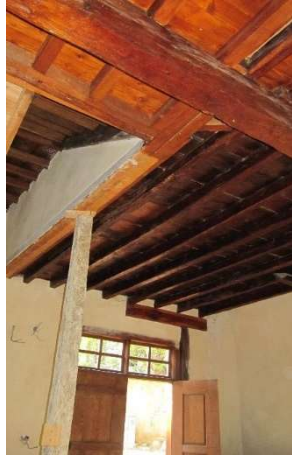
Figure 4.59. Current view of the GPOI03 that indicate the G.R1 (Author, 2013)

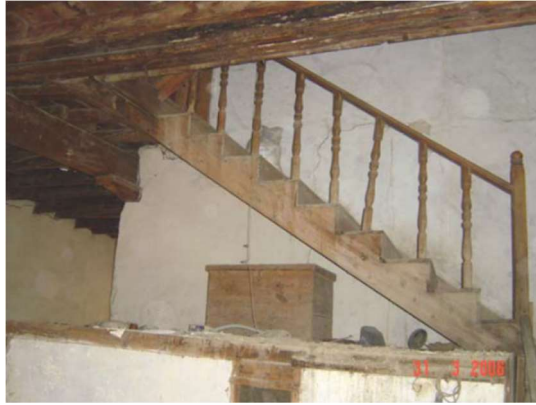
Figure 4.60. Pre-intervention view of the GPOI03 that indicate the G.R1 (Selçuk, 2008, p.104)

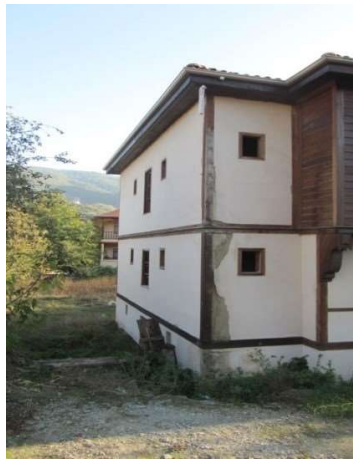
Figure 4.62. Current view of east side facade that indicate the F.AD1 and F.AD2 (Author, 2013)

F.AD1 and F.AD2 (Figure 4.62 and Figure 4.63) are mass additions that are used as a part of bathrooms.

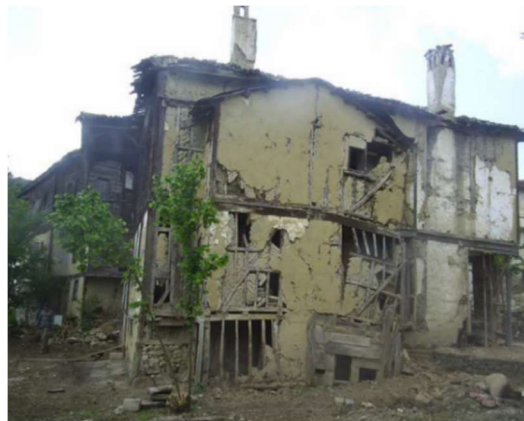
Figure 4.63. Pre-intervention view of east side facade that indicate the F.AD1 and F.AD2 (Özkan, 2008, p.123)

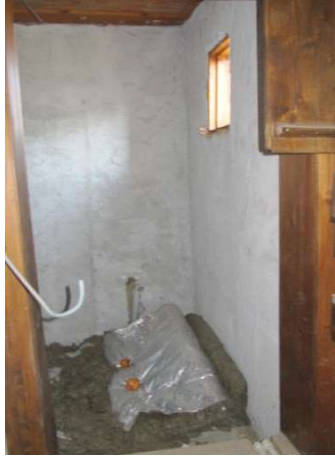
Figure 4.64. Alteration of wet spaces in first floor (Author, 2013)

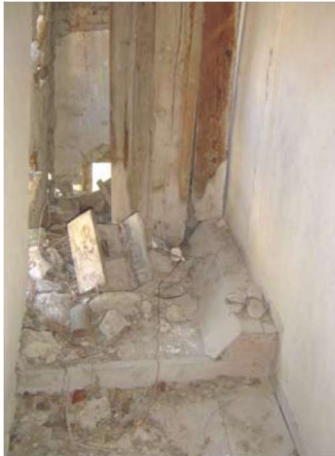
Figure 4.65. Pre-intervention view of wet spaces in first floor (Özkan, 2008)

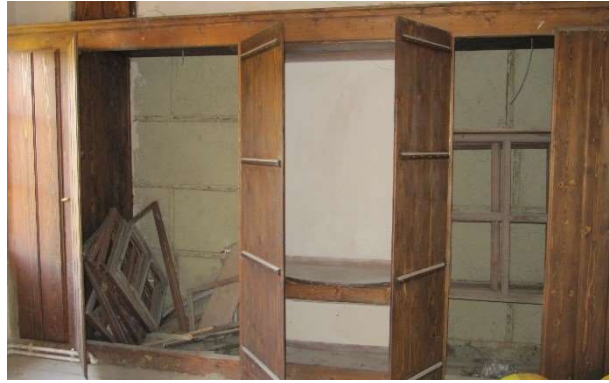
Figure 4.67. Alterations of closets at second floor of the house (Author, 2013)

For the second floor (Figure 4.66), S.A1 is an alteration of the fireplace and closets. Some parts of the closets were altered and used as a bathroom. The closets of SPOI01 and SPOI05 were altered. One of their closets was used as an entrance to the bathroom. The typology of closets and fireplaces was also altered. The closets of SPOI07 and SPOI08 were altered. Bathroom solutions were provided in the closets (Figure 4.67 and Figure 4.68). S.A2 is an alteration of SPOI03. S.A3 is an alteration on the facade. This part was altered and pulled back through the SPOI06.

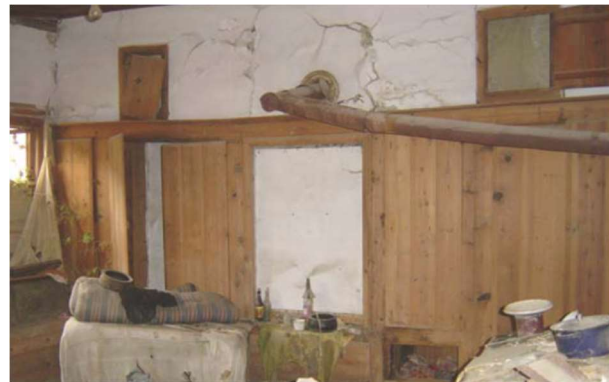
Figure 4.68. Pre-intervention view of closets at second floor of the house (Özkan, 2008, p.111)

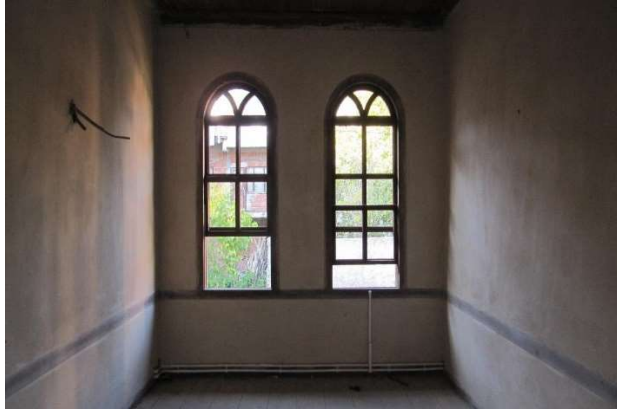
Figure 4.69. Removal of a sedir from SPOI06 (Author, 2013)

S.R1 indicates a removal of sedirs (Figure 4.69).

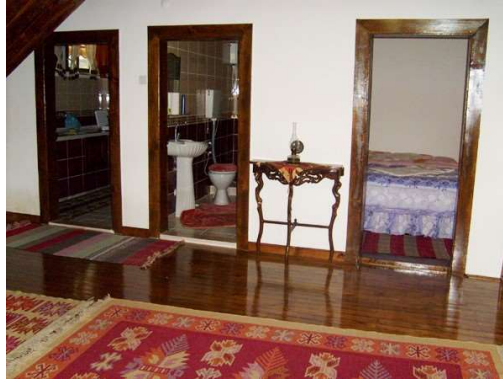
Figure 4.75. Alteration of FPOI02 and FPOI03 on first floor of Çakırlar House (taken from the Taraklı Municipality, 2013)

For the first floor (Figure 4.74), F.A1 is an alteration of windows. Old window frames were enlarged and changed with new frames. The material of old window frames was timber. The new material of the new window frame is PVC. F.A2 is an alteration of the kitchen (Figure 4.75 and Figure 4.76). The floor and wall material of the kitchen were changed with ceramic tile. F.A3 is an alteration of the bathroom (Figure 4.77). The floor and wall material of the bathroom were changed with ceramic tile. Contemporary type of bathroom fixtures and a bathtub were added. F.A4 is an alteration of a wall. The wall was altered and a new window was opened on this wall. F.A6 indicates the alteration of the entrance. Decoration and color of the wooden material was changed with new one (Figure 4.78 and Figure 4.79).

The function of the room was changed to the kitchen in FPOI02 during the hotel transformation (Figure 4.75 and Figure 4.76).

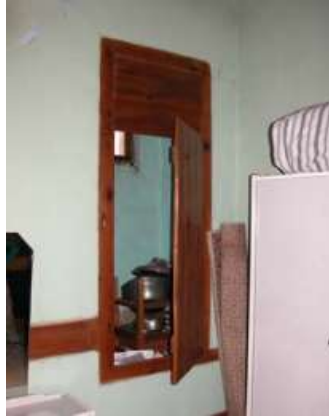
Figure 4.76. Pre-intervention view of FPOI02 (Çetin, 2006, p.508)

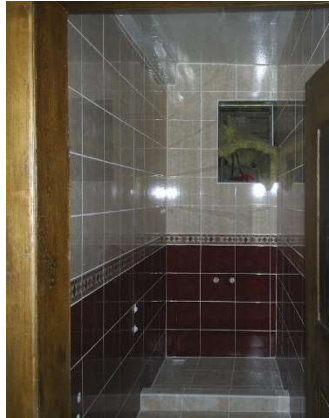
Figure 4.77. Alterations of FPOI03 during the hotel transformation of Çakırlar House (taken from the Taraklı Municipality, 2013)

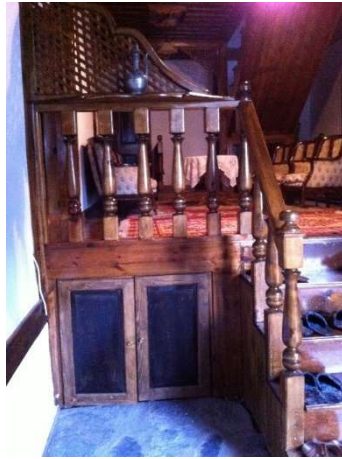
Figure 4.78. F.A6 indicates the alteration of details on entrance staircase at left side (Author, 2013)

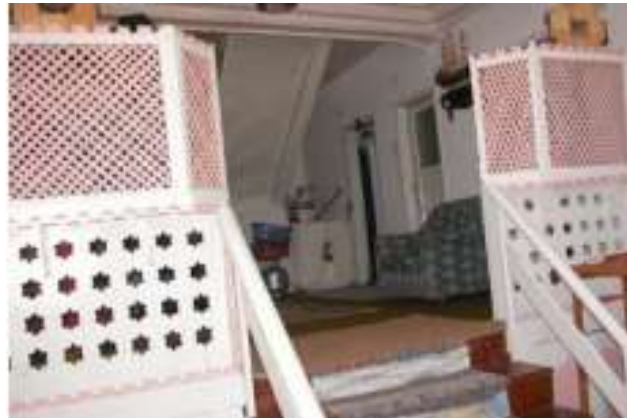
Figure 4.79. Pre-intervention view of the entrance staircase at right side (Çetin, 2006, p.548)

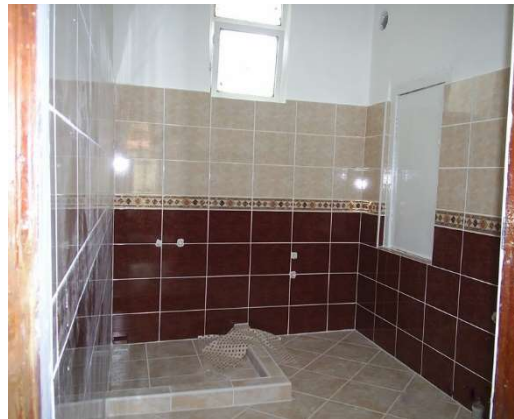
Figure 4.81. Alteration of SPOI02 during the hotel transformation (taken from the Taraklı Municipality, 2013)

S.A1 is an alteration of the bathroom (Figure 4.81). The floor and wall material of the bathroom were changed with ceramic tile. Contemporary type of bathroom fixtures and a bathtub were added. S.A2 is an alteration of the kitchen (Figure 4.82). The floor and wall material of the kitchen were changed with ceramic tile. S.A3 (Figure 4.83) is an alteration of the window. The window was enlarged and altered. A new door opening was opened instead of a window.

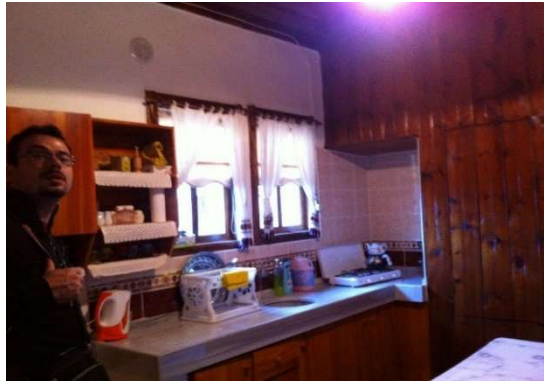
Figure 4.82. Alteration of SPOI03 during the hotel transformation (Author, 2013)

SPOI03 is a change in the function of space in SPOI03. It was used as a room. After the hotel transformation, it was used as a kitchen. There is a change in the function of space in SPOI04. It was used as a part of a sofa. After the transformation, it is used as an entrance to a floor.

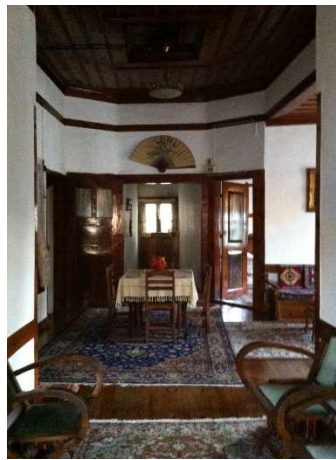
Figure 4.83. The picture indicates S.A3 and S.R1 in SPOI04 (Author, 2013)

S.R1 is a removal of sedir.

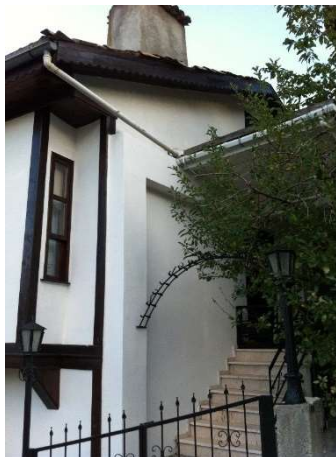
Figure 4.84. The picture indicates S.AD2 (Author, 2013)

S.AD1 is an addition to the kitchen counter and cabinet. S.AD2 (Figure 4.84) is an addition of an outer staircase.

NF.AD1 is the addition of timber decoration to the roof. NF.AD2 is the addition of timber decoration to the window frame. NF.AD3 is the addition of a roof to the main entrance door. S.AD2 is the addition of an outdoor staircase to the second floor plan.
