A FRAMEWORK FOR IDENTIFYING POST-INTERVENTION VALUE SHIFT
IN HERITAGE RESIDENTIAL BUILDINGS: THE CASE OF ANTALYA,
KALEIÇI IN TURKEY

A THESIS SUBMITTED TO
THE GRADUATE SCHOOL OF NATURAL AND APPLIED SCIENCES
OF
MIDDLE EAST TECHNICAL UNIVERSITY

IN PARTIAL FULFILLMENT OF THE REQUIREMENTS
FOR
THE DEGREE OF MASTER OF ARCHITECTURE
IN
CONSERVATION OF CULTURAL HERITAGE IN ARCHITECTURE

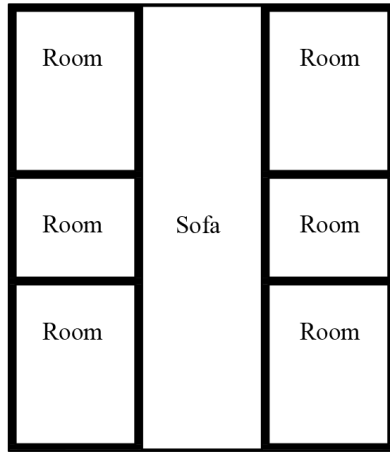
Figure 1.3. Schematic drawing of Ottoman House Inner Sofa Typologies found in Antalya, Kaleiçi. Drawn by the author as represented by Eldem (1968), Kuban (1995) and Küçükerman's (1991) in Güçhan (2017).

Inner Sofa with **Rooms** on both sides.

Inner **central Sofa** with **Rooms** on each corner and an **Eyvan** in between them.

Hence the buildings in question are late Ottoman buildings hosting a similar building technique and plan typology, most evidently the traditional Ottoman house with a central or inner sofa surrounded by rooms and/or eyvans. (Güçhan, 2017) This was a main criterion while choosing the site; intending for this study to be applicable and easily altered and adapted to equivalent heritage residential buildings of the late 19th to early 20th century located in and around the Mediterranean area.

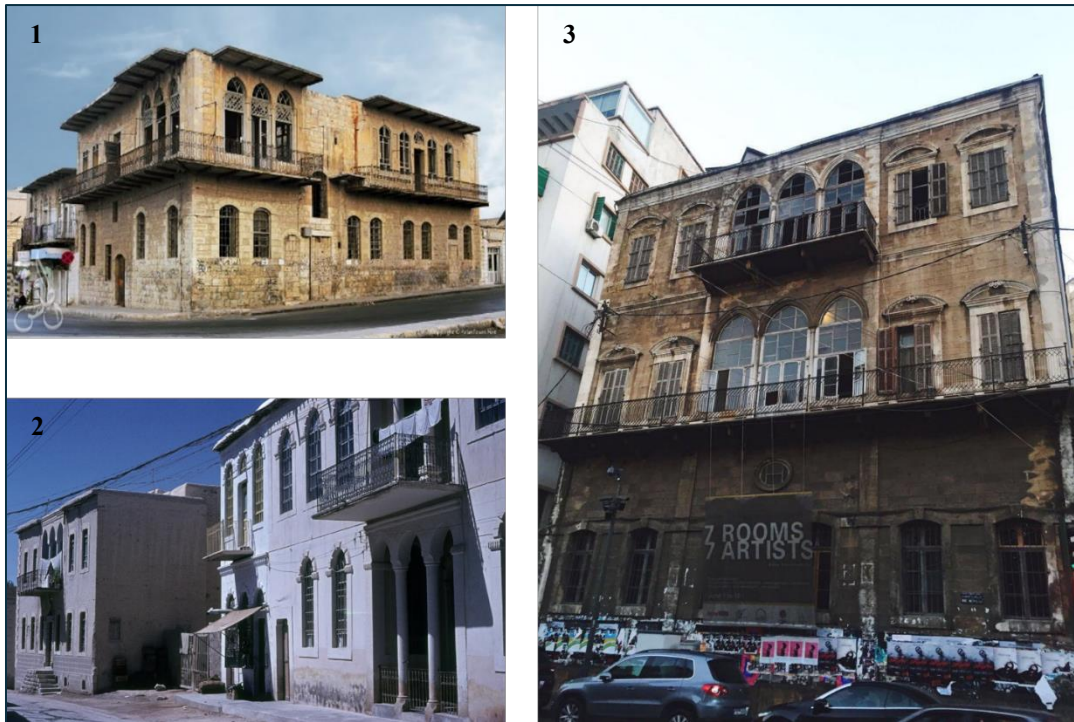
Figure 1.4. Similar typologies to heritage residential buildings found in Kaleiçi. (1) Al Nabulsi House, Irbid, Jordan featuring a central sofa with eyvan. Retrieved from book2jordan.com (2) Yabrud, Syria: Residential heritage houses with inner sofa floor plans. Taken by: Eugen Wirth, retrieved from syrian-heritage.org (3) Beirut Heritage Houses in Gemmayzeh Area. Taken by: Mira Dandan, retrieved from beirut.com on 16/01/2023.

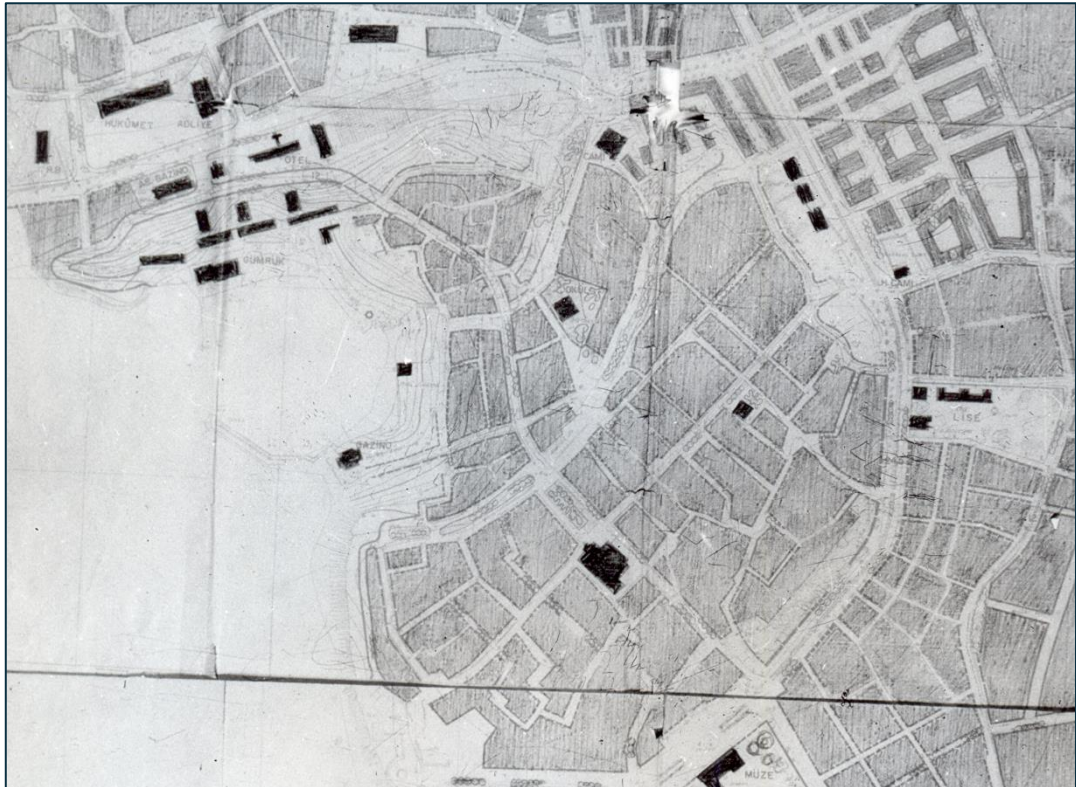
Figure 3.15. 1977 Antalya Kaleiçi Conservation Development Plan Lot Analysis. Retrieved from METU Library Archives.

Then in 1977 the study of the entire Kaleiçi Area (excluding the harbor) on a social, physical, and economic scale began through an Urban Conservation Plan by the mentioned METU team, with the contract issued from the Ministry of Tourism. The goals of this plan as summarized by Gönül Tankut, the leader of the study, (1979; as cited in Argin, 2012, pp. 81-82, & Başok, 2016, p. 161) included rejuvenating the habitability of the area by congruently blending the conservation of cultural heritage aspects and values, the touristic goals asserted by the stakeholders, along with restructuring the social, economic, and physical dimensions of the area for a better quality of livelihood according to modern standards. (Öztekin, 2010; as cited in Uluç, 2014, p. 115) Hence alongside the focus on conserving the physical heritage for its myriad of values; the social, economic, and health aspects of the current users were front and center when developing the urban conservation plan. Decisions were based on physical, social, economic, commercial, and ownership data gathered via surveys within the area. (Başok, 2016) It was presented as a holistic process that takes into account the economic benefits from heritage and cultural tourism, while trying to nourish the roots of the current users.

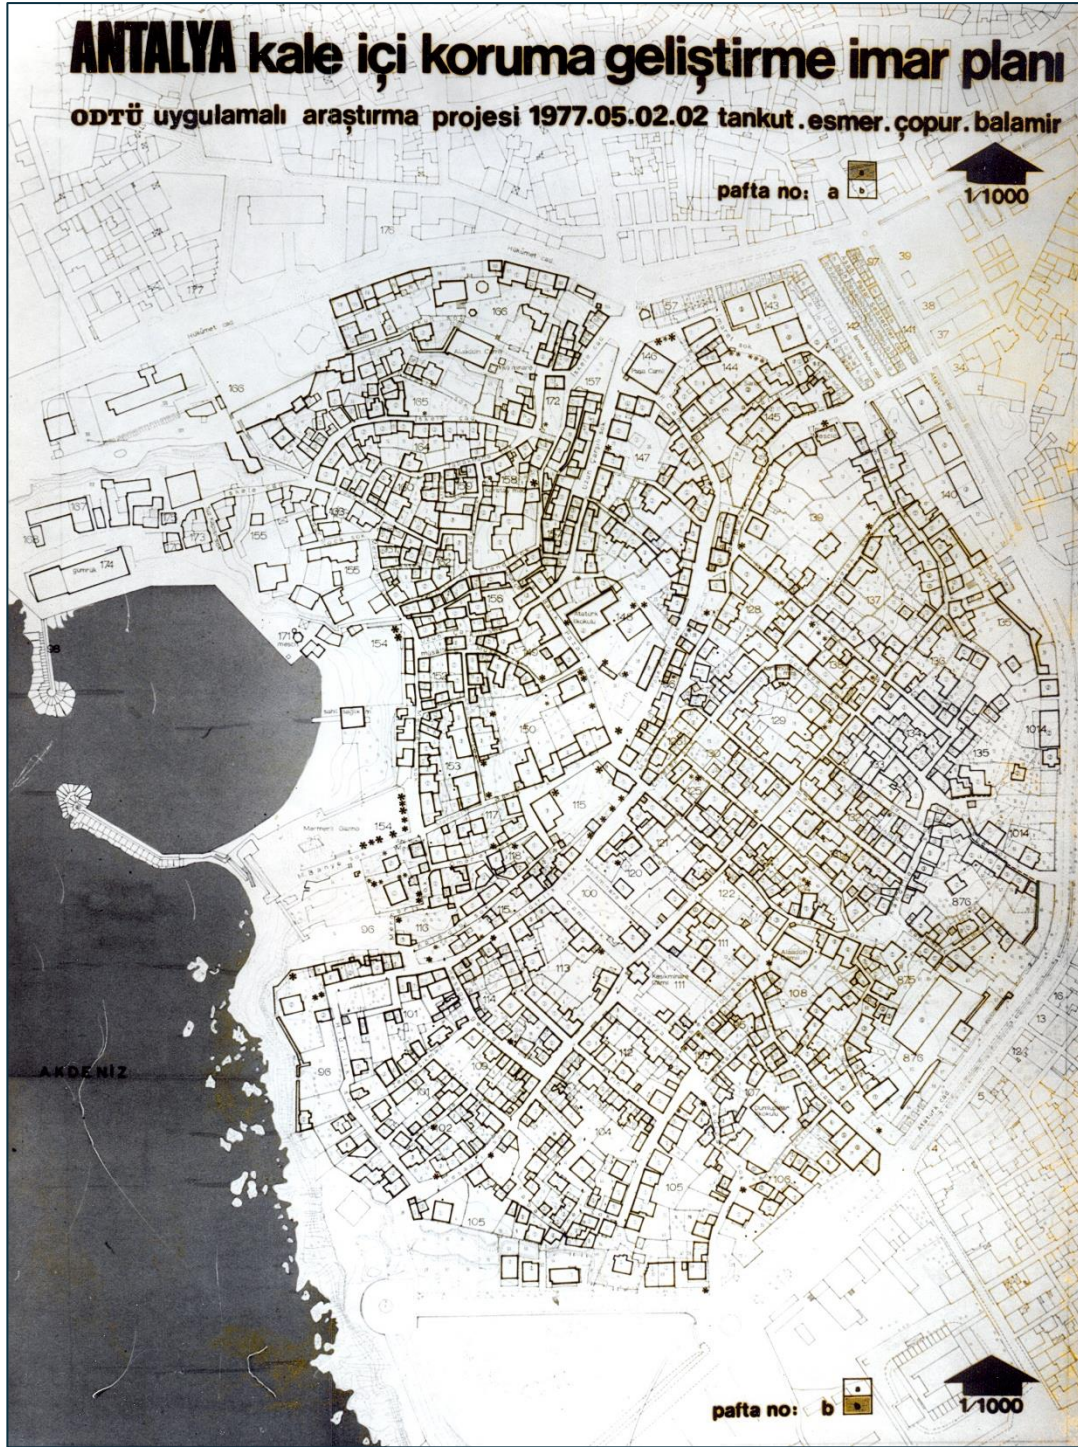
Figure 3.16. 1977 Antalya Kaleiçi Conservation Plan. Retrieved from METU Library Archives.

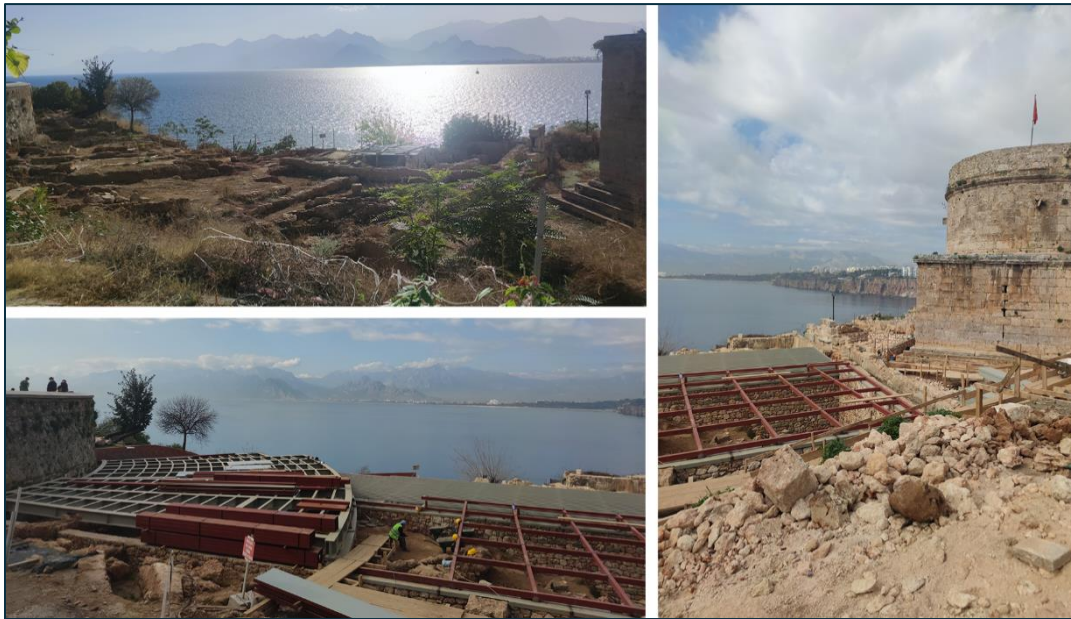
Figure 3.22. The before and during of the Conservation and Development Project of Hıdırlık Tower. Taken by the Author on 23/09/2023 and 07/02/2024.

Another large-scale project is the ongoing renovation of Hıdırlık Tower and its surrounding open space. It started to be implemented at the end of 2023 after the end of the summer touristic period and aims at introducing an ease of accessibility to Hıdırlık Tower while better defining the open space around it. Other reoccurring projects usually focus on the rehabilitation of a single heritage building to transform its function into a more touristic friendly and commercially beneficial one. This parallelism in goals, financially charged from one end while historically and culturally dependent from another, gives way to one terminus over the other; with the touristically charged financial gain set by the stakeholders overwhelmingly dominant in determining the past, present, and future of conservation activities in the Kaleiçi.

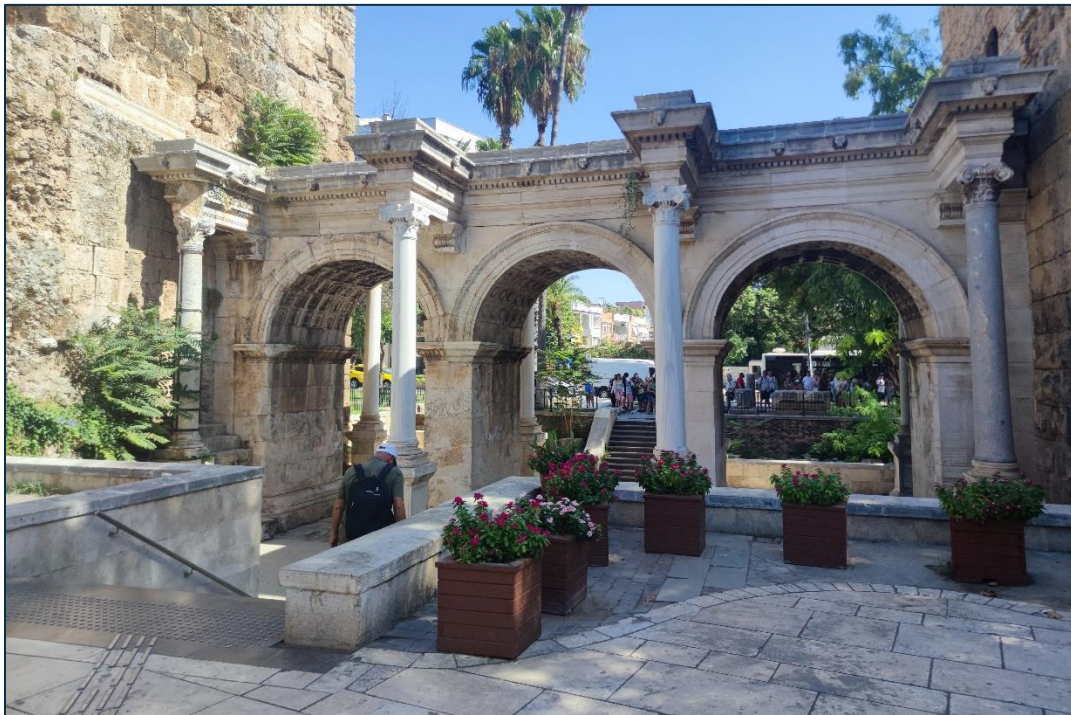
Figure 3.26. Refurbishment Hadrian's Gate as a part of the Urban Conservation Plan. Taken by the Author.

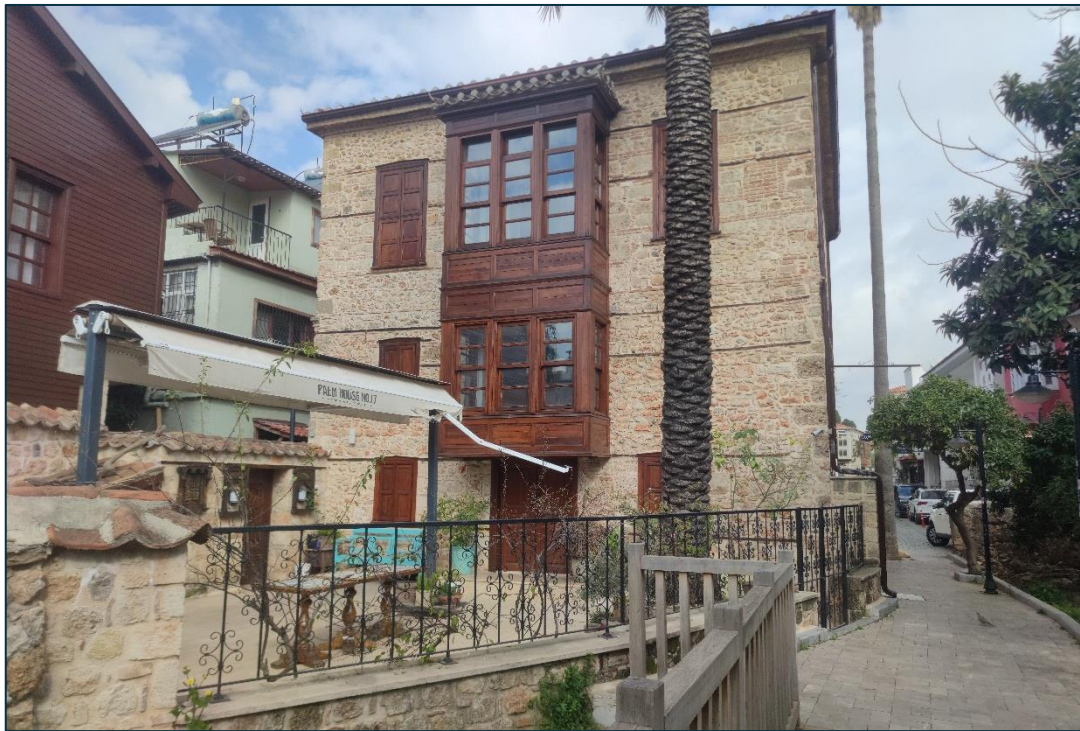
Figure 3.30. Photograph of the building and lot relationship in Building D. Taken by the Author.

The first physical form factor analyzed is the lot, starting with the basis of the heritage residential building within the lot itself. Based on site surveys and reinforced by Erarslan (2020), the residential buildings are oriented towards the Southeast – Northwest axis, with the main entrance and *sofa* with its projection mainly existing on this axis. Some buildings can be seen oriented towards the Southwest – Northeast axis with the main entrance located along that direction; however, they tend to feature either additional sofa-like projections or windows along their Southeastern façade. This distinct orientation is selected to maximize the sunlight exposure during winter especially through the Southeastern oriented *sofa*, and to funnel in the Antalya prominent North and Northwestern winds from the sea into the house for better cooling and ventilation during the summer.

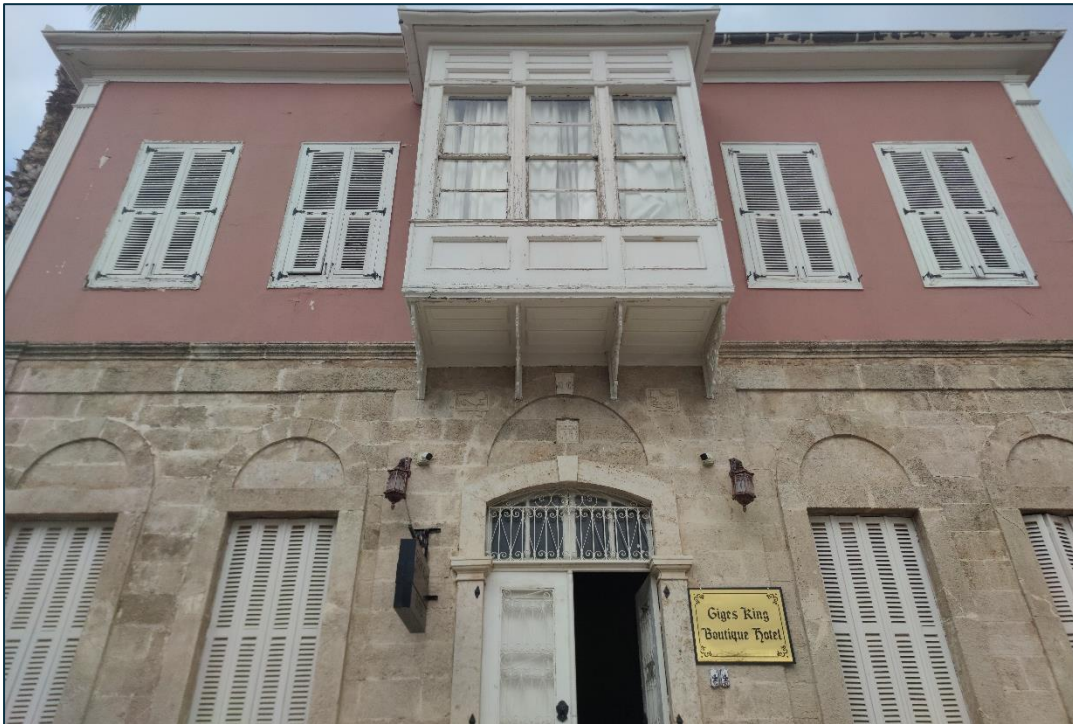
Figure 3.31. Photograph of the main elevation of Building B. Taken by the Author.

The houses are situated at the edge or the corner of the lot so that either one, two, or if the lot is small three sides are connected to the surrounding streets; one or two roads being in direct contact with the buildings' sides are the most observed. (Cerasi, 1998) Main building entrance doors open directly to the streets with the projections coming off the first floor creating a visual semi open buffer zone between the exterior and interior and marking a perceivable building-related section of the street. (Erarslan, 2020; and Ulusoy & Üstün, 2019)

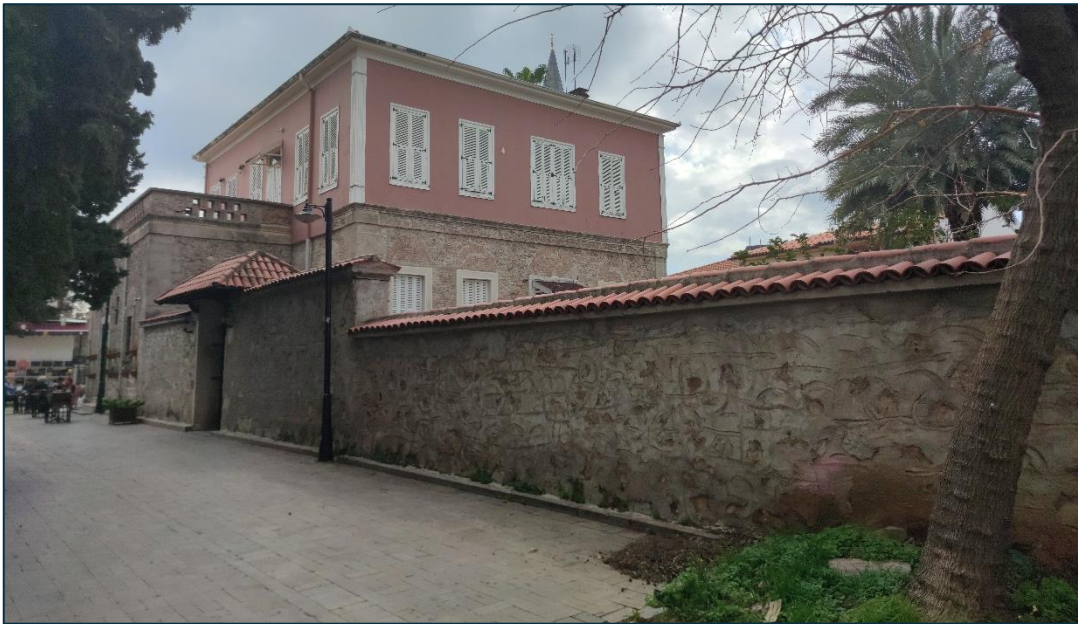
Figure 3.32. Photograph of the lot wall of Building B. Taken by the Author.

Almost every residential building has its own courtyard which acts more like an enclosed private garden specifically to serve the residents of that house. Completely isolated visually from the public street via a high stone wall all around the lot's borders, except for the sight of the trees within reaching out to the common narrow space beyond the wall, (Erarslan, 2020) creating bits of shade throughout the street. These walls enforce the privacy required by the courtyards, (Ulusoy & Üstün, 2019) only accessible through a double hinged door through a side road. (Erarslan, 2020)

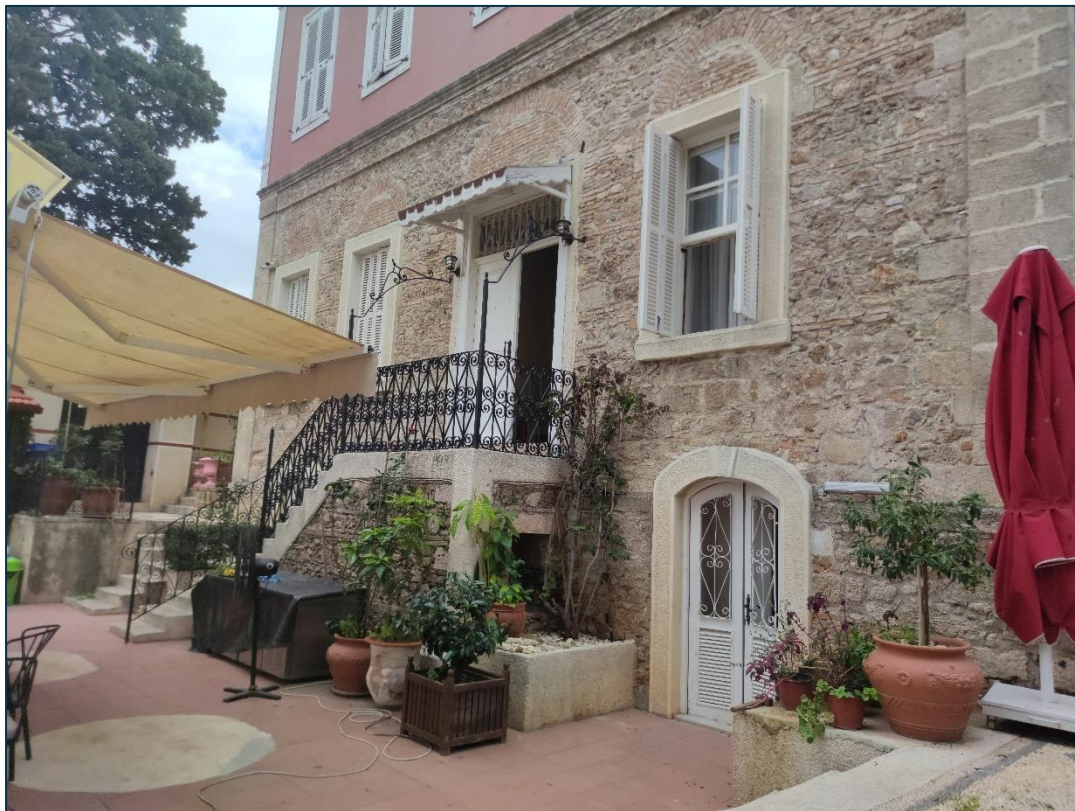
Figure 3.33. Photograph of the back courtyard entrance of Building B. Taken by the Author.

The courtyard played an integral part in the daily life of Antalya’s occupants. In a Mediterranean port city, green open private spaces were a necessity especially for the major Muslim population in the area. Accessible through a large double hinged door via a side road, the courtyard acted as the independent house entrance towards the private area. Where the main front entrance primarily welcomed visitors, the courtyard entrance was meant for all other purposes related to the *haremlik* and service areas.

The courtyard door has an eave on top shielding pedestrians underneath from the weather elements. (Ulusoy & Üstün, 2019) Household daily activities extended to the courtyard as it became a main element in fulfilling tasks such as laundry, providing a recreational zone for the household, and a garden to grow essential crops and local produce like orange trees. In Antalya every courtyard features a cistern for water utilization whether it's drinking, cleaning, or irrigation; it can also be used for cooling vegetables and fruits. (Erarslan, 2020; & Ulusoy & Üstün, 2019)

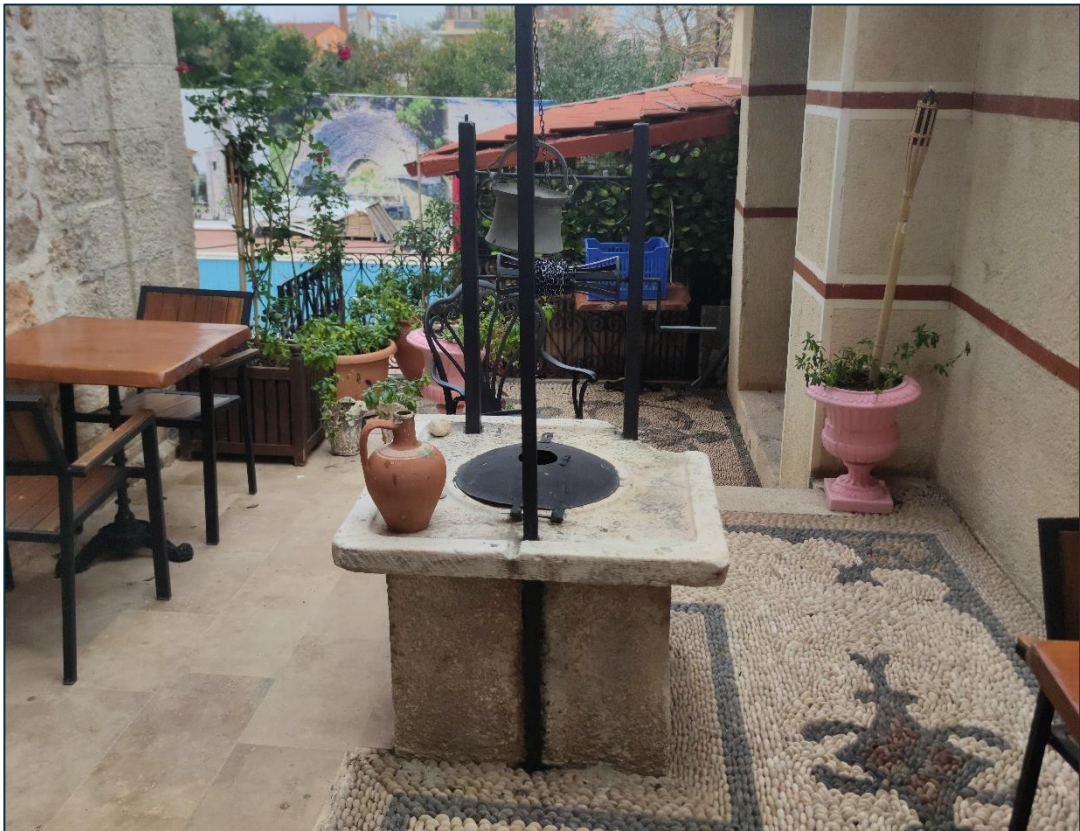
Figure 3.34. Photograph of the cistern within the courtyard of Building B. Taken by the Author.

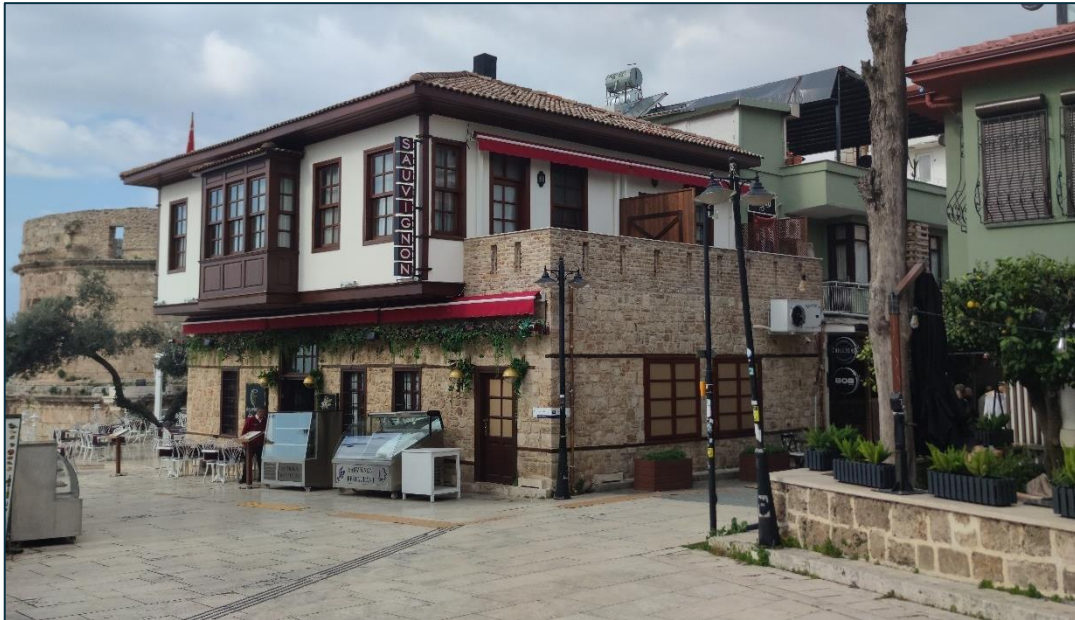
Figure 3.35. Photograph of the outside of Building A showcasing its form. Taken by the Author.

The form of the ottoman residential building is a rectangular cuboid with a pitched roof, where the base ranges between a square to a short rectangle. Some projections, motifs, balcony cantilevers, or minor mass additions could be found around the edges of the buildings without detracting from the dominant symmetrical form of the main building. The main residential building is made up of a ground floor, a mezzanine floor that covers a minor portion of the building area, usually located above service zones, and a first floor covered with a pitched roof. In some rare cases a second floor consisting of one room and a terrace could be found.

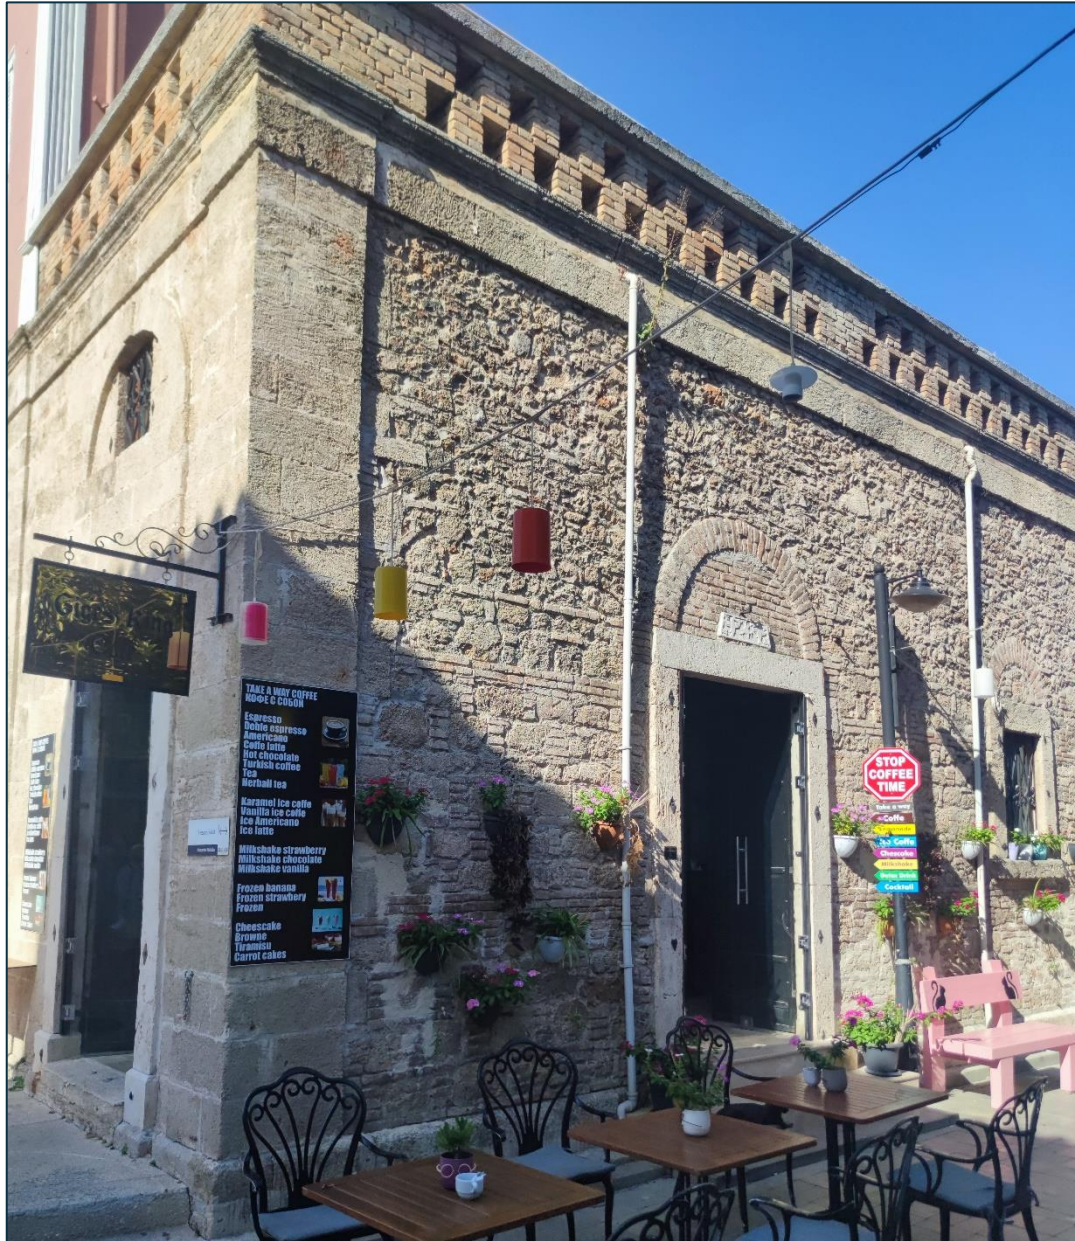
Figure 3.36. Photograph of the dukkan (shop) mass of Building B. Taken by the Author.

Some residential buildings feature an attached mass to the main one. One story high and accessible via a door from the main street, this space acts as a shop, or *dukan*, related to the house's occupants. It is longitudinal running along the building's side, occasionally featuring a back access towards the courtyard and to a side storage

room, with a roof that slopes down the short end of the structure towards a side street. The shop's roof space can additionally be utilized as a terrace for the upper rooms as observed in some extravagantly designed houses. (Erarslan, 2020)

The mass of Building B consisted of the main building that was two floors high and a roof. A small mass is connected to the main mass towards the southwest elevation used for storage. From the northeastern direction a rectangular mass was connected to the main residential building which functions as a shop. Originally the shop had a terrace on top that got ruined and replaced by a makeshift pitched roof.

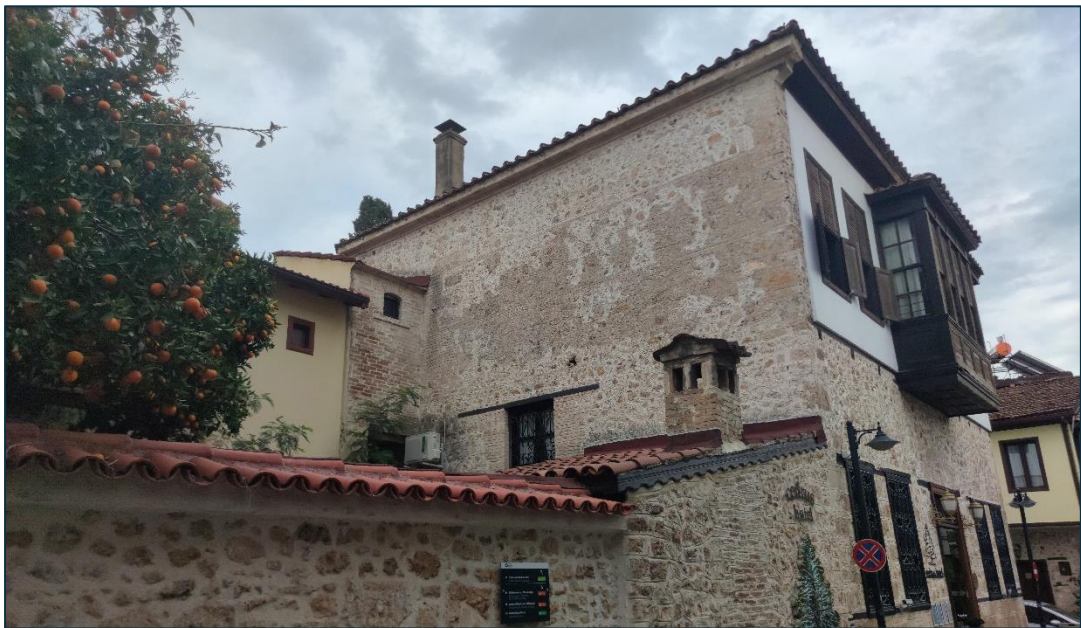
Figure 3.37. Photograph of service wall of Building C. Taken by the Author.

Heading upwards, one of the walls of the service areas downstairs is extended towards the first floor, considered as a service wall. If it isn't present, then chimneys or brick shafts are used. Interior walls are of timber construction with lighter infill material or left hollow, similarly a *bağdadi* lathwork covers the frames which is plastered over then painted. (Erarslan, 2020) The roof is sloped across a soft pitch on four sides, covering the plan area under it completely. (Cerasi, 1998) It is framed with timber beams nailed on top the uppermost timber plates. Frames along the ridges with the aid of king posts are installed, then girders are set which finalizes the structure. Wooden planks are set on top then covered with roof tiles. (Güçhan, 2017) After the roof is finished the outer walls are plastered as specified the interior ones are plastered and painted, and interior architectural elements are installed.

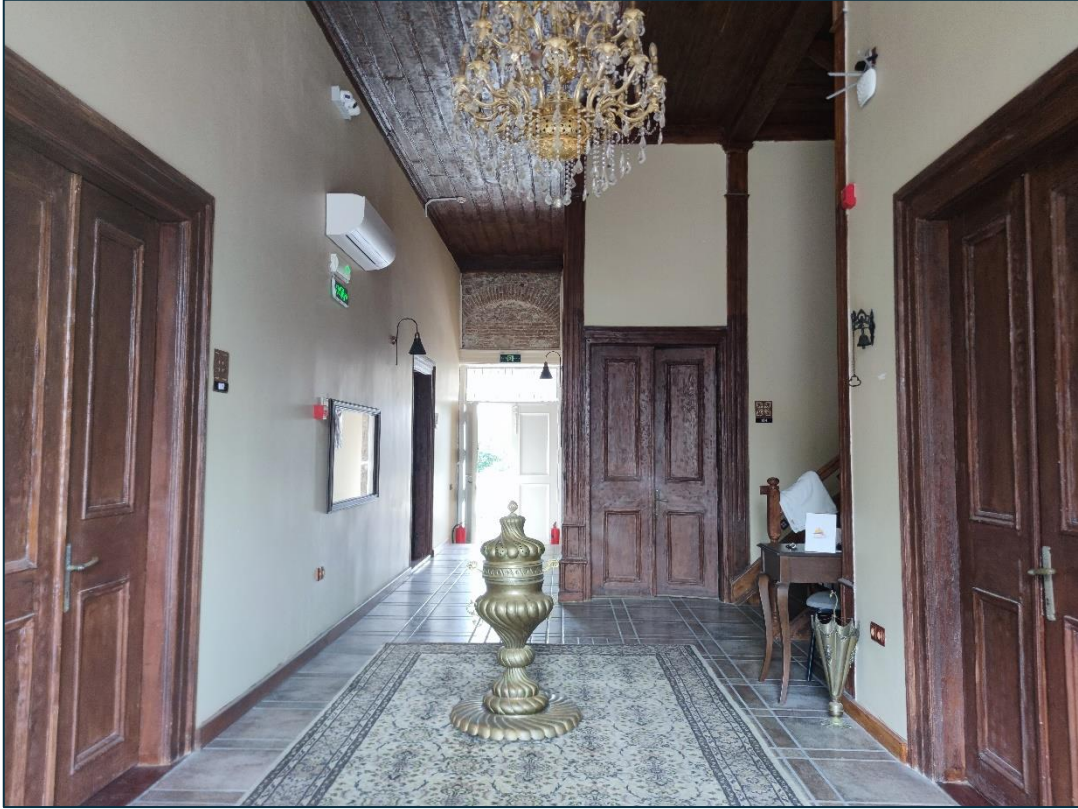
Figure 3.38. Photograph of the interior of the ground floor in Building B. Taken by the Author.

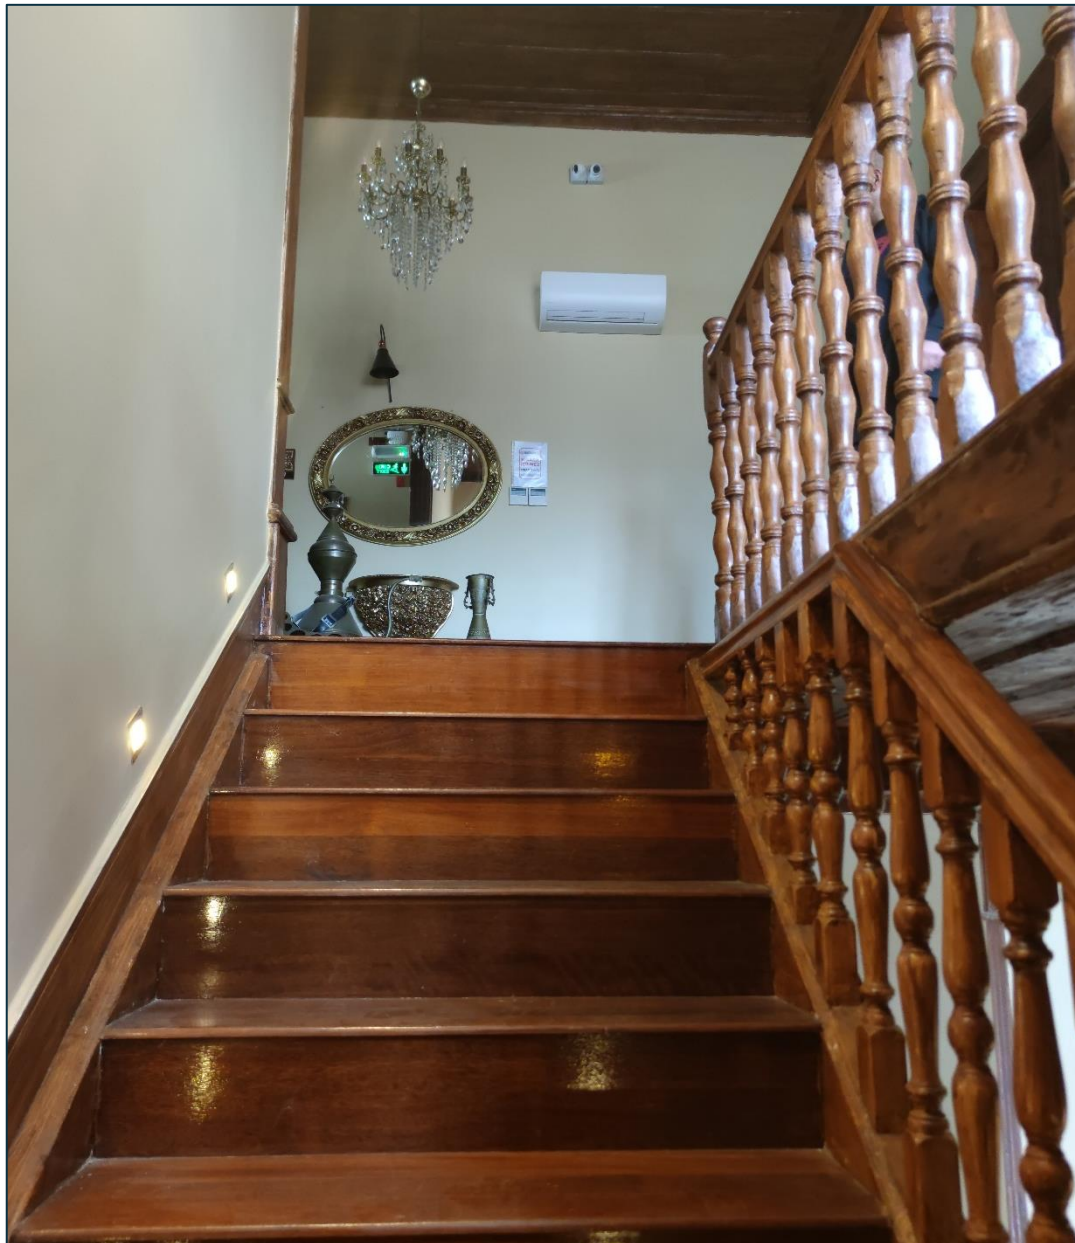
Figure 3.39. Photograph of the main staircase in Building B. Taken by the Author.

Vertical circulation elements leading upwards to the first floor can be observed at two distinct locations. It is established that the main function of the stairs is to access the private upper section of the house which is reserved for the house occupants. Thus, it is considered as a component of the private unit; as such always visually disconnected from the semipublic domain (*selamlık*) of the ground floor, and occasionally physically and visually detached. In the first case, the stairs are accessible via the *taşlık* circulation zone through the mid space between the guest rooms adjacent to the entrance and the service spaces closer to the courtyard. This implementation results in easy accessibility from the *haremlık* to the service areas without the need to pass through the private courtyard.

The second typology features completely unlinked direct circulation between the *selamlık* and *haremlık*, evident by the accessibility to the stairs from the courtyard. Hence, the courtyard becomes a tethering zone between the first floor and the ground service areas; it is perceived that the solemn way to access the first floor is through the stairs in the courtyard, rendering the private outdoors a main element in the daily circulation and space hierarchy, while increasing the private nature of the *haremlık*. (Ulusoy & Üstün, 2019)

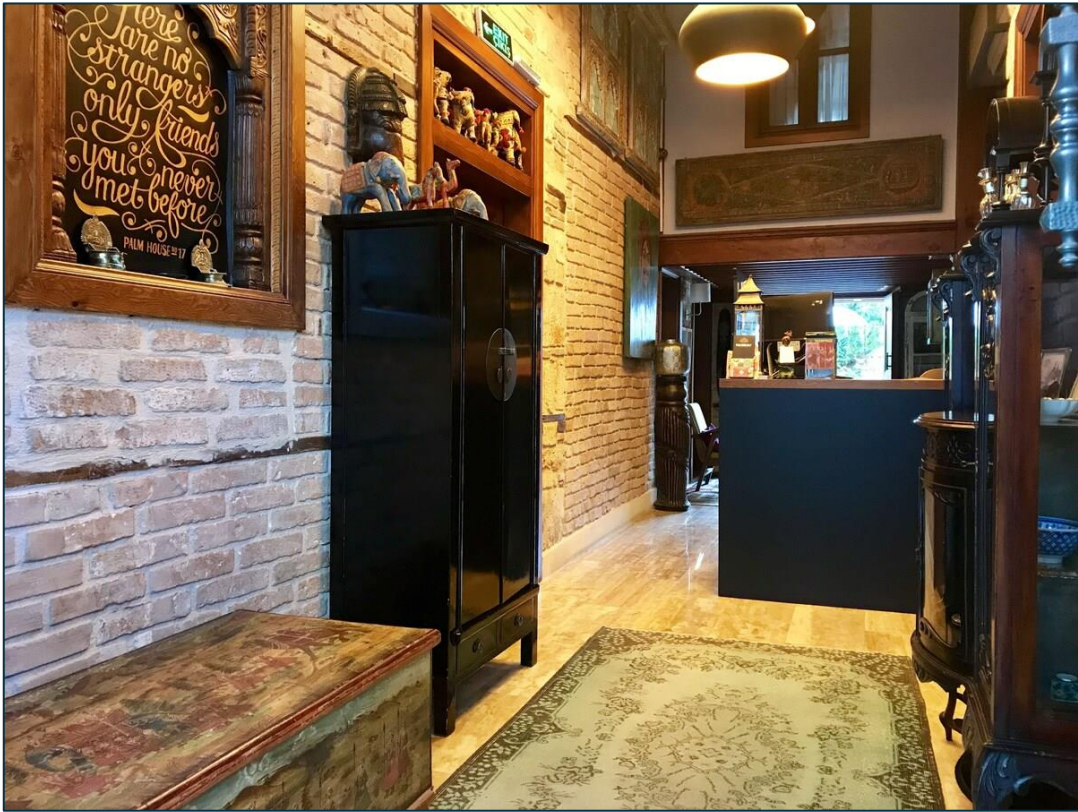
Halfway along the stairs, the mezzanine level can be accessed. This low ceiling space is a flexible zone used in accordance with the occupants' needs. Usually barebone and lacks decorations, the mezzanine can be utilized as a storage space, a pantry, service area, a winter room, or an extra bedroom. (Erarslan, 2020)

Figure 3.40. Photograph of the interior of Building D showcasing the mezzanine floor with a window projecting towards the ground floor, seen in the upper right corner. Retrieved on 22/02/2024 from <https://tr.hotels.com/ho608497408/palm-house-17-oriental-misafir-evi-antalya-turkiye/>.

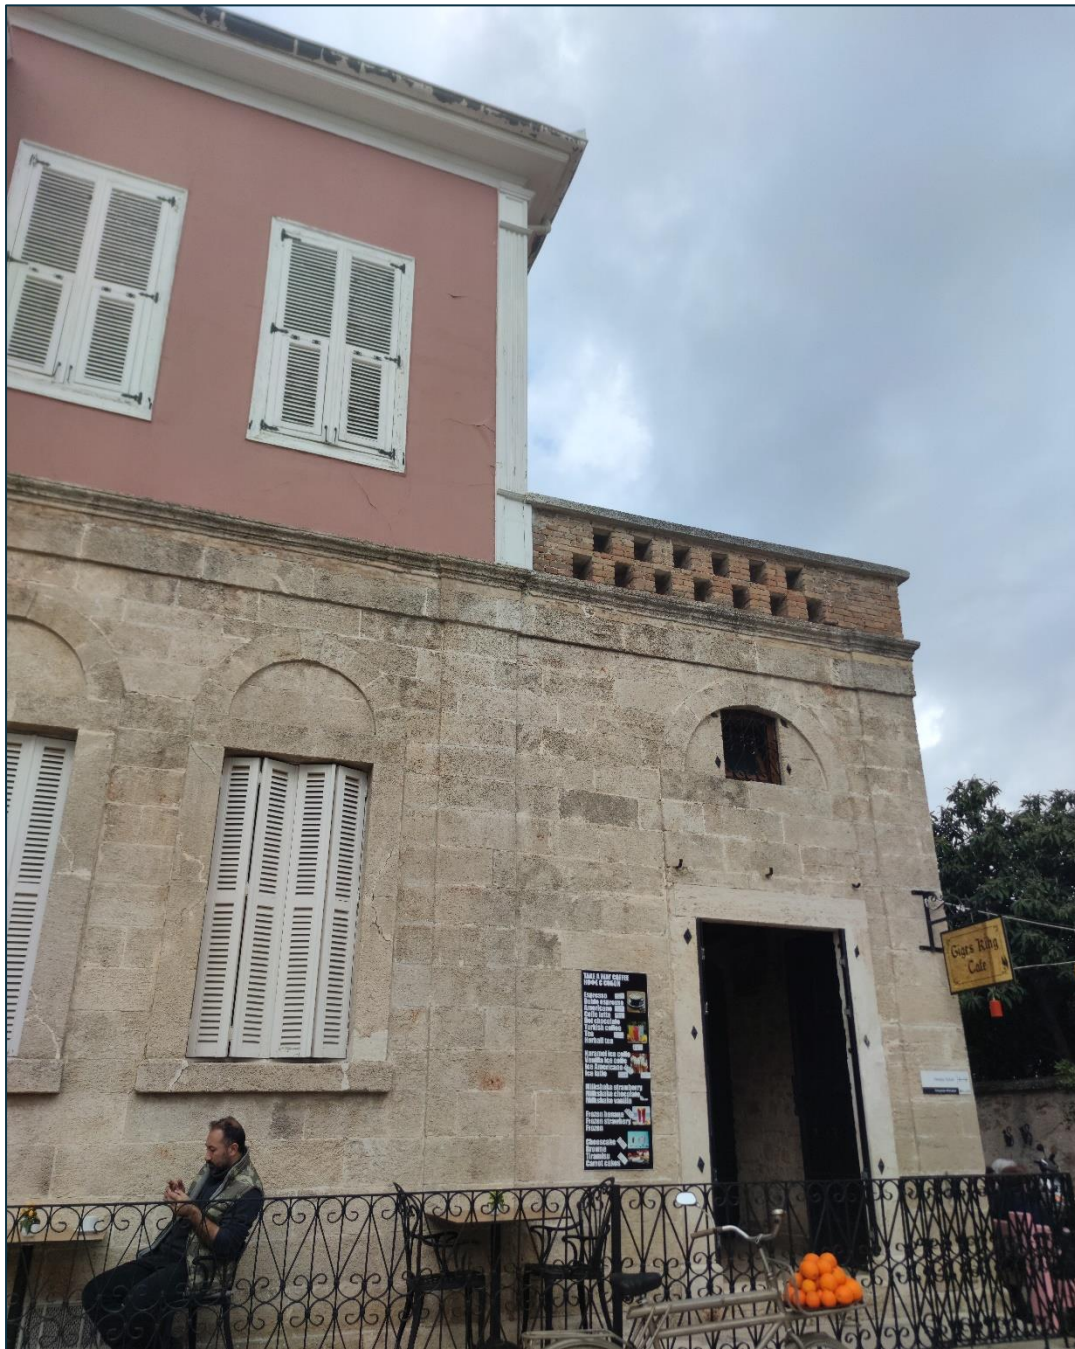
The shop mass hosts a more simplistic wooden door and an upper fixed opening for lighting that lacks the intricate design of the main entrance. The ground floor's top edge features a stone cornice along the entire front elevation, (Erarslan, 2020) visually dividing the ground and first floor while establishing a visual solid and steady base for the upper sections of the house.

Figure 3.42. Photograph of the architectural elements within and around the shop mass of Building B. Taken by the Author.

Figure 3.41. Portion of the plan of the first floor of building D showcasing the two main odas. Retrieved from the official documentation drawings of Building D	118
Figure 3.42. Photograph of the architectural elements within and around the shop mass of Building B. Taken by the Author	120
Figure 3.43. Photograph of the courtyard (Northwest) elevation of Building B. Taken by the Author	122
Figure 3.44. The southwest elevation of Building B. Retrieved from the official documentation drawings of Building B	123

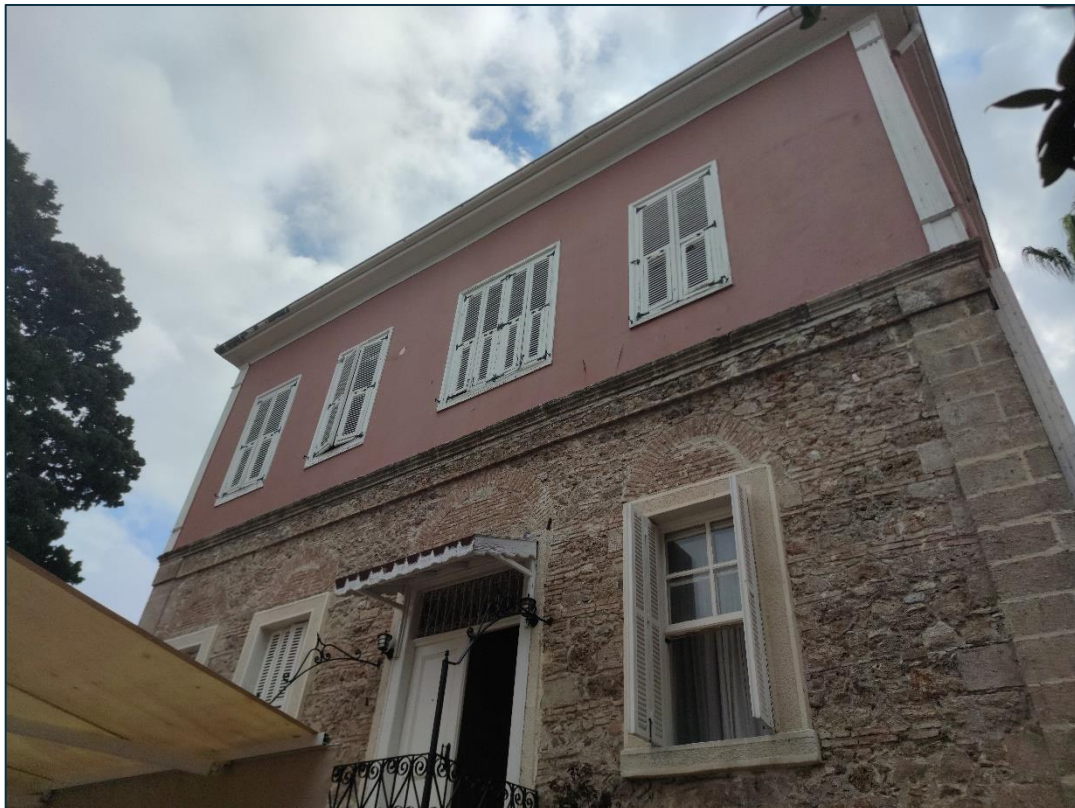
The other three elevations of the building do not feature similarly detailed inclusions and settle for the basic execution of architectural elements. In the more elaborate buildings, only the edges of the elevations are erected via fine cut stone that are left bare forming the façade. The stone elaborate cornice goes around the building even along the secondary elevations whereas the walls between them are built with the rough-cut stone and brick blend notable in this area, plastered, then painted. The back doors connecting the *taşlık* to the courtyards are less elaborate than their front counterparts, while windows are built via basic timber designs.

Figure 3.43. Photograph of the courtyard (Northwest) elevation of Building B. Taken by the Author.

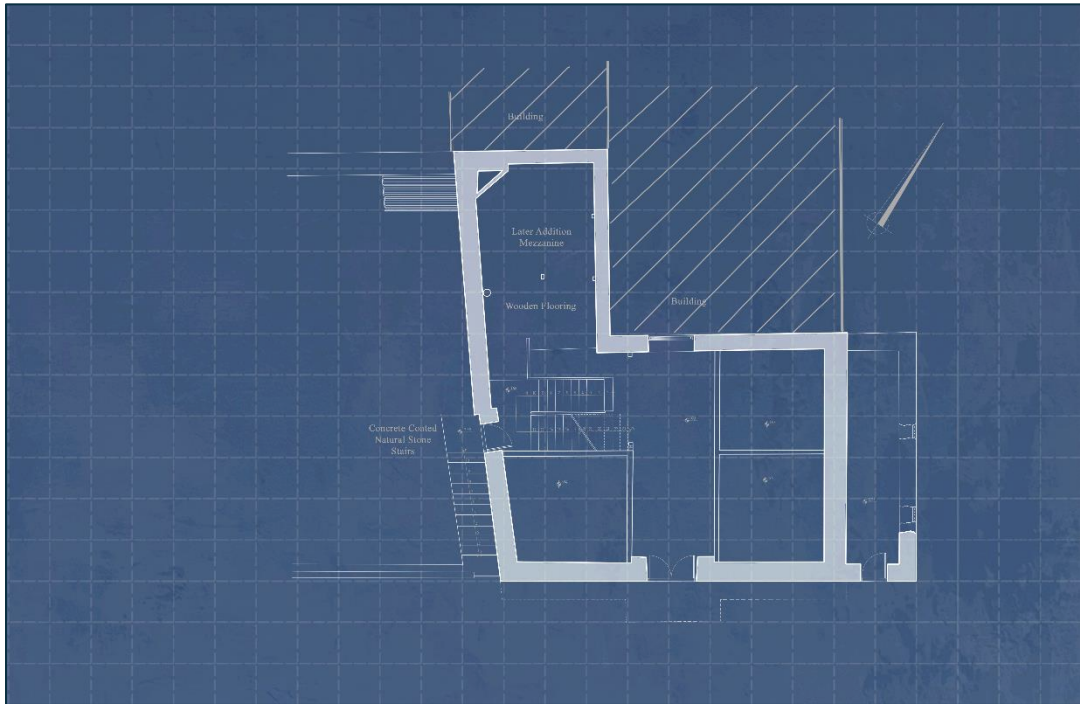
Figure 3.47. Mezzanine pre-intervention plan of Building A. Prepared by the Author based on the original documentation drawings.

Originally there was no access from the street to the courtyard, with a tall masonry wall separating the courtyard from the public street as was common in Kaleiçi. There was one access point from the street to the building's first floor which is the main entrance, whereas a secondary entrance was allocated from the street to the mezzanine floor directly via stairs that ran along southwestern elevation. The courtyard was sloped downwards towards the west such that the points of connection between the building and the courtyard are the highest and get lower towards the west. Soil was the dominant ground material, and trees were planted all over the courtyard. In addition to the front lot wall a back one was also erected to separate the site from the neighboring lots.

Figure 3.45. The location of Building A within Kaleiçi. Prepared by the Author	127
Figure 3.46. Ground floor pre-intervention plan of Building A. Prepared by the Author based on the original documentation drawings	128
Figure 3.47. Mezzanine pre-intervention plan of Building A. Prepared by the Author based on the original documentation drawings	129
Figure 3.48. First floor pre-intervention plan of Building A. Prepared by the Author based on the original documentation drawings	130
Figure 3.49. Intervention analysis key. Prepared by the Author	134
Figure 3.50. Original ground floor intervention analysis plan of Building A. Prepared by the Author	135
Figure 3.51. Restored ground floor intervention analysis plan of Building A. Prepared by the Author	136
Figure 3.52. Original mezzanine intervention analysis plan of Building A. Prepared by the Author	137
Figure 3.53. Original first floor intervention analysis plan of Building A. Prepared by the Author	138
