A FRAMEWORK FOR IDENTIFYING POST-INTERVENTION VALUE SHIFT
IN HERITAGE RESIDENTIAL BUILDINGS: THE CASE OF ANTALYA,
KALEIÇI IN TURKEY

A THESIS SUBMITTED TO
THE GRADUATE SCHOOL OF NATURAL AND APPLIED SCIENCES
OF
MIDDLE EAST TECHNICAL UNIVERSITY

IN PARTIAL FULFILLMENT OF THE REQUIREMENTS
FOR
THE DEGREE OF MASTER OF ARCHITECTURE
IN
CONSERVATION OF CULTURAL HERITAGE IN ARCHITECTURE

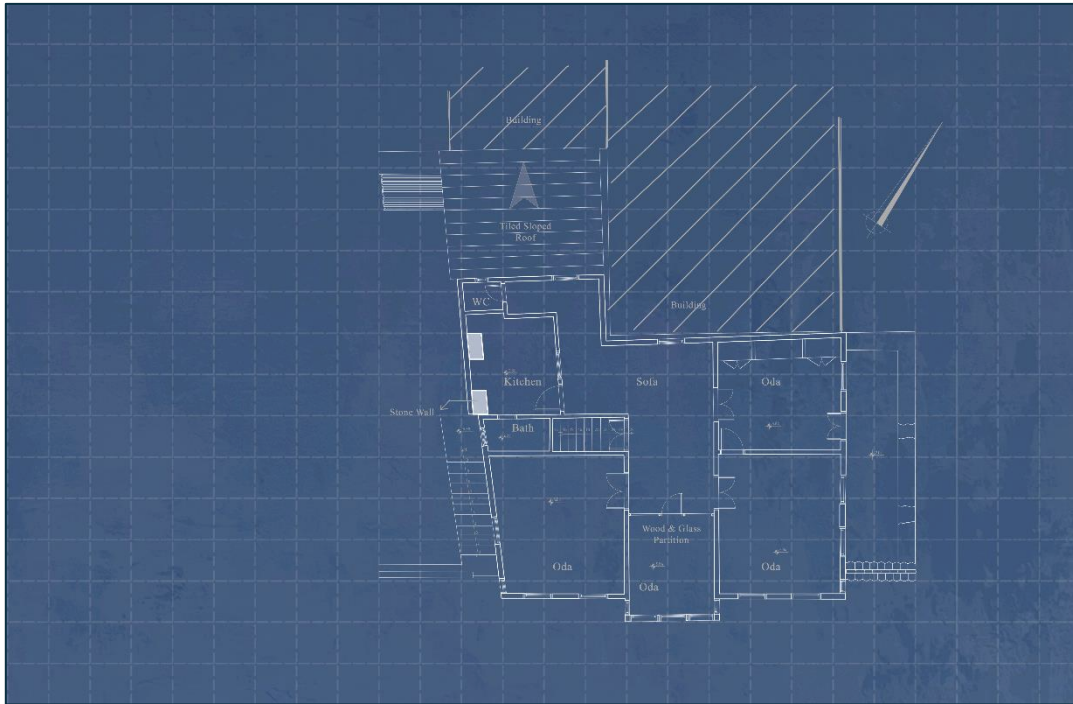
Figure 3.48. First floor pre-intervention plan of Building A. Prepared by the Author based on the original documentation drawings.

As for the structure, the building features a rough-cut stone base that's plastered and painted. The upper section is timber construction using the *bağdadi* method. The floor / ceiling, roof, and stairs are all made by timber construction methods. Through the service area of the house, which was located at the upper left section throughout the plans, has a service wall going up towards the first floor to where it services a kitchen, WC, and bath area.

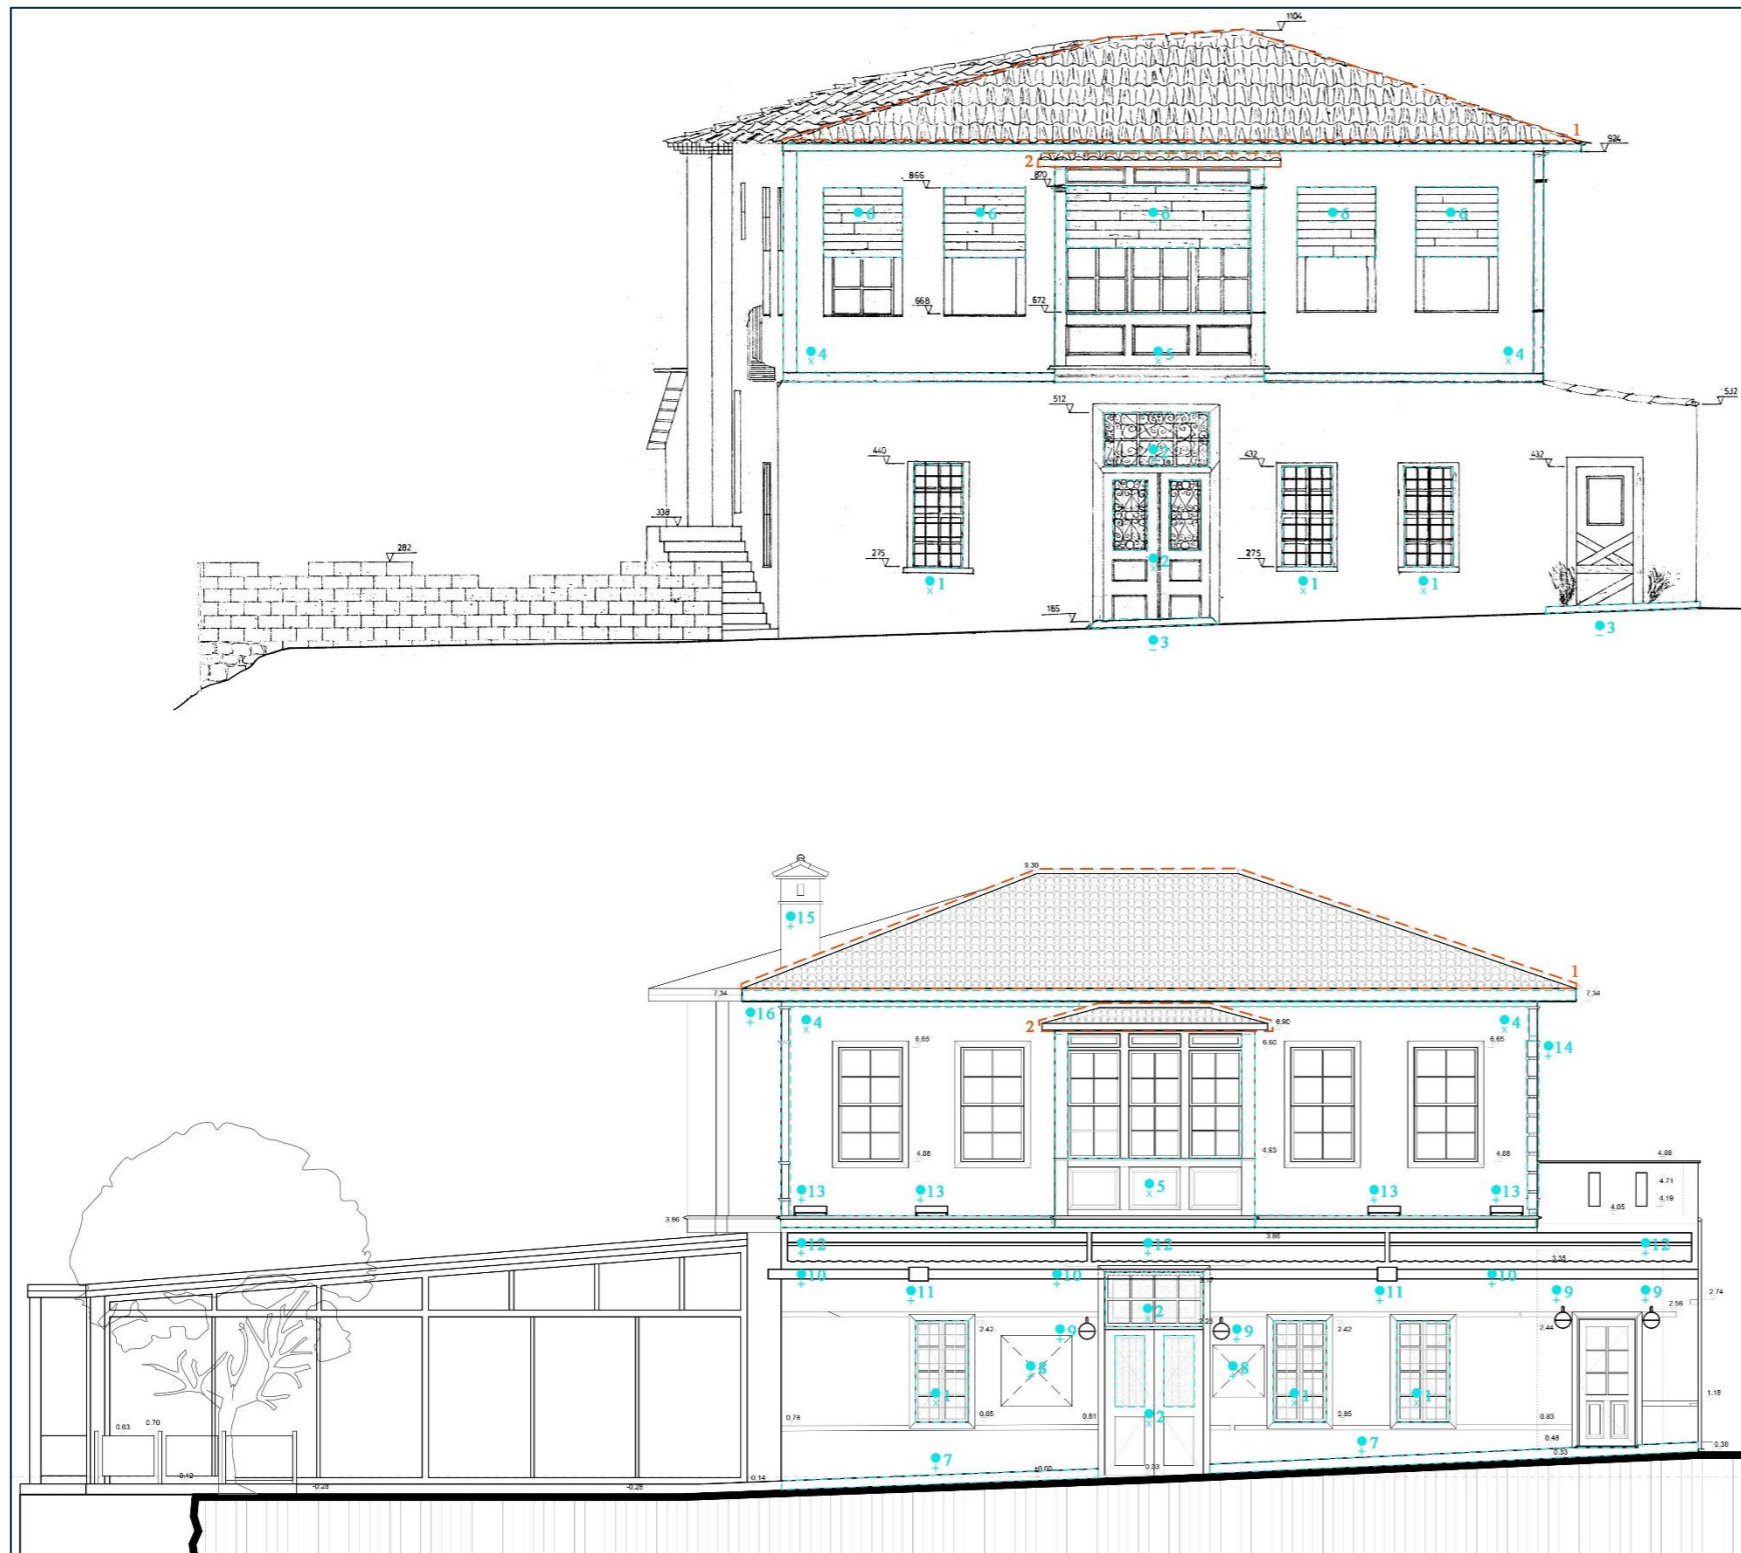
Figure 3.55. Restored (bottom) and original (top) southeast elevation intervention analysis of Building A. Prepared by the Author based on the official original and restoration drawings.

Figure 3.54. Restored first floor intervention analysis plan of Building A. Prepared by the Author	139
Figure 3.55. Restored (bottom) and original (top) southeast elevation intervention analysis of Building A. Prepared by the Author based on the official original and restoration drawings	140
Figure 3.56. Restored (bottom) and original (top) northeast elevation intervention analysis of Building A. Prepared by the Author based on the official original and restoration drawings	140
Figure 3.57. Restored (bottom) and original (top) southwest elevation intervention analysis of Building A. Prepared by the Author based on the official original and restoration drawings	141
Figure 3.58. Building A leveled and tiled flooring in direct relation with the street. Taken by the Author	142
Figure 3.59. Building A before the major conservation interventions to its main mass. Retrieved from google earth photo archive	143

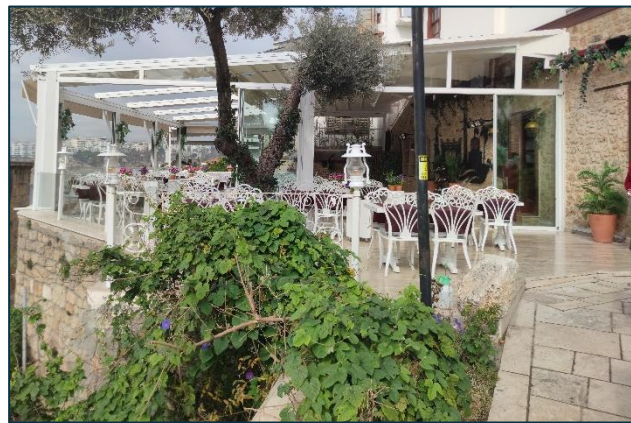
(5) Changing the topography of the courtyard from its original sloped nature and filling it to a straight height which is level with the street and the building. This change affected the relationship between the house and street to the courtyard in terms of accessibility and interaction in addition to the visual relation of the courtyard with the surrounding lots. The courtyard could now be directly accessed from the street due to the removal of the wall and the ground levelling.

Figure 3.58. Building A leveled and tiled flooring in direct relation with the street. Taken by the Author.

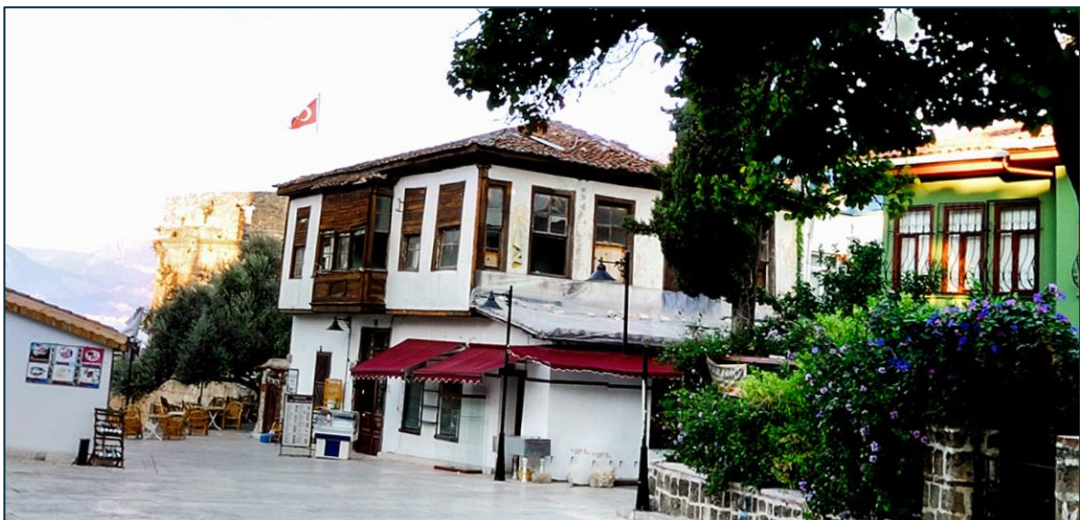
Figure 3.59. Building A before the major conservation interventions to its main mass. Retrieved from google earth photo archive.

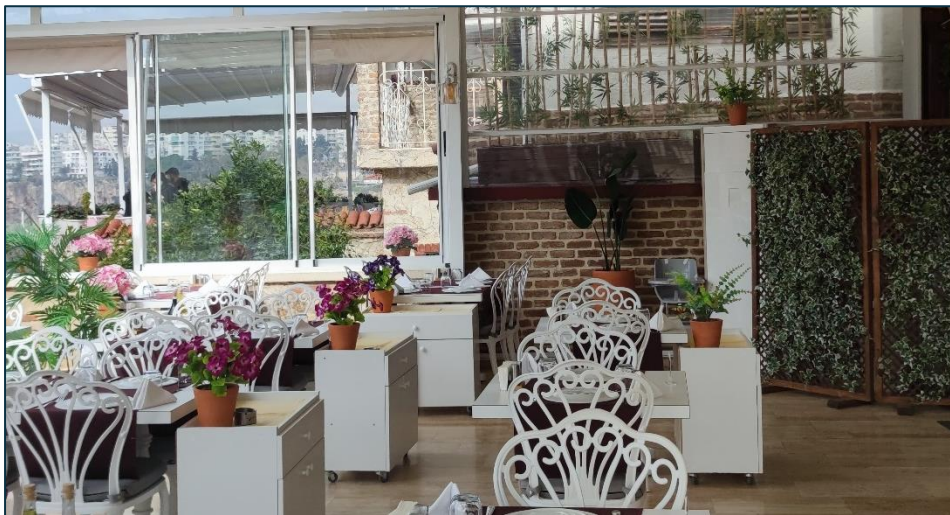
(11) Addition of a low height red brick wall as a back separator between the courtyard and the neighboring lot. This addition replaces the removed high stone wall and uses brick building techniques that are foreign to this area with properties that are not compatible with the intended usage. In addition, the added wall is not meant for privacy but for lining the lot limit which is diminishing to the original intended purpose of the lot wall.

Figure 3.60. Courtyard added brick wall. Taken by the Author.

Figure 3.60. Courtyard added brick wall. Taken by the Author	144
Figure 3.61. Courtyard added low parapet and glass railing. Taken by the Author	145
Figure 3.62. Displaced trees within the courtyard. Taken by the Author	145
Figure 3.63. Added mass at the side of Building A within the courtyard. Taken by the Author	146
Figure 3.64. Added porch on top of the shop area. Taken by the Author	147
Figure 3.65. Added interior floor tiles. Taken by the Author	148
Figure 3.66. New brick wall replacing the original stone masonry one. Taken by the Author	148
Figure 3.67. New stone and brick composite wall replacing the original stone masonry one. Taken by the Author	149
Figure 3.68. New brick minor partition. Taken by the Author	150
Figure 3.69. Maintained and cleaned exterior masonry wall. Taken by the Author	150
Figure 3.70. Partially reconstructed masonry wall. Taken by the Author	151
Figure 3.71. Extensively repaired timber exterior wall. Taken by the Author	153

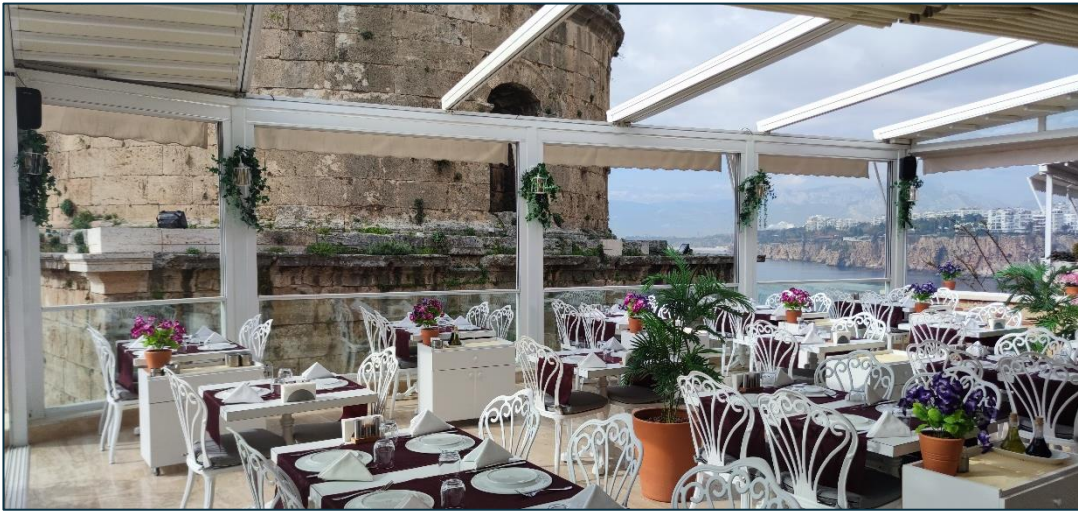
(12) Addition of a new low parapet along the edges of the lot with new techniques and materials compatible with the added floor tiles.

(13) Addition of metal and glass railing above the parapet as a barrier between the courtyard and neighboring steep slope.

Figure 3.61. Courtyard added low parapet and glass railing. Taken by the Author.

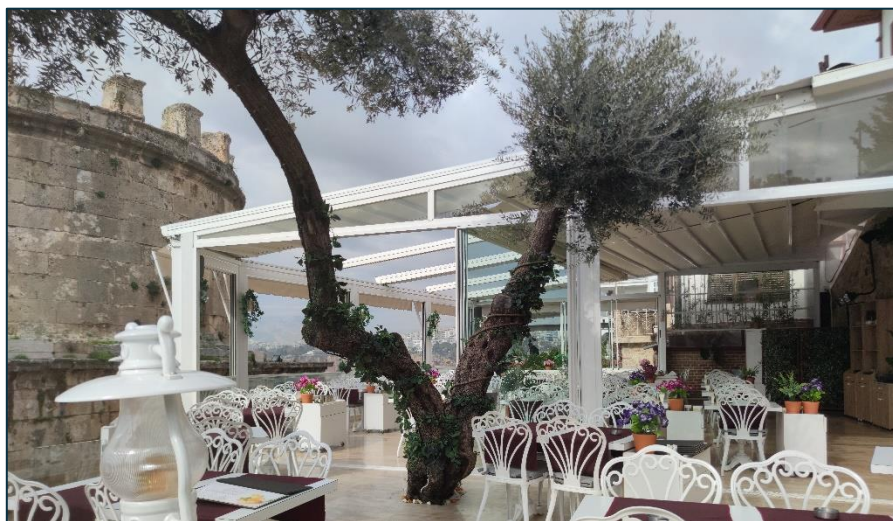
(9) Displacement of the original trees from their original location to another within the lot.

Figure 3.62. Displaced trees within the courtyard. Taken by the Author.

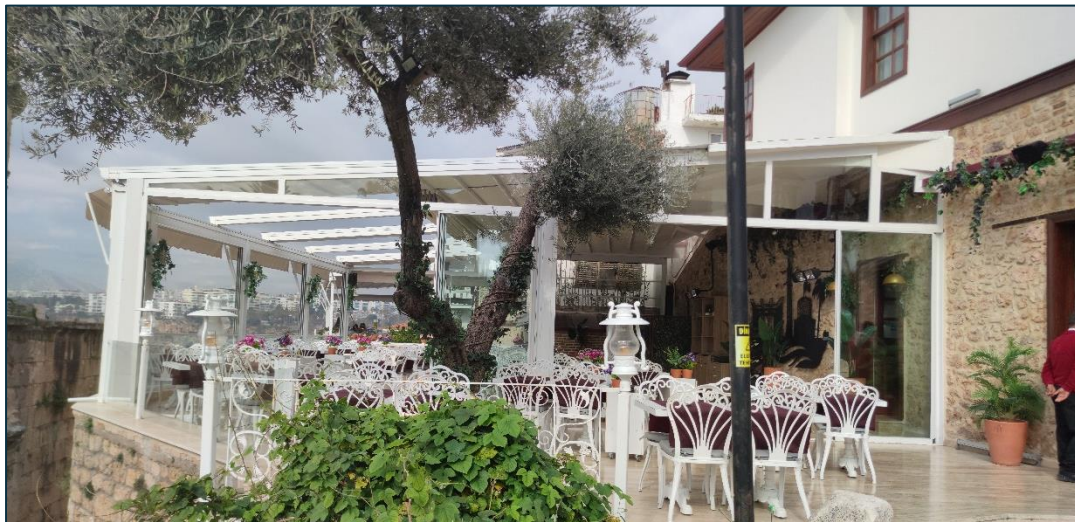
(2) Addition of a large metal and glass construction space attached to the side of the building. The addition is clearly seen from the main street and covers up parts of the ground floor façade of the building. It is erected as a shelter for the outdoor area with a retractable roof. It is a lightweight structure with a sloped roof and a large footprint that covers around 70 percent of the open courtyard and is directly accessible from the street without the need to enter the building first. This mass facilitates the changed function of the building by providing a sheltered space for the outdoor area turned café.

Figure 3.63. Added mass at the side of Building A within the courtyard. Taken by the Author.

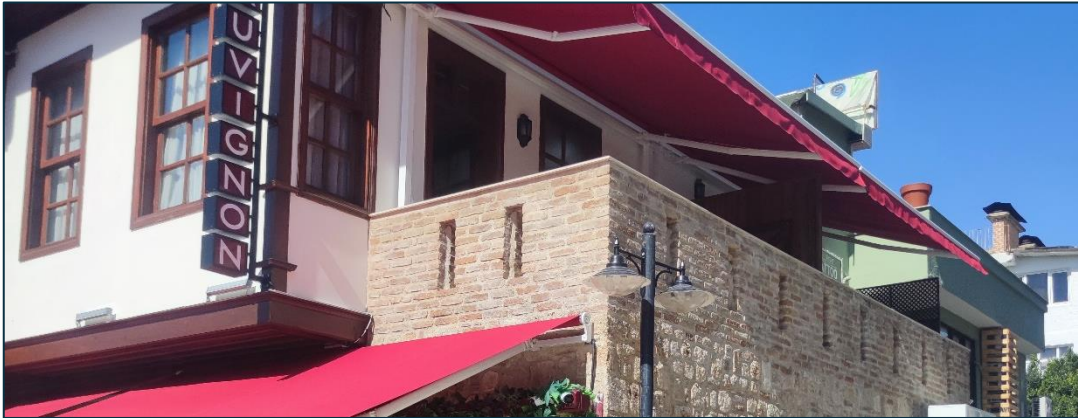
(3) Addition of a porch on top of the shop area attached to the side of the building along the entire Northeast Elevation. This porch is based on previous iterations of the building concluded from the building clues and earlier documentation. The material used is red brick which was not used previously in such manners and techniques. This addition provides a porch to one of the bedrooms situated on the first floor and as a covering for the previously demolished and primitively covered shop roof.

Figure 3.64. Added porch on top of the shop area. Taken by the Author.

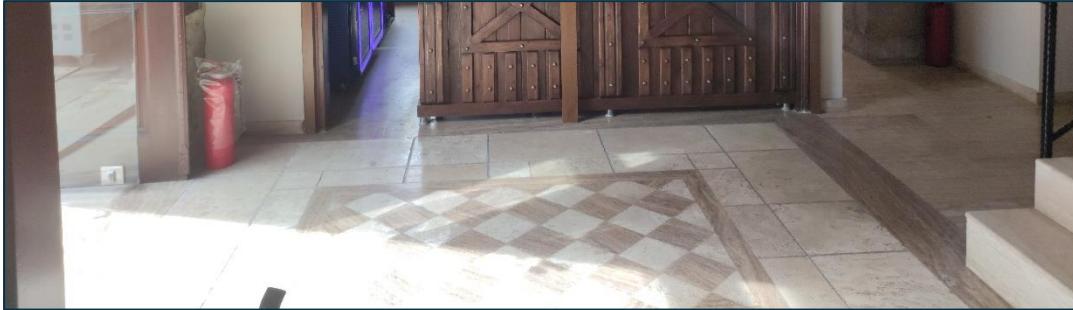
(3) Replacement of the flooring across the ground floor with new modern tiles, some containing patterns and designs, and others for service areas.

Figure 3.65. Added interior floor tiles. Taken by the Author.

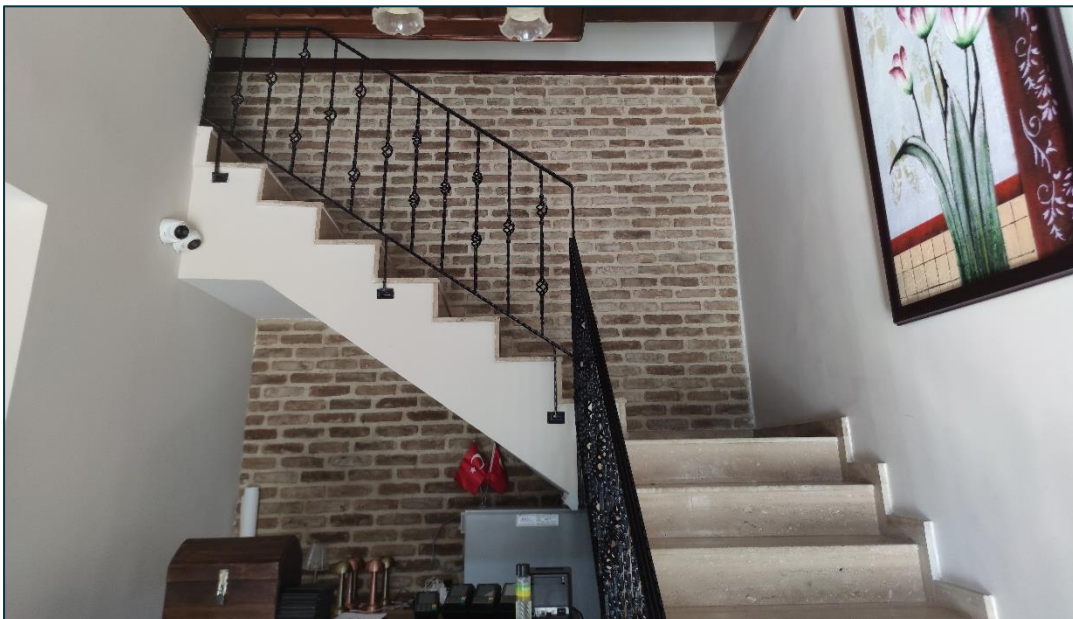
(4) Replacement of a masonry wall with a new one of different materials that extends towards the first floor and covered with bricks. The use of bricks in such techniques is not complementary with the building techniques used in these structures even if brick slates and some brick blocks were utilized in the original masonry walls mixture; the bricks were consistently to a lesser proportion than the primarily laid stones.

Figure 3.66. New brick wall replacing the original stone masonry one. Taken by the Author.

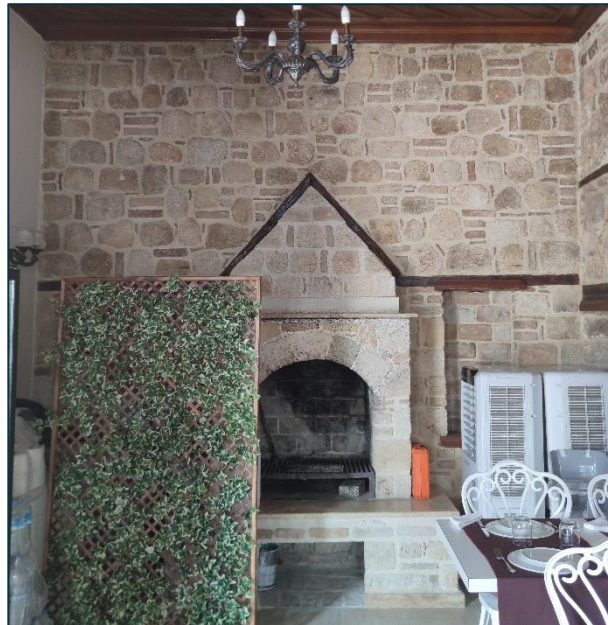
(5) Replacement of a masonry wall with a new one of similar materials, primarily cut stone and some brick blocks. The new wall shares some material properties with the original adjacent masonry walls, although some differences could be pointed out. The masonry is more smoothly cut than the original ones which are predominantly rough cut, the masonry rows are more linear and straighter than the original, the mortar joints appear newer, and brick slates are absent from the new wall. Some architectural elements like niches and a fireplace were added to this wall, previously absent from the original iteration of the structure giving it an authentic aesthetic at first glance, but with further observation the differences in construction techniques are more visible.

Figure 3.67. New stone and brick composite wall replacing the original stone masonry one. Taken by the Author.

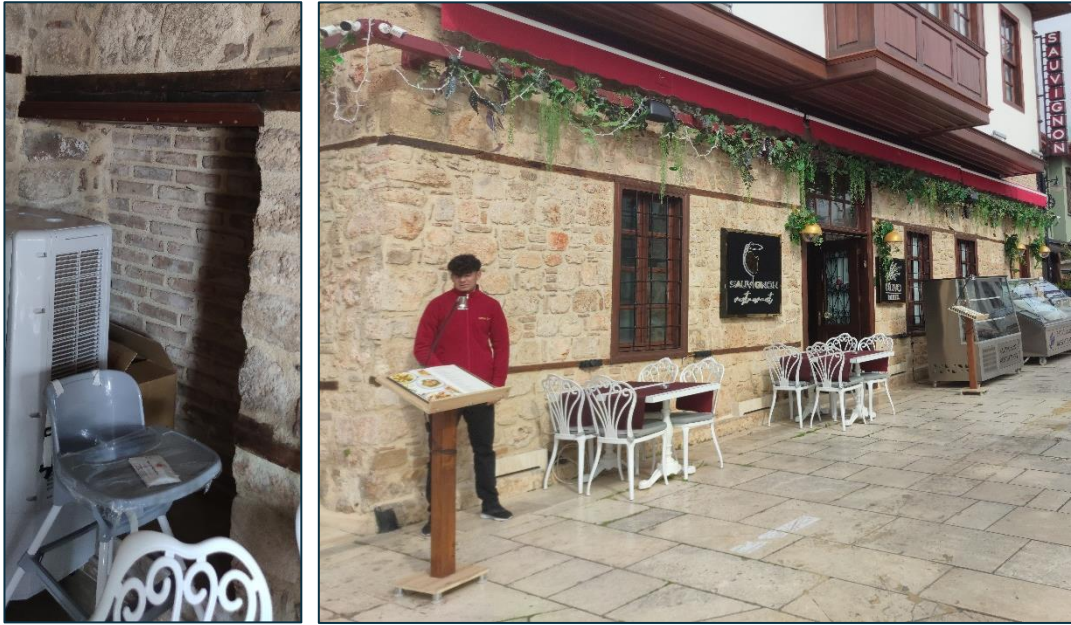
(6) Addition of a brick partition within a created opening in a masonry wall. The cavity was created by carving out a niche and an opening that was previously closed, the stones were taken out and the openings enlarged. They were then filled in with a brick construction that wouldn't be found in these types of buildings.

Figure 3.68. New brick Figure 3.69. Maintained and cleaned exterior masonry wall. Taken by minor partition. Taken by the Author.
the Author.

(7) Maintenance and cleaning of masonry exterior walls with the removal of the exterior covering layers of paint and mortar. The mortar and paint were not original due to the continuous application of these layers over time for repair. The masonry was hence exposed which isn't in line with the type of construction implemented in this building. Rough cut stone constructions are dominantly covered in Kaleiçi opposed to the fine cut masonry which are left exposed. The cleaning process removed traces of age, biological growth, and coloring on the stone, while the joints were reinforced with lime-based mortar.

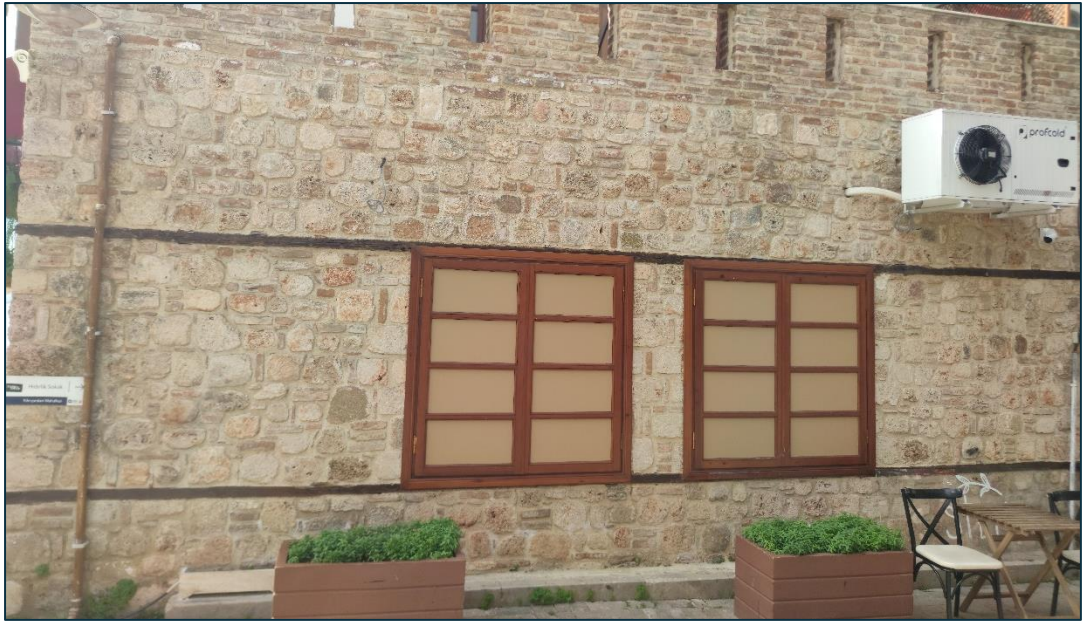
(8) Partial reconstruction of a masonry wall with similar material and techniques to the original used. Where a part of the masonry wall lost its elements and hence the space was rendered unusable, the reconstruction was required to seal the space again. Similar stones with similar binding techniques were used which makes it difficult to perceive the original portions from the later ones. Moreover, the stones were cleaned to remove traces of age, biological growth, and coloring and repaired or maintained were needed with the joints reinforced with lime-based mortar.

Figure 3.70. Partially reconstructed masonry wall. Taken by the Author.

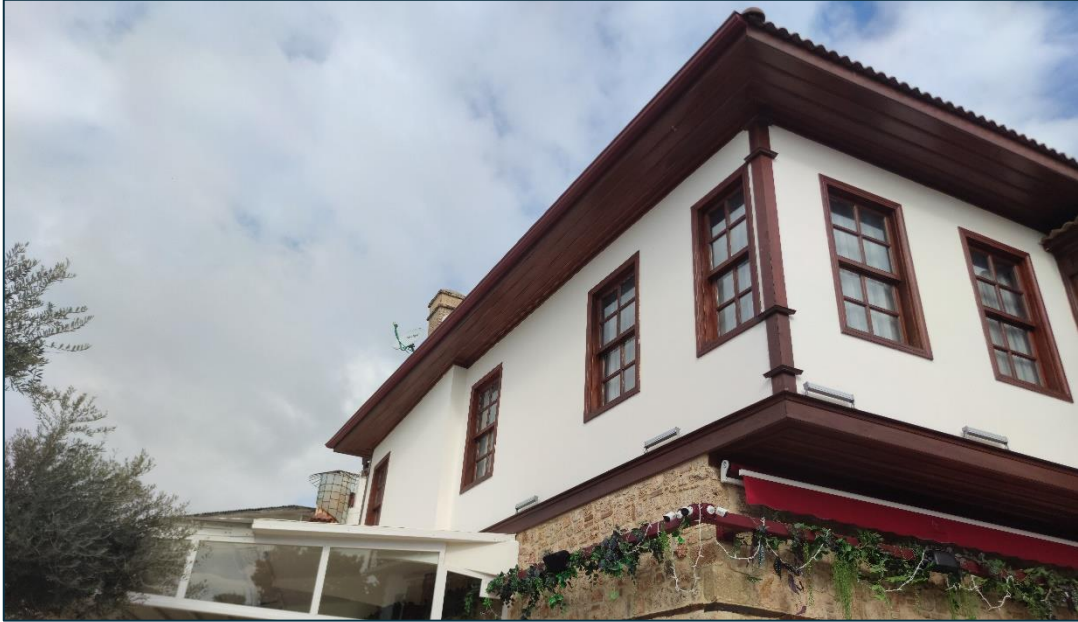
(11) Extensive repair of exterior timber walls including structural reinforcement and the partial reapplication of the bađdadi covering of thin timber slats over the main posts and infill materials. Moreover, the plaster and paint layers were reapplied.

Figure 3.71. Extensively repaired timber exterior wall. Taken by the Author.

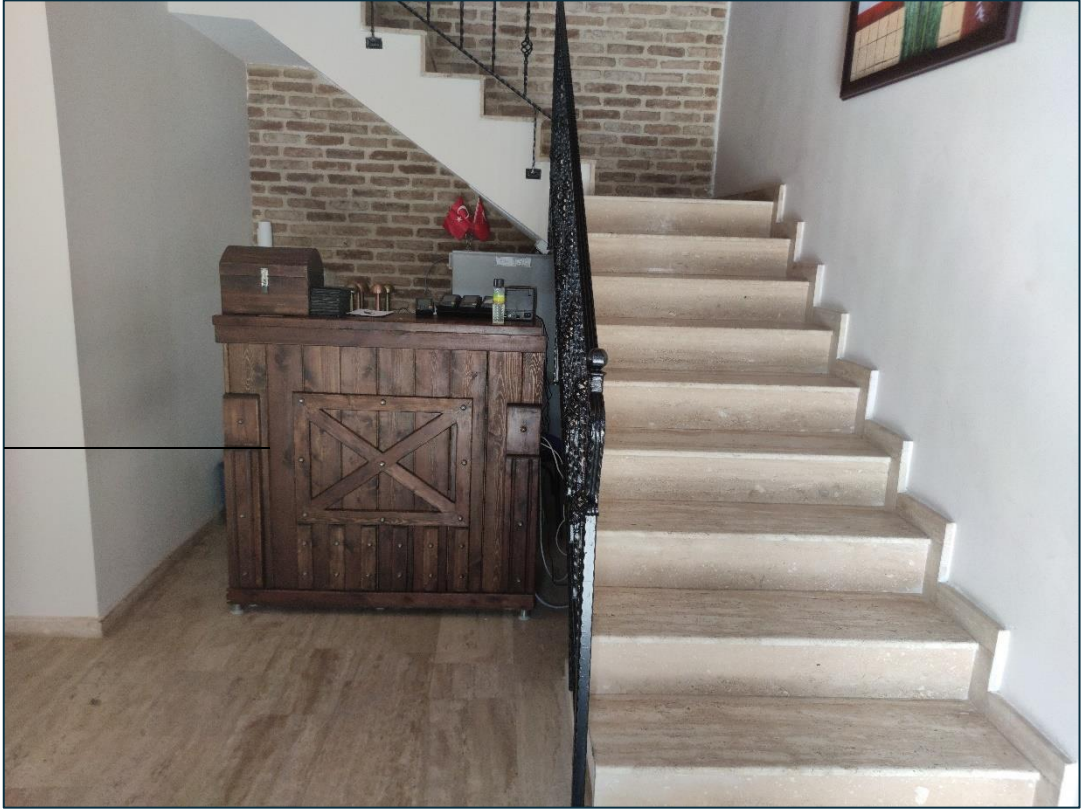
- (4) Removal of the interior timber stairs (S1) that connected the service area of the ground floor (G1) to the first-floor sofa (F1) which is a private zone.
- (5) Removal of the exterior masonry stairs (S2) that provided access from the main street directly towards the mezzanine floor then subsequently to the first floor without the need to access the selamlık zone on the ground floor. This access was important for the initial residential functioning of the building and the sociocultural values of the time.
- (7) Addition of concrete stairs (Sn1) at a different location than the initial stairs. The stairs are covered with marble tiles and connect the lobby area (A4) to the hotel rooms area on the first floor (B1).

Figure 3.72. Added concrete stairs. Taken by the Author.

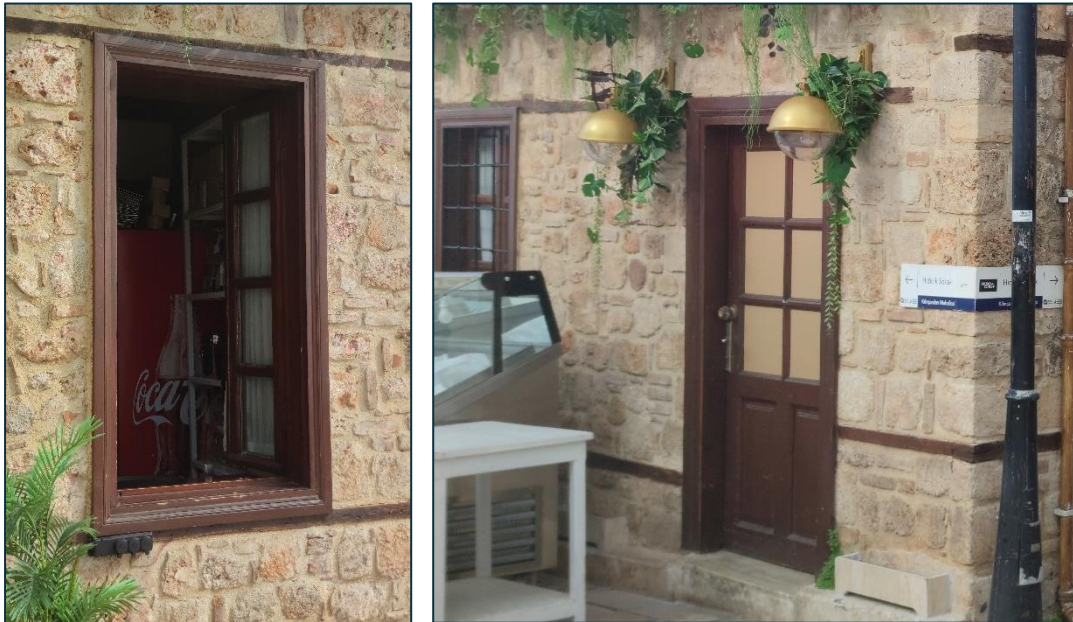
(1) Replacement of original timber windows with new ones of similar materials but different techniques. The original windows found in odas (G2) and (G3) were upward sliding timber windows, later replaced by double hinged windows found in rooms (A2) and (A3) of the post intervention ground floor plan. The added windows are timber with a veneer finish that gives them a restored or new look in line with all other restored elements. Without a study of the architectural elements in this typology of houses within Kaleiçi, the unauthentic nature of the windows wouldn't have been easily detected.

Figure 3.75. Timber window replacing an original one using unoriginal materials and techniques. Taken by the Author. Figure 3.76. Secondary door replacement using unoriginal materials and techniques. Taken by the Author.

(3) Replacement of a timber secondary door with a new one using different materials. The door providing access from the street to the shop area (G7) was replaced by a new door with a modern look and different construction technique, clearly distinguishable amidst other build elements.

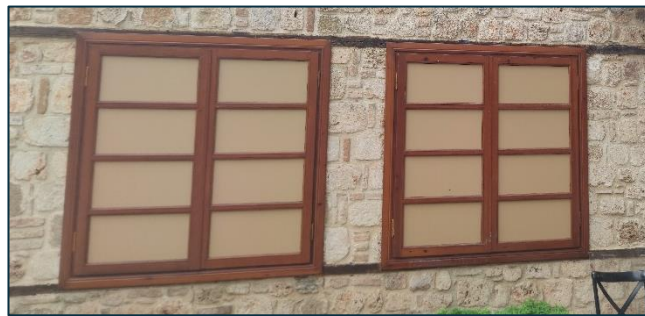
(4) Enlarging an opening, removing original architectural elements within, and installing new windows with different materials and techniques. The shop (G7) area had two small openings on its Northeast wall fitted with vertical iron bars. The bars were removed, the opening enlarged which entailed the removal of a large amount of original masonry, and new windows were fitted. The new windows seen in shop (A11) feature a modern look and construction techniques clearly distinguishable as later additions.

Figure 3.77. Enlarged opening with new materials and technique windows. Taken by the Author.

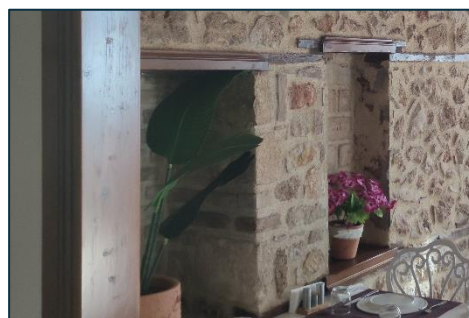
(5) Maintenance and cleaning of a niche, situated in oda (G4) inside a masonry stone wall, so that all signs of age, biological growth, and coloring are removed. With the change in the function of the building the niches lose their intended function and take on a new role within the oda (A2) of the post intervention ground floor plan.

Figure 3.78. Maintained and cleaned niche (right) and dismantled then rebuilt niche with new interior materials (left). Taken by the Author.

(6) The dismantling of a niche and rebuilding with different materials and techniques. The niche situated in a masonry wall, in oda (G2), was dismantled with the stones taken out and a hole spanning the entire depth of the wall was established. The edges were cleaned returning the stones to a pristine condition and the hole was filled with a brick partition establishing a niche like element that bears little resemblance to the original inside oda (A2) of the post intervention plan.

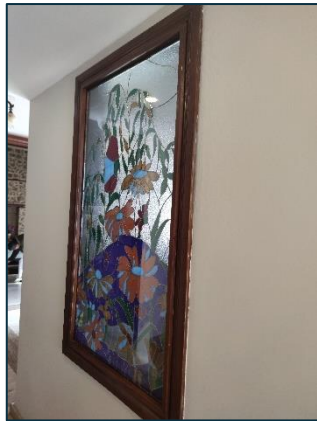
(10) Replacement of an original interior window with another one featuring different materials and building techniques. Moreover, the element was displaced from its original location into another farther right within the same wall. The original window and the new one are found on the northern wall of oda (G3) of the original plans and oda (A3) of the post intervention plan respectively. It could be seen how the wall was moved so it could align with the cistern (element 17) and thus creating a new experience within the narrow corridor like space. Moreover, the window was changed from being see-through to being encrusted with colored glass portraying an array of flowers. Without thorough research into previous documentation, this alignment of the window with the cistern seems originally intended, for it creates a visual dynamism within the small corridor area.

Figure 3.79. Window new replacement at a different location. Taken by the Author.

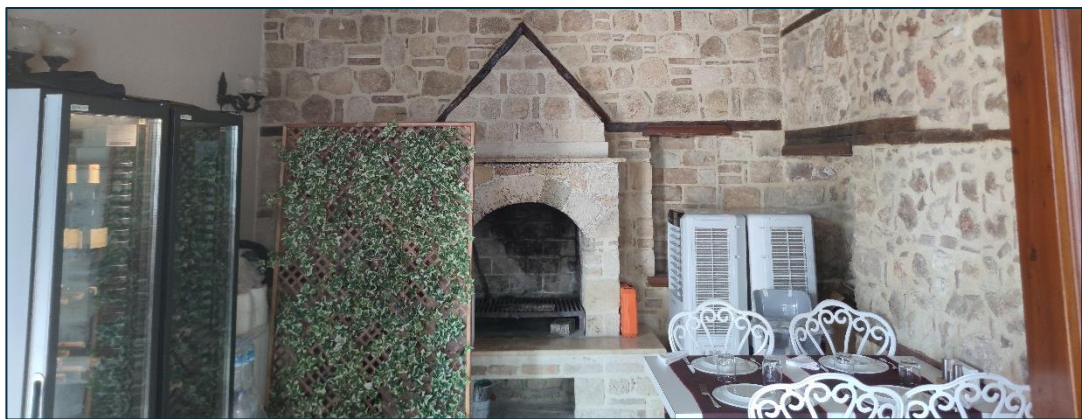
(18) Addition of niches within an added wall (Structure element 5) in oda (A2) on both sides of a centrally added fireplace to form an arrangement that is widespread throughout ottoman houses, just not the Antalya, Kaleiçi typology. Hence this addition introduces an architectural feature that is not used in the area and might portray an unauthentic image of the region's architecture.

(19) Addition of a fireplace at a central location in a wall within oda (A2), where no earlier fireplaces were found at this wall or in this zone.

Figure 3.81. Added architectural elements (niches and fireplace). Taken by the Author.

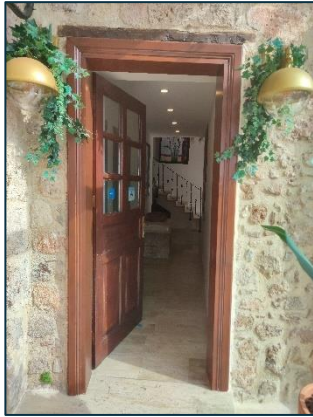
(20) Addition of a door connecting the interior corridor (A5) to the exterior garden (A8). Portions of the masonry wall needed to be taken out in order to make space for the door. The door is timber with a wood veneer covering, which is compatible with other timber elements hence forsaking the possibility of intuitively knowing that the door is a new addition.

Figure 3.82. Added architectural elements (door). Taken by the Author.

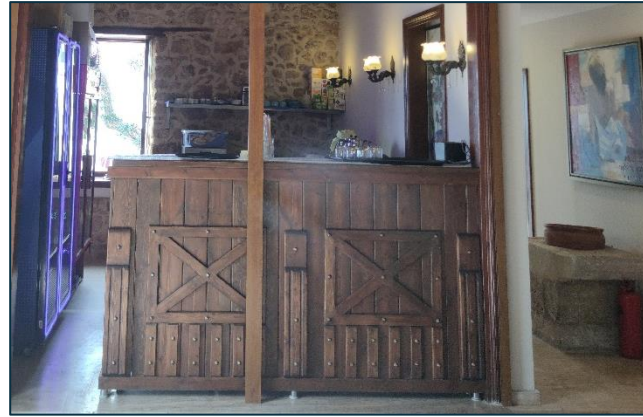
Figure 3.83. Added architectural elements (counter). Taken by the Author.

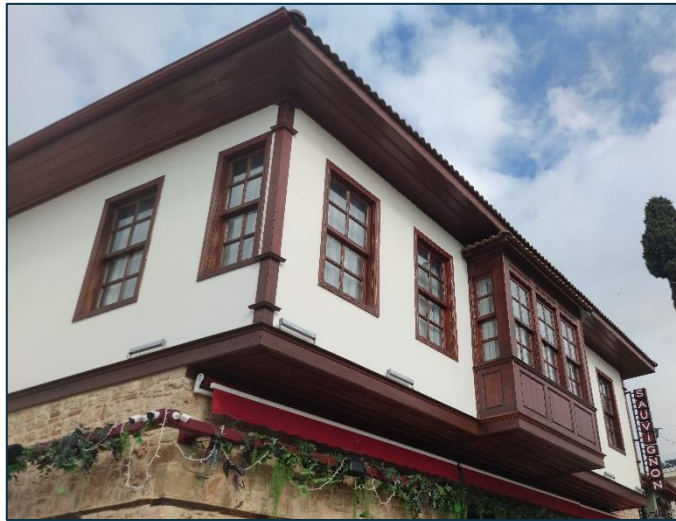
(13) Replacement of the timber windows with new ones using similar materials and techniques. The windows are placed within the timber extruded structure in oda (F4), and visible from the Southeast main elevation. The windows were taken out and replaced with new ones of the same materials and upwards sliding opening method. The new windows were nevertheless of a slightly different dimension as evident by the documentation and restoration drawings. The windows were coated with wood veneer for a finished restored look, complementary with the other timber architectural elements.

Figure 3.84. Timber windows replacement using the original techniques. Taken by the Author.

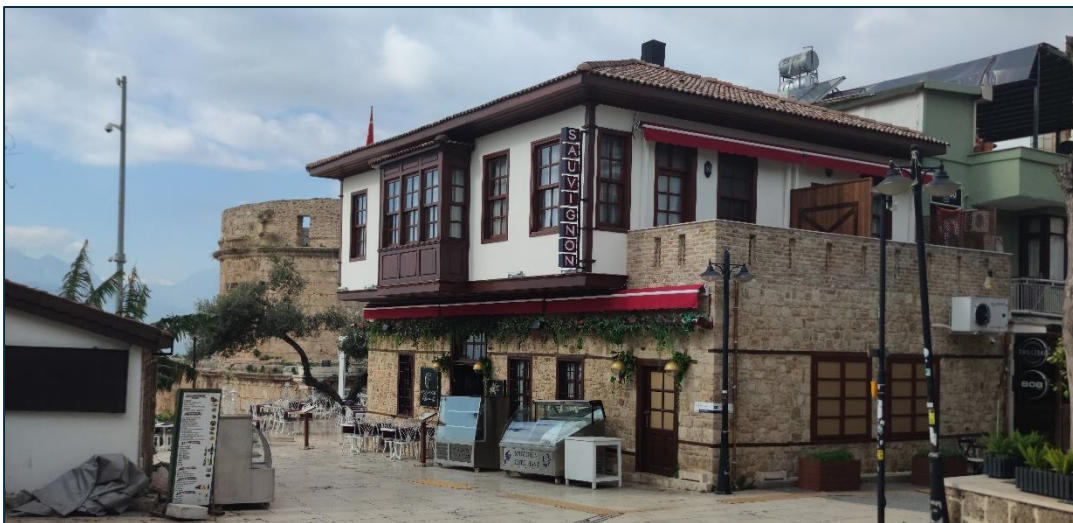
- (3) Removal of door threshold which creates a stoppage level between the street and the building entrances.
- (4) Modification of timber frames that surround the first-floor walls. The modification entails the repair of the timber frames from previous damage, then the addition of some architectural details that aren't originally present. The element is coated with a wood veneer for protection and a restored aesthetic.

- (5) Extensive repair of the timber oda projection which includes the structural repair of the main posts and beams, the reconstruction of the timber front and side lower partitions, and the coating of the wood with a protective veneer giving a restored aesthetic.

Figure 3.86. Building A facades showing the timber frames and the timber projection. Taken by the Author.

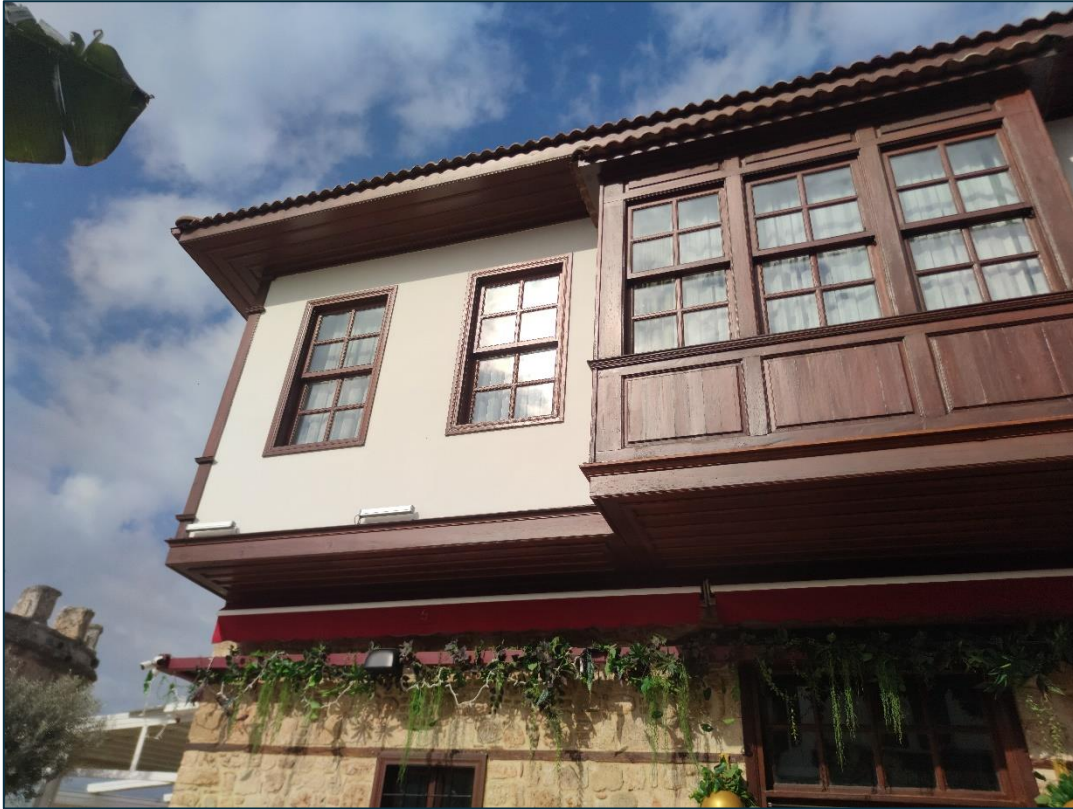
Figure 3.87. Façade additions. Taken by the Author.

(21) Addition of timber frames surrounding the first-floor walls. These frames were not originally installed at the southwest elevation; however, they were added to unify the style established at the main elevation. The timber was coated with wood veneer for protection and style unity.

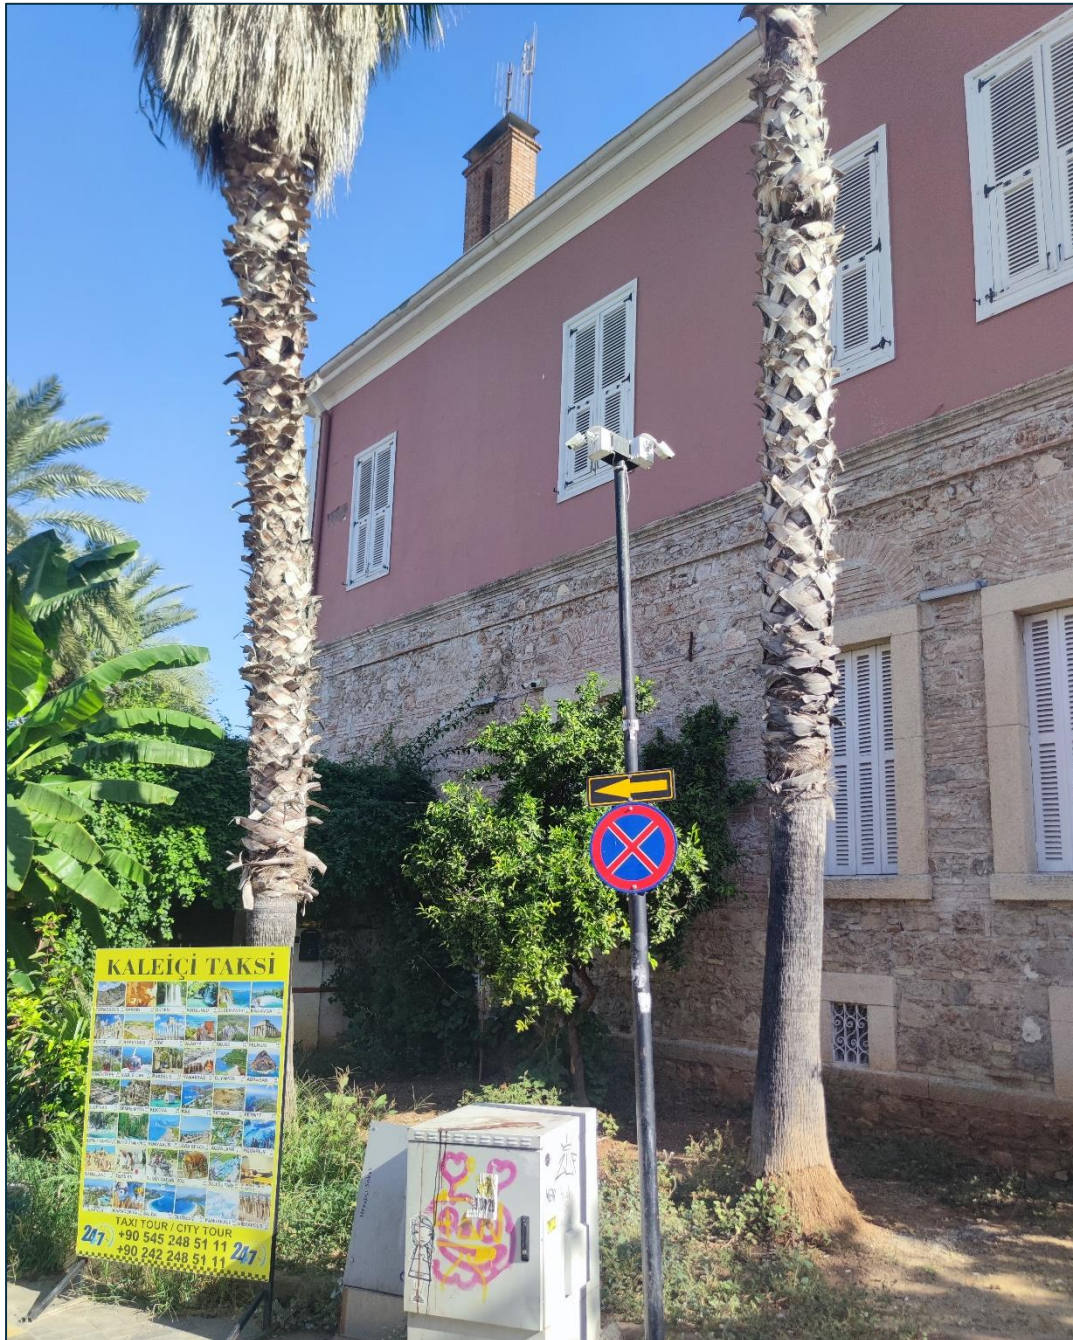
Within the lot of building B it is noticed that new natural elements predominantly trees have been planted. These trees were not part of the original lot organization and hence are considered as a new addition to the component.

Figure 3.90. Planted trees within the lot of Building B. Taken by the Author.

LA3: Addition of a tree – This type of intervention was observed in Building B where new elements were added to the courtyard to add the density of the natural elements.

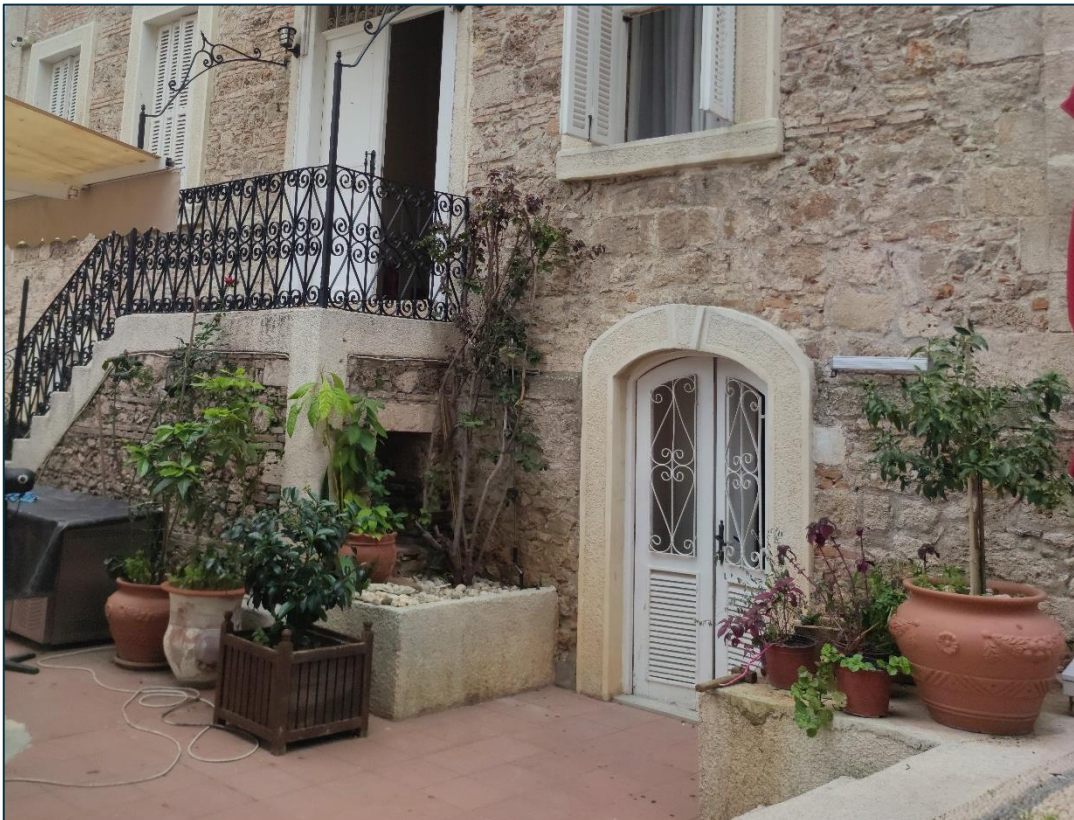
The first new intervention within building B regarding the structural component is seen within the basement of the building. Most of the buildings in Kaleiçi do not have deep basements with the space to facilitate functions. In building B though this type of cellar basement exists, and it has been rehabilitated into a spa area. This change was made possible through the alteration of the masonry thick foundation walls. Alteration of these walls entailed the addition of openings when there were previously none, doors or passageways were hence installed to enable movement between the different basement compartments.

Figure 3.91. Added doorway within the previously closed masonry wall in Building B. Taken by the Author.
