A FRAMEWORK FOR IDENTIFYING POST-INTERVENTION VALUE SHIFT
IN HERITAGE RESIDENTIAL BUILDINGS: THE CASE OF ANTALYA,
KALEIÇI IN TURKEY

A THESIS SUBMITTED TO
THE GRADUATE SCHOOL OF NATURAL AND APPLIED SCIENCES
OF
MIDDLE EAST TECHNICAL UNIVERSITY

IN PARTIAL FULFILLMENT OF THE REQUIREMENTS
FOR
THE DEGREE OF MASTER OF ARCHITECTURE
IN
CONSERVATION OF CULTURAL HERITAGE IN ARCHITECTURE

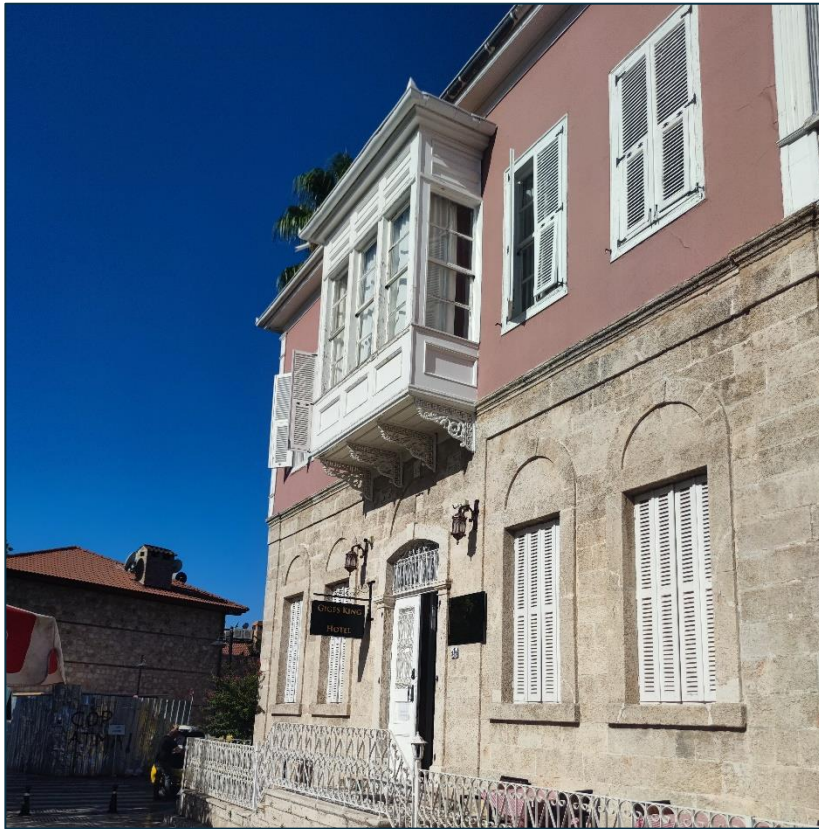
The second structural intervention exclusive to this typology of houses is the maintenance of the exterior fine cut masonry wall. Since this from elevation wall was originally constructed in this fashion, the stones were always exposed. Very minimal repair is needed for said construction due to the periodic maintenance of the stones and the geometric fashion of their execution. The stones were not as harshly cleaned as seen in other examples and hence maintenance is the clear intervention type applied to this masonry wall.

Figure 3.94. Perspective 1 of the entrance elevation of Building B. Taken by the Author.

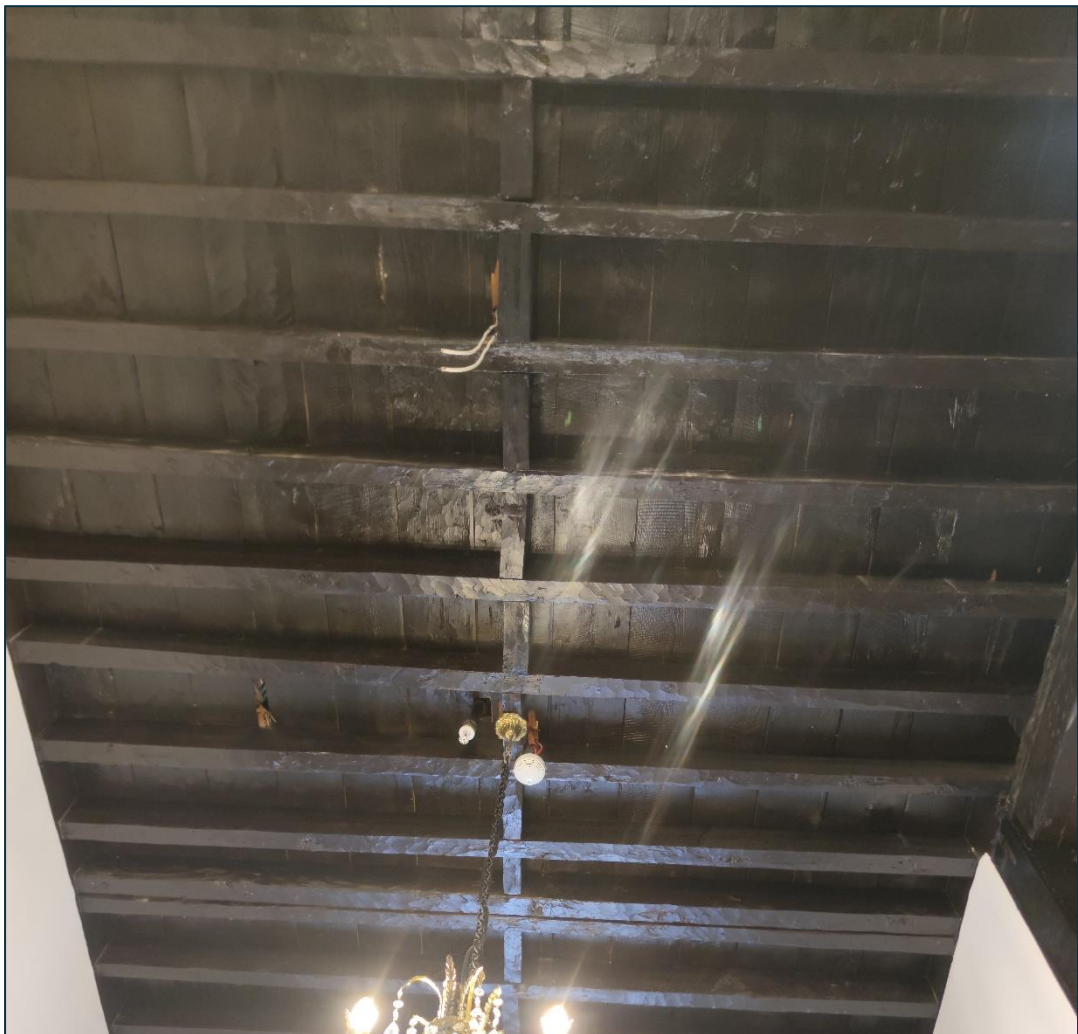
Floor planks and beams are a clear part of the building structural component and are showcased in Building C. The timber parts were repaired then painted with a wood veneer coating for protection and a restored aesthetic.

Figure 3.96. Ceiling structure and planks in Building C. Taken by the Author.

S12: Repair of timber floor beams and planks – Examined in building C, this intervention entails the repair of the timber floor (ceiling) structure and covering materials. The repair ensures structural integrity, and the timber elements are coated in wood veneer for protection and a restored aesthetic.

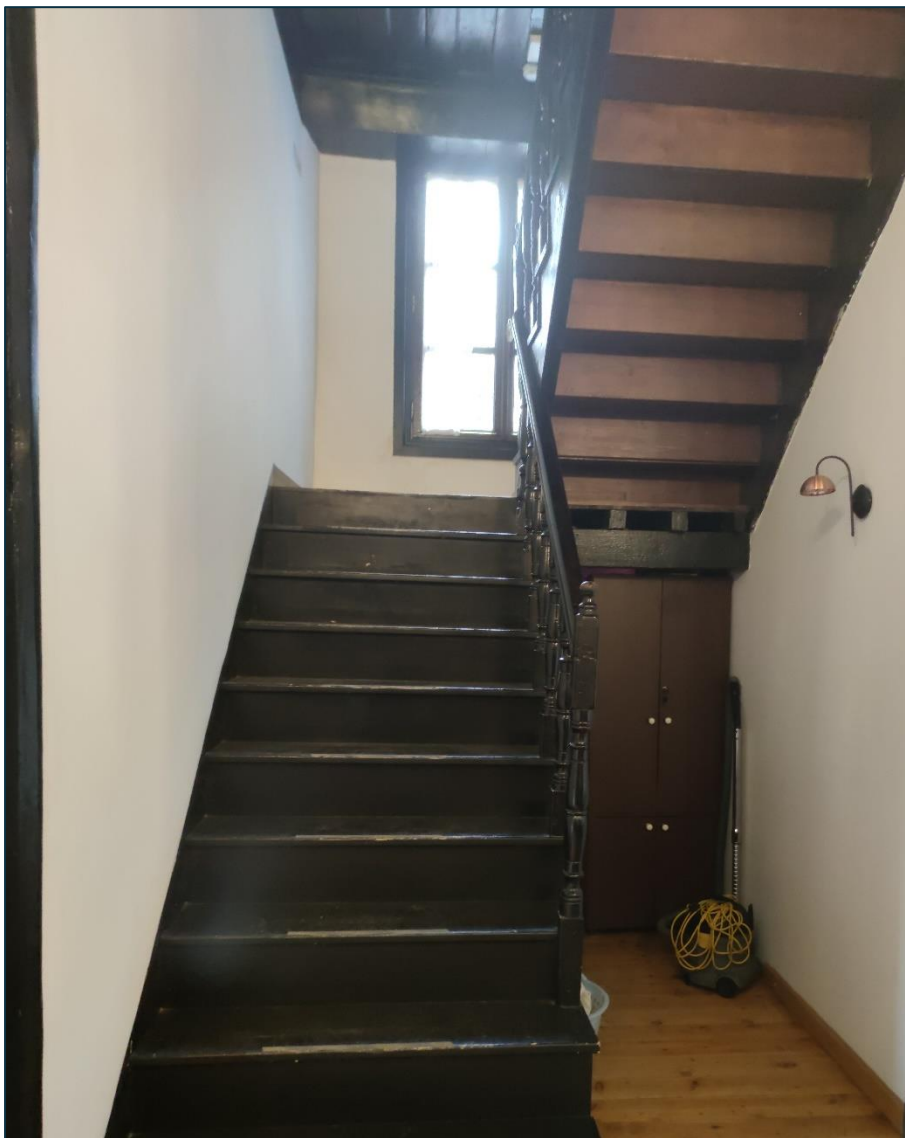
Building B showcased the repair of many of its original elements instead of removing them and adding new ones at the same or different location. For the most part the general layout of this building was used as is without the relocation of its elements. The stairs are one of those elements where it was reused; the surface planks were repaired, the structural aspects consolidated, and the entire timber elements coated with wood veneer for protection and the restored aesthetic.

Figure 3.97. Timber stair in Building C. Taken by the Author.

V2: Repair of stairs – Seen in building C where the stairs were not removed and new ones weren't added, the original one was simply repaired to ensure proper functioning and structural strength. The timber stairs were then covered with wood veneer for protection and a restored aesthetic.

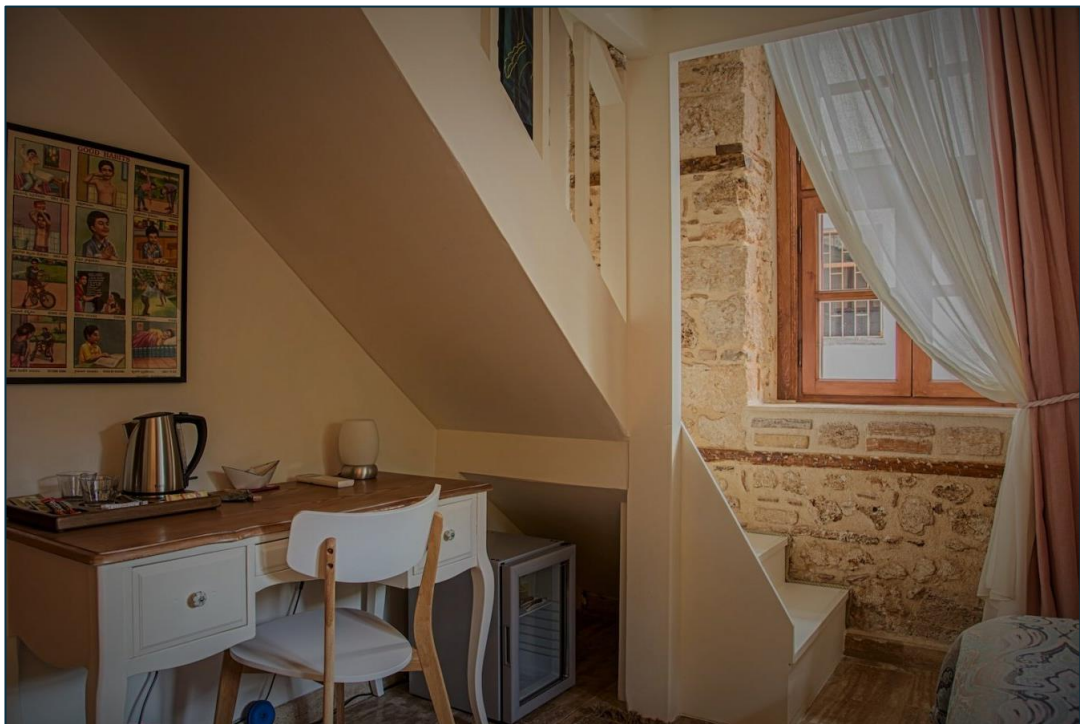
Figure 3.102. Stairs of the timber addition in Building D. Retrieved on 2/02/2024 from <http://palmhouse17.com/>

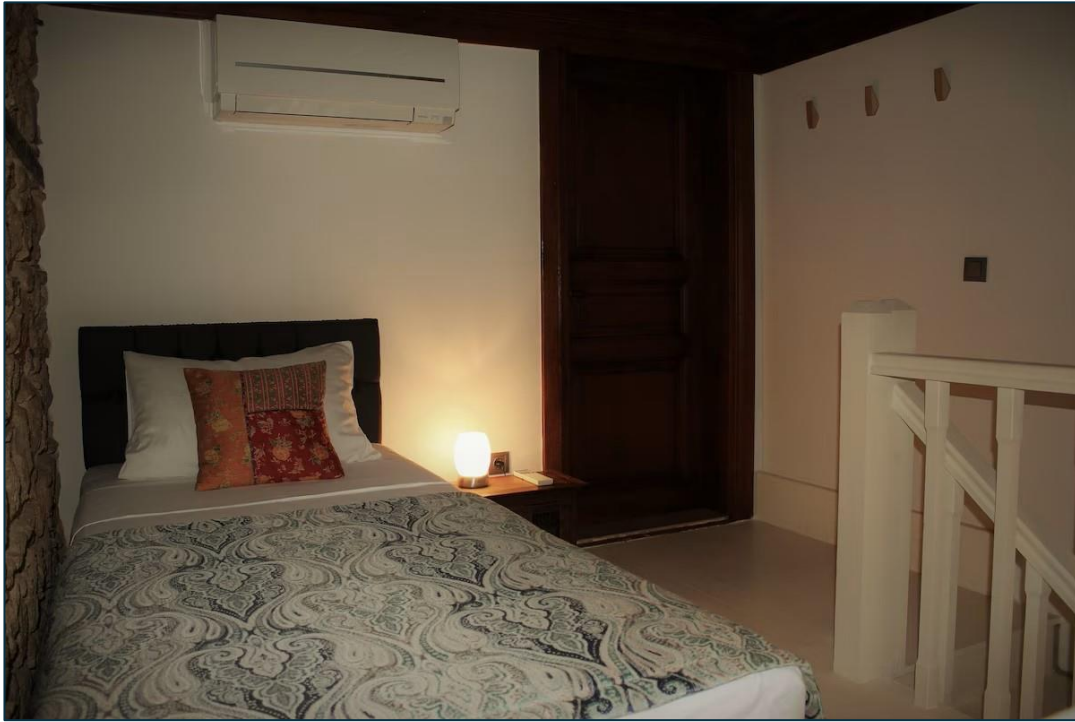
Figure 3.103. Timber mezzanine addition in Building D. Retrieved on 2/02/2024 from <https://tr.hotels.com/ho608497408/palm-house-17-oriental-misafir-evi-antalya-turkiye/>

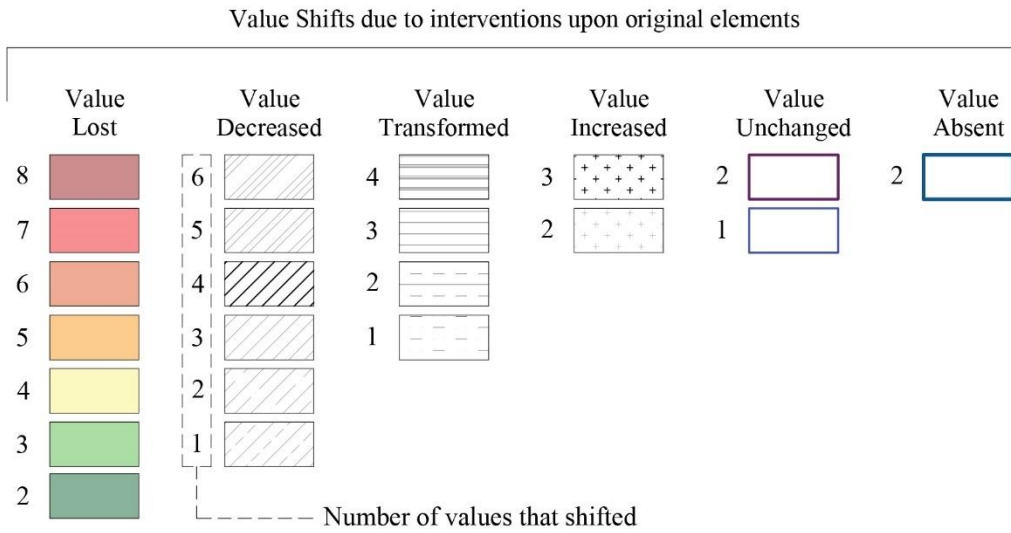
Value Shifts due to completely new additions upon the Lot, Mass, Structure, Plan, and Facade components

Figure 4.1. Value shift and state analysis key. Prepared by the Author.

To realize these **value shifts upon the components**, an element study is made using the plans and elevations of Building A in order to correlate the intervention type upon that element with the value shift perceived due to that intervention. The value shifts are categorized according to: Increased, Decreased, Lost, and Transformed, whereas other value states like Unchanged and Abscent are also observed. The drawings' key represents a system that correlates different hatches with the number of values that changed within an element as a response to the intervention. Hence with the overlapping of the hatches the number of values that were increased, decreased, lost, transformed, unchanged, or are abscent could be determined; with the set total number of values within every element being 8. The values as stated are the Age value, Documentary, Architectural., Technical, Integrity, Aesthetic, Memory, and Identity. Each hatched element is assigned an intervention type code that can be related to the intervention magnitudes table. Finally, through the post-intervention value shift table each intervention type is matched with its value shift in accordance with the drawings' illustrations.

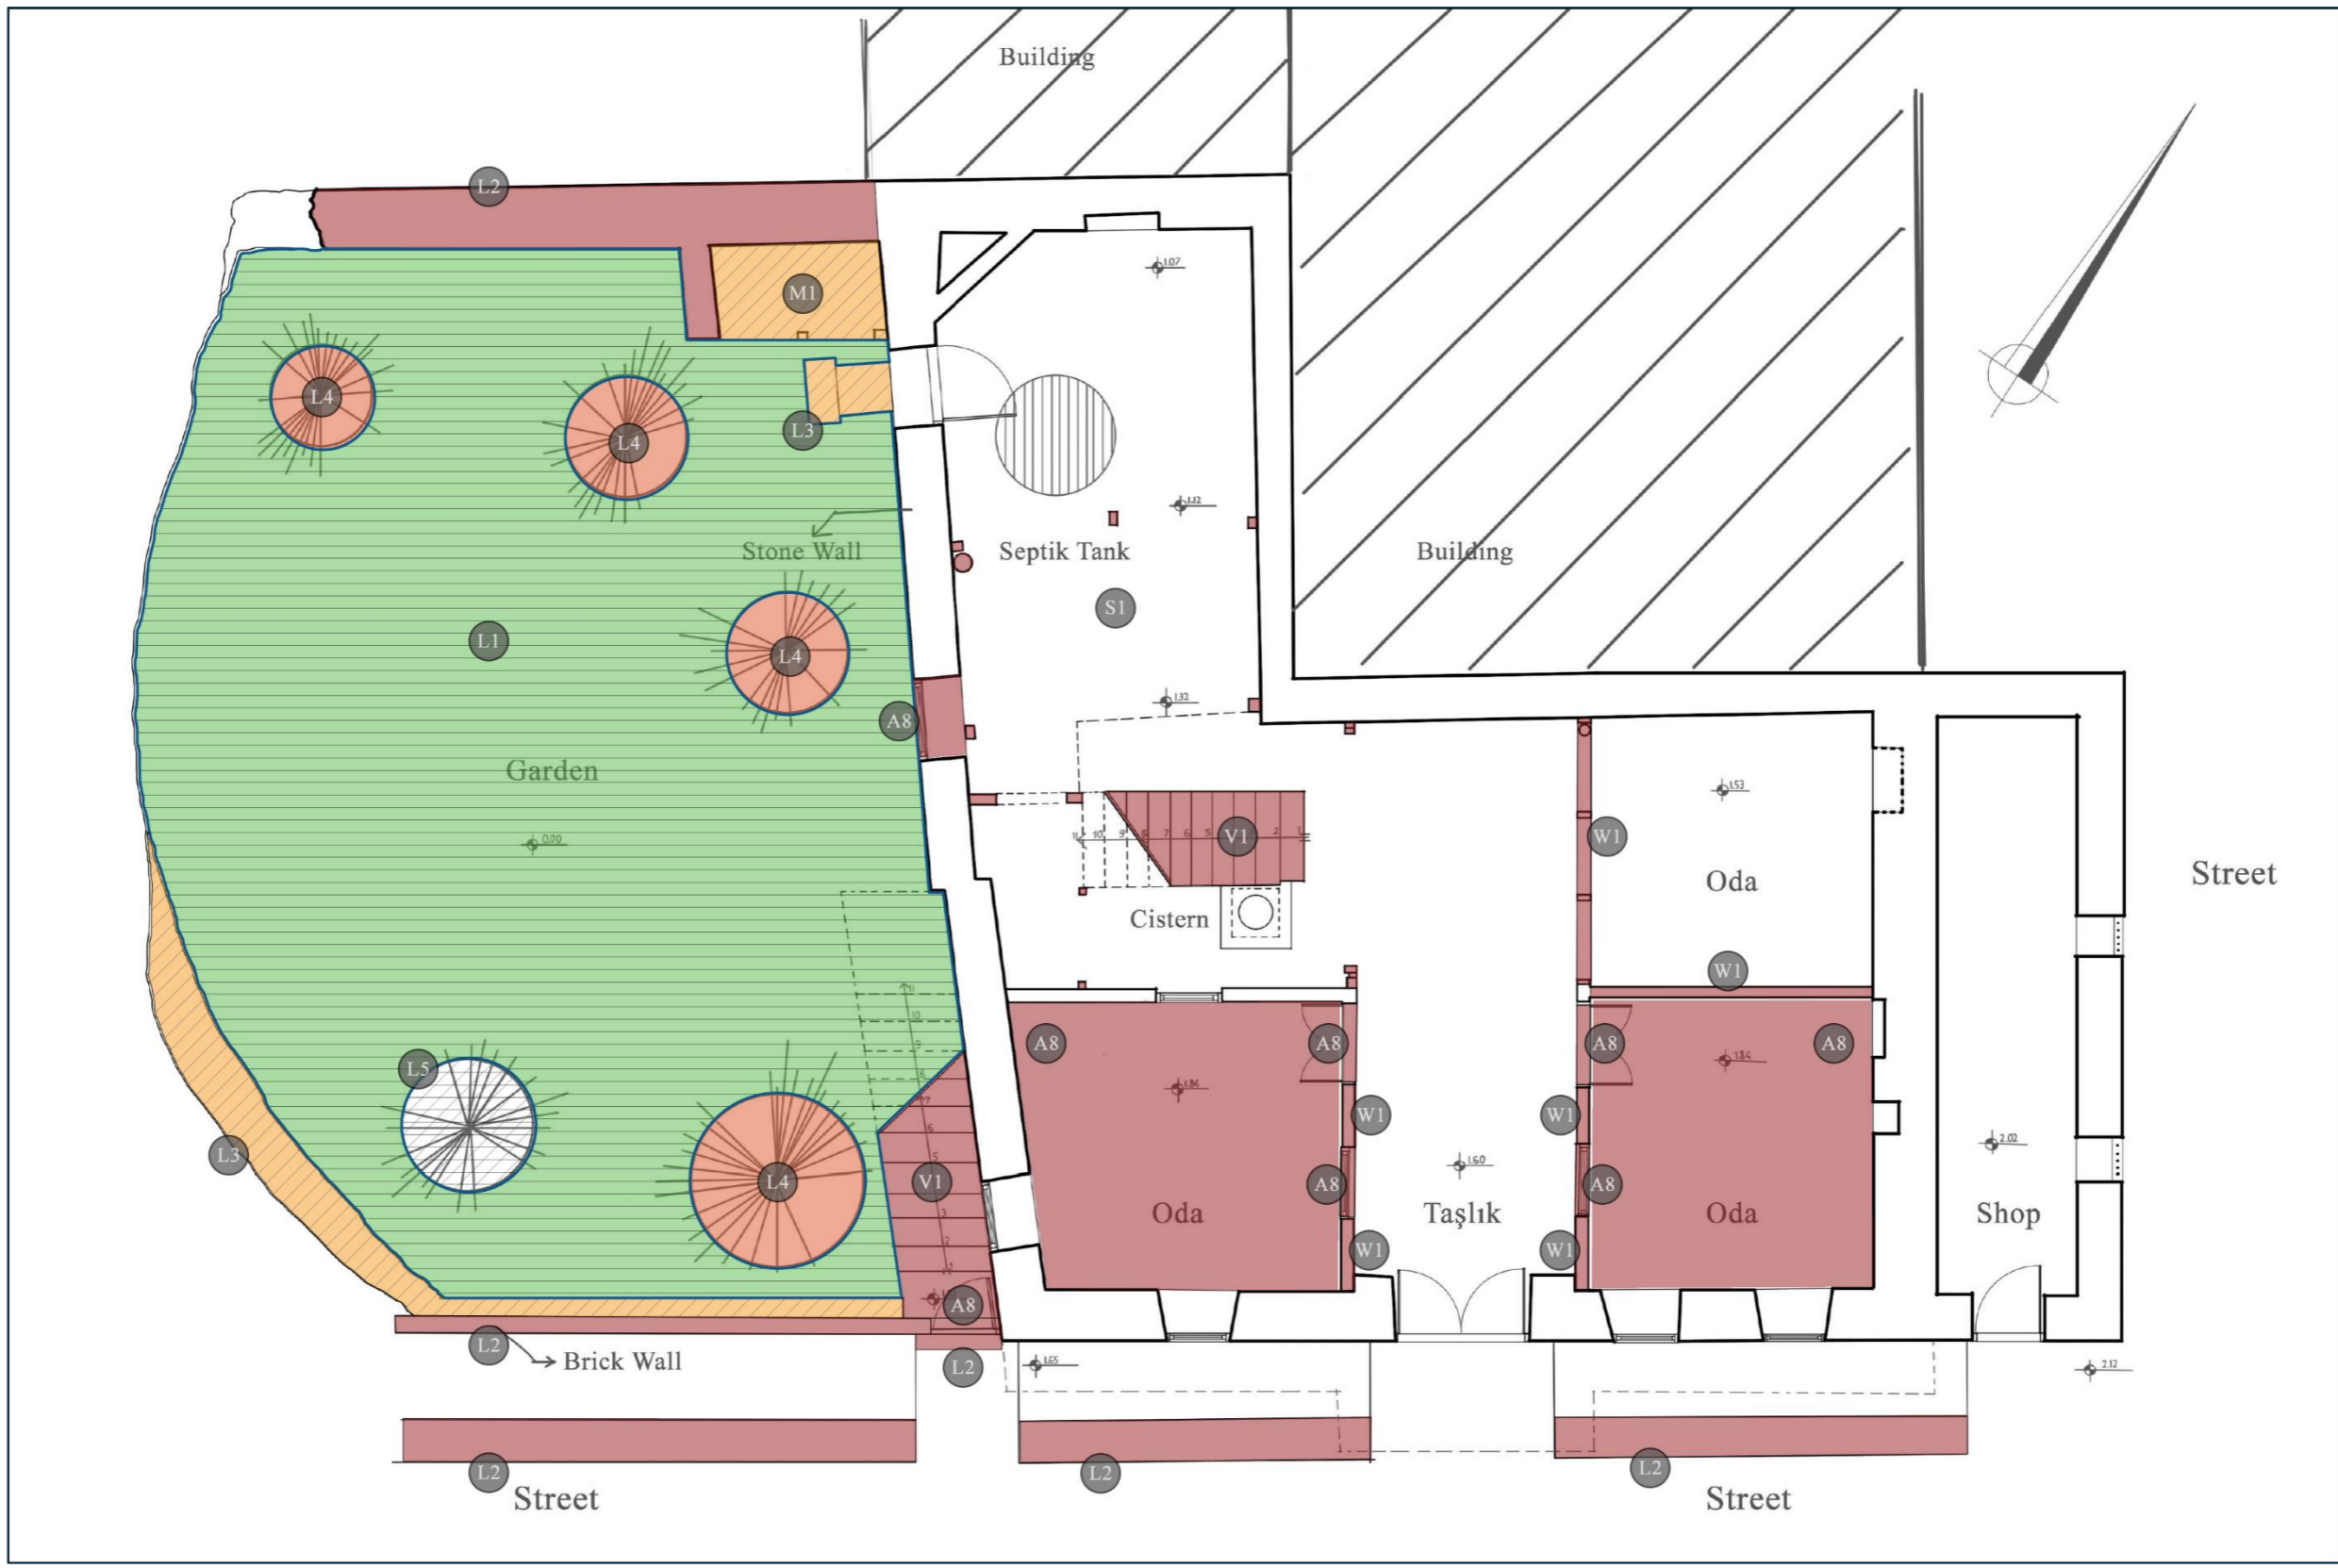
Figure 4.2. Original ground floor plan value shift analysis. Prepared by the Author.

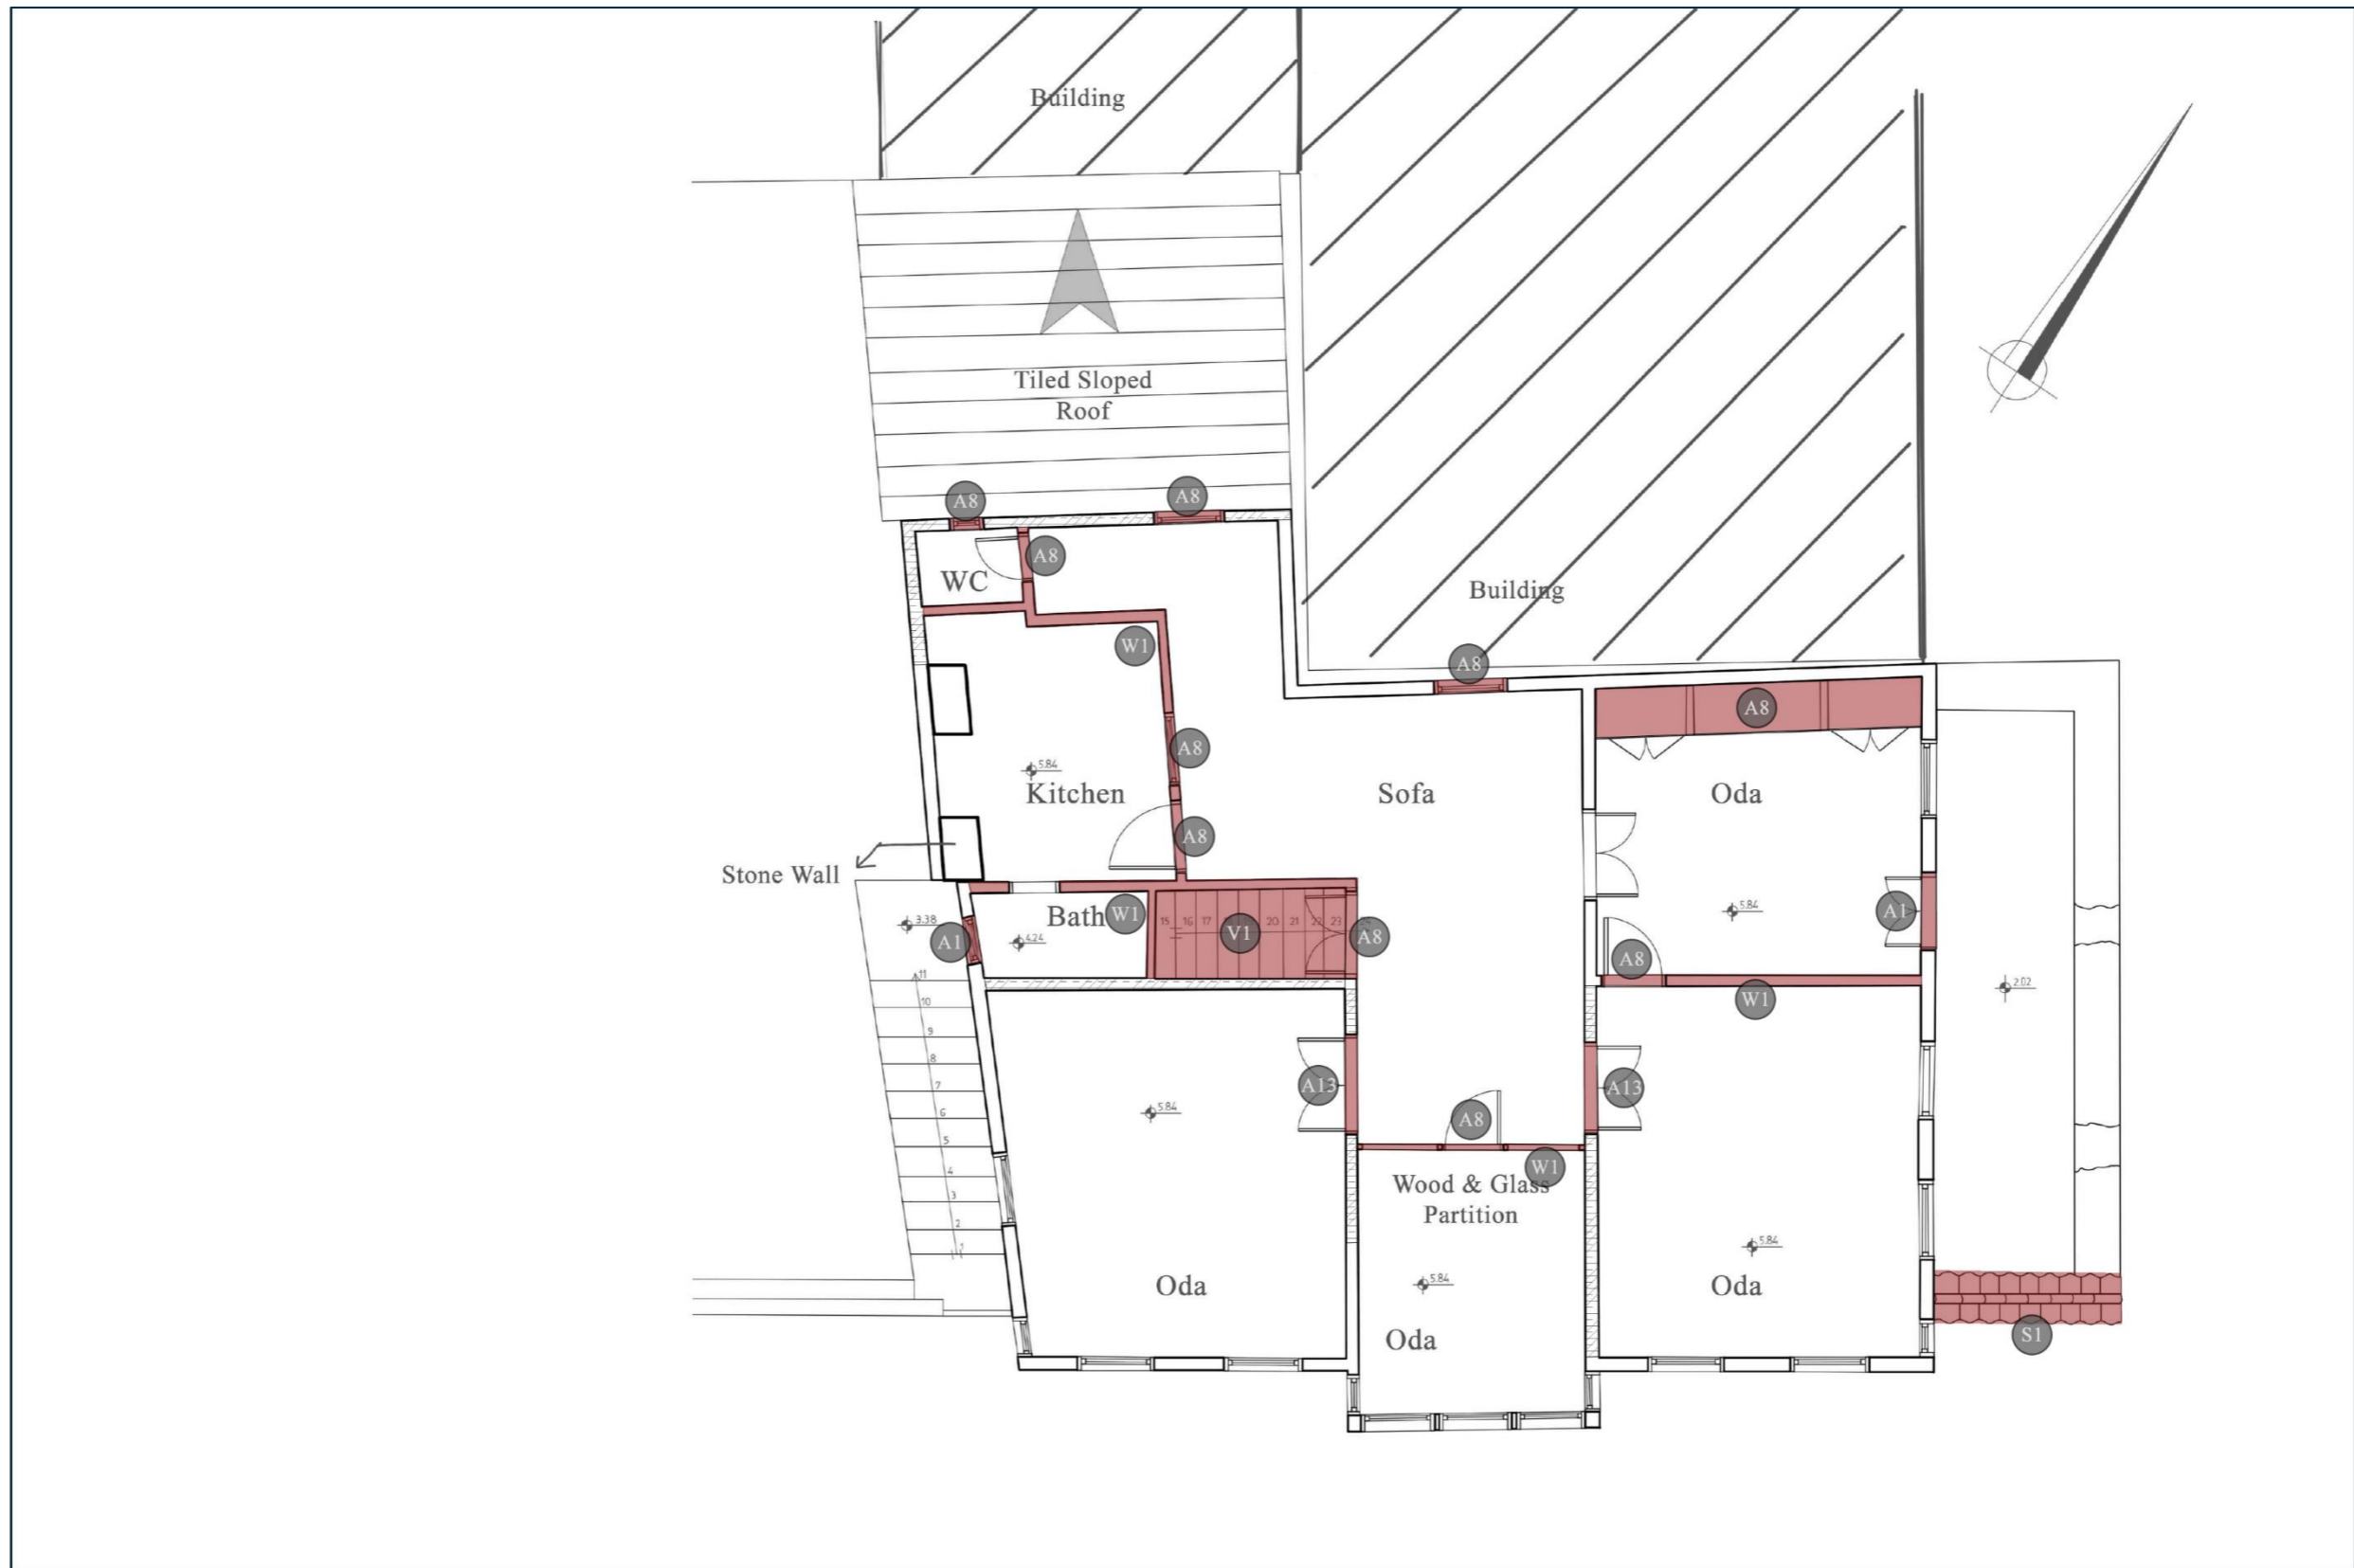
Figure 4.5. Original first floor plan value shift analysis. Prepared by the Author.

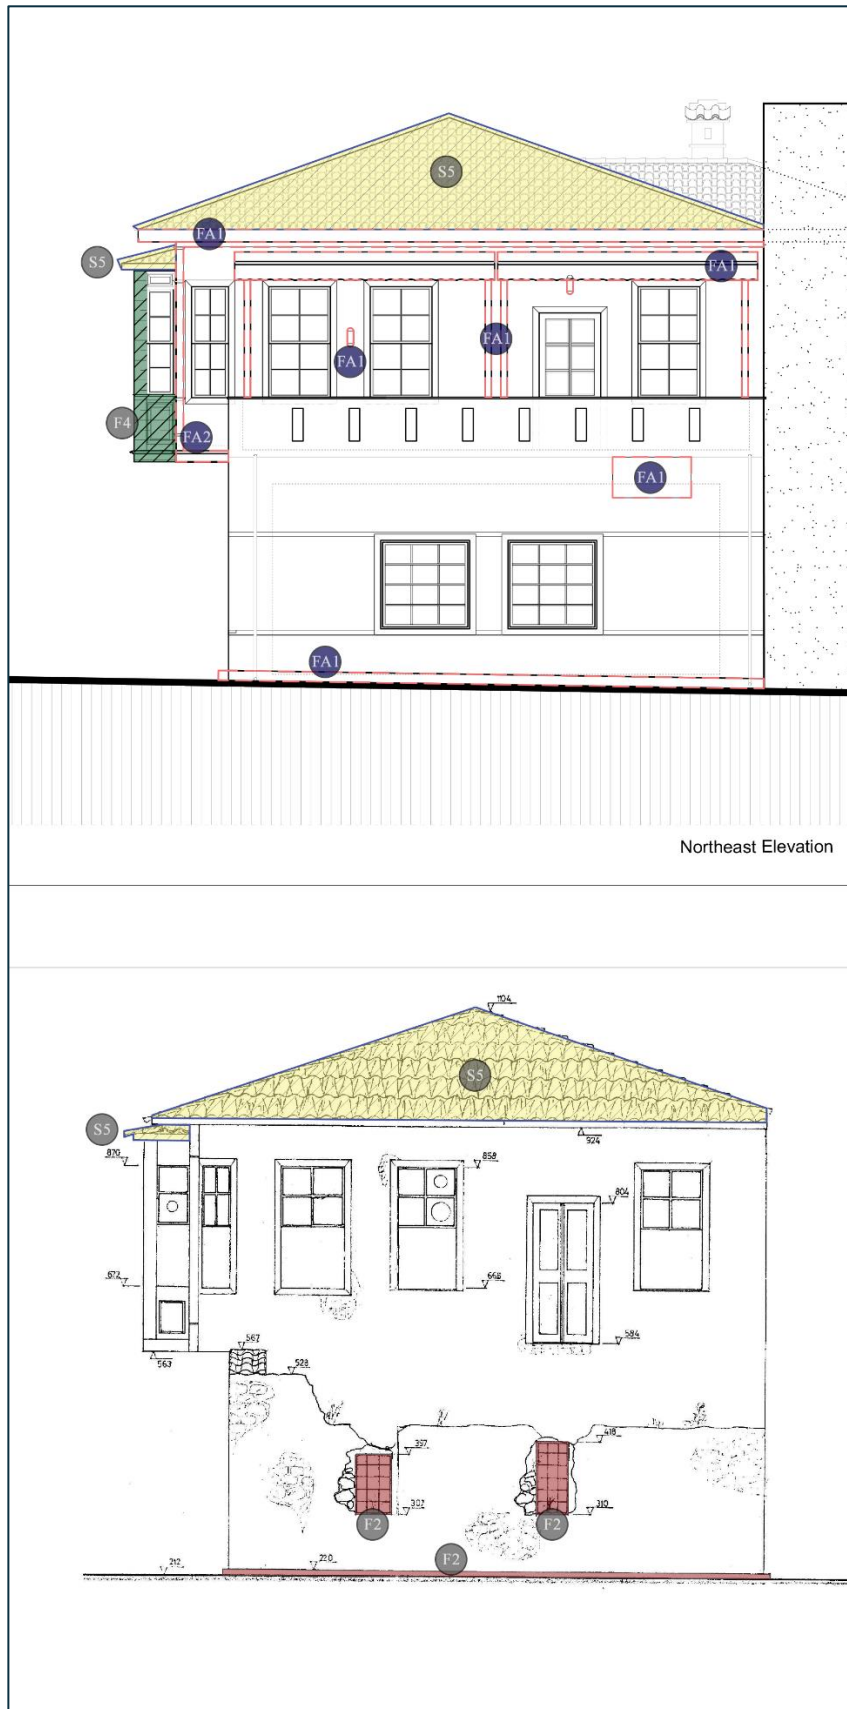
Figure 4.9. Restored (up) and original northeast elevation value shift analysis. Prepared by the Author.

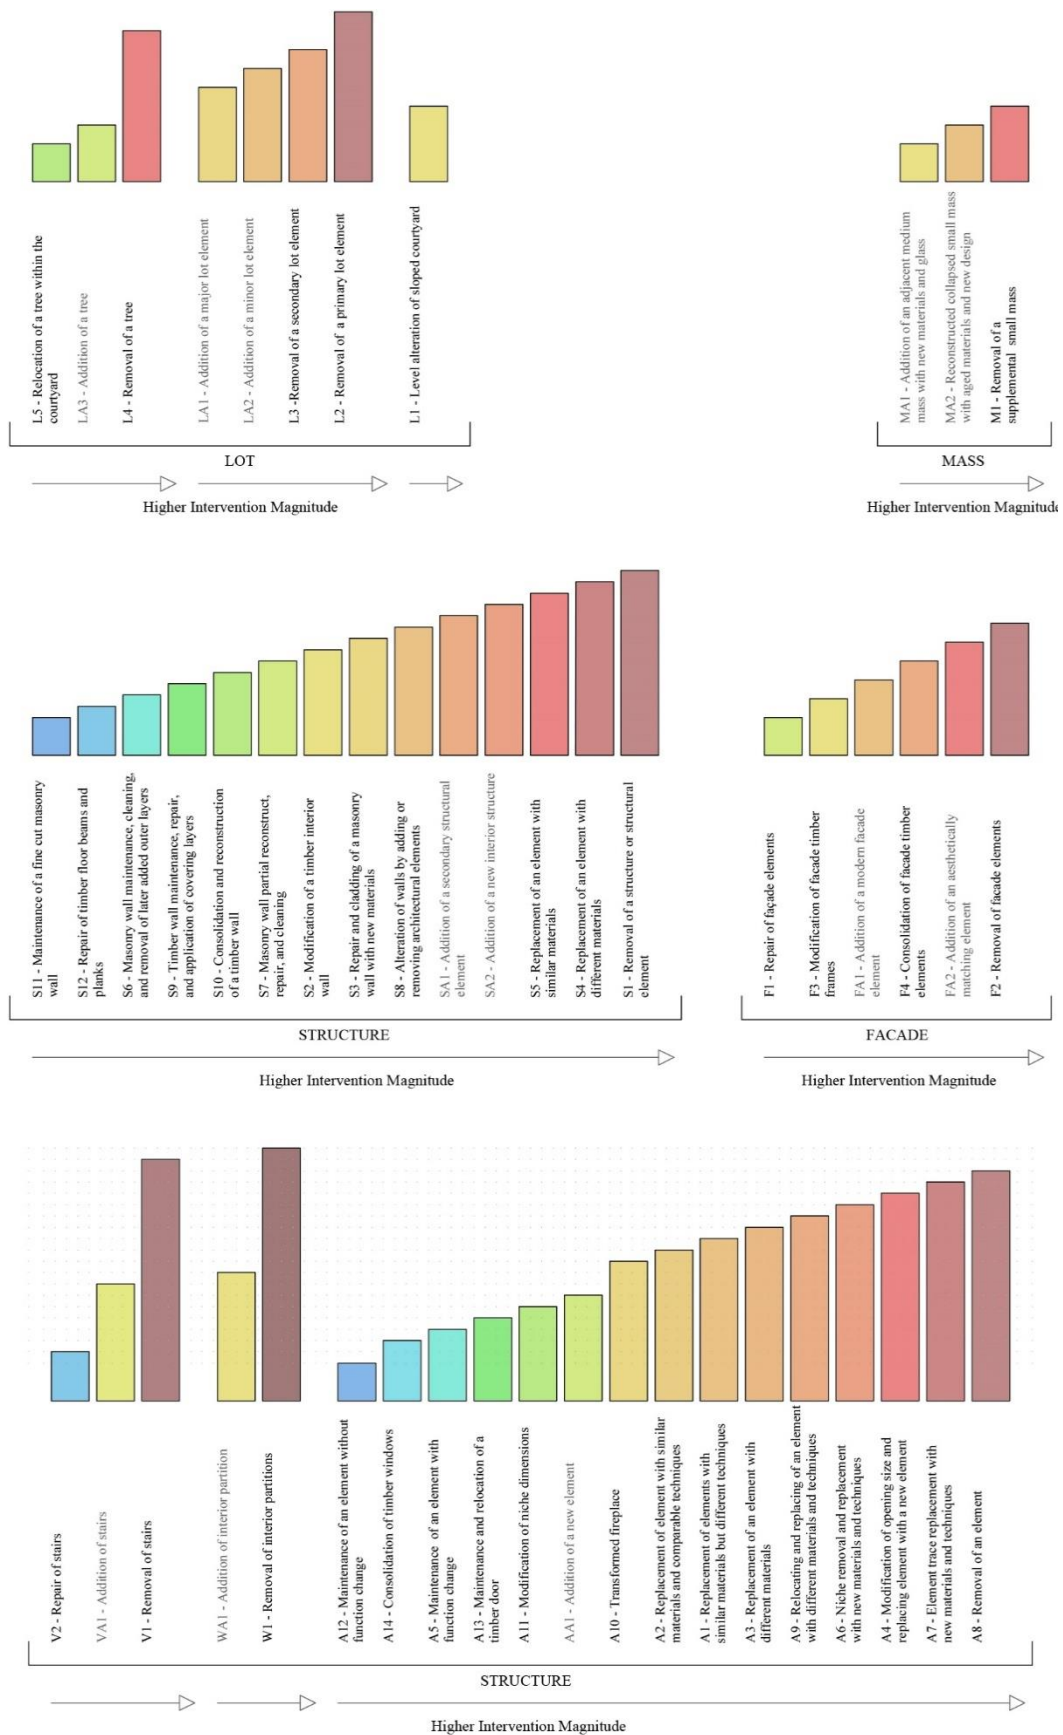
Moreover, as for the categorization of the intervention magnitudes, the interventions that cause more loss of values than other types of value change are considered the most negatively impactful upon the values of the building and vice versa. Followed by values decreased, whereas interventions that cause a value increase are seen at the other end of the spectrum.

Figure 4.12. Intervention magnitude effect on value. Prepared by the Author.
