REINSTITUTING KNOWLEDGE ON CONSTRUCTION TECHNIQUES AND  
MATERIALS OF A LATE OTTOMAN IMPERIAL BUILDING:  
ISTANBUL ARCHAEOLOGICAL MUSEUM

A THESIS SUBMITTED TO  
THE GRADUATE SCHOOL OF NATURAL AND APPLIED SCIENCES  
OF  
MIDDLE EAST TECHNICAL UNIVERSITY

DENİZ ÜSTOĞLU COŞKUN

JANUARY 2025

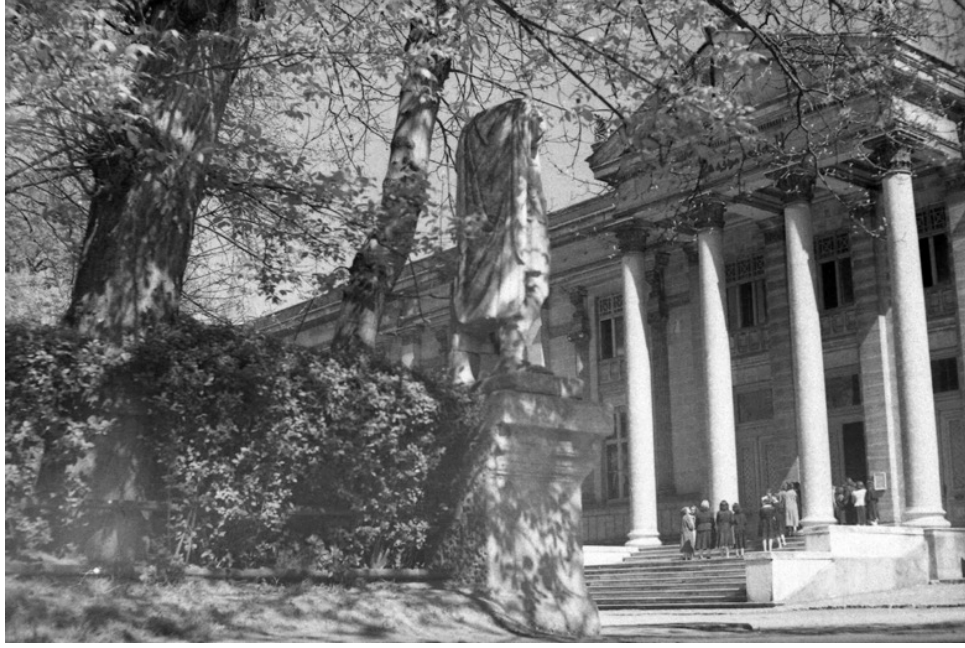
Figure 1. The old Photo of Istanbul Archaeological Museum Building (n.d.)(source: IAM-Photography Archive)

In this dissertation, the IAM Building is critically analyzed as a historical building that utilized all the technological opportunities available in the late 19<sup>th</sup> century (Figure 1). IAM Building, sprouting in the land wall of *Topkapı* Palace (Figure 2), played a significant role in educating architects during the late Ottoman and early Republican periods.

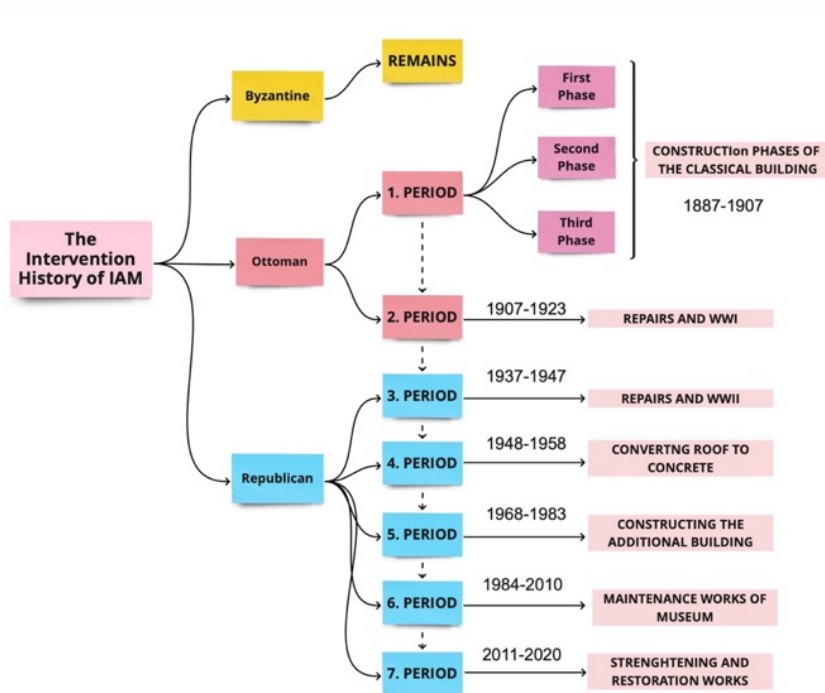
To accurately analyze the main intervention, its history is divided into seven phases (Figure 6). According to the research, it has been determined that the museum building underwent more extensive and radical interventions during certain periods, while in others, its continuity was maintained through smaller-scale interventions. These interventions are explained in detail in Chapter 3.

Figure 6. The scheme showing the intervention history of IAM Building (drawn by the author)

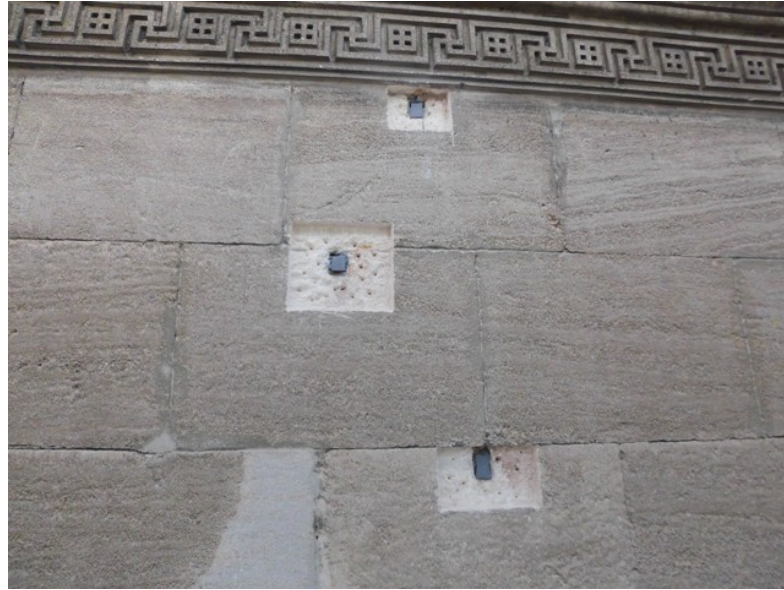
Figure 25. The iron clamps used between brick wall and stone claddings in IAM Building, photograph from 02.10.2012 dated presentation (source: IDSM Archive)

The most significant challenge in stone cladding wall construction is how to securely connect the cladding stones to the rubble stone or brickwork behind them. A toothed bond alone is insufficient for this purpose (Figure 25). For centuries, various iron elements have been used in masonry walls to ensure the connection between stones and the overall strength of the wall. Clamps and tenons, which connect the stones to each other, are among the most difficult elements to observe in surviving historical structures. Since they were embedded within the wall, they can typically only be identified in collapsed sections or during restoration work. In some cases, due to corrosion of the iron, the clamps may become visible through cracks or material losses in the wall. Since the exterior walls of the Istanbul Archaeological Museum are in structurally good condition, the technical details provided in Ali Talat's book are invaluable. The use of various iron elements to ensure the connection between stones and maintain the strength of the entire wall is particularly noteworthy.

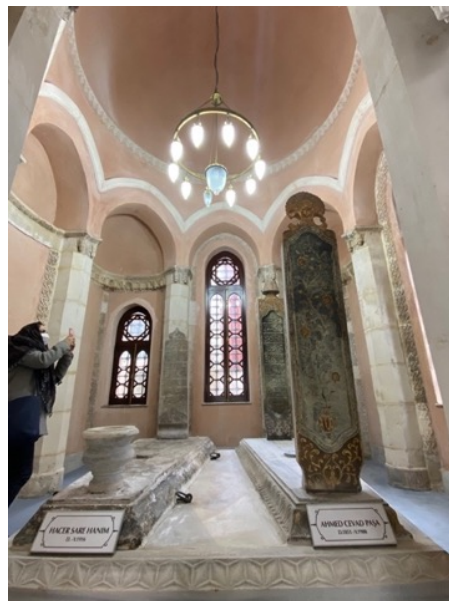
Figure 28. Left: The plan of Historical photograph showing the tomb of Grand Vizier Ahmet Cevad Pasa (source: IDSM Archive) Right: The inner section of the tomb of Grand Vizier Ahmet Cevad Pasha (taken by the author in 2021)

It was noticed in 2021, during a simple restoration project carried out by the Ministry of Culture, that there was plaster swelling on the wall on the right side of the entrance section of the tomb (Figure 28). Upon investigating the cause of the

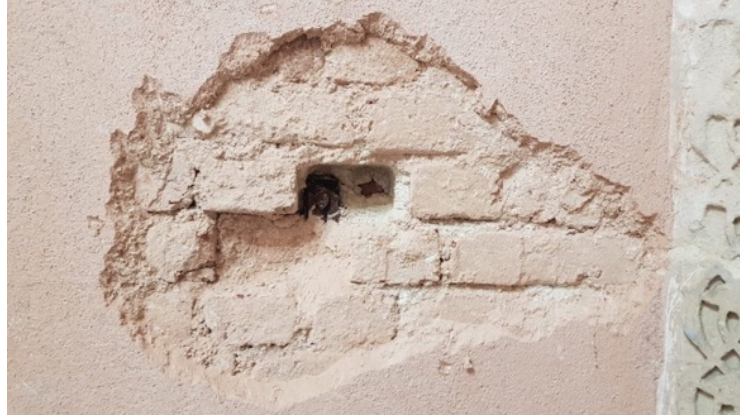
Figure 29. The clamp detail from the inner section of wall of the tomb of Grand Vizier Ahmet Cevad Pasa (taken by the author in 2021)

swelling, it was determined that this deformation was caused by an iron clamp inside the wall that had corroded, expanded, and exerted pressure on the plaster layer (Figure 29). Additionally, it was clearly observed that while the exterior of the wall was stone-clad, the interior part of the wall was built with bricks. Another iron clamp was discovered in the portion of the wall that aligns with the exterior (Figure 30). The clamp visible from the interior was placed perpendicular to the wall, while the one visible from the exterior was placed parallel to the wall. In this case, it is understood that the interior clamp is the 'tail clamp' that connects the brick wall to the stone wall, while the exterior clamp connects stone to stone.

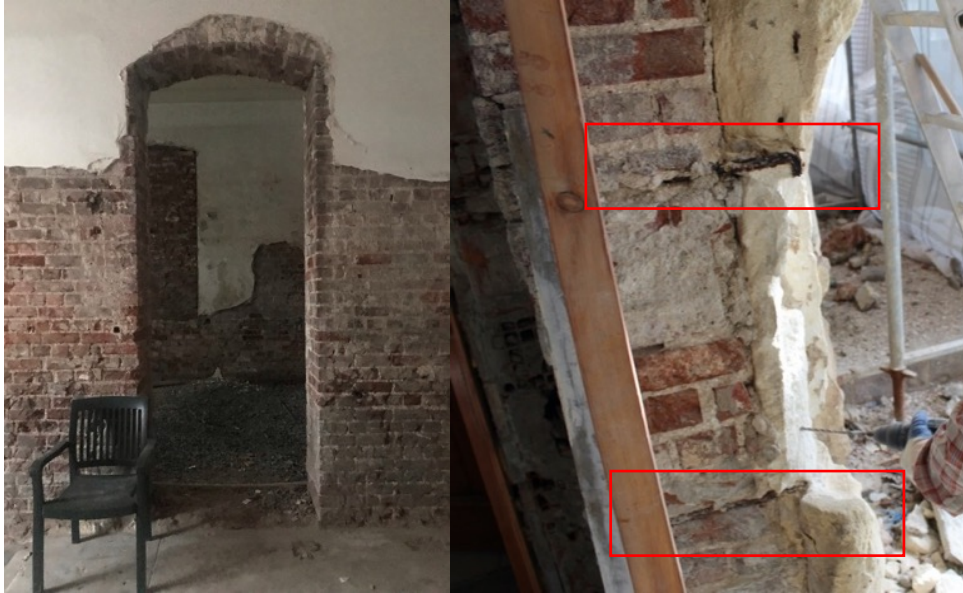
Figure 33. Left: The inner walls of historical *Yeniköy* Military Service Building, inside (source: IDSM Archive) (right) the section of exterior brick masonry wall with stone cladding

During the building's restoration controlled by Culture and Tourism Ministry, it became evident that the walls were constructed using brick masonry with the stone cladding for exterior walls while the brick masonry for inner walls (Figure 33, left). The clamps connecting the stone cladding to the brick sections of the wall were seen obviously in the exterior wall sections (Figure 33, right). The clamps are also an example of the tailed clamp. Another point understood from the image is that this tailed clamp repeats after every seven rows of bricks. Considering that bricks are usually in dimensions of 22-25x11-12x 5.5-10 cm, the height between two clamps should be around 38,5 cm-70 cm with. In addition, it is understood from the repairs

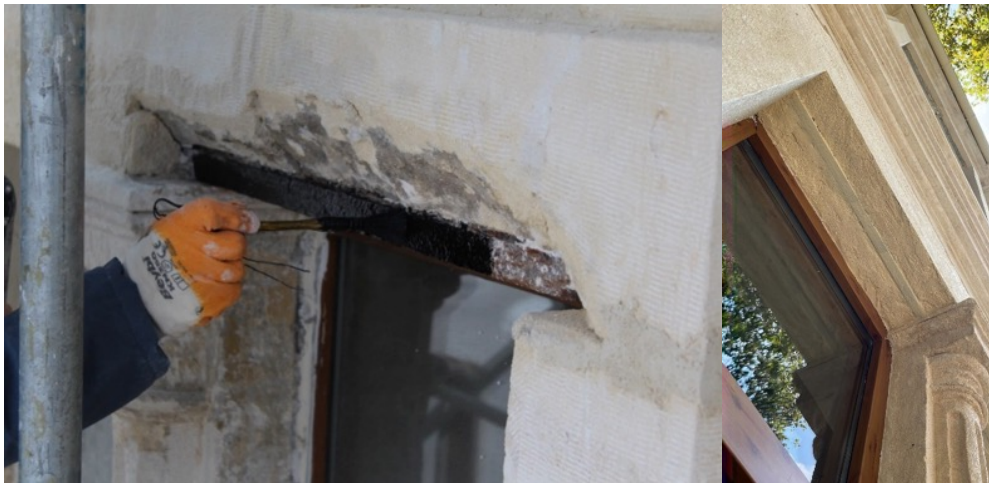
Figure 34. The historical *Yeniköy* Military Service Building, façade details (source: IDSM Archive)

on the exterior cladding of the guardhouse building that the window lintels were also constructed with iron elements (Figure 34).

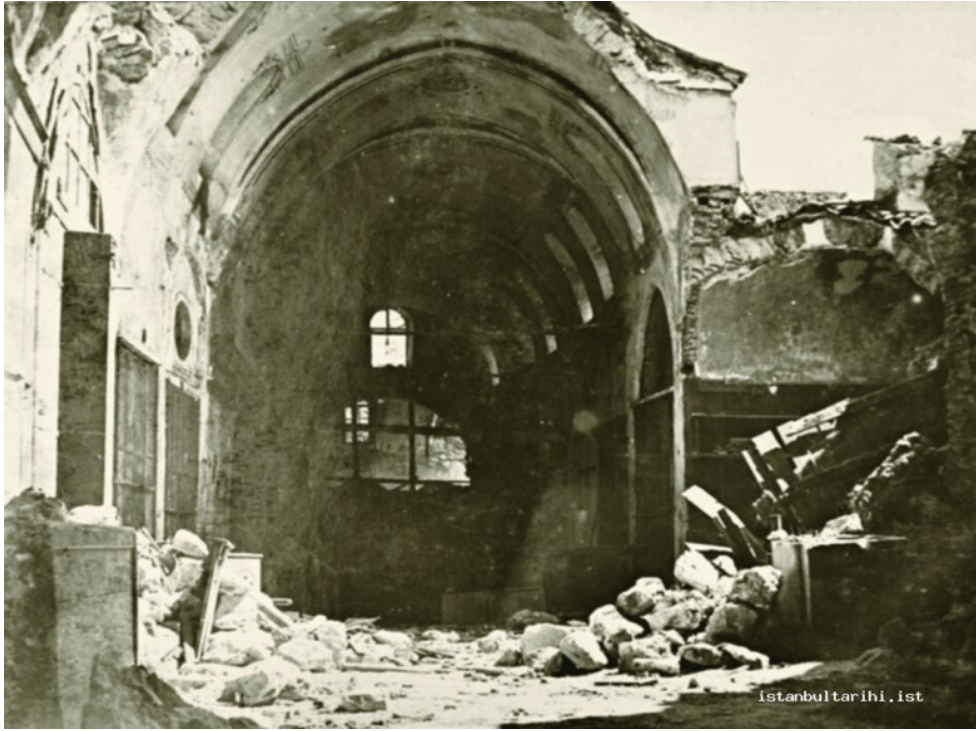
Figure 44. The 1894 earthquake and the damage it caused in Istanbul (source: İstanbul Atatürk Kitaplığı)

The earthquake that struck the Marmara Sea on July 10, 1894 was the most significant and destructive event to hit Istanbul and the eastern Marmara Sea region since the two earthquakes of May and September 1766 (Finkel & Ambraseys, 1997). It has been determined that the epicenter of the earthquake was 8 kilometers from *Yeşilköy*, located in the southeastern part of the Marmara Sea (Sezer, 1997). In this disaster, many civilian buildings and monumental public structures were damaged, and thousands of people lost their lives (Figure 44, Figure 45, Figure 46).

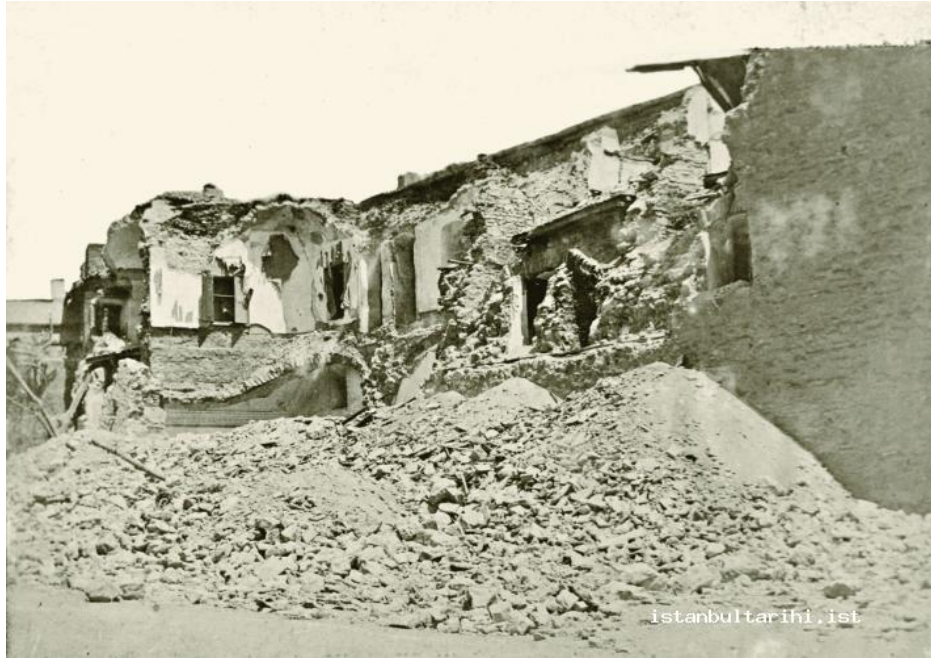
Figure 45. The 1894 earthquake and the damage it caused in Istanbul (source: İstanbul Atatürk Kitaplığı - <https://istanbultarihi.ist/27-bir-sehir-manzarasi-istanbulun-tarihinde-depremler>)

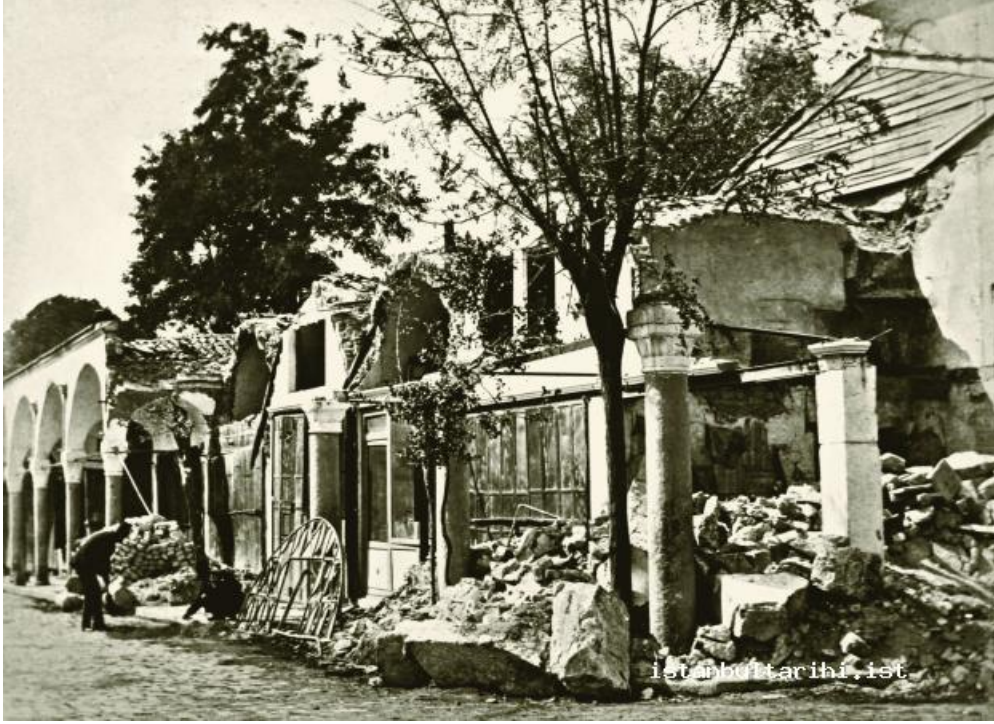
Figure 46. *Direklerarası* damaged during the Earthquake (source: İstanbul Atatürk Kitaplığı, “İstanbulda Vuku Bulan Büyük Hareket-i Arz’a ait Albümler”, Nr.184/2-<https://istanbultarihi.ist/27-bir-sehir-manzarasi-istanbulun-tarihinde-depremler>)

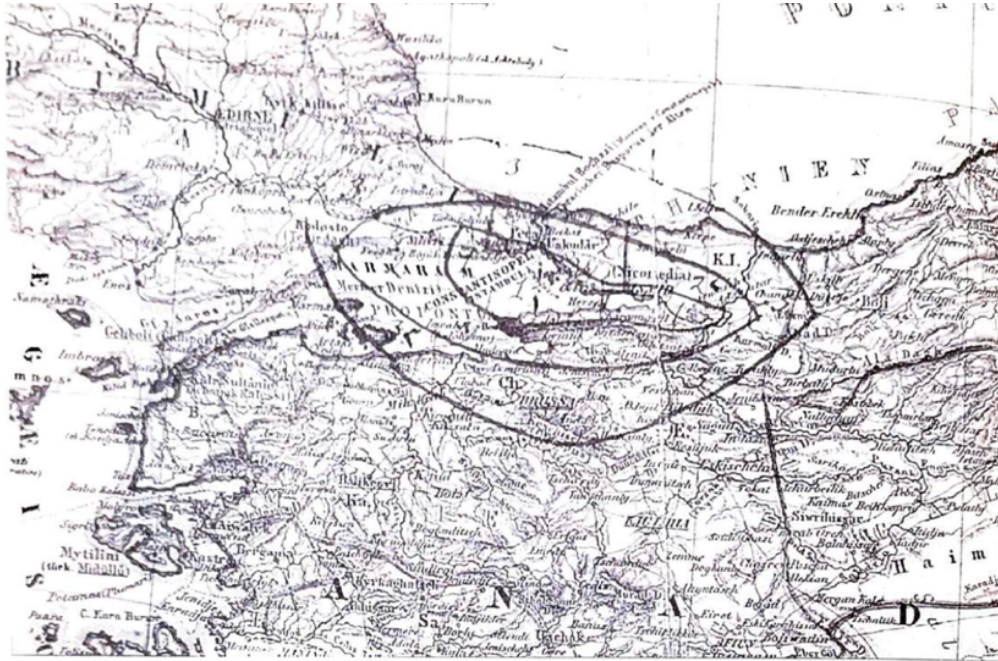
Figure 47. Earthquake zones identified on H. Kiepert's map source BOA, YEE, Nr. 11/14/126/C (Ürekli, 1999)

In addition to the report Eginitis prepared based on his research and investigations, Eginitis also identified the earthquake zones on the relevant section of H. Kiepert's map (Figure 47). The First Zone, as marked on the map on the center, constituted the epicenter of the earthquake and included the areas that suffered the most damage. All the buildings within this zone were destroyed. This central zone extended in a long line, with the major axis running from *Çatalca* to *Adapazarı* and along the Gulf of Izmit, covering 175 kilometers. In the Second Zone, some poorly constructed buildings collapsed, while other buildings developed minor cracks in their walls. In the Third Zone, although the earthquake was strong, it only caused some objects to fall or shift, without causing any damage to buildings (Ürekli, 1999, p. 17).

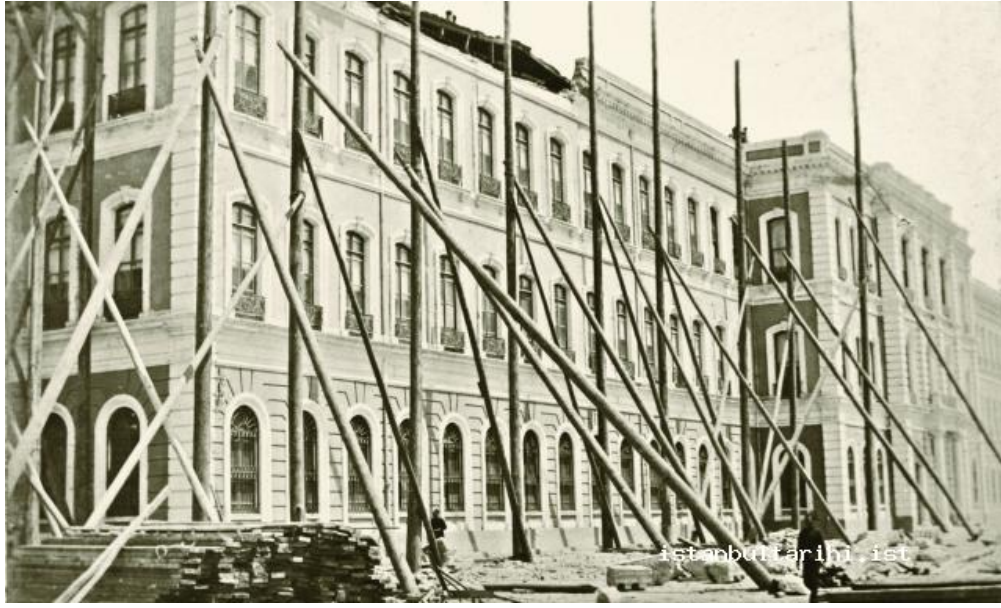
Figure 49. The repair works in the *Daire-i Umur-i Askeriye* building damaged in the earthquake (source: İstanbul Atatürk Kitaplığı, “İstanbulda Vuku Bulan Büyük Hareket-i Arz’a ait Albümler”, Nr.184/2- <https://istanbultarihi.ist/27-bir-sehir-manzarasi-istanbulun-tarihinde-depremler>)

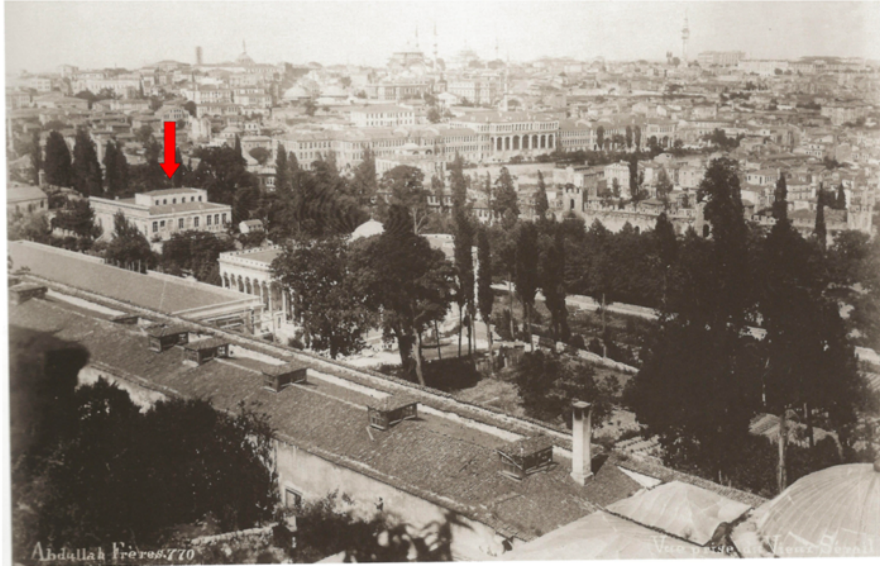
Figure 50. The *Sanayi-i Nefise Mektebi*, indicated by the red arrow, between 1883-1892, and the first phase of the *Müze-i Hümayun* across from the Tiled Kiosk (Restitution Report, IDSM Archive)

was very familiar with both the building and the area when he prepared the repair report (Figure 50, Figure 51, Figure 52).

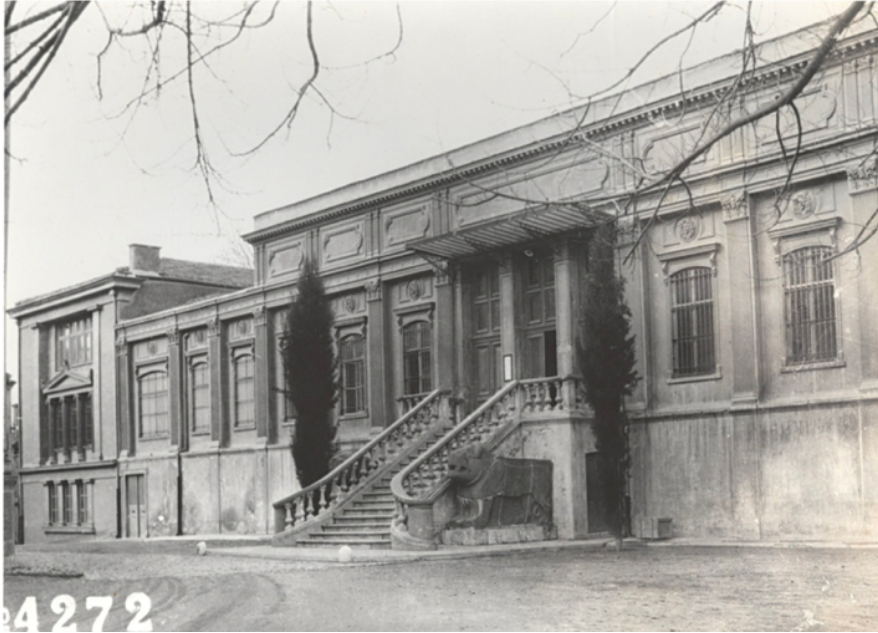
Figure 56. *Snayai-i Nefise Mektebi* güney doğu cephesi ve özgün merdiveni 1911 (Restitution Report prepared by *Seçkin Mimari hizmetler*, IDSM Archive)

The Museum of the Ancient Orient was originally constructed as the School of Fine Arts (*Sanayi-i Nefise Mektebi*) under the leadership of Osman Hamdi and was opened on March 3, 1883, marking the beginning of its educational mission. Believing in the advantage of having the school close to the Imperial Museum, Osman Hamdi obtained permission for the school to be built on the vacant land to the west of the museum, and construction began. The restitution report prepared by *Seçkin Mimari Hizmetler* divides the construction process of the building into three phases. These phases are described as follows: Phase 1 involves the construction of the initial building; Phase 2 includes the construction of a workshop and exhibition building on the Osman Hamdi Bey Street; and Phase 3 is the unification of the section between these two buildings (Figure 56).

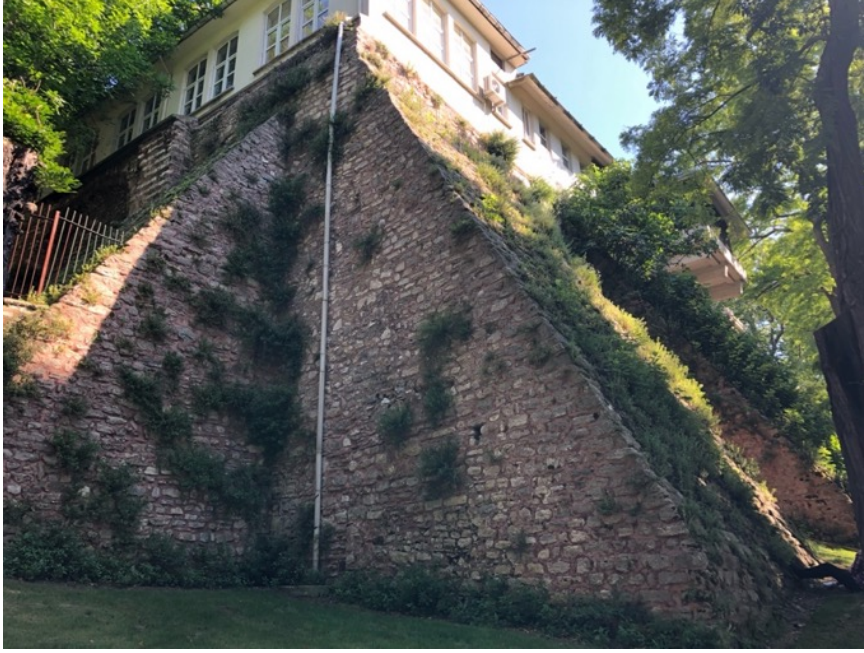
Figure 61. The buttresses under the *Sanayi-i Nefise Mektebi* (source: taken by the author in 2021)

The garden and buttress walls mentioned in the estimated cost book are likely the ones shown in Figure 58 and Figure 59. This suggests that the area, which contains Byzantine infrastructure and where Vallaury is believed to have positioned the first building based on the underlying remains adjacent to the buttress wall, was damaged during the earthquake. The movement in this section may have posed a threat to the superstructure (Figure 60). This situation explains why the *Müze-i Hümayun* building, constructed by the same architect using the same techniques and located in the same courtyard, did not sustain as much damage as the *Sanayi-i Nefise Mektebi building*. Consequently, the decision was made to reinforce these walls by renewing them with one-quarter new stone and adding new buttresses. Another notable intervention mentioned in the survey book is the use of iron girders to strengthen the superstructure (Figure 61).

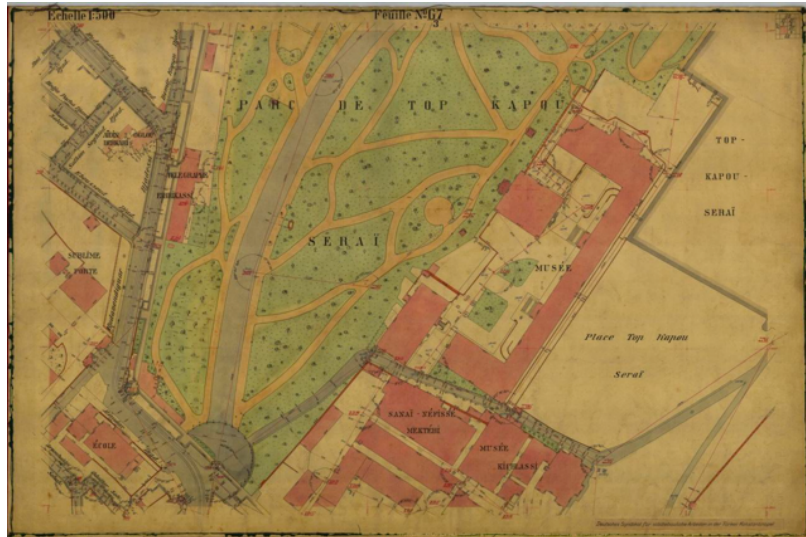
Figure 64. The complex of Istanbul Archeological Museums Buildings (source: *Alman Mavileri* (Deutsch Syndikat für Staebaliche Arbeiten))

Tiled Kiosk and the Museum of the Ancient Orient (formerly the School of Fine Arts, *Sanayi-i Nefise Mektebi*) (Figure 64).

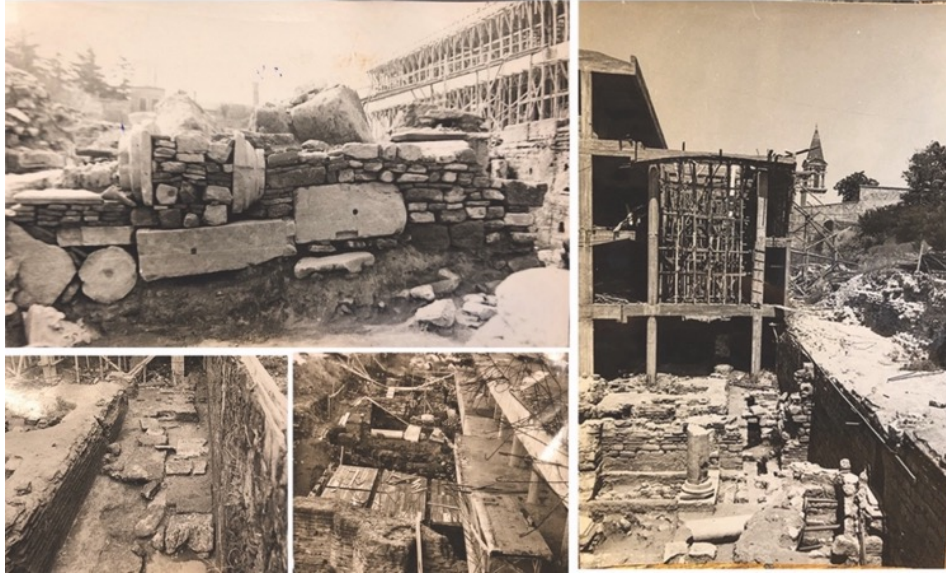
Figure 73. The photos of the foundation excavation during the construction of the Additional Building (source: The Personal Achive of Nezhir Fıratlı, IAM-Archive) (Üstođlu Coşkun & Şahin Güçhan, 2024)

The third one is the remains found during the foundation excavations of the Additional building of IAM (Figure 76, Figure 77). A significant cluster of remains was found in the back side of the IAM courtyard during the additional building's foundation excavation in 1968. These remains belong to a church, a bath, a large cistern, and the ruins of the sewer and road from Byzantine period (Fıratlı, 1969; Kızıltan & Saner, 2011). According to the decision taken by Conservation Council (no: 7414, date:15.09.1973), some remains were removed due to an earthquake beam required for the construction of the last block of additional building, while other were maintained in situ.

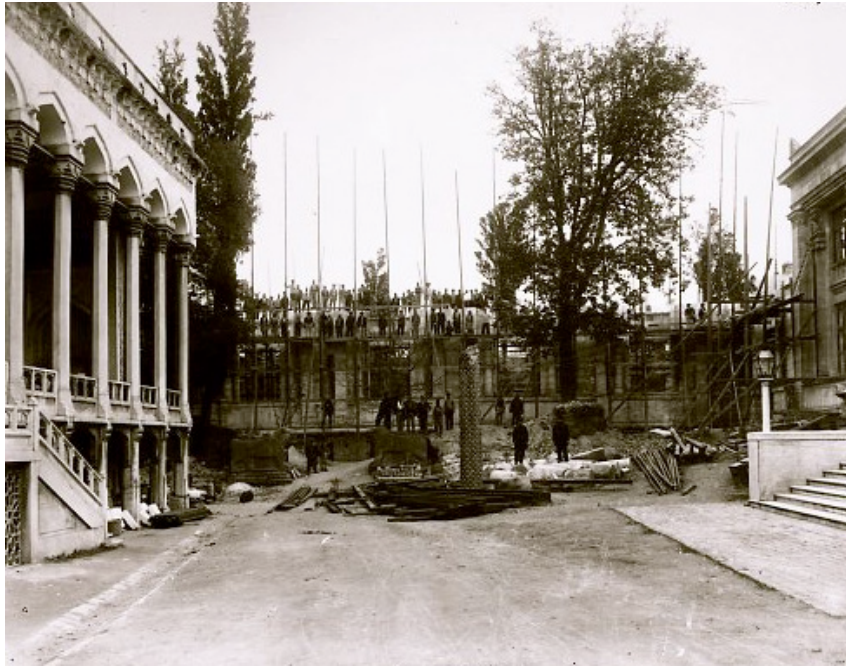
Figure 89. *Müze-i Hümayun* during the construction of 2<sup>nd</sup> phase 1899 -1907 (source: CAMGD Archive)

The ground-breaking ceremony of the second construction phase of IAM was done in 1899<sup>52</sup> (Document 2.01). The museum opened on November 7, 1903 (Cezar, 1971, p. 203). In this correspondence dated 1899 (Document 2.01), which was written by Osman Hamdi and addressed to the Ministry of Education, it was announced that in addition to the current buildings of the museum, the Sultan's approval had been granted for the starting of the construction of the new building, on the terrace opposite the Tiled Kiosk. Accordingly, the start date for the construction was chosen to coincide with the day of the Sultan's accession to the throne. On Thursday, after sacrifices were made and prayers were offered, work on some parts of the construction began (Figure 89).

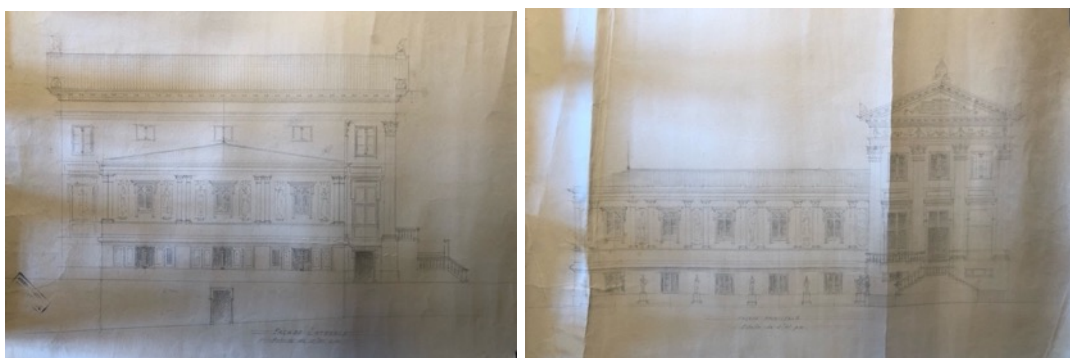
Figure 90. Left: Alternative Elevation drawing looking *Gülhane* Park “IAM Archive, 20, G2/R3/2” (n.d.), Right: Alternative Elevation drawing looking inner courtyard “IAM Archive, 28, G2/R3/10” (n.d.)

Like the first building, the second building was initially planned on a smaller scale and was later expanded during construction, as evidenced by documents from the Ottoman archives. It is understood that the plans and facade design of the Second Phase were changed and enlarged after the construction started within the knowledge and approval of Vallaury. This explains the presence of numerous different designs (Figure 90, Figure 91), varying in the number of floors and architectural details, found in the archives of the Istanbul Archaeology Museums.

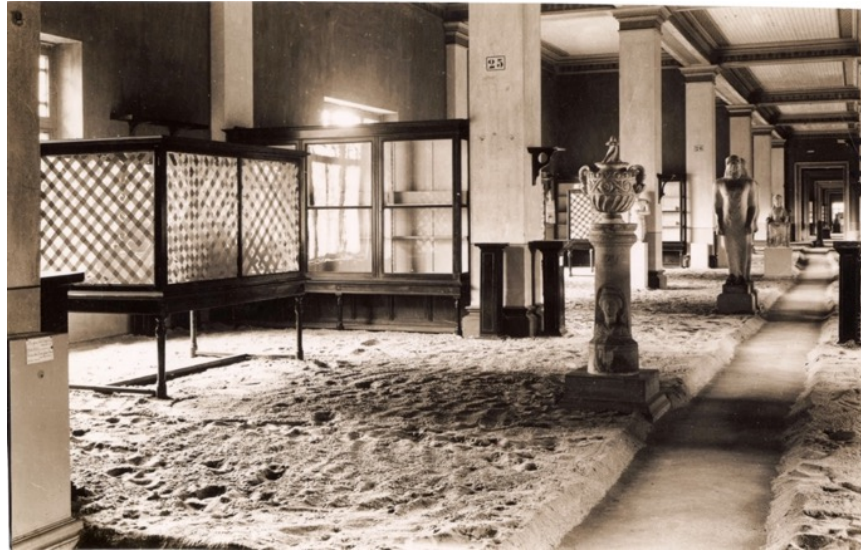
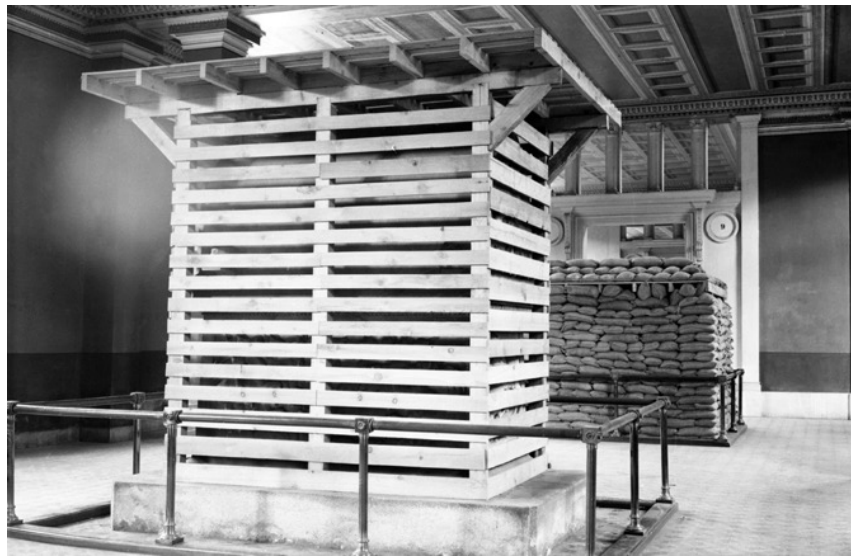
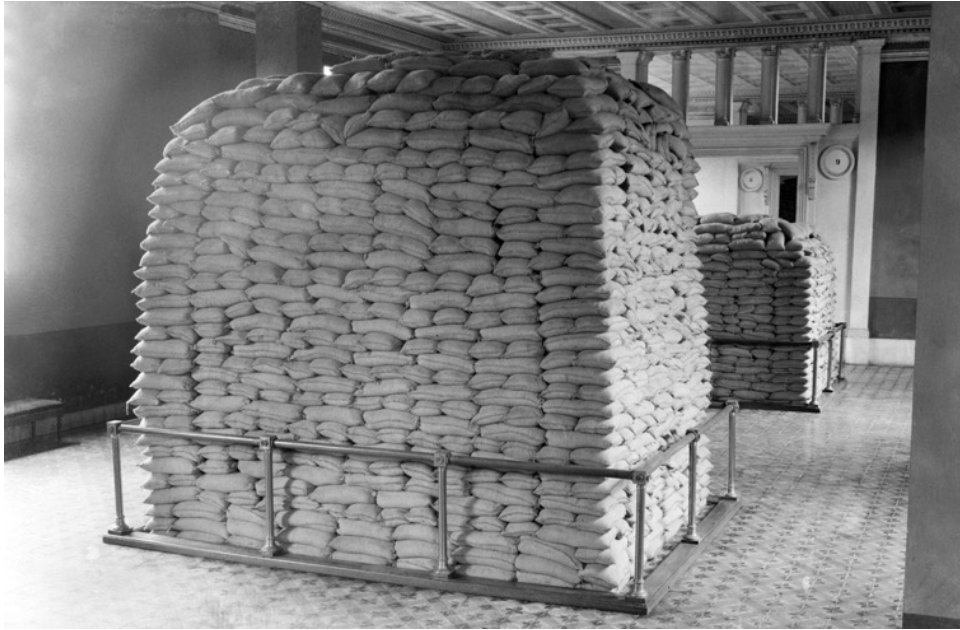
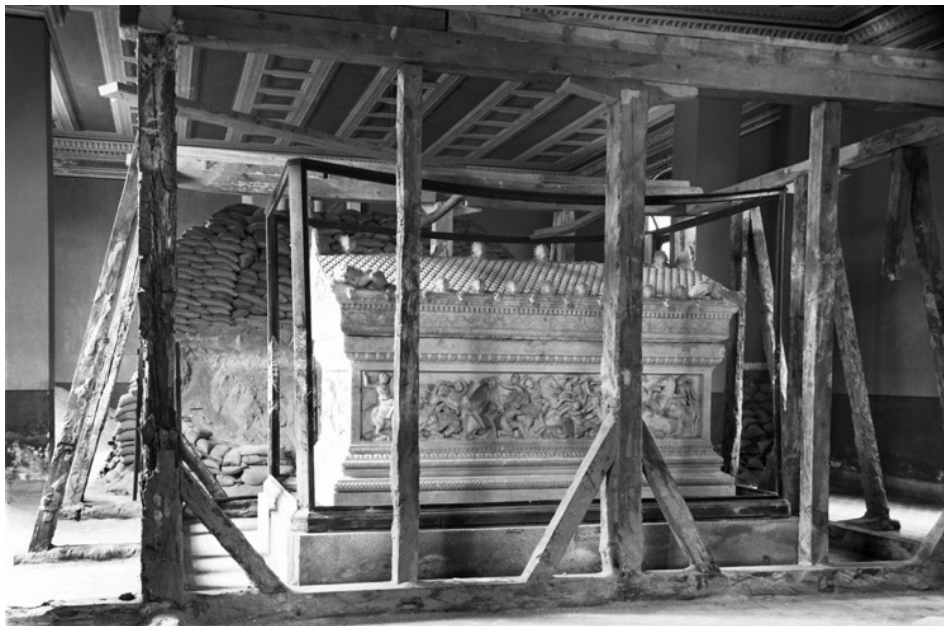
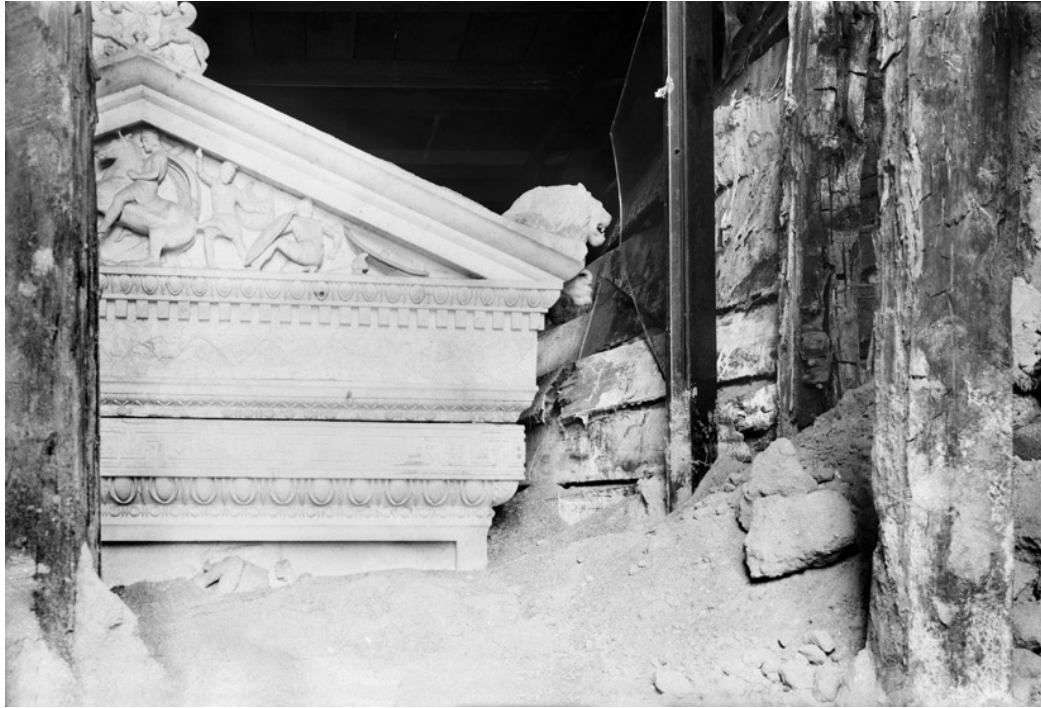
Figure 105. The interventions done the first floor of IAM during World War I (source: Salt Photography Archive)

Figure 106. The Interventions done for the protection of the museum and its artifacts against air attacks during World War I (source: IAM-Photography Archive)

Figure 107. The Interventions done for the protection of the museum and its artifacts against air attacks during World War I (source: IAM-Photography Archive)

Figure 108. The sarcophagus of Alexandre the Great after taking the Interventions done for the protection of the museum and its artifacts against air attacks during World War I (source: IAM-Photography Archive)

Figure 109. The sarcophagus of Alexandre the Great after taking the precautions for the protection of the museum and its artifacts against ariel bombardments during World War I (source: IAM-Photography Archive)

2. Although the floor appears to be solid, it is necessary to protect the most distinguished sarcophagi and similar valuable artifacts on the lower floor against all possible threats, particularly the possibility of direct hits by large and high-explosive bombs. To achieve this, it is recommended to cover the areas above these artifacts on the upper floor with train tracks, steel girders (*putrel*), or beams of 15/20 cm in cross-section and sufficient length, as shown in the first figure in the attached plate. Additionally, on the lower floor, small boxes should be constructed and filled with sand as per the second figure. If there are additional materials available, it would be very beneficial to apply this method to all valuable items (Figure 105, Figure 106, Figure 107, Figure 108, Figure 109).

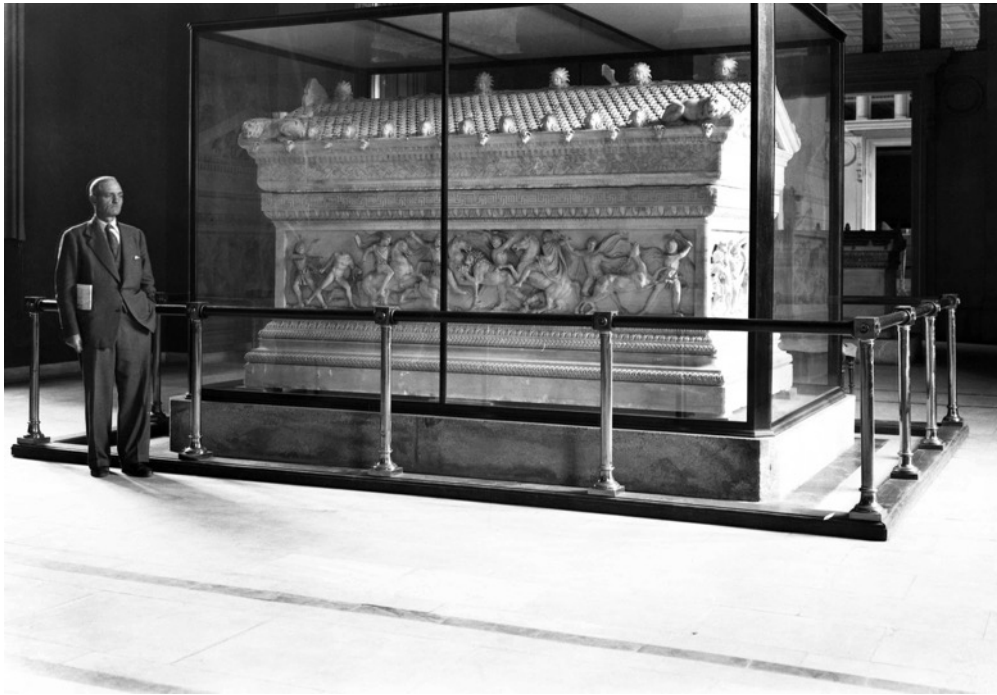
Figure 111. The photograph dated 1937-1947 after changing the flooring to marble (source: IAM-Photography Archive)

In Figure 111, it is clearly visible that a glass display case was built for the Alexandre Sarcophagus, and the previously square mosaic flooring was replaced with new marble. Even if other items were completed, they may not have been mentioned in the annual reports due to their technical nature, or perhaps they were not completed due to budget constraints.

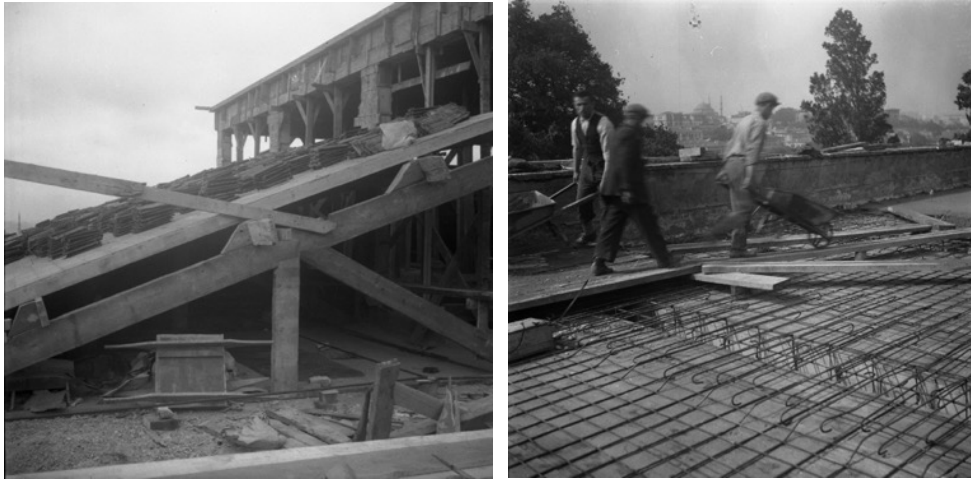
Figure 112. The photographs that were taken during the Conversion of the Roof of IAM from Timber to Concrete (1948-1956)

In Istanbul Aziz Ogan, (1931-1953) the director of the museum says that the roof of the Museum is being rebuilt of concrete: in 1949 the part covering the North wing, which includes the Department of Coins and Medals, the Library, and the Ceramic Rooms, has been completed (Istanbul Arkeoloji Müzeleri Yıllığı, 1950). In the same museum annual, architect Fikret Yücel, describes the work of transforming the ceiling into concrete with details under the title General Activity in Archaeological Museums in 1948 and 1949 (*1948 ve 1949 senelerinde arkeoloji müzelerindeki umumi faaliyet*). He says that a comprehensive repair work had been started in the building to prevent fire. In this context, the lantern and ceiling parts of the administration block are converted into reinforced concrete (*İstanbul Arkeoloji Müzeleri Yıllığı*, 1950) (Figure 112, Figure 113).

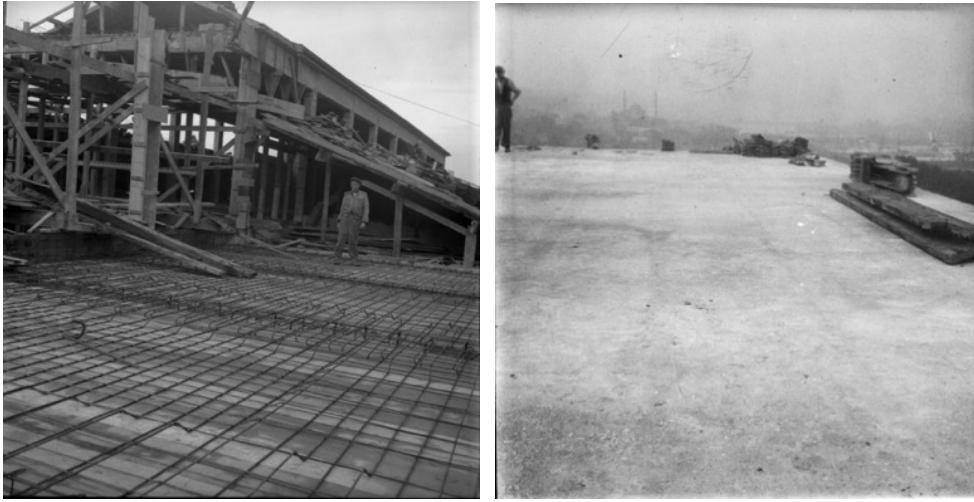
Figure 113. The photographs that were taken during the Conversion of the Roof of IAM from Timber to Concrete (1948-1956)

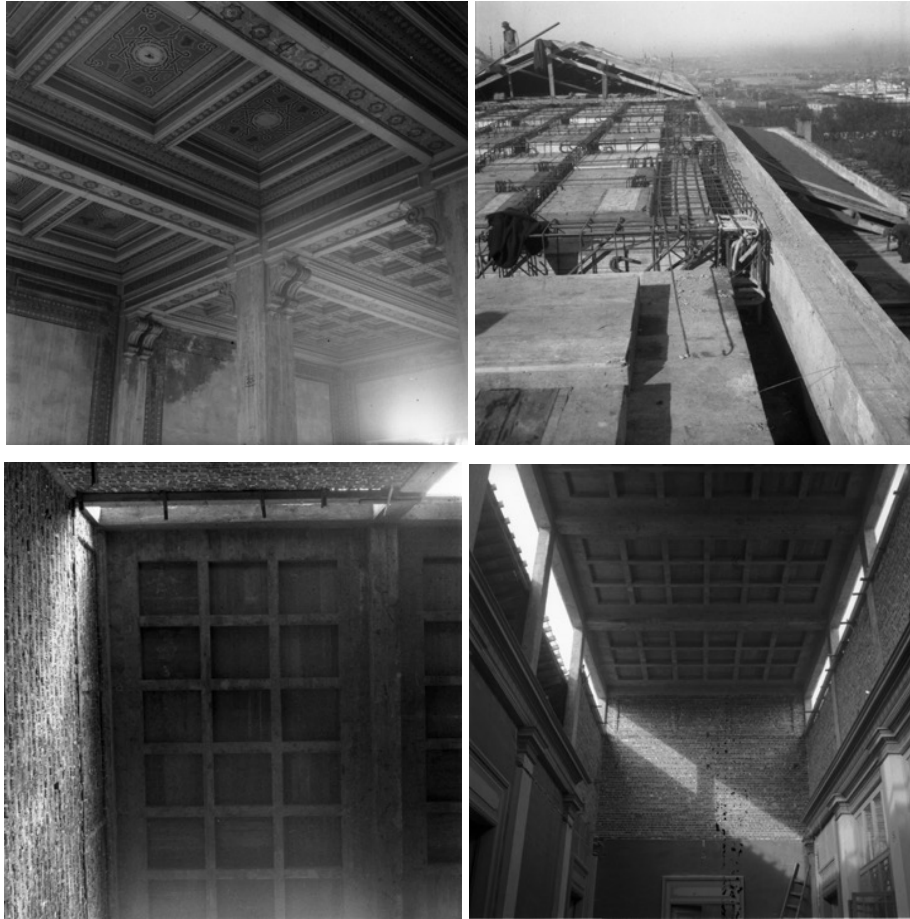
Figure 114. The conversion of roof floor and roof lanterns to reinforced concrete in 2<sup>nd</sup> Construction phase of IAM (source: IAM-Photograph Archive)

Yücel (1950) says that this section of the building (second phase) was meticulously crafted by engraving antique motifs onto the wood. In reality, covering this 3000 square meter wooden surface without compromising the building's interior décor, while constructing a reinforced concrete roof base over it, and thereby encasing it in a masonry shell to prevent fire hazards, was the chosen approach. After the roof dismantling began, it was discovered that some of the wooden posts supporting the skylight, which rested on the columns, had rotted. At the same time, since these wooden posts were positioned directly on the center of the brick columns, it was realized that it would not be possible to build additional reinforced concrete columns or even a concrete belt encircling the posts for the skylight. Therefore, the decision was made to preserve the decorative capitals, moldings, and ceilings while

completely dismantling the skylight portion and reconstructing the coffered ceiling with reinforced concrete (Figure 114, Figure 115). In this way, while the ceiling was converted to concrete, the building's original interior appearance was preserved. The decorated ceilings at the stair landing and in the hall opposite it were also left intact. The only changes were limited to the intricately designed wooden fillings continuing after the architrave and the flat painted ceiling portions. (İstanbul Arkeoloji Müzeleri Yıllığı, 1950). In Istanbul Museum Yearbook No. 7 (1956) it is written that within this three-year period, the concrete work of the last section of the Museum of Classical Works was completed.

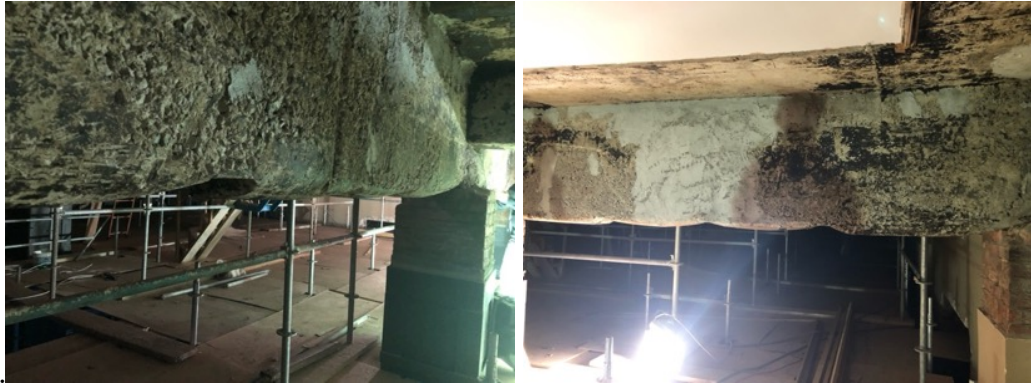
Figure 116. The reinforced concrete beams of 1<sup>st</sup> floor of 3<sup>rd</sup> Construction phase of IAM (source: taken by the author in 2018)

During the restoration in 2017, when the wooden cornices on the Second construction phase of IAM were removed, a very interesting details were encountered in order to strengthen the ceiling (Figure 116). In the photograph, it can be clearly seen that the forms of the reinforced concrete beams behind the wooden cornices are amorphous and not uniform. In other words, a new mold was not created while the beams were being cast in concrete. It looked as if the concrete had been poured directly onto the wooden cornices, which were used as decorative elements for the lower floor. The photographs taken from the third Phase of construction of IAM while Fikret Yücel mentions on Second Phase of construction of IAM. Since the second and third phase lanterns should be symmetric, they should apply the same technique for all ceiling of IAM building. Why did they not remove the cornices and create a new mold was not understanding. This may be caused by economic or time limitation problems.

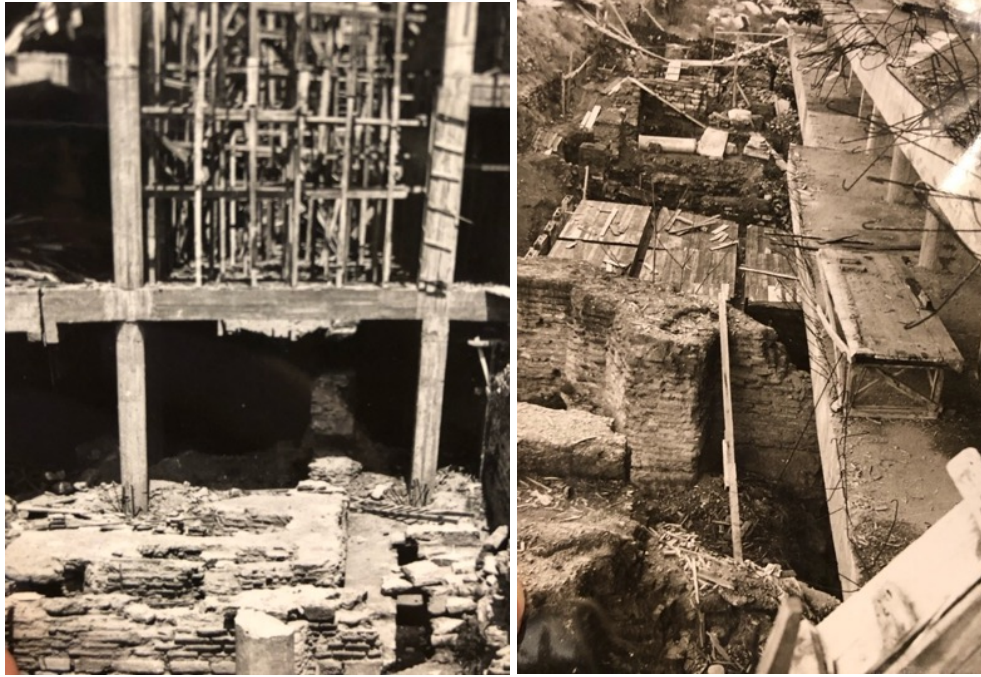
Figure 121. The Photos of the construction of Additional Building in the excavated area (source: The Personal Achieve of Nezhir Fıratlı, IAM Archive)

One of the radical interventions to the building was adding a structure to its rear facade between 1968-1983. This addition led to the exploration of the underground heritages hidden in the land of the İstanbul Archeological Museum (Figure 119, Figure 120, Figure 121). Although this construction is very controversial, it caused an excitement due to the Byzantine ruins exposed during the excavation. The construction of additional building completed and opened to the public in 1983. This repair process will be examined based on the archives of Museum' expert archaeologist Nezhir Fıratlı, Cultural Heritage Preservation Board and İstanbul Directorate of Surveying and Monuments.

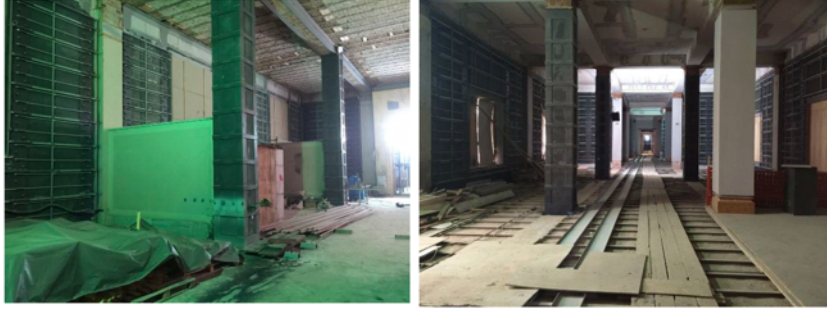
Figure 128. Photographs that were taken during Reinforcement and restoration works on columns and walls, Left: Hall 13-14-15 Right: Hall 25 (source: IDSM Archive)

foundations of load-bearing walls, Installation of reinforcement cables on the vault flooring, repairs to wooden door frames and panels, reinforcement of lintels above windows, cleaning of darkened areas at the roof level on the courtyard façade using pure water spray and various roof-related works (Figure 128, Figure 129).

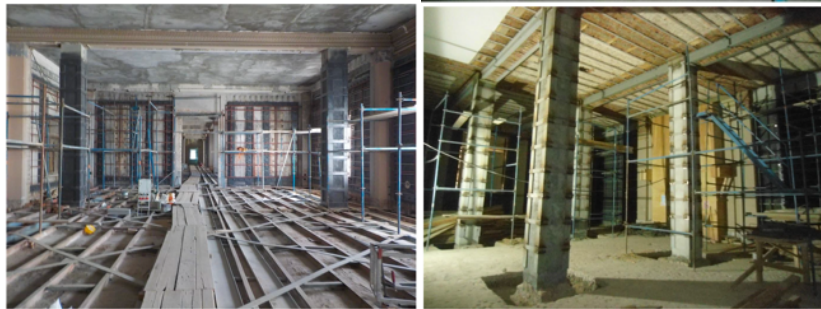
Figure 129. Photographs that were taken during Reinforcement and restoration works on ground floor, Left: Hall 28, Right: Hall 19 (source: IDSM Archive)
