REINSTITUTING KNOWLEDGE ON CONSTRUCTION TECHNIQUES AND  
MATERIALS OF A LATE OTTOMAN IMPERIAL BUILDING:  
ISTANBUL ARCHAEOLOGICAL MUSEUM

A THESIS SUBMITTED TO  
THE GRADUATE SCHOOL OF NATURAL AND APPLIED SCIENCES  
OF  
MIDDLE EAST TECHNICAL UNIVERSITY

DENİZ ÜSTOĞLU COŞKUN

JANUARY 2025

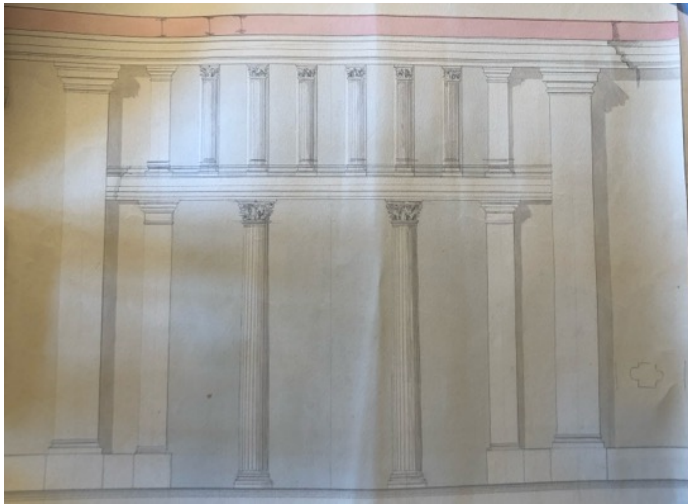
Figure 139. The original alternative drawing showing the design above the lintels of the doors between the exhibition halls (source: IAM Archive 16, G2/R2/3)

The first building consisted of an entrance section and two main halls housing sarcophagi brought from Sidon. In the hall, entered after passing through the propylon and aligned with the Tiled Kiosk, a single-armed staircase leads to the upper floor. On either side of the entrance hall, around 20 sarcophagi discovered during the excavations in Sidon, including the famous Alexander Sarcophagus, are displayed. Above the lintels of the doors between the exhibition halls, the architect left space for four mini-columns adorned with Ionic-order decorative elements, providing an interesting solution that ensures continuity between the spaces (Batur, 1993) (Figure 139, Figure 140). The height of the second floor is slightly less than that of the ground floor.

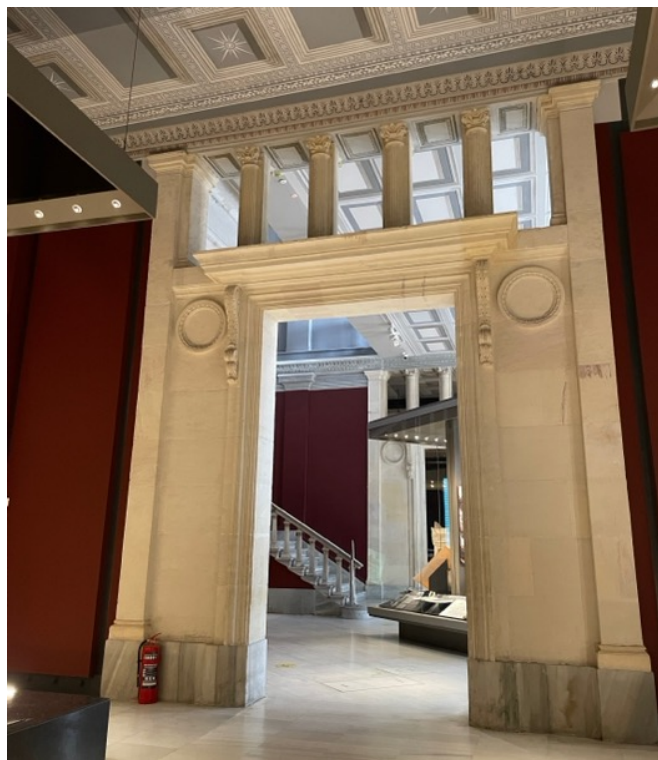
Figure 140. Applied design solution above the lintels of the doors between the exhibition halls (taken by author in 2024)

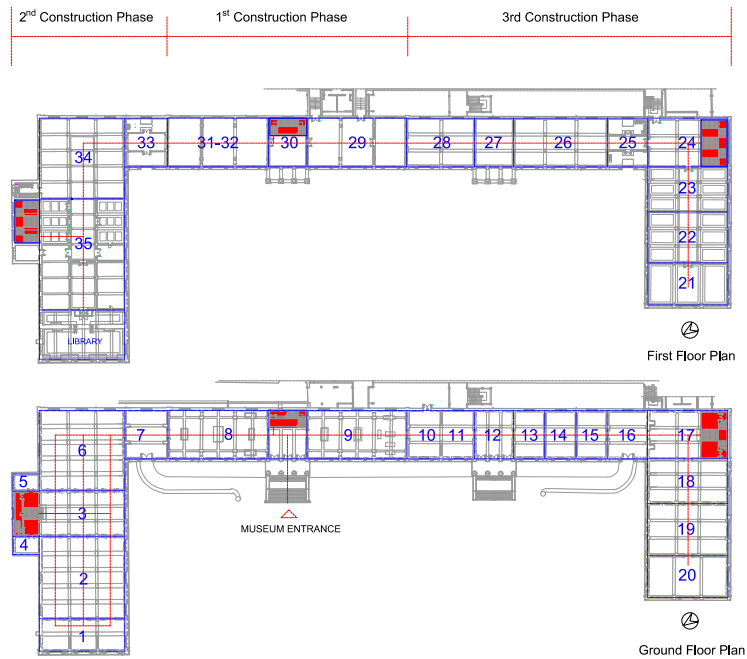
Figure 141. The circulation plan of IAM building for ground and first floor (drawn by the author on the restoration Project drawn by *Seçkin Mimari Hizmetleri*, IDSM Archive)

The third construction phase was originally intended to be symmetrical with the north wing (the second construction phase). However, due to the discovery of a cistern beneath the garden, the additional section was kept wider, as mentioned earlier. It is believed that Vallauray intended to create a symmetrical U-shaped plan surrounding the Tiled Kiosk, but he was unable to do so due to the presence of two cisterns in the courtyard (IAM Archive, Cartoon 45/2, File: 504, 18 Nisan 1322-Mai, 1 1906) and the growing needs of the museum over time (explained in Chapter 3.3.3). To address these challenges, the architect had to add another large door of the same size, featuring massive columns and marble stairs. Despite these changes, the building's "unity of style" remained intact. To maintain symmetry, the museum was designed with two main entrances; the south wing was integrated with the *Sanayi-i Nefise Mektebi* building. This part of the building is two stories tall, with all floors dedicated to exhibition space. As in the second construction phase, a double-armed monumental staircase was also included (Figure 141).

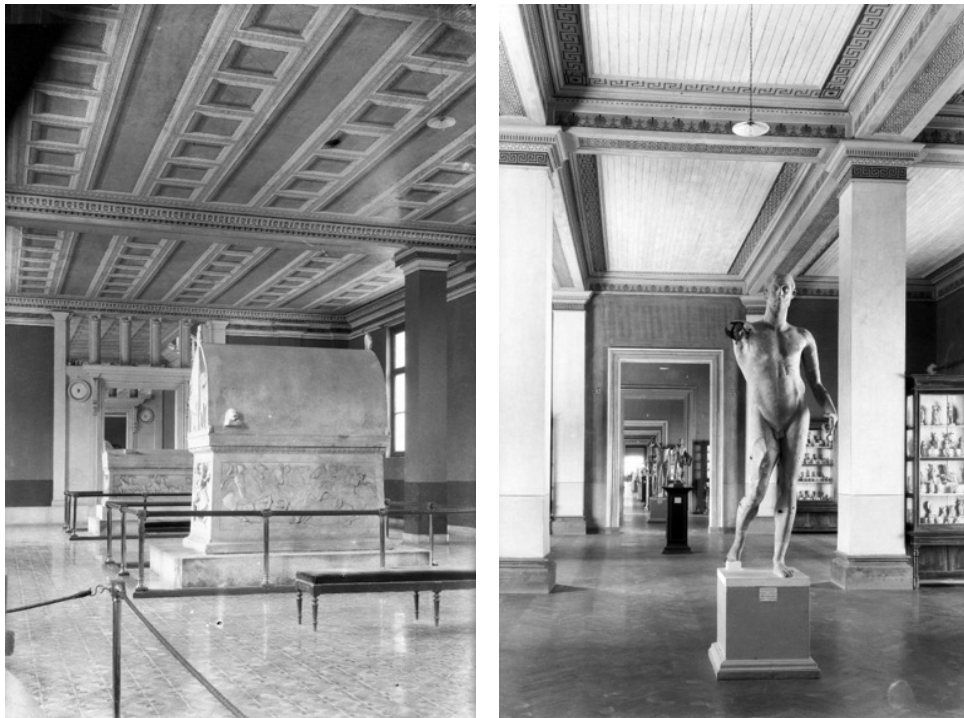
In the IAM building, hand-drawn painted decoration (*kalem işi*) on wood and painted decoration on plaster are the most commonly applied methods throughout the structure (Figure 147). In these painted decorations, patterns are applied to materials such as plaster, stone, wood, and leather using paint and brushes, and sometimes with the addition of gold leaf. Each material requires different techniques to produce ornamental paintwork.

Figure 147. (Left) The photograph taken from ground floor of 1<sup>st</sup> Construction Phase of IAM (Right) The photograph taken from second floor of 3<sup>rd</sup> Construction Phase of IAM (source: IAM-Photography Archive)

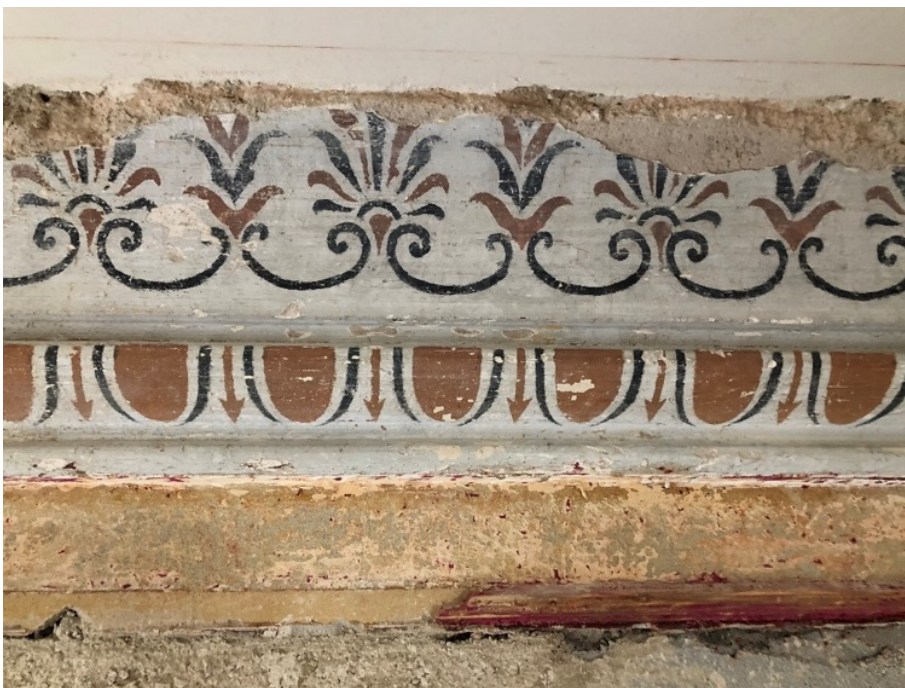
During the restoration of the building, which began in 2017, painted decorations were discovered on the ceiling cornices beneath the Bordeaux paint in halls 8A and 9, the halls housing the sarcophagi (Figure 148). The restoration revealed an anthemion pattern, where palmette and lotus motifs are painted together on the ceiling cornices, with an egg-and-dart sequence beneath the anthemion line. The frieze, which uses anthemion, lotus, and palmette motifs as decoration, reflects

Figure 148. The photograph taken from ground floor of 1<sup>st</sup> Construction phase of IAM Hall no:8 and Hall no:9 (taken by the author in 2018)

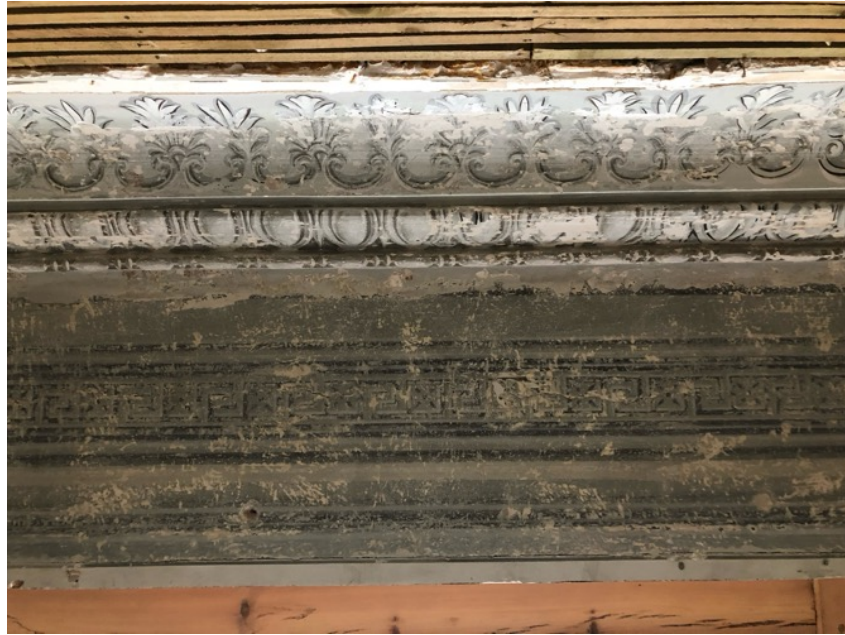
Similar decorations were observed on the wall cornices of the staircase landing on the second floor of 1<sup>st</sup> Phase. However, this time, it is noted that shades of gray were preferred instead of the red, black, and white color scheme (Figure 149).

Figure 149. Hand made decoration traces on the second floor of 1<sup>st</sup> construction phase, Hall no: 30 (taken by the author in 2018)

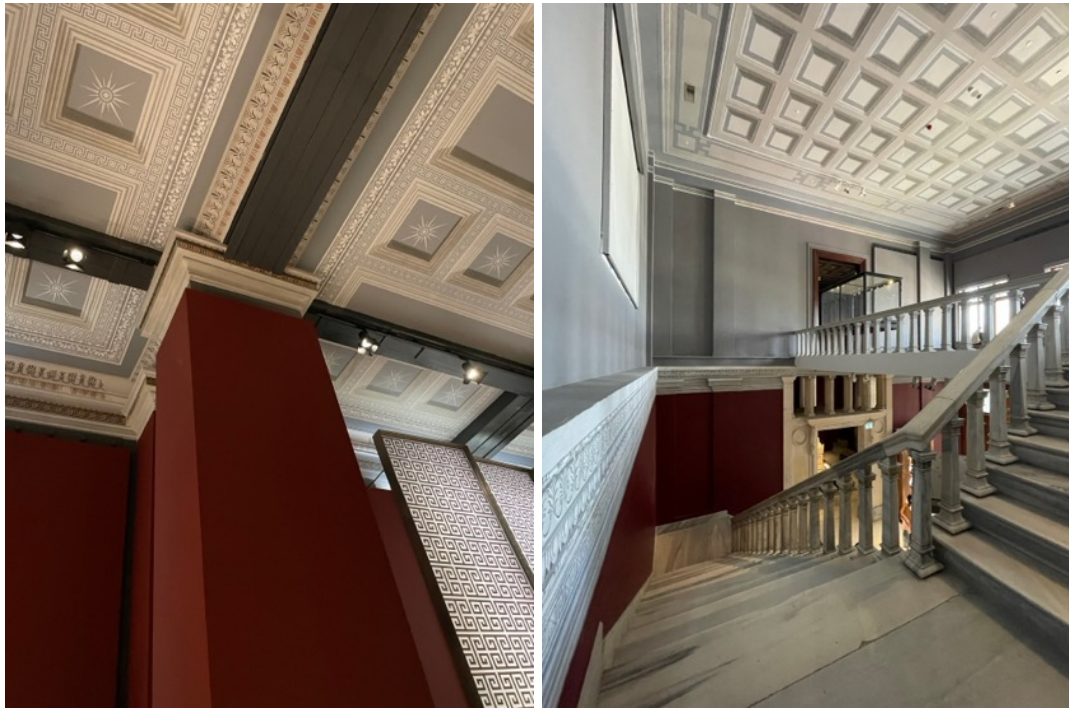
In light of all these analyses, the conservation work for the discovered decorative paintings on the ceiling cornices has been carried out. The ceiling paintings, which cover the entire ceiling and were documented in old photographs and the restoration project, were reapplied to the ceiling of the sarcophagus hall using the original construction techniques (For further details Chapter 4.3.2.2.) To distinguish them from the original decorative paintings, they were rendered in lighter tones (Figure 151).

Figure 151. (Left) The decorative ceiling Hall no: 8 after restoration, (Right) The decorative ceiling of Hall No: 30 after restoration (taken by the author in 2024)

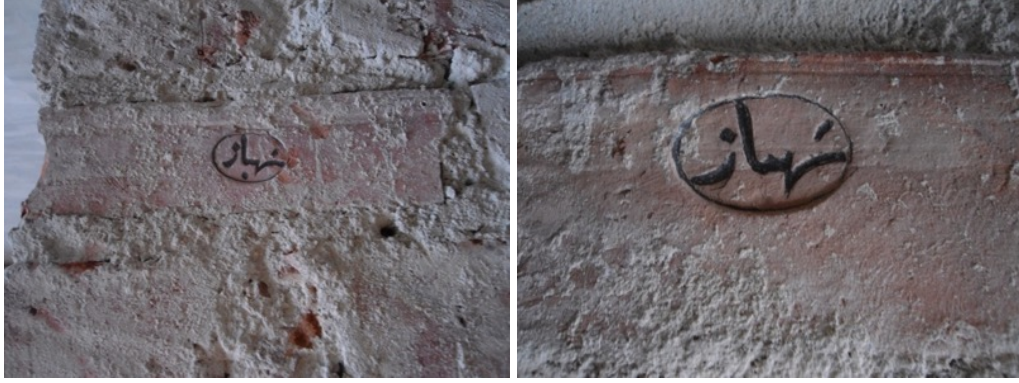
Figure 153. The *şahbaz* brand machine made bricks found in IAM building (source: *Güryapı İnşaat* Company, IDSM Archive)

The construction dates (1887-1907) of the IAM building align precisely with the period when modern-sized bricks began to be produced in local factories. It is known that two types of bricks were used in the museum: solid bricks and perforated bricks (bricks with six holes). The solid bricks were used in the load-bearing walls, while the perforated bricks were utilized in the jack-arched flooring systems and columns on the first floor. The name of the brick is not mentioned in the official correspondence related to the museum building. However, during the 2013 restoration of the museum, a brick bearing an emblem was discovered. The inscription, written in Ottoman script, reads "*Şahbaz*" which was a brick brand that produced machine-made bricks commonly used in 19<sup>th</sup> century buildings in Istanbul (Figure 153). During the building's restoration, solid bricks with the number "3" written in both the Latin and Ottoman alphabets were found on the partition walls that were removed as required by the approved project. Unfortunately, no information about the brand of these bricks was encountered (Figure 154).

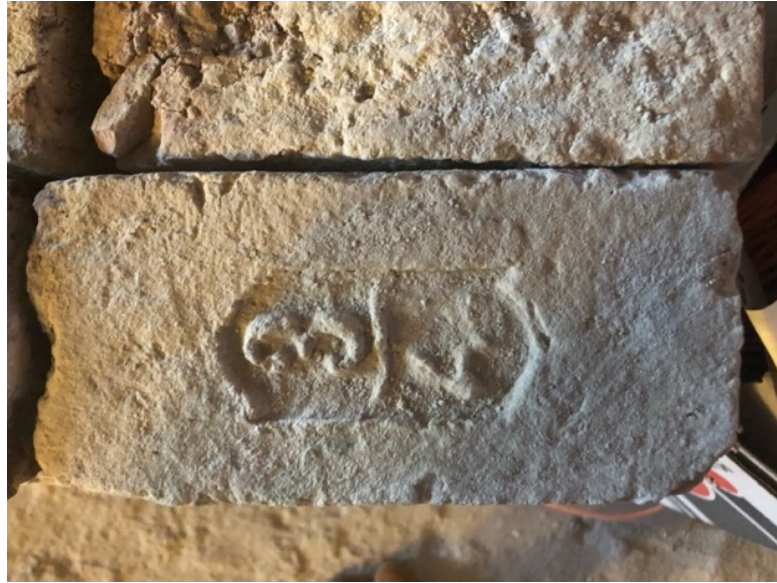
Figure 154. A solid brick example used in IAM building taken from a partition wall added to the building in later periods (taken by the author in 2018)

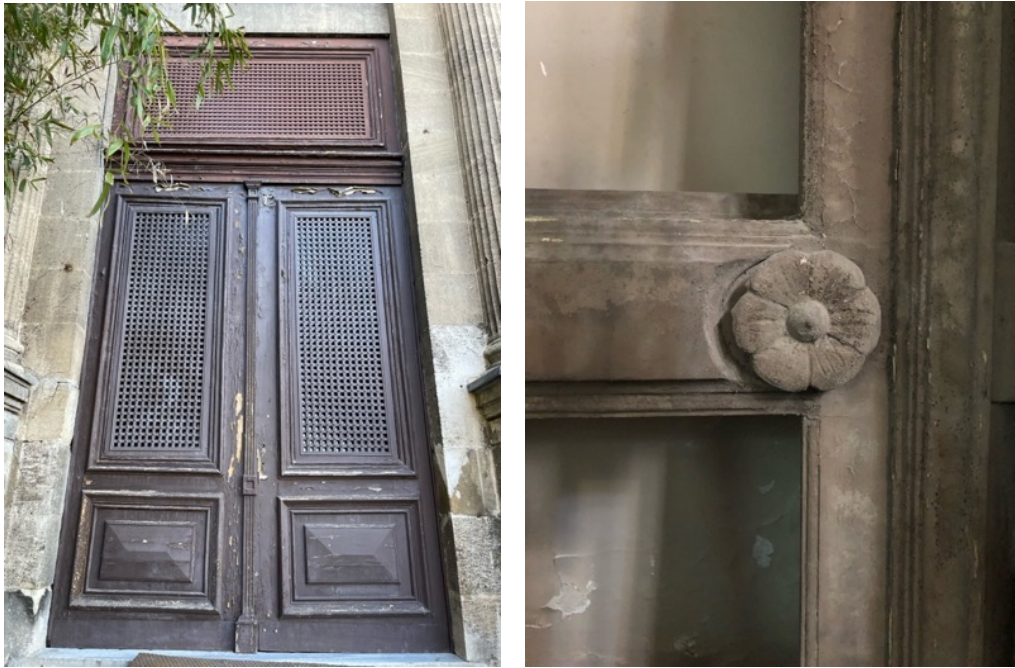
Figure 155. (Left) Exterior wooden door (Right) interior wooden door detail (taken by the author)

Continuing with local construction materials, wood was another commonly used material in the building. Primarily utilized in the ceilings, floors, doors, and Windows (Figure 155), it also played a structural role and provided necessary surfaces for decorative elements. Woodwork was crucial in integrating with the steel flooring structure. The construction details of the IAM building were carefully designed to incorporate timber, creating surfaces needed for decoration. For instance, timber framing was used for the cornices, a timber grid structure supported the wooden parquet on the first floor, and “*bağdadi*” techniques provided a flat surface beneath the iron beams for hand-drawn ceiling ornaments. In this context, it is crucial to understand how the architect integrated timber construction with the iron jack-arched flooring system. The solutions for combining timber and iron beams will be explained in detail under the heading of construction techniques (Chapter 4.3.2.2). This approach enabled the architect to create a traditional appearance for the building.

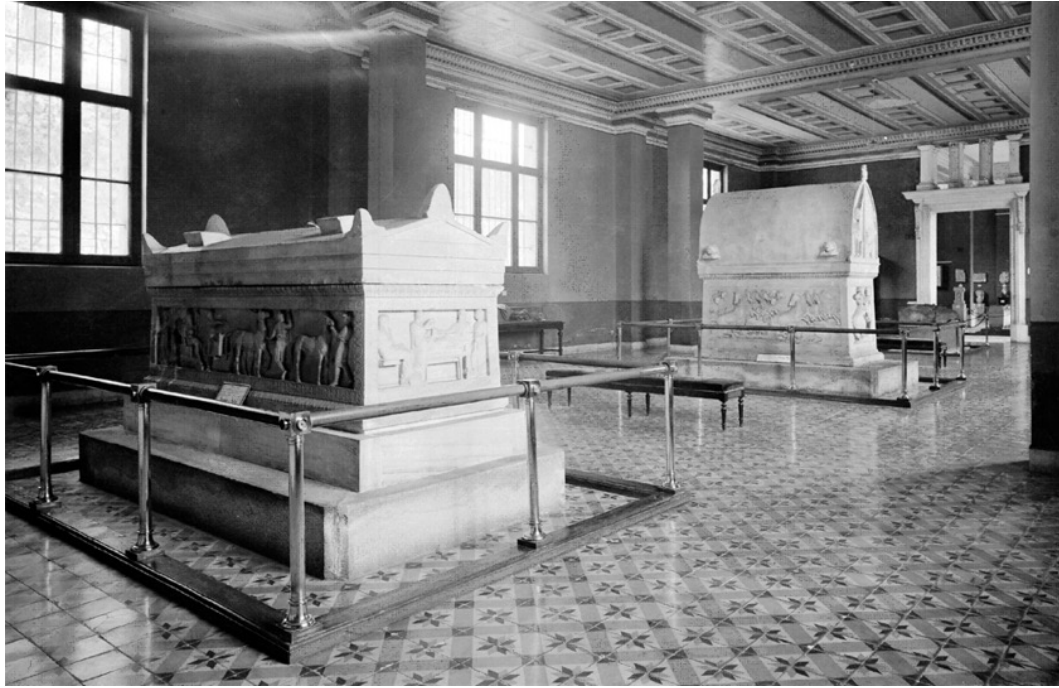
Figure 156. View from the interior of Sidon Sarcophagi Hall (source: IAM-Photography Archive)

Another building material used in the ground floor flooring of the Istanbul Archaeological Museums and worth mentioning is ceramic tile made of cement, also known as “*karomozaik*” or “*karosiman*”(Figure 156). Decorative floor tiles produced in France in the mid-19<sup>th</sup> century found a place in Ottoman architecture, becoming a decorative element that complemented architectural designs through the influence of Levantine families. Initially used in cities such as Istanbul, Izmir, and Mersin, where the Levantine population preferred to live, these tiles quickly became fashionable and left a lasting mark, being used in almost all buildings constructed between the mid-19<sup>th</sup> and mid-20<sup>th</sup> centuries (Uçar, 2013).

An interesting detail emerged during the restoration of the IAM building, as it became necessary to relocate certain Sidon sarcophagi in the Sarcophagus Hall as part of the new exhibition Layout Project. Under a sarcophagus that had been moved in Hall 9 for flooring work, traces of the old cement tile pattern, visible in earlier photographs, were discovered. The presence of cement tiles was already known from historical photos of the museum (Figure 156). Although marble replaced the original

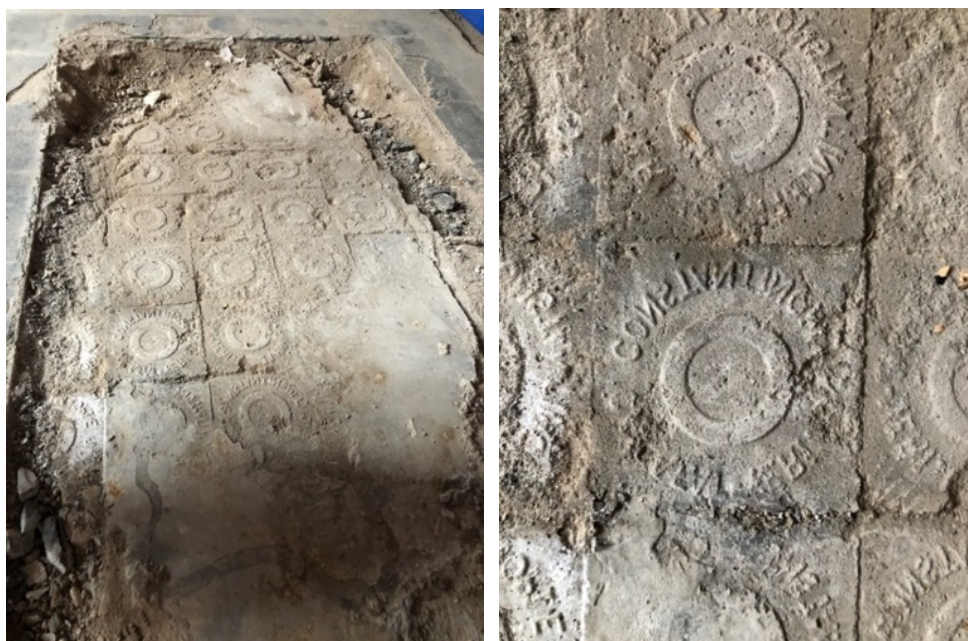
Figure 157. Cement tile “*karo mozaik*” traces written “*Constantinople Kalafat Yeri*” found under one of the sarcophagi in the Sarcophagus hall which was covered by marble later on (taken by the author in 2018)

On the reverse side of the tile, an embossed inscription, likely a brand mark, was clearly visible on the cement surface (Figure 157, Figure 158). This finding confirms the presence of both cement and cement tiles on the ground floor of the building. It is known that relatively smaller sarcophagi, which could be moved, were relocated within the exhibition area after the museum's opening. This situation must have contributed to concealing some traces in the flooring, which eventually evolved into a marble surface in time.

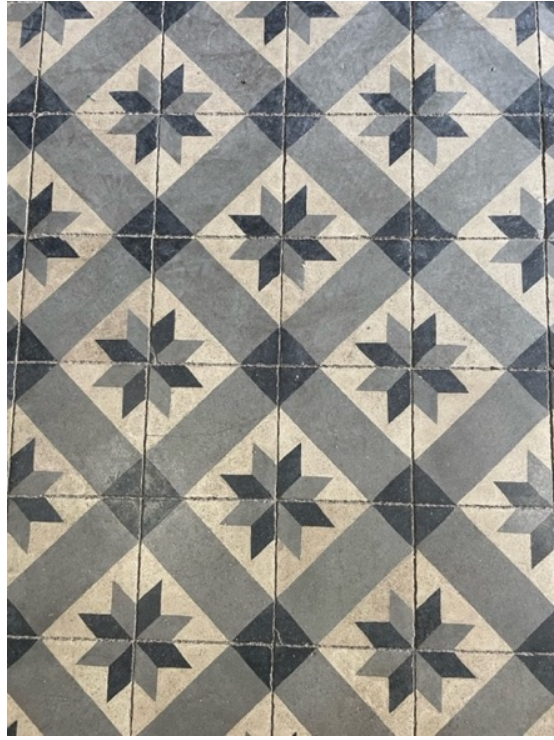
Figure 158. The Cement tiles “*karo mozaik*” in the 2<sup>nd</sup> phase of IAM (taken by the author in 2024)

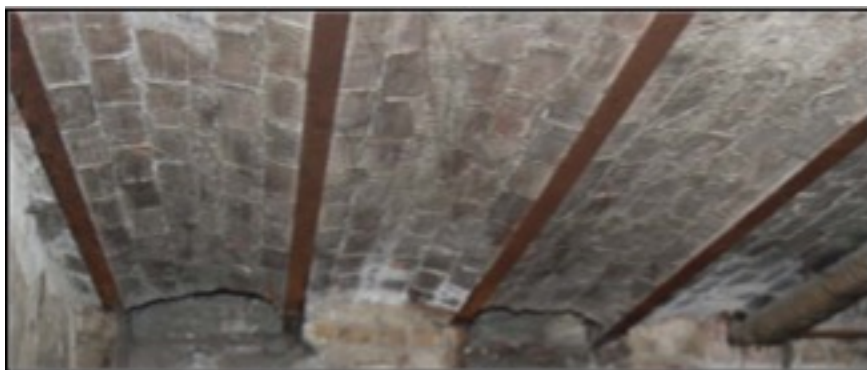
Figure 169. Jack Arched Flooring detail of Hezaren Han Building (Altan, 2007)

The contract of *Hezaren Han* (Figure 168-Figure 169) building signed by Vallaury gives important information related to the construction techniques of the building. According to contract.

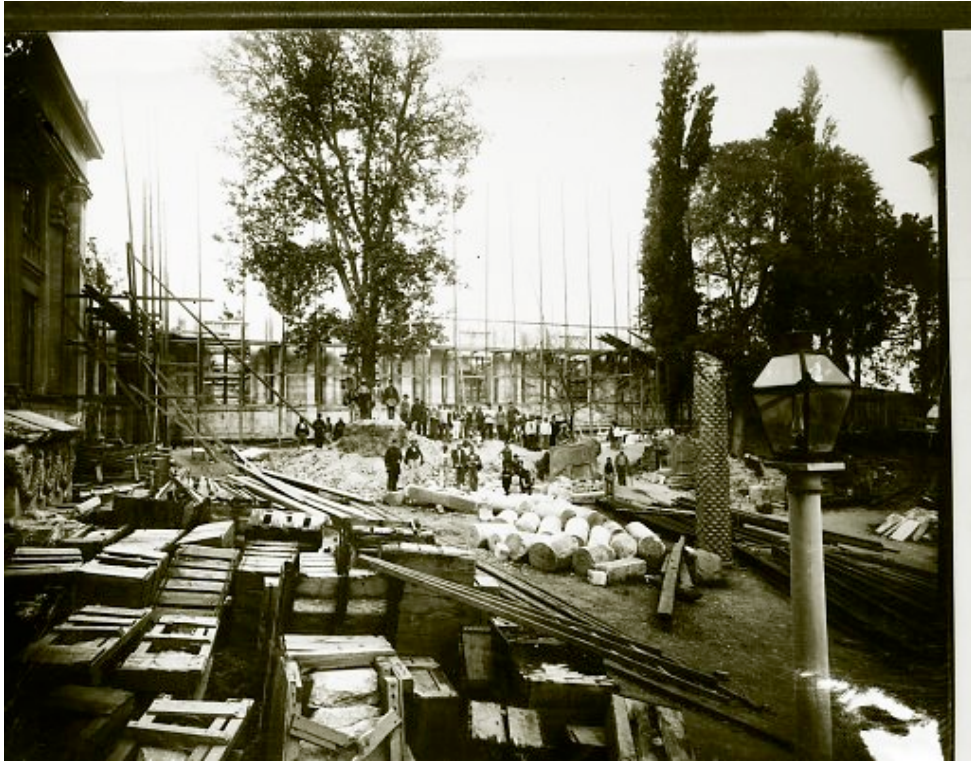
Figure 170. Stone blocks on the garden of the museum from the 3<sup>rd</sup> construction phase of the museum (source: CAMGD Archive)

From this point onward, an in-depth analysis of the research findings related to the stones used specifically on the façade of the Istanbul Archaeological Museum (Figure 170), along with comparative studies conducted in Marseille, will be presented.

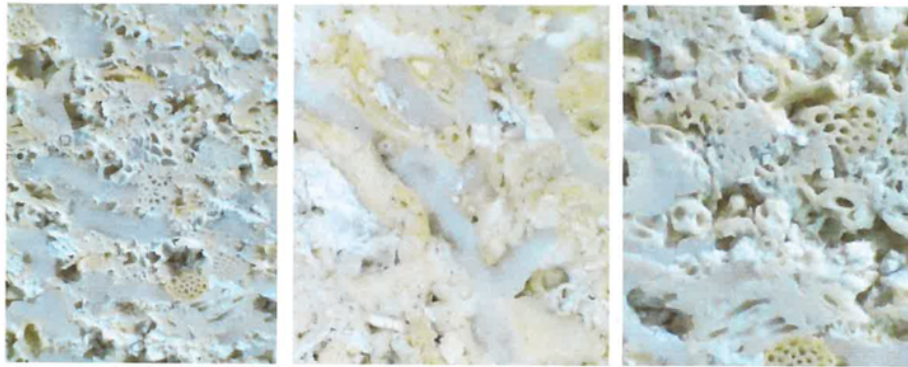
Figure 172. Micro Capture USB Microscope Viewed from cross-sectional surface. There is plenty of bryazone, diatomite and a few nummulites. (source: 26.01.2012 dated Istanbul Restoration and Conservation Regional and Central Laboratory Directorate Report prepared by İsmet OK, IDSMS Archive)

The thin section prepared in Istanbul Restoration and Conservation Regional and Central Laboratory Directorate was sent to the Geology Department of Istanbul Technical University in 2012, where it was examined and photographed under a Polarizing Microscope. During the examinations, *Bryazon* and *algal nummulite* were detected in the limestone (Figure 172, Figure 173). Looking at these fossil types according to Prof. Dr. Sinan Öngen, it has been stated that the stone is from the *Tertiary Eocene* period (Thrace formation - *Çatalca* Region) and gives the impression that it was formed in a shallow sea in a warm environment.

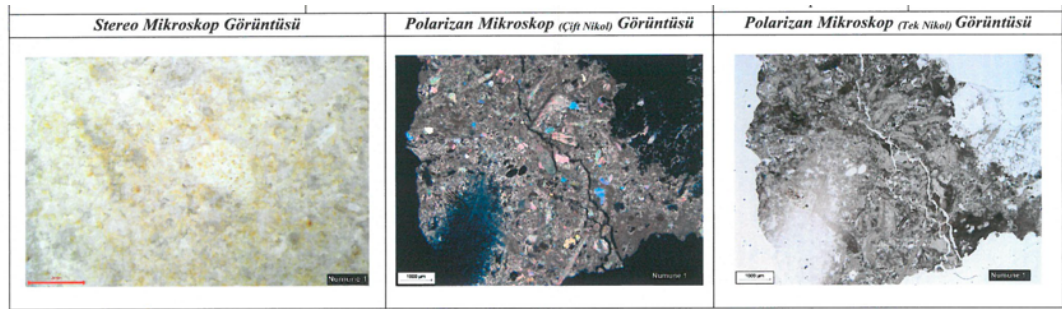
Figure 181. (Left) Stereo Microscope Image, (Right) Polarizing Microscope Image produced by Istanbul Municipality KUDEB

Ignition Analysis (Calcination) and 0,5 hour SEM-EDX) results conducted by *Istanbul Büyükşehir Belediyesi KUDEB Restorasyon ve Konservasyon Laboratuvarı (Koruma Uygulama ve Denetim Müdürlüğü)* on the samples (Figure 179, Figure 180, Figure 181, Figure 182) taken from the stones at the Fontvieille quarry are as follows.

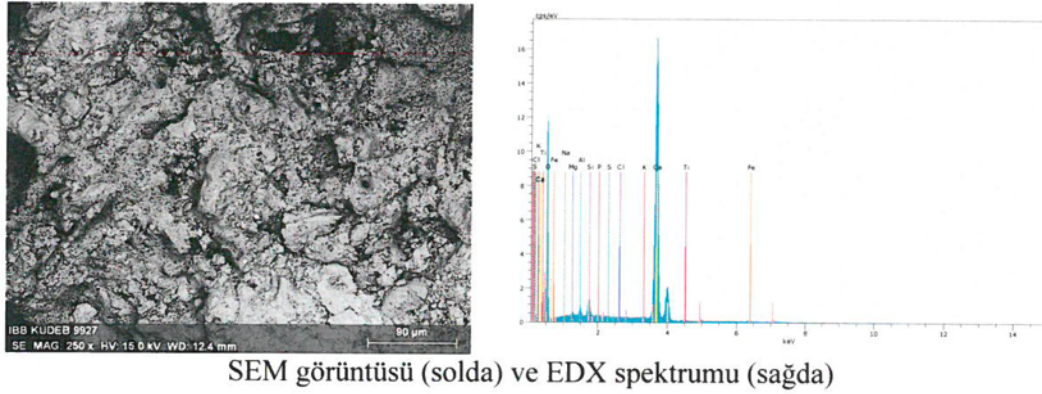
Figure 182. (Left) SEM image and (Right)EDX spectrum produced by Istanbul Municipality KUDEB

It was determined that the sample contained a very high amount of calcium, with significantly smaller amounts of silicon, aluminum, potassium, iron, magnesium, sodium, and phosphorus (Table 5).

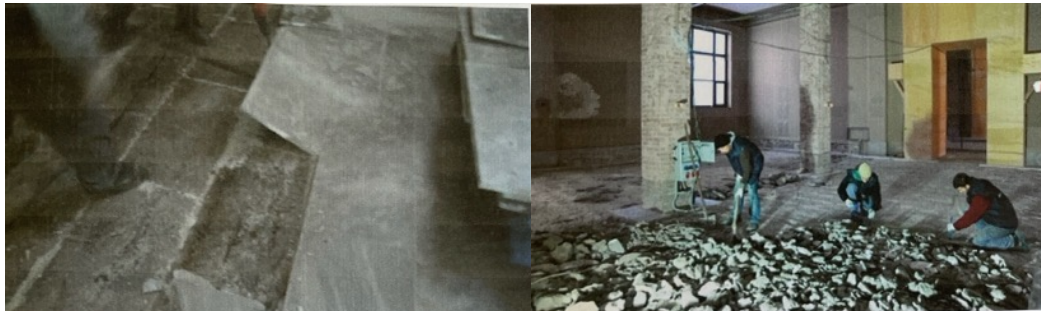
Figure 190. The removal of marble and cement layer from the ground floor of 3<sup>rd</sup> phase of IAM building.

The floor pavement of museum was originally made of with cement tiles (*karosiman*) on the ground floor and timber parquet on the upper floors. However, the cement tiles visible in old photographs were later replaced with marble. When the marble was removed, approximately 10 cm of cement slab was observed underneath. It is known that the screed was imported from abroad, but this does not necessarily prove that it was part of the original construction. At this point, a photograph (Figure 190) taken from the first section confirms that the original cement tiles flooring was laid over screed.

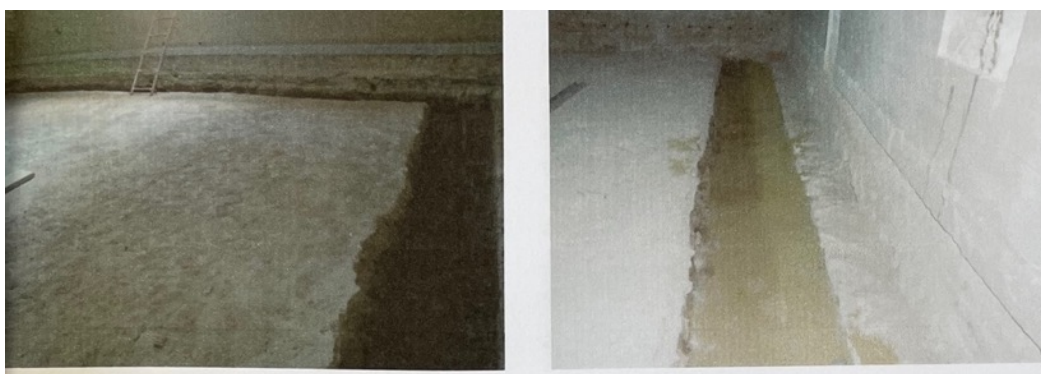
Figure 192. The photographs of the excavation along load bearing walls the ground level of 3<sup>rd</sup> Construction Phase of IAM (source: IDSM Archive)

As part of the restoration (2011-2017), the ground and the load-bearing walls were strengthened. According to the static project, the area around the columns and adjacent to the load-bearing walls at the ground level was reinforced with concrete. For this purpose, excavations measuring 50 cm in length and 41 cm in depth were undertaken along the load bearing walls of the 1<sup>st</sup> and 3<sup>rd</sup> construction phases of the museum. It was discovered that the thickness of the foundation walls is 27 cm greater below ground level compared to the walls on the ground floor (Figure 191, Figure 192).

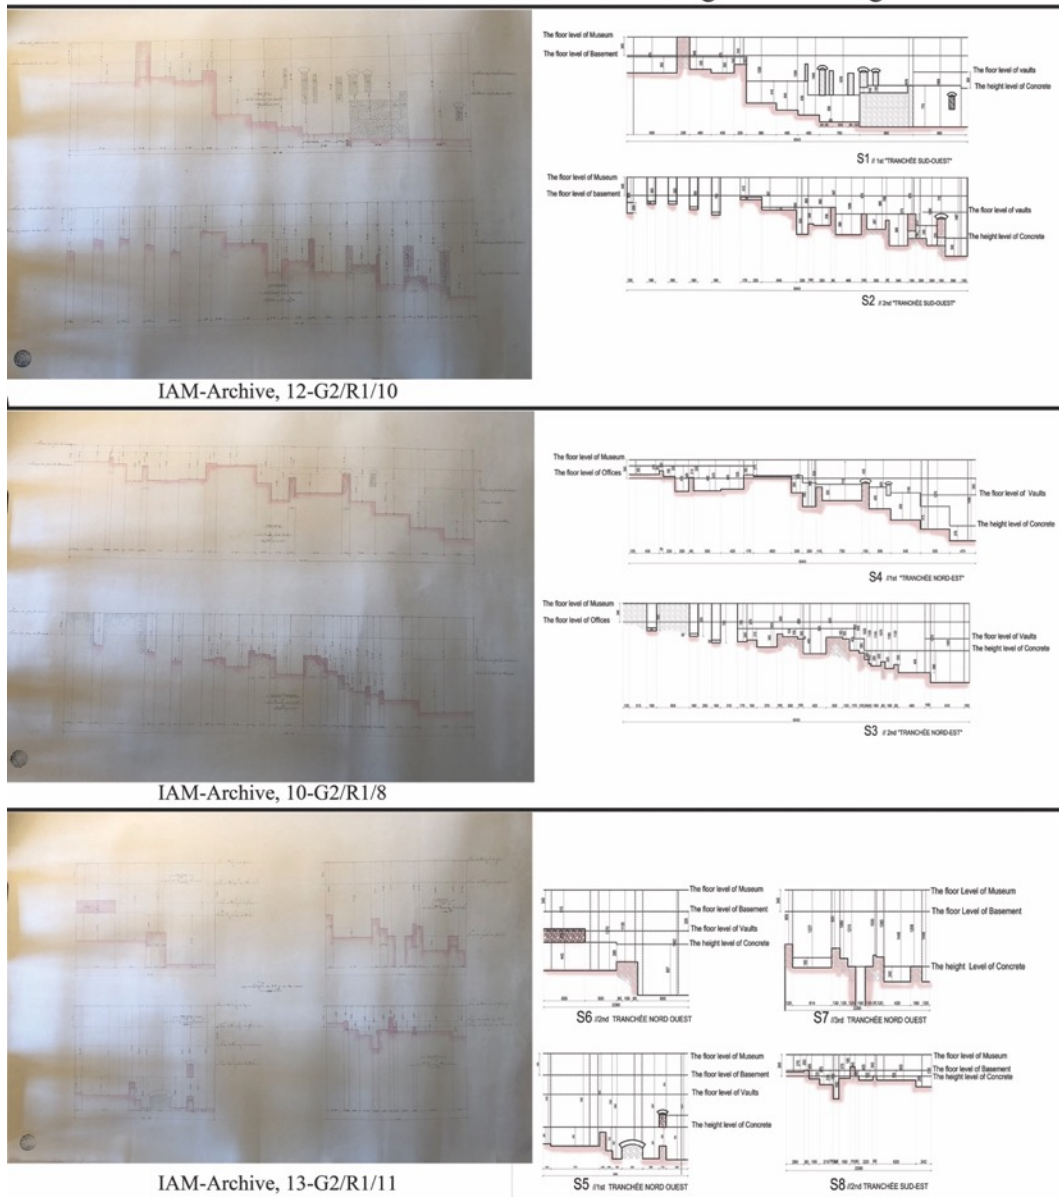
Figure 194. Original drawings (on left) and digital superimposed drawings (on right) (produced by the author based on their original drawings).

Looking at the original foundation plan of the Second Phase (Figure 194, Top), an interesting feature reveals itself. In this plan, there are continuous loadbearing walls on the south-east and singular column footings on north-west. While there should be eight column footings that continue in the upper floors as well, on the west side of the building, one of them was deliberately skipped and only seven column footings were drawn. This odd decision becomes more meaningful when the cross section passing through this direction is examined. In the S3 section (Figure 194, Middle) there are just three (3) column pits. A stone pattern was drawn in the place of missing footing. This pavement, which seems to be the remains of the understructure, might have served as a solid structure to carry the column. Another reason might be to protect the remains and take advantage of their existence.

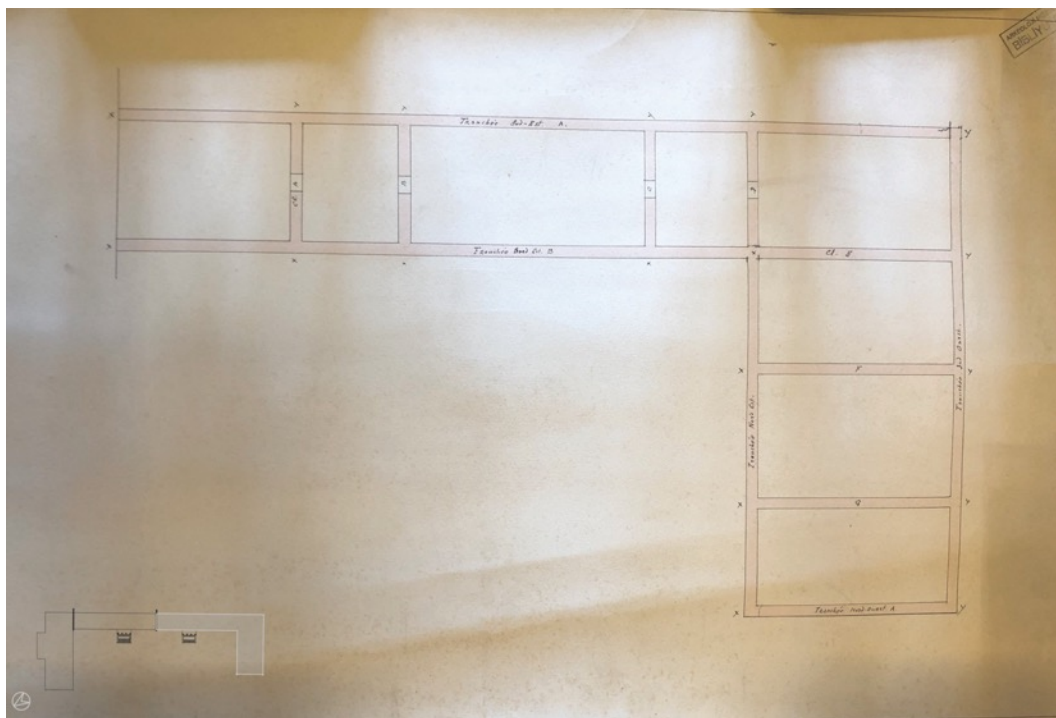
Figure 198. Key plan for foundation sections of the third construction phase of IAM buildings (“IAM-Archive, 102, G3/R3/13”, n.d.).

Among the original drawings analyzed, it is discovered that four of them are related to site excavations of the third construction phase. The purpose and style of drawings are similar to those related to the second phase, although they were prepared at least 5 years later than the drawings of the second phase. These are i) the foundation plan of the third construction phase (Figure 198), ii) two partial plans; the elongated entrance and short façade of the third phase (Figure 199, Top and Bottom), iii) two longitudinal sections of outer walls (Figure 199, Middle). However, this time,

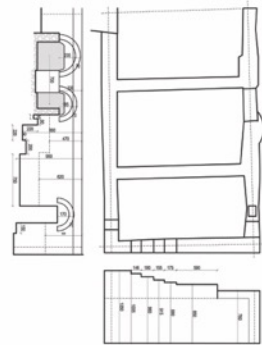
Figure 199. (Top) Partial plan of the south wing of the third construction phase of IAM ("IAM Archive, 101, G3/R3/12", n.d.) Middle: Longitudinal foundation sections of IAM's third construction phase ("IAM Archive, 105, G3/R3/16", n.d.) (Bottom) Partial plan of the south wing of the third construction phase ("IAM Archive, 129, G4/R2/15", n.d.)

the drawings are less detailed. They include neither a title nor dimensions. They display only some codes (numbers and letters) referring to other drawings. The drawings, which include a partial plan with sections together (Figure 199, Top and Bottom), allowed the researcher to create a more reliable map of remains for this phase. This plan showing the exact location of the remains also proved the accuracy of the method that was carried out at the beginning of the study.

The partial plan in IAM-Archive, 129-G4/R2/15 (Figure 199, Bottom) is one of the most important drawings analyzed within the scope of this study. It shows the elongated entrance façade plan of the museum. The traces of the remains have been processed on this plan. In addition, there are sections on the lower and upper sides of the plan that pass through the outer walls of the building. In these sections, the remains are clearly visible. The handwritten notes on the plan also provide additional information. The expression *petite cisterna* (little cistern) was used for the place coinciding with the remains drawn in the upper section of the plan. The thick walls seen in the plan, which is drawn at the intersection of the entrance facade and short wing, are noted as *mur* (wall). The lines in the plan and the section corresponds to each other exactly. This proves that the method the authors utilized to create the remains plan from the sections of foundation walls is correct.

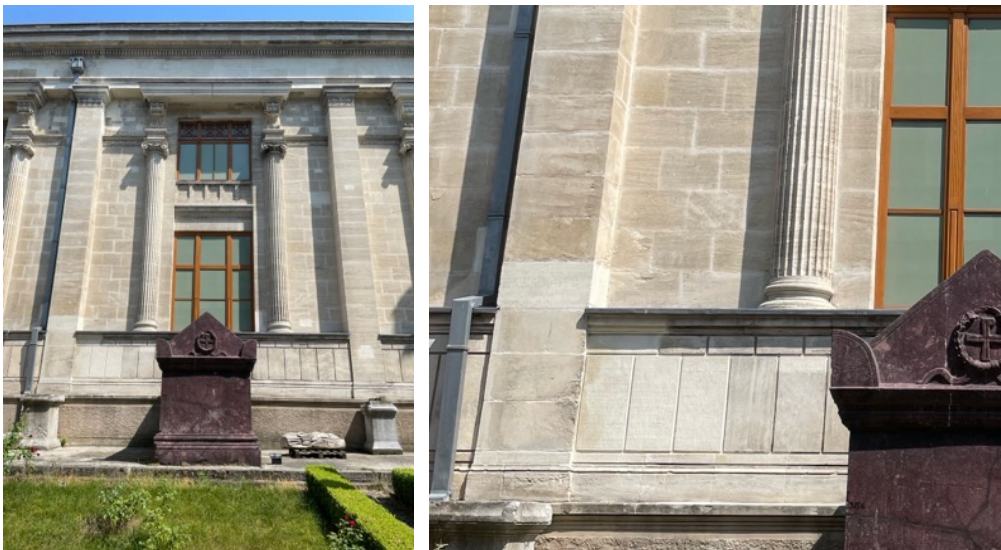
Figure 204. The details from the Facade of IAM building (taken by the author ÎN 2024)

The materials and methods used in the masonry walls vary in each phase, and these will be explained in detail in subsequent sections. The sketch is so similar to the current application (Figure 203, Figure 204), however it is also not known for which specific phase it was drawn. Upon examining the discrepancies, no iron beams were found during ground reinforcement work on-site, while a 10 cm high cement-based slab was identified beneath the marble cladding. Iron beams are present on the first-floor slab. In fact, a closer look at the drawing reveals that the iron beams shown in gray are lightly marked over in pencil, which could be interpreted as an indication of a change in the architectural decision.

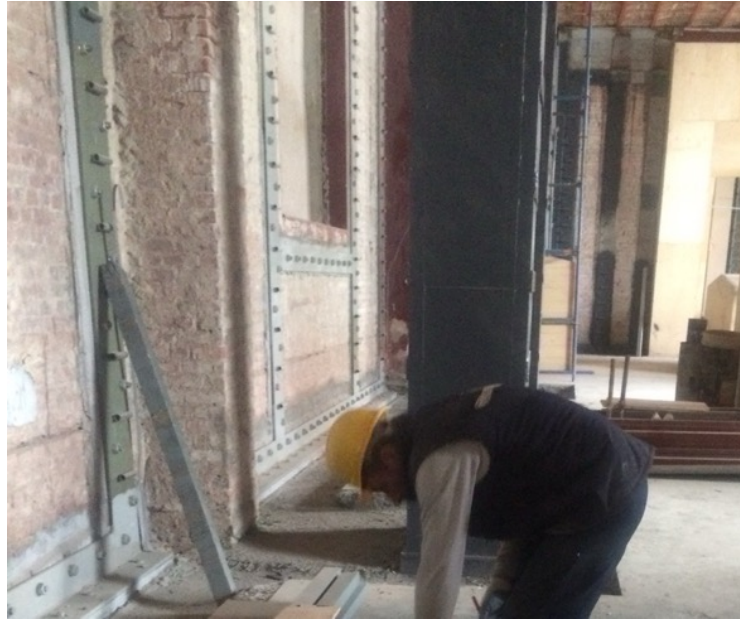
Figure 206. The photo showing brick masonry walls of 1<sup>st</sup> phase of IAM taken during strengthening work in between 2011-2017 (source: *Güryapı İnşaat* Company, IDSM Archive)

Restoration photographs indicate that the load-bearing wall construction system is based on brick masonry (Figure 206, Figure 207). Analyzing the construction technique of the columns reveals that solid bricks were used on the ground floor, while perforated bricks appear on the upper floor. However, this may not apply to every column, as no technical drawings detailing the construction techniques and their precise locations on the plan have been found in the archives (Figure 208). Additionally, it remains unknown whether vertical iron elements are present within the columns, as a ground-penetrating radar (GPR) survey has not yet been performed.

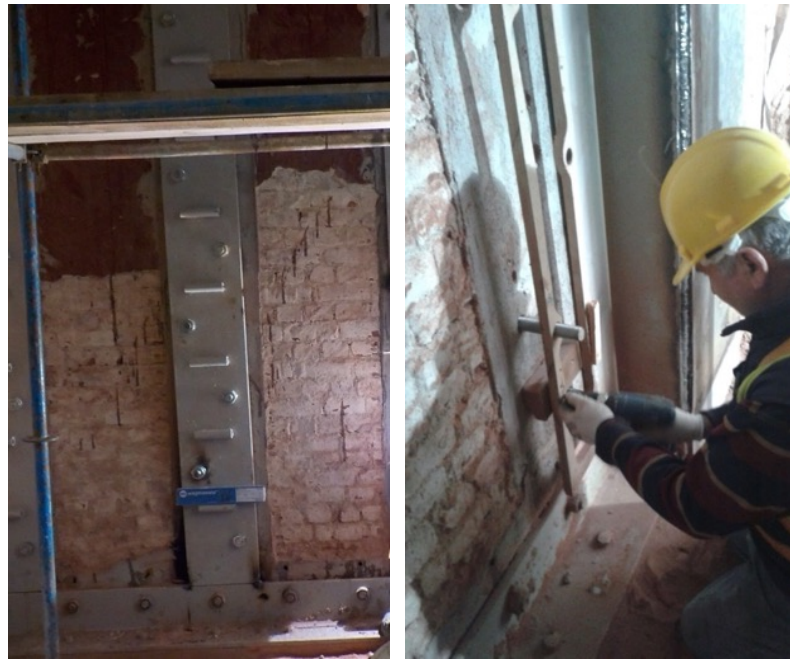
Figure 207. The photo showing brick masonry walls of 1<sup>st</sup> phase of IAM taken during strengthening work in between 2011-2017 (source: *Güryapı İnşaat*, IDSM Archive)

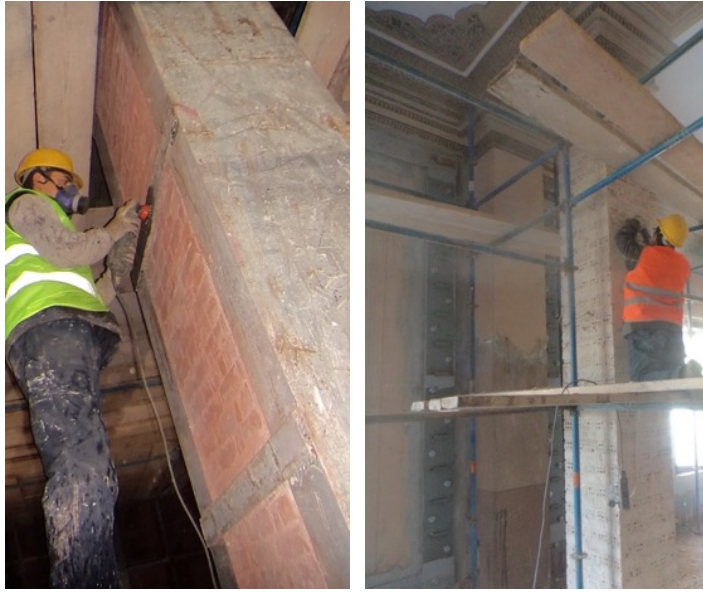
Figure 208. The photo showing brick masonry columns of 1<sup>st</sup> phase of IAM taken during strengthening work in between 2011-2017, left ground floor right: 1<sup>st</sup> floor (source: *Güryapı İnşaat*, IDSM Archive)

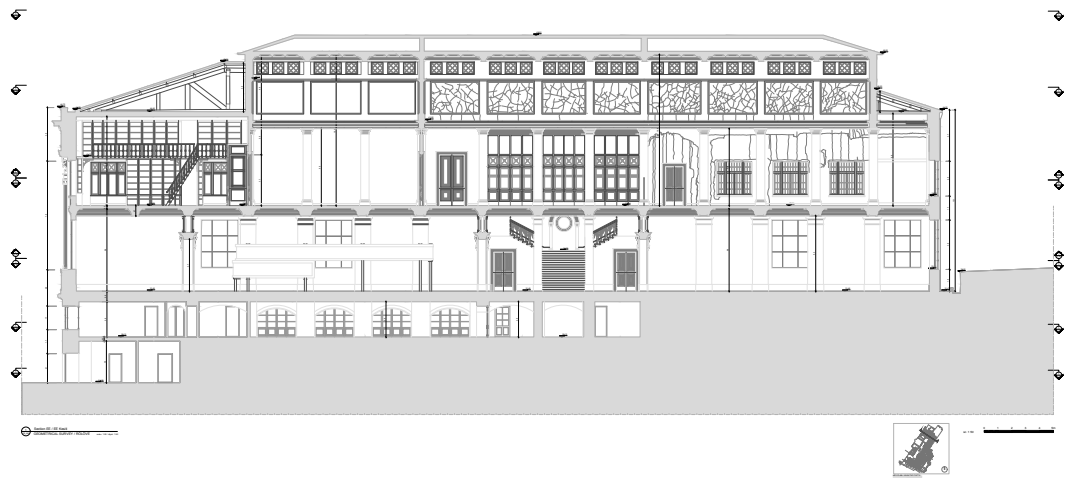
Figure 211. (Top) EE section of survey drawing drawn in 2009- 2010 (Bottom) Key plan of the section (source: Geometrical Survey Drawing prepared by OSM Engineering, IDSM Archive)

This phase consists of two basement floors, a ground floor, and a first floor. The architect Vallaurý has once again placed the stairwell along the central axis of the structure. Solutions similar to those in the 1<sup>st</sup> Construction Phase have been applied on the ground and first floors, with the masonry wall and column system continuing. However, some changes are noticeable this time. At first glance, the building's plan reveals that, compared to the first phase, the columns are positioned closer to the center of the structure and are spaced more densely (Figure 210). The ground and first floors are entirely dedicated to exhibition functions (with a library also located on the first floor), while the first basement floor serves administrative functions, and the second basement floor caters to technical needs (Figure 211).

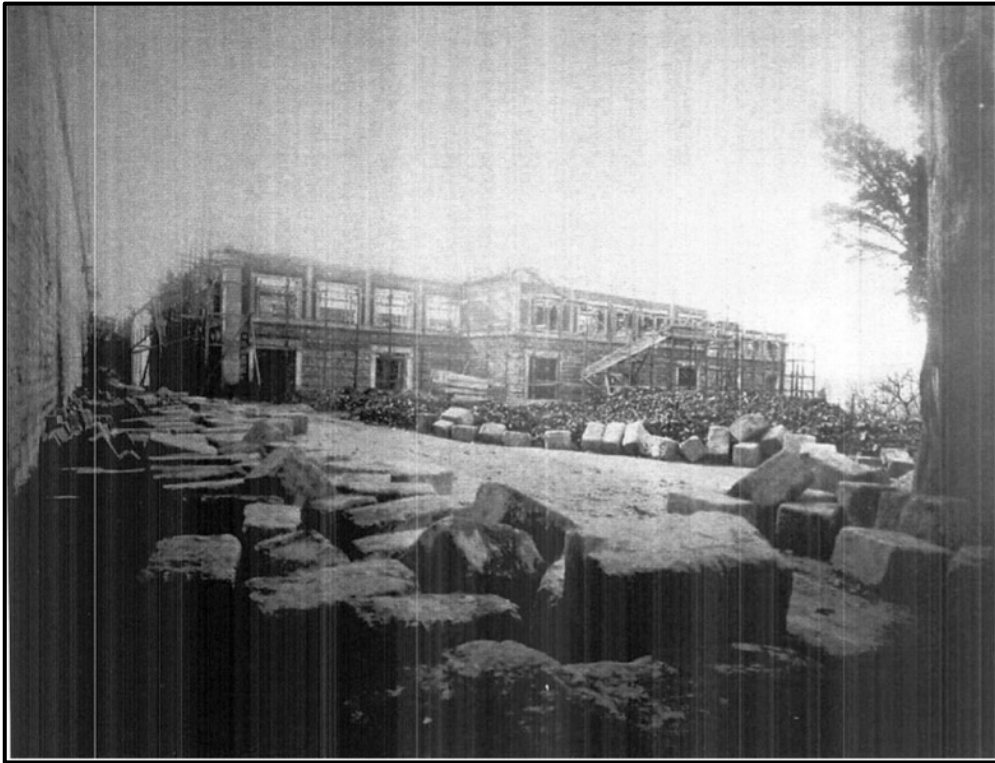
Figure 212. The old photo of rear façade of 2<sup>nd</sup> construction phase of IAM (source: Restitution Report of IAM prepared by *Seçkin Mimari Hizmetleri*, IDSM Archive)

While the photograph (Figure 212) obtained from the IAM archive provides valuable insight into the building's construction, its distant perspective makes it challenging to observe finer details. Upon closer inspection of the photograph, the left side of the ground floor appears to feature a rubble stone wall with clearly seen brick beams. However, this pattern does not seem to extend to the right side of the photograph, where the structure appears to consist entirely of brick masonry. This is evidenced by a photograph taken from inside the same area (Figure 212), as the exposed inner section of the wall, where the plaster has fallen off, reveals that the masonry is composed of brick (Figure 213, Figure 214). This area includes staircases and service spaces raising the question of whether brick masonry was used exclusively here due to the planned expansion in this part of the building, as suggested by the layout plans.

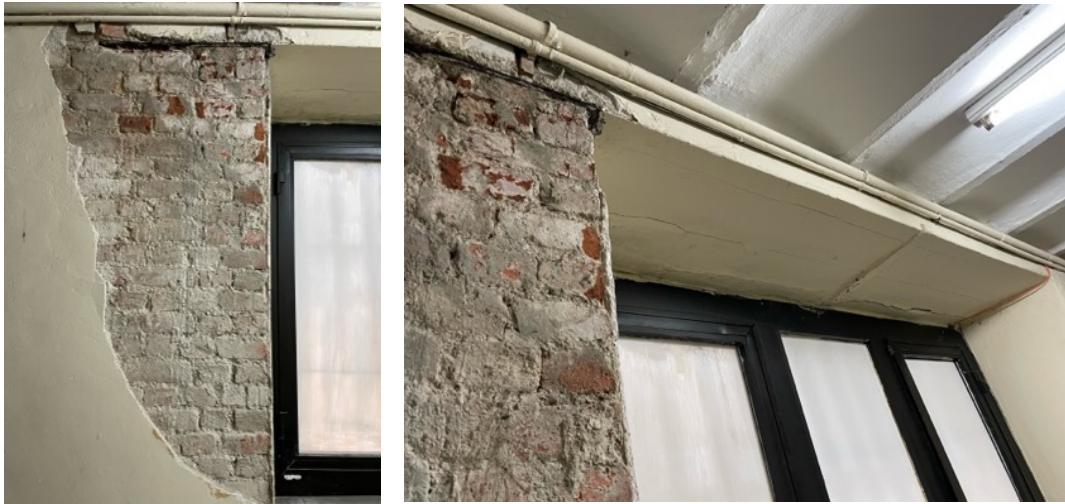
Figure 214. The inside view of the stairwell exterior walls of 2<sup>nd</sup> Construction Phase of IAM (taken by the author in 2024)
