REINSTITUTING KNOWLEDGE ON CONSTRUCTION TECHNIQUES AND  
MATERIALS OF A LATE OTTOMAN IMPERIAL BUILDING:  
ISTANBUL ARCHAEOLOGICAL MUSEUM

A THESIS SUBMITTED TO  
THE GRADUATE SCHOOL OF NATURAL AND APPLIED SCIENCES  
OF  
MIDDLE EAST TECHNICAL UNIVERSITY

DENİZ ÜSTOĞLU COŞKUN

JANUARY 2025

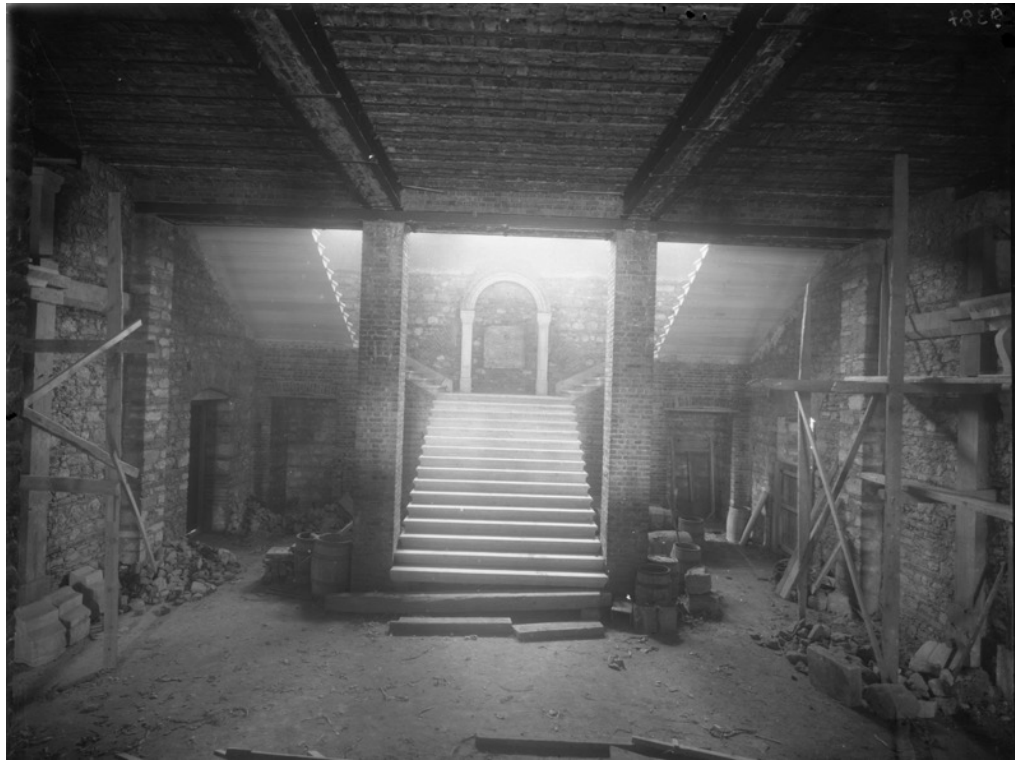
Figure 215. A photograph taken inside the 3<sup>rd</sup> Construction Phase of the building, across from the main staircase in Hall 16 (source: CAMGD-Archive)

In the Figure 215, the marble stair steps, brick columns, and wall construction system are clearly visible. Upon closer inspection of the wall system, the wall on the left side of the photograph is the external load-bearing wall, while the wall on the right is an internal wall that separates two rooms. However, this internal wall is also load-bearing, as evidenced by its thickness and the original foundation plan. At first glance, both walls appear to be rubble stone construction with a mix of stone and brick. Embedded columns are visible on both walls, indicating they were constructed using the same technique. While the stones are clearly distinguishable, it is difficult to ascertain whether there are brick courses between the stone layers. To clarify this, further analysis of a second photograph is required.

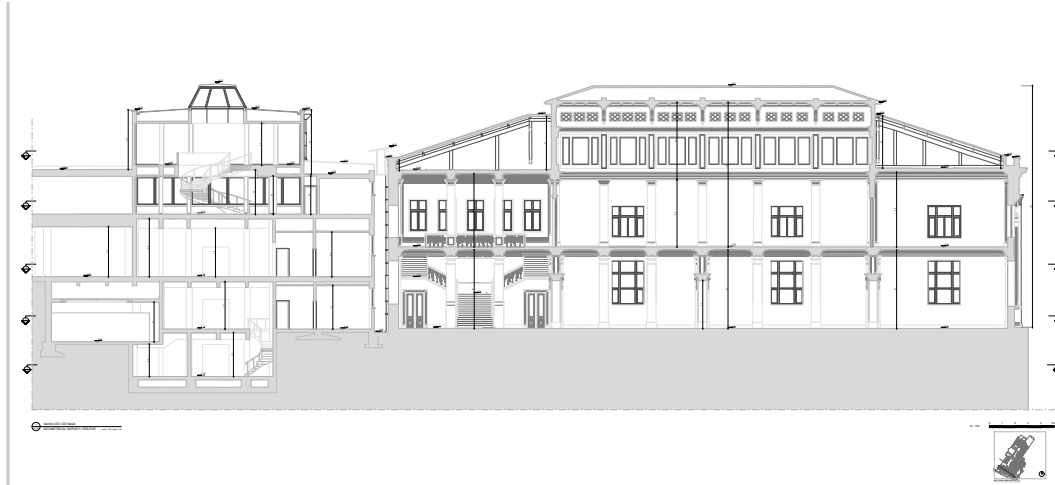
Figure 219. (Top) DD section of survey drawing drawn in 2009-2010 by *Seçkin Mimari Hizmetleri* (Bottom) Key plan of the section (source: Geometrical Survey Drawing prepared by OSM Engineering, IDSMArchive)

According to the survey drawing of the museum building, the thickness of the external wall on the front façade is 55 to 60 cm on both the ground floor and first floor. The thickness of the external wall on the rear façade varies, measuring 75 to 80 cm on the ground floor and 55 to 60 cm on the first floor. This thickness decreases to 65 to 70 cm on the ground floor of the rear façade, where there is no stone cladding. Regarding the columns, the independent columns throughout the building measure 60 to 65 cm in width. The largest span between columns is 8 meters. Based on this data, it can be observed that, in the 3<sup>rd</sup> Construction Phase, the wall thickness remains consistent between the ground and first floors, except for the rear façade, where it reduces from 75-80 cm to 55-60 cm. However, the column dimensions remain unchanged between the two floors.

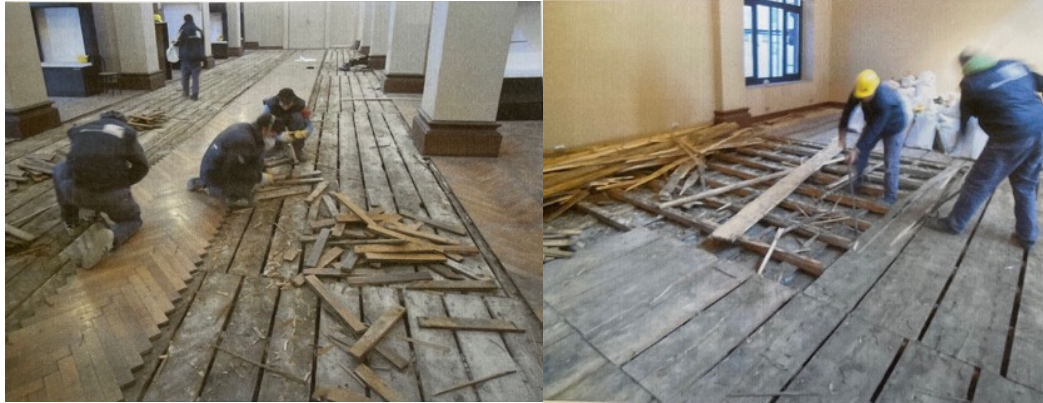
Figure 225. The removal of wooden parquet from first floor of 3<sup>rd</sup> Construction Phase of IAM (source: *Güryapı İnşaat Company*, IDSMArchive)

The process began with the removal of the parquet flooring on the first floor, during which a significant amount of information was gathered (Figure 225). This information came from structural system surveys conducted during the dismantling process and from the drawings and measurements of the iron beams stored in the museum archives. As previously mentioned, the restoration work was implemented only in the 1<sup>st</sup> and 2<sup>nd</sup> Construction Phases of the building.

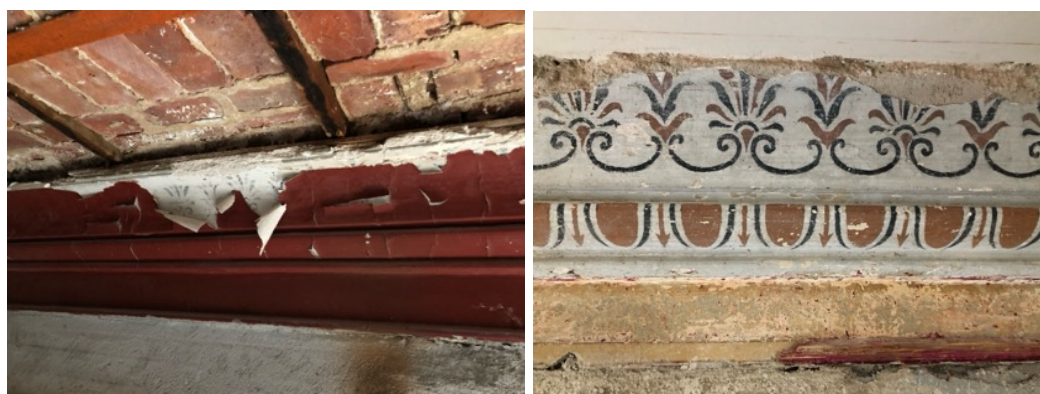
During the second-phase restoration, which began in 2016, investigative scraping conducted on the plaster cornices in Halls 8 and 9 revealed hand-painted decorations beneath the layers of paint (Figure 236). These decorations were determined to be original patterns, remnants of the decorations that once adorned the entire ceiling. As part of the restoration project, cleaning and consolidation work was carried out on these hand-painted details. Additionally, the ceiling decorations, known to have existed, were reconstructed in accordance with the original designs and restoration principles. First, the *Bağdadi*<sup>100</sup> framework was rebuilt, followed by the application of plaster layers in the proper sequence, culminating in the completion of the hand-painted decorations. This raises a key question: how were these hand-painted ornaments integrated into a structure built primarily with iron, stone, and brick masonry?

Figure 236. The photographs taken during the removal of painting layer from the cornice decorations (source: taken by the author in 2018)

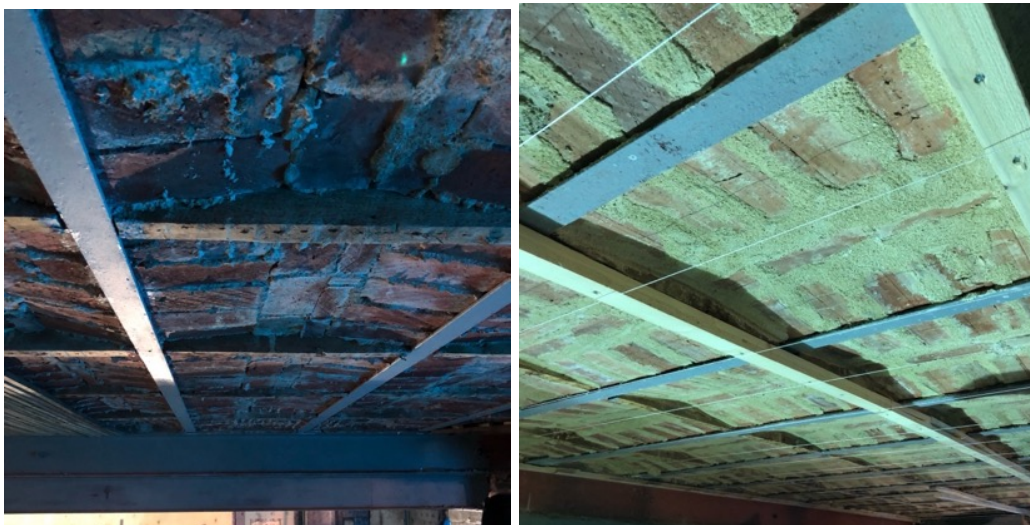
Attaching the “*Bağdadi*” (Figure 238) framework to the steel beams supporting the jack arch flooring is a complex process. Wooden wedges are placed inside of I profiles to achieve this (Figure 237). Long, thin timber pieces are then positioned perpendicularly to the wedges and secured with nails, creating a flat surface beneath the jack arch flooring. Once this surface is prepared, a layer of rough plaster (Figure 239 Left), followed by fine plaster with a lime binder, is applied. Finally, a coat of “*nefaset*” (Figure 239 Right) plaster is applied as the finishing layer, providing the smooth surface necessary for the hand-painted ornamentation.

Figure 237. The construction system under the ceiling (taken by the author in 2018)

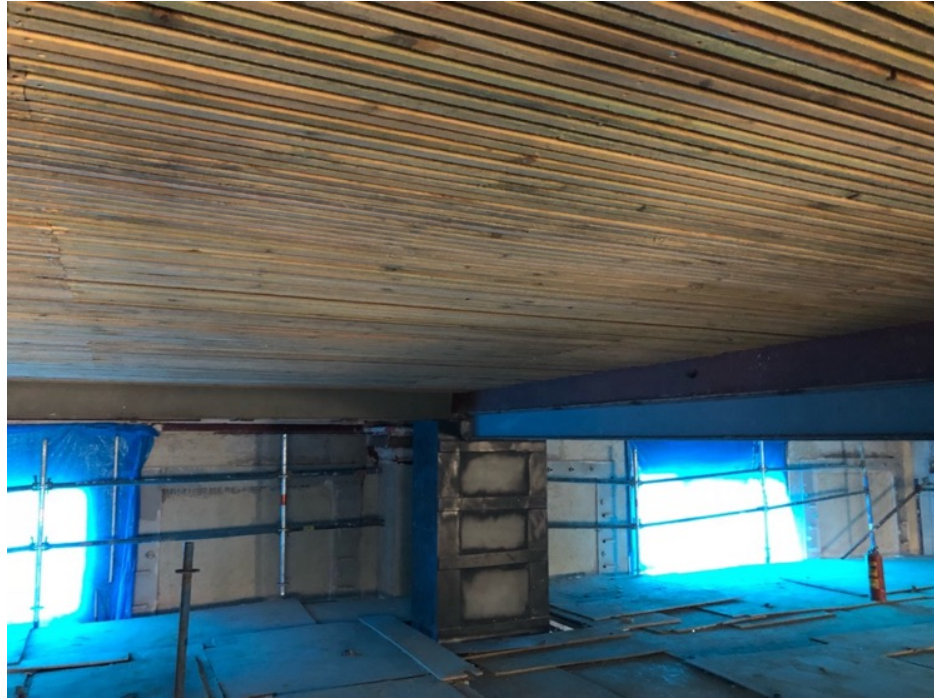
Figure 238. *Bağdadi* techniques under the Jack arched flooring (taken by the author in 2018)

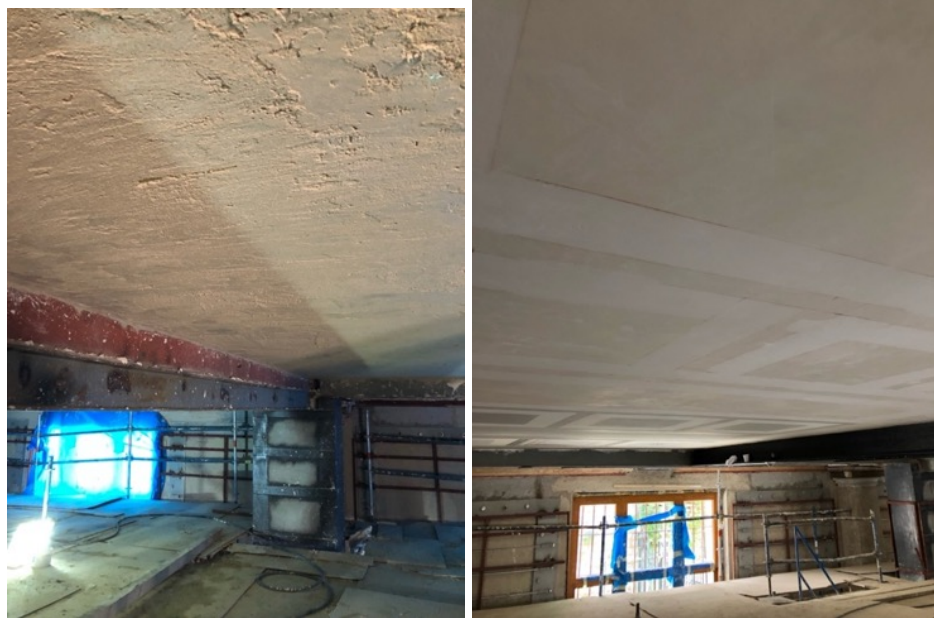
ceiling, a smooth surface for detailed decorative work is achieved by applying layers of rough plaster, fine plaster, and a finishing layer of ‘*nefaset*’<sup>101</sup> plaster. On the ground floor of the Archaeology Museum, it is clearly visible how this hand-painted ornamentation was successfully incorporated into the building's construction.

Figure 239. (Left) Plaster over the *bağdadi* techniques and (Right) *nefaset* fine plaster over it (taken by the author in 2018)

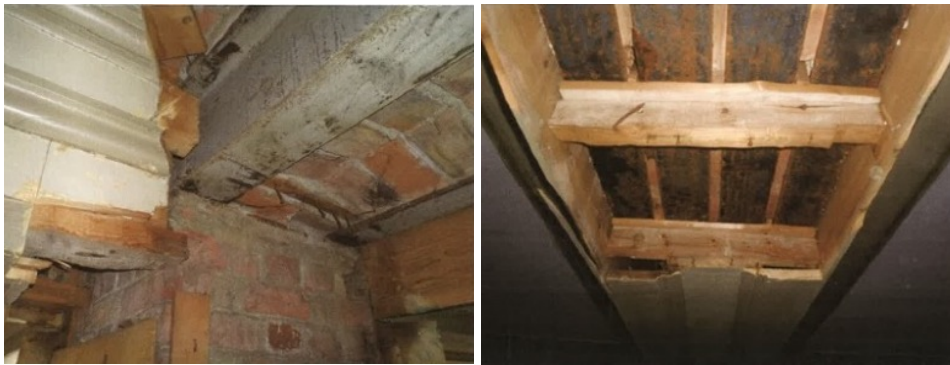
Figure 245. (Left) The photograph of AA section of Hall 22 jack arched flooring detail (Right) The photograph of BB section of Hall 21 jack arched flooring detail (*Güryapı İnşaat* Construction site report, November 2012, drawn by Rabia Şengün, IDSMArchive).

In Figure 245, it can be seen that the spaces between the profiles in both 2-profiled and 4-profiled beams are filled with bricks, a labor-intensive and time-consuming application. The photographs clearly show that wooden wedges were attached to these bricks. Using these wooden wedges, a wooden construction was created, resulting in stepped, decorative, and hand painted surfaces that served as the base for wooden cornices.

It appears that in Hall 21, to avoid the installation of the additional four columns, each beam was constructed using four I-beams, whereas in other halls, the load-bearing beams were formed with only two I-beams (Figure 244, Figure 245). Additionally, while the beams supporting the jack-arched floors in other halls measure 140 mm, in Hall 21, 180 mm beams were chosen. This allowed for larger spans to be covered without columns. However, despite these precautions, it seems that some issues arose, leading to intervention in the load-bearing system in 2007, when additional iron plates and L profiles were added to strengthen the structure. Detailed drawings and notes for the rooms mentioned in the report will be provided below.

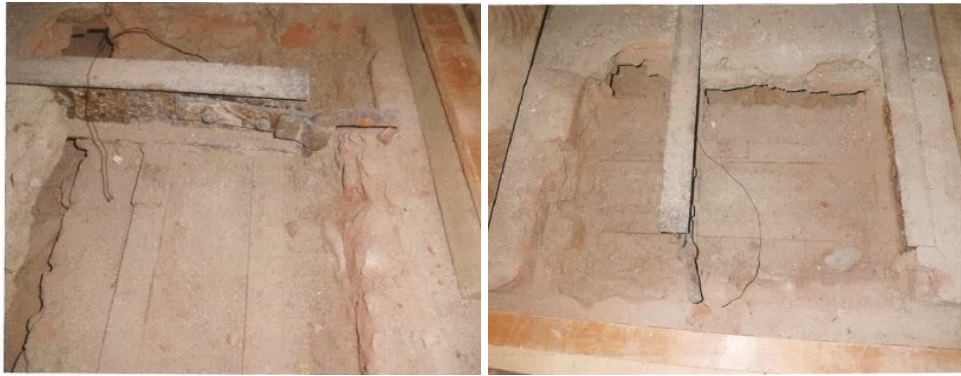
- The 180 mm profiles of jack arch floor are bolted to each other on 300 mm main beams (Figure 246).
- I 180 profiles sit freely on I 300 profiles, but there is brick filling between them.
- I 180 profiles are placed on a continuous iron flat bars of 60 mm x10 mm size, which placed along and inside the Wall (Figure 247).

Figure 247. The Photographs of AA section drawing of Hall 21 jack arched flooring details (*Güryapı İnşaat* Construction site report, November 2012, IDSM Archive).

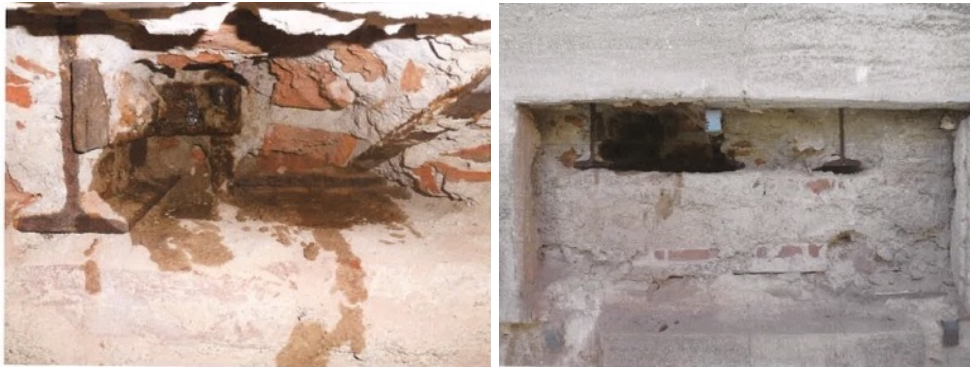
- I 180 profiles continue inside the wall until the facade cladding stone (it sits within the wall for approximately 40 cm) and are fixed into the brick wall with a sword (*kılıç ile sabitlenmiştir*) at the end (Figure 248).
- During the 2007 repair, 60x10 mm flat iron bars were welded on the I 180 profiles located between the wall-beam and beam-beam connections, as shown in Figure 249.
- In Hall 21, on arch floor system, there is a timber frame made of 5x5 cm pine timber, with 20 mm thick pine plywood covering and 22 mm thick oak parquet covering.

Figure 248. The Photographs of BB section drawing of Hall 21 jack arched flooring details (*Güryapı İnşaat* Construction site report, November 2012, IDSM Archive)

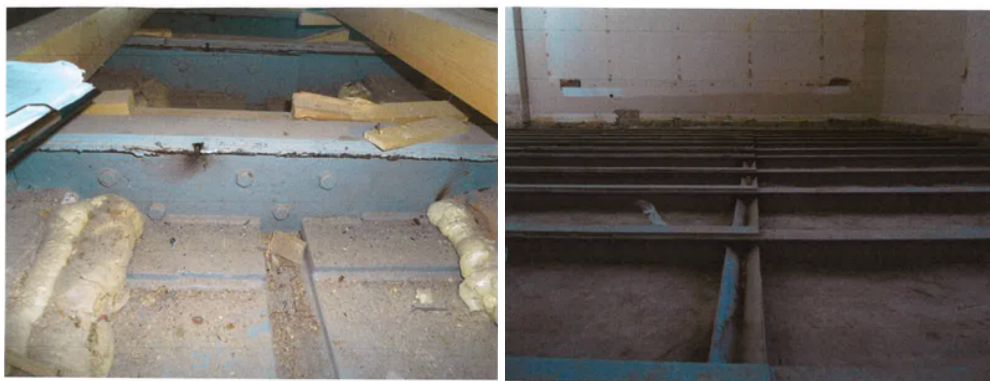
Figure 249. The Photographs of CC sections drawing of Hall 21 jack arched flooring details (*Güryapı İnşaat* Construction site report, November 2012, IDSM Archive)

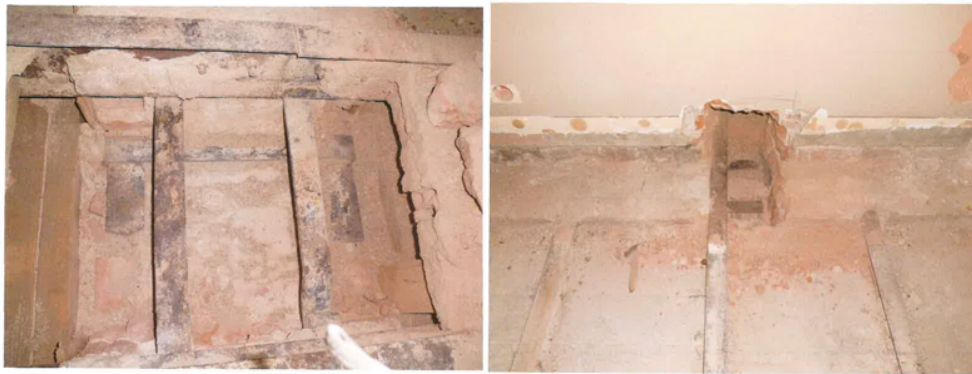
Figure 251. (Left) The Photograph of AA section drawing of Hall 22 jack arched flooring details (Right) The Photograph of BB section drawing of Hall 22 jack arched flooring details (Güryapı İnşaat Construction site report, November 2012, IDSMS Archive).

- The 140 mm profiles of the Jack arch floor are joined end-to-end without any connecting element over the main iron beams (Figure 251).
- The 140 mm profiles located within the wall are connected by bolts.
- The 140 mm profiles rest freely on the 300 mm iron beams, but brick infill is present between them (Figure 254).
- The 140 mm profiles sit on two continuous iron elements, each measuring 60x10 mm, that extend along the wall line inside the wall (Figure 253).
- Above the Volta floor in Hall 23, there is a timber frame made of pine timber with a cross-section of 6.5x11 cm, 20 mm thick pine timber cladding, and 2 mm thick oak parquet flooring.

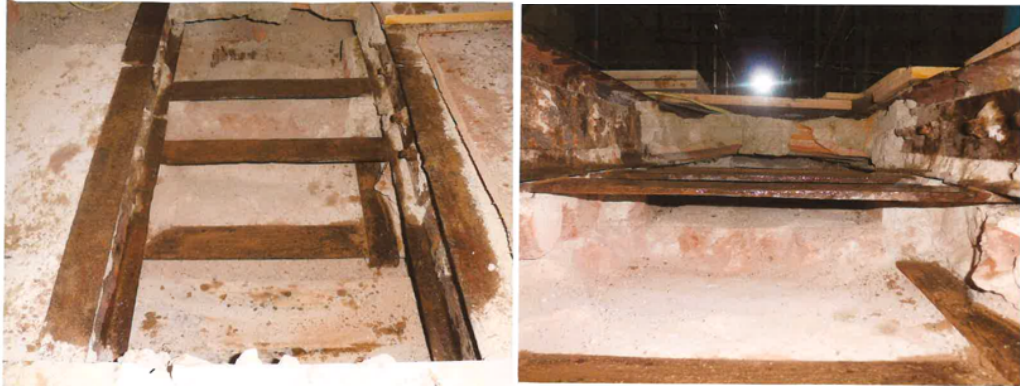
Figure 253. The Photographs of AA section drawing of Hall 23 jack arched flooring details (*Güryapı İnşaat* Construction site report, November 2012, IDSM Archive)

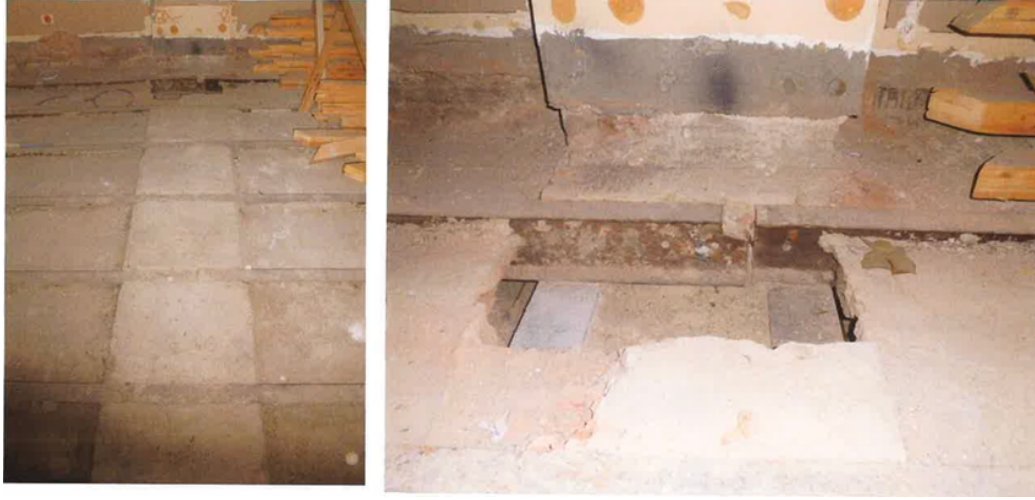
Figure 254. The Photographs of BB section drawing of Hall 23 jack arched flooring details (*Güryapı İnşaat* Construction site report, November 2012, IDSM Archive)

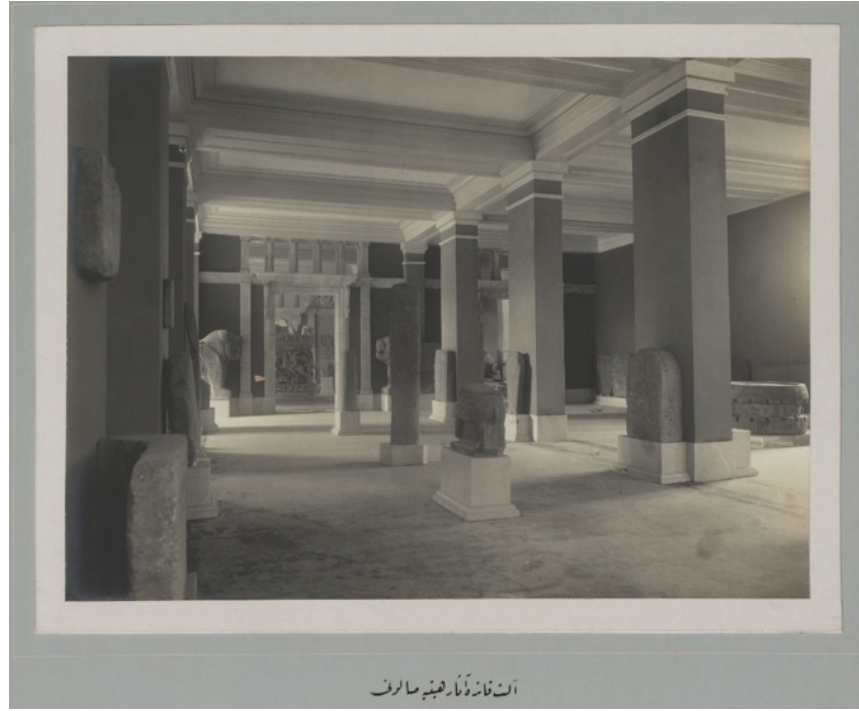
Figure 265. The ceiling decoration from 2<sup>nd</sup> Construction Phase of IAM (source: *Güryapı İnşaat*, IDSM Archive)

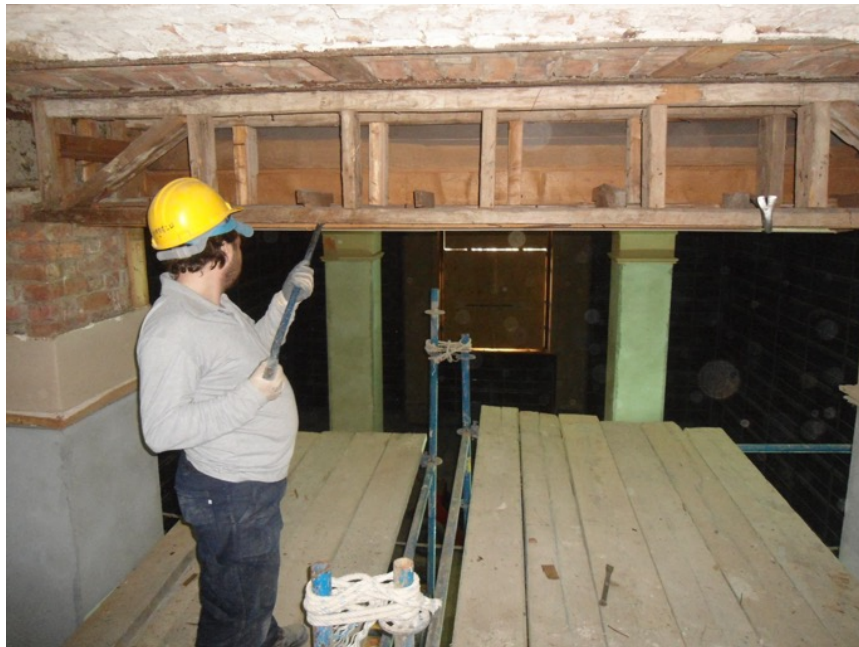
Figure 266. The removal of timber cornices (source: *Güryapı İnşaat*, IDSM Archive)

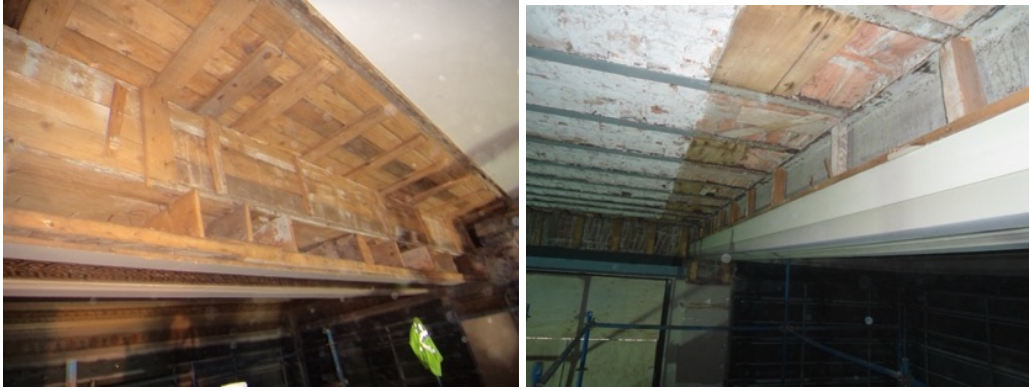
Figure 267. The removal of timber cornices (source: *Güryapı İnşaat*, IDSM Archive)

The points where the wooden cornices are attached to the iron girders are particularly important because the wooden decorations need to be secured to the iron elements (Figure 267, Figure 268). Except for the first phase, wooden cornices were used throughout the building in the second and third phases on both the ground and first floors to create a gridded appearance and maintain symmetry.

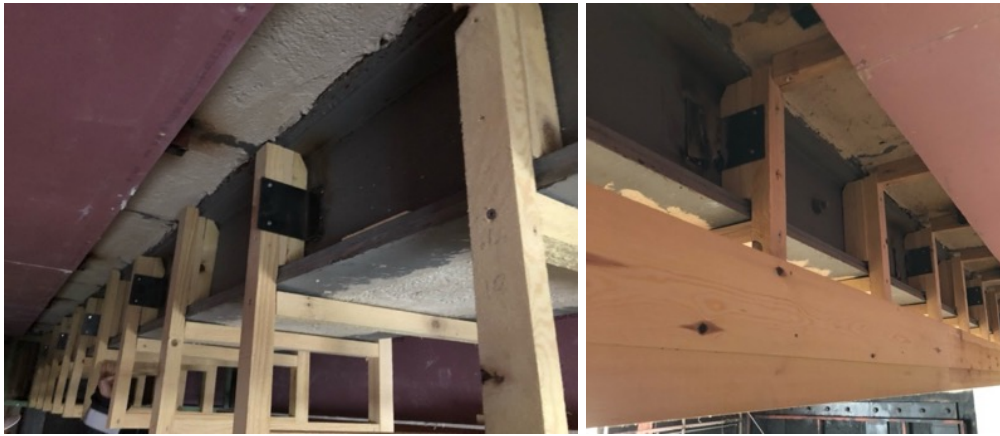
Figure 268. Construction of new wooden cornices to the iron beams with traditional techniques with some metal addition (taken by the author in 2019)

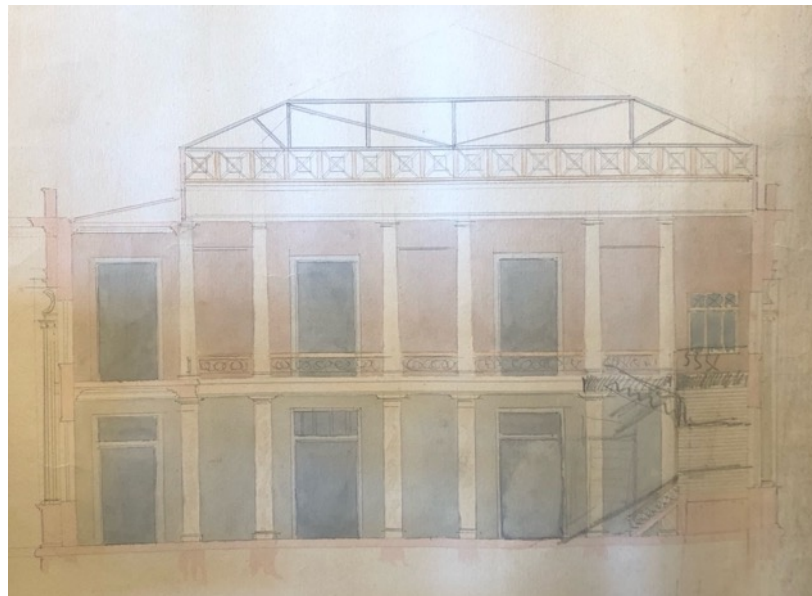
Figure 269. The original drawing of Vallaury period showing the roof structural system (source: “IAM Archive, 16-G2/R2/3”)

There is only one correspondence in the Presidential State Archive which mentioned about the roof of the museum. The main subject of the correspondence is about the cost estimate of the new building. However, when the cost estimate was examined, it was understood that the roof of the building would be wooden, but due to the fire hazard, it would be more appropriate to build it with iron instead of wood. A new discovery is requested to be prepared with this correction. Thereupon, the museum directorate states that there was a misunderstanding that the roof of the building would be iron anyway (Figure 269). As explained in Chapter 1, fire prevention was the primary reason for the selection of masonry and iron in the construction. It was crucial for the museum's administration to inform the relevant authorities about this direction for the continuation of the project. However, archival records show that the roof of the building was not made of iron. This may suggest that the intended use of an iron structure was abandoned, possibly due to financial constraints or other reasons. There is no information regarding whether the authorities were informed of this change.

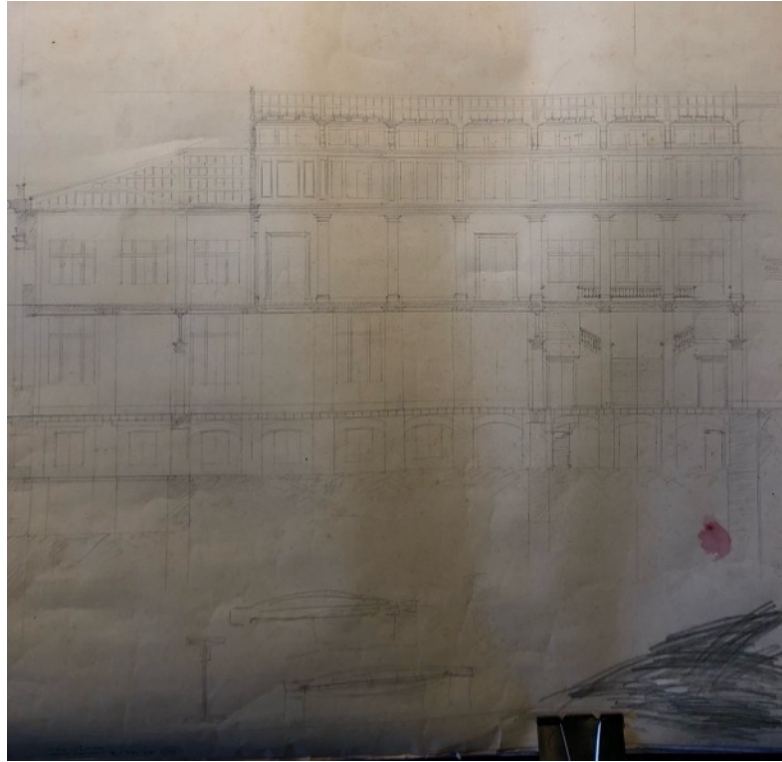
Figure 271. The original section drawing of Vallaury showing the roof structure (source: IAM Archive, “66, G2/R5/7”)

Continuing from the archive documents, there are wooden roof drawings in Vallaur's original drawings (Figure 270). The roof drawn in the sections follows the wooden system and is depicted in brown in some drawings. However, it is known that the roof was converted to reinforced concrete in 1950. It can be seen from the photographs that the roof that was removed during this major intervention was wooden. So, despite the above-mentioned correspondence stating that the roof would be made of iron and the sensitivity against fire in the 19<sup>th</sup> century, it must not have been realized for various reasons. These reasons may be due to material supply and budget-related reasons. Therefore, it can be assumed that the roof was originally made of wood. Moreover, in the restitution report prepared for the building, the roof was accepted as wooden (Figure 271).

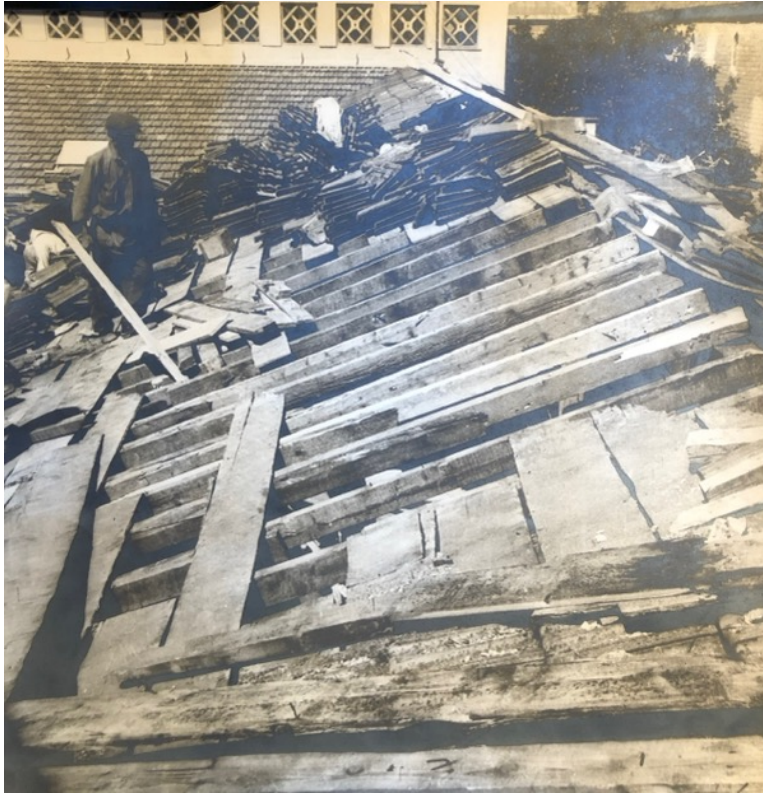
Figure 272. The old photograph showing the removal of timber roof (source: IAM Archive)

With this acceptance, it can be concluded that the 2<sup>nd</sup> floor’ ceiling slab and roof lanterns were originally made of wooden construction. In 1950, all this wooden construction was removed and replaced with a reinforced concrete system (Figure 272). While doing this, the inlaid wooden cornices on the 2<sup>nd</sup> floor ceilings were not removed and were used as molds for the new concrete to be applied, as can be seen from the concrete beams that emerged after the wood was removed.

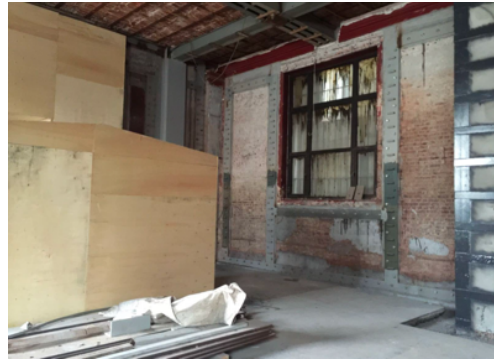
Figure 276. The brick masonry wall construction Techniques of 1<sup>st</sup> Phase of IAM (1887-1891) (taken by the author)

In fact, in the 1<sup>st</sup> construction phase, it was observed that the ground and second floors were constructed entirely with *brick masonry walls* (Figure 276). However, in the subsequent construction of the 2<sup>nd</sup> construction phase, it is seen in the old photo (Figure 277) that the rear facade's exterior walls on the ground floor were built using a *stone masonry system with brick lintels*<sup>104</sup>. Unfortunately, there are no images of the courtyard-facing facade or the interior walls, leaving no data available for these sections. It is highly likely that the front facade of the building, where the stone cladding was applied, consists of brick masonry (Figure 275). In the 3<sup>rd</sup> construction phase, it is seen that the old photo (Figure 278Figure 277) that the exterior walls on the ground floor were built using a *stone masonry system with brick lintels and brick masonry* together.

the richness of Byzantine remains in the area, it is very likely that there was a significant stockpile of stone available. It is also probable that large amounts of rubble and stone were encountered during these excavations, as some correspondence mentions the need to remove this rubble<sup>109</sup>. Considering the difficulty in securing funding for the construction (see Chapter 3.3), it seems highly plausible that the available materials on-site were used wherever appropriate or in the foundation work. Given that Osman Hamdi was reportedly requesting even to donate his one-year salary to continue the museum's construction<sup>110</sup>, utilizing the stones found on-site makes perfect sense. In Figure 276, the piles of rubble in the background can be seen.

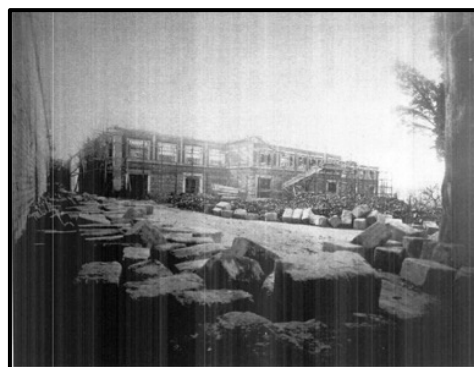
Figure 277. The stone masonry with brick lintel wall construction Techniques of 2<sup>nd</sup> Phase of IAM (1899-1903) (source: Restitution Report prepared by Seçkin Mimari Hizmetleri, IDSM Archive)

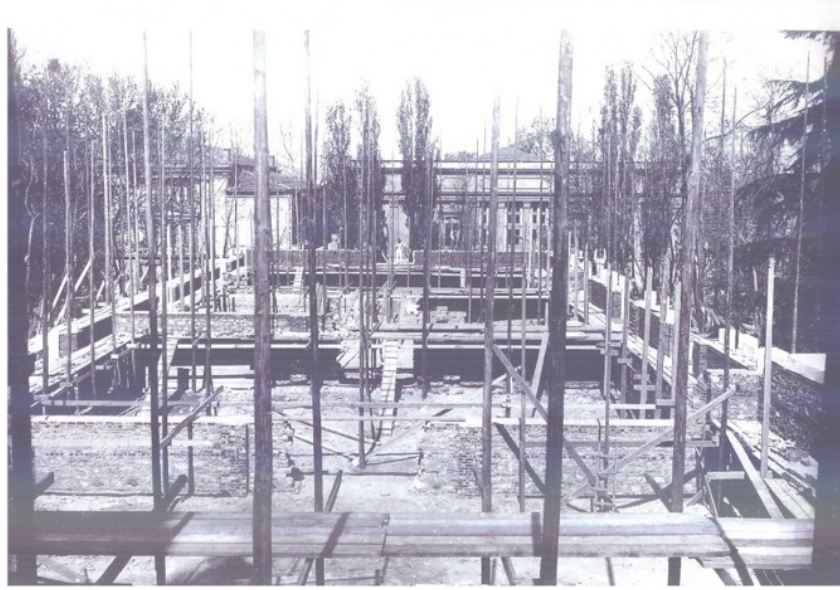
Figure 278. The brick and stone masonry with brick lintel wall construction Techniques of 3<sup>rd</sup> Construction Phase of IAM (1904-1907) (source: Restitution Report prepared by *Seçkin Mimari Hizmetleri*, IDSM Archive)

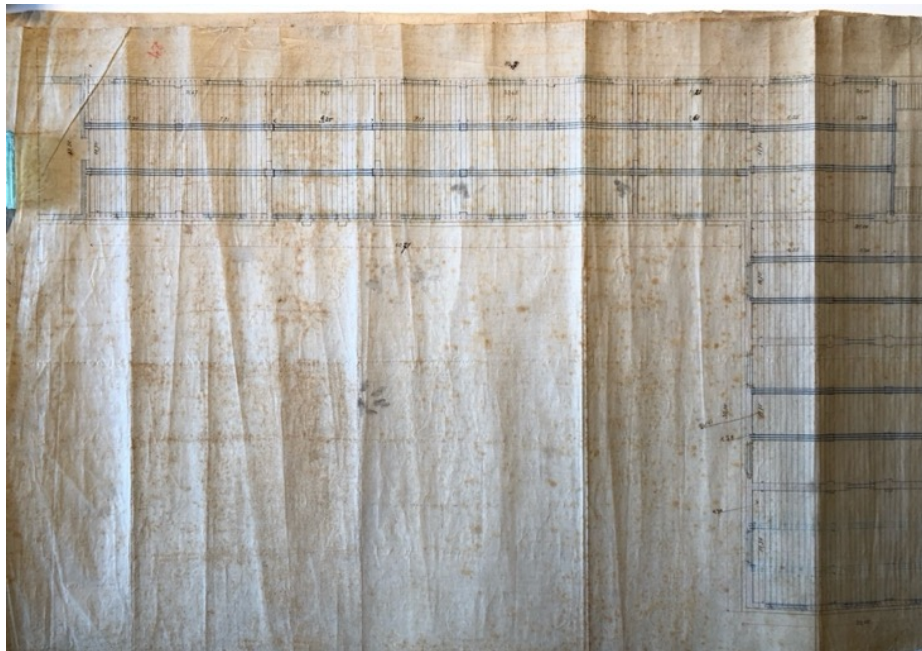
Figure 287. The revised iron I profile plan for 3<sup>rd</sup> Construction phase of IAM (source: “IAM Archive, 91, G3/R3/3”)

In the 3<sup>rd</sup> phase, it is not possible to make a more detailed comparison regarding the connection details, as the drawings and information about these details are not available for the other phases in the same level of detail. However, many details related to Phase 3, the last section built by the architect, have been uncovered. The following points detailed in Chapter 4 are particularly noteworthy:
