**PREPARATION OF A MAINTENANCE, SIMPLE REPAIR, AND  
INTERVENTION HANDBOOK FOR  
YENİ FOÇA- İZMİR**

**A THESIS SUBMITTED TO  
THE GRADUATE SCHOOL OF NATURAL AND APPLIED SCIENCES  
OF  
THE MIDDLE EAST TECHNICAL UNIVERSITY**

**IN PARTIAL FULFILMENT OF THE REQUIREMENTS FOR THE DEGREE OF  
MASTER OF SCIENCE  
IN  
THE DEPARTMENT OF ARCHITECTURE, IN RESTORATION**

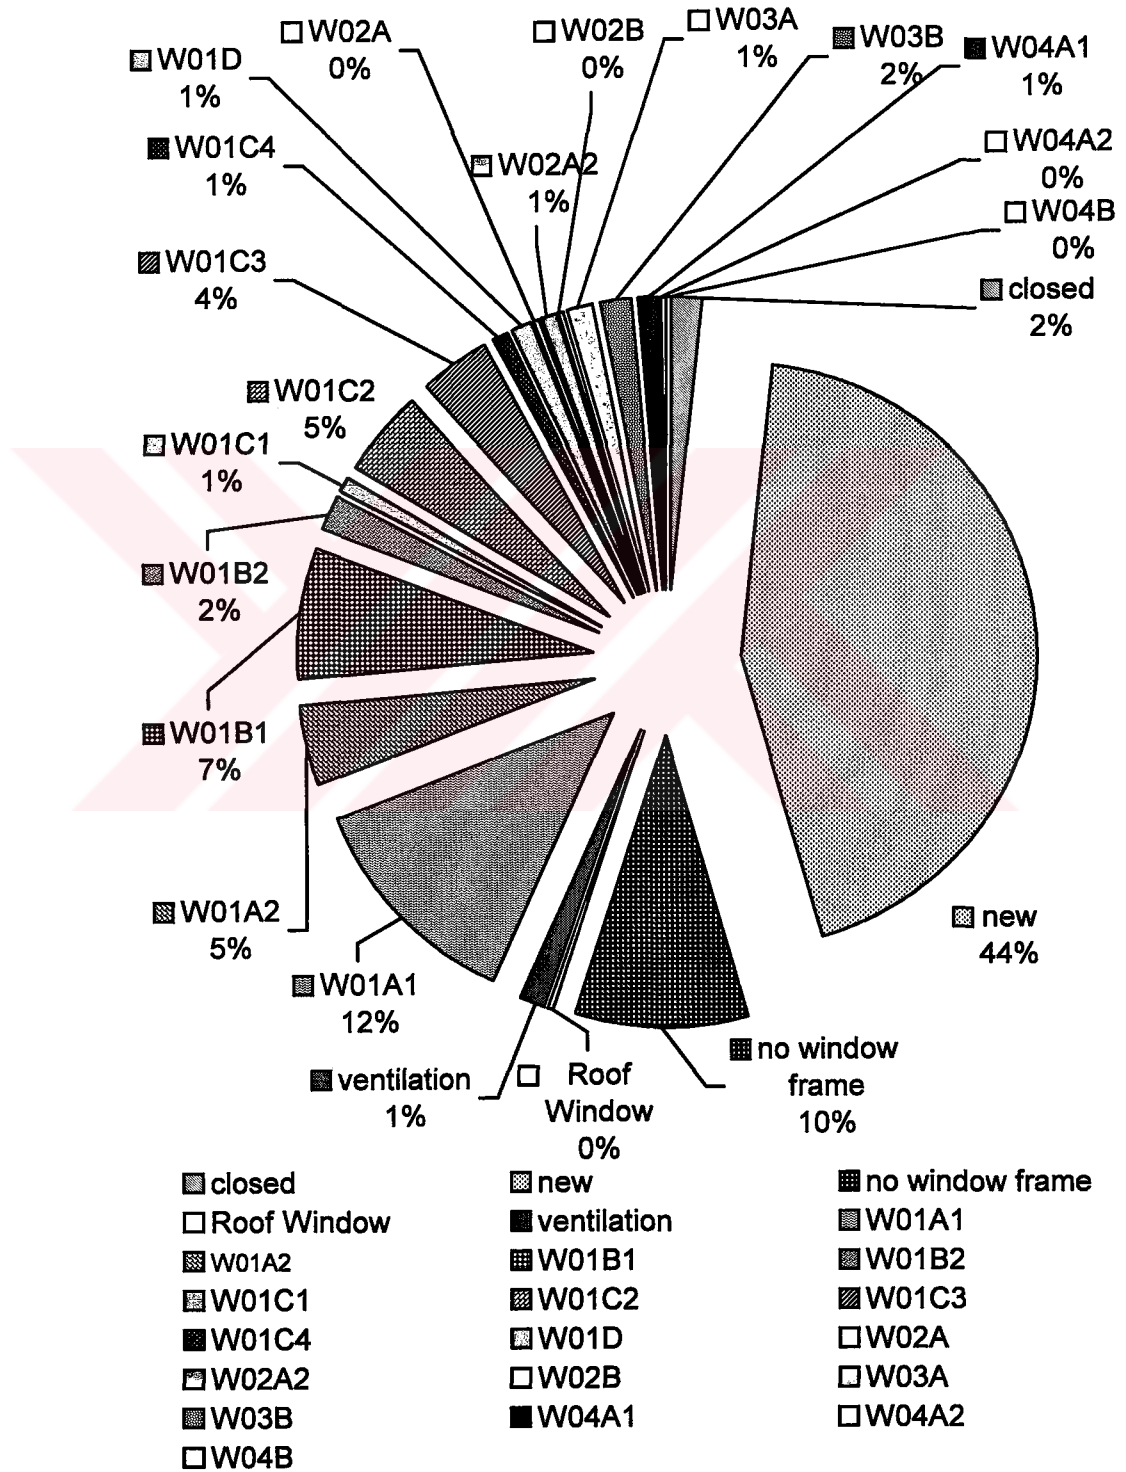
Table 3.3.1 Window Typology

## WINDOW TYPOLOGY

Window typology is prepared according to details and divisions of the window frames. (Figure 3.3.1) (Table 3.2.1) There are four main headings. Most of the window frames in the area have been replaced or lost. Majority of the original windows are from the first section. This group has four main divisions according to their upper and lower sections. There are subgroups according to their divisions. This type is very common.

The second type has wider cross sections than the first type and it has more crude workmanship. The third type is vertical sash window. This is probably the oldest type in the site. It is found only in buildings that have not been used for a long time. The fourth type is quite a recent type, yet it is different from the contemporary window types. (Figure 3.3.2)

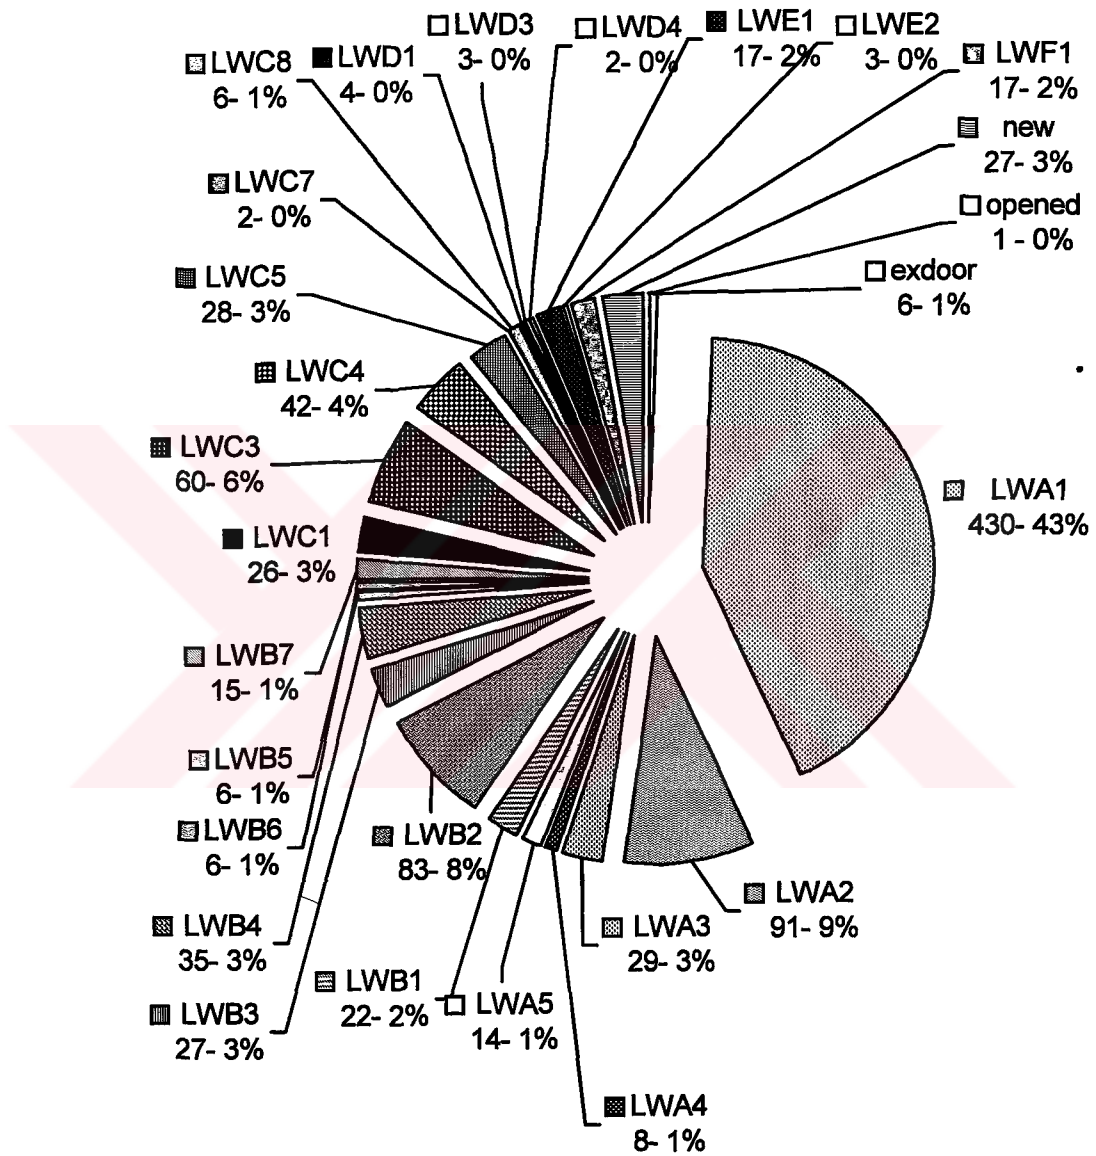
Table 3.3.2 Window Lintel Typology

WINDOW LINTEL TYPES

Window lintels are grouped according to their forms and the ornamentations. There is a group for lintels of the shop lintels and another group for wooden window lintels of the wooden skeleton buildings. (Figure 3.3.3) (Table 3.3.2)

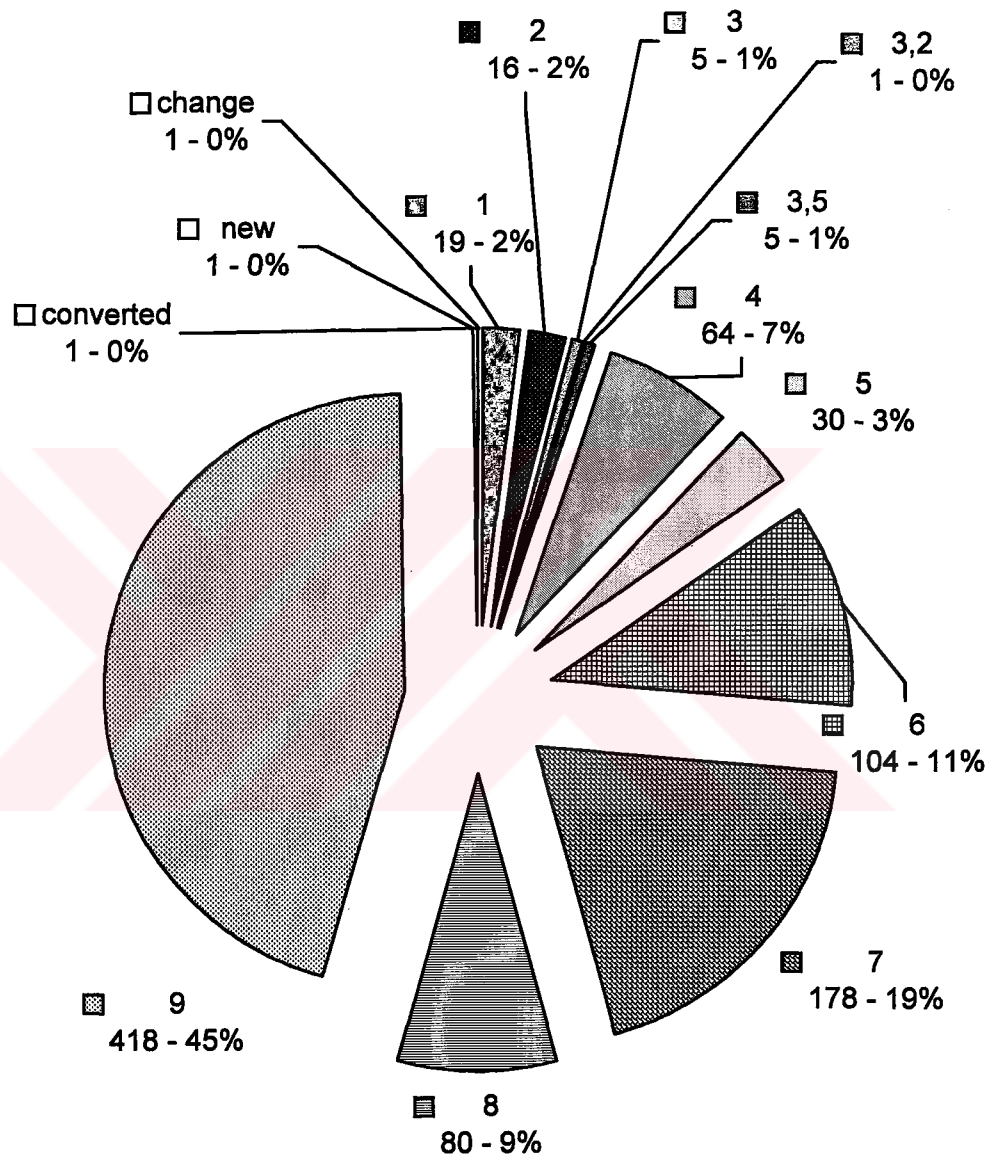
Table 3.3.3 Window Deterioration

### WINDOW DETERIORATION

- 1-loss of wing
- 2-partial material loss
- 3-serious material problems
- 3,2
- 3,5
- 4- mild material problems
- 5-needs repair, no material problems
- 6-usage problems
- 7-needs maintenance
- 8-no problems
- 9-lost
- conv. Fr. Door
- new
- size & locationchange

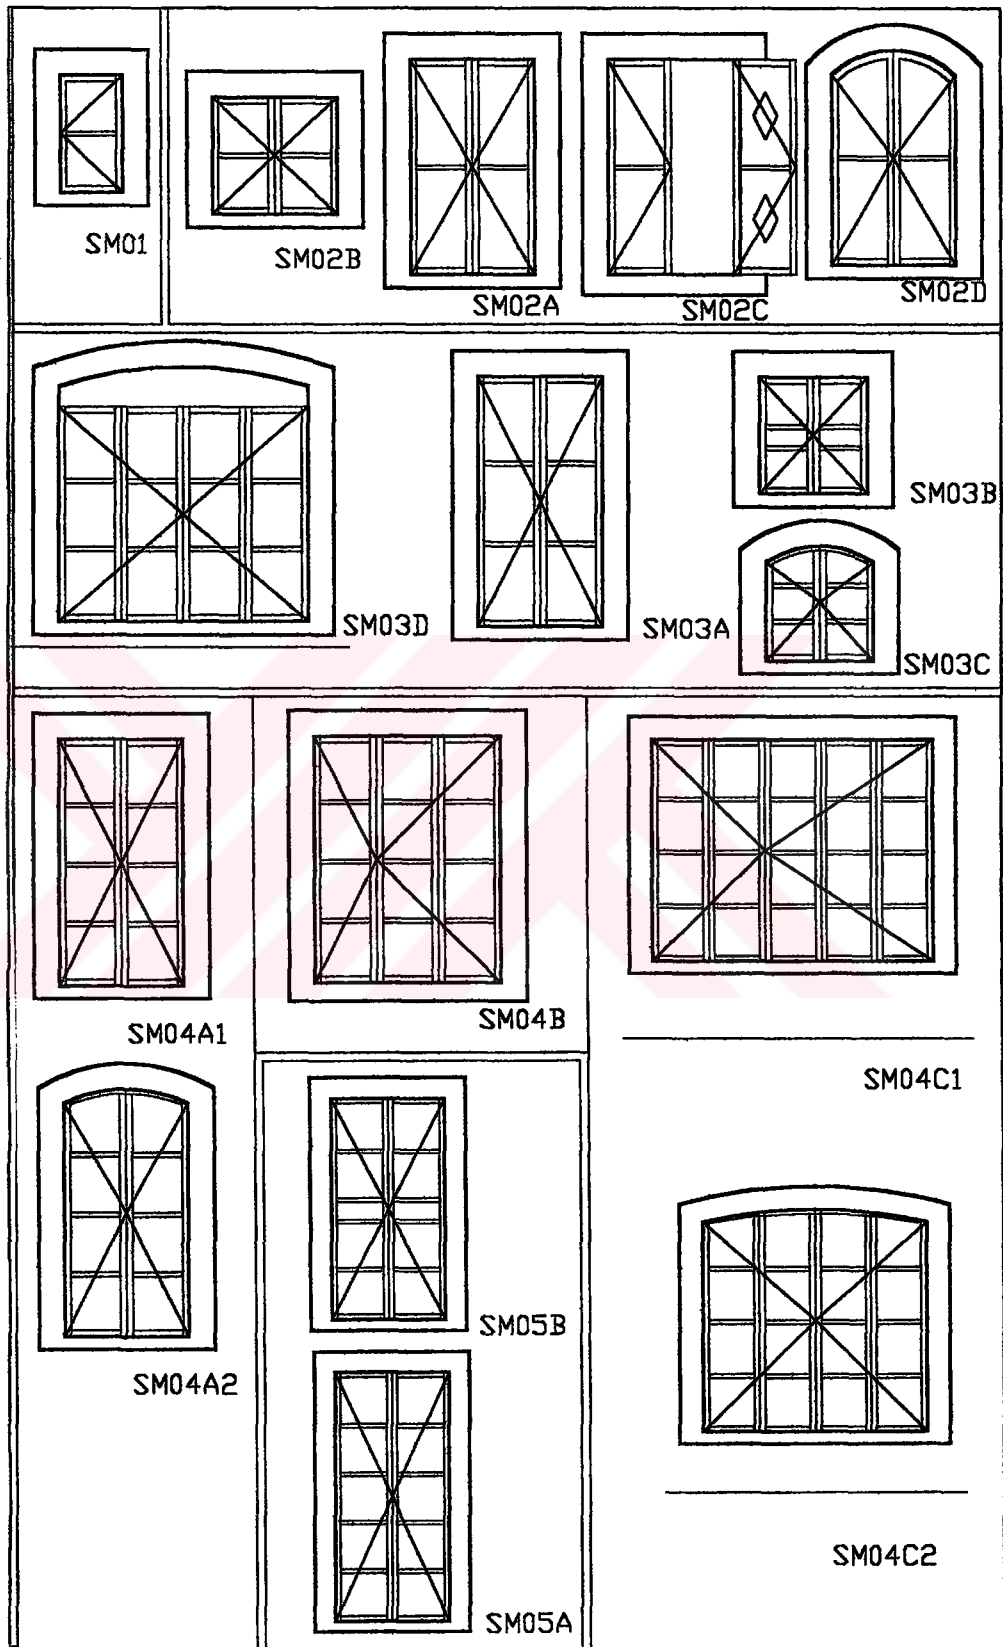
Figure 3.4.2 Shutter Typology (Iron)

**SHUTTER TYPES (IRON)**

Iron shutters are analysed under five main headings. These groups have no variations in their details. The only variation is in the divisions.

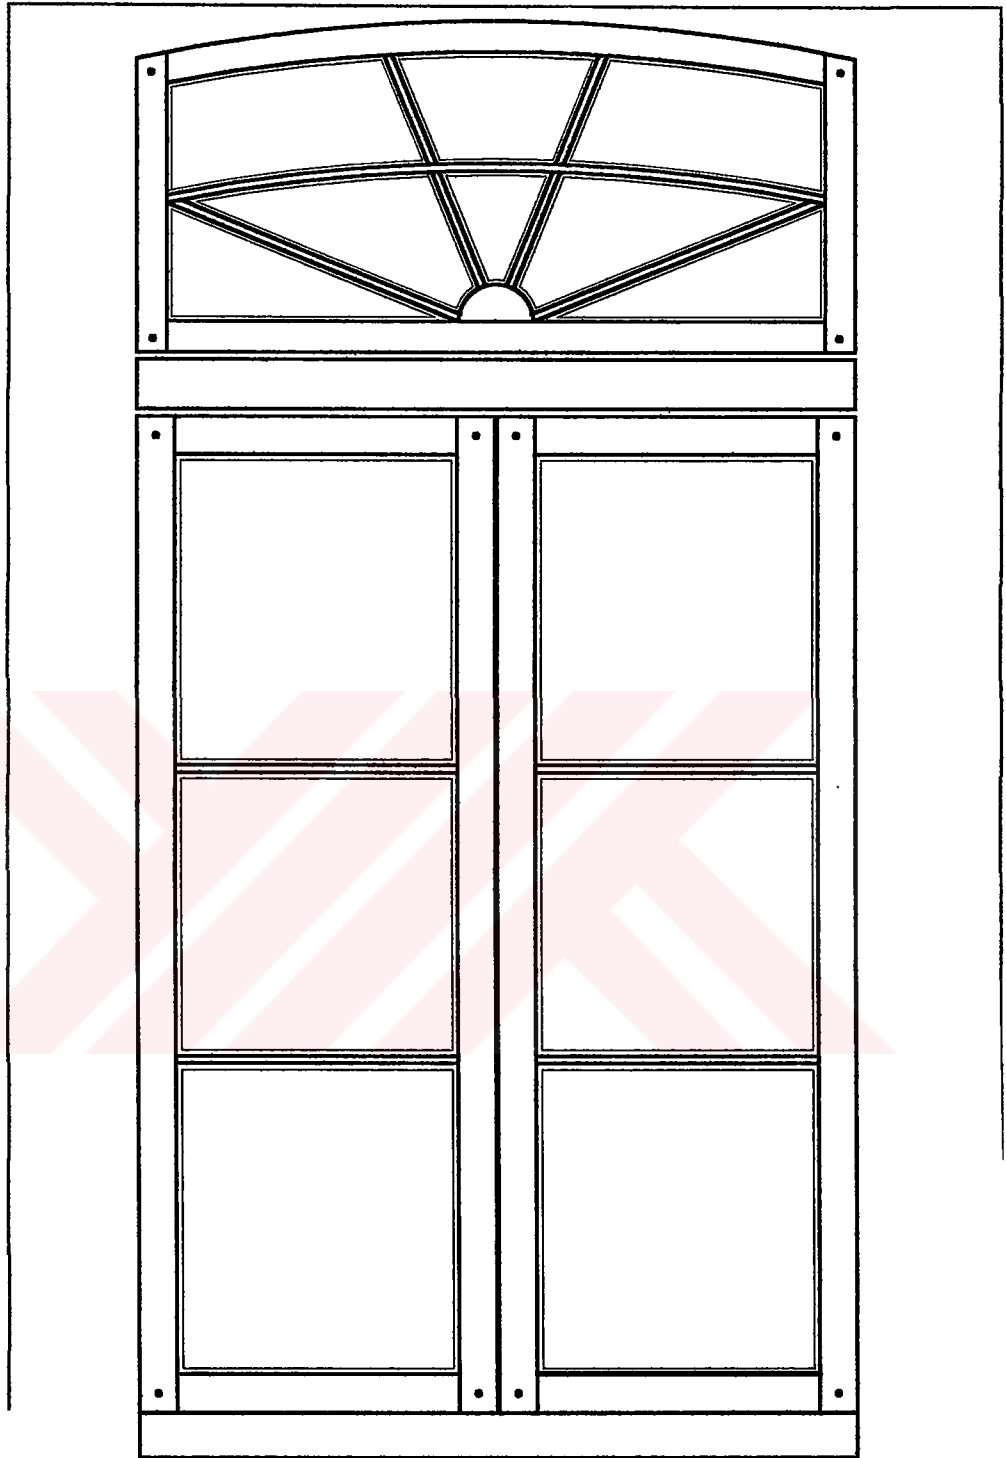
Figure 5.2.9 W01C Interior Elevation

ELEVATION INTERIOR  
FEVZİ ÇAKMAK CADDESİ NO:44

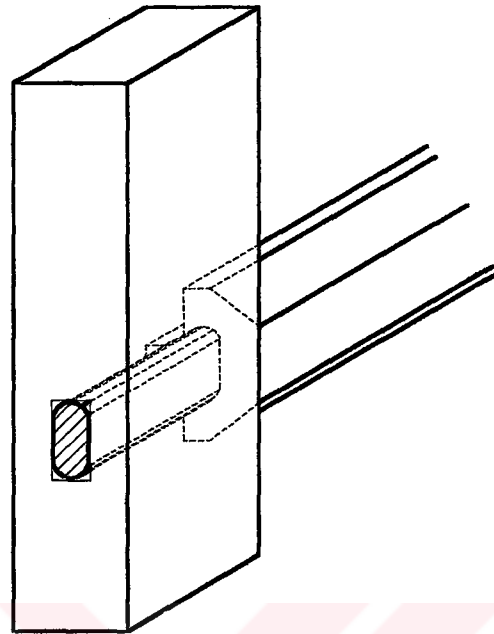
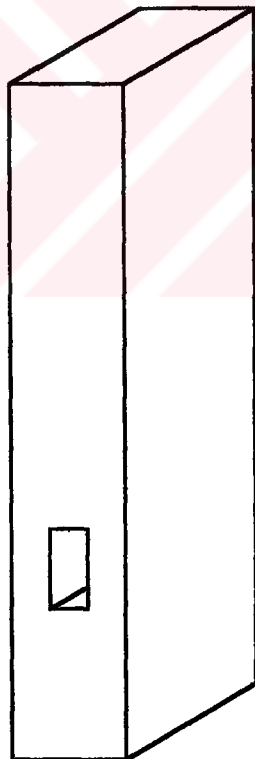
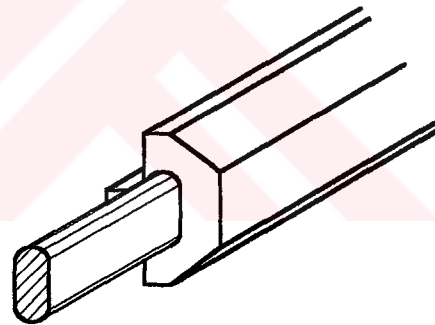
Figure 5.2.36 W03B Details

JOINT DETAIL B

W03B: It is a vertical sash window. Its sash is divided vertically and horizontally into four equal parts. The buildings that it is seen are; Sahil Caddesi no: 77, no:91, Atay Sokağı no:1, Hacı Mehmet Sokağı no:1, Merkez Caddesi no:9, İzmir Caddesi no:47, no:96, no:100, no:102. Check the drawings for further information) (Figure 5.2.49-5.2.66)

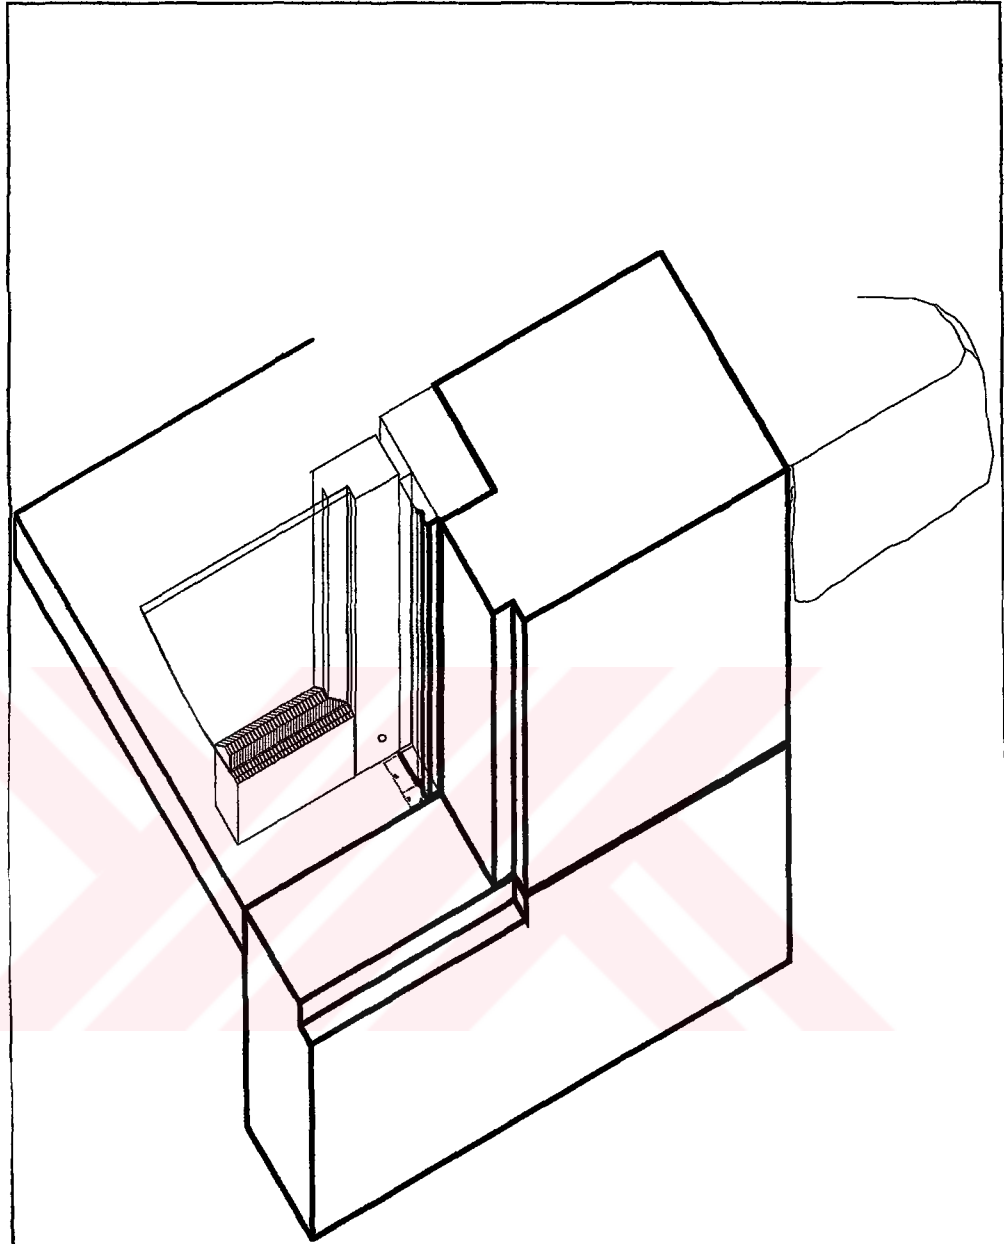
Figure 5.2.37 W03B Details

JOINT DETAIL D

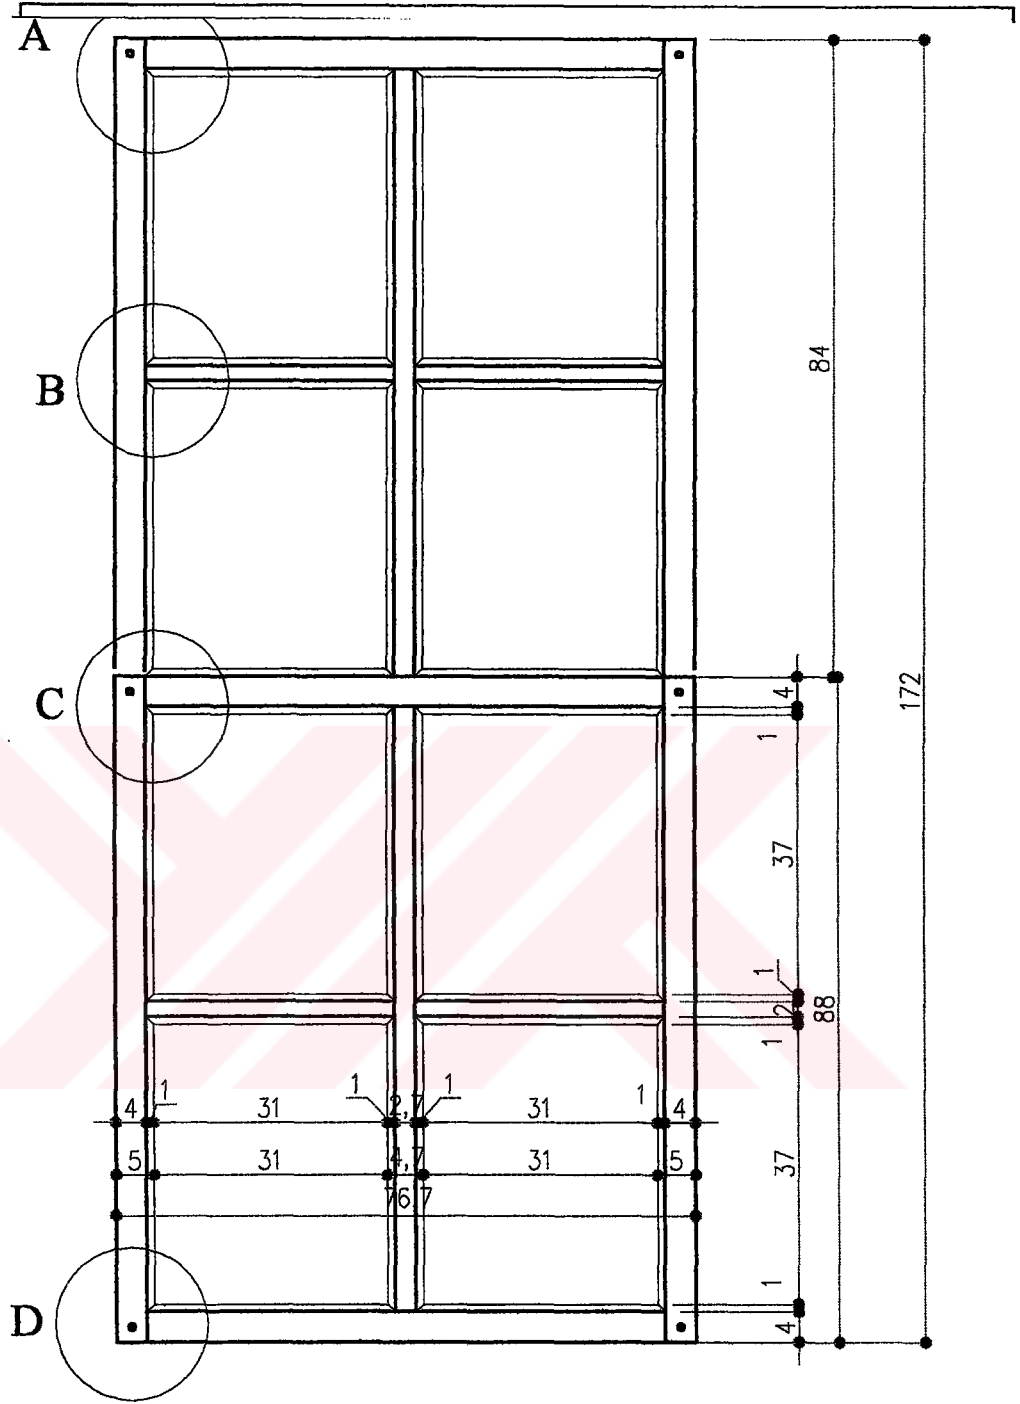
Figure 5.2.38 W03B Recommendations- Exterior Elevation

ELEVATION INTERIOR- sash

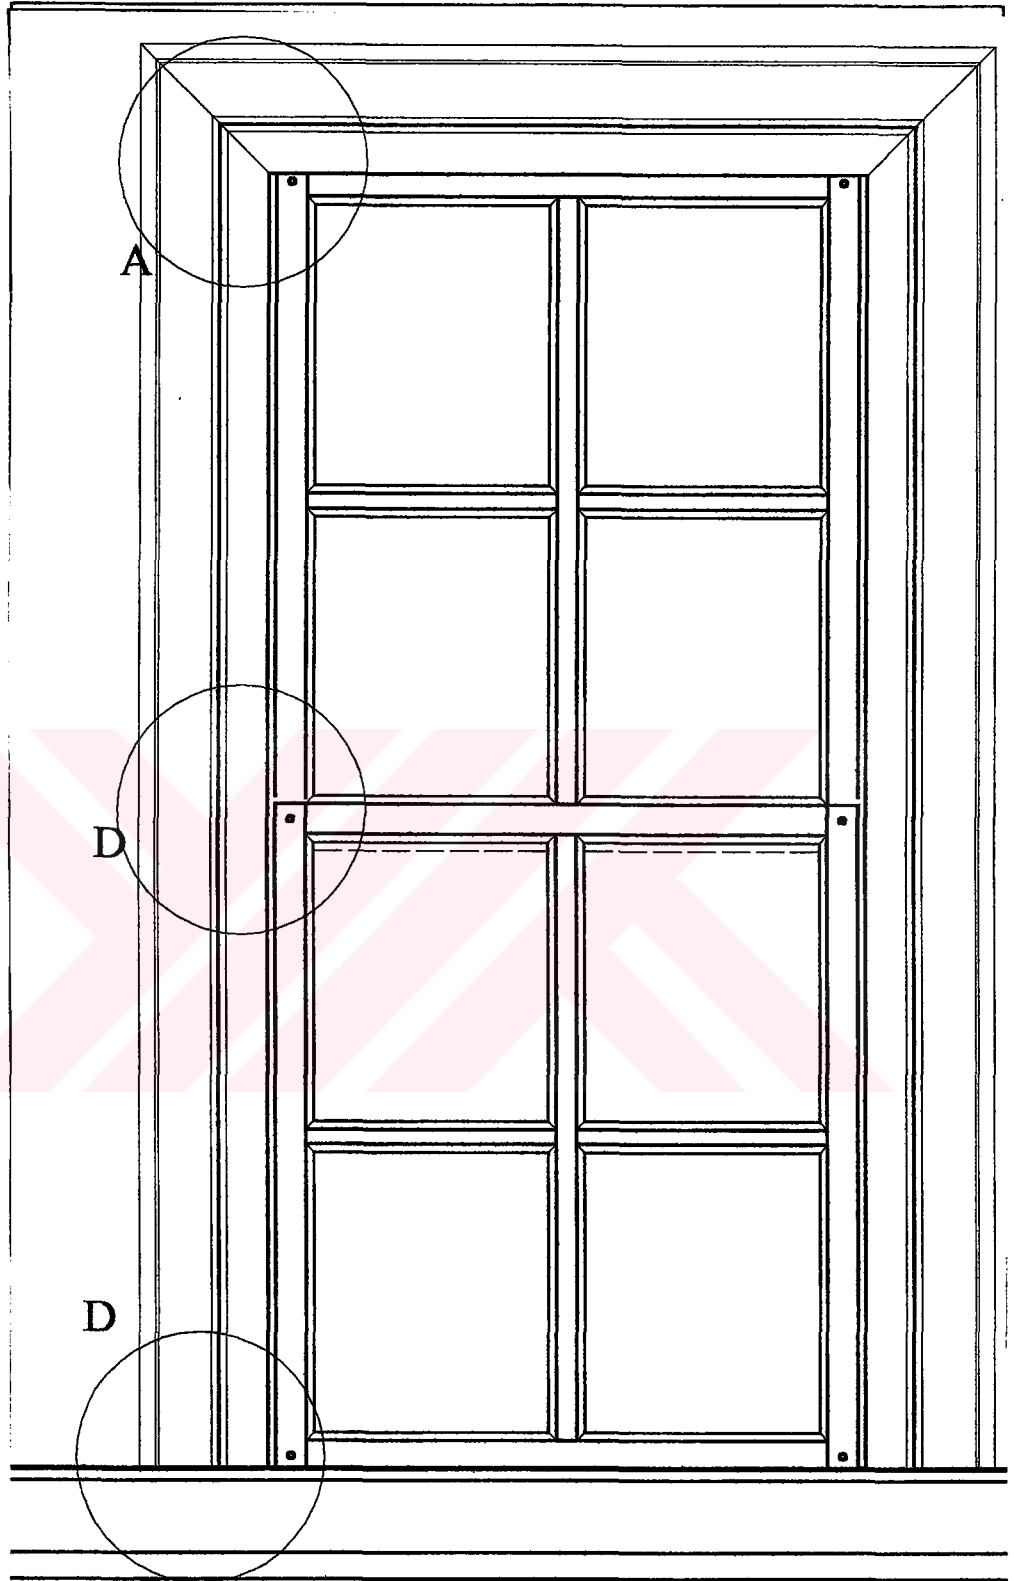
Figure 5.2.41 W03B Recommendations- Interior Elevation

ELEVATION INTERIOR

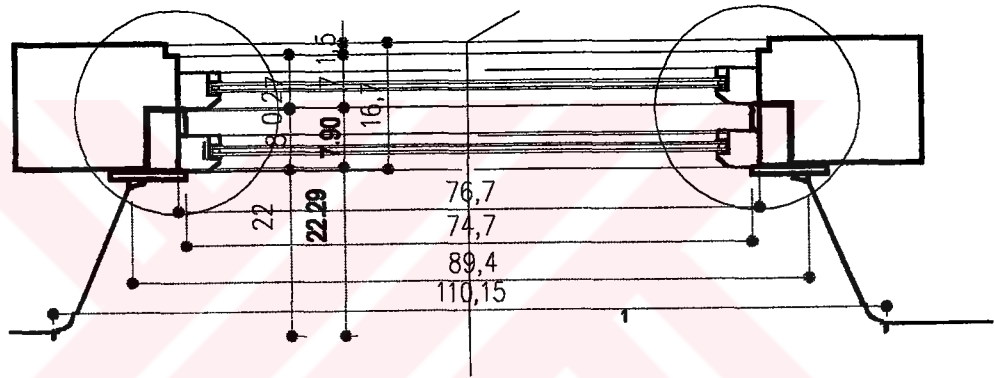
Figure 5.2.49 W03A Plan

PLAN

W03A: It is a vertical sash window. Its sash has no divisions. The buildings that it is seen are; Sahil Caddesi no: 63, Atay Sokağı no:2. Check the drawings for further information) (Figure 5.2.27-5.2.48)

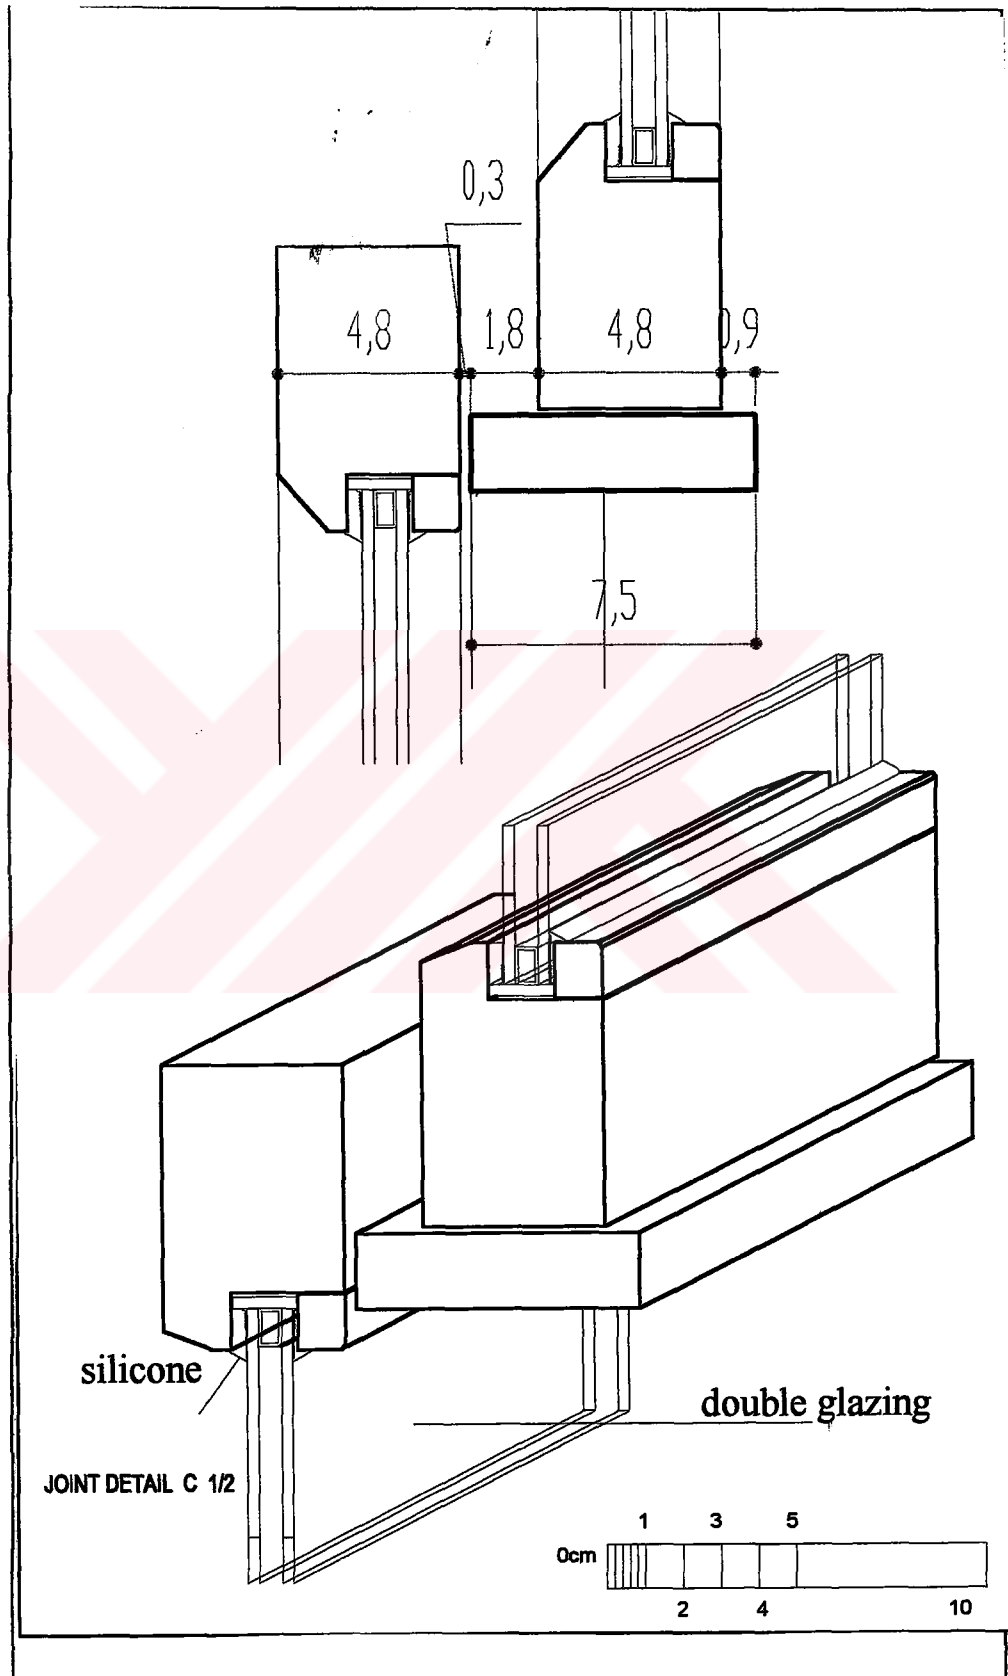
Figure 5.2.55 W03A Details

wooden dowel R=10mm

Top Section- sash

Top View- sash

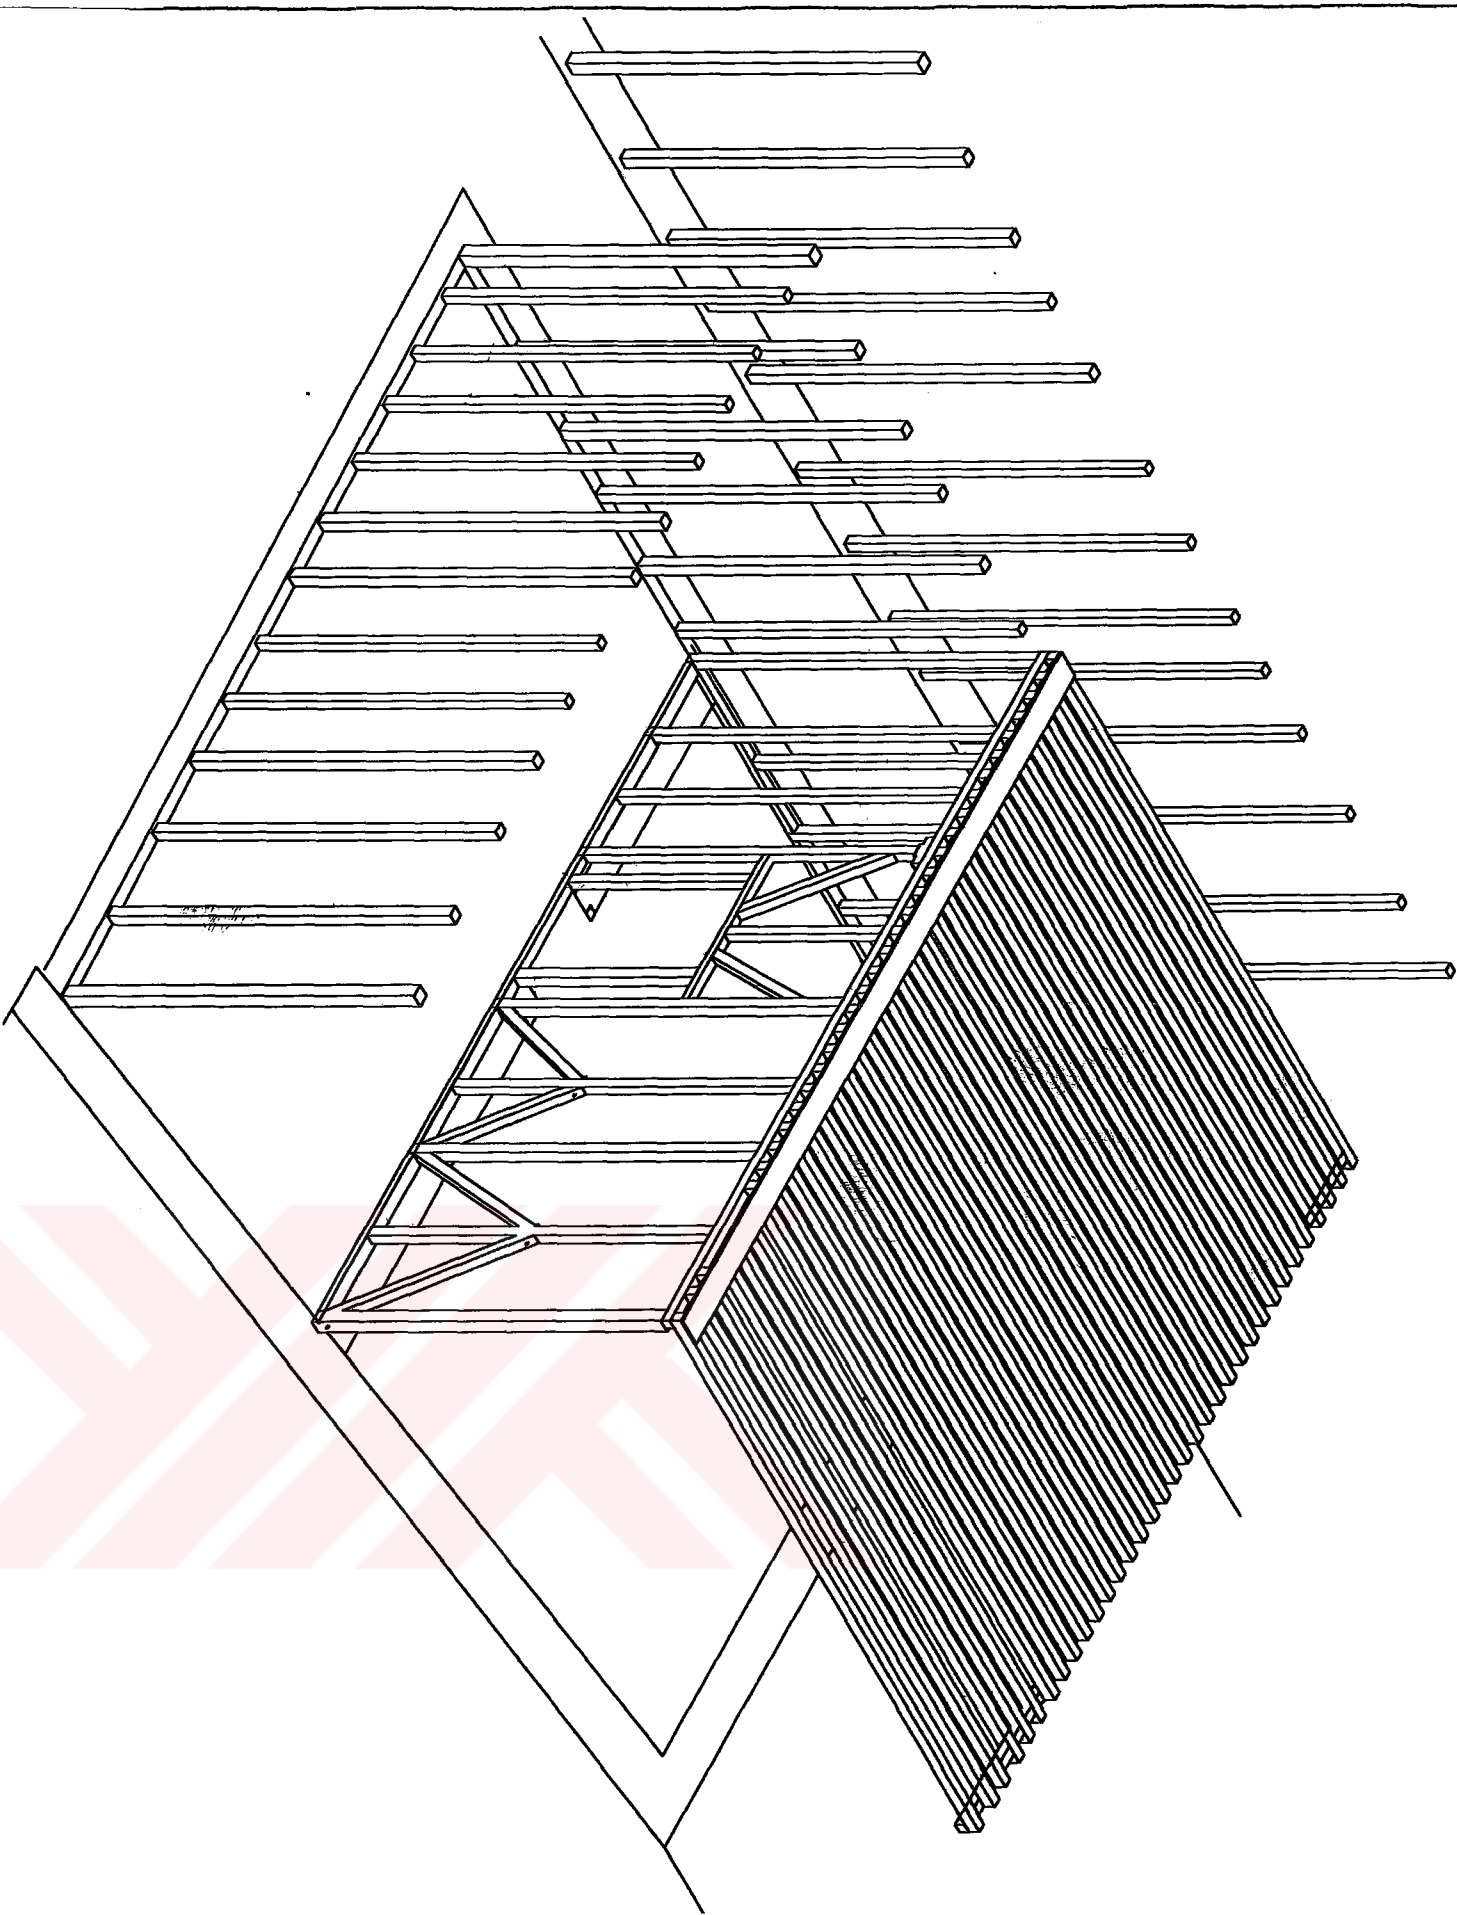
G.1 İzmir Caddesi No:1 – Partial 3D Model of the Ground Floor.

The drawings in this section are prepared during the thorough survey within the buildings. 3D models of the buildings and of various building components are drawn to the scale but are not pressed with a definite scale. They are included to give an idea of the construction system of the buildings of which the system could be observed.

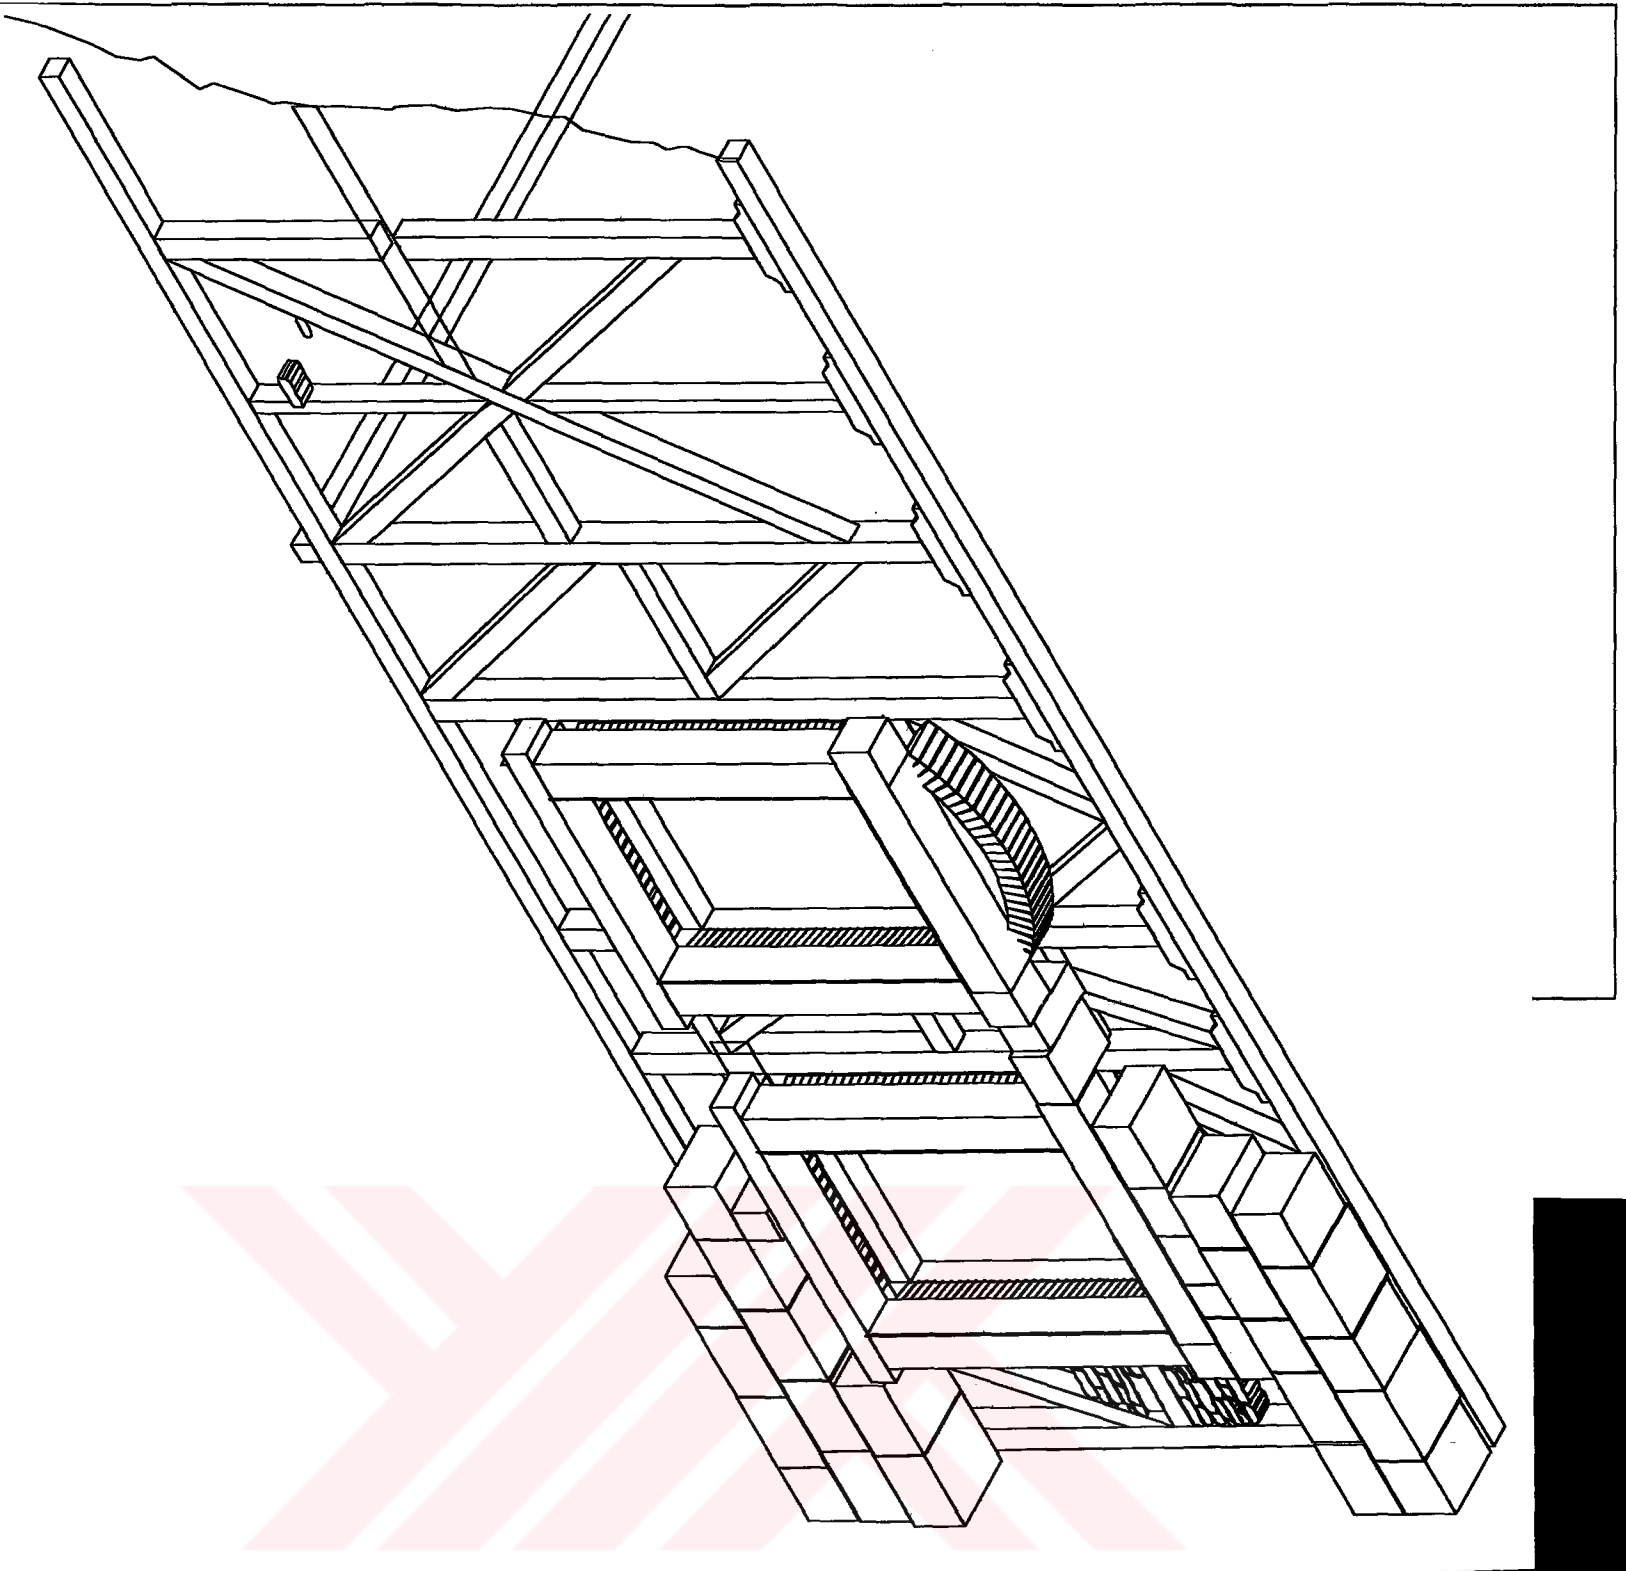
G.2 İzmir Caddesi No:1 – Partial 3D model of the second storey wall (exterior view)

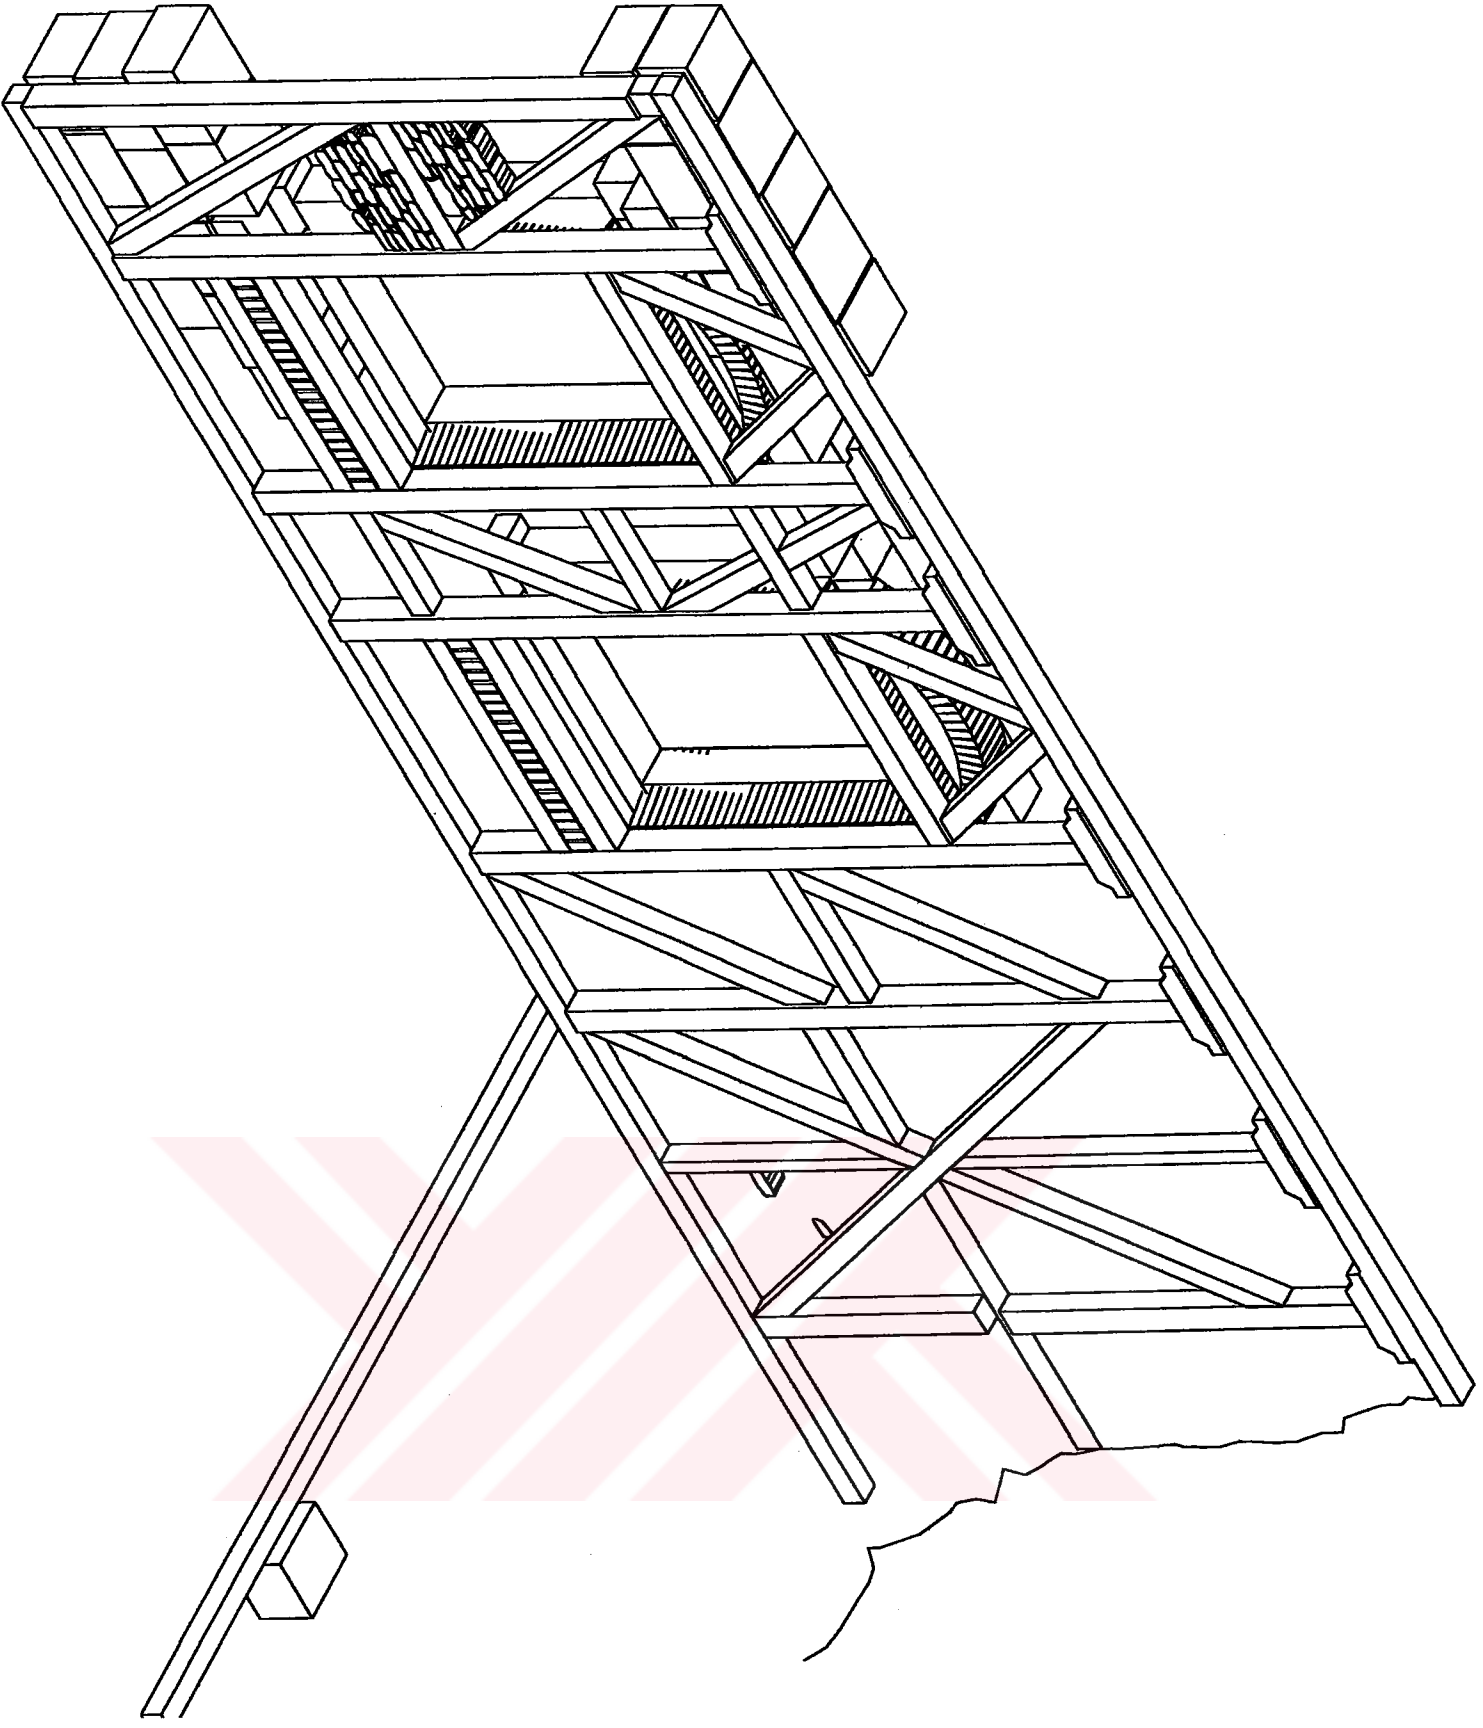
G.3 İzmir Caddesi No:1 – Partial 3D Model of the Second Storey Wall (Interior view)
