**PREPARATION OF A MAINTENANCE, SIMPLE REPAIR, AND  
INTERVENTION HANDBOOK FOR  
YENİ FOÇA- İZMİR**

**A THESIS SUBMITTED TO  
THE GRADUATE SCHOOL OF NATURAL AND APPLIED SCIENCES  
OF  
THE MIDDLE EAST TECHNICAL UNIVERSITY**

**IN PARTIAL FULFILMENT OF THE REQUIREMENTS FOR THE DEGREE OF  
MASTER OF SCIENCE  
IN  
THE DEPARTMENT OF ARCHITECTURE, IN RESTORATION**

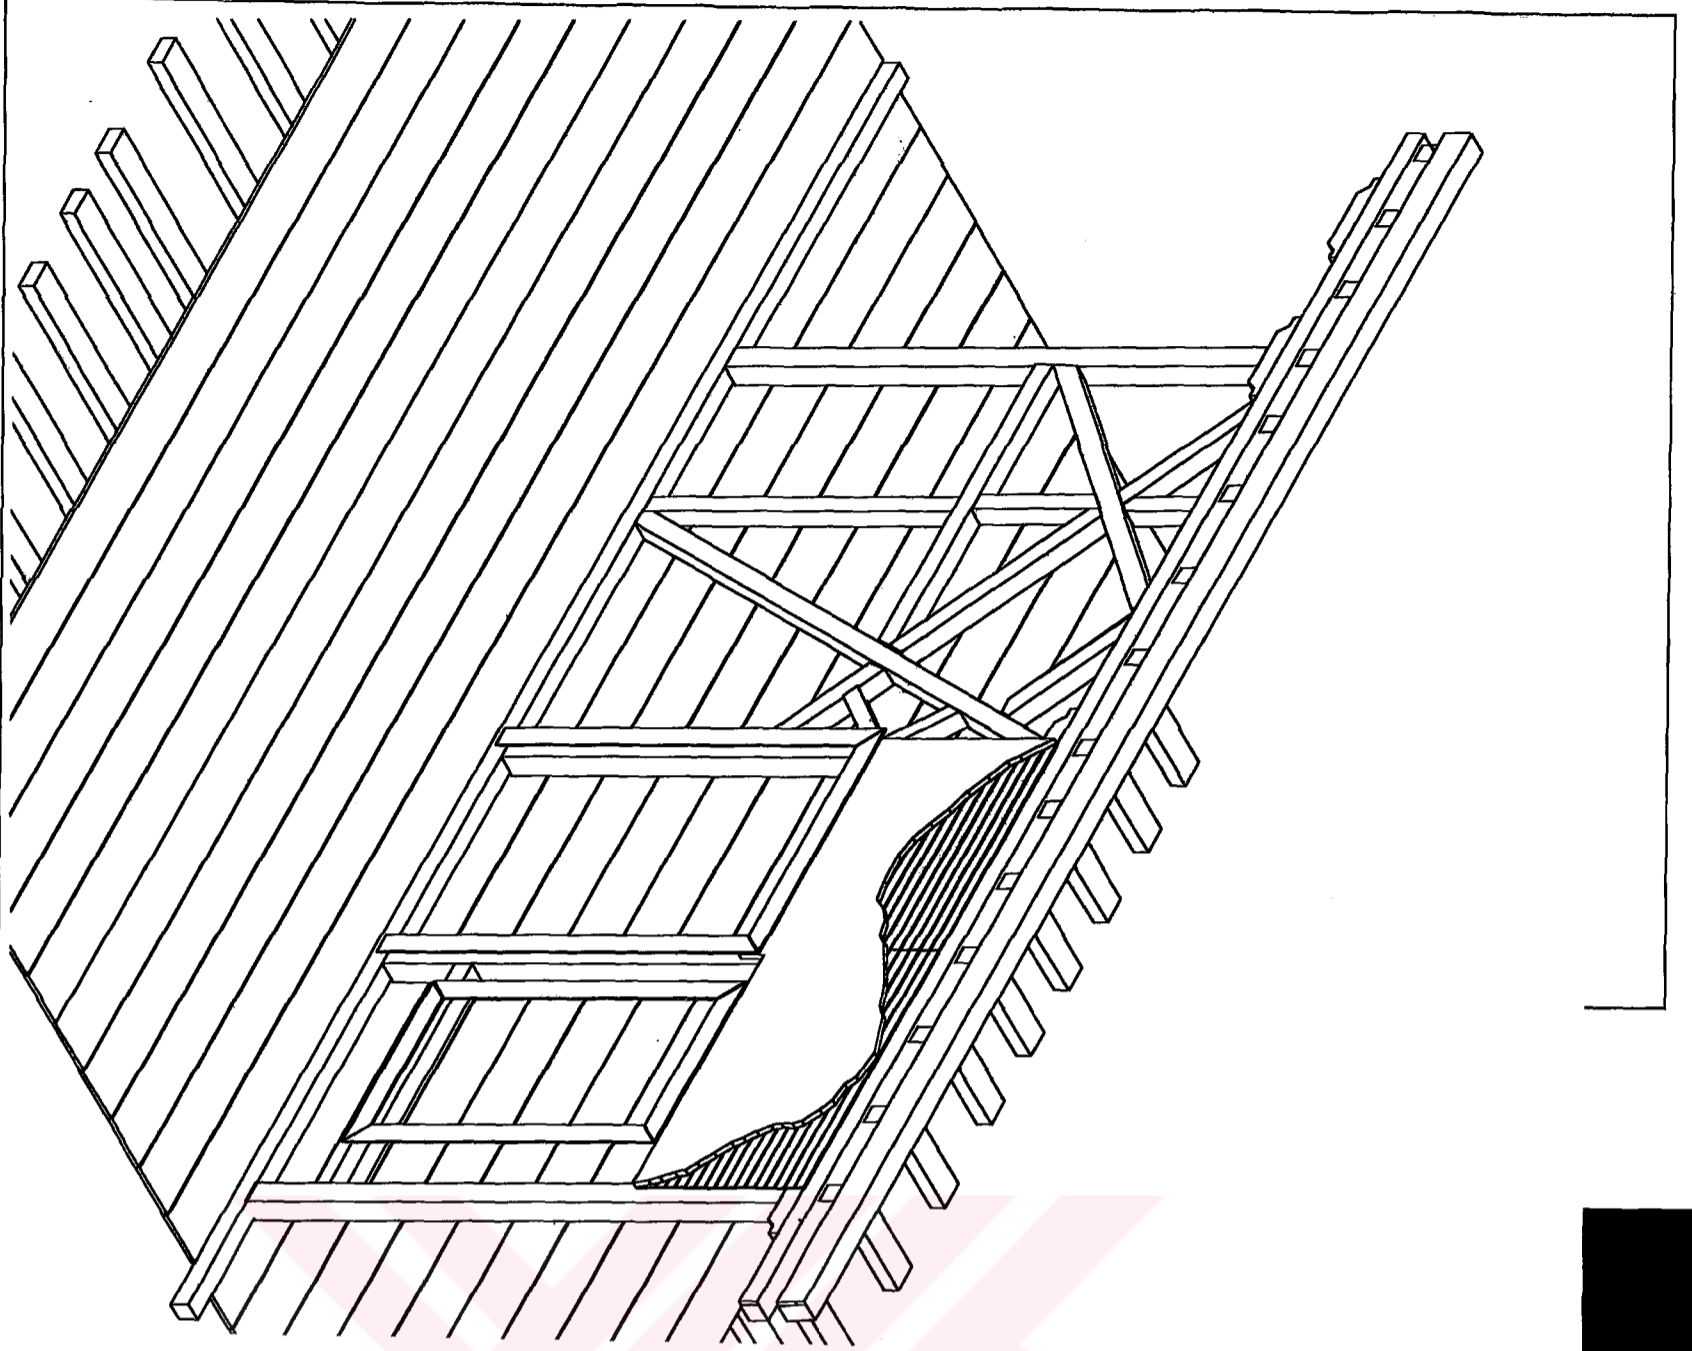
G.4 Partial 3D Model of an inner wall

The drawings in this section are prepared during the thorough survey within the buildings. 3D models of the buildings and of various building components are drawn to the scale but are not pressed with a definite scale. They are included to give an idea of the construction system of the buildings of which the system could be observed.

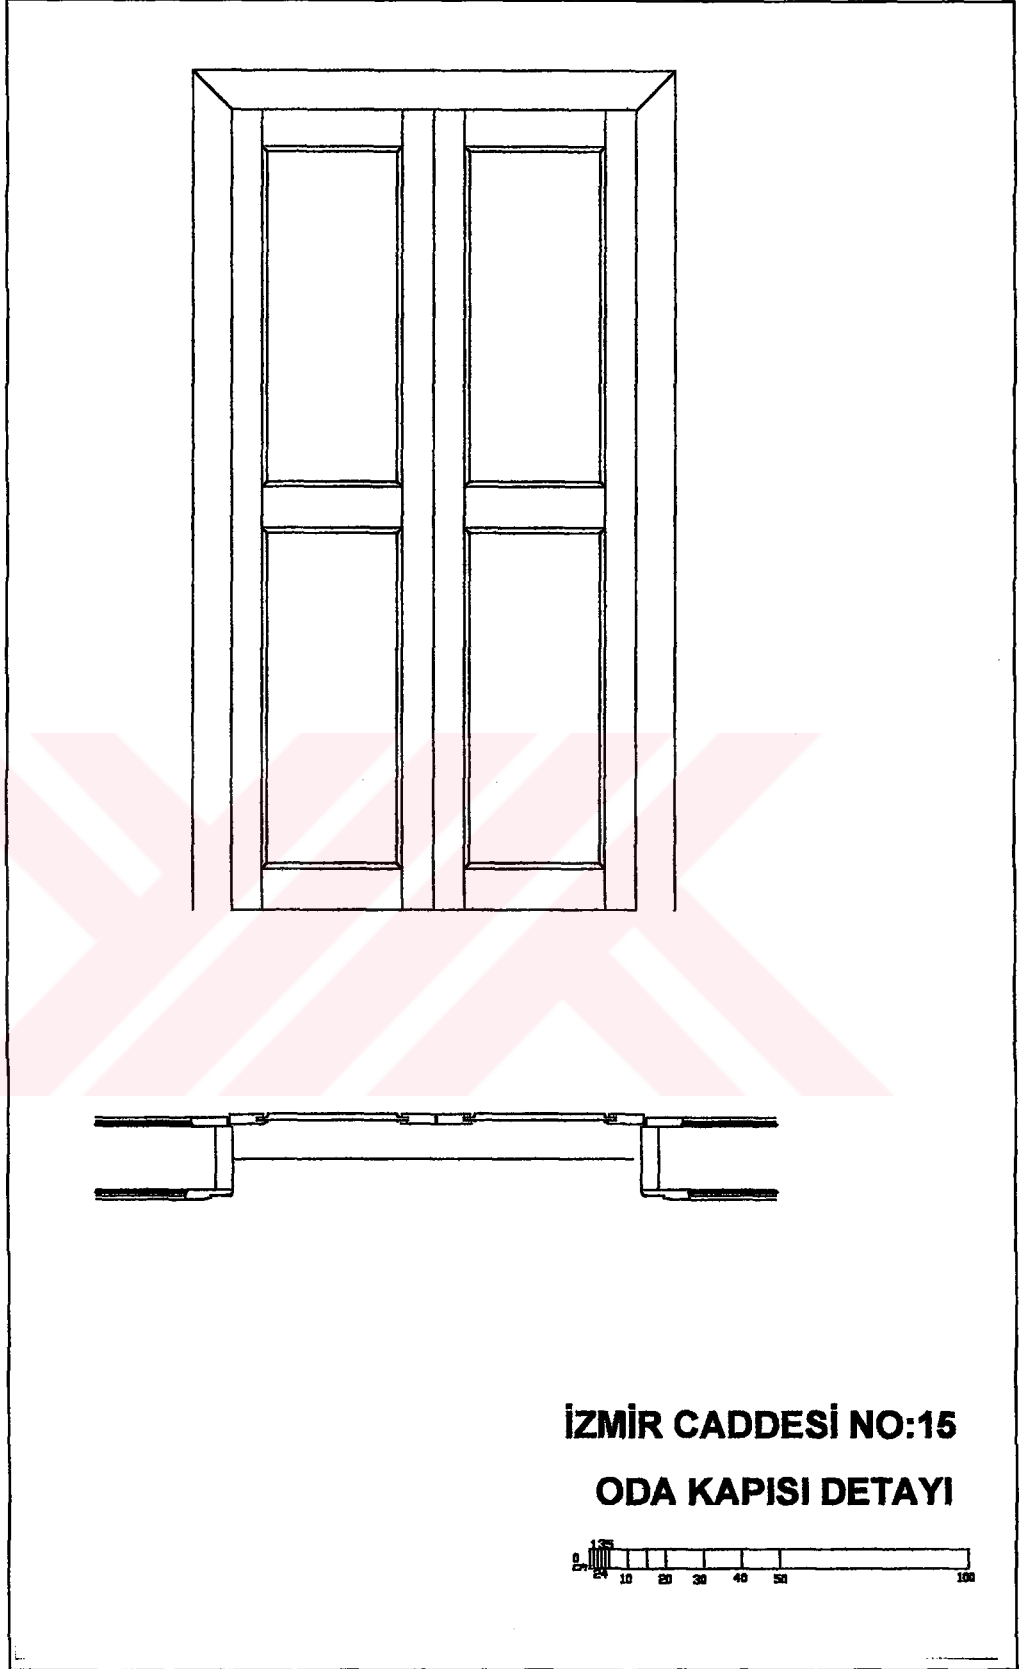
G.5 İzmir Caddesi No: 15 – A room door; Elevation and Plan

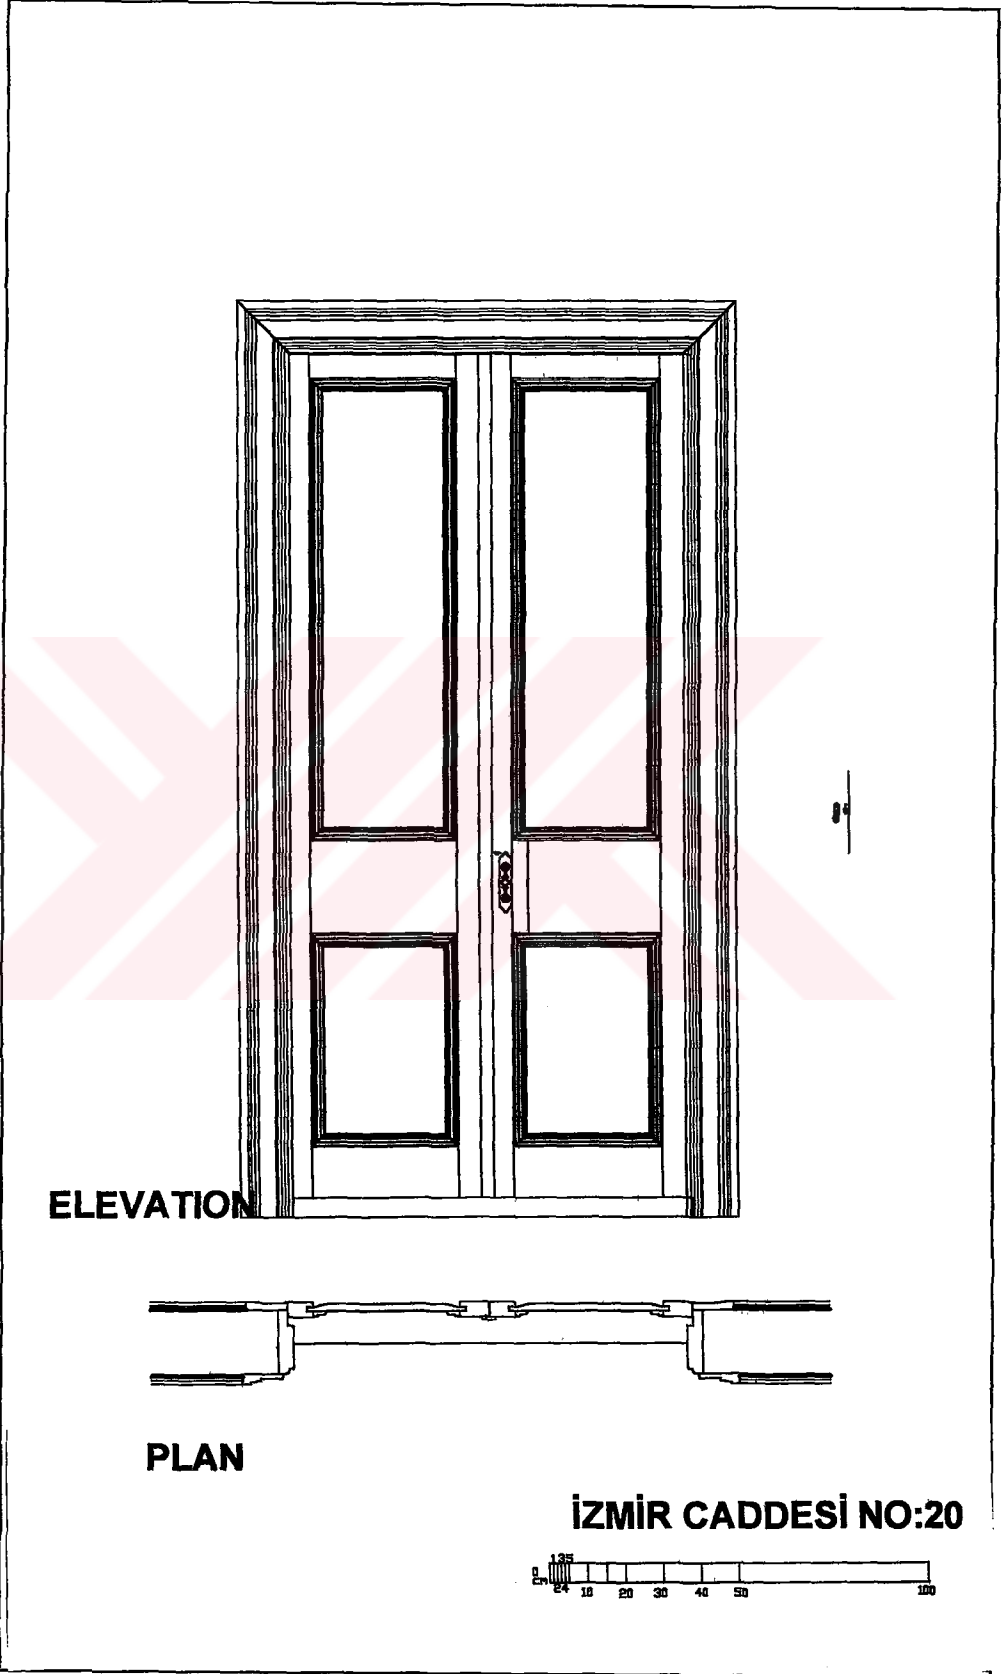
G.6 İzmir Caddesi No:20 – A room door; Elevation and Plan

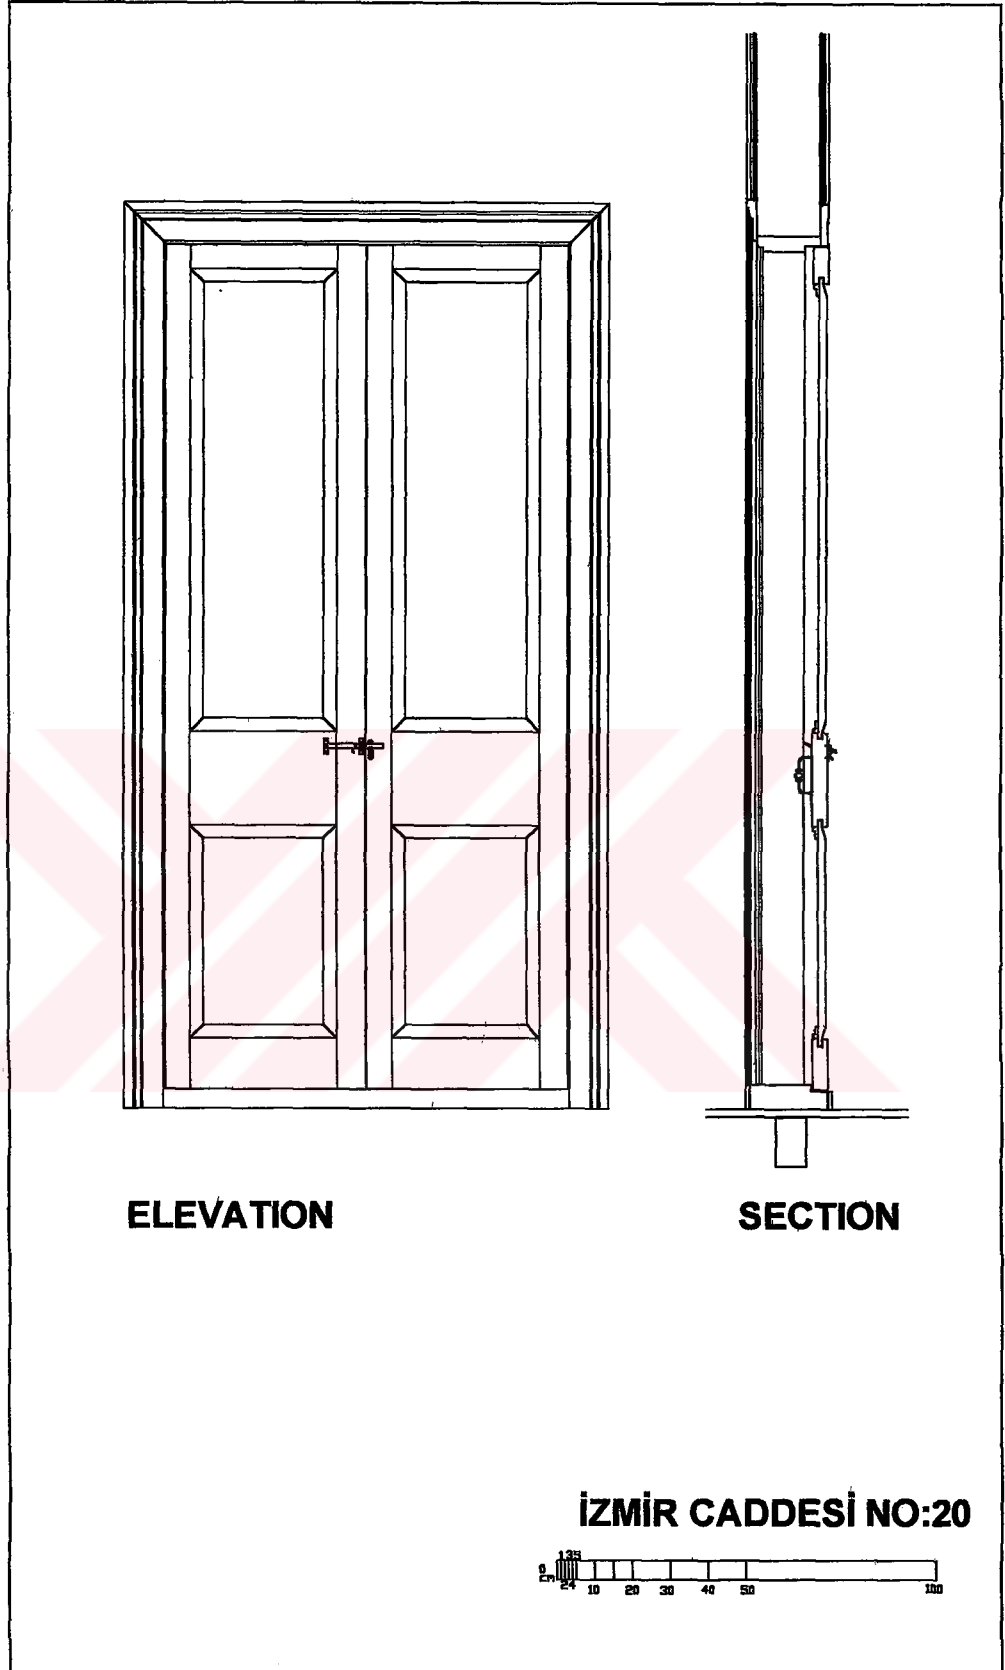
G.7 İzmir Caddesi No: 20 – A room Door; Elevation and Section

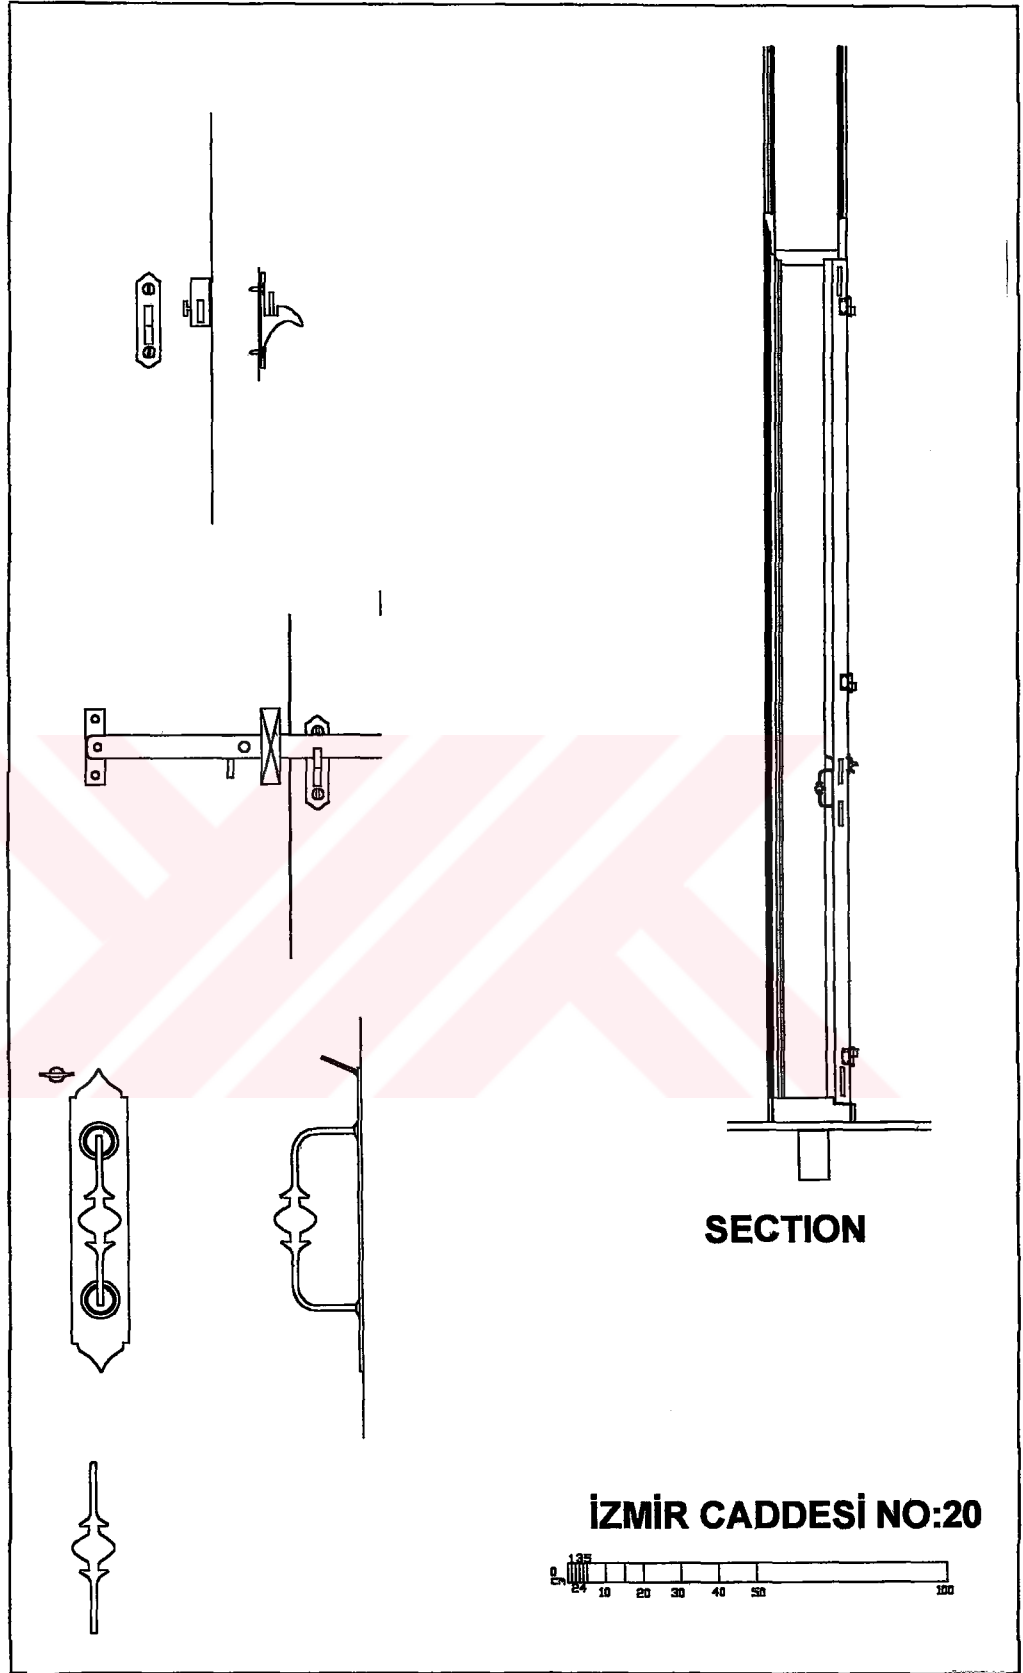
G.8 İzmir Caddesi No:20 – A room door; Section and details

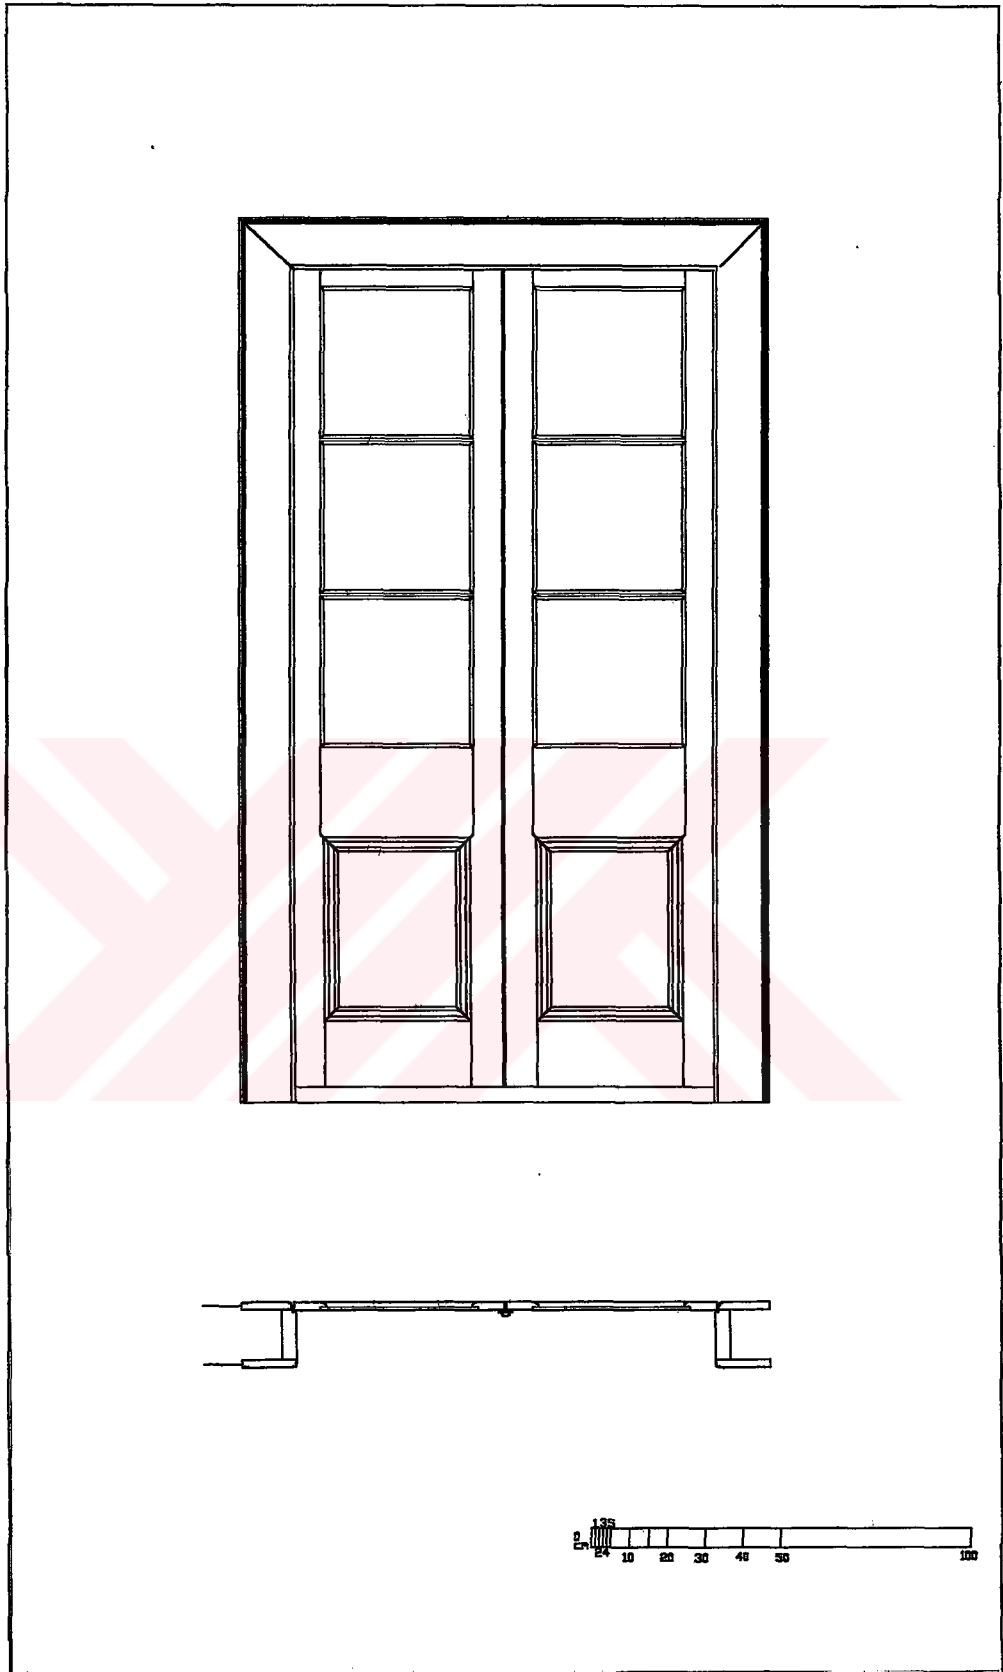
G.9 A room door: Plan And Elevation

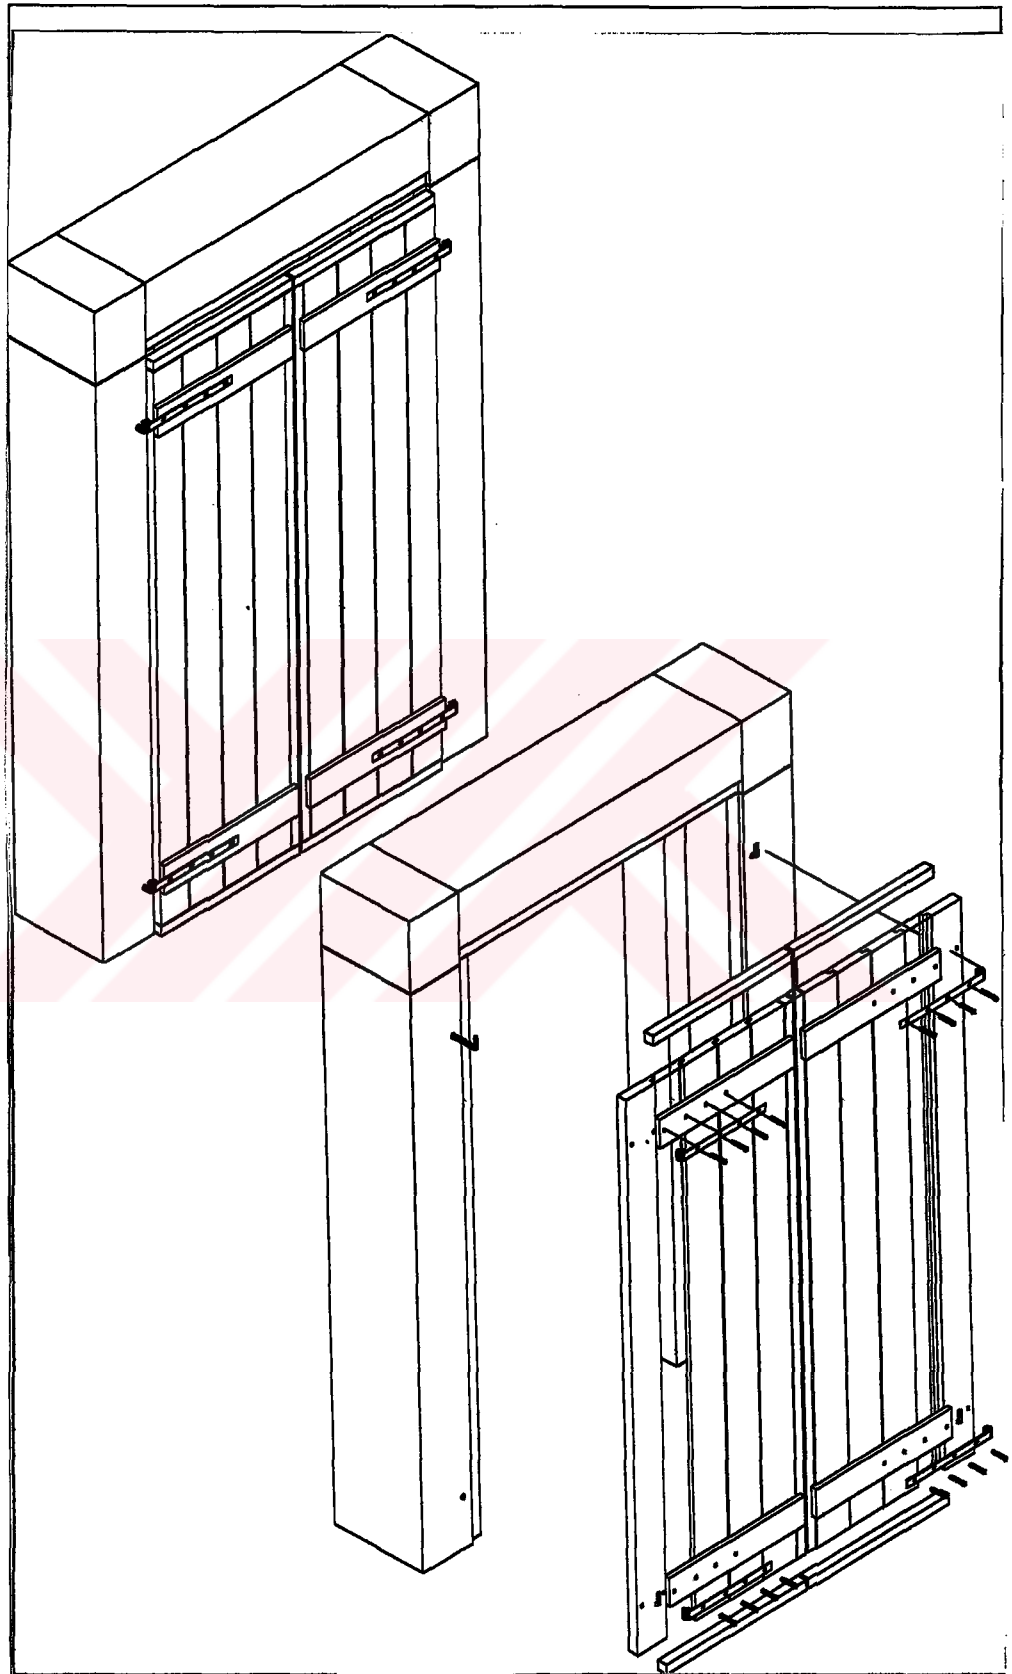
G.10 Wooden Shutter Detail – 3D Model

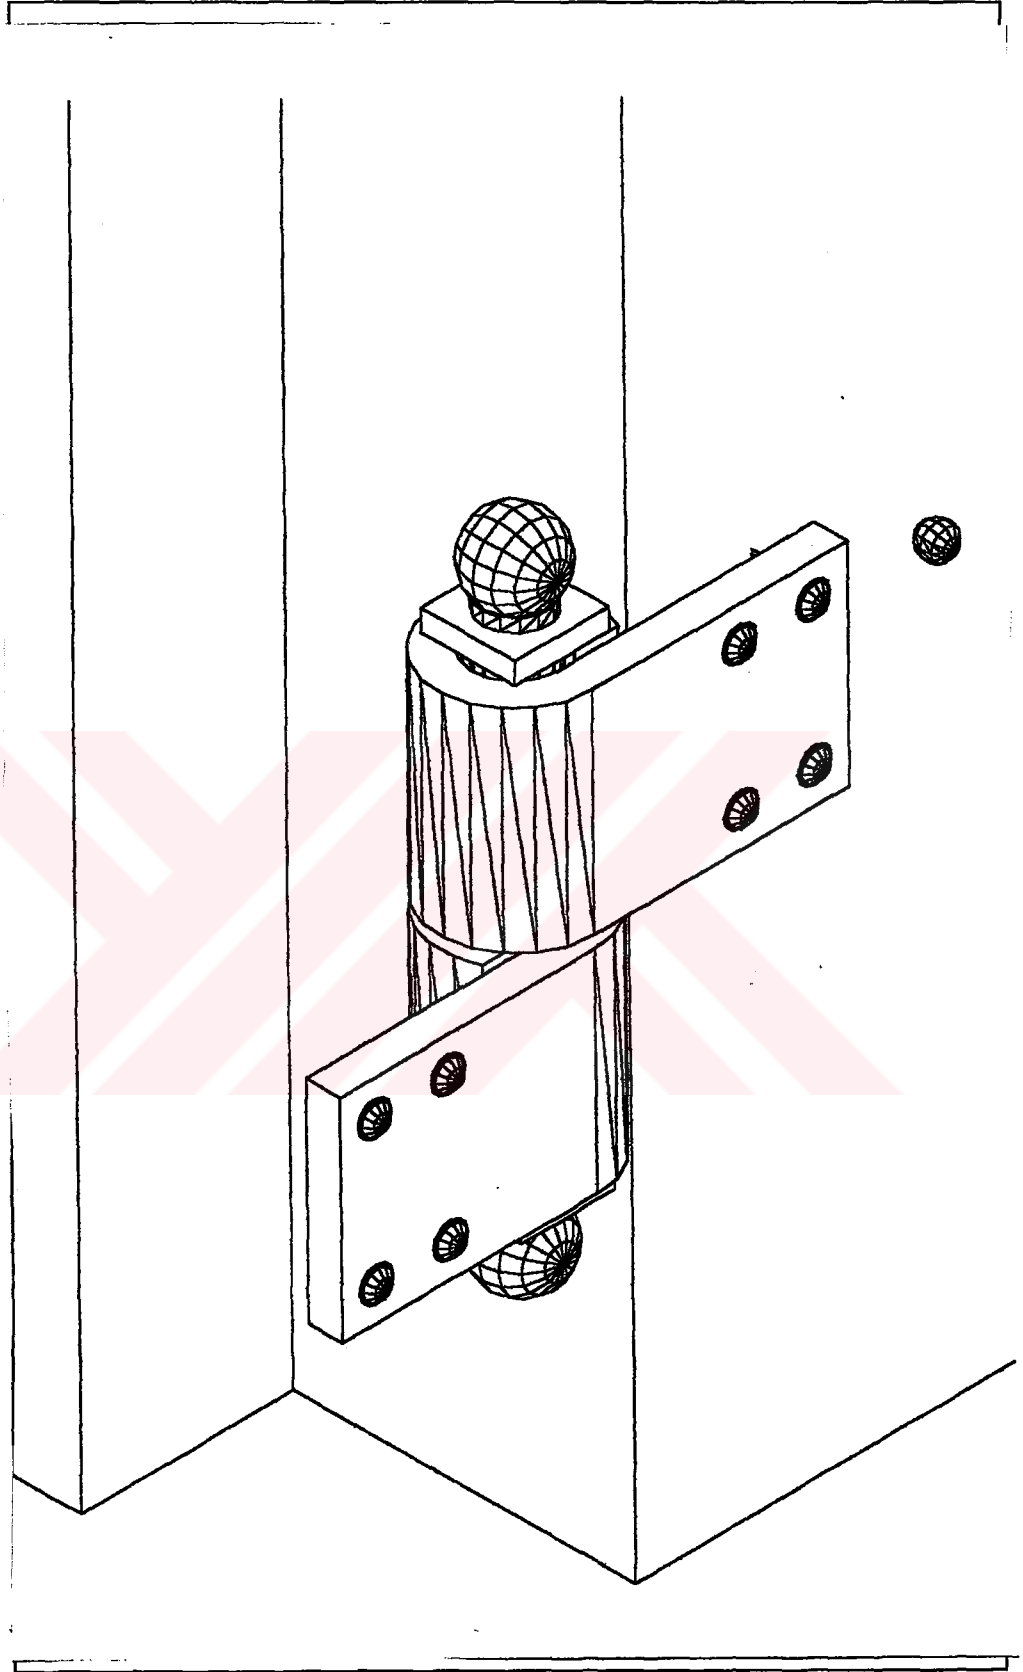
G.11 Kuşluk Detail
