Seismic resistance of traditional timber-frame *himiş* structures in Turkey: a brief overview

Yasemin Didem Aktaş

Keywords: *himiş*; timber-frame; vernacular architecture; connections; seismic behaviour

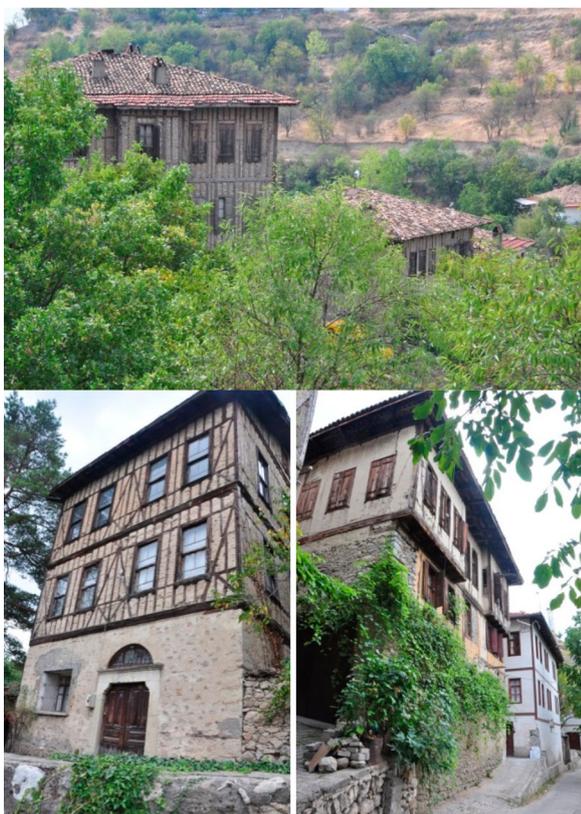
1 *Hımış* houses in Safranbolu

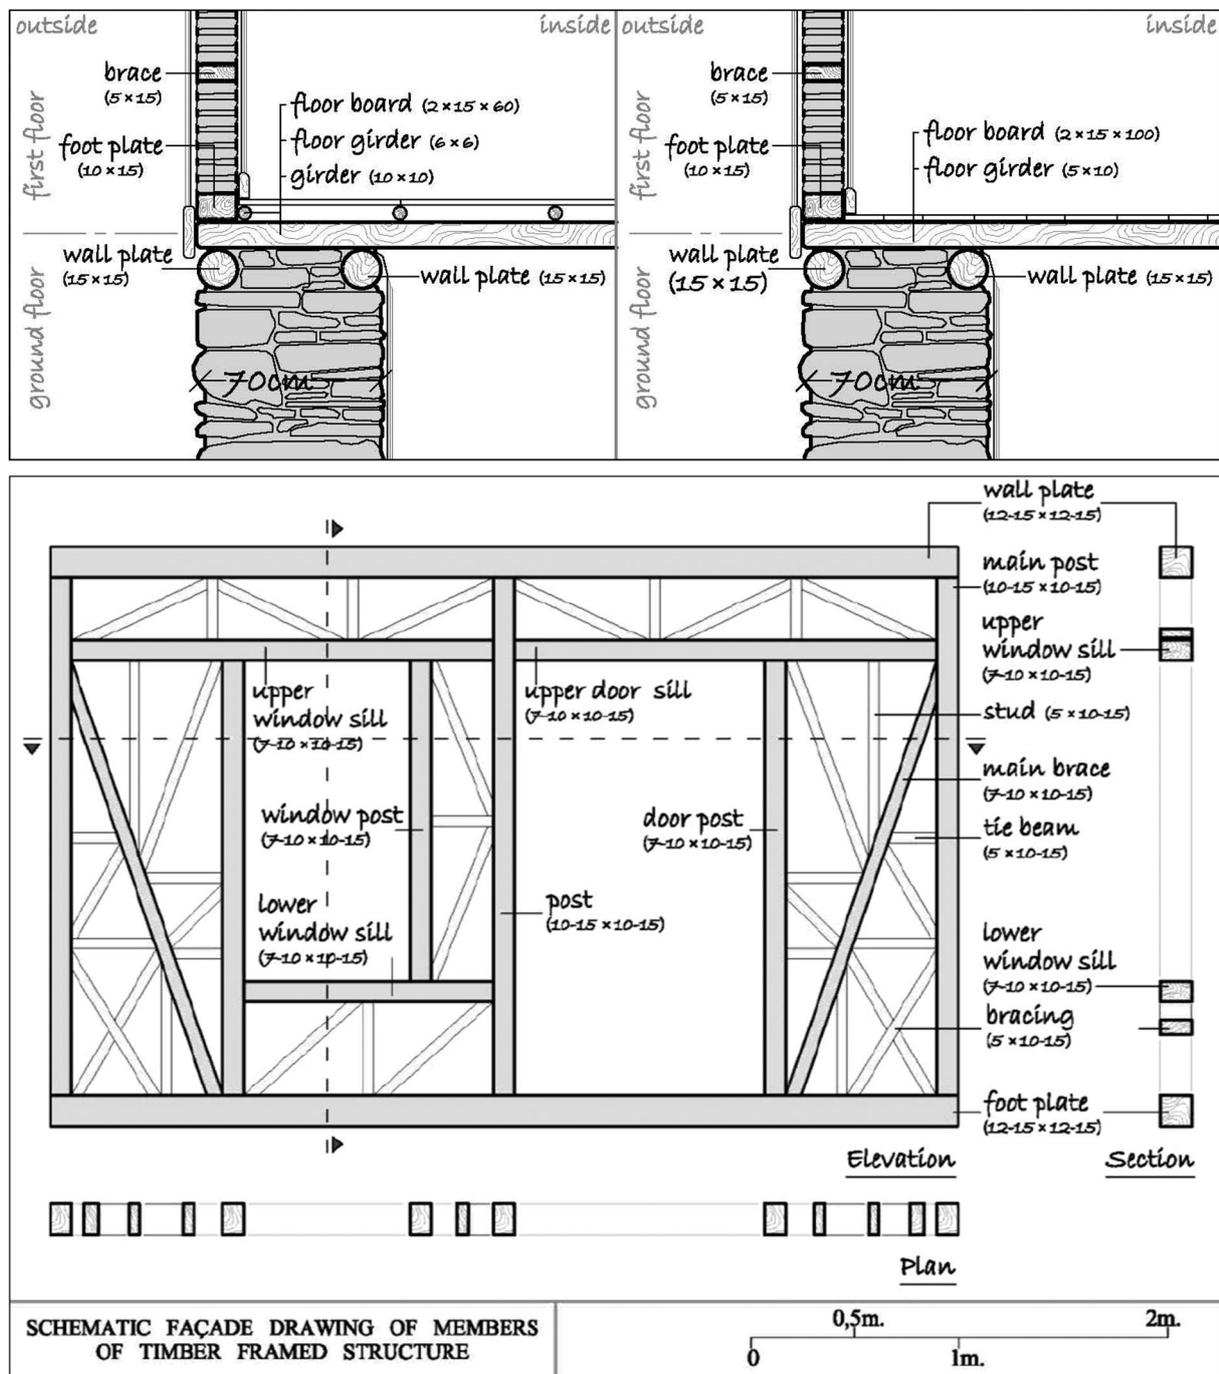
2 (top) Schematic drawing of the detailing between masonry ground floor and timber-frame upper floor and (bottom) members forming a timber-frame based on an case study structure from Birgi, Turkey (after Diri 2010)

usually but not always thinner than the other members, as well as diagonal members, which also help increase in-plane lateral load-bearing capacity. The horizontal and vertical spacing between these members is estimated by the builder so as to avoid shear cracking and dictated by the door and window openings that frame design requires (Fig. 2).

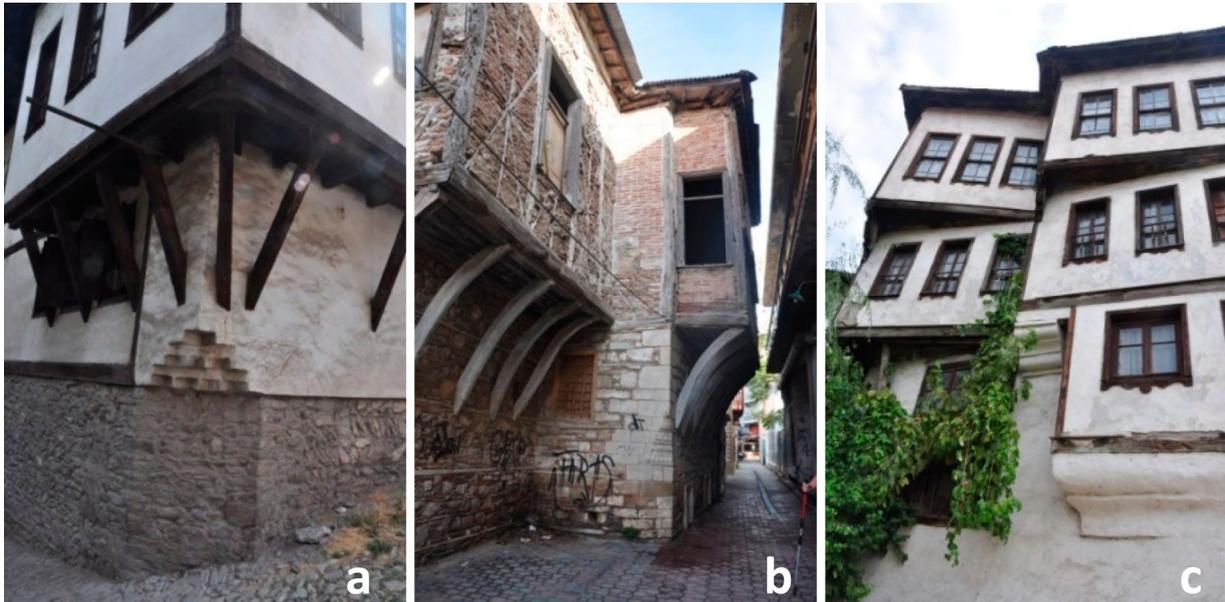
3 Braced projections from **a** Safranbolu, Turkey and **b** Chalkis, Greece (this concave variation is known as *eliböğünde*) and **c** simple cantilever projection from Safranbolu

(iv) Plan/elevation regularity: Most of the historic *hımış* houses sit on an irregular parcel of land, especially in cities where the city layout is highly organic, i.e. non-gridal, such as Istanbul. The irregular planar geometry of the ground floor is then ‘corrected’ in the upper-storeys using projections. Moreover, the height of ground floor can be considerably different than the other storeys, especially when it is designed to be used as animal shelter or for storage as frequently observed in rural areas, or for carriages or other services in more urban settings. These plan/elevation irregularities might be disadvantageous under seismic loading.

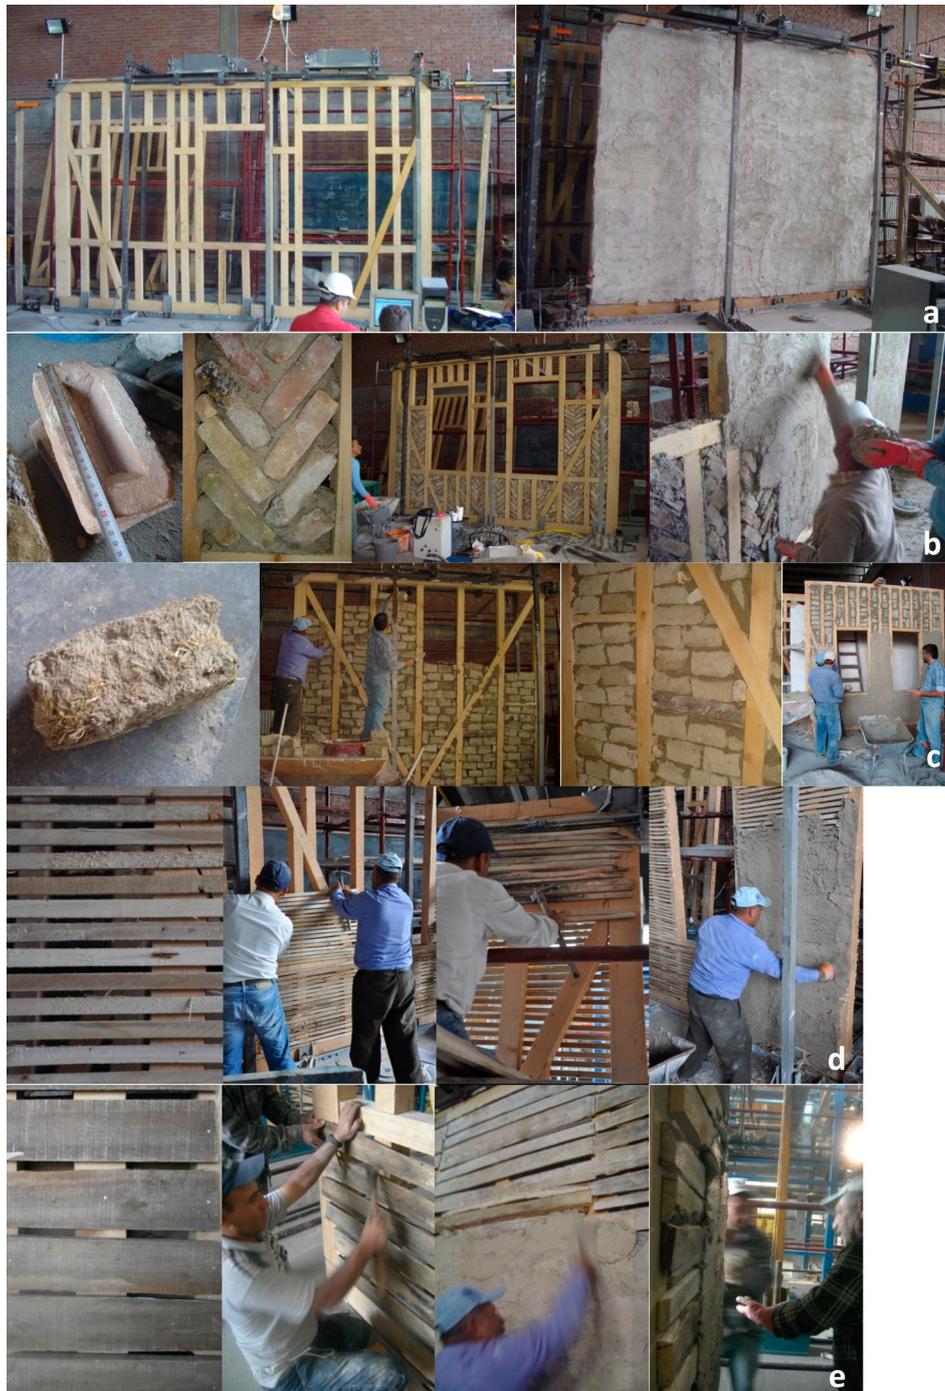
4 a Frame tests under reverse-cyclic lateral loading; b brick infill; c adobe infill; d bağdadi cladding; e şamdolma cladding.

is, to best of the author's knowledge, still limited to the extensive testing scheme carried out at METU, Structural Mechanics Laboratory in 2009–2011, as part of a research project titled 'Seismic Assessment of Traditional Ottoman Timber-Frame Houses', funded by TUBITAK. The project included testing of 8 full-scale *hımış* frames, built with different geometrical configurations selected from Safranbolu (UNESCO World Heritage Site) using (unaged) pine and fir under reversed cyclic lateral loading (Fig. 4a). The frames were first tested in their bare state, and then repaired and re-tested with infill (brick and adobe; Fig. 4b and 4c, respectively) and cladding (*bağdadi* and *şamdolma*, the latter being a central Anatolian variety of the

former, with up to five times wider laths, see Fig. 4d and 4e, respectively). The findings from the testing scheme were reported in detail elsewhere (see Aktaş *et al.* 2010; Aktaş *et al.* 2014a; Aktaş *et al.* 2014b; Aktaş and Türer 2016). In the following, certain structural features of *hımış* houses are further discussed in the light of the findings of the aforementioned testing scheme and other resources.

found to result in higher seismic capacity-to-demand ratios than *şamdolma* within the frame-set used in the mentioned testing. This is considered to be because in both cladding techniques each lath is nailed to the underlying frame with a nail every time it comes over one of its members, and therefore the average number of nails per unit area is five to six times more in *bağdadi*, resulting in a better diaphragm action. Post-disaster observations, too, often confirm that *bağdadi* results in a better seismic performance. Cladding in general decreases drift, while infill increases it.
