ASSESSMENT OF THE EFFECTS OF ADAPTIVE REUSE INTERVENTIONS  
ON  
THREE APARTMENT BUILDINGS IN BEYOĞLU, İSTİKLAL STREET

A THESIS SUBMITTED TO  
THE GRADUATE SCHOOL OF NATURAL AND APPLIED SCIENCES  
OF  
MIDDLE EAST TECHNICAL UNIVERSITY

IN PARTIAL FULFILLMENT OF THE REQUIREMENTS  
FOR  
THE DEGREE OF MASTER OF SCIENCE  
IN  
CONSERVATION OF CULTURAL HERITAGE IN ARCHITECTURE

SEPTEMBER 2020

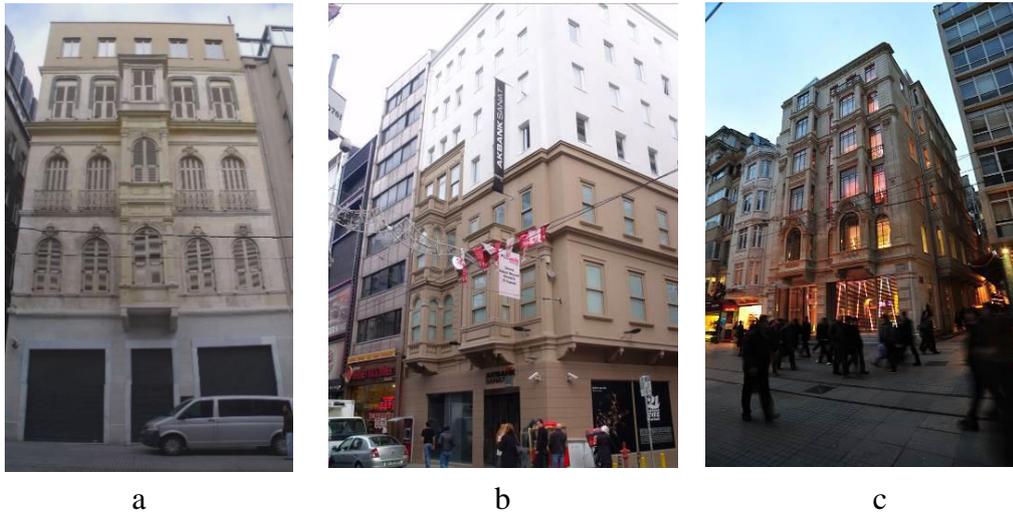
Figure 1.3. (a)SALT Cultural Center (Personal Archive), (b) Aksanat Cultural Center (Personal Archive), (c) Borusan Cultural Center. Source: [www.gadarchitecture.com](http://www.gadarchitecture.com), last accessed in February 11, 2020

İstiklal Street is chosen as the study area for this thesis, where the relationship between carrying capacity and the new function is examined in adaptive reuse interventions for the reasons explained above. The three apartment buildings on this street, which have been adapted as cultural centers with different approaches, have been selected as cases for the detailed analyses of adaptive reuse processes. (Figure 1.3) These buildings are;

- AKSANAT Cultural Center, which has a mass attachment next to and above the apartment building and whose interior has been completely changed,

- BORUSAN Cultural Center, whose façades have been conserved but its interior is completely emptied and redesigned.

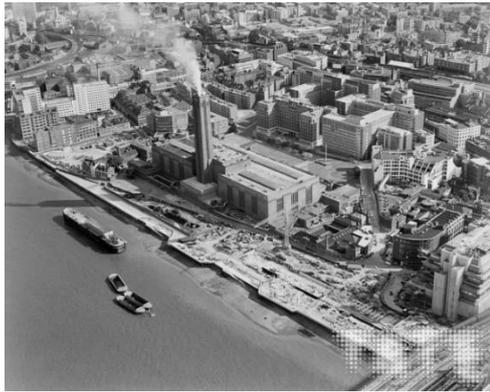
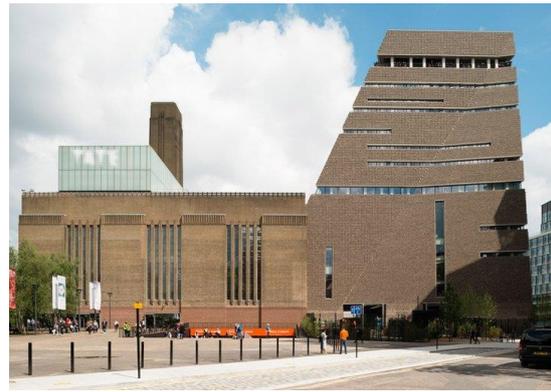
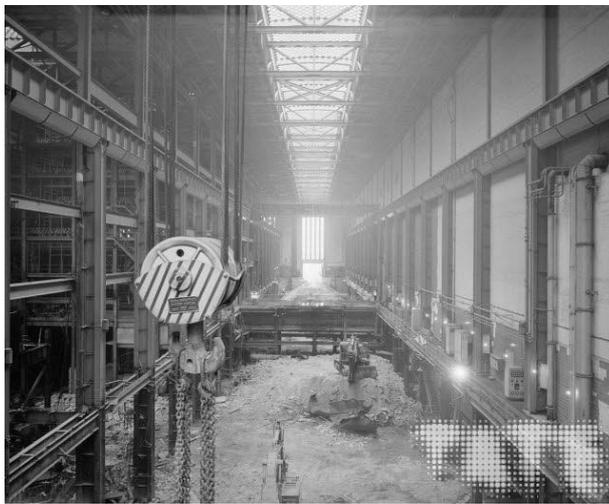
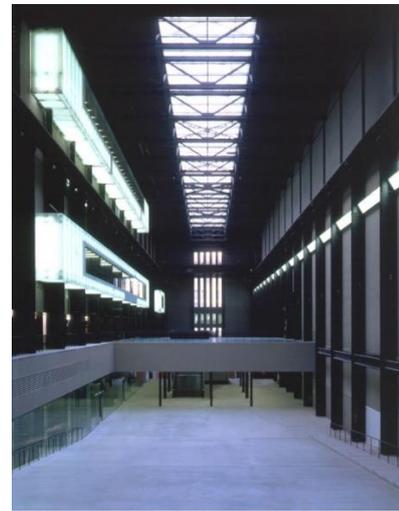
Figure 2.2. Photographs of Tate Modern Building; (a) Outer View Before Adaptive Reuse. Source: [www.tate.org.uk](http://www.tate.org.uk), last accessed in May 20, 2020, (b) Outer View After Adaptive Reuse (from Jim Stephenson's archive), (c) Inner View Before Adaptive Reuse. Source: [www.tate.org.uk](http://www.tate.org.uk), last accessed in May 20, 2020, (d) Inner View After Adaptive Reuse. Source: [www.artobserved.com](http://www.artobserved.com), last accessed in May 20, 2020

The abovementioned relationship between adaptive reuse, economic values and use value can be clearly seen in the example of Tate Modern building in London. The building, which was designed as a power station by Sir Giles Gilbert in 1947, closed down and abandoned in 1981 as a result of developments in the field of industry and energy. Thereafter, while it was being discussed that the building became dilapidated, posed a risk for the society and needed to be demolished, in 1995, Swiss architects Herzog & de Meuron expressed that they can prepare an adaptive reuse project to transform the building into a museum without demolishing. With this project, it is seen that the building is now one of the most famous buildings in London and attracts visitors from all over the world. (Figure 2.2)<sup>10</sup>

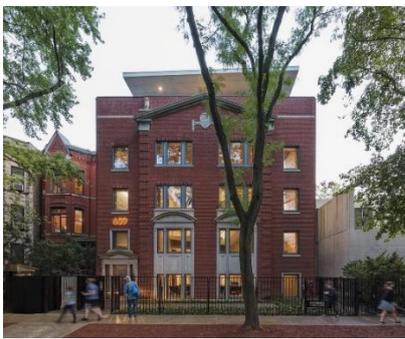
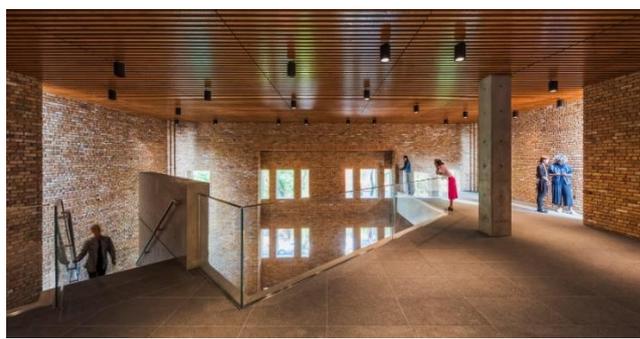
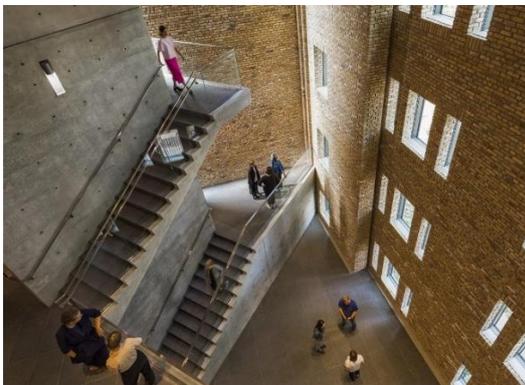
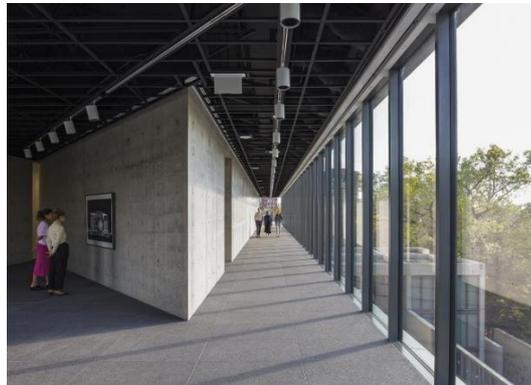
Figure 2.4. Photographs of Wrightwood 659 building (from Jeff Goldberg's archive); (a)Outer View, (b) Inner View, (c) Inner View from Circulation Gallery, (d) Inner View. Source: <http://www.archello.com/project/wrightwood-659/>, last accessed in May 23, 2020

Due to the lack of the original building to meet the requirements of the new function in spreading adaptive reuse implementations, it is frequently observed that only the authenticity of the building façades are conserved and the interior layout is partially or completely changed. This circumstance causes the authenticity and document value of architectural asset to be lost. Wrightwood 659 building in

Chicago, designed by Tadao Aldo, is an example of the mentioned adaptive reuse implementations. The apartment building, which was constructed in 1920s reflecting the character of the region, is being used as an exhibition hall as a result of its adaptation. It is seen that the outer walls of the building is conserved during the adaptive reuse implementation. However, the interior of the building was completely emptied and a new reinforced concrete structure was rebuilt in accordance with the requirements of exhibition hall in terms of light and space dimensions. (Figure 2.4)

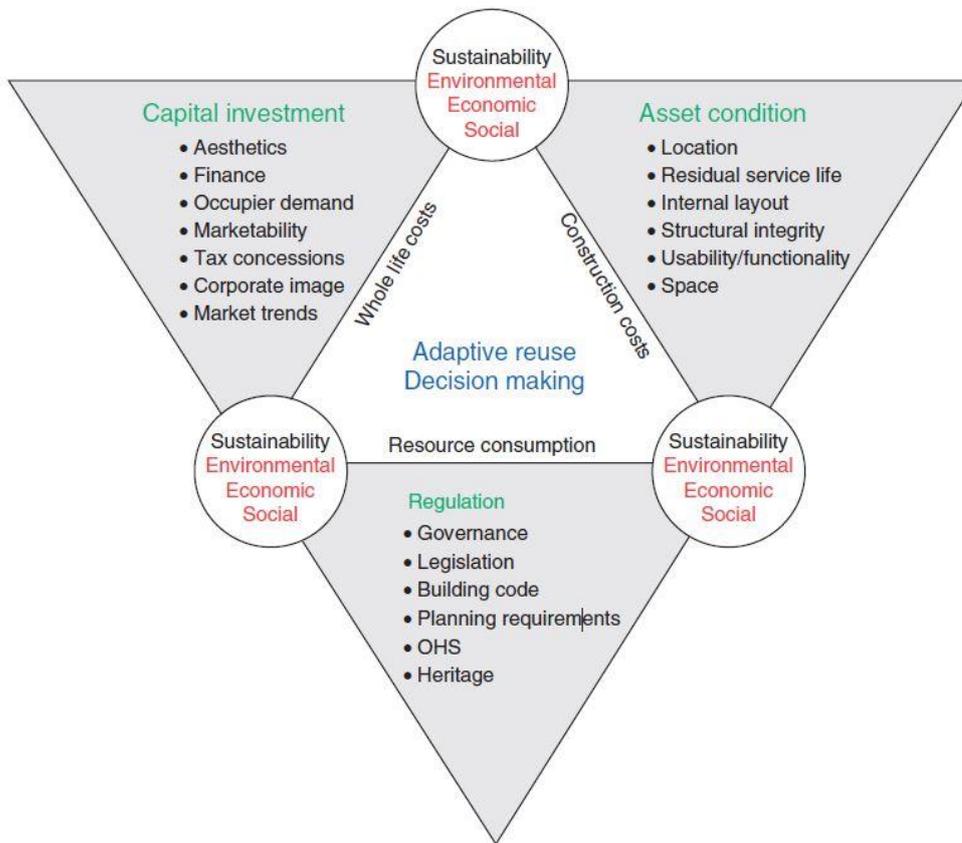
Figure 2.7. A model for adaptive reuse decision making

It is seen that Bullen and Love constituted a model for the adaptive reuse process in another work. In this model, an adaptive reuse evaluation is made on sustainability based on environmental, economic and social factors. Analyzing the details in the model, it is comprehended that asset condition, capital investments and regulations form the basis of the adaptive reuse process as the basic inputs to be examined (Bullen, Love, 2011, p.37). (Figure 2.7)

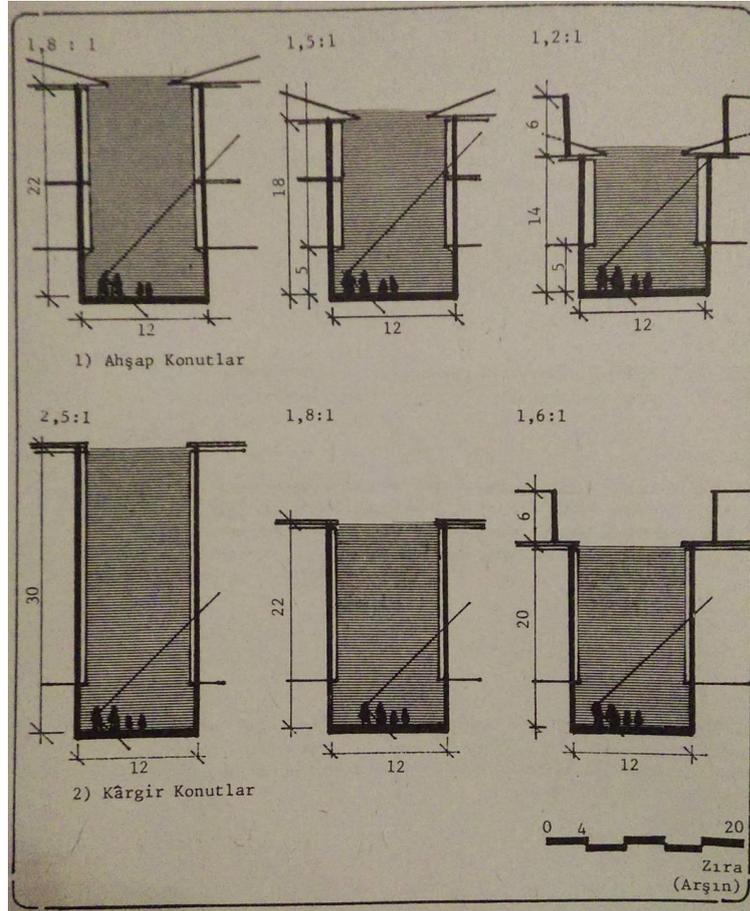
Figure 3.3. Drawings showing the rules on wooden frame and masonry building heights in Building Regulations (Ebniye Nizamnamesi) (Denel, 1982, p.80)

regulations were established aiming to direct citizens to prefer masonry construction instead of wooden frame structures (Kuban, 2010, p.458-459).

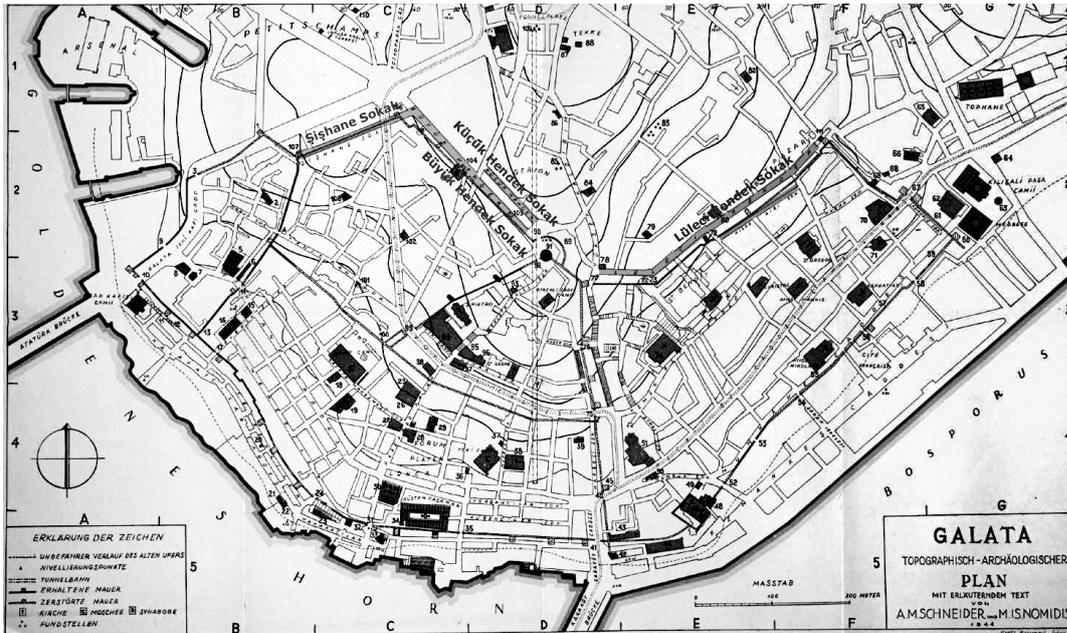
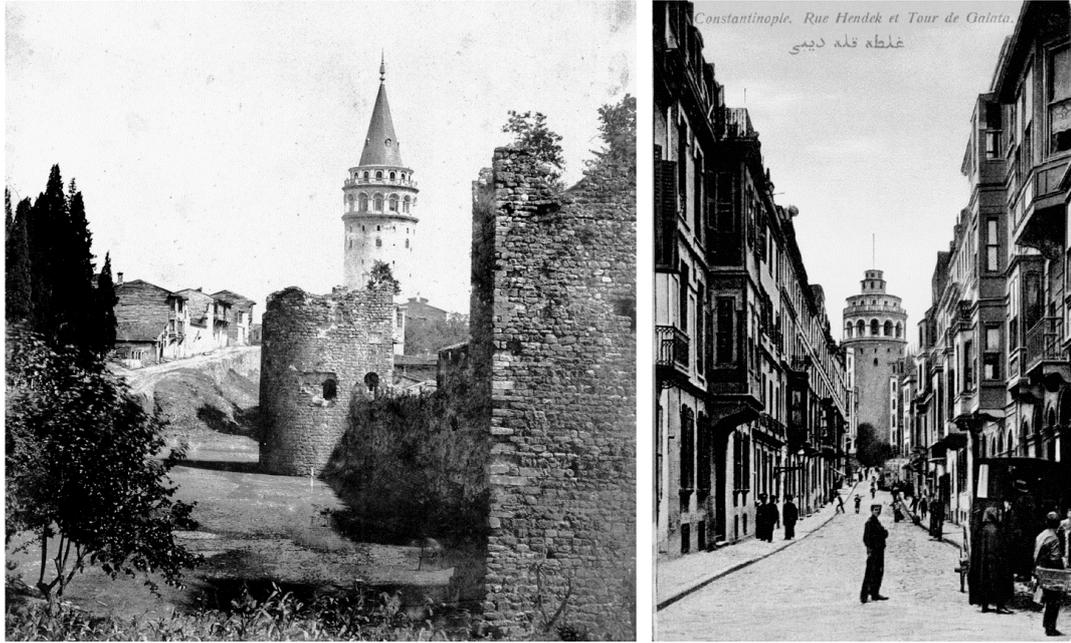
Figure 3.5. (a) Plan showing the new roads that was planned after destruction of the city walls, (b) Pictures showing the ditch before the destruction and Büyük Hendek Street afterwards the destruction (Öncel, 2010, p.46,70)

From the 13th to the 19th centuries, between Galata and Pera, there were Galata Walls surrounded with ditches, built by Genoese. In 1864, the Sixth Department Municipality (Altıncı Daire Belediyesi) made a decision on the destruction of these walls and started its execution. As the city walls were demolished and the ditches were filled, new roads were constructed and the rest of the land were sold to the citizens in order to generate income for the municipality. In consequence of these works, new access roads emerged between Galata and Pera as well as among other settlements (Figure 3.5). In 1865, Pera – Galata region tramway project started to be implemented. It is comprehended that, within the same period, road extension works in Beyoğlu district including İstiklal Street, were proceeding (Akın, 2011, p.106-108).

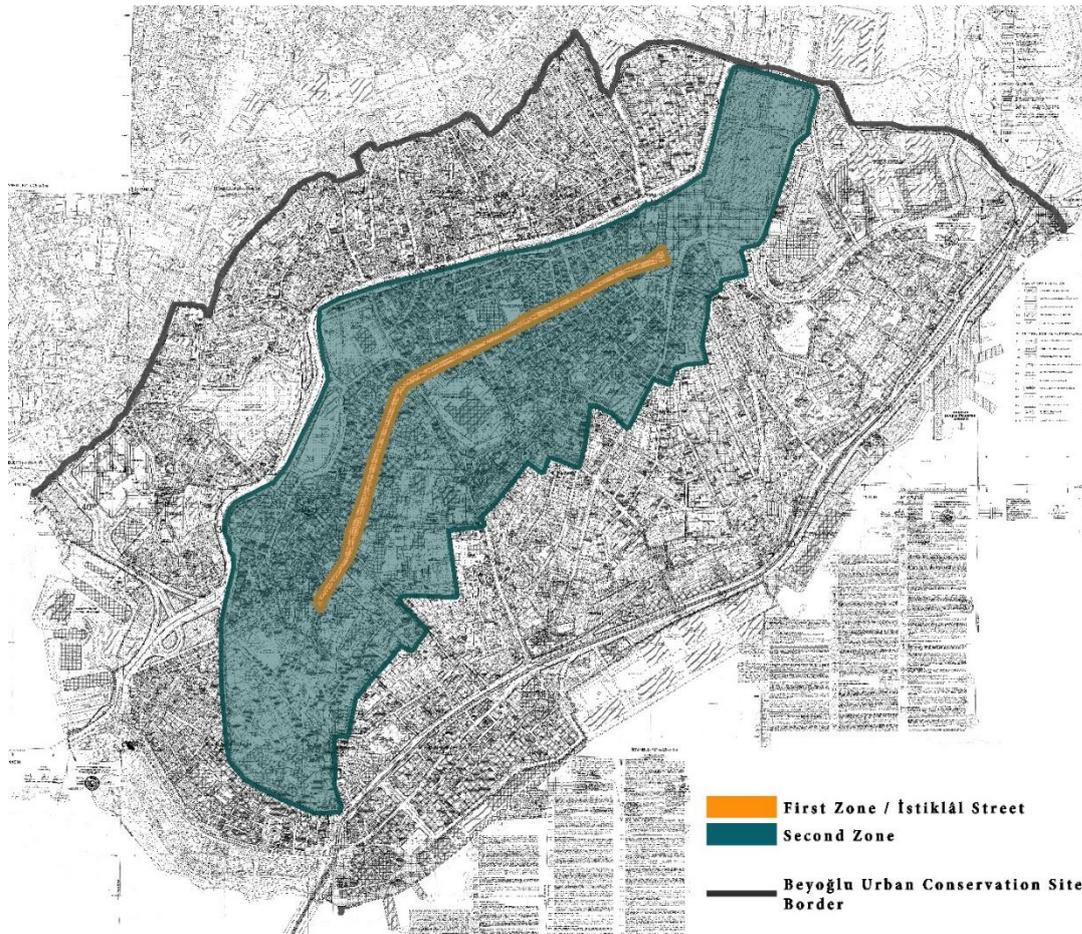
Figure 3.7. Map showing zones of the study area (prepared by the author based on the map obtained from Beyoğlu Municipality Archive)

As a result of historical researches and the planning process surveys, it is understood that the apartment buildings built in Beyoğlu in the 19th century, which form an architectural fabric with certain distinctive features, have an important place for Beyoğlu. For this reason, the area where these apartments are densified is determined by the site surveys in the region and by means of literature research. Therewith, this area is designated as the study area of the thesis. Within the scope of the thesis, it is determined that this area, which is not possible to be studied entirely in the same detail due to its extensity and density, is divided into two separate zones and is studied in various detail with different methods. As it is understood from the previous researches, İstiklal Street is one of the earliest settlements in Beyoğlu, yet it is one of the most changed regions. For these reasons, İstiklal Street is designated as the center of the study, namely the first zone, and the immediate surroundings of the street is specified as the second zone of the study (Figure 3.7). The zone, which is marked on the map as the second zone is studied to comprehend the types and formation processes of Beyoğlu apartments in general. This zone is examined by strolling the area, making observations and utilizing literature research. İstiklal Street, which is the first zone is studied during the site surveys by examining all the building façades on the street individually.

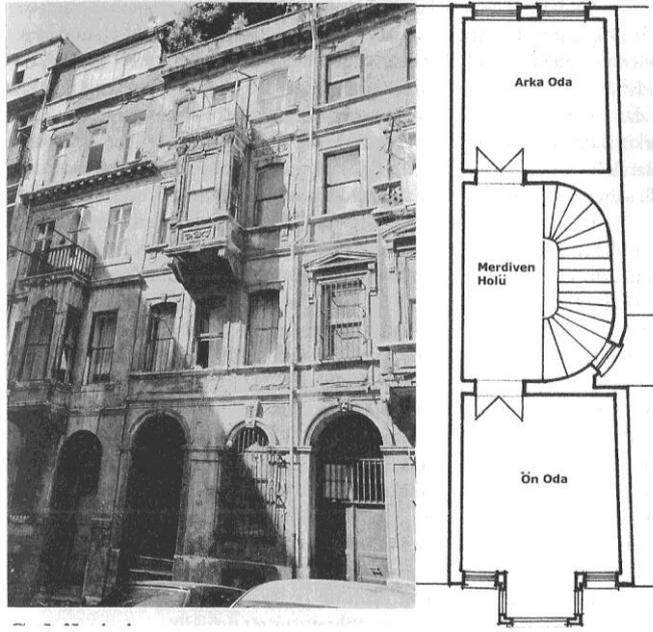
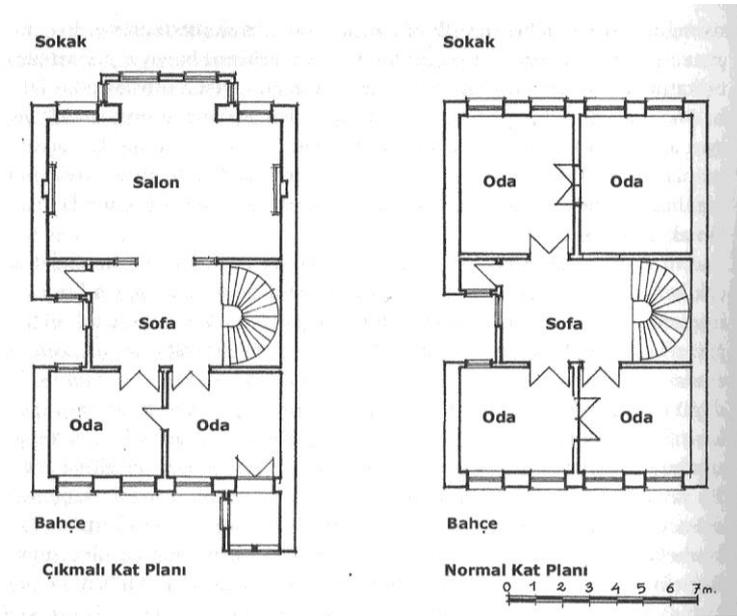
Figure 3.8. (a)A photograph and the second floor plan of a rental house in Galata,  
 (b) Floor plans of a rental house in Galata (Öncel, 2010, p.235, 242)

When the extant examples of these dwellings are analyzed, it is found out that in certain of them, each floor was arranged by adding toilets and kitchens in order to be hired out individually. For this reason, these buildings are also named as “rental houses” (Figure 3.8).

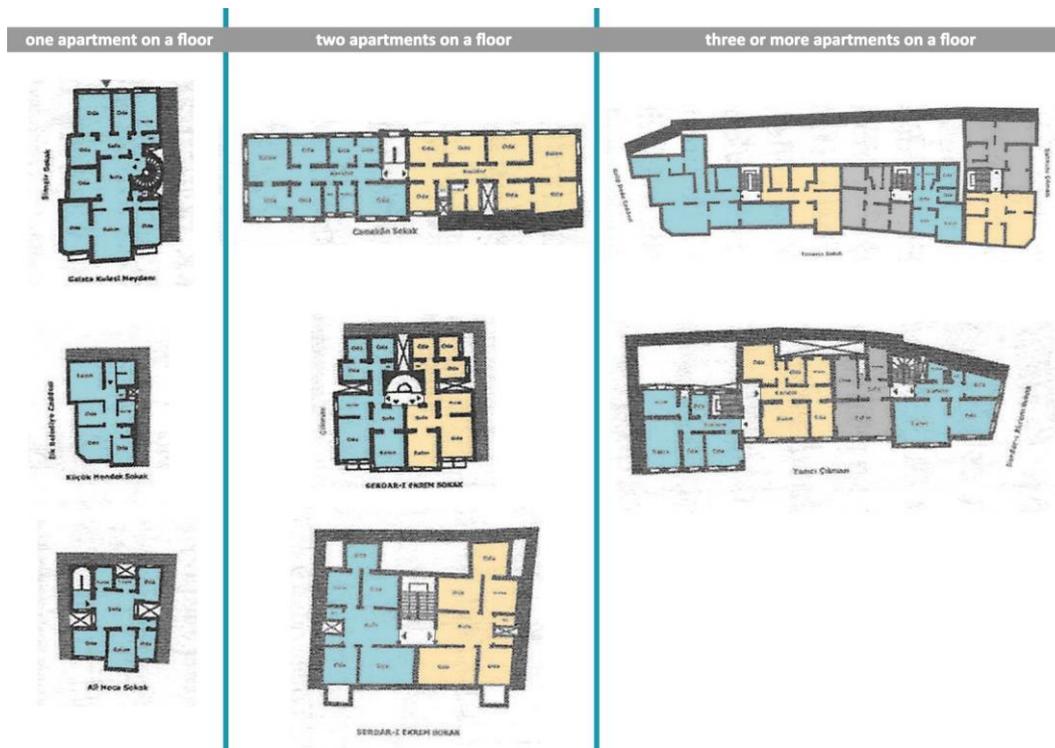
Table 3.5 Apartment building types according to number of apartments on a floor (prepared by the author based on the drawings obtained from the book named “Apartman”) (Öncel, 2010, p. 263-264).

connected to entrance hall or the sofa at the entrance. These spaces are designed to be in the most prestigious location of the flats and towards prevailing vista, on the front façade of the building. They are either positioned in the middle of the façade or extended from one side of the façade to the middle.

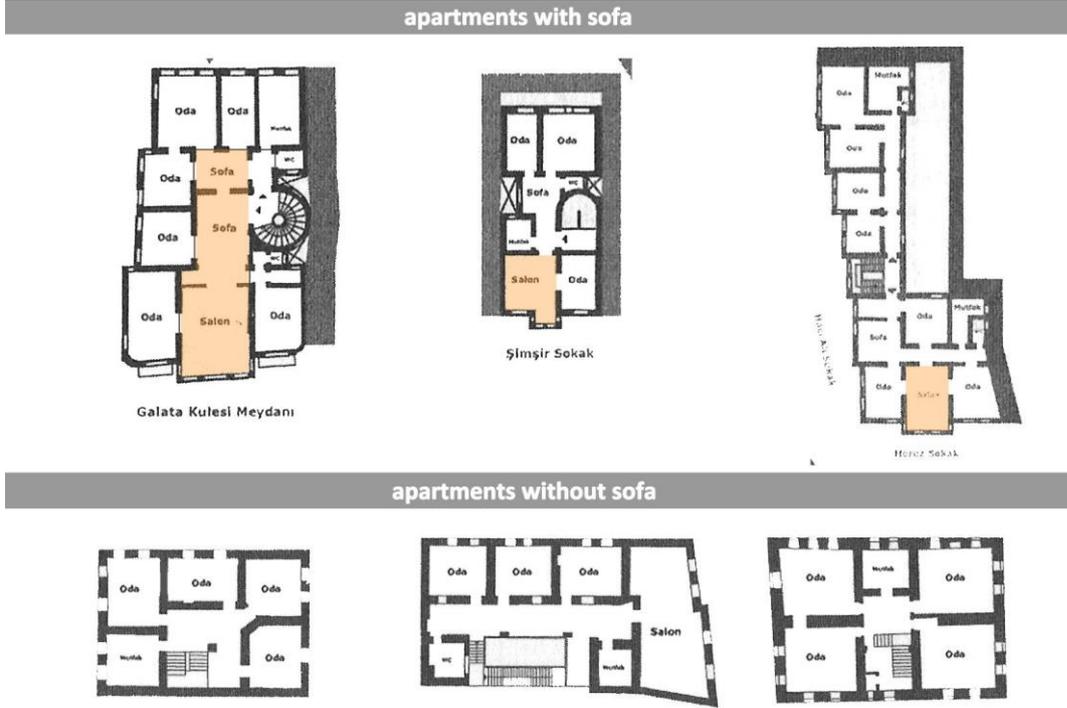
Table 3.6 Apartment building types whether there is sofa or not (prepared by the author based on the drawings obtained from the book named “Apartman”) (Öncel, 2010, p. 263-264).

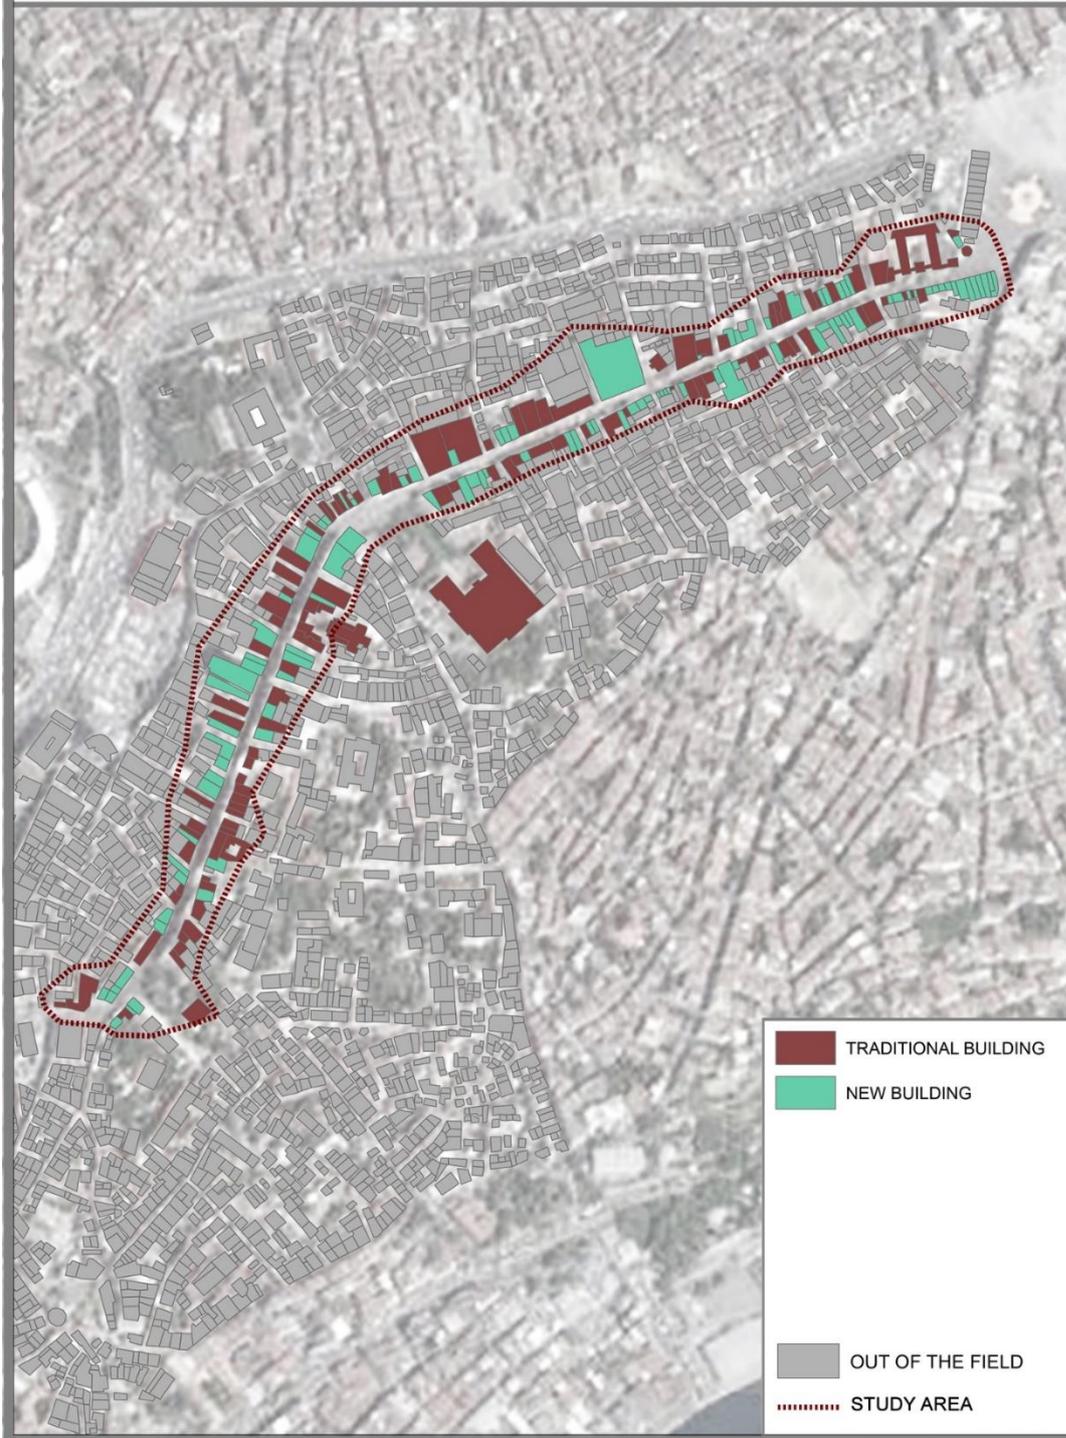
**SHEET NO :01**

**SHEET TITLE : BUILDING TYPES**

Figure 3.9. Map showing distribution of building types in the first zone (prepared by the author)

Within the scope of the thesis, building type is related to whether the building is new or traditional. The traditional buildings in this zone are the ones that form the architectural features of the region, which were constructed in the 19<sup>th</sup> century and are described at the beginning of the chapter. The new buildings were constructed in the 20<sup>th</sup> century and differs from the traditional ones in terms of their architectural features. When the traditional/new building distribution in the study area is looked over, it is seen that there is a homogeneous settlement. Also quantitatively, traditional buildings are almost equal in number with the new ones (Table 3.7). Their locations on the street are distributed homogeneously, though. (Figure 3.9)

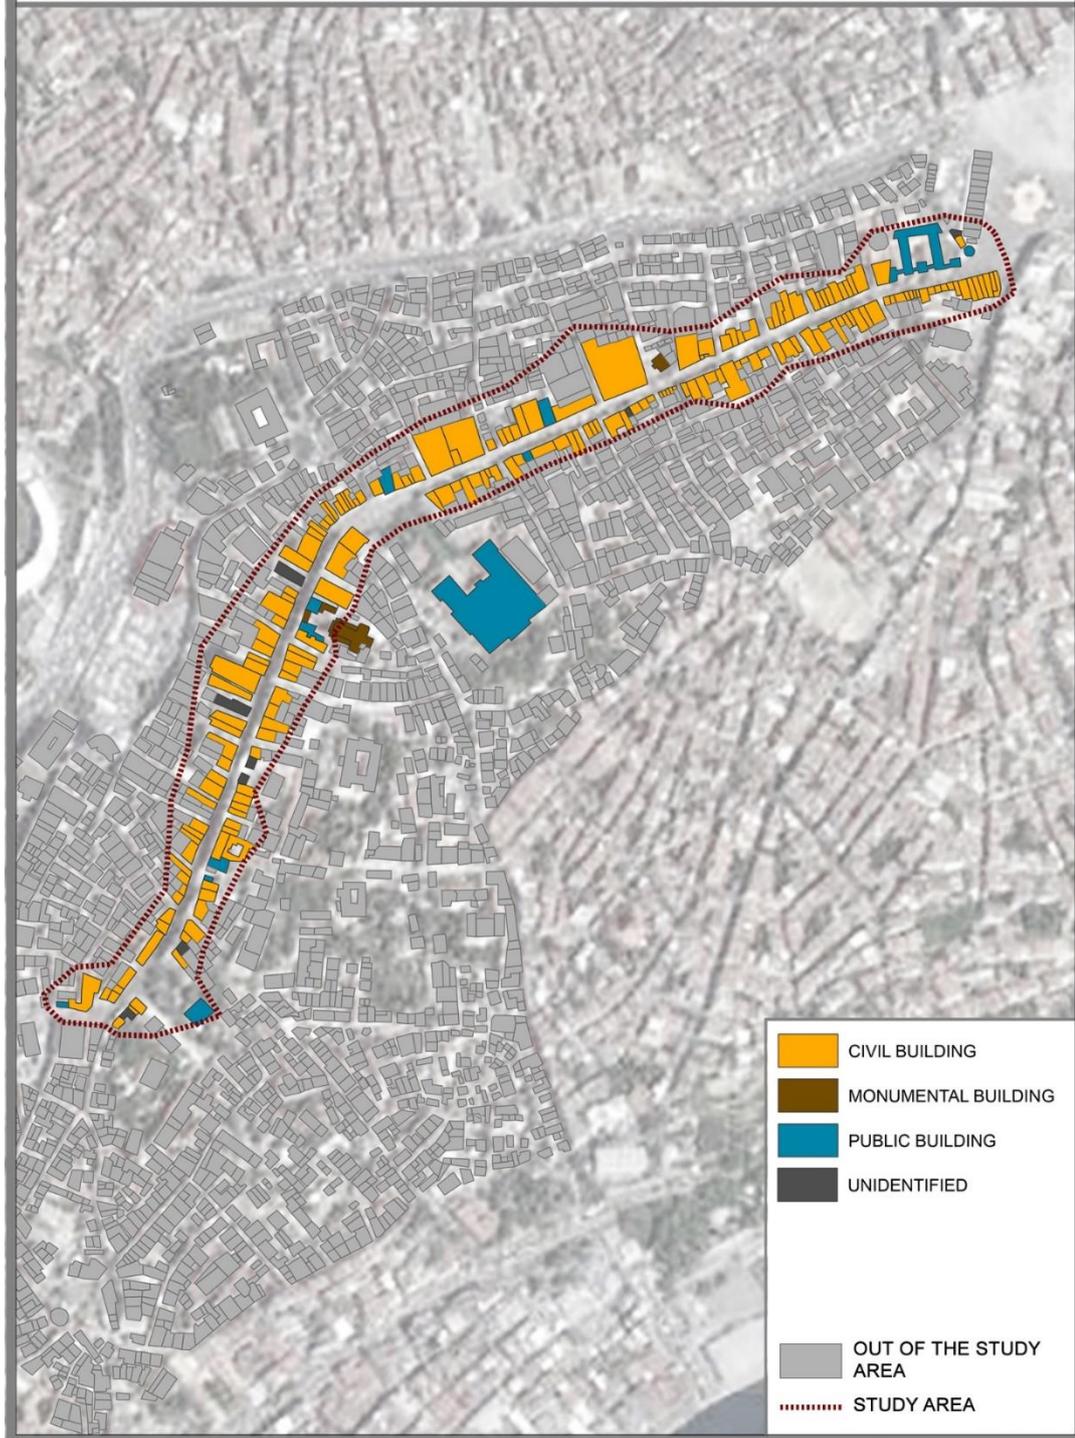
**SHEET NO : 02**

**SHEET TITLE : BUILDING CATEGORY**

Figure 3.10. Map showing distribution of building categories in the first zone (prepared by the author)

Building category deals with whether the original use of building is civil, public or monumental (Table 3.8). Civil buildings are the buildings that are owned or used by private citizens with functions of housing, commercial etc. Public buildings are the buildings that are used by public institutions for public service and comprise functions such as school, municipality, consulate, etc. The monumental buildings are mosques, churches, madrasas, etc. Considering the categories, it is observed that most of the buildings are examples of civil architecture. It is detected that the public and monumental buildings, which are less in number compared to the civil architecture examples, are mainly located on the part of the street that is close to Galata region. (Figure 3.10)

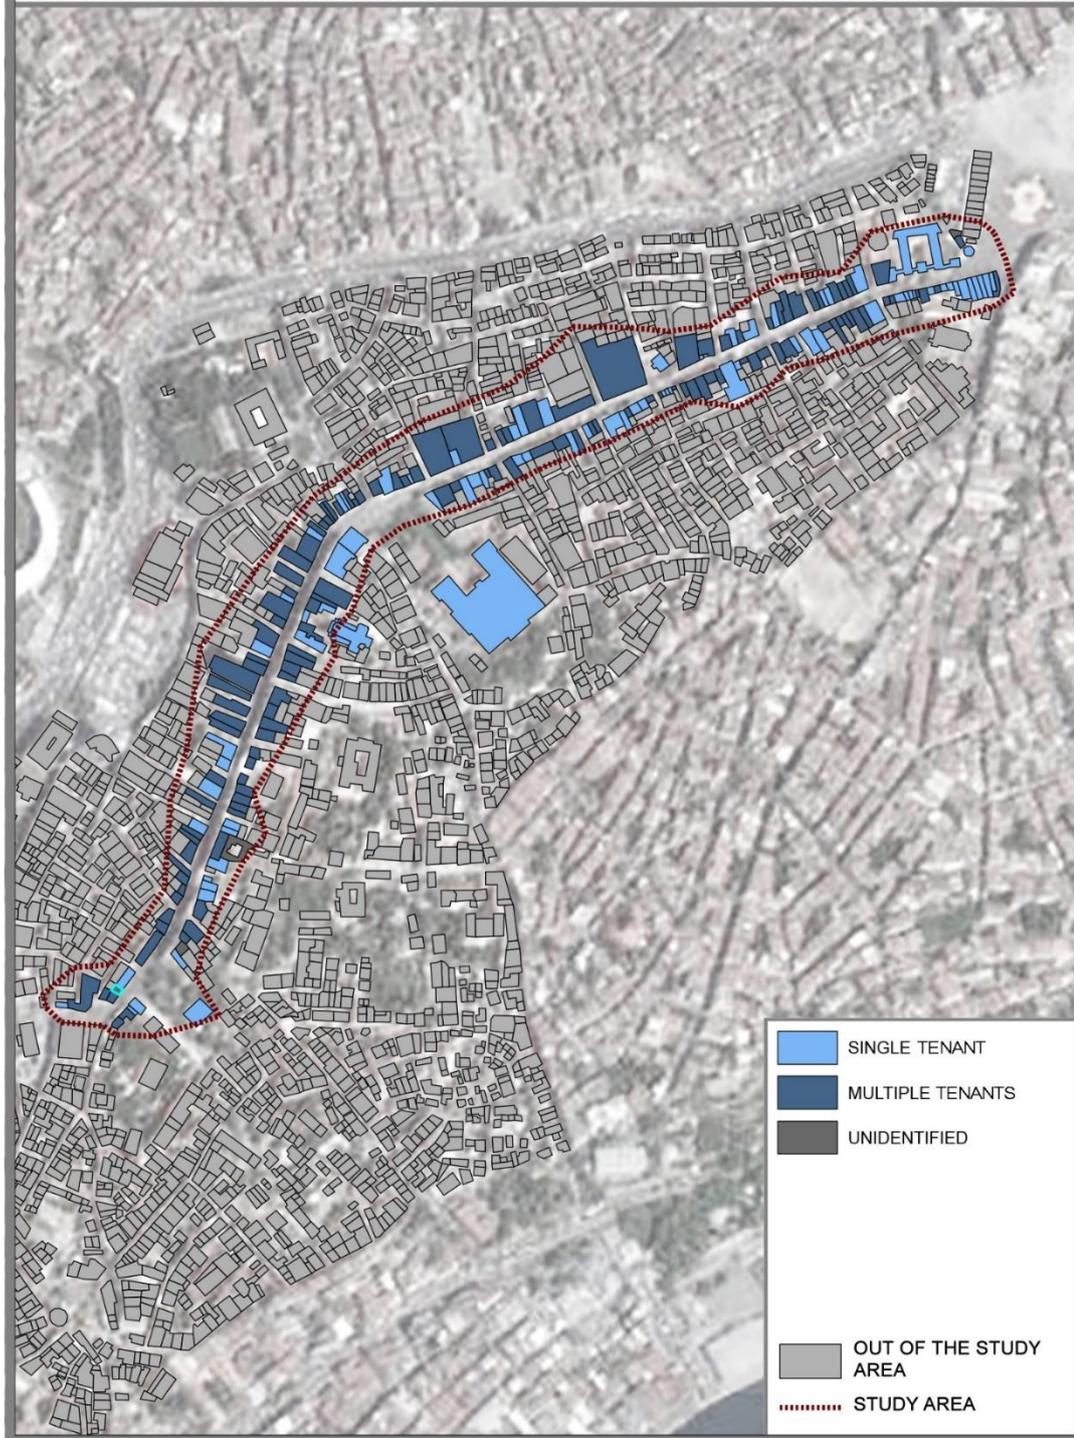
**SHEET NO : 03**

**SHEET TITLE : NUMBER OF TENANTS**

Figure 3.11. Map showing distribution of buildings according to number of tenants in the first zone (prepared by the author)

In the study area, it is determined that in the early years, most buildings had multiple tenants or proprietor individuals or families. However, with the change in functional fabric, some buildings were transferred to single person, institution or family ownership or use. In order to understand the density of this situation in the zone, data is collected on whether the number of tenants of the buildings is single or multiple, as far as it could be determined from outside the buildings. The purpose of collecting this data is to be able to comment on whether this state of usage, which results from the change of functional and social fabric, has an impact on architectural alterations of the buildings. It is found that 71 of the traditional buildings (110) on the street have multiple tenants and 36 of them are used by single person or institution (Table 3.9) (Figure 3.11). In the new buildings, the situation is slightly different. While 56 of the new buildings (104) are used by more than one person or institution, 47 of them are used by single person or institution (Table 3.9) (Figure 3.11).

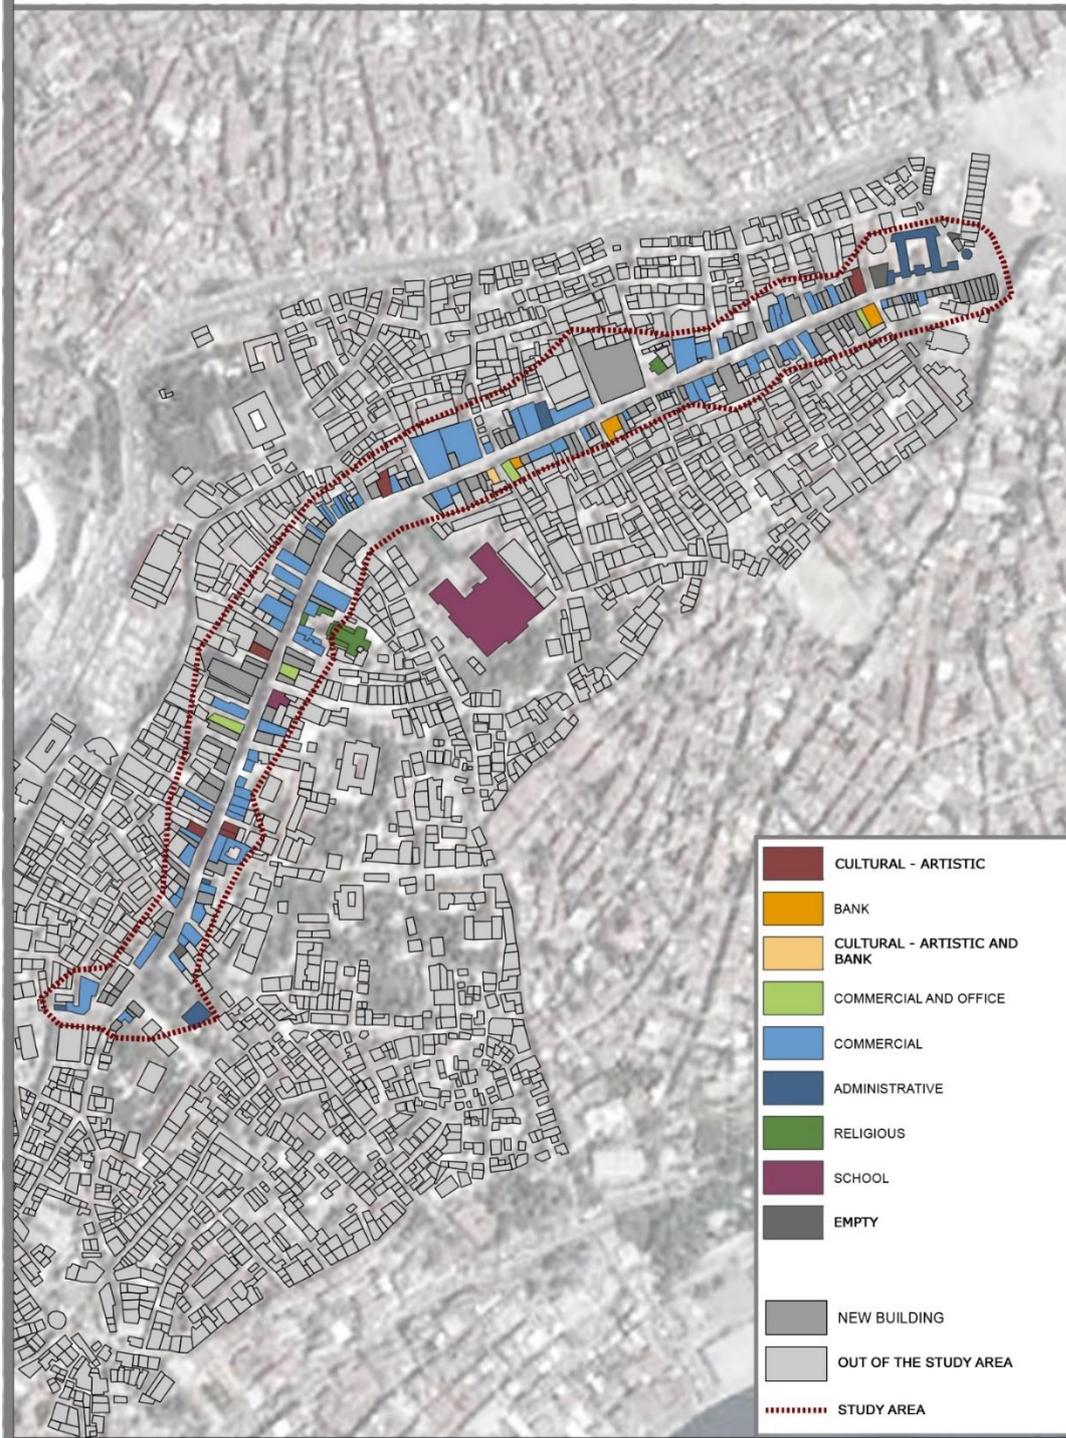
**SHEET NO : 04**

**SHEET TITLE : CURRENT FUNCTIONS OF TRADITIONAL BUILDINGS**

Figure 3.12. Map showing distribution of traditional buildings according to their current functions in the first zone (prepared by the author)

It is observed that some functions in the zone are the original functions of the buildings, while some functions were imposed on the buildings afterwards. In the zone, apart from the commercial use, there are various public functions, banks, offices, cultural centers, mosques and churches. Public buildings include schools, municipal service buildings and consulates. The majority of these public functions exist in the traditional buildings. Only Beyoğlu Government Office and one of the service buildings of Beyoğlu Municipality are the new public buildings. When the locations of the functions on the street are looked over, it is seen that the bank and commercial functions densify on Taksim Square side of the street, while functions like cultural center and school are close to Galata (Figure 3.12) (Figure 3.13).

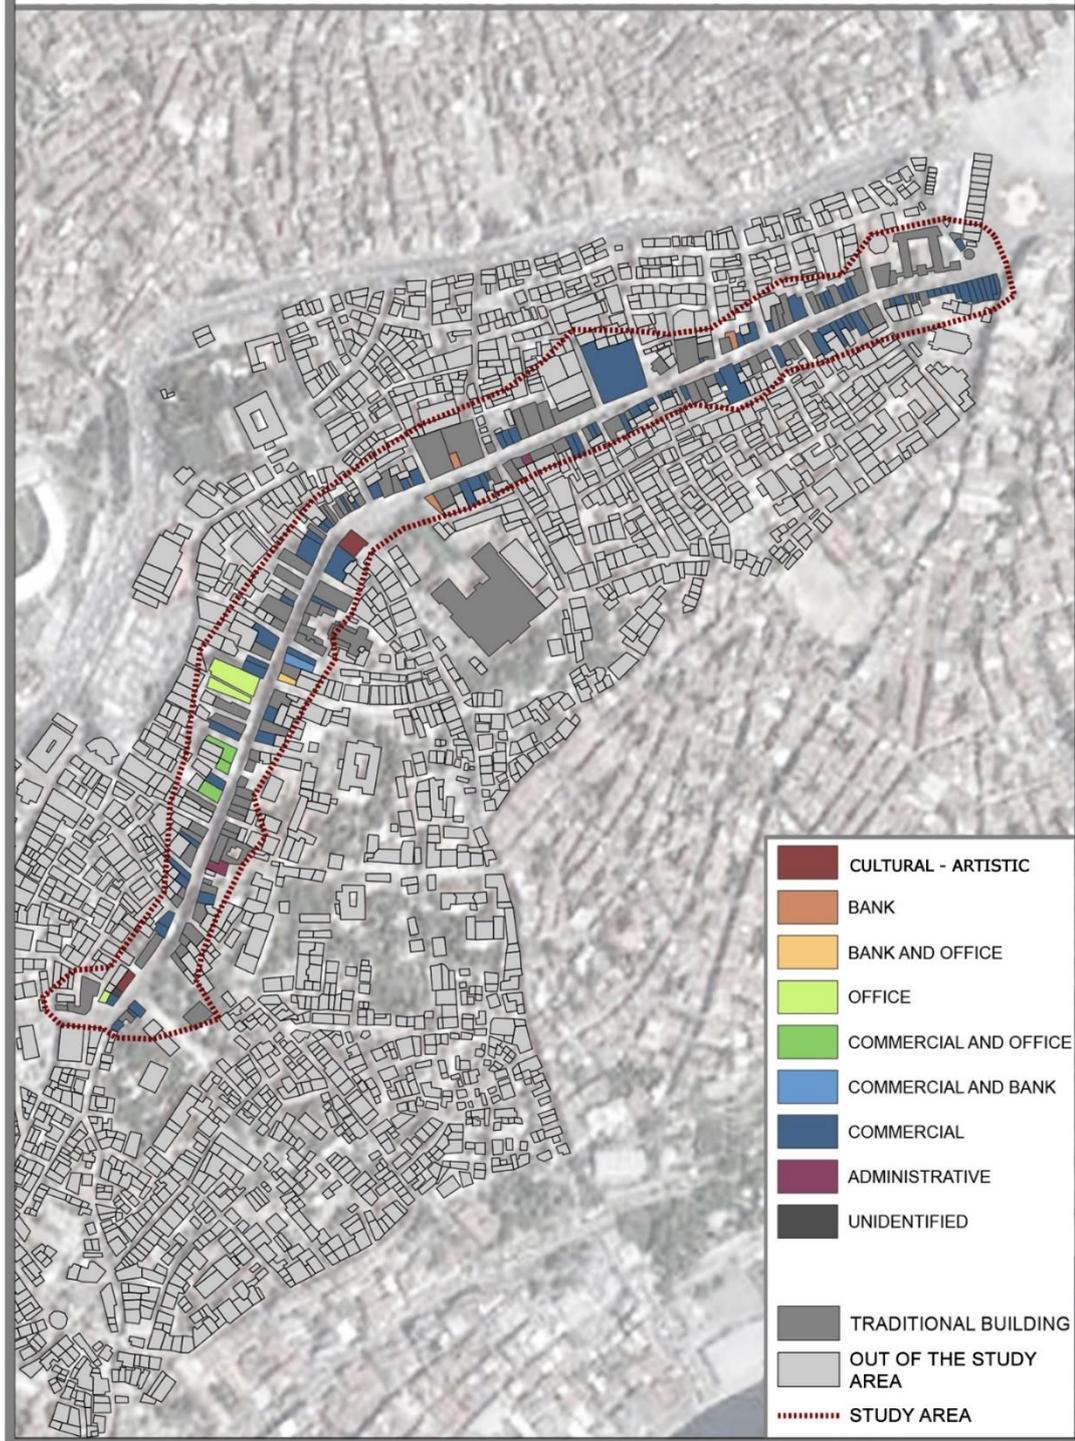
**SHEET NO : 05**

**SHEET TITLE : FUNCTIONS OF NEW BUILDINGS**

Figure 3.13. Map showing distribution of new buildings according to their functions in the first zone (prepared by the author)

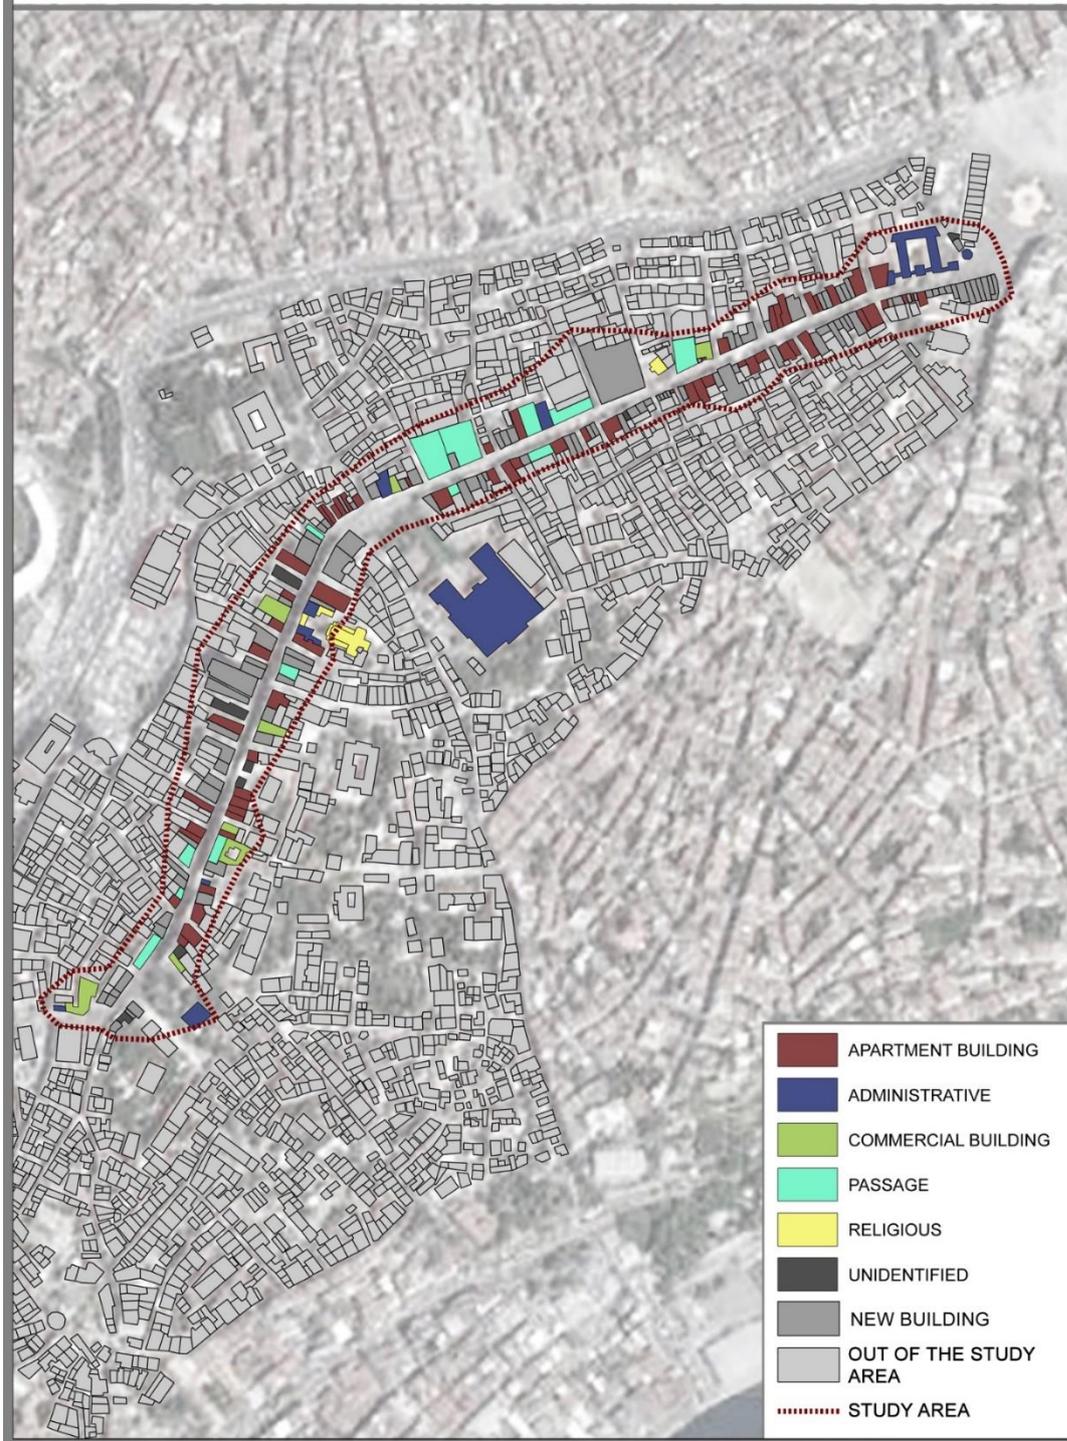
**SHEET NO : 06**

**SHEET TITLE : ORIGINAL FUNCTIONS OF TRADITIONAL BUILDINGS**

Figure 3.14. Map showing distribution of traditional buildings according to their original functions in the first zone (prepared by the author)

When the abovementioned functions are studied, it is determined that public functions mostly preserve their existence. However, two of these public buildings are adaptively reused with a commercial function, and one of them as a cultural center. The rest of the buildings retain their original functions. When the buildings that originally function as passage and commercial complex are analyzed, it is seen that the majority of them maintain their existence in accordance with their original use by comprising commercial function. Only two of these buildings were adapted, one of them into a cultural center and the other one into an office. With regard to the buildings originally designed as apartments, five of them are used as cultural centers, three of them as banks and three of them as offices. The rest of the apartment buildings (53) contain various commercial functions (Table 3.11) (Figure 3.14).

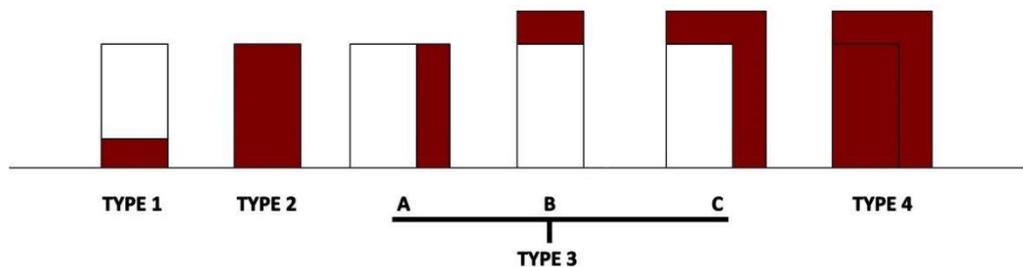
In order to understand the effect of the transformation on the architectural features of the buildings on İstiklal Street, which underwent a functional transformation, it is necessary to comprehend the physical change of the buildings in the zone in first place. To detect the change in the zone, four types of change are designated. The first of these is the degree of change specified by the name “original”, indicating that the building is completely or almost completely original. Partial changes are seen on the façades of buildings stated as “1”, mostly on ground floors. These changes are such that the original state of the building is almost completely understandable. For instance, a building which only had its joineries changed is included in this group. The type of change indicated by “2” is used for buildings that changed so that their façade layouts can no longer be comprehended. Buildings whose type is specified as “3” have partial changes in their original mass or conserve their authenticity but have mass additions brought to their original state. As it is determined that mentioned mass additions can be found in the zone in three different ways, this type of change is subdivided into “A, B, C”. It is specified that the mass additions brought to the traditional buildings in the zone are located next to the building (A), on top (B) or on both side and top (C). Finally, the buildings graded with “4” are those whose original façade layouts are no more legible because of alterations and which have mass addition in any manner. (Figure 3.15)

Figure 3.15. Scheme of types of change
