ASSESSMENT OF THE EFFECTS OF ADAPTIVE REUSE INTERVENTIONS  
ON  
THREE APARTMENT BUILDINGS IN BEYOĞLU, İSTİKLAL STREET

A THESIS SUBMITTED TO  
THE GRADUATE SCHOOL OF NATURAL AND APPLIED SCIENCES  
OF  
MIDDLE EAST TECHNICAL UNIVERSITY

IN PARTIAL FULFILLMENT OF THE REQUIREMENTS  
FOR  
THE DEGREE OF MASTER OF SCIENCE  
IN  
CONSERVATION OF CULTURAL HERITAGE IN ARCHITECTURE

SEPTEMBER 2020

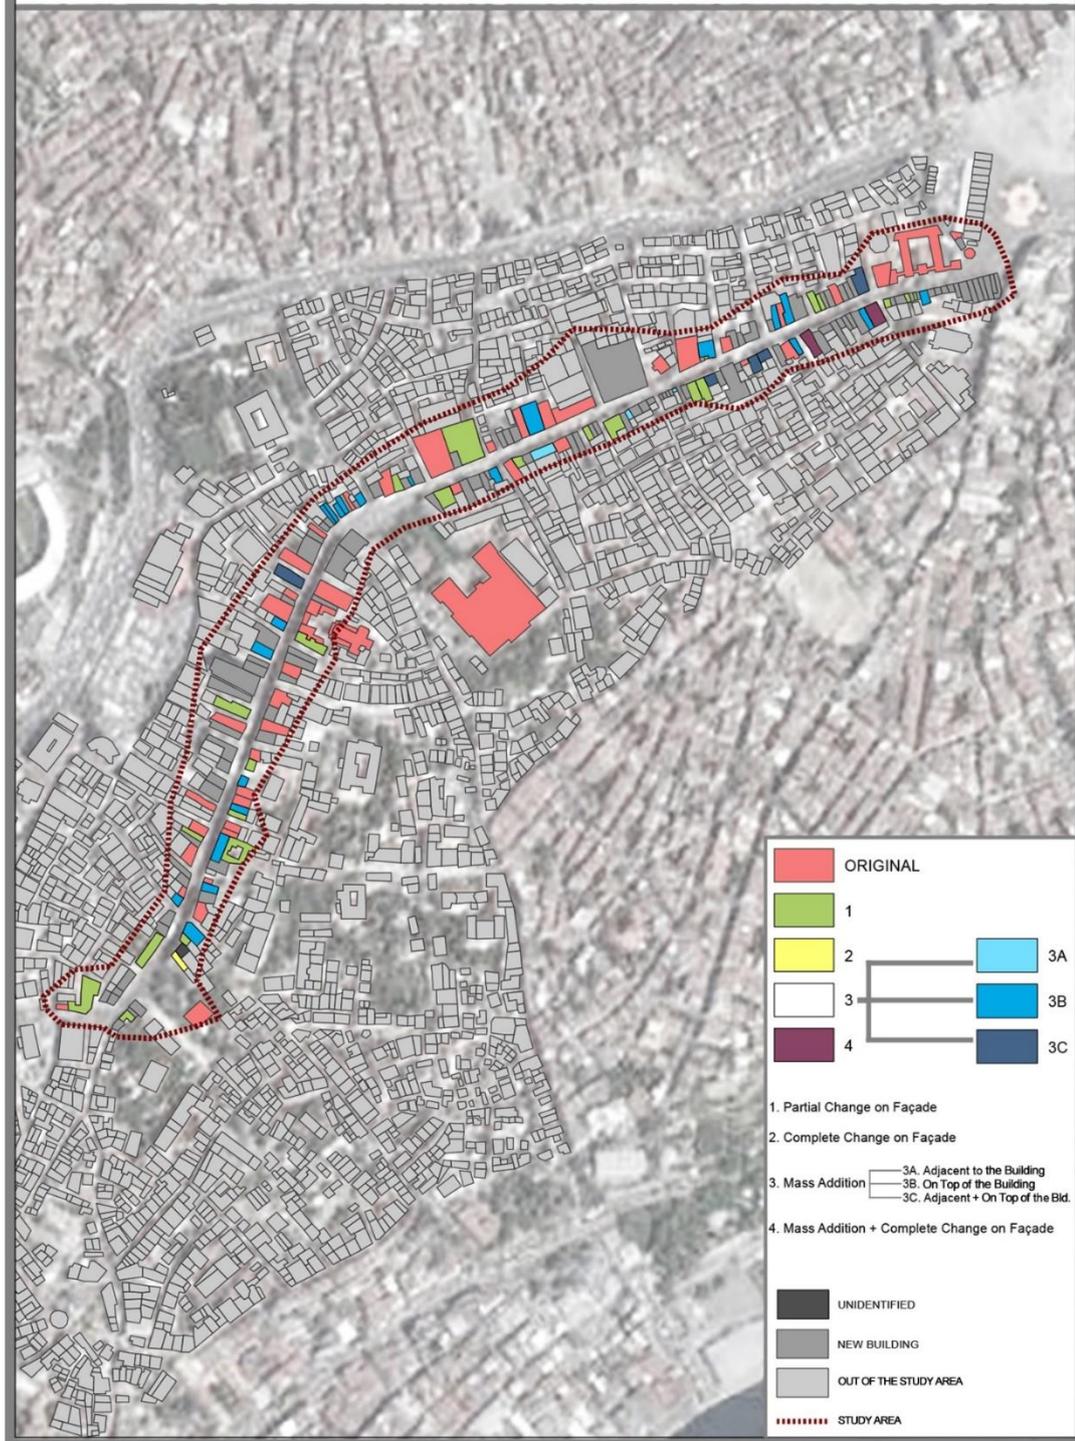
**SHEET NO : 07**

**SHEET TITLE : TYPES OF CHANGE**

Figure 3.16. Map showing distribution of traditional buildings according to their types of change in the first zone (prepared by the author)

As a result of the analyzes carried out from the façades, the distribution of the types of change determined in the traditional buildings (110) are as follows (Table 3.12) (Figure 3.16).

It is seen in the study area that the buildings conserving their authenticity and can be considered almost original are more than the buildings which changed more. Nevertheless, considering that the number of new buildings is almost equal to the number of traditional buildings, it can be said that more than half of the buildings in the zone either collapsed and changed or were exposed to influential interventions in time that cause loss in terms of authenticity. On the other hand, it is observed that for the buildings which changed more, either the façade features of the ground floors changed or mass additions were brought on top of them.

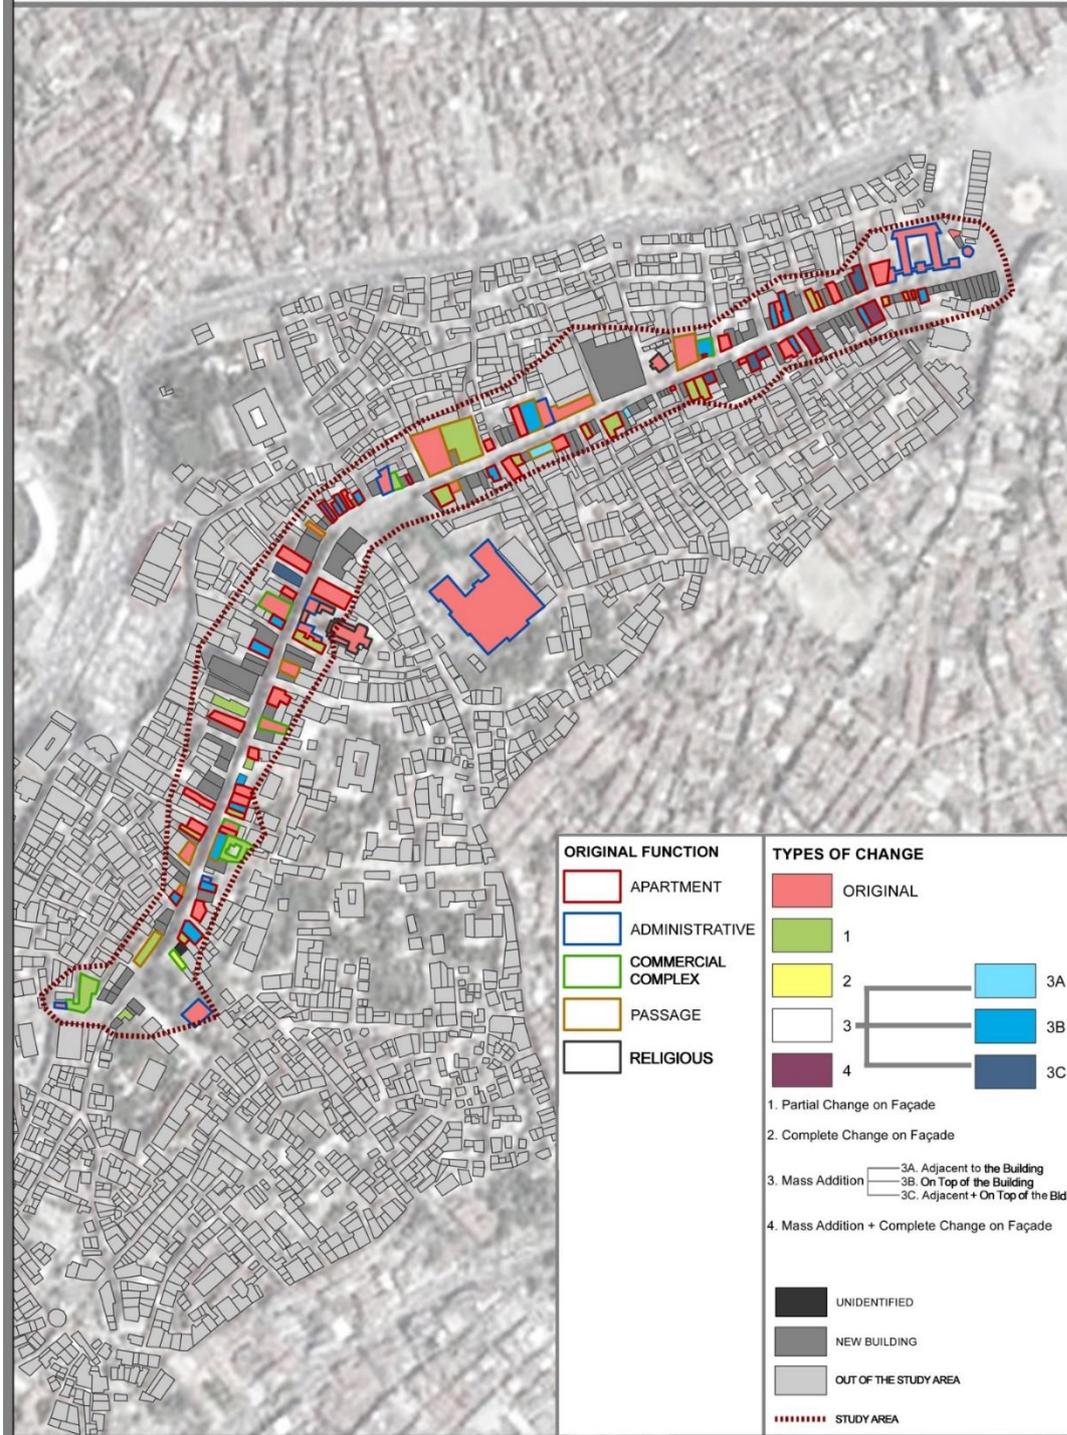
**SHEET NO : 08**

**SHEET TITLE : TYPES OF CHANGE AND ORIGINAL FUNCTION RELATION  
IN TRADITIONAL BUILDINGS**

Figure 3.17. Map showing relation between types of change and original function of traditional buildings in the first zone (prepared by the author)

In consequence of the analyzes made by observing the façades of the buildings in the study area, it is seen that the buildings whose original function is apartment were exposed to more alterations compared to other buildings. Of the types described above, the types graded with 2, 3 and 4 indicate buildings that underwent more changes than the type 1. Based on this information, 39 of the buildings whose original function is apartment (64), are original and/or their façades partially changed. Of the remaining 25 buildings, 23 have mass additions, and 2 have completely changed façades and mass additions. It is understood that 10 of the passage buildings (13) in the zone are original and/or have partially altered façades, and 3 of them have mass additions. Only 1 of the buildings whose original function is commercial complex (8), has mass additions and again only 1 of them has a completely changed façade. The rest of the commercial complex buildings are either original or partially altered. When the buildings whose original function is public (17) are examined, it is observed that all of them are original (Table 3.11) (Figure 3.17).

When the types of change of the apartment buildings are analyzed in detail, it is determined that the majority of the changed buildings (23/41) have mass additions. It is also specified that in most of the apartment buildings which have mass additions, the additions were brought on top of the building (18), and 4 of them have mass additions constructed on both side and top (Table 3.13) (Figure 3.17).

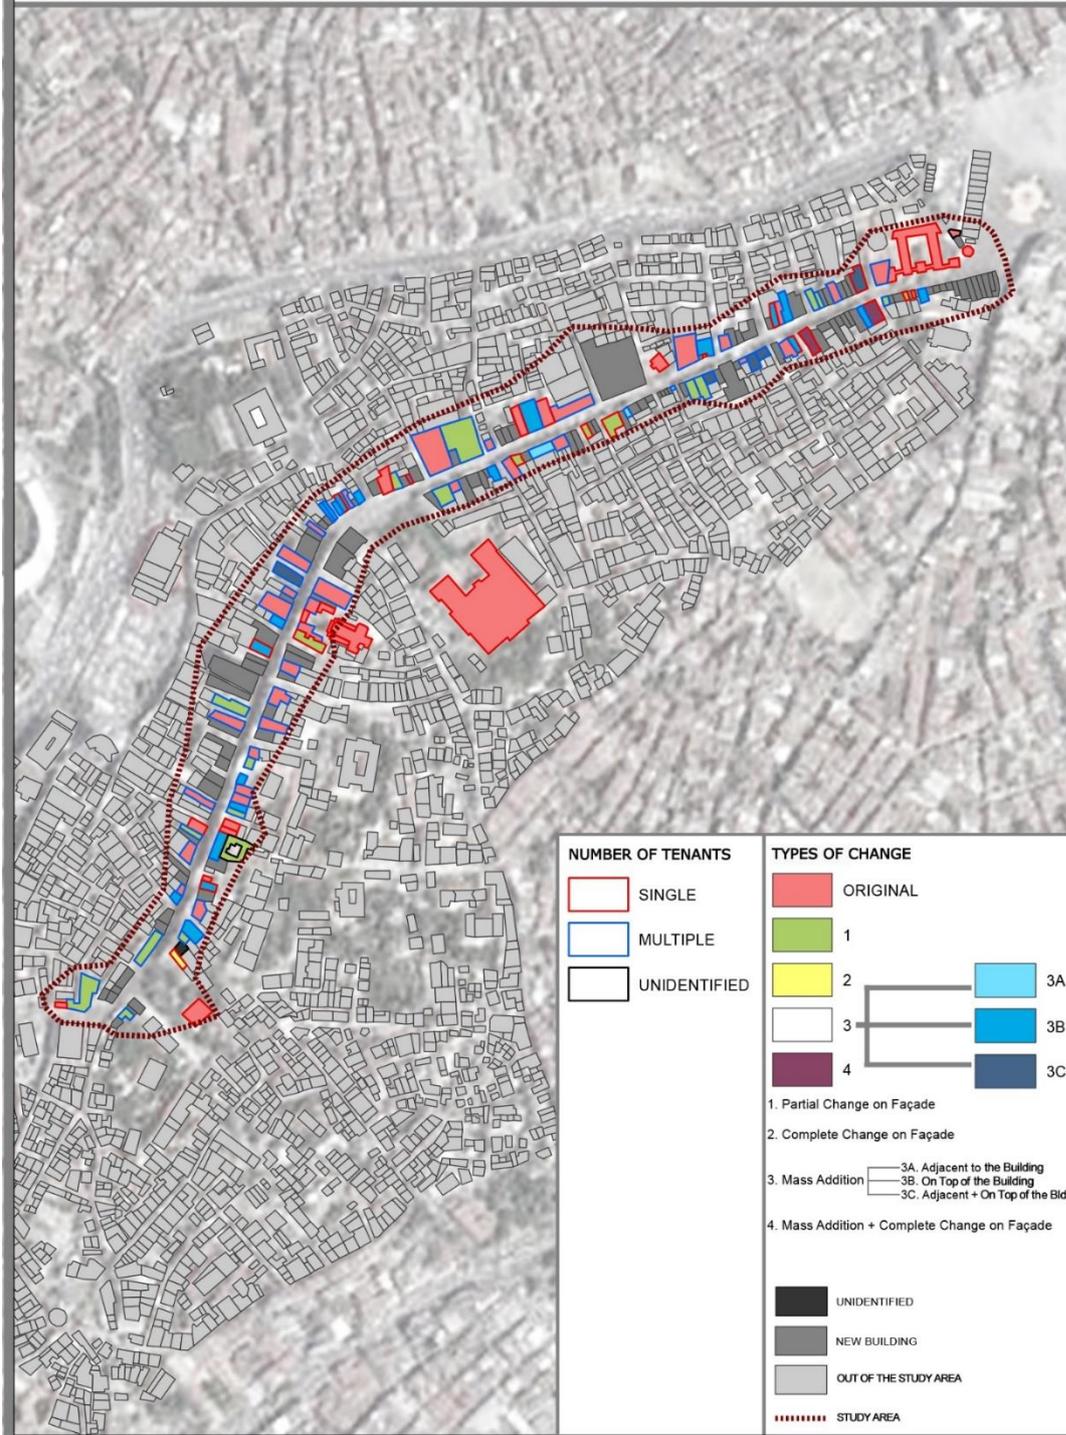
**SHEET NO : 10**

**SHEET TITLE : TYPES OF CHANGE - NUMBER OF TENANTS RELATION OF TRADITIONAL BUILDINGS**

Figure 3.19. Map showing relation between types of change and number of tenants of traditional buildings in the first zone (prepared by the author)

In the study area, the determinations related to the current number of tenants in the buildings and the type of change of the buildings are superposed. Hereby it is tried to comprehend whether the presence of single tenant or multiple tenants in the buildings has an impact on the change of the buildings. According to the data obtained from the analyzes, it is designated that the buildings comprising multiple tenants changed more, albeit with minor difference, than the others. Of the buildings with multiple tenants (71), 23 of them have a degree of change 3. In other words, it is found that 23 of the buildings with multiple tenants were exposed to mass additions. Of the remaining 16 of these buildings, only the façades changed partially, while 32 conserve their authenticity. On the other hand, while 19 of the buildings with single tenant (36) retain their originality, the façades of 7 partially changed, the façade of 1 completely changed, 7 of them have mass additions and 2 of them have both mass additions brought and completely changed façades (Table 3.15) (Figure 3.19).

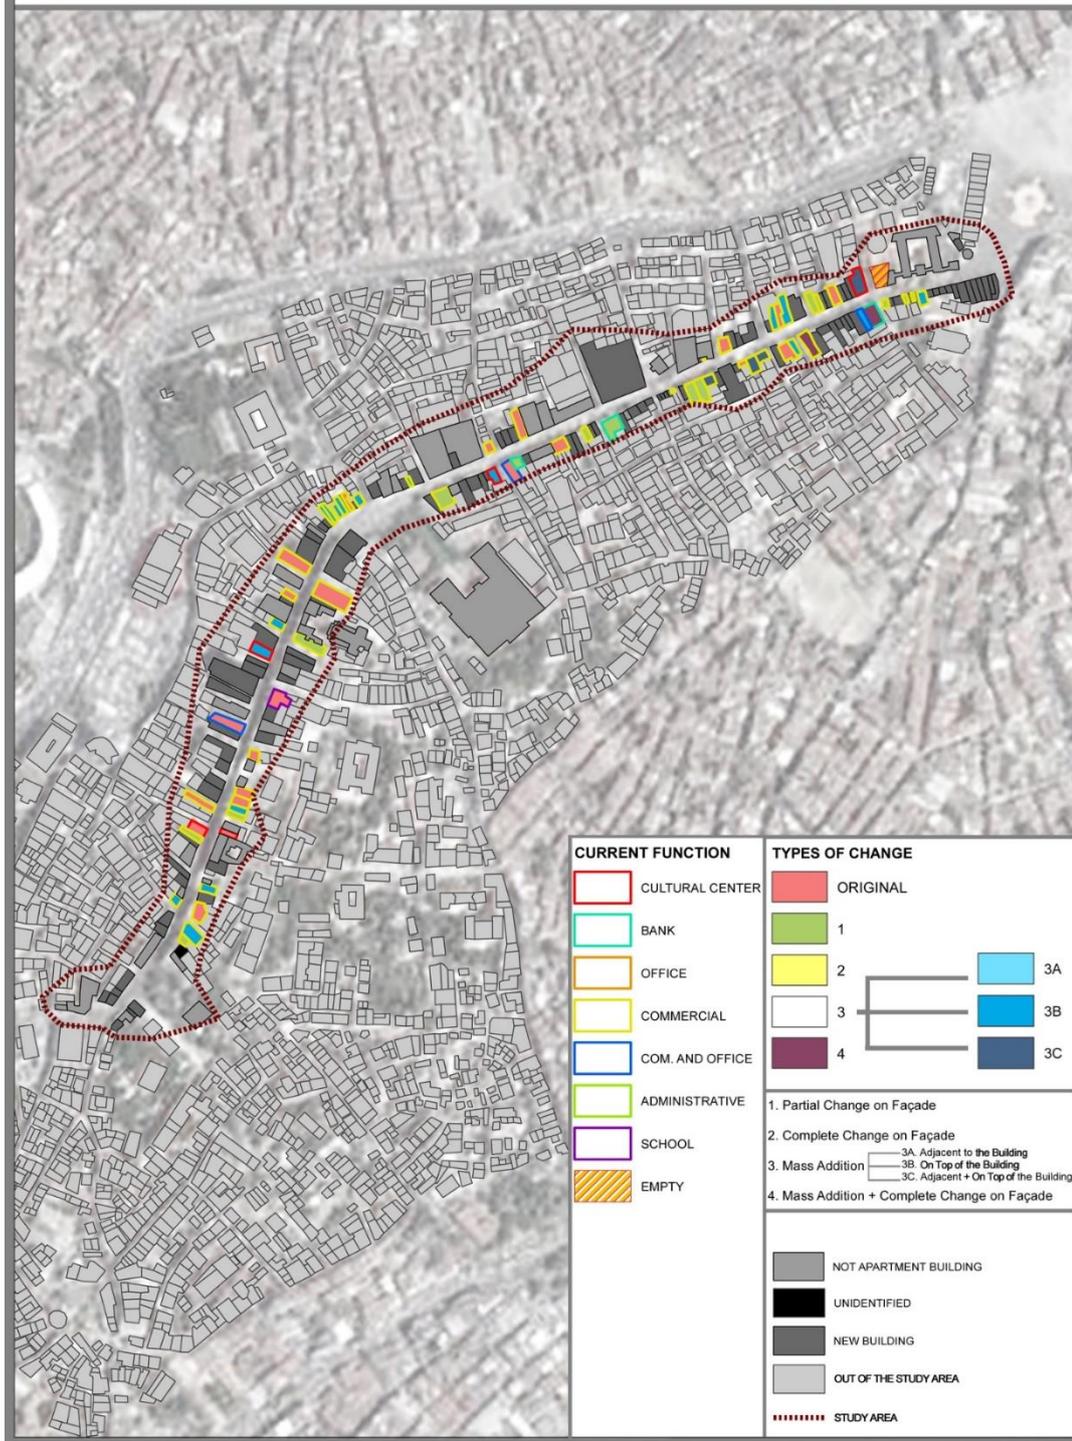
**SHEET NO : 11**

**SHEET TITLE : TYPES OF CHANGE - CURRENT FUNCTION RELATION IN APARTMENT BUILDINGS**

Figure 3.20. Map showing relation between types of change and current function of apartment buildings in the first zone (prepared by the author)

as banks (3), none of which retain their originality, 2 have partially changed façades and 1 has both mass addition and façade alterations. 2 of the apartment buildings which were adaptively reused as offices (3) retain their authenticity, while 1 was brought mass addition (Table 3.16) (Figure 3.20).

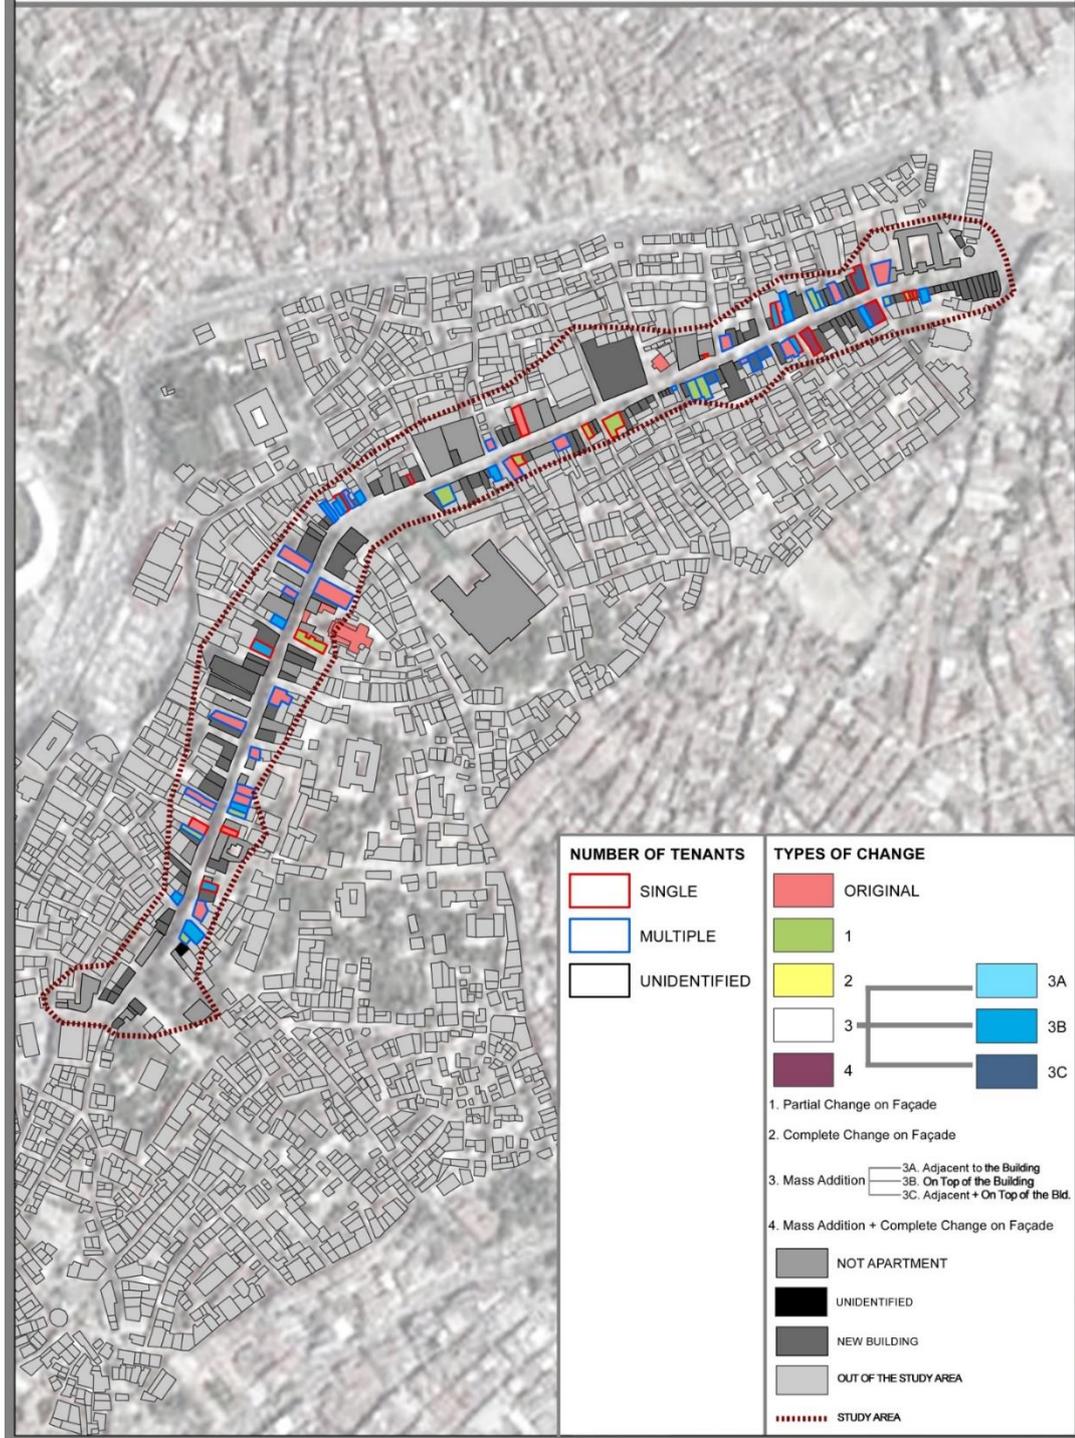
**SHEET NO : 12**

**SHEET TITLE : TYPES OF CHANGE AND NUMBER OF TENANTS RELATION IN APARTMENTS**

Figure 3.21. Map showing relation between types of change and number of tenants of apartment buildings in the first zone (prepared by the author)

In order to comprehend whether the change of the buildings whose original functions were apartments, the most changed function in the zone, were affected by the number of tenants or not, the change data and number of tenants in the apartments are analyzed together. In consequence of this analysis, a different point is reached from the result obtained by superposing the number of tenants in all buildings and their changes. It is determined that the change rate of the buildings with multiple tenants is lower than the others. 9 of the apartment buildings with single tenant (19) either have mass additions or have both mass additions and façade alterations. The rest of these buildings retain their originality or have partially changed façades. It is seen that 16 of the apartment buildings with multiple tenants (45) were exposed to mass additions. Of the remaining 29, 20 retain their authenticity and 9 have only partial changes on the façade (Table 3.17) (Figure 3.21).

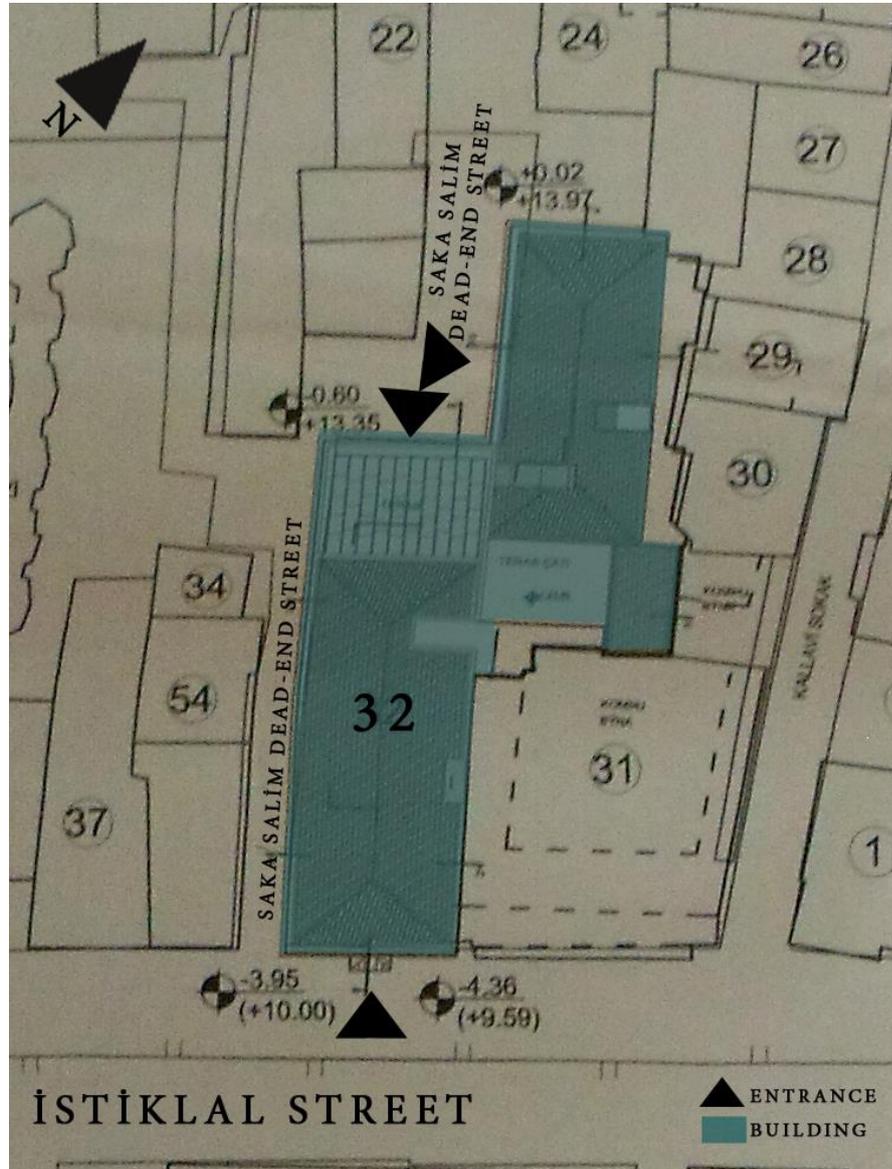
Figure 3.24. Location of SALT Cultural Center on the plot (prepared by the author, based on the drawing obtained from İstanbul No. II Regional Conservation Committee of Cultural Assets Archive)

The building subject to the study is located on block #303 plot #32 in the east-west direction. The building has two separate entrances (Figure 3.24). The main entrance is on the façade overlooking İstiklal Street. The other entrance is reached via Saka Salim Dead End Street at the back of the building. Apart from these entrances, there is a fire exit opening to the dead end street. There is a level difference of 4.30 m between İstiklal Street and the end point of the building on Saka Salim Dead End Street. For this reason, the main entrance at İstiklal Street is located at -4.30 m level according to the zero level of the restoration project prepared in 2009, while the entrance at Saka Salim Dead End is at -0.12 level. The building consists of two blocks which are interconnected from the interior. Throughout this study, the eastern block of the building reached from İstiklal Street will be referred to as Block

A, and the western block reached from Saka Salim Dead End will be referred to as Block B.

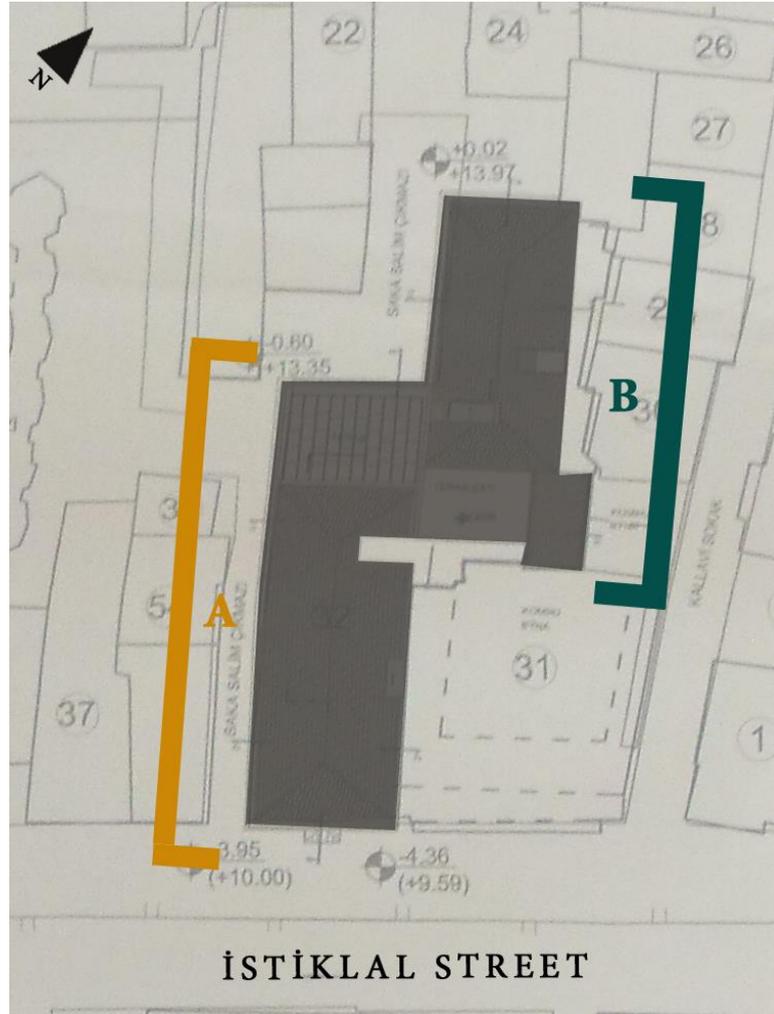
Figure 3.25. Drawing showing blocks of the building (prepared by the author, based on the drawing obtained from İstanbul No. II Regional Conservation Committee of Cultural Assets Archive)

Looking at the mass properties of the building, it looks like the combination of two masses. The effects of this feature in the mass can also be observed from the interior. Therefore, in this study, these masses will be referred to as A and B blocks (Figure 3.25).

When the façade features of the building are analyzed in general, it is seen that the lower floors and the top floor of the building are distinctly different from each other. When the façade of the building that overlooks İstiklal Street is analyzed, it is seen that the façade is cladded with stone on the ground floor and the first three floors of Block A. The top floor is painted on the same façade. It is remarkable that the paint and stones on the façade have the same color hue. Although the surface material is stone on the ground floor and the three floors above it, it is easily realized that the ground floor is cladded with a different kind of stone than the others. This difference is thought to be made in order to strengthen the difference of the floors on façade layout. On the other façades of the building, which look at Saka Salim Dead

End, it is seen that the material is the same color painting with the façades except for the ground floor façade in Block A and the basement floor façade in Block B. In these façades, surface of the ground floor of Block A and the basement floor of Block B are cladded with stone.

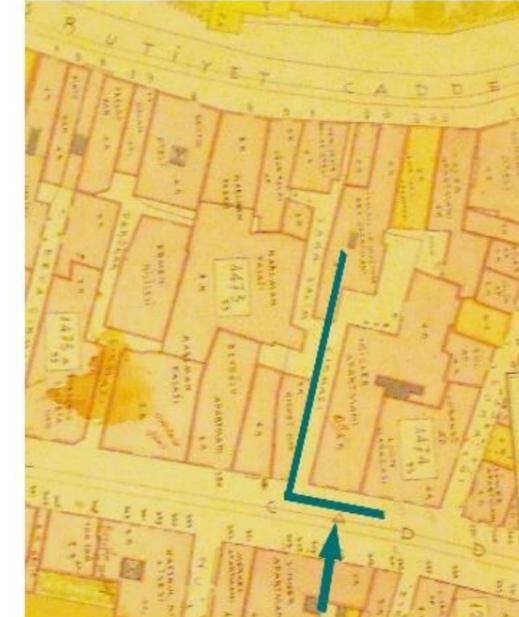
**1948 SUAT NİRVEN MAP**

Table 3.18 Location of the plot in old maps; 1853 City Map. Source: www.istanbulurbandatabase.com, last accessed in January 21, 2020, 1861-1876 Cadastral Map (Restitution Project Report), 1882 City Map. Source: www.istanbulurbandatabase.com, last accessed in January 21, 2020, 1905 Goad Insurance Map (Dağdelen, İ. (2007). 1948 Suat Nirven Map (Tarih Vakfi, 2000), 2018 Aerial Photo (Google Earth) (prepared by the author based on the maps obtained from the sources written before)

When the Goad Maps of 1905 are analyzed, it is understood that the plot being worked on was in the same state in 1905 as the present (Dağdelen, İ. 2007) (Table 3.18). In the maps prepared by Suat Nirven in 1948, the plot and the building on it are very similar to the current state (Tarih Vakfı, 2000) (Table 3.18).

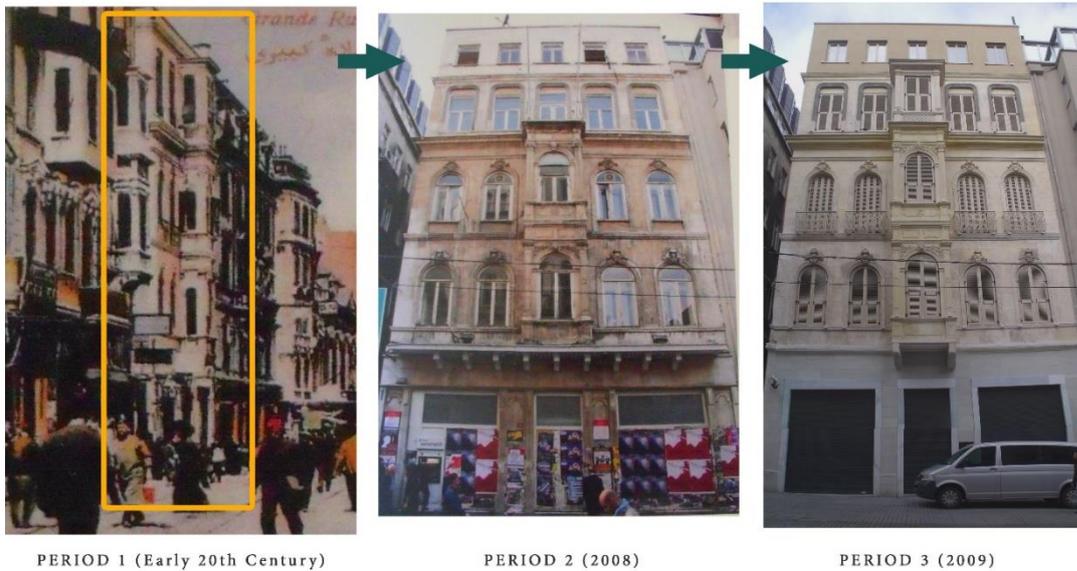
Table 3.19 Situation of the building in three periods; the photo of the 1<sup>st</sup> and 2<sup>nd</sup> Periods (Photo Album of Restoration Project), the photo of 3<sup>rd</sup> Period (Personal Archive) (prepared by the author, based on the photographs obtained from İstanbul No. II Regional Conservation Committee of Cultural Assets Archive and Personal Archive)

According to the old photographs, aerial photographs, maps and the restitution project report in 2009, (although the exact date is not known) it is found that a floor was added on top of the block A before 1950. Before the mentioned floor was added, it is thought that the original building had 4 floors above street level in both blocks. As a result of the economic, political activity in the region from the 1950s onwards and finally 1973 Beyoğlu Development Plan which is explained in the history of Beyoğlu, the aforementioned building lost its residential function.

Finally, in 2008, a private bank purchased the building and adapted it as a cultural center with a restoration and reuse project (Table 3.19).

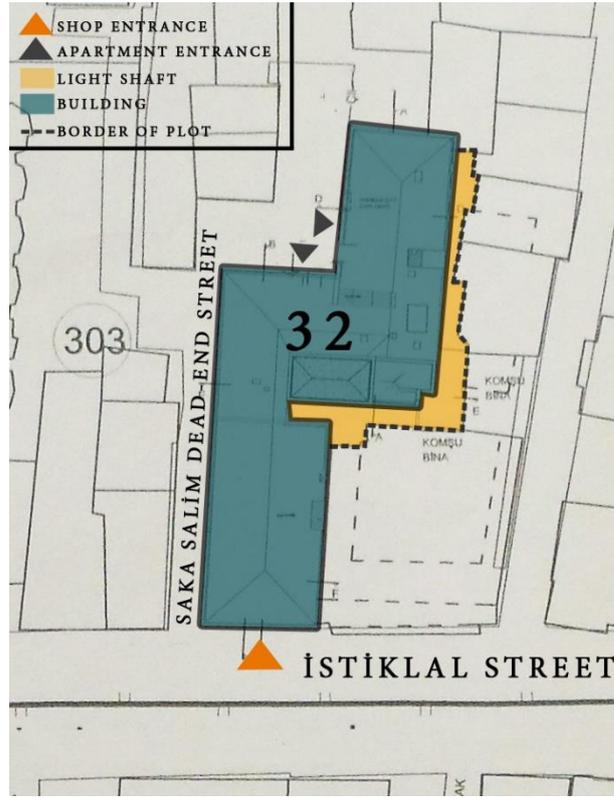
At the original state of the building, Block A has two entrances, one on the east and the other on the west. In Block B, there are three entrances on the south façade, one main entrance and two service entrances. (Figure 3.27)

Figure 3.27. Original location of the building on the plot (prepared by the author, based on the drawing obtained from İstanbul No. II Regional Conservation Committee of Cultural Assets Archive)

It was determined that the plot #32 where the building analyzed in the thesis is located on has been conserved in its current state since 1905. Although the positioning of the building and the way it is located on the plot of the building is not clearly understood in the maps of the 1880s, the building resembles its original features today as it is comprehended from some other maps and projects (Figure 3.27). It is understood that the building was designed as two blocks on the plot extending from İstiklal Street towards the back street. In other words, the building was built in east-west direction as two blocks namely A and B, which are physically connected in the interior. These blocks are connected to have vertical circulation elements at the intersection point. At the intersection with the neighboring plots on the north side of the building, a space was left and it was thought to be used as light well.

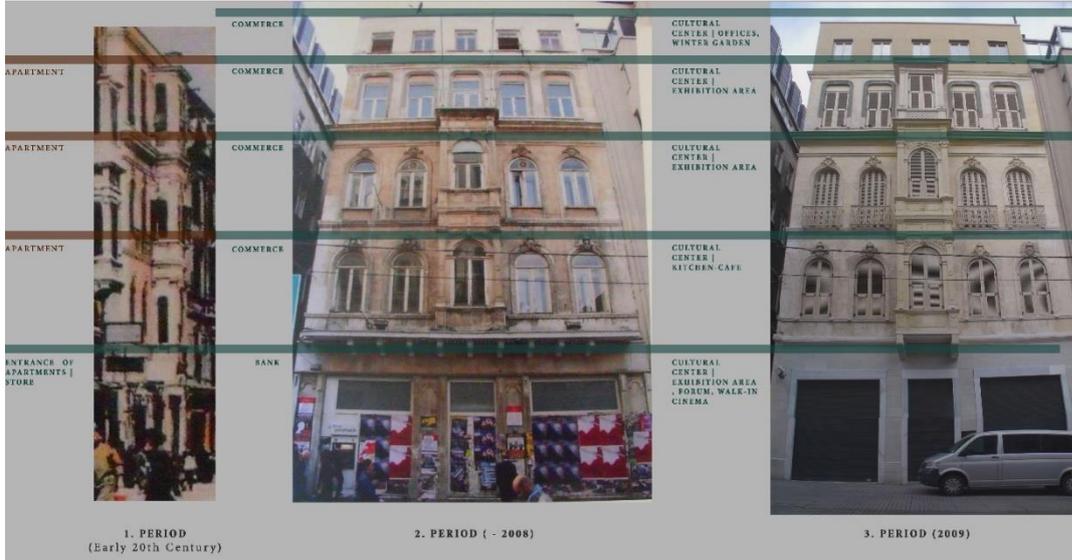
Table 3.21 Change of function according to floors in the building in three periods; Photo of 1<sup>st</sup> and 2<sup>nd</sup> Period (Photo Album of Restoration Project), Photo of 3<sup>rd</sup> Period (Personal Archive) (prepared by the author, based on the photographs obtained from İstanbul No. II Regional Conservation Committee of Cultural Assets Archive and Personal Archive)

it is mentioned in the previous chapters that there was a rapid transformation in the socio-economic and functional fabric of the region especially after the Events of September 6, 7 in 1955 (Kırmızı, M. 2011). Residential dominance in Beyoğlu started to decrease during these periods, moreover developments such as the decision not to make residence buildings on İstiklal Street in the notes of the zoning plan in 1973, designation of Beyoğlu as the "Central Business District" in the notes of the zoning plan in 1980 pushed İstiklal Street to have commercial intensity. The building which was built in the 1860s for Siniosoglou family to accommodate commercial and residential functions, has hosted several functions in time as a result of the changes mentioned above in the region. Although the property owners and handover dates in this process are not exactly known, it is understood that in some periods there was only one function and tenant in the entire building and in some periods there were different functions and tenants on each floor. It is mentioned in the 2008 documentation report of the building that the building was used for functions such as office, art gallery, provincial presidency building of a political party and bank before 2008 (Table 3.21). In 2008, Company of Garanti Bank purchased the entire building and adapted it as a cultural center with the restoration project approved in 2009. The building is still being used as a cultural center today.

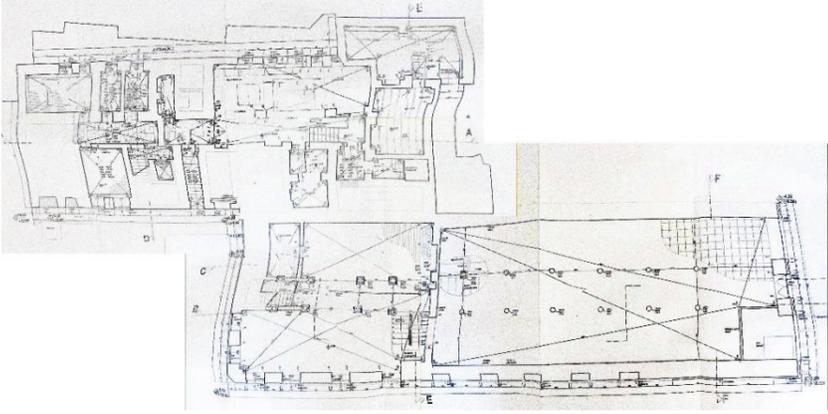
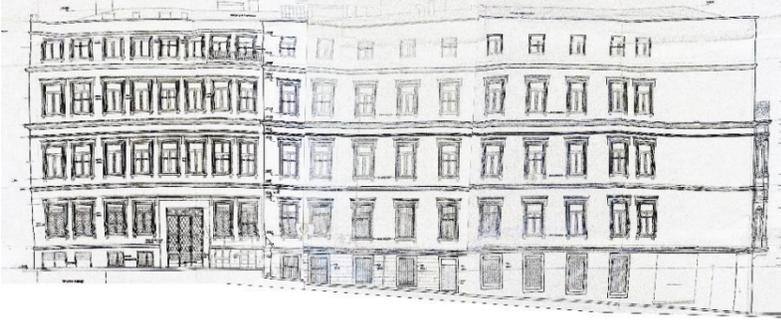
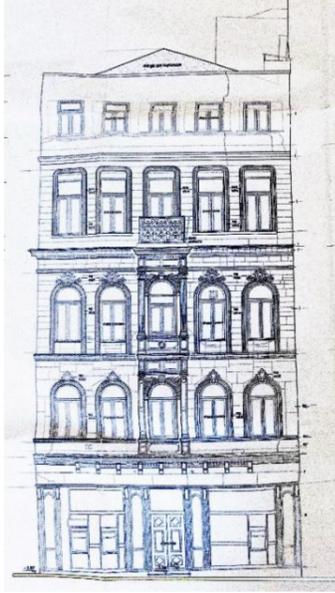
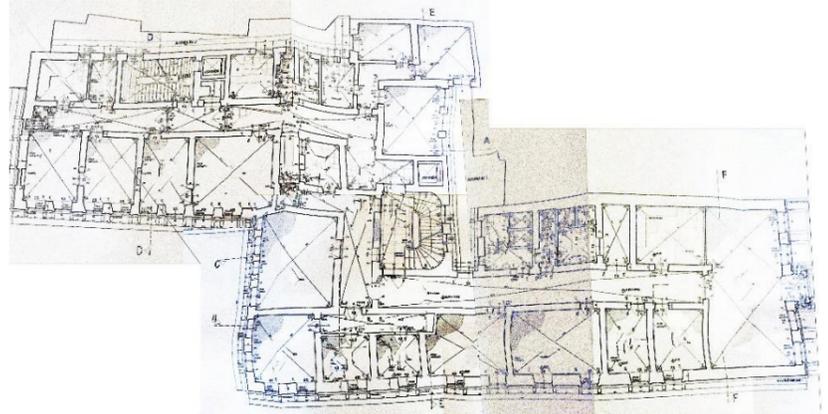
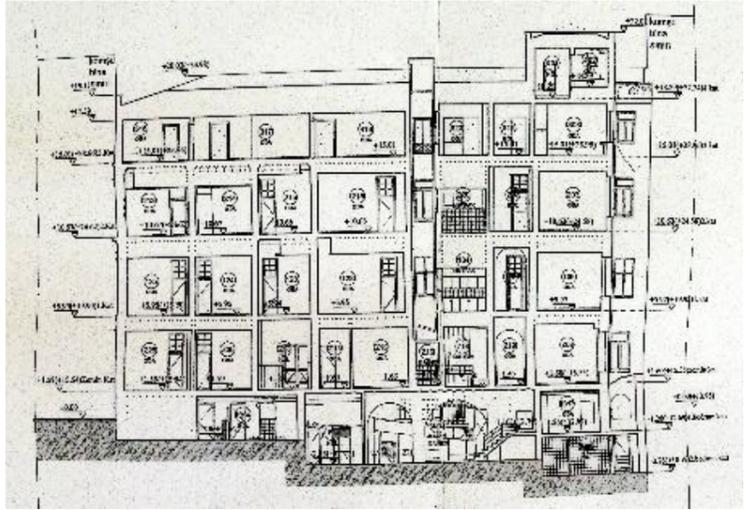
Table 3.23 Measured drawings prepared in 2008 (the drawings were obtained from İstanbul No. II Regional Conservation Committee of Cultural Assets Archive)

| GROUND FLOOR PLAN | SOUTH FAÇADE | EAST FAÇADE |
| | | <p><b>MEASURED DRAWINGS</b><br/> prepared in 2008<br/> by ALİ EMRAH ÜNLÜ<br/> approved by and obtained from<br/> İSTANBUL NO. II CONSERVATION<br/> COMMITTEE OF CULTURAL<br/> ASSETS</p> |
| FIRST FLOOR PLAN | SECTION | |

When the plans of the building are examined, it is found that there were more changes in Block B before 2008 than the other. In Block A, it is seen that a staircase was added to directly reach the first floor from the extra floor used by the commercial

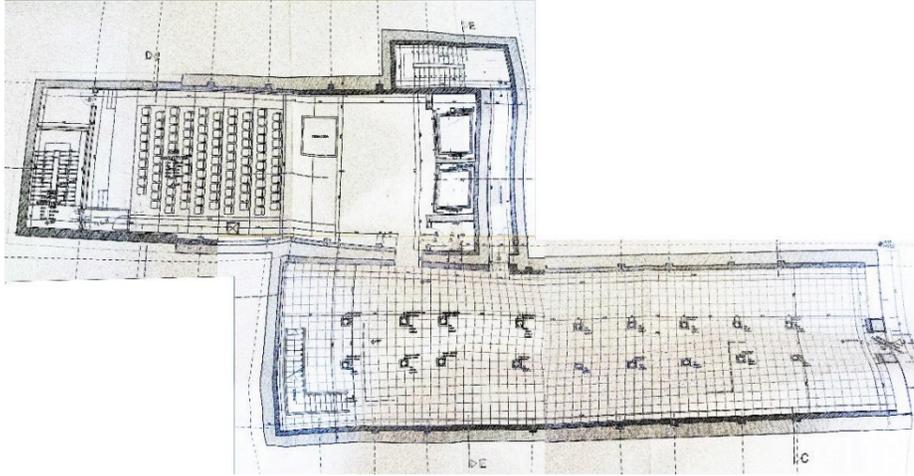
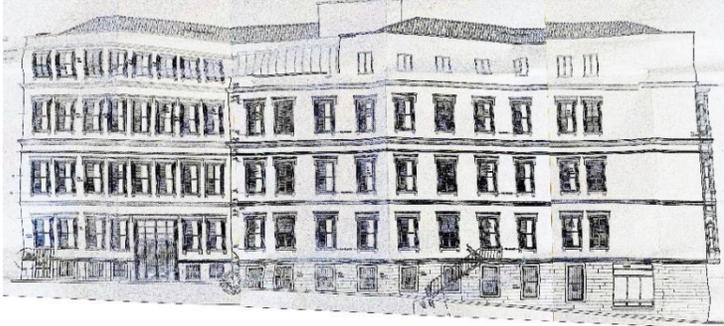
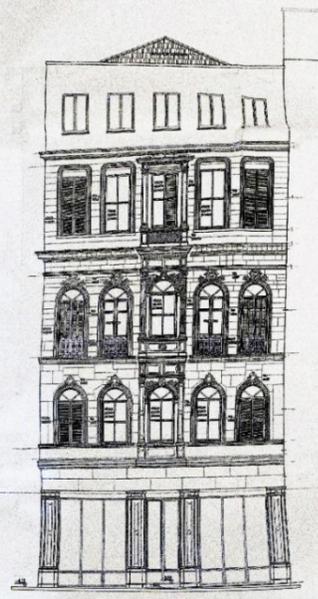
Table 3.24 Restoration project prepared in 2009 (the drawings were obtained from İstanbul No. II Regional Conservation Committee of Cultural Assets Archive)

| GROUND FLOOR PLAN | SOUTH FAÇADE | EAST FAÇADE |
| | | <p style="text-align: center;"><b>RESTORATION PROJECT</b><br/> prepared in 2009<br/> by ALİ EMRAH ÜNLÜ<br/> approved by<br/> and obtained from<br/> İSTANBUL NO. II REGIONAL<br/> CONSERVATION COMMITTEE OF<br/> CULTURAL ASSETS</p> |
| <p style="text-align: center;">FIRST FLOOR PLAN</p> | <p style="text-align: center;">SECTION</p> | |

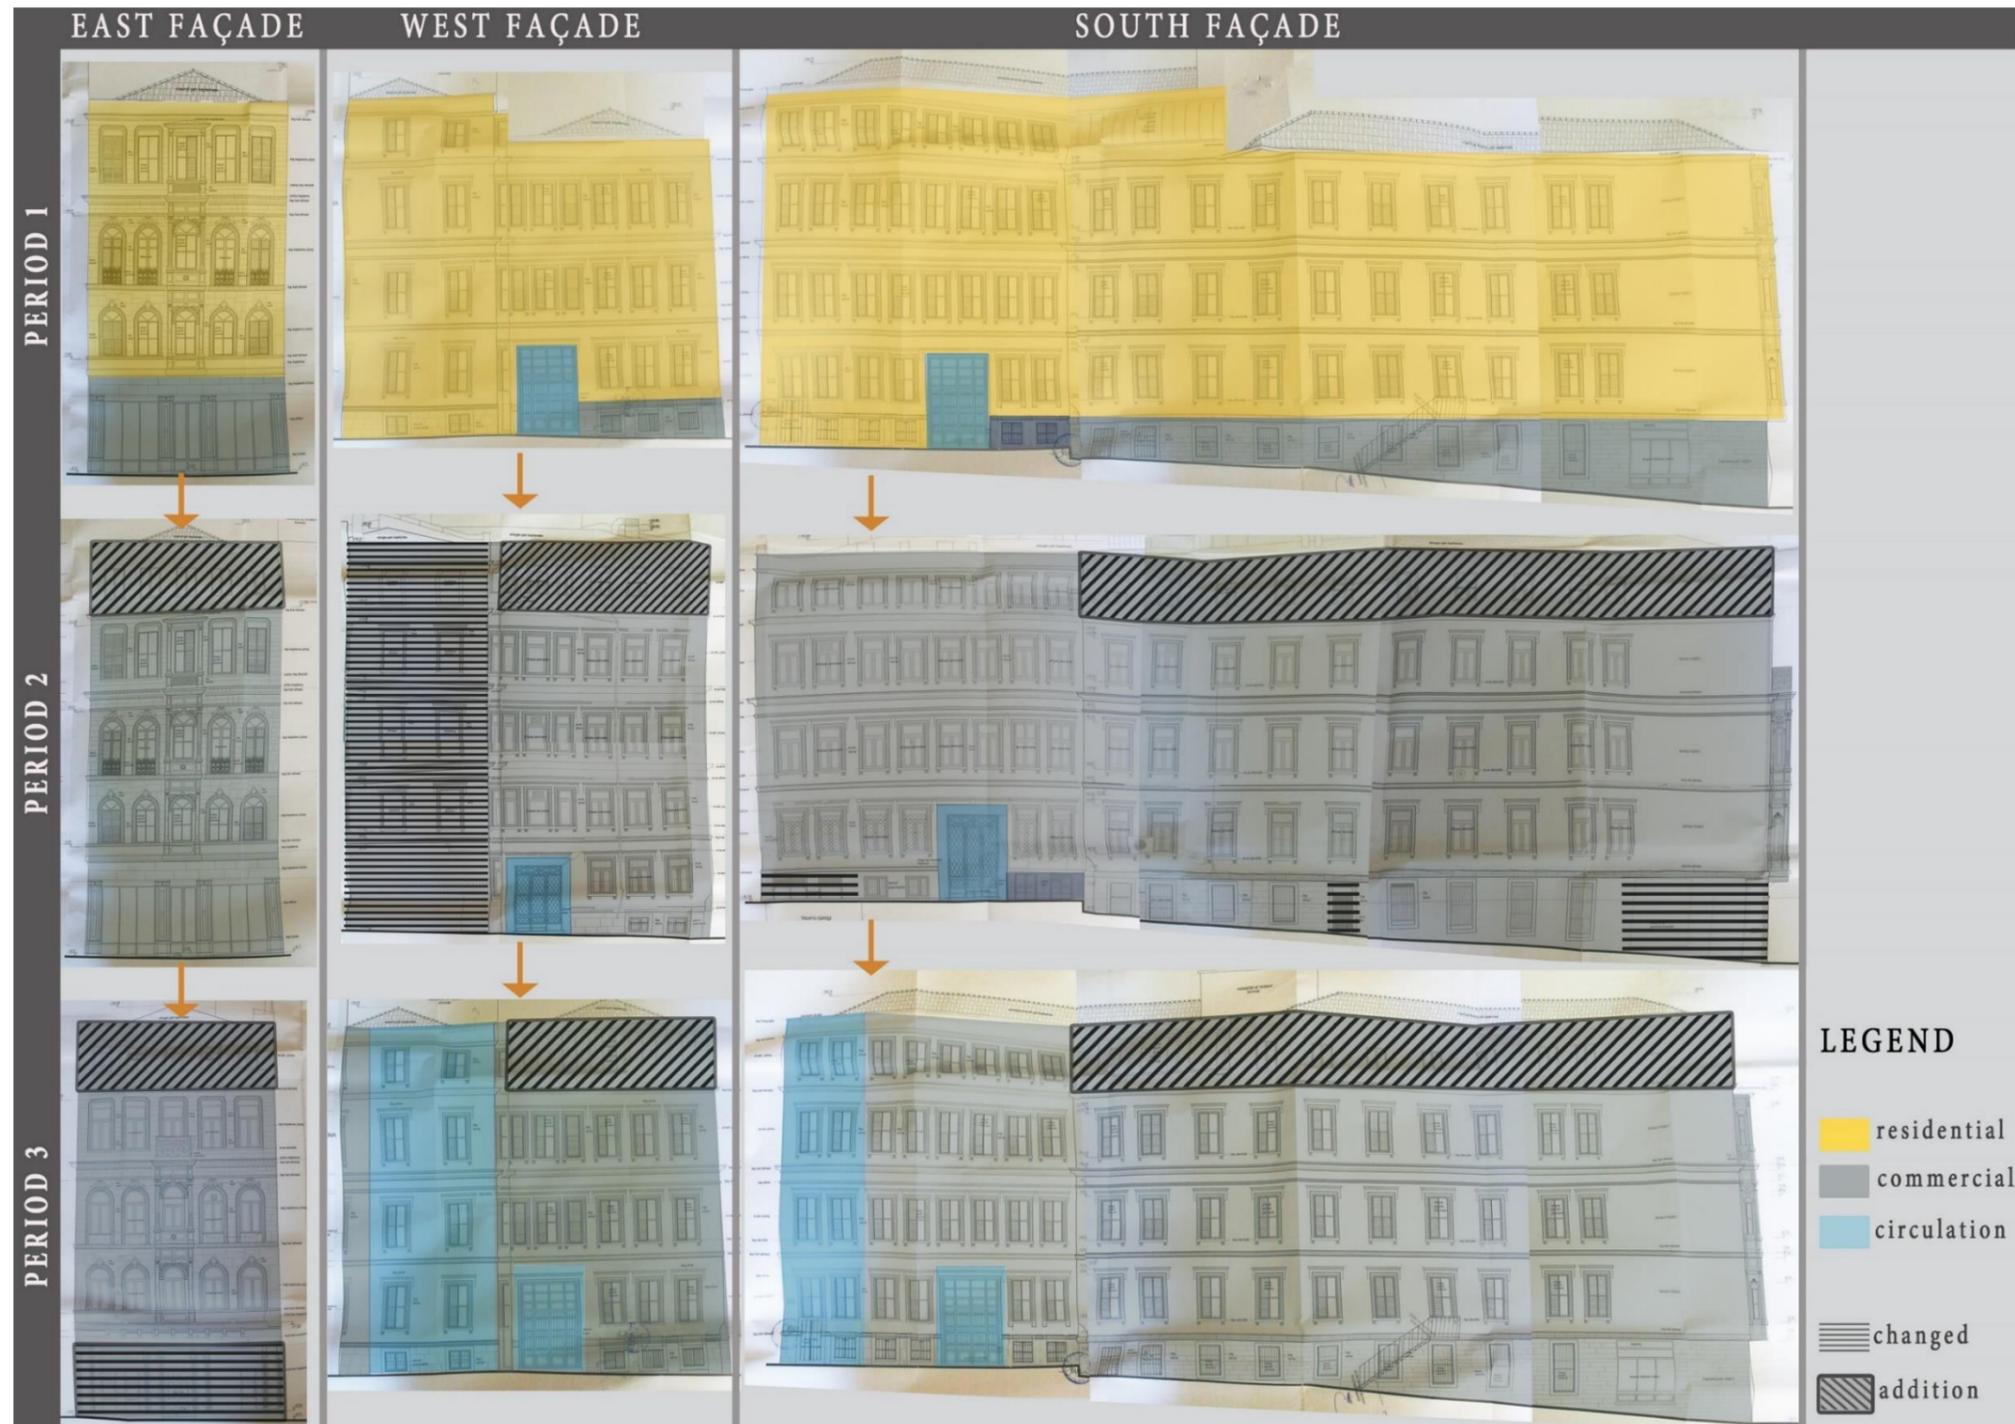
Table 3.25 Changes in the façade layout of SALT building in three periods (prepared by the author, based on the drawings obtained from İstanbul No. II Regional Conservation Committee of Cultural Assets Archive)
