ASSESSMENT OF THE EFFECTS OF ADAPTIVE REUSE INTERVENTIONS  
ON  
THREE APARTMENT BUILDINGS IN BEYOĞLU, İSTİKLAL STREET

A THESIS SUBMITTED TO  
THE GRADUATE SCHOOL OF NATURAL AND APPLIED SCIENCES  
OF  
MIDDLE EAST TECHNICAL UNIVERSITY

IN PARTIAL FULFILLMENT OF THE REQUIREMENTS  
FOR  
THE DEGREE OF MASTER OF SCIENCE  
IN  
CONSERVATION OF CULTURAL HERITAGE IN ARCHITECTURE

SEPTEMBER 2020

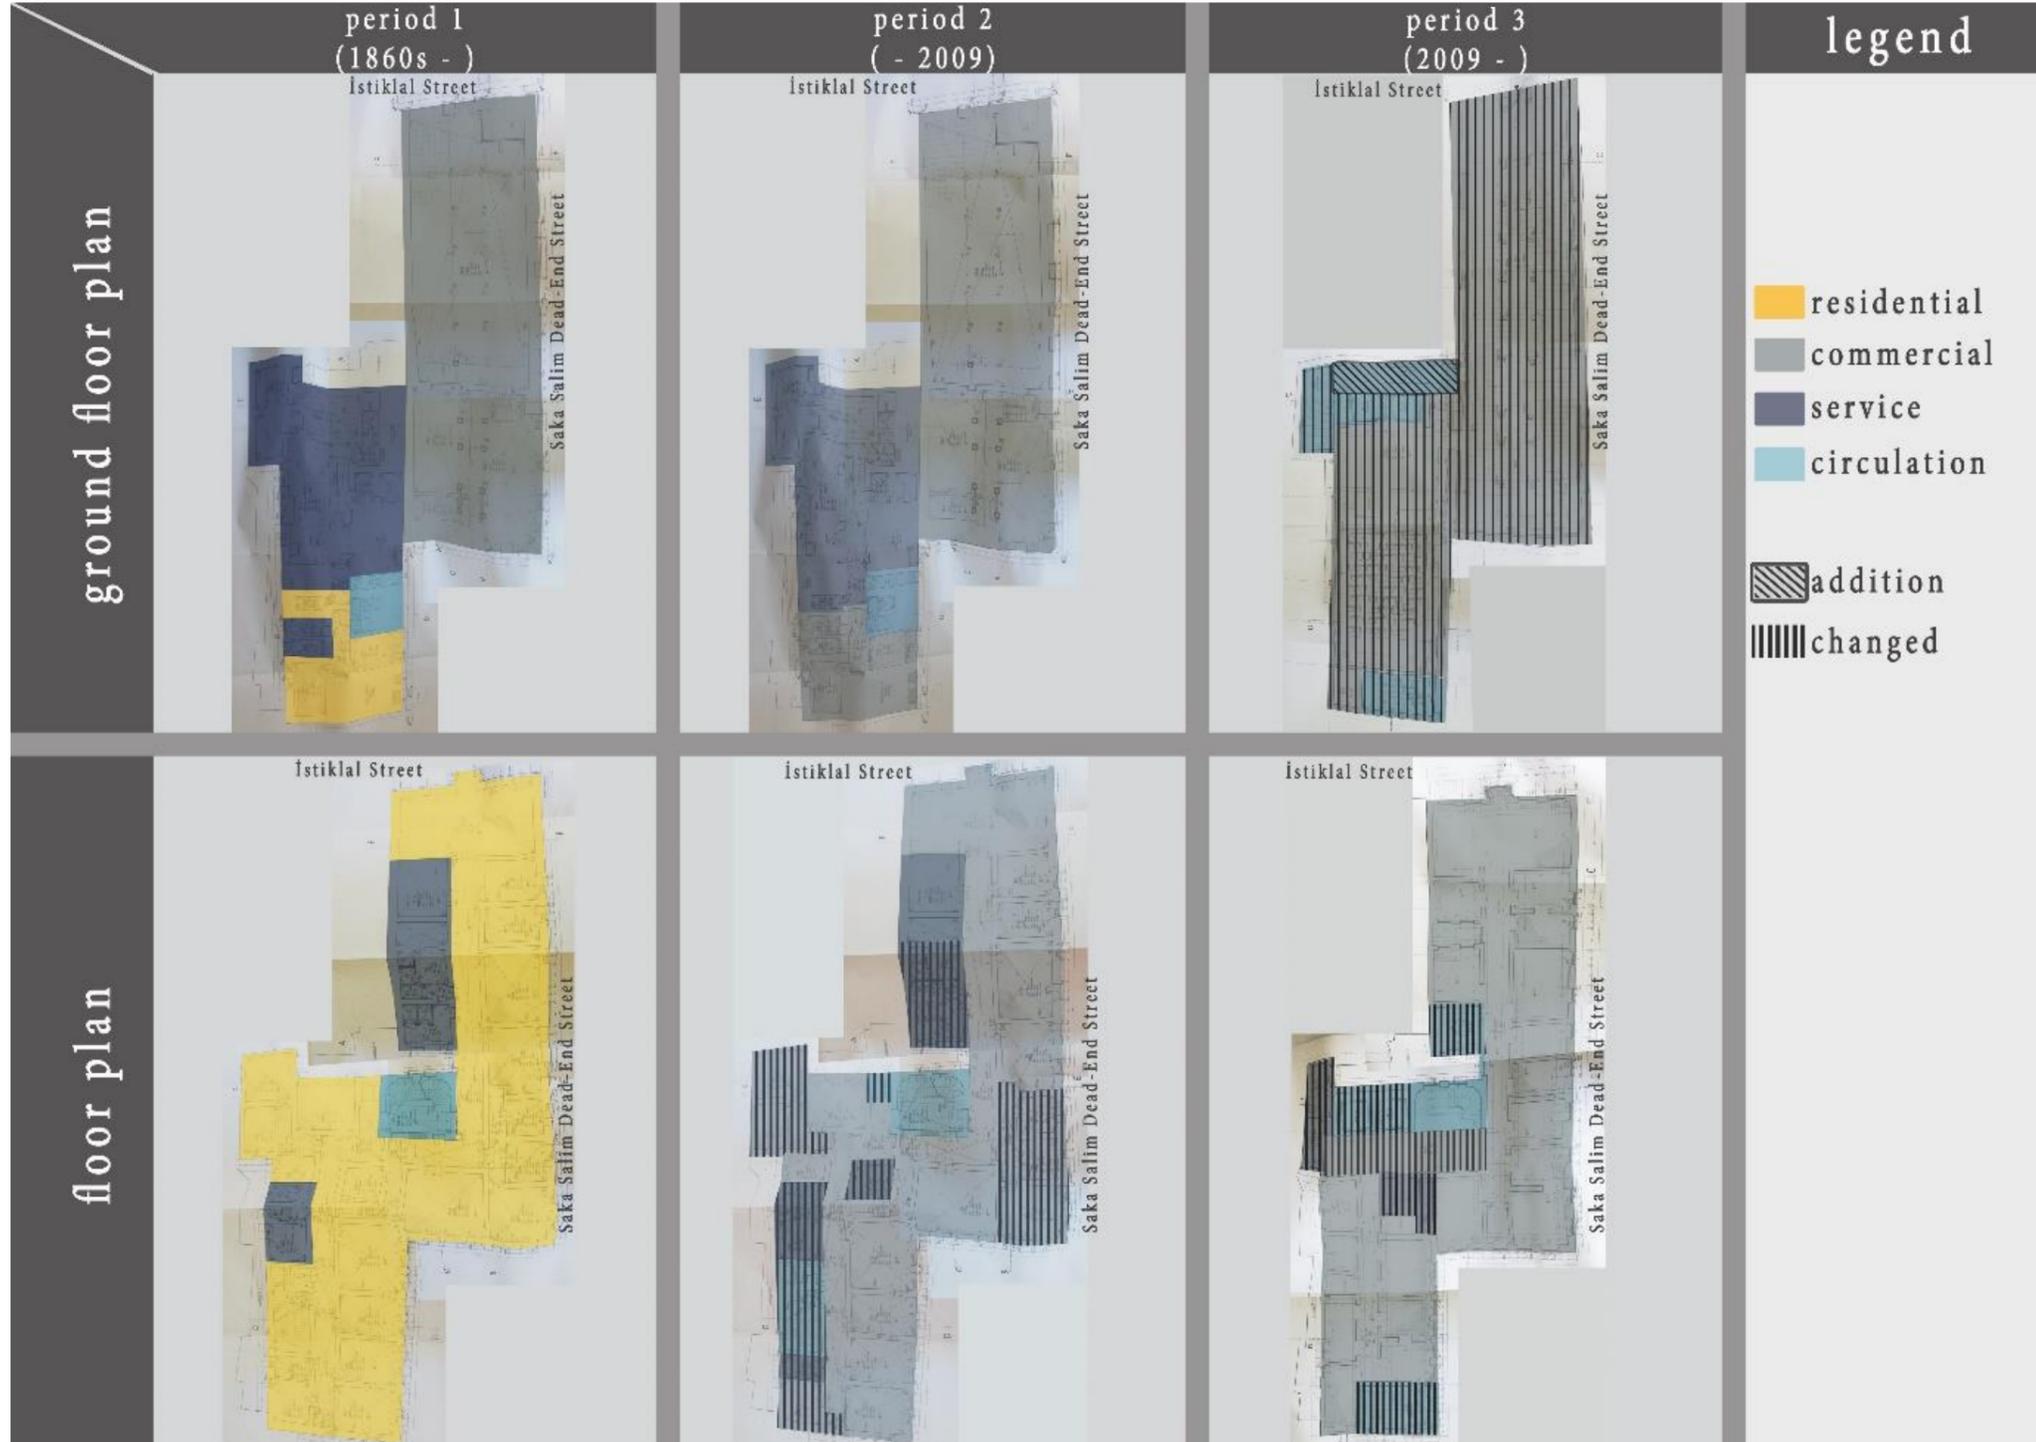
Table 3.26 Changes in the plan layout of SALT building in three periods (prepared by the author, based on the drawings obtained from İstanbul No. II Regional Conservation Committee of Cultural Assets Archive)

When the plan layout of the building is analyzed, it is determined that there is a slightly different situation on plans than the façades (Table 3.26). Before the building was adapted to a cultural center, no important change in the interior and plan layout that obstruct to perceive the original plan is seen. Because cultural center function needs large and high spaces, some small spaces and even some floors were removed in the building. Similarly, because of the greater dynamism of the cultural center within the building than the residential function, in-floor circulation areas needed to be extended, the circulation systems were changed and the number of vertical circulation elements were increased.

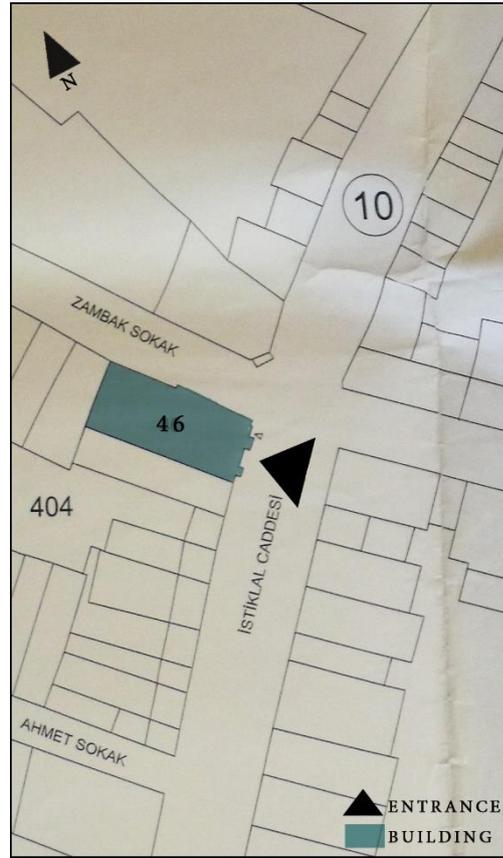
Figure 3.29. Location of Aksanat Cultural Center on the plot (prepared by the author, based on the drawing obtained from İstanbul No. II Regional Conservation Committee of Cultural Assets Archive)

The building is located on map section #10 block #404 plot #46. The building completely covers the plot which is at a corner of the block (Figure 3.29). There is no open area on the plot. Since it is located in an adjacent corner plot, the building has two façades facing the street. Consisting of a single building, the cultural center has a main entrance from İstiklal Street and a fire exit to the side street.

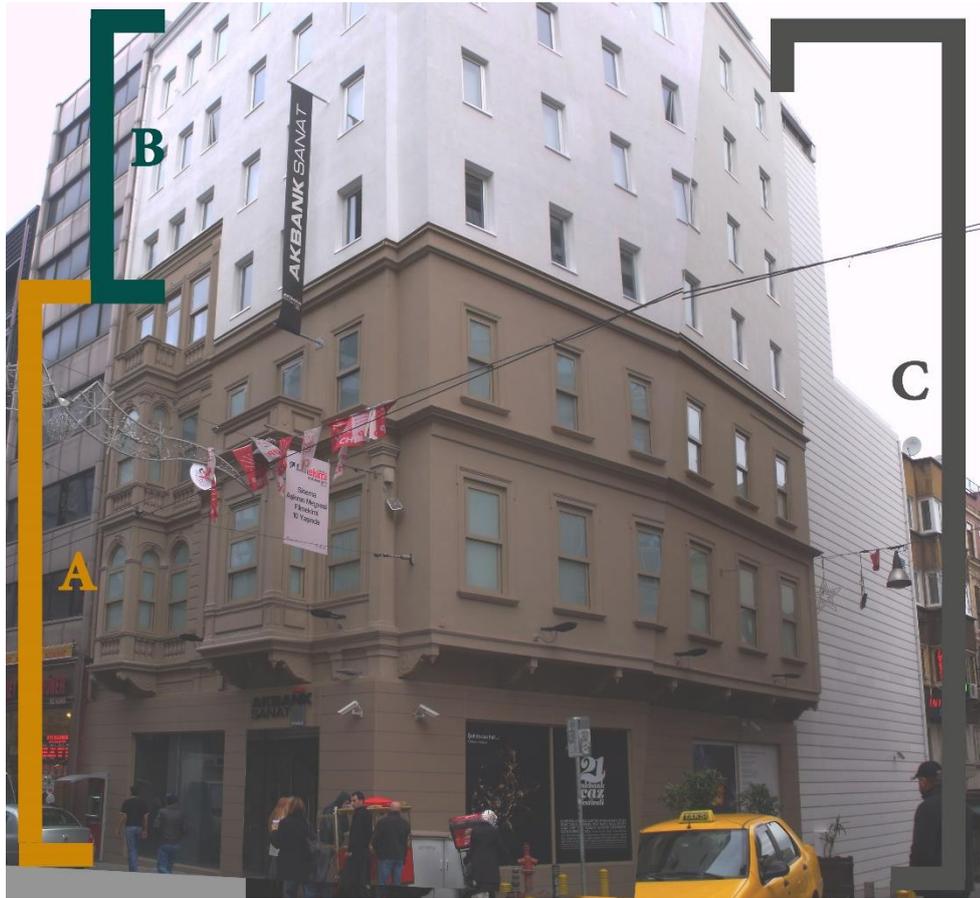
Figure 3.30. Drawing showing blocks of the building (prepared by the author, based on the photograph obtained from Personal Archive)

When the Aksanat Cultural Center building is viewed from the outside, it can be seen that three different blocks named as A, B, C, are built adjacent to each other on the vertical and horizontal axis (Figure 3.30). The three different block perception

formed on the façades has no perception in the interior and plan layout. A part of the brown painted Block A has three floors and the other part of it has four floors. Cantilevers, openings and ornaments that reflect the 19th century architectural features of Beyoğlu district can be observed on the façades of this block. There are wide openings and a wide entrance door at the ground floor level. At this level, a façade is coated with a distinct horizontal lined cladding material in a compatible color with the upper floors. The upper floors have balconies, closed cantilevers and arched or rectangular window openings repeated along the façade. At the same time, there are ornaments around of the windows and on the corners of the cantilevers on the façade of the block facing İstiklal Street.

White painted Block B was built on top of Block A. Since Block A, which is the part where the original façades are conserved, has two floors over the ground floor on the east side and three floors over the ground floor on the west side, Block B rises from the third floor on the east side and from the fourth floor to the sixth floor. There is only one type of window opening on both façades of Block B. These openings were arranged to be simplified repetitions of original window openings in Block A in terms of their proportions and positions.

The other block, namely Block C, was attached to the north side of the building. This block has only one façade facing Zambak Street. The block rises from the street level and a part of the block has six floors and the other part has three floors above the ground. Block C is completely blank and it is coated with a distinct horizontal lined cladding material.

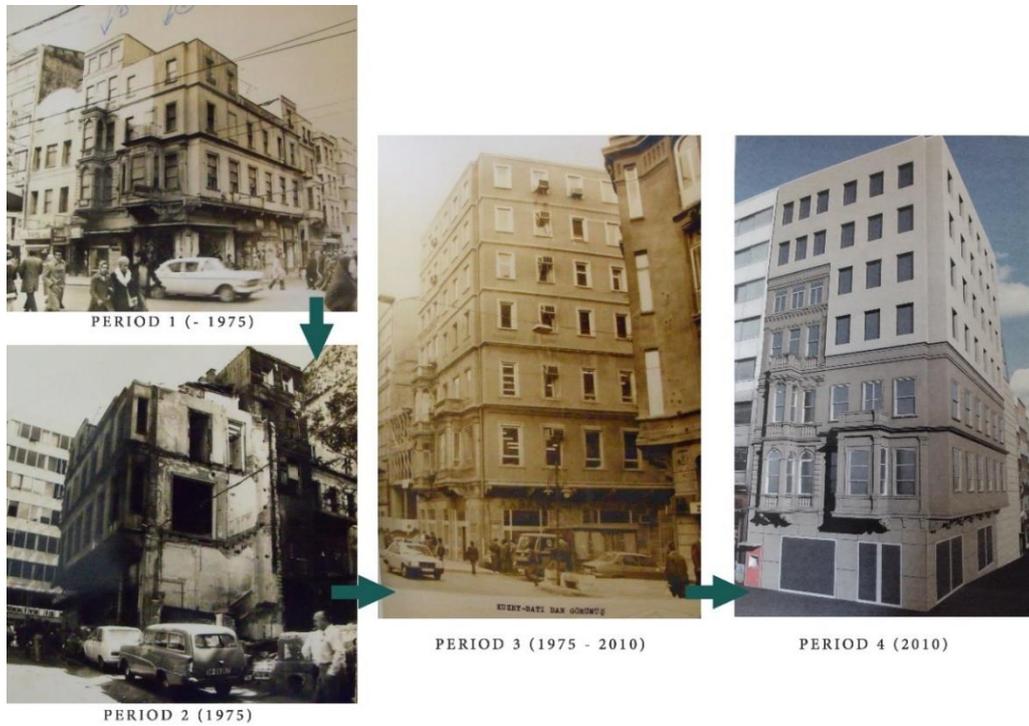
Table 3.28 Situation of the building in four periods; Photo of the 1st, 2nd and 3rd Period (Photo Album of Restitution Project), Photo of the 4th Period (3D image of Restoration Project) (prepared by the author, based on the photographs obtained from İstanbul No. II Regional Conservation Committee of Cultural Assets Archive and Personal Archive)

has reached its current state. The final state of the building is determined as the fourth period and is shown with the 3D model image which was submitted to the committee with the project. (Table 3.28)

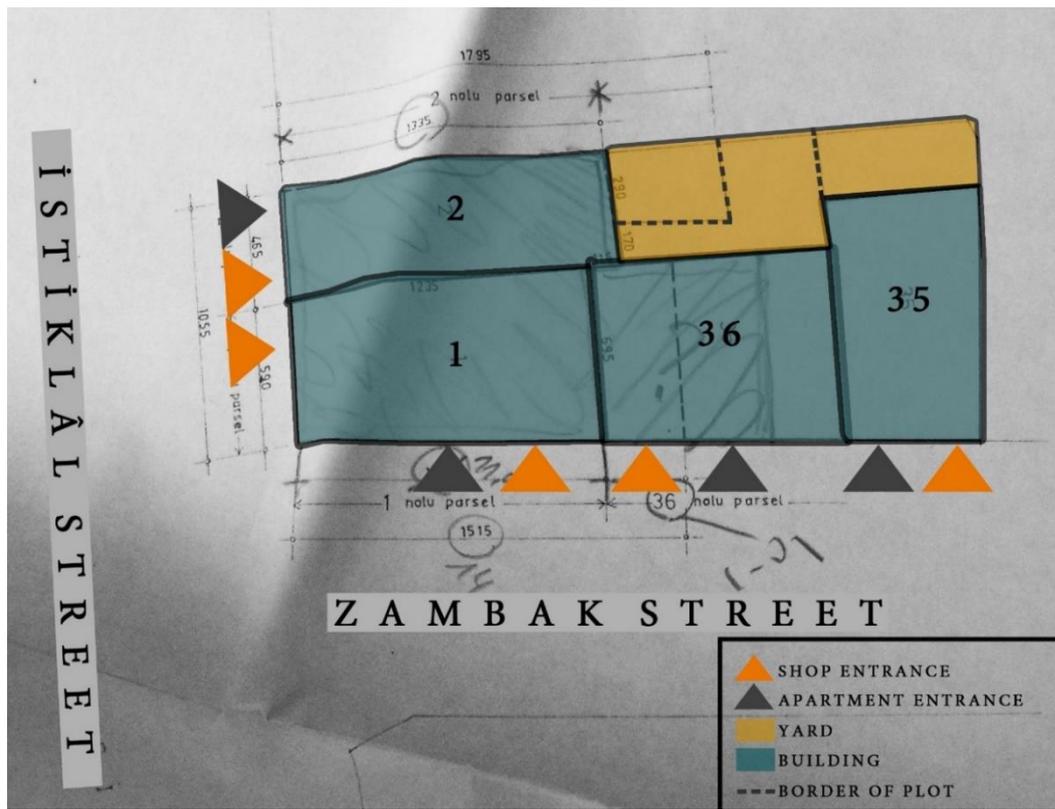
Figure 3.32. Original location of the building on the plot (prepared by the author, based on the drawing obtained from İstanbul No. II Regional Conservation Committee of Cultural Assets Archive)

The plot where the building is located today (plot #46) is formed by the amalgamation of four different plots (plot #1, #2, #35, #36) on block #404. According to the measured drawings in 1975 and the conservation committee's reports about the plots, which are the resources containing the details of the original state of these plots, there were four separate apartment buildings constructed on four plots in the original state (Figure 3.32).

Four separate buildings were designed to have commercial units on the ground floors and residential units on the upper floors. When the photographs of the period before 1975 are also analyzed, it is understood that each of these buildings had an apartment entrance and a commercial entrance except the building on plot #1 at the corner, which had two commercial entrances. The entrances of both the commercial unit and the apartment unit of the building on plot #2 were provided through İstiklal Street. The entrance of one of the commercial units of the building on plot #1 was on İstiklal Street and the other one was on Zambak Street. The apartment unit entrance of this building was between two commercial units and was provided through Zambak Street. The buildings on plots #35 and #36 had both commercial and apartment unit entrances on Zambak Street (Figure 3.32).

As it is understood from the measured drawings prepared in 1975, there was a small courtyard behind plots #2, #35 and #36. Although the exact information could not be reached, it is thought that these buildings had exits to the courtyard (Figure 3.32).

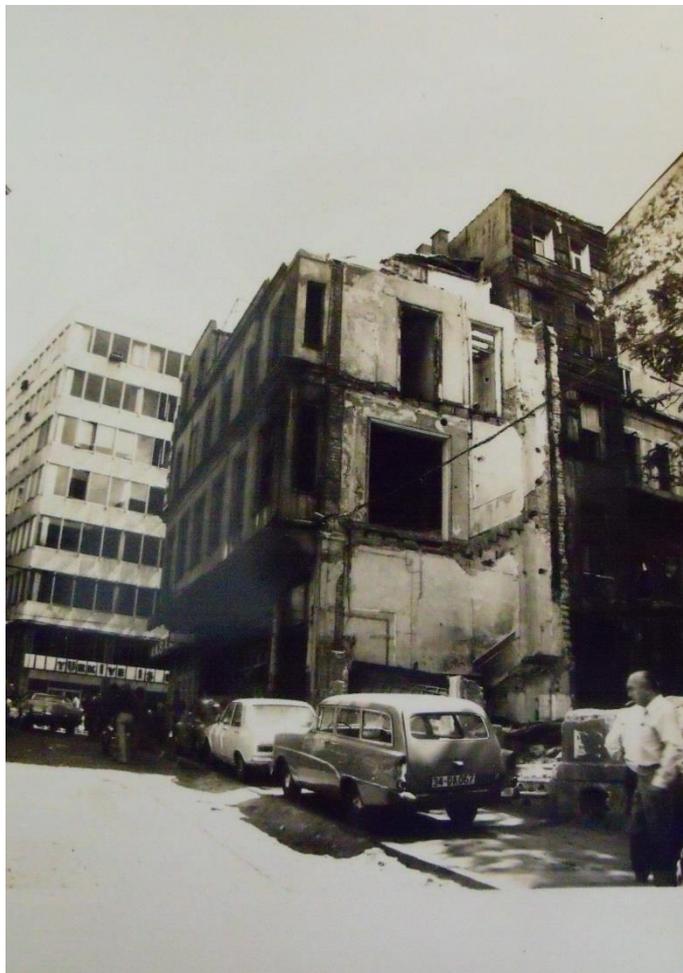
Figure 3.33. Photograph taken in 1975 (Photo Album of Restitution Project)

By analyzing the photographs between 1960 and 1975, the structural system of the original buildings on block #404 plot #1, #2 and #36, is understood to be formed of masonry brick wall system with jack arches (Figure 3.33).

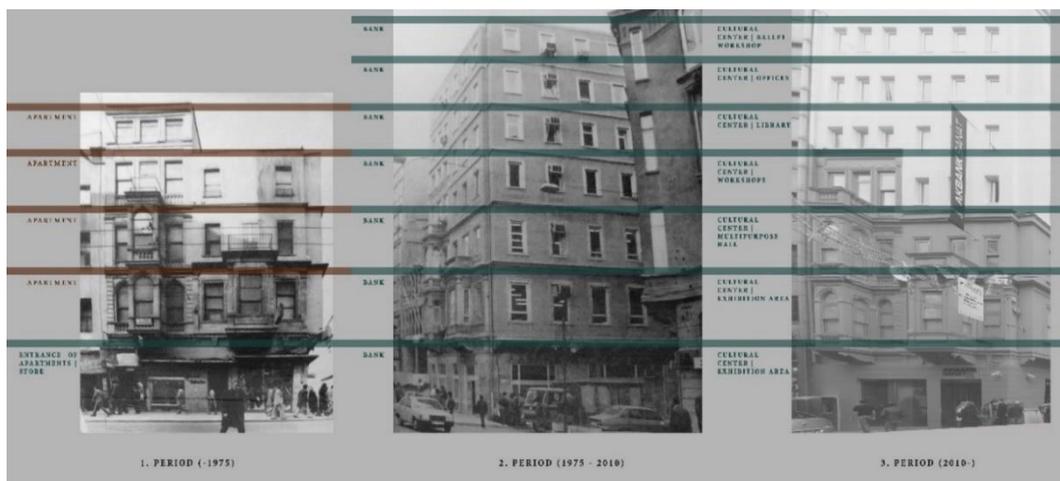
Table 3.30 Change of function according to floors in the building in three periods; Photo of the 1st and 2nd Periods (Photo Album of Restitution Project), Photo of the 3rd Period (Personal Archive) (prepared by the author, based on the photographs obtained from İstanbul No. II Regional Conservation Committee of Cultural Assets Archive and Personal Archive)

In this process, it is observed that the upper floors, which were originally residential units, have gradually adaptively reused as commercial functions (Table 3.30). During this period, the spaces on the upper floors of the buildings were separated from the vertical circulation by partitions in interior, and different commercial functions such as a dentist clinic and a photography studio were placed on each floor. According to the restoration project in 1975, it is understood that separate commercial units on the ground floors of the buildings were combined and adapted to be used as an Akbank branch. In the same year, the new building that was formed by combining the buildings also on the upper floors and constructing additional masses was started to be adaptively reused as a bank building (Table 3.30). The building, which continued to be used as a bank until 1990, started to be used as a cultural center in 1990.

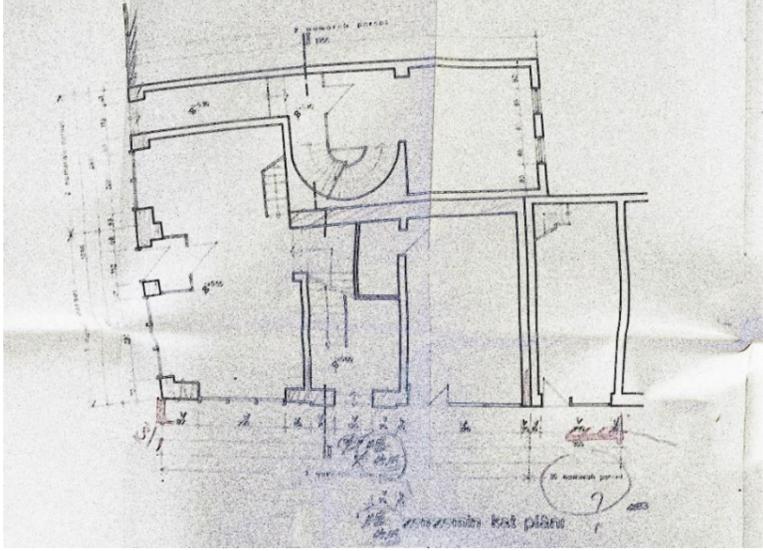
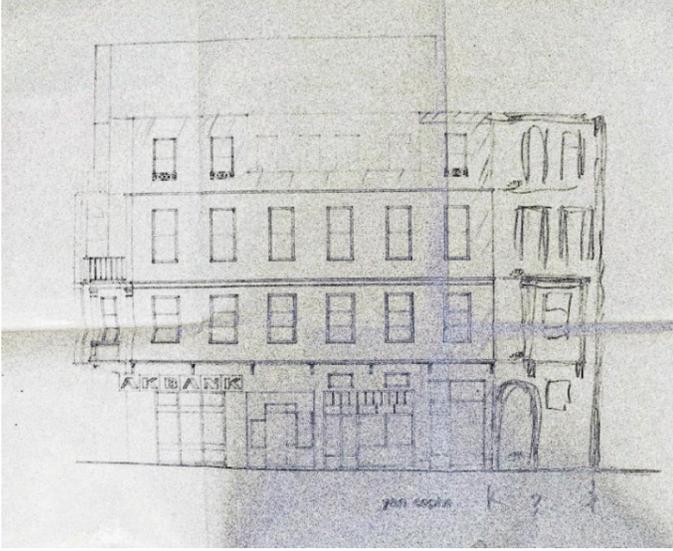
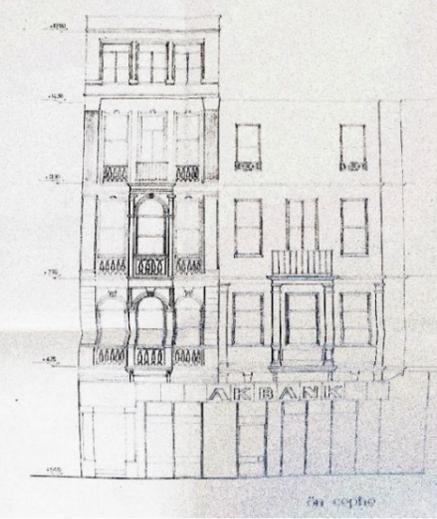
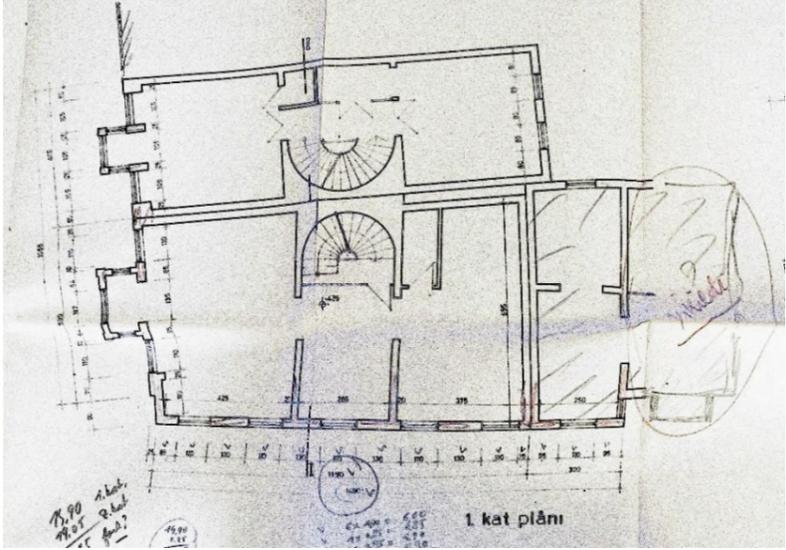
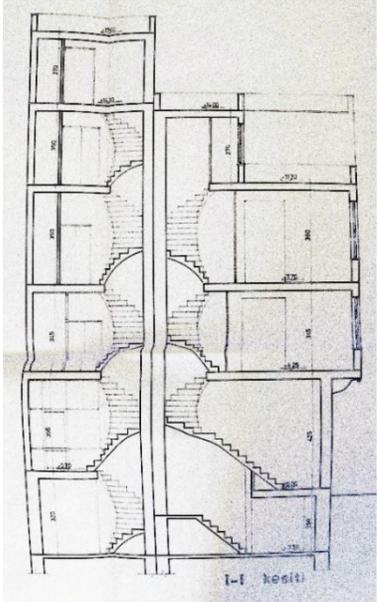
Table 3.32 Measured drawings prepared in 1975 (the drawings were obtained from İstanbul No. II Regional Conservation Committee of Cultural Assets Archive)

| GROUND FLOOR PLAN | NORTH FAÇADE | EAST FAÇADE |
| FIRST FLOOR PLAN | SECTION | |

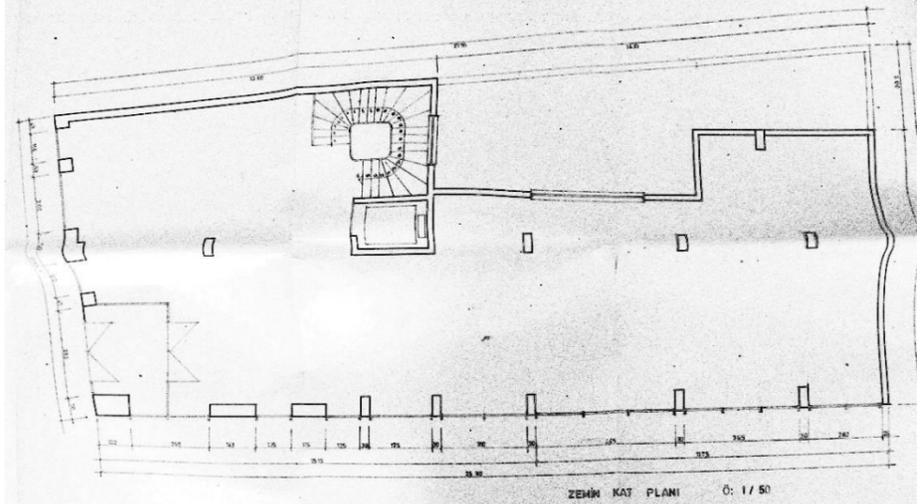
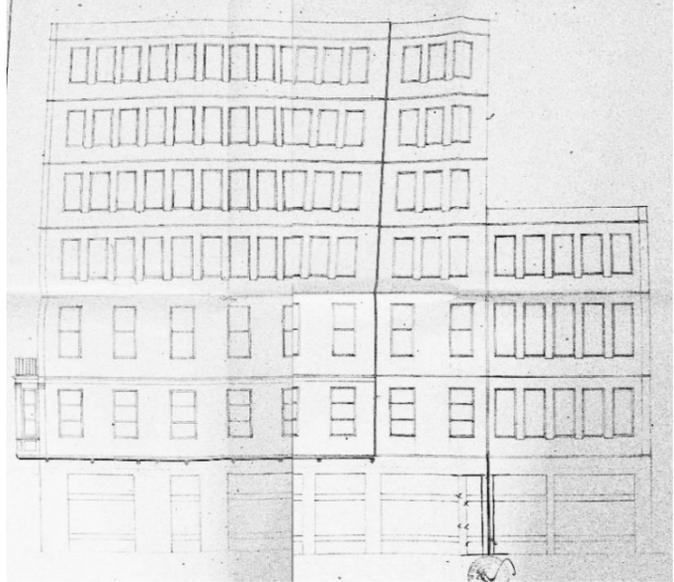
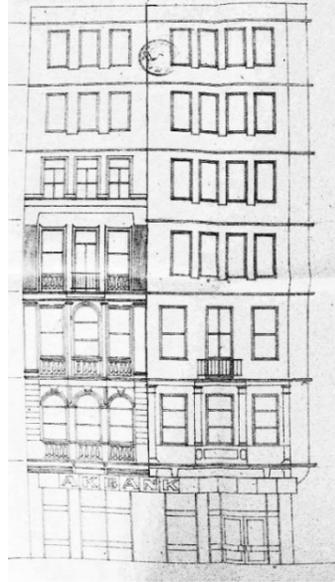
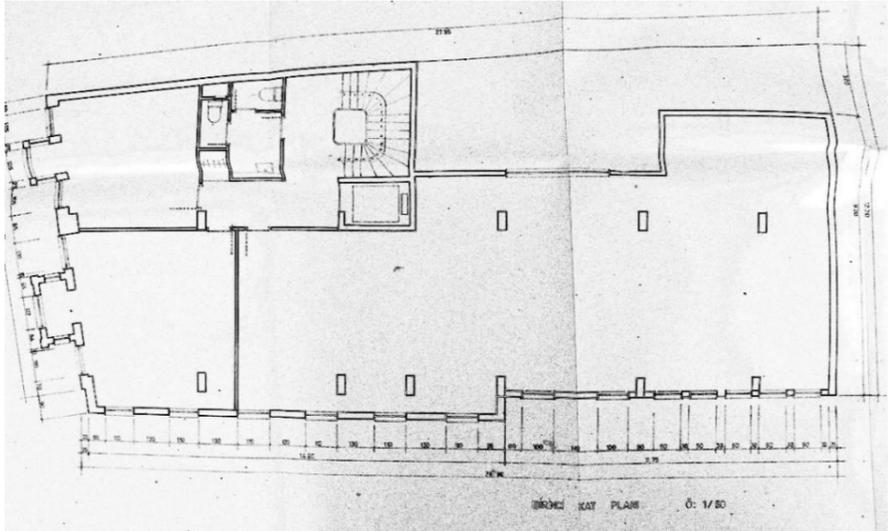
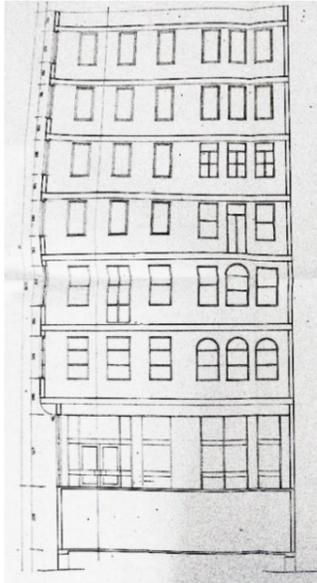
Table 3.33 Restoration project prepared in 1975 (the drawings were obtained from İstanbul No. II Regional Conservation Committee of Cultural Assets Archive)

| GROUND FLOOR PLAN | NORTH FAÇADE | EAST FAÇADE |
| <p style="text-align: center;">FIRST FLOOR PLAN</p> | <p style="text-align: center;">SECTION</p> | |

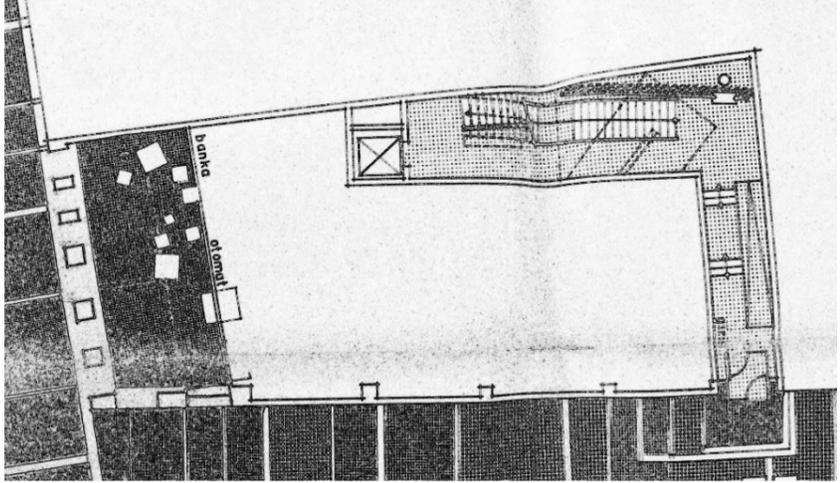
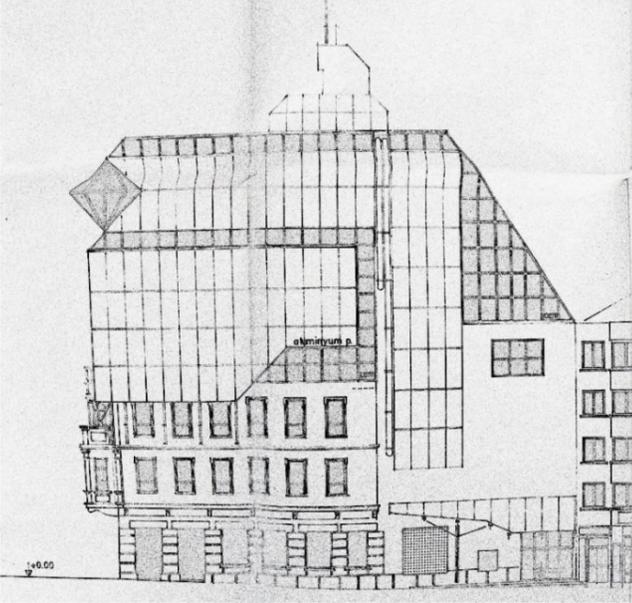
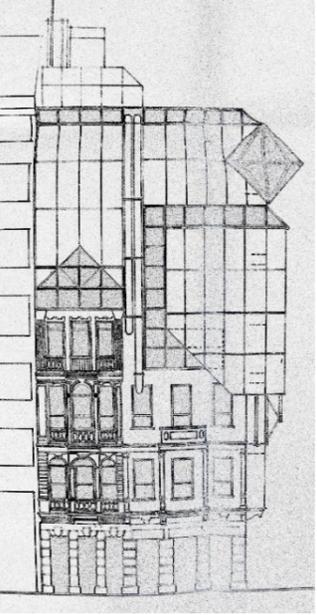
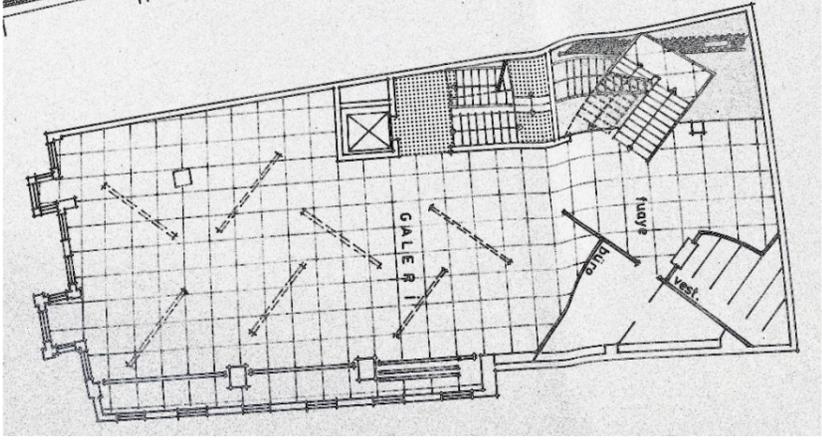
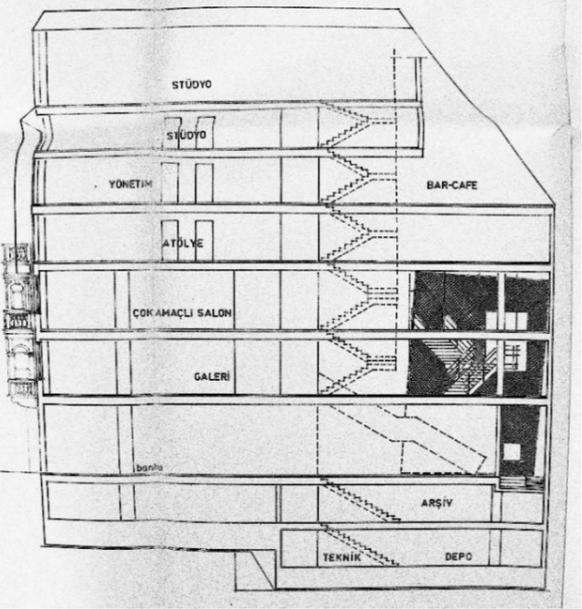
Table 3.34 Preliminary project prepared in 1990 (the drawings were obtained from İstanbul No. II Regional Conservation Committee of Cultural Assets Archive)

| GROUND FLOOR PLAN | NORTH FAÇADE | EAST FAÇADE |
| FIRST FLOOR PLAN | SECTION | |

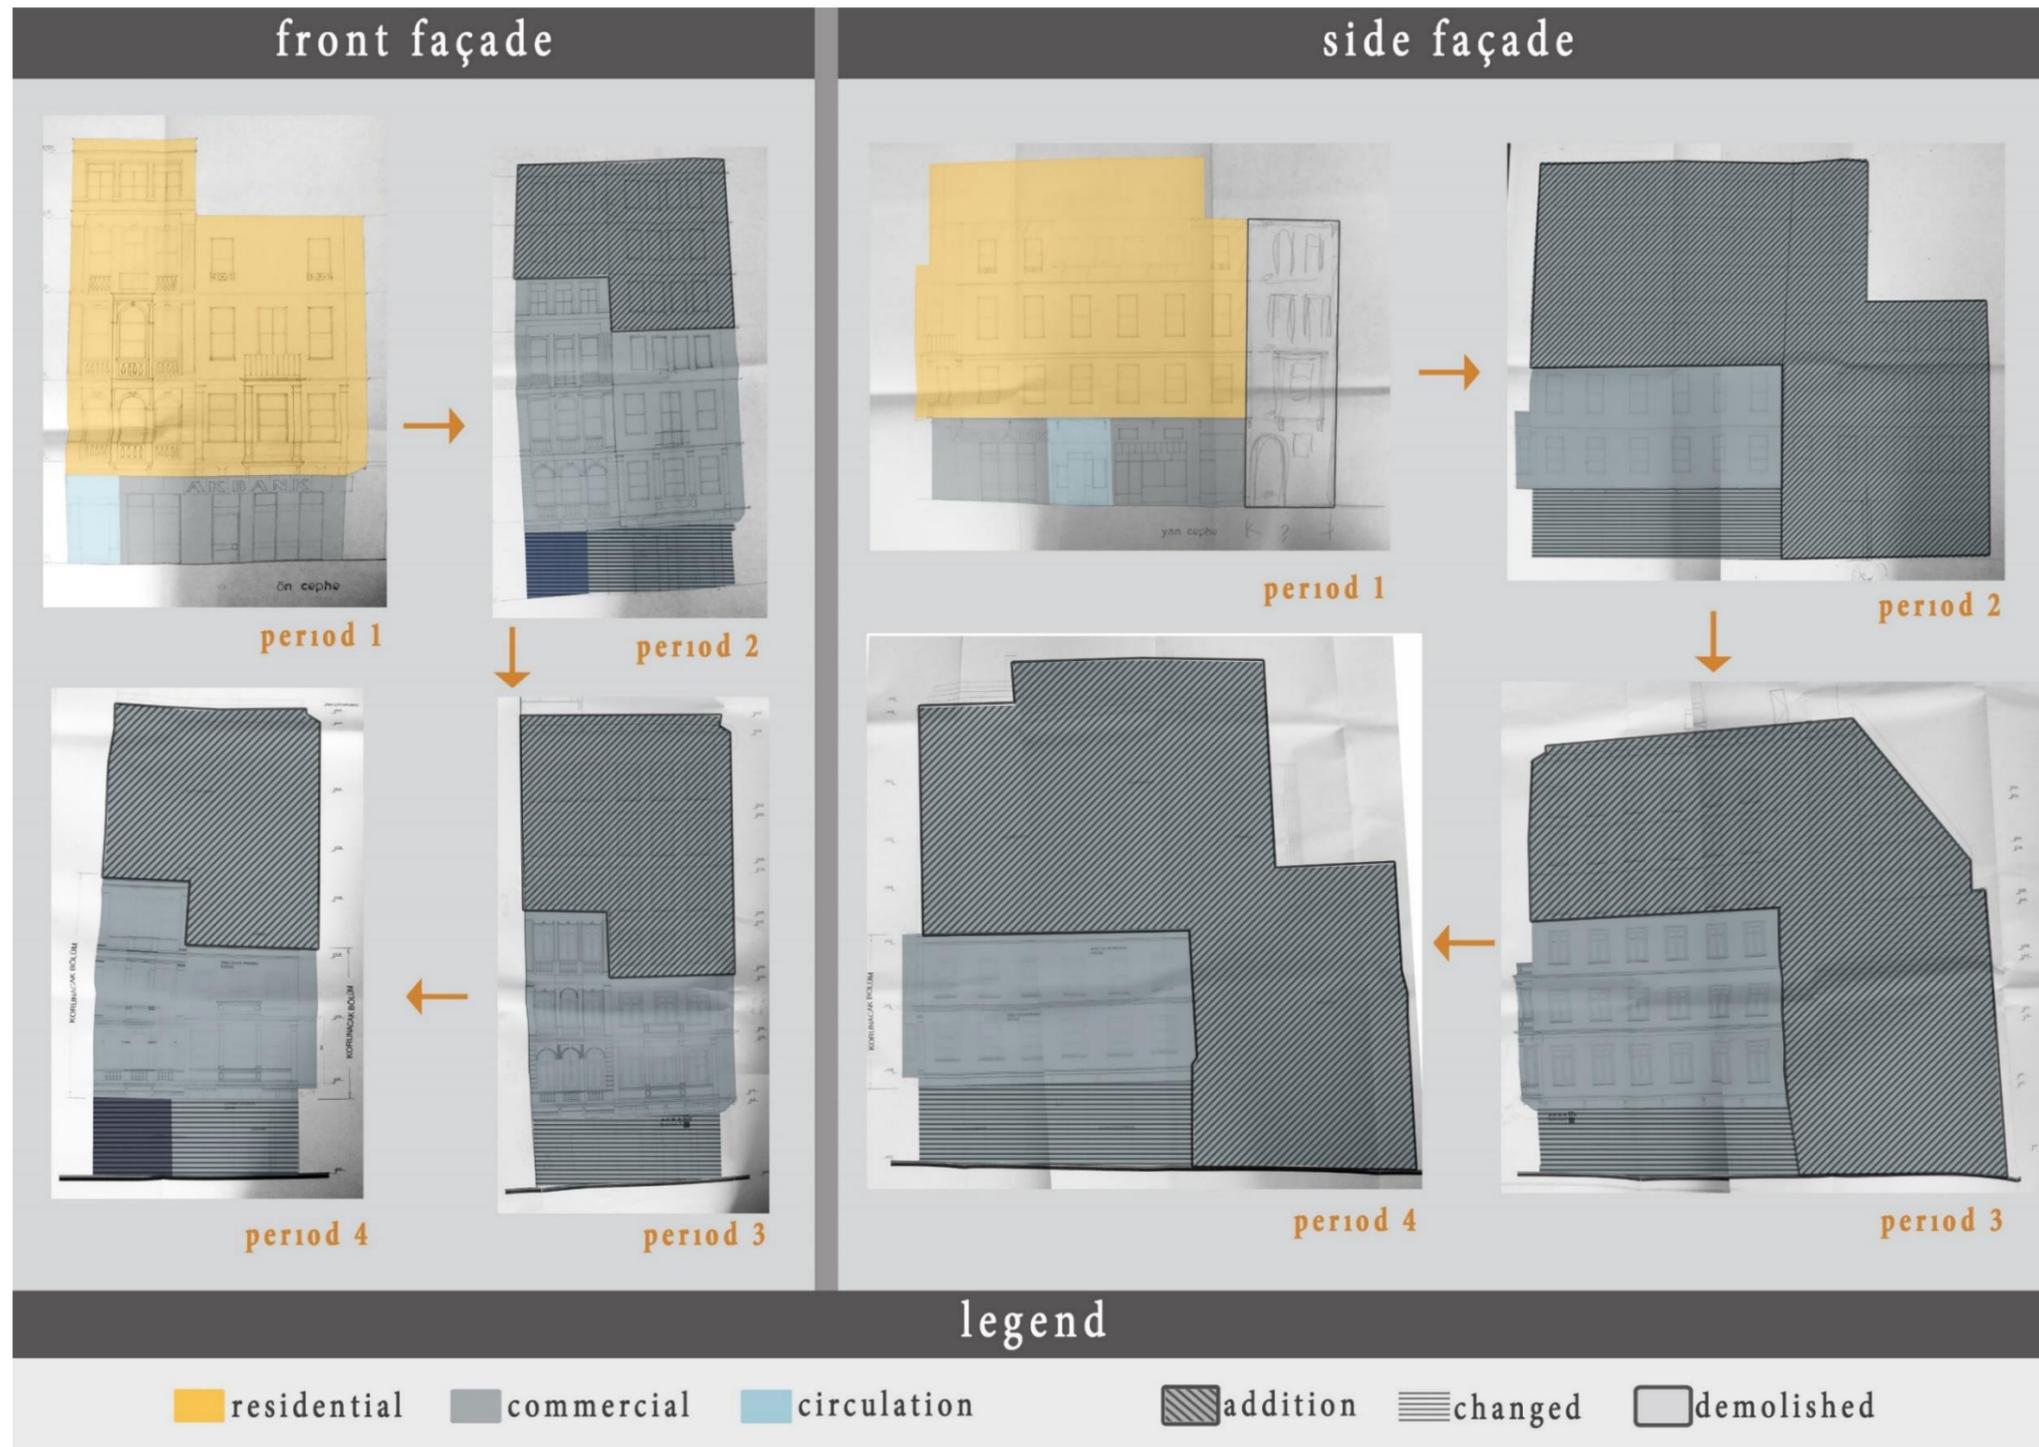
Table 3.37 Changes in the façade layout of Aksanat building in four periods (prepared by the author, based on the drawings obtained from İstanbul No. II Regional Conservation Committee of Cultural Assets Archive)

When the façade layout of Aksanat building is examined, it is observed that some of the ground floor openings in the authentic state of the plot disappeared. Most of the openings remain in their original shape, yet both the windows on the conserved floors and most of the windows on the additional masses were closed in the interior. On the floors with closed openings, there are exhibition areas, a multi-purpose hall and a ballet studio. It is evident that these functions have very divergent opening requirements than the housing function. Moreover, as it can be seen from the building, it is understood that all the openings of the spaces where these functions are located were closed. When filling out the Solid / Void Ratio and Location of Openings lines in the evaluation form, especially the perception of the interior is taken into consideration. Besides, the fact that the openings were closed in the interior can be perceived even though it is not completely comprehended from the exterior. Numerical data related to the opening ratios in the form are determined by comparing the opening area on the exterior wall surface with the blank walls and the closed opening area. When the opening ratio is considered, it can be seen that there is a big difference between the original buildings and the new design. Evaluating the

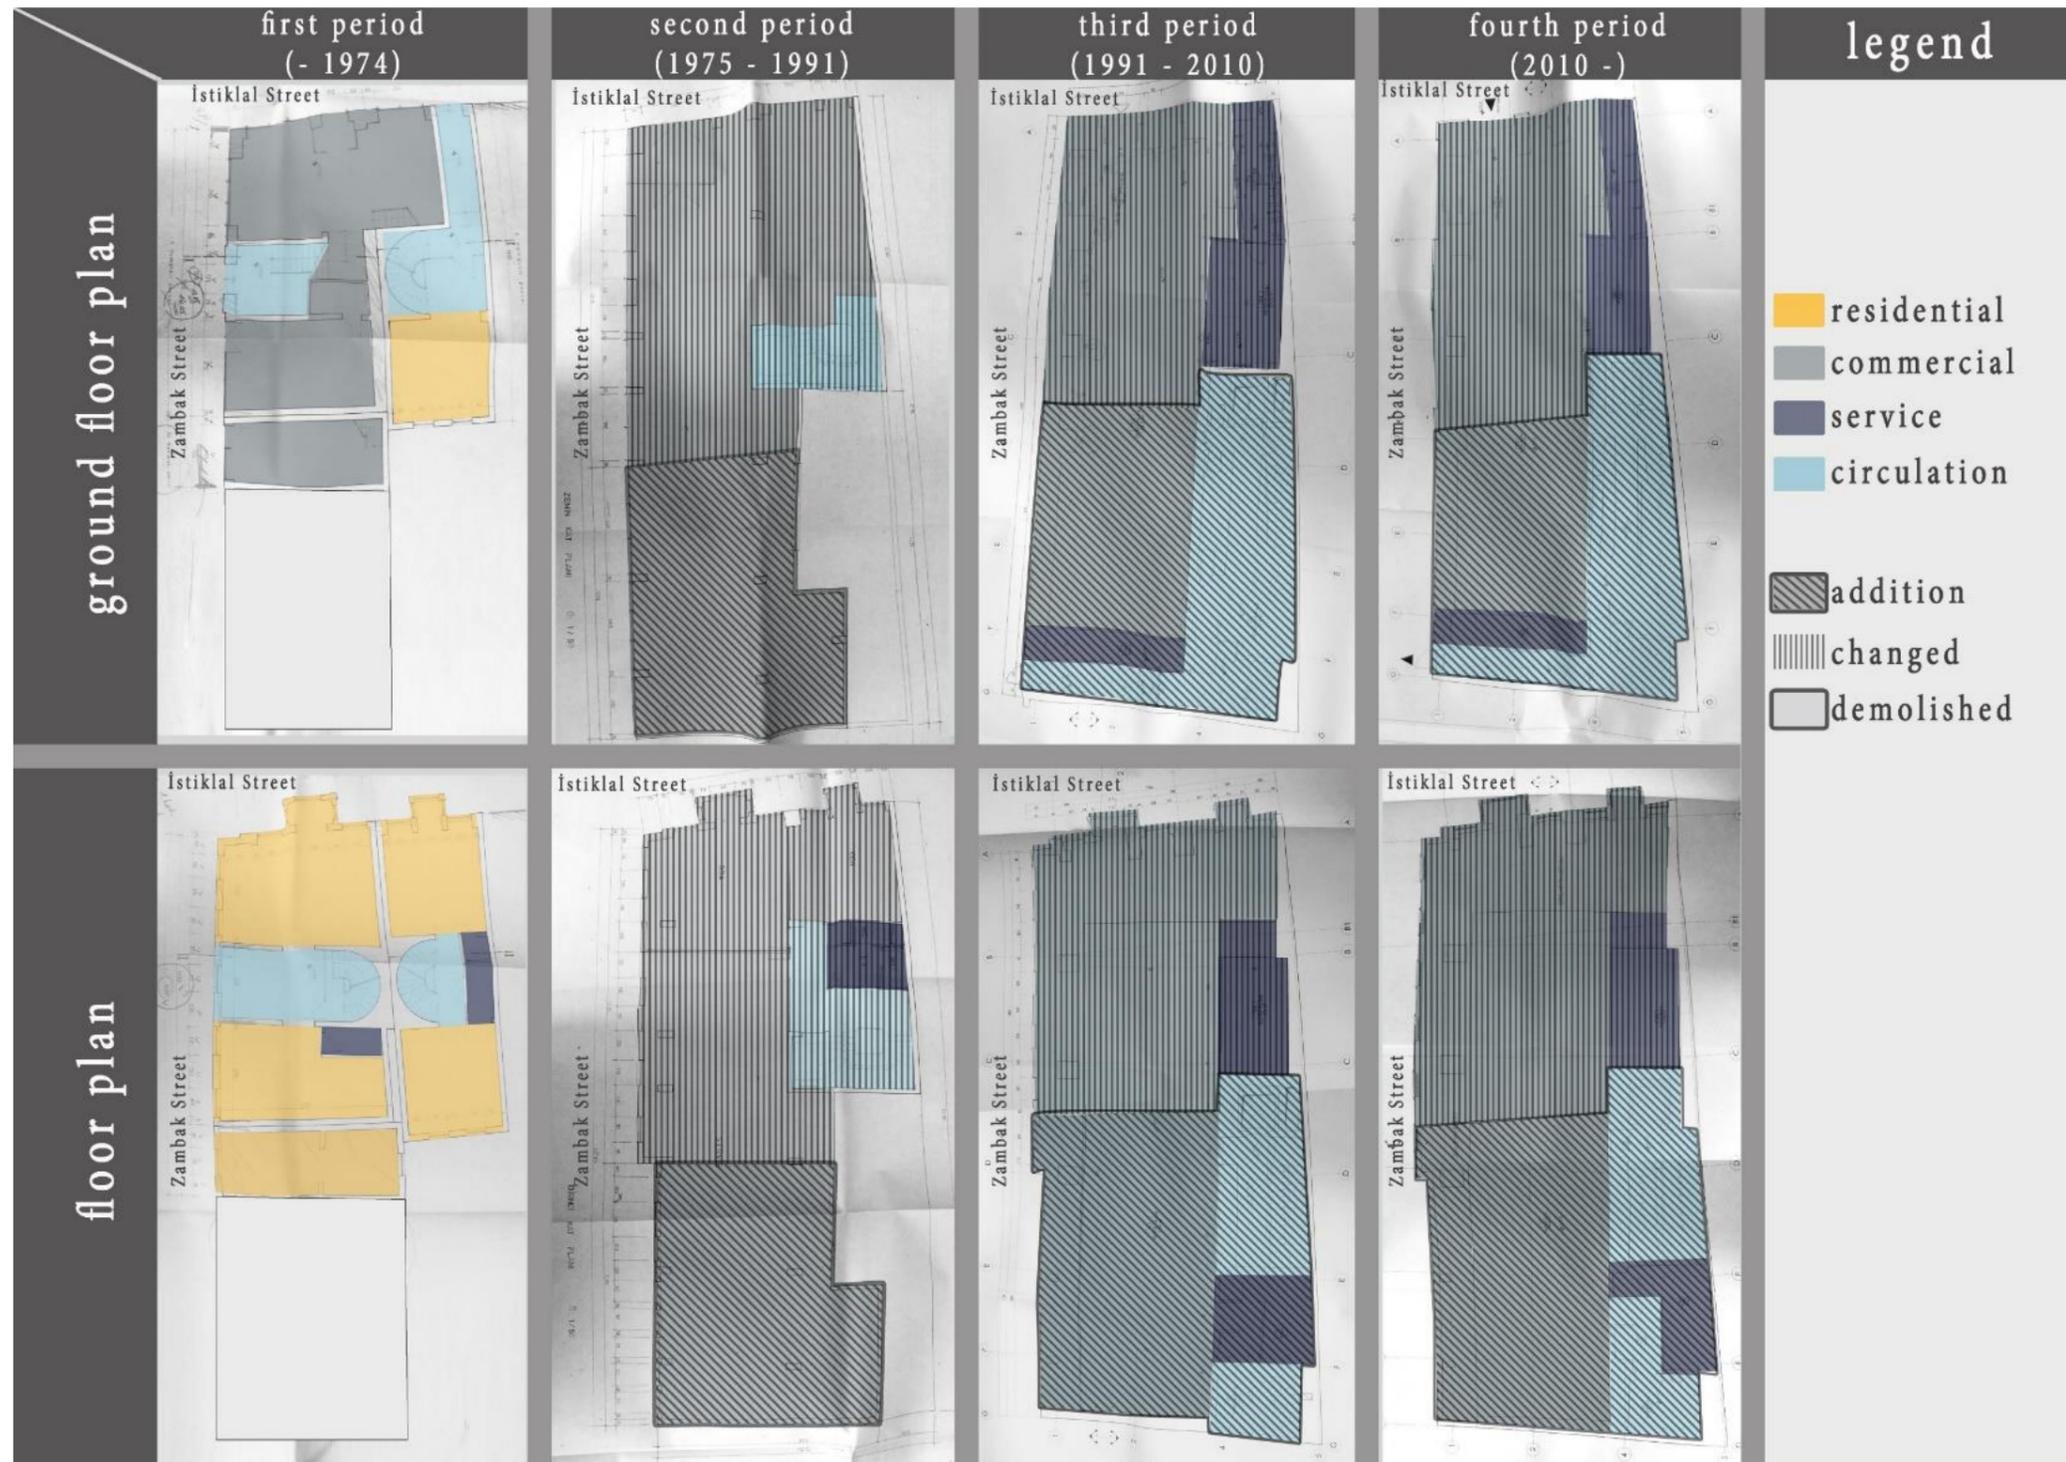
Table 3.38 Changes in the plan layout of Aksanat building in four periods (prepared by the author, based on the drawings obtained from İstanbul No. II Regional Conservation Committee of Cultural Assets Archive)

When the interior history of the building is analyzed from the measured drawings and restoration projects in 1975, 1990 and 2010, it is seen that there is no trace of the original plan layout today (Table 3.38). While the plot where the building is located, originally contains four separate buildings, today there is only one building on the whole area of these buildings and this building hosts a function that needs large spaces unlike the old functions. As a result of all this, it is seen that the plan layout consisting of a large main space facing the streets and small service spaces located next to it, does not have a common point with the original plan layout, which was designed in such a way that there were service spaces in the middle and several main spaces facing the streets around them in four different buildings.

The change in plan layouts of the buildings on the plot as a result of adaptive reuse is also considered as a separate category. The circumstance that mostly affects the plan layout on this plot is the utilization of four separate buildings which previously existed on the plot before adaptive reuse, as a single building by means of combination. Hereby, all the original plan features were lost. When the data in the evaluation form are examined, this condition can be seen clearly. Considering the vertical circulation elements in the building, currently there are three stairs, two of which are fire escape stairs, and two elevators. In the measured drawings prepared in 1975, it is observed that three remaining buildings had a total of three stairs, each of which was in a separate building, besides there was no elevator. In addition, it is seen from the obtained photographs that the fourth building which was demolished before 1975 had a staircase. The reason for the fact that the number of circulation elements did not change is thought to be because each building required a separate stair in the authentic state. The changes in the zoning legislation and the new function affecting the number of visitors of the building caused the vertical circulation needs to alter. (Table 4.4)

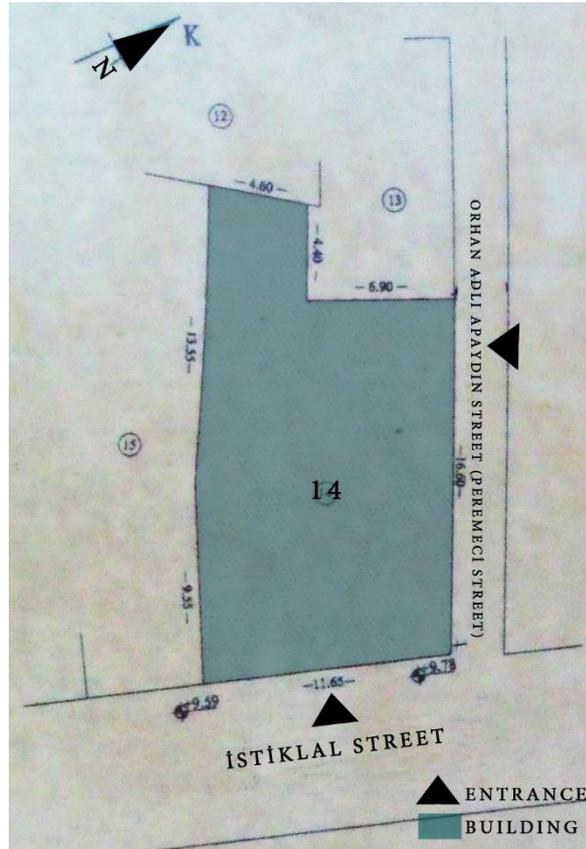
Figure 3.35. Location of Borusan Cultural Center on the plot (prepared by the author, based on the drawing obtained from İstanbul No. II Regional Conservation Committee of Cultural Assets Archive)

The building of Borusan Cultural Center is located on a corner plot with a square shape. Since there is an adjacent zoning scheme on both sides, only two façades of the building overlook the street. The building has two entrances, one from İstiklal Street and the other from Piremecı Street. The entrance on Piremecı Street is specified as the zero level of the restoration project in 2007, according to that specification, the entrance on İstiklal Street is at -0.22 level. There is no open area of the building, which occupies the adjacent corner plot completely covering the plot (Figure 3.35).
