ASSESSMENT OF THE EFFECTS OF ADAPTIVE REUSE INTERVENTIONS  
ON  
THREE APARTMENT BUILDINGS IN BEYOĞLU, İSTİKLAL STREET

A THESIS SUBMITTED TO  
THE GRADUATE SCHOOL OF NATURAL AND APPLIED SCIENCES  
OF  
MIDDLE EAST TECHNICAL UNIVERSITY

IN PARTIAL FULFILLMENT OF THE REQUIREMENTS  
FOR  
THE DEGREE OF MASTER OF SCIENCE  
IN  
CONSERVATION OF CULTURAL HERITAGE IN ARCHITECTURE

SEPTEMBER 2020

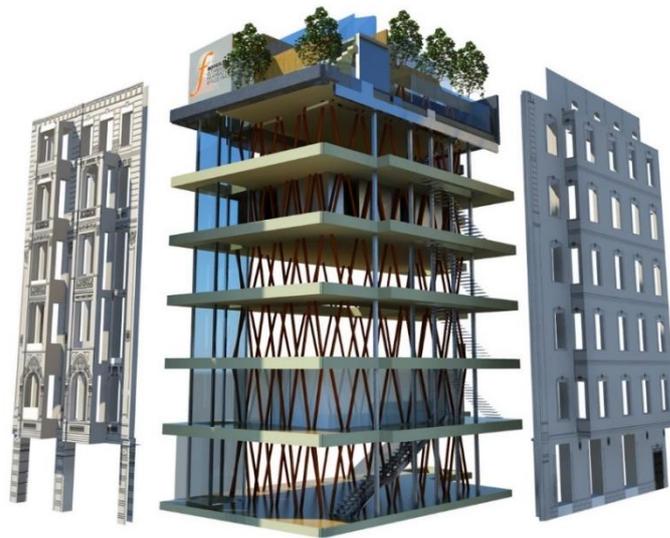
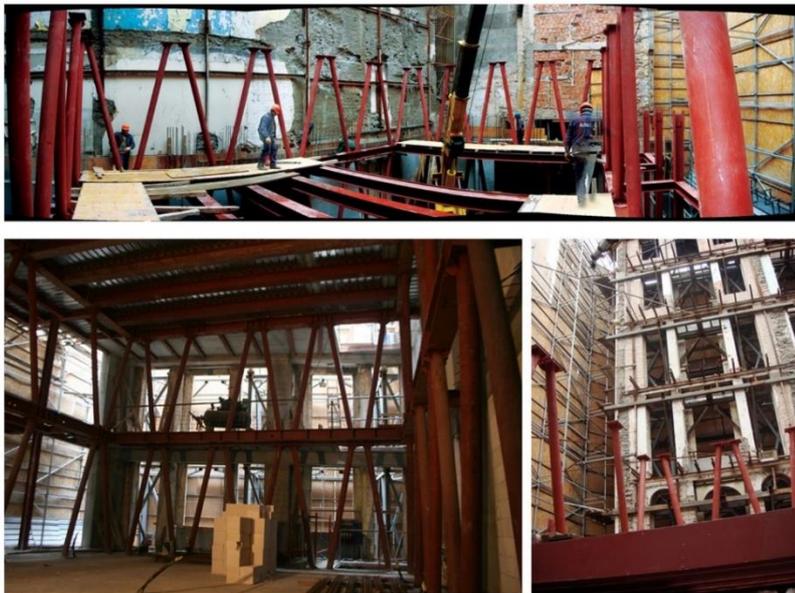
Figure 3.36. (a) Conceptual 3D image of the restoration project, (b) Photographs taken during the construction of new structure. Source: [www.gadarchitecture.com](http://www.gadarchitecture.com), last accessed in December 27, 2019

The structural system of the cultural center is formed by masonry brick outer walls and a separate steel structure system that consists of steel bracings and beams that do not touch the walls (Figure 3.36). The steel system is designed not to touch the outer walls. That is to say, there are two independent structural systems. What connects these two systems is a steel-beam slab.

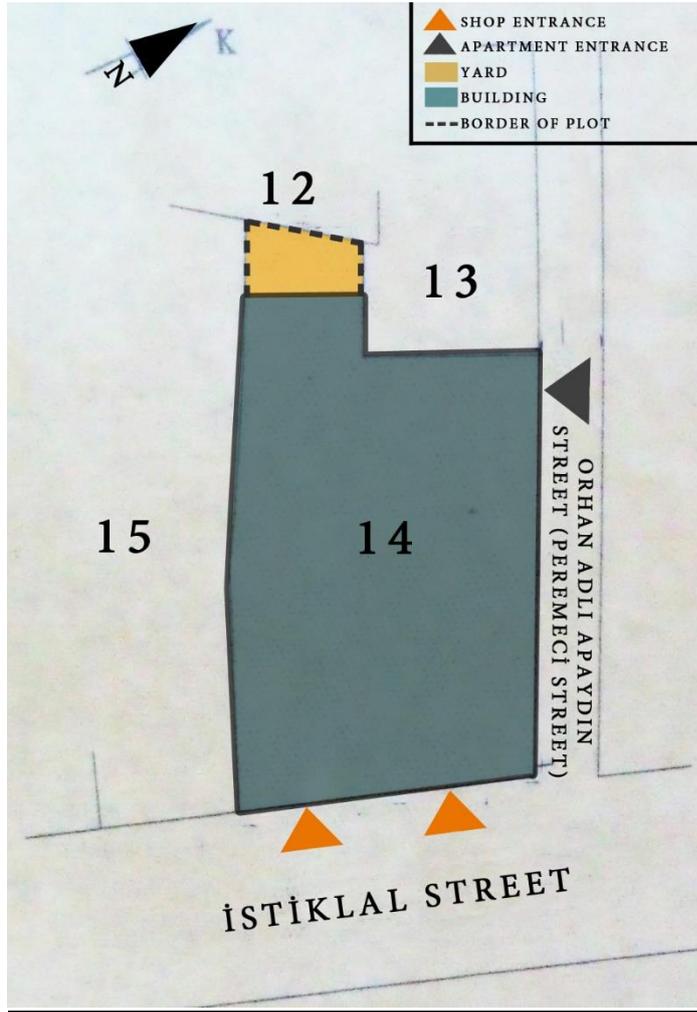
Figure 3.38. Original location of the building on the plot (prepared by the author, based on the drawing obtained from İstanbul No. II Regional Conservation Committee of Cultural Assets Archive)

The oldest information about the building located in Beyoğlu on block #314 plot #14 belongs to 1948. According to this information and the restitution project prepared in 2004, the original state of the building covers the whole plot as its present state. In other words, the original building is on İstiklal Street with narrow façade and Piremeci Street with wide façade and it is placed in east-west direction to cover the whole plot. On the ground floor, there are three main entrances, two of them for shops and one of them for residential units (Figure 3.38). Two of these entrances are from the eastern façade, İstiklal Street, and one from the northern façade, Piremeci Street. It is noteworthy that the entrances of the commercial units in the building are given through the busy street, while the entrance of the residential units are given from the street which is less used than the main street and the farthest part of the building from the street. The building is adjacent at the west and south sides. On the western façade, a part of the building is adjacent to the neighboring building, while the rear part extends further to the west, distorting the rectangular shape of the building. It is seen that this elongated part is not extended until the neighboring plot and thus a light well is obtained by leaving a gap between two buildings (Figure 3.38).

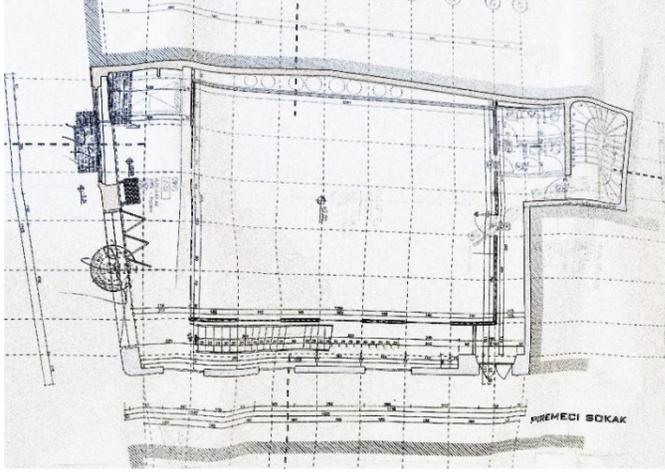
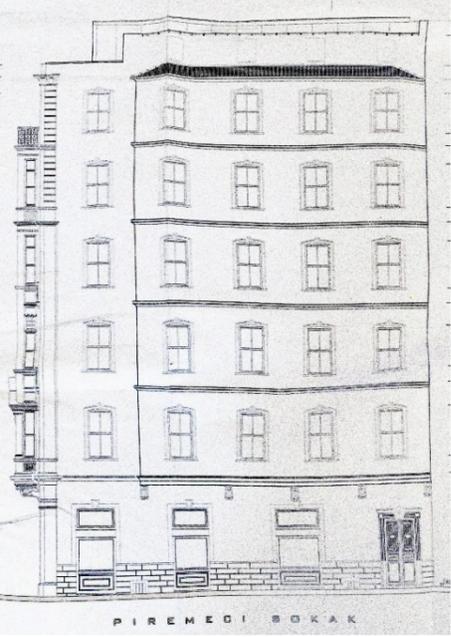
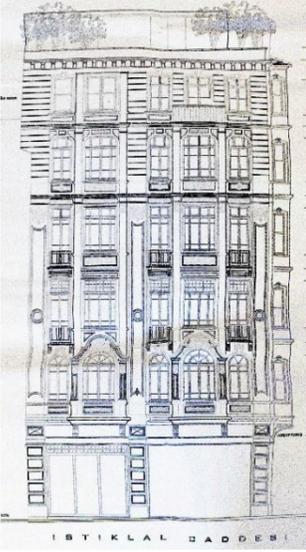
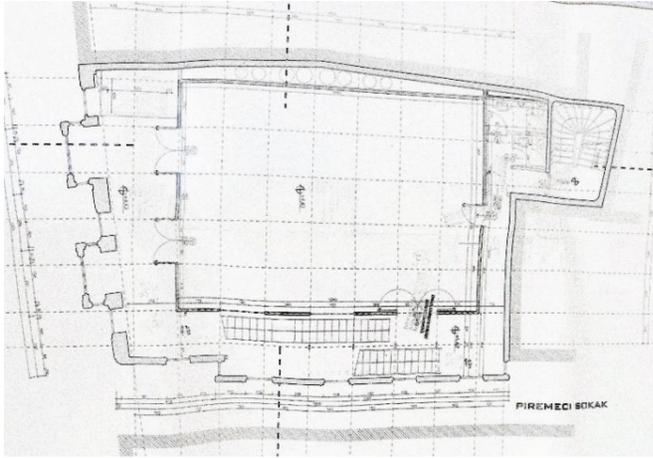
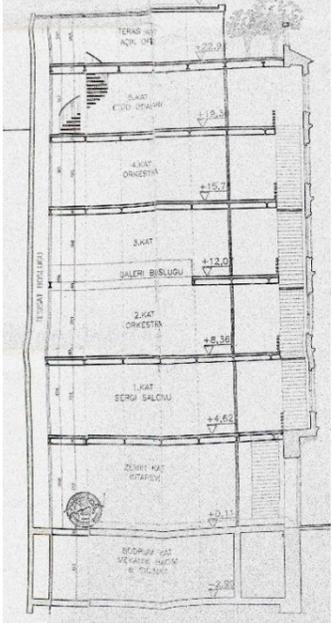
Table 3.46 Restoration project prepared in 2007 (the drawings were obtained from İstanbul No. II Regional Conservation Committee of Cultural Assets Archive)

| GROUND FLOOR PLAN | NORTH FAÇADE | EAST FAÇADE |
| | | <p style="text-align: center;"><b>RESTORATION PROJECT</b><br/> prepared in 2007<br/> by GÖKHAN AVCIOĞLU<br/> approved by and obtained from<br/> İSTANBUL NO. II REGIONAL<br/> CONSERVATION COMMITTEE OF<br/> CULTURAL ASSETS</p> |
| FIRST FLOOR PLAN | SECTION | |

When the façades of the building are analyzed, it is seen that there was no such situation as the interior since façades were restored very similar to their original states. There are a few minor differences between the original façade layout and the one after restoration. The joineries on the eastern façade of the ground floor are different from their states in the previous periods and from their original states in terms of their materials and details. However, unlike these openings, it is found out that the other openings were changed to their original size and detail. The roof of the building was also changed. Before 2007, the structure of the roof, which was a hipped roof, was the same as the original one, but it was converted into a flat roof when it was adapted as a cultural center. In addition, as understood from the northern façade of the building, the side wall of the terrace floor was turned into a high parapet with a terrace at the back and its openings were closed.

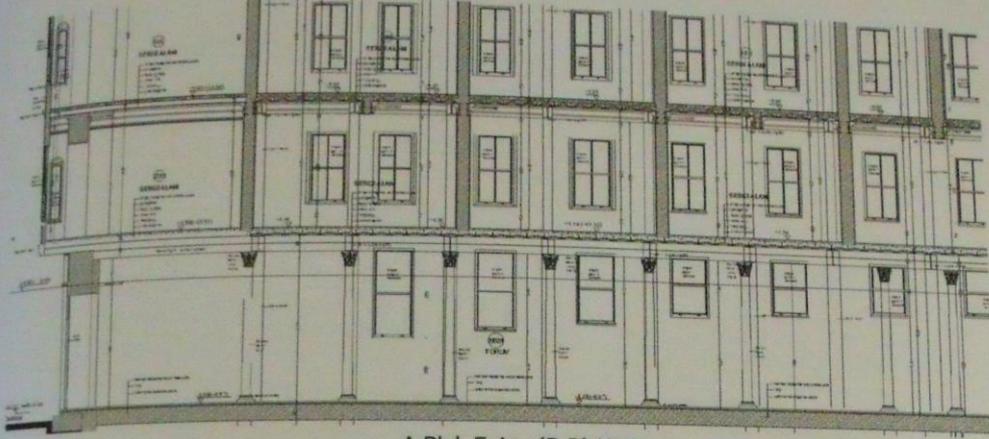
A Blok Enine (B-B) Kesit

Restorasyon Raporu'nun eklerini oluşturan bu iki rapor yapının statik iyileştirme ve güçlendirme projelerinin hazırlanması ve restorasyon ana kararlarının alınabilmesi için önemli veri olarak kullanılmıştır. Binanın A Bloğu'nun 1.bodrumunda (-3.98 m.) (İstiklal Caddesi tarafından giriş katı) özgün durumda iki sıra halinde toplam 20 adet döküm demir sütun bulunmaktadır. Bu durum A blok üst katlardaki tüm taşıyıcı duvarların bu kata geldiğinde zemine oturmadığı, bu sütunlar tarafından taşınan iki paralel çelik giriş üzerine oturduğu görülmektedir.

Bu durum deprem yükleri açısından, binaya hiç yeni fonksiyon verilmese de sakıncalı bir durum ortaya koymaktadır. Binanın kısa yönünde (kuzey-güney) ciddi bir deprem karşısındaki dayanımı çok zayıf olacaktır. Bu durum statik raporlar ve yerinde yapılan testlerle de bilimsel olarak ortaya konulmuştur. Binanın mevcut statik durumu açısından ikinci önemli tespit de yapının temel derinliği ile ilgilidir. Binanın -3.98 m. kotunda yapılan sondaj çalışması sonucu yapının özgün temel derinliği ve kullanılan malzemeler görülmüştür. Bina taşıyıcı duvar altı mevcut temel derinliği 30 cm. olarak ölçülmüştür.

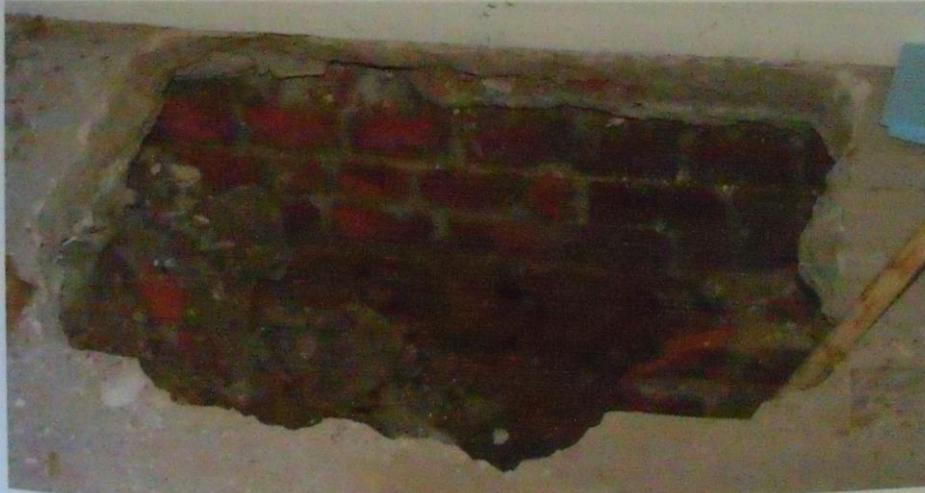
1.Bodrum kat (-3.98 m.) temel

Bu durum, mevcut kat adedi ve etkileyen yükler dikkate alındığında, mevcut taş duvar altı temel sisteminin yetersiz<sup>1</sup> olmasına neden olmaktadır.
