MECHANICAL PROPERTIES OF REPAIRED CARBON FIBER REINFORCED
POLYMER COMPOSITES

A THESIS SUBMITTED TO
THE GRADUATE SCHOOL OF NATURAL AND APPLIED SCIENCES
OF
MIDDLE EAST TECHNICAL UNIVERSITY

IN PARTIAL FULFILLMENT OF THE REQUIREMENTS
FOR
THE DEGREE OF DOCTOR OF PHILOSOPHY
IN
MECHANICAL ENGINEERING

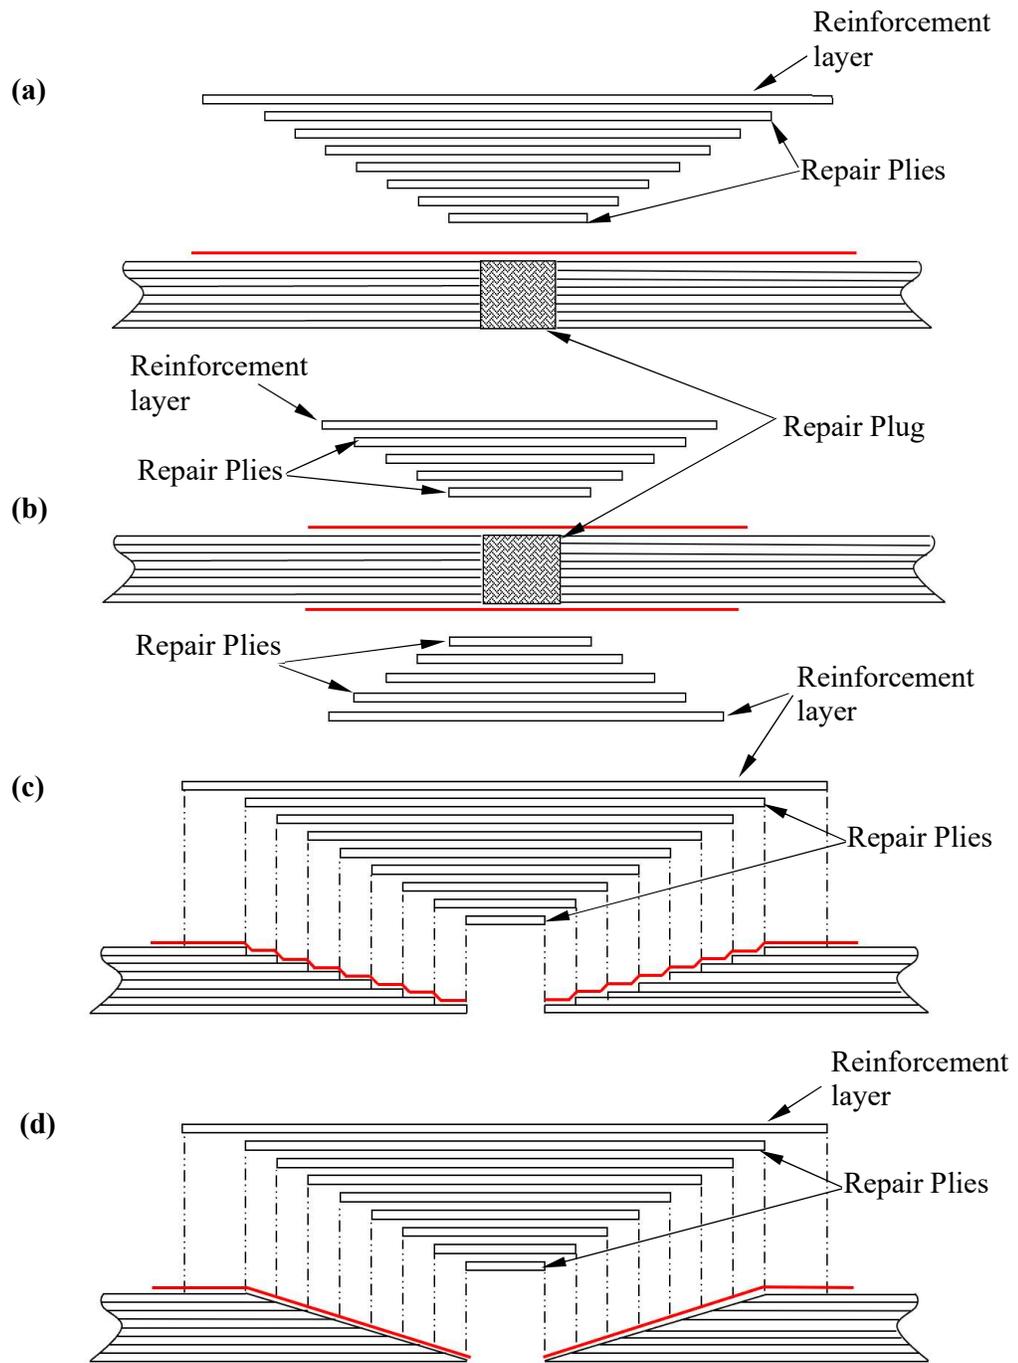
Figure 1.1. Typical repair methods. (a) Single lap repair, (b) Double lap repair, (c) Stepped repair, (d) Scarf repair. Red lines represent the film adhesive for the prepreg repairs.

The use of bonded repairs in the aerospace industry is becoming increasingly popular due to the advantages discussed in the previous section. There are numerous bonded repair configurations for the laminated composite parts, such as single lap, double lap, step, and scarf repairs, as shown in Figure 1.1.

Among these, lap repairs have no extra ply removal; and therefore, they are the easiest to apply. In the single lap method, only the damaged area is removed, and the repair layers are laid down on the accessible surface of the part. Although it is a relatively simple repair, the unsymmetrical geometry makes the stress field very complex, and the inevitable bending negatively affects the strength of the joint. Double lap joints exhibiting a symmetric geometry overcome this bending problem; however, this approach requires that both sides of the surfaces are accessible, which often is not the case in aerospace components. For the single lap and double lap repairs, the cavity resulting from the removal of the damaged area can be filled with a proper epoxy mixed with chopped fibers or the plies matching with the dimensions of the emptied area.

The stepped/scarf repairs are the most effective repair techniques, where high strength recovery and aerodynamically smooth surfaces are needed. Since the protrusion from the surface is minimal, the peel stresses acting on the edges of the adhesive are much smaller on these structures, and they do not cause any bending of the adherends. Although they are known as flush repairs, generally, one or two extra plies are laid on the repair section to protect the repair layers from environmental effects and to reinforce the repair. Stepped and scarf techniques differ by the removal geometry of the damaged area, with equal steps or a uniform taper angle, respectively. A composite patch matching the dimensions and the layup of the removed part is then prepared and bonded to the repair zone with an adhesive. Sanding the repair area with predefined step sizes or a smooth angle without damaging the underlying layer is challenging and needs skilled operators.

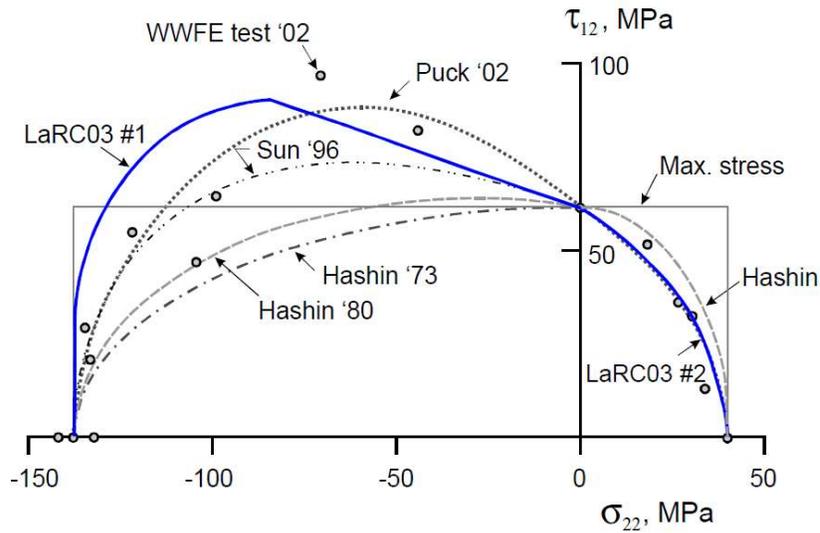
Figure 1.3. Comparison of different failure criteria with the WWFE test results. Figure taken from ref. [25]

A comparison of different failure criteria for a set of WWFE test data [25] for unidirectional composite E-Glass/LY556 is given in Figure 1.3. The selected failure theorems give similar results for the tensile loading conditions except for the Maximum Stress criteria, which is less conservative. The failure theorems have more distinctive properties under compressive loading. LARC03 and Puck can closely predict the failure envelope under compression, whereas Hashin gives conservative results.

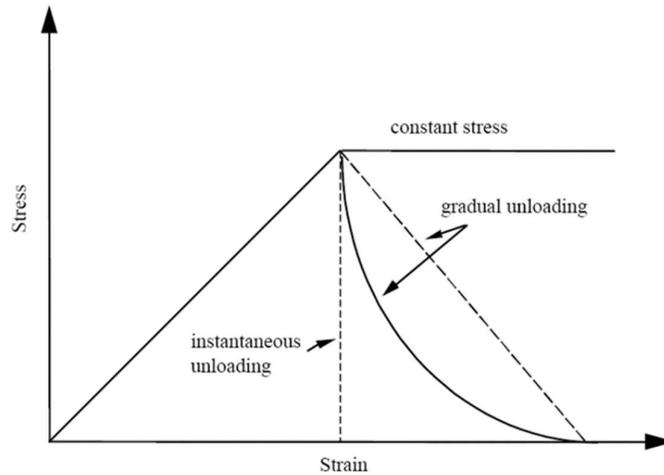
Figure 1.4. Types of ply discount methods in composite laminates. Figure taken from ref. [36].

Many post-failure material property degradation models may be categorized into three main categories: instantaneous unloading, gradual unloading, and constant stress, as shown in Figure 1.4 [36].

In the “**Instantaneous (or Sudden) Degradation**” method, the material stiffness coefficients associated with the mode of the failure are degraded to zero abruptly. A very small degradation factor (e.g., 10^{-4}) is common to avoid convergence problems due to ill-conditioned stiffness matrices and singularities. Sleight [36] has performed a study to compare different degradation factors such as 10^{-1} , 10^{-2} , and 10^{-20} for the instantaneous unloading case for a rail-shear specimen. The study showed that the rate of material degradation had little effect on the failure prediction. Many other authors also used sudden degradation progressive failure analysis with very small degradation factors [26,30,37–39].

Gradual Degradation Method: The material elastic properties associated with the relevant mode of failure are recursively reduced until they reach zero. The gradual degradation may be linear or exponential, as shown in Figure 1.4. Selecting the degradation factor is crucial to model the damage accumulation in gradual

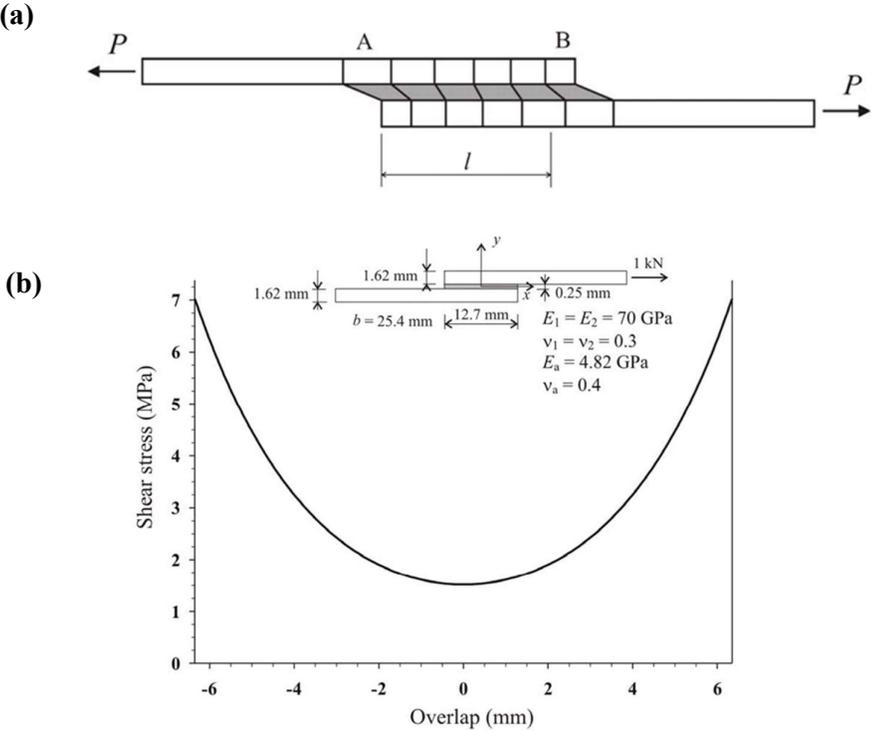
Figure 1.5. (a) Volkersen model with elastic adherends, (b) Distribution of the shear stress distribution over the bonded area. Figure taken from ref. [56].

transverse moduli and strength. Therefore, the model is more convenient for analyzing double lap joints rather than single lap joints. The representation of the Volkersen model with elastic adherends and the distribution of the shear stress over the bonded area is shown in Figure 1.5 [56].

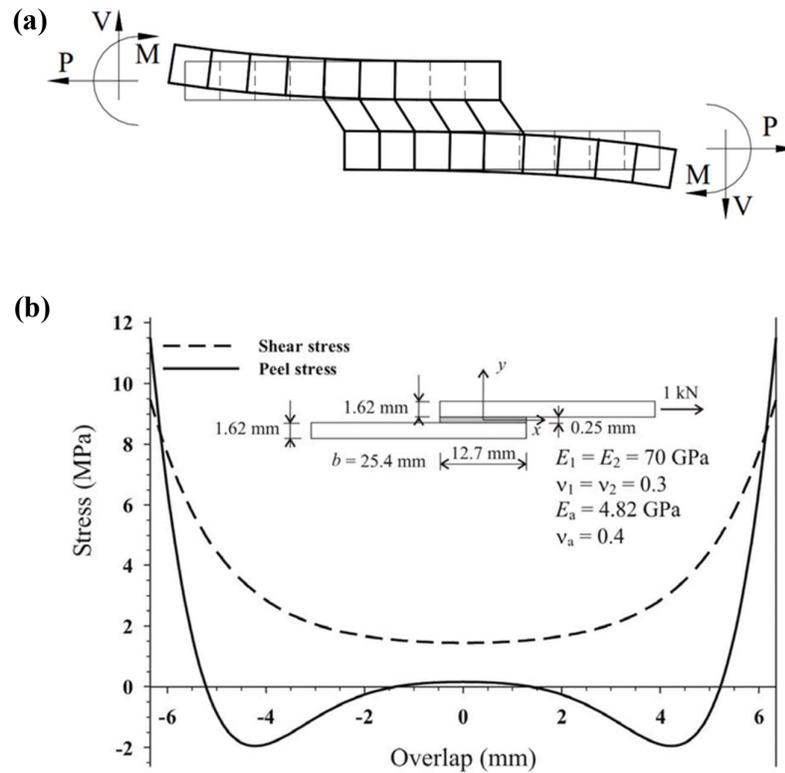
Figure 1.6. (a) Goland and Reissner model with elastic adherends. (b) Distribution of the shear stress distribution over the bonded area. Figure taken from ref. [56].

In 1944, Goland and Reissner [57] improved the Volkersen model by accounting for the adherend bending and adhesive peel stresses. The rotation of the overlap region alters the load path and induces significant peel stresses at the end of the adhesive. The representation of the model and shear and peel stress distribution over the bonded area is shown in Figure 1.6.

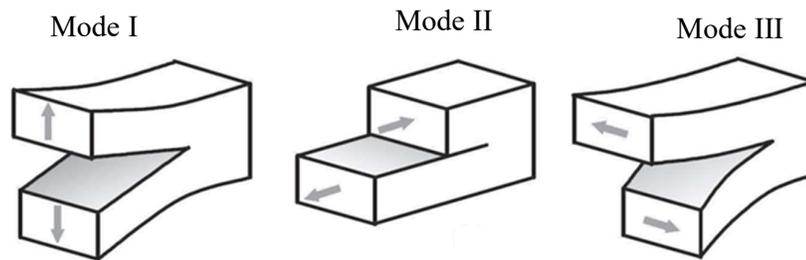
Figure 1.7. Failure modes in adhesive joints.

The loading in adhesively bonded joints is often not a single load. Instead, it is a mixture of the loadings in 3 different directions, as shown in Figure 1.7. As a result, things are more complex for this type of mixed-mode loading due to the interaction between different modes of fracture.

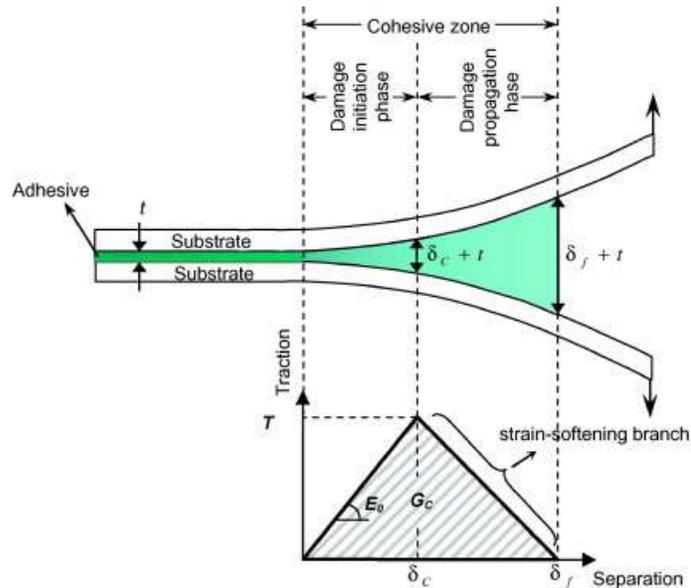
Figure 1.8. Damage progression schematic in an adhesively bonded joint. Figure taken from ref. [83].

separation curve), the traction is reduced to zero, and new crack surfaces are formed. The schematic representation of damage progression is shown in Figure 1.8.

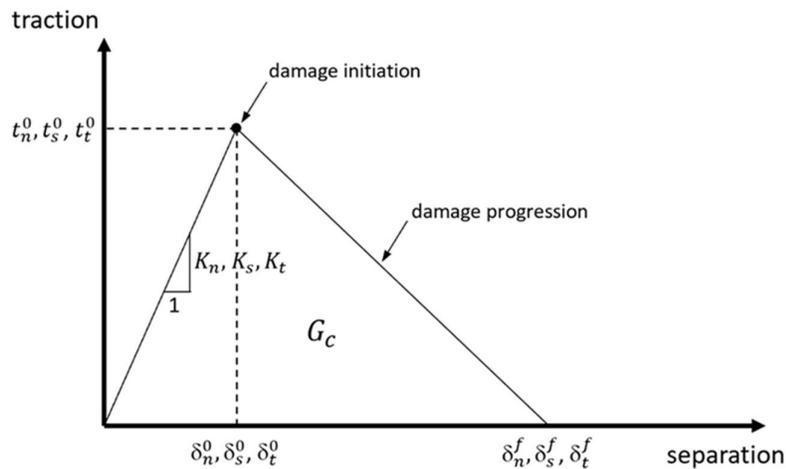
Figure 1.9. Graphical representation of the bilinear traction-separation behavior used for the modeling of the adhesive. Figure taken from ref.[35].

Figure 1.9 shows the built-in bilinear traction-separation model in ABAQUS FEA [35], exhibiting linear elastic behavior followed by linear degradation. In the figure, t^0 is the maximum traction, δ^0 is the displacement at damage initiation, δ^f is the displacement at failure, and K indicates the stiffness. Subscripts n, s, and t describe normal, shear, and transverse directions, respectively. The area under the traction-separation curve gives the fracture toughness (G_c).

For a single-mode loading, damage initiation occurs when the traction is equal to the allowable traction in that direction. The traction value is linearly dependent on the separation value, and when the area under the triangle is equal to the fracture toughness value, damage propagates.

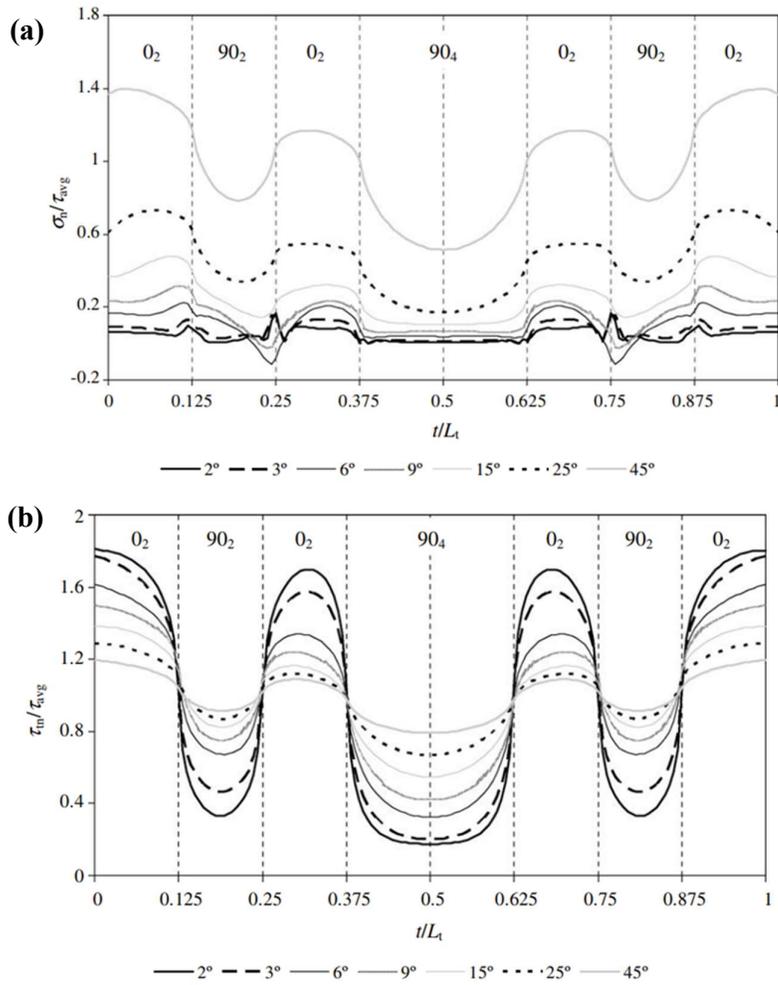
Figure 1.10. (a) Peel stress distribution in the adhesive (b) Shear stress distribution in the adhesive. Figure taken from ref. [92].

Campilho et al. [92] investigated the peel and shear distribution along the bond-line of a scarf joint using CZM methods. They showed that the peak stresses considerably diminish for the lower scarf angles, enabling higher strength values. This distribution of peel and shear stresses is shown in Figure 1.10. It is also seen that the stress concentration is higher in 0° plies which are parallel to the loading direction.

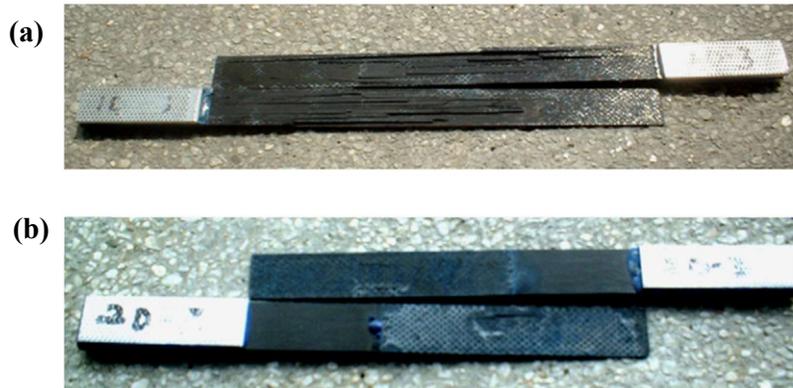
Figure 1.11. (a) Fiber fracture and fiber pull-out in the composite adherends bonded with 0.5° scarf angle (b) Cohesive failure of the adhesive for a scarf angle of 2.9° . Figure taken from ref. [106].

As mentioned before, the failure mode of the bonded parts mainly depends on the scarf angle. Fiber fractures and pull-out are the primary behavior for small scarf angles, whereas cohesive failure occurs within the adhesive for larger angles [92,106]. Kumar [106] showed the dependence of the failure mode to the scarf angle, as shown in Figure 1.11.

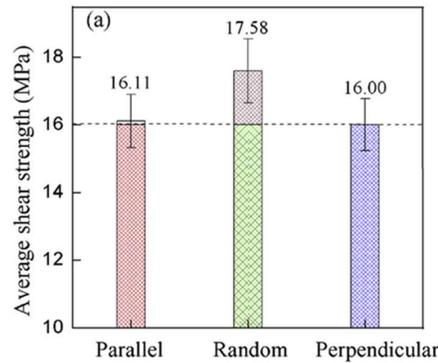
Figure 1.12. Shear strength distribution of the single lap joints with respect to the sanding direction. Figure taken from ref. [117].

Yang et al. [117] investigated the effect of sanding with different grit sizes ranging between 60 to 200 on the tensile strength of the scarf and single lap joints. They concluded that sanding direction significantly affects joint strength. The randomly sanded specimen has approximately 10% higher shear strength than the unidirectional grinding in both directions, as shown in Figure 1.12.

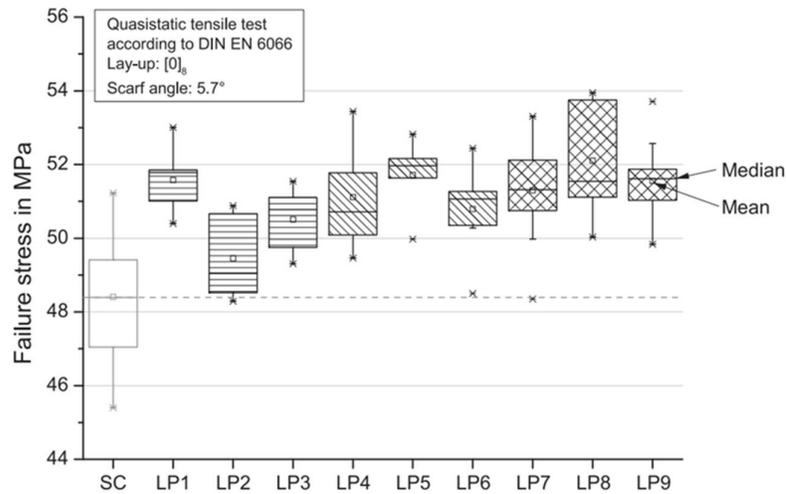
Figure 1.13. Failure stress distribution for a scarf joint with respect to different laser treatments, SC representing solvent cleaned specimen as the reference, each LP representing different infrared laser treatment parameters. Figure taken from ref. [121].

Besides conventional mechanical and chemical treatments, many studies about surface preparation with plasma or laser techniques also exist. Infrared laser surface treatment has become of particular interest recently due to the high speed and automation of the process. Harder et al. [121] investigated the effect of laser surface treatment on the surface morphology and the overall tensile strength of the scarf

bonded specimens. The results showed a 5% increase in the bonding strength on the laser-treated specimen concerning the solvent-cleaned specimen, as shown in Figure 1.13.

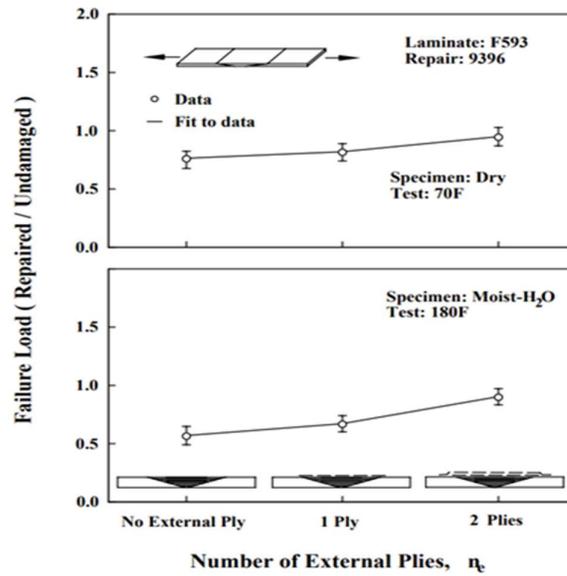
Figure 1.14. The effect of the number of extra plies on the repair strength. Figure taken from ref. [128].

Most of the SRMs suggest using one or more extra layers on top of the repair patch. Such practice enhances the repair, protects the patch's tips, and acts as a moisture barrier to the repair. Ahn and Springer [128] showed the influence of an extra ply on the repair strength, especially for the moisturized specimen, as shown in Figure 1.14. Feng et al. [127] investigated the effect of overlap length and the stacking sequence of the extra plies for thin structures.

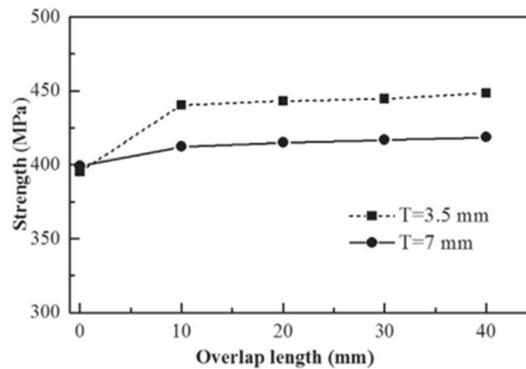
Figure 1.15. Influence of overlap dimension of the extra ply for adherend thicknesses of 3.5 mm and 7 mm. Figure taken from ref. [127].

As shown in Figure 1.15, the reinforcement effect of the over-plies is more evident for the thin laminates and increases as the overlap dimension increases up to a specific limit. Patches bigger than that limit have no further benefit on the repair strength. The same study also showed that the stacking sequence of the extra layers has a significant effect on the repair strength, especially for the thin laminates. $[90^\circ/90^\circ]$ over-plies have little effect on the failure strength, whereas $[0^\circ/0^\circ]$ over-plies enhance the strength up to 30% for the thick joints.

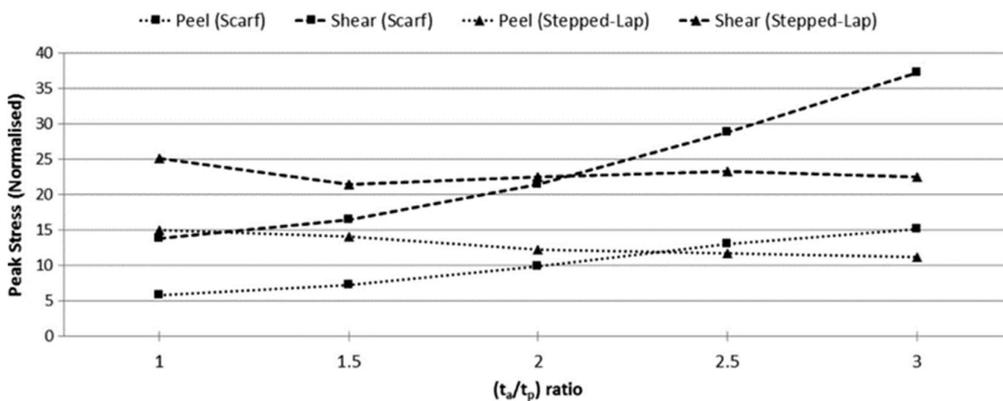
Figure 1.16. Normalized peak peel and shear stress in the adhesive bond-line (t_a : adhesive thickness ranging from 0.13 mm to 0.39 mm; t_p : ply thickness 0.13 mm). Figure taken from ref. [105].

In addition to the adhesive's strength and toughness, the other primary parameter affecting the strength of the repair is the adhesive thickness. Various studies investigated the effect of adhesive thickness on joint efficiency. Almost all these studies show that an optimum adhesive thickness value exists for the highest joint strength [105,110,129–136]. The optimum thickness of the adhesive can be selected between 0.1 and 0.5 mm for the conventional aerospace repair adhesives. However, for more ductile adhesives, the thickness might be slightly higher. For the scarf joints, as the adhesive thickness increases, the peak peel and shear stress on the bond-line also increase, leading to the premature failure of the joint, as shown in Figure 1.16 [105].

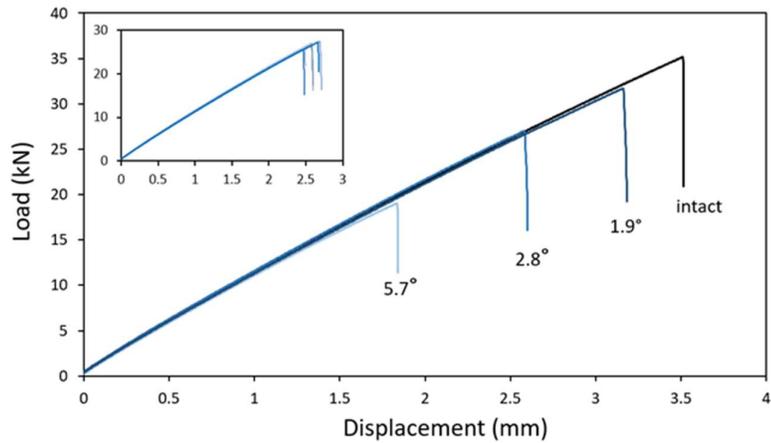
Figure 2.2. Load-displacement curves of the intact and scarf-bonded specimens. Inset shows the data for all 2.8° specimens, demonstrating the good repeatability of the tests. The inset has the same axes and units as the main plot.

Table 2.3 summarizes the average tensile strength, coefficient of variation (CoV) which is the ratio of the standard deviation to the average value, and recovery rate values for each specimen type. The tensile strength values correspond to the maximum load divided by the initial cross-sectional area of each specimen. The recovery rate is defined as follows.

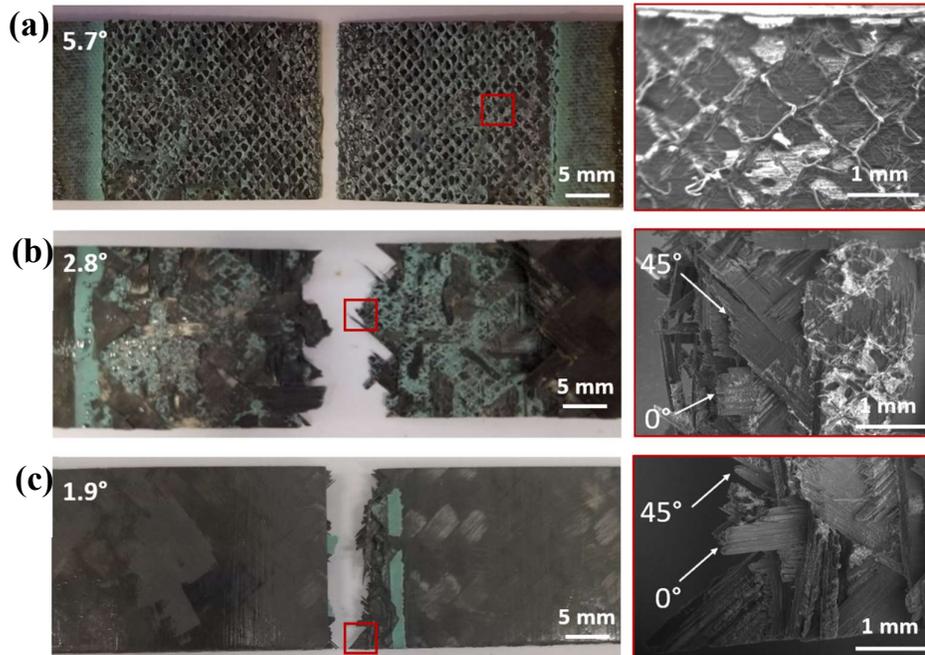
Figure 2.3. Photographs and SEM views of the fracture surfaces of representative test specimens. (a) Cohesive failure of a 5.7° specimen. (b) Cohesive failure + intralaminar failure of a 2.8° specimen with detail showing the fiber breakages in 0° and 45° fibers (c) pull out fracture of a 1.9° specimen with detail showing the fiber breakages in 0° and 45° fibers. Specimen pieces on the right-hand side are flipped to reveal the failure surfaces more clearly.

Figure 2.3 shows photographs and SEM views of fractured specimens, demonstrating the typical failure types of the repaired specimens for each scarf angle.

Type A failure: 5.7° specimens exhibit this type, where the failure is cohesive; that is, the fracture takes place within the adhesive. As the adhesive layer mediates the fracture, the failure takes place at the joint. The SEM image of the joint area in Figure 2.3 (a) shows no fiber failure, further confirming the type of failure.

Type B failure: 2.8° specimens exhibit this type, where the failure is a combination of laminate failure and cohesive failure. The laminate failure took place at the joint area. The SEM image in Figure 2.3 (b) shows the failure of the 0° and 45° fibers in detail.

Type C failure: 1.9° specimens exhibit this type, where failure has the appearance of a pull-out fracture, a typical failure type for intact laminates. The failure occurred near the end of the joint, with the fracture surface mainly being perpendicular to the loading axis. No adhesive failure is present on the failure surface.

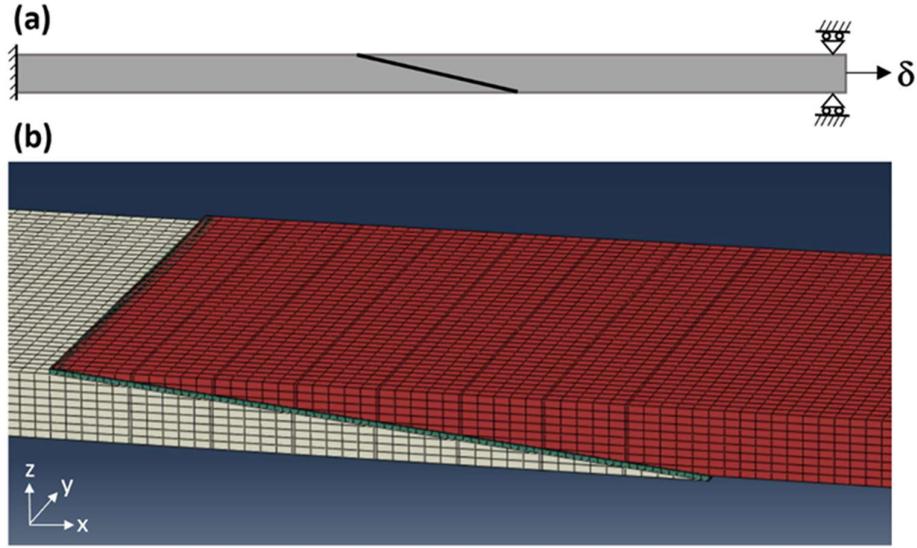
Figure 2.5. (a) Schematic description of the finite element model. (b) Close-up view of the mesh structure around the scarf.

The tensile testing of the scarf-bonded specimens is modeled by finite element method using ABAQUS 6.14 Standard. Figure 2.5(a) shows a schematic side view of the model and its boundary conditions. A fixed boundary condition at one end and a linear displacement boundary condition at the other end provided the tensile test conditions. The model's size was the same as that of the actual specimens; the only difference was the omission of the grip regions of the actual specimens to reduce the computational load. It is verified that modeling with and without these grip regions yields virtually identical results. The material properties used for the composite adherend and the adhesive are summarized in Table 2.1 and Table 2.2. The two parts of the composite have an offset in the z-direction, corresponding to the thickness of

Figure 2.5 (b) shows the details of the mesh structure. 3D solid elements discretized the composite adherends. These were 8-node hexahedral C3D8R elements, except 6-node triangular prism (C3D6) elements used for the scarf tips. The $[45/0/-45/90]_s$ lay-up was implemented in the model by identifying each layer's material, thickness, and orientation. Eight-node 3D cohesive elements (COH3D8) discretized the adhesive layer. After performing a mesh sensitivity study for the composite adherend, it is verified that 0.6 mm is a sufficiently small element size to avoid snap-back in the damage modeling. The resulting optimized mesh starts with a size of 1.5 mm far away from the joint and gradually becomes 0.6 mm near the joint region to capture the damage progression behavior. Therefore, next to the joint, the elements of the adherends are selected as 0.6 mm x 0.6 mm x 0.3 mm. For the cohesive elements, element sizes in the range of 0.2 – 0.8 mm are considered, and selected the optimum cohesive element size as 0.3 mm × 0.3 mm × 0.2 mm. Tie constraints connected the mismatching nodes at the adherend-adhesive interface, assuming perfect bonding.

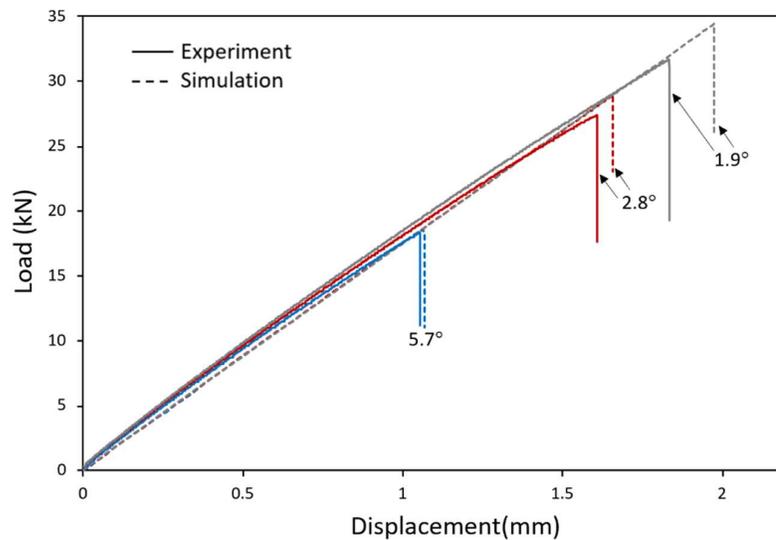
Figure 2.6. Experimental and numerical load-displacement curves for the specimens with three different scarf angles. The experimental displacement measurements correspond to the extensometer data.

Figure 2.6 shows a comparison of the experimental and numerical load-displacement curves for each scarf angle. The results show that the finite element model can closely predict the actual load-displacement behavior. The simulation also captures

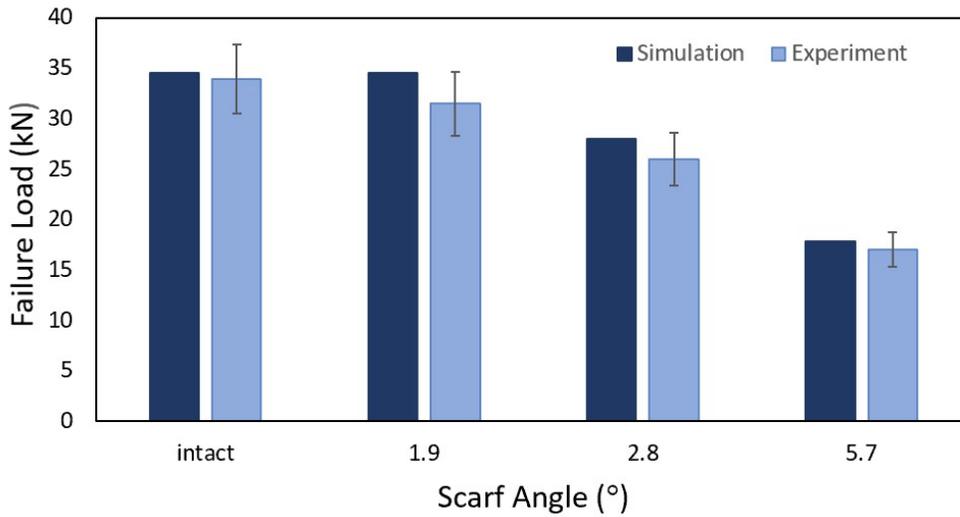
Figure 2.7. Failure load values for intact and scarf specimens, as determined by experiments and as predicted by simulations.

the sudden failure behavior well. Figure 2.7 compares the simulation predictions with the experimental results in terms of the failure load. The differences between the experimental and the modeling results are within 10%. Simulations slightly overpredict the failure load, and the overprediction is higher for smaller scarf angles. The trend in the overprediction suggests that the differences are due to the increasing likelihood of defects and surface irregularities in the manufacturing of small-angle scarfs. As the number of defects and surface irregularities increase, the experimentally measured strength decreases.

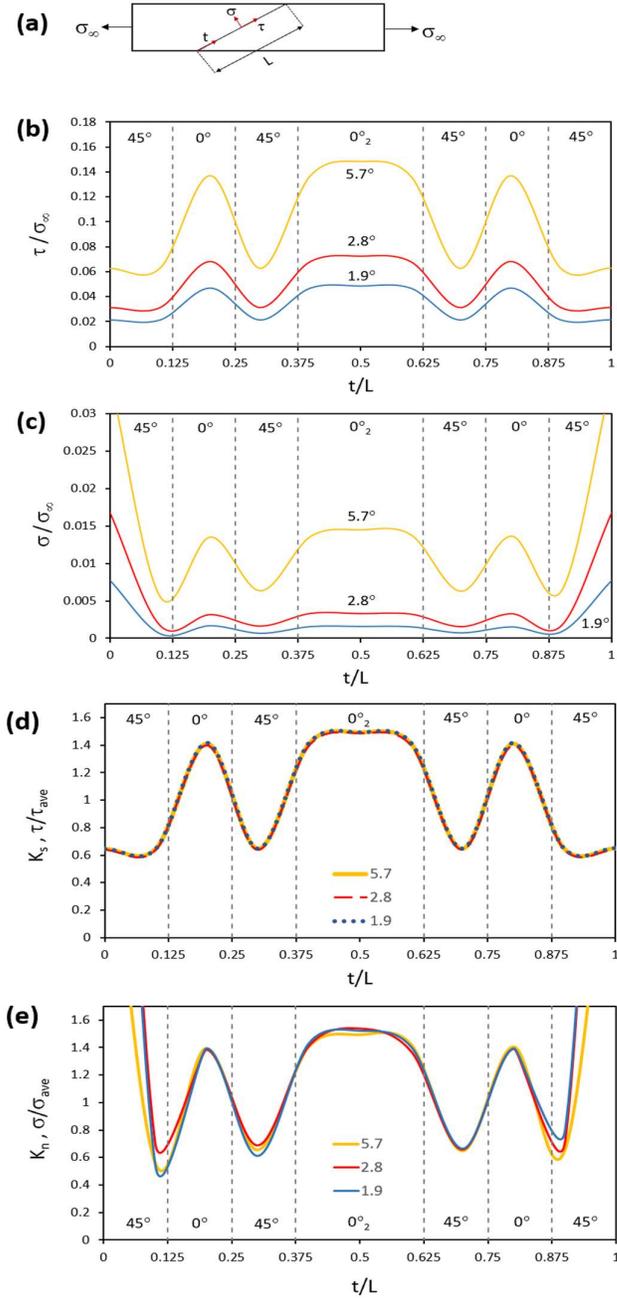
Figure 2.8. Schematic describing the definitions of the stress components and the coordinate frame. (b) Normalized shear stress distribution. (c) Normalized peel stress distribution. (d) Shear stress concentration distribution. (e) Peel stress concentration distribution.

One can obtain further insight into the problem by investigating the stress variations in the joint region. Figure 2.8 shows the normalized shear & peel stresses and associated local stress concentration factors, K_s and K_n , over the bonding area for different scarf angles. The far-field tensile stress (σ_∞) is 270 MPa in each case, corresponding to an undamaged condition of the specimen. The stress distributions do not vary significantly over the specimen width except for variations at the edges. Therefore, the plateau values around the center of the specimen are used for plotting purposes.

Figure 2.8 (b) and (c) shows the variation of shear stress and peel stress, both normalized by σ_∞ . The normalized stresses considerably increase with scarf angle. In addition, the stress distributions exhibit significant variations through the thickness of each layer. The normalized peel stress rises sharply towards the edges. This rise is due to the additional bending of the adherend induced by the load eccentricity in the scarf geometry described at the beginning of Section 2.4. Although normalized stress becomes quite large towards the edges, the absolute peel stress remains below the strength of the adhesive due to the small scarf angles employed.

Figure 2.8 (d) shows the variation of the shear stress concentration factor, K_s , over the length of the scarf. The behavior is virtually independent of the scarf angle and exhibits symmetry around the $0^\circ - 0^\circ$ interface due to the symmetric nature of the lay-up. The maximum stress concentration factor is 1.5, which occurs within the 0° -plies. This result is in relatively good agreement with the experimentally determined values around 1.3 (see Section 2.3), considering all the approximations and uncertainties in the experiments and the modeling.

Figure 2.8 (e) shows the peel stress concentration factor, K_n , over the length of the scarf. While this factor is of secondary importance compared to K_s in affecting the fracture behavior, it still provides insight into the problem. Similar to K_s , the variation of K_n exhibits symmetry, and it is mostly independent of the scarf angle. Due to the previously discussed bending effects, K_n rises towards the edges, reaching almost 7.

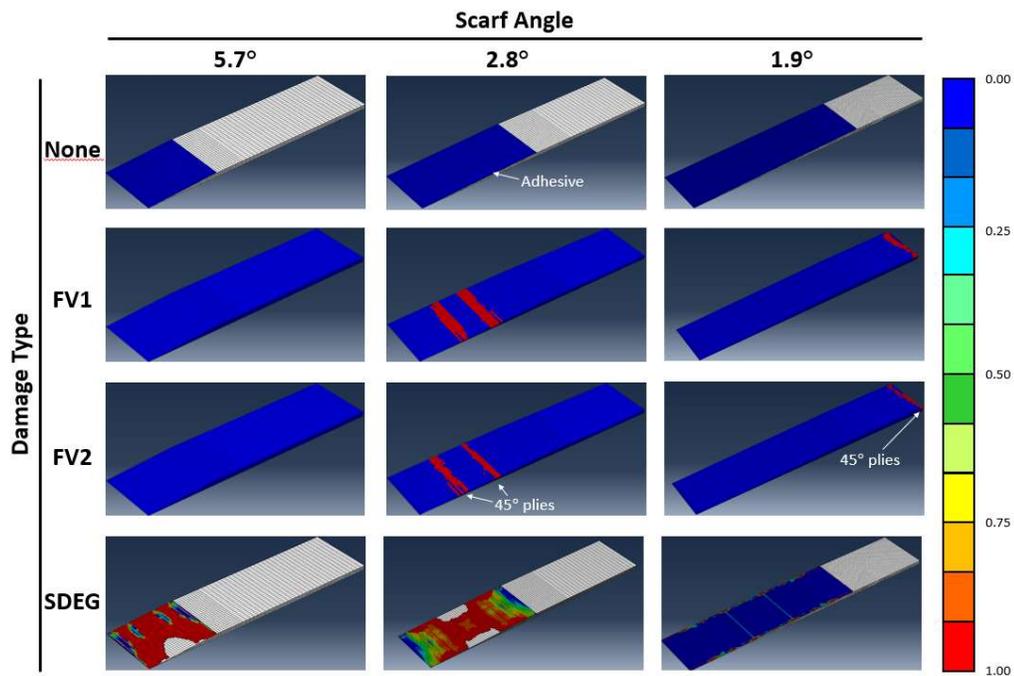
Figure 2.9. Color maps of the damage states of the bond area for each scarf angle. All maps correspond to 99% of the ultimate loading. 0 is undamaged, and 1 is fully damaged. In SDEG plots, white regions within the bonding area correspond to complete cohesive failure. The top row shows the geometry before loading, where the blue color represents the adhesive. FV1: Fiber failure in the warp direction, FV2: Fiber failure in the weft direction, SDEG: Adhesive failure.

Figure 2.9 presents the damage condition of the bonding area in terms of adhesive and fiber damage for each scarf angle, which highlights the dominant modes of failure. The damage parameters presented are adhesive damage (SDEG), fiber damage in the warp direction (FV1), and fiber damage in the weft direction (FV2). The color maps show the results corresponding to 99% of the ultimate load for each scarf angle. A value of zero corresponds to the undamaged state, and 1 indicates complete failure. FV1 and FV2 can only take 0 or 1, whereas SDEG can have intermediate values due to the progressive nature of its modeling.

2.8° specimen exhibits cohesive failure accompanied with some fiber failure in both warp and weft directions, in other words, a mixed-mode failure. SDEG color plot shows that the cohesive failure begins from the side edges of the 0°-plies, similar to that of 5.7° specimens. However, unlike the 5.7° case, fiber failure starts before the cohesive failure spreads to the whole bond area, as seen in the associated FV1 and FV2 plots. The fiber failure in the warp direction starts within the 0°-plies, whereas in the weft direction, the fiber failure starts in the neighboring 45° layers. The presence of fiber failure before complete failure is consistent with the cracking sounds just before the failure during the experimental tests.

1.9° specimens show intralaminar fiber failure without any cohesive failure, consistent with the experimental findings. Slight degradation of the adhesive is present at the edges of the joint area; however, fiber failure takes place outside the bonding region before any considerable cohesive damage occurs. All layers except 45° ones fail in the warp direction, whereas 45° layers show failure in both directions. The failure took place next to the bond-line in the experiments. In the simulations, failure occurred at the edge of the domain, corresponding to the grip region in the experiments. In the experiments, the bond-line defects or minor geometrical deviations might be responsible for the observed behavior. On the other hand, in the simulations, the stress concentrations at the edges of the domain are likely to promote failure.

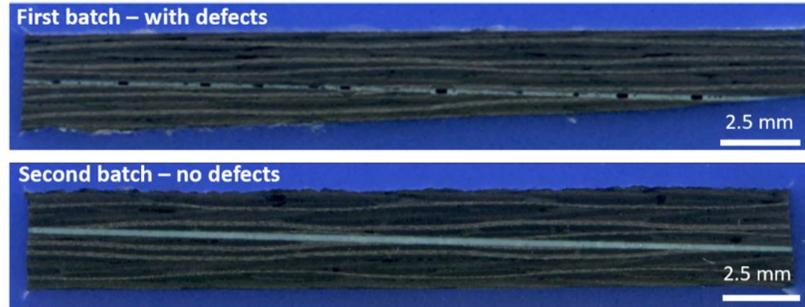
Figure 2.10. Cross-section photographs of 2.8° specimens, showing example bond-lines with and without defects.

Two separate batches for the 2.8° scarf angle case have been prepared and tested due to unexpectedly high porosity levels in the first batch. These two batches allowed us to assess the effect of bonding defects on mechanical strength. Figure 2.10 shows the cross-sections of representative specimens from each batch. The specimen from the first batch has various bond-line defects with dimensions in the range of 0.1 – 0.5 mm. A simple calculation based on the image suggests an overall porosity of about 10% over the bond area. In addition, the average failure load for this batch (24 kN) is 13% lower than that of the second batch with no defects (28 kN), which agrees with the predicted porosity.

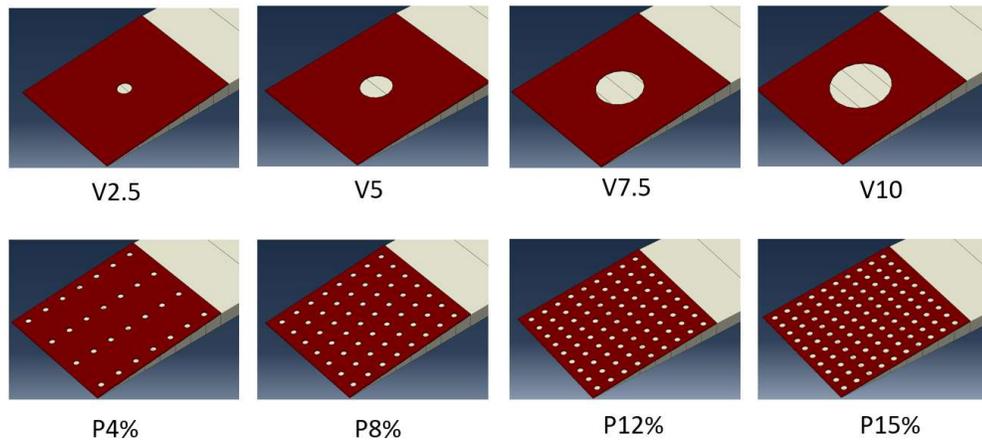
Figure 2.11 Modeling geometry for the investigation of bond defects on the mechanical response. V refers to single-void samples, where the number indicates the size of the void in mm. P refers to the distributed pore scenario with a constant pore diameter of 1 mm. The percentage indicates the total percent area loss due to the presence of the pores.

A numerical analysis is performed to obtain a more systematic understanding of the effect of defects on the static strength of the scarf joints. The details of the modeling approach are the same as those described in Section 2.4. 5.7° scarf angle is focused on, in which the failure of the adhesive dominates the response. The analysis investigated two prominent cases, namely, isolated large defects (single-void) and distribution of small defects (porous structure). Figure 2.11 shows a total of 8 different defect scenarios – four cases of different void sizes and four cases of

different porosity levels. In each case, the defects are modeled by merely removing the adhesive from the associated regions.

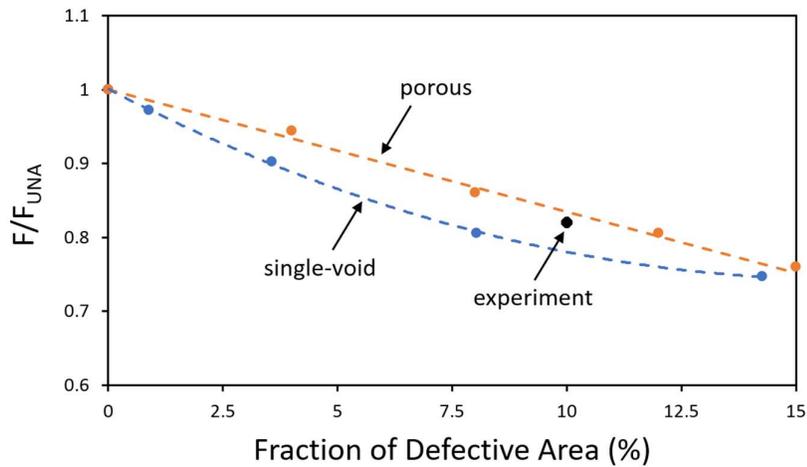
Figure 2.12. Variation of the normalized load of failure with the fraction of defective area in the adhesive. The colored markers indicate simulation results, and the single black marker indicates the experimental data. Dashed lines are provided as a guide to the eye.

Figure 2.12 summarizes the results in terms of the normalized failure load vs. defect area percentage. The data show a monotonic decrease in the load-carrying capacity with increasing defect area for both the single-void and porous structure cases. The porous structure shows a slightly higher load-carrying capacity for a given amount of defective area fraction than the single-void case. Experimental data with an estimated defect fraction of 10% agree well with the simulation predictions, where the failure load is normalized by the experimentally measured failure load of the defect-free specimens.

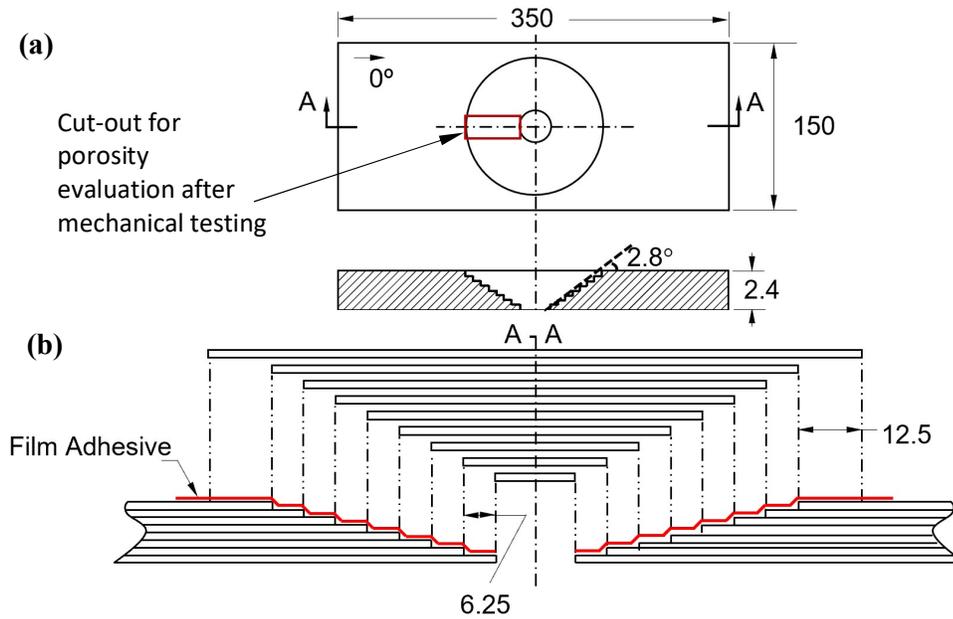
Figure 3.1. (a) Schematic view of the test specimens before repair. Thickness is exaggerated for clarity. (b) Cross-sectional schematic showing the repair geometry. Film adhesive and prepreps are used for prepreg repairs, and adhesive impregnated dry fabrics are used for the wet lay-up repairs. Dimensions are in mm.

Figure 3.1 shows a schematic of the repair geometry. A three-axis milling machine prepared the step geometry with 6.25 mm steps on the parent laminate to minimize the experimental scatter that can be a manual operation. Before the bonding process, 120 grit sandpaper abraded the surfaces. Water break tests on the bonding surfaces, followed by drying for 1 hour at 80°C, verified the uniformity of the sanding according to ASTM F22-13 Standard Test Method for Hydrophobic Surface Films [165]. Three of the stepped panels were tested to determine the tensile strength before repair. The prepreg and wet lay-up repair applications followed the general procedures given in the structural repair manuals, as follows [3,4].

Porosity Evaluation: After the mechanical tests, 35 mm X 15 mm slices were cut from the repair zone as shown in Figure 3.1, and microscope examinations according to ASTM E3-11 [175] evaluated the extent of porosity in the repair zones. The cross-sections of these slices are microscopically examined for three prepreg and three wet lay-up repaired specimens. After a diamond-coated cutting blade cut the specimen, the surfaces were cleaned thoroughly. Then the samples were mounted in cold-curing epoxy resin and ground with different grit SiC papers to remove the scratches and surface defects. Then the surfaces were polished with 3 μm and 1 μm diamond paste. An Olympus GX53 Inverted Microscope imaged the cross-sections, and the Olympus Stream Essentials software package [176] measured the patch porosity through image processing.

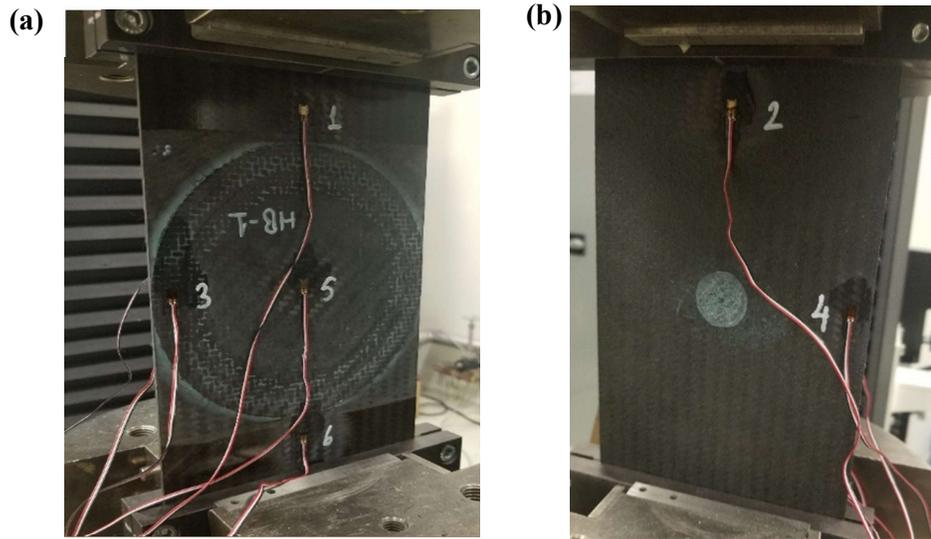
Figure 3.2. Photographs of the test setup for a representative prepreg repaired specimen, (a) front surface, (b) back surface.

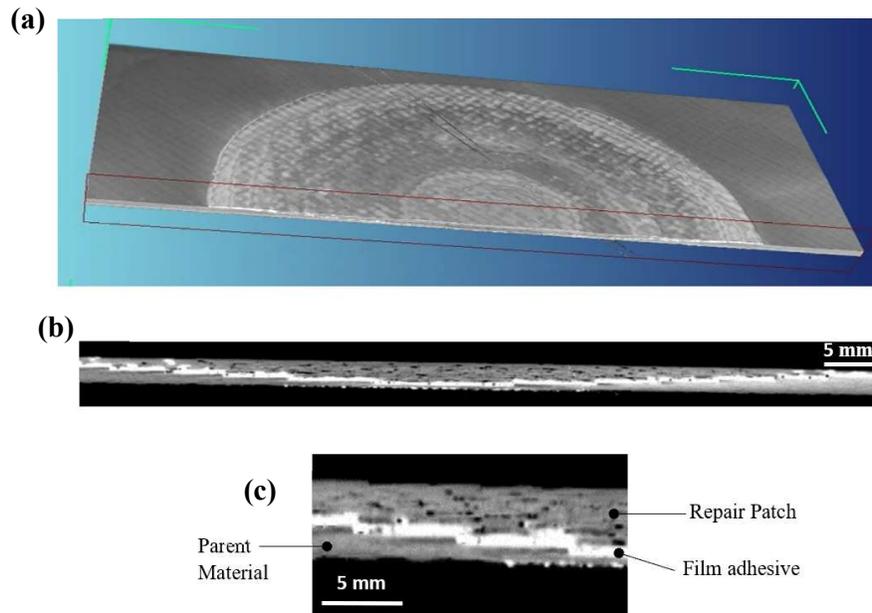
Figure 3.3. Computed tomography (CT) images of a representative prepreg repair zone before tensile testing. (a) A general view showing the cross-section used for the repair examination. (b) Cross-sectional view of the same CT scan. White contrast regions represent the film adhesive. (c) A close-up view showing the adhesive, parent material, and the repair patch more clearly.

Before the mechanical testing of the parts, a representative specimen was imaged with CT to gain further information about the geometry of the repair section. Figure 3.3 shows a section of the CT scan around the repair zone. The white contrast regions correspond to the FM-300K adhesive layer. The thickness of the adhesive layer was measured as ~ 0.2 mm, consistent with the manufacturer's data [166]. The stepped geometry and dimensions were consistent with the target geometry schematically shown in Figure 3.1. The image shows clear signs of porosity, which will be further discussed in the following sections.

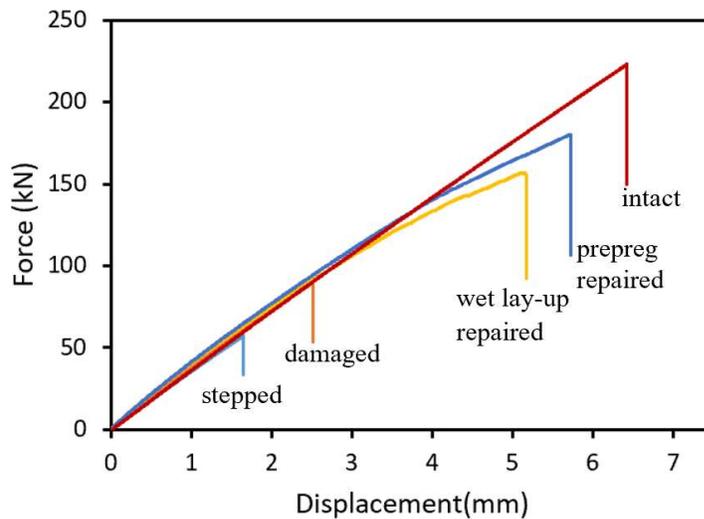
Figure 3.4. Force-displacement curves for intact, damaged, stepped, and repaired specimens. The intact coupon's force and displacement data were scaled for a meaningful comparison.

Figure 3.4 shows the representative experimental tensile force vs. displacement curves for the stepped, damaged, repaired, and intact specimens. The intact panels were coupon-sized specimens smaller than the other cases, and the associated force-displacement curve was scaled based on the cross-sectional area and length for a meaningful comparison.

The data of the intact specimen exhibits a linear elastic response. On the other hand, repaired specimens exhibit a decrease in the load-displacement slope for the later stages of the data, indicative of adhesive failure. This slope change becomes more evident for the wet lay-up repaired specimens, where adhesive failure accompanies the laminate failure. The minor deviations from linearity in the earlier stages are due to the minor slippage in the testing machine grips. The ultimate failure takes place abruptly without any significant plasticity for all specimens. There was a fiber breakage sound just before failure, in agreement with this observation.
