MECHANICAL PROPERTIES OF REPAIRED CARBON FIBER REINFORCED
POLYMER COMPOSITES

A THESIS SUBMITTED TO
THE GRADUATE SCHOOL OF NATURAL AND APPLIED SCIENCES
OF
MIDDLE EAST TECHNICAL UNIVERSITY

IN PARTIAL FULFILLMENT OF THE REQUIREMENTS
FOR
THE DEGREE OF DOCTOR OF PHILOSOPHY
IN
MECHANICAL ENGINEERING

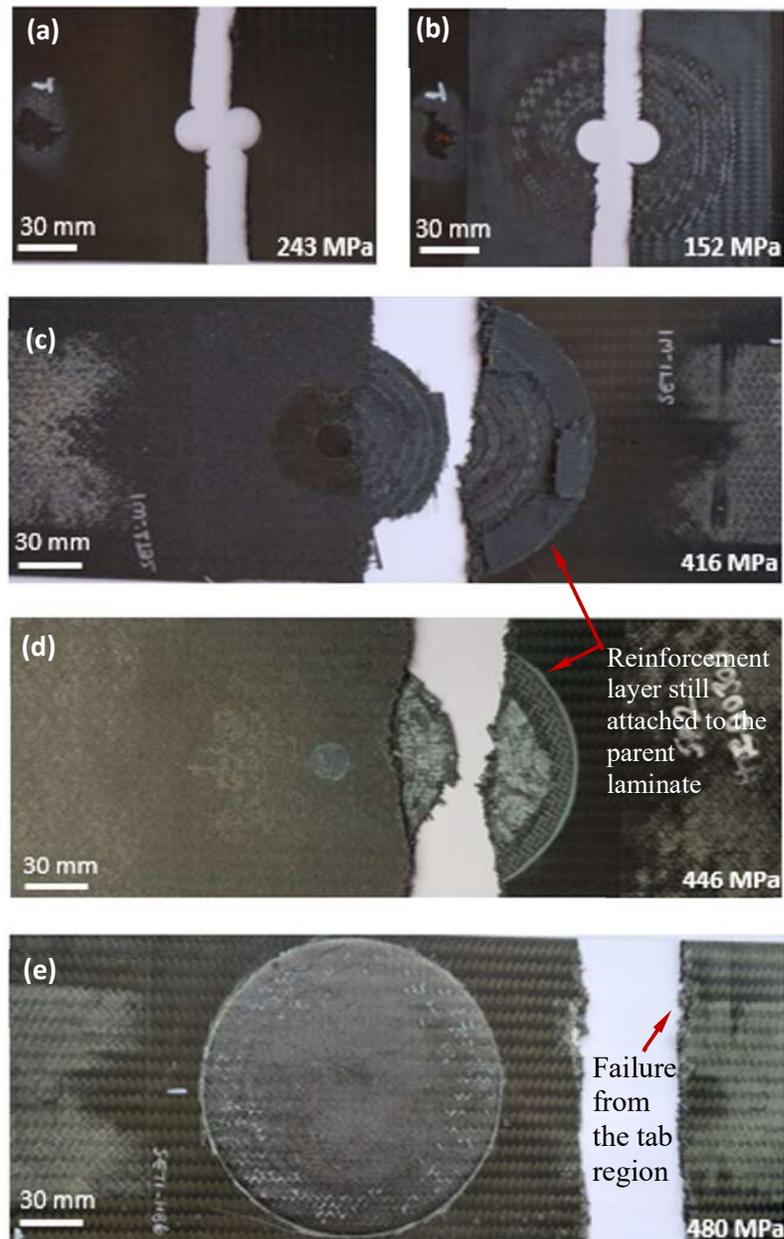
Figure 3.5. Photographs of the fracture surfaces of representative test specimens. The values at the bottom right indicate the average strength for each case. (a) damaged specimen, (b) stepped specimen, (c) wet lay-up repaired specimen, (d) and (e) prepreg repaired specimens. In (d) and (e), the right-hand side parts are flipped to reveal the failure surfaces more clearly.

Figure 3.5 shows photographs of representative specimens upon fracture, providing insight into the mechanisms of failure. The fracture plane is perpendicular to the loading axis for the damaged and stepped specimens, and the fracture initiates from the hole. This is an expected result caused by the stress concentration near the holes and the stepped regions.

When it comes to prepreg specimens, the higher strength of the repair results in either limited or no cohesive failure, as exemplified in Figure 3.5(d) and (e). The stronger repair moves the fracture plane away from the hole. In fact, in Figure 3.5(e), the failure takes place outside the repair region.

Figure 3.5(d) specimen exhibits a cohesive and laminate failure combination, with green regions corresponding to the FM-300K film adhesive. This specimen's lower strength and adhesive failure are probably due to an undetected defect on the bonding region that caused a stress concentration. Except for a few low-strength repairs excluded from the test data due to detected defects, most prepreg repair surface failures are cohesive, indicating satisfactory surface preparation before bonding.

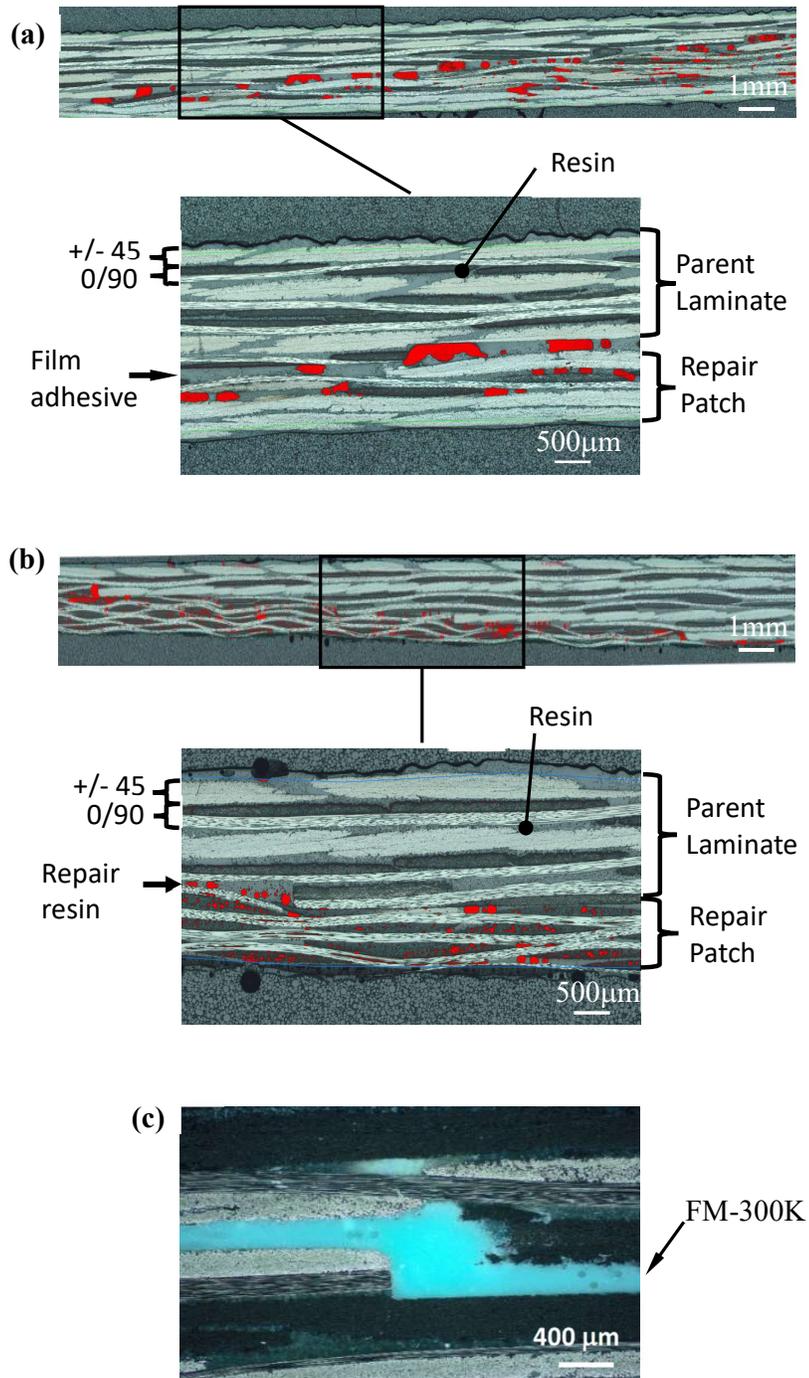
Figure 3.6. Optical micrographs of selected tested specimens. Red regions mark the porosities. (a) Prepreg repaired specimen, (b) Wet lay-up repaired specimen, (c) A polarized view of the FM-300K adhesive.

Figure 3.6 shows representative views of the cross-sections of each repair technique. The parent laminate is free of porosity, whereas the repair patch and the adhesive include various porosities, as observed in the CT scans presented in Figure 3.3.

The porosities are mainly due to the lack of sufficient pressure in the curing process. The porous zones are primarily located in adhesive-rich zones and inter-fiber regions of the repair patch. As the thickness of the repair patch increases, more volatiles become trapped on the repair zone, which causes more pronounced porosity formation at the center of the repairs for both wet lay-up and prepreg. Wet lay-up exhibits the additional intra-fiber porosities due to the manual wetting process of the dry fabrics. Figure 3.7 shows the effect of porosity on the tensile repair strength. The tensile strength is normalized by the maximum strength attained for the prepreg repairs (480 MPa). The results show that tensile strength decreases as porosity increases for the higher porosity levels. There is no significant reduction for the porosity levels less than 3 %, which coincides with the Chapter 2 results. The repair strength is not just only related to the porosity content but also the larger porosities, namely voids, creating stress concentration sites that may reduce the strength dramatically.

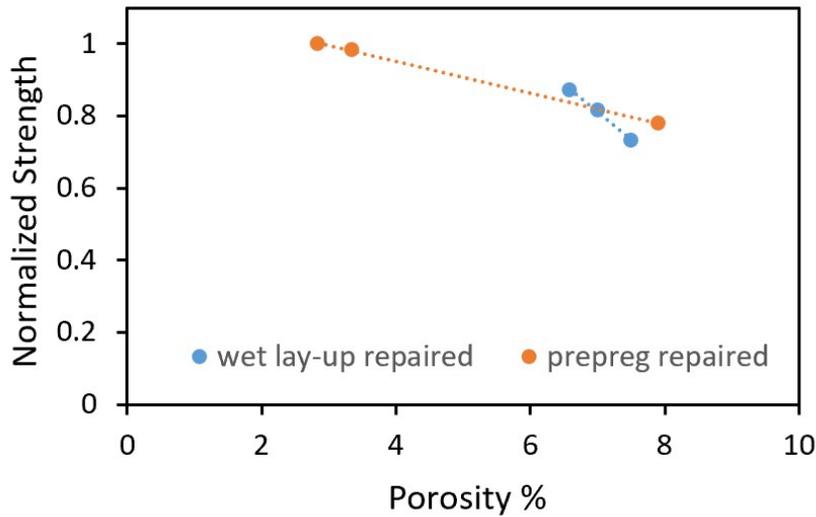
Figure 3.7. Normalized tensile strength of the prepreg and wet lay-up repairs for different porosity levels.

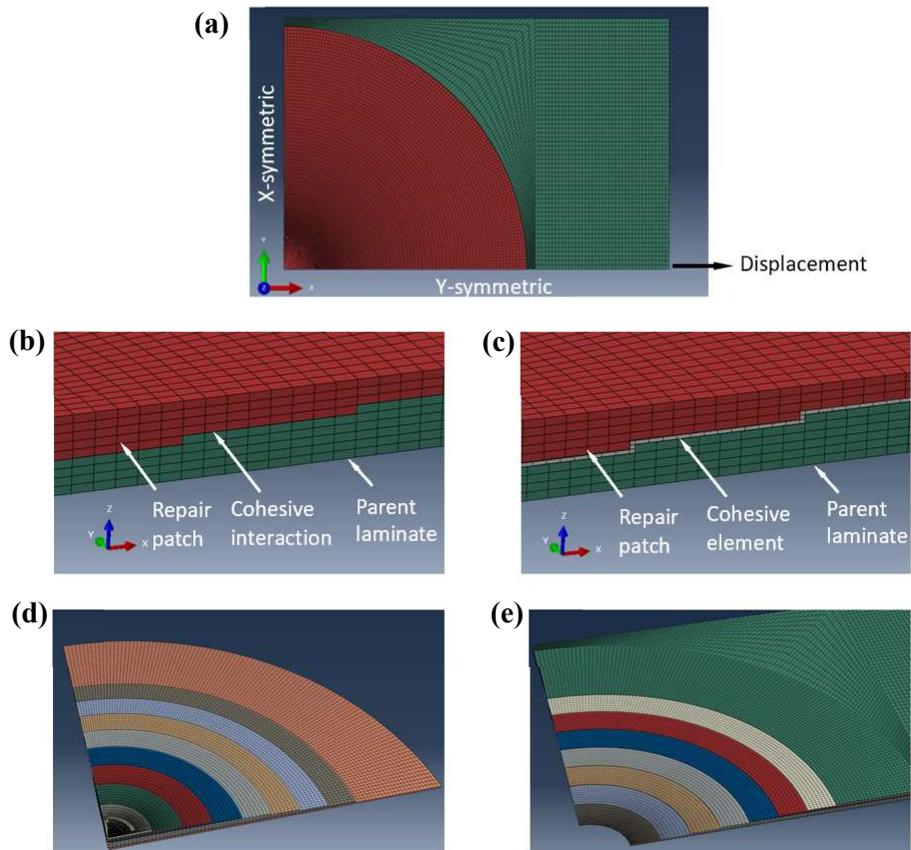
Figure 3.8. (a) Schematic description of the finite element model. (b) Close-up view of the mesh structure around the steps for wet lay-up repair and (c) prepreg repair. (d, e) Interface region of the repair; repair patch and parent laminate sides, respectively. Each color represents a separate layer.

The tensile testing of the stepped repaired specimens was modeled by finite element method using ABAQUS 6.14 Standard. Figure 3.8 shows schematic views of the model and the boundary conditions. The model considered a quarter of the test specimen and excluded the clamped regions for reducing the computational load. Modeling using a full-sized specimen verified that the quarter-model's results are virtually identical to that of full-sized. Symmetry boundary conditions over the two edges of the quarter-specimen and a linear displacement boundary condition at the edge next to the clamped regions provided the tensile testing conditions. The material properties for the composite parent material, repair patch, and adhesive were based on the data presented in Table 2.2, Table 2.3, Table 3.1, and Table 3.2 respectively.

Figure 3.8(b) shows modeling details of the bonding region for the wet lay-up repairs. There was no extra adhesive layer bonding the patch and the parent material; instead, adhesive-impregnated layers maintained the bonding. Therefore, the model neglected the thickness of Hysol EA 9396 and considered it as an interaction property, which helped to reduce the simulation time. The model used a high interface stiffness of 10^6 N/mm^3 for the three directions of Hysol EA 9396. Such high interface stiffness values are required to prevent any disruption to the general compliance of the system before the damage starts [178]. When the interface stiffness is in the range of $10^5 - 10^6 \text{ N/mm}^3$, the cohesive elements do not affect the system's overall load-displacement behavior [168,178], while higher stiffness values can cause numerical convergence issues.

Figure 3.8 (c) shows modeling details of the bonding region for the prepreg repairs, which were modeled by the cohesive element tool of ABAQUS. The model took the thickness of FM-300K into account, with K_n , K_t , and K_s being calculated from Eq. 1.18. 23140 eight-node 3D cohesive elements (COH3D8) discretized the adhesive domain. The element size varied in the range of 0.1 – 0.5 mm. To model with the cohesive elements, tie constraints connected the mismatching nodes at the adherend-adhesive interface, assuming perfect bonding.

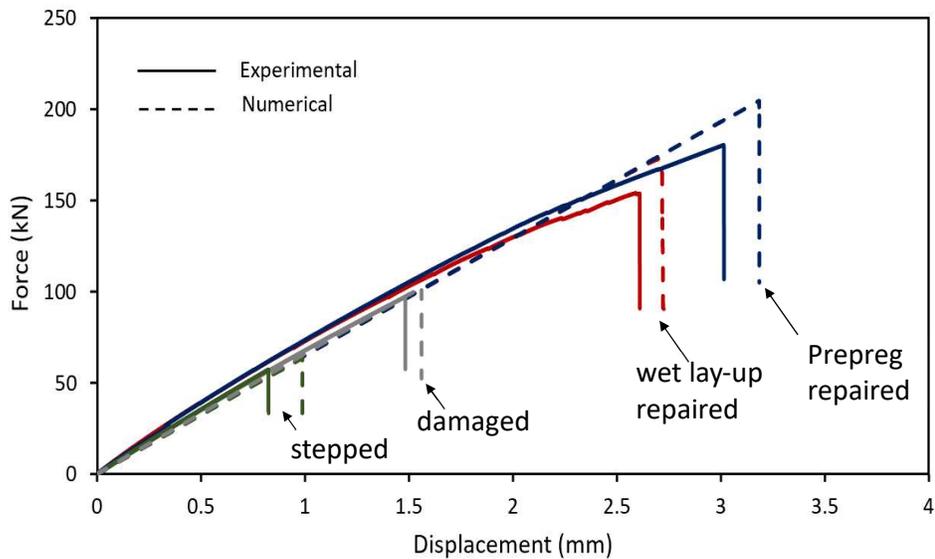
Figure 3.9. Experimental and numerical load-displacement curves for stepped, damaged, wet lay-up repaired, and prepreg repaired specimens. The experimental displacement data are based on strain gauge measurements.

Figure 3.9 shows load-displacement predictions of the finite element analysis for stepped, damaged, wet lay-up repaired, and prepreg repaired specimens. The figure also shows the strain gauge-based experimental data for comparison. The results show that the finite element model can closely predict the experimentally observed load-displacement behavior. The slight discrepancy between the analysis predictions and experimental data is mainly due to the minor slippage in the testing machine grips, which becomes more evident for higher loads.

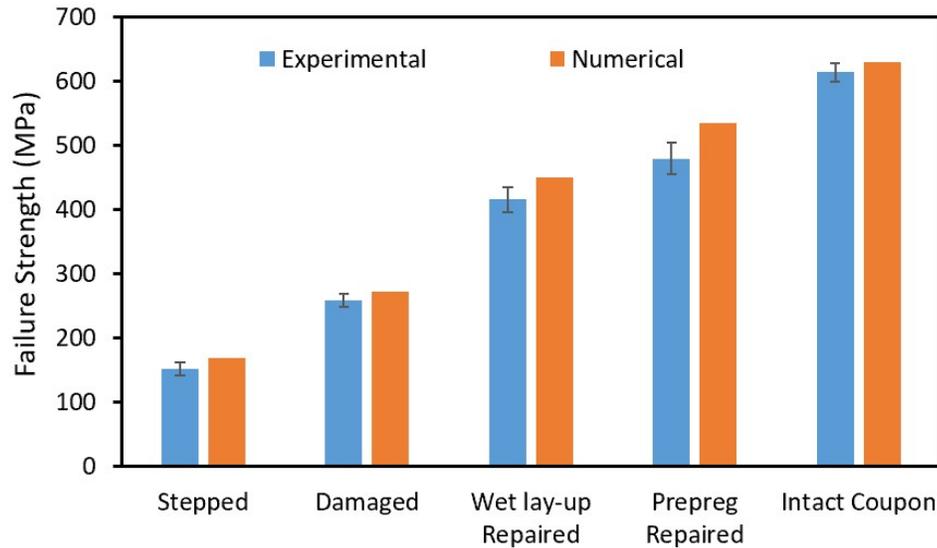
Figure 3.10. Failure strength of the specimens as determined by experiments and as predicted by simulations.

Figure 3.10 compares the simulation predictions with the experimental results regarding the failure strength, which is calculated by dividing the maximum force to the initial cross-sectional area. The differences between the experimental data and the simulation predictions are within 10%. Simulations slightly overpredict the failure load.

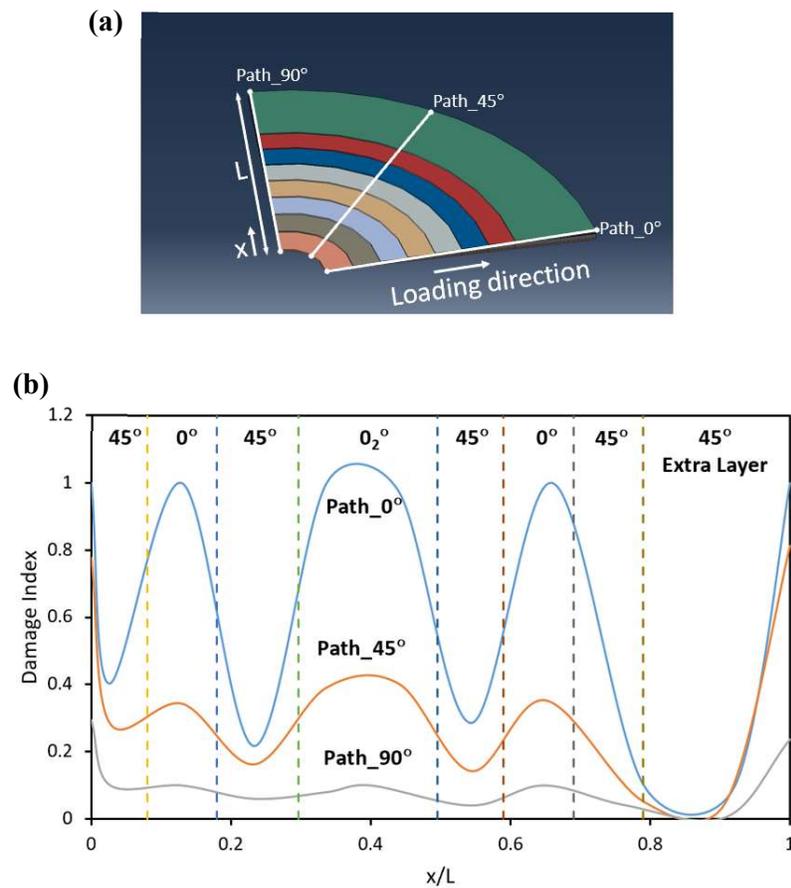
Figure 3.11. (a) Schematic description of the three paths on the bonding area, defined with respect to the loading direction on the parent laminate side. (b) Damage index distribution with respect to the normalized distance along the bonding area over different paths, shown for the onset of damage.

An investigation of the scalar damage variable for cohesive surfaces in general contact (CSDMG), as defined in Eqn. (1.22) provided further insight into the damage evolution in the joint region. Figure 3.11 shows the damage variable (damage index) for wet lay-up repair over the bonding area at the onset of damage. The data is presented for directions having 0° , 45° , and 90° angles with respect to the loading direction, through the middle of the steps to eliminate the edge effects caused by thickness changes.

The results show that the damage index strongly depends on the direction. The damage index is highest for the 0° path and gradually decreases for 45° and 90° paths, respectively such that it is nearly zero for the case of 90° . The damage index also exhibits oscillations that depend on the ply orientation for each direction. Specifically, plies having an orientation of 0° exhibits a larger damage index than 45° -oriented plies. This dependency of ply orientation on the damage index is due to the anisotropic nature of the composite [66,68,92]. The anisotropy causes variations in the laminate's stiffness over the scarf length as opposed to the uniform stiffness of

the adhesive. The resulting adhesive-adherent stiffness mismatch is highest for the 0° plies, resulting in higher stress concentrations and earlier failure. On the other hand, the damage is nearly zero on the extra layer bonding zone due to the similarity (stiffness and orientation) of the reinforcement layer and the outermost layer of the parent laminate. In addition to the variations over the scarf length, the damage index is also higher at the edges due to the step geometry creating peel stresses [92,179].

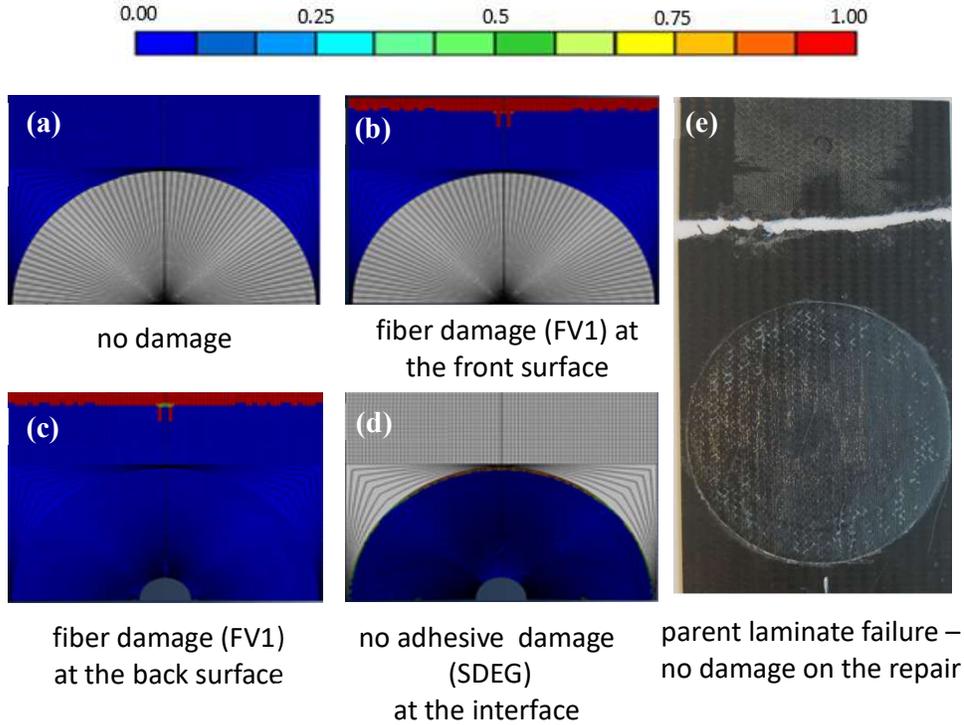
Figure 3.12. Failure map of prepreg repairs corresponding to 99% of the ultimate load. The simulation results are mirrored with respect to the symmetry axis for ease of visualization. (a) No damage. Grey region indicating the repair patch, blue region is the parent laminate. (b) Fiber damage at the front surface of the parent laminate; no damage is present on the repair zone. (c) Fiber damage at the back surface of the parent laminate; no damage is present on the repair zone. Parent laminate on the bonded surface, showing no fiber damage. (d) Adhesive damage on the repair region; no damage is present on the repair zone. (e) Photograph of an experimentally tested specimen where parent laminate failure is visible with no damage on the repair zone.

Figure 3.12 and Figure 3.13 presents the damage condition of the repaired parts for 99% of the ultimate failure load. The damage parameters under consideration are scalar damage variable of cohesive elements (SDEG) for prepreg repairs, the scalar damage variable of cohesive surfaces in general contact (CSDMG) for wet lay-up repairs, fiber damage in warp direction (FV1), and fiber damage in weft direction (FV2). Since FV1 and FV2 exhibit similar trends, the figures only show the FV1 data. FV1 is observed both 0° and 45° plies whereas FV2 is only for 45° plies. A value of zero corresponds to the undamaged state, and 1 indicates complete failure. FV1 and FV2 can only take 0 or 1, whereas SDEG and CSDMG can have intermediate values due to the built-in cohesive modeling.

For the prepreg repairs shown in Figure 3.12, the primary failure mode is fiber failure in both directions leading to the total laminate failure near the tab region. There is no cohesive failure on the adhesive predicted by the simulation except for a slight degradation at the edges of the adhesive due to the peel stresses. These simulation predictions are in agreement with the experimental result shown in Figure 3.12 (e). The analysis shows no adhesive failure is expected for FM-300K adhesive-bonded with 6.25 mm step length (2.8° scarf angle). As a result, the repair strength is close to the intact laminate's strength.

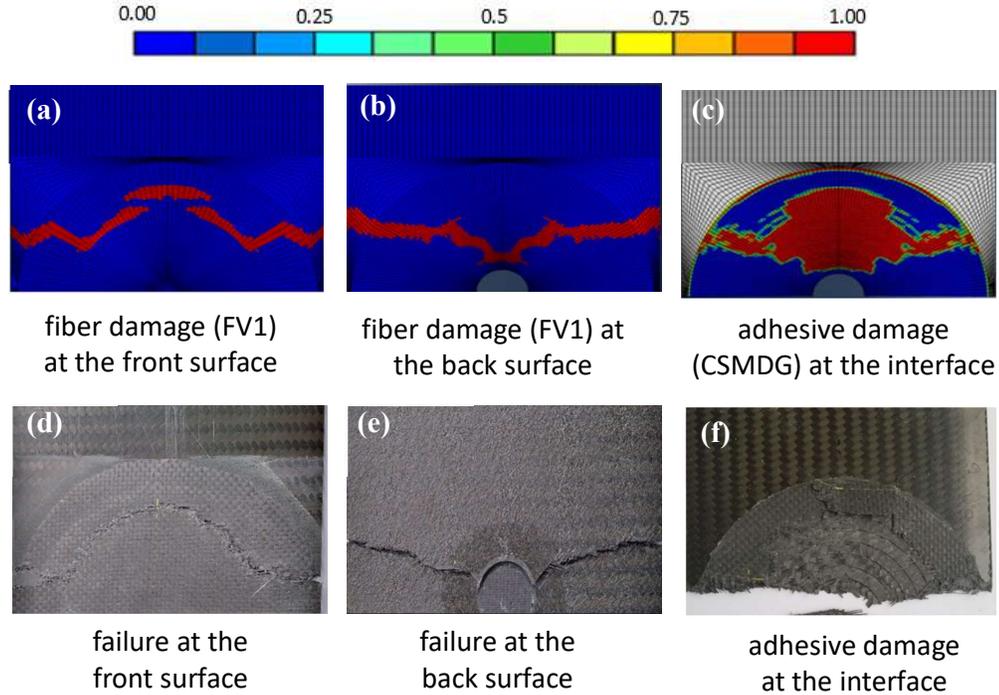
Figure 3.13. Failure map of wet lay-up repair corresponding to 99% of the ultimate load. The simulation results are mirrored with respect to the symmetry axis for ease of visualization. (a) Fiber damage at the front surface. (b) Fiber damage at the back surface. (c) Adhesive damage on the bonded region. (d) Experimental observation of the front surface exhibiting laminate failure. (e) Experimental observation of the back surface exhibiting laminate failure. (f) Adhesive failure of the bonded region.

Figure 3.13 shows similar information for the case of wet lay-up repairs. In this scenario, cohesive failure is accompanied by fiber failure in both warp and weft directions. The fracture begins from the bonded surface, and when the load-carrying capacity of the adhesive is exceeded, it spreads to the parent laminate. Figure 3.13 shows the photo of an experimentally observed failure, where there is no debonding between the extra layer and the uppermost layer of the parent laminate, in agreement with the simulation predictions.

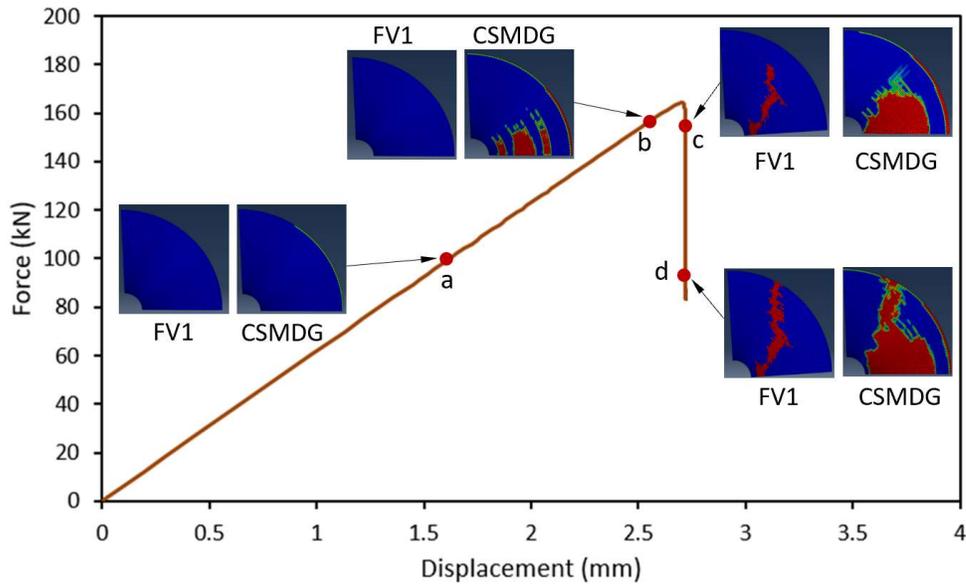
Figure 3.14. Evolution of the adhesive and fiber damages shown together with the force-displacement curve for the case of wet lay-up. CSMDG represents adhesive damage, and FV1 represents fiber damage.

Figure 3.14 shows snapshots of the damage evolution on a representative force-displacement curve for the wet lay-up repairs. At point (a), the loading is within the elastic limits. Therefore, there is no damage neither on the adhesive nor on the composite part. Point (b) shows the initial damage in the adhesive region of the 0° overlapping plies, which progresses both circumferentially and towards the 45° layers. Upon the failure of approximately half the adhesive area, the fracture spreads to the parent laminate, and fiber failure begins near the edge of the hole. This can be inferred from the snapshot of point (c). At this stage, the damage evolution is very

rapid, and complete failure occurs as the fiber failure follows the adhesive failure path and reaches the edge of the part, as demonstrated in the snapshot of point (d).

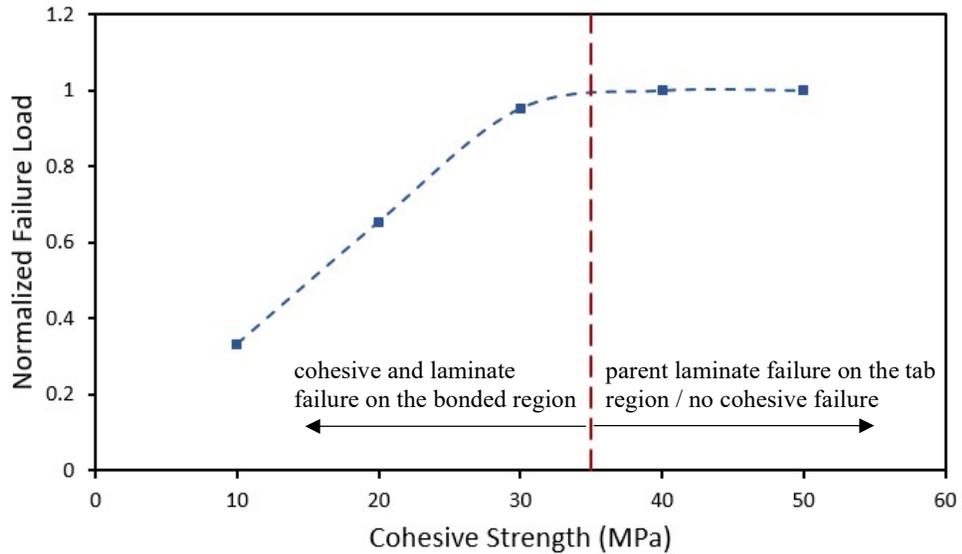
Figure 3.15. Normalized failure load for varying cohesive strength of the adhesive.

Figure 3.15 shows the results of the failure load of the repaired specimen normalized by the parent laminate's failure load. For adhesive strengths up to 35 MPa, the failure load increases as adhesive strength increases. This dependence is caused by the fact that the failure initiates from the adhesive region and leads to the fracture of the repaired area. Beyond 35 MPa, the failure load reaches the undamaged parent

laminates, and the fracture occurs near the tab area. The 35 MPa adhesive strength that defines the transition from repair failure to laminate failure is in close agreement with the analytical prediction of 37.5 MPa discussed in Section 3.3.

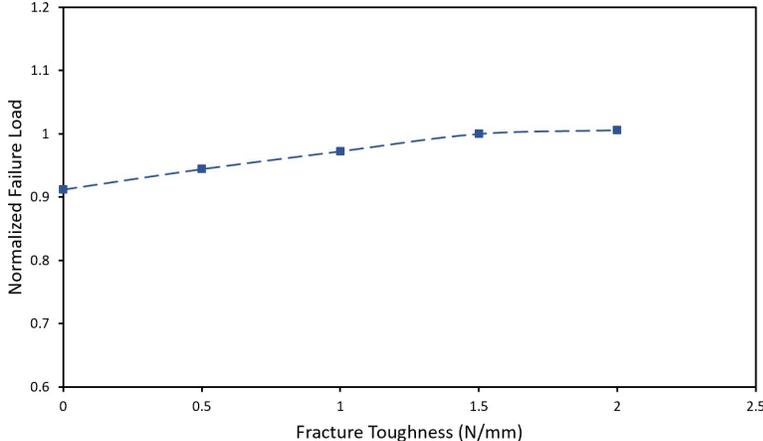
Figure 3.16. Normalized failure load for different toughness values.

Next, Figure 3.16 demonstrates the effect of fracture toughness on the failure load of the repairs. The analysis performed in this part assumed an isotropic adhesive shear strength value of 25 MPa in all directions. The fracture toughness was also assumed to be isotropic for simplicity. The results show that the fracture toughness has little effect on the failure load under these circumstances.

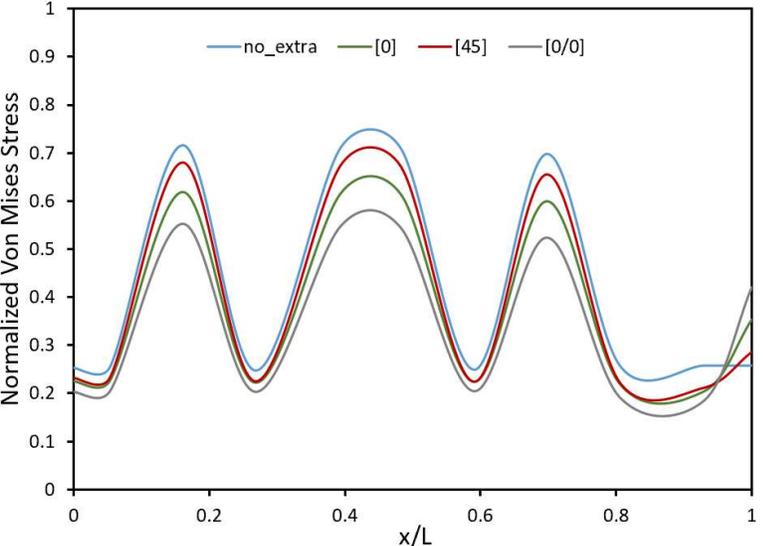
Figure 3.17. Normalized von Mises stress distribution over the bonded area of the parent laminate.

Lastly, the effect of the extra layer and its orientation on the repair strength was investigated. Figure 3.17 shows the normalized von-Mises stress over the parent laminate bonding surface for repairs with no extra layer, and with extra layers having lay-ups of [45] and [0], and two extra layers with [0/0] lay-up. Again, the normalization was done with respect to the maximum far-field stress.

As the stiffness of the repair patch increases, it carries more load, so the stress passing the parent laminate decreases. 0° oriented extra layers decrease the stress

concentration on the parent laminate and so the adhesive. Choosing the orientation of the extra layer different from the uppermost layer of the parent laminate creates undesired peel stresses on the edge of the bonding region, decreasing the failure strength if any adhesive or patch failure is involved.

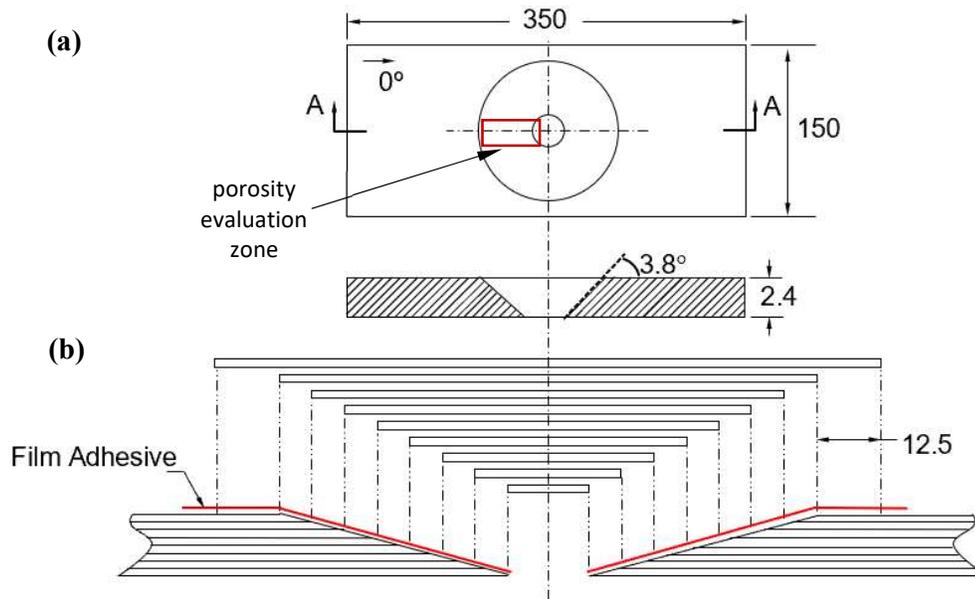
Figure 4.1 (a) Schematic view of the test specimens before repair. Thickness is exaggerated for clarity. (b) Cross-sectional schematic showing the repair geometry. Film adhesive and prepregs were used for prepeg repairs, and adhesive impregnated dry fabrics were used for the wet lay-up repairs.

The repair and inspection procedures have followed the same details described in Section 3.2. The main exception was the sanding of the repair surface to maintain a scarf angle of 3.8° (1/15 taper ratio). Figure 4.1 shows a schematic view of the repair. Table 4.1 shows the specimen types considered to investigate the effect of post-bond moisture on the repair strength. Both prepreg and wet lay-up repaired specimens were moisturized before testing by immersing them in a 70°C water bath for 14 days until 1.1% moisture content was reached. The bath's elevated temperature helped to accelerate the moisture intake of the parts. These conditioned specimens are named "hot-wet" specimens, whereas the untreated specimens are "dry". After 14-day conditioning, the specimens were preserved in sealed bags and within 3 hours, they were tested at 70°C . The dry specimens, on the other hand, were tested at 25°C . An Instron 5985 Testing Machine tested the hot-wet and dry panels according to the ASTM D3039/3039M Standard for Tensile Testing of Polymer Matrix Composites. The measurements employed displacement control at a rate of 0.5 mm/min.

After the mechanical testing, 35 X 15 mm slices were cut out from the repair zone, as shown in Figure 4.1. These slices were first ultrasonically and then microscopically evaluated in terms of porosity.

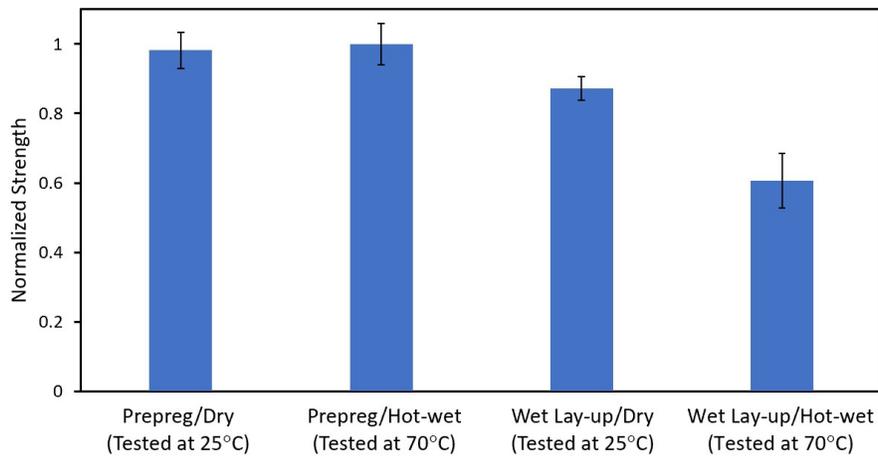
Figure 4.2. Normalized strength values of prepreg and wet lay-up repairs for dry and hot-wet conditions.

Figure 4.2 shows the same results, normalized concerning the maximum strength of dry prepreg repaired specimens. For the wet lay-up repairs, the average repair strength of the hot-wet case is lower by nearly 30% concerning the repair strength of the as-received specimens. This strength is almost as low as the damaged hole strength reported in Table 3.3.

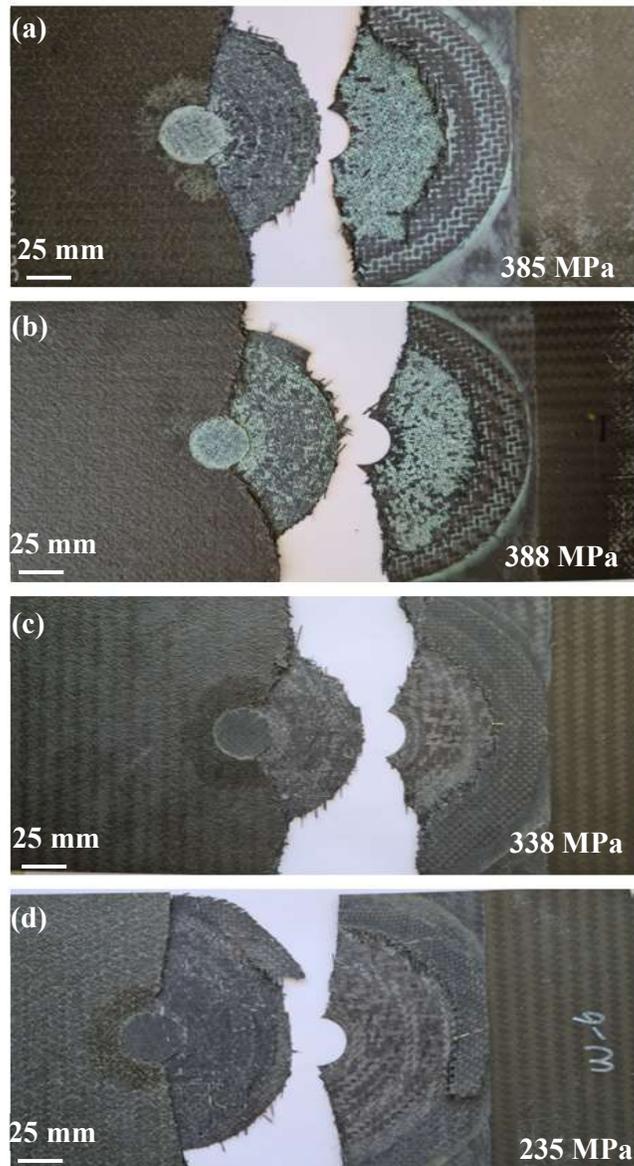
Figure 4.3. Photographs of the fracture surfaces of representative test specimens. The values at the bottom right indicate the average strength for each case. (a) prepreg repaired specimen in dry condition, (b) prepreg repaired specimen in hot-wet condition, (c) wet lay-up repaired specimen in dry condition, (b) wet lay-up repaired specimen in hot-wet condition. Right-hand sides are flipped for revealing the failure surfaces more clearly.

The photographs of representative specimens upon fracture are shown in Figure 4.3. By investigating the fracture surfaces, it can be concluded that the failure begins from the adhesive and then continues with the laminate until fracture of the part for both types of repairs

The failure strength and the fracture plane are the same for dry and hot-wet specimens for the prepreg repairs, as shown in Figure 4.3 (a) and (b). Adhesive residues are observed on both surfaces of the parts, which is indicative of good surface preparation. The wet lay-up repairs show a considerable variation in the failure load and the fracture plane for dry and hot-wet specimens, as shown in Figures (c) and (d). The fracture plane for the conditioned wet lay-up repairs is nearly perpendicular to the loading direction, which is expected due to very low repair strength, just as the damaged specimen shown in Figure 3.5.

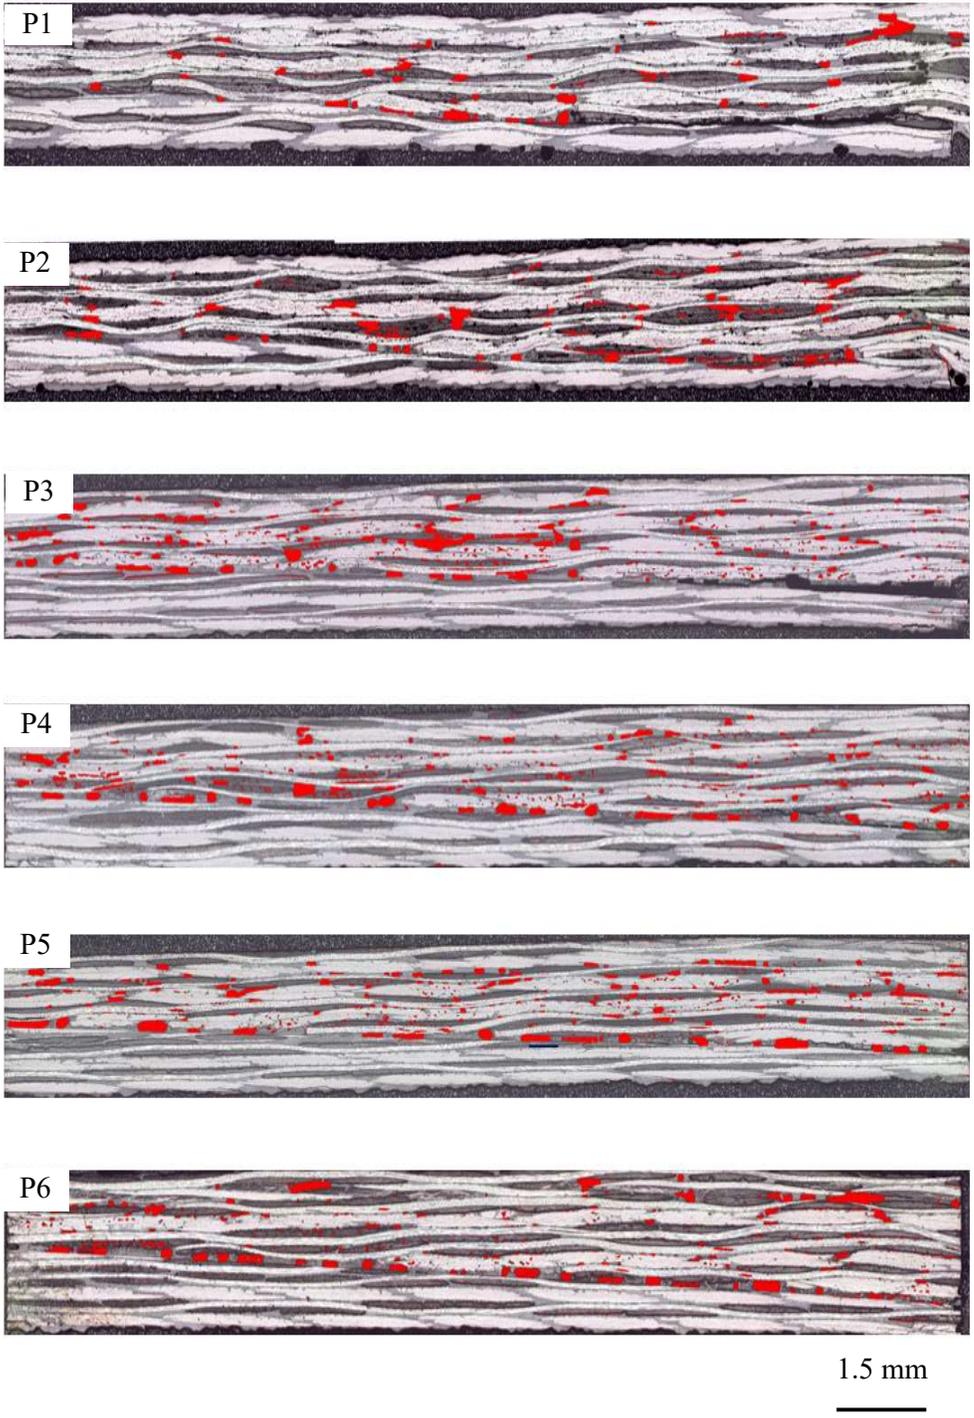
Figure 4.4. Optical micrographs of the prepreg repaired specimens. Red regions mark the porosities.

Figure 4.4 and Figure 4.5 show representative views of the cross-sectional morphology of prepreg and wet lay-up repairs, respectively. P1, P2, P3, W1, W2, and W3 are the dry specimens, and P4, P5, P6, W4, W5, and W6 are the hot-wet specimens. By looking at the microscopic views, it can be easily seen that the parent

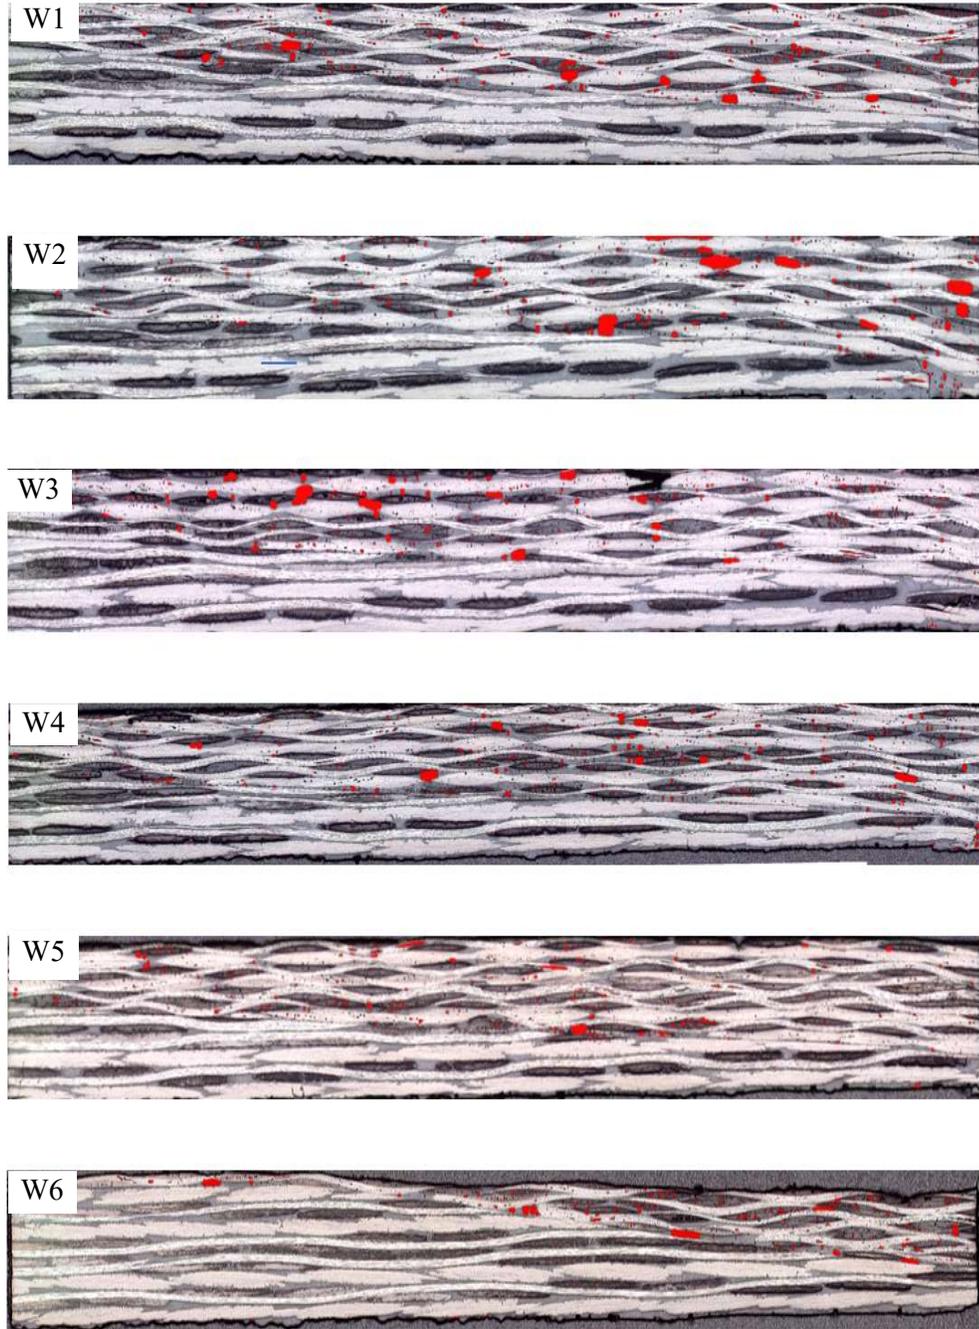
Figure 4.5. Optical micrographs of the wet lay-up repaired specimens. Red regions mark the porosities.

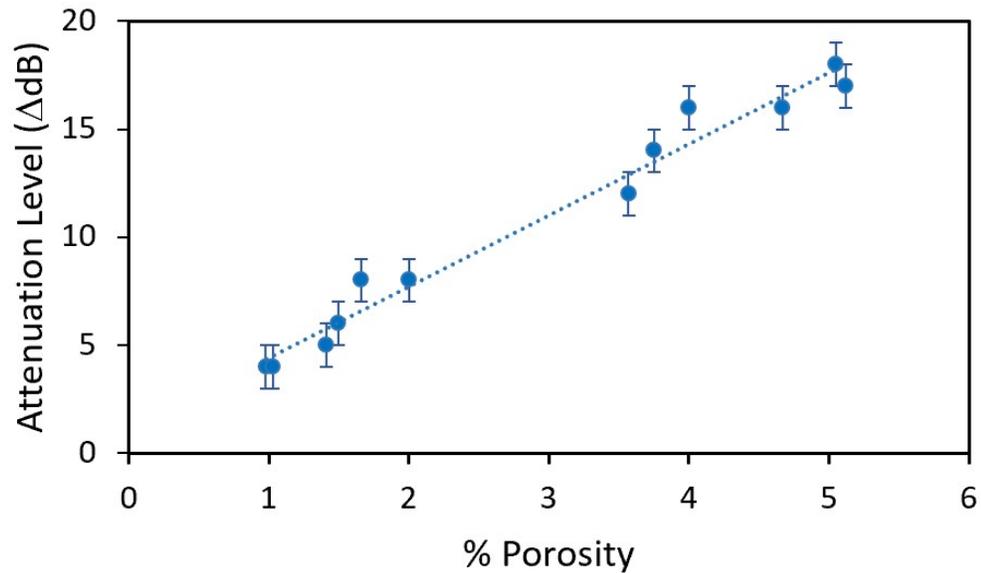
Figure 4.6. The measured ultrasonic attenuation values for specimens with different porosity levels.

The results of the ultrasonic inspection, microscopic porosity evaluation, and the related tensile experimental test results are summarized in Table 4.3. Also, in Figure 4.6, the correlation between the ultrasonic attenuation value and the microscopically found volume porosity percent is given. By looking at Table 4.3 and Figure 4.6, it is clear that as the porosity percent increases, Δ dB value also increases and can be as high as 20 dB for a porosity percentage of 5.25 %.

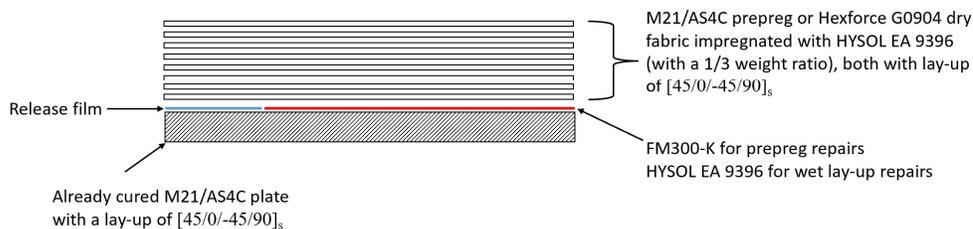
Figure A.1. Schematic representation of the specimen for the DCB and ENF tests.

To find the fracture toughness values of the two-part adhesive HYSOL EA 9396, eight plies of Hexforce G0904 dry fabric impregnated with HYSOL EA 9396 (with a 1/3 weight ratio) having a quasi-isotropic lay-up of $[45/0/-45/90]_s$, is co-bonded to the base plate with HYSOL EA 9396. Then, according to the manufacturer's cure cycle requirements, the co-bonded structure is vacuum-bagged and cured with a heat blanket; 66°C ($\pm 5^\circ\text{C}$) for 1 hour. The repair schematic of the specimen is shown in Figure A.1.

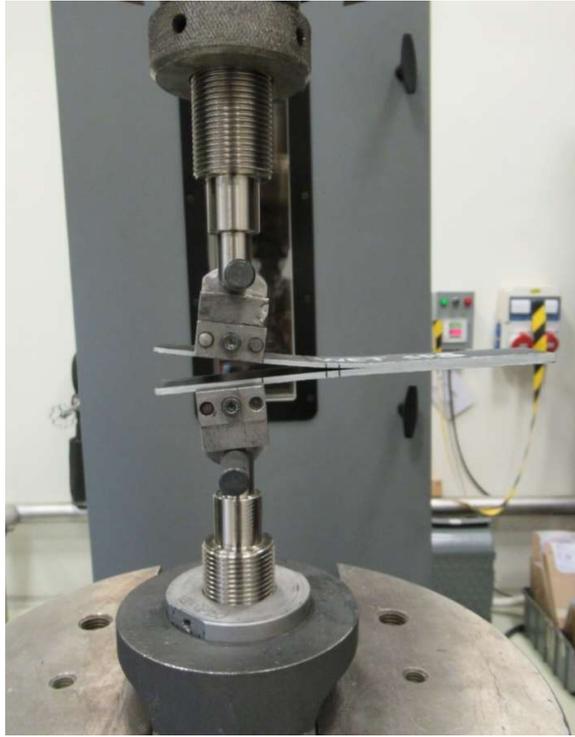
Two piano hinges mechanically clamped to the specimens. Then the specimens are loaded from the hinges on the opening direction with a test speed of 10 mm/min, and the corresponding crack length and propagation are measured with a ruler and recorded. The test was continued until 100 mm crack length was achieved. For the ease of visualization of the crack tip, a thin white layer of ink was applied to the longitudinal side faces of the specimen. Force-cross head displacement is recorded during the test; the graph is shown in Figure A-3.

Figure A.2. Test set-up for DCB testing

The DCB test specimen for the evaluation of G_{IC} the value was prepared with co-bonding repair prepregs to the pre-cured laminate with either FM300-K or HYSOL EA 9396 and tested per DIN EN 6033 “Determination of interlaminar fracture toughness energy - Mode I - GIC”. The test set-up is shown in Figure A-2.

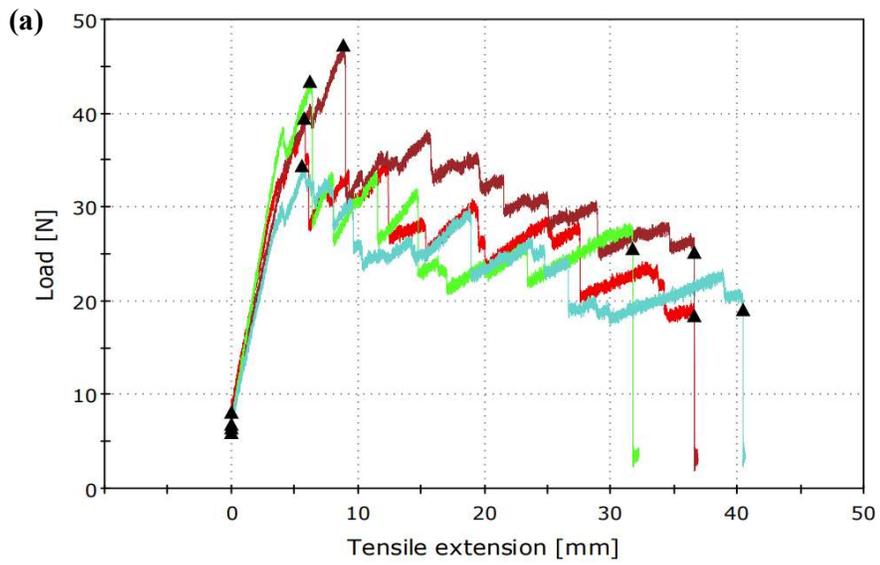
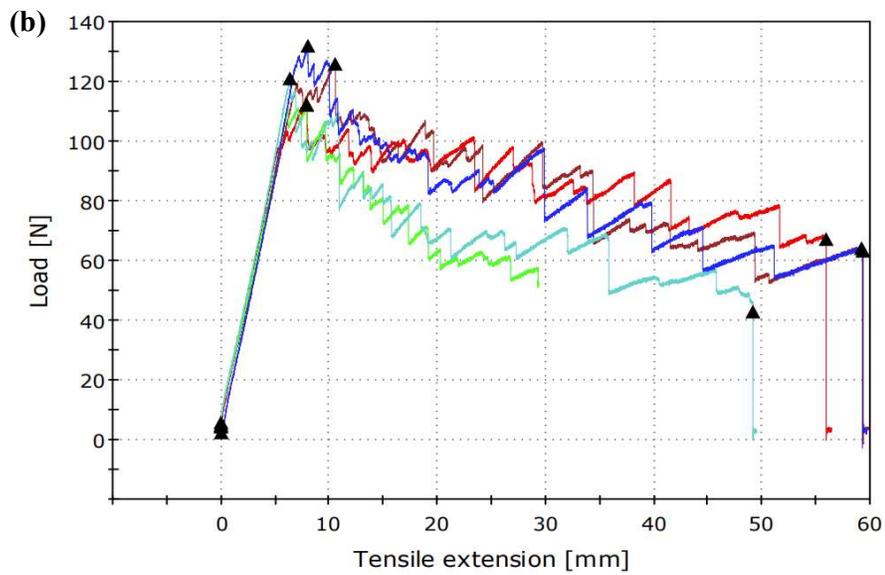
Figure A.3. Force- Crosshead displacement graph of DCB tests, (a) Specimen bonded with HYSOL EA 9396 (b) Specimen bonded with FM 300-K.

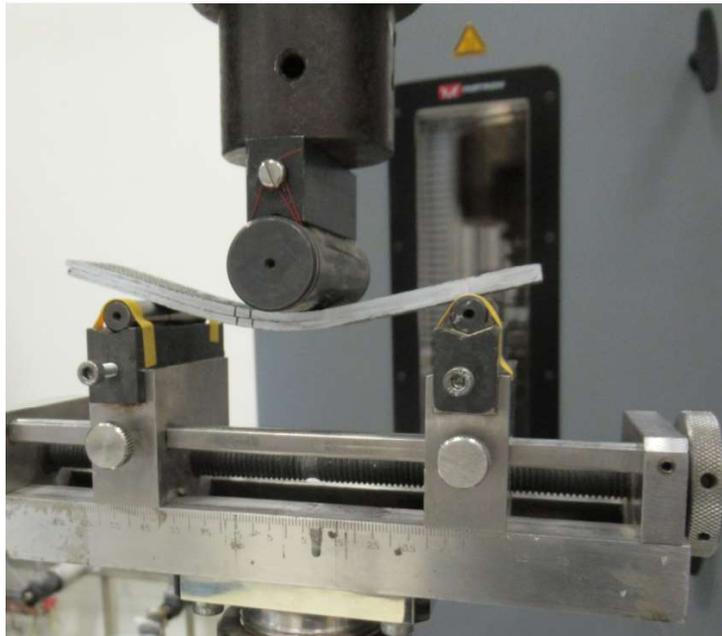
Figure A.4. Test set-up for ENF testing

The test is performed with the remaining portions of the G_{IC} specimen where the initial crack has been introduced. 40 mm pre-cracked specimens having a total length of 120 mm are used for the testing. As shown in Figure A.4, a perpendicular load is applied on the middle of the specimen by a roller (having a diameter of 25 mm and made of steel) with a speed of 1 mm/min. The span is selected to be as 100 mm as the testing specification suggests. The support rollers (having a diameter of 10 mm and made of steel) are located 50 mm apart from the loading support.

The ENF test specimen for the evaluation of G_{IIC} was prepared with co-bonding repair prepregs to the pre-cured laminate with either FM300-K or HYSOL EA 9396 and tested per DIN EN 6034 “Determination of interlaminar fracture toughness energy - Mode II - GIIC. The test set-up is shown in Figure A.4
