MECHANICAL PROPERTIES OF REPAIRED CARBON FIBER REINFORCED
POLYMER COMPOSITES

A THESIS SUBMITTED TO
THE GRADUATE SCHOOL OF NATURAL AND APPLIED SCIENCES
OF
MIDDLE EAST TECHNICAL UNIVERSITY

IN PARTIAL FULFILLMENT OF THE REQUIREMENTS
FOR
THE DEGREE OF DOCTOR OF PHILOSOPHY
IN
MECHANICAL ENGINEERING

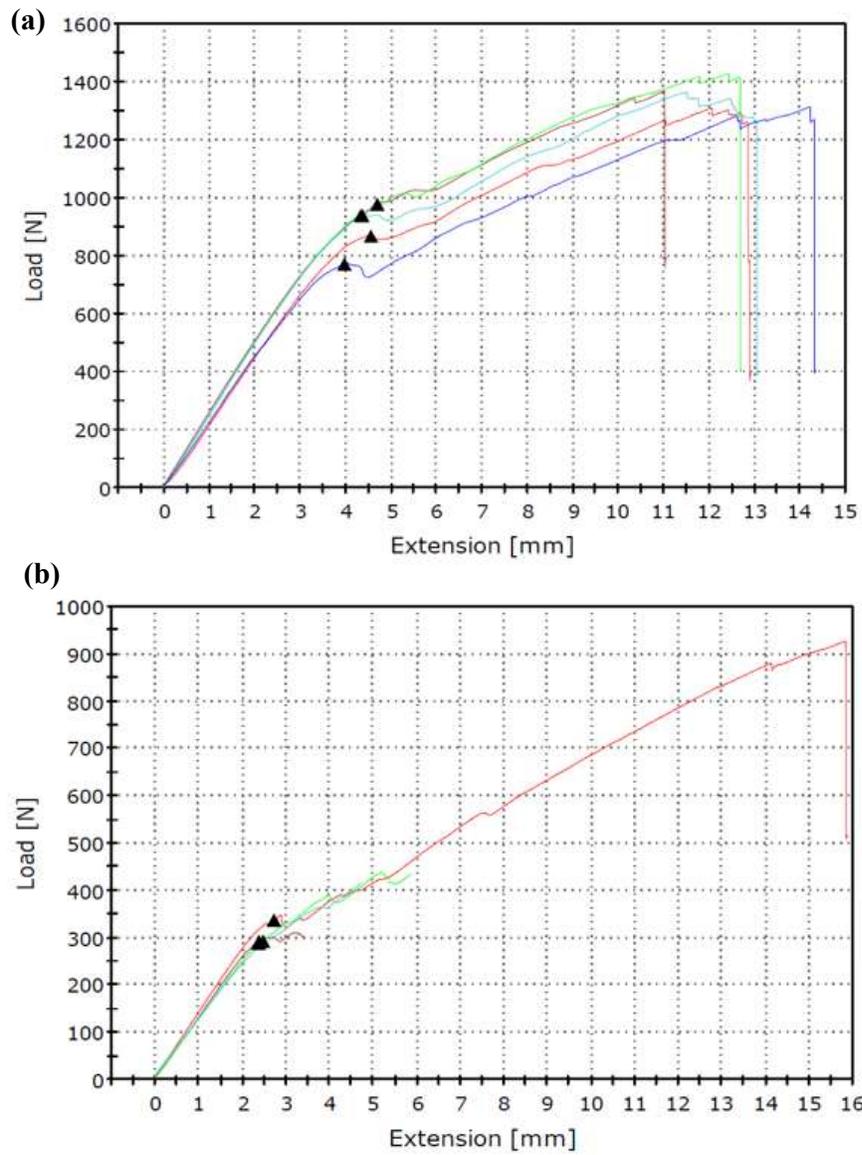
Figure A.5. Force- Crosshead displacement graph of ENF test. (a) Specimen bonded with HYSOL EA 9396 (b) Specimen bonded with FM 300-K.

The critical load at debond onset is recorded during the test, and part is unloaded as soon as a small drop confirms the crack propagation. In addition, force-cross head displacement is recorded during the test; the graphs for both tests are shown in Figure A-5.

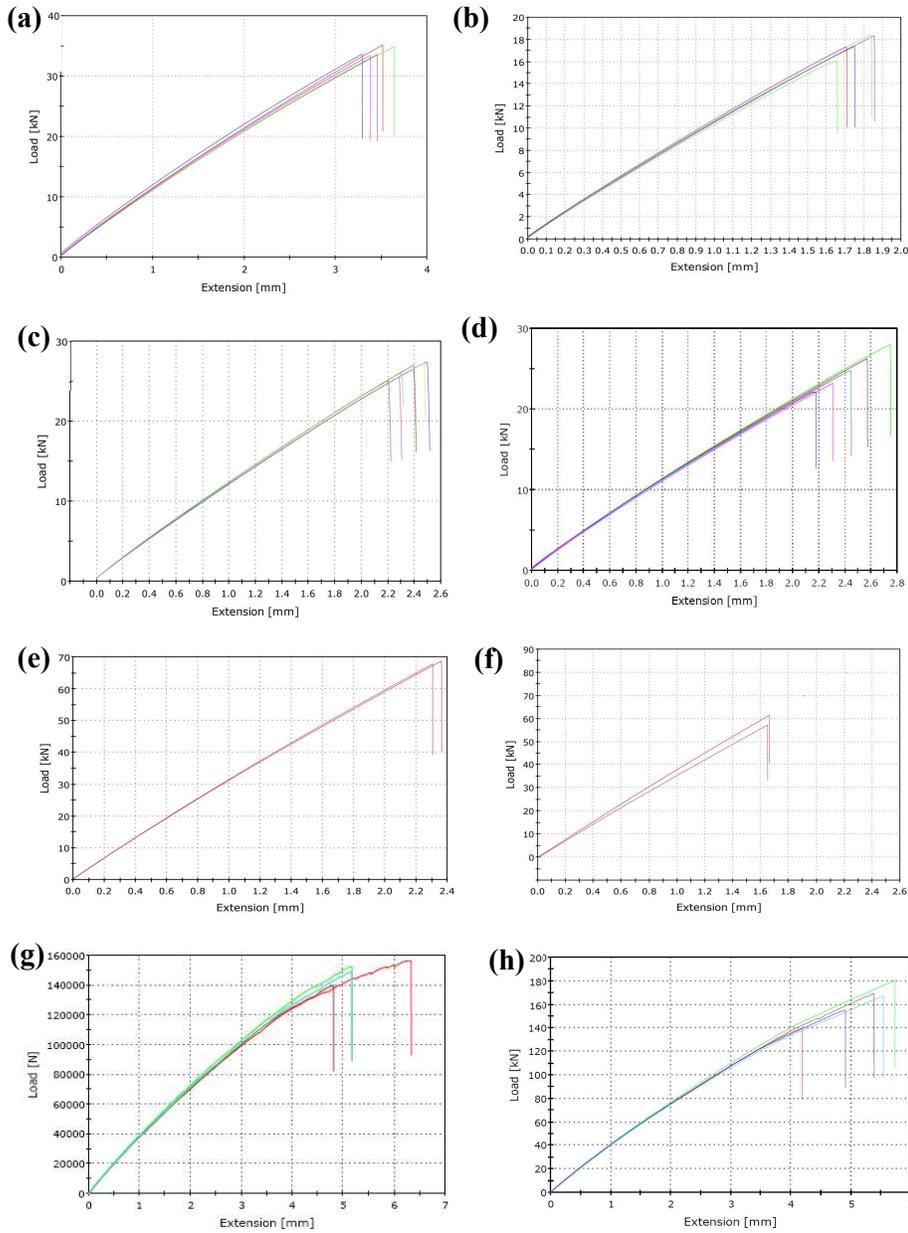
Figure C.1. Force-Displacement curves for (a) intact, (b) 5.7° scarf-bonded specimen, (c) 2.8° scarf-bonded specimen, (d) 1.9° scarf-bonded specimen, (e) open hole panel, (f) scarfed panel, (g) 2.8° wet lay-up repaired, (h) 2.8° prepreg repaired

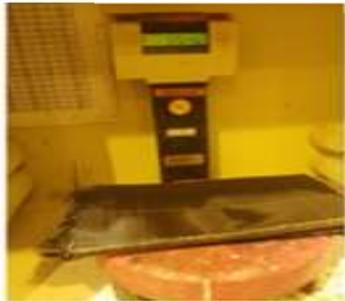
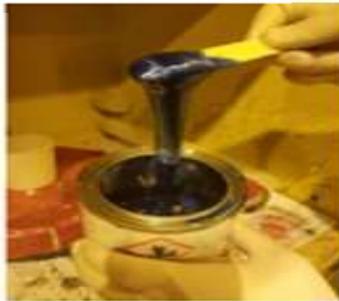
Weighing and preparation of the adhesive

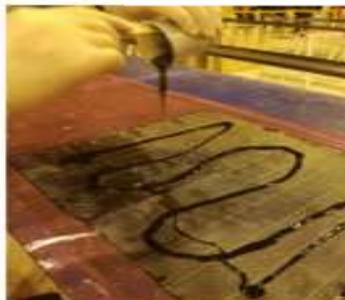
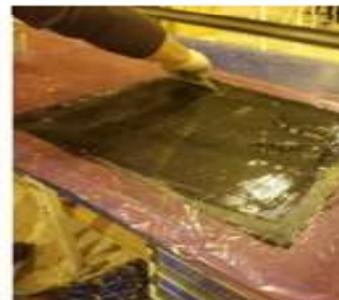
Wetting of the dry fabrics with the adhesive

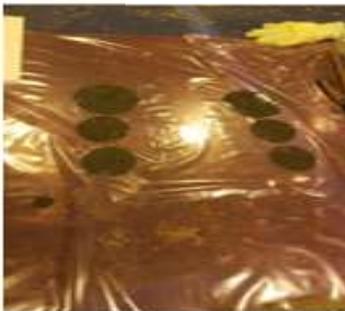
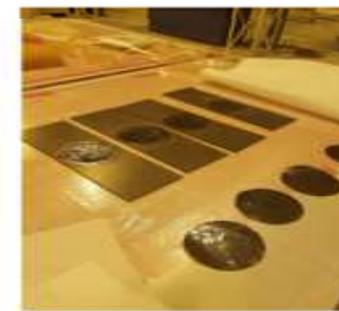
Preparation of the repair plies and lay-up

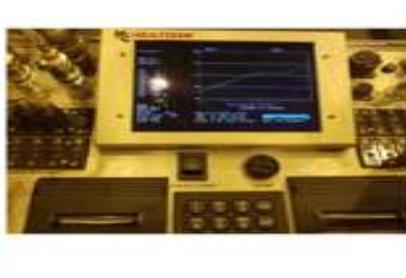
Bagging and curing with the HEATCON (heat blanket)
