INTERVENING WITH LANDSCAPE: A TOOL FOR URBAN
CONSERVATION

THE CASE OF YAŞIBEY, BURSA

A THESIS SUBMITTED TO
GRADUATE SCHOOL OF NATURAL AND APPLIED SCIENCE
OF
MIDDLE EAST TECHNICAL UNIVERSITY

DECEMBER 2016

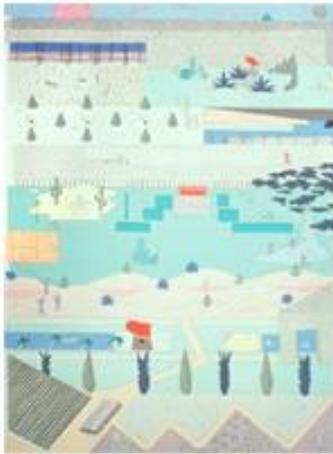
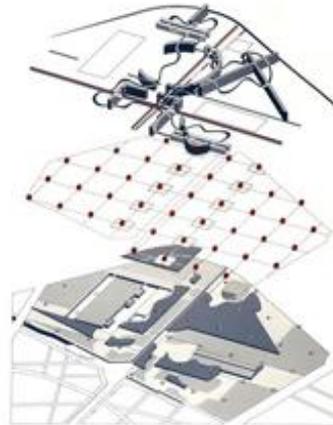
Figure 2.1 Bernard Tshumi and Koolhaas/OMA Parc La Villette Competition Entries. (a) Koolhaas/OMA miniature of the proposal, (b) Koolhaas/OMA layered program of the proposal. (OMA, n.d.) (c) Bernard Tshumi layered program of the proposal. (Bernard Tschumi Architect, n.d.).

nineteenth century slaughterhouse complex into an urban park in 1982 in Paris. The area became the large-scale leftover and unoccupied wasteland in the city after the functional outmoded of the complex. With this aim, the competition for the area succeeded beyond its aim with its landscape approaches. Rem Koolhaas/OMA and Bernard Tschumi's projects used landscape as a tool to organize different program and functions. The most important emphasis of the project is to use landscape as a medium for a dynamic and flexible structure to embody social, cultural, functional and programmatic changes over time. Rather than creating picturesque parks and recreational areas, architects improved living organism as a reflection and boulder element of both history and future (Figure 2.1). This competition showed that landscape was capable of connect and manage urban relations by providing layered, flexible, dynamic and non-hierarchical open structures for "all sorts of urban activities, planned and unplanned, imagine and unimagined, over time" (Waldheim, 2006:41).

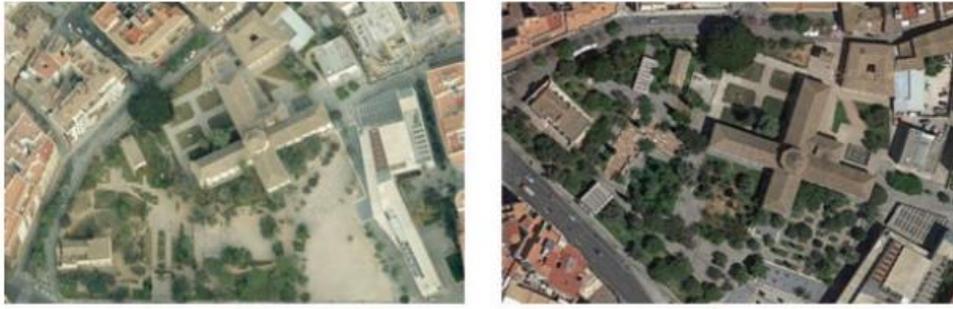
Figure 2.6 Gardens of Hospital de le Pobres Inocente in Valencia, Spain. (a) Before the rehabilitation. (Consuegra, n.d.) (b) After the rehabilitation of the hospital garden.²⁵

Regarding that, gardens of Hospital de la Pobres Inocentes in Valencia, Spain was the original hospital historic garden in the fifteenth century. Gardens were deteriorated after the demolition of hospital complex and new museum building additions. However, in its original location, garden preserved its boundaries and vegetation character. In 2013, with the aim of rehabilitation decision of old gardens, landscape intervention was performed to regain its historic values. Consequently, gardens were rehabilitated and regained their values within the new museum addition complex. Garden was rehabilitated to regain its value and to regenerate the integration of it historic relationship (Gardens of the Old Hospital, 2014)(Figure 2.6).

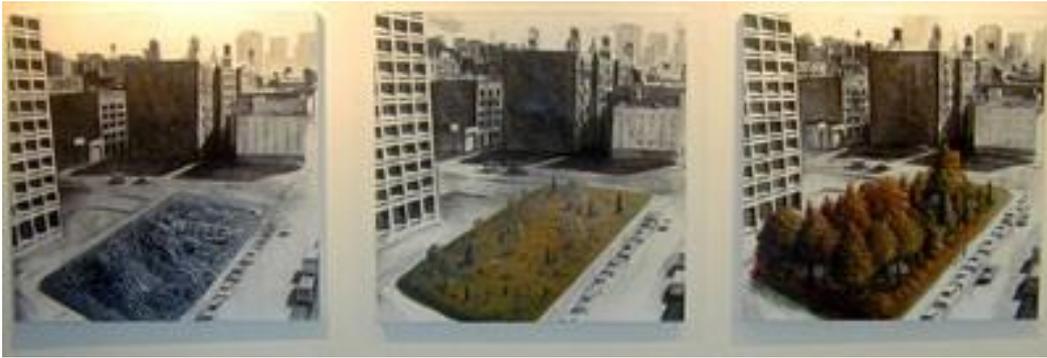
Figure 2.13 Time Landscape installation diagram by Alan Sonfist (Sonfist, 2014)

The Time Landscape project represent recalling of the totally disappeared environment within the lower Manhattan in New York. As Sonfist mentioned, In the previous condition, the area had abundant bird and tree population which some of the streets named after these populations. However, because of the urbanization, natural phenomena were lost and forgotten. Therefore, the project was designed as an artwork of Alan Sonfist which represent recalling of natural environment once existed in the area (Figure 2.13, Figure 2.14).

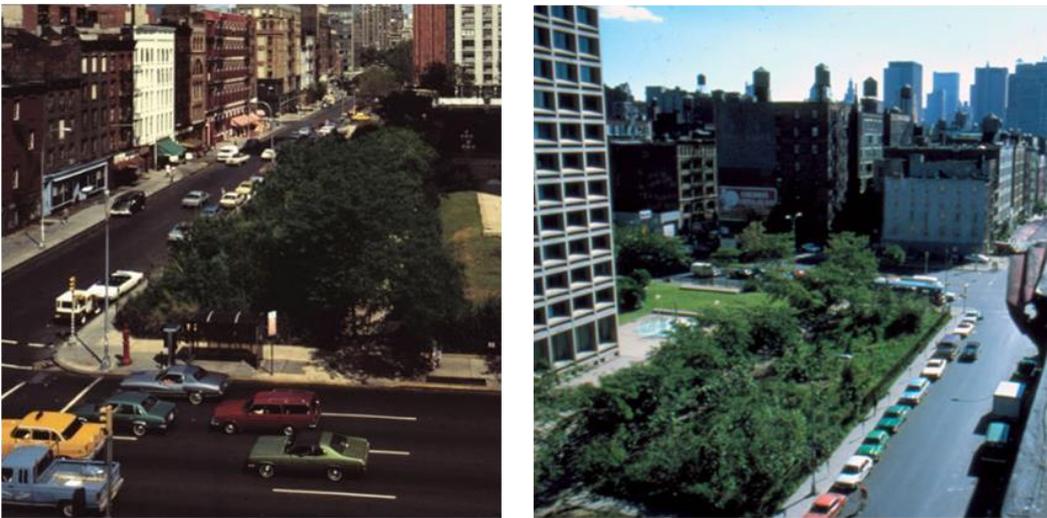
Figure 2.14 Time Landscape after the installation (Sonfist, 2014).

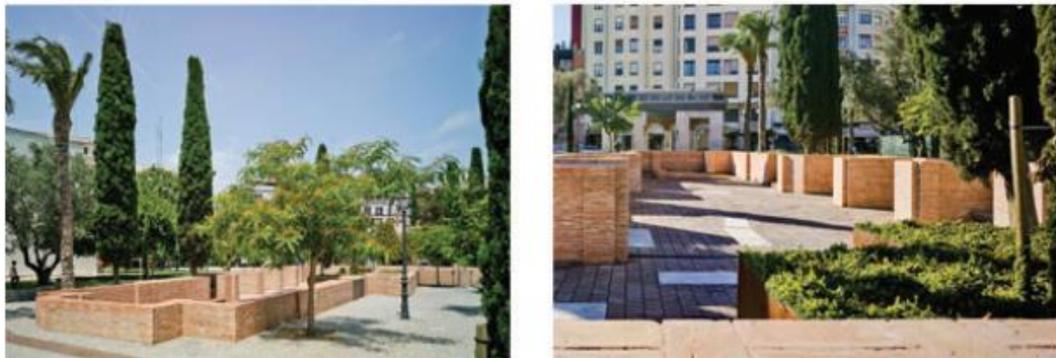
Figure 2.15 Gardens of Hospital de le Pobres Inocente in Valencia Spain, Garden Rehabilitation (Frutos, 2014).

Following, gardens of Hospital de la Pobres Inocentes in Valencia, Spain which was mentioned in the rehabilitation intervention had integrated conservation intervention as tracing the heritage values. While gardens were rehabilitating the traces of its hospital complex also which is the distinctive feature of the project to regain the relationship of building and integrated open area. Garden was designed as the integrative part of the building. Therefore, by using the building traces the lost relationship was regained within the contemporary museum complex open area (Gardens of the Old Hospital, 2014) (Figure 2.15).

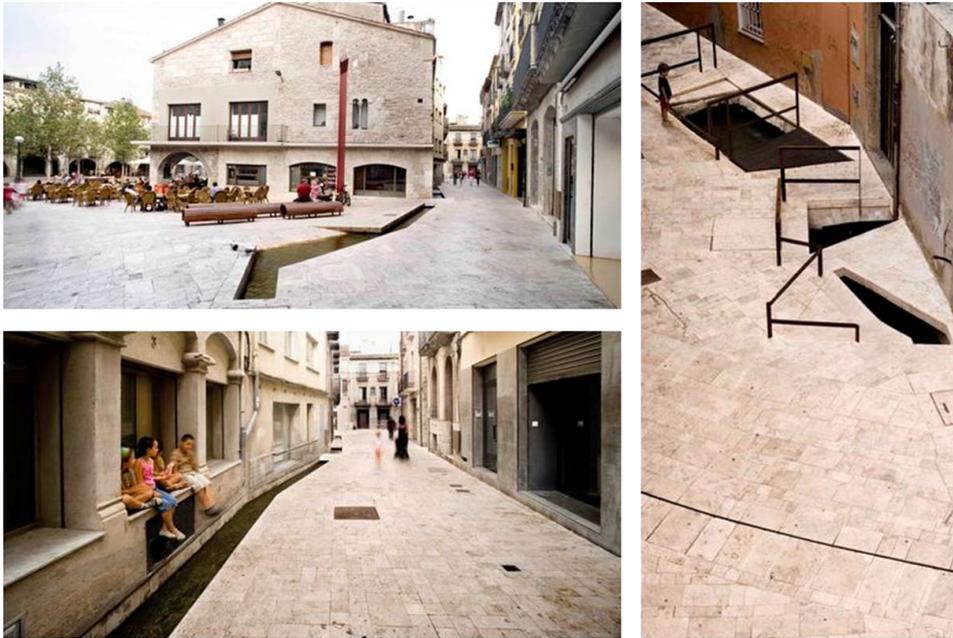
Figure 2.16 Banyoles Old Town Refurbishment Project (Goula, n.d.).

Banyoles old town refurbishment project in Banyoles, Girona, Spain consist of streets of a historic area rather than abandoned lot or area. However, within the refurbishment of general historic open spaces, landscape intervention which irrigation canals were followed traces of previous sewer system of the city made this project valuable. By tracing historic infrastructure route, required irrigation system were designed and regained to recall the irreplaceable value of water for the historic pattern of Banyoles. Besides, preserving circulation of water through the old town of Banyoles landscape intervention provide contemporary way of conservation plan by tracing the old route (Banyoles old town, 2014) (Figure 2.16).

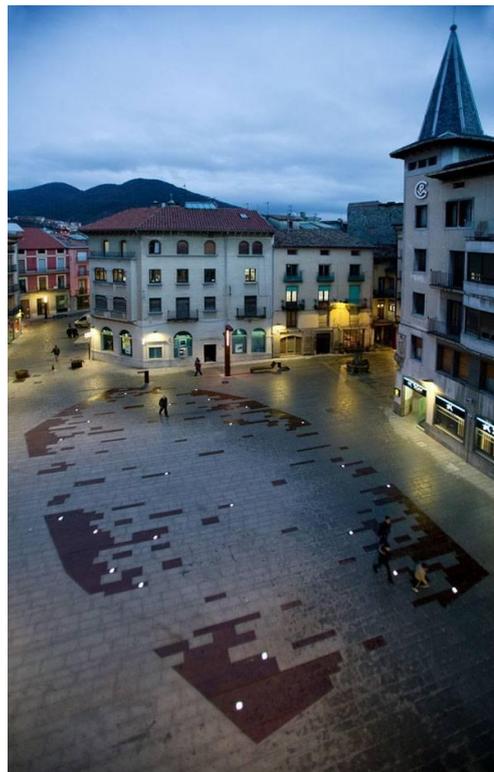
Figure 2.17 Ripoll Downtown Traces of Old Theatre (Comas, n.d.).

Likewise, Downtown Ripoll project has also used traces for recalling conservation intervention for the demolished historic theater. The area has located in Girona, Spain as an important historic industrial city of Catalonia. Within the pedestrianization project, historic theater boundaries were drawn with core-ten steel which is also the remembrance of city historic socio-economic industrial identity, on the ground at the original place. With this intervention, traces were used to recall its historic cultural and economic values altogether (McAtomney, 2009) (Figure 2.17).

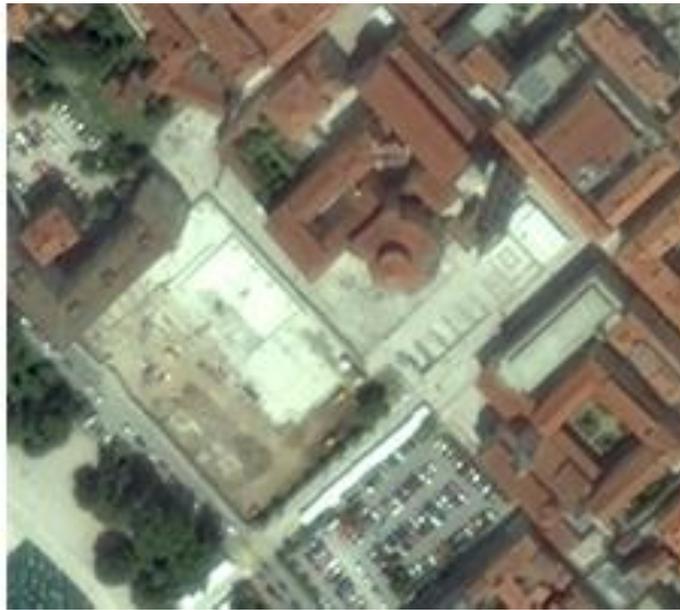
Figure 2.19 John Paul II Square, Zadar, Croatia before the intervention.²⁷

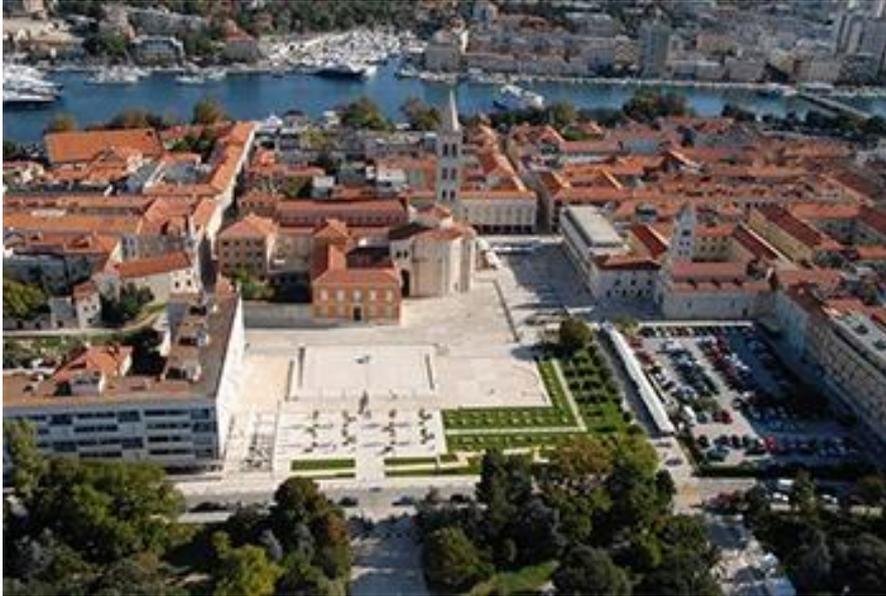
Figure 2.20 John Paul II Square, Zadar, Croatia after the intervention (Jakupovic, n.d.).

The John Paul II Square is another recall intervention in Zadar, Croatia. The area has a multi-layered characteristic such as Roman Forum, Severian basilica, the 16th century cistern and remains of medieval town walls. These multi-layered ruins were left abandoned and functioned as a car park. However, historic center was regenerate as a public open space in 2010. Within this project, traces of historic layer were used as open space elements to conserve and maintain the identity of the area with contemporary daily life (John Paul II Square in Zadar,2016) (Figure 2.19, Figure 2.20)

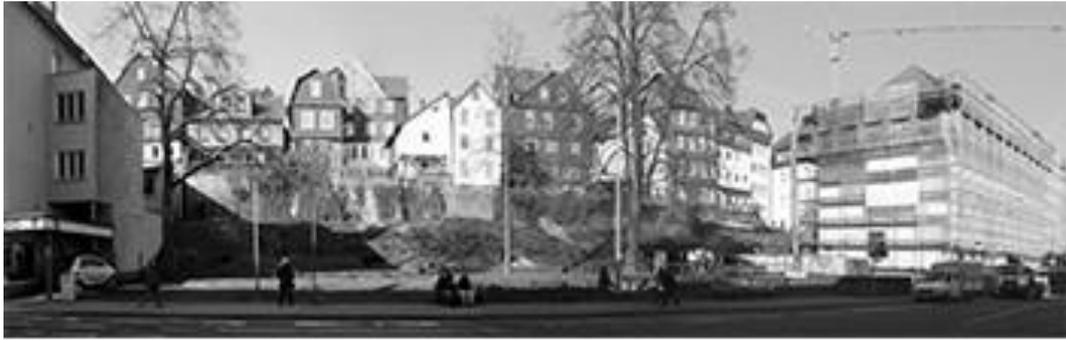
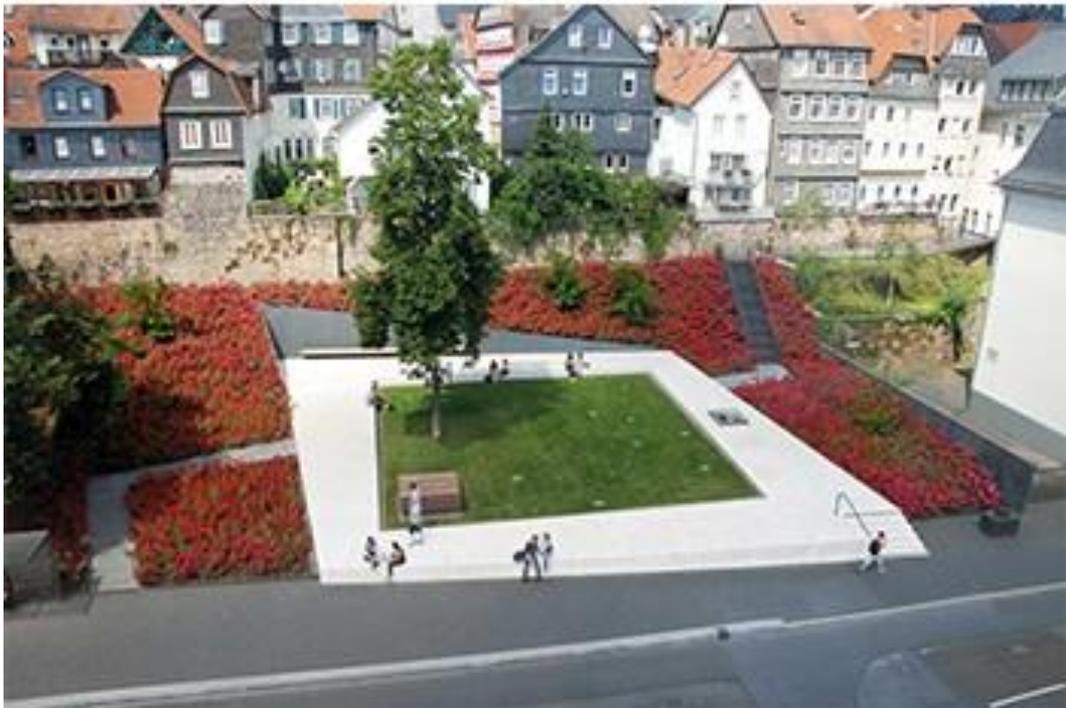
Figure 2.21 (a): top. Garden of Remembrance before the intervention (scape Landschaftsarchitekten, n.d.). **(b): bottom.** After the landscape intervention. (Nützel, n.d.).

The Garden of Remembrance is a landscape intervention project to become memorial and remembrance of war-related demolition. In the area, there was Jewish synagogue which was demolished in 1938 by Nazi regime in Germany. After the bombing, ruins were covered with soil to forget totally. Therefore, the project represents as a memorial to the Jewish culture and their struggles in these times. The area was designed as open public space and destroyed synagogue traces were used as the boundaries of the area. Additionally, some of the preserved elements from demolition were also added to recall the previous structure (Garden of Remembrance, 2016) (Figure 2.21).

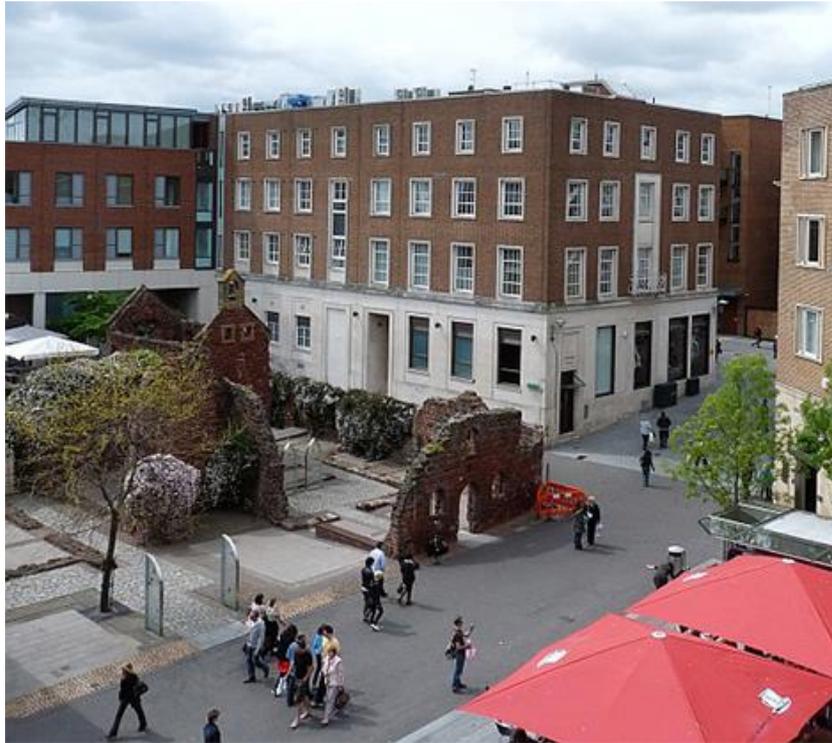
Figure 2.22 St. Catherine's Chapel and Almshouses in Exeter, UK, after the intervention.²⁸

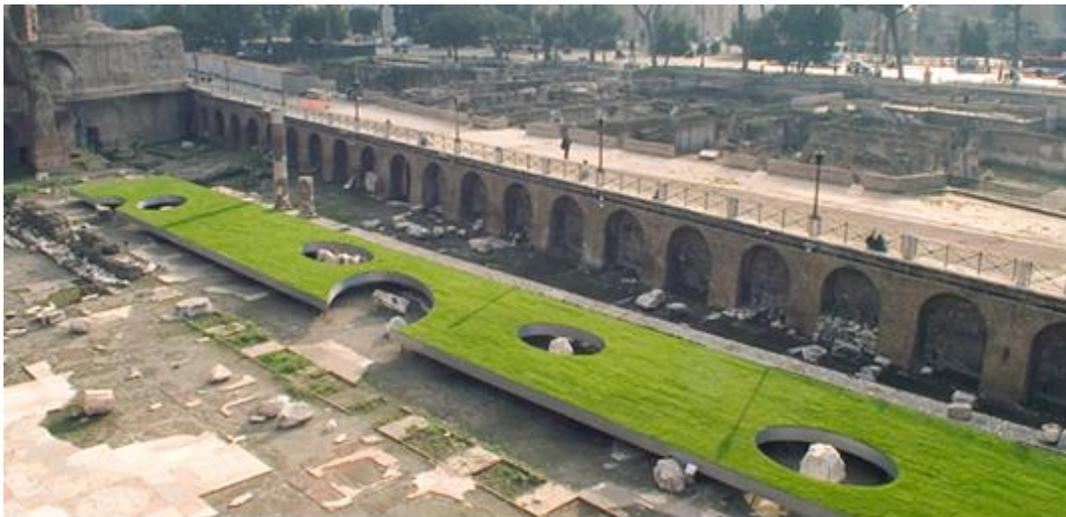
Figure 2.29 Wonder Holland, temporary landscape intervention in Rome by West 8 (Wonder Holland, 2004).

Wonder Holland is a landscape injection to Mercati di Traiano archeologic site by West8 Urban Design and Landscape Architecture. The aim of this project is to ensure the temporary new injection as a symbol for Dutch landscape greenness with providing users experienced both historical and contemporary values at the same time. With the respect of historic remains, intervention was installed in harmonious with archaeological site by creating minimum contacts and impact between historic and contemporary elements (Wonder Holland, 2004) (Figure 2.29, Figure 2.30).

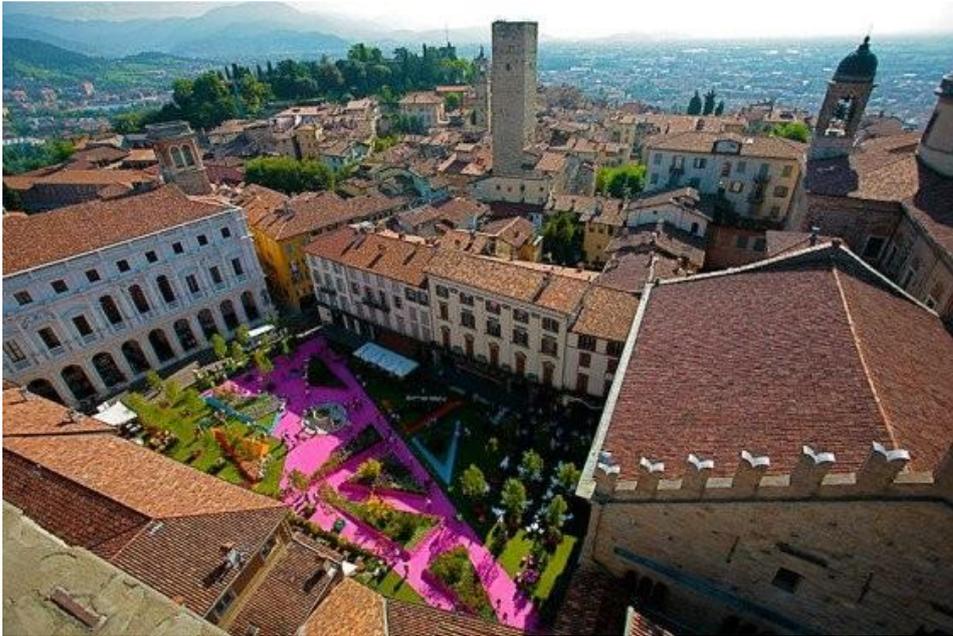
Figure 2.30 Piazza Verde Temporary Landscape Temporary intervention. (Studio Fink, n.d.)

Piazza Verde project is another temporary landscape intervention in Bergamo, Italy. Originally, the area is a historic square named as Piazza Vecchia. In September 2014, international landscape symposium Arketipos held in Bergamo to transmit the main theme of well-being and healing. An important consideration of the project is that designers main question is “How could the new and old coexist momentarily in an unexpected way as a part of a continually evolving urban narrative?” (Piazza Verde, 2015: parag. 3). With this aim, London-based landscape architecture firm Studio Fink decided to use the old historic square as the main object for transferring the theme. Designers considered very carefully to preserve the fabric of historic

area as well as to inject new theme and temporary functions in the area. Thus, Piazza Verde established around between old and new regarding creating new and purposeful social platform, on the other hand, provide temporarily dialog with the historic urban element (Piazza Verde, n.d.) (Figure 2.31).

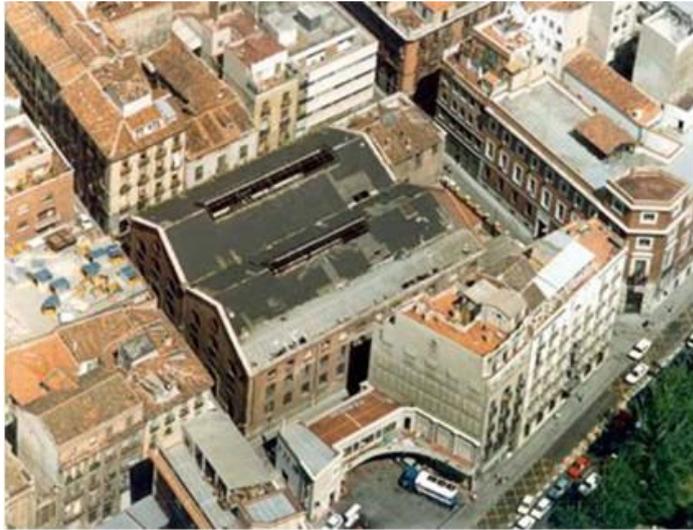
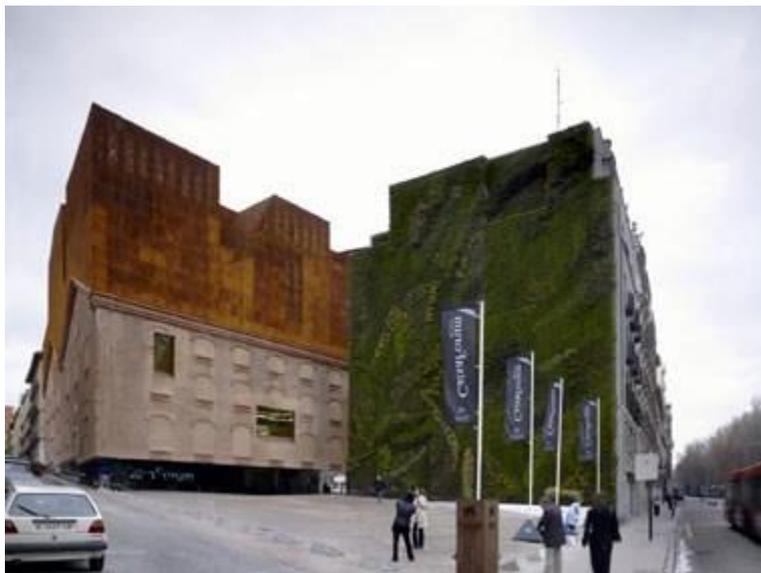
Figure 2.31 Caixa Forum vertical landscape intervention, Madrid, Spain. (a) Before the intervention (Herzog & de Mauron, n.d.). (b) after the intervention of vertical garden. (Rihters, n.d.).

As an example, vertical landscape injection, Caixa Forum green wall intervention is very descriptive project. Caixa Forum is located at the core of Madrid historic areas which consist of renovated old power station. Historic building remains which is one of the valuable industrial area in Madrid, was became invisible by building additions. After renovating the existing complex and cleared the area in front of the building designers got into different difficulties which is neighbor existing buildings. These buildings facades and height and fabric are not incompatible with the historic area moreover, they dominated the importance of renovated building. To demolished or shorter the neighbor building is not an option because of the economic and functional reasons. At this point designers intervene the building façade next to renovated historic building with minor but very effective vertical landscape element. They transformed neighbor facade into green wall to prevent fabric disharmony and give main attention to historic areas. With this intervention,

they provide economical and efficient way for connect and the same time separate two different fabric (Figure 2.32) (CaixaForum, 2008).

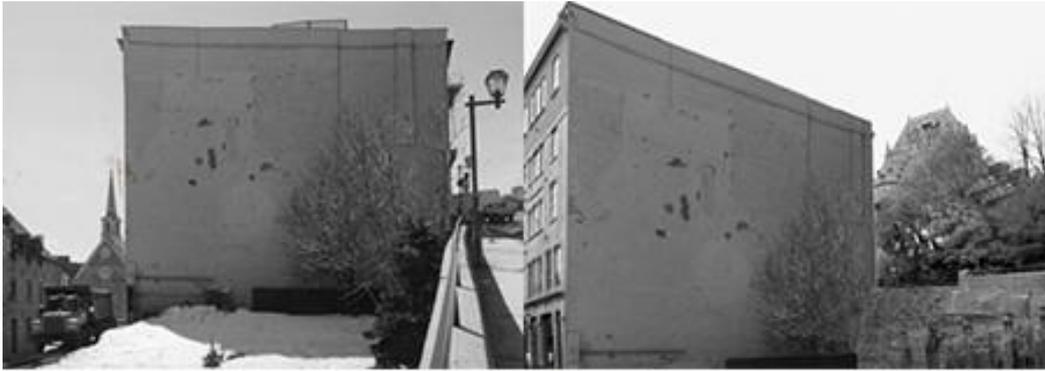
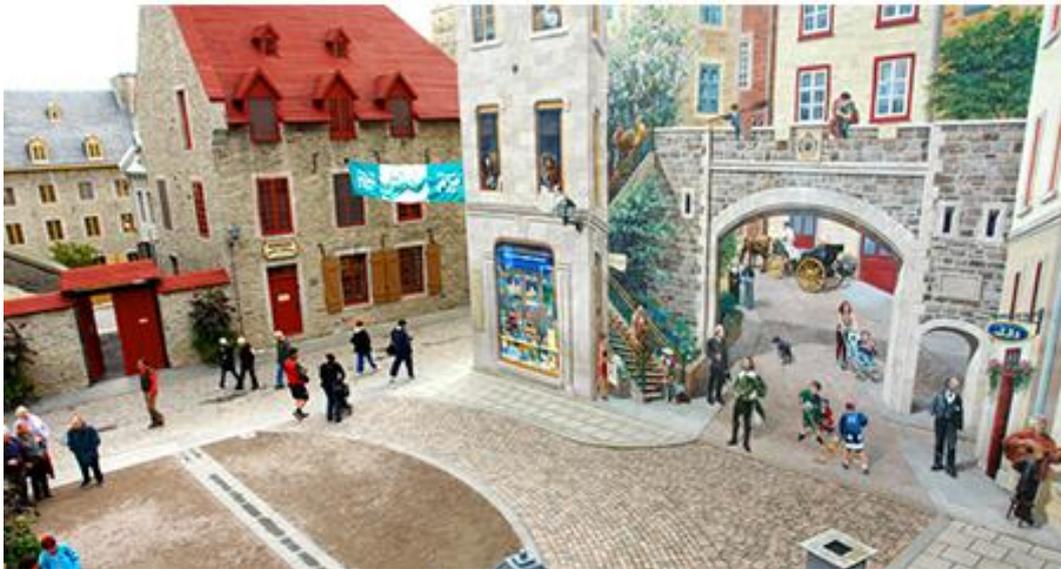
Figure 2.32 Canada, Quebec old city vertical landscape intervention. (a) before the intervention. (b) after the intervention.³⁰

Another example of vertical intervention is held in Quebec, Canada. Quebec old city is the only remaining fortified city in North America which registered as UNESCO heritage site as a Historic District of Old Quebec in 1985. Some of these fortified colonial city blind facades were intervened with Fresco wall arts regarding the urban heritage project. With the help of numerous fresco, fragments which formed the city identity depicted on different vertical planes. These intervention aims to help visitors to understand and celebrate the identity of the area and commemorate the history of the city with its inhabitants, districts and buildings. As a social part of this project, by depicting different cultural identities, this intervention ensure to tighten connection between diverse groups and to give them sense of belongings (Figure 2.33) (Cousson, n.d.).

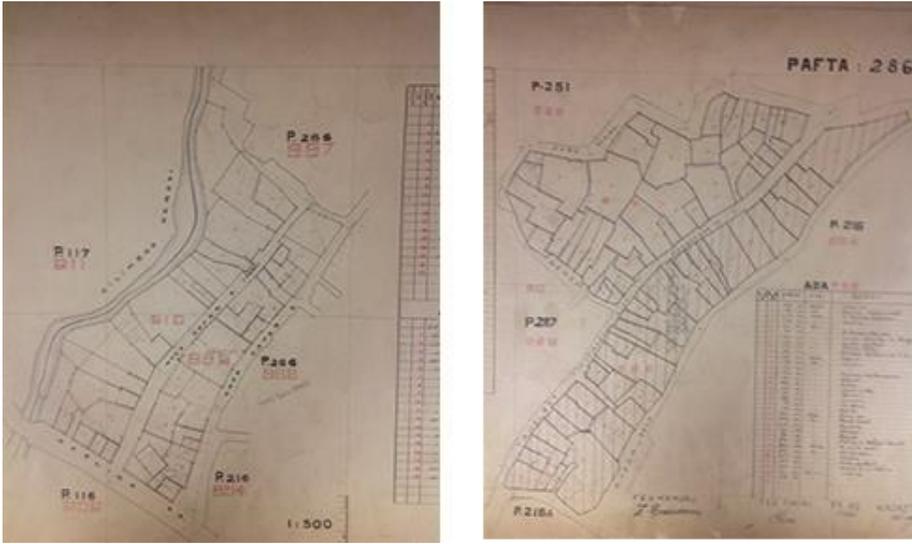
Figure 3.22 1939 Cadastral Map (Bursa Regional Directorate of Land Registry and Cadastre archive)

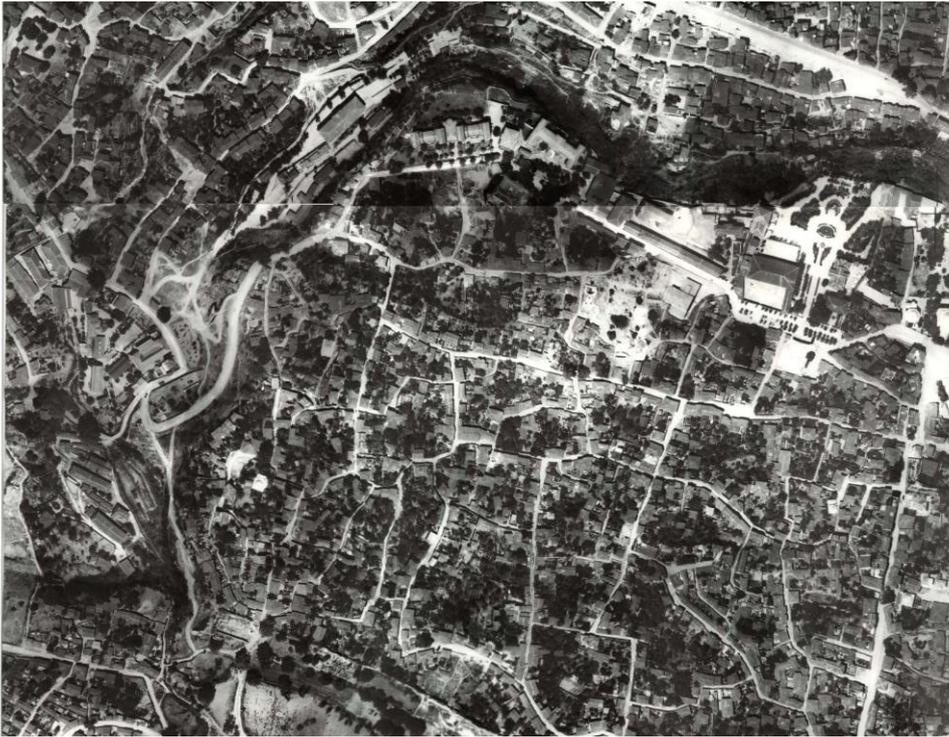
Figure 3.23 1939 Yahşibey aerial photo. (Bursa Metropolitan Municipality Archive)

According to the building lot functions and aerial photo of 1939, some of the traditional urban landscape was lost its functions and existence which created several empty lots and blocks within the area (Figure 3.21, Figure 3.23). As Dörtok Abacı (2007) mentioned, although the 19th century was very bright for this quarters both socially and economically, as a result of political and economic movements in Bursa, the area lost its social and economic importance at the end of 20th century. Moreover, problems about silk industry and new industrial focal points caused the relocation of these complexes (Dörtok Abacı, 2007). Regarding that, one of the significant urban landscape elements of silk factories were either abandoned or demolished.

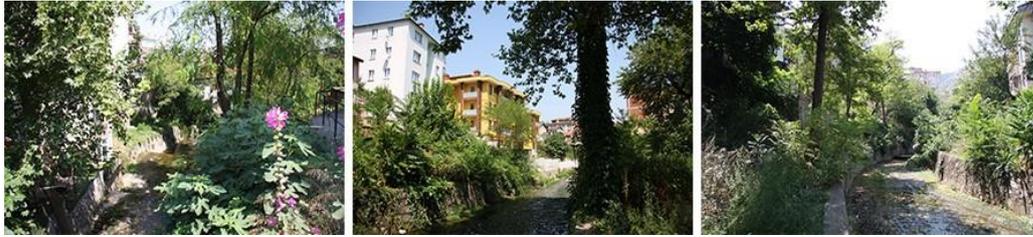
Figure 3.26 Cilimboz streambank natural landscape characteristic; Cilimboz Stream (Arslan Sönmez, 2015)

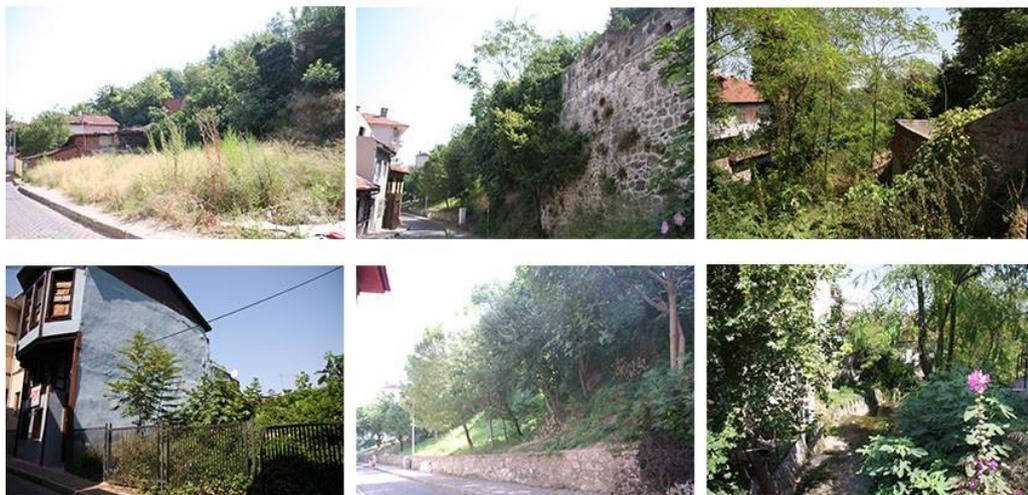
Figure 3.27 Yahşibey natural landscape characteristic; vegetation (Arslan Sönmez, 2015)

In the present time, area consist of one of the characteristic landscape in harmonious with traditional settlement in the city center result from Cilimboz stream (Figure 3.25) and the citadel hillside natural landscape. There are three different vegetation characteristics depend on their landforms. First, one of the most abundant vegetation extend along from the beginning from citadel foothill to Cilimboz stream. Especially, abandoned lots and open spaces create natural and spontaneous green characteristics on this side of the area. On the other hand, the west side of the Cilimboz stream has plain and uniform land characteristic which has denser urban forms resulted less green tissue than the other side of the stream. Lastly, characteristic landscape is settled near the Cilimboz stream. The stream bank has abundant but uncontrolled vegetation characteristic because of the abandonment of the area (Figure 3.26, Figure 3.27).

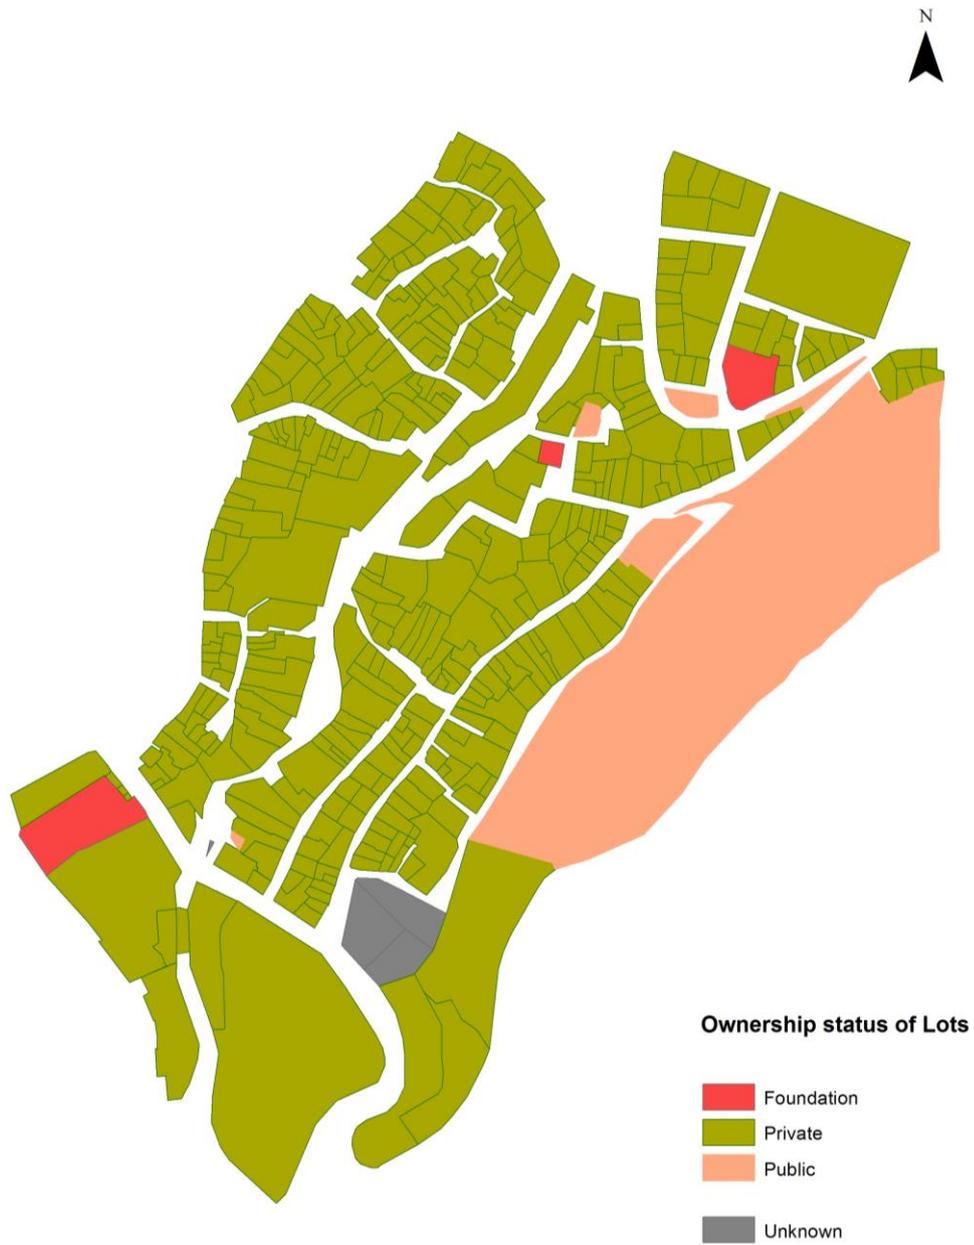
Figure 3.28 Ownership status of the area (Arslan Sönmez, 2015)

Concerning the Yahşibey's ownership and registration status shows that, the area mostly consists of the private lots with few foundation and public lots in the urban landscape. On the other hand, existing lots show that there are ninety-one registered lot which mostly comprise of traditional residential areas which are predominantly gathered around the Yahşibey street.

Following the general ownership and registration status of the lots, as previous studies indicated, there are different open space uses integrated with build-up areas in this area (Figure 3.28, Figure 3.29). From the Suphi Bey Map, area has faced different changes and developments. Because of the planning activities and perspectives about open spaces, these areas were the most impressible parts of the historic urban landscape of Yahşibey. To understand the open space characteristics comprehensive site survey needs to be done. However, both because of the existence of private lots and the scope of the thesis most of the open space did not study elaborately. However, general site survey was done by the author and supplementary sources which both visual and site survey data was taken from the previous studies.³⁶

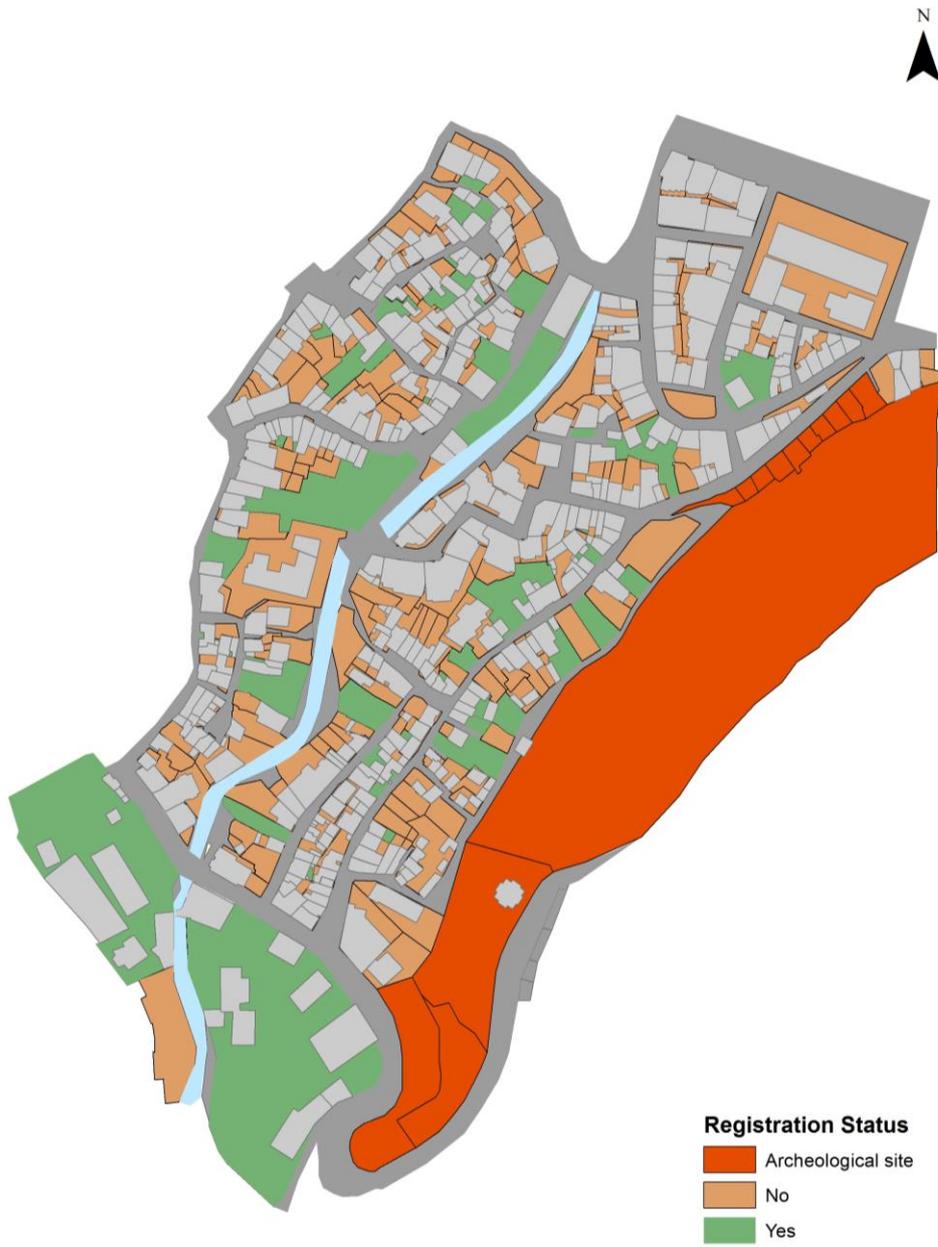
Figure 3.29 Registration status of the area (Arslan Sönmez, 2015)

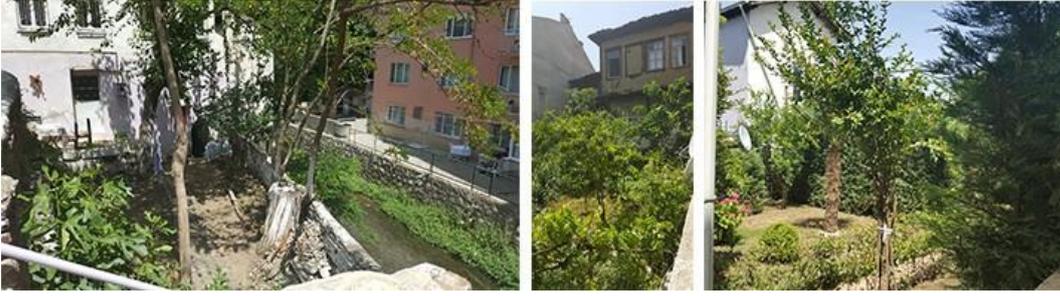
Figure 3.30 House garden (Arslan Sönmez, 2015)

Concerning that, there are eight different open area uses in the area. First, house gardens can be identified as the integrated open areas of residential buildings. This function is an active green space in the area which are used as garden. Within the area this function predominantly adjacent with the traditional houses. These open areas are part of the traditional houses in the area (Figure 3.30, Figure 3.31).

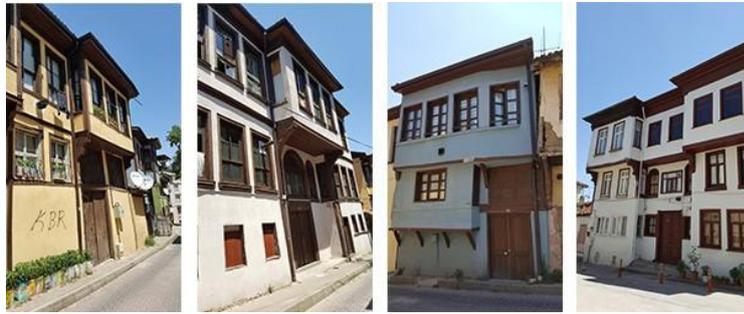
Figure 3.31 Traditional houses in the area (Arslan Sönmez, 2015)

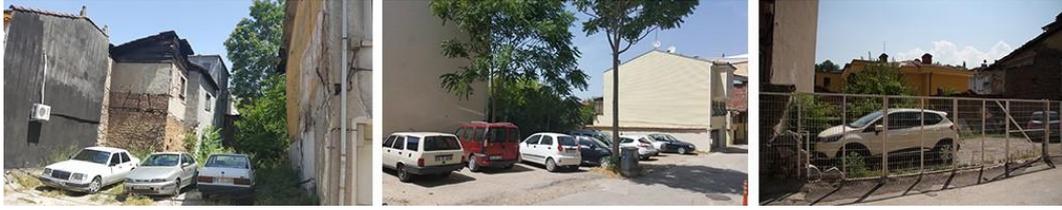
In the area, there is no official parking area for the residents or other visitors. Because of the traditional tissue's narrow street features parking lots are essential needs for the historic areas. In this sense, most of the empty lots use as parking areas which are surrounded with fences or chains for private purposes (Figure 3.32). In the area, most of the empty building lot uses indicate as a carpark. On the other hand, at the north end of the Yahşibey street, there is another parking area which the space is within the boundaries of the registered Archeological site. Addition to that, in the planning strategies for the area, new high-rise apartment buildings' open areas or buildings that are compatible with the historic fabric open spaces organized as parking area in this sense.

Figure 3.32 Car park areas (Arslan Sönmez, 2015)

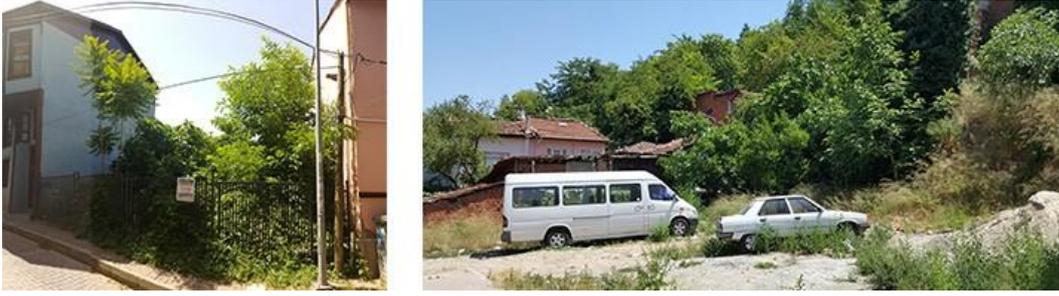
Another open area compromise of empty building lots (Figure 3.33). In the area, starting from the beginning of 20th century, traditional buildings were demolished and new structures had been constituted. However, empty lots begin to increased day by day. Moreover, new construction establishes immediately within these areas. Most of these areas formed because the traditional houses lose their structural strength and whether they collapse by themselves or because of the security concerns local authorities demolish them. Within the area, empty building lots predominantly exist around the Yahşibey street which holds the traditional pattern of Yahşibey.

Figure 3.33 Empty building lots (Arslan Sönmez, 2015)

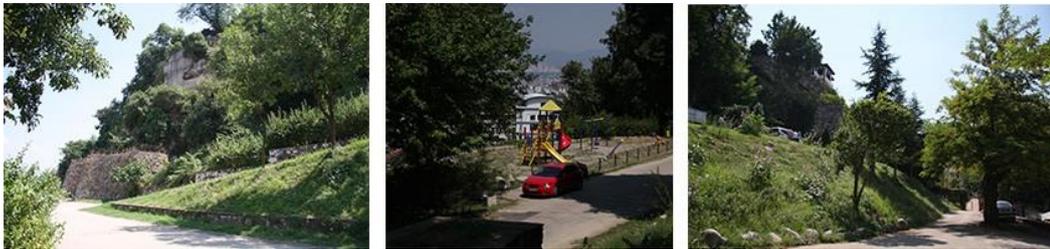
In the area, there is one open area which identified as recreational green area (Figure 3.34). The area is part of the Archaeological site on the citadel foothill which the largest green area of Yahşibey. This area is organized as a recreational green space which within the boundaries there is a playground, walking paths and sitting elements. Rather than recreational areas, there are some green open spaces which identified as unqualified green areas because of their unqualified open space uses. One of the open area is at the intersection of Yahşibey street and 17. Dere street. The area organized with pathways to enable the connection with the Citadell hillside however because of the abandoned vegetation and inadequate functional elements area remains unqualified. On the other hand, the open area at the Kaplıca street identified as unqualified green area. Like the other area, this area organized with sitting elements and some pathways however, because of the abandoned vegetation and inadequate recreation elements this area also remained unqualified.

Figure 3.34 The Citadel Hillside recreational green area (Arslan Sönmez, 2015)

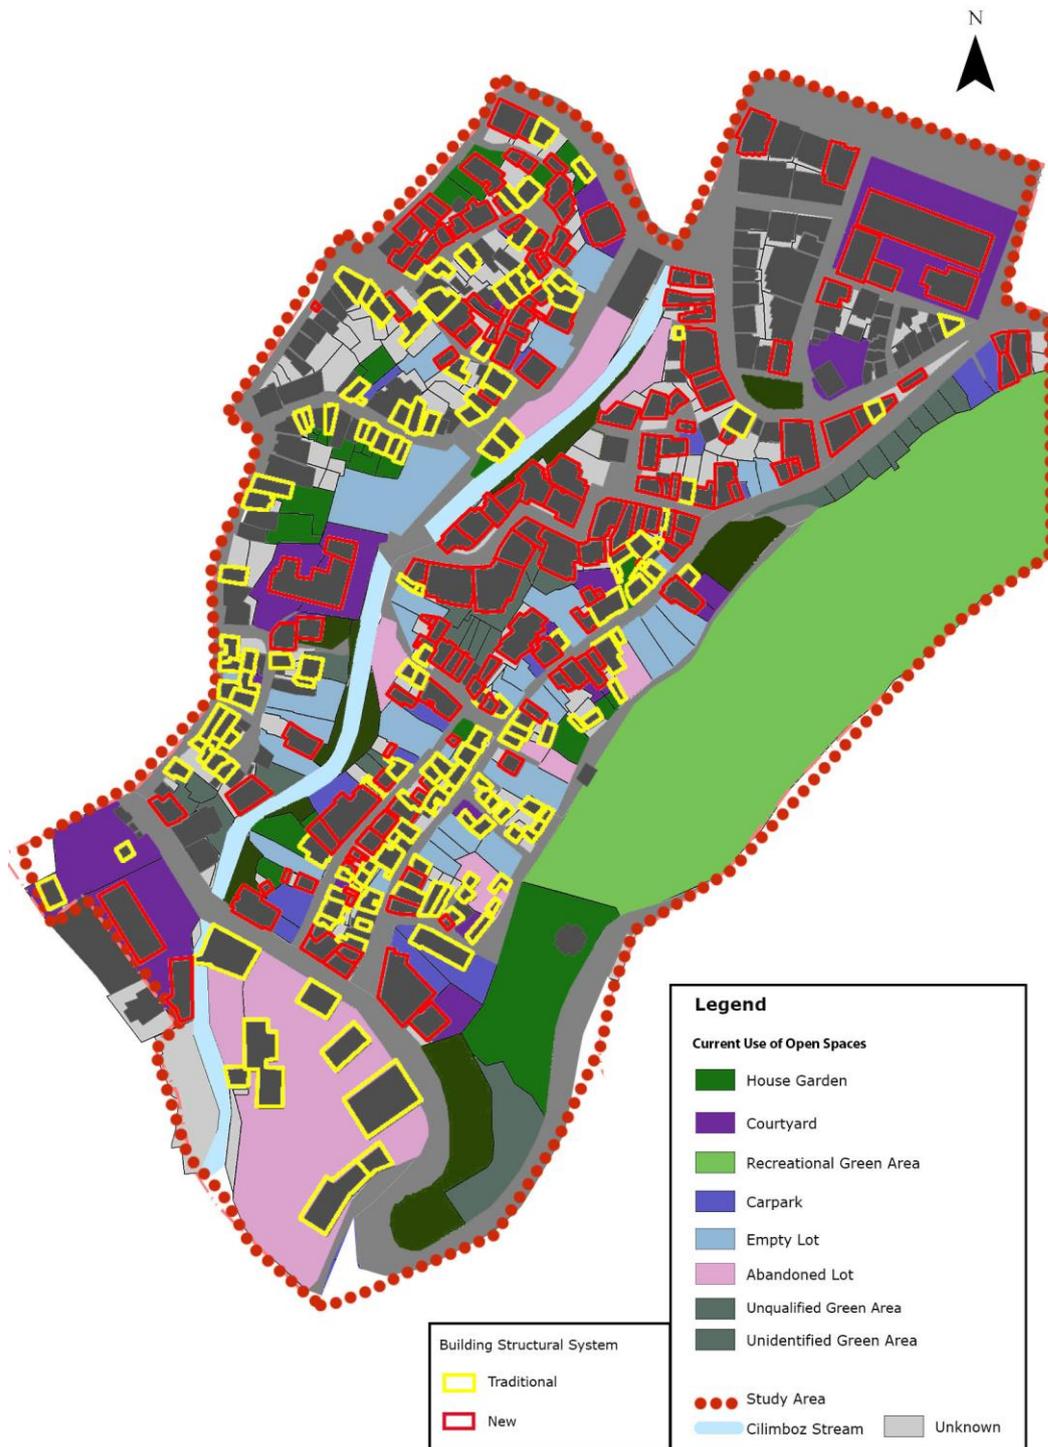
Therefore, open areas in the Yahşibey historic landscape have different uses (Figure 3.35). Concerning to that uses, traditional open areas integration with the buildings are identified depend on the building values in the area. The value attribution first determined to rely on their structural systems, traditional and new buildings. Concerning that, based on the open space uses integrated with traditional buildings, indicates that landscape culture lost their qualities in the area. There is few qualified open area uses in the area which preserves their traditional relationships. Most of the areas were abandoned, lost their qualification or worst they were demolished

Figure 3.35 Current open space uses of the area (Arslan Sönmez, 2015)
