INTERVENING WITH LANDSCAPE: A TOOL FOR URBAN
CONSERVATION

THE CASE OF YAŞIBEY, BURSA

A THESIS SUBMITTED TO
GRADUATE SCHOOL OF NATURAL AND APPLIED SCIENCE
OF
MIDDLE EAST TECHNICAL UNIVERSITY

DECEMBER 2016

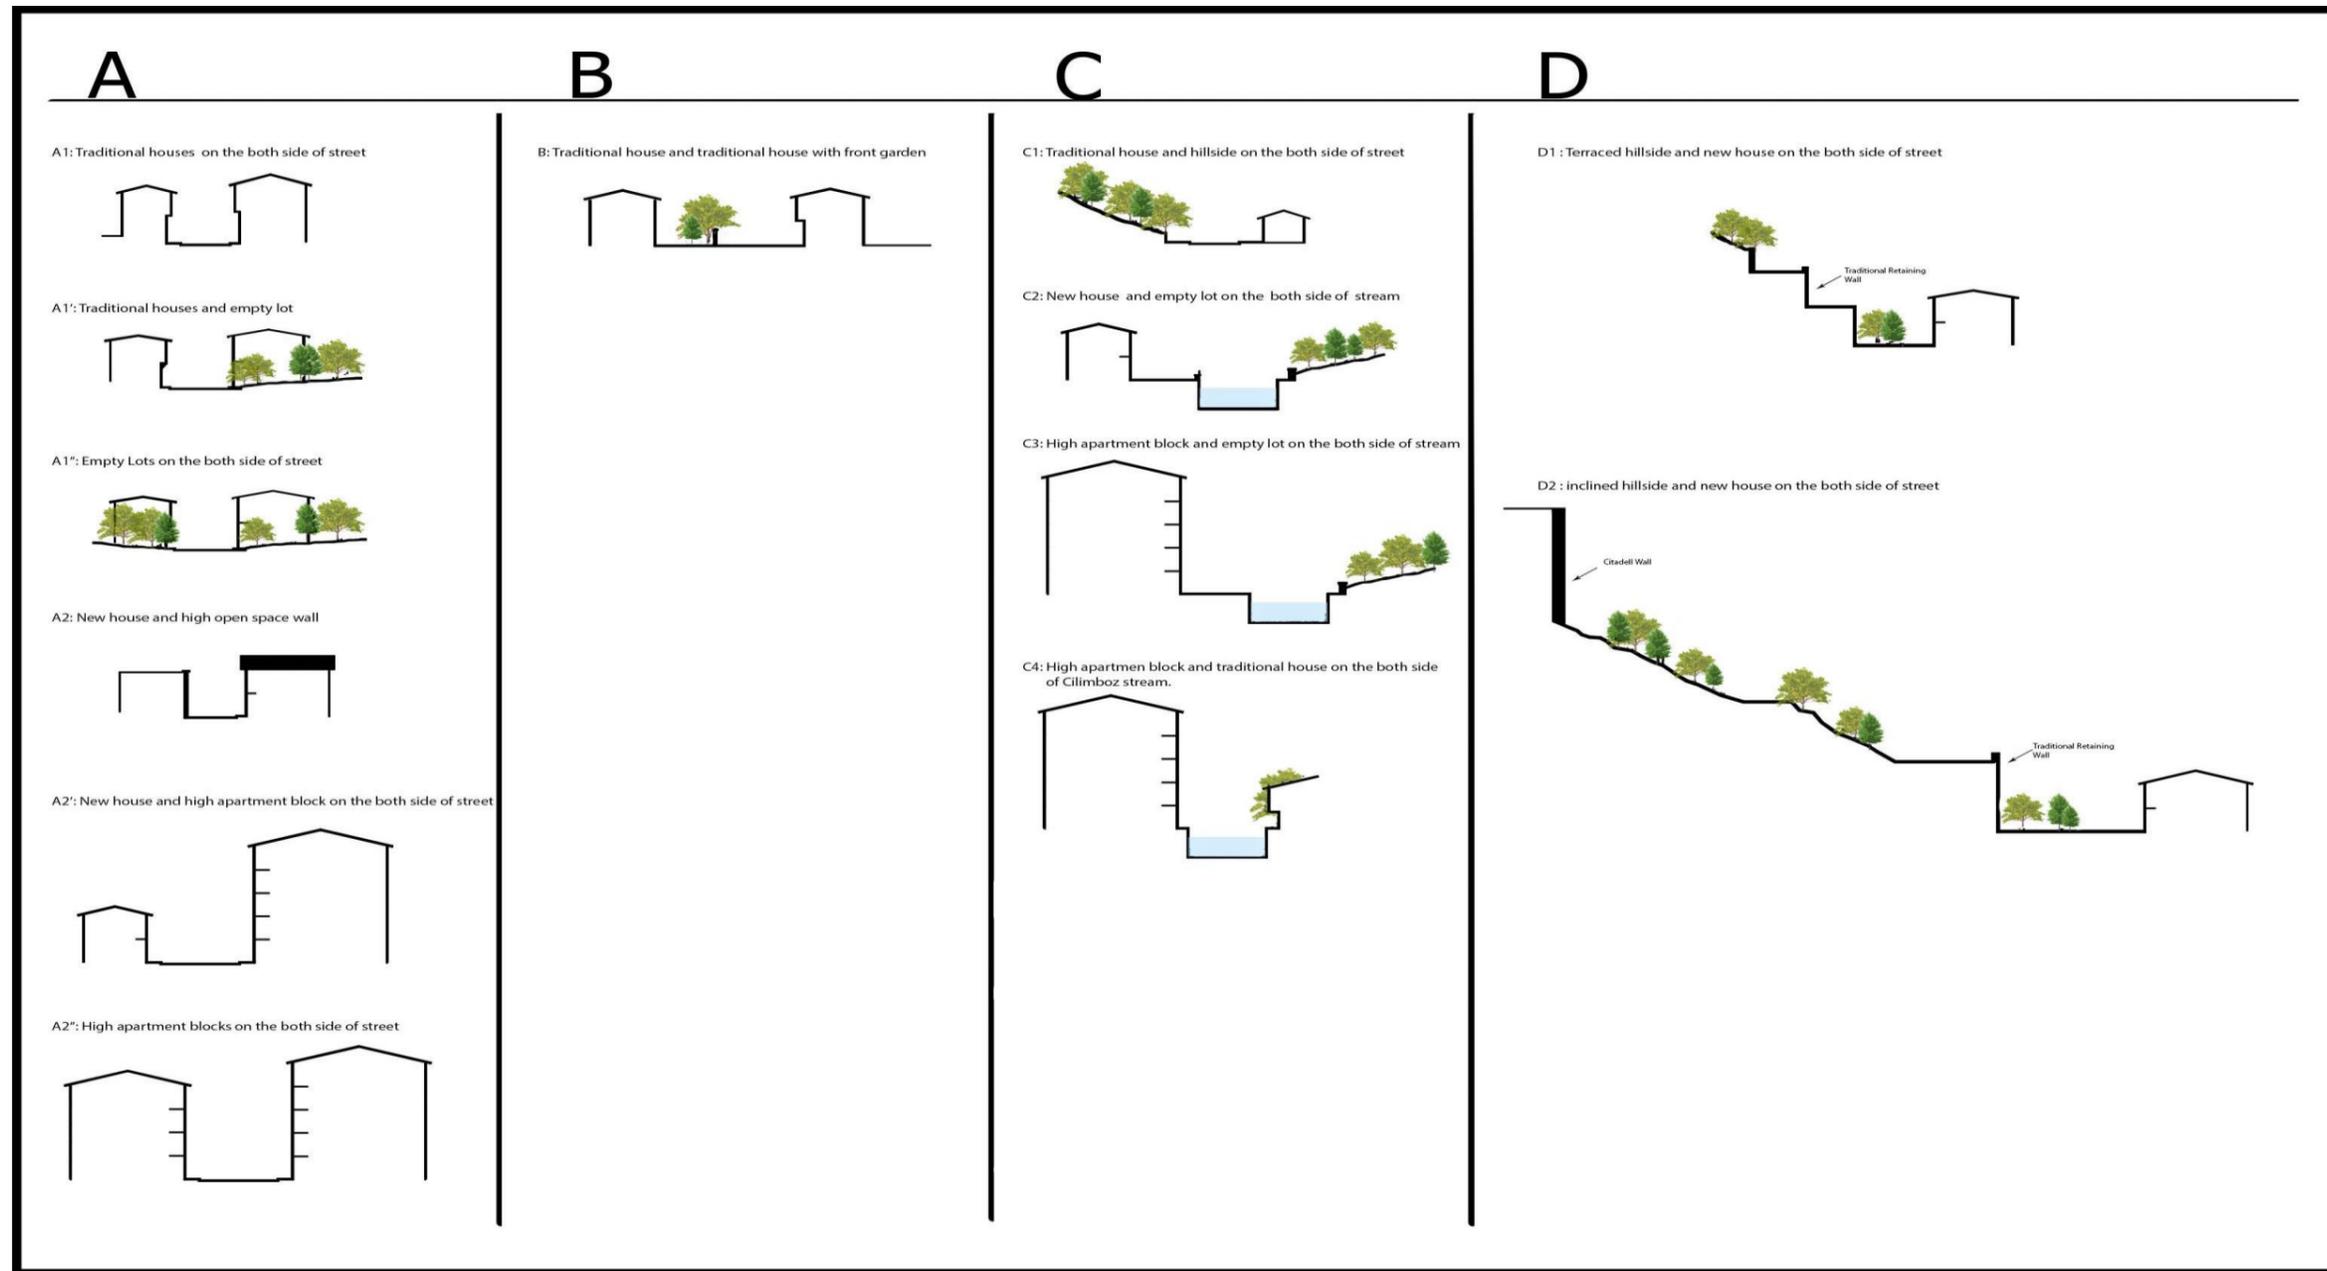
Figure 3.38 Street sections of the area. (Sections were modified by the author on the basis on the drawings of the ‘Urban Conservation Project of Muradiye’ study.³⁷

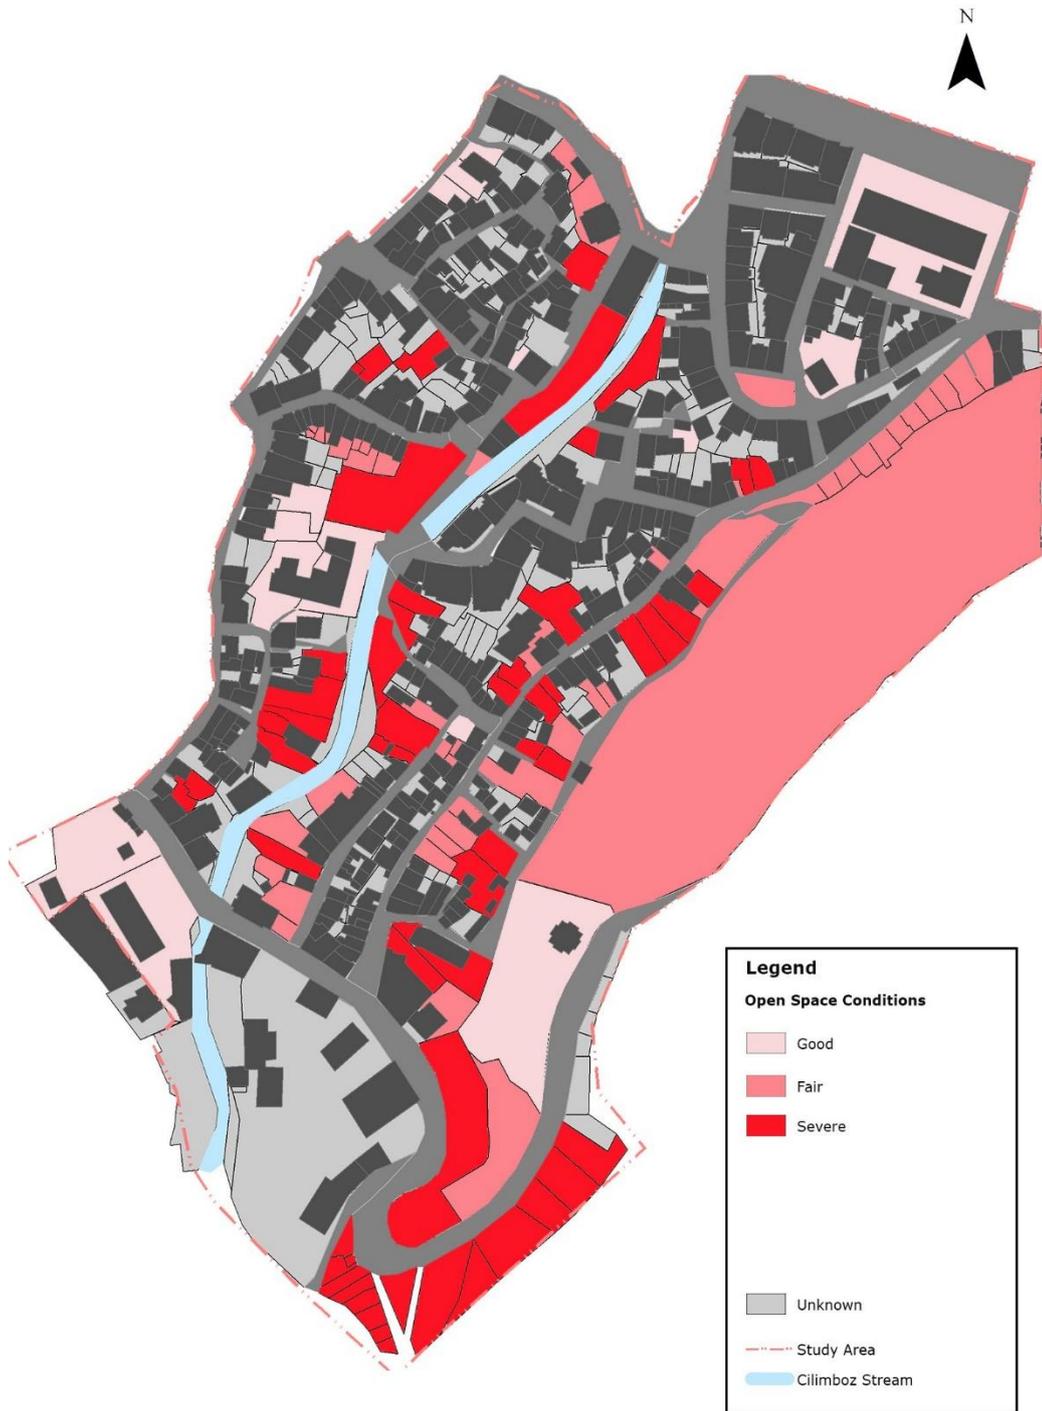
Lastly to understand the current conditions of the historic urban area, conditions of the open spaces identified as good, fair and severe (Figure 3.39). Rather than their contributions to historic pattern or values, they were evaluated solely. In this evaluation, their functions, whether they are used in their functions or not, daily use, how active these open spaces, together with sanitary and security conditions comprised the main concerns. In this sense, open spaces that are used daily with their functions and provide sanitary and security conditions were categorized in good conditions. These open spaces are very few in the area. Because most of the open space are not used actively anymore. Secondly, open spaces that are still preserve their function however, not used actively or they used daily without their own function together with sanitary and security conditions. Most of the open spaces are in fair conditions. Whether they used or not residents and local authorities try to maintain their sanitary and security conditions. Then, open spaces which are not in use and have serious sanitary and security conditions are categorized as severe condition. These spaces mostly comprise of empty and abandoned lots which areas were used whether trash collecting spaces which create sanitary problems such as bad odor, infestation etc. or temporarily used which create security problems. These open spaces can be seen at the east side of Cilimboz stream because of the empty and abandoned spaces commonness.

Figure 3.39 Current open space conditions (Arslan Sönmez, 2015)

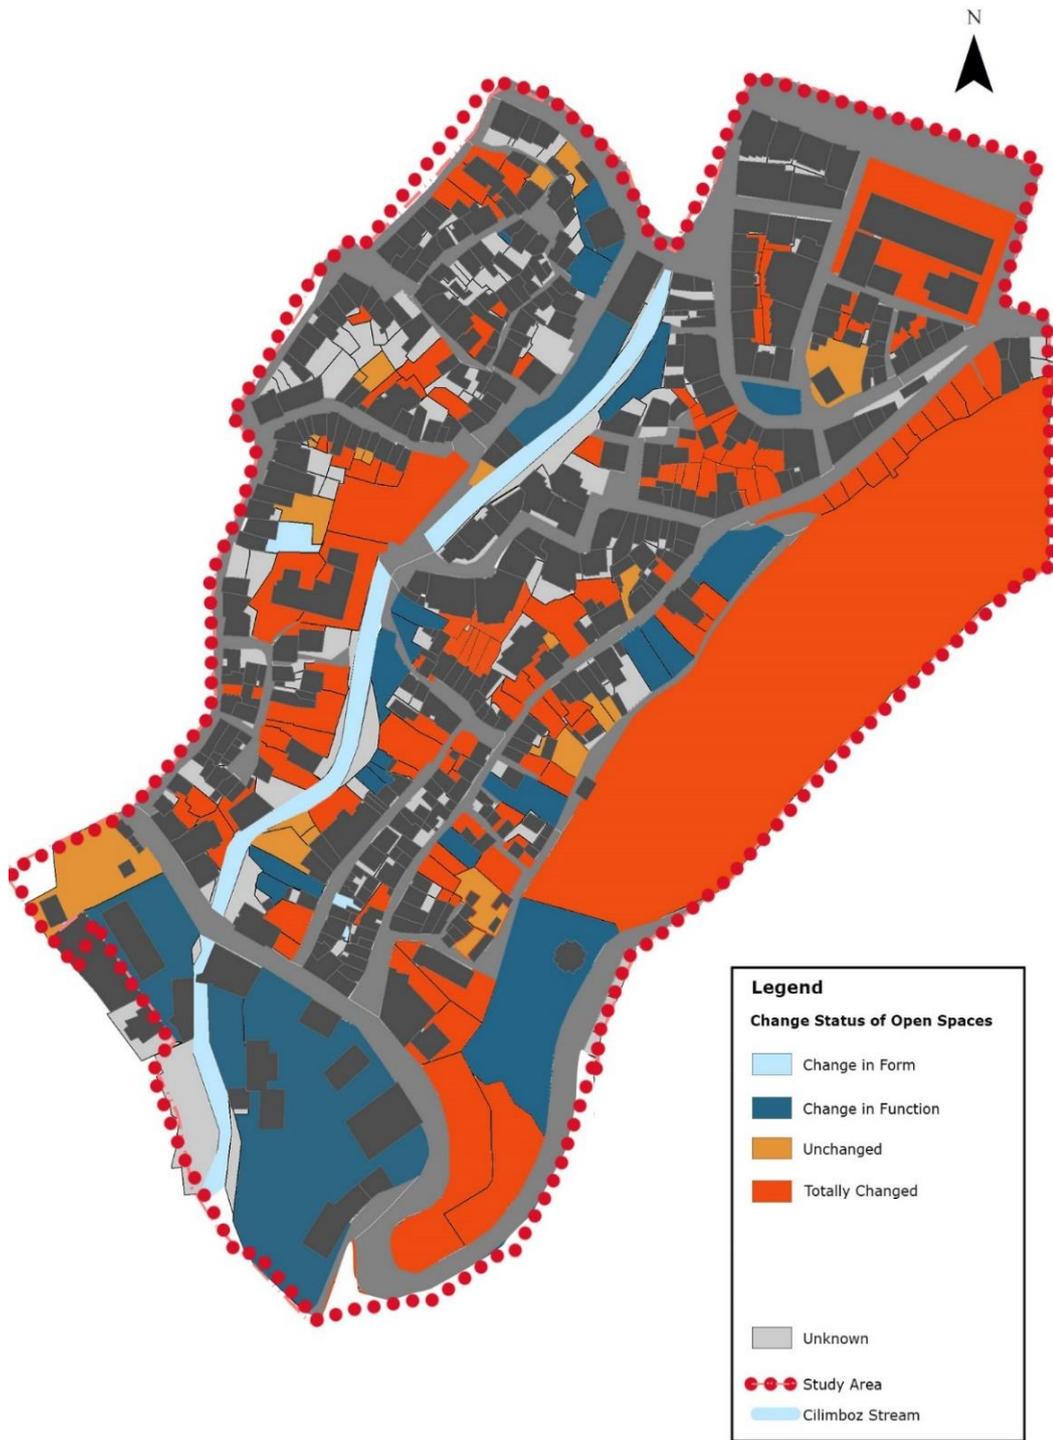
Lastly, there are very few open spaces that preserve their forms and functions since Suphi Bey Map. The comparative study shows that these areas comprise of the two religious complexes which are Altıparmak Mosque and Kocanaib Tomb and few traditional building lots. However, these traditional areas are not registered, and some of them have compatible new buildings (Figure 3.40).

Figure 3.40 Change status of the study area (Arslan Sönmez,2015)

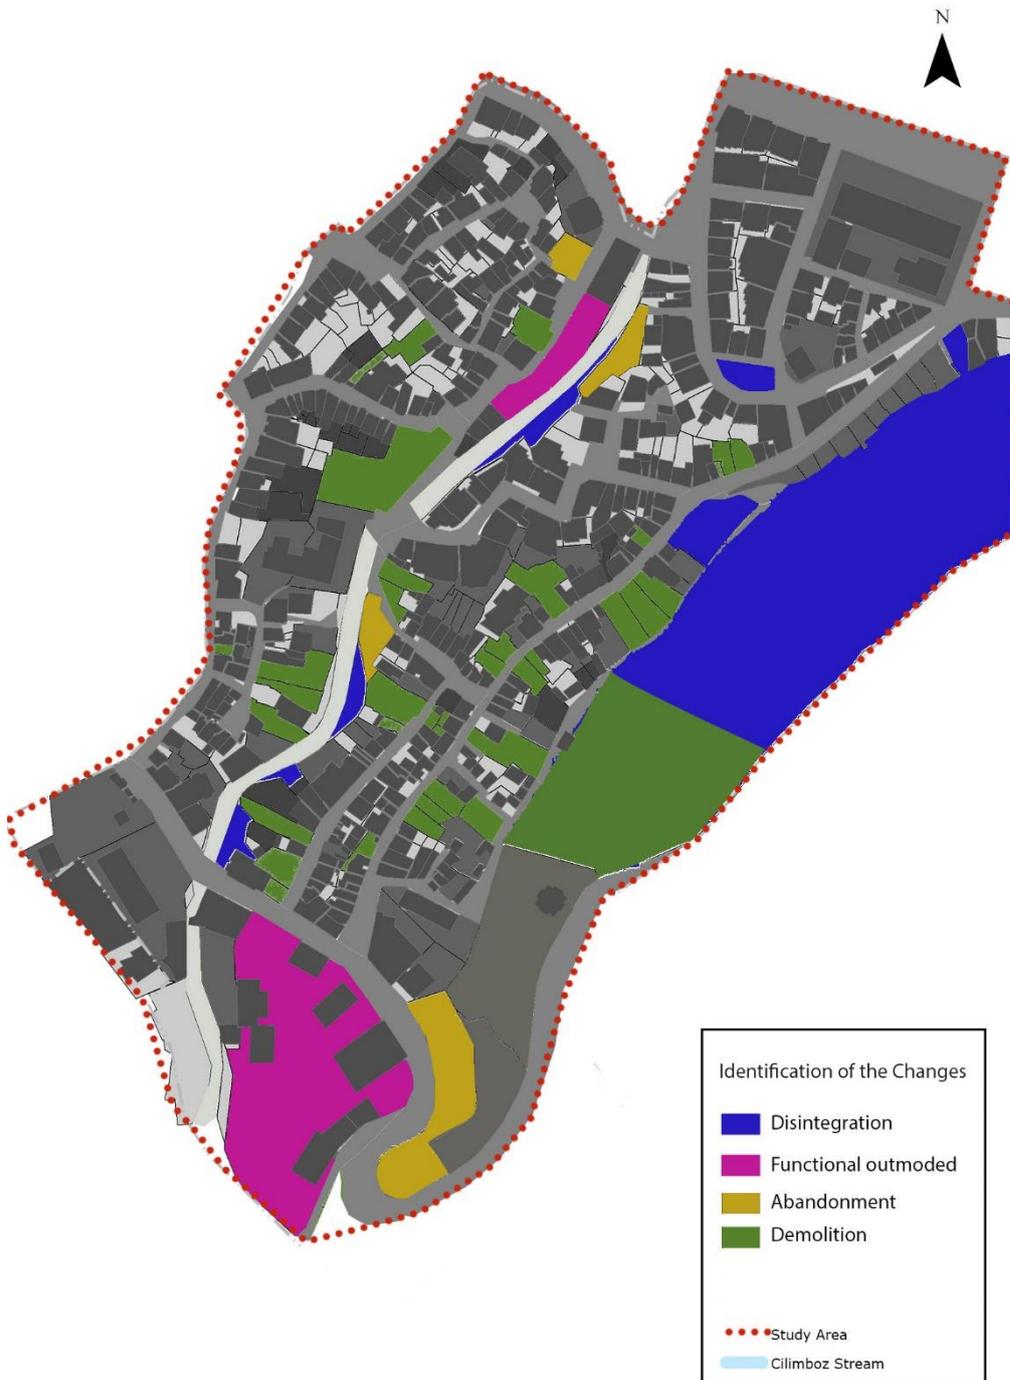
Figure 3.41 Identification of the changes in Yahşibey (Arslan Sönmez,2015)

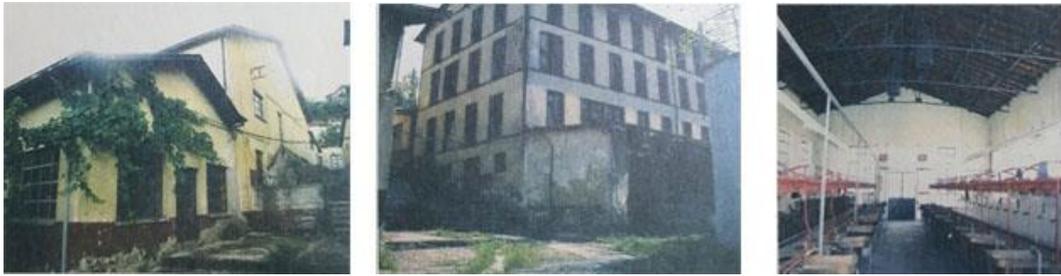
In the present, traditional houses with silk production space and orchard areas, especially around Yahşibey street. Additionally, Romangal Silk factory (Figure 4.1) which preserved some of its production spaces and elements in respect to understand the process of silk production and Fabrika-i Hümayun Silk factory which was restored and re-used as university in Kaplıca street, has most important historic, cultural and educational values for the area. Moreover, the other two

Figure 4.1 Turgut Yılmazipek Silk Factory -Romangal Silk Factory-. (Aydın, 2007)

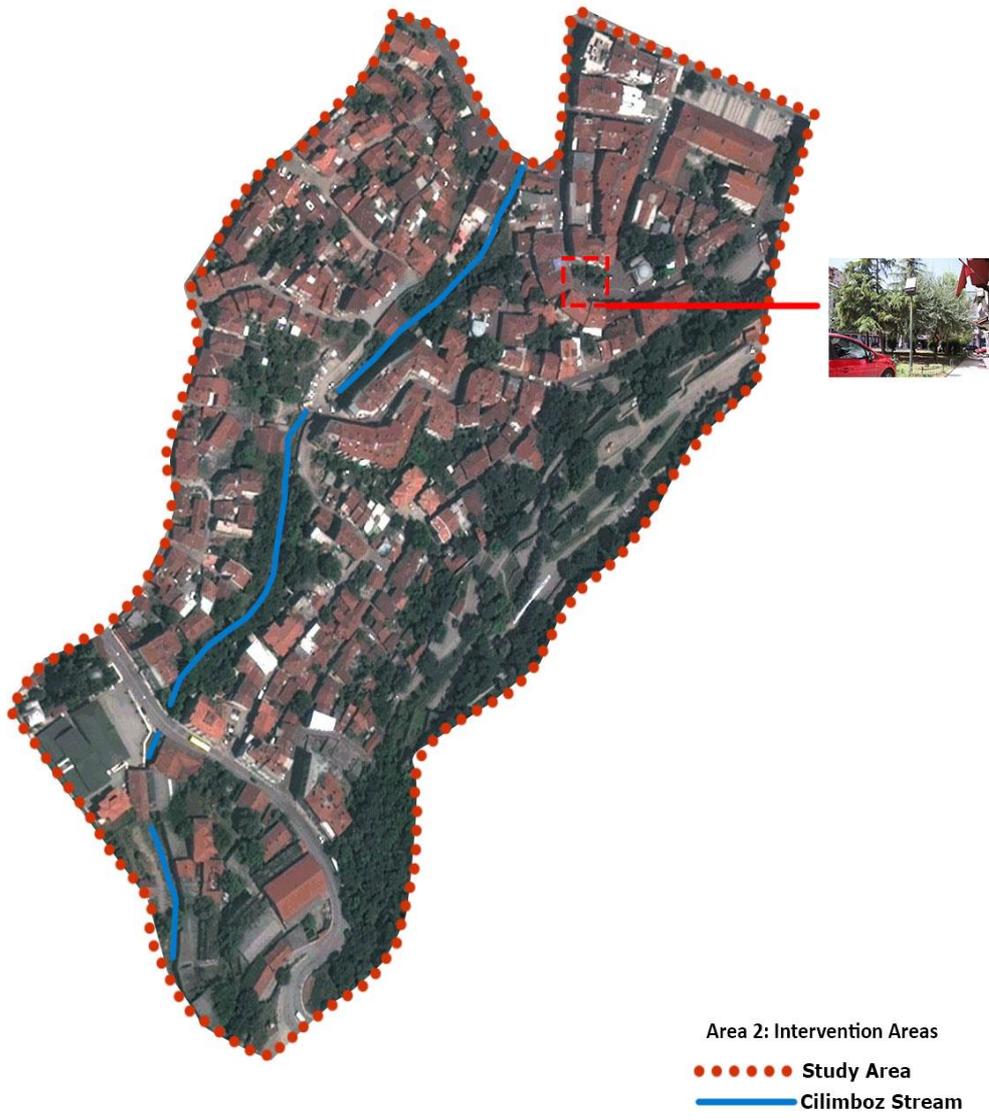
Figure 4.4 Action area 2.⁴⁰

Area 2: Area comprises of the west side of the Yahşibey street and the east side of the Cilimboz streambank which mostly contains residential fabric in Yahşibey. Within the area, there is a public open space which is unqualified and located in front of the Altıparmak Mosque on Bozkurt street. As stated in the Suphi Bey Map, area was functioned as cemetery. However, depend on the 1939 Cadastral Map area lost its function but preserved its open feature. In the current situation area is not in actively used because of its religious value. Therefore, area can be **rehabilitated** with landscape intervention. Within the conservation intervention, rehabilitation and the integration with its surrounding of natural features are the main aims of this interventions. (Figure 4.4).

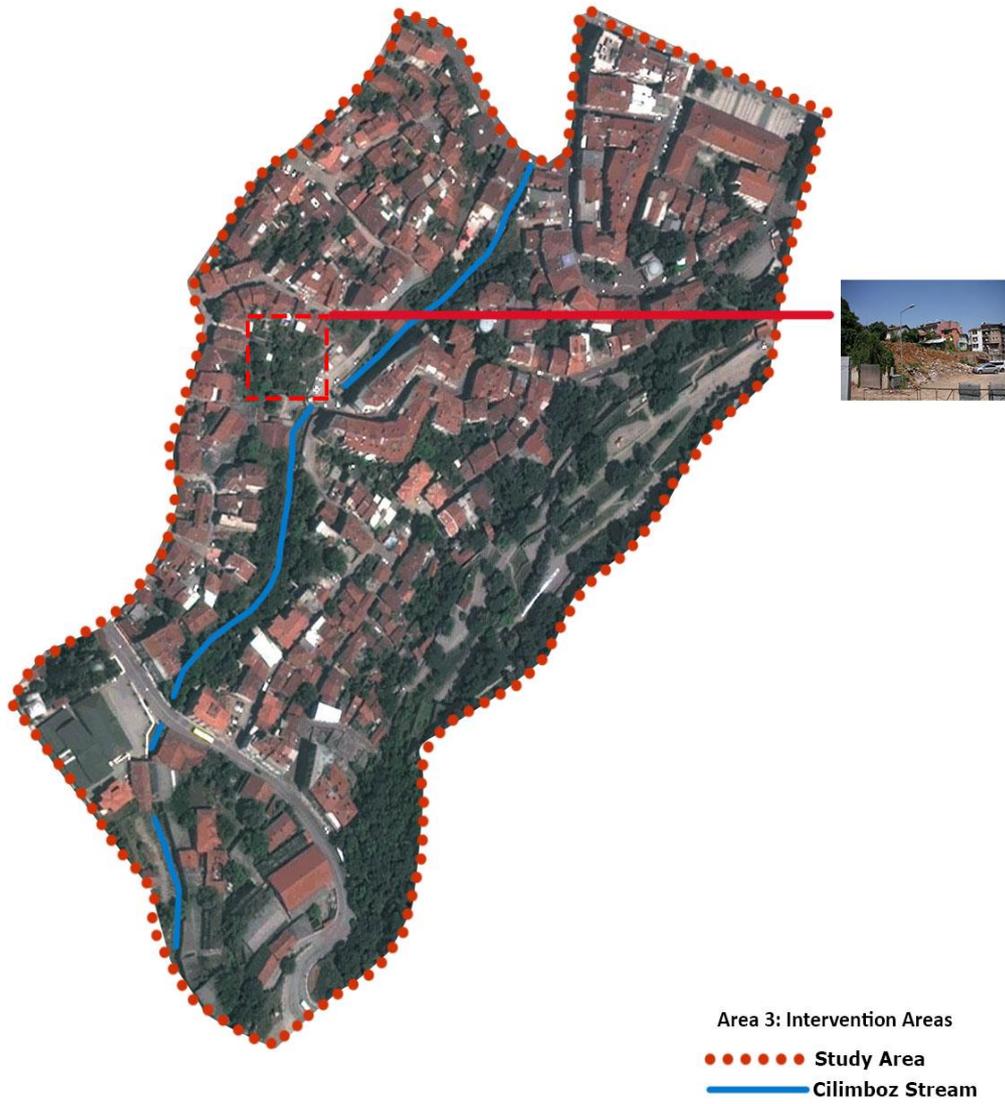
Figure 4.5 Action area 3.⁴¹

the lost silk heritage of the area and integrate the historic context with contemporary functions (Figure 4.5).

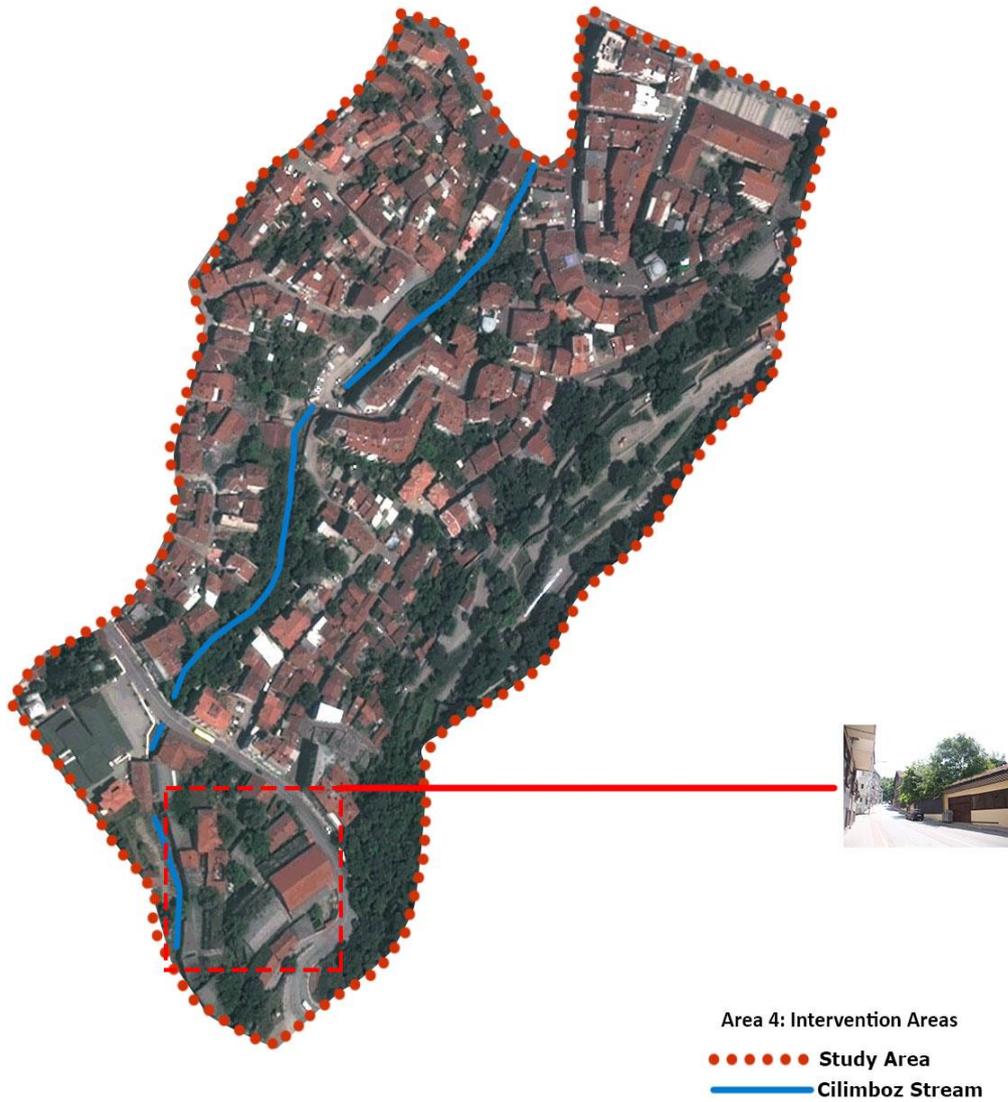
Figure 4.6 Action area 4.⁴²

Consequently, comprehensive landscape intervention into the Romangal Silk factory can be enabled to regain and integrate the historic and cultural values of the area with minimum, ecological, reversible and sustainable solutions. Most importantly, interventions revitalize and reconnect the area with contemporary urban life within the natural dissolution process of the outmoded industrial complex (Figure 4.6).

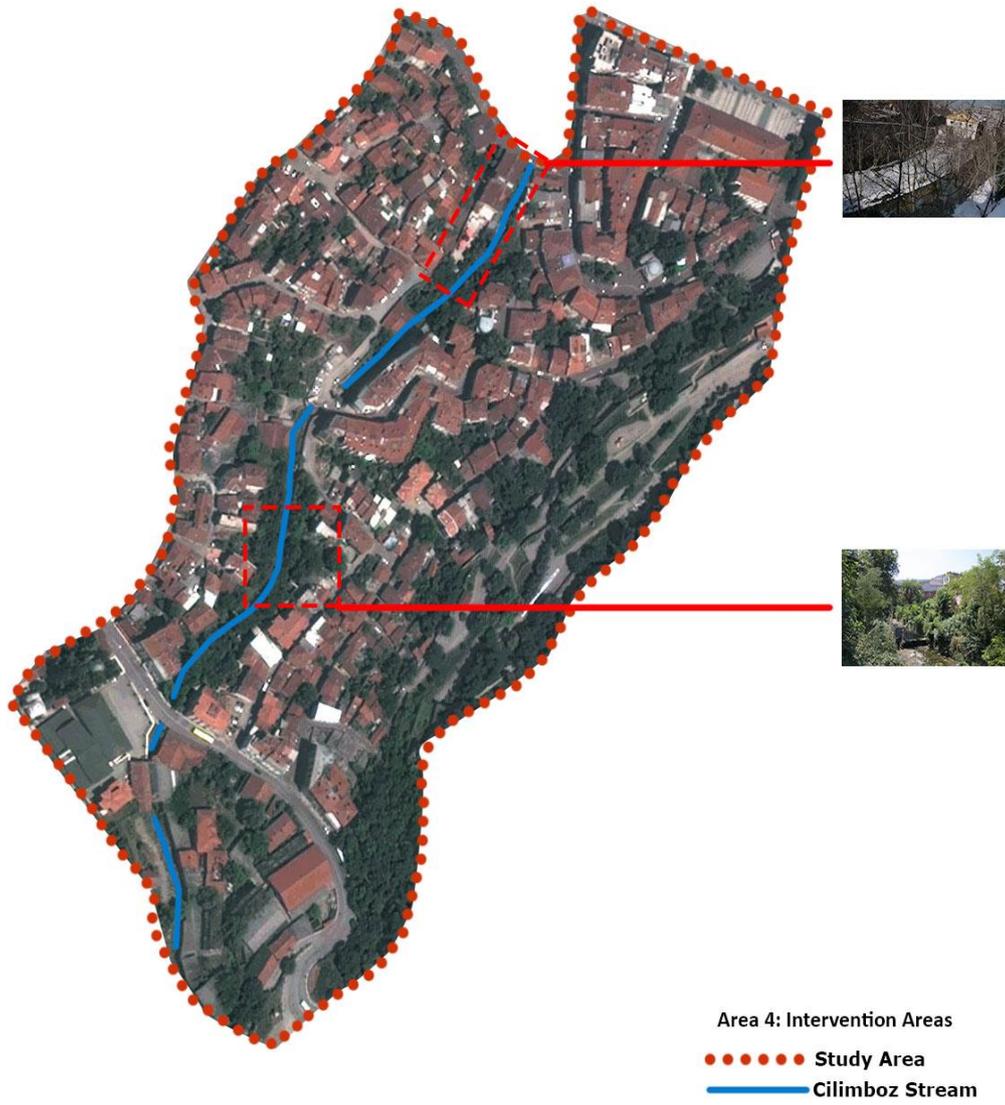
Figure 4.7 Action area 5.⁴³

Area 5: Area comprises of Cilimboz stream, its streambank and the former mill complex which has physically and functionally direct relationship with the stream. These interrelated areas defined as problematic open areas in previous section depend on abandonment and functional outmoded. Within this frame, abandoned Cilimboz stream and streambank degraded natural values can be **rehabilitated** based on ecological and sustainable solutions. As a model for Cilimboz rehabilitation, recovery of the irrigation system of the spa allotment in Caldes de Montbui, as defined in Chapter 2, can be used for natural rehabilitation approach. Therefore, the contaminated stream water and polluted streambank may be rehabilitated with ecological approaches which enables to use plants to clean the water and soil system without interfering the natural environment of the area. Therefore, the intervention aims to enable sustainable, economic and ecological solutions while regaining the historic value and strengthening the natural environment of the area.

In conjunction with the Cilimboz stream rehabilitation, the former mill complex can be intervened with the **adaptive reuse** conservation intervention. In this sense, existing natural and structural compounds may be used to restore and regain the value of the area. Rehabilitation of the natural structure can be implemented in collaboration with Cilimboz stream's remediation to support each other's process and to strengthen their relationship. As a comprehensive intervention, should concern regaining the natural and historic values of the area with sustainable and ecological solutions without interfering the natural process of the area (Figure 4.7).
