## Risk Assessment and Design of Prevention Structures for Enhanced Tsunami Disaster Resilience (RAPSODI)/Euro-Japan Collaboration

Coastal Engineering Journal, Vol. 58, No. 4 (2016) 1640012 (37 pages)

The 2011 Tōhoku event showed the massive destruction potential of tsunamis. The Euro-Japan “Risk assessment and design of prevention structures for enhanced tsunami disaster resilience (RAPSODI)” project aimed at using data from the event to evaluate tsunami mitigation strategies and to validate a framework for a quantitative tsunami mortality risk analysis. Coastal structures and mitigation strategies against tsunamis in Europe and Japan are compared. Failure mechanisms of coastal protection structures exposed to tsunamis are discussed based on field data. Knowledge gaps on failure modes of different structures under different tsunami loading conditions are identified. Results of the wave-flume laboratory experiments on rubble mound breakwaters are used to assess their resilience against tsunami impact. For the risk analysis, high-resolution digital elevation data are applied for the inundation modeling. The hazard is represented by the maximum flow depth, the exposure is described

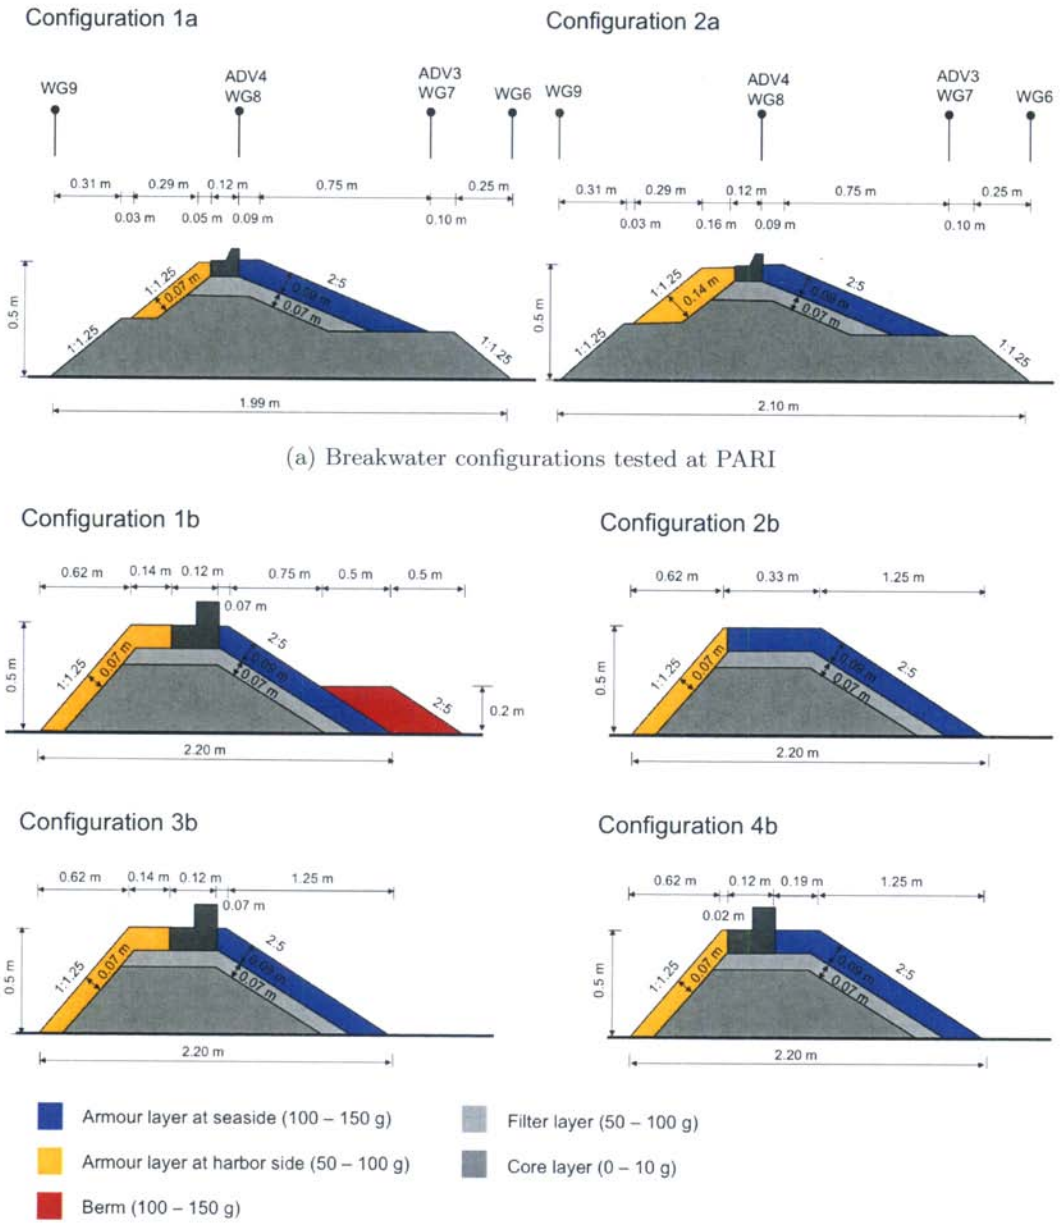
(b) Breakwater configurations tested at TU-BS

Fig. 5. Configurations of rubble mound breakwaters tested at (a) PARI with the locations of instruments: (configuration 1a) original breakwater configuration and (configuration 2a) improved configuration with doubled leeward layer [Guler *et al.*, 2015], and (b) TU-BS: (configuration 1b) with a berm and a crown wall unit, (configuration 2b) without a crown wall unit, (configuration 3b) with a crown wall unit corresponding to the prototype of Haydarpaşa breakwater, Istanbul, Turkey and (configuration 4b) with a shifted crown wall unit [LWI, 2015a]. Not to scale.

slope of thickness of 0.09 m with armor weight from 100 to 150 g, and harbour slope of thickness of 0.07 m (0.14 m in the breakwater of the improved stability, Fig. 5(a), configuration 2a) with armor weight from 50 to 100 g (Fig. 5(a)). The breakwater model was 0.52 and 0.50 m high on sea- and harbor side, respectively, with length of its crown of 0.12 m. The length of breakwater basis was 1.99 m (2.1 m in the breakwater of the improved stability) with the slopes of 1:1.25 and 2:5, and 1:1.25 on sea and harbor sides, respectively. The crown wall, placed on the breakwater crown, consisted of four concrete units, each 0.19 m wide, 0.12 m long, and 0.12 m high (Fig. 6(a)). Performance of the original breakwater model (configuration 1a) was examined under two flow regimes: solitary-like waves with the heights of 0.05, 0.075, and 0.1 m, and constant overflow with depths ranging from 1.1 to 1.95 cm above the breakwater crown wall units, while the breakwater with the improved cross-section (configuration 2a) was examined solely under constant overflow of flow depths from 1.5 to 4.6 cm above the crown wall units. The measuring technique employed in the experiments encompassed 8 wave gauges (WGs) measuring water free surface elevations, 4 ADV-type current meters recording flow velocities as well as 9 miniature pressure sensors (PSs) placed on the crown wall unit. The locations of the instruments are depicted in Figs. 4–7. Guler *et al.* [2015] provide the results of the experiments at PARI in detail.

In addition, four variations of the breakwater prototype with simplified geometries were examined at TU-BS (Fig. 5(b)) [LWI, 2015a]. The configurations were breakwater with a berm and a crown wall unit (configuration 1b), breakwater without a crown wall unit (configuration 2b), breakwater with a crown wall unit (configuration 3b, corresponding to the prototype of Haydarpasa), and breakwater with a

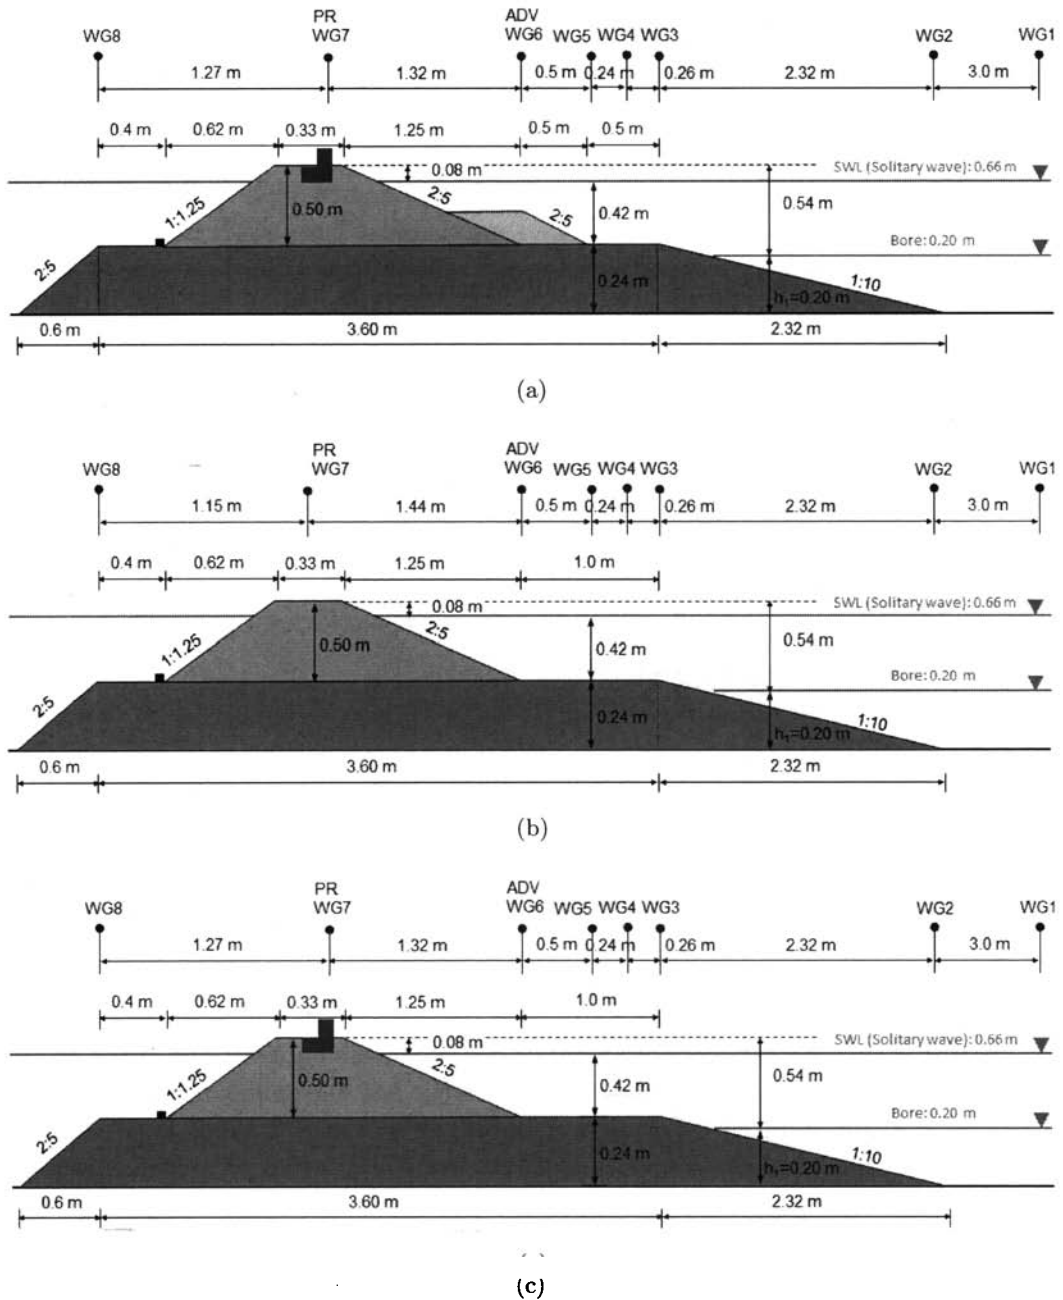
Fig. 7. Experimental setup details with measurement locations at TU-BS [LWI, 2015a].

Fig. 7. (Continued)

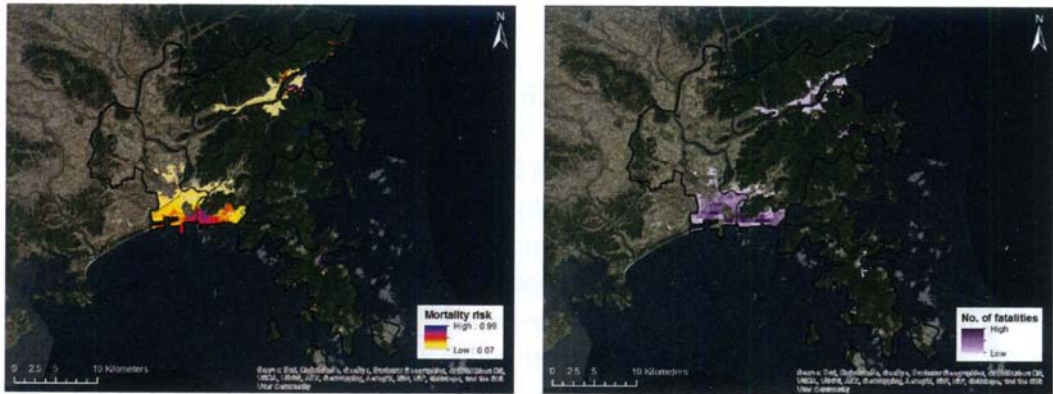
Fig. 11. Tsunami mortality risk map (left panel) and map depicting estimated number of fatalities (right panel). Black line = Ishinomaki city border.

Since the information to differ between low (0) and high (1) building vulnerability was not available, two different model runs were performed, i.e. the uniform building vulnerability was set to 0.25 and 0.5. These values correspond to the building ratio for buildings washed away for flow depths of about 3–4 m as presented by Suppasri *et al.* [2013]. Not including buildings that collapsed or were damaged without being washed away (i.e. using a low building vulnerability) is a rough proxy for not including the people that managed to escape before the impact of the tsunami. The resulting mortality risk map is presented in Fig. 11 (left panel).
